# **Annual Monitoring Report**

Monitoring Year 3 of 7

Pee Dee Stream Restoration Project

NCDMS Project No.: 95350

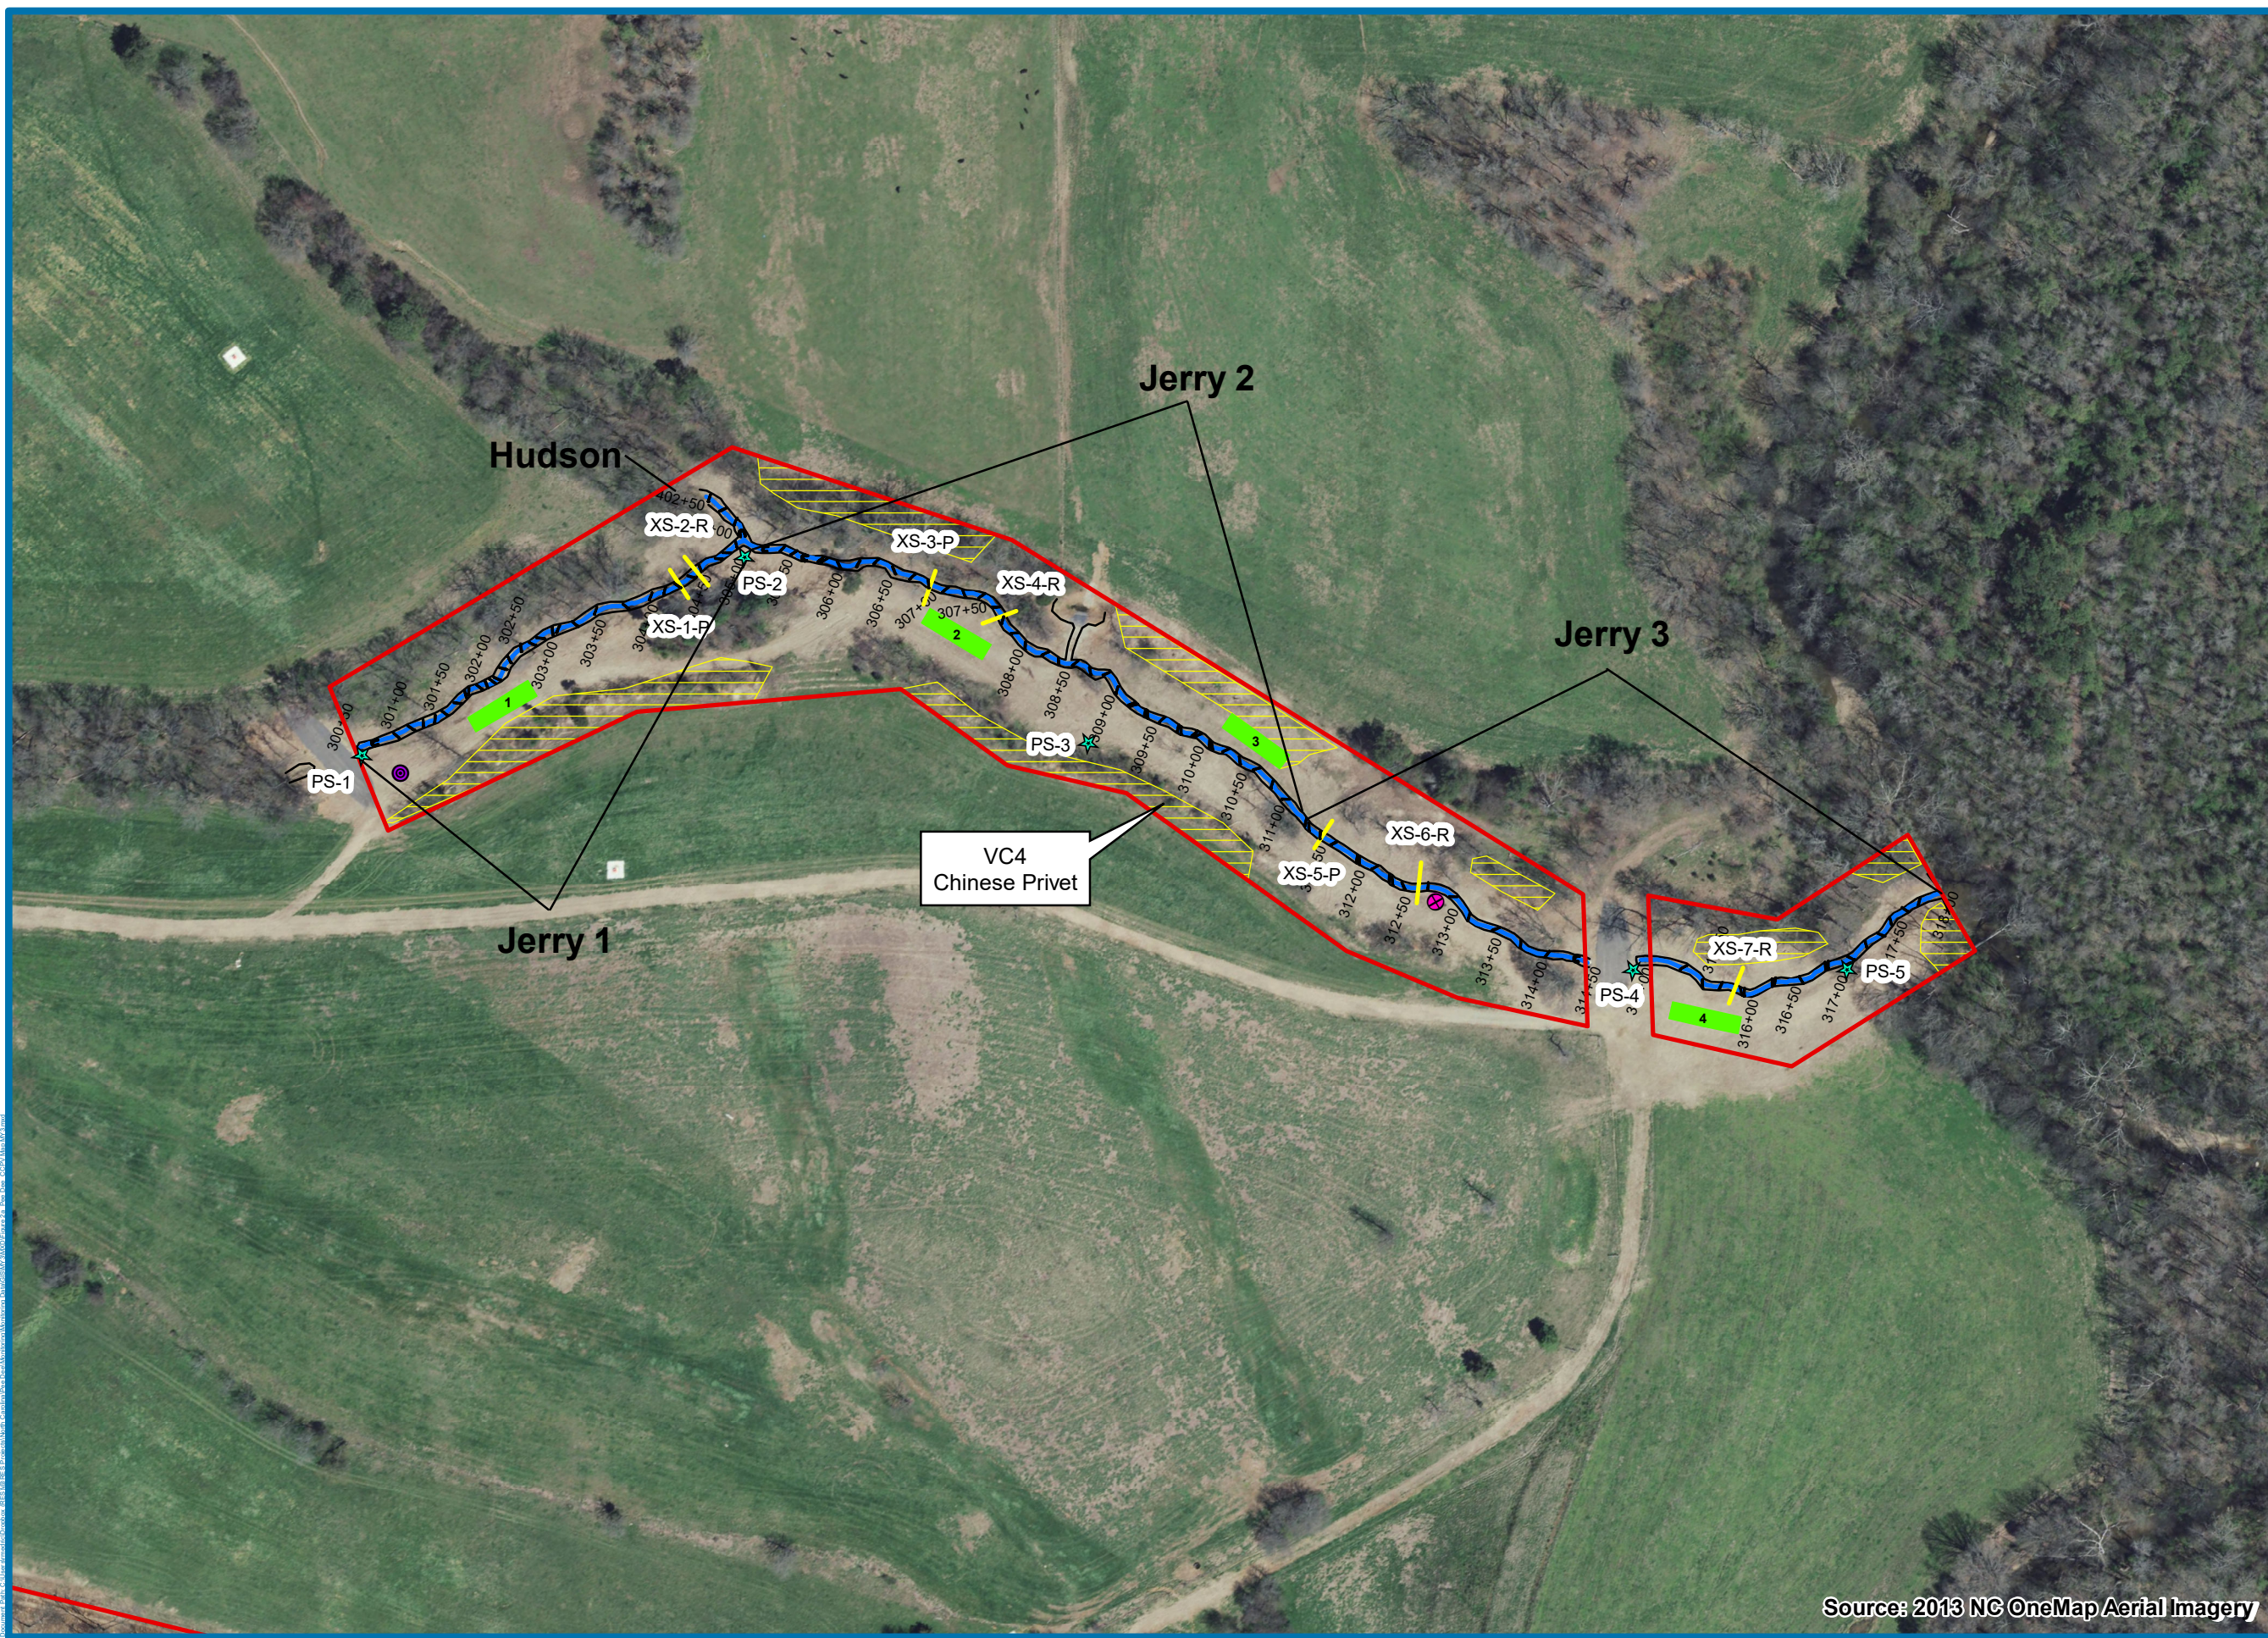
**Current Conditions  
Plan View Map**

**Vegetation Plot Success**

**Riparian Buffer Conditions**

Invasive Species	Target Community		
	Present	Marginal	Absent
Absent	No Fill	Yellow	Red
Present	Yellow	Green	Red
Common	Red	Green	Red

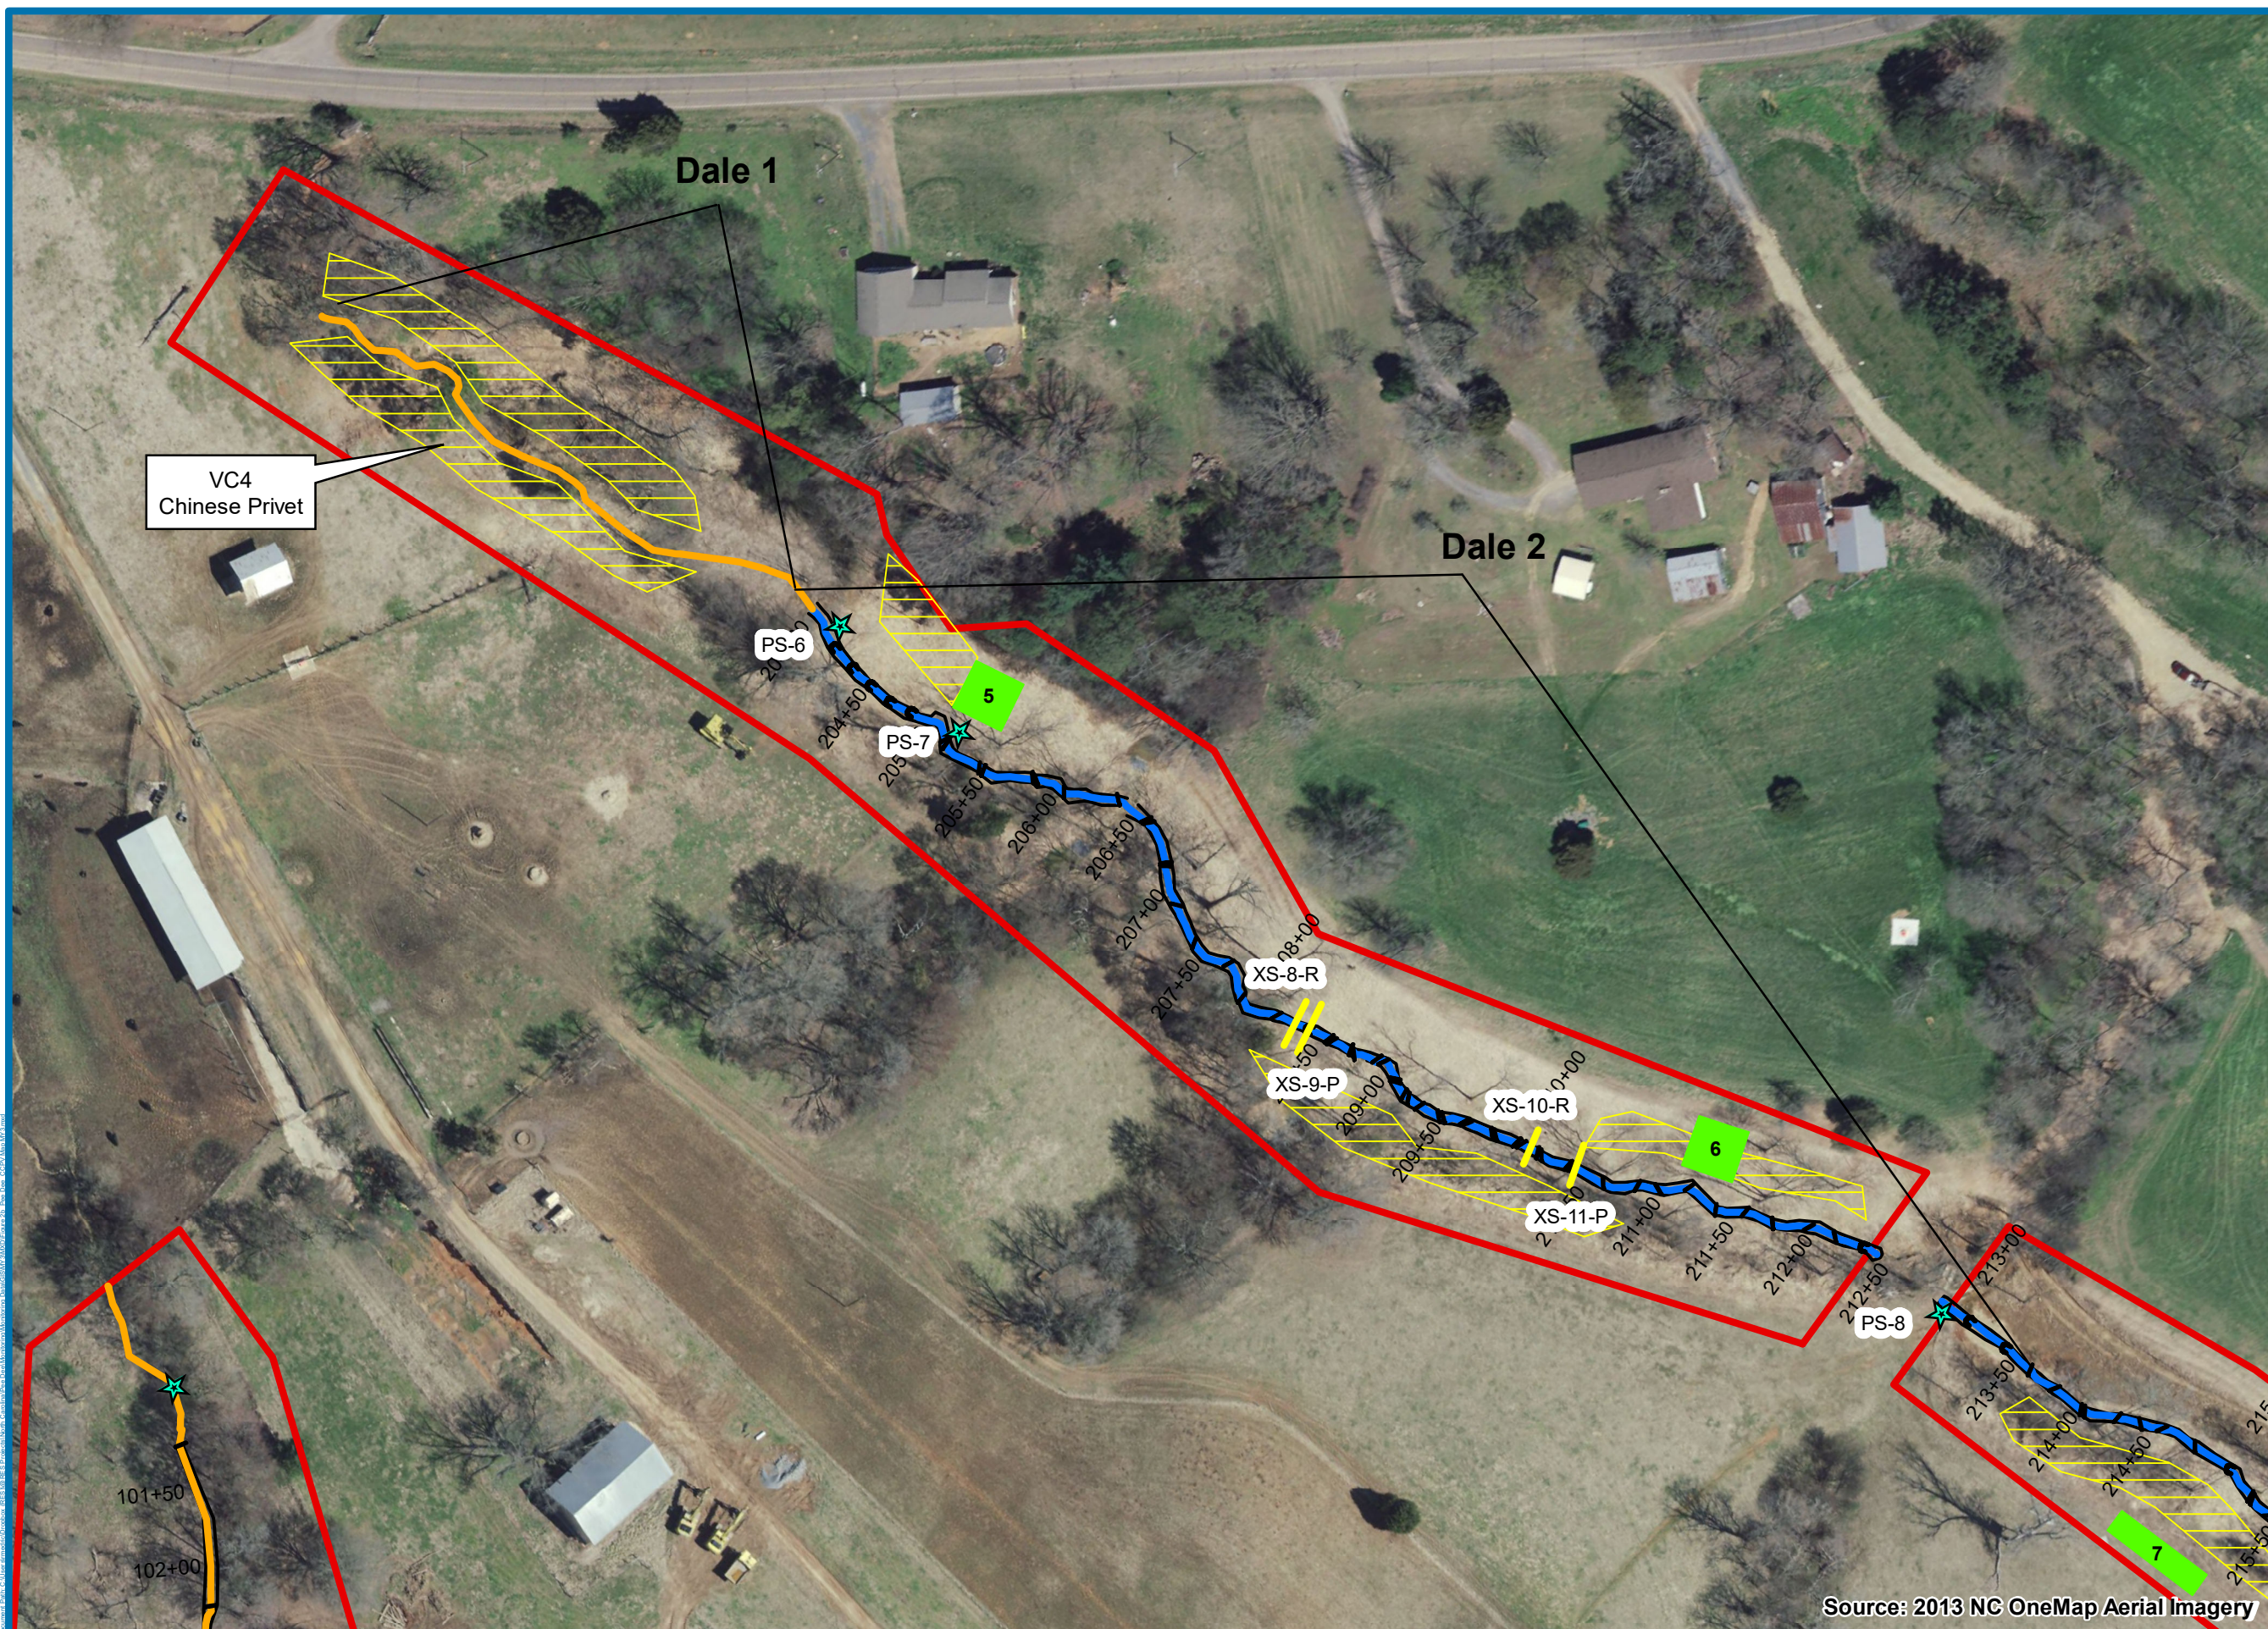
**Current Conditions  
Plan View Map**

**Riparian Buffer Conditions**

Invasive Species	Target Community		
	Present	Marginal	Absent
Absent	No Fill		
Present			
Common

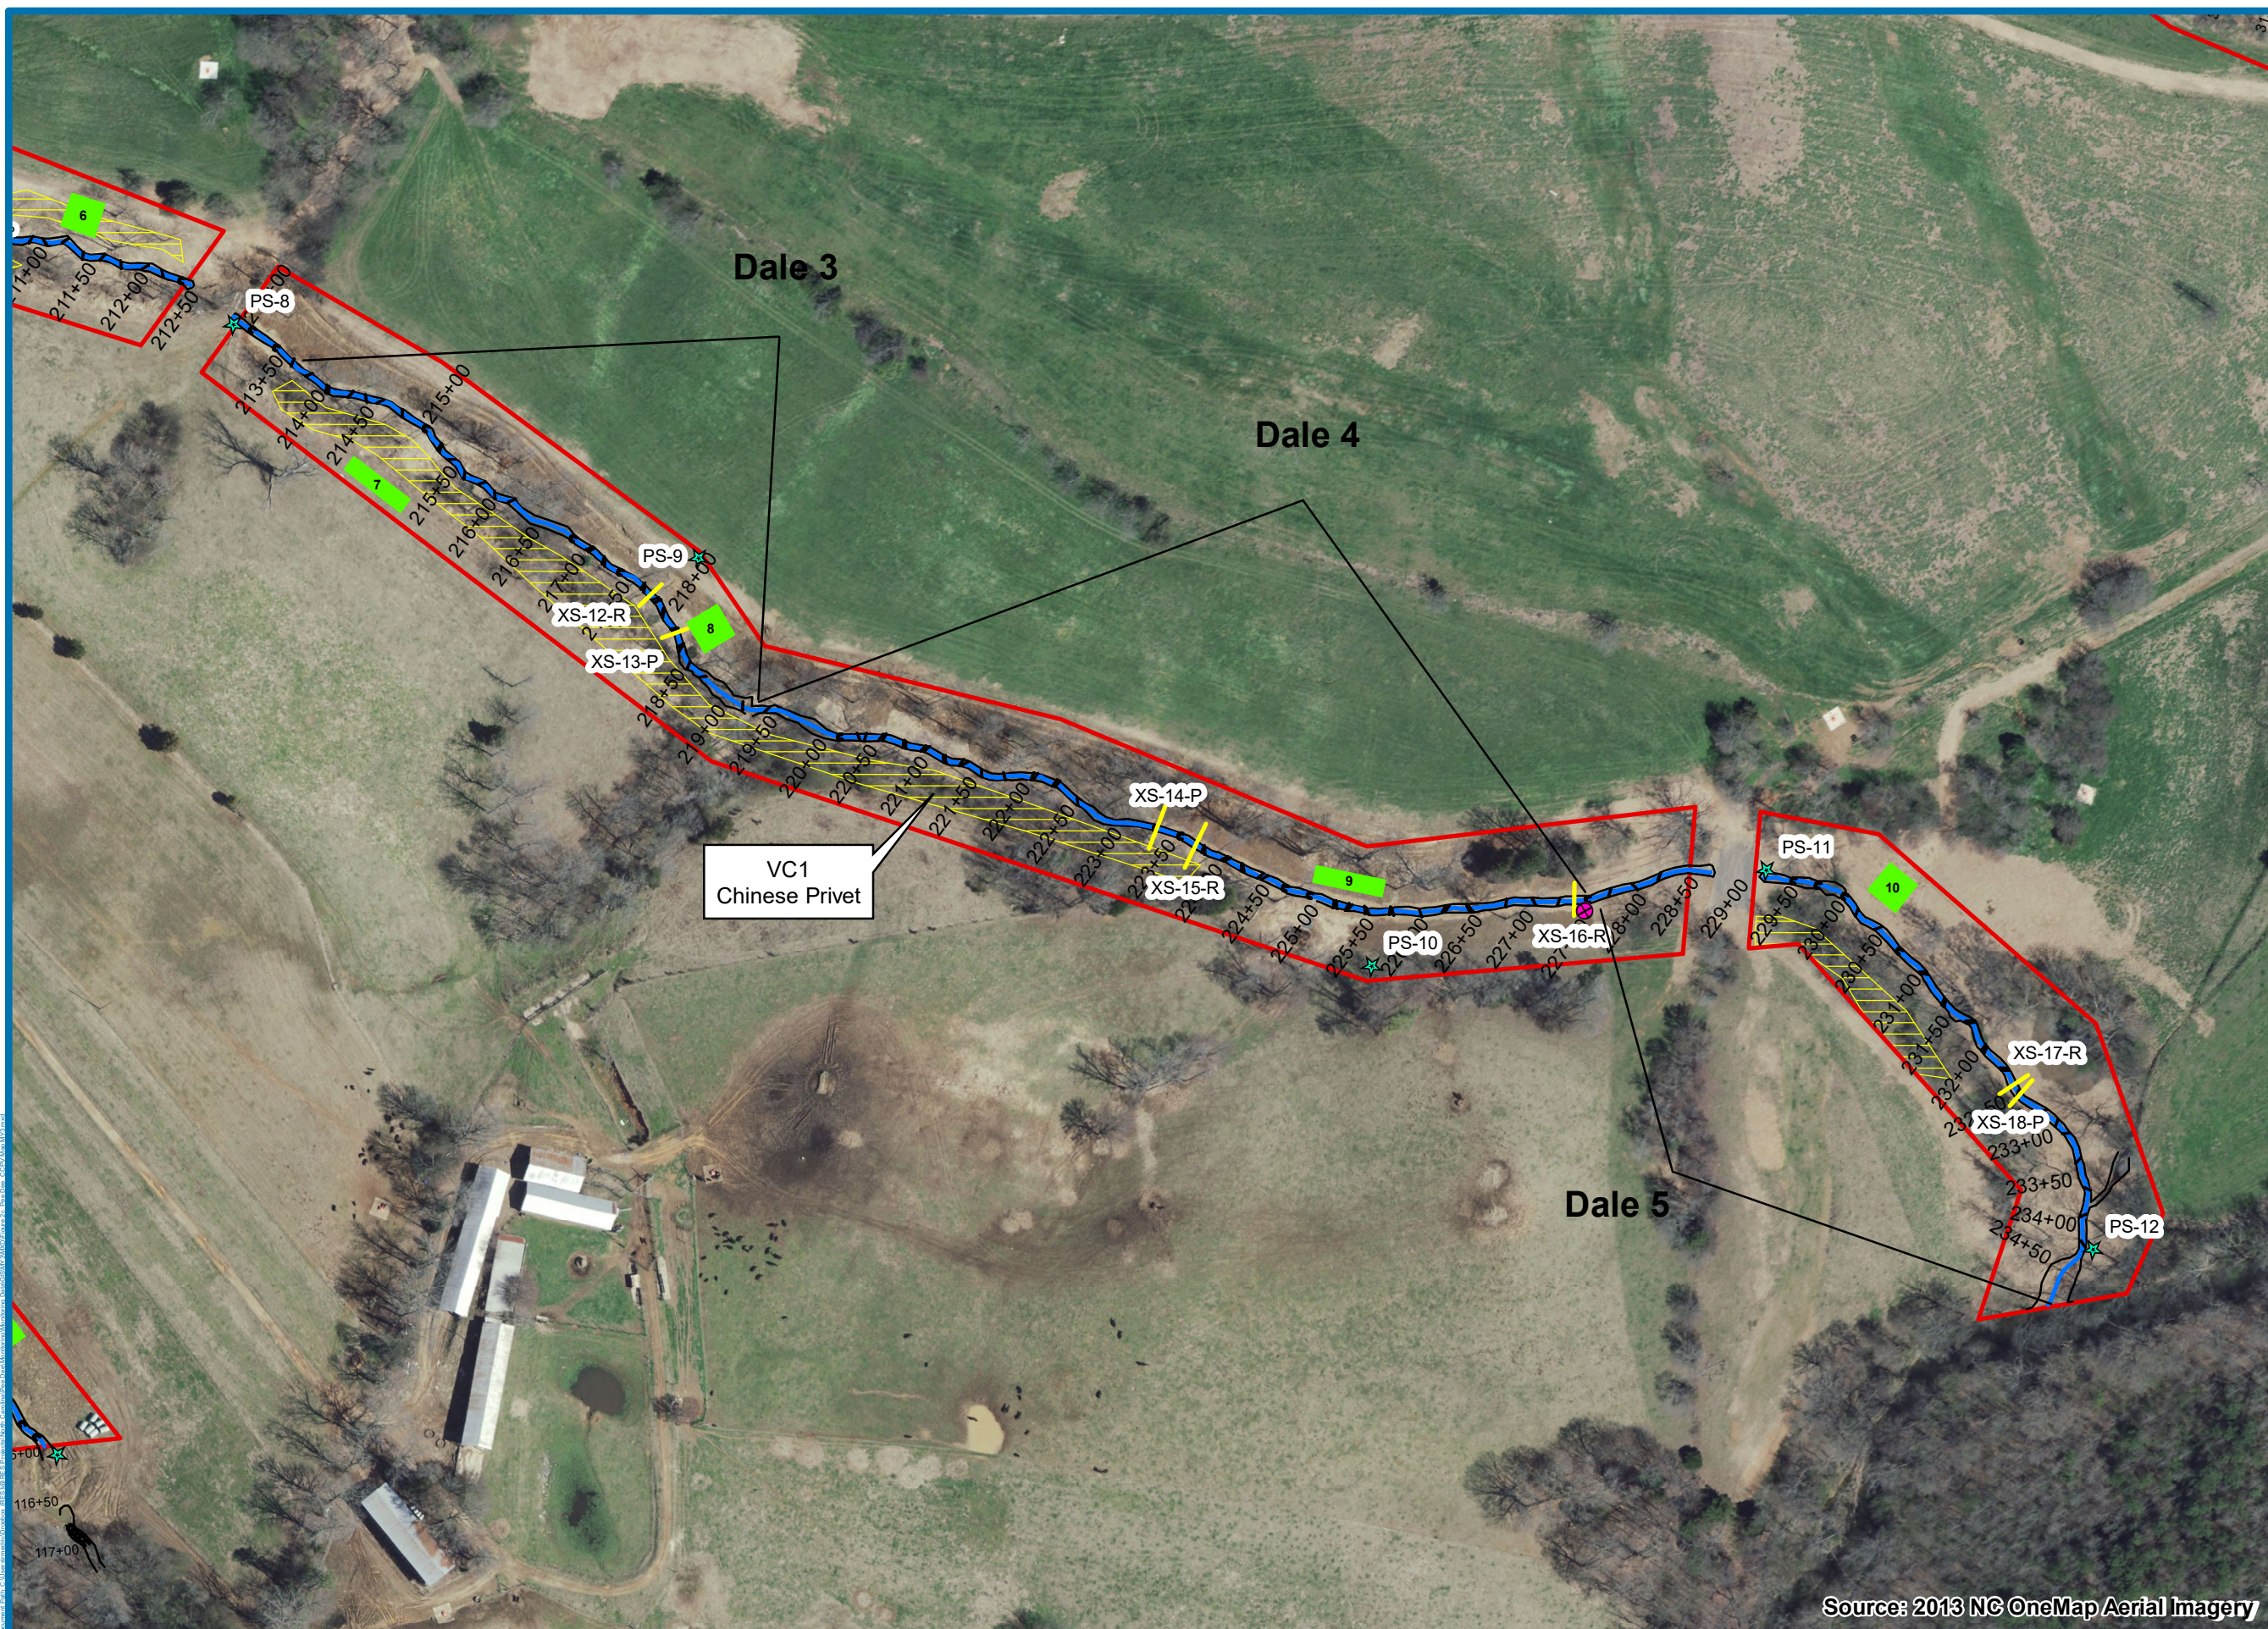
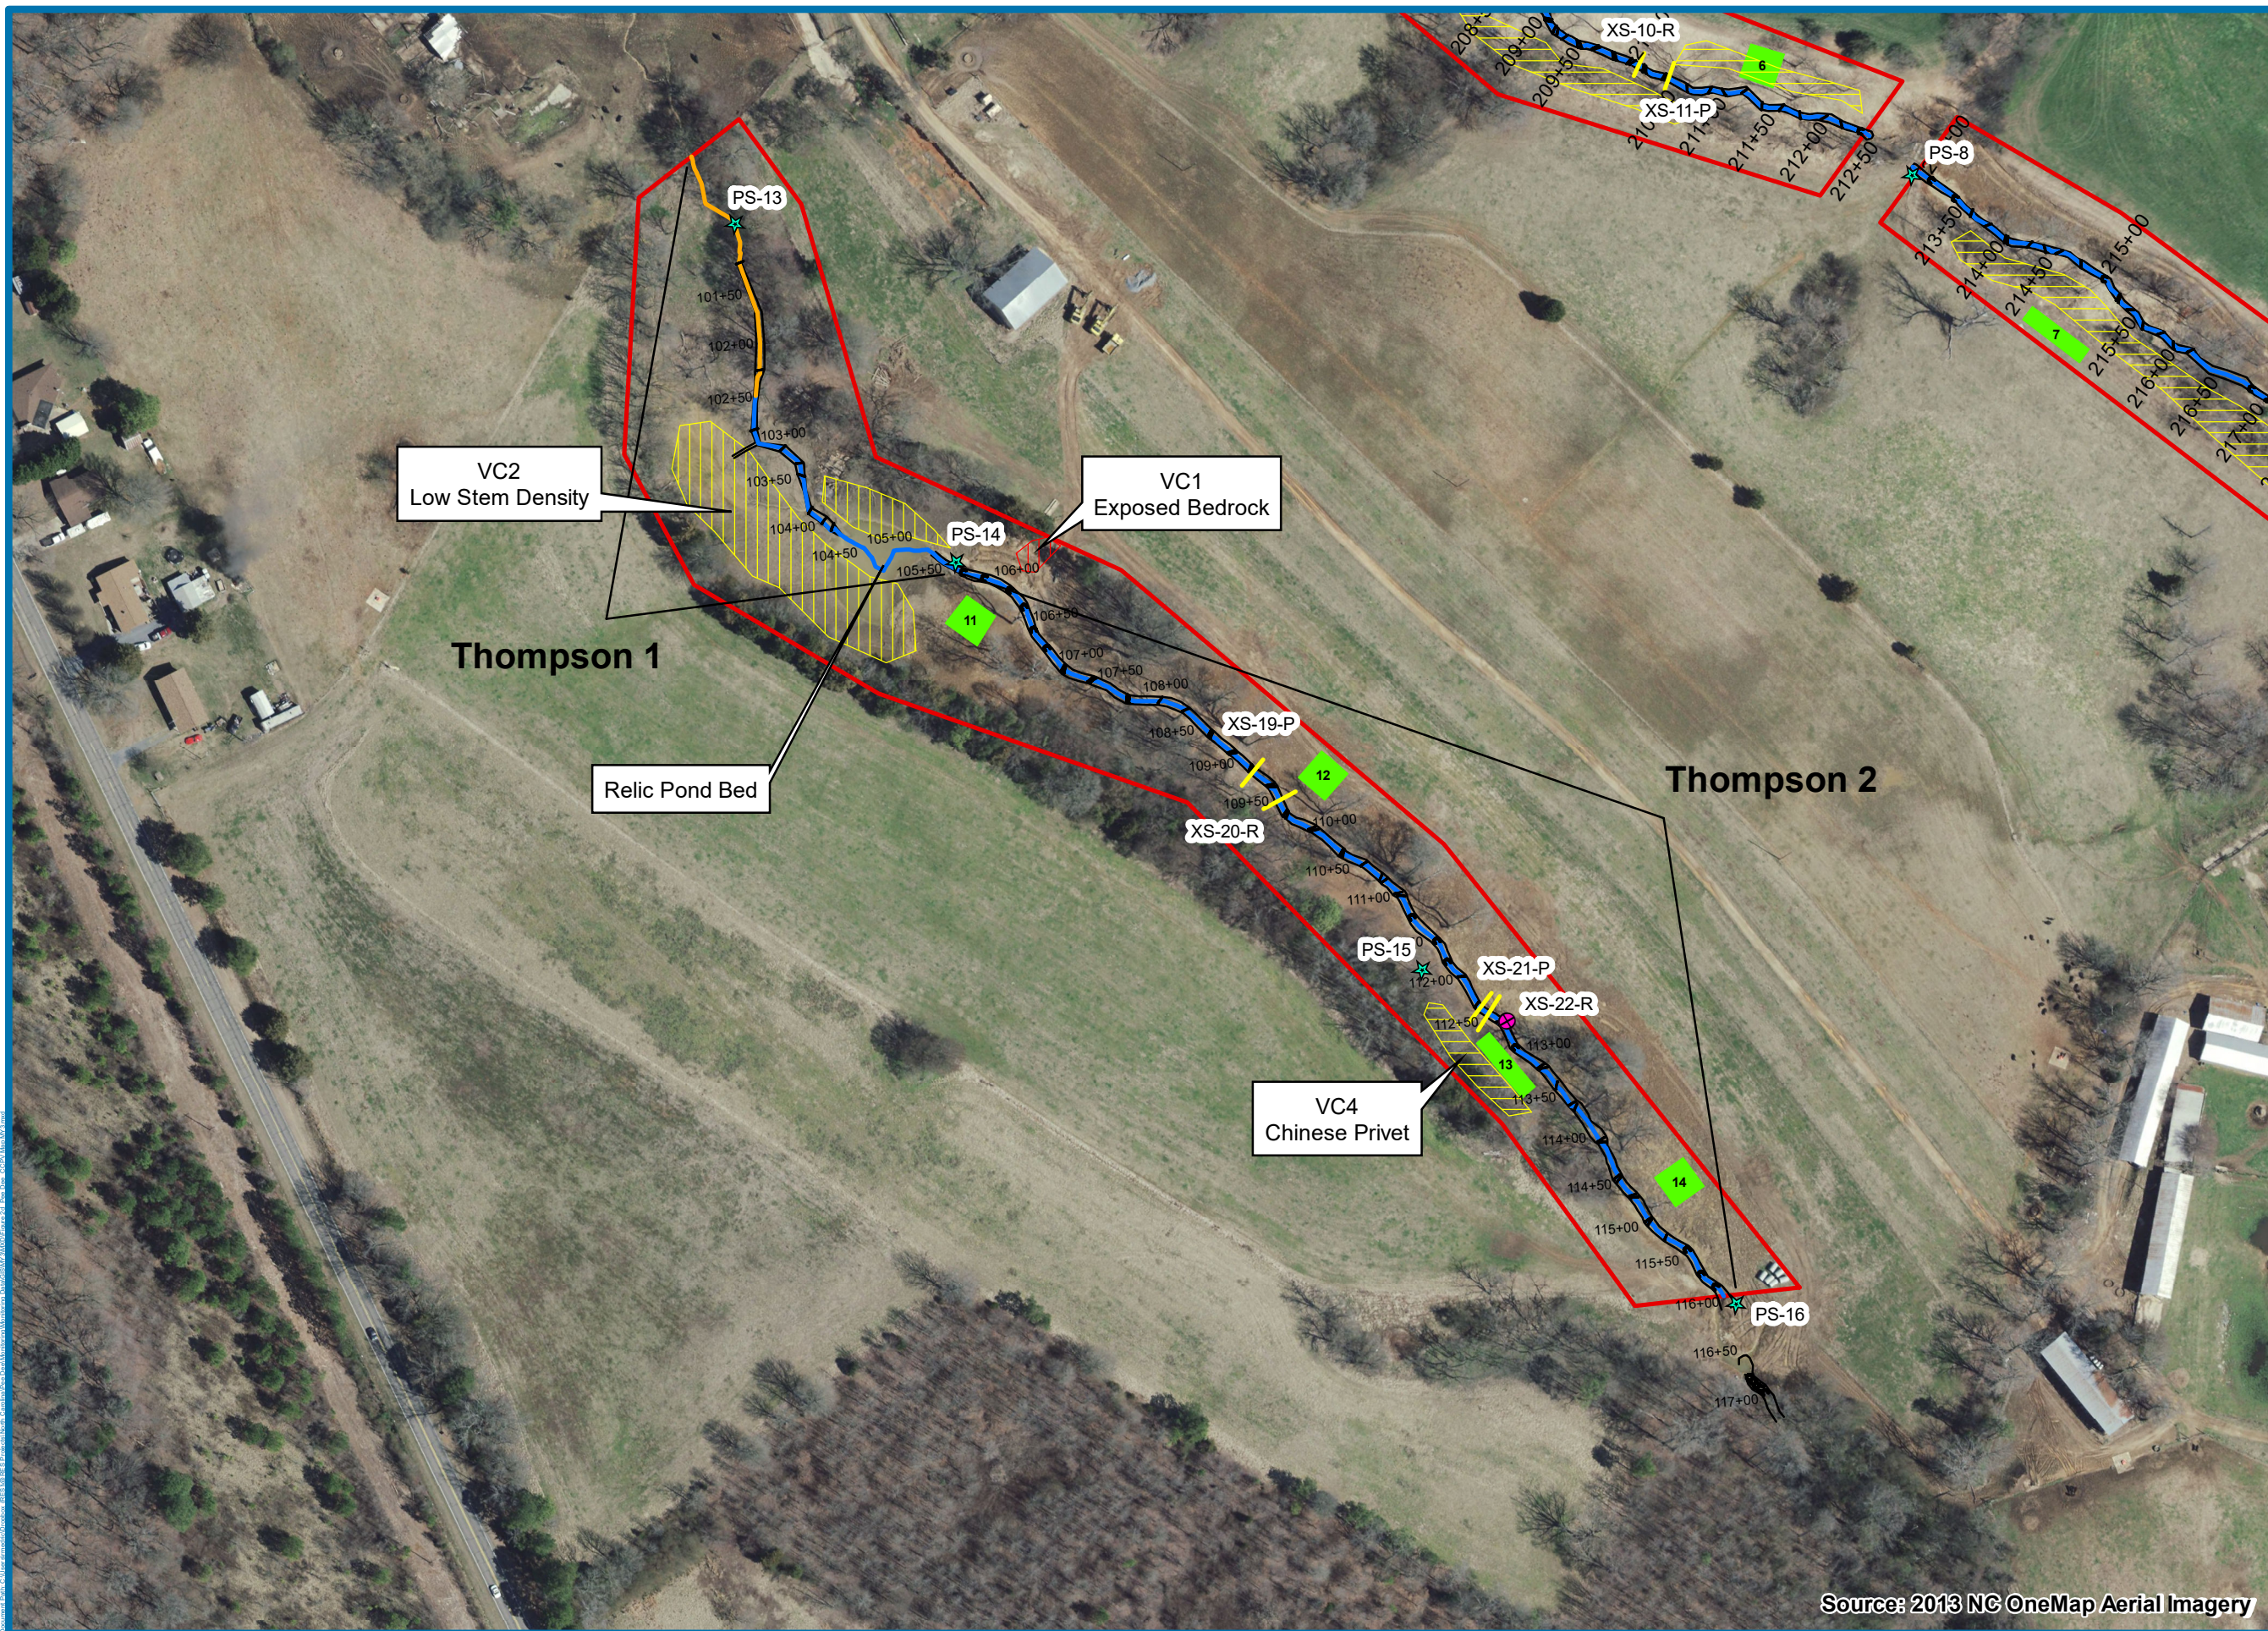
**Figure 2d**  
**Pee Dee Stream**  
**Restoration Project**  
**MY3 2017**  
**Current Conditions**  
**Plan View Map**

**Riparian Buffer Conditions**

Target Community		
		Present	Marginal	Absent
Invasive Species	Absent	No Fill	<span style="background-color: yellow;">■</span>	<span style="background-color: red;">■</span>
	Present	<span style="background-color: yellow;">■</span>	<span style="background-color: red;">■</span>	<span style="background-color: red;">■</span>
	Common	<span style="background-color: red;">■</span>	<span style="background-color: red;">■</span>	<span style="background-color: red;">■</span>

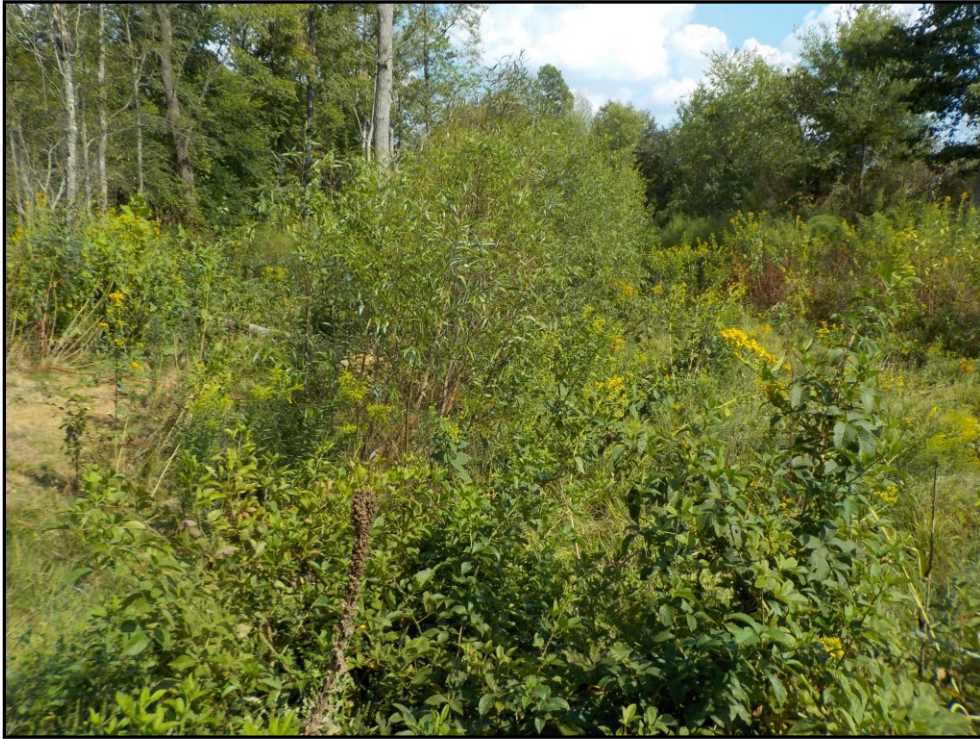
Jerry Branch – Permanent Photo Station 1  
Station 300+25 - Downstream  
September 20, 2017

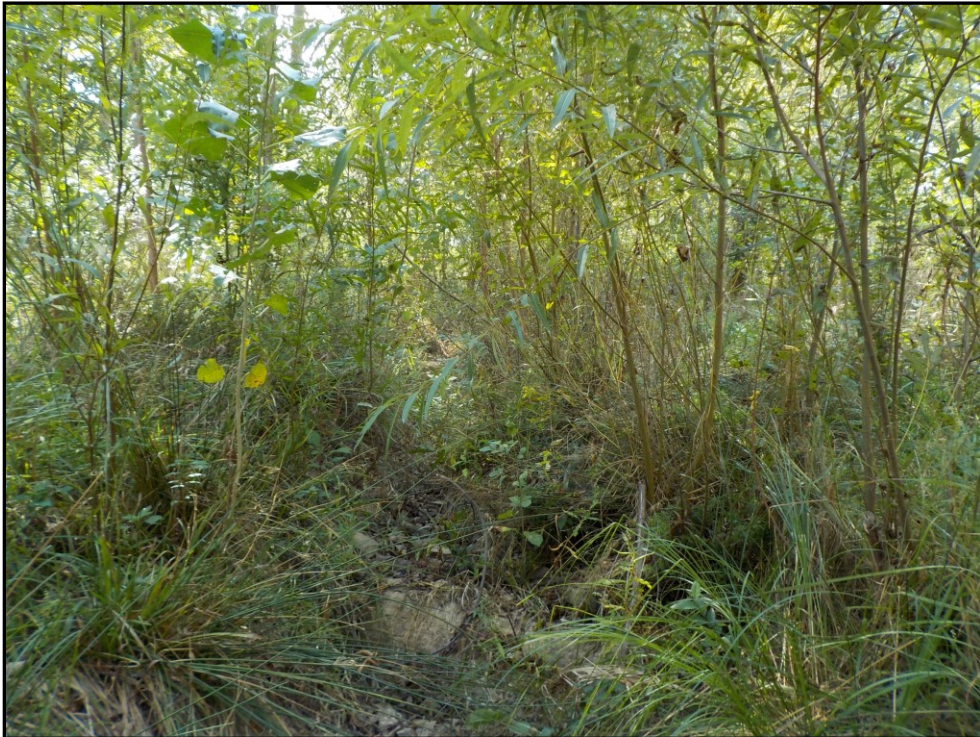
Jerry Branch – Permanent Photo Station 2  
Station 305+04 – Upstream  
September 20, 2017

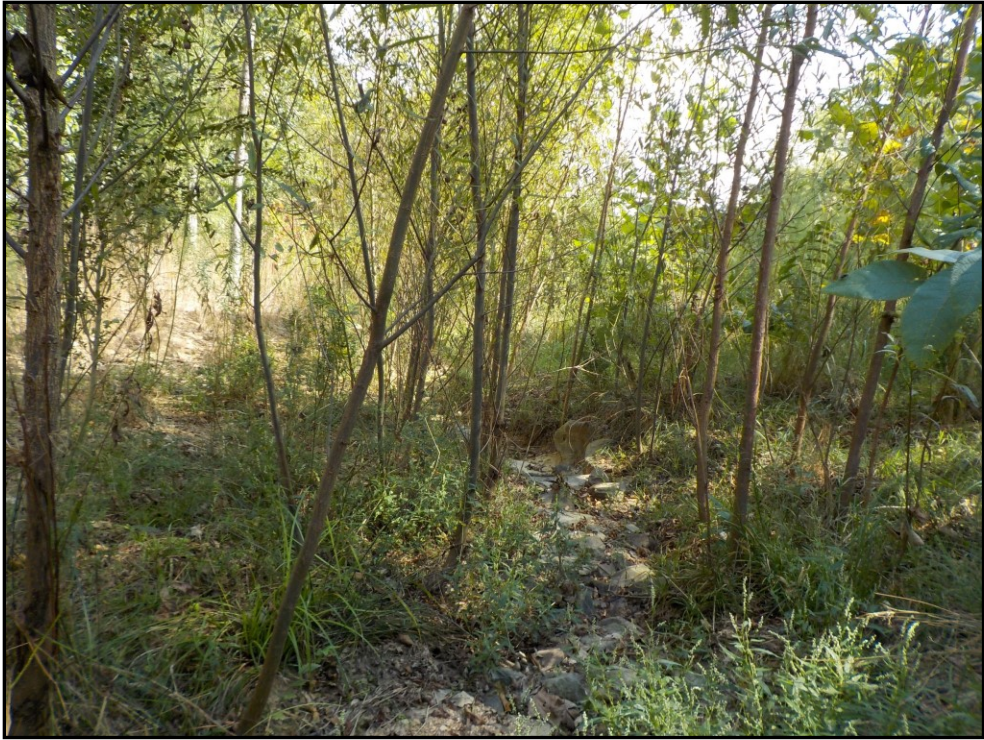
Jerry Branch – Permanent Photo Station 2  
Station 305+04 - Downstream  
September 20, 2017

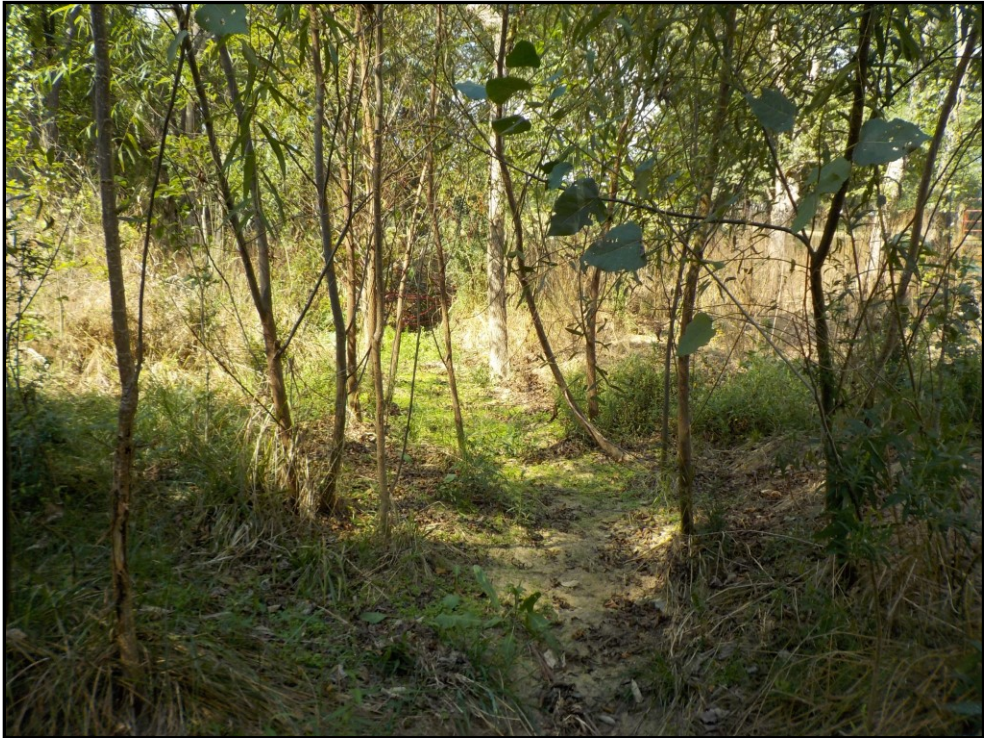
Hudson Branch – Permanent Photo Station 2  
Station 305+04 – Looking Upstream from Confluence with Jerry Branch  
September 20, 2017

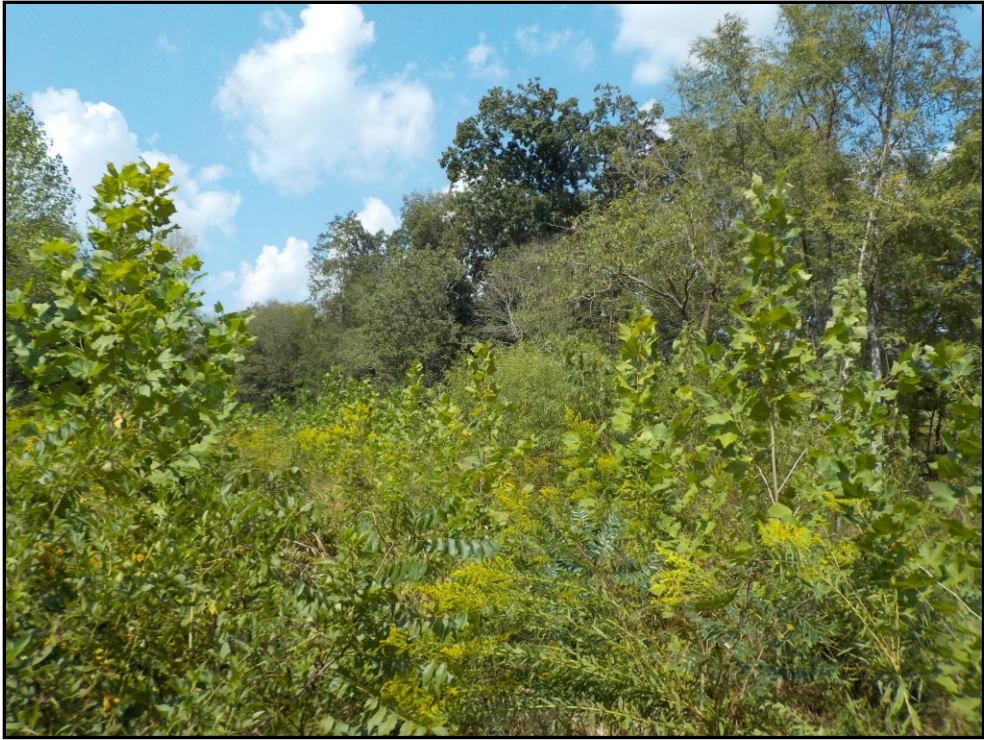
Jerry Branch – Permanent Photo Station 3  
Looking North Northwest/Upstream Jerry Branch  
September 20, 2017

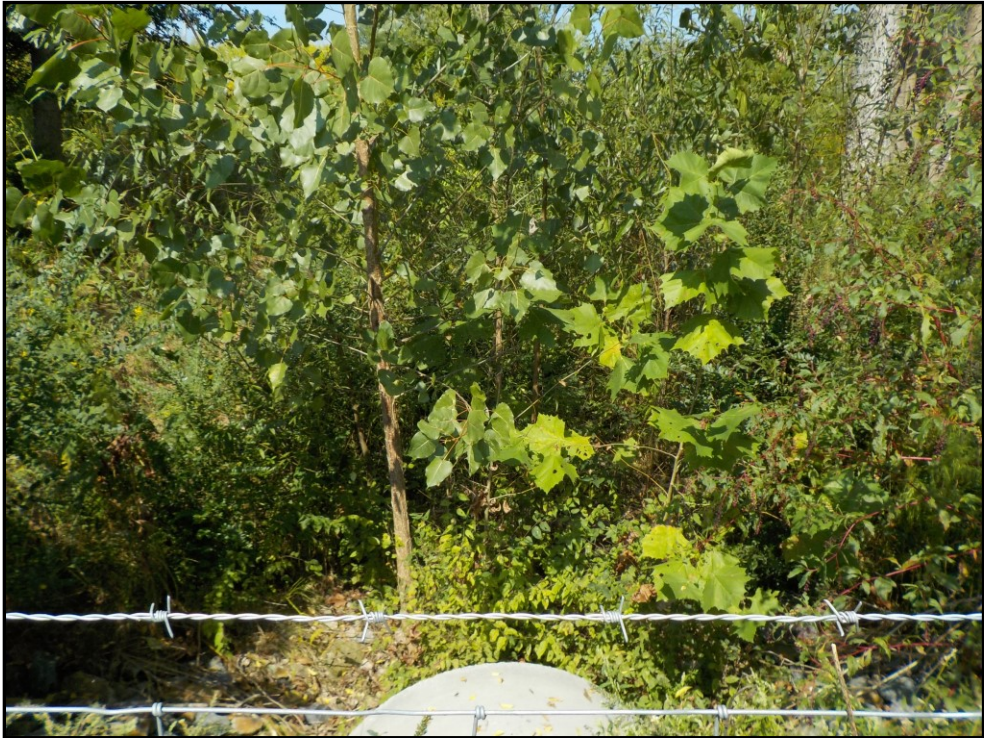
Jerry Branch – Permanent Photo Station 4  
Station 304+80 – Upstream  
September 20, 2017

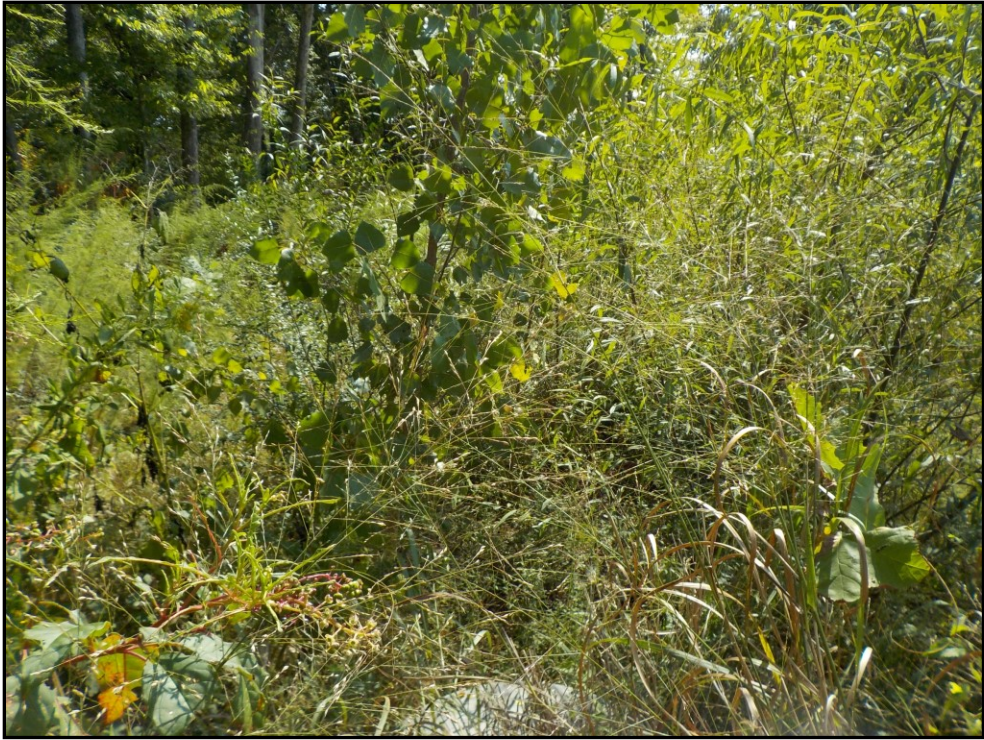
Jerry Branch – Permanent Photo Station 4  
Station 304+80 – Downstream  
September 20, 2017

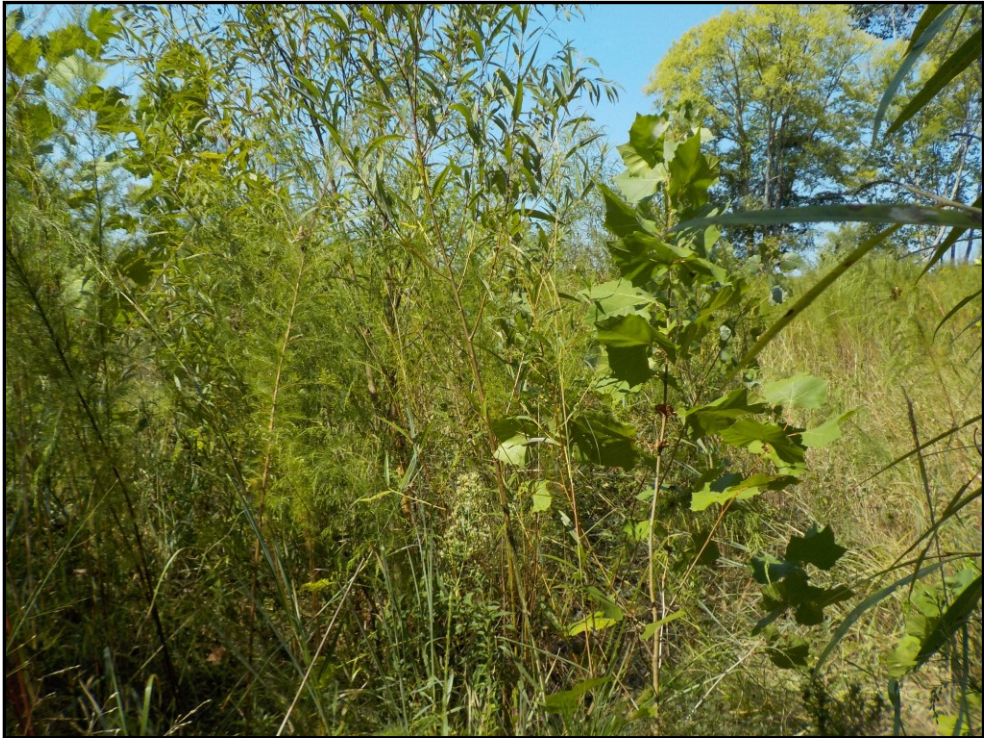
Jerry Branch – Permanent Photo Station 5  
Station 316+95 – Upstream  
September 20, 2017

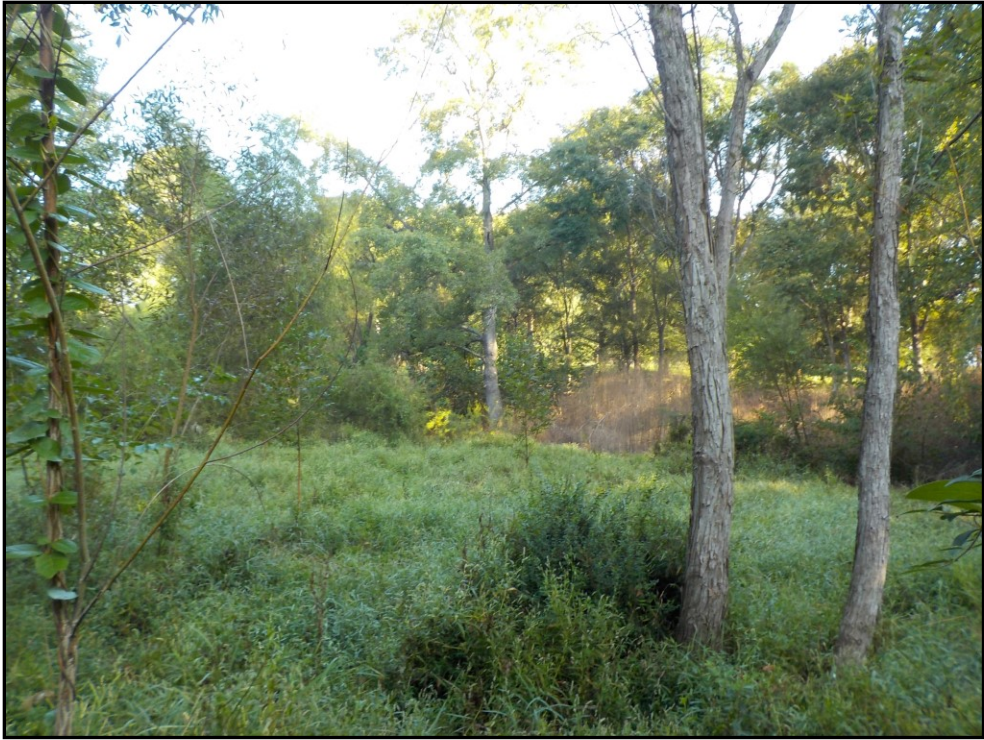
Dale Branch – Permanent Photo Station 6  
Station 204+15 – Upstream  
September 21, 2017

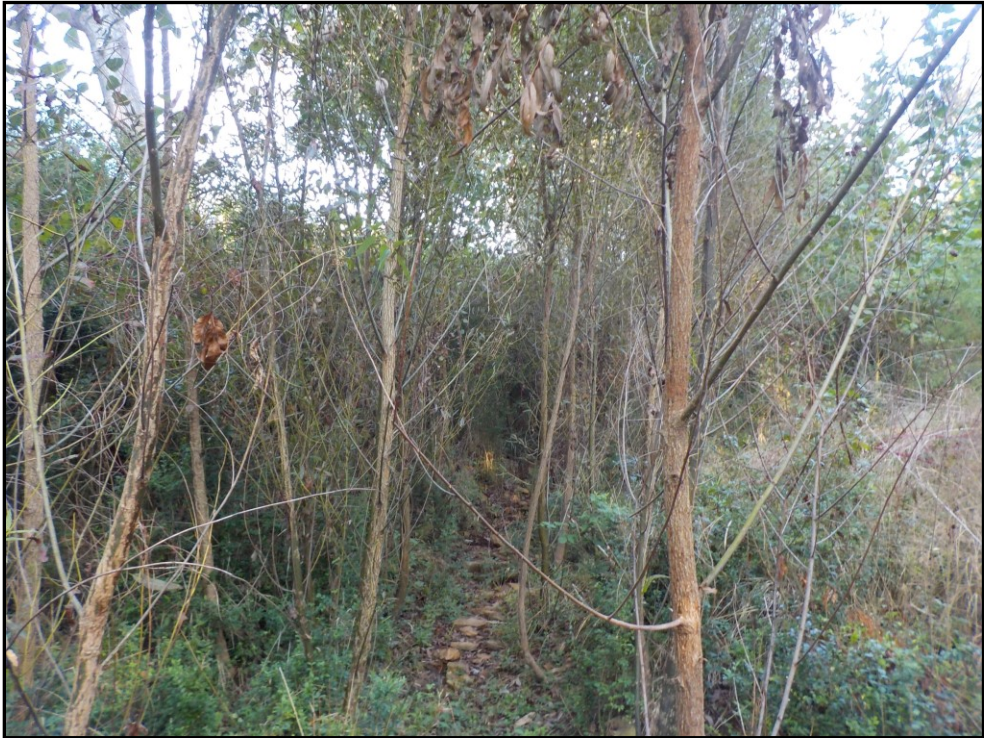
Dale Branch – Permanent Photo Station 7  
Station 205+15 – Upstream  
September 21, 2017
