# **Annual Monitoring Report**

Monitoring Year 3 of 7

Pee Dee Stream Restoration Project

NCDMS Project No.: 95350

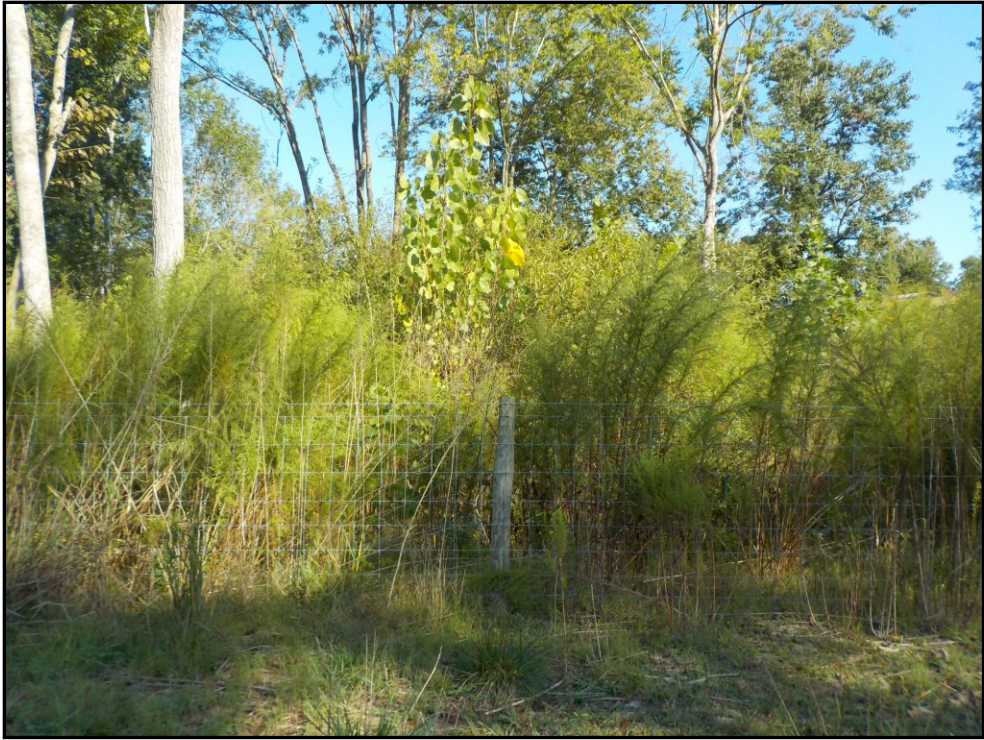
Dale Branch – Permanent Photo Station 8  
Station 212+95 – Upstream  
September 21, 2017

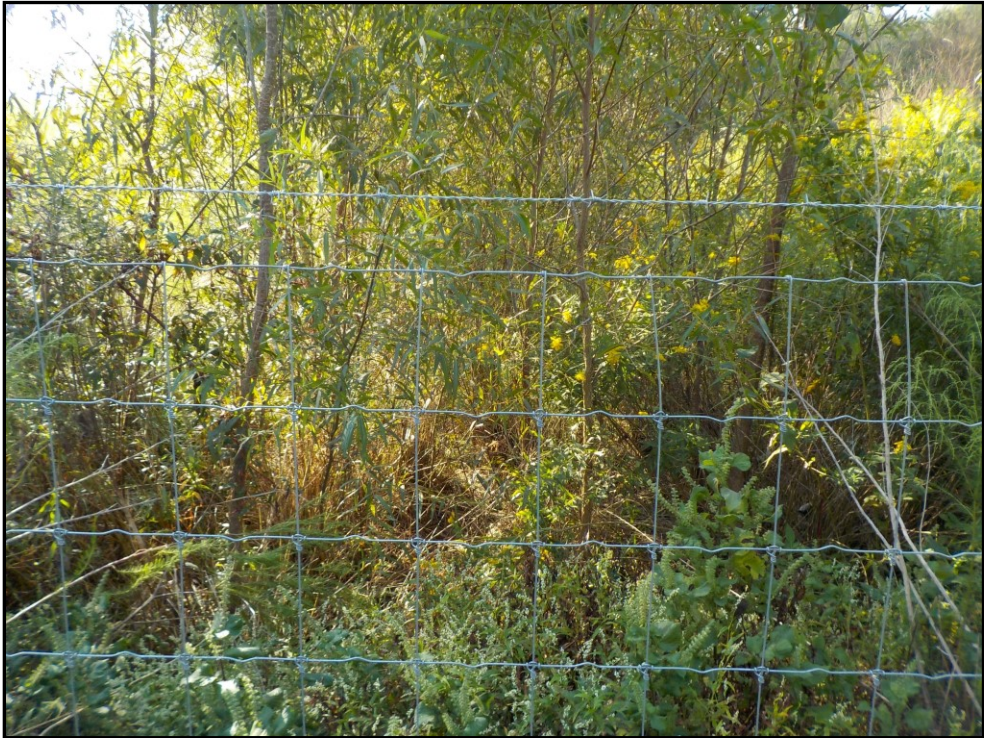
Dale Branch – Permanent Photo Station 8  
Station 212+95 – Downstream  
September 21, 2017

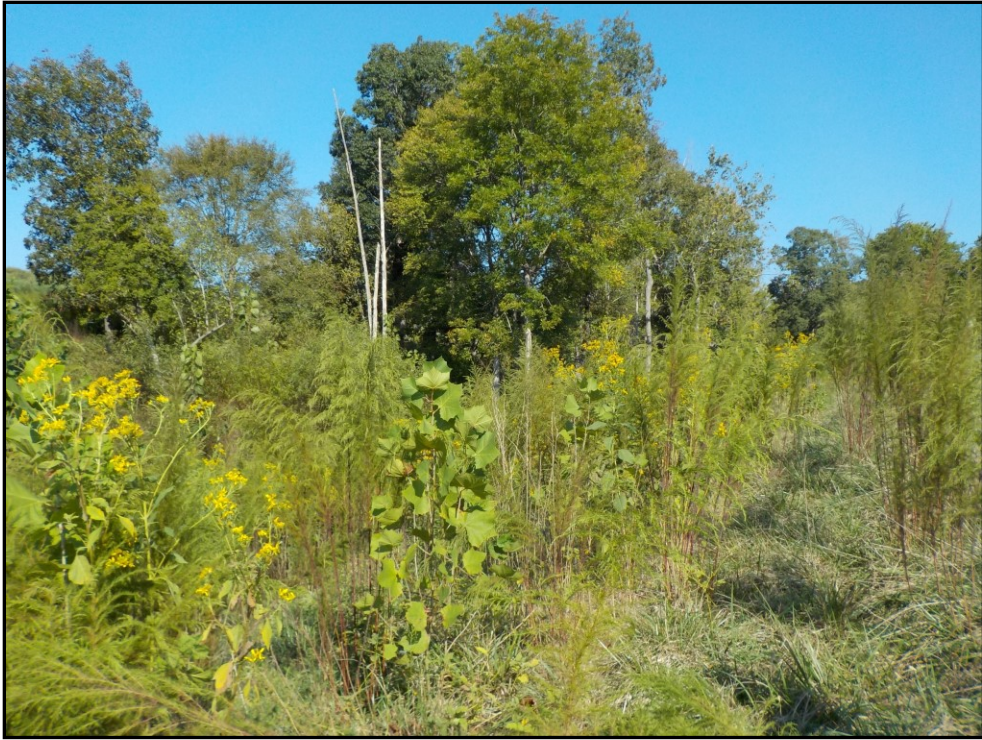
Dale Branch – Permanent Photo Station 9  
Looking North-Northwest – Upstream Dale  
September 21, 2017

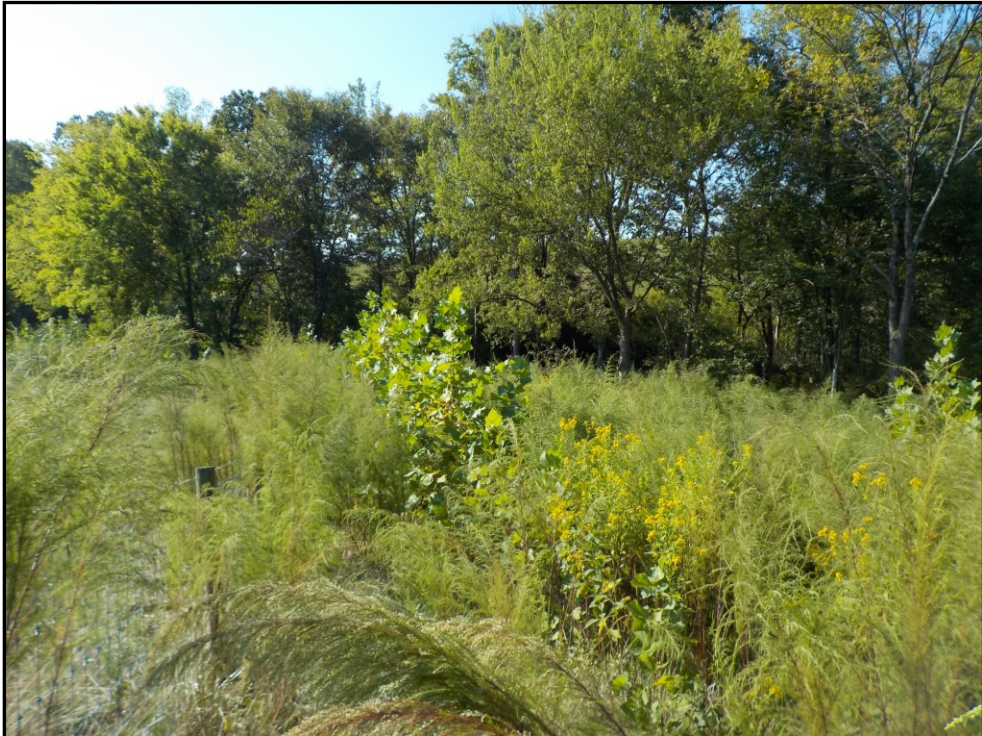
Dale Branch – Permanent Photo Station 9  
Looking South-Southeast- Downstream  
September 21, 2017

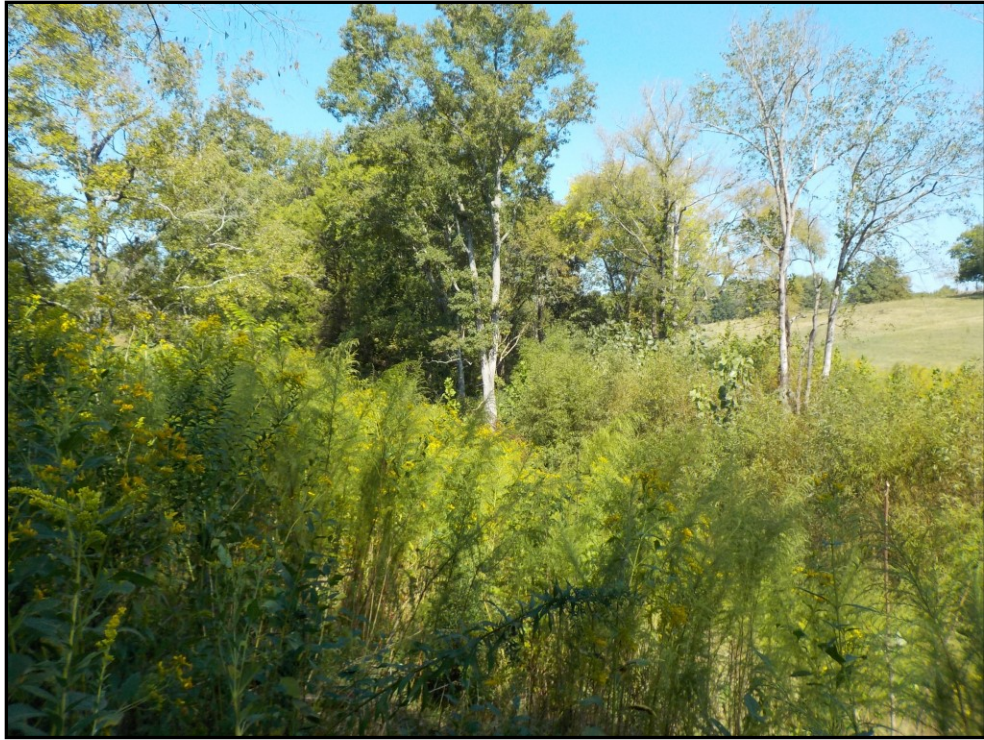
Dale Branch – Permanent Photo Station 10  
Looking North-Northeast – Upstream  
September 21, 2017

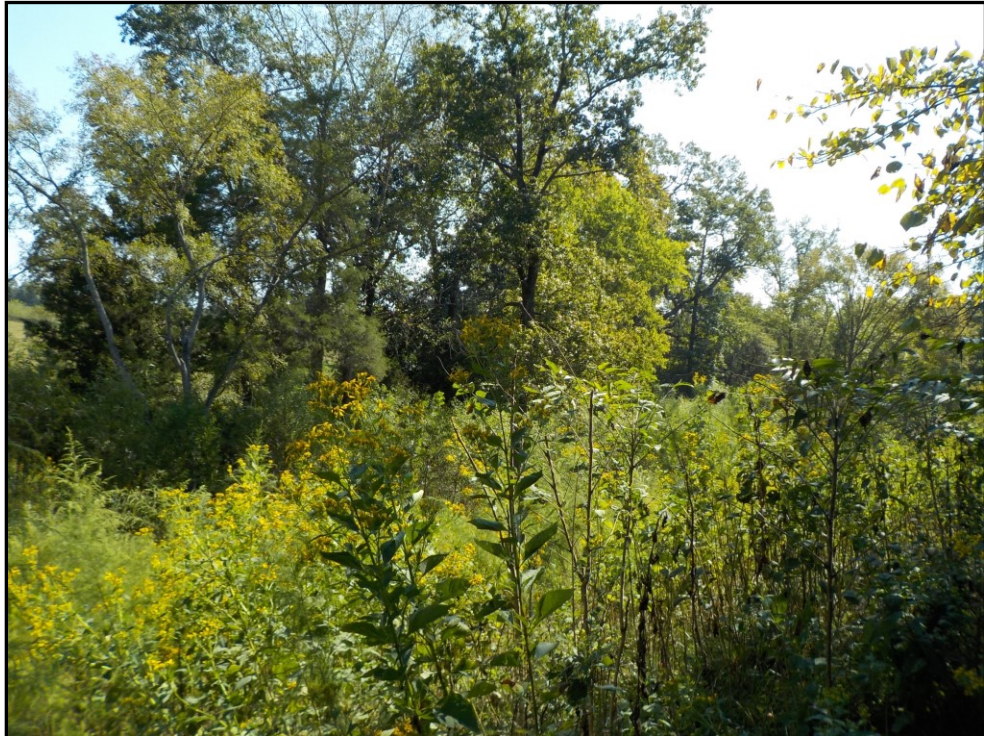
Dale Branch – Permanent Photo Station 10  
Looking South-Southwest – Downstream  
September 21, 2017

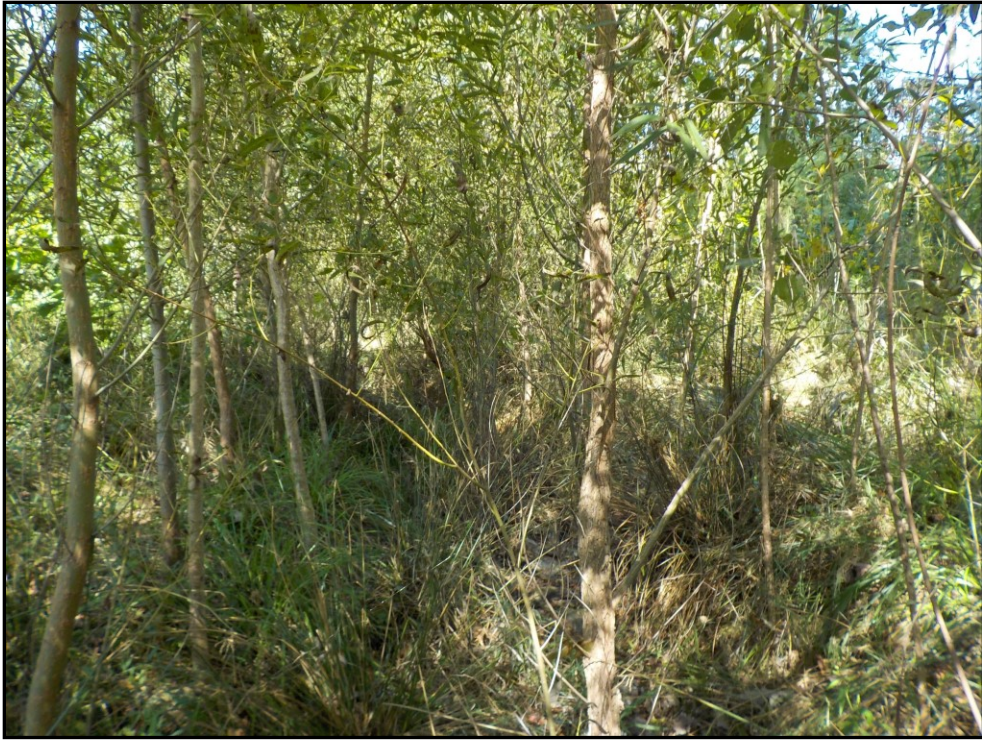
Dale Branch – Permanent Photo Station 11  
Station 229+20 – Upstream  
September 21, 2017

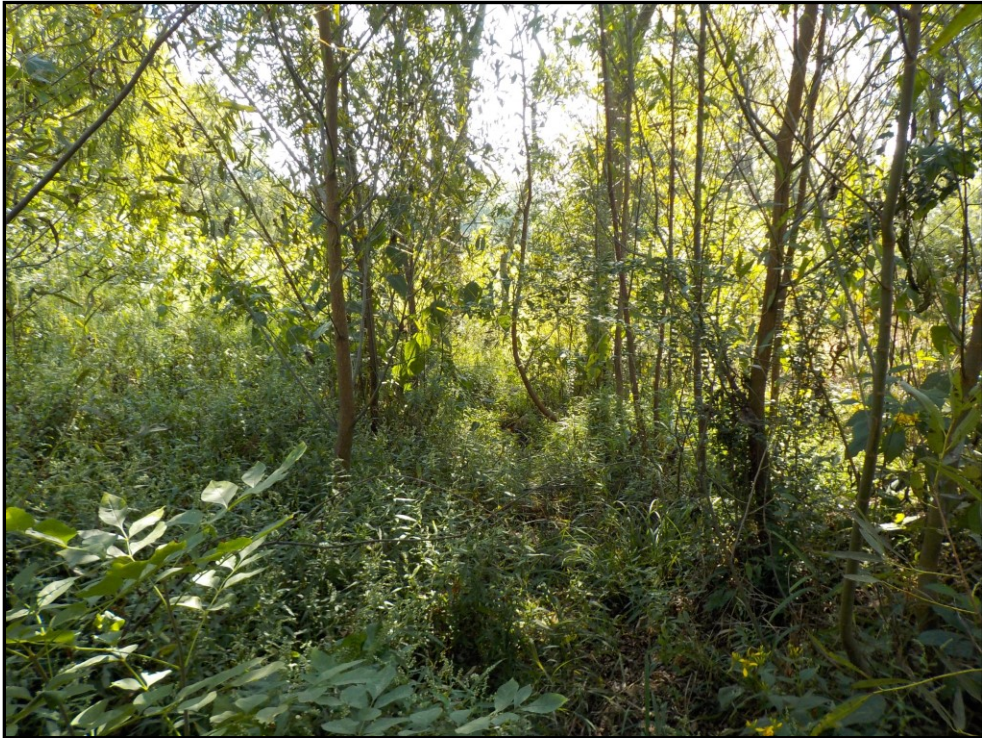
Dale Branch – Permanent Photo Station 11  
Station 229+20 – Downstream  
September 21, 2017

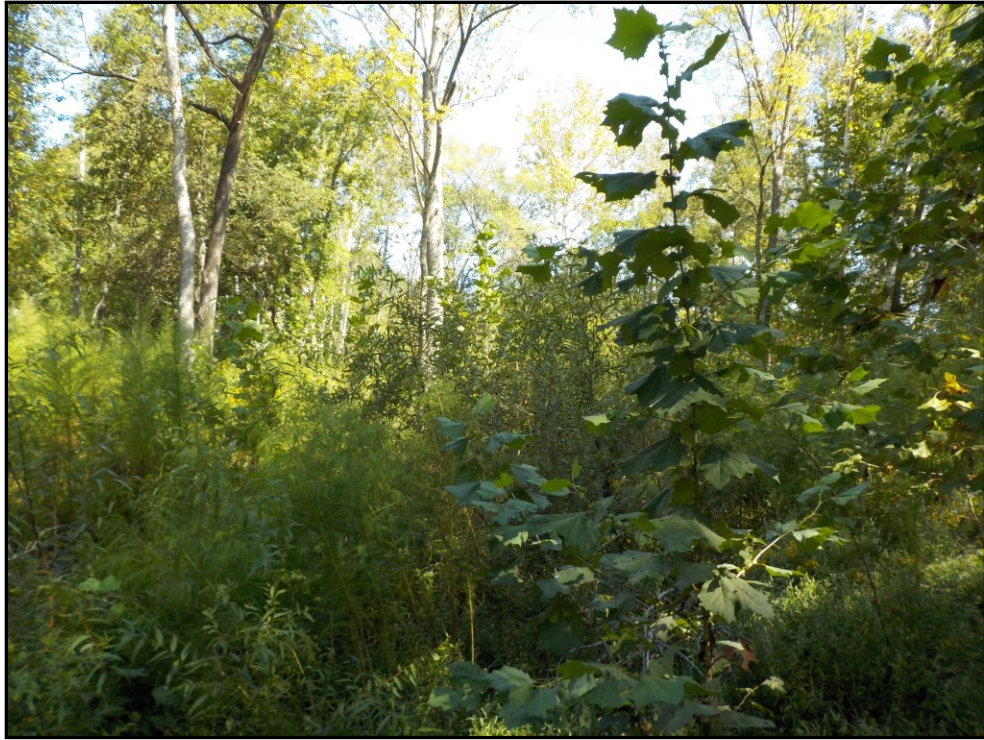
Dale Branch – Permanent Photo Station 12  
Station 234+25 – Upstream  
September 21, 2017

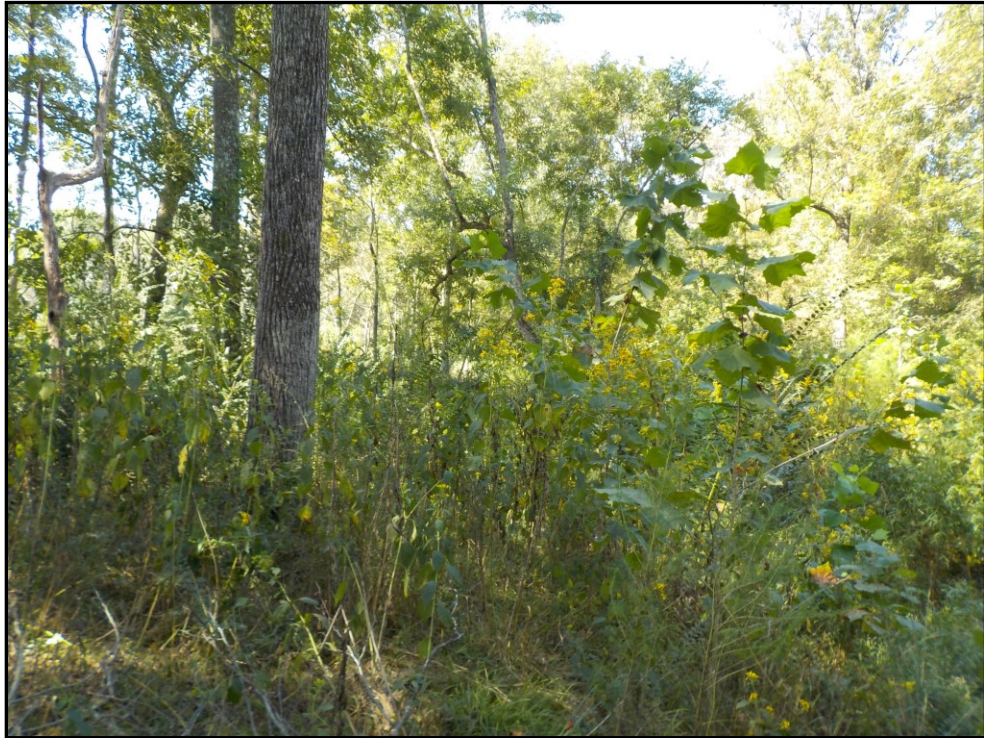
Dale Branch – Permanent Photo Station 12  
Station 234+25 – Downstream  
September 21, 2017

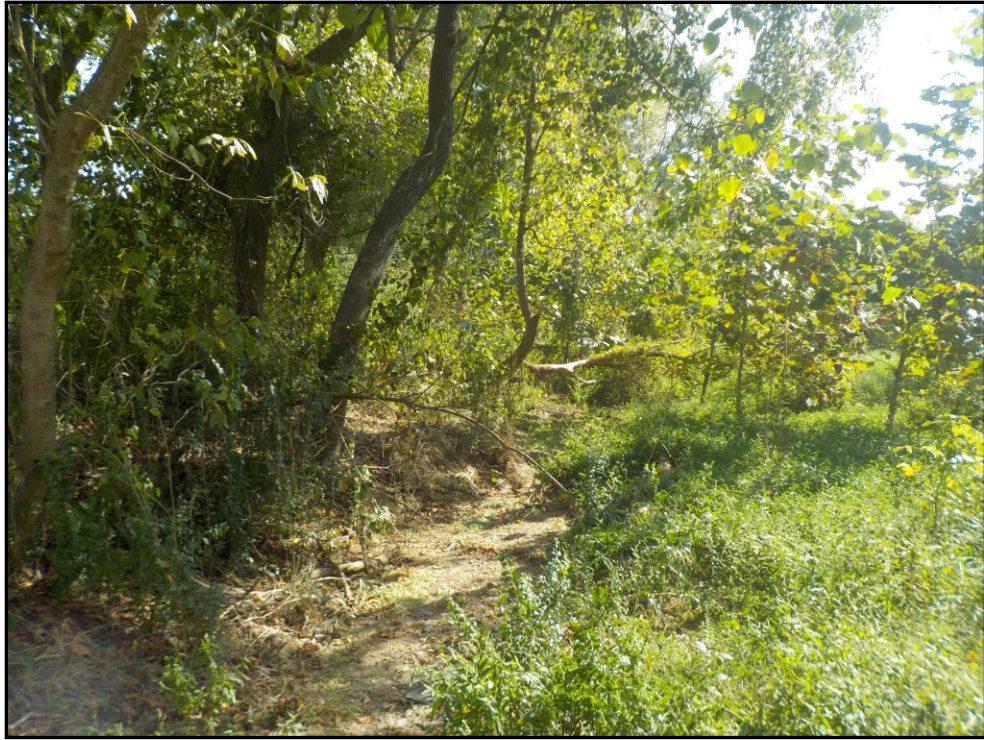
Thompson Branch – Permanent Photo Station 13  
Station 101+15 – Downstream  
September 20, 2017

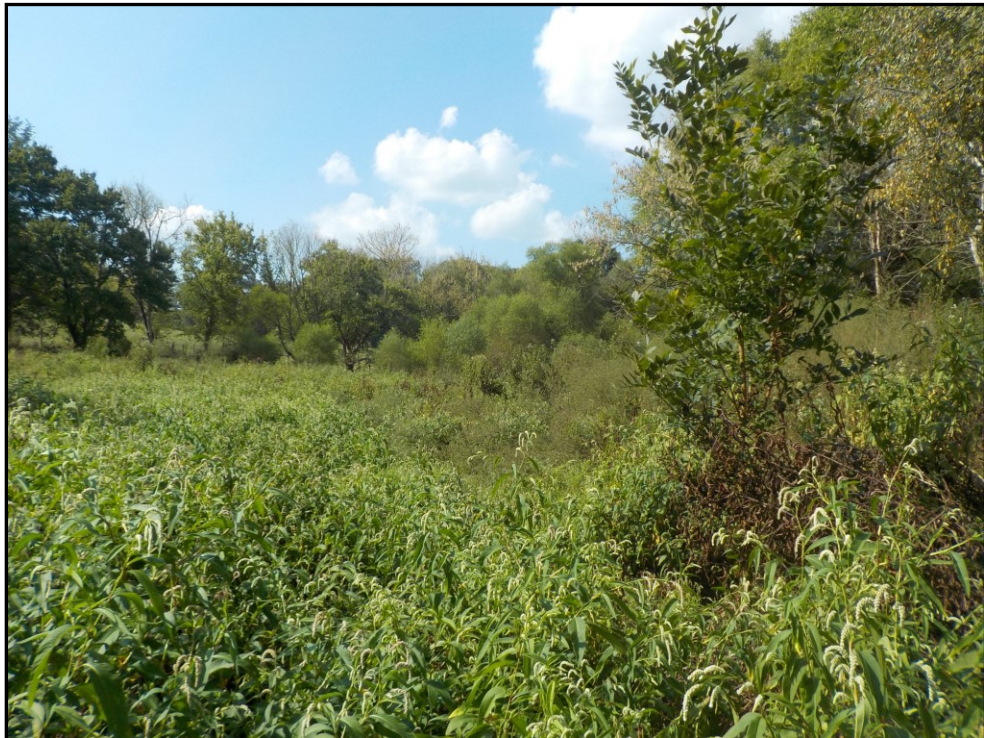
Thompson Branch – Permanent Photo Station 14  
Station 105+25 – Upstream  
September 20, 2017

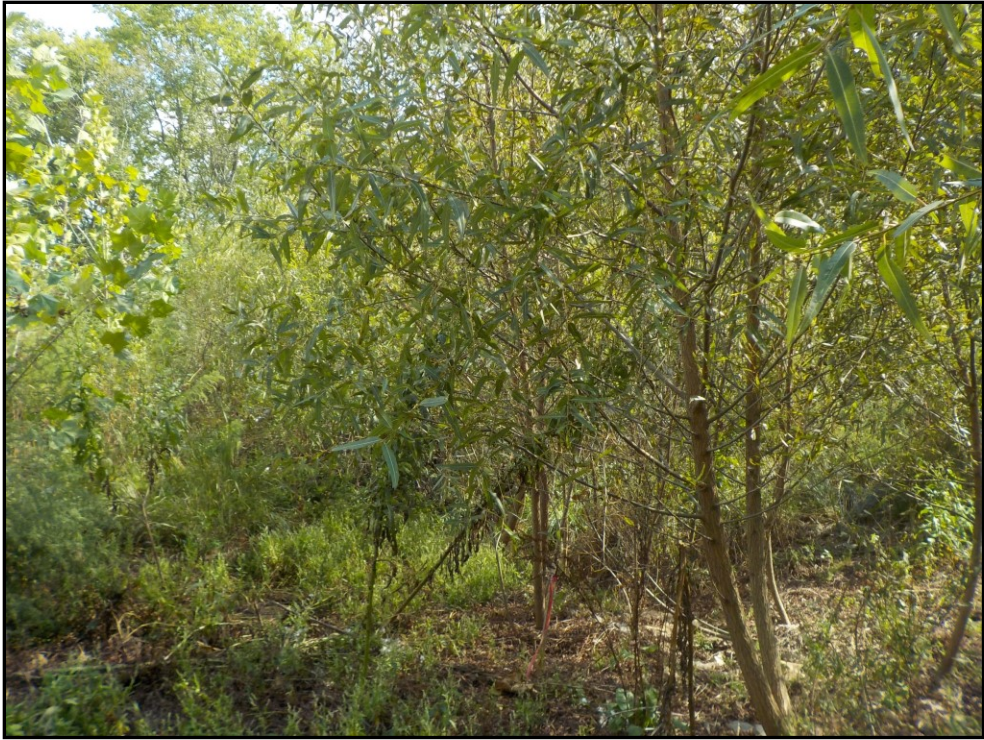
Thompson Branch – Permanent Photo Station 14  
Station 105+25 – Downstream

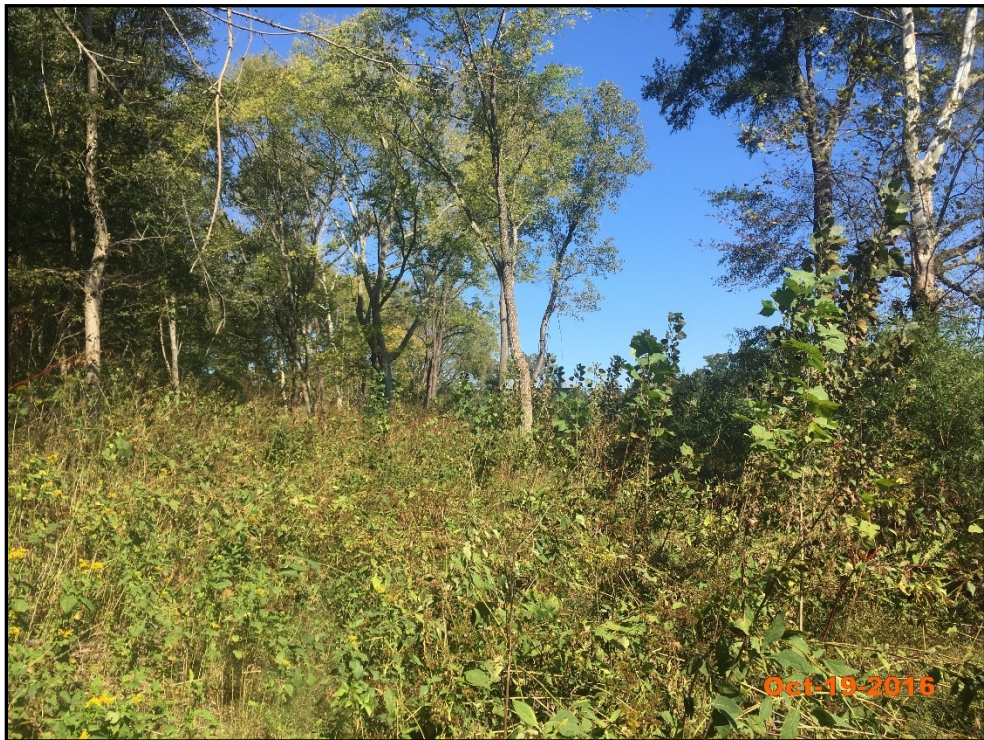
Thompson Branch – Permanent Photo Station 15  
Station 115+50 – Upstream  
September 20, 2017

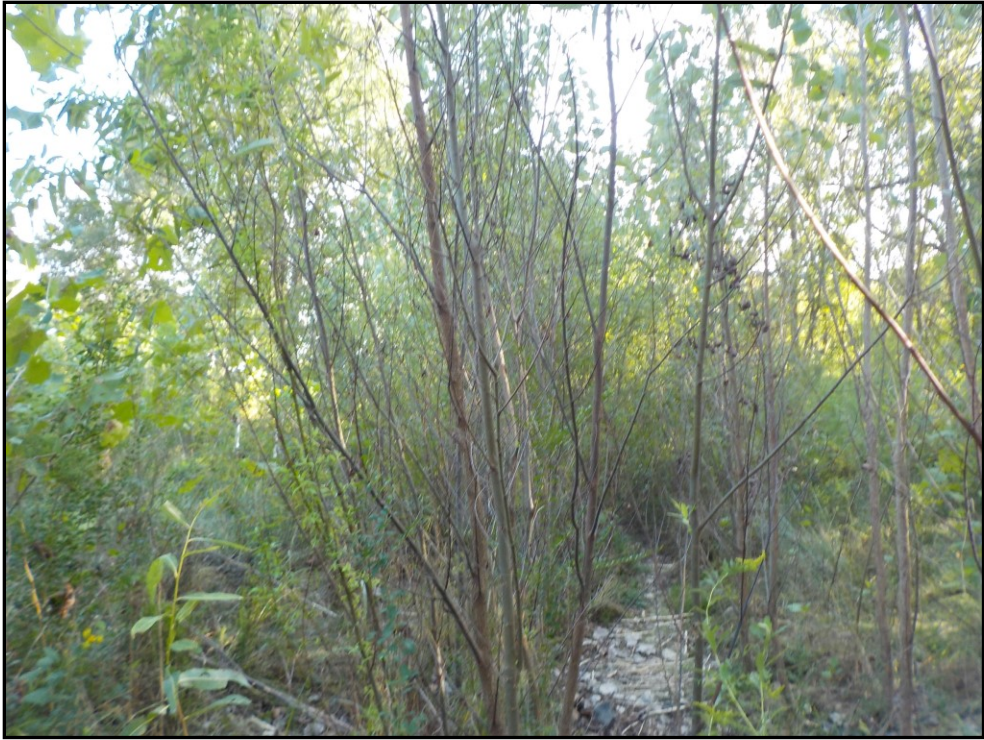
Thompson Branch – Permanent Photo Station 15  
Station 111+50 – Downstream  
September 20, 2017

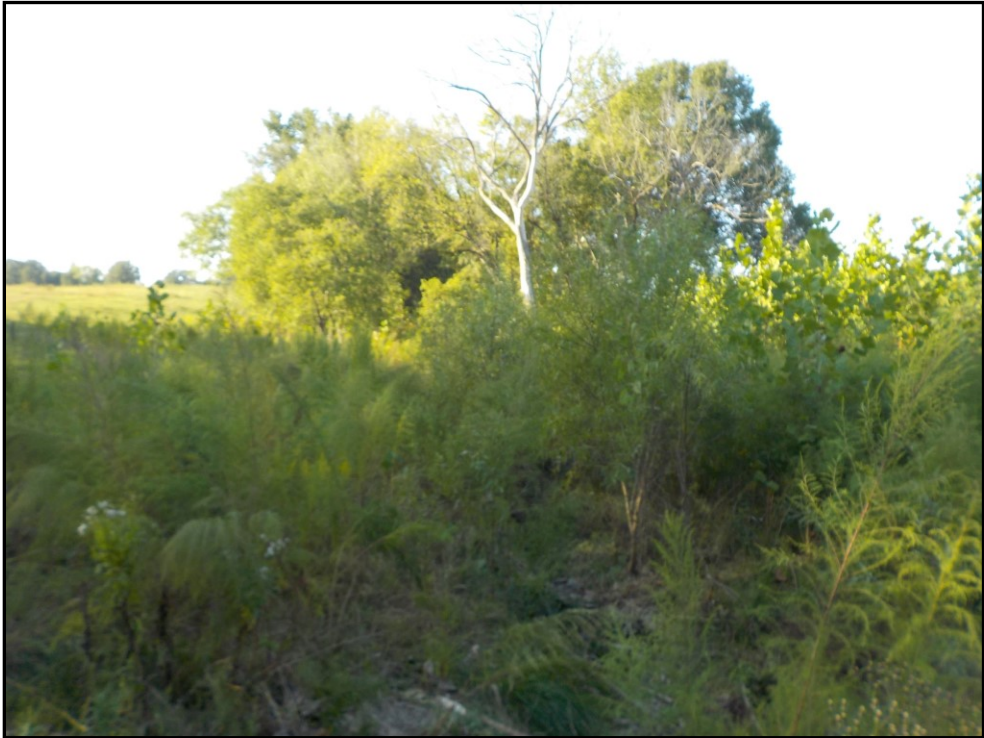
Thompson Branch – Permanent Photo Station 16  
Station 115+85 – Upstream  
September 20, 2017

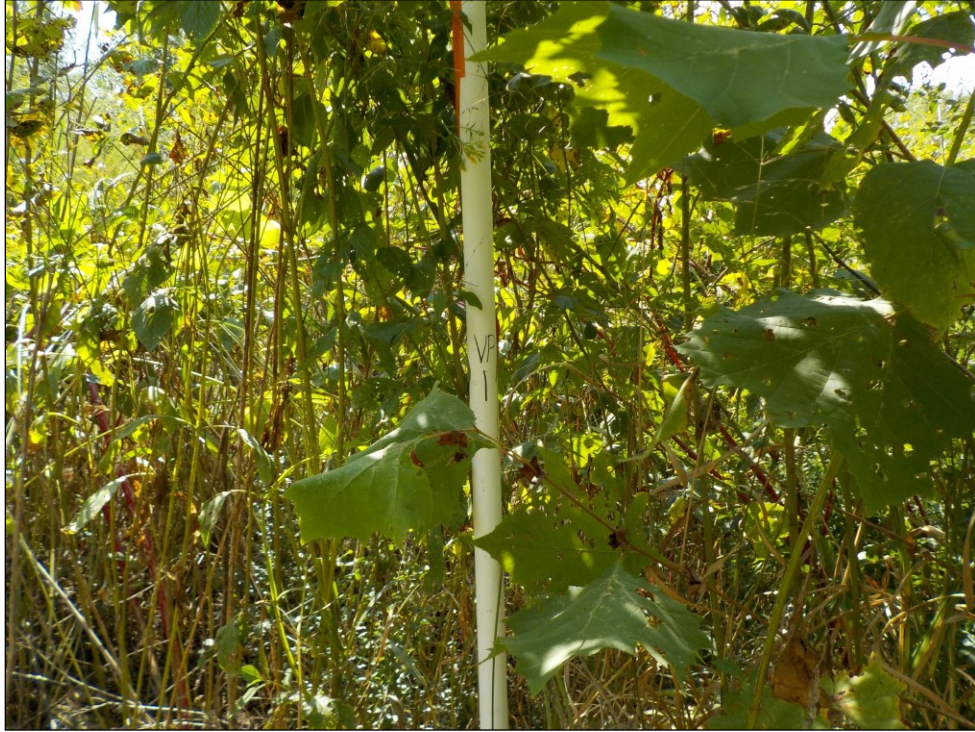
Pee Dee - Vegetation Monitoring Plot 1  
September 20, 2017

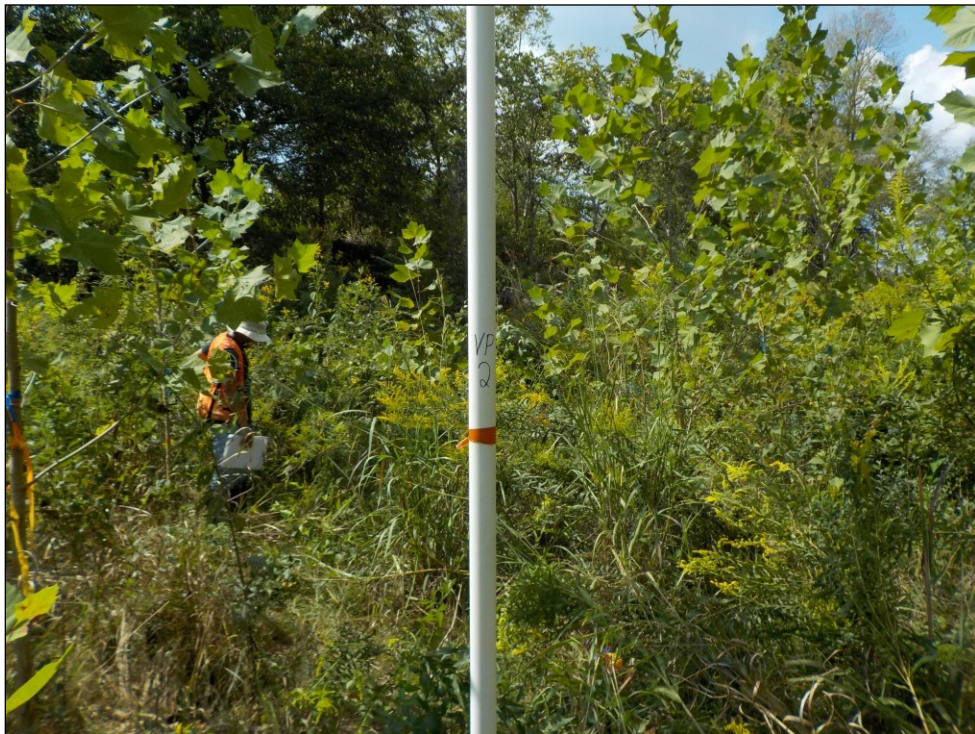
Pee Dee - Vegetation Monitoring Plot 2  
September 20, 2017

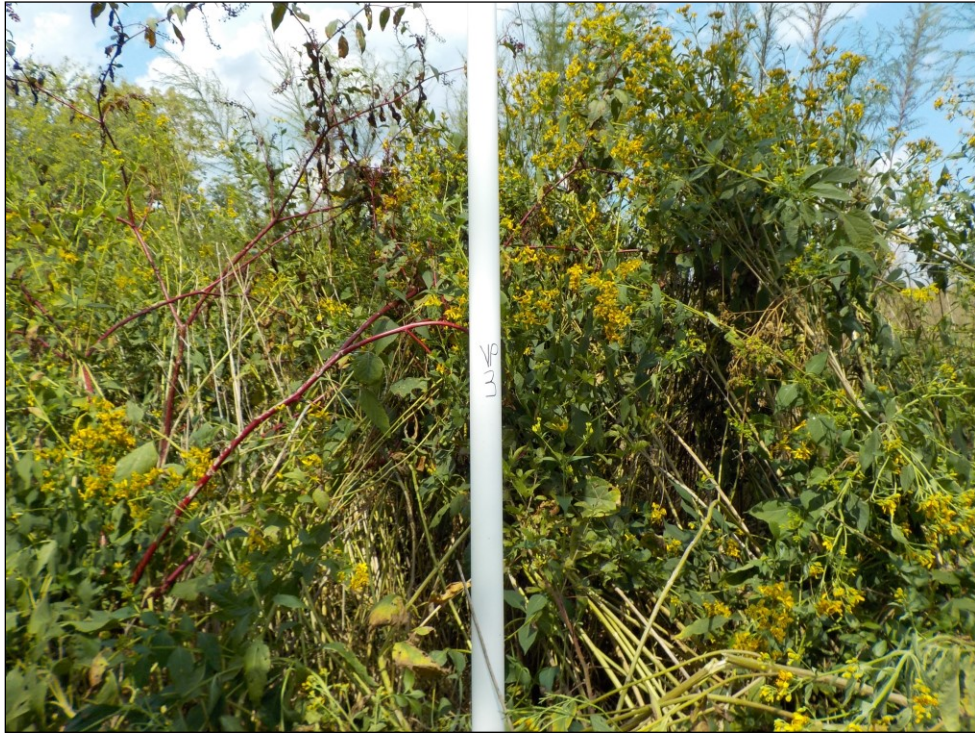
Pee Dee - Vegetation Monitoring Plot 3  
September 20, 2017

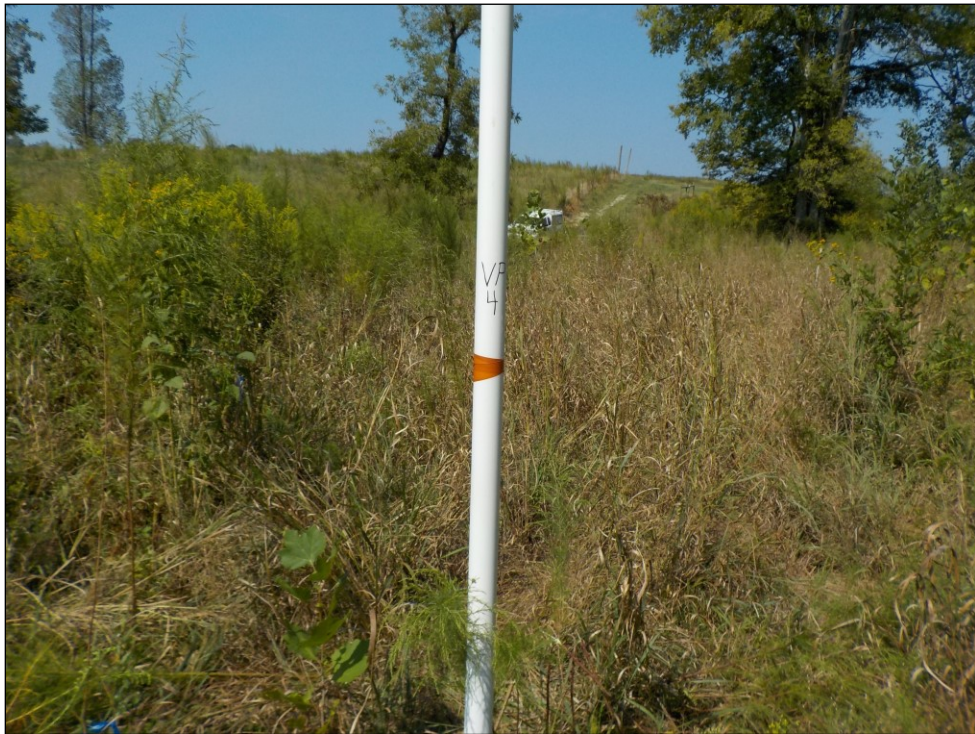
Pee Dee - Vegetation Monitoring Plot 4  
September 20, 2017

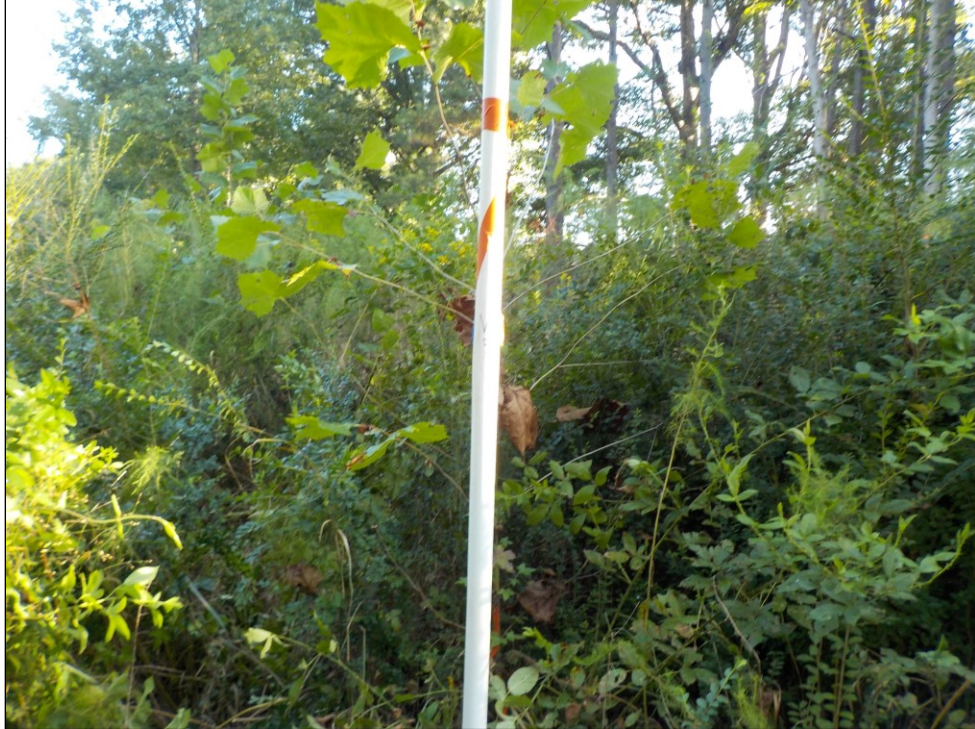
Pee Dee - Vegetation Monitoring Plot 5  
September 21, 2017

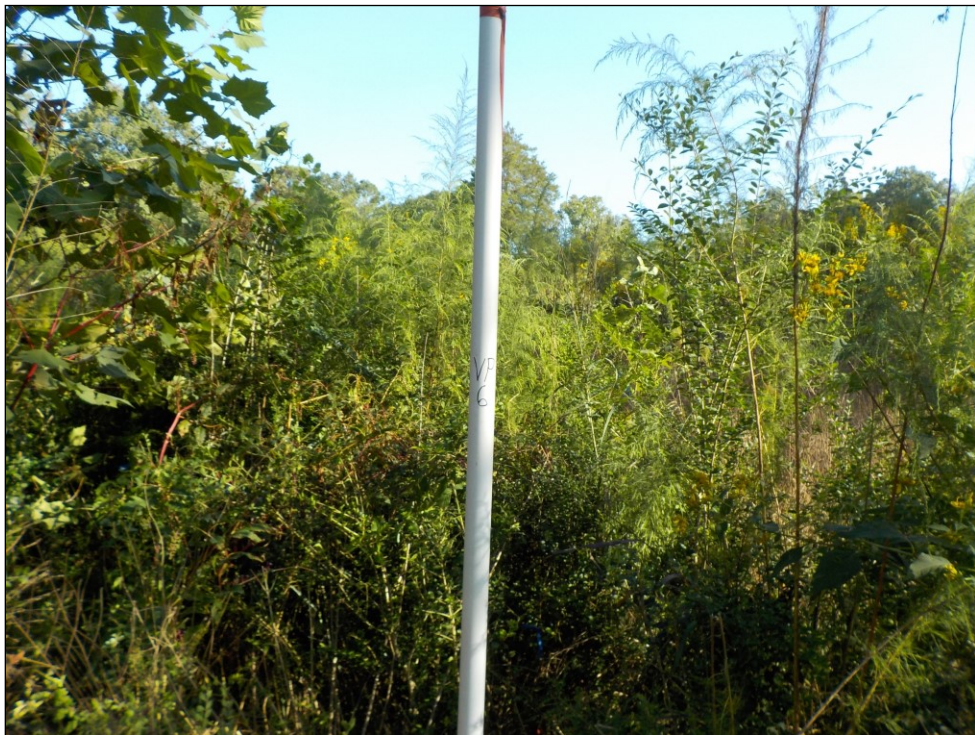
Pee Dee - Vegetation Monitoring Plot 6  
September 21, 2017

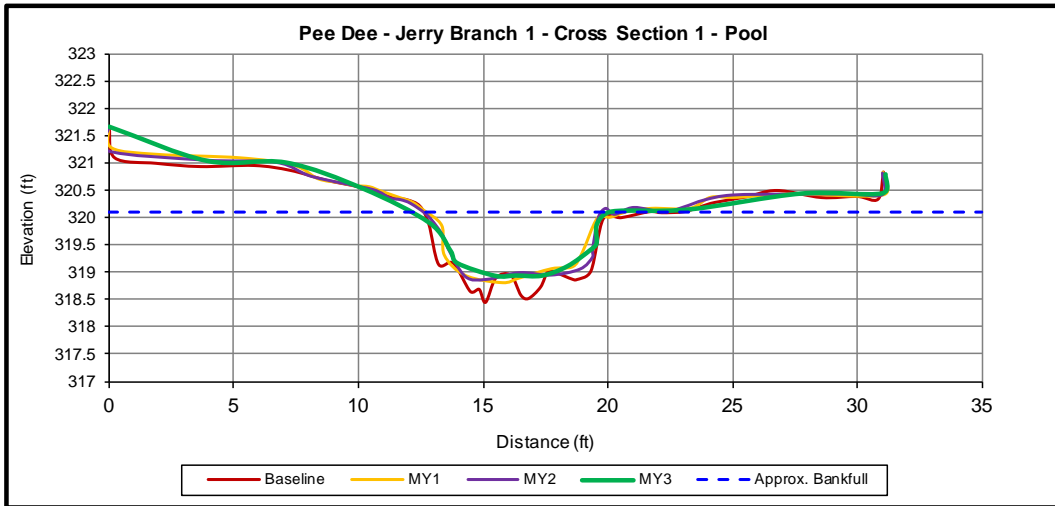
DIMENSIONS SUMMARY	MY0	MY1	MY2	MY3	MY4	MY5	MY6	MY7
Bankful Width (ft)	9.1	8.3	8.3	8.2	-	-	-	-
Floodprone Width (ft)	25.0	25.0	25.0	25.0	-	-	-	-
Bankfull Mean Depth (ft)	0.9	0.8	0.8	0.8	-	-	-	-
Bankfull Max Depth (ft)	1.7	1.3	1.2	1.2	-	-	-	-
Bankfull Cross-Sectional Area (ft <sup>2</sup> )	8.5	6.8	6.9	6.6	-	-	-	-
Width/Depth Ratio	9.8	10.1	9.9	10.1	-	-	-	-
Entrenchment Ratio	2.7	3.0	3.0	N/A	-	-	-	-
Bank Height Ratio	1.0	1.0	1.0	N/A	-	-	-	-

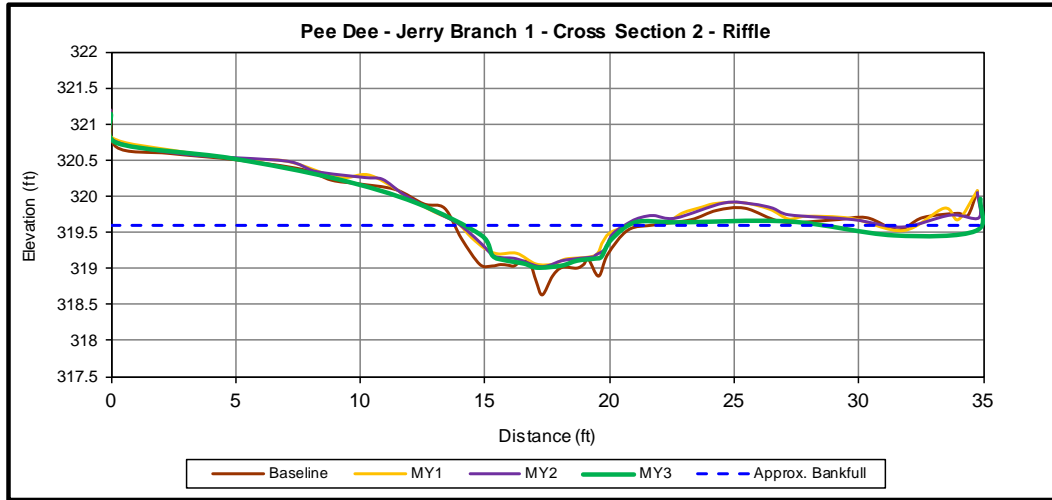
<b>DIMENSIONS SUMMARY</b>	<b>MY0</b>	<b>MY1</b>	<b>MY2</b>	<b>MY3</b>	<b>MY4</b>	<b>MY5</b>	<b>MY6</b>	<b>MY7</b>
Bankful Width (ft)	8.1	7.0	6.7	6.9	-	-	-	-
Floodprone Width (ft)	30.0	30.0	30.0	30.0	-	-	-	-
Bankfull Mean Depth (ft)	0.5	0.3	0.4	0.4	-	-	-	-
Bankfull Max Depth (ft)	1.0	0.5	0.6	0.6	-	-	-	-
Bankfull Cross-Sectional Area (ft <sup>2</sup> )	3.7	2.4	2.6	2.7	-	-	-	-
Width/Depth Ratio	17.7	20.3	17.5	17.6	-	-	-	-
Entrenchment Ratio	3.7	4.3	4.5	4.0	-	-	-	-
Bank Height Ratio	1.0	1.0	1.0	1.0	-	-	-	-

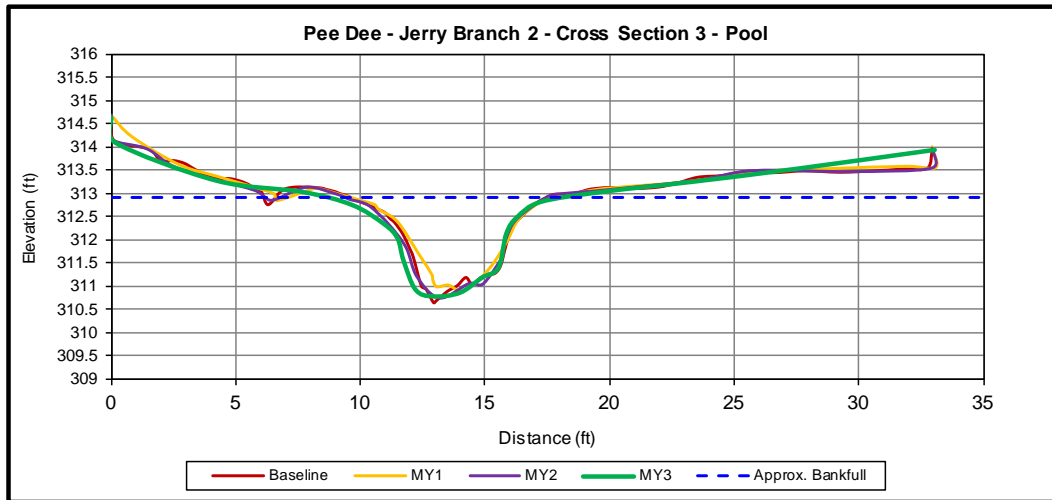
<b>DIMENSIONS SUMMARY</b>	<b>MY0</b>	<b>MY1</b>	<b>MY2</b>	<b>MY3</b>	<b>MY4</b>	<b>MY5</b>	<b>MY6</b>	<b>MY7</b>
Bankful Width (ft)	7.8	8.1	8.1	9.8	-	-	-	-
Floodprone Width (ft)	30.0	30.0	30.0	30.0	-	-	-	-
Bankfull Mean Depth (ft)	1.1	1.0	1.1	1.0	-	-	-	-
Bankfull Max Depth (ft)	2.3	2.0	2.2	2.1	-	-	-	-
Bankfull Cross-Sectional Area (ft <sup>2</sup> )	8.3	7.7	8.7	9.4	-	-	-	-
Width/Depth Ratio	7.4	8.4	7.6	10.2	-	-	-	-
Entrenchment Ratio	3.8	3.7	3.7	N/A	-	-	-	-
Bank Height Ratio	1.0	1.0	1.0	N/A	-	-	-	-

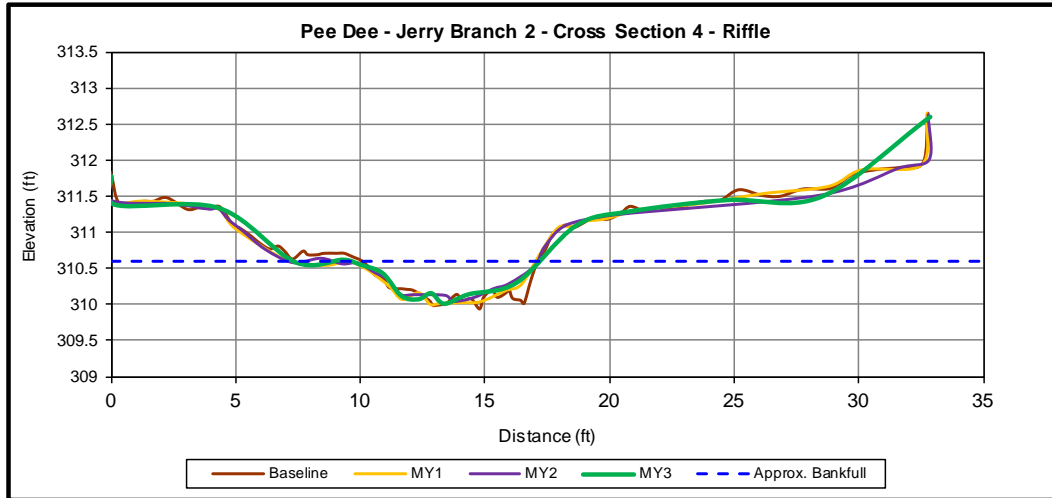
DIMENSIONS SUMMARY	MY0	MY1	MY2	MY3	MY4	MY5	MY6	MY7
Bankful Width (ft)	7.1	7.2	7.2	7.7	-	-	-	-
Floodprone Width (ft)	25.0	25.0	25.0	25.0	-	-	-	-
Bankfull Mean Depth (ft)	0.4	0.4	0.4	0.3	-	-	-	-
Bankfull Max Depth (ft)	0.7	0.6	0.6	0.6	-	-	-	-
Bankfull Cross-Sectional Area (ft <sup>2</sup> )	3.1	3.0	2.7	2.6	-	-	-	-
Width/Depth Ratio	16.4	17.0	19.4	22.6	-	-	-	-
Entrenchment Ratio	3.5	3.5	3.5	3.2	-	-	-	-
Bank Height Ratio	1.0	1.0	1.0	0.9	-	-	-	-

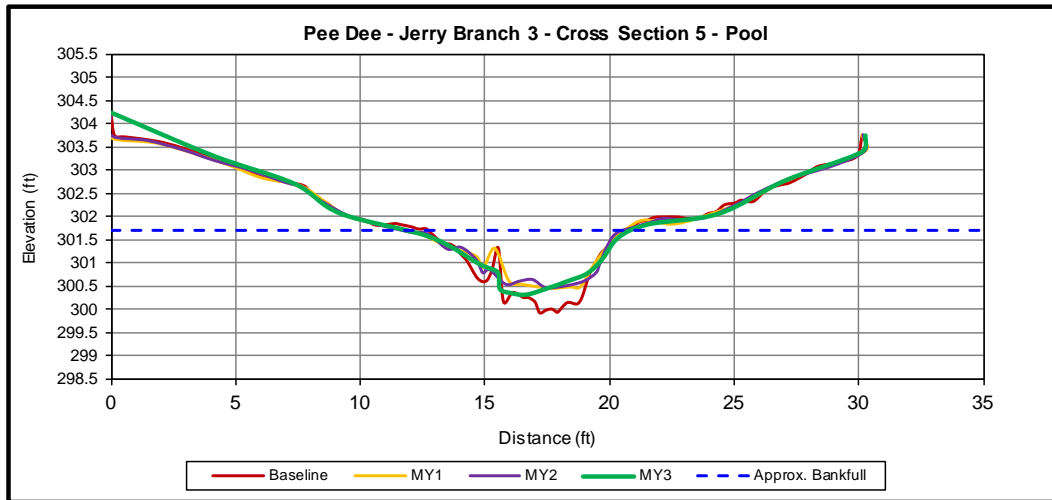
<b>DIMENSIONS SUMMARY</b>	<b>MY0</b>	<b>MY1</b>	<b>MY2</b>	<b>MY3</b>	<b>MY4</b>	<b>MY5</b>	<b>MY6</b>	<b>MY7</b>
Bankfull Width (ft)	8.1	9.2	9.7	9.4	-	-	-	-
Floodprone Width (ft)	25.0	25.0	25.0	25.0	-	-	-	-
Bankfull Mean Depth (ft)	1.0	0.7	0.7	0.7	-	-	-	-
Bankfull Max Depth (ft)	1.8	1.3	1.3	1.4	-	-	-	-
Bankfull Cross-Sectional Area (ft <sup>2</sup> )	7.9	6.3	6.8	6.9	-	-	-	-
Width/Depth Ratio	8.3	13.2	13.7	13.0	-	-	-	-
Entrenchment Ratio	3.1	2.7	2.6	N/A	-	-	-	-
Bank Height Ratio	1.0	1.0	1.0	N/A	-	-	-	-

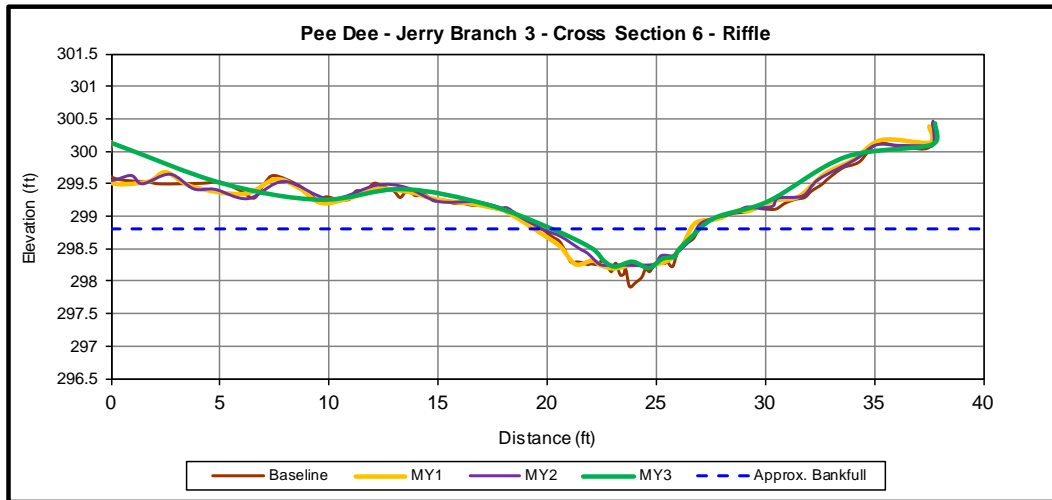
DIMENSIONS SUMMARY	MY0	MY1	MY2	MY3	MY4	MY5	MY6	MY7
Bankful Width (ft)	7.4	7.5	7.3	6.9	-	-	-	-
Floodprone Width (ft)	30.0	30.0	30.0	30.0	-	-	-	-
Bankfull Mean Depth (ft)	0.4	0.4	0.4	0.4	-	-	-	-
Bankfull Max Depth (ft)	0.9	0.6	0.6	0.6	-	-	-	-
Bankfull Cross-Sectional Area (ft <sup>2</sup> )	3.3	3.3	2.9	2.4	-	-	-	-
Width/Depth Ratio	16.6	16.7	18.7	19.4	-	-	-	-
Entrenchment Ratio	4.1	4.0	4.1	4.4	-	-	-	-
Bank Height Ratio	1.0	1.0	1.0	1.0	-	-	-	-

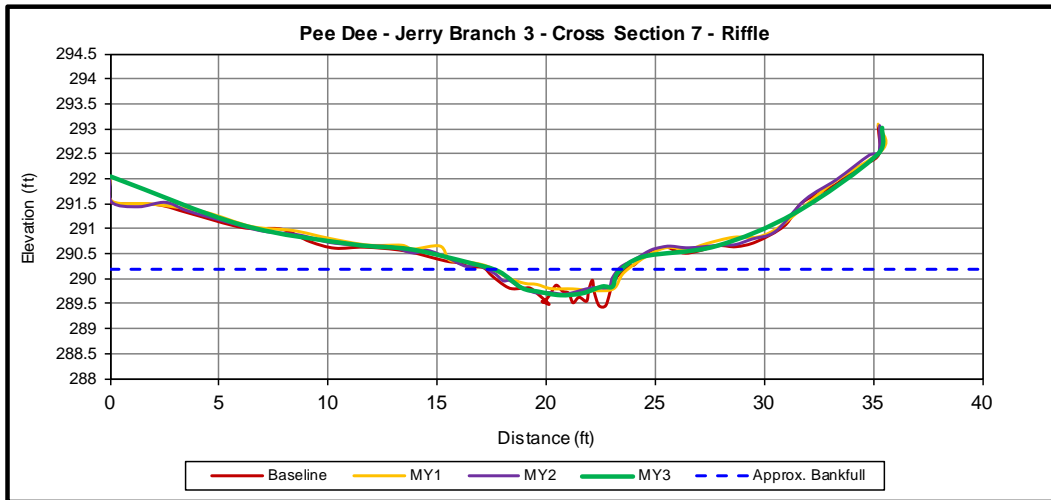
DIMENSIONS SUMMARY	MY0	MY1	MY2	MY3	MY4	MY5	MY6	MY7
Bankful Width (ft)	7.2	6.7	6.4	6.2	-	-	-	-
Floodprone Width (ft)	25.0	25.0	25.0	25.0	-	-	-	-
Bankfull Mean Depth (ft)	0.4	0.3	0.4	0.4	-	-	-	-
Bankfull Max Depth (ft)	0.8	0.5	0.5	0.5	-	-	-	-
Bankfull Cross-Sectional Area (ft <sup>2</sup> )	3.0	2.3	2.4	2.2	-	-	-	-
Width/Depth Ratio	17.7	19.4	17.0	17.4	-	-	-	-
Entrenchment Ratio	3.4	3.7	3.9	4.0	-	-	-	-
Bank Height Ratio	1.0	1.0	1.0	0.9	-	-	-	-

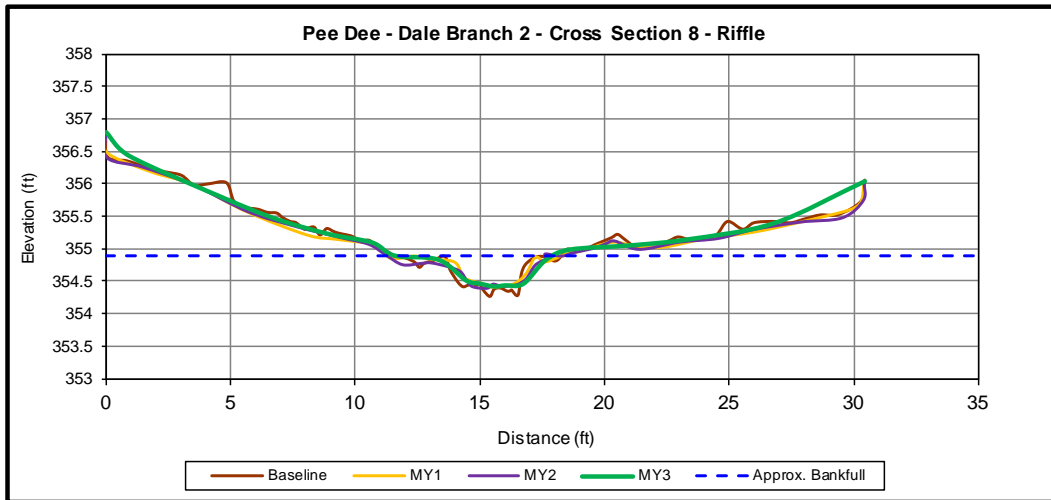
DIMENSIONS SUMMARY	MY0	MY1	MY2	MY3	MY4	MY5	MY6	MY7
Bankfull Width (ft)	7.0	7.3	7.2	6.5	-	-	-	-
Floodprone Width (ft)	25.0	25.0	25.0	25.0	-	-	-	-
Bankfull Mean Depth (ft)	0.3	0.2	0.3	0.2	-	-	-	-
Bankfull Max Depth (ft)	0.7	0.5	0.5	0.5	-	-	-	-
Bankfull Cross-Sectional Area (ft <sup>2</sup> )	2.0	1.7	2.0	1.6	-	-	-	-
Width/Depth Ratio	24.6	30.6	26.0	26.9	-	-	-	-
Entrenchment Ratio	3.6	3.4	3.5	3.9	-	-	-	-
Bank Height Ratio	1.0	1.0	1.0	0.9	-	-	-	-

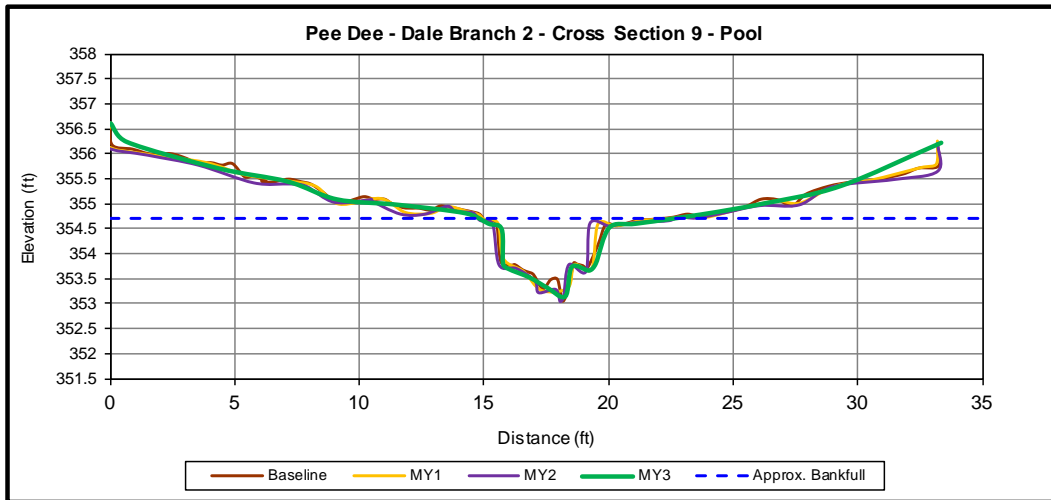
<b>DIMENSIONS SUMMARY</b>	<b>MY0</b>	<b>MY1</b>	<b>MY2</b>	<b>MY3</b>	<b>MY4</b>	<b>MY5</b>	<b>MY6</b>	<b>MY7</b>
Bankful Width (ft)	7.7	8.0	8.1	7.7	-	-	-	-
Floodprone Width (ft)	25.0	25.0	25.0	25.0	-	-	-	-
Bankfull Mean Depth (ft)	0.6	0.6	0.6	0.6	-	-	-	-
Bankfull Max Depth (ft)	1.7	1.5	1.7	1.5	-	-	-	-
Bankfull Cross-Sectional Area (ft <sup>2</sup> )	4.8	4.8	5.0	5.0	-	-	-	-
Width/Depth Ratio	12.3	13.5	13.3	11.8	-	-	-	-
Entrenchment Ratio	3.3	3.1	3.1	N/A	-	-	-	-
Bank Height Ratio	1.0	1.0	1.0	N/A	-	-	-	-

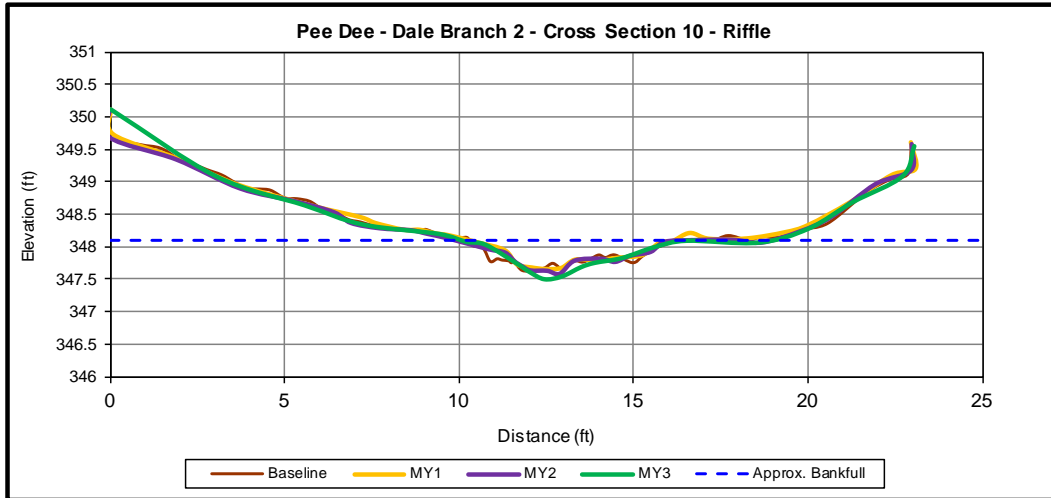
DIMENSIONS SUMMARY	MY0	MY1	MY2	MY3	MY4	MY5	MY6	MY7
Bankful Width (ft)	6.4	6.2	6.2	6.5	-	-	-	-
Floodprone Width (ft)	25.0	25.0	25.0	25.0	-	-	-	-
Bankfull Mean Depth (ft)	0.3	0.3	0.3	0.3	-	-	-	-
Bankfull Max Depth (ft)	0.5	0.5	0.5	0.6	-	-	-	-
Bankfull Cross-Sectional Area (ft <sup>2</sup> )	1.8	1.6	1.7	1.8	-	-	-	-
Width/Depth Ratio	22.6	23.7	21.7	23.4	-	-	-	-
Entrenchment Ratio	3.9	4.0	4.1	3.9	-	-	-	-
Bank Height Ratio	1.0	1.0	1.0	0.9	-	-	-	-
