# **Annual Monitoring Report**

Monitoring Year 3 of 7

Pee Dee Stream Restoration Project

NCDMS Project No.: 95350

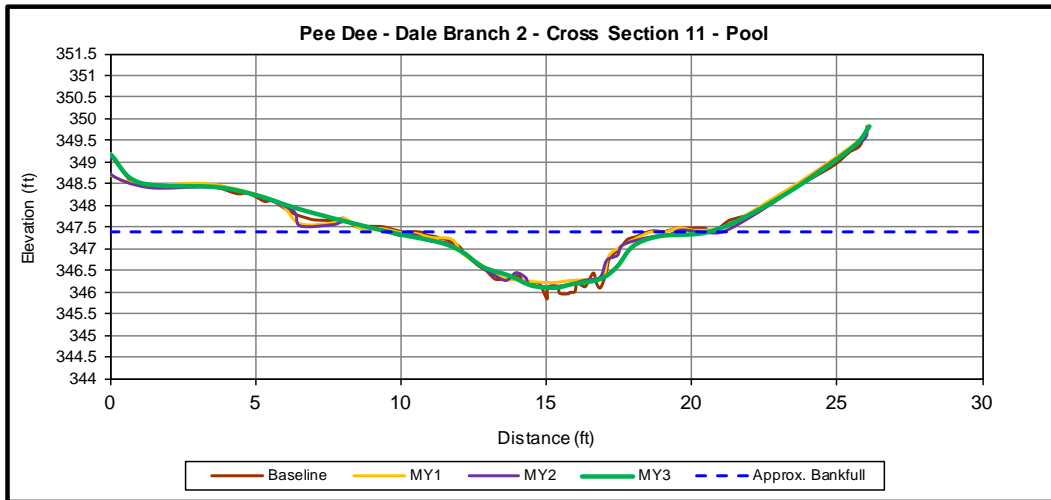
DIMENSIONS SUMMARY	MY0	MY1	MY2	MY3	MY4	MY5	MY6	MY7
Bankful Width (ft)	7.6	8.0	8.3	9.4	-	-	-	-
Floodprone Width (ft)	20.0	20.0	20.0	20.0	-	-	-	-
Bankfull Mean Depth (ft)	0.8	0.7	0.7	0.7	-	-	-	-
Bankfull Max Depth (ft)	1.6	1.2	1.3	1.3	-	-	-	-
Bankfull Cross-Sectional Area (ft <sup>2</sup> )	6.1	5.9	6.0	6.7	-	-	-	-
Width/Depth Ratio	9.5	10.9	11.5	13.3	-	-	-	-
Entrenchment Ratio	2.6	2.5	2.4	N/A	-	-	-	-
Bank Height Ratio	1.0	1.0	1.0	N/A	-	-	-	-

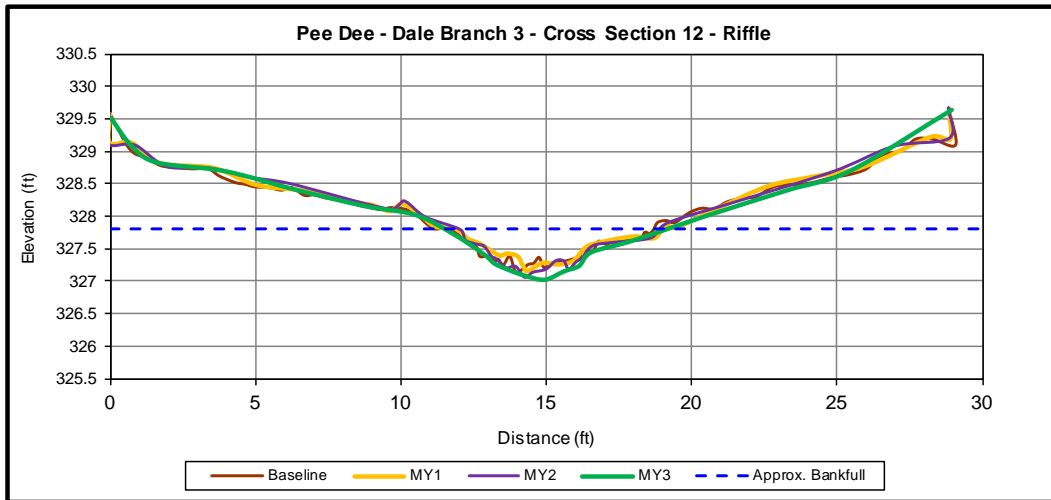
DIMENSIONS SUMMARY	MY0	MY1	MY2	MY3	MY4	MY5	MY6	MY7
Bankfull Width (ft)	7.3	7.1	7.1	7.8	-	-	-	-
Floodprone Width (ft)	20.0	20.0	20.0	20.0	-	-	-	-
Bankfull Mean Depth (ft)	0.3	0.3	0.4	0.4	-	-	-	-
Bankfull Max Depth (ft)	0.7	0.6	0.8	0.8	-	-	-	-
Bankfull Cross-Sectional Area (ft <sup>2</sup> )	2.5	2.2	2.7	3.1	-	-	-	-
Width/Depth Ratio	21.1	23.1	18.7	19.3	-	-	-	-
Entrenchment Ratio	2.8	2.8	2.8	2.6	-	-	-	-
Bank Height Ratio	1.0	1.0	1.0	0.5	-	-	-	-

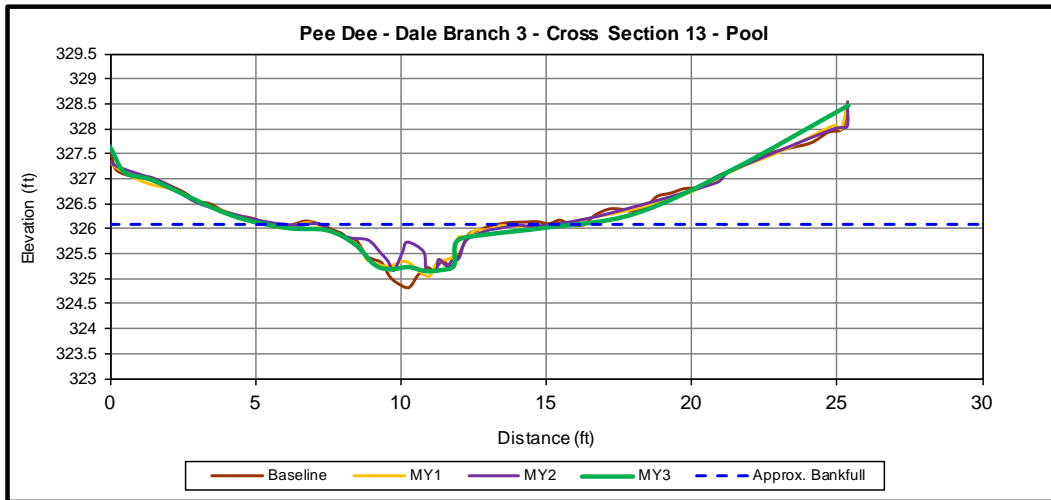
DIMENSIONS SUMMARY	MY0	MY1	MY2	MY3	MY4	MY5	MY6	MY7
Bankful Width (ft)	7.8	7.6	7.7	8.3	-	-	-	-
Floodprone Width (ft)	20.0	20.0	20.0	20.0	-	-	-	-
Bankfull Mean Depth (ft)	0.5	0.5	0.4	0.4	-	-	-	-
Bankfull Max Depth (ft)	1.3	1.1	1.0	0.9	-	-	-	-
Bankfull Cross-Sectional Area (ft <sup>2</sup> )	3.9	3.5	3.0	3.7	-	-	-	-
Width/Depth Ratio	15.7	16.7	19.7	18.5	-	-	-	-
Entrenchment Ratio	2.6	2.6	2.6	N/A	-	-	-	-
Bank Height Ratio	1.0	1.0	1.0	N/A	-	-	-	-

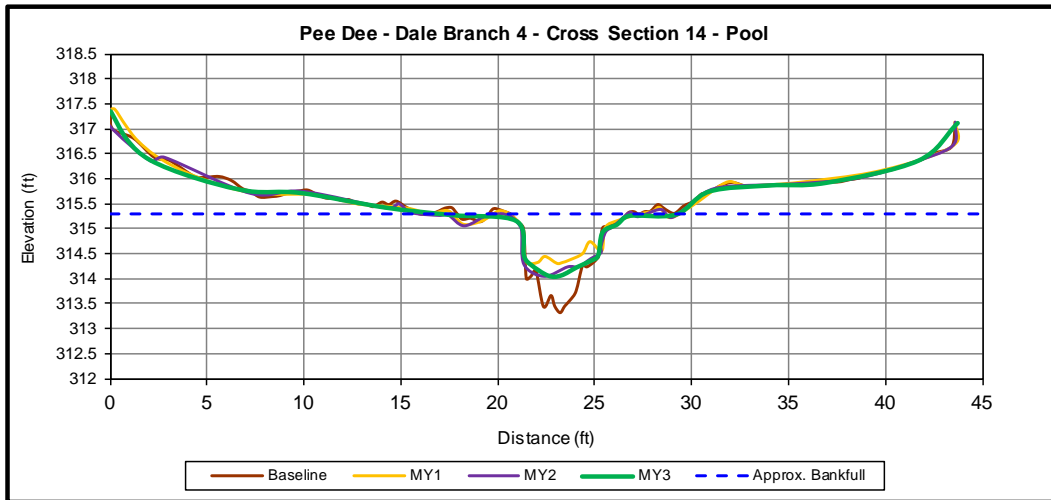
DIMENSIONS SUMMARY	MY0	MY1	MY2	MY3	MY4	MY5	MY6	MY7
Bankful Width (ft)	6.7	7.2	7.0	5.8	-	-	-	-
Floodprone Width (ft)	30.0	30.0	30.0	30.0	-	-	-	-
Bankfull Mean Depth (ft)	0.9	0.6	0.7	0.8	-	-	-	-
Bankfull Max Depth (ft)	2.0	1.0	1.3	1.3	-	-	-	-
Bankfull Cross-Sectional Area (ft <sup>2</sup> )	6.2	4.3	5.2	4.9	-	-	-	-
Width/Depth Ratio	7.1	12.1	9.5	7.0	-	-	-	-
Entrenchment Ratio	4.5	4.2	4.3	N/A	-	-	-	-
Bank Height Ratio	1.0	1.0	1.0	N/A	-	-	-	-

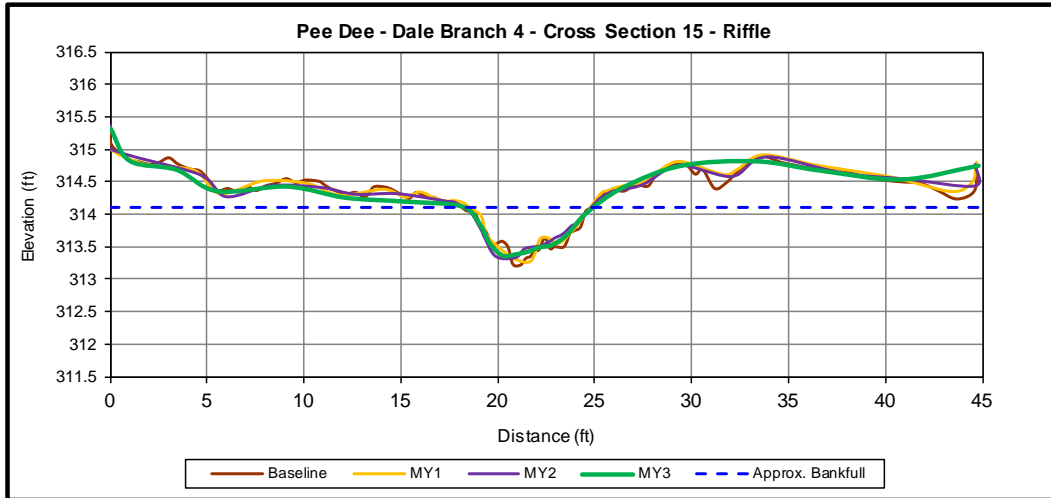
DIMENSIONS SUMMARY	MY0	MY1	MY2	MY3	MY4	MY5	MY6	MY7
Bankful Width (ft)	6.5	6.2	6.5	6.8	-	-	-	-
Floodprone Width (ft)	40.0	40.0	40.0	40.0	-	-	-	-
Bankfull Mean Depth (ft)	0.5	0.5	0.5	0.5	-	-	-	-
Bankfull Max Depth (ft)	0.9	0.8	0.8	0.8	-	-	-	-
Bankfull Cross-Sectional Area (ft <sup>2</sup> )	3.1	2.9	3.0	3.2	-	-	-	-
Width/Depth Ratio	13.8	13.2	14.2	14.7	-	-	-	-
Entrenchment Ratio	6.1	6.5	6.2	5.9	-	-	-	-
Bank Height Ratio	1.0	1.0	1.0	1.0	-	-	-	-

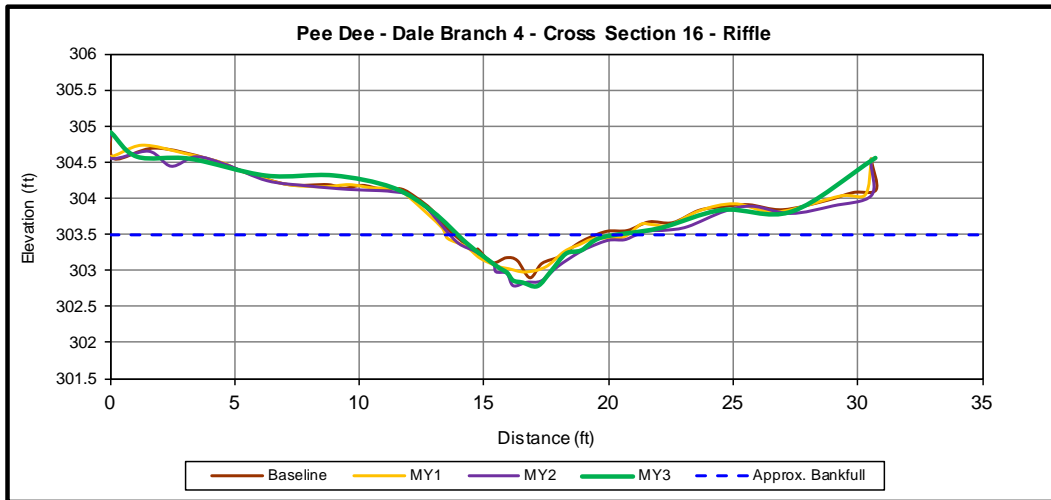
DIMENSIONS SUMMARY	MY0	MY1	MY2	MY3	MY4	MY5	MY6	MY7
Bankful Width (ft)	6.3	7.2	7.6	6.7	-	-	-	-
Floodprone Width (ft)	25.0	25.0	25.0	25.0	-	-	-	-
Bankfull Mean Depth (ft)	0.3	0.3	0.4	0.3	-	-	-	-
Bankfull Max Depth (ft)	0.7	0.6	0.7	0.7	-	-	-	-
Bankfull Cross-Sectional Area (ft <sup>2</sup> )	1.9	2.3	2.7	2.2	-	-	-	-
Width/Depth Ratio	21.0	23.0	20.9	19.9	-	-	-	-
Entrenchment Ratio	4.0	3.5	3.3	3.8	-	-	-	-
Bank Height Ratio	1.0	1.0	1.0	0.9	-	-	-	-

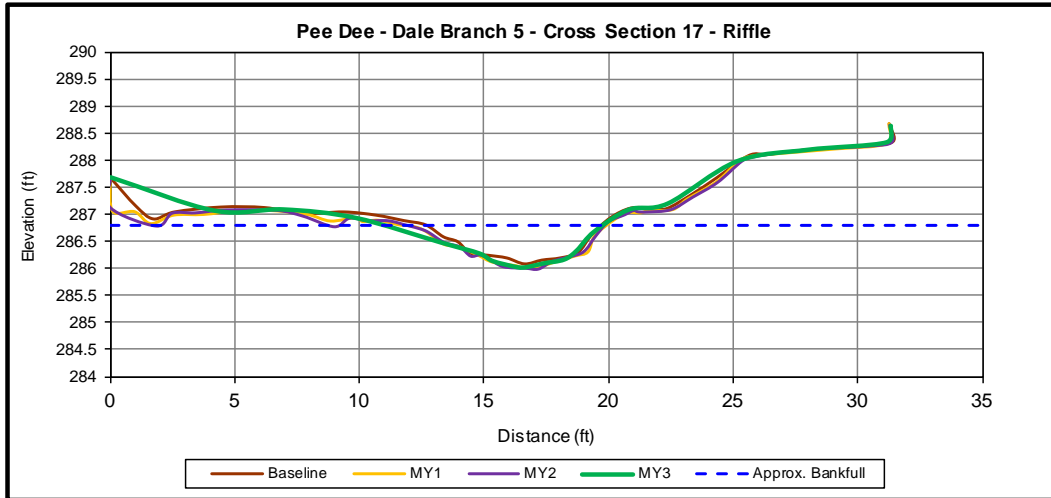
<b>DIMENSIONS SUMMARY</b>	<b>MY0</b>	<b>MY1</b>	<b>MY2</b>	<b>MY3</b>	<b>MY4</b>	<b>MY5</b>	<b>MY6</b>	<b>MY7</b>
Bankful Width (ft)	7.1	7.9	7.9	9.1	-	-	-	-
Floodprone Width (ft)	25.0	25.0	25.0	25.0	-	-	-	-
Bankfull Mean Depth (ft)	0.5	0.5	0.5	0.4	-	-	-	-
Bankfull Max Depth (ft)	0.7	0.8	0.8	0.8	-	-	-	-
Bankfull Cross-Sectional Area (ft <sup>2</sup> )	3.3	3.8	3.9	4.1	-	-	-	-
Width/Depth Ratio	15.2	16.2	16.3	20.6	-	-	-	-
Entrenchment Ratio	3.5	3.2	3.2	2.7	-	-	-	-
Bank Height Ratio	1.0	1.0	1.0	1.2	-	-	-	-

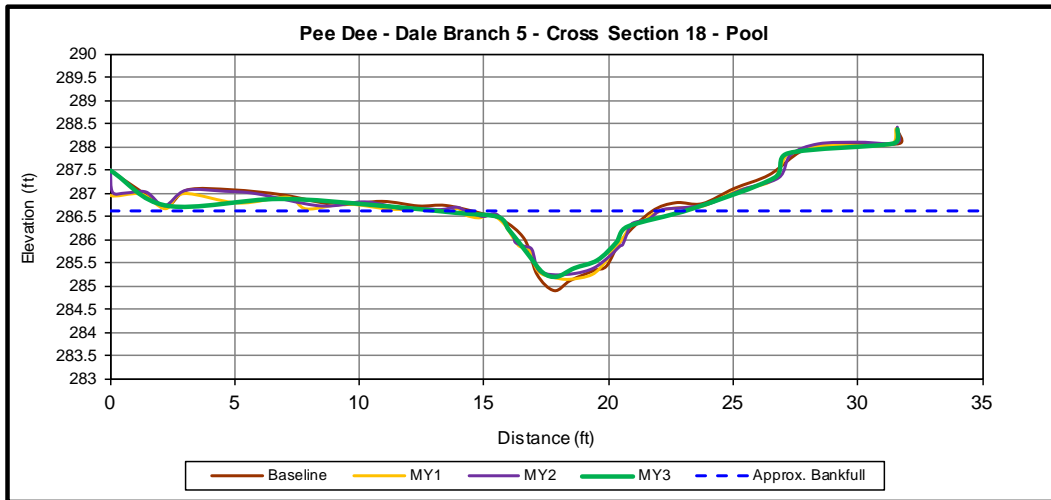
<b>DIMENSIONS SUMMARY</b>	<b>MY0</b>	<b>MY1</b>	<b>MY2</b>	<b>MY3</b>	<b>MY4</b>	<b>MY5</b>	<b>MY6</b>	<b>MY7</b>
Bankful Width (ft)	7.2	8.0	7.7	7.4	-	-	-	-
Floodprone Width (ft)	25.0	25.0	25.0	25.0	-	-	-	-
Bankfull Mean Depth (ft)	0.8	0.7	0.7	0.7	-	-	-	-
Bankfull Max Depth (ft)	1.7	1.5	1.4	1.4	-	-	-	-
Bankfull Cross-Sectional Area (ft <sup>2</sup> )	5.9	5.8	5.6	5.3	-	-	-	-
Width/Depth Ratio	8.7	11.0	10.7	10.4	-	-	-	-
Entrenchment Ratio	3.5	3.1	3.2	N/A	-	-	-	-
Bank Height Ratio	1.0	1.0	1.0	N/A	-	-	-	-

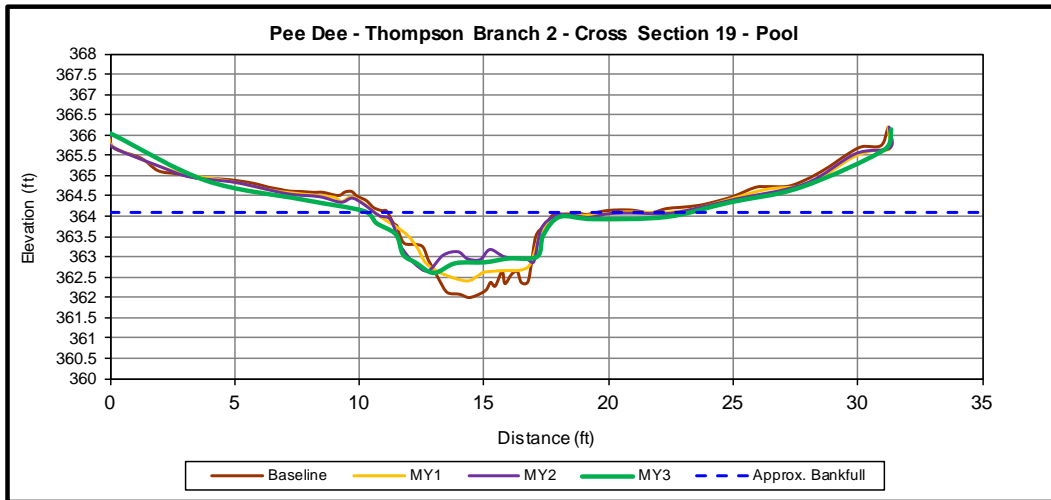
DIMENSIONS SUMMARY	MY0	MY1	MY2	MY3	MY4	MY5	MY6	MY7
Bankful Width (ft)	8.4	9.2	9.2	7.8	-	-	-	-
Floodprone Width (ft)	30.0	30.0	30.0	30.0	-	-	-	-
Bankfull Mean Depth (ft)	1.0	0.9	0.8	1.0	-	-	-	-
Bankfull Max Depth (ft)	2.1	1.7	1.5	1.5	-	-	-	-
Bankfull Cross-Sectional Area (ft <sup>2</sup> )	8.8	8.1	7.0	7.7	-	-	-	-
Width/Depth Ratio	8.0	10.4	12.1	8.0	-	-	-	-
Entrenchment Ratio	3.6	3.3	3.3	N/A	-	-	-	-
Bank Height Ratio	1.0	1.0	1.0	N/A	-	-	-	-

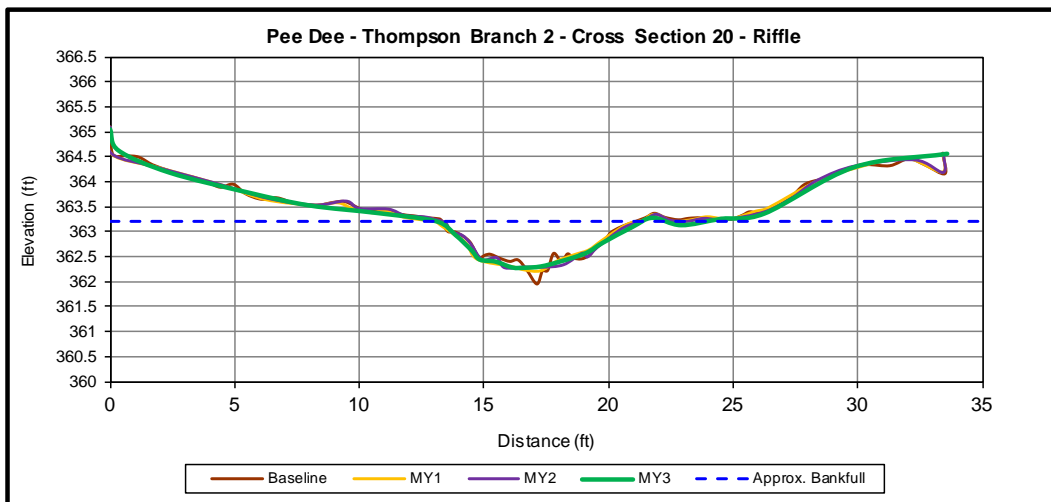
DIMENSIONS SUMMARY	MY0	MY1	MY2	MY3	MY4	MY5	MY6	MY7
Bankful Width (ft)	7.5	7.7	7.6	8.4	-	-	-	-
Floodprone Width (ft)	30.0	30.0	30.0	30.0	-	-	-	-
Bankfull Mean Depth (ft)	0.6	0.6	0.6	0.6	-	-	-	-
Bankfull Max Depth (ft)	1.2	0.9	0.9	0.9	-	-	-	-
Bankfull Cross-Sectional Area (ft <sup>2</sup> )	4.2	4.4	4.4	4.8	-	-	-	-
Width/Depth Ratio	13.3	13.5	13.0	14.5	-	-	-	-
Entrenchment Ratio	4.0	3.9	3.9	3.6	-	-	-	-
Bank Height Ratio	1.0	1.0	1.0	1.0	-	-	-	-

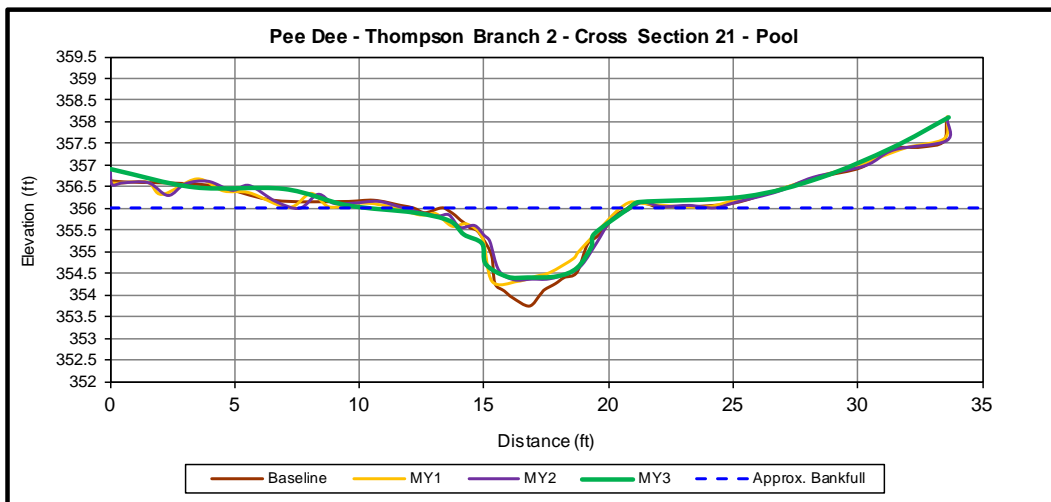
DIMENSIONS SUMMARY	MY0	MY1	MY2	MY3	MY4	MY5	MY6	MY7
Bankful Width (ft)	8.6	9.1	9.2	10.2	-	-	-	-
Floodprone Width (ft)	30.0	30.0	30.0	30.0	-	-	-	-
Bankfull Mean Depth (ft)	1.0	0.8	0.8	0.8	-	-	-	-
Bankfull Max Depth (ft)	2.3	1.7	1.7	1.6	-	-	-	-
Bankfull Cross-Sectional Area (ft <sup>2</sup> )	8.5	7.5	7.8	8.0	-	-	-	-
Width/Depth Ratio	8.7	10.9	10.9	12.9	-	-	-	-
Entrenchment Ratio	3.5	3.3	3.2	N/A	-	-	-	-
Bank Height Ratio	1.0	1.0	1.0	N/A	-	-	-	-

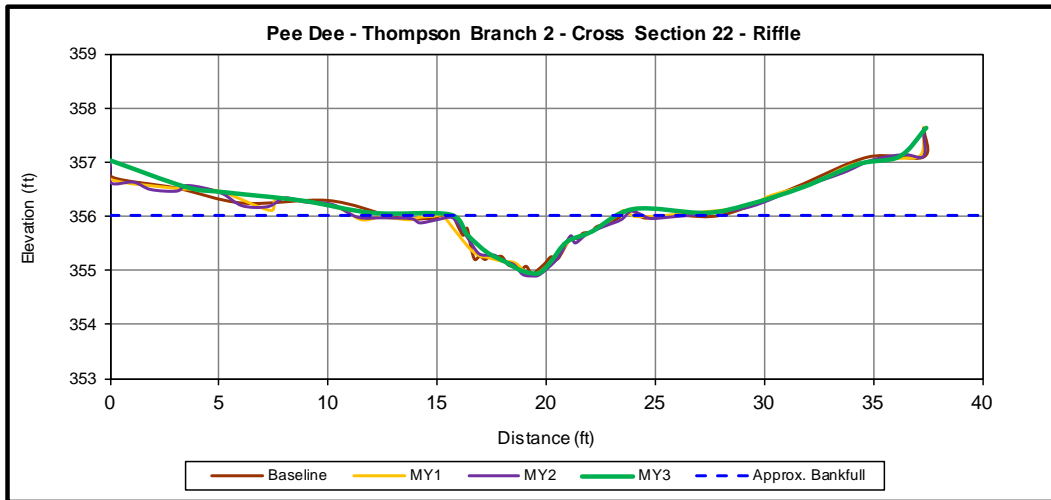
<b>DIMENSIONS SUMMARY</b>	<b>MY0</b>	<b>MY1</b>	<b>MY2</b>	<b>MY3</b>	<b>MY4</b>	<b>MY5</b>	<b>MY6</b>	<b>MY7</b>
Bankful Width (ft)	7.6	7.7	7.7	7.8	-	-	-	-
Floodprone Width (ft)	30.0	30.0	30.0	30.0	-	-	-	-
Bankfull Mean Depth (ft)	0.6	0.6	0.6	0.6	-	-	-	-
Bankfull Max Depth (ft)	1.1	1.0	1.1	1.1	-	-	-	-
Bankfull Cross-Sectional Area (ft <sup>2</sup> )	4.3	4.4	4.4	4.4	-	-	-	-
Width/Depth Ratio	13.4	13.5	13.5	13.8	-	-	-	-
Entrenchment Ratio	3.9	3.9	3.9	3.9	-	-	-	-
Bank Height Ratio	1.0	1.0	1.0	1.0	-	-	-	-

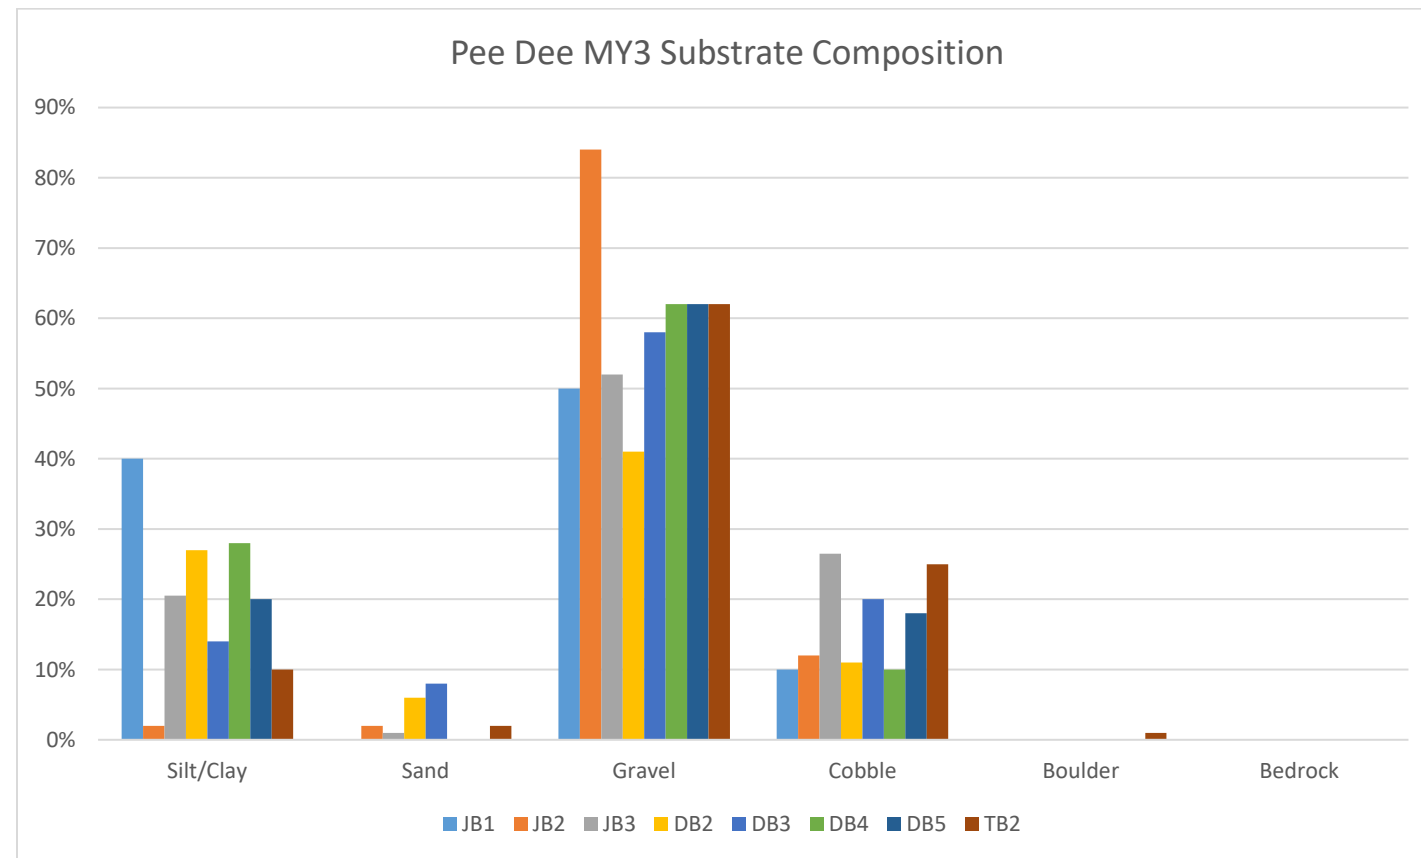
**Chart 1.**

**Charts 1-9. MY3 Stream Reach Substrate Composition Charts**

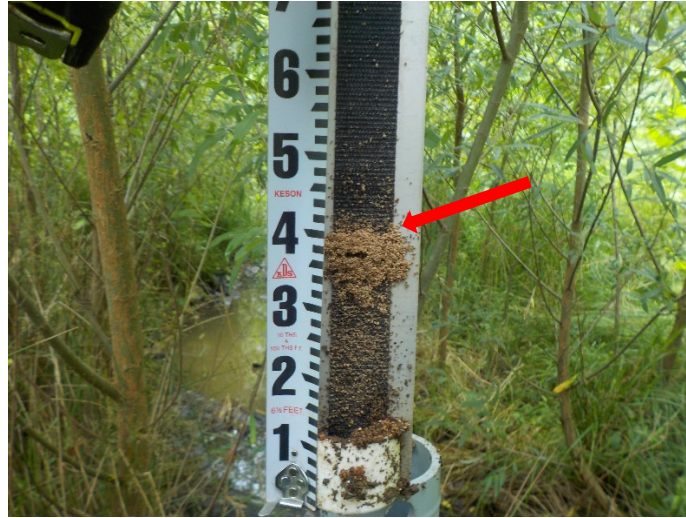
**Photo Verification of Bankfull Events**

Crest Gauge @ Thompson Branch – 0.4 ft. (Est. Date of Occurrence: 6/5/2017)

Reach	Method	Number of Bankfull Events	Maximum Bankfull Height (ft.)
Jerry Branch	Crest Gauge	0	N/A
Dale Branch	Crest Gauge	0	N/A
Thompson Branch	Crest Gauge	1	0.4

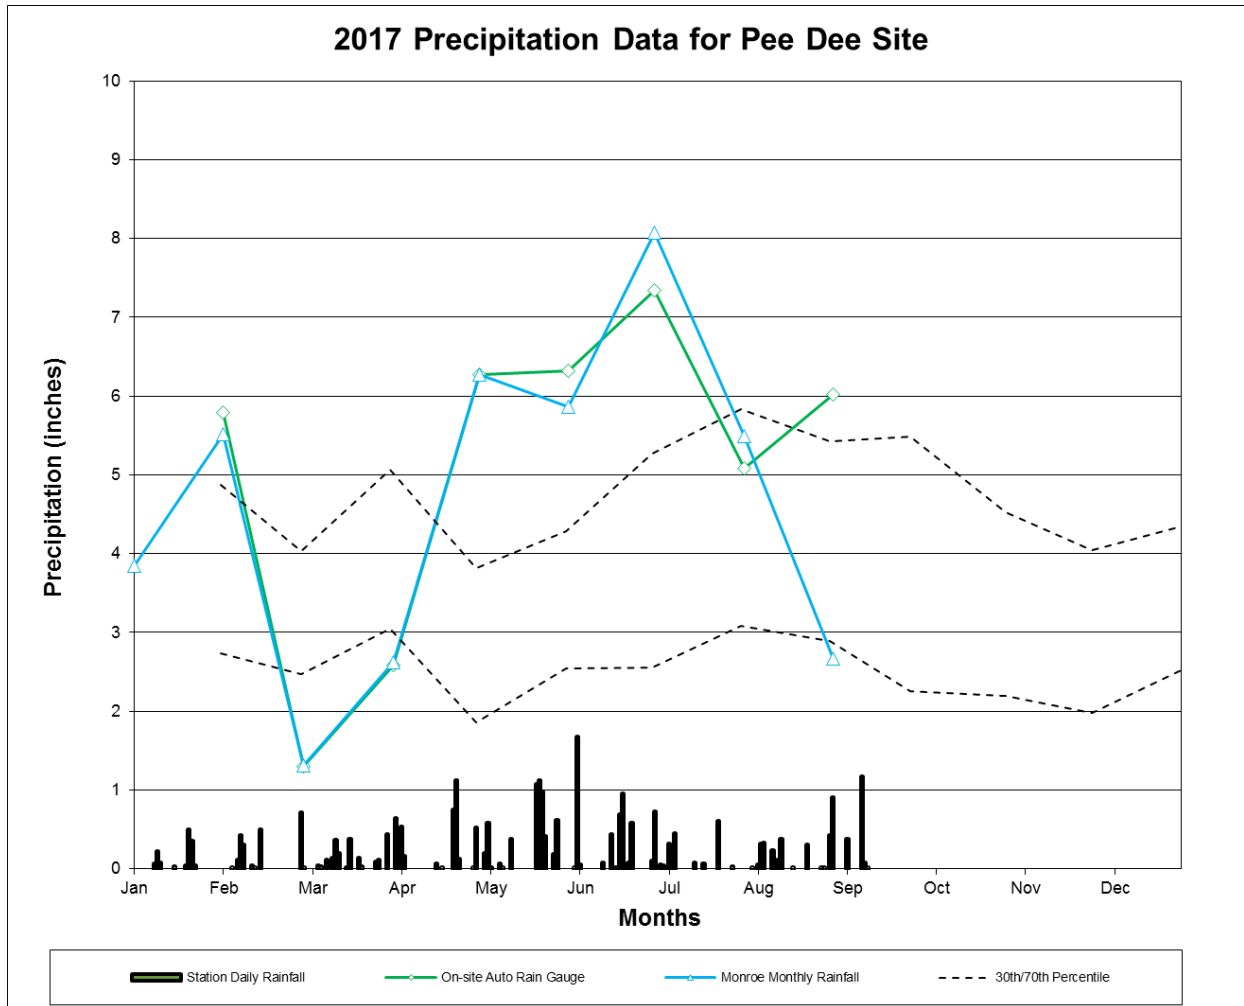
Chart 10. 2017 Precipitation Data for Pee Dee Site

**Note:** Station Data up until June 2017 from NCCRONOS Uwharrie (Troy) station then the NCCRONOS Albemarle 5.1 SSE station. Normal Limits and Average data provided by the NRCS Jackson Springs WETS Table.
