POPLIN RIDGE STREAM RESTORATION PROJECT BASELINE MONITORING REPORT

UNION COUNTY, NORTH CAROLINA
PROJECT # 95359
CONTRACT #004672

**Poplin Ridge
Union County, North Carolina
DMS Project ID 95359**

**Yadkin River Basin
HUC 03040105070050**

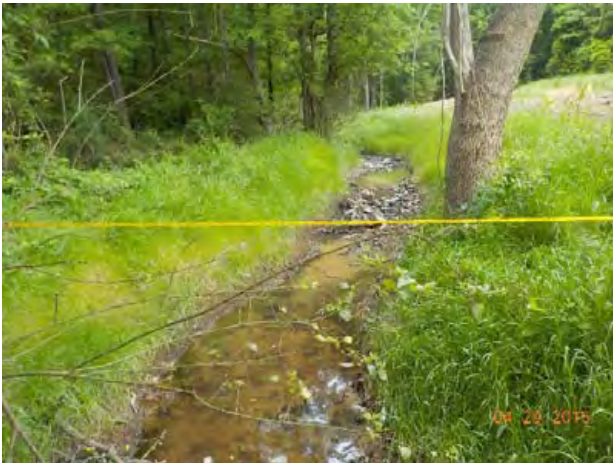
UT1-1 STA 8+53 Looking Upstream (4/29/2015)

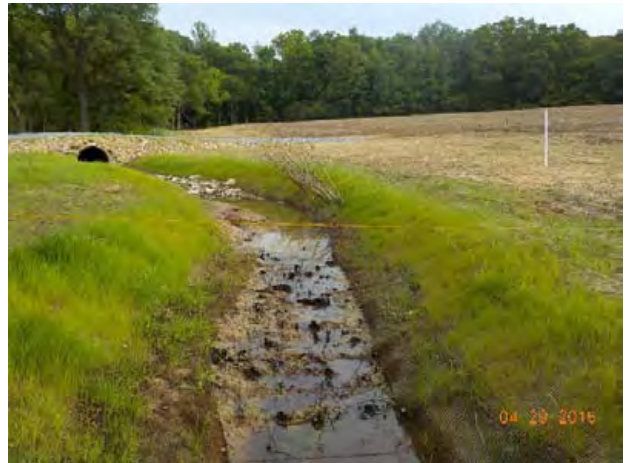
UT1-2 STA 14+58 at Crossing (4/29/2015)

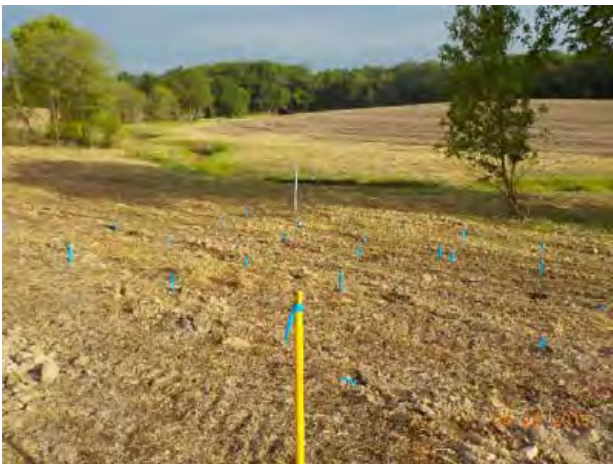
UT1-2 STA 21+50 Looking Upstream (4/29/2015)

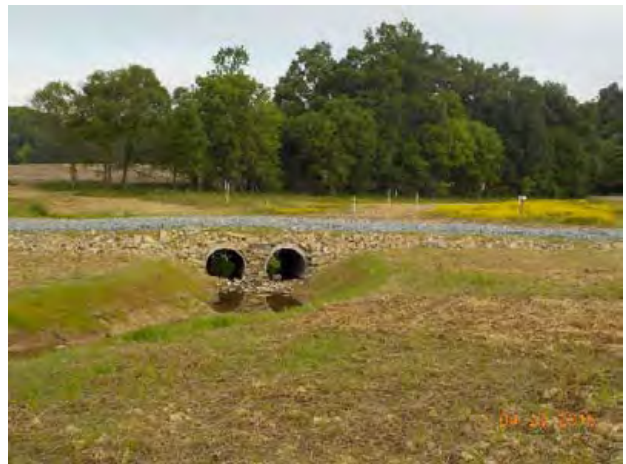
UT1-3 STA 26+50 at Crossing (4/29/2015)

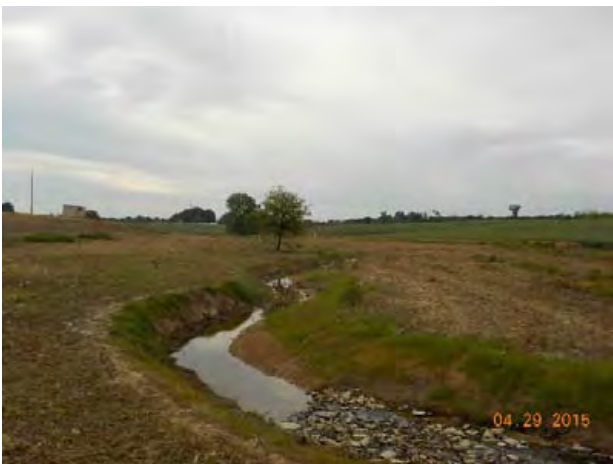
UT1-3 STA 27+50 Looking Downstream (4/29/2015)

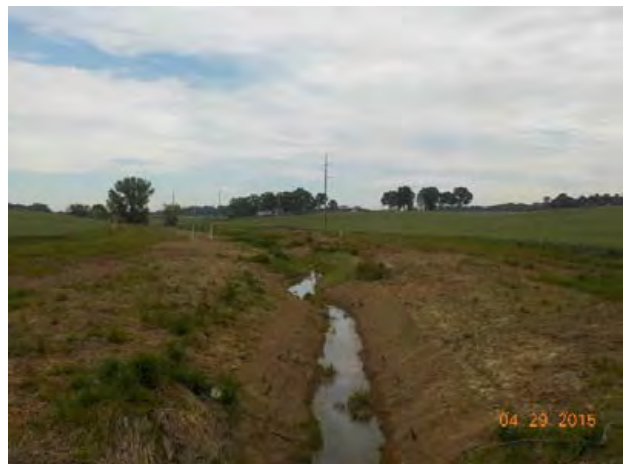
UT1-4 STA 47+20 Looking Upstream (4/29/2015)

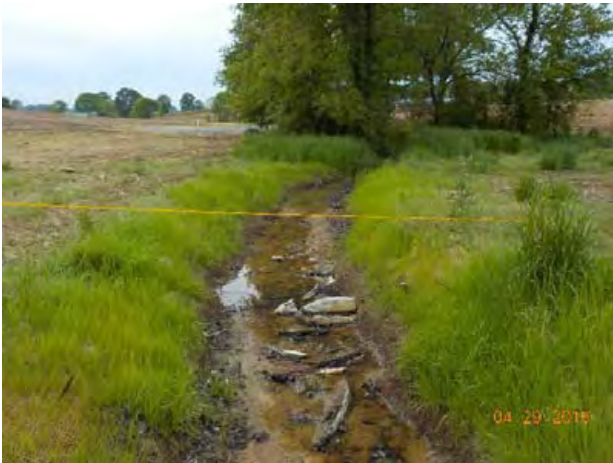
UT1-A STA 2+00 Looking Downstream (4/29/2015)

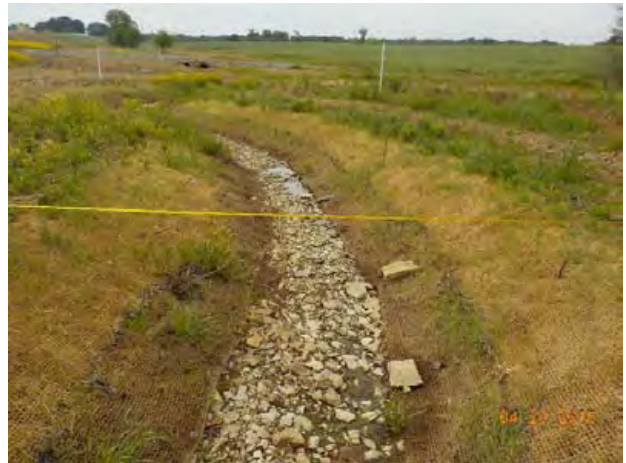
UT1-B STA 9+86 Looking Downstream (4/29/2015)

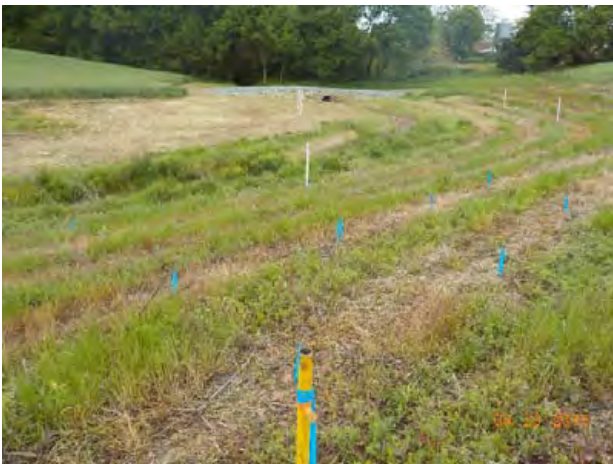
UT1-C STA 2+50 Looking Upstream (4/29/2015)

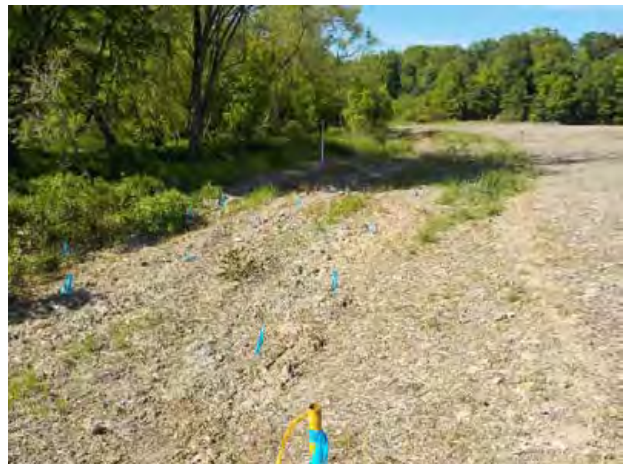
UT2-1 STA 4+50 Looking Upstream (4/29/2015)

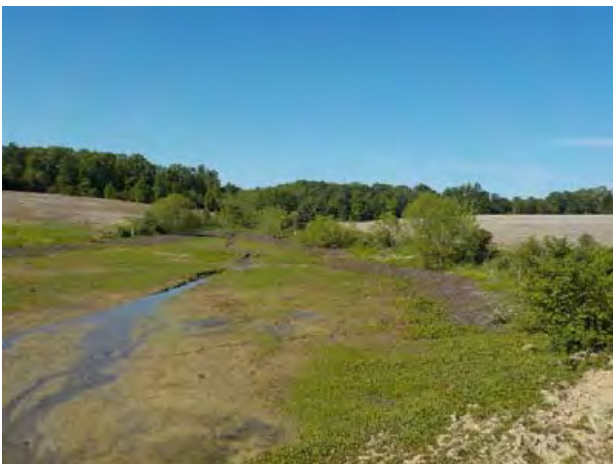
UT2-2 STA 11+00 Pond Bottom (US) (4/29/2015)

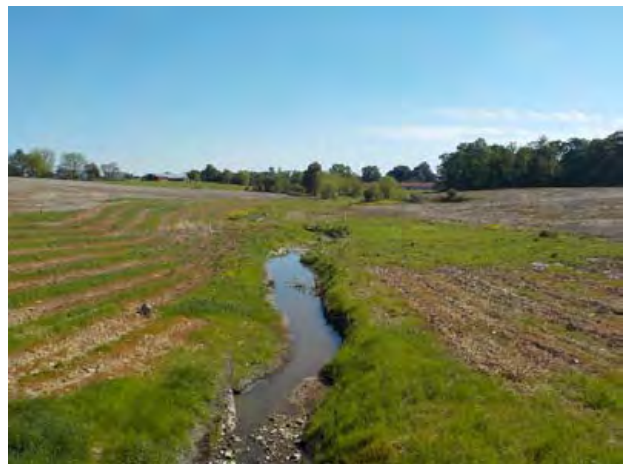
UT2-2 STA 11+00 Looking Downstream (4/29/2015)

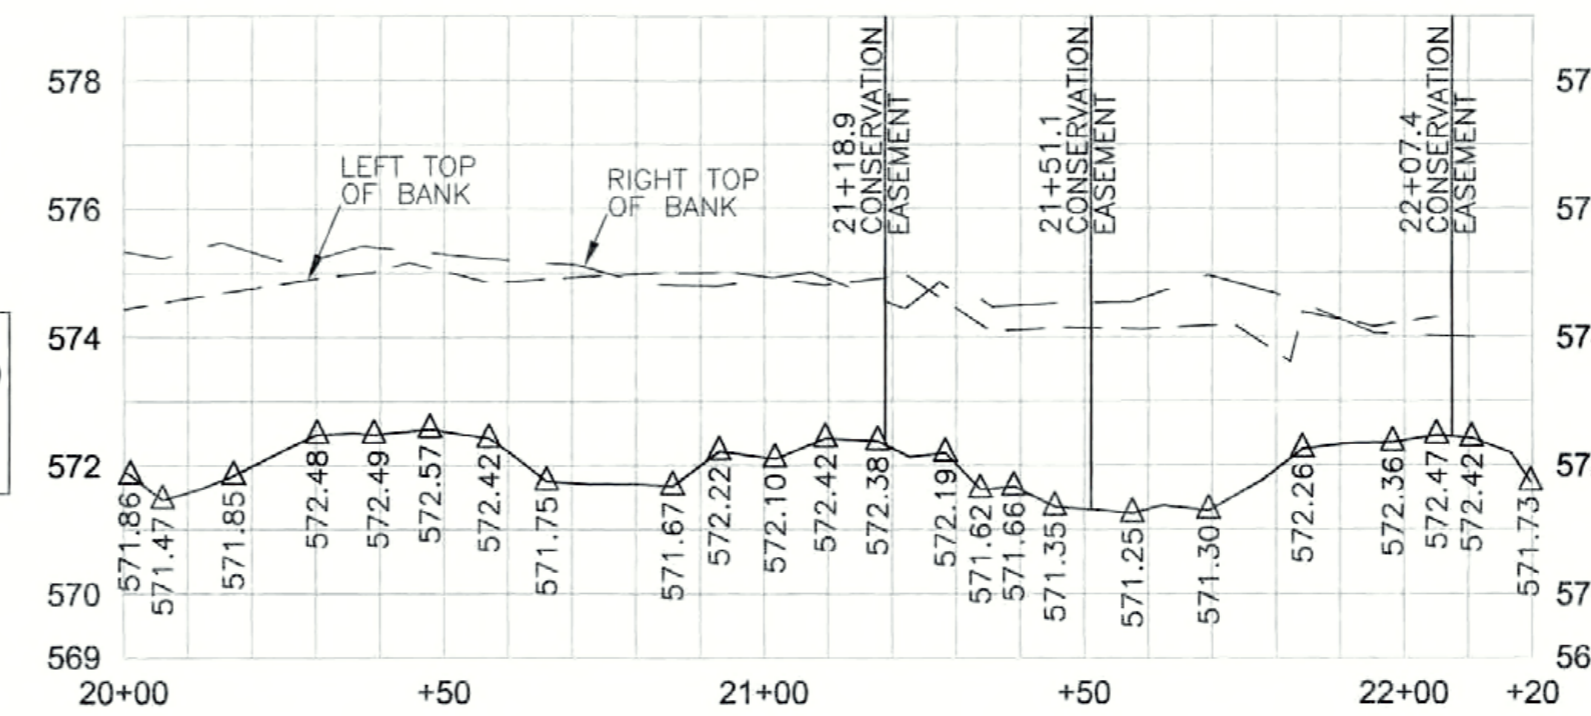
AS-BUILT PROFILE
UT2-4
STA 20+00 TO 22+20

PROFILE SCALE
HORIZONTAL: 1"=30'(22x34)
1"=60'(11x17)
VERTICAL: 1"=3'(22x34)
1"=6'(11x17)
