Puzzle Creek Restoration Plan
Rutherford County, North Carolina
EEP Project No. D06027-C

Puzzle Creek Stream Restoration Plan

Rutherford County, North Carolina

Report Prepared and Submitted by Baker Engineering NY, Inc.

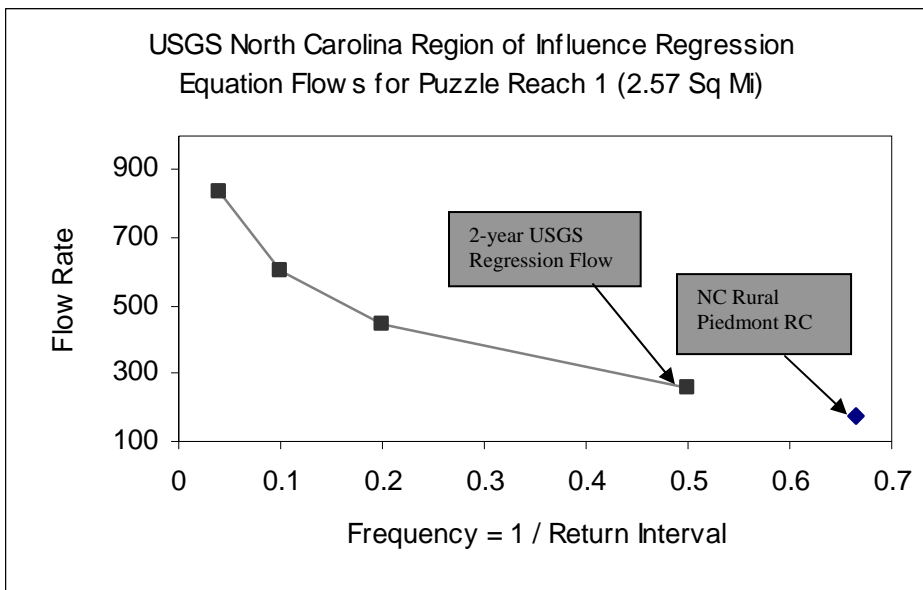
Figure 3.2. USGS Regional Regression Equation Flood Events

North Carolina USGS Regionalized Regression Equations (Pope et al. 2001) incorporate latitude, longitude, and drainage area information when used to calculate flood estimates based on data from USGS gages. These regression equations were used to calculate the estimates for the 2-, 5-, 10-, and 25-year floods. An example for Puzzle Creek reach 1 is plotted in Figure 3.2 below, with the NC regional curve flow for the rural Piedmont at the far right (assumed return interval of 1.5 or 0.66 frequency for plotting purposes). These regression equation flows were used as comparative estimates of different flow frequencies.

Figure 3.4 depicts the discharge rating curve overlapped on a cross-section in Puzzle Creek reach 2. As described in Section 3.3, slight differences in water surface elevation make large differences in discharge in the channel section. And as shown in Figure 3.2, small differences in the estimate of

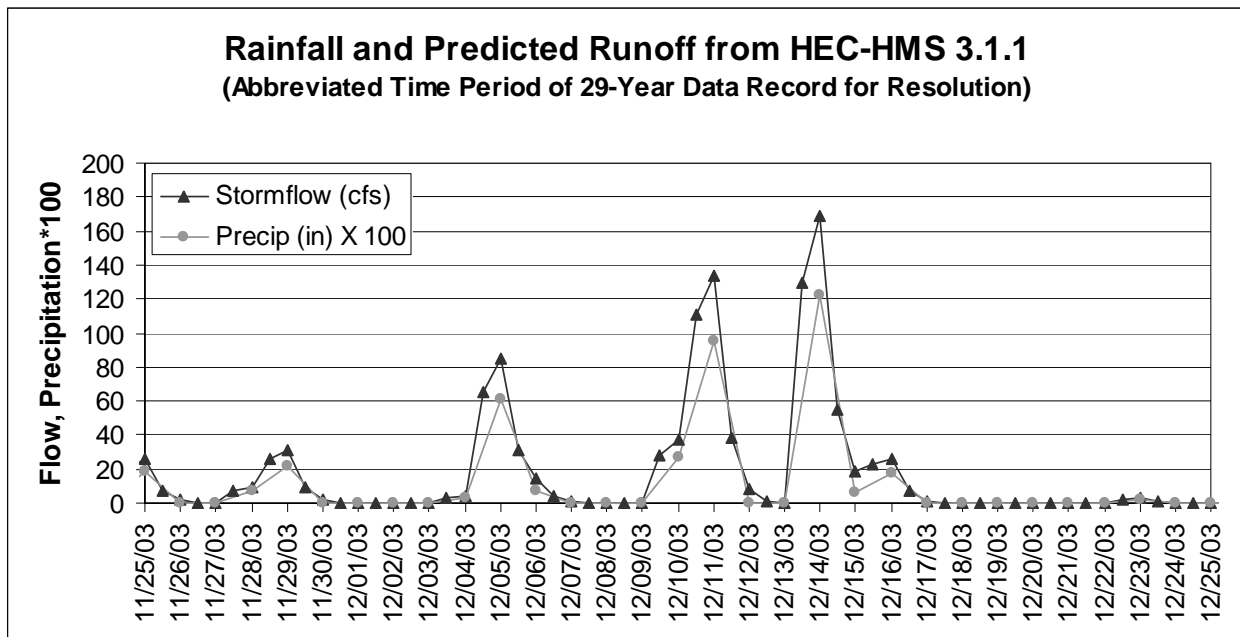
Figure 3.3. HMS Input (Rainfall) and Output (Runoff) at Downstream Terminus of Project for Abbreviated Time Period

from NOAA’s National Climatic Data Center (NCDC) (<http://www.ncdc.noaa.gov/oa/ncdc.html>) for Forest City, NC, the closest location to the project site (~5 miles) with long term rainfall data. The HEC-HMS 3.0.0 “Specified Hyetograph” meteorological model can accept a long term hyetograph and run the model to produce the corresponding hydrograph. The SCS Curve Number Method is the “Loss Method” which determines the quantity of rainfall which is converted to runoff. Figure 3.3 depicts an abbreviated period of the rainfall and resulting output hydrograph- it depicts the runoff at the downstream end of the entire project for a 1-month period of the 29 year record. Note that the precipitation is multiplied by 100 for plotting comparison.

* Precipitation is multiplied by 100 for plotting comparison.

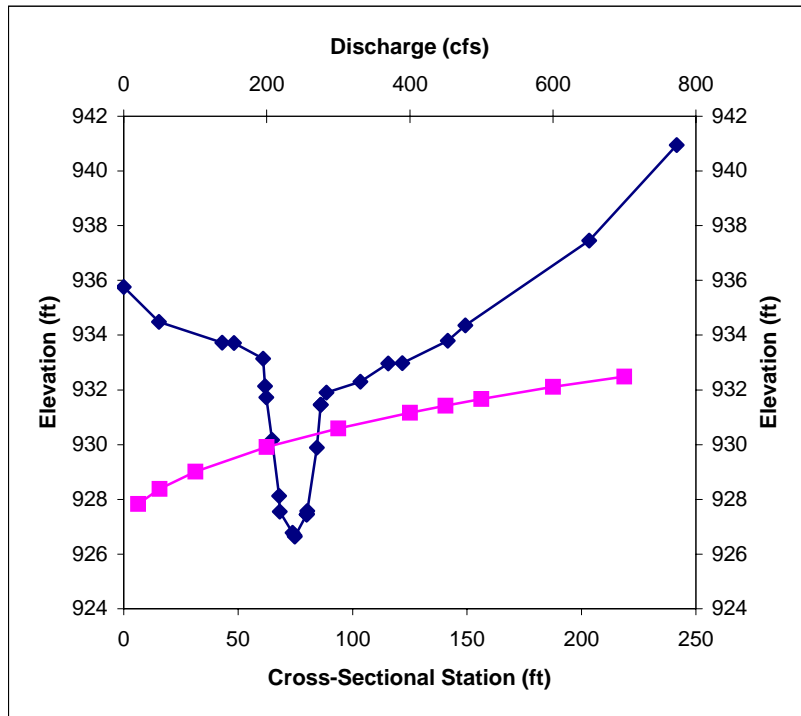
Figure 3.4 Stage-Discharge Relationship for Cross-section

discharge correspond to relatively large differences in the recurrence interval of the flow. The product of the flow frequency curve and the sediment rating curve produce cumulative sediment discharge are depicted in Figure 3.5. For the Puzzle Creek outlet, where the watershed area is 5.46 square miles, the effective discharge curve reaches a maximum at a flow discharge of 500 cfs, a value slightly larger than the 2-year discharge predicted by the USGS Regression Equation (465 cfs). This difference could be related to un-calibrated roughness estimation, but the over-estimation of the effective discharge is not surprising given the issues present in developing a flow duration curve with the HMS model, which underestimates or omits lower flows due to initial abstraction calculations in the SCS Method Curve Number Method. In an attempt to rectify this limitation, another method was investigated to develop an adequate flow duration curve; this regional duration curve method is described in the next sub-section.

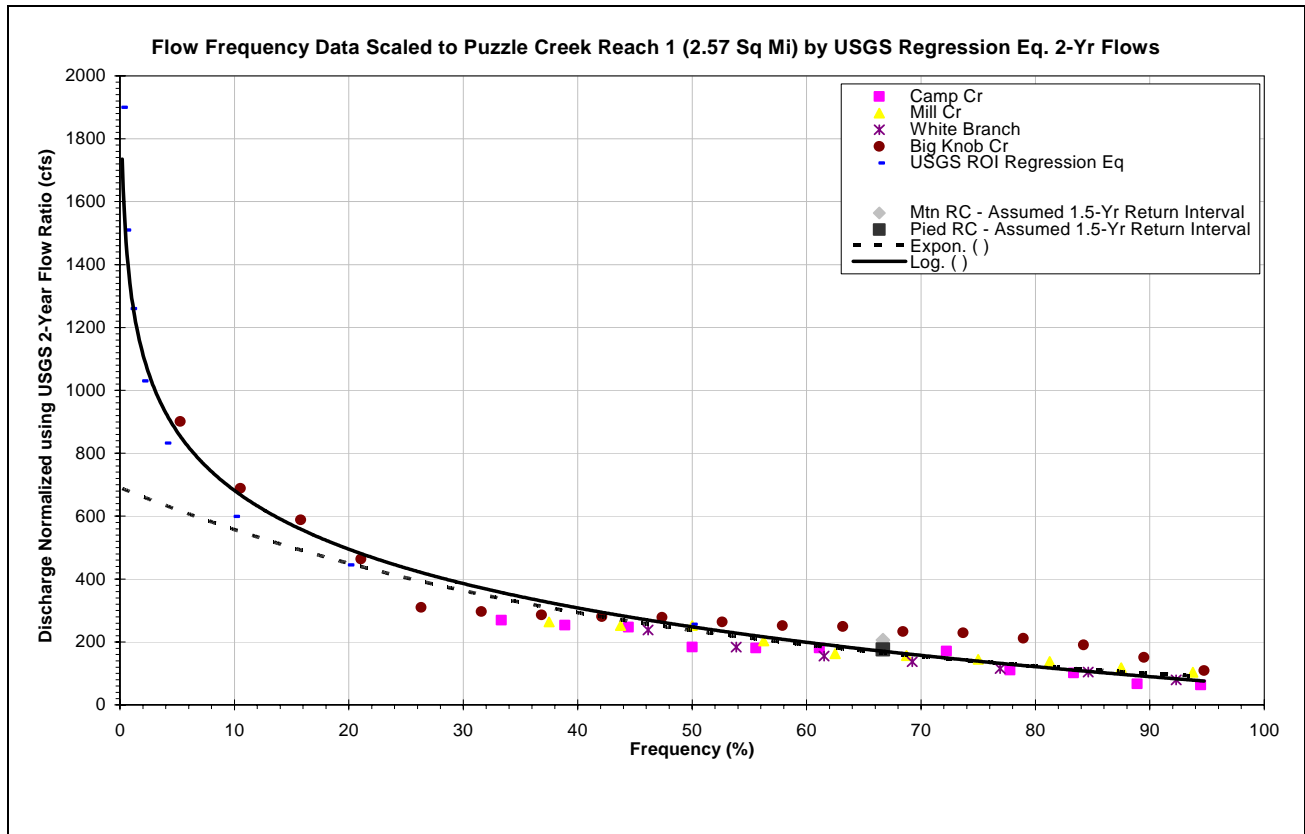
Figure 3.6 Regional Duration Curve for Puzzle Creek Reach 2

were scaled to produce a flow frequency curve for the restoration watershed. After being normalized by the Q2 flow for their watershed, they were multiplied by the Q2 flow for the restoration reach (in this case, Puzzle Creek reach 1). The resulting data points were fit with a best fit line estimating flow frequency as shown in Figure 3.6. Note that the large events (low frequency) do not coincide as well as the smaller events - most of the gages used here have a period of record much smaller than the return interval for the large events (15-20 years of gage data is often times inadequate at estimating the magnitude of a 100-year event). The regional curve and USGS regression flows are shown on the plot as reference flows. The basic procedure for this method is detailed in the reference above.

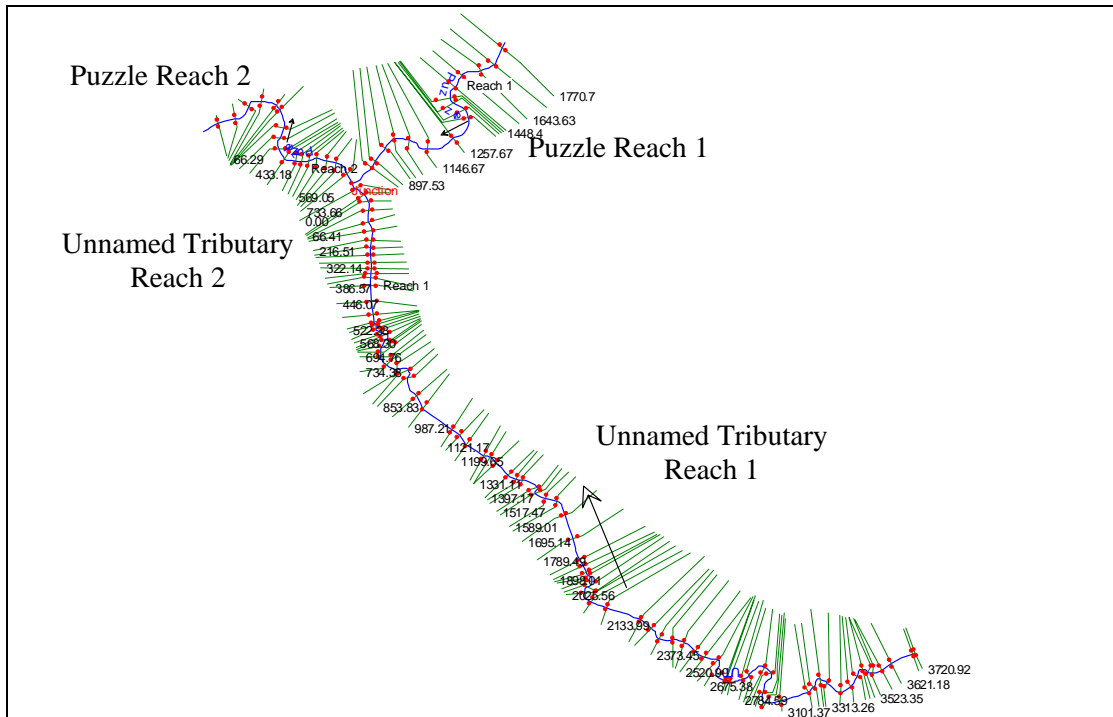
Figure 3.7 Puzzle Creek Restoration Reach HEC-RAS Hydraulic Model

Extensive topographic data was collected during the existing conditions survey. This information was used to create a three-dimensional topographic surface, or Triangulated Irregular Network (TIN), in AutoCAD, from which it is possible to extract cross-sections at desired intervals and export them into HEC-RAS. By this method, a detailed hydraulic model was created in HEC-RAS (Figure 3.7 depicts the location of the cross-sections in green overlain on the reaches).

The HEC-RAS 3.1.3 hydraulic model was refined in an attempt to model site conditions such as debris jams, vegetation, confluences, and other hydraulic conditions. The result was a detailed model that was used to determine the stage-discharge relationship throughout the restoration reach. In this manner, the model was used to assess the degree of connectivity to the floodplain that segments of stream exhibited at different modeled flow rates (mainly those flow rates thought to be reasonable estimates of the bankfull flow as determined from the previously described methods). Physical indicators such as the top of the bank and depositional benches and point bars were used to assess which flow rates of the estimates available were most consistent estimates of bankfull flow in each of the design reaches.

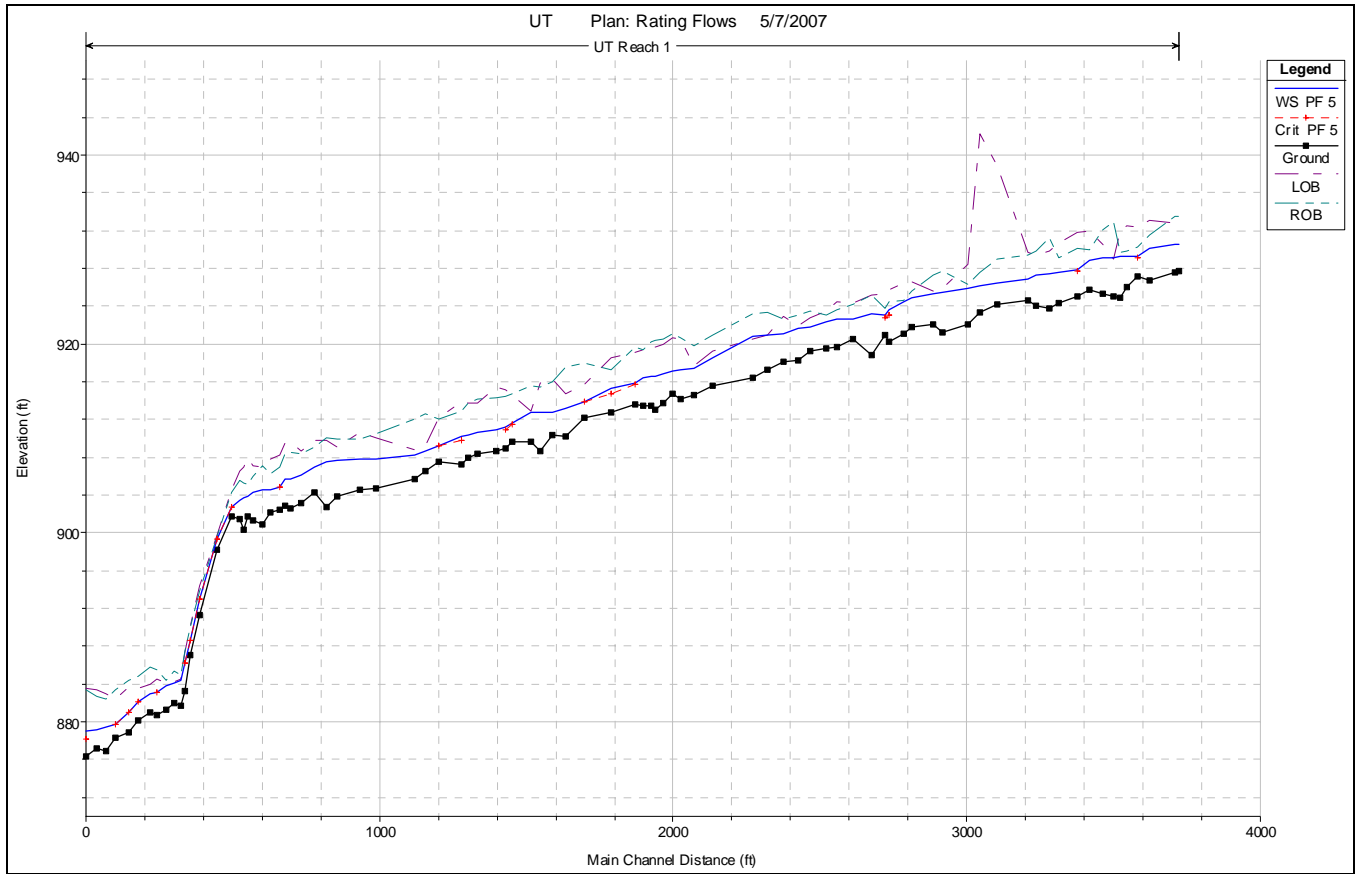
Figure 3.8 Existing Longitudinal Bed Profile for Unnamed Tributary Reaches 1 and 2 and HEC-RAS Water Surface Profile for Design Flow (140 cfs)

To determine floodplain connectivity for the unnamed tributary, HEC-RAS data were plotted longitudinally using water surface and top-of-bank (reflected as “LOB” or “ROB” for left and right banks) elevations which are depicted in Figure 3.8 below. The water surface is for the chosen design discharge, 140 cfs. Cross-sectional data (see example in Figure 3.9) was also used to more carefully scrutinize water surface data and assess coincidence with top of bank, benches, slope breaks, and other depositional features throughout reaches of constant drainage area.

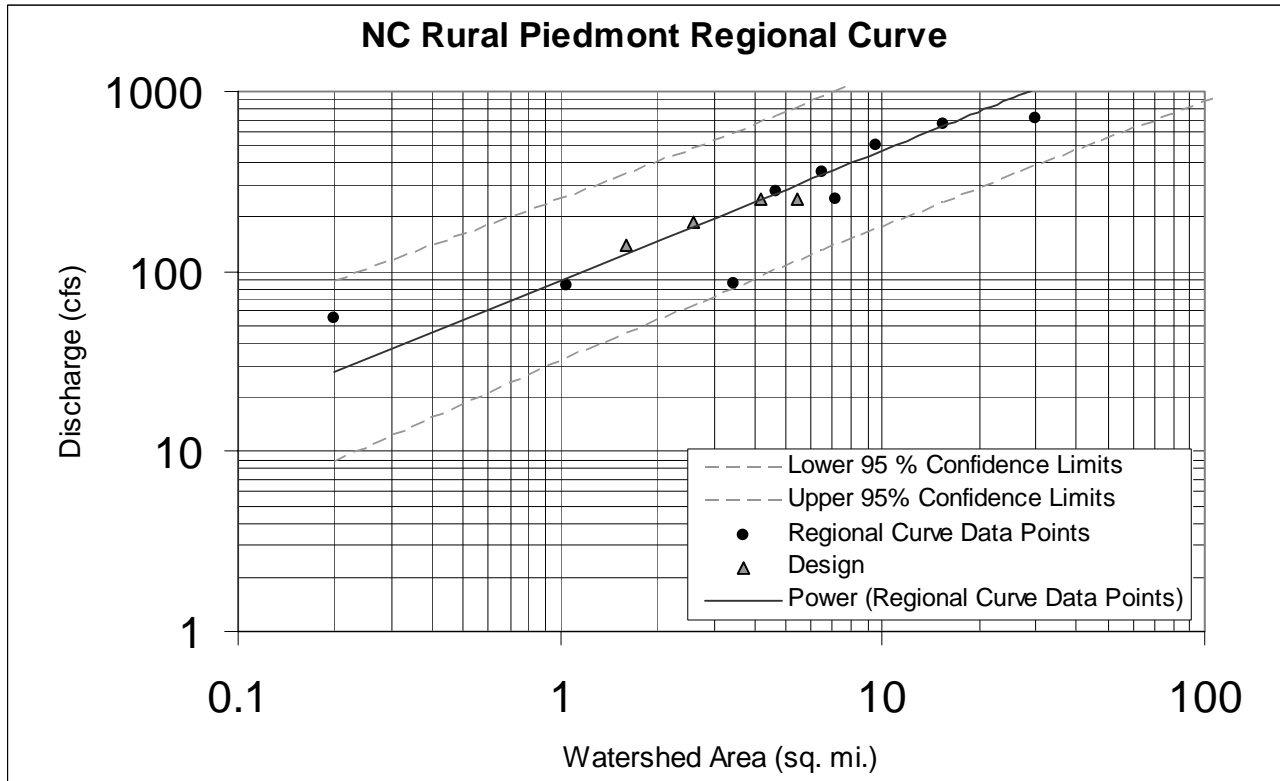
Figure 3.10 NC Rural Piedmont Regional Curve with Design Flows for all Streams on the Puzzle Restoration Site

Table 3.4 below summarizes the design discharges chosen by reach and drainage area. For comparison, the design discharges have been overlain on the reference data making up the NC Rural Piedmont Regional Curve in Figure 3.10.

Project Feature	Downstream Drainage Area (mi²)	Design Discharge (cfs)
Tributary Reaches 1 and 2	1.60	140
Puzzle Reach 1	2.58	190
Puzzle Reach 2	4.18	250

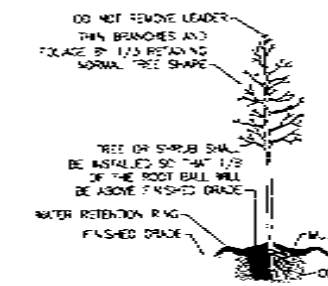
TREE AND SHRUB PLANTING
NTS

- GENERAL NOTES:
1. KEEP ROOTS MOIST WHILE DISTRIBUTING OR WAITING TO PLANT BY MEANS OF NET CANVAS, BURLAP, OR STRAW.
 2. -EEL- N PLANTS IN MOST SOIL OR SAND/LOESS IF NOT PROMPTLY PLANTED UPON ARRIVAL TO PROJECT SITE.
 3. PRUNE ANY BROKEN LIMBS AND TREAT TOXIC BARK WITH TREE WOUND DRESSING.
 4. EVERY EFFORT SHOULD BE MADE TO KEEP SOIL DAMAGED FOR PLANTING FROM ENTERING STREAM. ACCIDENTAL FILL SHOULD BE REMOVED IMMEDIATELY.
