Puzzle Creek Mitigation Project

Year 1 Monitoring Report

Rutherford County, North Carolina

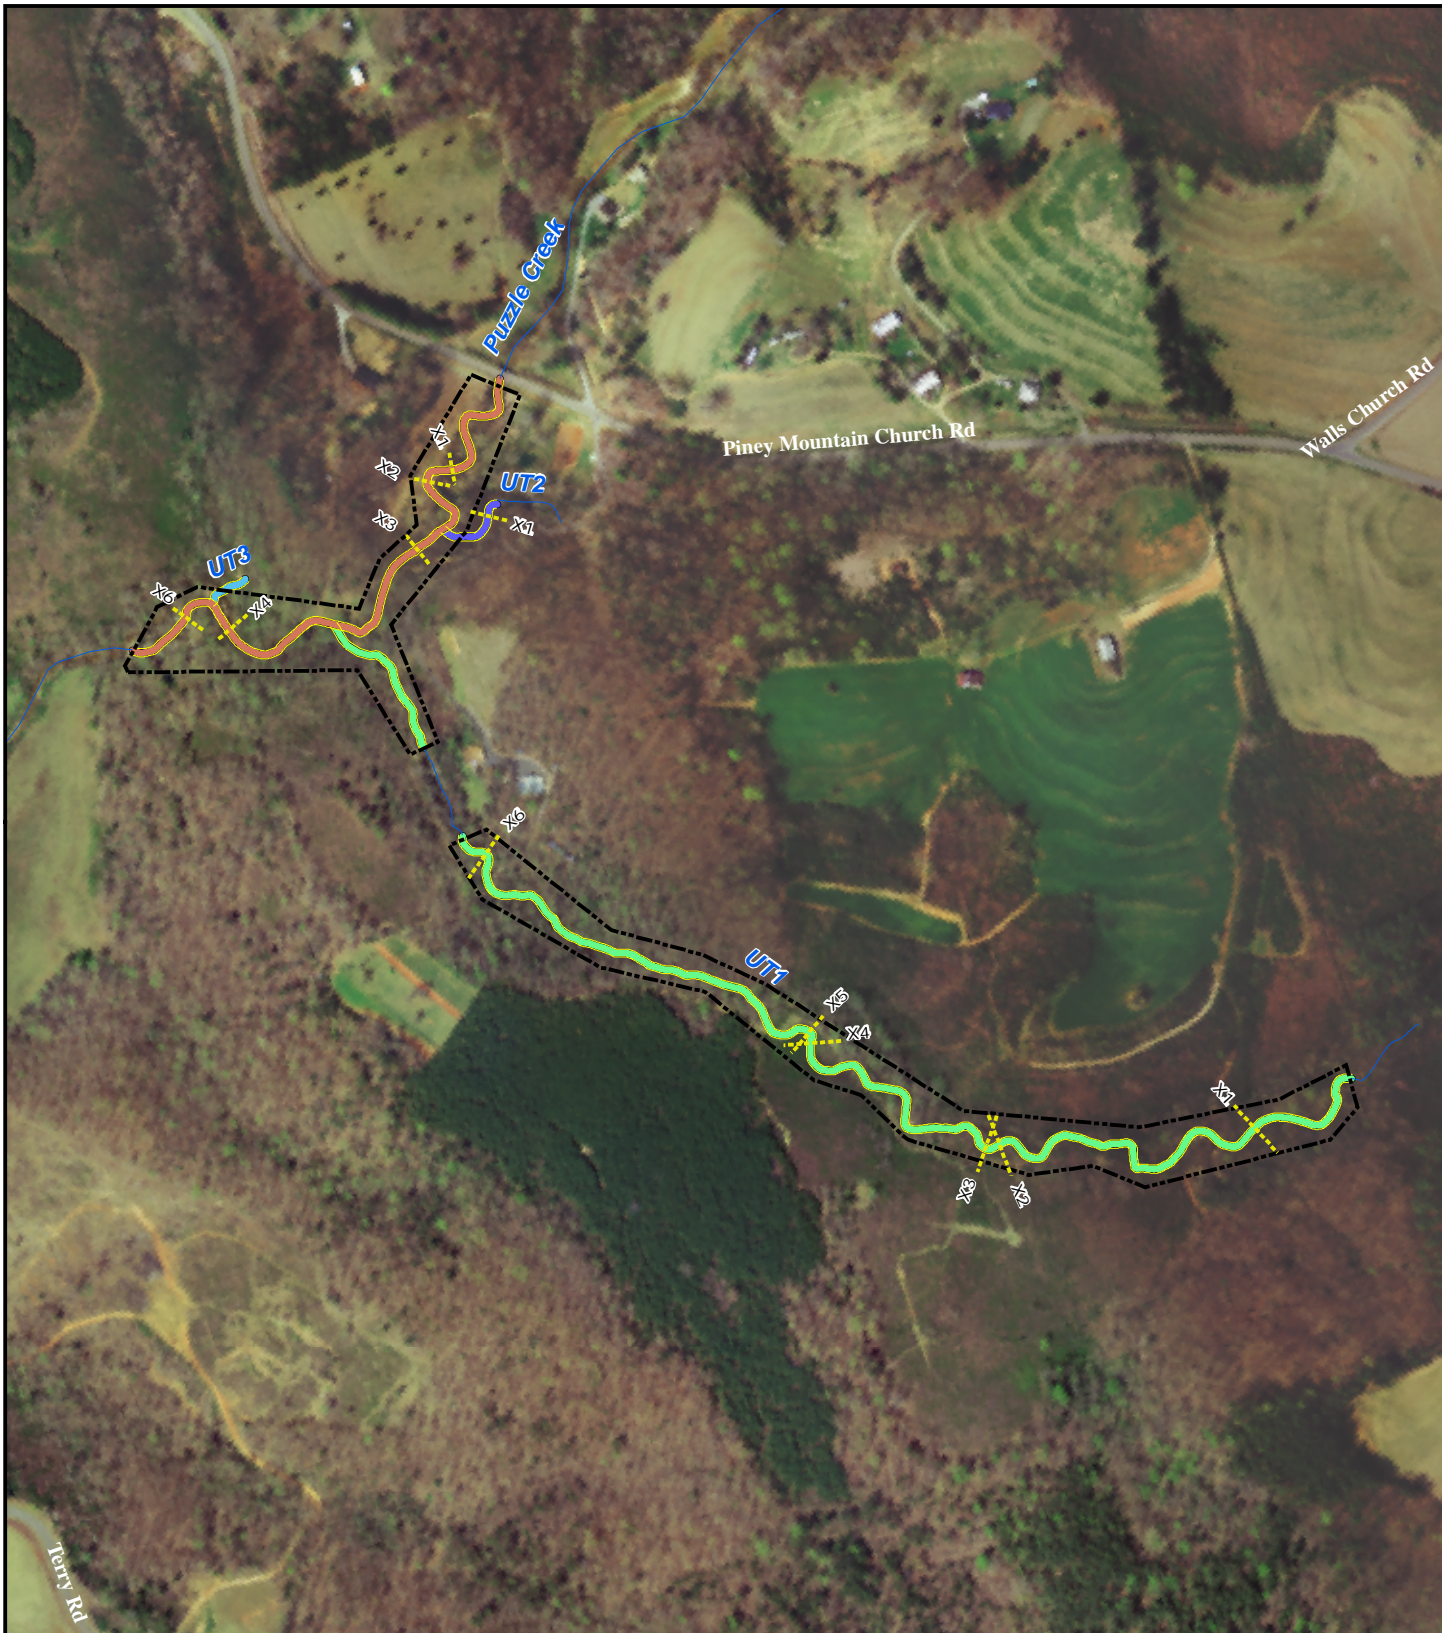
Figure 2 Restoration Summary Map
Puzzle Creek Restoration Project
 Rutherford County, NC

A set of plans depicting the monitoring features for the Puzzle Creek Mitigation Project is attached to the monitoring report. The plan set also provides call outs at locations where stream and vegetation problem areas are present. With the exception of intermittent areas of kudzu encroachment and patches of Chinese privet or multiflora rose scattered throughout the project reaches on Puzzle Creek and UT1, there are no additional problems present. These areas with invasive species are being treated to eradicate them if possible. Figure 2 illustrates the project as it is delineated by reach.

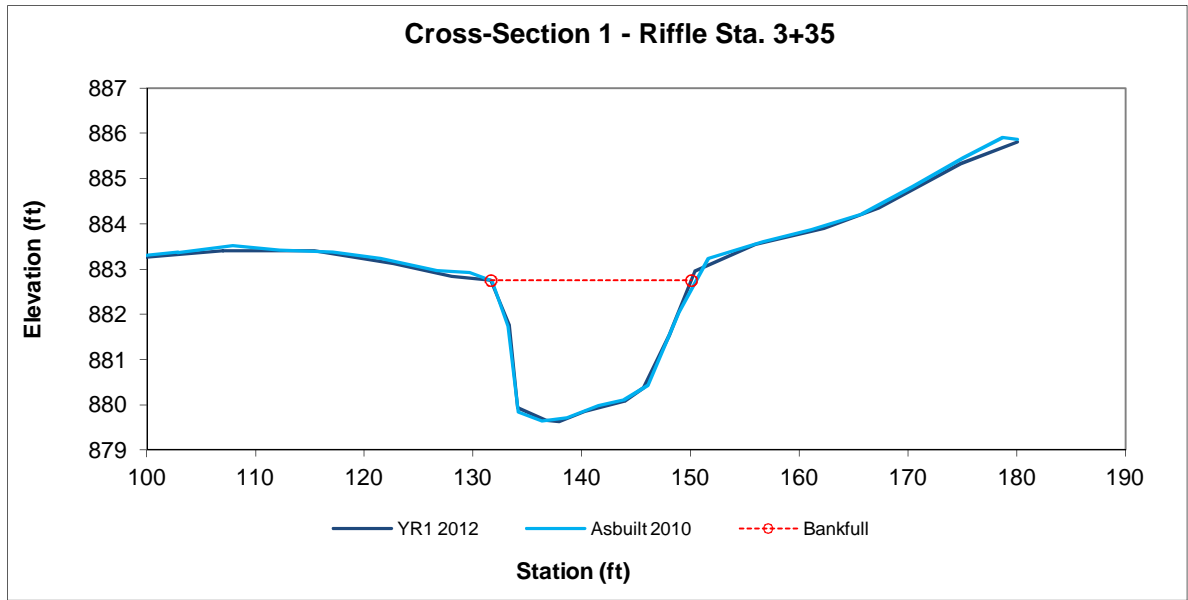
Feature	Stream Type	BKF Area	BKF Width	BKF Depth	Max BKF Depth	W/D	BH Ratio	ER	BKF Elev	TOB Elev
Riffle	E	40.8	18.43	2.21	3.12	8.32	1	4.3	882.75	882.75

There should be little change in the as-built cross-sections. If changes do take place, they will be evaluated to determine if they represent movement toward a more unstable condition (e.g., down-cutting or erosion) or movement toward increased stability (e.g., settling, vegetative changes, or deposition along the banks).

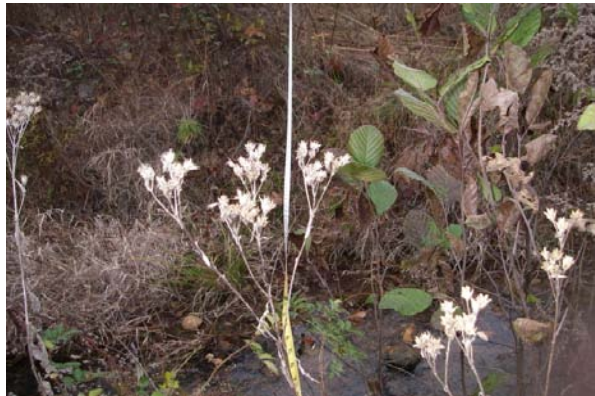
Photo 1: XS-1 facing right bank

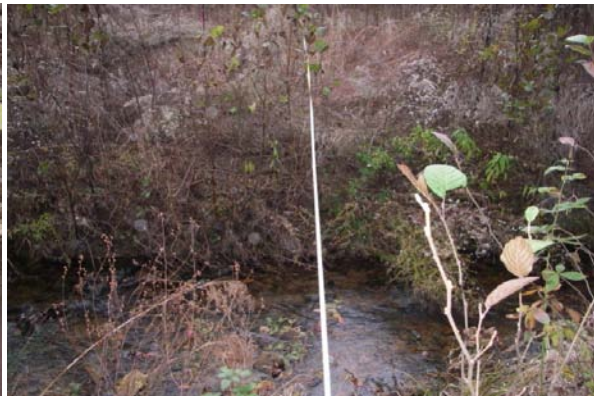
Photo 2: XS-1 facing left bank

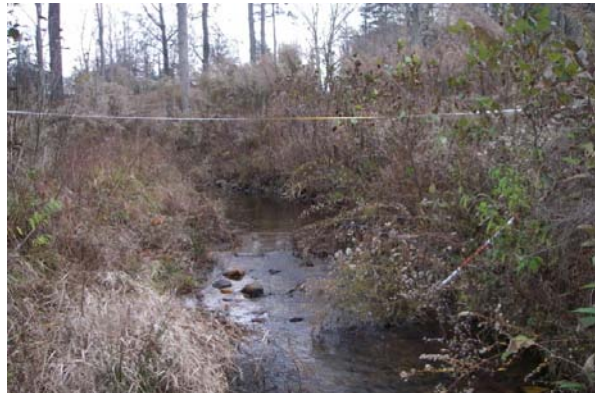
Photo 3: XS-1 facing upstream

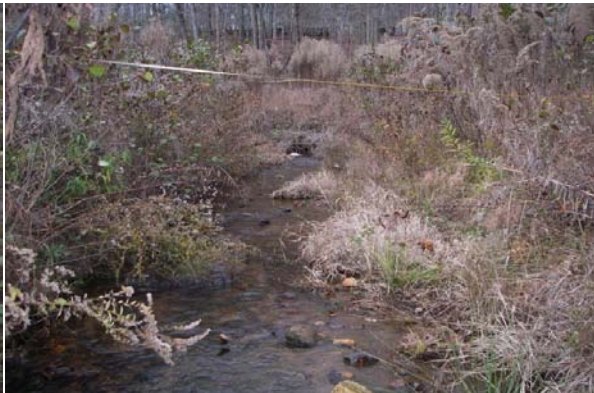
Photo 4: XS-1 facing downstream

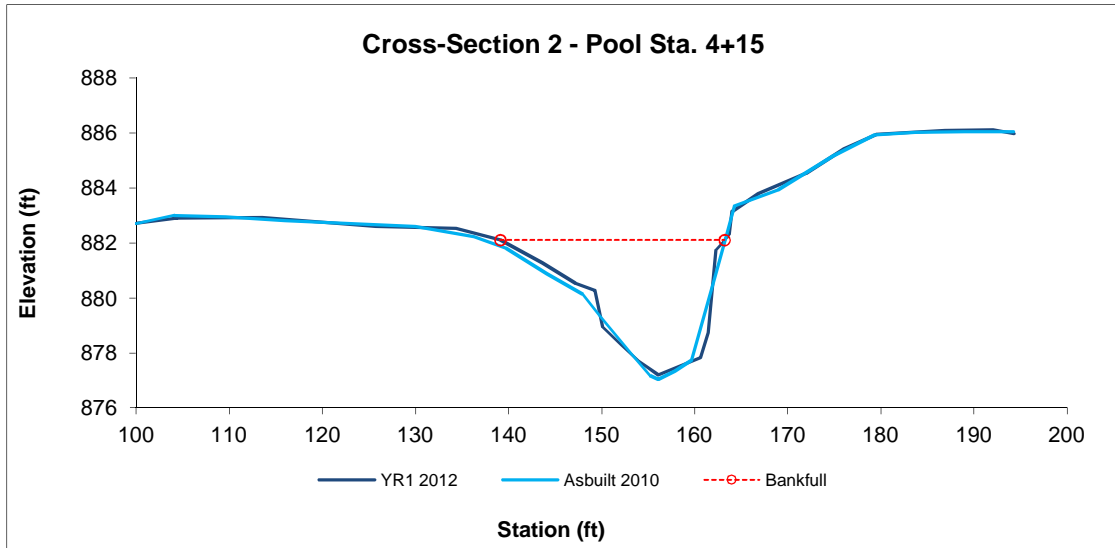
Feature	Stream Type	BKF Area	BKF Width	BKF Depth	Max BKF Depth	W/D	BH Ratio	ER	BKF Elev	TOB Elev
Pool	E	62.1	24.1	2.58	4.9	9.35	1	3.9	882.11	882.11

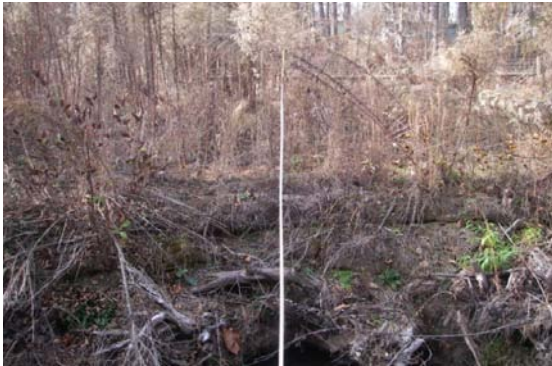
Photo 5: XS-2 facing right bank

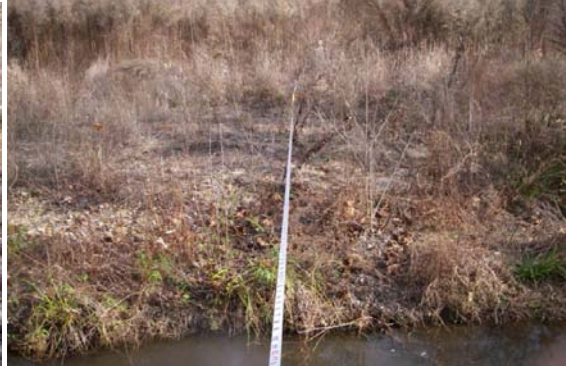
Photo 6: XS-2 facing left bank

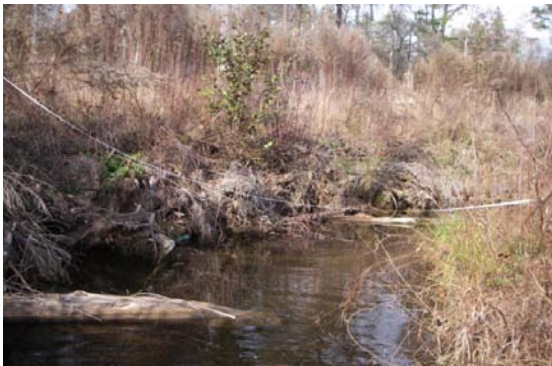
Photo 7: XS-2 facing upstream

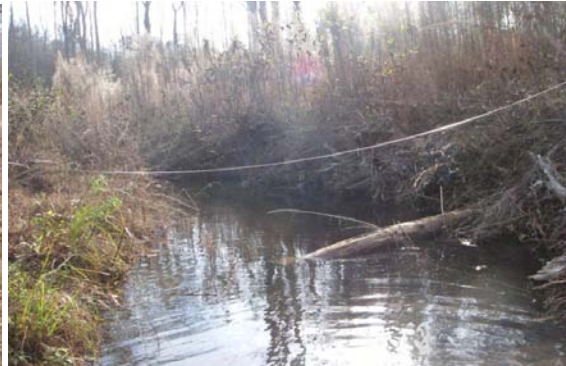
Photo 8: XS-2 facing downstream

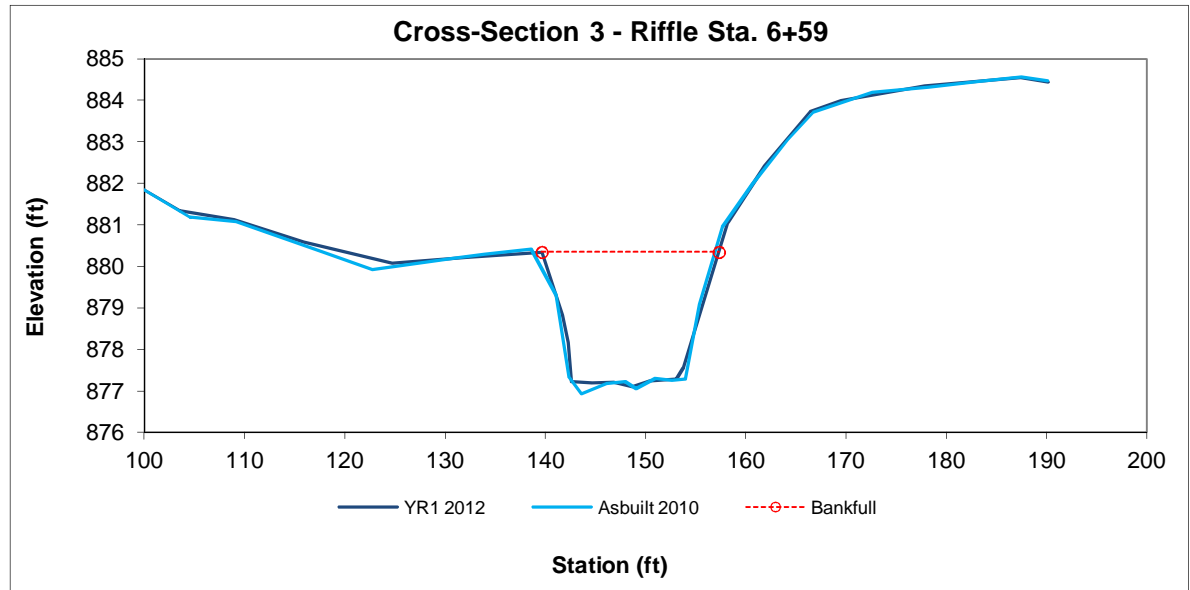
Feature	Stream Type	BKF Area	BKF Width	BKF Depth	Max BKF Depth	W/D	BH Ratio	ER	BKF Elev	TOB Elev
Riffle	E	43.4	17.66	2.46	3.24	7.19	1	3.7	880.34	880.34

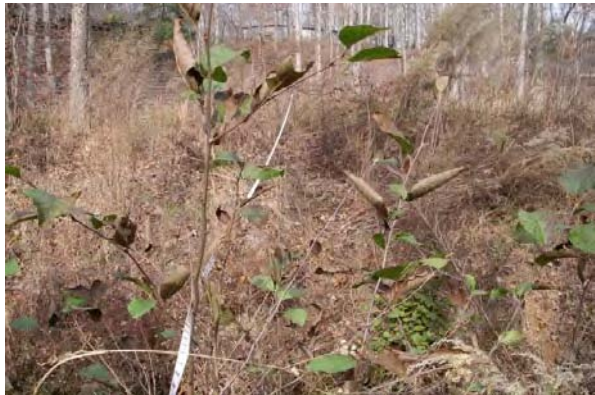
Photo 9: XS-3 facing right bank

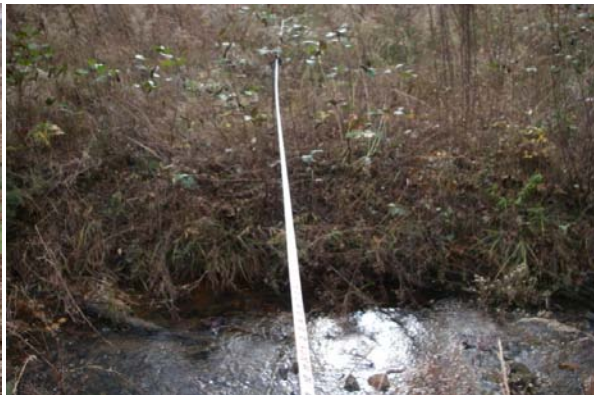
Photo 10: XS-3 facing left bank

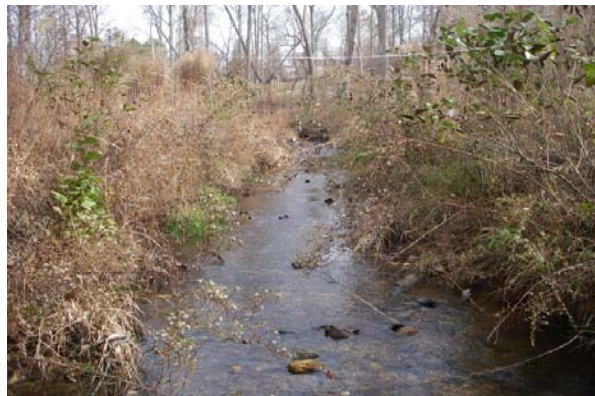
Photo 11: XS-3 facing upstream

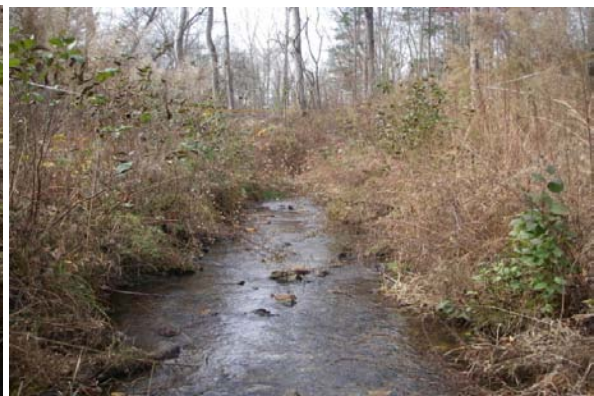
Photo 12: XS-3 facing downstream

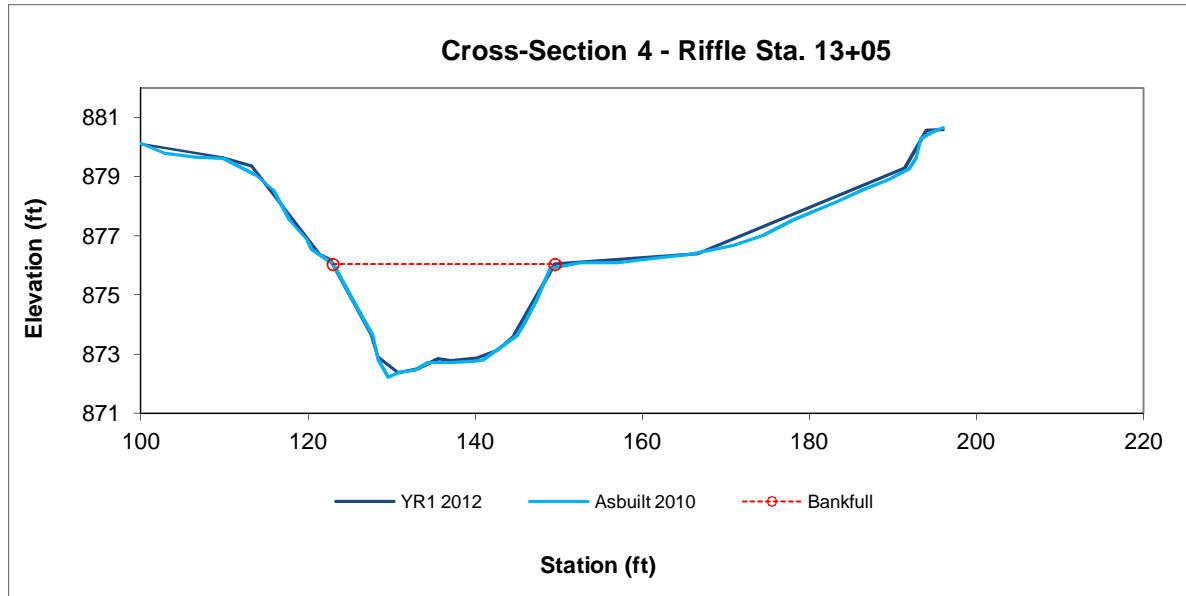
Feature	Stream Type	BKF Area	BKF Width	BKF Depth	Max BKF Depth	W/D	BH Ratio	ER	BKF Elev	TOB Elev
Riffle	E	66.1	26.55	2.49	3.66	10.66	1	3.2	876.04	876.04

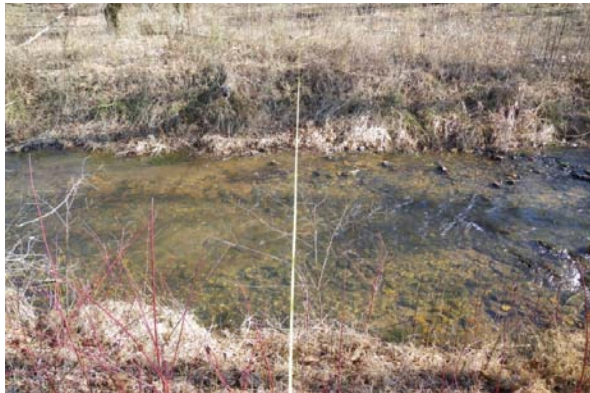
Photo 13: XS-4 facing right bank

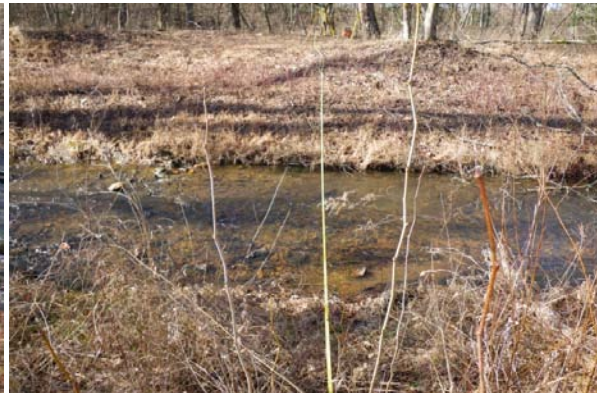
Photo 14: XS-4 facing left bank

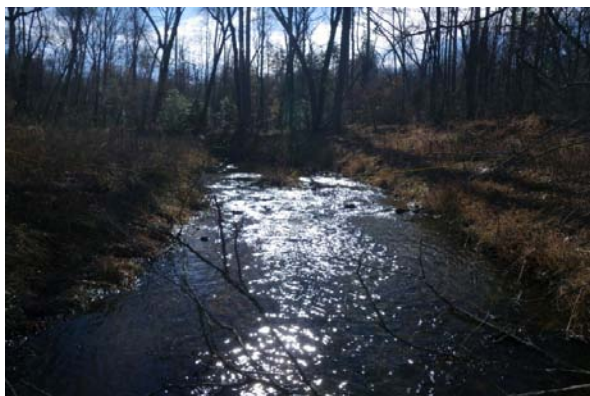
Photo 15: XS-4 facing upstream

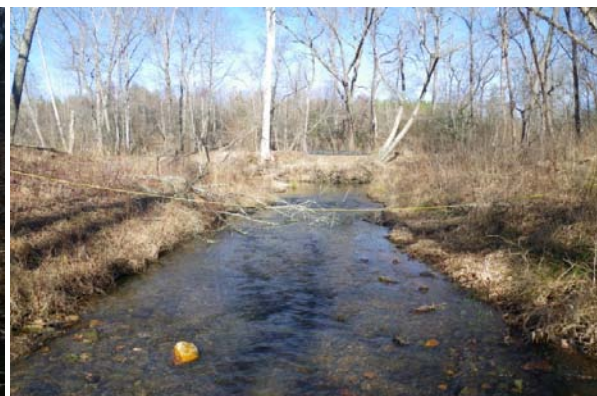
Photo 16: XS-4 facing downstream

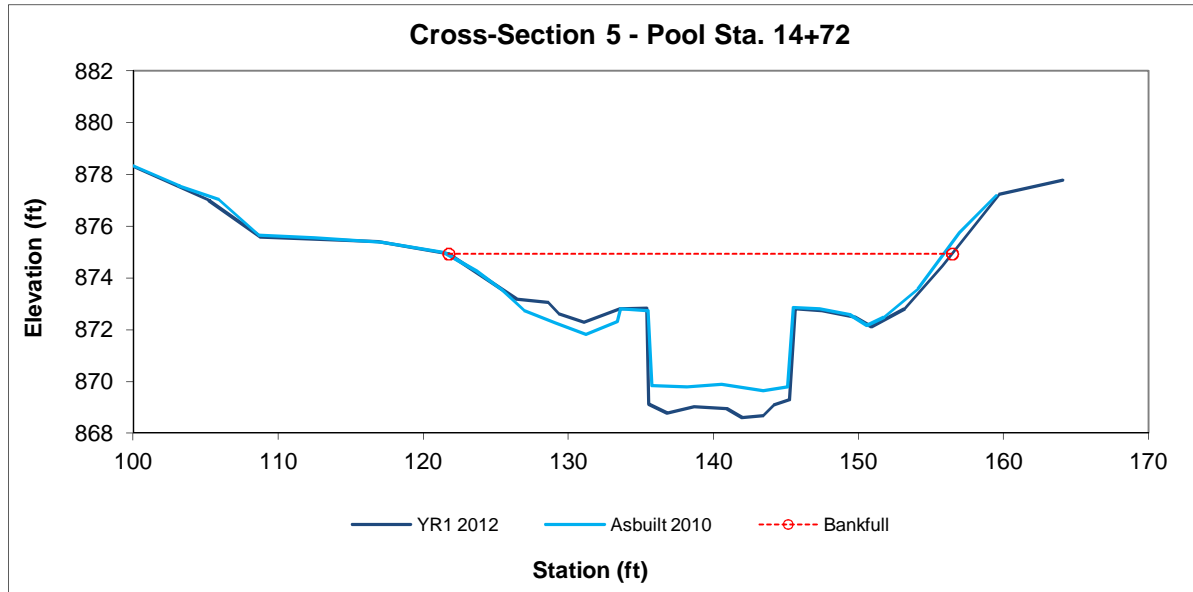
Feature	Stream Type	BKF Area	BKF Width	BKF Depth	Max BKF Depth	W/D	BH Ratio	ER	BKF Elev	TOB Elev
Pool	C	105.8	34.73	3.05	6.33	11.4	1	1.8	874.93	874.93

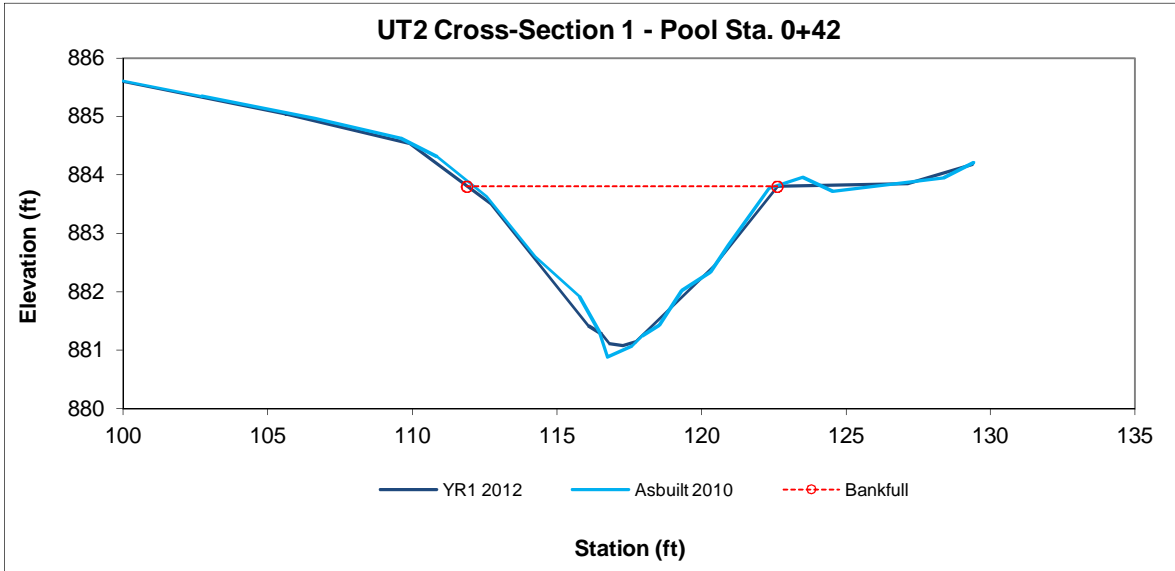
Feature	Stream Type	BKF Area	BKF Width	BKF Depth	Max BKF Depth	W/D	BH Ratio	ER	BKF Elev	TOB Elev
Pool	E	15.9	10.73	1.48	2.72	7.26	1.1	2.7	883.8	884.18

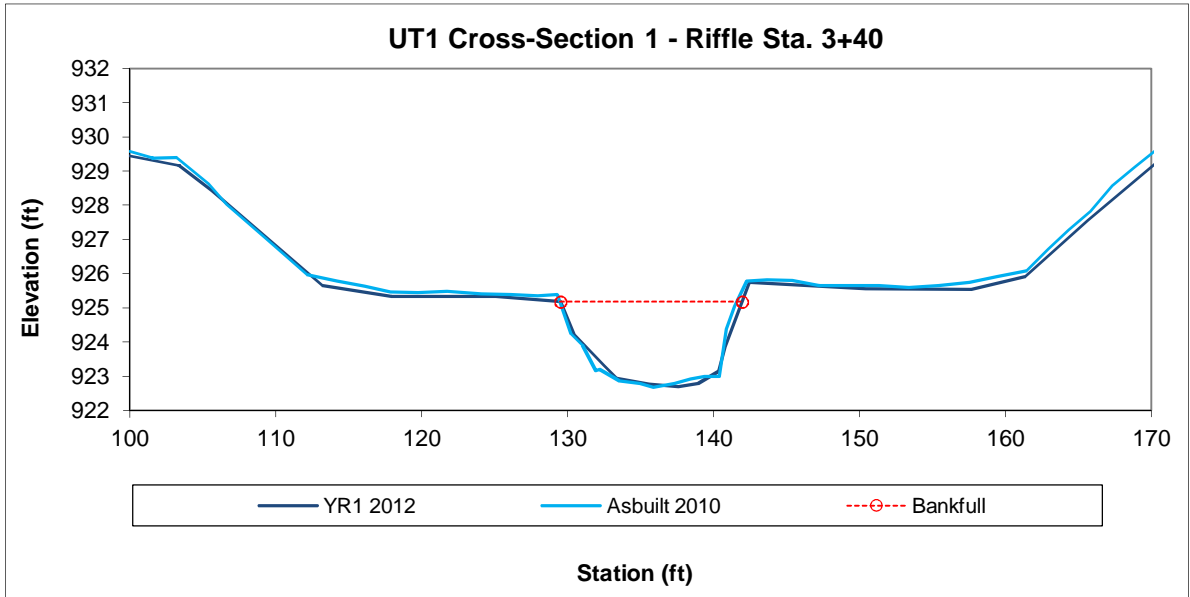
Feature	Stream Type	BKF Area	BKF Width	BKF Depth	Max BKF Depth	W/D	BH Ratio	ER	BKF Elev	TOB Elev
Riffle	E	23.1	12.45	1.85	2.48	6.72	1	4.7	925.17	925.17

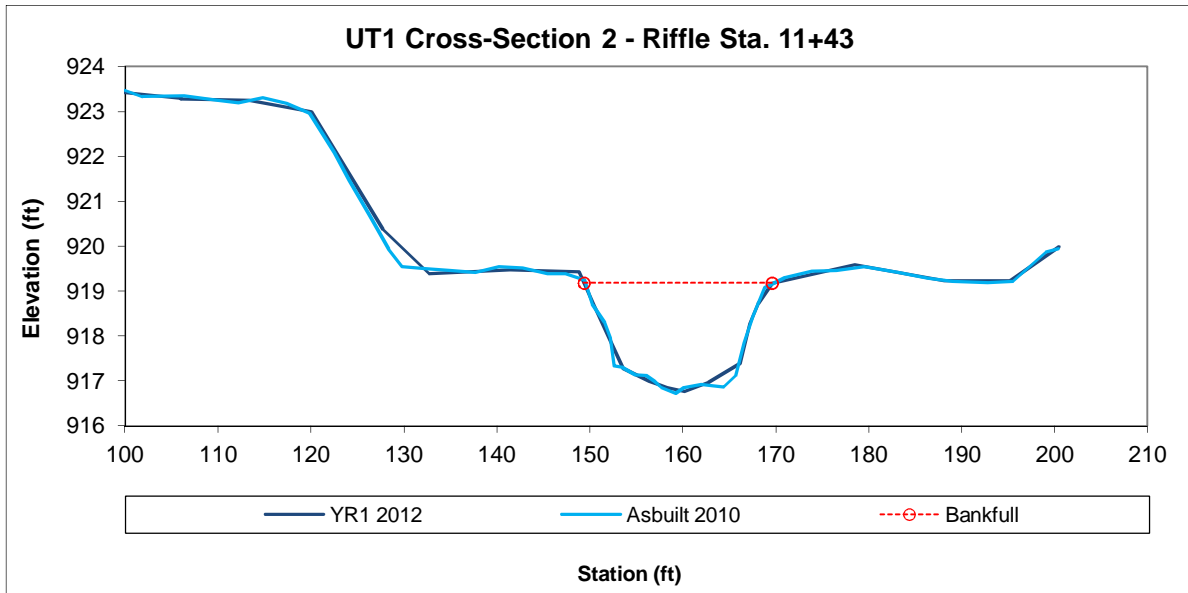
Feature	Stream Type	BKF Area	BKF Width	BKF Depth	Max BKF Depth	W/D	BH Ratio	ER	BKF Elev	TOB Elev
Riffle	E	33.8	20.23	1.67	2.42	12.12	1	3.8	919.18	919.18

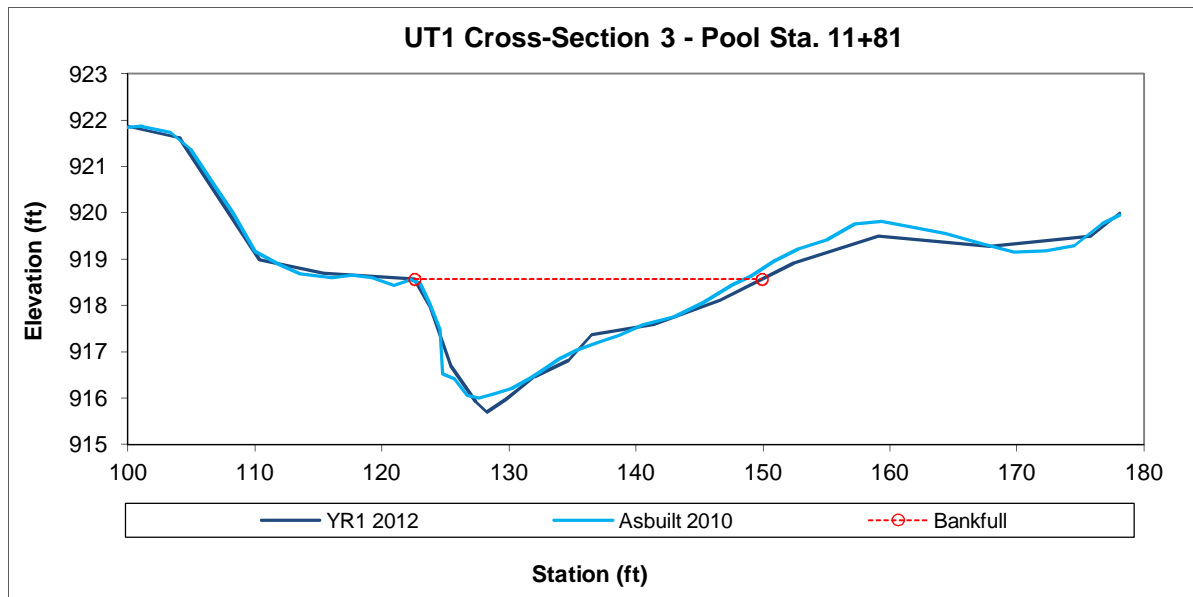
Feature	Stream Type	BKF Area	BKF Width	BKF Depth	Max BKF Depth	W/D	BH Ratio	ER	BKF Elev	TOB Elev
Pool	C	36.4	27.36	1.33	2.87	20.59	1	2.7	918.57	918.57

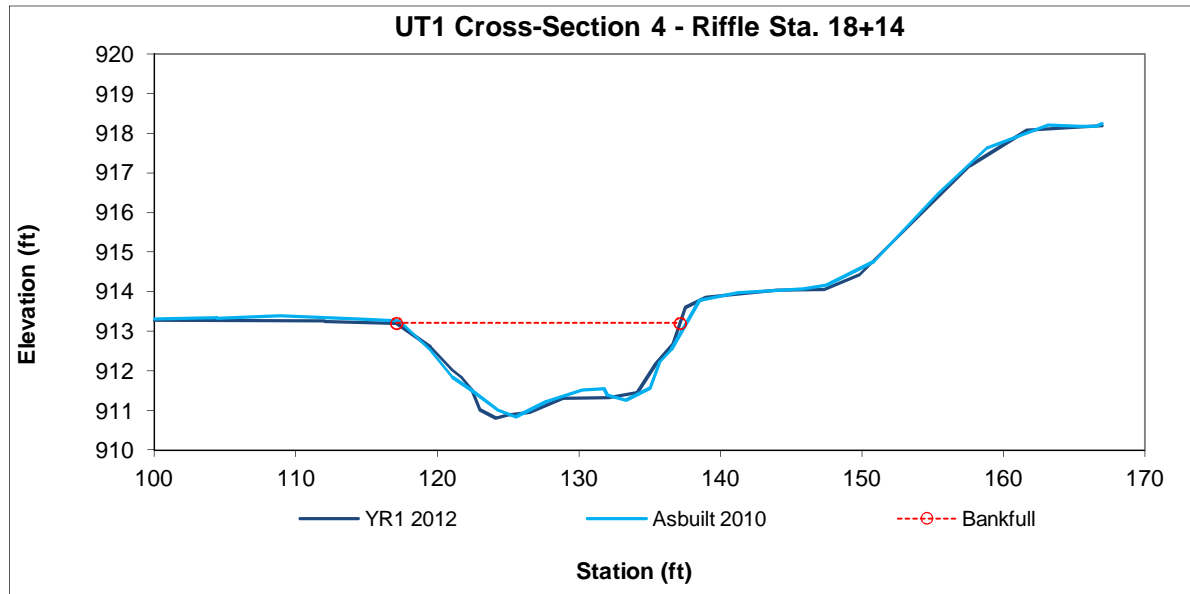
Feature	Stream Type	BKF Area	BKF Width	BKF Depth	Max BKF Depth	W/D	BH Ratio	ER	BKF Elev	TOB Elev
Riffle	C	30.8	20.05	1.54	2.4	13.04	1	2.7	913.2	913.2

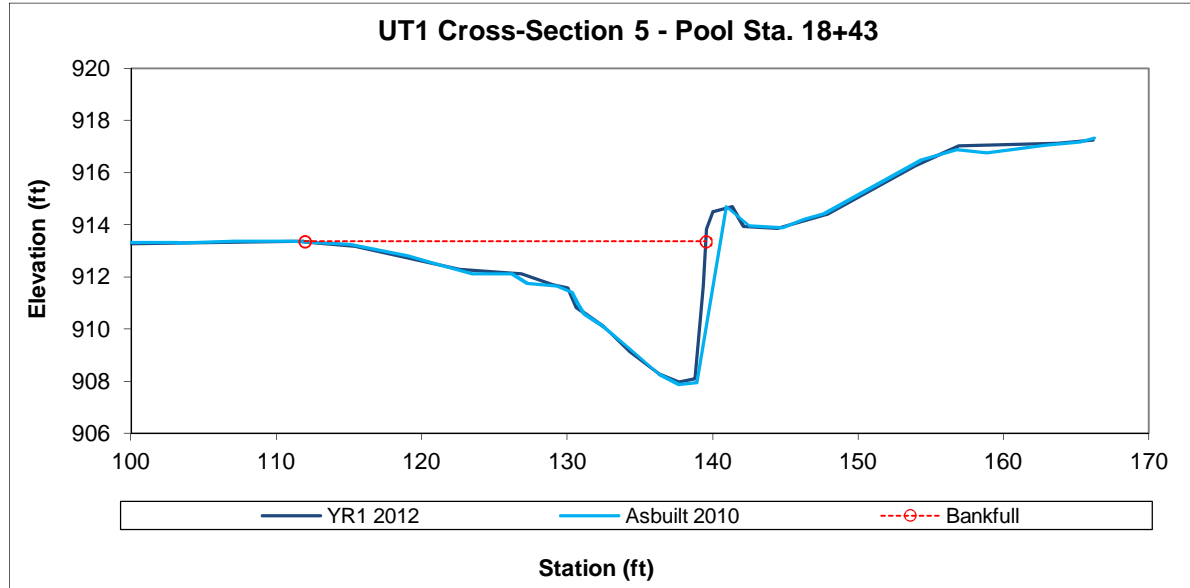
Feature	Stream Type	BKF Area	BKF Width	BKF Depth	Max BKF Depth	W/D	BH Ratio	ER	BKF Elev	TOB Elev
Pool	C	52.3	27.58	1.9	5.38	14.55	0.7	2.4	913.35	911.57

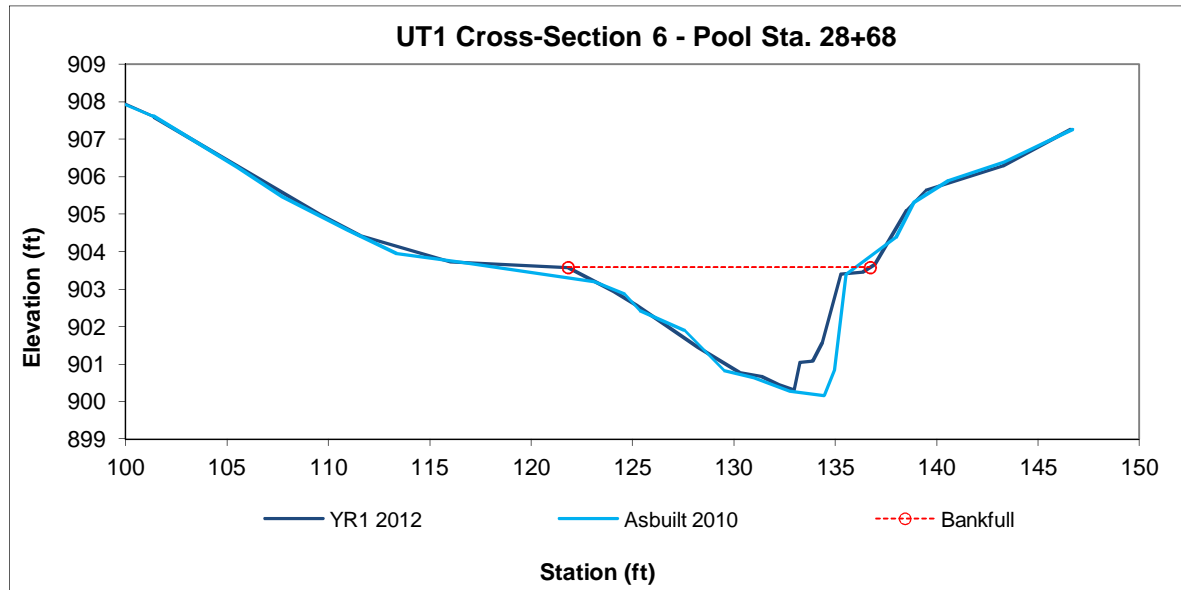
Feature	Stream Type	BKF Area	BKF Width	BKF Depth	Max BKF Depth	W/D	BH Ratio	ER	BKF Elev	TOB Elev
Pool	C	24.2	14.9	1.62	3.26	9.18	1	2.8	903.58	903.58

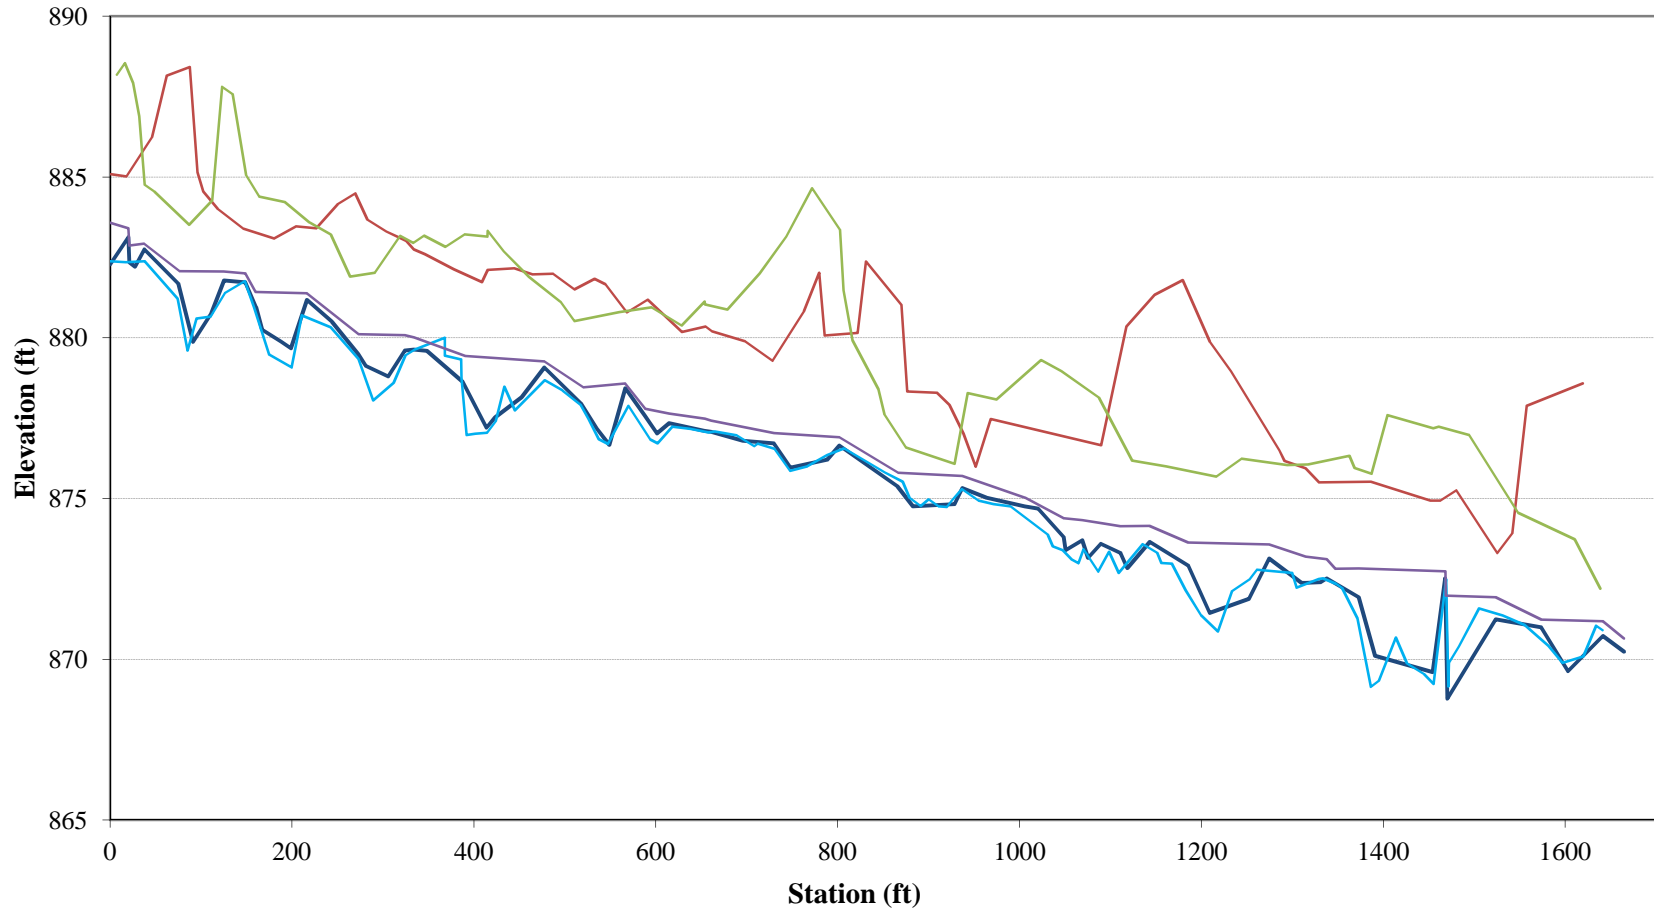
Longitudinal Profile-Puzzle Creek

— TWG-YR1 2012 — TWG-Asbuilt 2010 — LTB 2012 — RTB 2012 — WSF 2012

reaches. There was also little to no change in the profile of UT1 to Puzzle Creek. No areas of instability were noted during Year 1 monitoring.

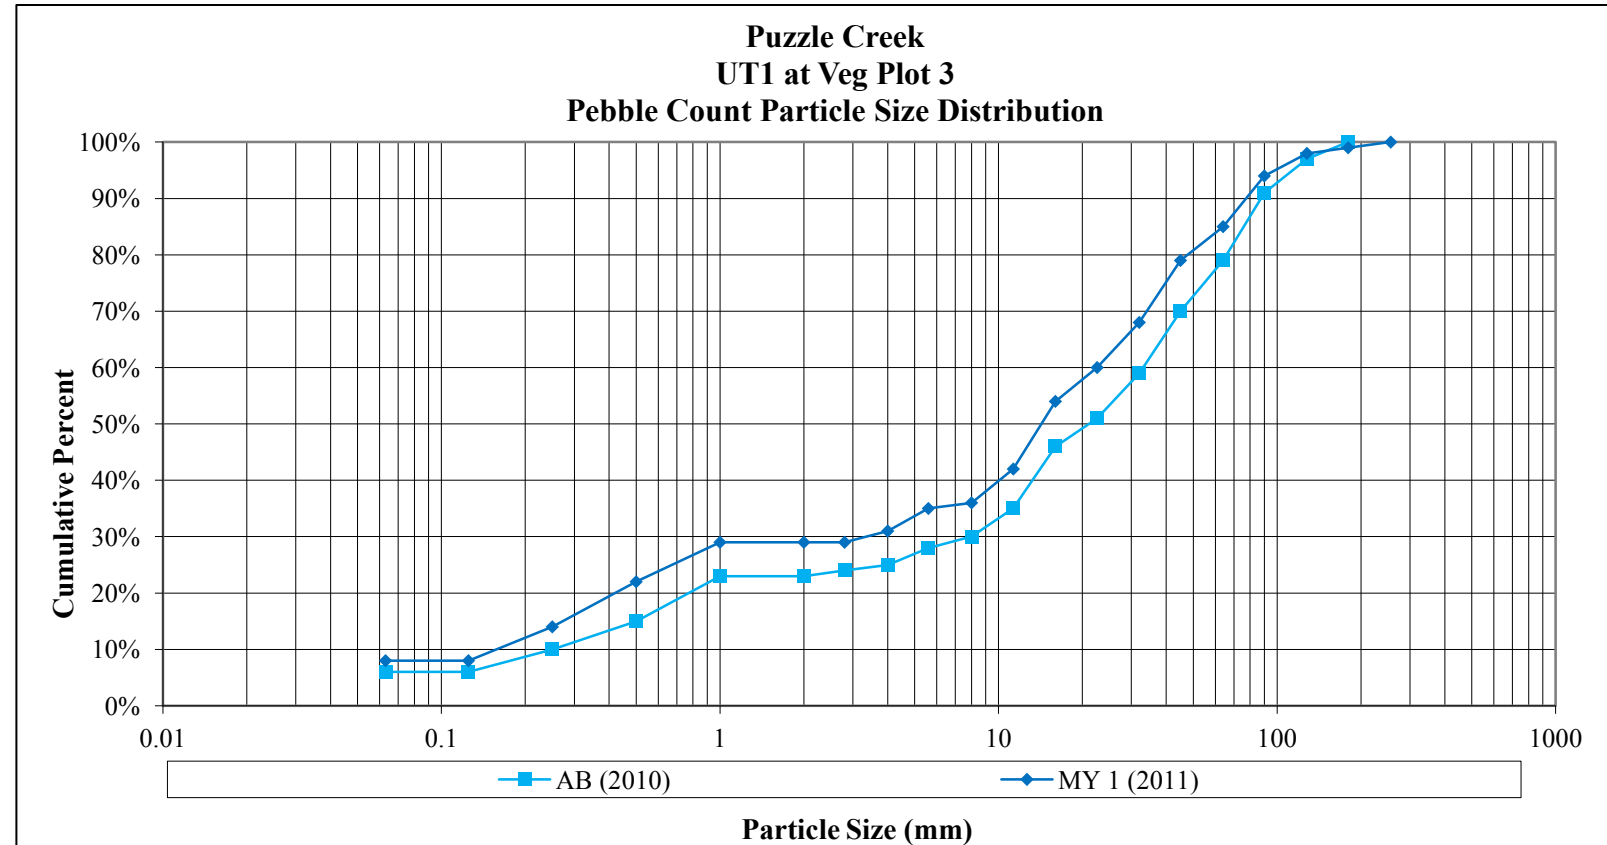
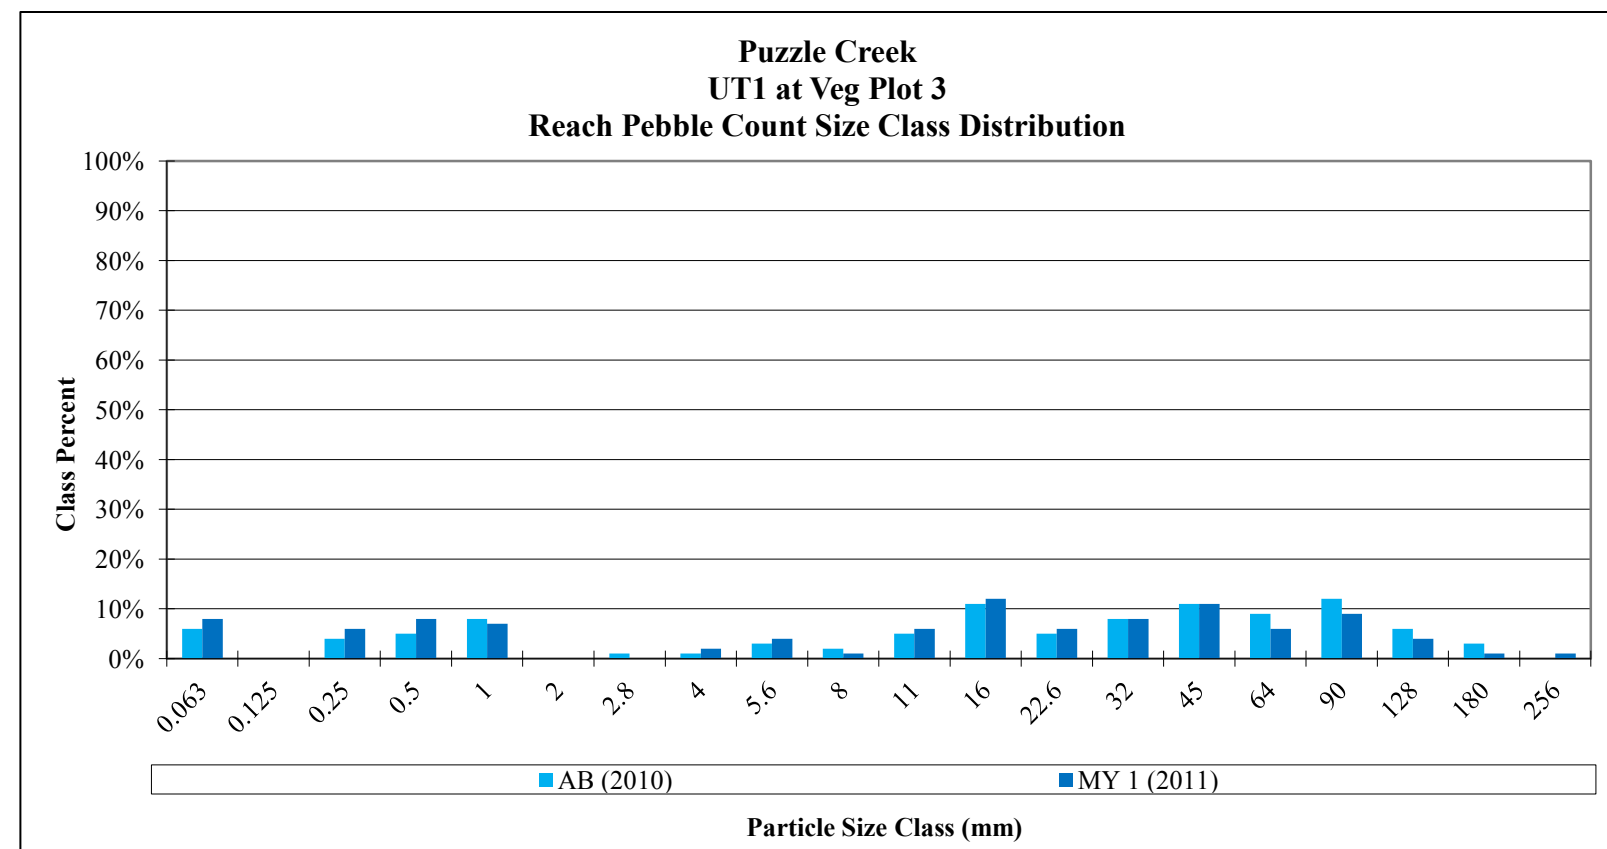
2011		
MATERIAL	PARTICLE	SIZE (mm)	Total	Class %	% Cum
Silt/Clay	Silt / Clay	< .063	8	8%	8%
Sand	Very Fine	.063 - .125			8%
	Fine	.125 - .25	6	6%	14%
	Medium	.25 - .50	8	8%	22%
	Coarse	.50 - 1.0	7	7%	29%
	Very Coarse	1.0 - 2.0			29%
Gravel	Very Fine	2.0 - 2.8			29%
	Very Fine	2.8 - 4.0	2	2%	31%
	Fine	4.0 - 5.6	4	4%	35%
	Fine	5.6 - 8.0	1	1%	36%
	Medium	8.0 - 11.0	6	6%	42%
	Medium	11.0 - 16.0	12	12%	54%
	Coarse	16 - 22.6	6	6%	60%
	Coarse	22.6 - 32	8	8%	68%
	Very Coarse	32 - 45	11	11%	79%
	Very Coarse	45 - 64	6	6%	85%
Cobble	Small	64 - 90	9	9%	94%
	Small	90 - 128	4	4%	98%
	Large	128 - 180	1	1%	99%
	Large	180 - 256	1	1%	100%
Boulder	Small	256 - 362			100%
	Small	362 - 512			100%
	Medium	512 - 1024			100%
	Large-Very Large	1024 - 2048			100%
Bedrock	Bedrock	> 2048			100%
Total % of whole count			100	100%	100%

Summary Data	
Channel materials	
D ₅₀ =	14.00
D ₈₄ =	60.00
D ₉₅ =	98.00

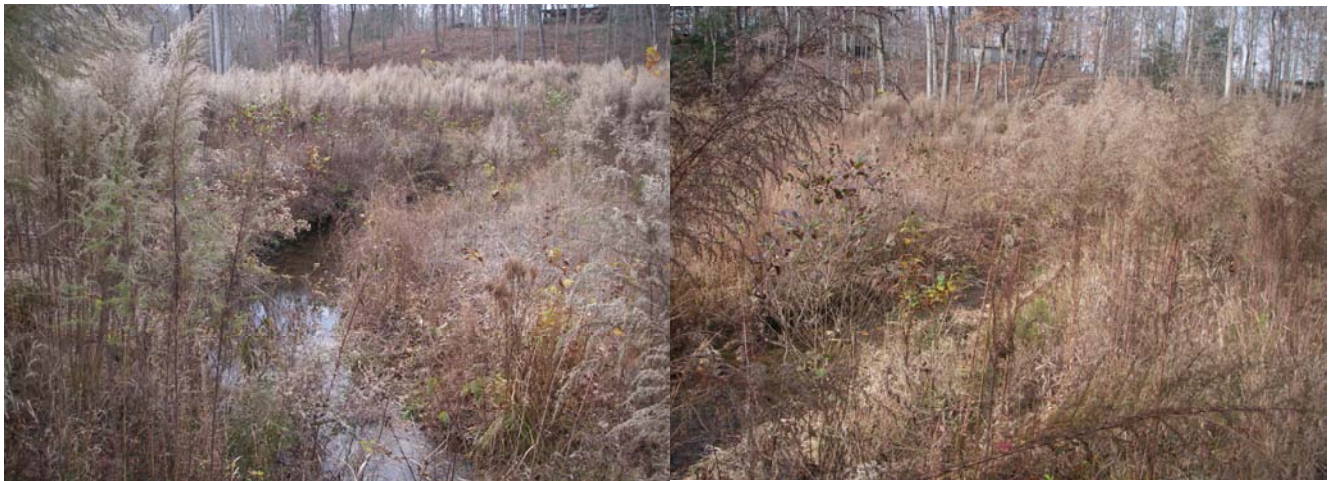
Photo Point 2: facing downstream

Photo Point 3: facing upstream

Lateral and structure photographs are used to evaluate channel aggradation or degradation, bank erosion, success of riparian vegetation, structure function, and stability, and effectiveness of erosion control measures subjectively. Lateral photos should not indicate excessive erosion or degradation of the banks. A series of photos over time should indicate successive maturation of riparian vegetation and consistent structure function. Photo documentation of the site during Year 1 monitoring reflects stable site conditions in restored or enhanced areas as well as a healthy stand of herbaceous and woody vegetation in the riparian corridors.
