Mitigation Report

Rockwell Pastures Site

Stanly County, North Carolina
USGS HUC: 03040104010020
Project ID# D-000624

Submitted: May 2009

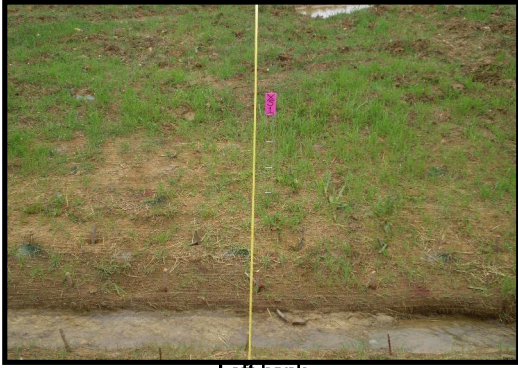
Cross-Section Data

Left bank

Right bank

| Reach ID | UT 1 |
| Cross Sectional Area | 1.8 |
| Hydraulic Radius | 0.4 |
| Width:Depth Ratio | 10.5 |

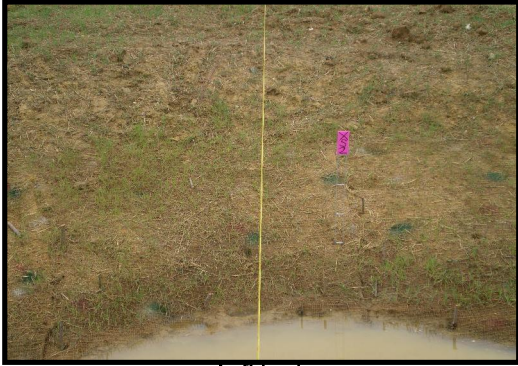
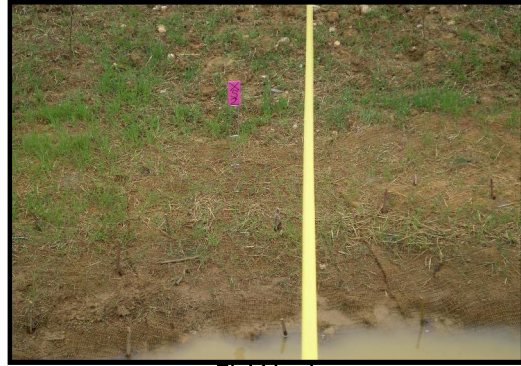
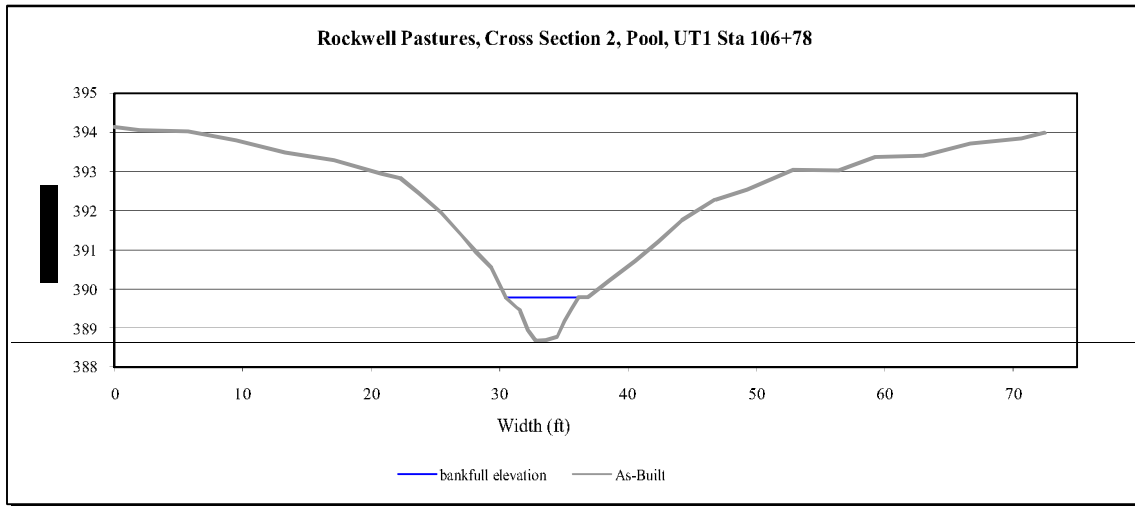
Left bank

Right bank

| Reach ID | UT 1 |
| Cross Sectional Area | 7.6 |
| Hydraulic Radius | 0.8 |
| Width:Depth Ratio | 10.9 |

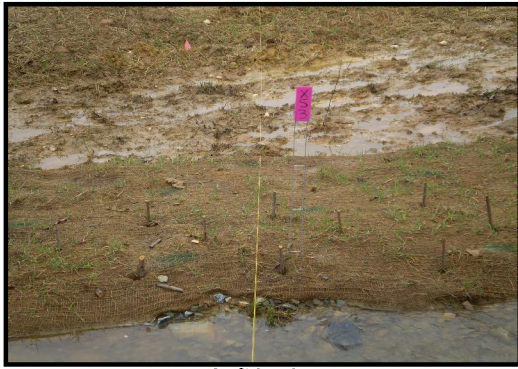
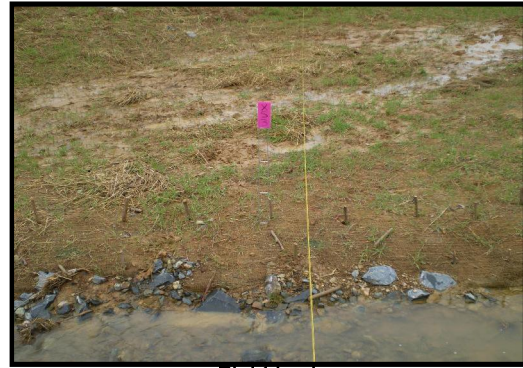
Left bank

Right bank

| Reach ID | UT 1 |
| Cross Sectional Area | 1.5 |
| Hydraulic Radius | 0.3 |
| Width:Depth Ratio | 20.3 |

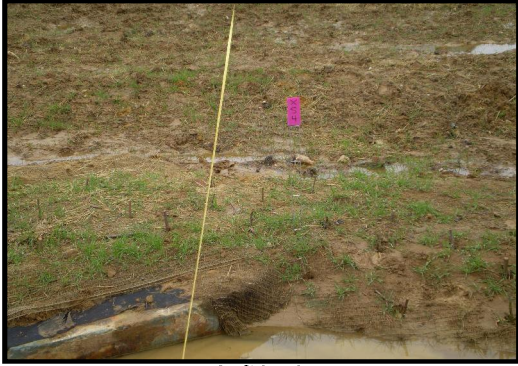
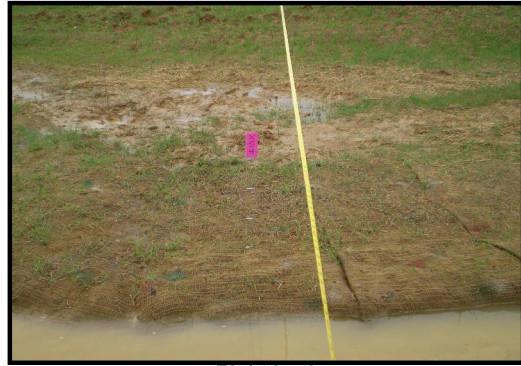
Left bank

Right bank

| Reach ID | UT 1 |
| Cross Sectional Area | 8.6 |
| Hydraulic Radius | 0.6 |
| Width:Depth Ratio | 19.8 |

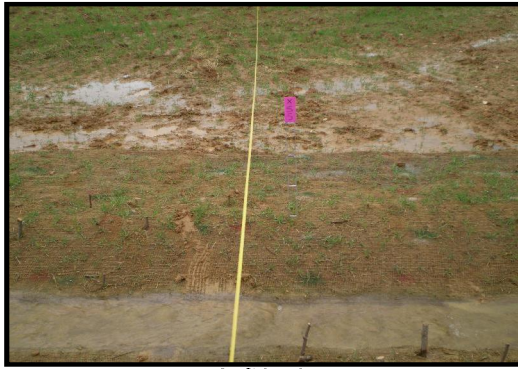
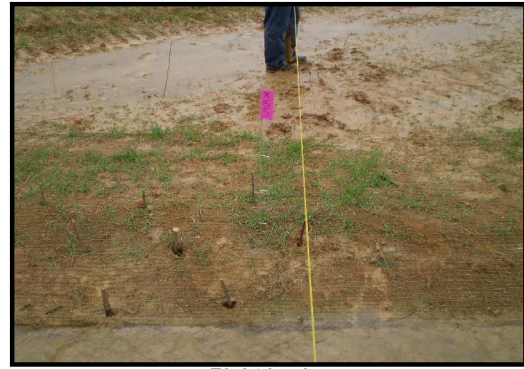
Left bank

Right bank

| Reach ID | UT 1 |
| Cross Sectional Area | 2.6 |
| Hydraulic Radius | 0.4 |
| Width:Depth Ratio | 19.2 |

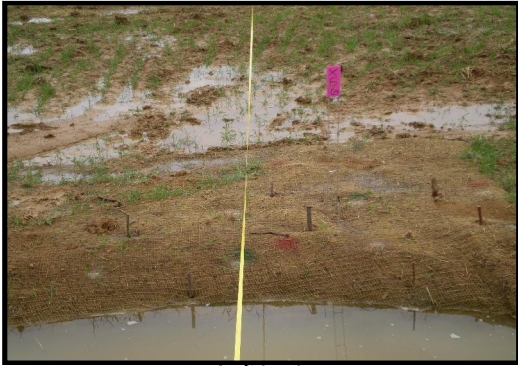
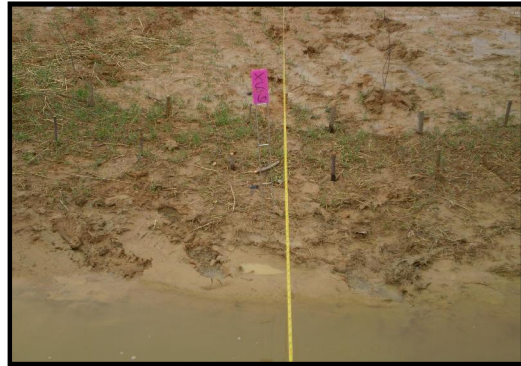
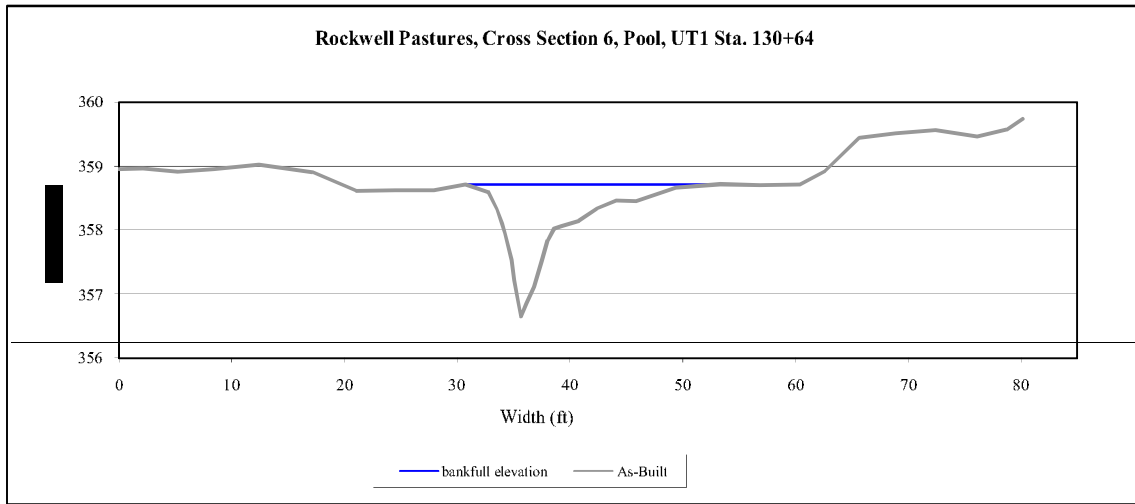
Left bank

Right bank

| Reach ID | UT 1 |
| Cross Sectional Area | 10.5 |
| Hydraulic Radius | 0.5 |
| Width:Depth Ratio | 46.3 |

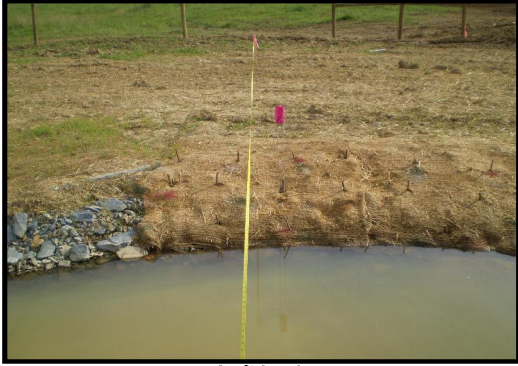
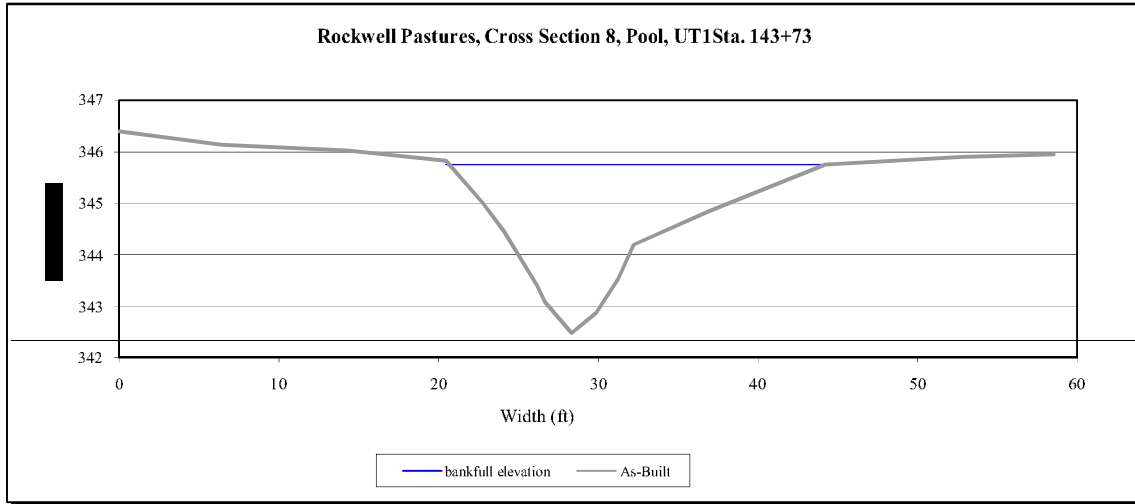
Left bank

Right bank

| Reach ID | UT 1 |
| Cross Sectional Area | 31.3 |
| Hydraulic Radius | 1.3 |
| Width:Depth Ratio | 17.7 |

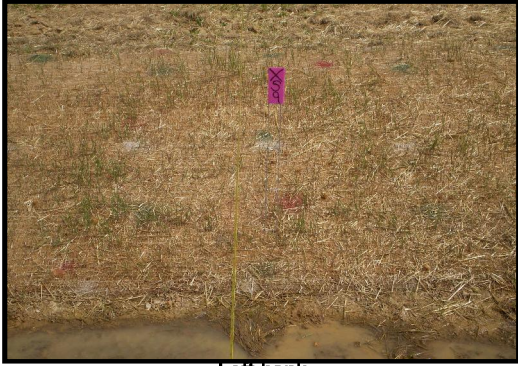
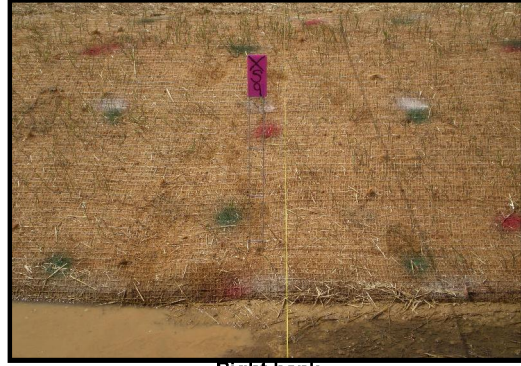
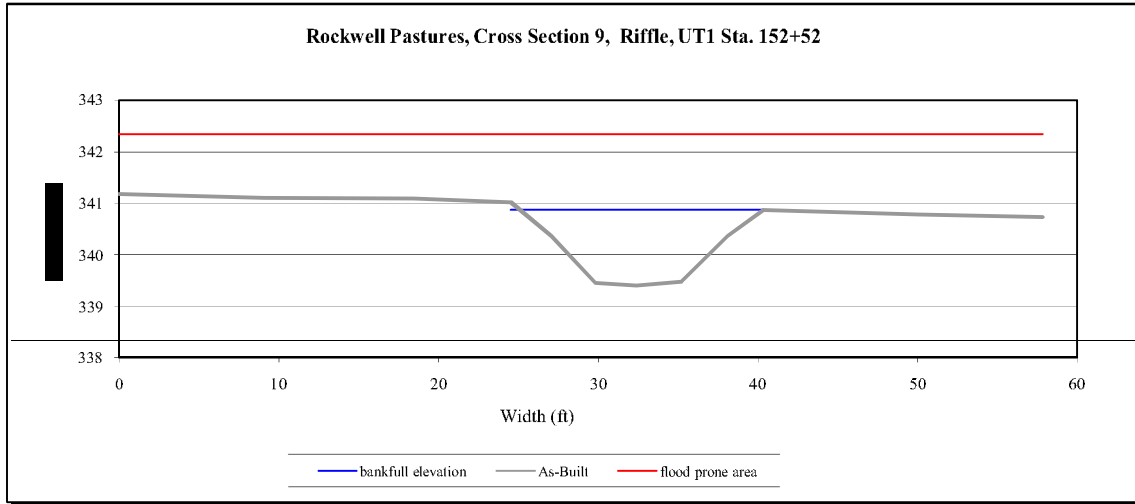
Left bank

Right bank

| Reach ID | UT 1 |
| Cross Sectional Area | 14.3 |
| Hydraulic Radius | 0.9 |
| Width:Depth Ratio | 16.4 |

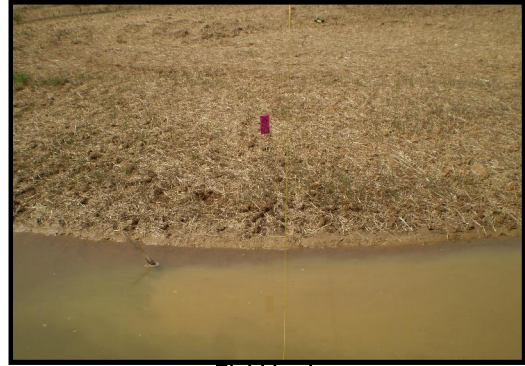
Left bank

Right bank

| Reach ID | UT 1 |
| Cross Sectional Area | 26.5 |
| Hydraulic Radius | 1.2 |
| Width:Depth Ratio | 15.4 |

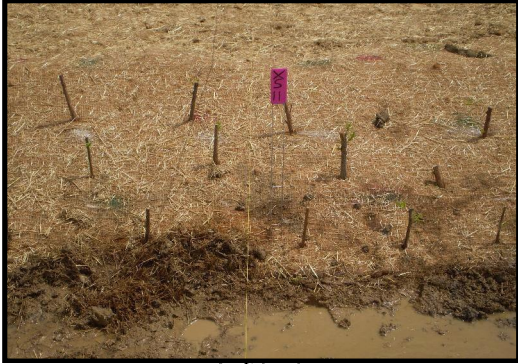
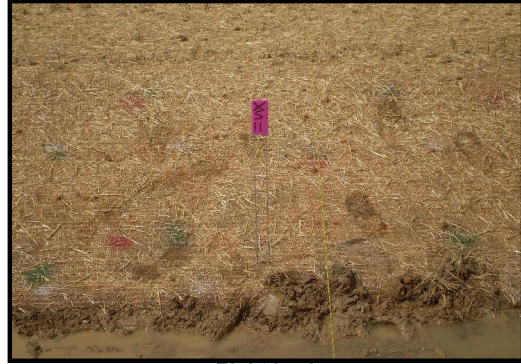
Left bank

Right bank

| Reach ID | UT 1 |
| Cross Sectional Area | 20.8 |
| Hydraulic Radius | 1.2 |
| Width:Depth Ratio | 13.8 |

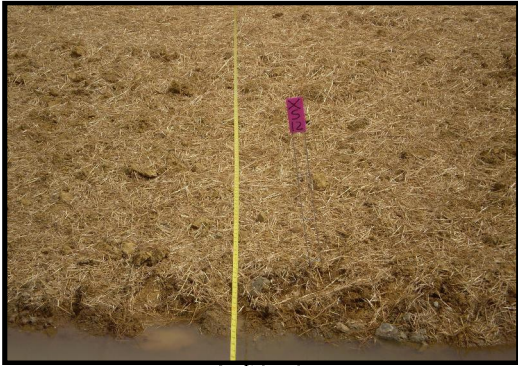
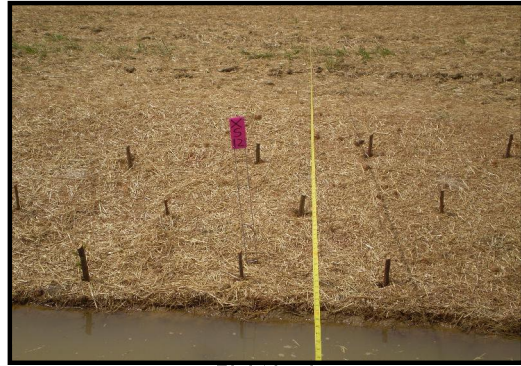
Left bank

Right bank

| Reach ID | UT 1 |
| Cross Sectional Area | 27.2 |
| Hydraulic Radius | 1.2 |
| Width:Depth Ratio | 15.7 |

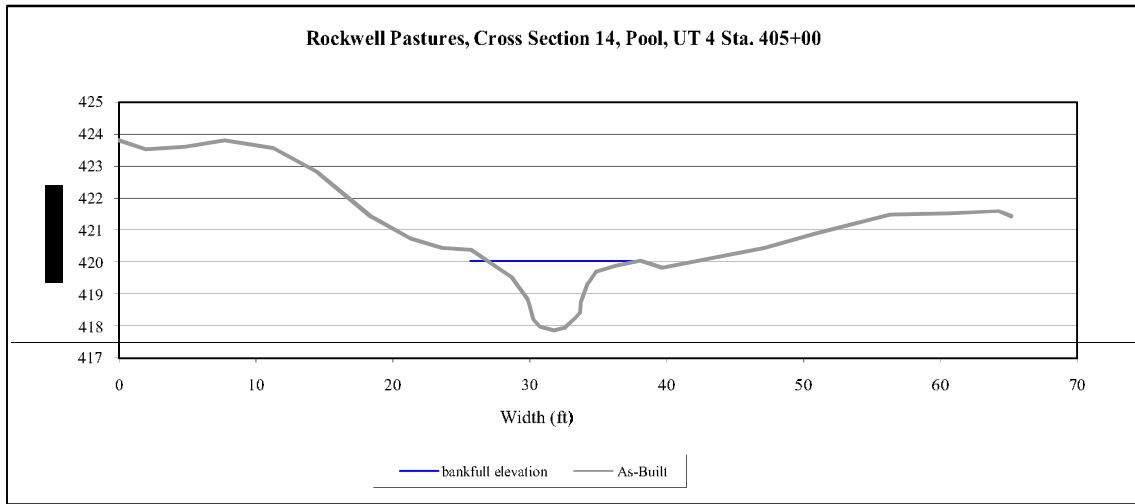
| Reach ID | UT 4 |
| Cross Sectional Area | 10.4 |
| Hydraulic Radius | 0.8 |
| Width:Depth Ratio | 12.0 |

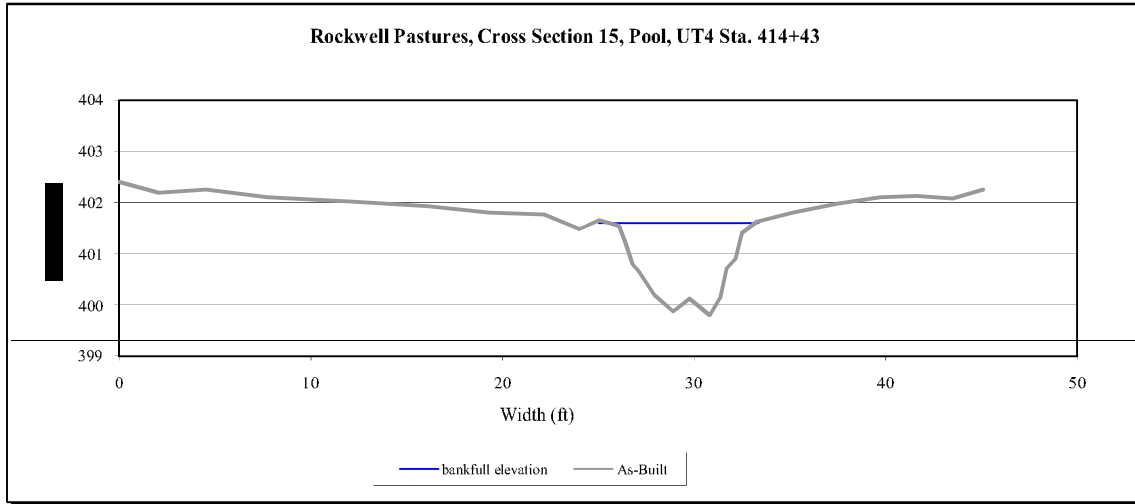
| Reach ID | UT 4 |
| Cross Sectional Area | 8.4 |
| Hydraulic Radius | 0.9 |
| Width:Depth Ratio | 8.1 |

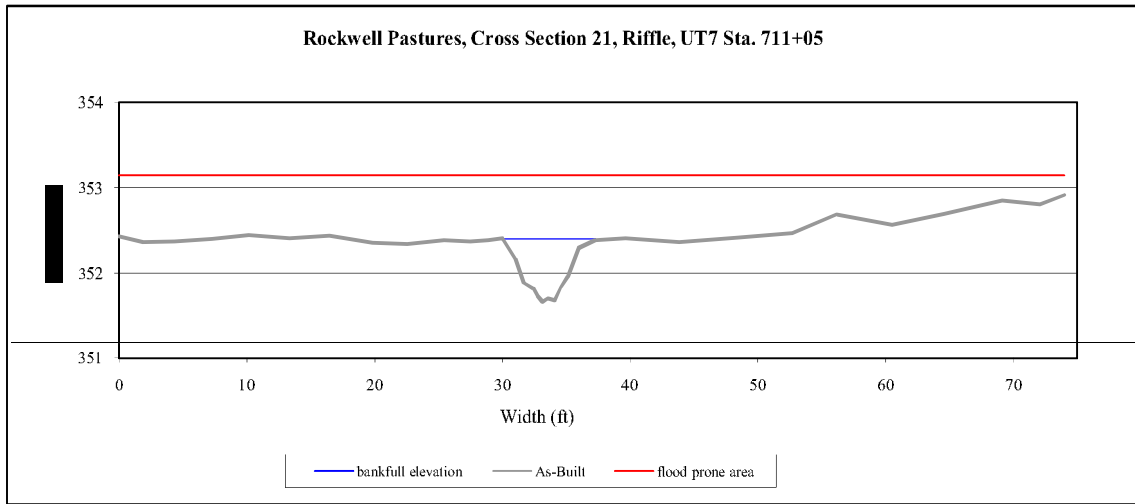
| Reach ID | UT 7 |
| Cross Sectional Area | 2.8 |
| Hydraulic Radius | 0.4 |
| Width:Depth Ratio | 18.5 |

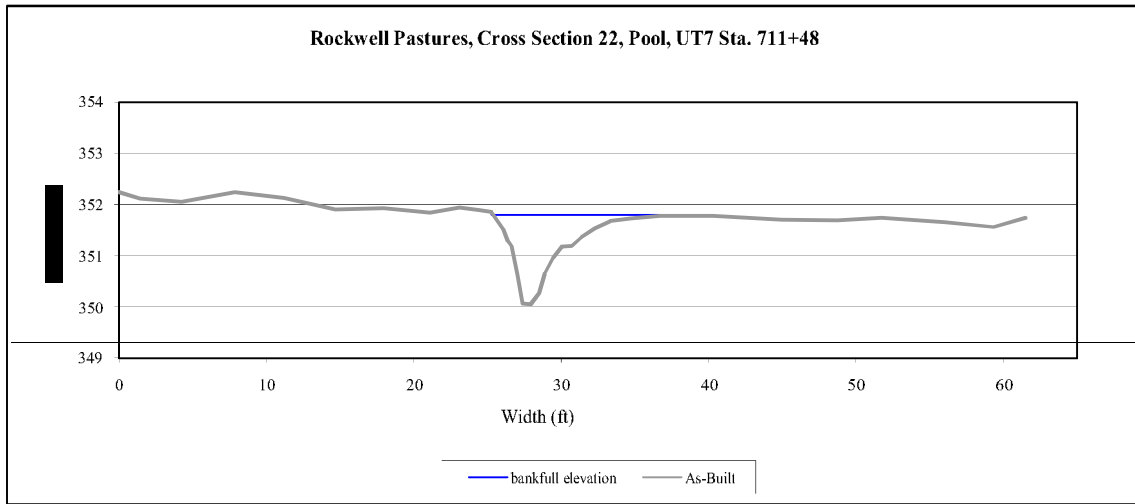
| Reach ID | UT 7 |
| Cross Sectional Area | 5.8 |
| Hydraulic Radius | 0.5 |
| Width:Depth Ratio | 20.6 |

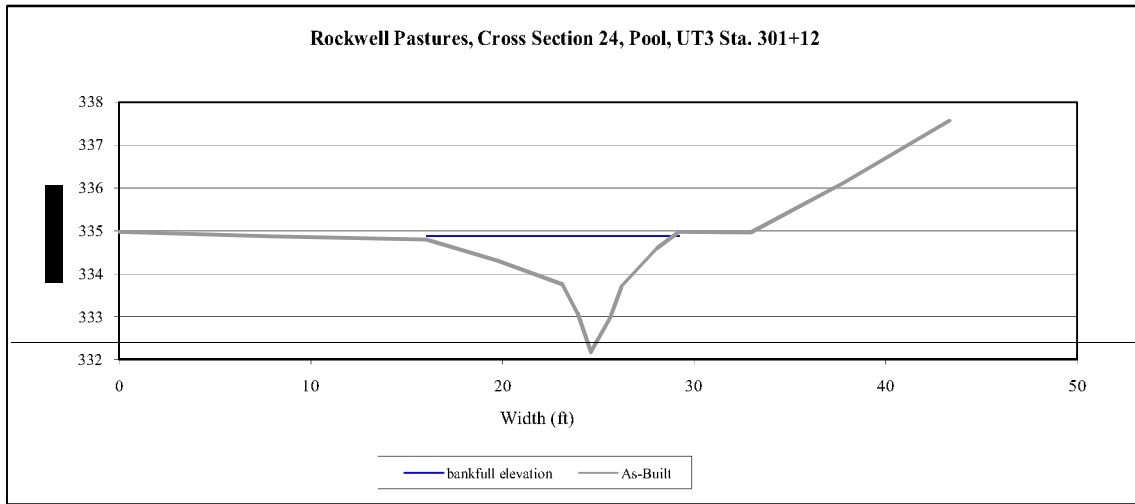
| Reach ID | UT 3 |
| Cross Sectional Area | 11.5 |
| Width:Depth Ratio | 14.4 |
