# ***BASELINE MONITORING DOCUMENT & AS-BUILT BASELINE REPORT***

## **ROSES CREEK STREAM MITIGATION SITE**

Burke County, North Carolina  
NCDMS Project # 96309

Data Collected: May 9 – May 20, 2016  
Submitted: September 12, 2016

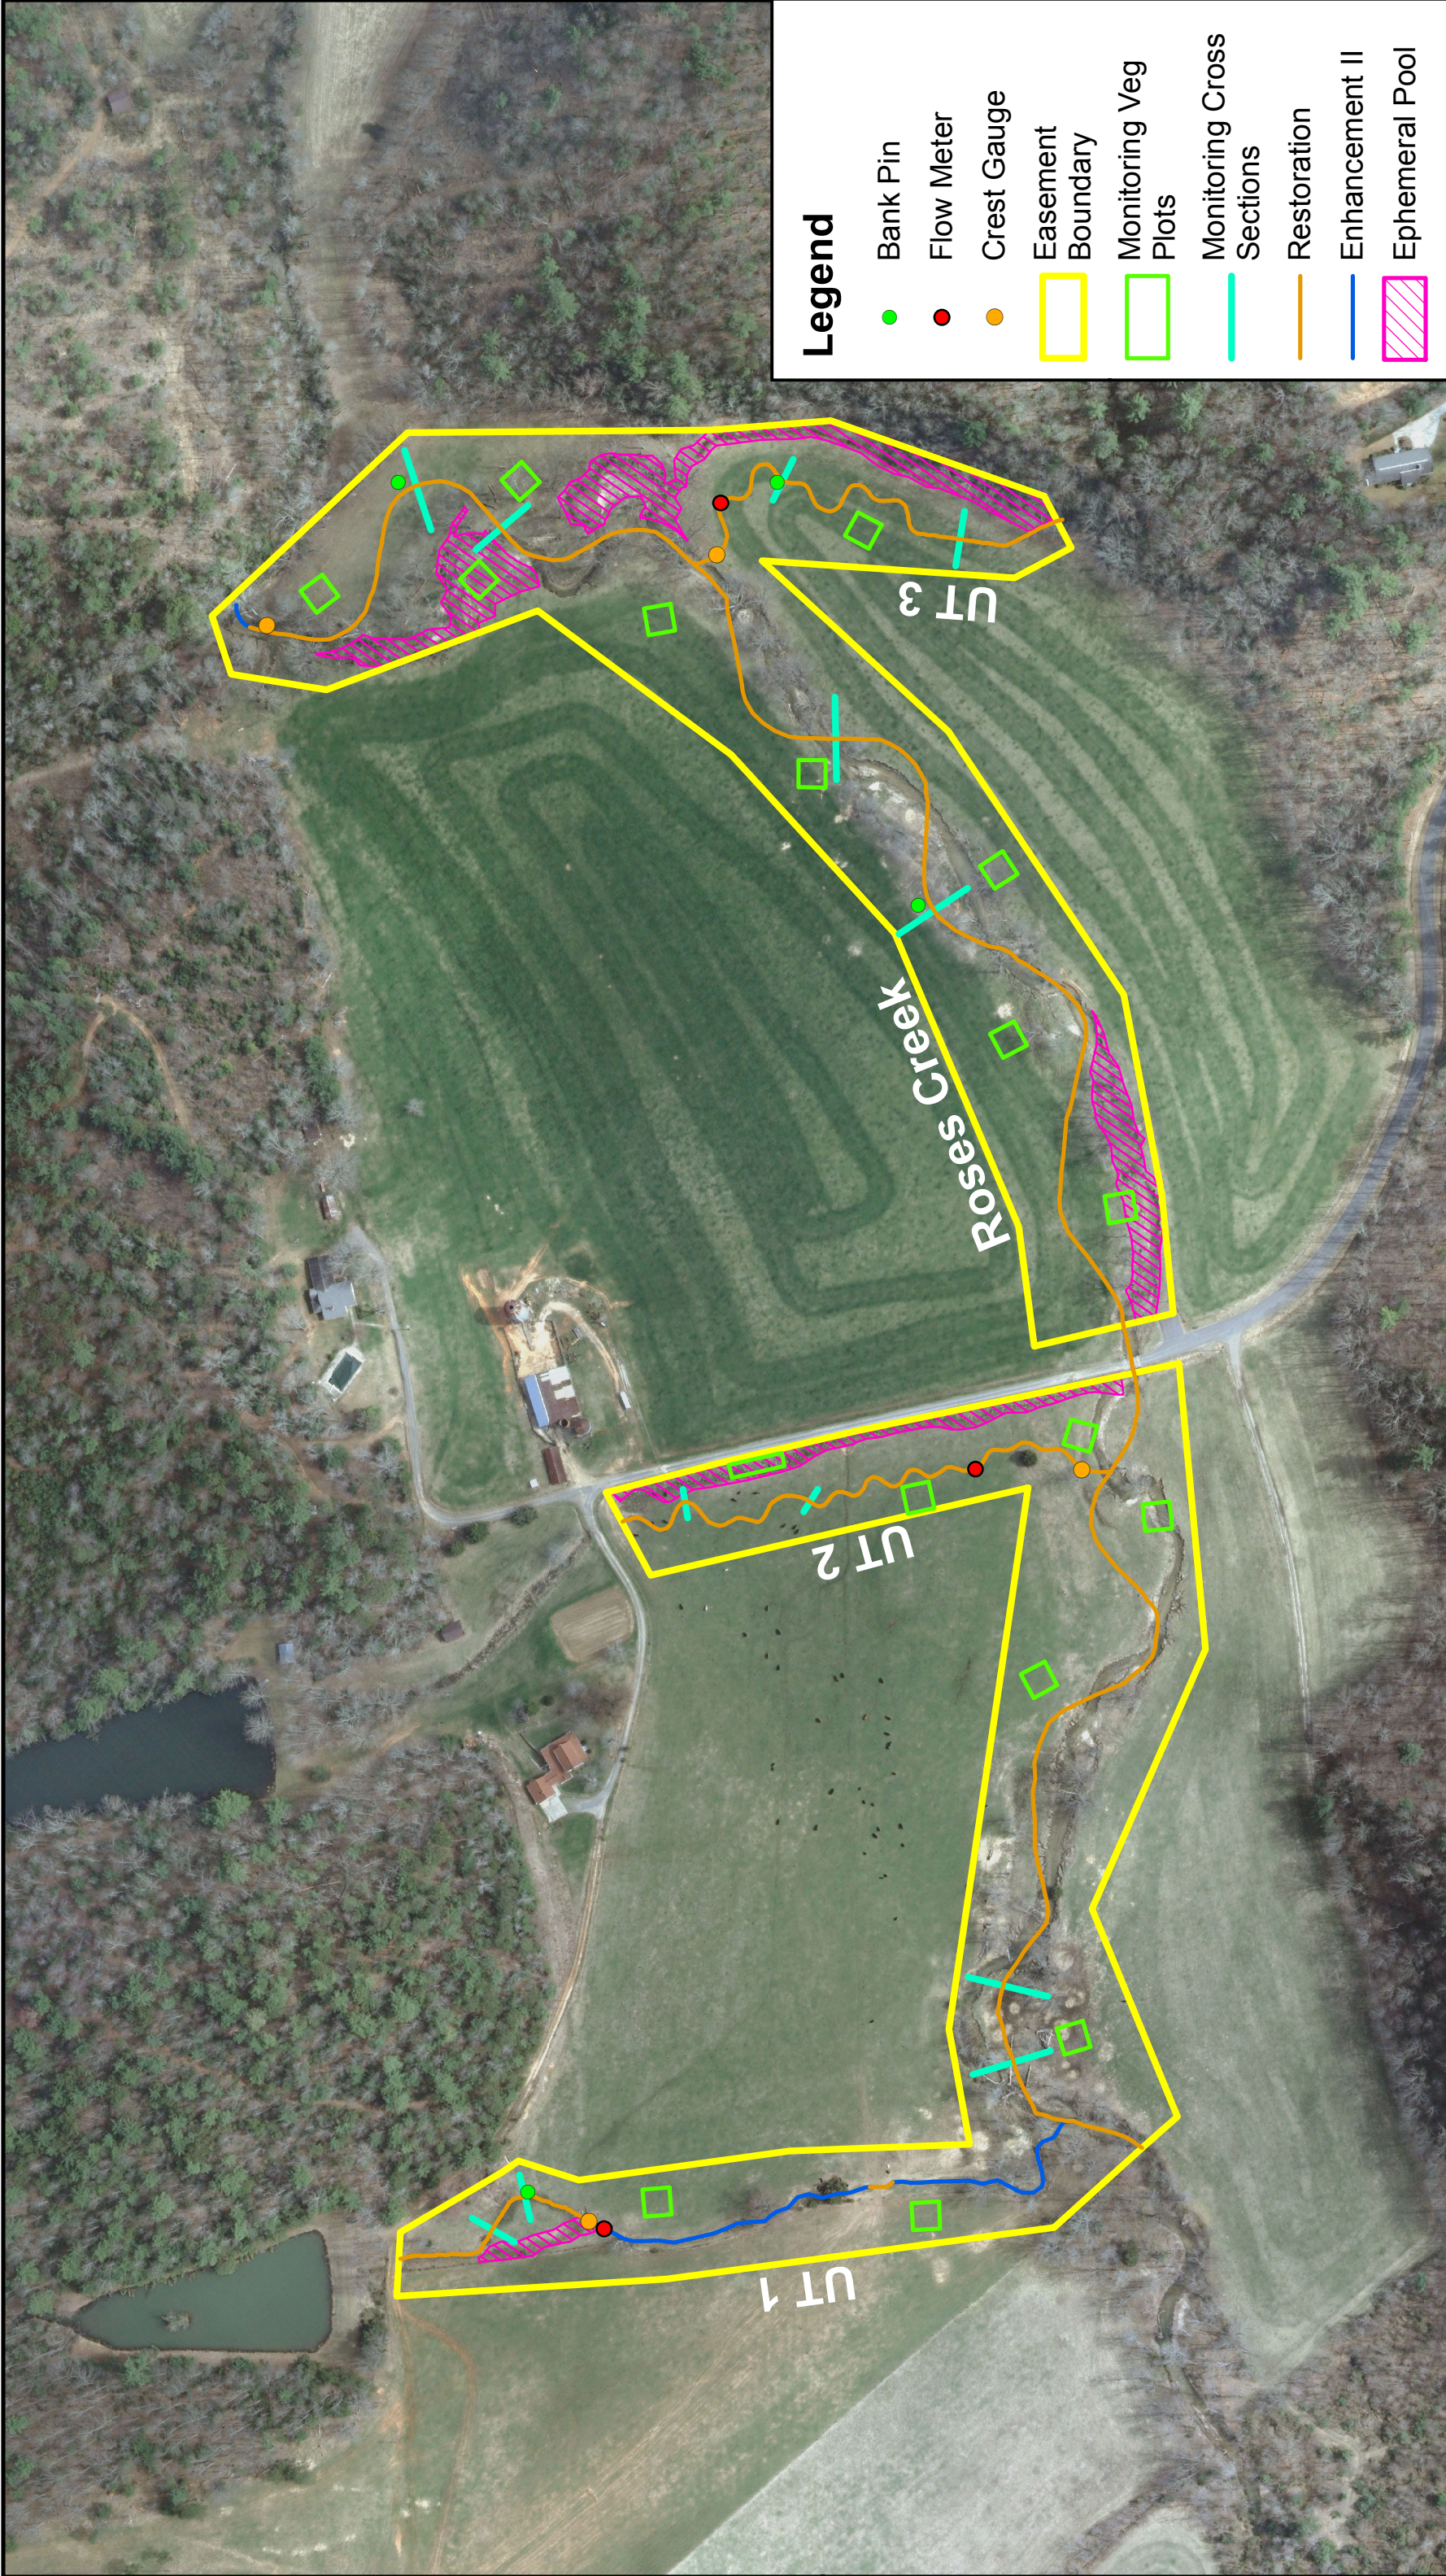
- Bank Pin
- Flow Meter
- Crest Gauge
- Easement Boundary
- Monitoring Veg Plots
- Monitoring Cross Sections
- Restoration
- Enhancement II
- Ephemeral Pool

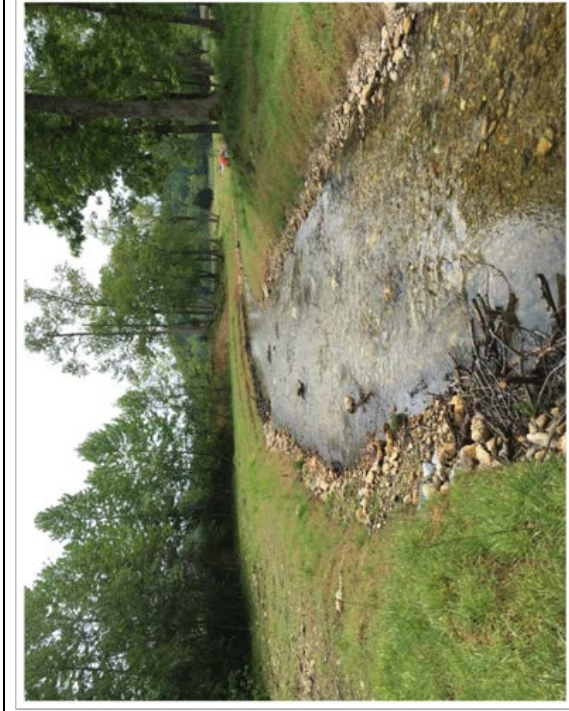
XS-1

Dimension and substrate	Cross Section 1 (Riffle)						
	Base	MY1	MY2	MY3	MY4	MY5	MY+
Based on fixed baseline bankfull elevation							
Bankfull Width (ft)	33.80						
Floodprone Width (ft)	508.32						
Bankfull Mean Depth (ft)	2.00						
Bankfull Max Depth (ft)	2.81						
Bankfull Cross Sectional Area (ft <sup>2</sup> )	67.70						
Bankfull Width/Depth Ratio	16.90						
Bankfull Entrenchment Ratio	15.04						
Bankfull Bank Height Ratio	1.00

Upon completion of grading and structure installation, a baseline survey was performed for the entire restored length of stream and included 12 cross-sections. Baseline morphologic data is summarized in Table 5 and Table 6 in Appendix B. Plots of the profiles are shown in Figures B.1-B.3 in Appendix B. Cross-section plots and photos can also be found in Appendix B. Cross-section photos were taken facing the downstream direction.

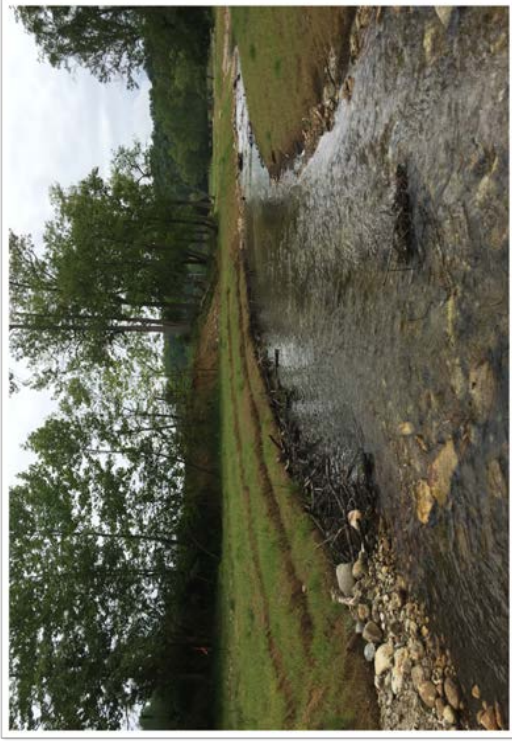
XS-2

Dimension and substrate	Cross Section 2 (Pool)						
	Base	MY1	MY2	MY3	MY4	MY5	MY+
Based on fixed baseline bankfull elevation							
Bankfull Width (ft)	38.53						
Floodprone Width (ft)							
Bankfull Mean Depth (ft)	1.73						
Bankfull Max Depth (ft)	3.47						
Bankfull Cross Sectional Area (ft <sup>2</sup> )	66.48						
Bankfull Width/Depth Ratio							
Bankfull Entrenchment Ratio							
Bankfull Bank Height Ratio

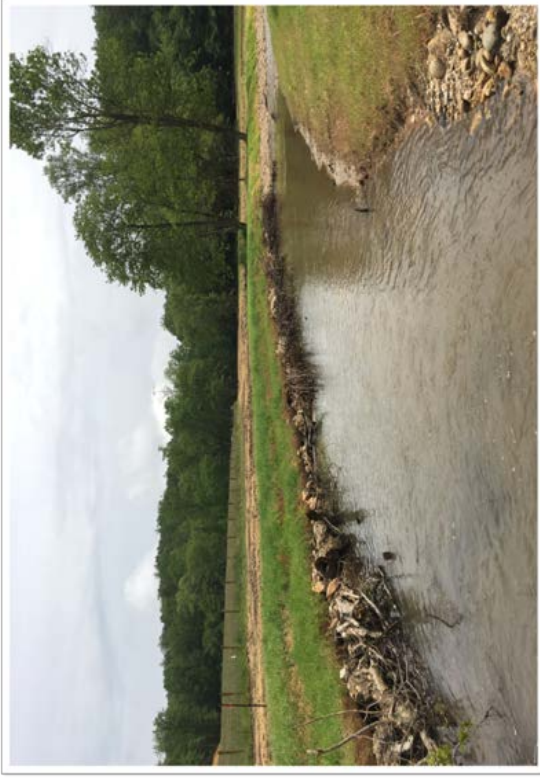
XS-3

Dimension and substrate	Cross Section 3 (Riffle)						
	Base	MY1	MY2	MY3	MY4	MY5	MY+
Based on fixed baseline bankfull elevation							
Bankfull Width (ft)	32.44						
Floodprone Width (ft)	812.77						
Bankfull Mean Depth (ft)	2.19						
Bankfull Max Depth (ft)	4.10						
Bankfull Cross Sectional Area (ft <sup>2</sup> )	71.10						
Bankfull Width/Depth Ratio	14.81						
Bankfull Entrenchment Ratio	25.05						
Bankfull Bank Height Ratio	1.00

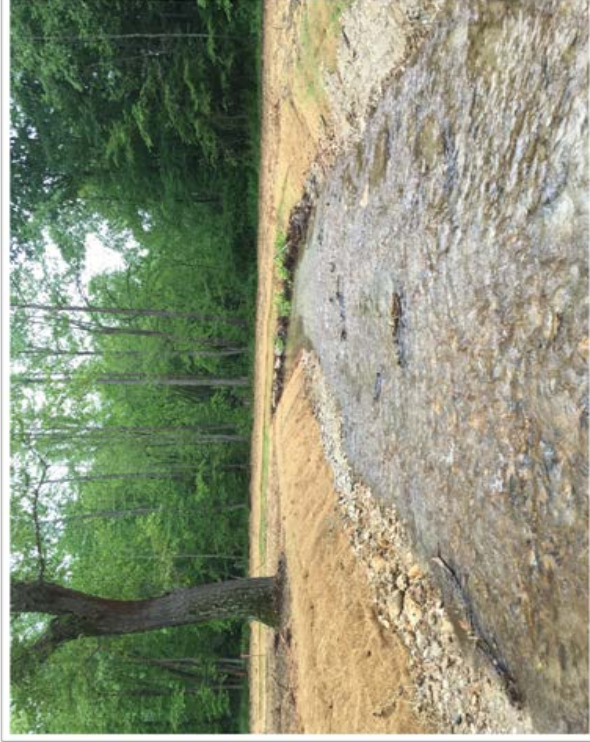
XS-5

Dimension and substrate	Cross Section 5 (Riffle)						
	Base	MY1	MY2	MY3	MY4	MY5	MY4
Based on fixed baseline bankfull elevation							
Bankfull Width (ft)	32.56						
Floodprone Width (ft)	563.60						
Bankfull Mean Depth (ft)	2.13						
Bankfull Max Depth (ft)	3.16						
Bankfull Cross Sectional Area (ft <sup>2</sup> )	69.41						
Bankfull Width/Depth Ratio	15.29						
Bankfull Entrenchment Ratio	17.31						
Bankfull Bank Height Ratio	1.00

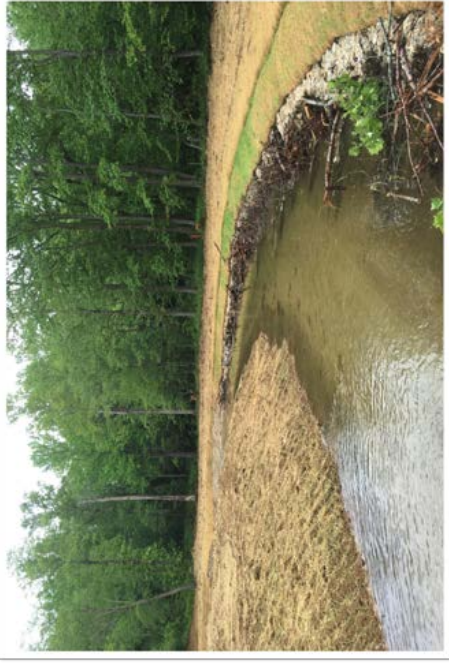
9-SX

Dimension and substrate	Cross Section 6 (Pool)						
	Base	MY1	MY2	MY3	MY4	MY5	MY+
Based on fixed baseline bankfull elevation							
Bankfull Width (ft)	31.02						
Floodprone Width (ft)							
Bankfull Mean Depth (ft)	2.37						
Bankfull Max Depth (ft)	4.07						
Bankfull Cross Sectional Area (ft <sup>2</sup> )	73.63						
Bankfull Width/Depth Ratio							
Bankfull Entrenchment Ratio							
Bankfull Bank Height Ratio

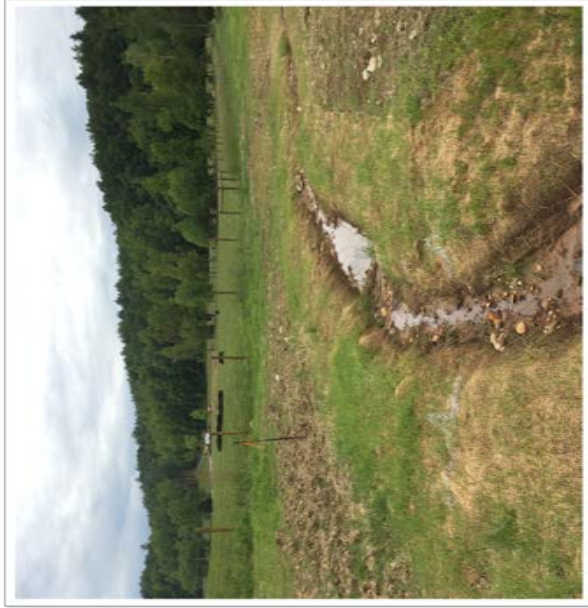
8-SX

Dimension and substrate	Cross Section 8 (Pool)						
	Base	MY1	MY2	MY3	MY4	MY5	MY+
Based on fixed baseline bankfull elevation							
Bankfull Width (ft)	6.24						
Floodprone Width (ft)							
Bankfull Mean Depth (ft)	0.58						
Bankfull Max Depth (ft)	0.96						
Bankfull Cross Sectional Area (ft <sup>2</sup> )	3.64						
Bankfull Width/Depth Ratio							
Bankfull Entrenchment Ratio							
Bankfull Bank Height Ratio

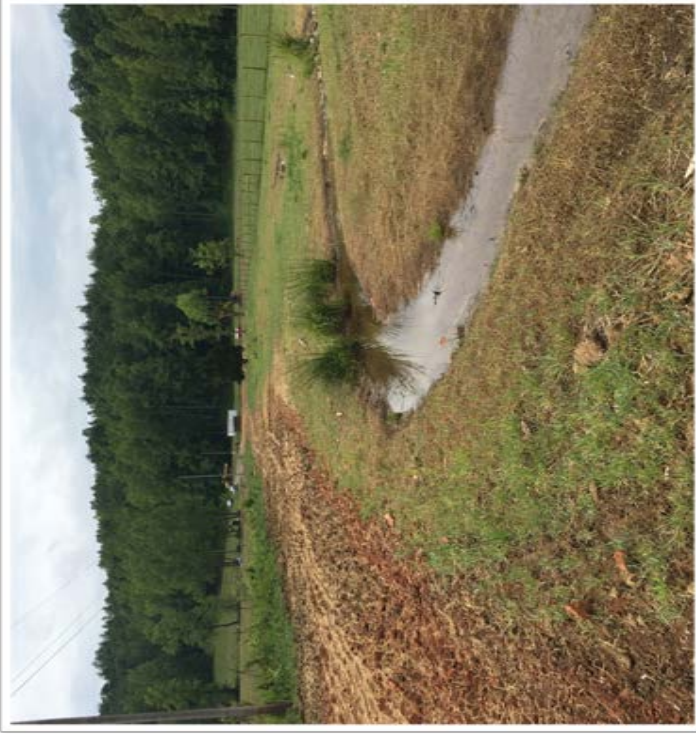
6-5X

Dimension and substrate	Cross Section 9 (Riffle)					
	Base	MY1	MY2	MY3	MY4	MY5
Based on fixed baseline bankfull elevation						
Bankfull Width (ft)	5.56					
Floodprone Width (ft)	418.38					
Bankfull Mean Depth (ft)	0.37					
Bankfull Max Depth (ft)	0.86					
Bankfull Cross Sectional Area (ft <sup>2</sup> )	2.07					
Bankfull Width/Depth Ratio	15.03					
Bankfull Entrenchment Ratio	75.25					
Bankfull Bank Height Ratio	1.00

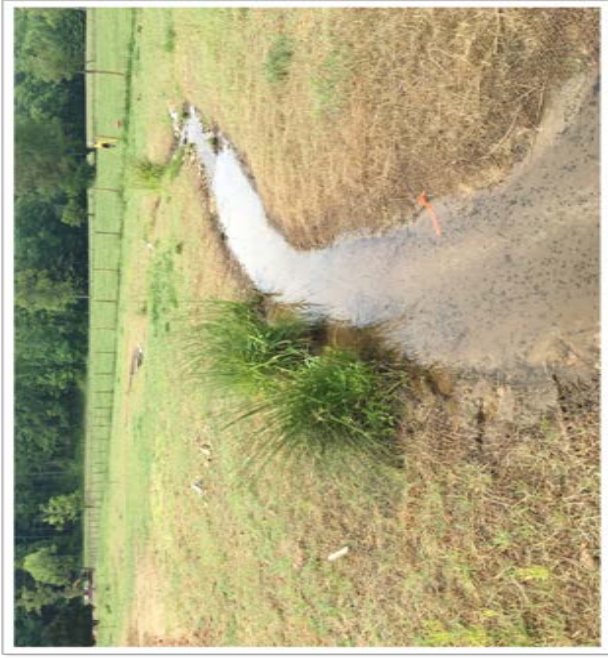
XS-10

Dimension and substrate	Cross Section 10 (Pool)						
	Base	MY1	MY2	MY3	MY4	MY5	MY+
Based on fixed baseline bankfull elevation							
Bankfull Width (ft)	6.7						
Floodprone Width (ft)							
Bankfull Mean Depth (ft)	0.4						
Bankfull Max Depth (ft)	0.77						
Bankfull Cross Sectional Area (ft <sup>2</sup> )	2.79						
Bankfull Width/Depth Ratio							
Bankfull Entrenchment Ratio							
Bankfull Bank Height Ratio

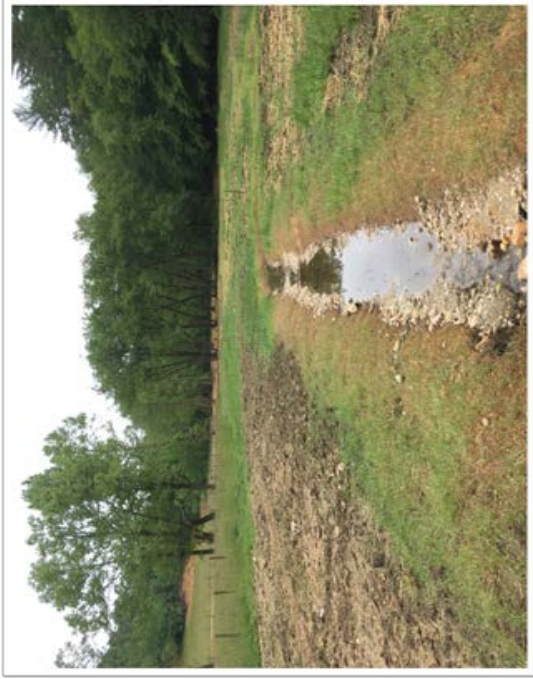
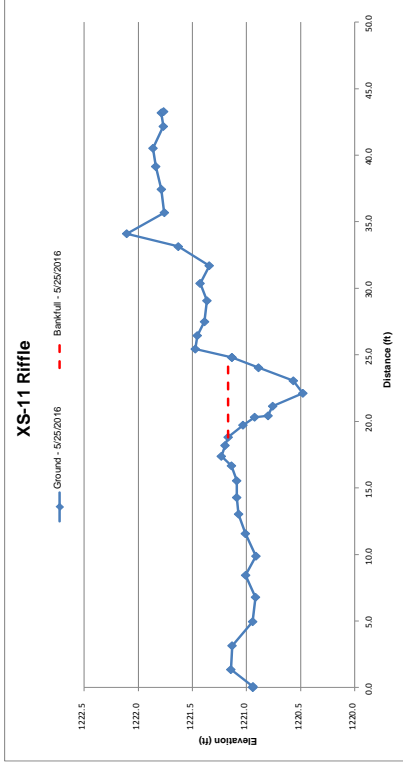
XS-11

Dimension and substrate	Cross Section 11 (Riffle)						
	Base	MY1	MY2	MY3	MY4	MY5	MY+
Based on fixed baseline bankfull elevation							
Bankfull Width (ft)	6.00						
Floodprone Width (ft)	175.41						
Bankfull Mean Depth (ft)	0.36						
Bankfull Max Depth (ft)	0.69						
Bankfull Cross Sectional Area (ft <sup>2</sup> )	2.19						
Bankfull Width/Depth Ratio	16.67						
Bankfull Entrenchment Ratio	29.24						
Bankfull Bank Height Ratio	1.00

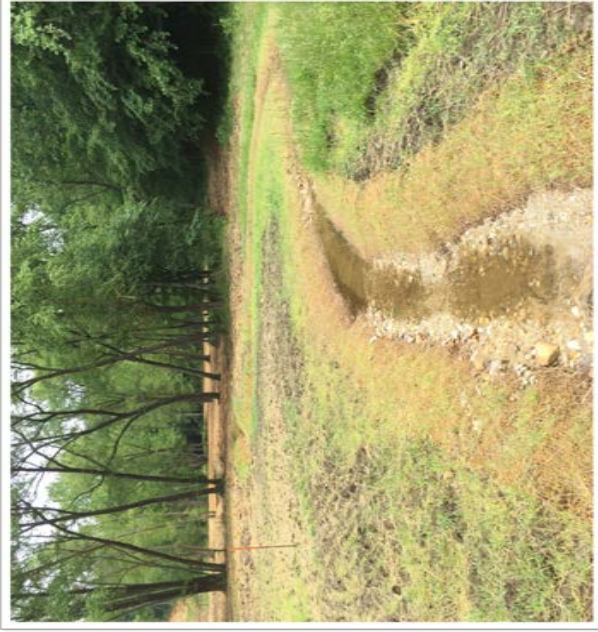
XS-12

Dimension and substrate	Cross Section 12 (Pool)						
	Base	MY1	MY2	MY3	MY4	MY5	MY+
Based on fixed baseline bankfull elevation							
Bankfull Width (ft)	8.85						
Floodprone Width (ft)							
Bankfull Mean Depth (ft)	0.4						
Bankfull Max Depth (ft)	0.9						
Bankfull Cross Sectional Area (ft <sup>2</sup> )	3.61						
Bankfull Width/Depth Ratio							
Bankfull Entrenchment Ratio							
Bankfull Bank Height Ratio
