MONITORING YEAR 1 ANNUAL REPORT FINAL

SANDY BRANCH MITIGATION SITE

Chatham County, NC
Cape Fear River Basin
HUC 03030003

DMS Project No. 100060
NCDEQ Contract No. 7527
USACE Action ID No. SAW-2018-01167
NCDWR Project No. 2018-0786

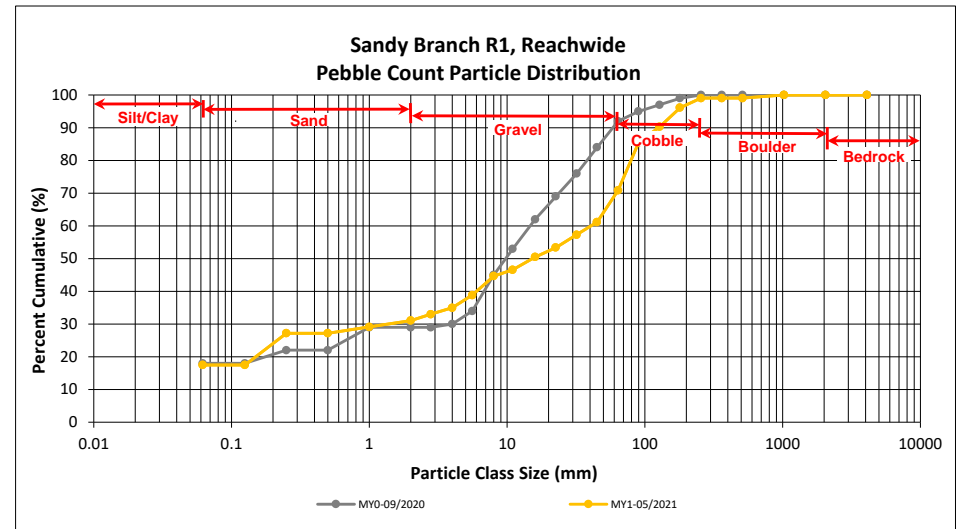
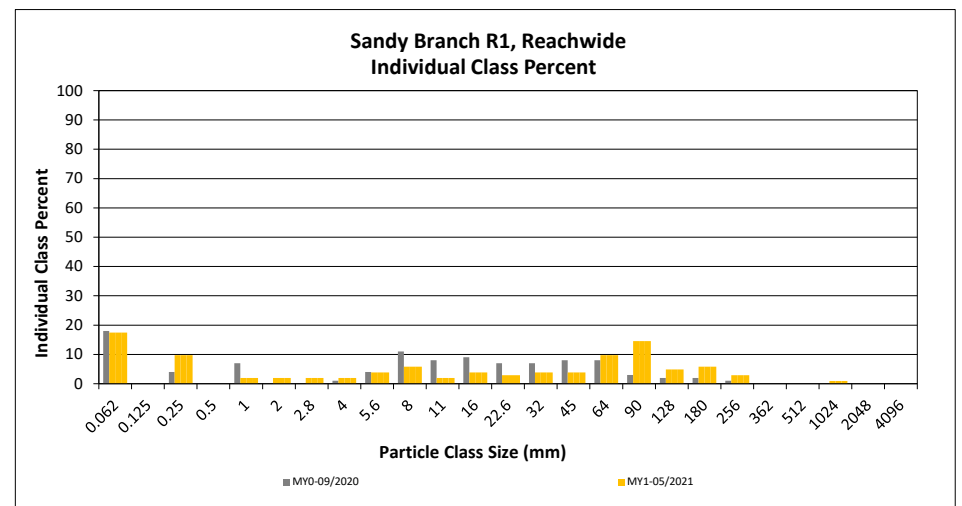
Reachwide Pebble Count Plots

Reachwide Channel materials (mm)	
D ₁₆ =	Silt/Clay
D ₃₅ =	4.02
D ₅₀ =	15.3
D ₈₄ =	87.0
D ₉₅ =	168.6
D ₁₀₀ =	1024.0

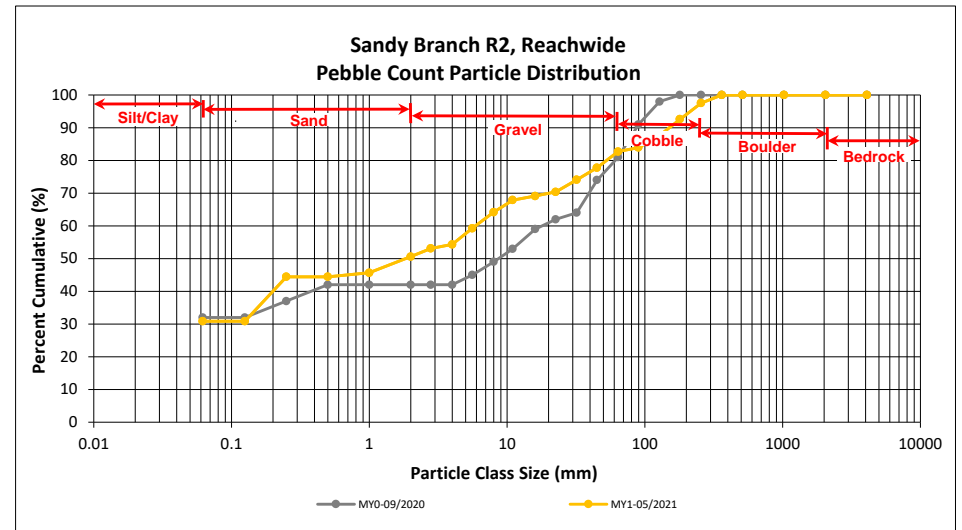
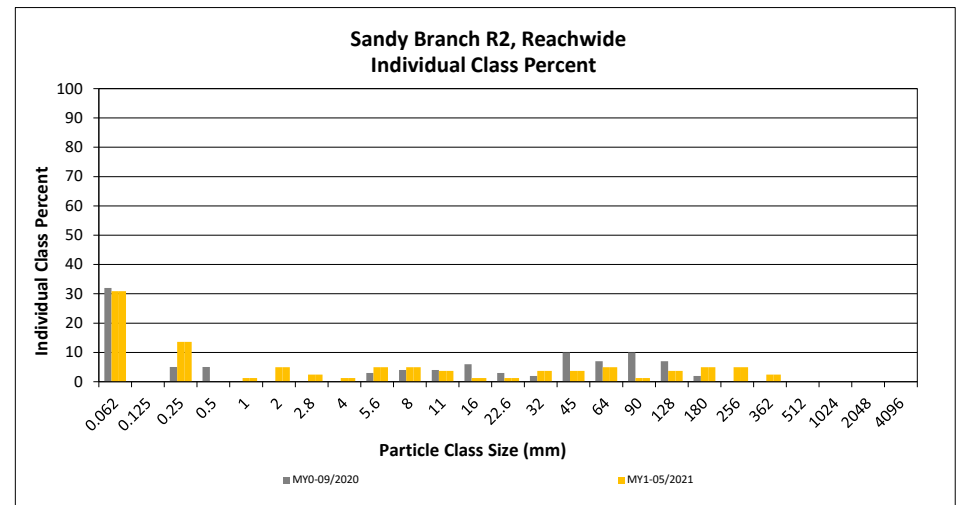
Reachwide Pebble Count Plots

Reachwide Channel materials (mm)	
D ₁₆ =	Silt/Clay
D ₃₅ =	0.15
D ₅₀ =	1.8
D ₈₄ =	90.4
D ₉₅ =	213.7
D ₁₀₀ =	362.0
