# **As-built Baseline Monitoring Report**

**Sandy Bridge Restoration Site  
DMS Contract 6400  
DMS Project Number 96920**

**DWR #: 15-0414  
USACE Action ID: 201500827  
Rutherford County, North Carolina**

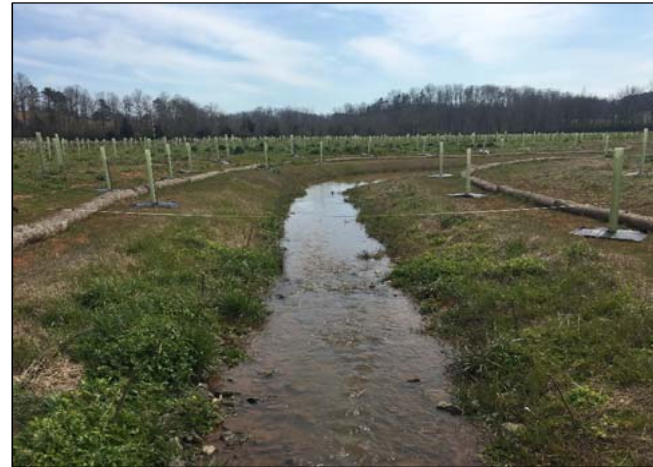
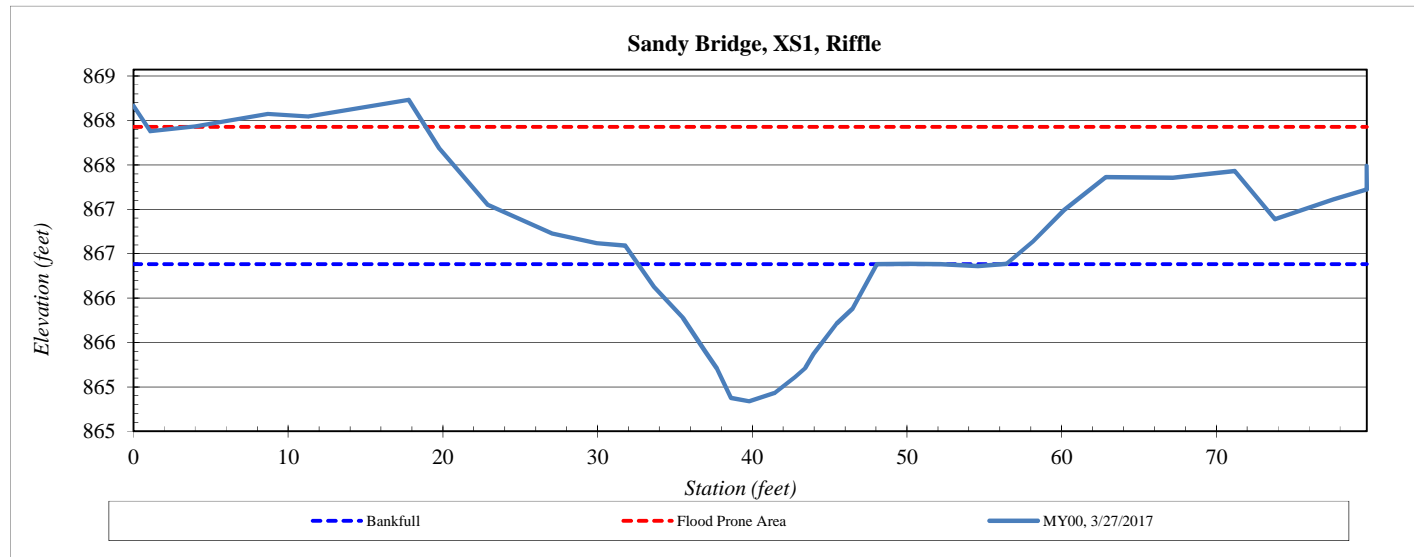
<b>River Basin:</b>	Broad
<b>Site:</b>	Sandy Bridge
<b>XS ID</b>	XS1, Riffle
<b>Drainage Area:</b>	837 acres
<b>Date:</b>	3/27/2017
<b>Field Crew:</b>	T. Seelinger, Kevin O'Briant

Station	Elevation
0.0	868.5
1.1	868.2
4.0	868.3
8.7	868.4
11.3	868.4
17.8	868.6
19.8	868.0
22.9	867.4
27.1	867.1
30.0	867.0
31.8	866.9
33.7	866.5
35.5	866.1
36.9	865.7
37.7	865.5
38.6	865.2
39.8	865.2
41.4	865.3
42.8	865.4
43.4	865.5
44.0	865.7
45.4	866.1
46.5	866.2
48.1	866.7
50.1	866.7
52.2	866.7
56.4	866.7
58.2	867.0
60.2	867.3
62.9	867.7
67.2	867.7
71.2	867.8
73.8	867.2
79.7	867.6
79.7	867.8

SUMMARY DATA	
<b>Bankfull Elevation:</b>	866.72
<b>Bankfull Cross-Sectional Area:</b>	13.8
<b>Bankfull Width:</b>	15.4
<b>Flood Prone Area Elevation:</b>	868.3
<b>Flood Prone Width:</b>	63.6
<b>Max Depth at Bankfull:</b>	1.5
<b>Mean Depth at Bankfull:</b>	0.9
<b>W / D Ratio:</b>	17.3
<b>Entrenchment Ratio:</b>	4.1
<b>Bank Height Ratio:</b>	1.0

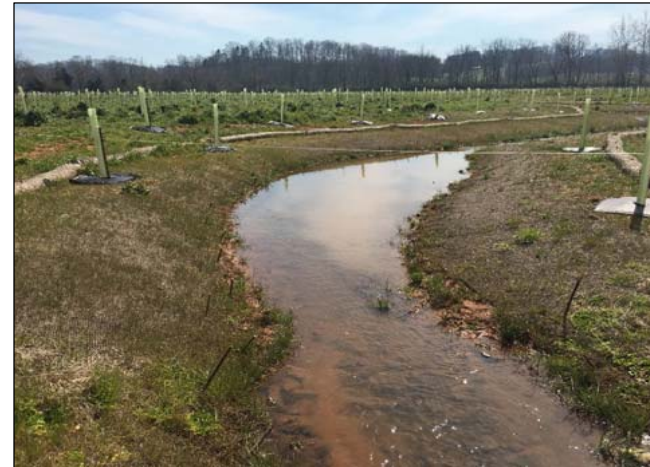
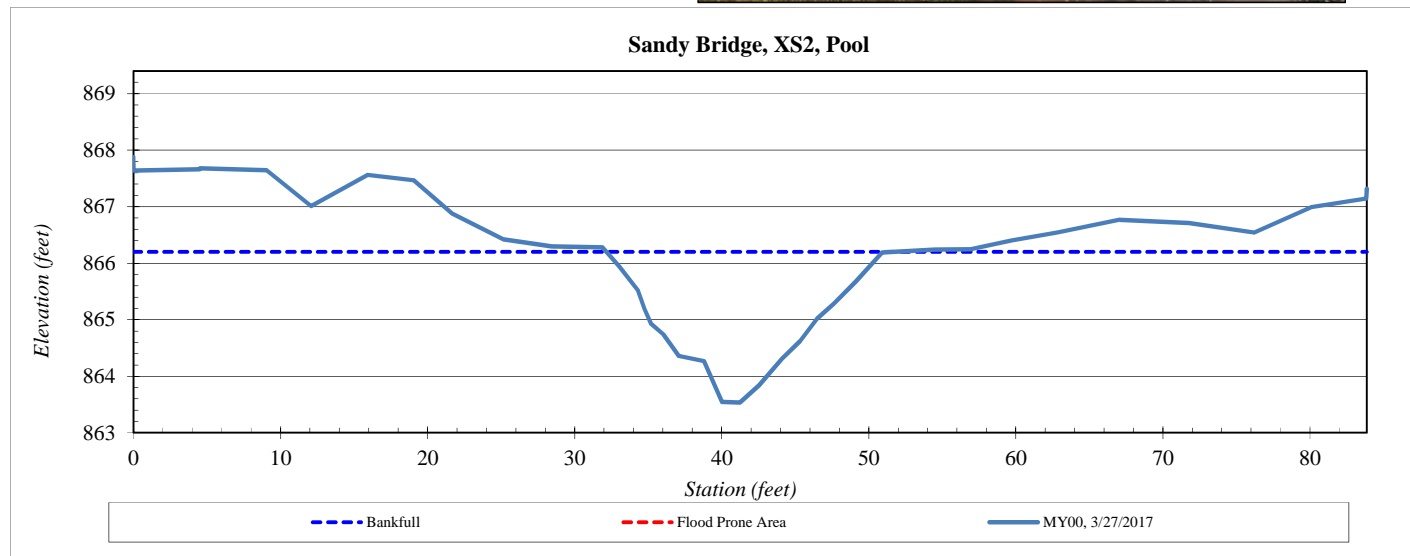
<b>River Basin:</b>	Broad
<b>Site:</b>	Sandy Bridge
<b>XS ID</b>	XS2, Pool
<b>Drainage Area:</b>	837 acres
<b>Date:</b>	3/27/2017
<b>Field Crew:</b>	T. Seelinger, Kevin O'Briant

Station	Elevation
0.0	868.3
0.0	868.1
4.5	868.1
4.5	868.1
9.1	868.1
12.1	867.5
15.9	868.0
19.1	867.9
21.7	867.3
28.4	866.8
31.9	866.7
34.8	865.7
35.2	865.4
36.0	865.2
37.1	864.8
40.0	864.0
41.2	864.0
42.5	864.3
44.1	864.8
45.3	865.1
46.5	865.5
47.6	865.7
49.1	866.1
50.9	866.7
51.7	866.7
54.5	866.7
57.0	866.7
59.7	866.9
62.8	867.0
67.0	867.2
71.8	867.2
76.2	867.0
80.1	867.5
83.8	867.6
83.9	867.8

SUMMARY DATA	
<b>Bankfull Elevation:</b>	866.66
<b>Bankfull Cross-Sectional Area:</b>	26.8
<b>Bankfull Width:</b>	18.8
<b>Flood Prone Area Elevation:</b>	-
<b>Flood Prone Width:</b>	-
<b>Max Depth at Bankfull:</b>	2.7
<b>Mean Depth at Bankfull:</b>	1.4
<b>W / D Ratio:</b>	-
<b>Entrenchment Ratio:</b>	-
<b>Bank Height Ratio:</b>	1.0

**Sandy Bridge, XS2, Pool**

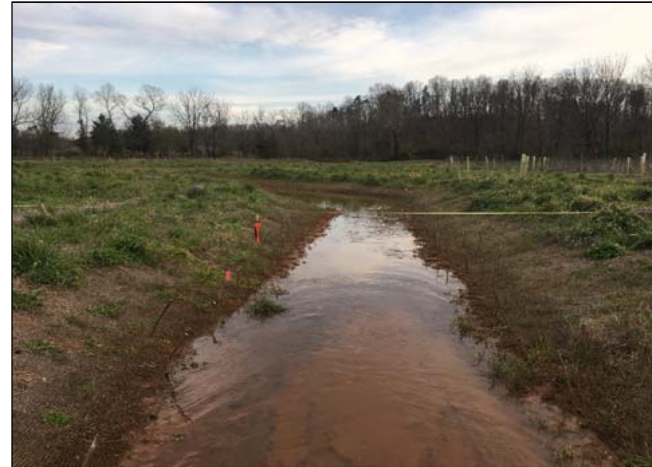
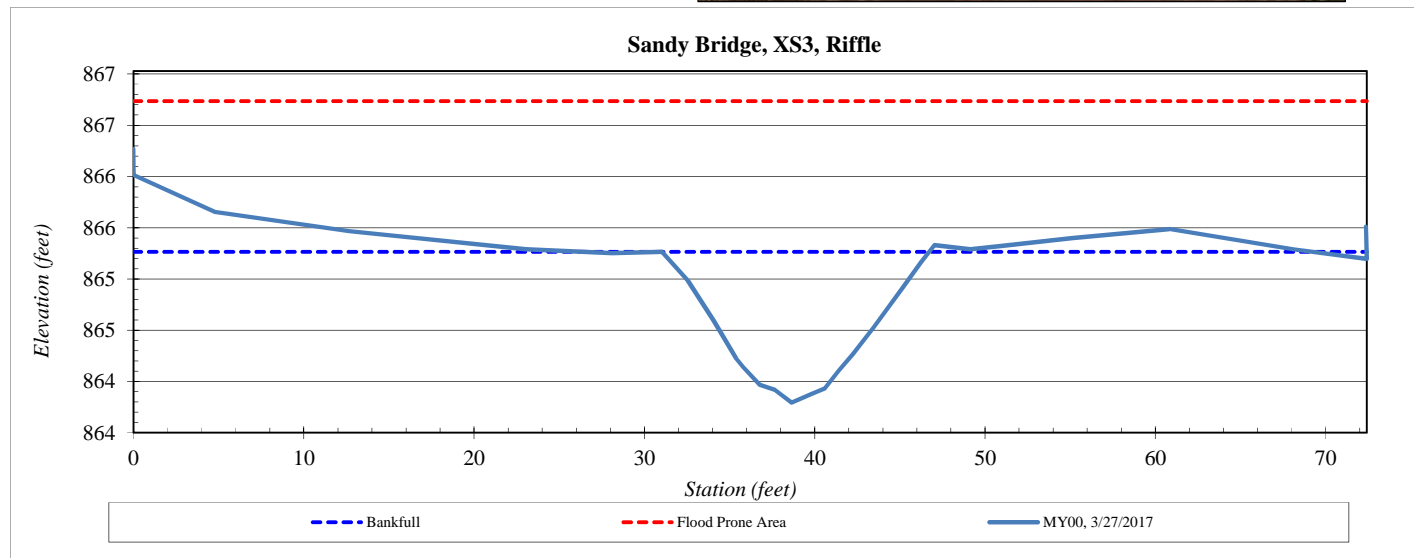
<b>River Basin:</b>	Broad
<b>Site:</b>	Sandy Bridge
<b>XS ID</b>	XS3, Riffle
<b>Drainage Area:</b>	837 acres
<b>Date:</b>	3/27/2017
<b>Field Crew:</b>	T. Seelinger, Kevin O'Briant

Station	Elevation
0.0	866.3
0.0	866.0
4.8	865.7
12.7	865.5
23.1	865.3
28.1	865.3
31.0	865.3
32.6	865.0
34.1	864.6
35.4	864.3
35.8	864.2
36.8	864.0
37.7	863.9
38.6	863.8
39.8	863.9
40.6	864.0
41.4	864.1
42.3	864.3
43.5	864.6
45.1	864.9
46.2	865.2
47.0	865.4
49.1	865.3
51.2	865.4
55.1	865.4
60.8	865.5
68.2	865.3
72.4	865.2
72.4	865.5

SUMMARY DATA	
<b>Bankfull Elevation:</b>	865.29
<b>Bankfull Cross-Sectional Area:</b>	13.1
<b>Bankfull Width:</b>	15.7
<b>Flood Prone Area Elevation:</b>	866.8
<b>Flood Prone Width:</b>	72.4
<b>Max Depth at Bankfull:</b>	1.5
<b>Mean Depth at Bankfull:</b>	0.8
<b>W / D Ratio:</b>	18.8
<b>Entrenchment Ratio:</b>	4.6
<b>Bank Height Ratio:</b>	1.0

<b>Based on fixed baseline elevation</b>														
Bankfull Width (ft)	15.7							18.7						
Floodprone Width (ft)	>70							-						
Bankfull Mean Depth (ft)	0.8							1.5						
Bankfull Max Depth (ft)	1.5							3.0						
Bankfull Cross-Sectional Area (ft <sup>2</sup> )	13.1							28.8						
Bankfull Width/Depth Ratio	18.8							-						
Bankfull Entrenchment Ratio	4.6							-						
Bankfull Bank Height Ratio	1.0							-						
d50 (mm)	0.062							-

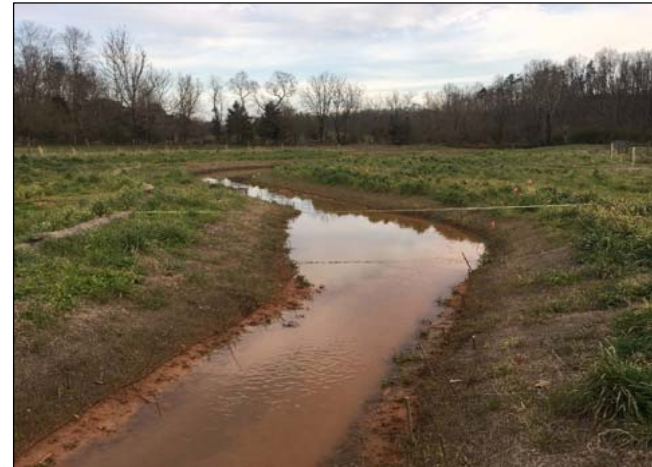
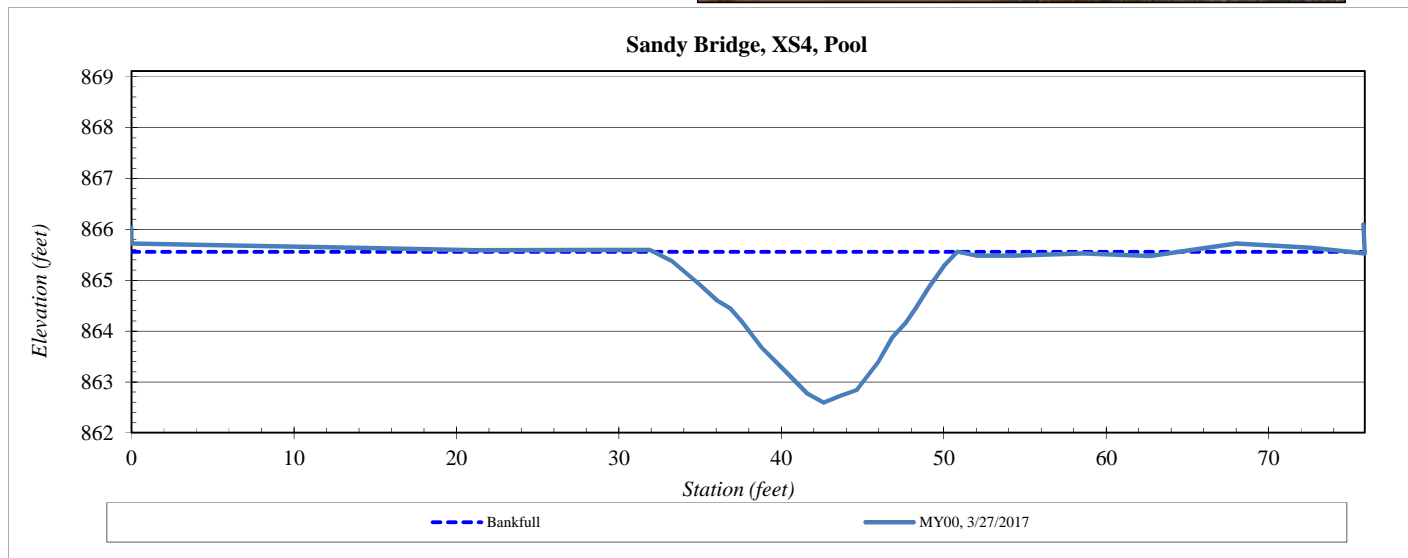
<b>River Basin:</b>	Broad
<b>Site:</b>	Sandy Bridge
<b>XS ID</b>	XS4, Pool
<b>Drainage Area:</b>	837 acres
<b>Date:</b>	3/27/2017
<b>Field Crew:</b>	T. Seelinger, Kevin O'Briant

Station	Elevation
0.0	865.7
0.0	865.4
7.1	865.4
12.5	865.4
21.3	865.3
28.7	865.3
31.9	865.3
33.3	865.1
35.0	864.6
36.1	864.3
36.8	864.2
37.6	863.9
38.8	863.4
40.3	862.9
41.6	862.5
42.6	862.3
43.6	862.4
44.6	862.5
46.0	863.1
46.9	863.6
47.6	863.8
48.2	864.1
49.1	864.6
50.0	865.0
50.8	865.3
52.0	865.2
54.2	865.2
58.6	865.2
62.7	865.2
68.0	865.4
72.5	865.3
75.9	865.2
75.8	865.8

SUMMARY DATA	
<b>Bankfull Elevation:</b>	865.26
<b>Bankfull Cross-Sectional Area:</b>	28.8
<b>Bankfull Width:</b>	18.7
<b>Flood Prone Area Elevation:</b>	-
<b>Flood Prone Width:</b>	-
<b>Max Depth at Bankfull:</b>	3.0
<b>Mean Depth at Bankfull:</b>	1.5
<b>W / D Ratio:</b>	-
<b>Entrenchment Ratio:</b>	-
<b>Bank Height Ratio:</b>	1.0

**Sandy Bridge, XS4, Pool**

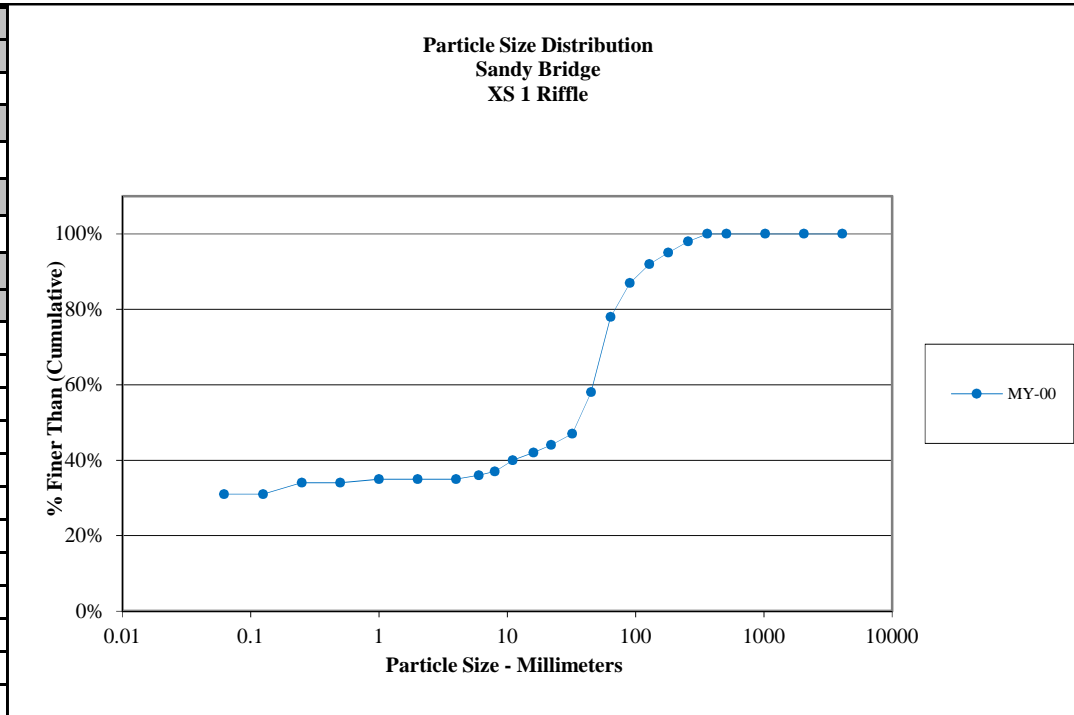
Cross-Section 1 Riffle - MY-00			
Particle	Millimeter		Count
Silt/Clay	< 0.062	S/C	31
Very Fine	.062 - .125	S	
Fine	.125 - .25	A	3
Medium	.25 - .50	N	
Coarse	.50 - 1	D	1
Very Coarse	1 - 2	S	
Very Fine	2 - 4		
Fine	4 - 5.7	G	1
Fine	5.7 - 8	R	1
Medium	8 - 11.3	A	3
Medium	11.3 - 16	V	2
Coarse	16 - 22.6	E	2
Coarse	22.6 - 32	L	3
Very Coarse	32 - 45	S	11
Very Coarse	45 - 64		20
Small	64 - 90	C	9
Small	90 - 128	O	5
Large	128 - 180	B	3
Large	180 - 256	L	3
Small	256 - 362	B	2
Small	362 - 512	L	
Medium	512 - 1024	D	
Lrg- Very Lrg	1024 - 2048	R	
Bedrock	>2048	BDRK	
		<b>Total</b>	100
Note:

Size (mm)		Type	
D16	0.062	silt/clay	31%
D35	1	sand	4%
D50	35	gravel	43%
D65	51	cobble	20%
D84	80	boulder	2%
D95	180	bedrock	0%
		hardpan	0%
		wood/det	0%
		artificial	0%

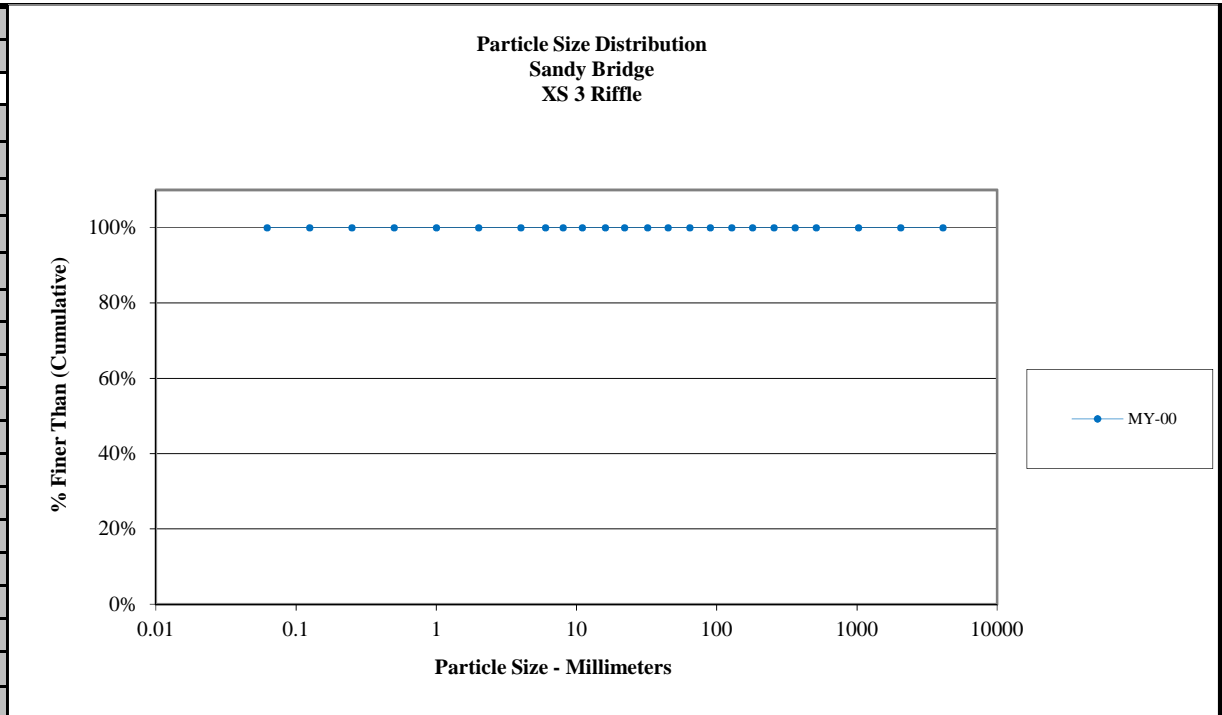
Cross-Section 3 Riffle - MY-00			
Particle	Millimeter		Count
Silt/Clay	< 0.062	S/C	100
Very Fine	.062 - .125	S	
Fine	.125 - .25	A	
Medium	.25 - .50	N	
Coarse	.50 - 1	D	
Very Coarse	1 - 2	S	
Very Fine	2 - 4		
Fine	4 - 5.7	G	
Fine	5.7 - 8	R	
Medium	8 - 11.3	A	
Medium	11.3 - 16	V	
Coarse	16 - 22.6	E	
Coarse	22.6 - 32	L	
Very Coarse	32 - 45		
Very Coarse	45 - 64		
Small	64 - 90	C	
Small	90 - 128	O	
Large	128 - 180	B	
Large	180 - 256	L	
Small	256 - 362	B	
Small	362 - 512	L	
Medium	512 - 1024	D	
Lrg- Very Lrg	1024 - 2048	R	
Bedrock	>2048	BDRK	
		<b>Total</b>	100
Note:

Size (mm)	
D16	0.062
D35	0.062
D50	0.062
D65	0.062
D84	0.062
D95	0.062

Size Distribution	
mean	0.1
dispersion	1.0
skewness	---
