SCALY BARK CREEK MITIGATION SITE

*Stanly County, NC
DENR Contract 002030
EEP Project Number 94148*

Baseline Monitoring Document and As-Built Baseline Report FINAL

SCALY BARK CREEK MITIGATION SITE
Baseline Monitoring Document and As-Built Baseline Report

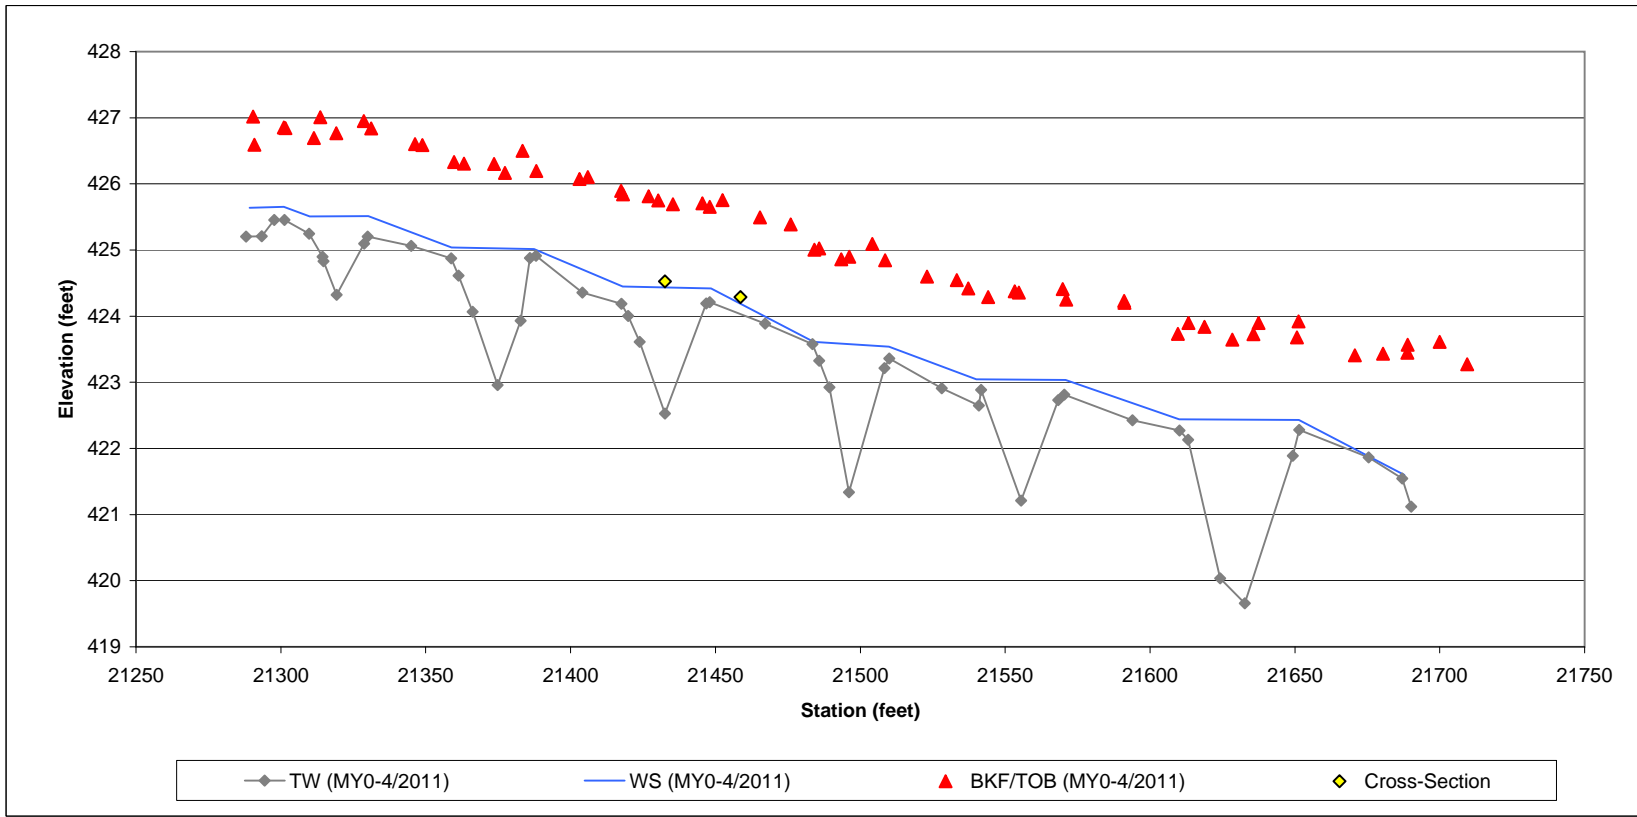
Appendix 2. Morphological Summary Data and Plots
Figure 3c. Longitudinal Profile Plots
Scaly Bark Creek Mitigation Site (EEP Project No. 94148)
UT1 Reach 2
Monitoring Year 0 of 5

$BKF = -0.0094 \cdot STA + 626.7$
 $WS = -0.0101 \cdot STA + 640.85$

The baseline (MY-0) profile numbers are closely matched to the design parameters. The plotted longitudinal profile and related summary data can be found in Appendix 2.

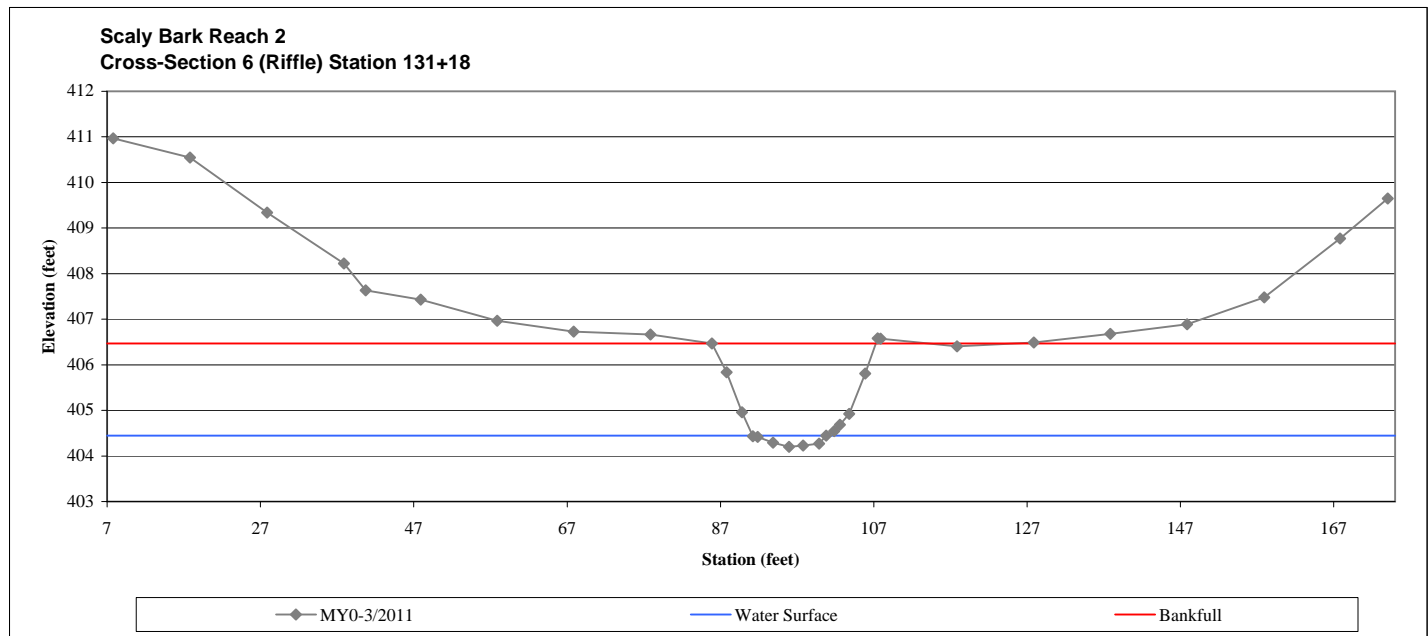
Figure 4f. Cross-Section Plots

River Basin	Yadkin
Watershed	Rocky River
XS ID	6
Drainage Area	2.5 sq.mi
Date	4/2011
Field Crew	Dewberry

Summary Data	
Bankfull Elevation (ft)	406.47
Bankfull Cross-Sectional Area (ft²)	34.33
Bankfull Width (ft)	21.35
Flood Prone Area Elevation (ft)	408.74
Flood Prone Width (ft)	200+
Max Depth at Bankfull (ft)	2.27
Mean Depth at Bankfull (ft)	1.61
W/D Ratio	13.28
Entrenchment Ratio	2.2+
Bank Height Ratio	1.00
Stream Type	C

The baseline (MY-0) dimension numbers are closely matched to the design parameters. Summary data and cross-section plots can be found in Appendix 2.

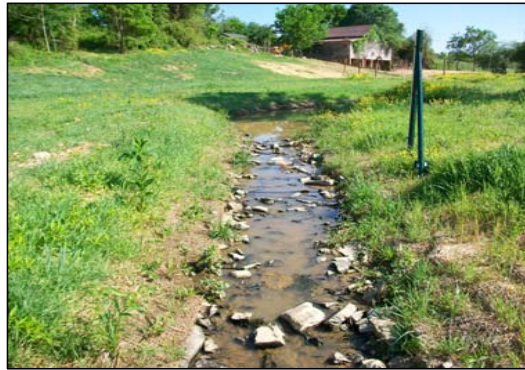
Cross-Section 10: View Upstream (4/27/2011)

River Basin	Yadkin
Watershed	Rocky River
XS ID	10
Drainage Area	2.5 sq.mi
Date	Apr-11
Field Crew	Dewberry

Summary Data	
Bankfull Elevation (ft)	425.68
Bankfull Cross-Sectional Area (ft²)	12.39
Bankfull Width (ft)	12.14
Flood Prone Area Elevation (ft)	427.41
Flood Prone Width (ft)	200+
Max Depth at Bankfull (ft)	1.73
Mean Depth at Bankfull (ft)	1.02
W/D Ratio	11.89
Entrenchment Ratio	n/a
Bank Height Ratio	1.00
Stream Type	C

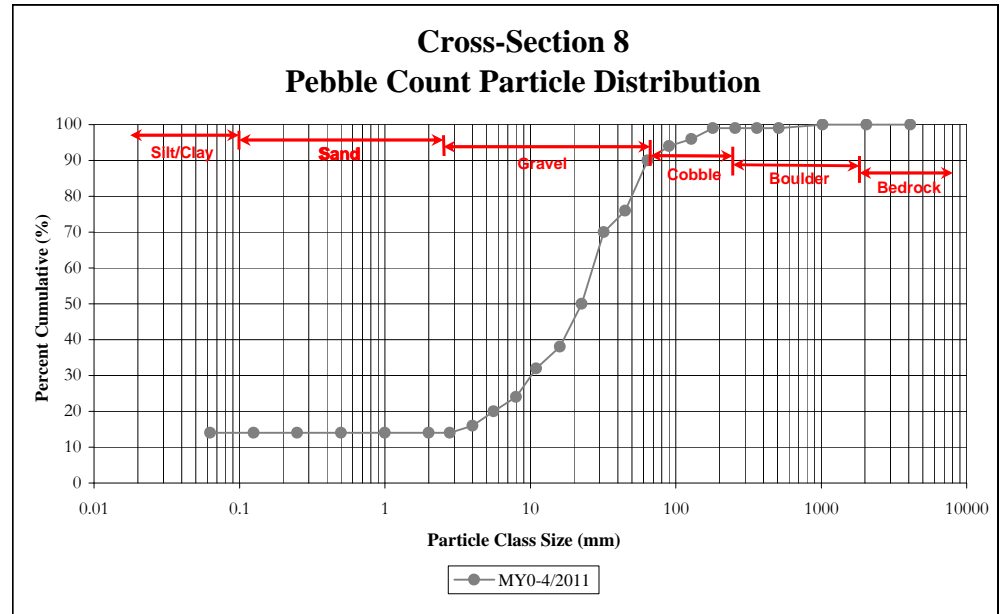
Appendix 2. Morphological Summary Data and Plots
Figure 5f. Reachwide and Cross-Section Substrate Plots
Scaly Bark Creek Mitigation Site (EEP Project No. 94148)
Scaly Bark Reach 2, Cross-Section 8 (Riffle)
Monitoring Year 0 of 5

Cross-Section 8 Channel materials (mm)	
D ₁₆ =	4.00
D ₃₅ =	13.27
D ₅₀ =	22.60
D ₈₄ =	55.03
D ₉₅ =	107.33
D ₁₀₀ =	1024.00

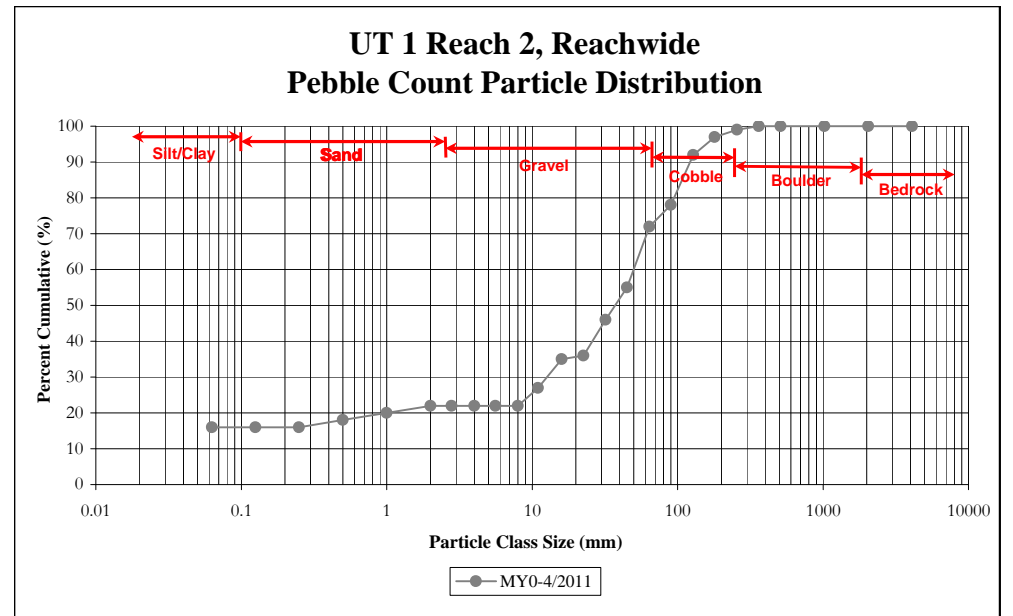
Appendix 2. Morphological Summary Data and Plots
Figure 5g. Reachwide and Cross-Section Pebble Count Plots
Scaly Bark Creek Mitigation Site (EEP Project No. 94148)
UT1 Reach 2, Reachwide
Monitoring Year 0 of 5

Cross-Section 10	
Channel materials (mm)	
D ₁₆ =	0.25
D ₃₅ =	16.00
D ₅₀ =	37.24
D ₈₄ =	104.66
D ₉₅ =	157.05
D ₁₀₀ =	362
