SCALY BARK CREEK MITIGATION SITE

*Stanly County, NC
DENR Contract 002030
EEP Project Number 94148*

Monitoring Year 1 Annual Report FINAL

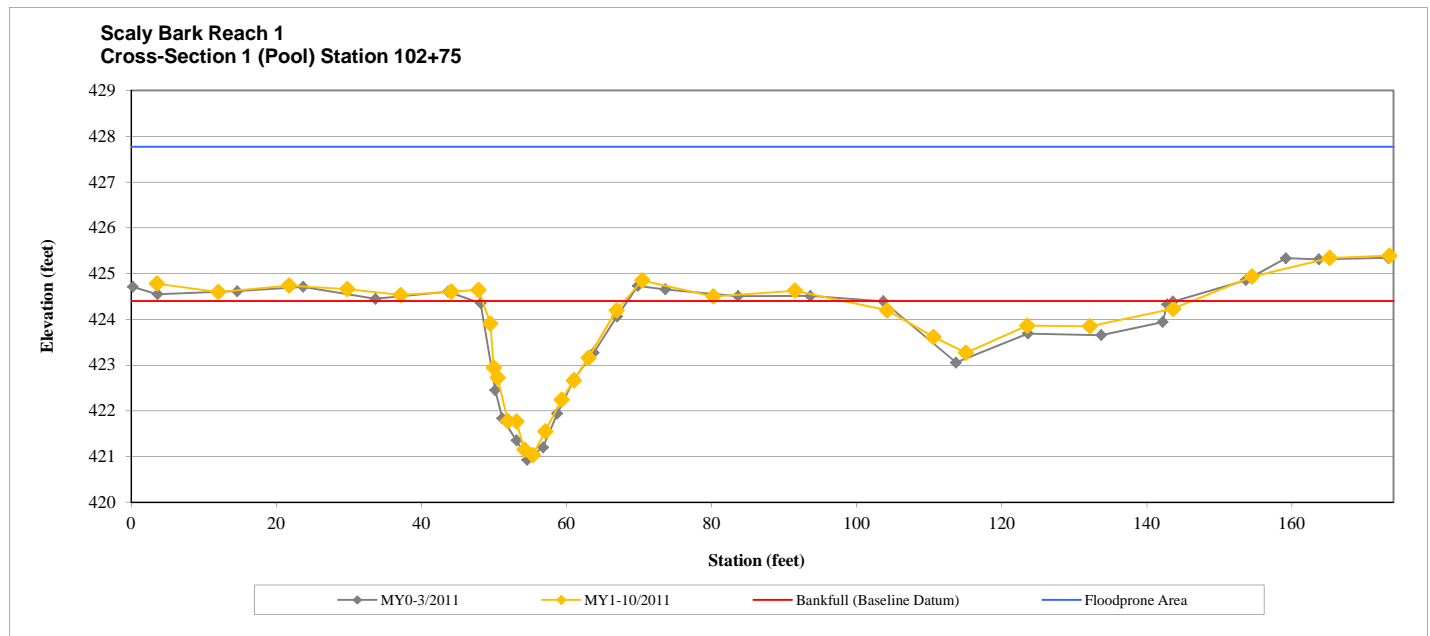
River Basin	Yadkin
Watershed	Rocky River
XS ID	1
Drainage Area	2.5 sq.mi
Date	10/26/2011
Field Crew	Wildlands Engineering

Summary Data	
Bankfull Elevation (ft)	424.4
Bankfull Cross-Sectional Area (ft²)	34.95
Bankfull Width (ft)	19.61
Flood Prone Area Elevation (ft)	n/a
Flood Prone Width (ft)	n/a
Max Depth at Bankfull (ft)	3.37
Mean Depth at Bankfull (ft)	1.78
W/D Ratio	11
Entrenchment Ratio	n/a
Bank Height Ratio	1
Stream Type	n/a

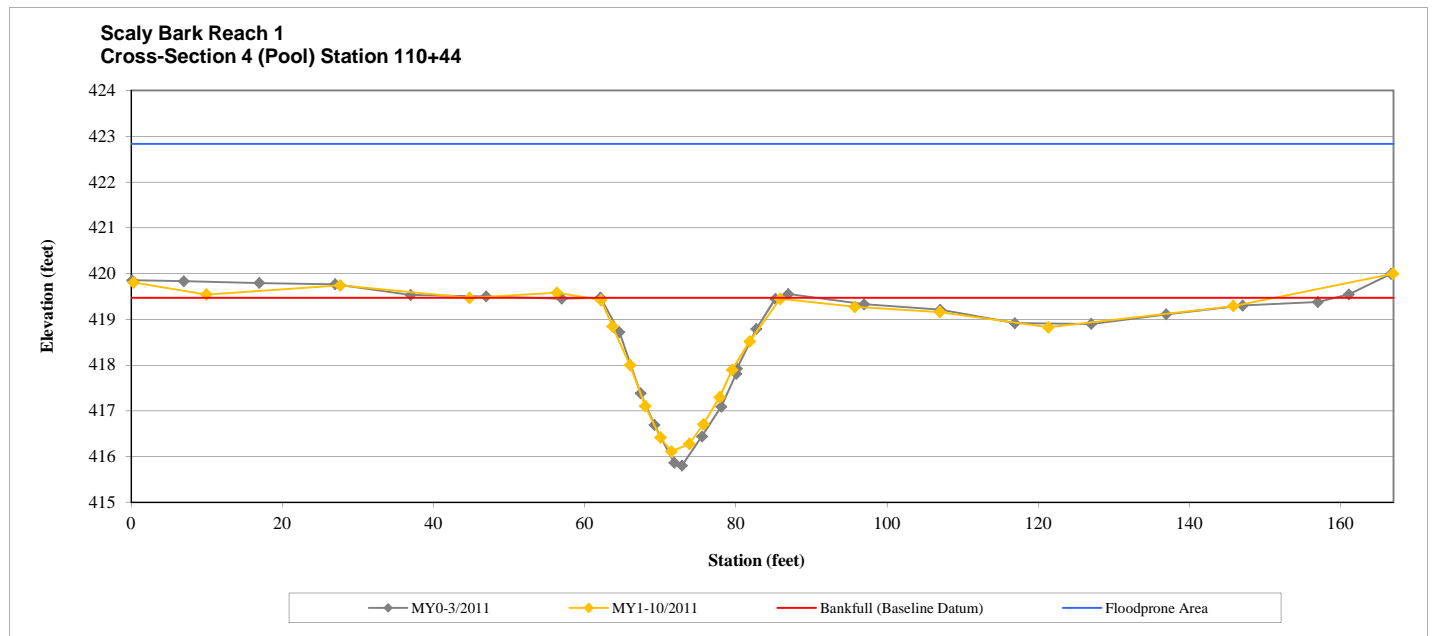
Appendix 4. Morphological Summary Data and Plots
Figure 5d. Cross-Section Plots
Scaly Bark Creek Mitigation Site (EEP Project No. 94148)
Scaly Bark Reach 1, Cross-Section 4 (Pool)
Monitoring Year 1 of 5

River Basin	Yadkin
Watershed	Rocky River
XS ID	4
Drainage Area	2.5 sq.mi
Date	10/26/2011
Field Crew	Wildlands Engineering

Summary Data	
Bankfull Elevation (ft)	419.47
Bankfull Cross-Sectional Area (ft²)	43.63
Bankfull Width (ft)	25.80
Flood Prone Area Elevation (ft)	n/a
Flood Prone Width (ft)	n/a
Max Depth at Bankfull (ft)	3.36
Mean Depth at Bankfull (ft)	1.69
W/D Ratio	15.26
Entrenchment Ratio	n/a
Bank Height Ratio	1.00
Stream Type	n/a

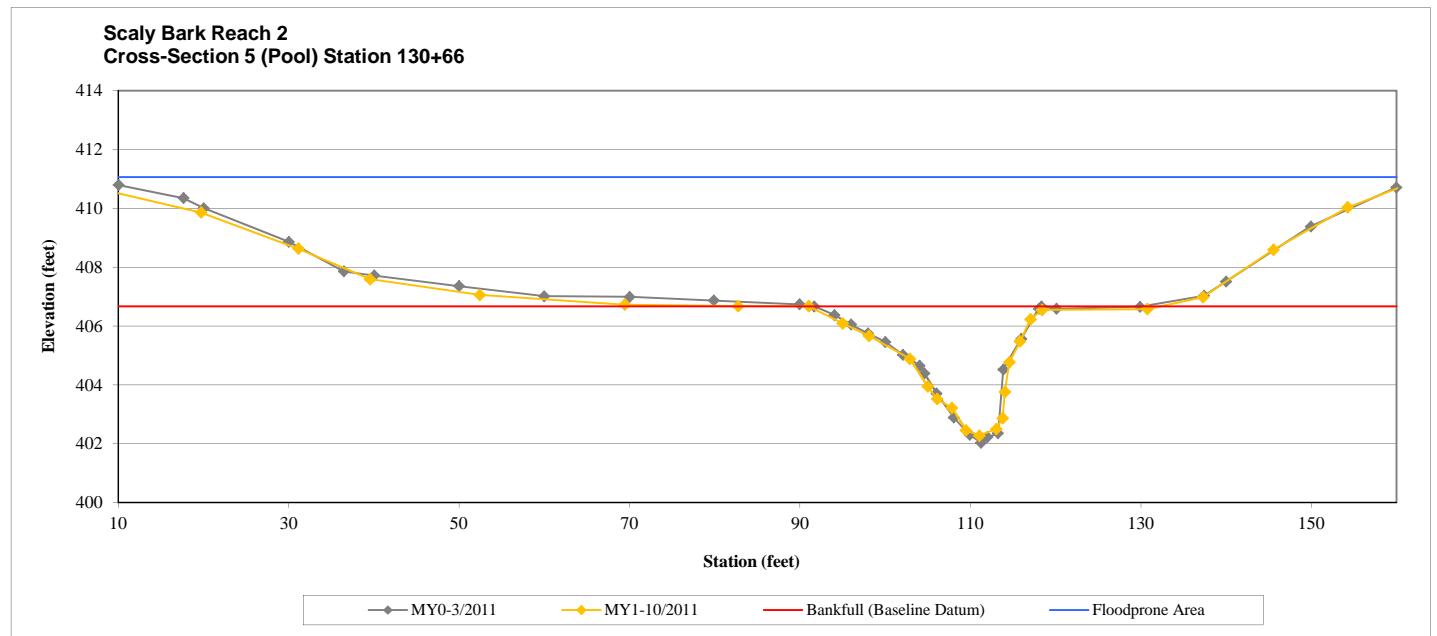
Appendix 4. Morphological Summary Data and Plots
Figure 5e. Cross-Section Plots
Scaly Bark Creek Mitigation Site (EEP Project No. 94148)
Scaly Bark Reach 2, Cross-Section 5 (Pool)
Monitoring Year 1 of 5

River Basin	Yadkin
Watershed	Rocky River
XS ID	5
Drainage Area	2.5 sq.mi
Date	10/26/2011
Field Crew	Wildlands Engineering

Summary Data	
Bankfull Elevation (ft)	406.67
Bankfull Cross-Sectional Area (ft2)	53.92
Bankfull Width (ft)	27.41
Flood Prone Area Elevation (ft)	n/a
Flood Prone Width (ft)	n/a
Max Depth at Bankfull (ft)	4.40
Mean Depth at Bankfull (ft)	1.97
W/D Ratio	13.93
Entrenchment Ratio	n/a
Bank Height Ratio	1.00
Stream Type	n/a

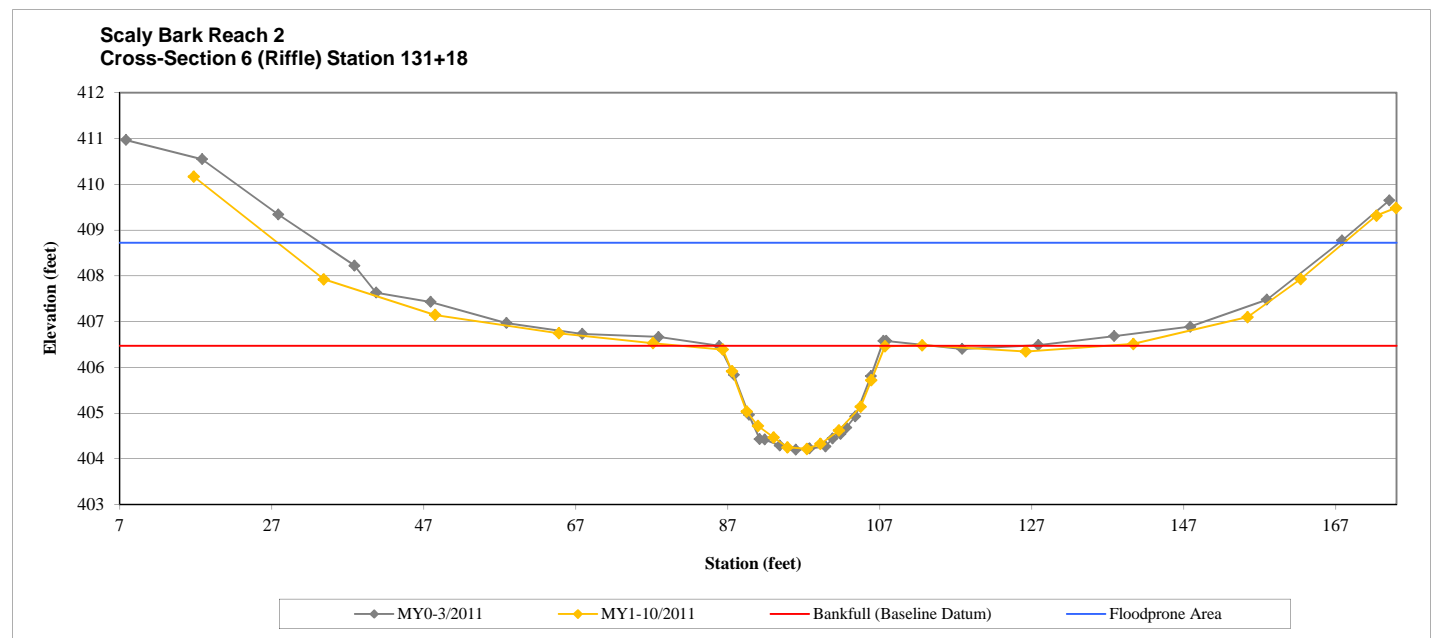
Appendix 4. Morphological Summary Data and Plots
Figure 5f. Cross-Section Plots
Scaly Bark Creek Mitigation Site (EEP Project No. 94148)
Scaly Bark Reach 2, Cross-Section 6 (Riffle)
Monitoring Year 1 of 5

River Basin	Yadkin
Watershed	Rocky River
XS ID	6
Drainage Area	2.5 sq.mi
Date	10/26/2011
Field Crew	Wildlands Engineering

Summary Data	
Bankfull Elevation (ft)	406.47
Bankfull Cross-Sectional Area (ft²)	33.76
Bankfull Width (ft)	26.65
Flood Prone Area Elevation (ft)	408.72
Flood Prone Width (ft)	200+
Max Depth at Bankfull (ft)	2.25
Mean Depth at Bankfull (ft)	1.27
W/D Ratio	21.04
Entrenchment Ratio	2.2+
Bank Height Ratio	1.00
Stream Type	C

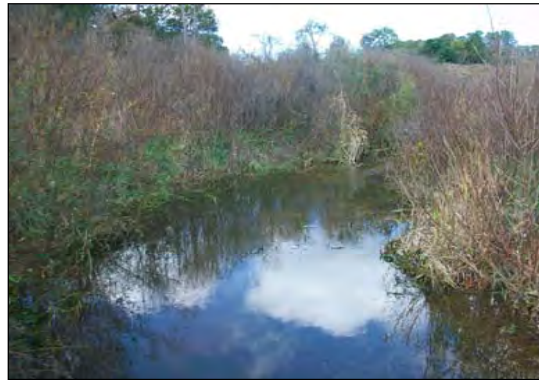
Cross-Section 11: View Upstream (10/26/2011)

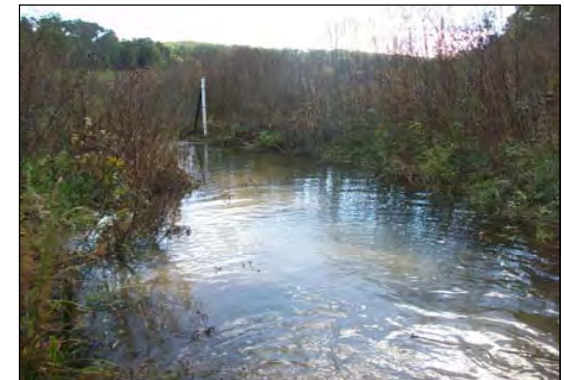
Cross-Section 11: View Downstream (10/26/2011)

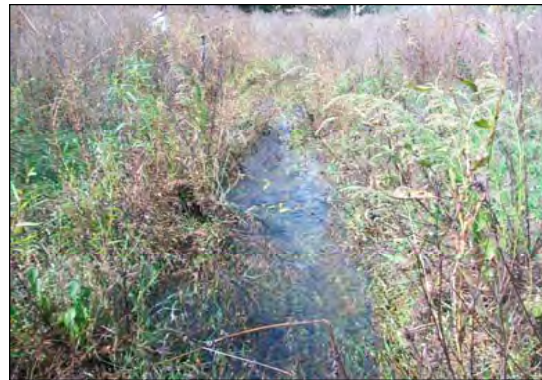
Cross-Section 12: View Upstream (10/26/2011)

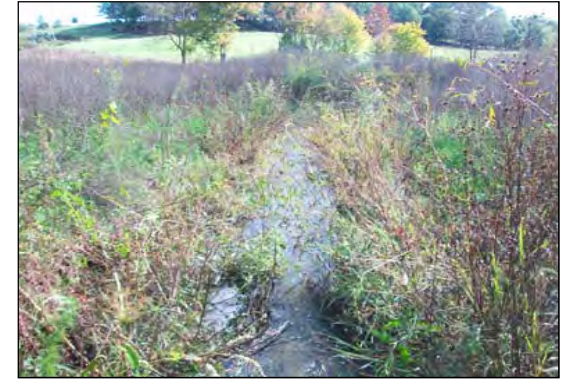
Cross-Section 12: View Downstream (10/26/2011)

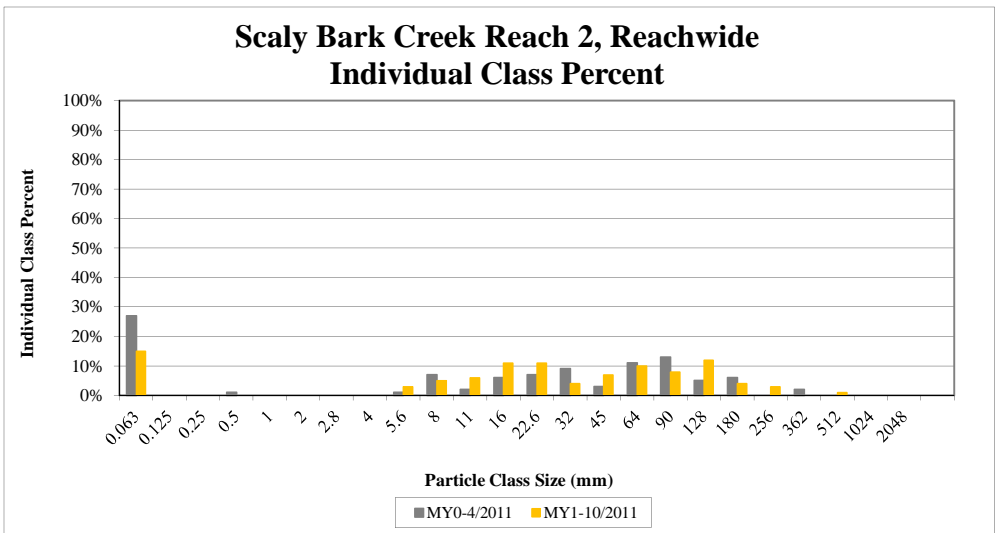
Appendix 4. Morphological Summary Data and Plots
Figure 6d. Reachwide and Cross-Section Substrate Plots
Scaly Bark Creek Mitigation Site (EEP Project No. 94148)
Scaly Bark Creek Reach 2, Reachwide
Monitoring Year 1 of 5

Particle Class		Diameter (mm)		Particle Count			Scaly Bark Reach 2 Summary	
		min	max	Riffle	Pool	Total	Class Percentage	Percent Cumulative
<i>SILT/CLAY</i>	Silt/Clay	0.000	0.062	1	14	15	15	15
<i>SAND</i>	Very fine	0.062	0.125					15
	Fine	0.125	0.250					15
	Medium	0.250	0.500					15
	Coarse	0.5	1.0					15
	Very Coarse	1.0	2.0					15
<i>GRAVEL</i>	Very Fine	2.0	2.8					15
	Very Fine	2.8	4.0					15
	Fine	4.0	5.7	2	1	3	3	18
	Fine	5.7	8.0		5	5	5	23
	Medium	8.0	11.3	1	5	6	6	29
	Medium	11.3	16.0	2	9	11	11	40
	Coarse	16.0	22.6	8	3	11	11	51
	Coarse	22.6	32	1	3	4	4	55
	Very Coarse	32	45	5	2	7	7	62
Very Coarse	45	64	9	1	10	10	72	
<i>COBBLE</i>	Small	64	90	7	1	8	8	80
	Small	90	128	7	5	12	12	92
	Large	128	180	3	1	4	4	96
	Large	180	256	3	3	3	3	99
<i>BOULDER</i>	Small	256	362					99
	Small	362	512	1		1	1	100
	Medium	512	1024					100
<i>BEDROCK</i>	Large/Very Large	1024	2048					100
	Bedrock	2048	> 2048					100
Total				50	50	100	100	100

Reachwide Channel materials (mm)	
D ₁₆ =	Silt/Clay
D ₃₅ =	Silt/Clay
D ₅₀ =	21.90
D ₈₄ =	101.21
D ₉₅ =	165.29
D ₁₀₀ =	512.00

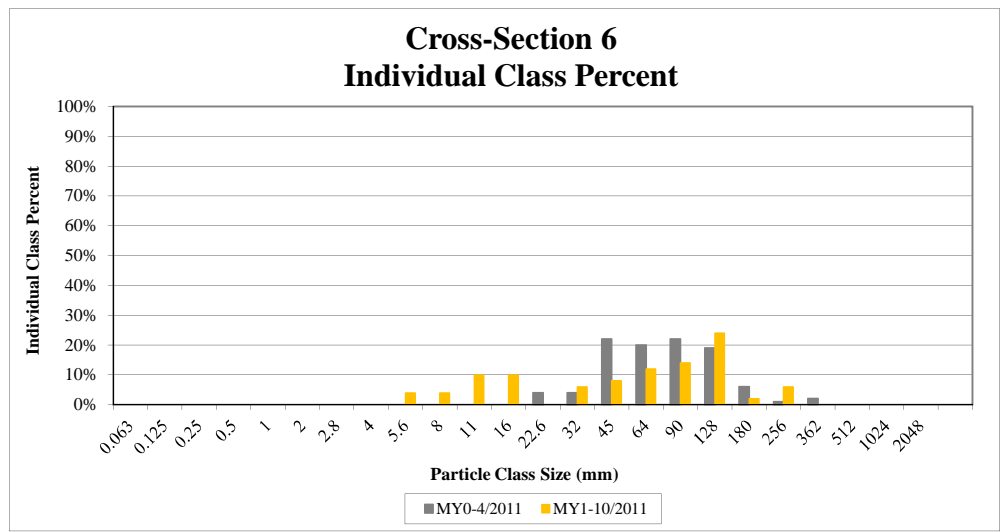
Appendix 4. Morphological Summary Data and Plots
Figure 6e. Reachwide and Cross-Section Substrate Plots
Scaly Bark Creek Mitigation Site (EEP Project No. 94148)
Scaly Bark Reach 2, Cross-Section 6 (Riffle)
Monitoring Year 1 of 5

Particle Class		Diameter (mm)		Particle Count Total	Cross-Section 6 Summary	
		min	max		Class Percentage	Percent Cumulative
<i>SILT/CLAY</i>	Silt/Clay	0.000	0.062			0
SAND	Very fine	0.062	0.125			0
	Fine	0.125	0.250			0
	Medium	0.250	0.500			0
	Coarse	0.5	1.0			0
	Very Coarse	1.0	2.0			0
GRAVEL	Very Fine	2.0	2.8			0
	Very Fine	2.8	4.0			0
	Fine	4.0	5.7	4	4	4
	Fine	5.7	8.0	4	4	8
	Medium	8.0	11.3	10	10	18
	Medium	11.3	16.0	10	10	28
	Coarse	16.0	22.6			28
	Coarse	22.6	32	6	6	34
	Very Coarse	32	45	8	8	42
Very Coarse	45	64	12	12	54	
COBBLE	Small	64	90	14	14	68
	Small	90	128	24	24	92
	Large	128	180	2	2	94
	Large	180	256	6	6	100
BOULDER	Small	256	362			100
	Small	362	512			100
	Medium	512	1024			100
	Large/Very Large	1024	2048			100
<i>BEDROCK</i>	Bedrock	2048	>2048			100
Total				100	100	100

Cross-Section 6 Channel materials (mm)	
D ₁₆ =	10.32
D ₃₅ =	33.39
D ₅₀ =	56.91
D ₈₄ =	113.82
D ₉₅ =	190.88
D ₁₀₀ =	256.00

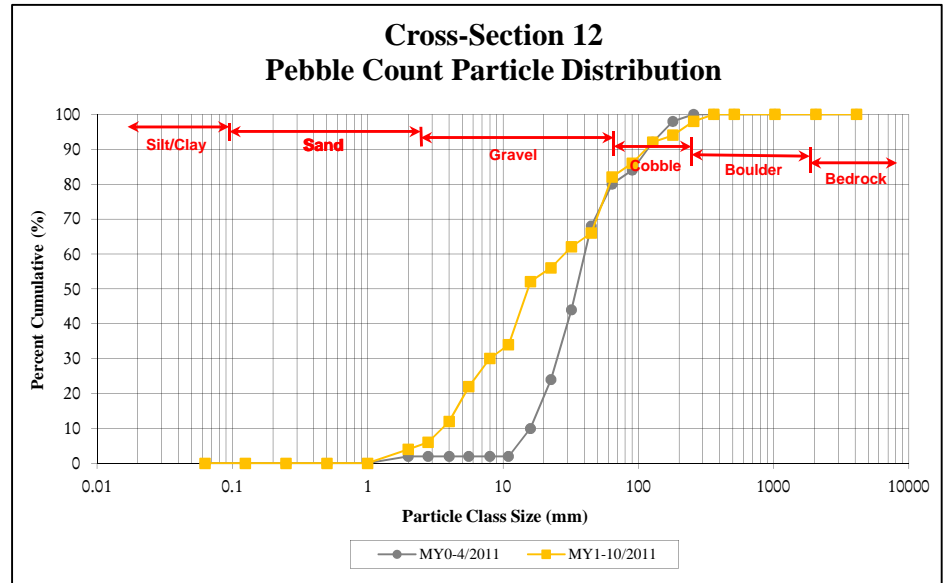
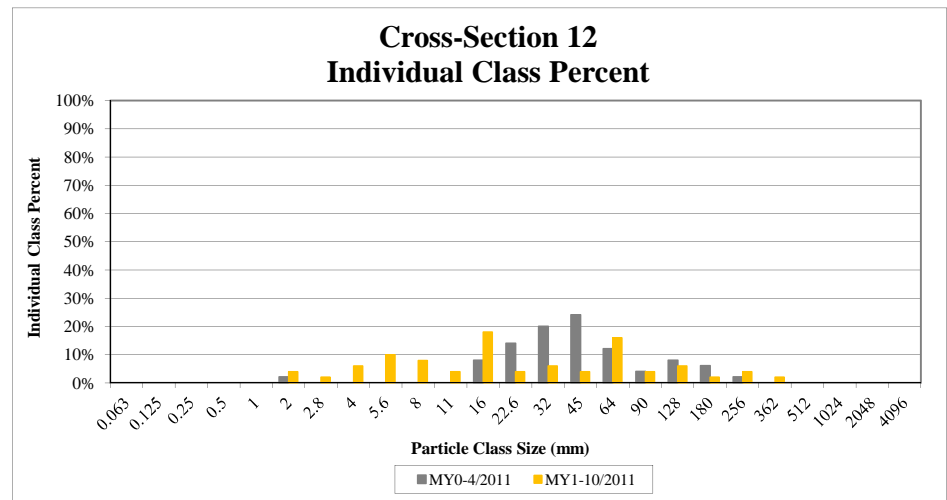
Appendix 4. Morphological Summary Data and Plots
Figure 6j. Reachwide and Cross-Section Substrate Plots
Scaly Bark Creek Mitigation Site (EEP Project No. 94148)
UT2, Cross-Section 12 (Riffle)
Monitoring Year 1 of 5

Particle Class		Diameter (mm)		Particle Count	Cross-Section 12 Summary		
		min	max		Class Percentage	Percent Cumulative	
<i>SILT/CLAY</i>		Silt/Clay	0.000	0.062			0
<i>SAND</i>	Very fine	0.062	0.125				0
	Fine	0.125	0.250				0
	Medium	0.250	0.500				0
	Coarse	0.5	1.0				0
	Very Coarse	1.0	2.0	4	4		4
<i>GRAVEL</i>	Very Fine	2.0	2.8	2	2		6
	Very Fine	2.8	4.0	6	6		12
	Fine	4.0	5.7	10	10		22
	Fine	5.7	8.0	8	8		30
	Medium	8.0	11.3	4	4		34
	Medium	11.3	16.0	18	18		52
	Coarse	16.0	22.6	4	4		56
	Coarse	22.6	32	6	6		62
	Very Coarse	32	45	4	4		66
	Very Coarse	45	64	16	16		82
<i>COBBLE</i>	Small	64	90	4	4		86
	Small	90	128	6	6		92
	Large	128	180	2	2		94
	Large	180	256	4	4		98
<i>BOULDER</i>	Small	256	362	2	2		100
	Small	362	512				100
	Medium	512	1024				100
	Large/Very Large	1024	2048				100
<i>BEDROCK</i>	Bedrock	2048	>2048				100
Total				100	100	100

Cross-Section 12 Channel materials (mm)	
D ₁₆ =	4.58
D ₃₅ =	11.23
D ₅₀ =	15.35
D ₈₄ =	75.89
D ₉₅ =	196.57
D ₁₀₀ =	362.00
