SCALY BARK CREEK MITIGATION SITE
Stanly County, NC
DENR Contract 002030
EEP Project Number 94148

Monitoring Year 2 Annual Report
FINAL

**SCALY BARK CREEK MITIGATION SITE
Monitoring Year 2 Annual Report**

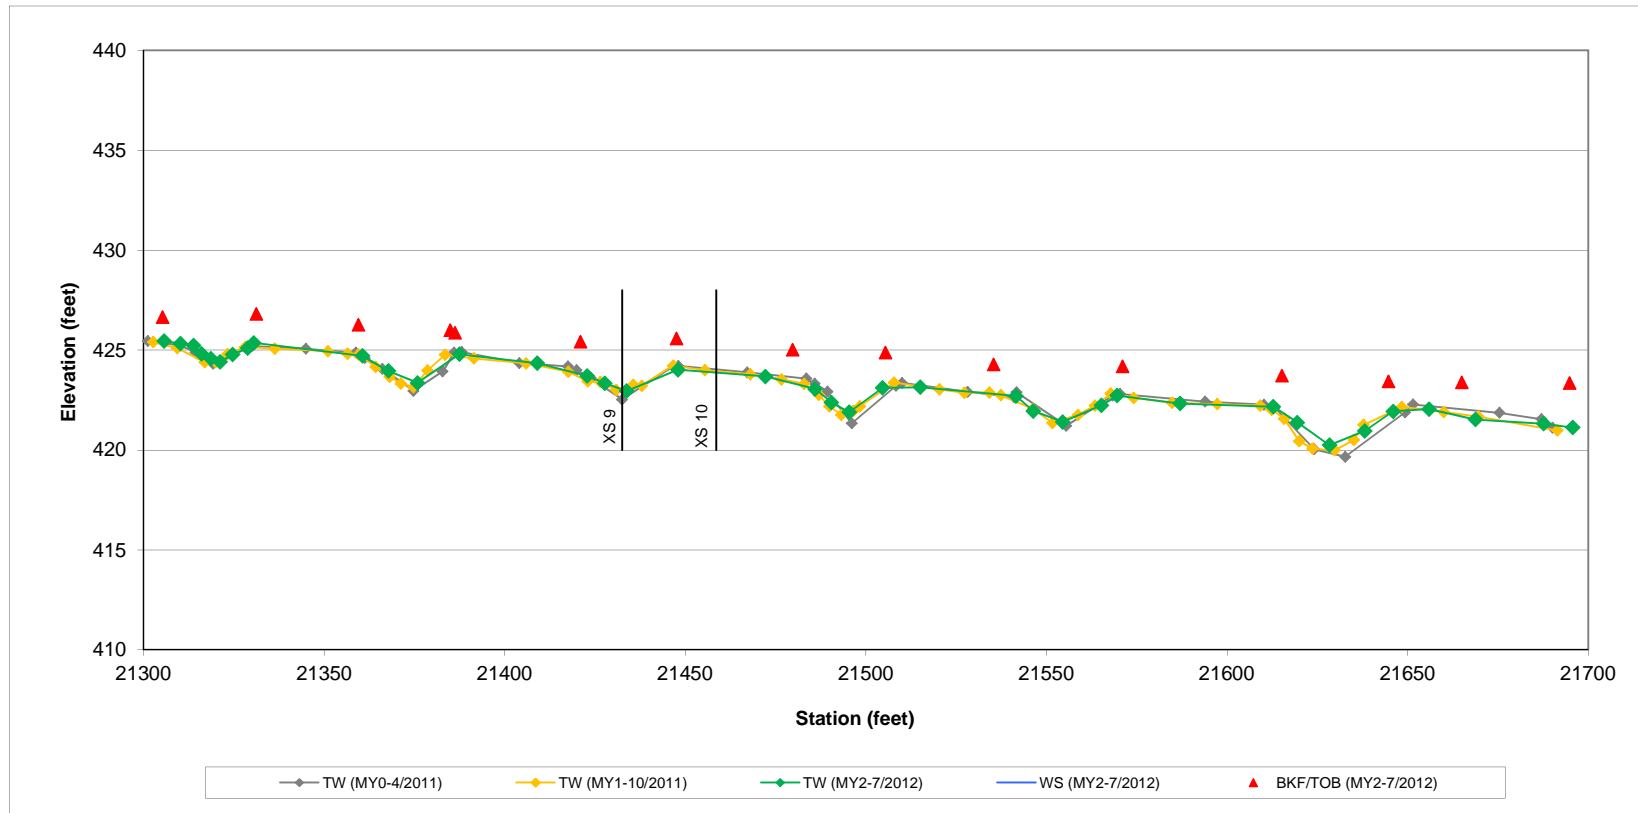
Appendix 4. Morphological Summary Data and Plots
Figure 4c. Longitudinal Profile Plots
Scaly Bark Creek Mitigation Site (EEP Project No. 94148)
UT1 Reach 2
Monitoring Year 2

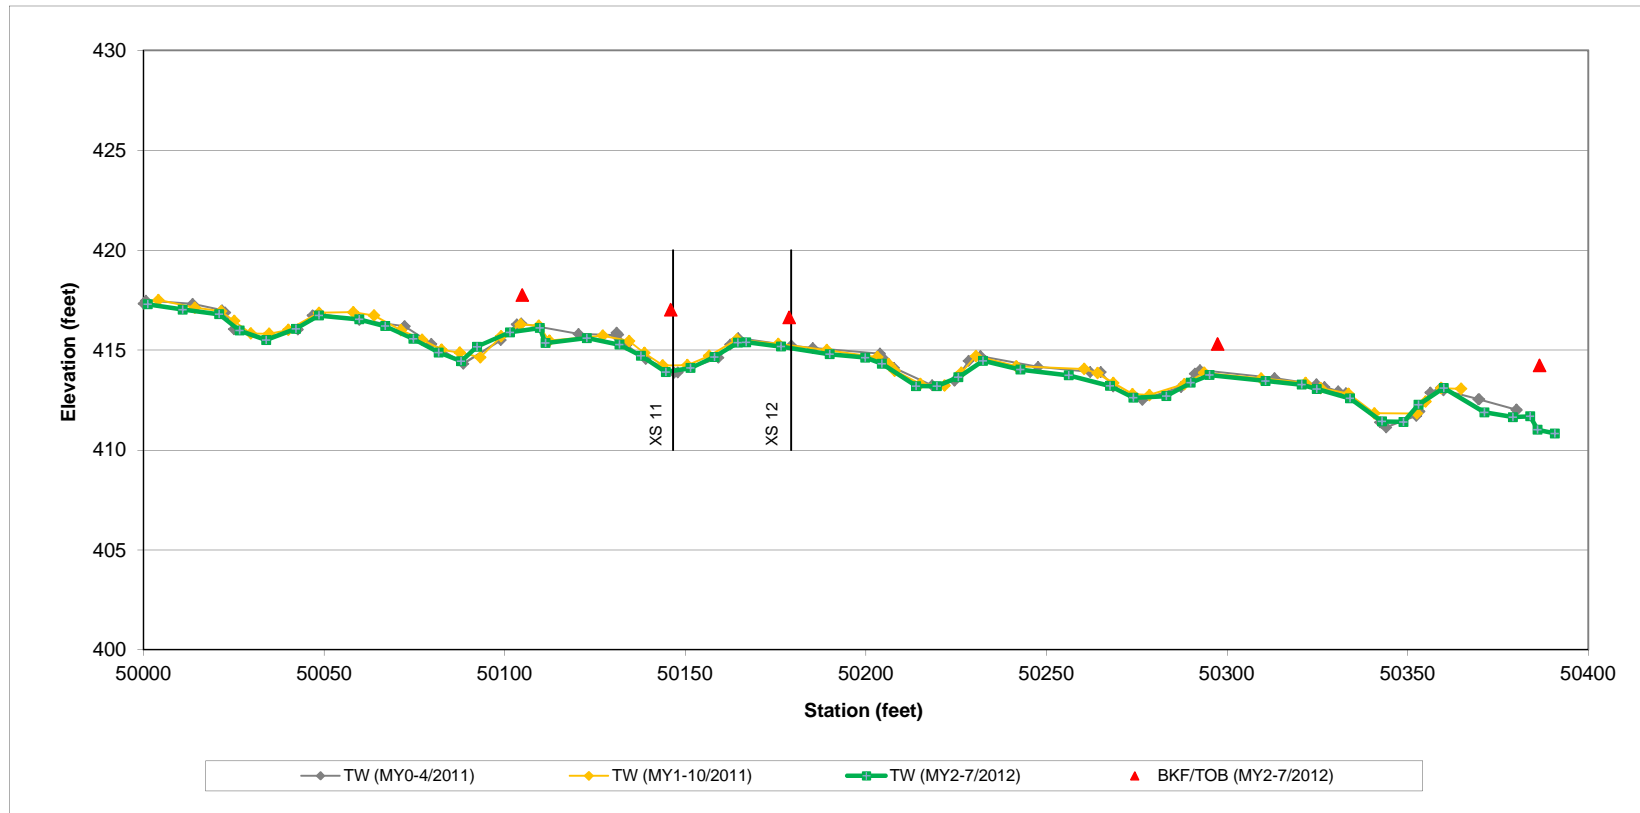
Appendix 4. Morphological Summary Data and Plots
Figure 4d. Longitudinal Profile Plots
Scaly Bark Creek Mitigation Site (EEP Project No. 94148)
UT2
Monitoring Year 2

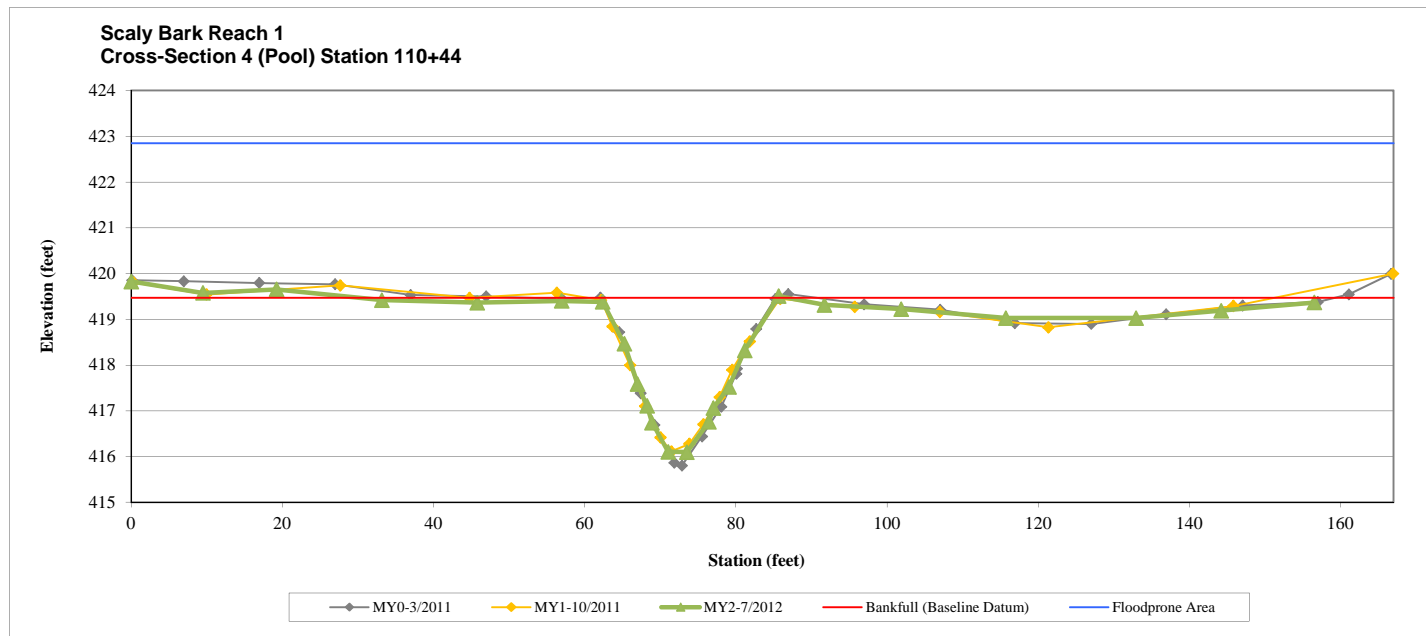
Appendix 4. Morphological Summary Data and Plots
Figure 5d. Cross-Section Plots
Scaly Bark Creek Mitigation Site (EEP Project No. 94148)
Scaly Bark Reach 1, Cross-Section 4 (Pool)
Monitoring Year 2

Summary Data	
Bankfull Elevation (ft)	419.47
Bankfull Cross-Sectional Area (ft²)	43.90
Bankfull Width (ft)	23.52
Flood Prone Area Elevation (ft)	n/a
Flood Prone Width (ft)	n/a
Max Depth at Bankfull (ft)	3.38
Mean Depth at Bankfull (ft)	1.87
W/D Ratio	12.59
Entrenchment Ratio	n/a
Bank Height Ratio	1.00
Stream Type	n/a

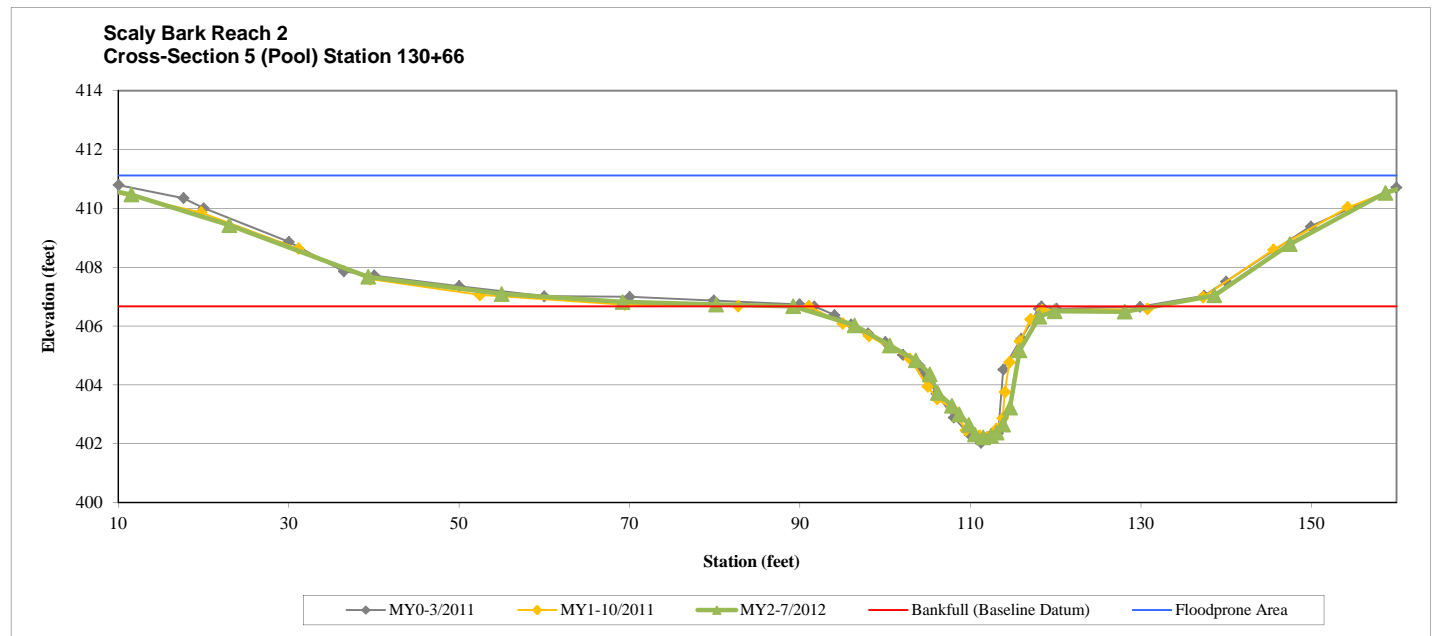
Appendix 4. Morphological Summary Data and Plots
Figure 5e. Cross-Section Plots
Scaly Bark Creek Mitigation Site (EEP Project No. 94148)
Scaly Bark Reach 2, Cross-Section 5 (Pool)
Monitoring Year 2

Summary Data	
Bankfull Elevation (ft)	406.67
Bankfull Cross-Sectional Area (ft2)	55.28
Bankfull Width (ft)	30.69
Flood Prone Area Elevation (ft)	n/a
Flood Prone Width (ft)	n/a
Max Depth at Bankfull (ft)	4.46
Mean Depth at Bankfull (ft)	1.80
W/D Ratio	17.04
Entrenchment Ratio	n/a
Bank Height Ratio	1.00
Stream Type	n/a

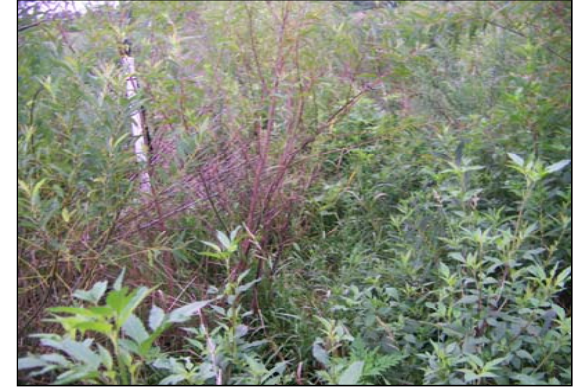
Cross-Section 10: View Downstream (7/25/2012)

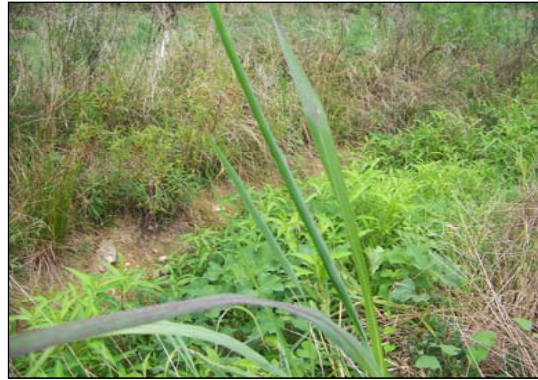
Cross-Section 11: View Upstream (7/25/2012)

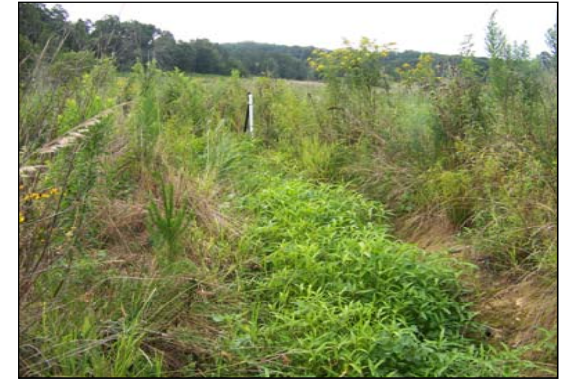
Cross-Section 11: View Downstream (7/25/2012)

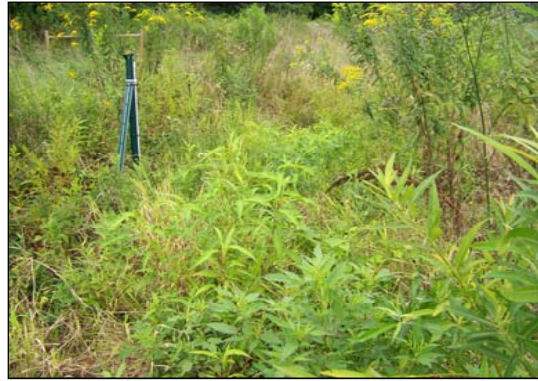
Cross-Section 12: View Upstream (7/25/2012)

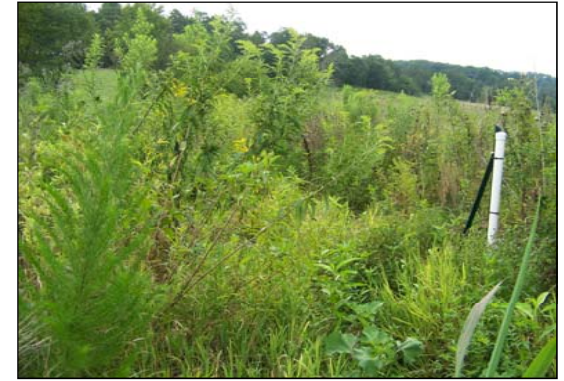
Cross-Section 12: View Downstream (7/25/2012)

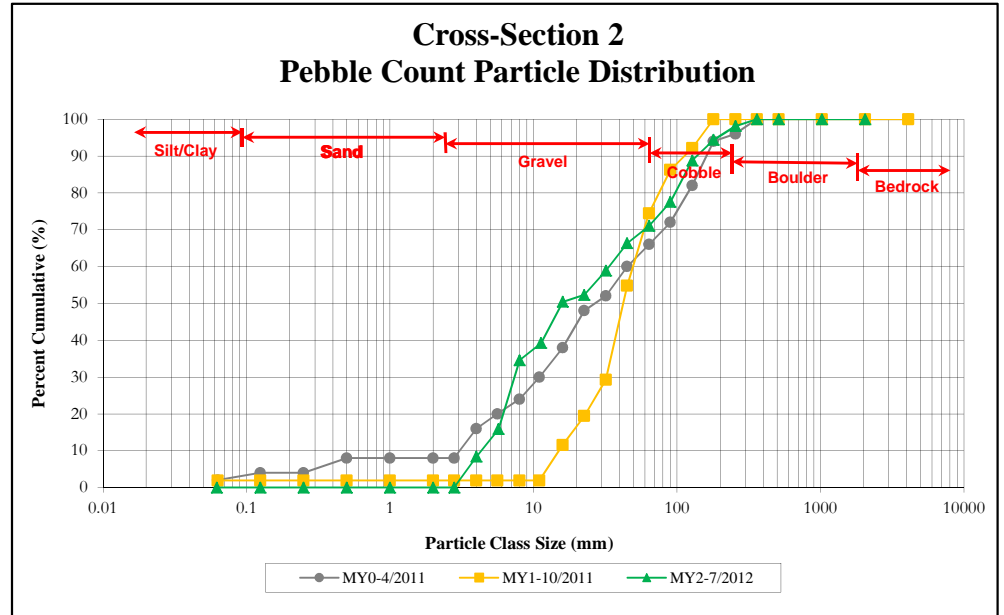
Appendix 4. Morphological Summary Data and Plots
Figure 6b. Reachwide and Cross-Section Substrate Plots
Scaly Bark Creek Mitigation Site (EEP Project No. 94148)
Scaly Bark Creek Reach 1, Cross-Section 2 (Riffle)
Monitoring Year 2

Particle Class		Diameter (mm)		Particle Count Total	Cross-Section 2 Summary	
		min	max		Class Percentage	Percent Cumulative
<i>SILT/CLAY</i>	Silt/Clay	0.000	0.062			0
<i>SAND</i>	Very fine	0.062	0.125			0
	Fine	0.125	0.250			0
	Medium	0.250	0.500			0
	Coarse	0.5	1.0			0
	Very Coarse	1.0	2.0			0
<i>GRAVEL</i>	Very Fine	2.0	2.8			0
	Very Fine	2.8	4.0			0
	Fine	4.0	5.7	9	8	8
	Fine	5.7	8.0	8	7	16
	Medium	8.0	11.3	20	19	35
	Medium	11.3	16.0	5	5	39
	Coarse	16.0	22.6	12	11	50
	Coarse	22.6	32	2	2	52
	Very Coarse	32	45	7	7	59
Very Coarse	45	64	8	7	66	
<i>COBBLE</i>	Small	64	90	5	5	71
	Small	90	128	7	7	78
	Large	128	180	12	11	89
	Large	180	256	6	6	94
<i>BOULDER</i>	Small	256	362	4	4	98
	Small	362	512	2	2	100
	Medium	512	1024			100
	Large/Very Large	1024	2048			100
<i>BEDROCK</i>	Bedrock	2048	>2048			100
Total				107	100	100

Cross-Section 2 Channel materials (mm)	
D ₁₆ =	8.02
D ₃₅ =	11.38
D ₅₀ =	22.28
D ₈₄ =	155.63
D ₉₅ =	270.83
D ₁₀₀ =	512.00

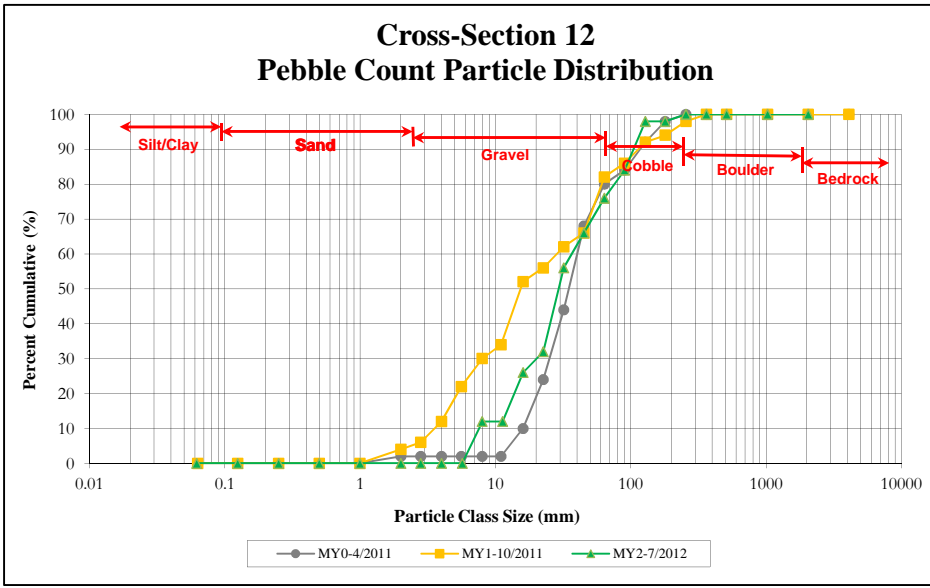
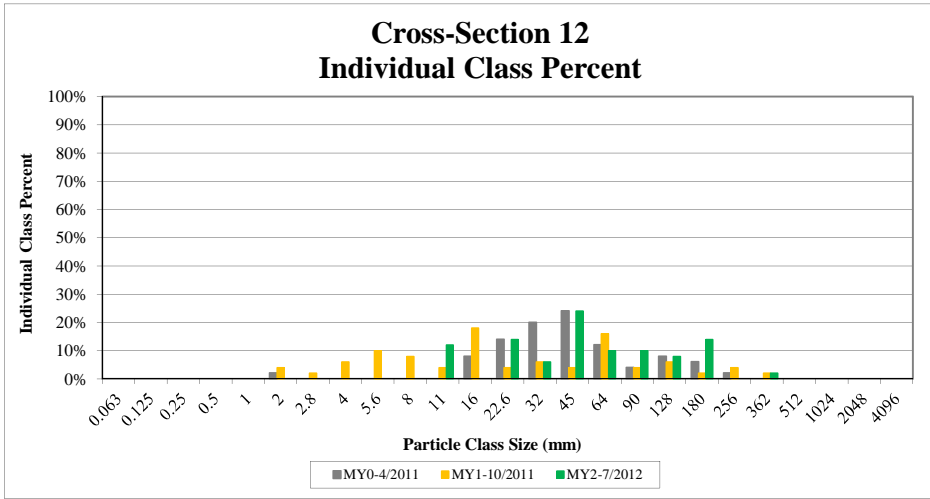
Appendix 4. Morphological Summary Data and Plots
Figure 6j. Reachwide and Cross-Section Substrate Plots
Scaly Bark Creek Mitigation Site (EEP Project No. 94148)
UT2, Cross-Section 12 (Riffle)
Monitoring Year 2

Particle Class		Diameter (mm)		Particle Count	Cross-Section 12 Summary	
		min	max		Class Percentage	Percent Cumulative
SILT/CLAY		Silt/Clay				0
SAND	Very fine	0.062	0.125			0
	Fine	0.125	0.250			0
	Medium	0.250	0.500			0
	Coarse	0.5	1.0			0
	Very Coarse	1.0	2.0			0
GRAVEL	Very Fine	2.0	2.8			0
	Very Fine	2.8	4.0			0
	Fine	4.0	5.7			0
	Fine	5.7	8.0			0
	Medium	8.0	11.3	12	12	12
	Medium	11.3	16.0			12
	Coarse	16.0	22.6	14	14	26
	Coarse	22.6	32	6	6	32
	Very Coarse	32	45	24	24	56
	Very Coarse	45	64	10	10	66
COBBLE	Small	64	90	10	10	76
	Small	90	128	8	8	84
	Large	128	180	14	14	98
	Large	180	256			98
BOULDER	Small	256	362	2	2	100
	Small	362	512			100
	Medium	512	1024			100
	Large/Very Large	1024	2048			100
BEDROCK	Bedrock	2048	>2048			100
Total				100	100	100

Cross-Section 12 Channel materials (mm)	
D ₁₆ =	17.66
D ₃₅ =	33.39
D ₅₀ =	41.32
D ₈₄ =	128.00
D ₉₅ =	167.32
D ₁₀₀ =	362.00
