FINAL-As-Built Baseline Monitoring Report
Seniard Creek Mitigation Site

Henderson County
French Broad River Basin
Cataloging Unit # 06010105

NCDMS Project No. 100017

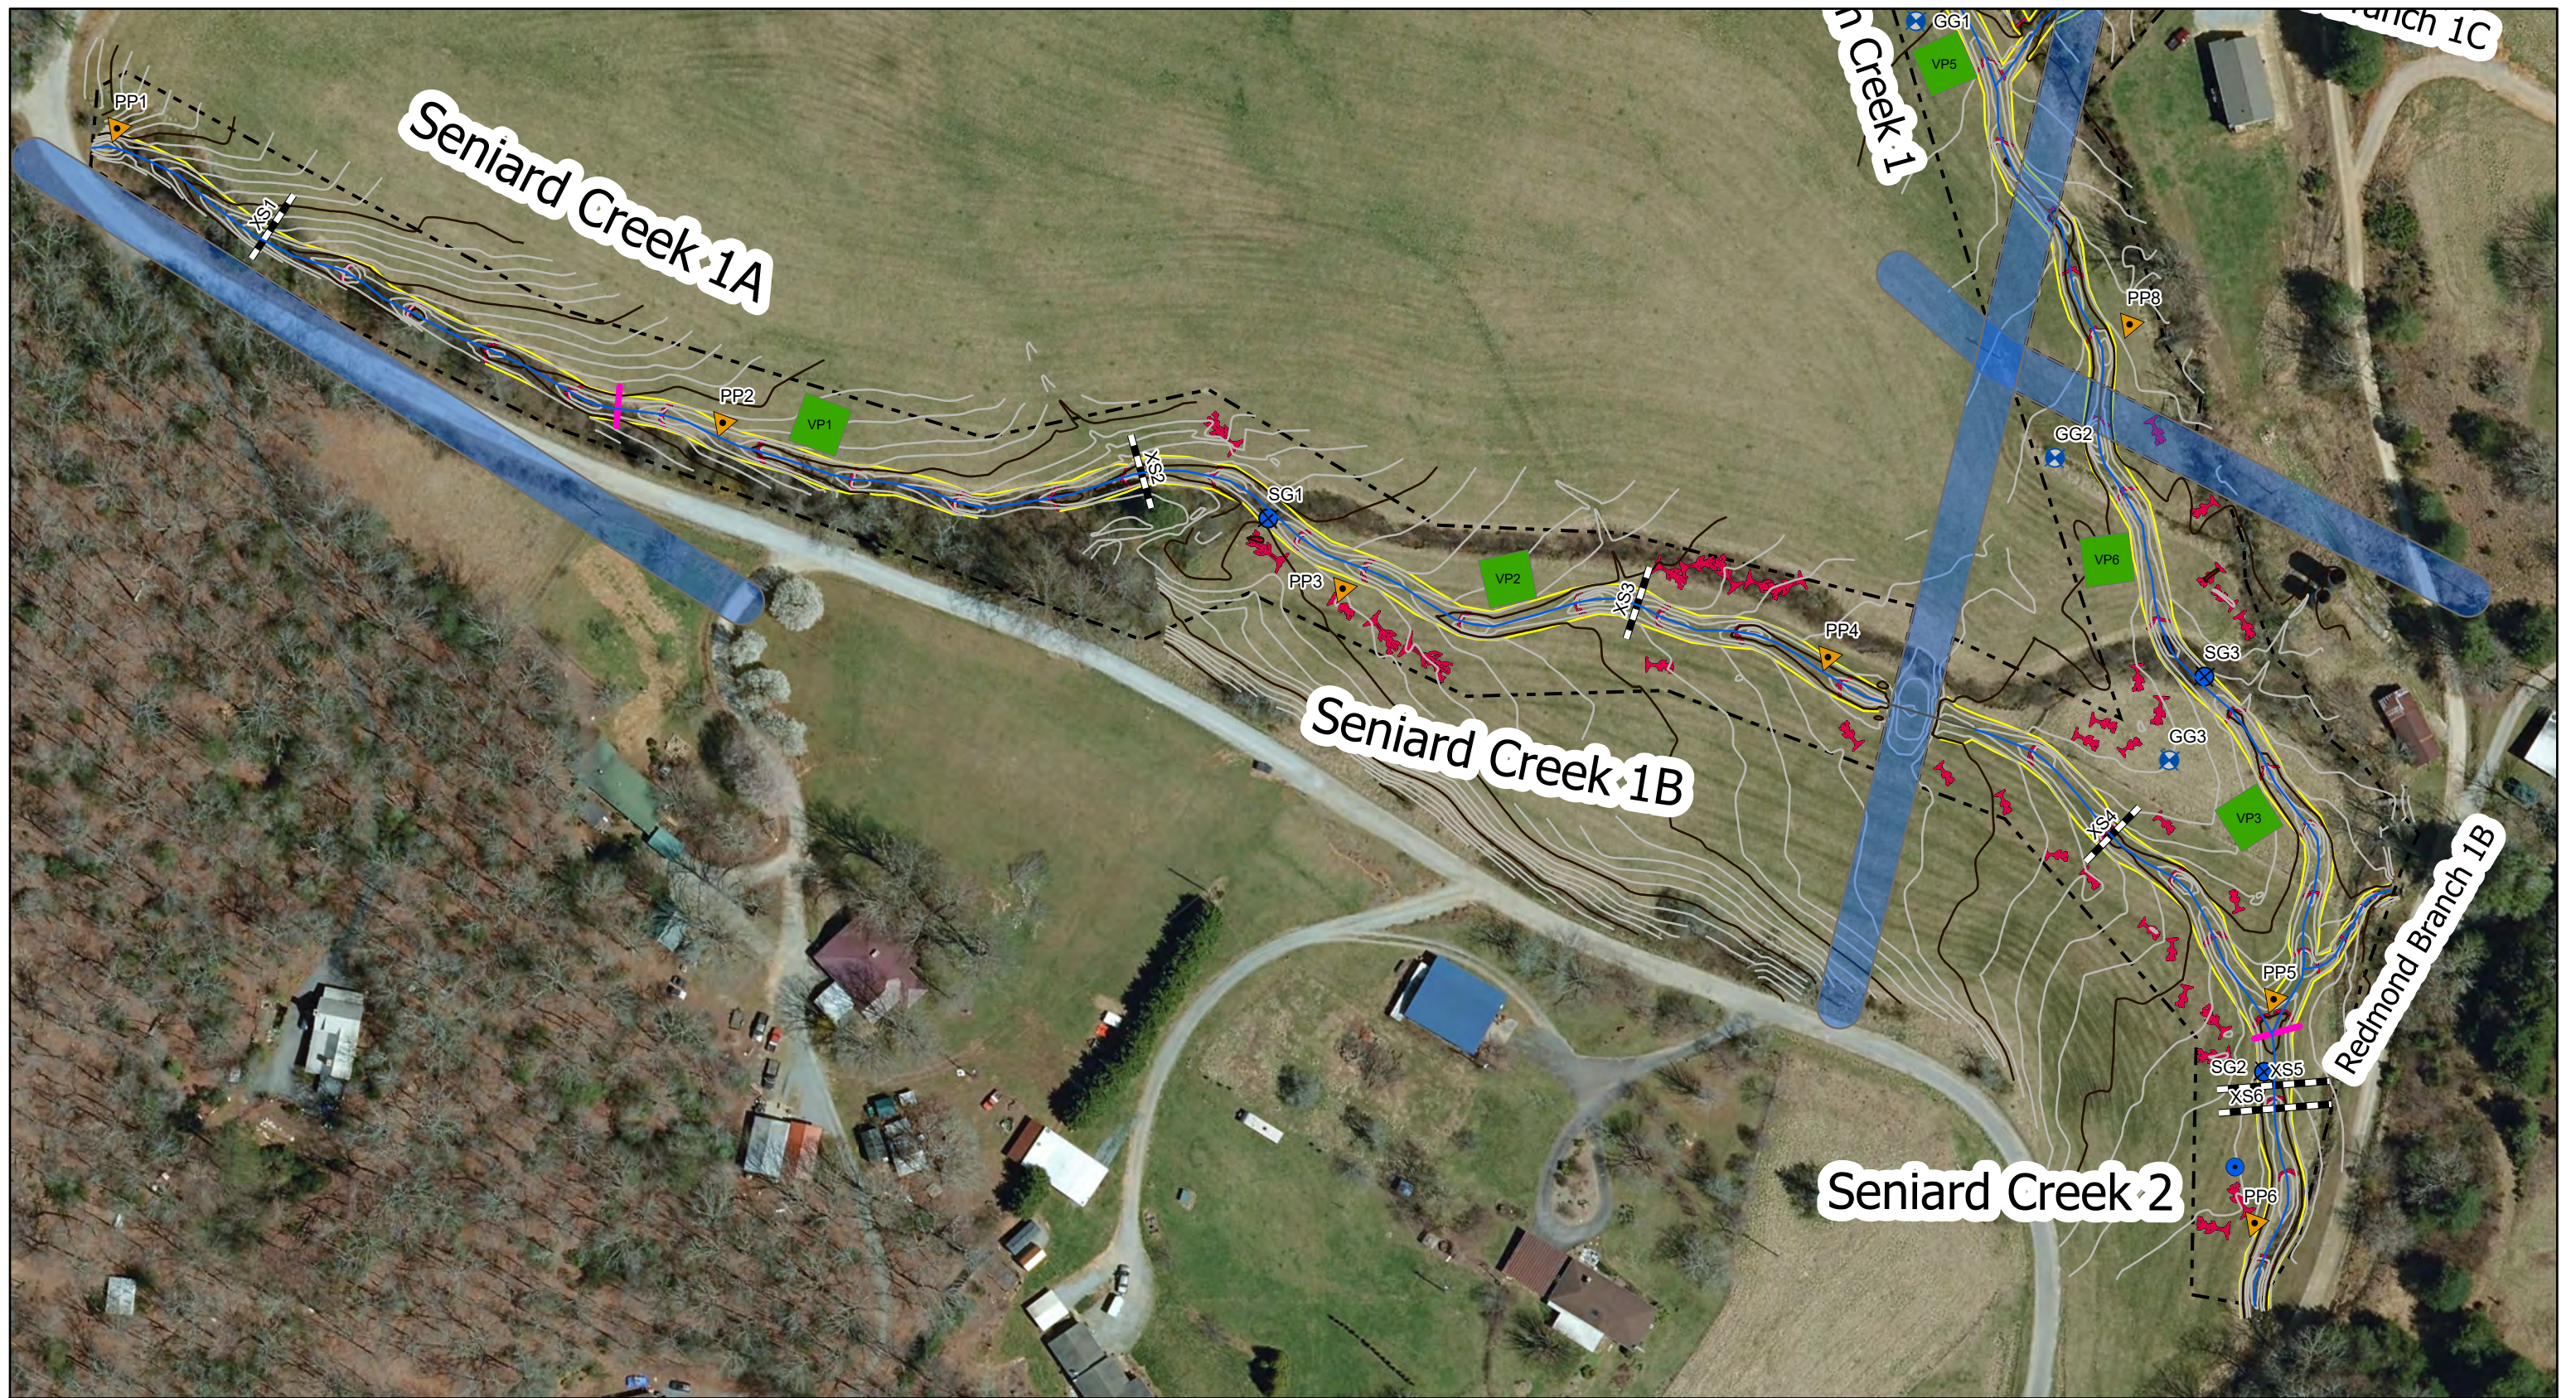
CCPV MY0
 Sheet 1
 Seniard Creek Stream Restoration Site
 Henderson Co., NC
 April 2021

As-Built Centerline
 Restoration Type
 Enhancement II
 Preservation
 Restoration
 NC

Reach Breaks
 Utility Easement
 Photo Station
 Continuous Stage Recorder
 Groundwater Gauge

Rain Gauge
 Cross Section
 Vegetation Plot
 Top of Bank
 Structures
 Conservation Easement

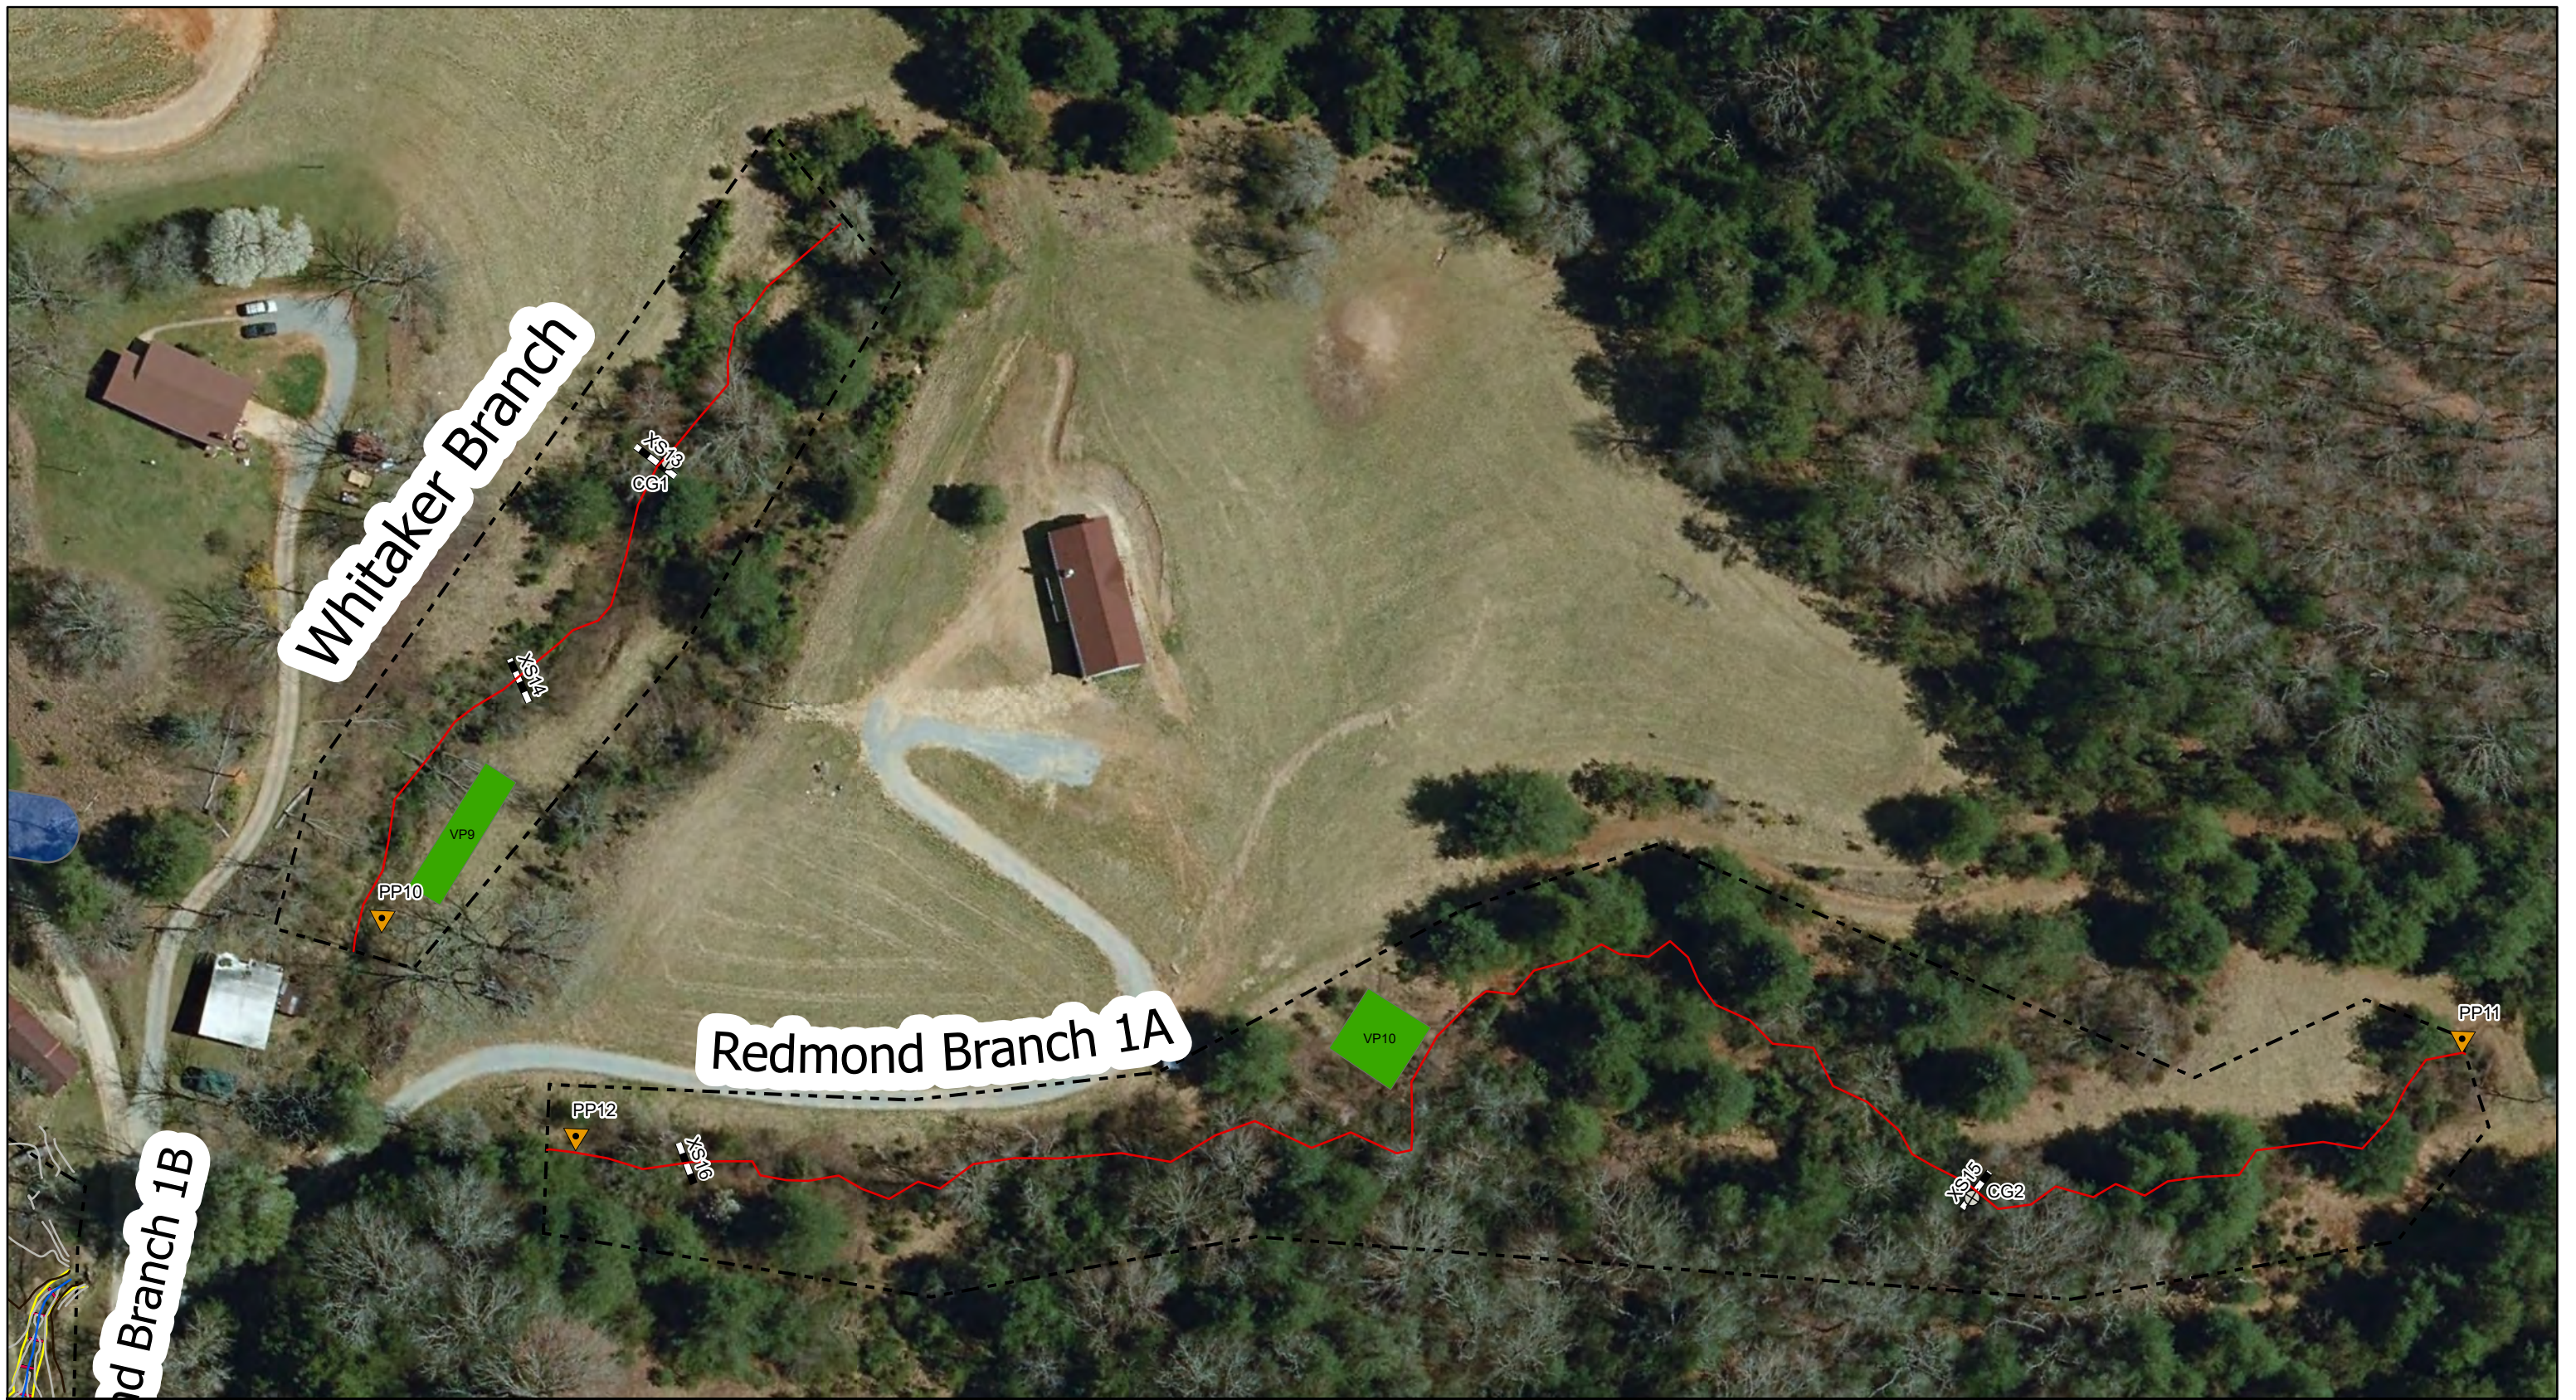
CCPV MY0
 Sheet 4
 Seniard Creek Stream Restoration Site
 Henderson Co., NC
 April 2021

As-Built Centerline
 Restoration Type
 — Enhancement II
 — Preservation
 — Restoration

— NC
 — Reach Breaks
 — Utility Easement
 ▲ Photo Station
 ⊕ Crest Gauge

— Cross Section
 ■ Vegetation Plot
 — Top of Bank
 — Structures
 - - - Conservation Easement

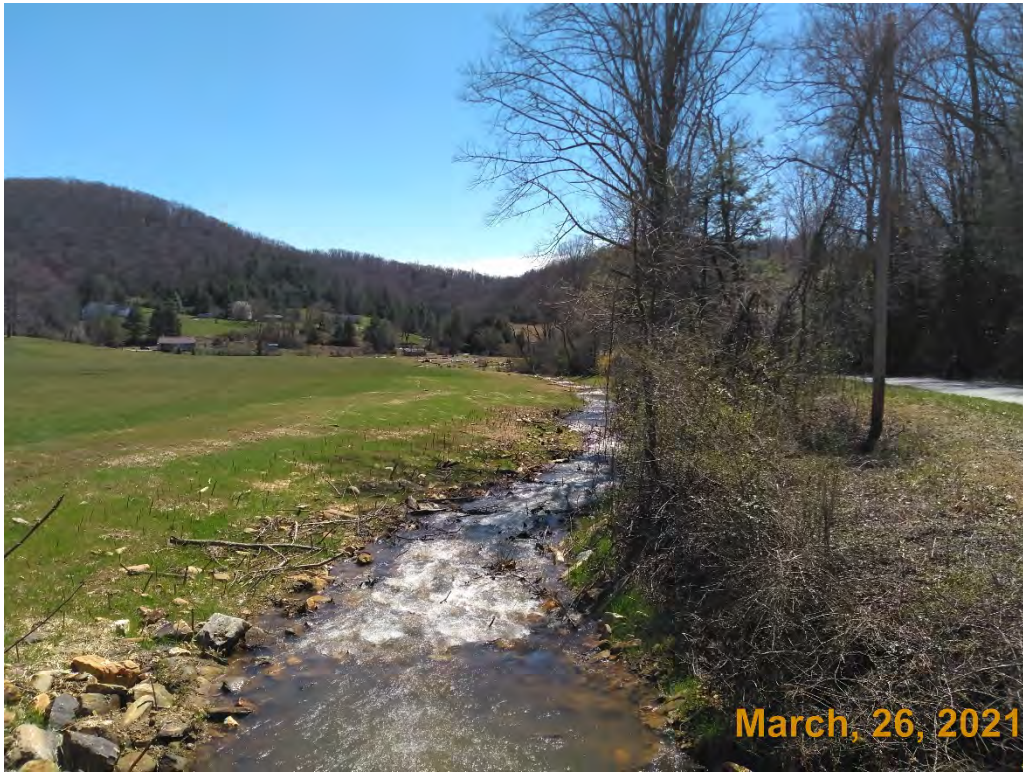
Photo Point 1. Facing downstream

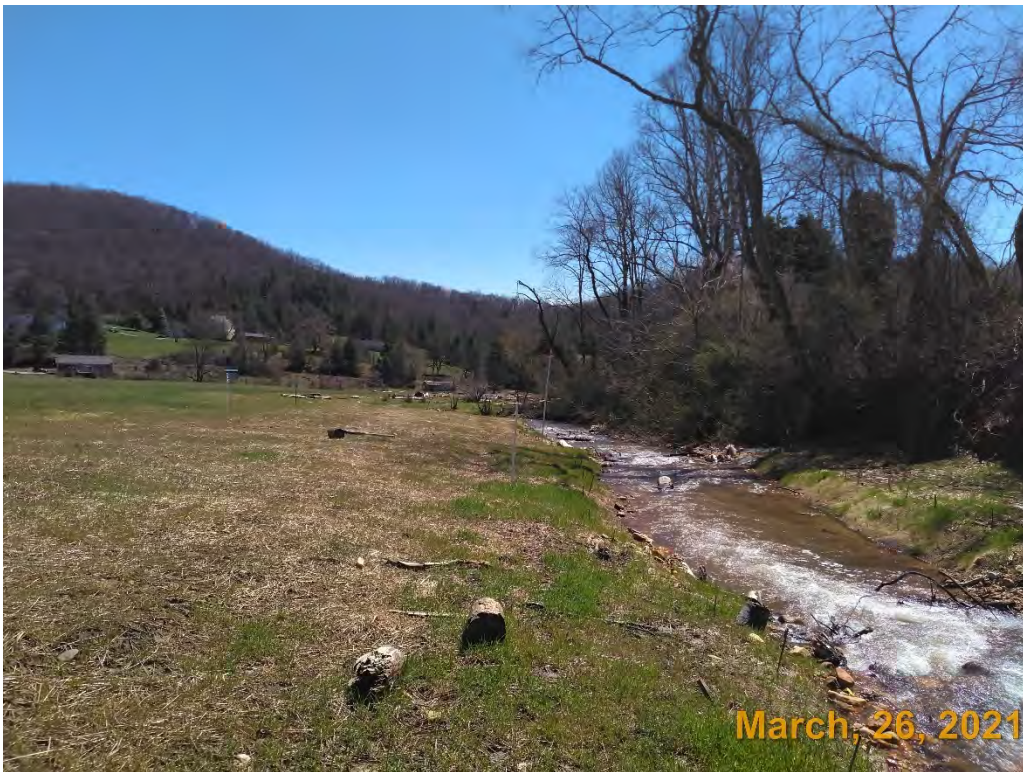
Photo Point 2. Facing downstream

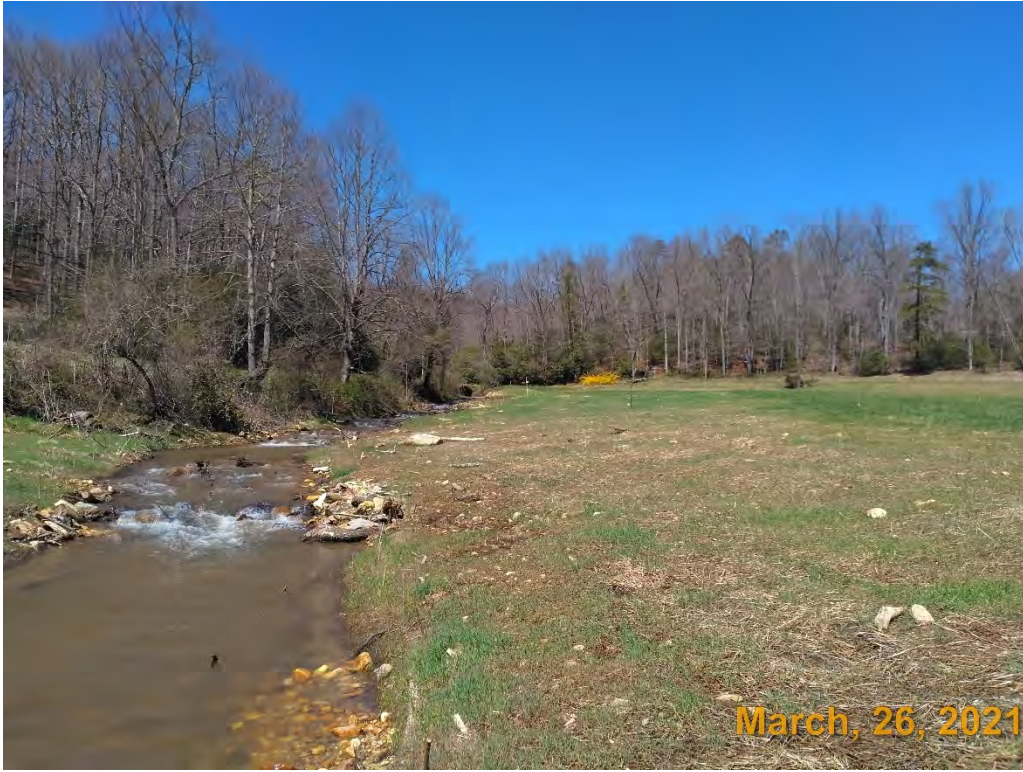
Photo Point 2. Facing upstream

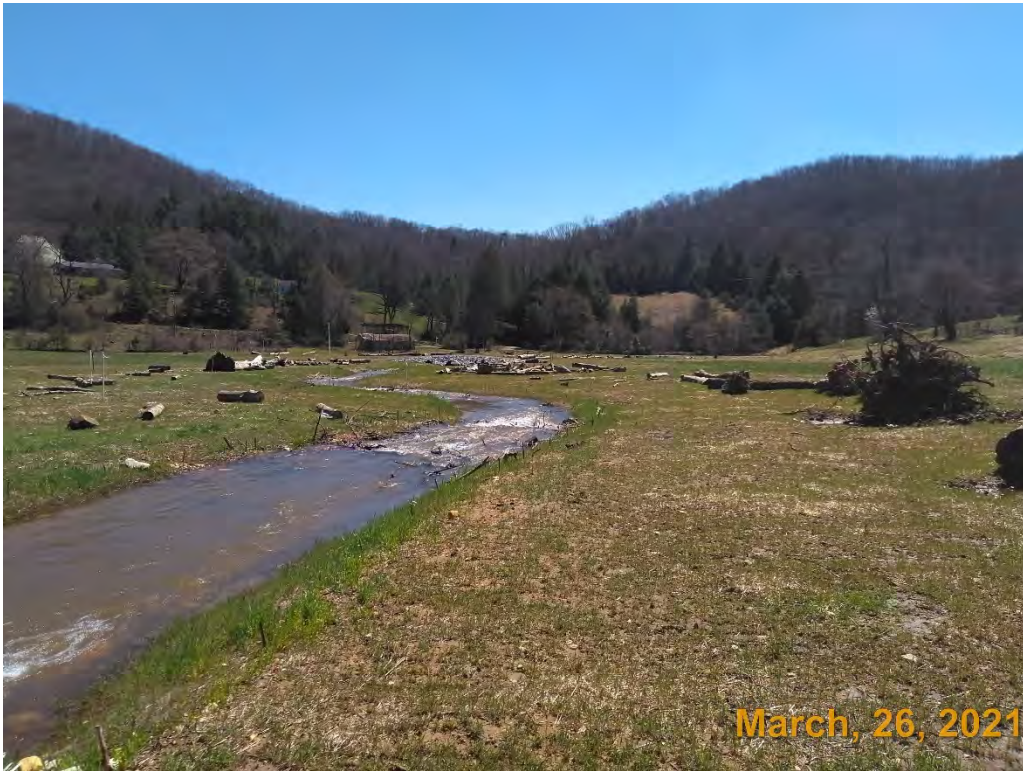
Photo Point 3. Facing downstream

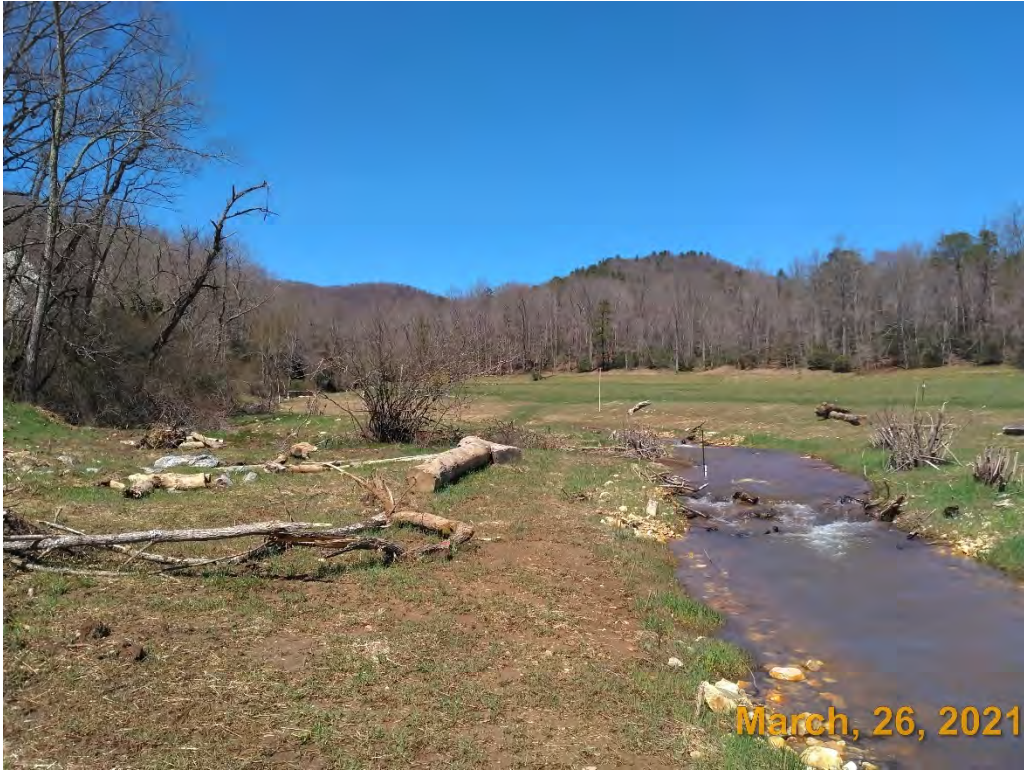
Photo Point 3. Facing upstream

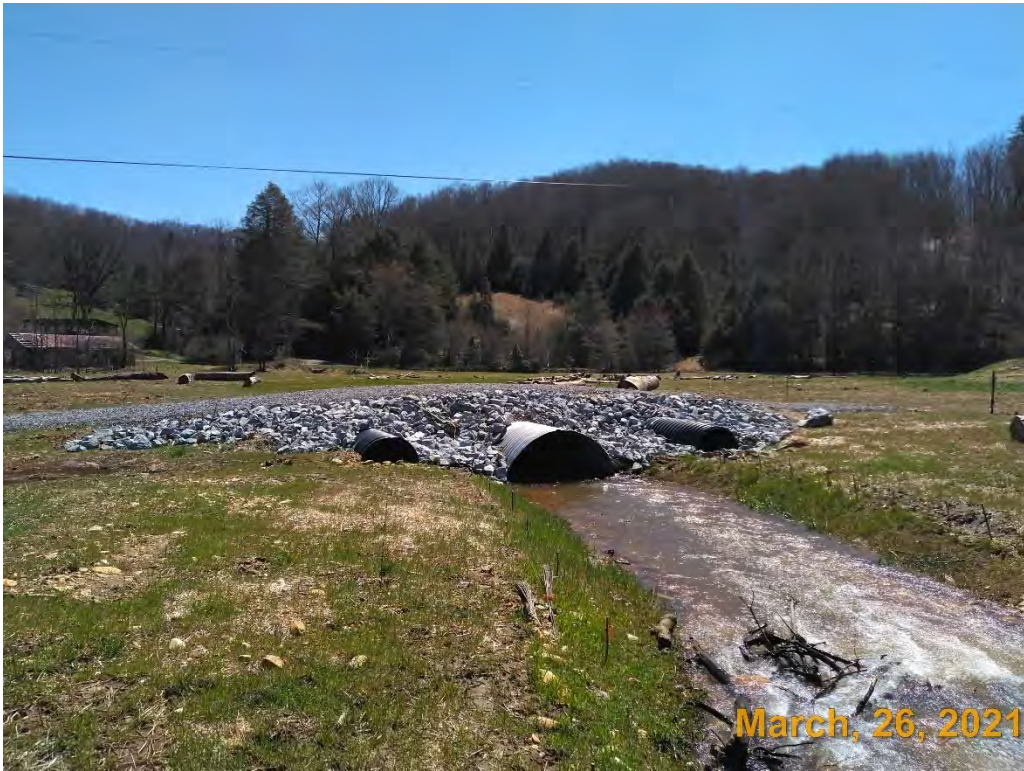
Photo Point 4. Facing downstream

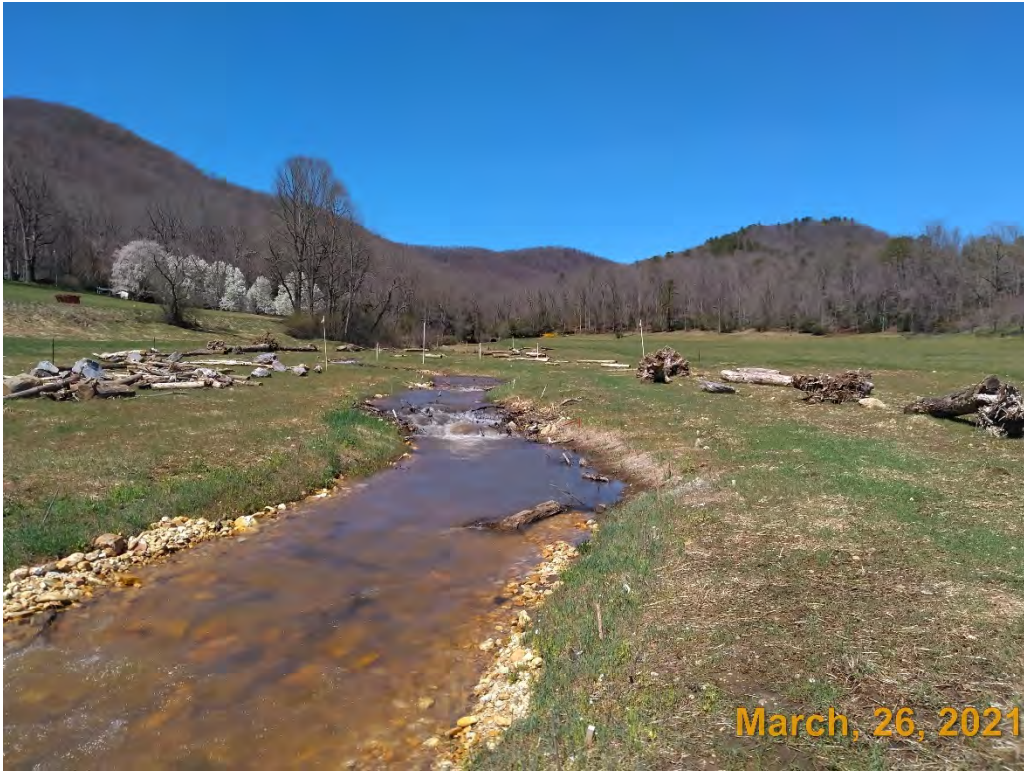
Photo Point 4. Facing upstream.

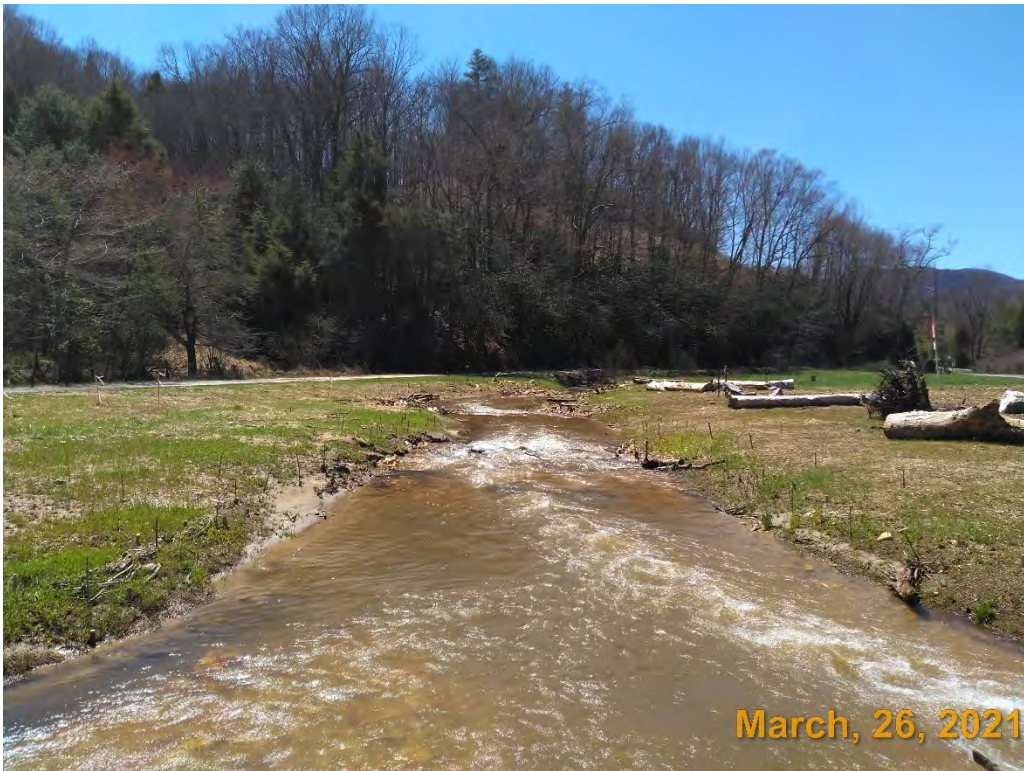
Photo Point 5. Facing downstream

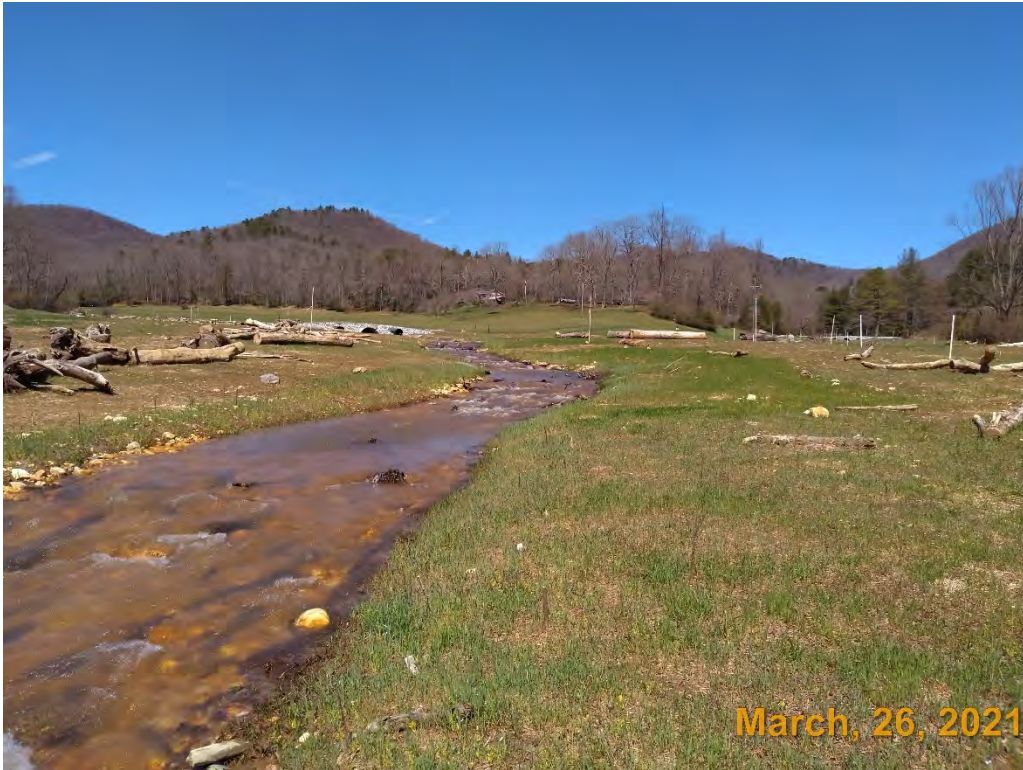
Photo Point 5. Facing upstream Seniard Creek

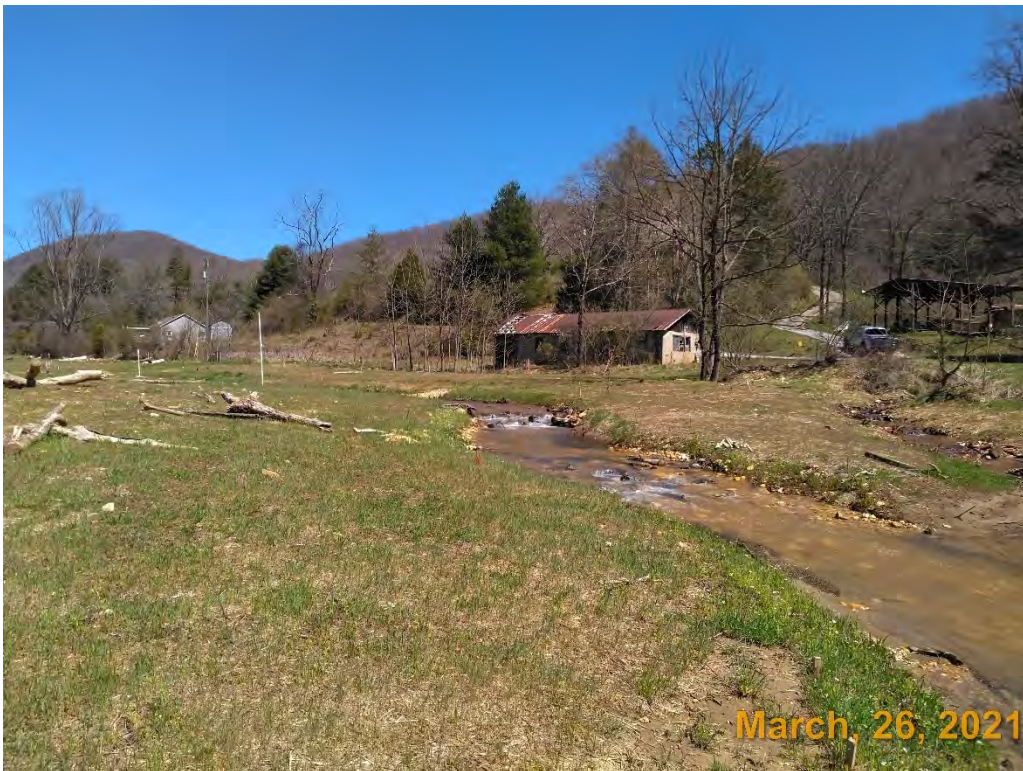
Photo Point 5. Facing upstream Sitton Creek and Redmond Br.

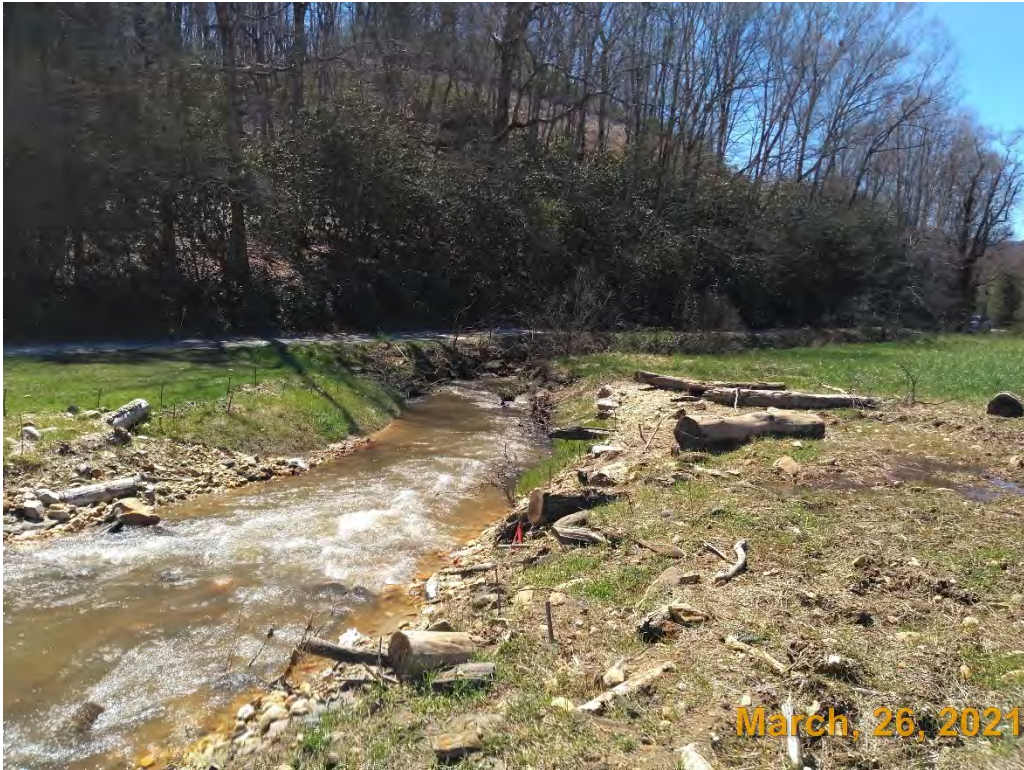
Photo Point 6. Facing downstream

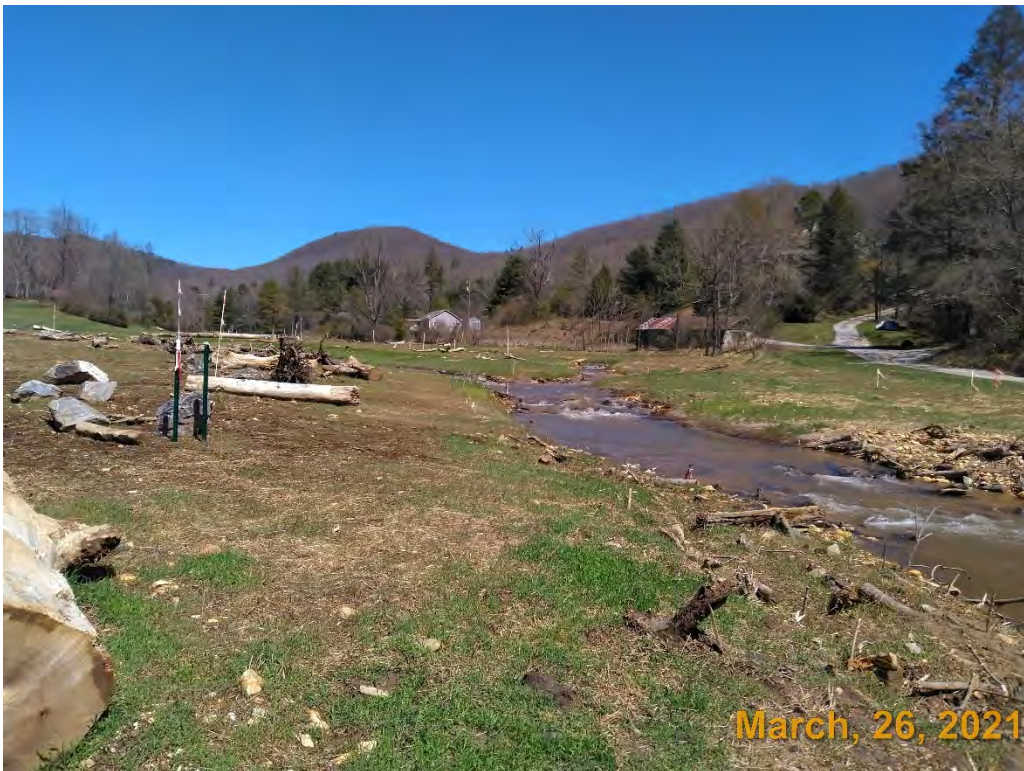
Photo Point 6. Facing upstream

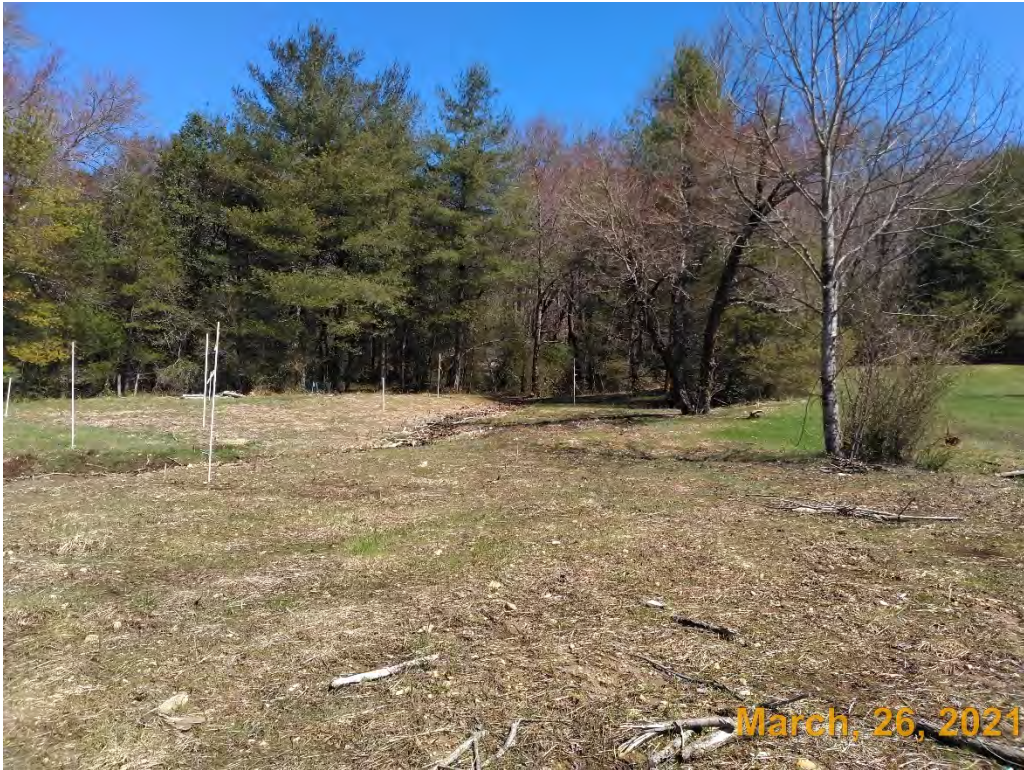
Photo Point 7. Facing upstream Lee Branch

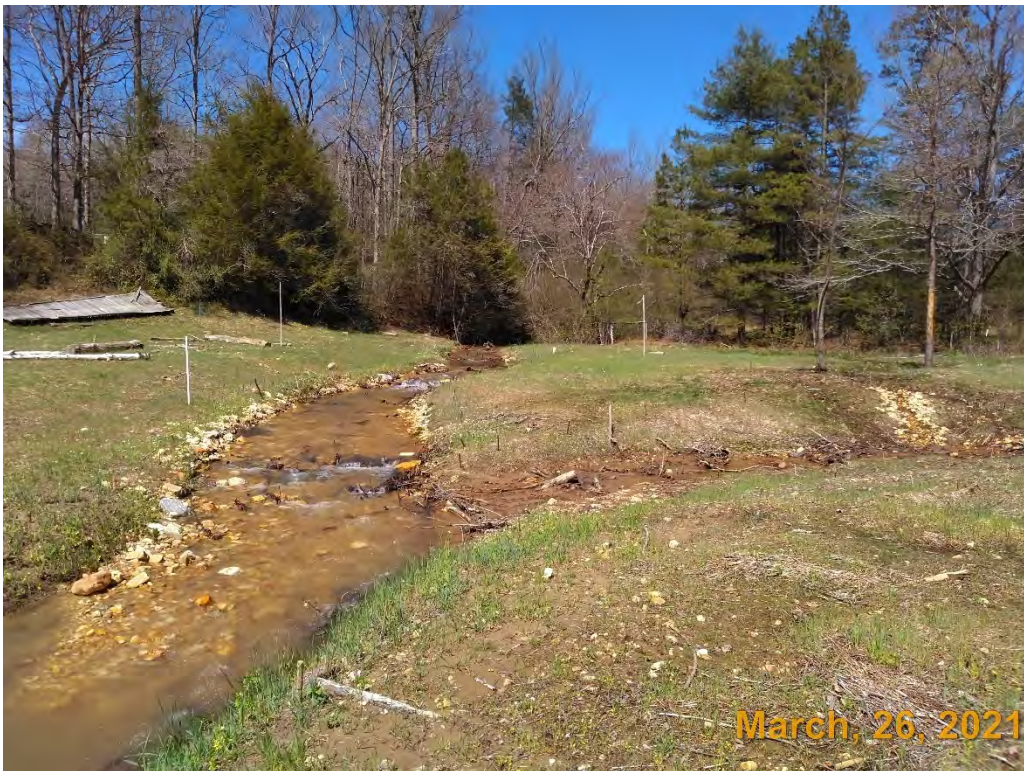
Photo Point 7. Facing upstream Sitton Creek

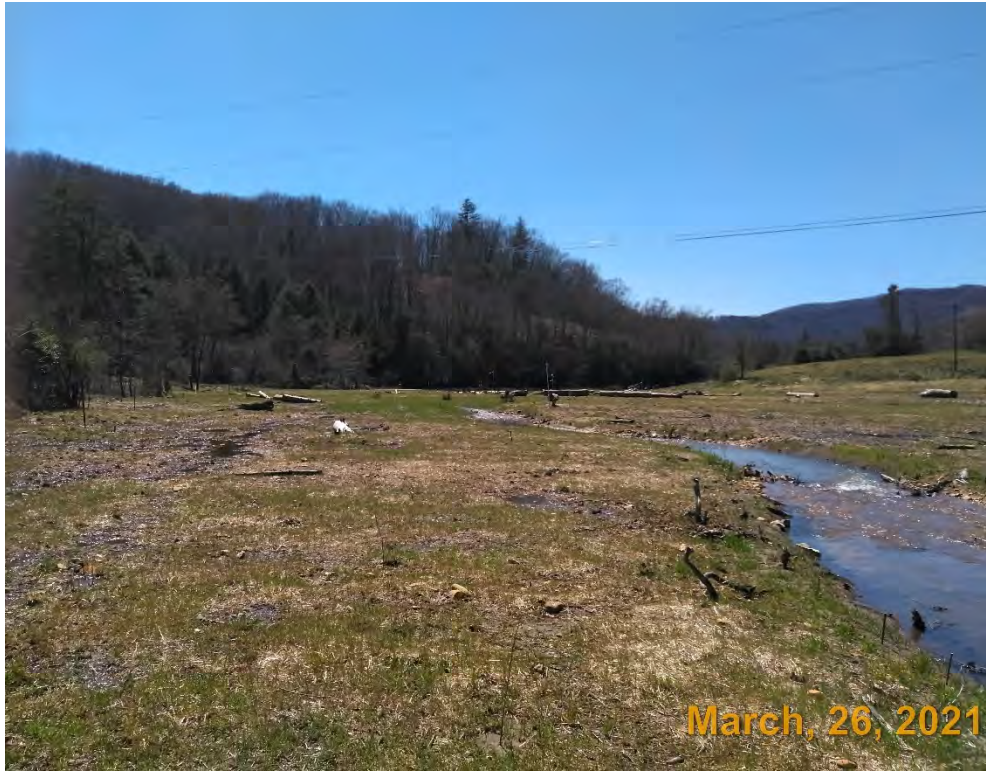
Photo Point 8. Facing downstream

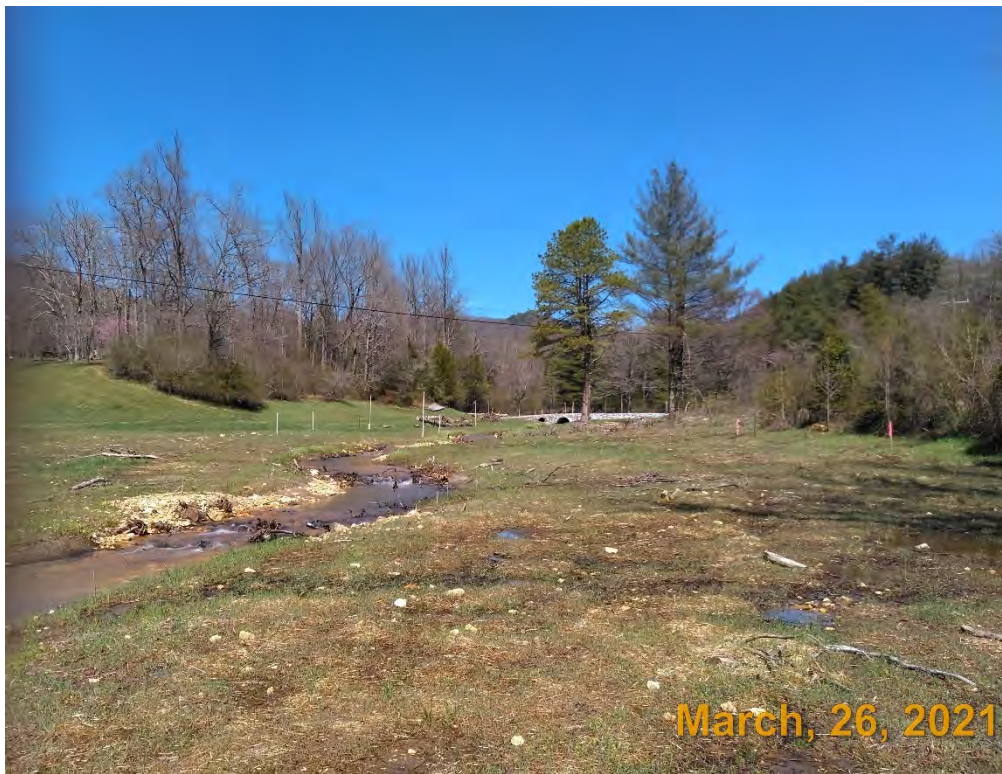
Photo Point 8. Facing upstream

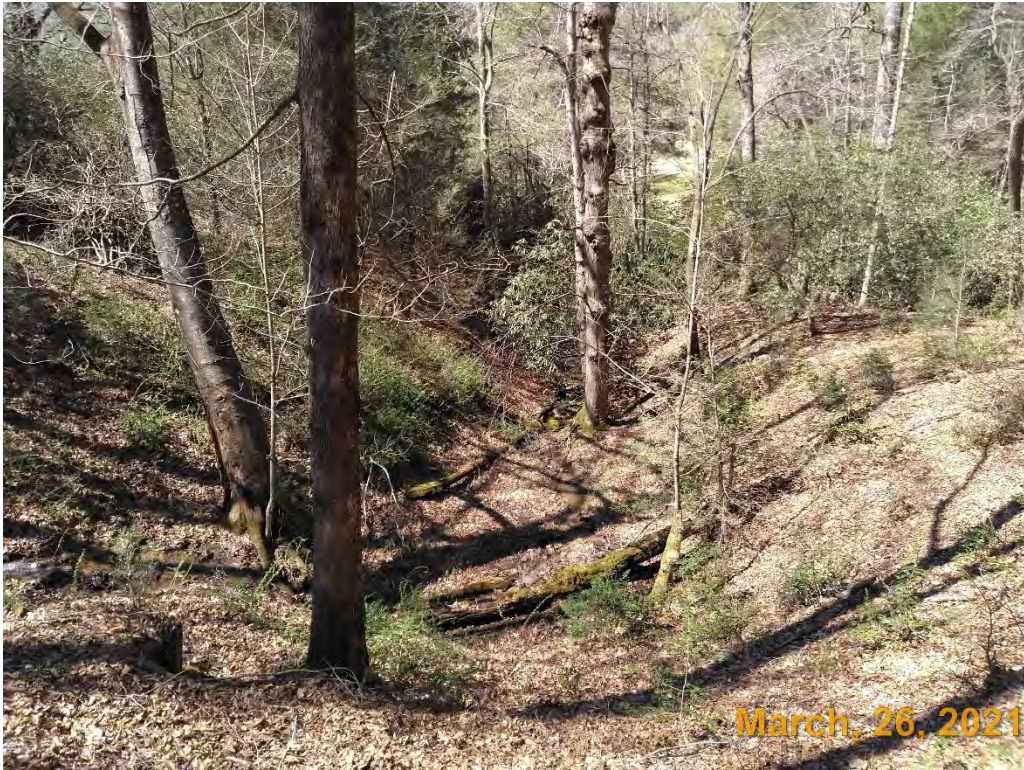
Photo Point 9. Facing downstream

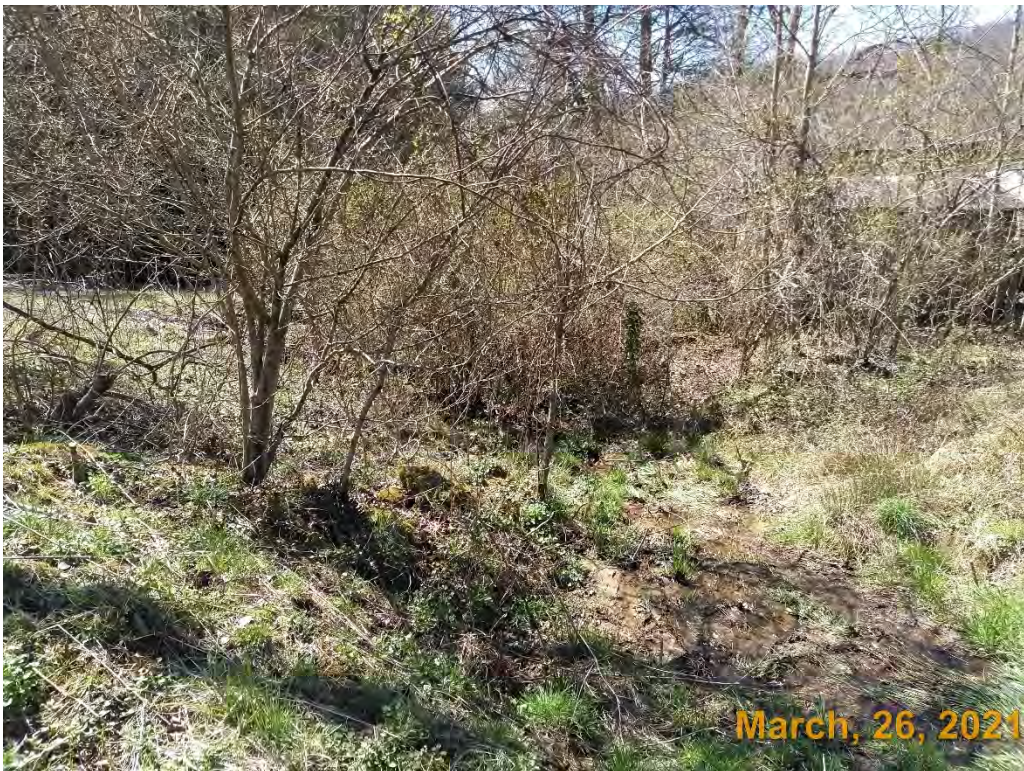
Photo Point 10. Facing downstream

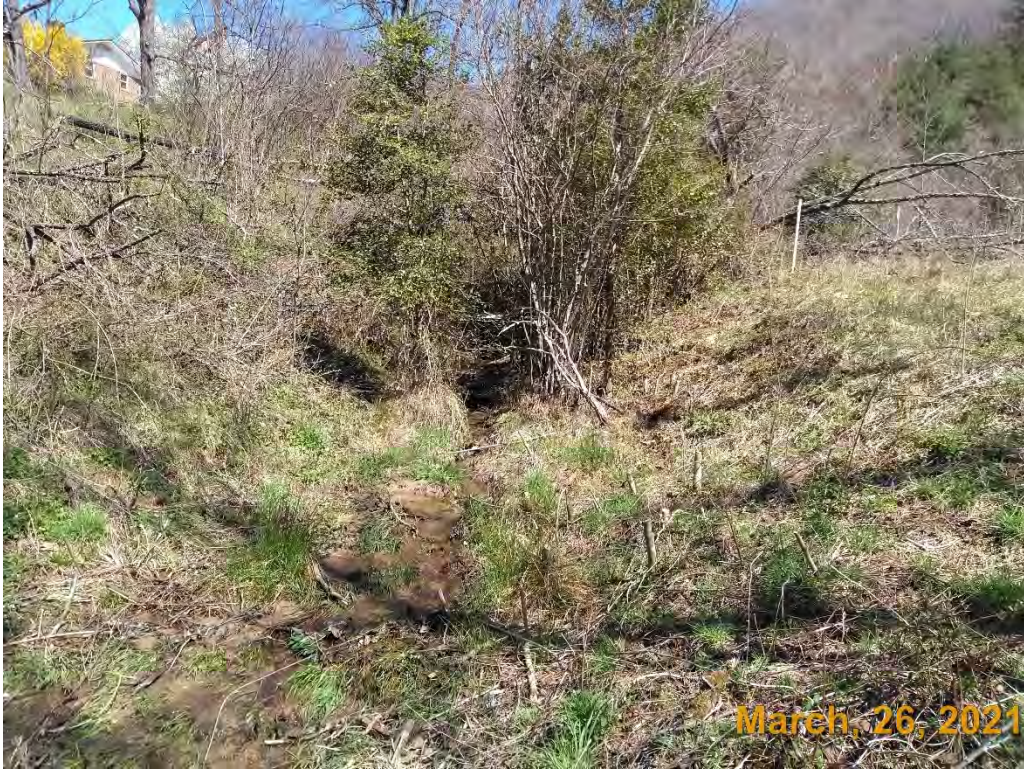
Photo Point 10. Facing upstream

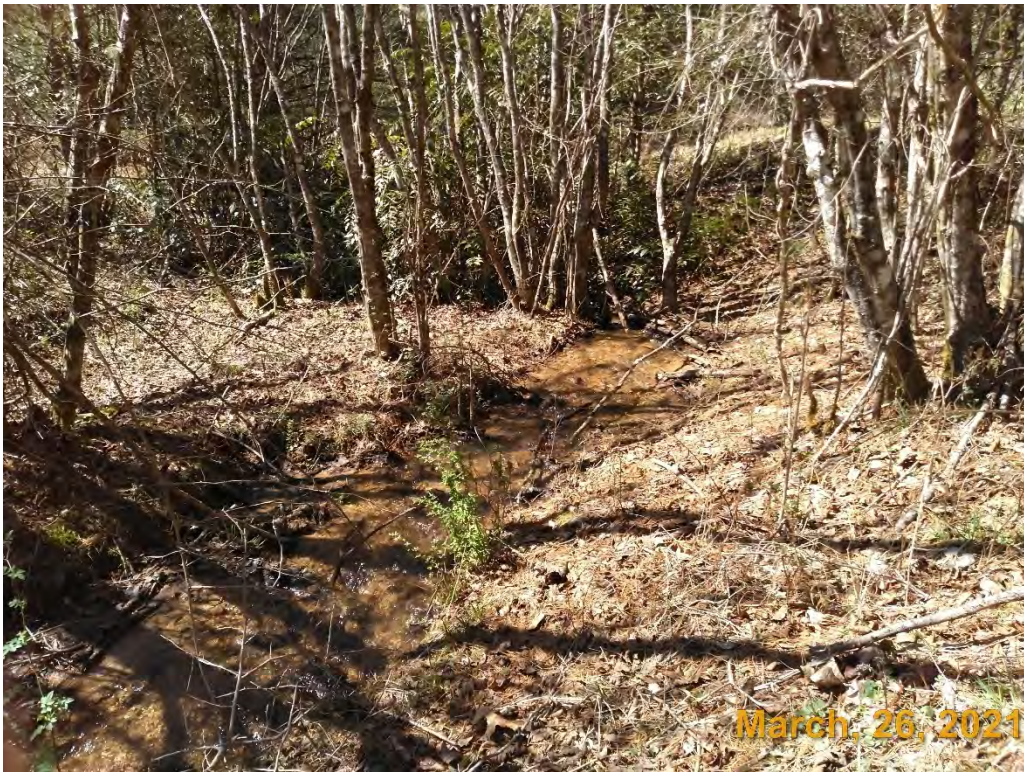
Photo Point 11. Facing downstream
