FINAL-As-Built Baseline Monitoring Report
Seniard Creek Mitigation Site

Henderson County
French Broad River Basin
Cataloging Unit # 06010105

NCDMS Project No. 100017

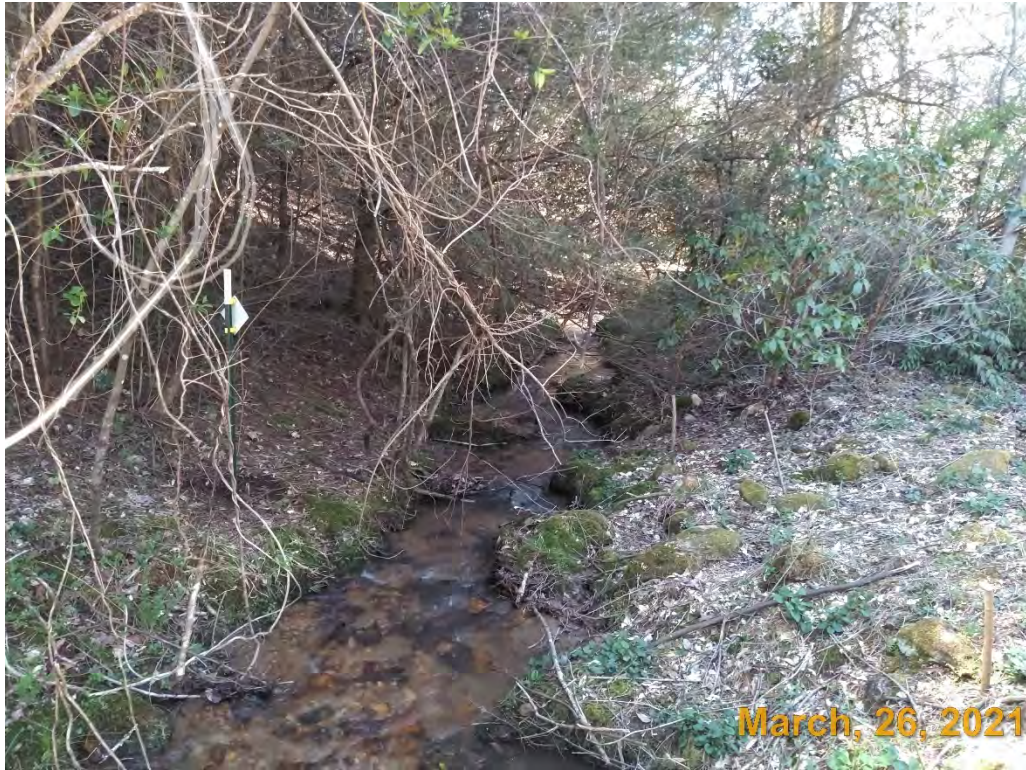
Photo Point 12. Facing downstream

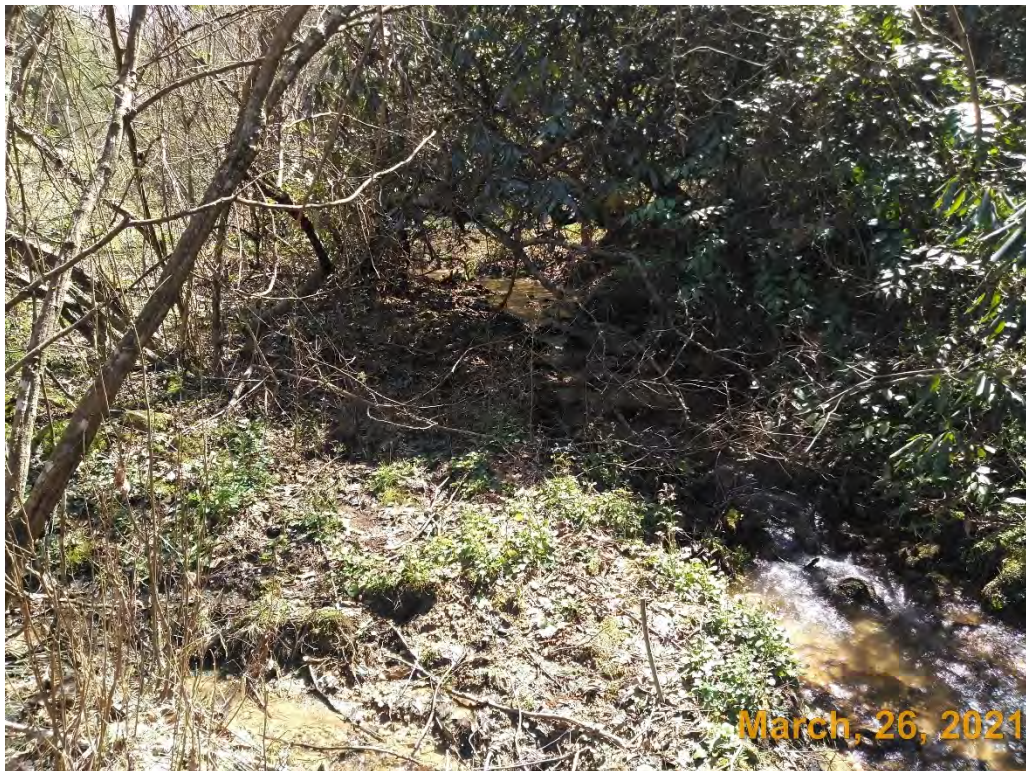
Photo Point 12. Facing upstream

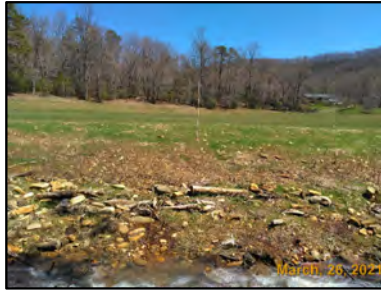
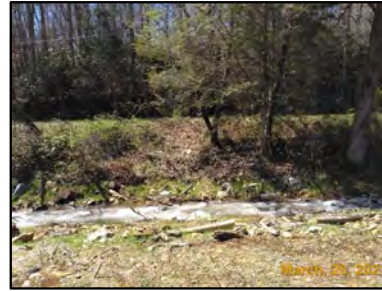
Project Name: Seniard XS Number: 1 Station: 100+32
 Reach Name: Seniard Creek 1A XS Type: Riffle

CHANNEL DIMENSIONS SUMMARY	MY0	MY1	MY2	MY3	MY4	MY5	MY6	MY7
Bankfull Width (ft)	18.0	-	-	-	-	-	-	-
Floodprone Width (ft)	50.0	-	-	-	-	-	-	-
Bankfull Mean Depth (ft)	0.8	-	-	-	-	-	-	-
Bankfull Max Depth (ft)	1.5	-	-	-	-	-	-	-
Bankfull Cross-Sectional Area (ft ²)	14.1	-	-	-	-	-	-	-
Width/Depth Ratio	22.9	-	-	-	-	-	-	-
Entrenchment Ratio	2.8	-	-	-	-	-	-	-
Bank Height Ratio	1.3	-	-	-	-	-	-	-

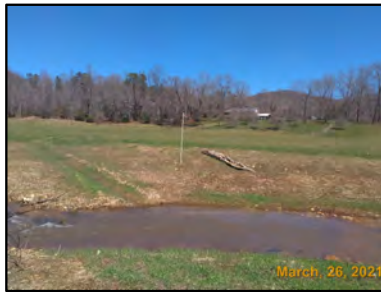
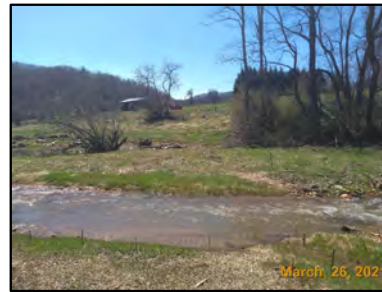
Project Name: Seniard XS Number: 2 Station: 107+60
 Reach Name: Seniard Creek 1B XS Type: Pool

CHANNEL DIMENSIONS SUMMARY	MY0	MY1	MY2	MY3	MY4	MY5	MY6	MY7
Bankfull Width (ft)	16.9	-	-	-	-	-	-	-
Floodprone Width (ft)	50.0	-	-	-	-	-	-	-
Bankfull Mean Depth (ft)	1.6	-	-	-	-	-	-	-
Bankfull Max Depth (ft)	3.1	-	-	-	-	-	-	-
Bankfull Cross-Sectional Area (ft ²)	27.2	-	-	-	-	-	-	-
Width/Depth Ratio	10.5	-	-	-	-	-	-	-
Entrenchment Ratio	3.0	-	-	-	-	-	-	-
Bank Height Ratio	1.2	-	-	-	-	-	-	-

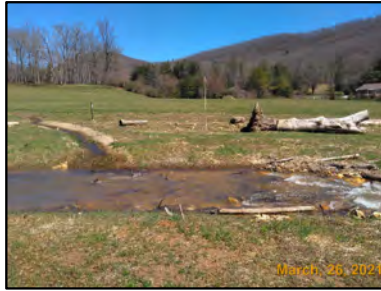
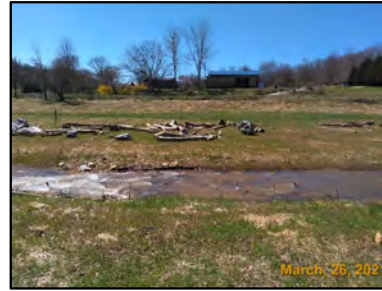
Project Name: Seniard XS Number: 3 Station: 111+23
 Reach Name: Seniard Creek 1B XS Type: Riffle

CHANNEL DIMENSIONS SUMMARY	MY0	MY1	MY2	MY3	MY4	MY5	MY6	MY7
Bankfull Width (ft)	17.7	-	-	-	-	-	-	-
Floodprone Width (ft)	50.0	-	-	-	-	-	-	-
Bankfull Mean Depth (ft)	0.9	-	-	-	-	-	-	-
Bankfull Max Depth (ft)	1.6	-	-	-	-	-	-	-
Bankfull Cross-Sectional Area (ft ²)	15.6	-	-	-	-	-	-	-
Width/Depth Ratio	20.1	-	-	-	-	-	-	-
Entrenchment Ratio	2.8	-	-	-	-	-	-	-
Bank Height Ratio	1.0	-	-	-	-	-	-	-

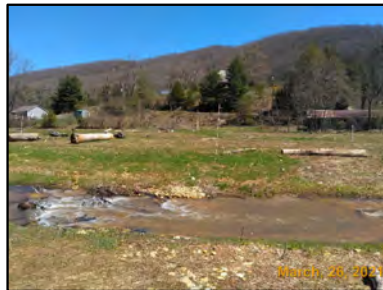
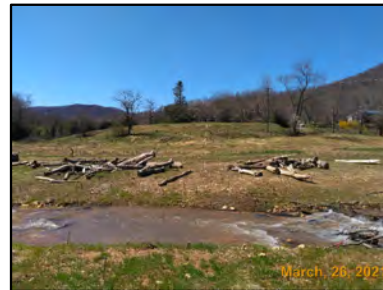
Project Name: Seniard XS Number: 4 Station: 114+85
 Reach Name: Seniard Creek 1B XS Type: Pool

CHANNEL DIMENSIONS SUMMARY	MY0	MY1	MY2	MY3	MY4	MY5	MY6	MY7
Bankfull Width (ft)	21.0	-	-	-	-	-	-	-
Floodprone Width (ft)	50.0	-	-	-	-	-	-	-
Bankfull Mean Depth (ft)	1.4	-	-	-	-	-	-	-
Bankfull Max Depth (ft)	3.4	-	-	-	-	-	-	-
Bankfull Cross-Sectional Area (ft ²)	29.6	-	-	-	-	-	-	-
Width/Depth Ratio	14.9	-	-	-	-	-	-	-
Entrenchment Ratio	2.4	-	-	-	-	-	-	-
Bank Height Ratio	1.1	-	-	-	-	-	-	-

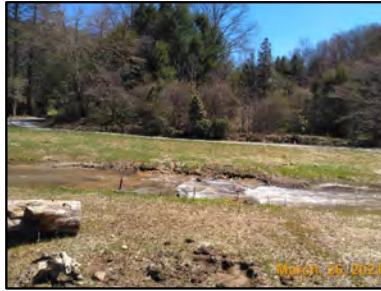
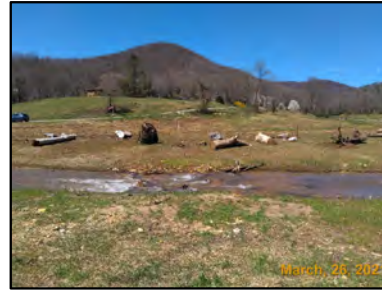
Project Name: Seniard XS Number: 5 Station: 116+93
 Reach Name: Seniard Creek 2 XS Type: Riffle

CHANNEL DIMENSIONS SUMMARY	MY0	MY1	MY2	MY3	MY4	MY5	MY6	MY7
Bankfull Width (ft)	26.1	-	-	-	-	-	-	-
Floodprone Width (ft)	100.0	-	-	-	-	-	-	-
Bankfull Mean Depth (ft)	1.1	-	-	-	-	-	-	-
Bankfull Max Depth (ft)	2.1	-	-	-	-	-	-	-
Bankfull Cross-Sectional Area (ft ²)	27.9	-	-	-	-	-	-	-
Width/Depth Ratio	24.4	-	-	-	-	-	-	-
Entrenchment Ratio	3.8	-	-	-	-	-	-	-
Bank Height Ratio	1.2	-	-	-	-	-	-	-

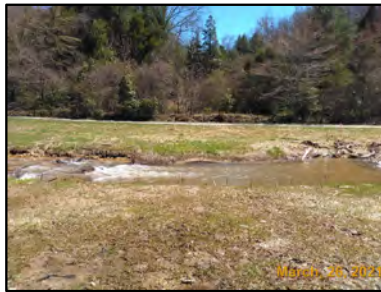
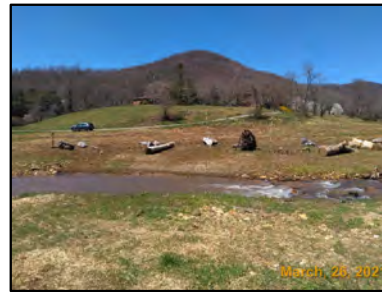
Project Name: Seniard XS Number: 6 Station: 117+09
 Reach Name: Seniard Creek 2 XS Type: Pool

CHANNEL DIMENSIONS SUMMARY	MY0	MY1	MY2	MY3	MY4	MY5	MY6	MY7
Bankfull Width (ft)	17.7	-	-	-	-	-	-	-
Floodprone Width (ft)	100.0	-	-	-	-	-	-	-
Bankfull Mean Depth (ft)	1.9	-	-	-	-	-	-	-
Bankfull Max Depth (ft)	3.8	-	-	-	-	-	-	-
Bankfull Cross-Sectional Area (ft ²)	34.0	-	-	-	-	-	-	-
Width/Depth Ratio	9.2	-	-	-	-	-	-	-
Entrenchment Ratio	5.6	-	-	-	-	-	-	-
Bank Height Ratio	1.0	-	-	-	-	-	-	-

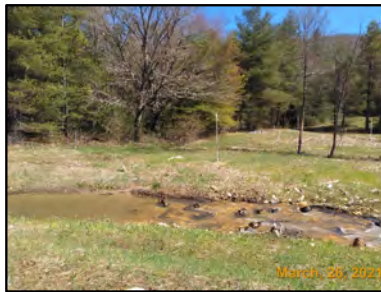
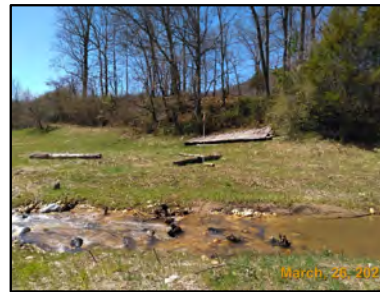
XS Number: 7
 XS Type: Riffle

CHANNEL DIMENSIONS SUMMARY	MY0	MY1	MY2	MY3	MY4	MY5	MY6	MY7
Bankfull Width (ft)	15.5	-	-	-	-	-	-	-
Floodprone Width (ft)	50.0	-	-	-	-	-	-	-
Bankfull Mean Depth (ft)	0.8	-	-	-	-	-	-	-
Bankfull Max Depth (ft)	1.3	-	-	-	-	-	-	-
Bankfull Cross-Sectional Area (ft ²)	12.1	-	-	-	-	-	-	-
Width/Depth Ratio	19.8	-	-	-	-	-	-	-
Entrenchment Ratio	3.2	-	-	-	-	-	-	-
Bank Height Ratio	1.2	-	-	-	-	-	-	-

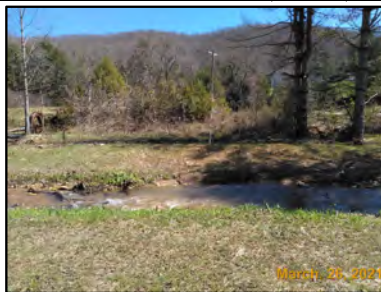
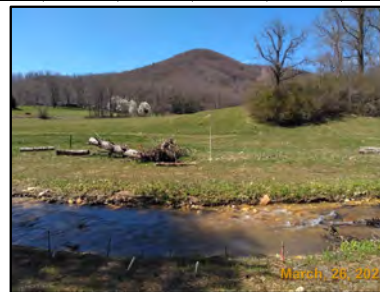
XS Number: 8
 XS Type: Pool

CHANNEL DIMENSIONS SUMMARY	MY0	MY1	MY2	MY3	MY4	MY5	MY6	MY7
Bankfull Width (ft)	15.3	-	-	-	-	-	-	-
Floodprone Width (ft)	50.0	-	-	-	-	-	-	-
Bankfull Mean Depth (ft)	1.7	-	-	-	-	-	-	-
Bankfull Max Depth (ft)	2.6	-	-	-	-	-	-	-
Bankfull Cross-Sectional Area (ft ²)	25.8	-	-	-	-	-	-	-
Width/Depth Ratio	9.1	-	-	-	-	-	-	-
Entrenchment Ratio	3.3	-	-	-	-	-	-	-
Bank Height Ratio	1.2	-	-	-	-	-	-	-

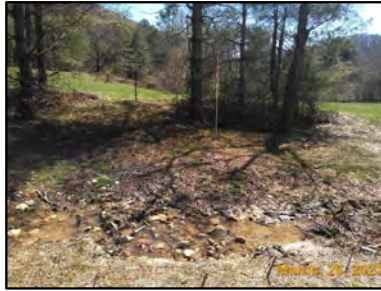
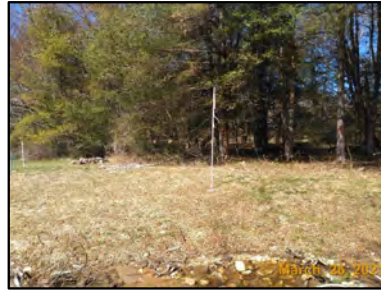
Project Name: Seniard XS Number: 9 Station: 300+51
 Reach Name: Lee Branch I XS Type: Riffle

CHANNEL DIMENSIONS SUMMARY	MY0	MY1	MY2	MY3	MY4	MY5	MY6	MY7
Bankfull Width (ft)	5.9	-	-	-	-	-	-	-
Floodprone Width (ft)	25.0	-	-	-	-	-	-	-
Bankfull Mean Depth (ft)	0.3	-	-	-	-	-	-	-
Bankfull Max Depth (ft)	0.6	-	-	-	-	-	-	-
Bankfull Cross-Sectional Area (ft ²)	2.0	-	-	-	-	-	-	-
Width/Depth Ratio	17.4	-	-	-	-	-	-	-
Entrenchment Ratio	4.3	-	-	-	-	-	-	-
Bank Height Ratio	1.4	-	-	-	-	-	-	-

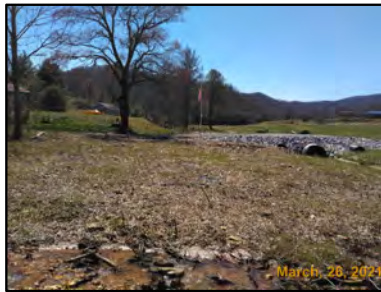
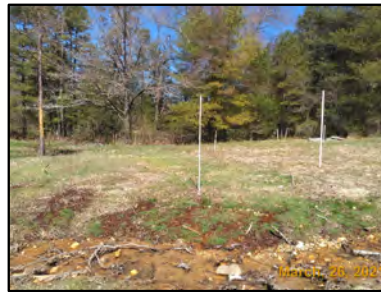
Project Name: Seniard XS Number: 10 Station: 301+61
 Reach Name: Lee Branch I XS Type: Pool

CHANNEL DIMENSIONS SUMMARY	MY0	MY1	MY2	MY3	MY4	MY5	MY6	MY7
Bankfull Width (ft)	8.6	-	-	-	-	-	-	-
Floodprone Width (ft)	25.0	-	-	-	-	-	-	-
Bankfull Mean Depth (ft)	0.2	-	-	-	-	-	-	-
Bankfull Max Depth (ft)	0.4	-	-	-	-	-	-	-
Bankfull Cross-Sectional Area (ft ²)	2.1	-	-	-	-	-	-	-
Width/Depth Ratio	35.6	-	-	-	-	-	-	-
Entrenchment Ratio	2.9	-	-	-	-	-	-	-
Bank Height Ratio	1.3	-	-	-	-	-	-	-

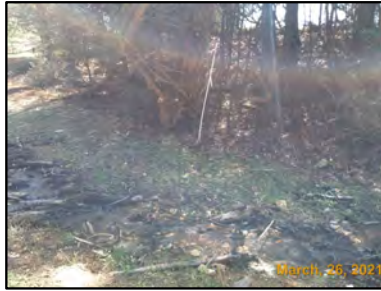
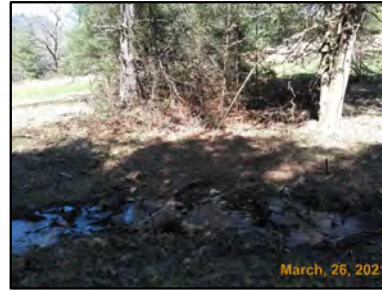
Project Name: Seniard XS Number: 11 Station: 402+31
 Reach Name: David Branch 1B XS Type: Riffle

CHANNEL DIMENSIONS SUMMARY	MY0	MY1	MY2	MY3	MY4	MY5	MY6	MY7
Bankfull Width (ft)	3.2	-	-	-	-	-	-	-
Floodprone Width (ft)	10.0	-	-	-	-	-	-	-
Bankfull Mean Depth (ft)	0.2	-	-	-	-	-	-	-
Bankfull Max Depth (ft)	0.4	-	-	-	-	-	-	-
Bankfull Cross-Sectional Area (ft ²)	0.6	-	-	-	-	-	-	-
Width/Depth Ratio	17.5	-	-	-	-	-	-	-
Entrenchment Ratio	3.1	-	-	-	-	-	-	-
Bank Height Ratio	1.3	-	-	-	-	-	-	-

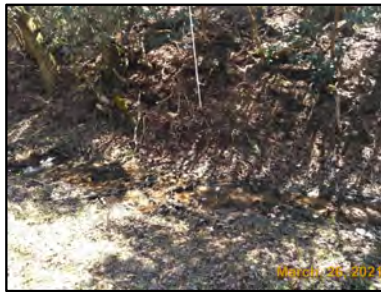
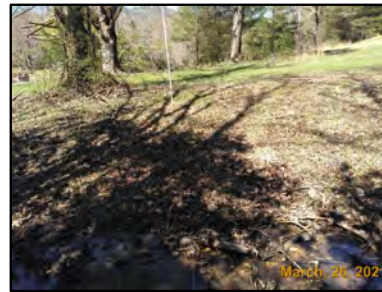
Project Name: Seniard XS Number: 12 Station: 403+24
 Reach Name: David Branch 1B XS Type: Pool

CHANNEL DIMENSIONS SUMMARY	MY0	MY1	MY2	MY3	MY4	MY5	MY6	MY7
Bankfull Width (ft)	4.2	-	-	-	-	-	-	-
Floodprone Width (ft)	10.0	-	-	-	-	-	-	-
Bankfull Mean Depth (ft)	0.4	-	-	-	-	-	-	-
Bankfull Max Depth (ft)	0.9	-	-	-	-	-	-	-
Bankfull Cross-Sectional Area (ft ²)	1.7	-	-	-	-	-	-	-
Width/Depth Ratio	10.2	-	-	-	-	-	-	-
Entrenchment Ratio	2.4	-	-	-	-	-	-	-
Bank Height Ratio	1.2	-	-	-	-	-	-	-
