# AS-BUILT BASELINE MONITORING REPORT

## SHAKE RAG MITIGATION SITE

Madison County, NC

DMS Project No. 100018

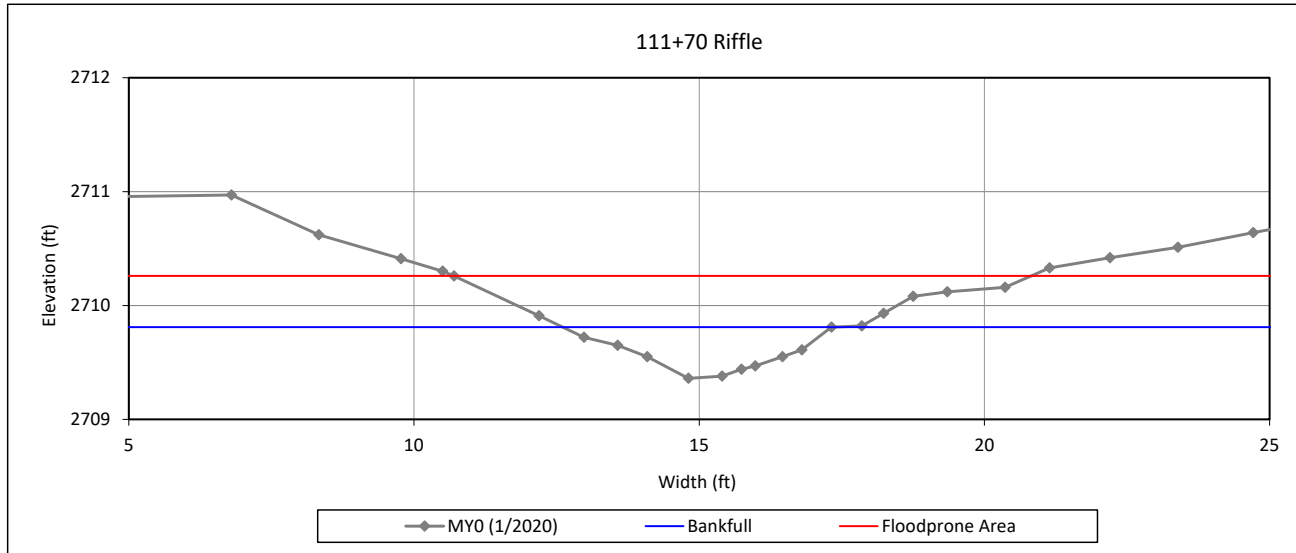
#### Cross-Section 1-UT1 Reach 2

1.2	x-section area (ft.sq.)
4.7	width (ft)
0.3	mean depth (ft)
0.4	max depth (ft)
4.8	wetted perimeter (ft)
0.3	hydraulic radius (ft)
18.4	width-depth ratio
10.1	W flood prone area (ft)
2.1	entrenchment ratio
1.0	low bank height ratio

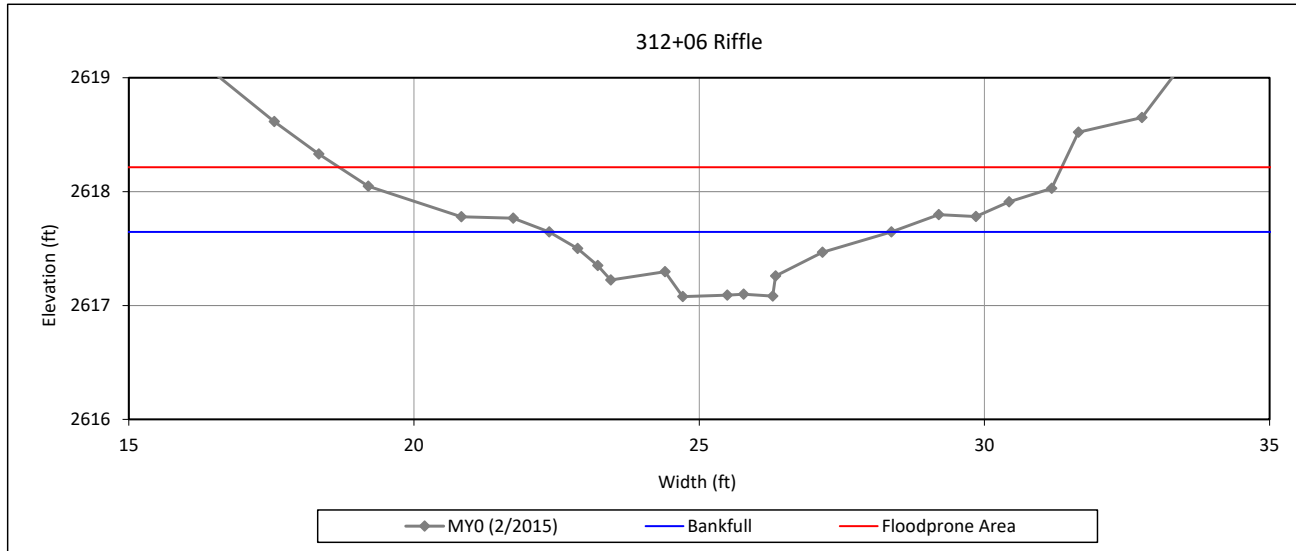
#### Cross-Section 3-UT3 Reach 2

1.9	x-section area (ft.sq.)
6.0	width (ft)
0.3	mean depth (ft)
0.6	max depth (ft)
6.3	wetted perimeter (ft)
0.3	hydraulic radius (ft)
18.4	width-depth ratio
12.7	W flood prone area (ft)
2.1	entrenchment ratio
1.0	low bank height ratio

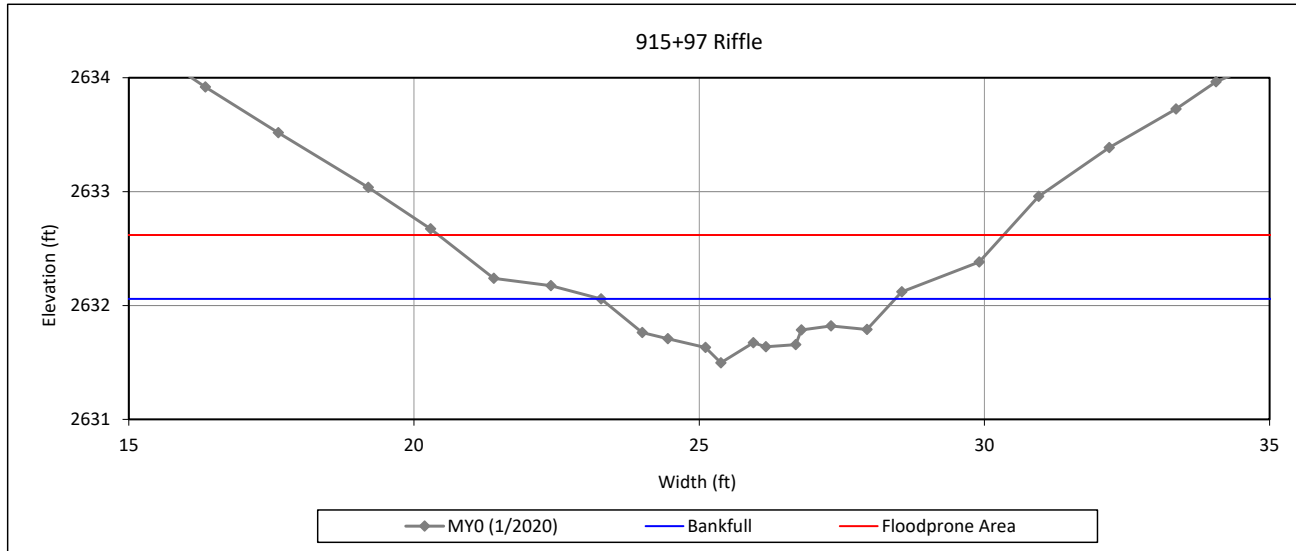
#### Cross-Section 8-Shake Rag Branch Reach 3

1.6	x-section area (ft.sq.)
5.2	width (ft)
0.3	mean depth (ft)
0.6	max depth (ft)
5.4	wetted perimeter (ft)
0.3	hydraulic radius (ft)
16.6	width-depth ratio
9.9	W flood prone area (ft)
1.9	entrenchment ratio
1.0	low bank height ratio

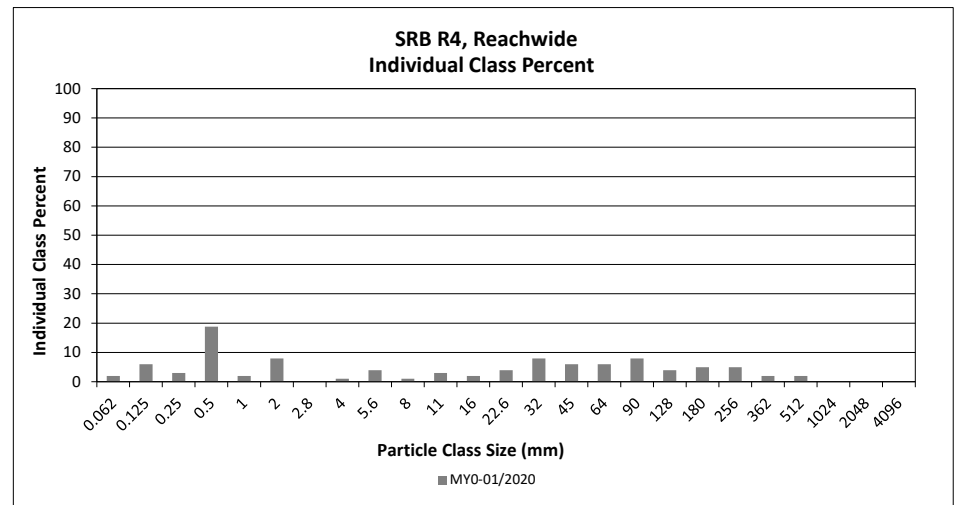
**Reachwide and Cross-Section Pebble Count Plots**

Particle Class		Diameter (mm)		Particle Count			Reach Summary	
		min	max	Riffle	Pool	Total	Class Percentage	Percent Cumulative
<b>SILT/CLAY</b>	Silt/Clay	0.000	0.062		2	2	2	2
<b>SAND</b>	Very fine	0.062	0.125		6	6	6	8
	Fine	0.125	0.250		3	3	3	11
	Medium	0.25	0.50	1	18	19	19	30
	Coarse	0.5	1.0	2		2	2	32
	Very Coarse	1.0	2.0		8	8	8	40
<b>GRAVEL</b>	Very Fine	2.0	2.8					40
	Very Fine	2.8	4.0		1	1	1	41
	Fine	4.0	5.6	2	2	4	4	45
	Fine	5.6	8.0	1		1	1	46
	Medium	8.0	11.0	1	2	3	3	49
	Medium	11.0	16.0	1	1	2	2	50
	Coarse	16.0	22.6	4		4	4	54
	Coarse	22.6	32	4	4	8	8	62
	Very Coarse	32	45	6		6	6	68
	Very Coarse	45	64	4	2	6	6	74
<b>COBBLE</b>	Small	64	90	7	1	8	8	82
	Small	90	128	4		4	4	86
	Large	128	180	5		5	5	91
	Large	180	256	5		5	5	96
<b>BOULDER</b>	Small	256	362	2		2	2	98
	Small	362	512	2		2	2	100
	Medium	512	1024					100
<b>BEDROCK</b>	Large/Very Large	1024	2048					100
	Bedrock	2048	>2048					100
<b>Total</b>				<b>51</b>	<b>50</b>	<b>101</b>	<b>100</b>	<b>100</b>

Reachwide Channel materials (mm)	
D <sub>16</sub> =	0.3
D <sub>35</sub> =	1.3
D <sub>50</sub> =	14.6
D <sub>84</sub> =	105.8
D <sub>95</sub> =	237.7
D <sub>100</sub> =	512.0

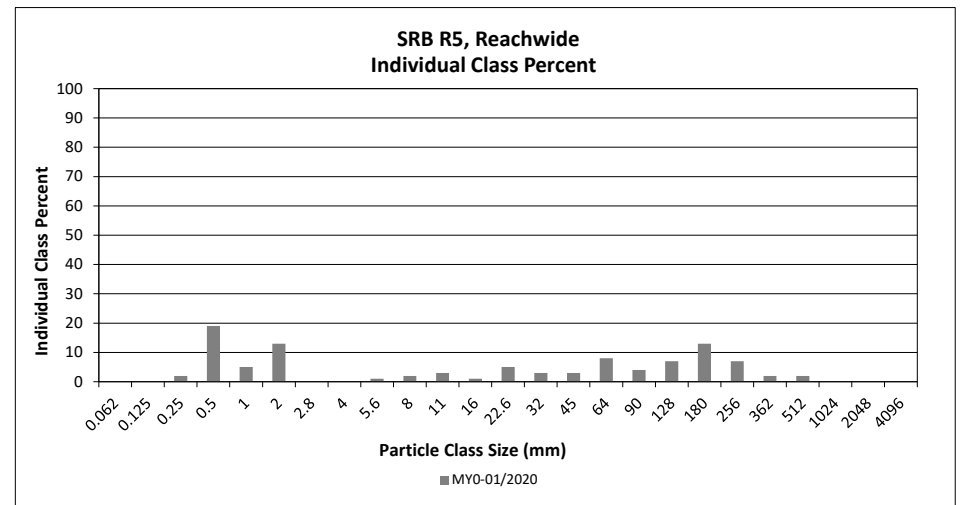
**Reachwide and Cross-Section Pebble Count Plots**

Particle Class		Diameter (mm)		Particle Count			Reach Summary	
		min	max	Riffle	Pool	Total	Class Percentage	Percent Cumulative
<b>SILT/CLAY</b>	Silt/Clay	0.000	0.062					0
	Very fine	0.062	0.125					0
<b>SAND</b>	Fine	0.125	0.250		2	2	2	2
	Medium	0.25	0.50	2	17	19	19	21
	Coarse	0.5	1.0		5	5	5	26
	Very Coarse	1.0	2.0	4	9	13	13	39
<b>GRAVEL</b>	Very Fine	2.0	2.8					39
	Very Fine	2.8	4.0					39
	Fine	4.0	5.6	1		1	1	40
	Fine	5.6	8.0		2	2	2	42
	Medium	8.0	11.0	1	2	3	3	45
	Medium	11.0	16.0	1		1	1	46
	Coarse	16.0	22.6	2	3	5	5	51
	Coarse	22.6	32	2	1	3	3	54
	Very Coarse	32	45	3		3	3	57
	Very Coarse	45	64	4	4	8	8	65
<b>COBBLE</b>	Small	64	90	2	2	4	4	69
	Small	90	128	7		7	7	76
	Large	128	180	11	2	13	13	89
	Large	180	256	6	1	7	7	96
<b>BOULDER</b>	Small	256	362	2		2	2	98
	Small	362	512	2		2	2	100
	Medium	512	1024					100
	Large/Very Large	1024	2048					100
<b>BEDROCK</b>	Bedrock	2048	>2048					100
<b>Total</b>				<b>50</b>	<b>50</b>	<b>100</b>	<b>100</b>	<b>100</b>

Reachwide Channel materials (mm)	
D <sub>16</sub> =	0.4
D <sub>35</sub> =	1.6
D <sub>50</sub> =	21.1
D <sub>84</sub> =	157.9
D <sub>95</sub> =	243.4
D <sub>100</sub> =	512.0

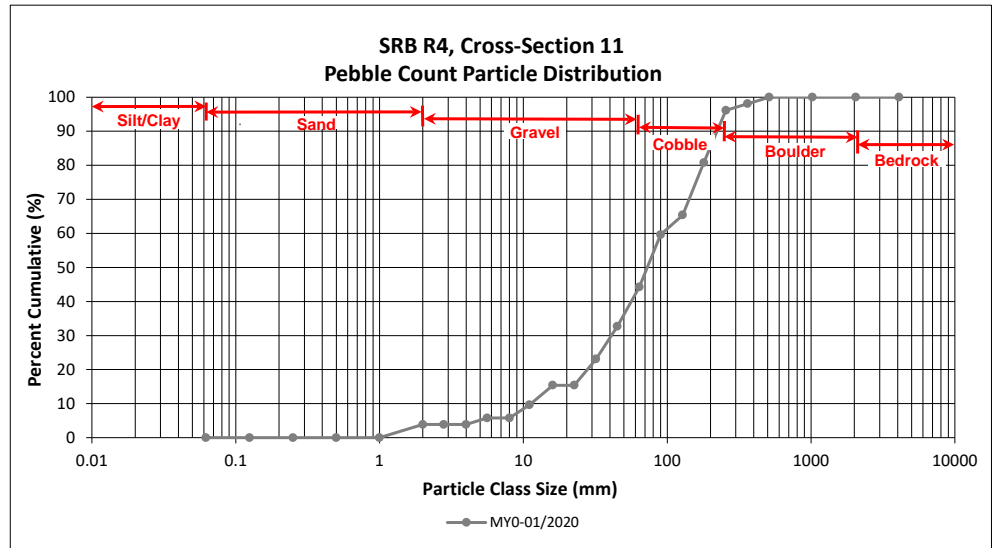
**Reachwide and Cross-Section Pebble Count Plots**

Particle Class		Diameter (mm)		Riffle 100-Count	Summary	
		min	max		Class Percentage	Percent Cumulative
<b>SILT/CLAY</b>	Silt/Clay	0.000	0.062			0
<b>SAND</b>	Very fine	0.062	0.125			0
	Fine	0.125	0.250			0
	Medium	0.25	0.50			0
	Coarse	0.5	1.0			0
	Very Coarse	1.0	2.0	4	4	4
<b>GRAVEL</b>	Very Fine	2.0	2.8			4
	Very Fine	2.8	4.0			4
	Fine	4.0	5.6	2	2	6
	Fine	5.6	8.0			6
	Medium	8.0	11.0	4	4	10
	Medium	11.0	16.0	6	6	15
	Coarse	16.0	22.6			15
	Coarse	22.6	32	8	8	23
	Very Coarse	32	45	10	10	33
	Very Coarse	45	64	12	12	44
<b>COBBLE</b>	Small	64	90	16	15	60
	Small	90	128	6	6	65
	Large	128	180	16	15	81
	Large	180	256	16	15	96
<b>BOULDER</b>	Small	256	362	2	2	98
	Small	362	512	2	2	100
	Medium	512	1024			100
	Large/Very Large	1024	2048			100
<b>BEDROCK</b>	Bedrock	2048	>2048			100
<b>Total</b>				<b>104</b>	<b>100</b>	<b>100</b>

Cross-Section 11 Channel materials (mm)	
D <sub>16</sub> =	23.2
D <sub>35</sub> =	48.3
D <sub>50</sub> =	72.7
D <sub>84</sub> =	193.8
D <sub>95</sub> =	249.3
D <sub>100</sub> =	512.0

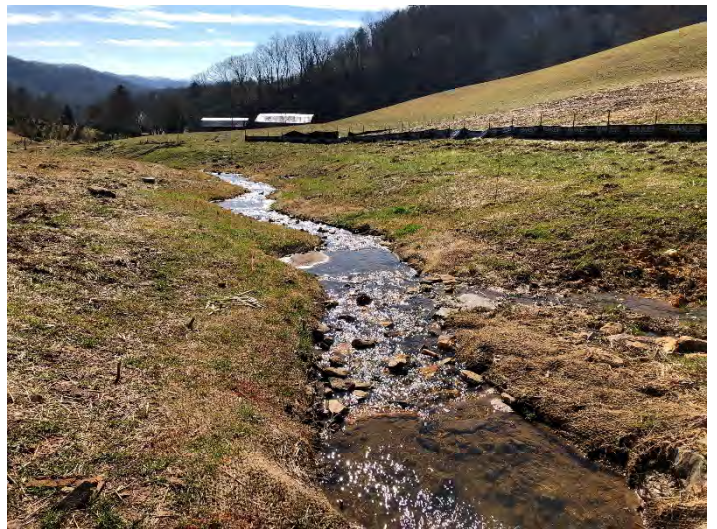
**Photo Point 26 – SRB Reach 5, view downstream (01/28/2020)**

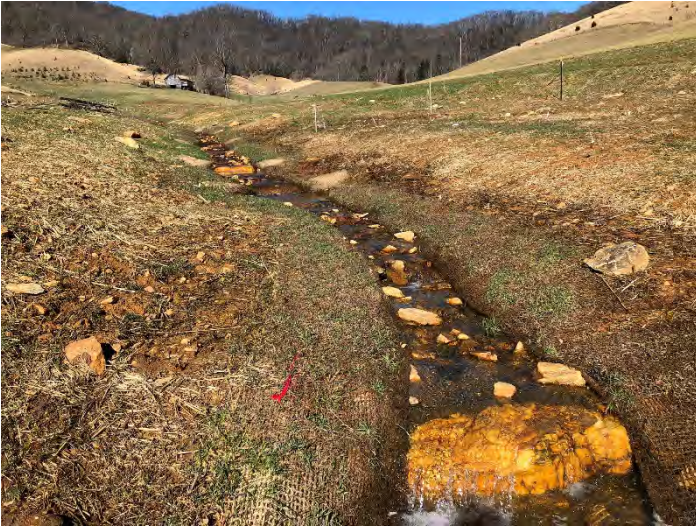
**Photo Point 27 – SRB Reach 5, view upstream (01/28/2020)**

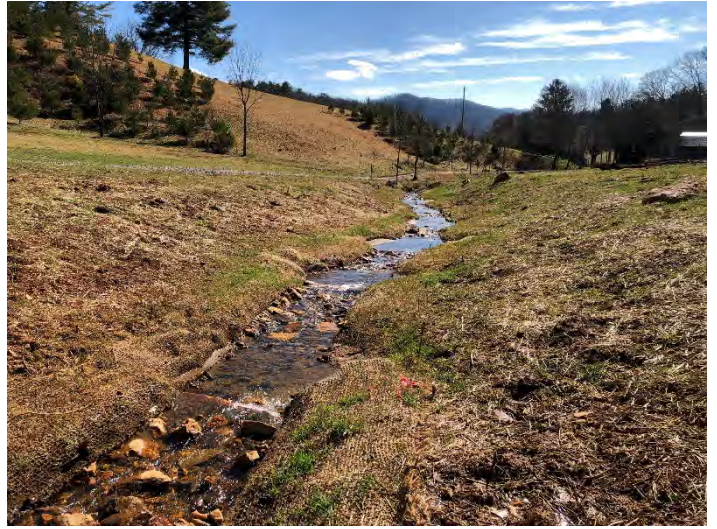
**Photo Point 27 – SRB Reach 5, view downstream (01/28/2020)**

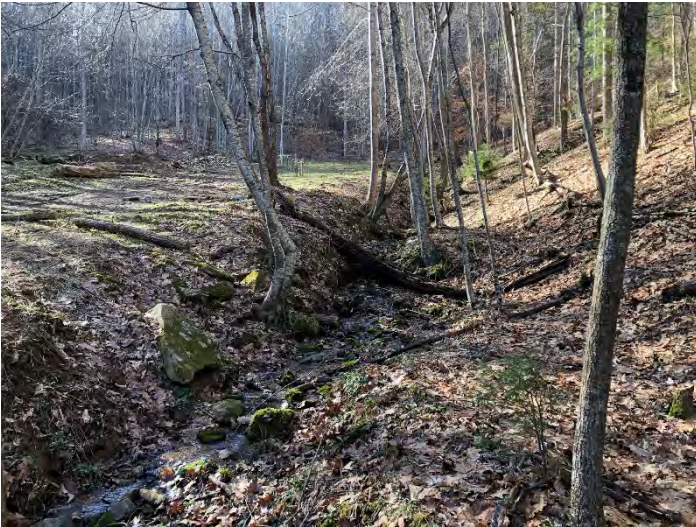
**Photo Point 28 – UT6, view upstream (01/28/2020)**

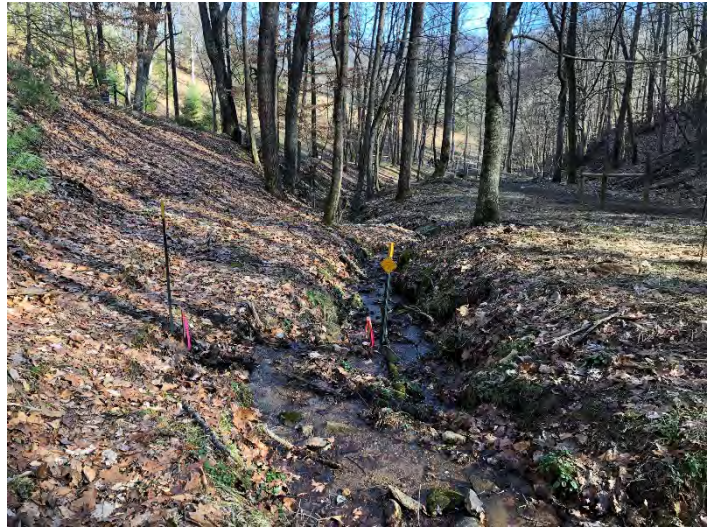
**Photo Point 28 – UT6, view downstream (01/28/2020)**

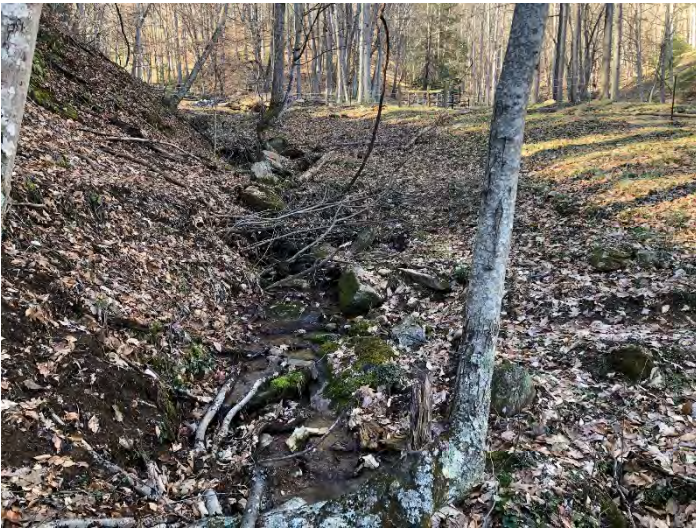
**Photo Point 29 – UT6, view upstream (01/28/2020)**

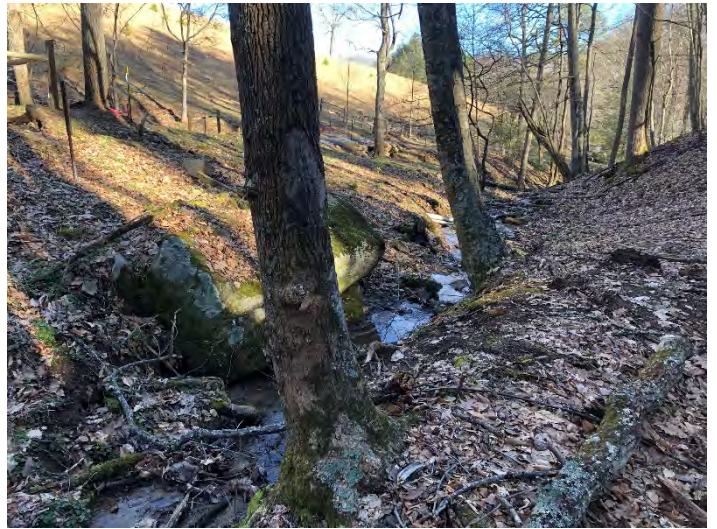
**Photo Point 29 – UT6, view downstream (01/28/2020)**

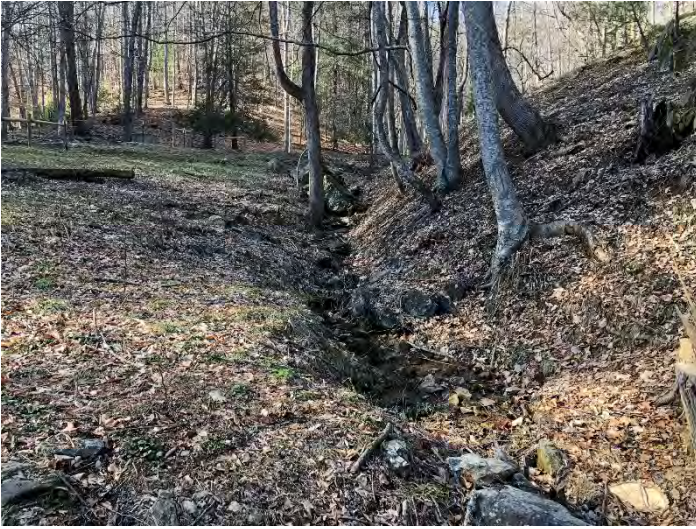
**Photo Point 30 – UT5, view upstream (01/28/2020)**

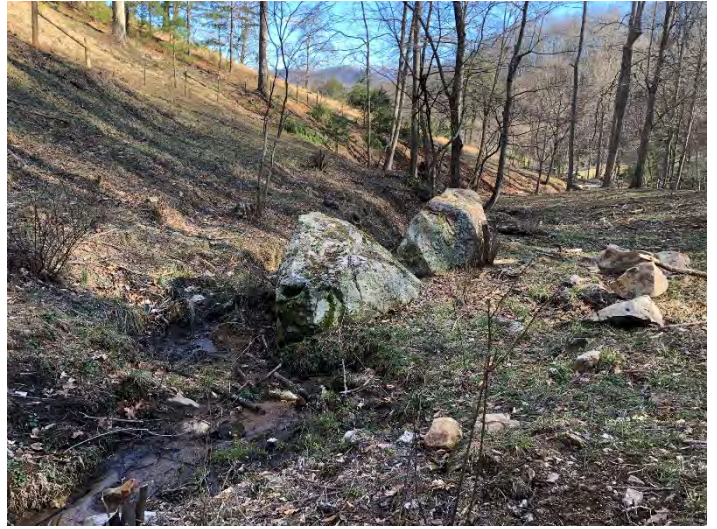
**Photo Point 30 – UT5, view downstream (01/28/2020)**

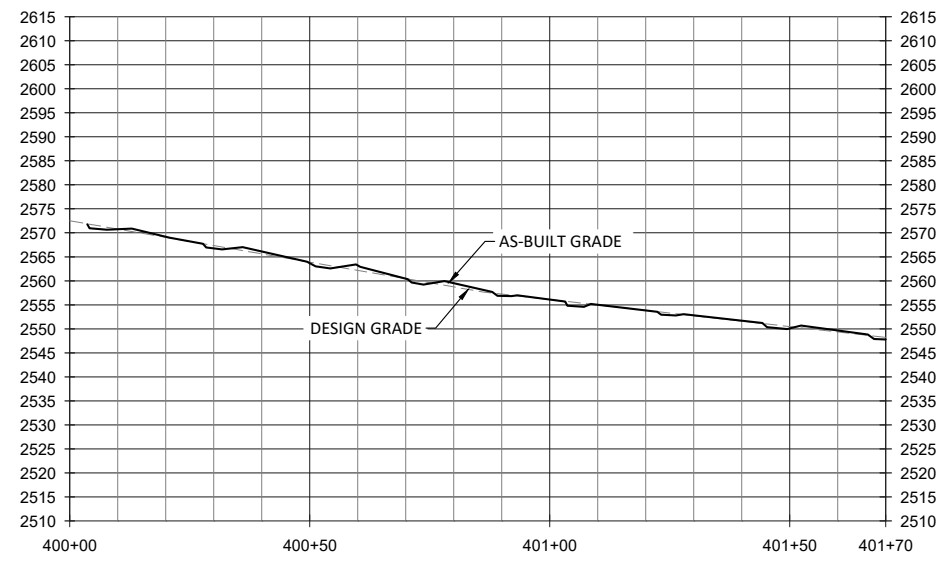
UT4  
 Stream Plan and Profile

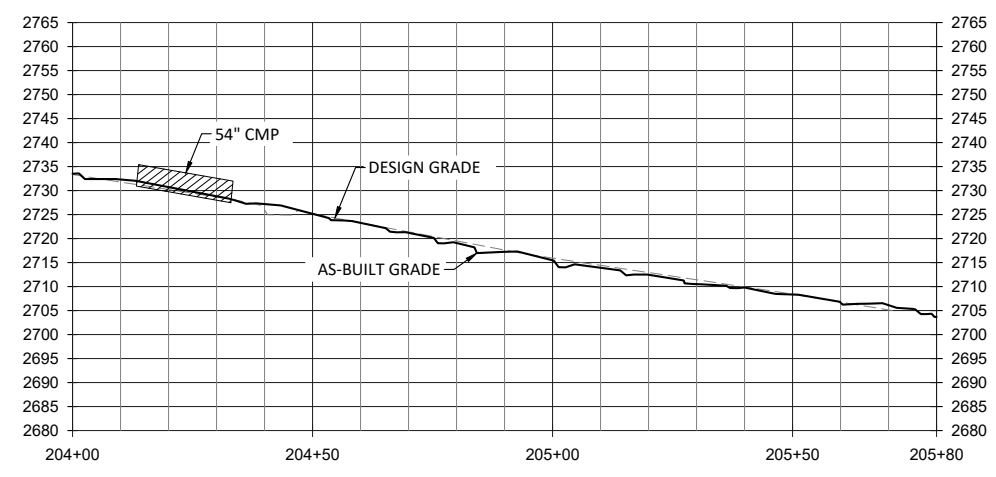
UT2  
 Stream Plan and Profile

Shake Rag Branch Mitigation Site Record Drawings  
 Madison County, North Carolina

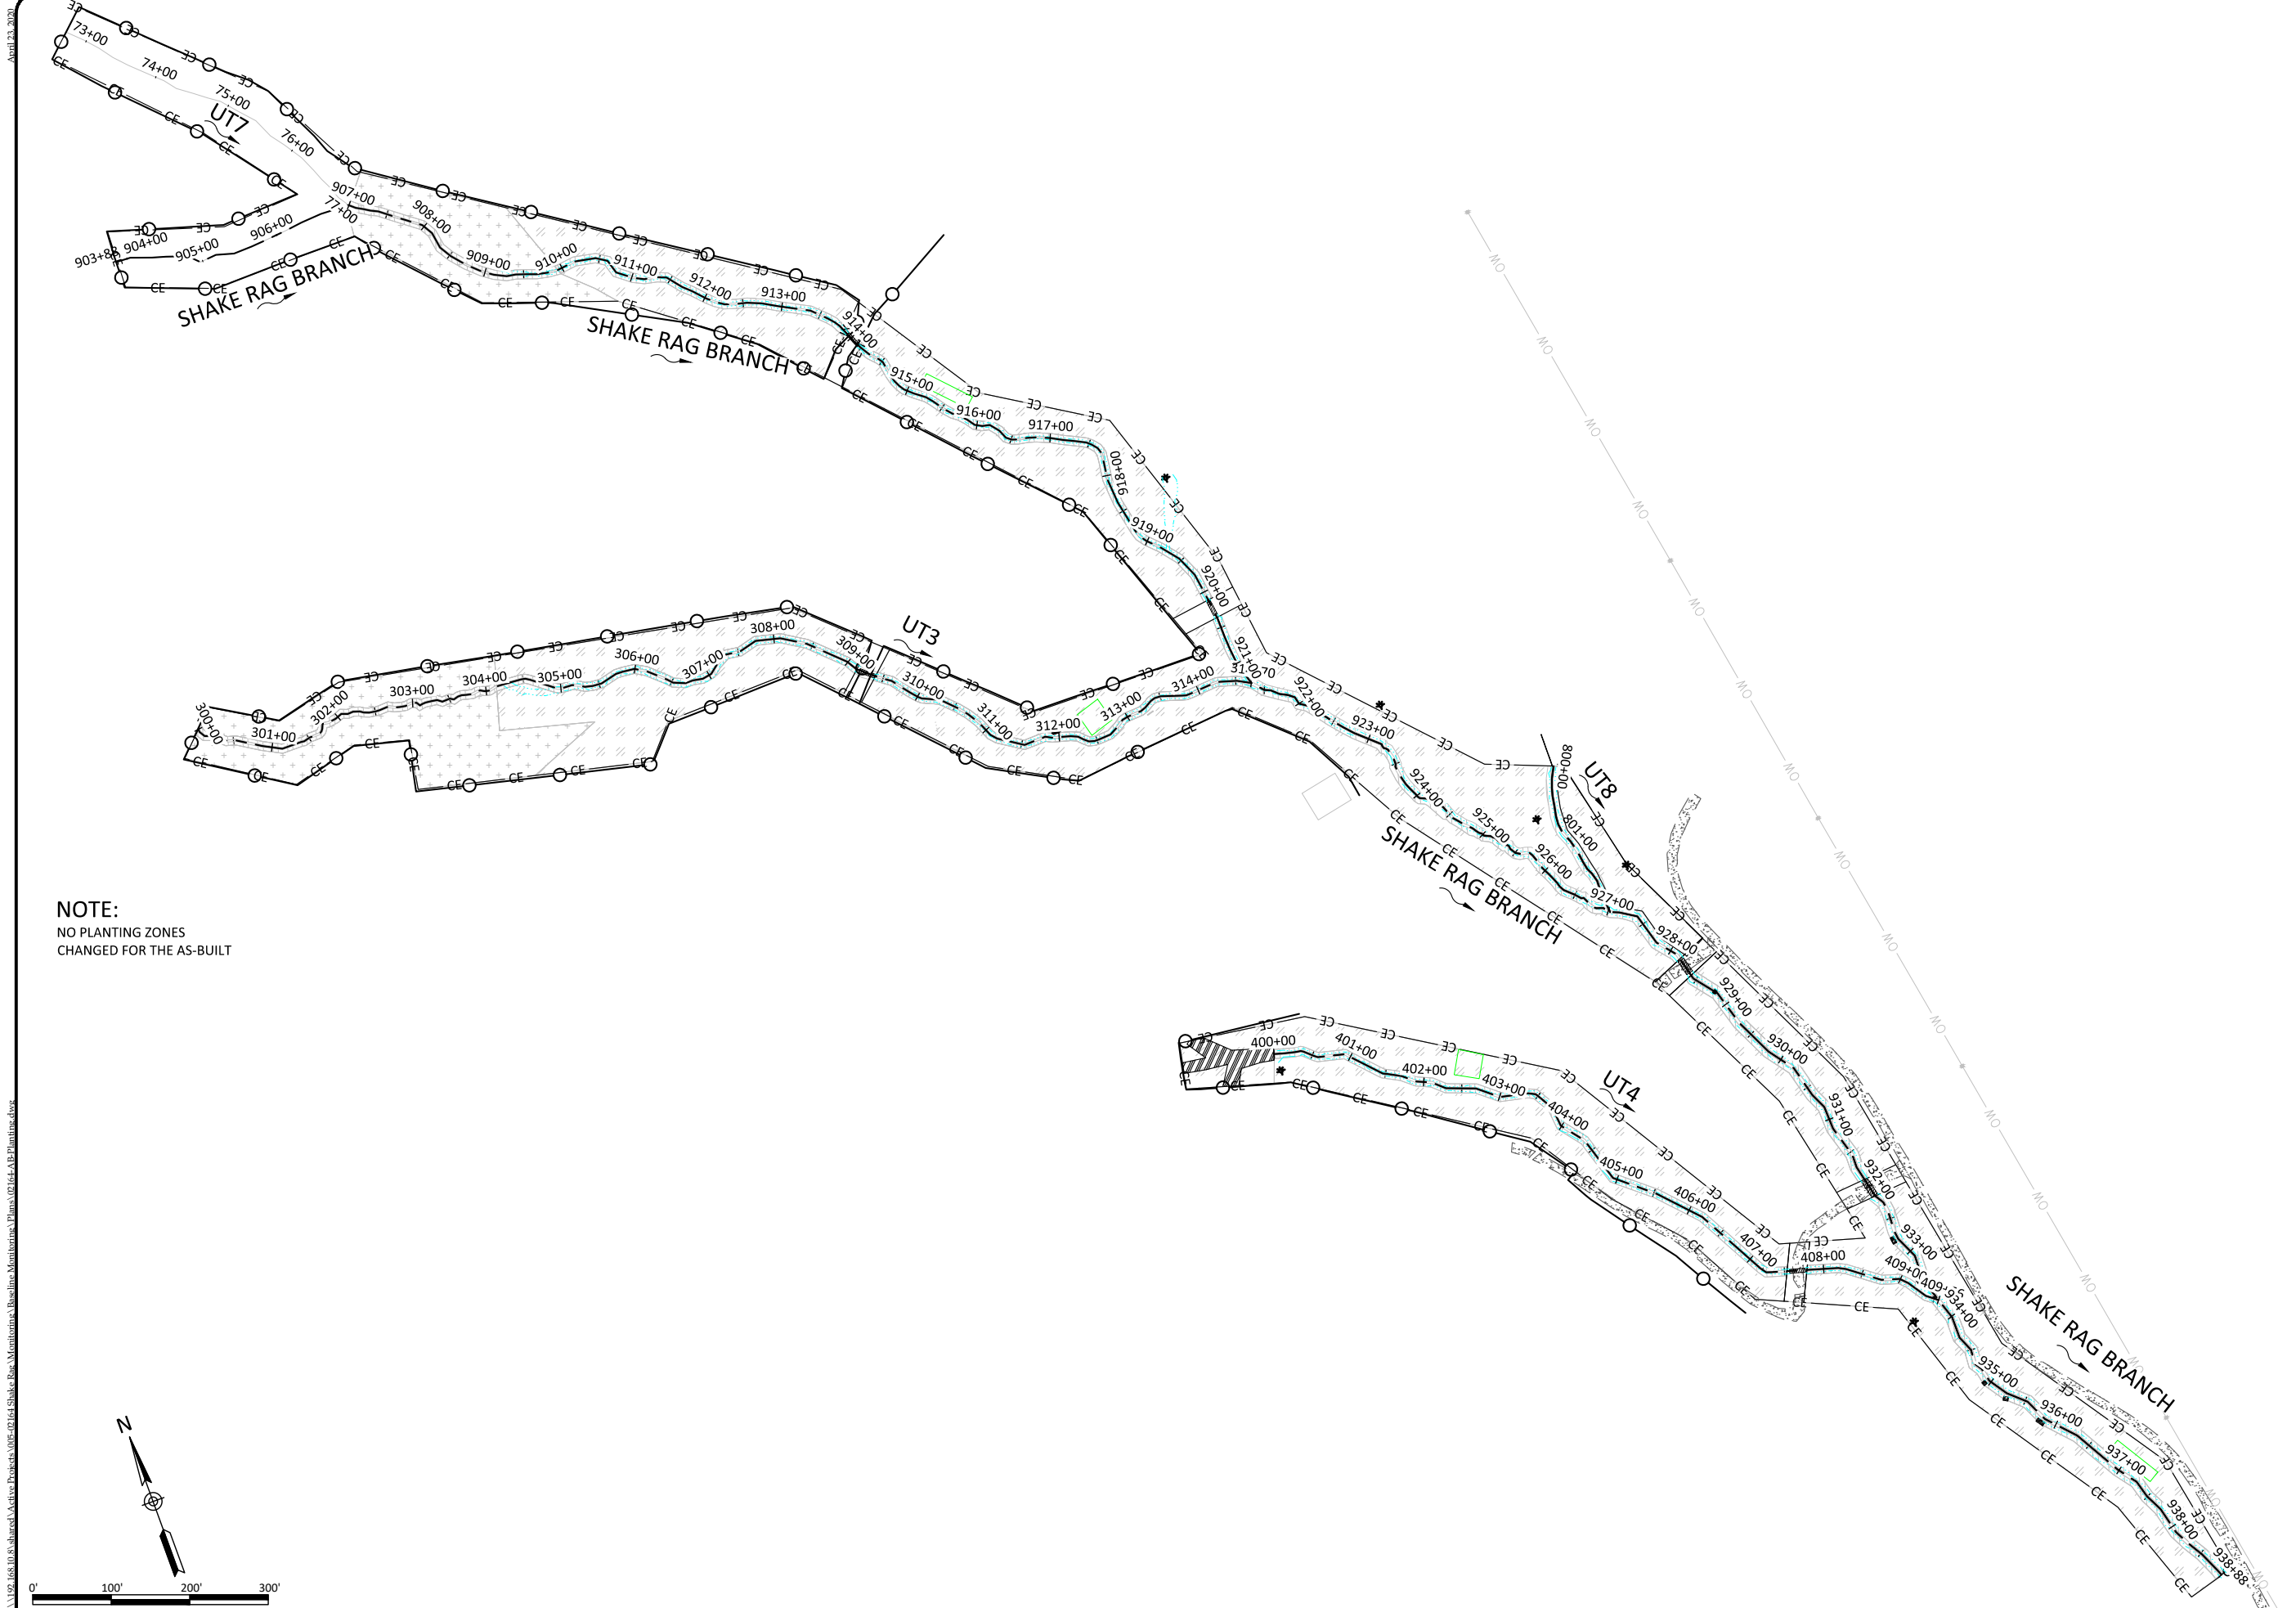
NOTE:  
NO PLANTING ZONES  
CHANGED FOR THE AS-BUILT

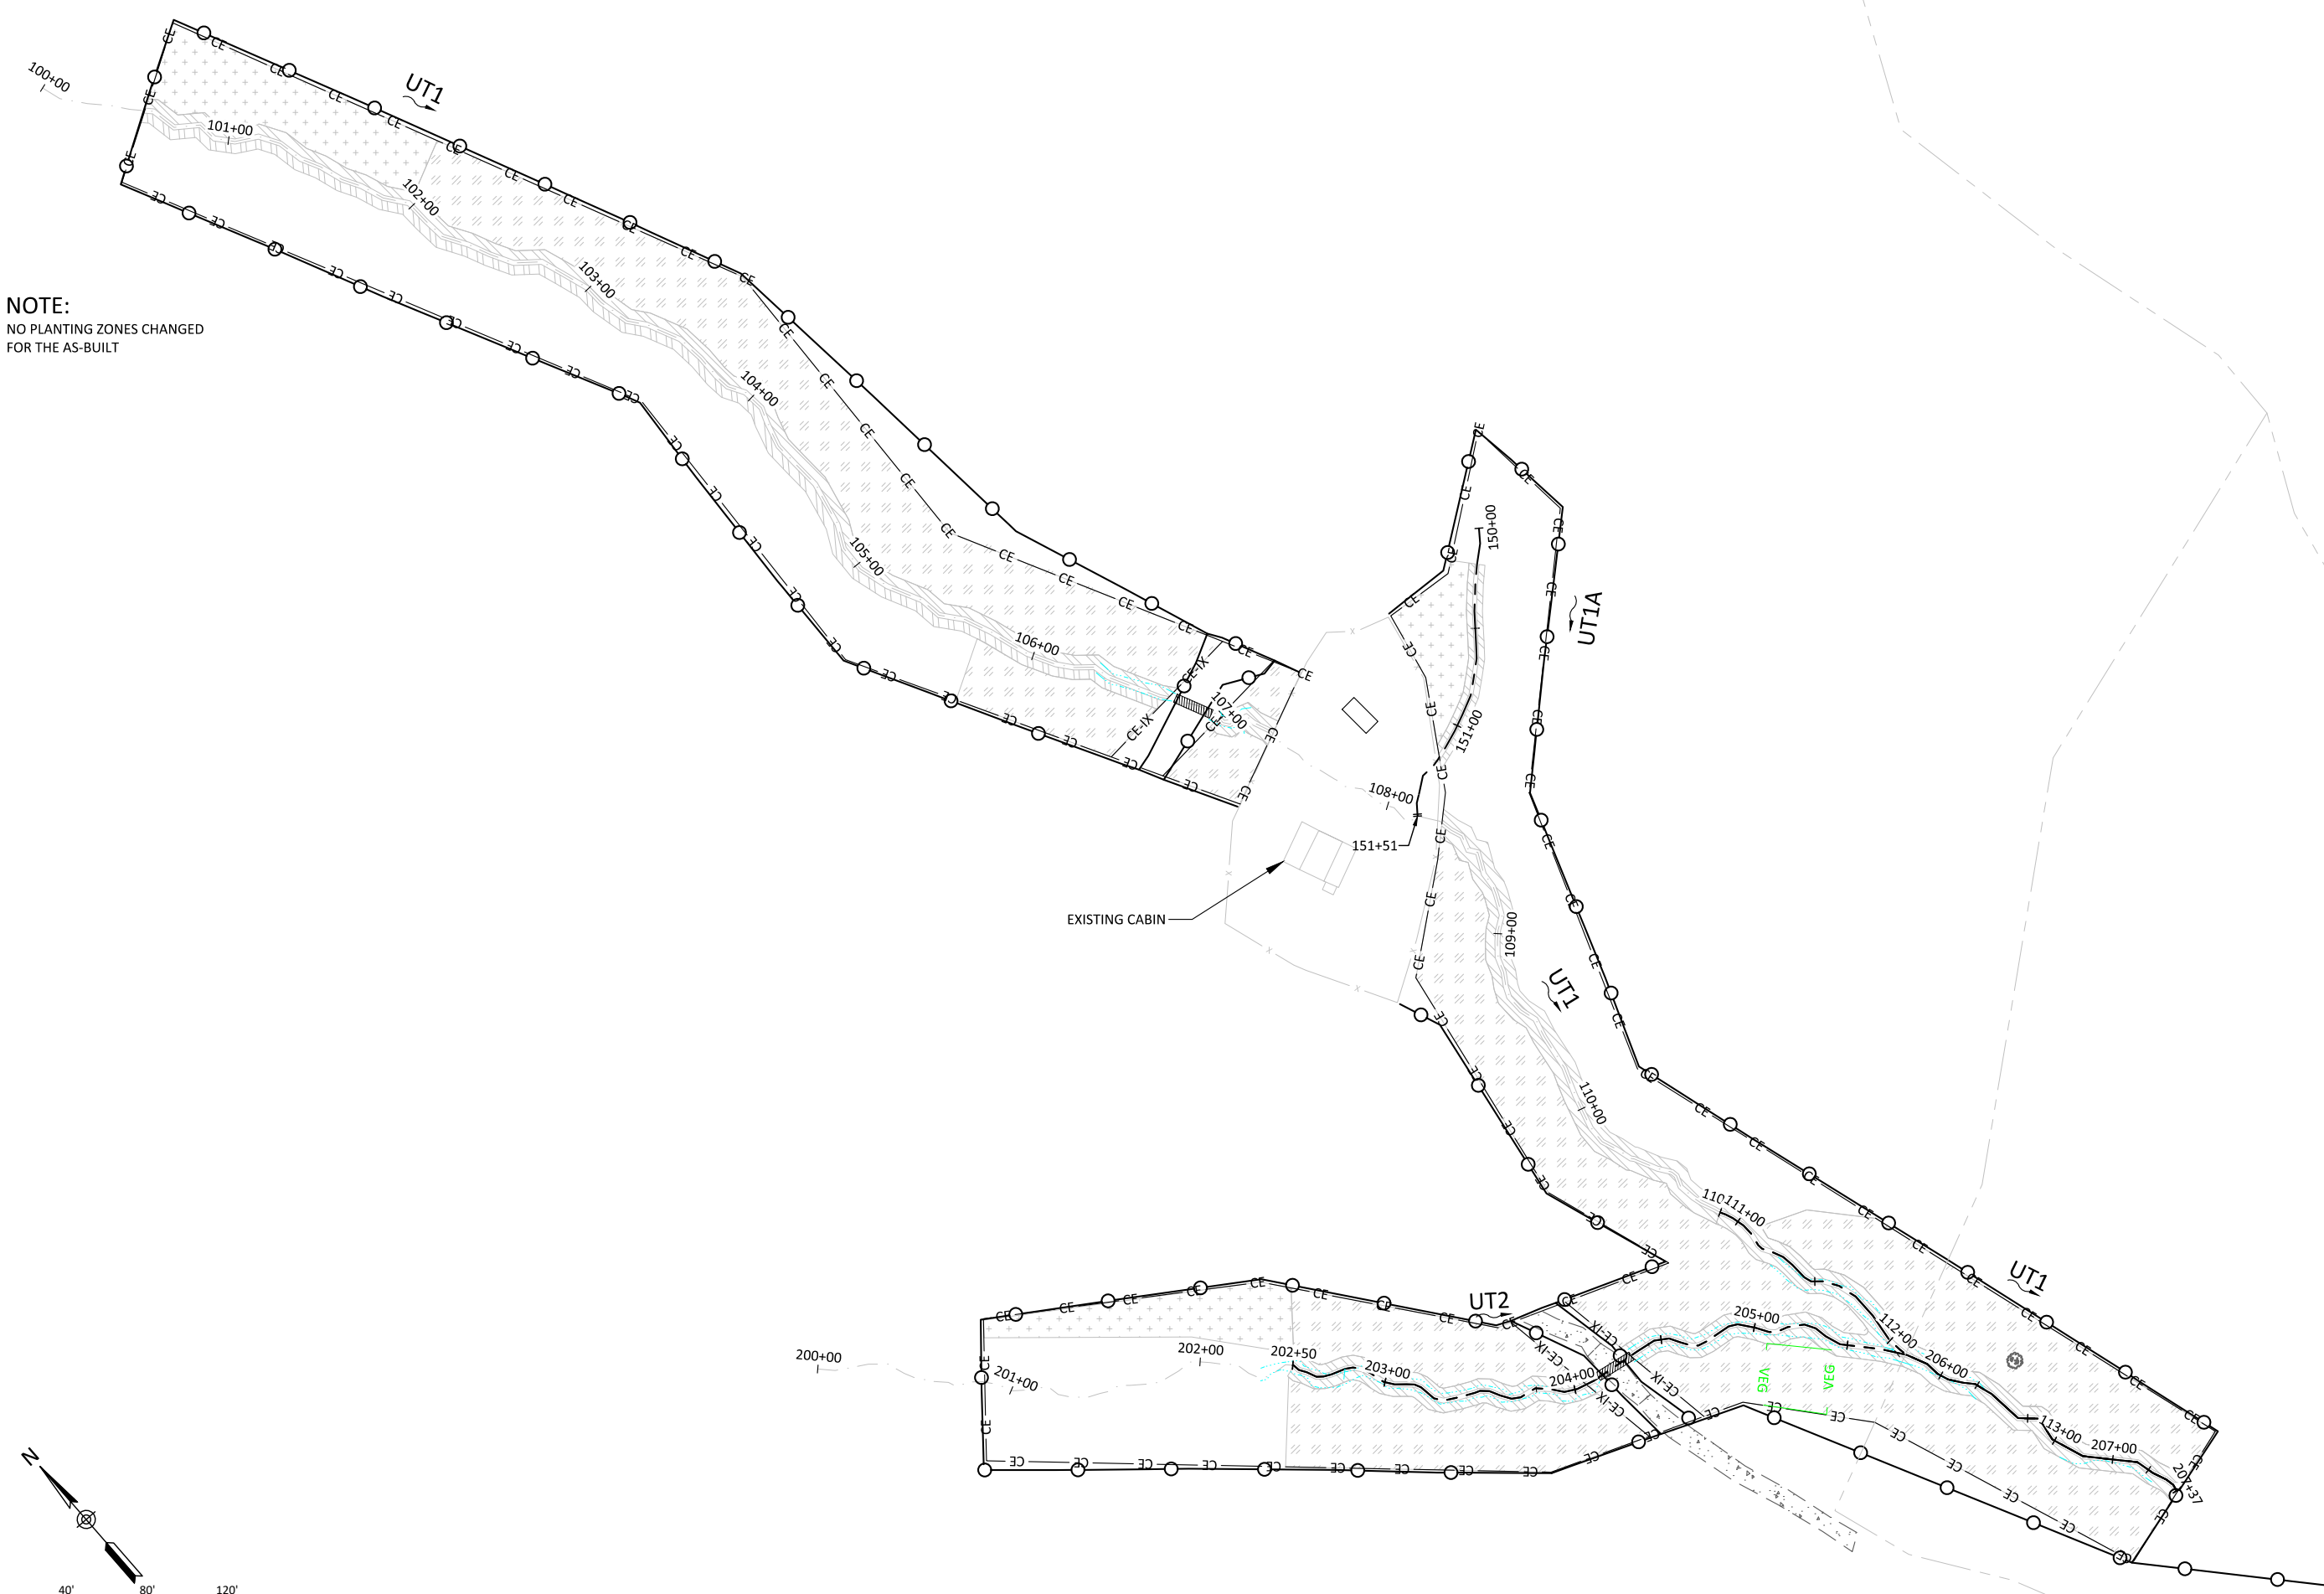
**NOTE:**  
NO PLANTING ZONES CHANGED  
FOR THE AS-BUILT
