Silas Creek Stream Restoration Project Winston-Salem, North Carolina

Mitigation Plan

North Carolina Department of Environment and Natural Resources
Ecosystem Enhancement Program

Mitigation Plan Prepared By Buck Engineering PC

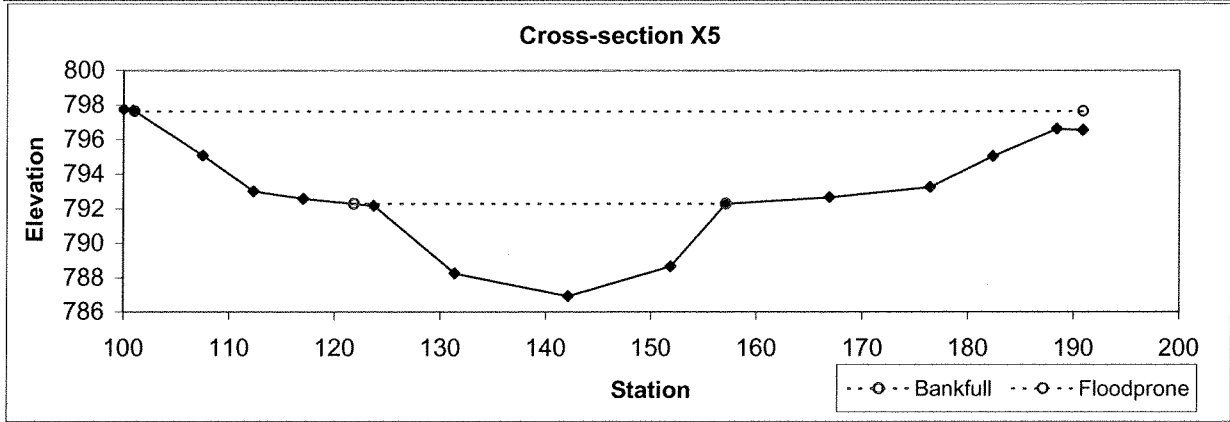
Feature	Stream Type	BKF Area	BKF Width	BKF Depth	Max BKF Depth	W/D	BH Ratio	ER	BKF Elev	TOB Elev
Pool		119.8	35.27	3.4	5.36	10.39	1.8	2.5	792.27	796.62

Pt #	North	East	Elevation	Note	Station
1939	859015.8	1613823	797.7401	X5 LMON	100
1938	859016.1	1613822	797.6844	X5 TOP	100.8857
1937	859018.5	1613816	795.0667	X5	107.5112
1936	859020.3	1613811	792.9919	X5 TOE	112.2833
1935	859021.9	1613807	792.5657	X5	117.0449
1934	859021.4	1613799	792.158	X5 LBKFL	123.7048
1933	859026	1613793	788.2296	X5 LCHNL	131.3716
1931	859030.8	1613783	786.9155	X5 TW	142.1228
1930	859037.6	1613776	788.6442	X5 RCHNL	151.8445
1929	859040.4	1613771	792.2725	X5 RBKFL	157.1061
1927	859045.7	1613763	792.6487	X5	166.909
1926	859051.6	1613755	793.2467	X5 TOE	176.4046
1925	859055.1	1613750	795.0279	X5	182.3739
1924	859058.3	1613745	796.6204	X5 TOP	188.4181
1923	859059.3	1613743	796.5314	X5 RMON	190.9047

Bankfull Line	
Station	Elevation
121.83	792.27
157.11	792.27

Floodprone Line	
Station	Elevation
101.02	797.63
190.9	797.63

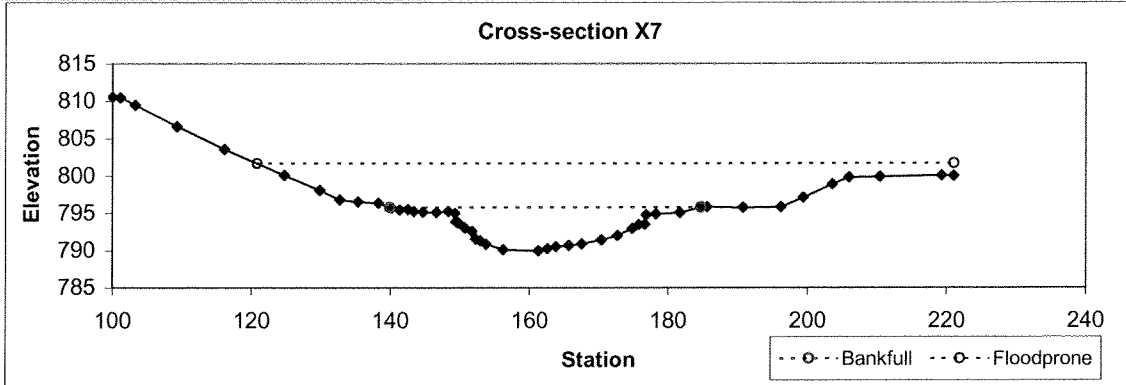
Cross-section Data:

Feature	Stream Type	BKF Area	BKF Width	BKF Depth	Max BKF Depth	W/D	BH Ratio	ER	BKF Elev	TOB Elev
Pool		135.5	44.74	3.03	5.87	14.77	1.7	2.2	795.8	800.05

Pt #	North	East	Elevation	Note	Station
2675	859911.5	1614010	810.5368	X7RPIN	100
2674	859910.9	1614011	810.4303	X7	101.0923
2673	859909.8	1614012	809.4452	X7	103.237
2672	859907.3	1614018	806.6361	X7	109.2909
2671	859904.9	1614024	803.584	X7	116.0965
2670	859901.6	1614032	800.0816	X7	124.7221
2669	859900.5	1614037	798.0853	X7	129.843
2668	859899.6	1614040	796.7652	X7	132.6584
2667	859898.7	1614043	796.5091	X7	135.3198
2666	859897.5	1614045	796.3263	X7 RBKF	138.2746
2665	859896.3	1614047	795.7142	X7	140.2005
2664	859895.9	1614048	795.4358	X7	141.3447
2663	859895.5	1614049	795.4761	X7	142.4667
2662	859894.9	1614050	795.222	X7	143.3395
2661	859894.1	1614051	795.1466	X7	144.6912
2660	859893	1614053	795.0845	X7	146.6193
2659	859892	1614054	795.2149	X7	148.3296
2658	859891.1	1614055	794.9622	X7	149.2839
2657	859891	1614055	793.8392	X7	149.4097
2656	859890.8	1614055	793.6967	X7	149.8388
2655	859890.1	1614056	793.0525	X7 REWW	150.7291

2654	859889.4	1614057	792.5739	X7	151.7359
2653	859889.3	1614057	791.5435	X7	152.2465
2652	859889	1614058	791.3381	X7	152.9405
2651	859888.6	1614059	790.861	X7	153.7762
2650	859887.3	1614061	790.1131	X7 TW	156.2571
2649	859887.8	1614066	789.9316	X7	161.2551
2648	859887.4	1614068	790.2401	X7	162.5986
2647	859886.9	1614069	790.4982	X7	163.8501
2646	859886.7	1614071	790.6631	X7	165.6561
2645	859886.2	1614072	790.8947	X7	167.576
2644	859885.8	1614075	791.3898	X7	170.3818
2643	859885.7	1614078	792.0167	X7	172.7111
2642	859885.1	1614080	792.9572	X7 LEW	174.8254
2641	859885	1614081	793.4616	X7	175.7326
2640	859884.8	1614082	793.5191	X7	176.6212
2639	859884.7	1614082	794.798	X7	176.5905
2638	859884.5	1614083	794.8717	X7	178.2106
2637	859883.2	1614086	795.0689	X7	181.6887
2636	859882.1	1614089	795.8045	X7 BKF	184.6575
2635	859881.5	1614090	795.8247	X7	185.5699
2634	859881.6	1614095	795.7489	X7	190.7245
2633	859880	1614101	795.8242	X7	196.1918

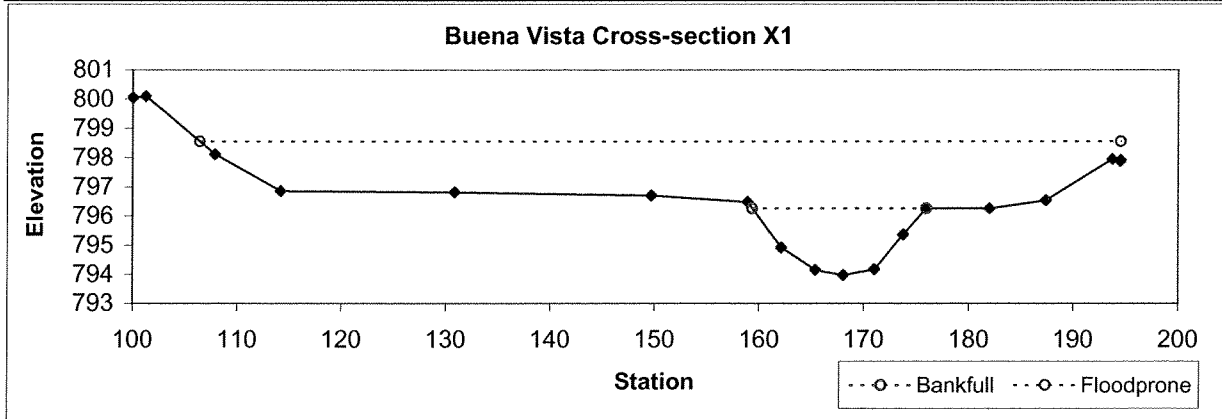
Feature	Stream Type	BKF Area	BKF Width	BKF Depth	Max BKF Depth	W/D	BH Ratio	ER	BKF Elev	TOB Elev
Riffle	E	24.9	16.64	1.5	2.29	11.09	1.7	5.3	796.26	797.94

Pt #	North	East	Elevation	Note	Station
1693	858955.3	1614054	800.0408	X1 RMON	100
1720	858955.2	1614054	800.0439	X1 RMON	100.0315
1719	858954.3	1614053	800.0938	X1 TOP	101.2598
1718	858948.2	1614049	798.109	X1	107.9073
1717	858943	1614046	796.8527	X1 TOE	114.1899
1716	858932.4	1614033	796.8023	X1	130.8487
1715	858920.6	1614018	796.6974	X1	149.6997
1714	858915.9	1614010	796.4719	X1 BKFL	158.9074
1713	858914.8	1614006	794.9167	X1	162.1197
1712	858912.4	1614004	794.1454	X1 RCHNL	165.3987
1710	858910.6	1614002	793.9638	X1 TW	168.0628
1709	858908.4	1614000	794.1718	X1 LCHNL	171.0254
1708	858906.3	1613998	795.3593	X1	173.7823
1707	858904.6	1613997	796.2554	X1 BKFL	175.991
1706	858900.5	1613993	796.2625	X1	181.9967
1705	858896.7	1613989	796.5307	X1 TOE	187.3854
1704	858893.3	1613983	797.9437	X1 TOP	193.7251
1694	858892.7	1613983	797.8788	X1 LMON I	194.4824
1703	858892.6	1613983	797.908	X1 LMON	194.5282

Bankfull Line	
Station	Elevation
159.35	796.26
175.99	796.26

Floodprone Line	
Station	Elevation
106.44	798.55
194.53	798.55

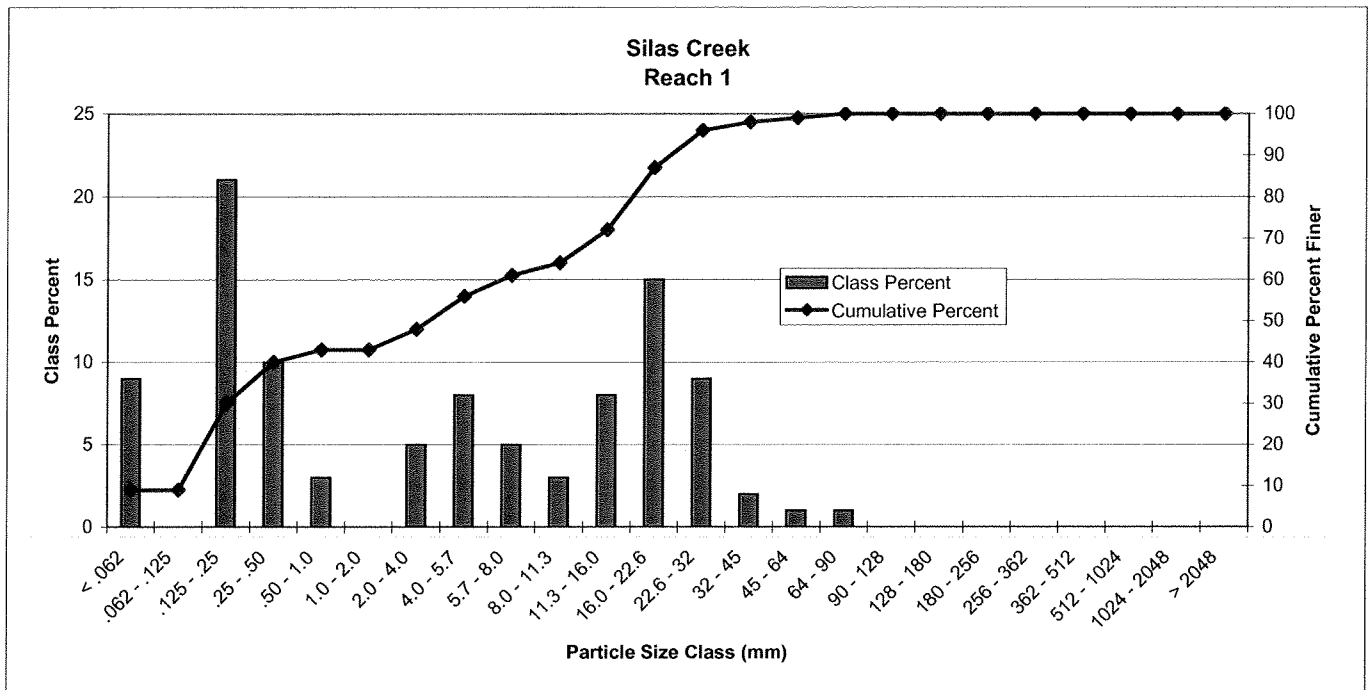
PEBBLE COUNT DATA SHEET

SITE OR PROJECT:	SILAS CREEK
REACH/LOCATION:	REACH 1
DATE COLLECTED:	2/9/2004
FIELD COLLECTION BY:	JBP
DATA ENTRY BY:	EEG

Channel materials
D ₁₆ = 0.17mm
D ₃₅ = 0.38mm
D ₅₀ = 4.43mm
D ₈₄ = 21.28mm
D ₉₅ = 30.96mm

Annual pebble counts will be performed on all gravel-bed project reaches based on the percent of pools and riffles.

Success Criteria: Established D50 and D85 should increase in coarseness in riffles, and increase fineness in pools.

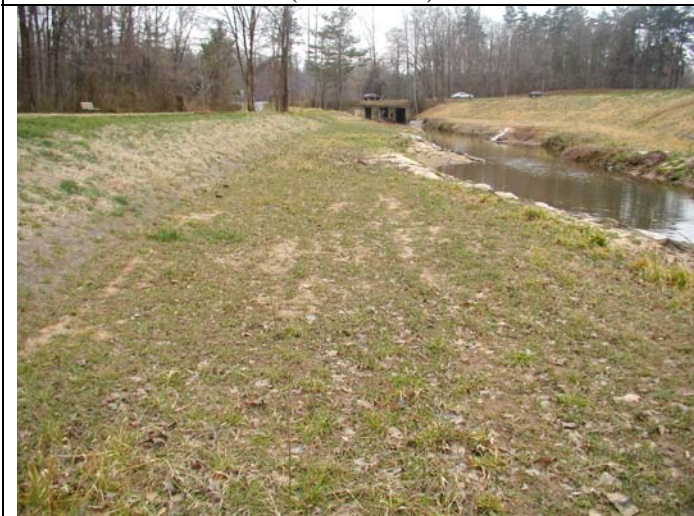
Photo 113- Vegetation Plot 1 (Silas Creek) looking downstream

Vegetation Plot 1- Photo 113

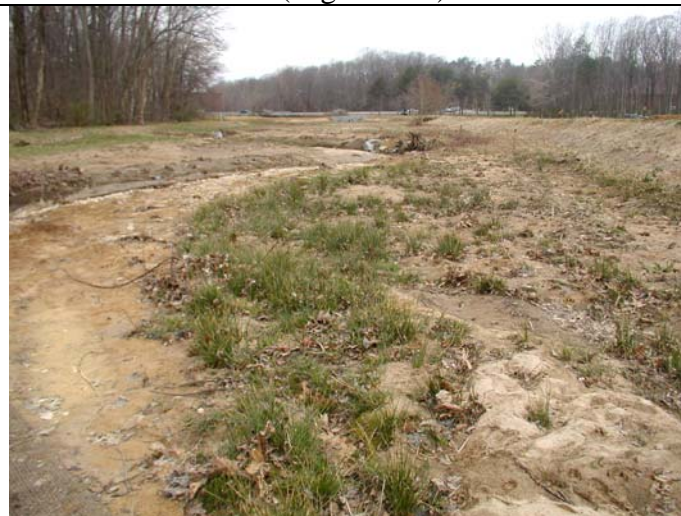
Photo 114- Vegetation Plot BV (Buena Vista Branch) looking downstream

Vegetation Plot BV- Photo 114
