Sink Hole Creek Mitigation Project

Year 2 Monitoring Report

Mitchell County, North Carolina

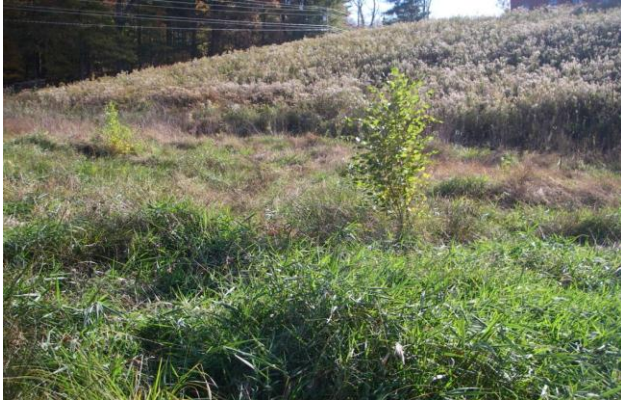
Photo 1: Veg Plot 1

1. Vegetation plots marked by t-posts at corners; herbaceous plot marked by stake within larger plot.
2. Planted vegetation flagged and tagged for future identification.

Photographs are used to visually document vegetation success in sample plots. Reference photos of tree and herbaceous condition within plots are taken at least once per year. Photos of the plots are included in Appendix A of this report.

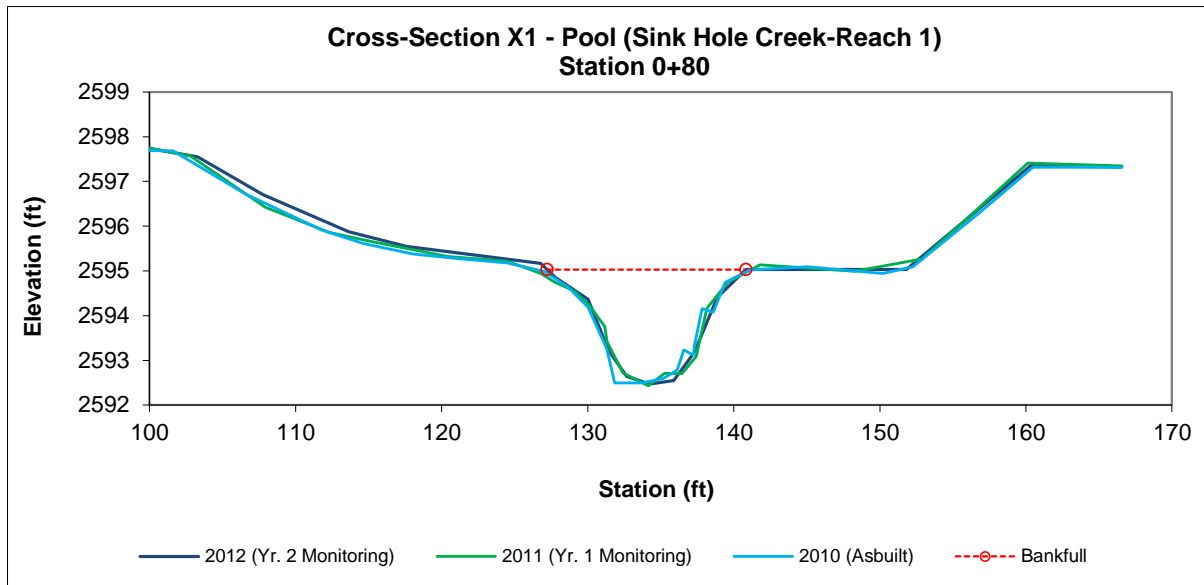
| Feature | Stream Type | BKF Area | BKF Width | BKF Depth | Max BKF Depth | W/D | BH Ratio | ER | BKF Elev | TOB Elev |
| Pool | Eb | 19 | 13.62 | 1.39 | 2.56 | 9.78 | 1 | 4.7 | 2595.03 | 2595.03 |

Geomorphic monitoring of restored stream reaches is being conducted over a five year period to evaluate the effectiveness of the restoration practices installed. Monitored stream parameters include channel dimension (cross-sections), profile (longitudinal survey), pattern (to a lesser degree for reasons noted below), bed composition, bank stability, bankfull flows, and stability of reference sites documented by photographs. Crest gauges, as well as high flow marks, will be used to document the occurrence of bankfull events. The methods used and any related success criteria are described below for each parameter. To monitor stream success criteria, fifteen permanent cross-sections, four longitudinal profile sections and two crest gauges were installed. Detailed channel morphology was surveyed with a total station and survey data is georeferenced.

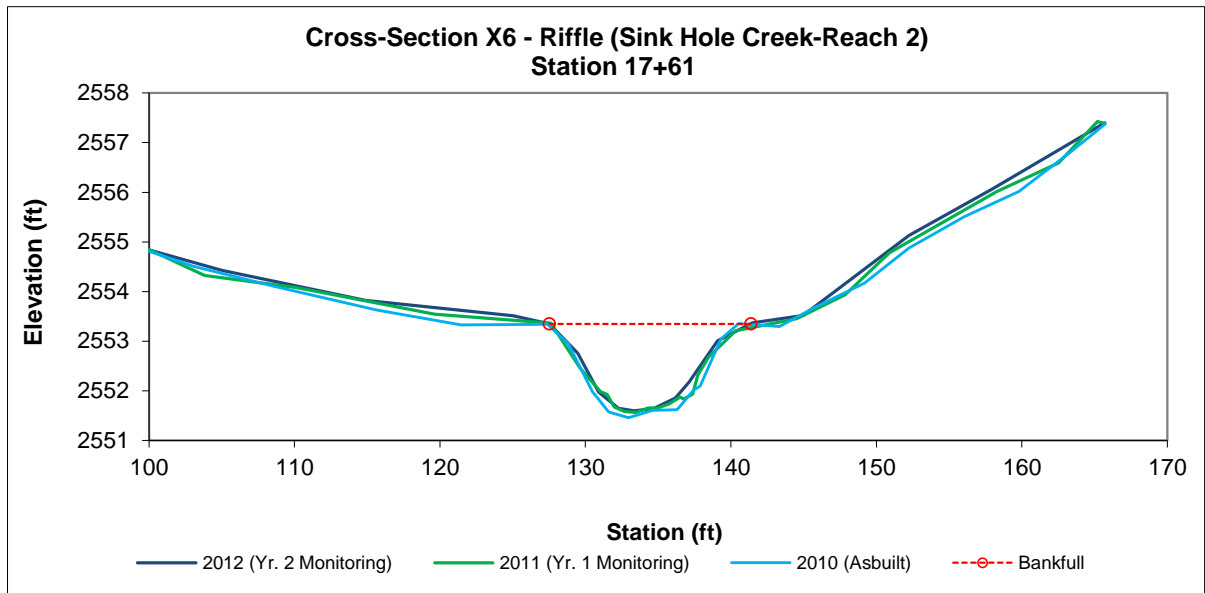
| Feature | Stream Type | BKF Area | BKF Width | BKF Depth | Max BKF Depth | W/D | BH Ratio | ER | BKF Elev | TOB Elev |
| Riffle | Eb | 13.8 | 13.85 | 1 | 1.75 | 13.86 | 1 | 3.8 | 2553.35 | 2553.35 |

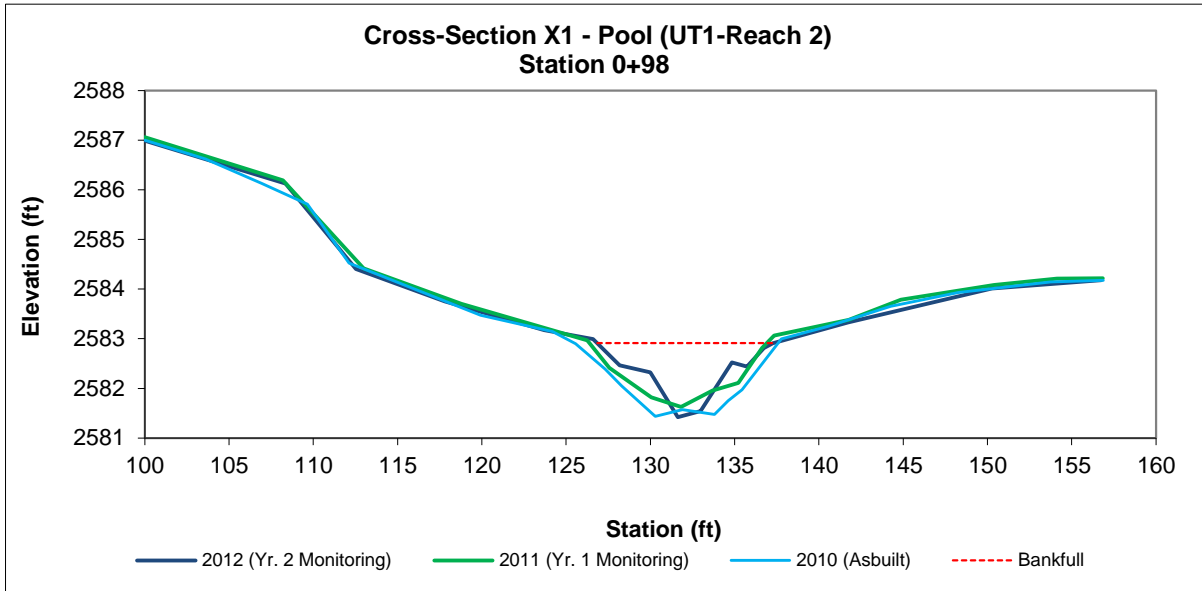
| Feature | Stream Type | BKF Area | BKF Width | BKF Depth | Max BKF Depth | W/D | BH Ratio | ER | BKF Elev | TOB Elev |
| Pool | B | 7.2 | 10.42 | 0.69 | 1.49 | 15.17 | 1 | 4.2 | 2582.91 | 2582.91 |

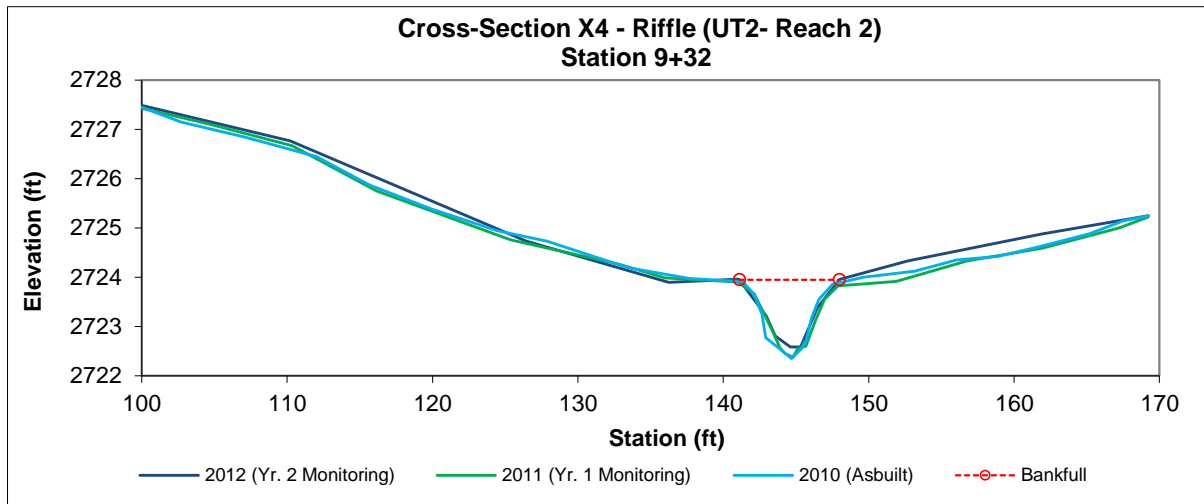
| Feature | Stream Type | BKF Area | BKF Width | BKF Depth | Max BKF Depth | W/D | BH Ratio | ER | BKF Elev | TOB Elev |
| Riffle | A | 5.1 | 6.88 | 0.74 | 1.37 | 9.31 | 1 | 6.9 | 2723.95 | 2723.95 |

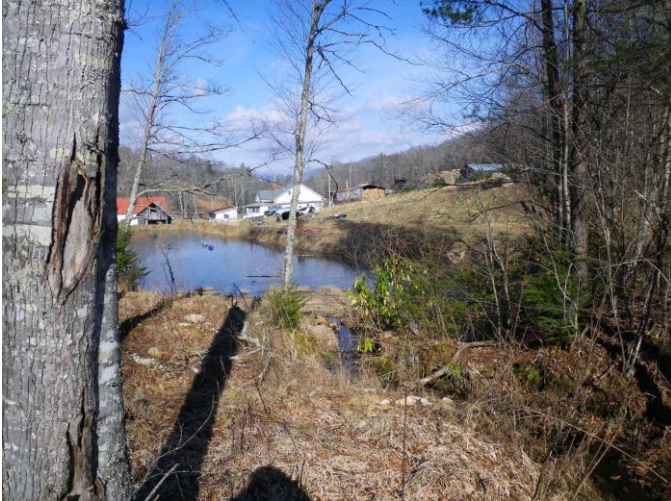
Photo Point 1: looking downstream

1. All points are marked with a wooden stake and flagging tape. For channel points, the stake is set up on an adjacent bank.

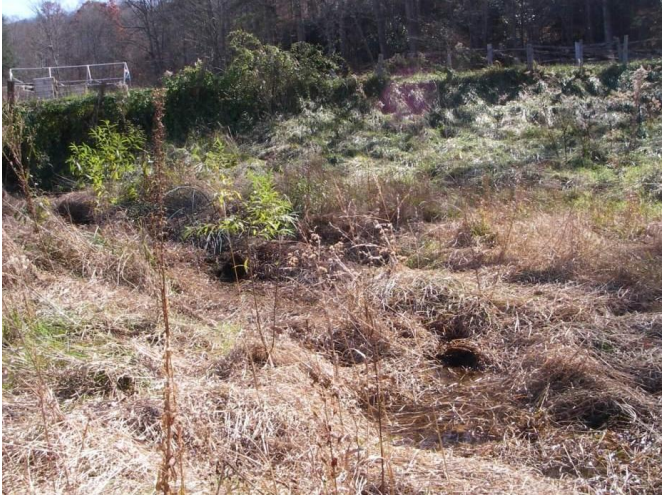
UT1 Photo Point 1: looking upstream

1. Photo point locations are shown on the plan views in the actual location the picture was taken.
2. All points are marked with a wooden stake and flagging tape. For channel points, the stake is set up on an adjacent bank.

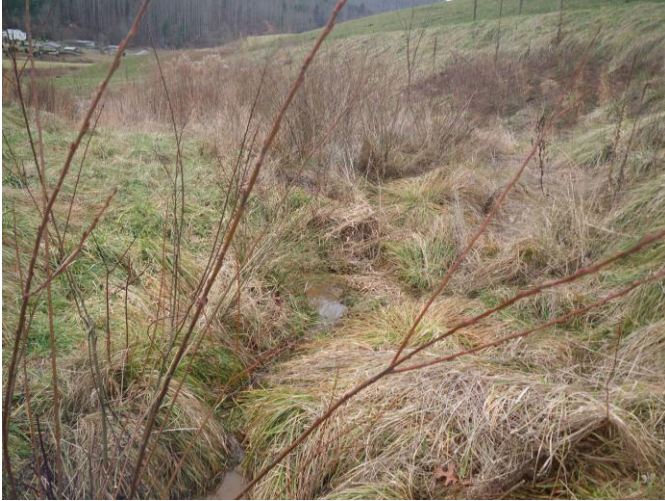
Photo Point 1: looking downstream

1. Photo point locations are shown on the plan views in the actual location the picture was taken.
2. All points are marked with a wooden stake and flagging tape. For channel points, the stake is set up on an adjacent bank.
3. Cattle (mostly a couple of calves) made it through fencing around photo point 14. Baker approached landowner; landowner indicated he would be fixing the fence.
