# Sink Hole Creek Mitigation Project

## Year 4 Monitoring Report

### Mitchell County, North Carolina

Date Submitted: December, 2014

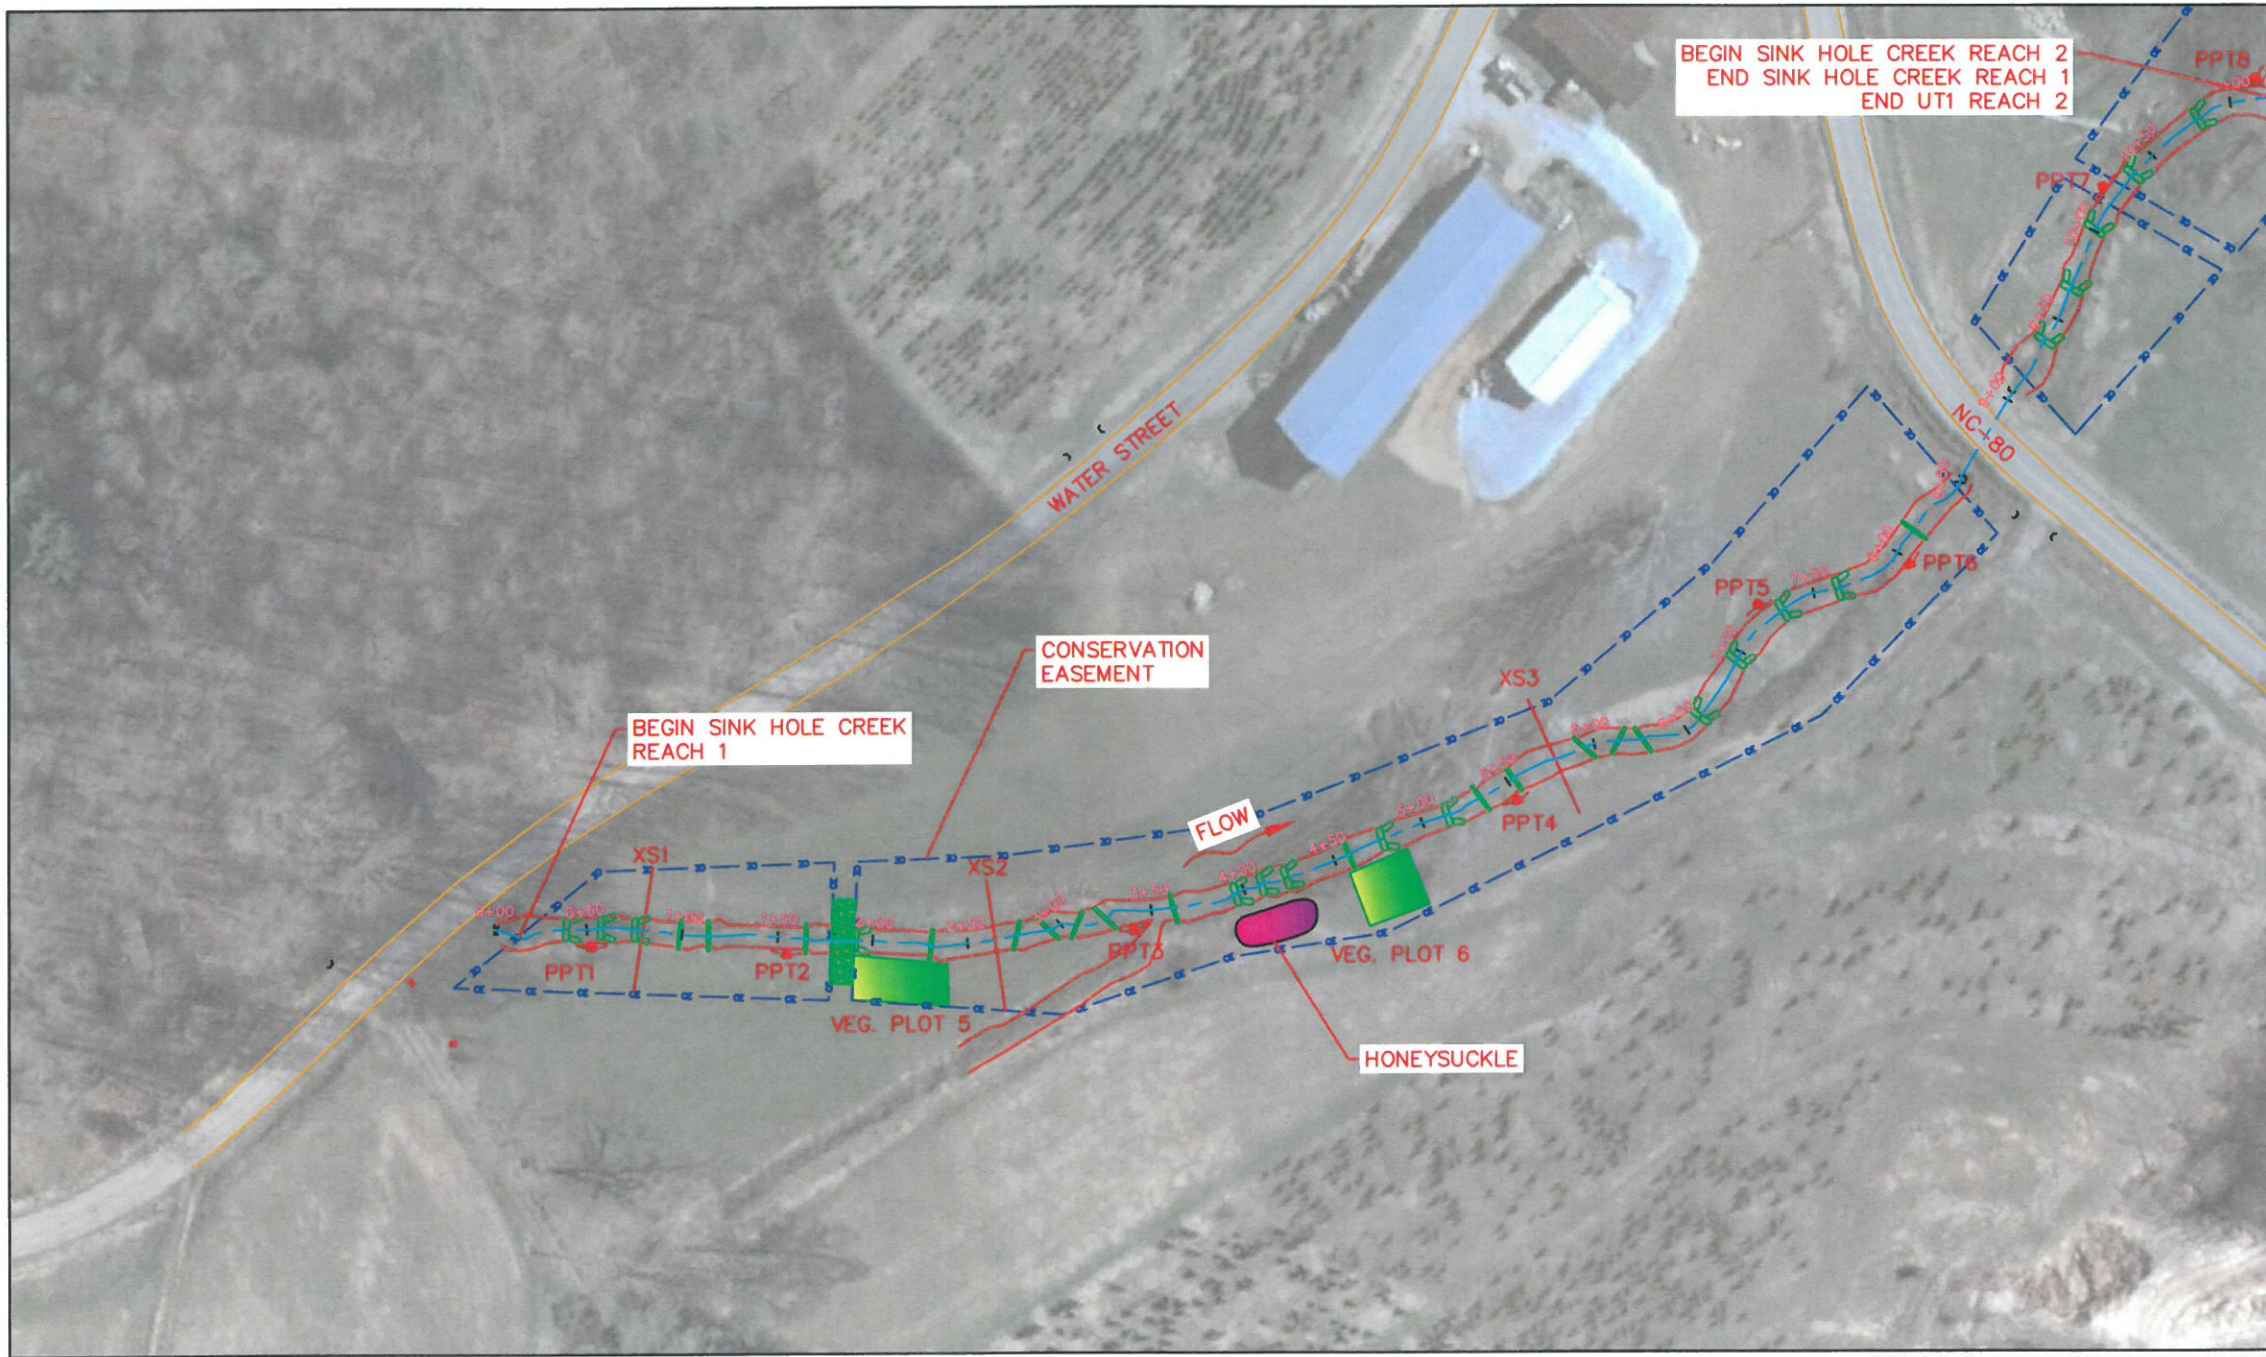
SINK HOLE CREEK  
CURRENT CONDITION  
PLAN VIEW  
YEAR 4 MONITORING

The current conditions plan view (CCPV) depicts the monitoring features for the Sink Hole Creek Mitigation Project. The plan set also provides call outs at locations where stream and vegetation problem areas are present. Figure 2 illustrates the project as it is delineated by reach.

Table 7 in Appendix A presents information on the stem counts for each of the vegetation monitoring plots. Data from the Year 4 monitoring event showed a range of 243-607 planted stems per acre, with approximately 85.8% of the stems showing no signs of damage. The average density of planted bare root stems, based on data collected from the eight monitoring plots during Year 4 monitoring, is 464.5 stems per acre which indicates that the Site is meeting the minimum success interim criteria of 320 trees per acre by the end of Year 3 and the final success criteria of 260 trees per acre by the end of Year 5. The only plot that falls below the 260 trees per acre is veg. plot 1 which is impacted by thick stands of reed canary grass. The locations of the vegetation plots are shown on the CCPV.

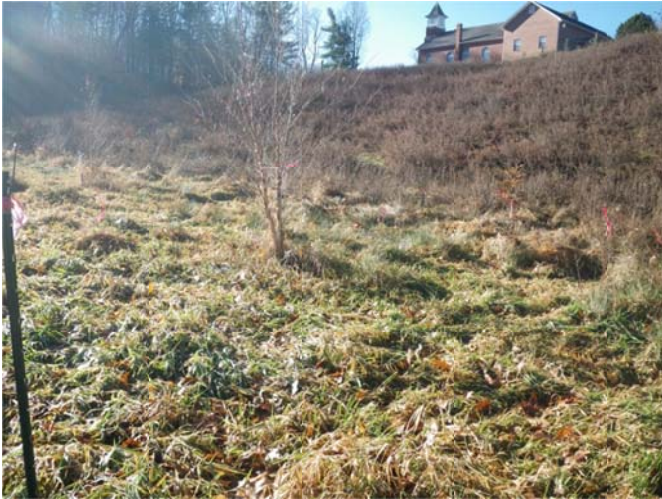
Photo 1: Veg. Plot 1

1. Vegetation plots marked by t-posts at corners; herbaceous plot marked by stake within larger plot.
2. Planted vegetation flagged and tagged for future identification.

Photographs are used to visually document vegetation success in sample plots. Reference photos of tree and herbaceous condition within plots are taken at least once per year. Photos of the plots are included in Appendix A of this report.

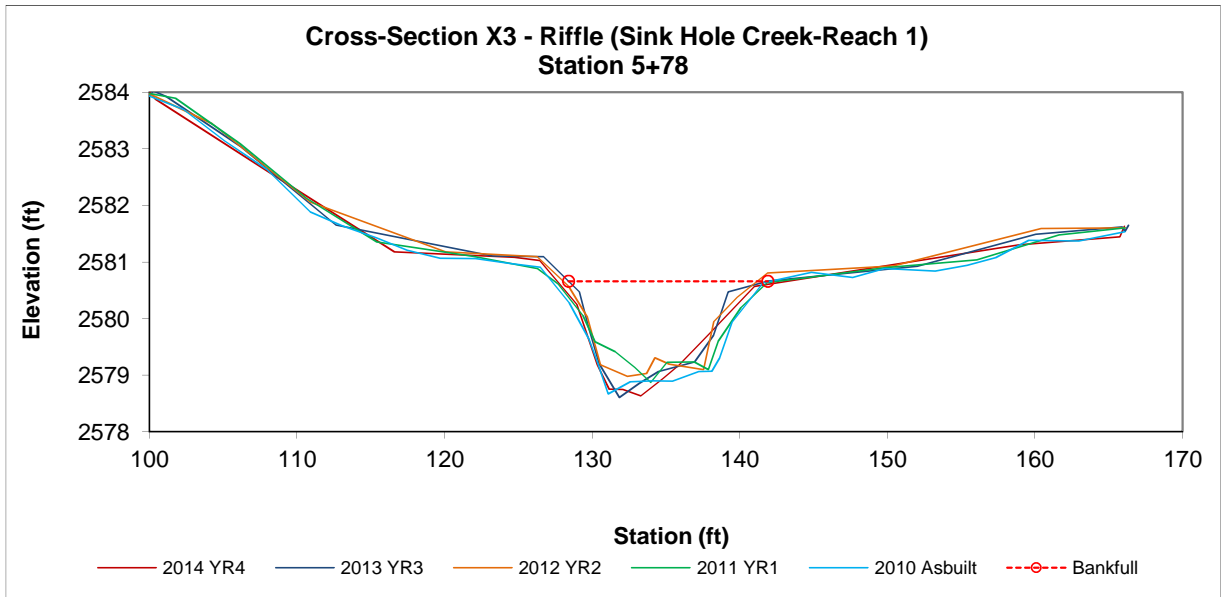
Feature	Stream Type	BKF Area	BKF Width	BKF Depth	Max BKF Depth	W/D	BH Ratio	ER	BKF Elev	TOB Elev
Riffle	Eb	14.4	13.02	1.11	1.93	11.78	1	4.4	2580.56	2580.57

The cross-sections show that there has been little to no adjustment in stream dimension across the project reaches since construction. What adjustment has occurred has primarily been observed in riffle cross-sections that are exhibiting signs of narrowing or pools that have gotten slightly deeper. Based on field observation, this narrowing of riffles can be attributed to herbaceous vegetation that has become well established. High stream flows over the last two years has caused pools to deepen as an adjustment to higher energy dissipation. At this time, cross-sectional measurements do not indicate any streambank or channel stability issues.

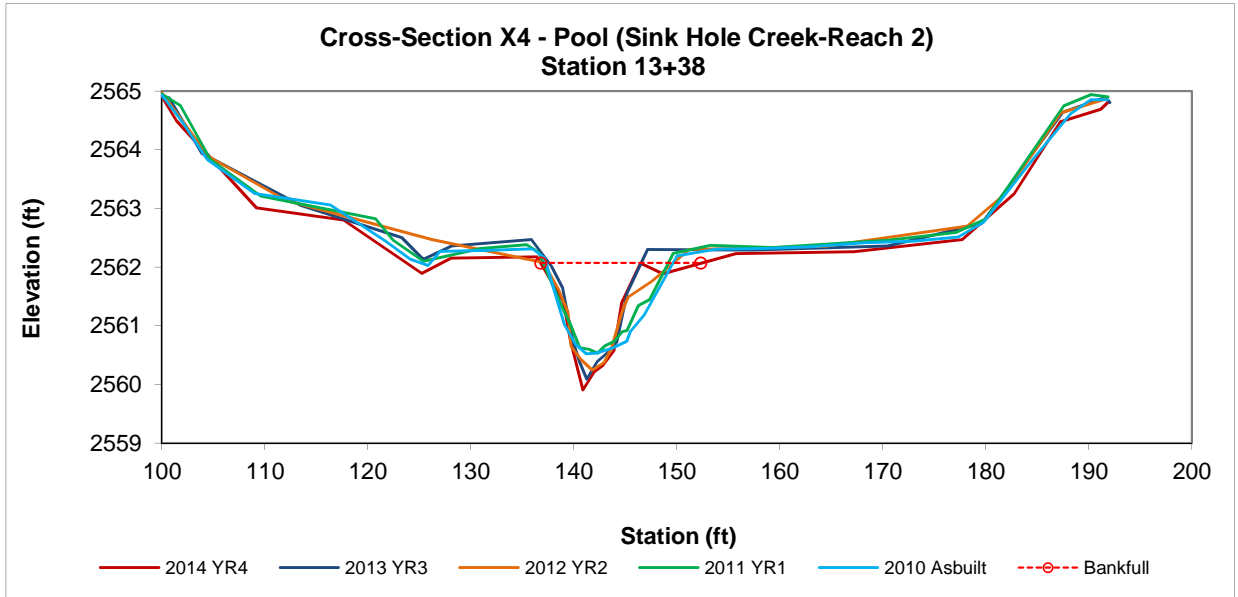
Feature	Stream Type	BKF Area	BKF Width	BKF Depth	Max BKF Depth	W/D	BH Ratio	ER	BKF Elev	TOB Elev
Pool	Cb	10.9	15.53	0.7	2.16	22.12	1	5.4	2562.07	2562.07

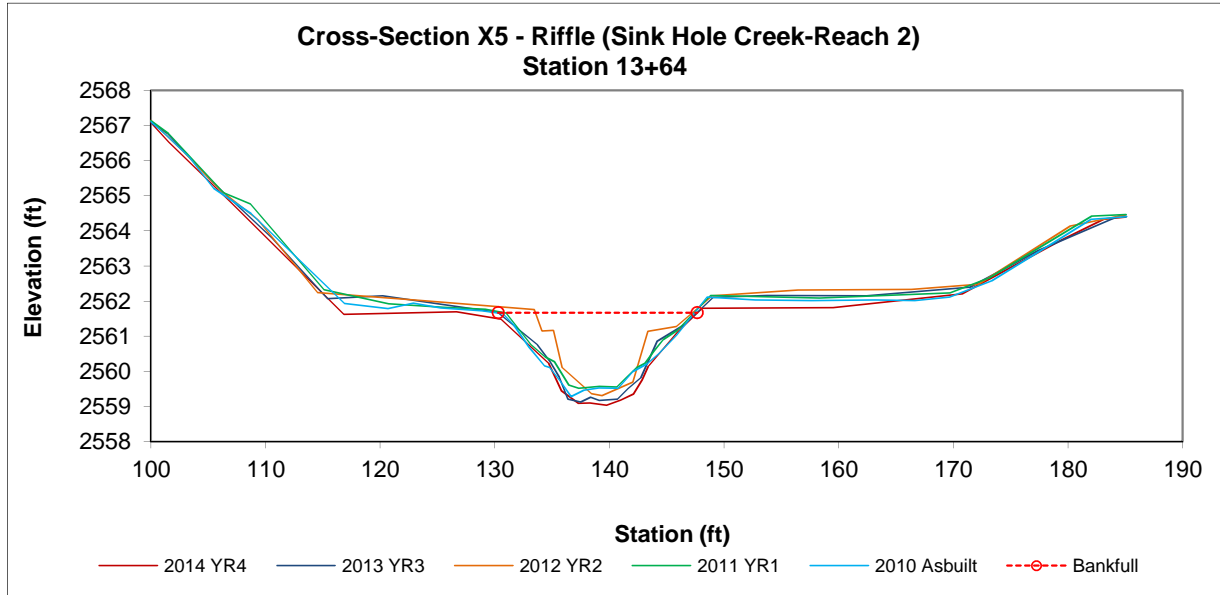
Feature	Stream Type	BKF Area	BKF Width	BKF Depth	Max BKF Depth	W/D	BH Ratio	ER	BKF Elev	TOB Elev
Riffle	Eb	27.1	20.6	1.32	2.64	15.64	1	3.6	2561.67	2561.69

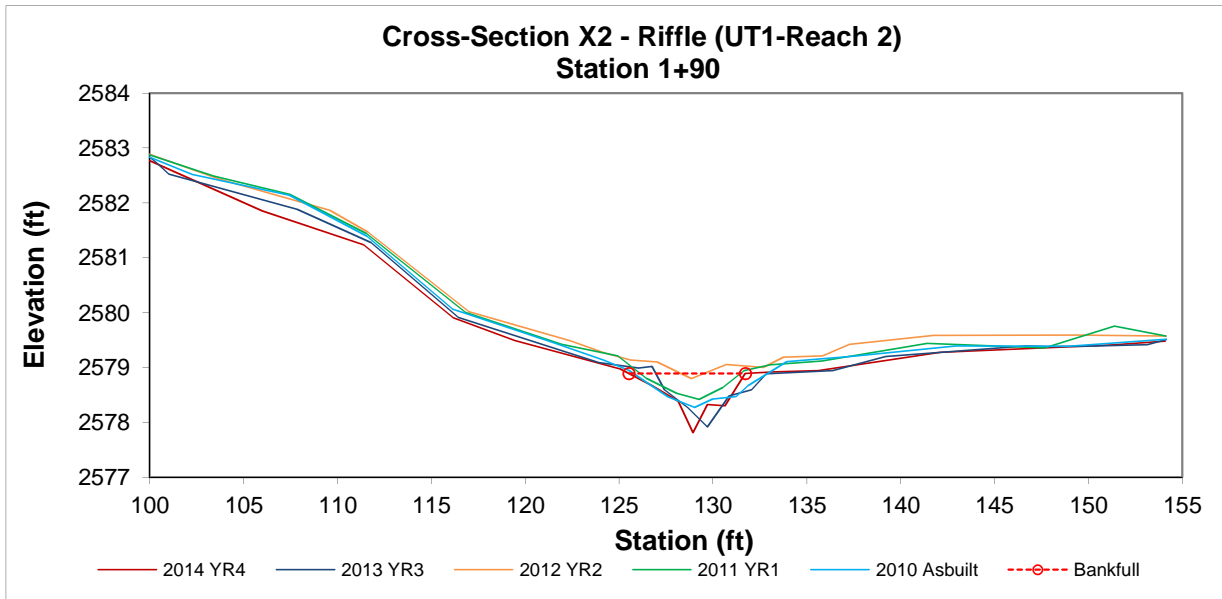
Feature	Stream Type	BKF Area	BKF Width	BKF Depth	Max BKF Depth	W/D	BH Ratio	ER	BKF Elev	TOB Elev
Riffle	Cb	2.7	6.18	0.44	1.08	13.9	1	6.2	2578.89	2578.92

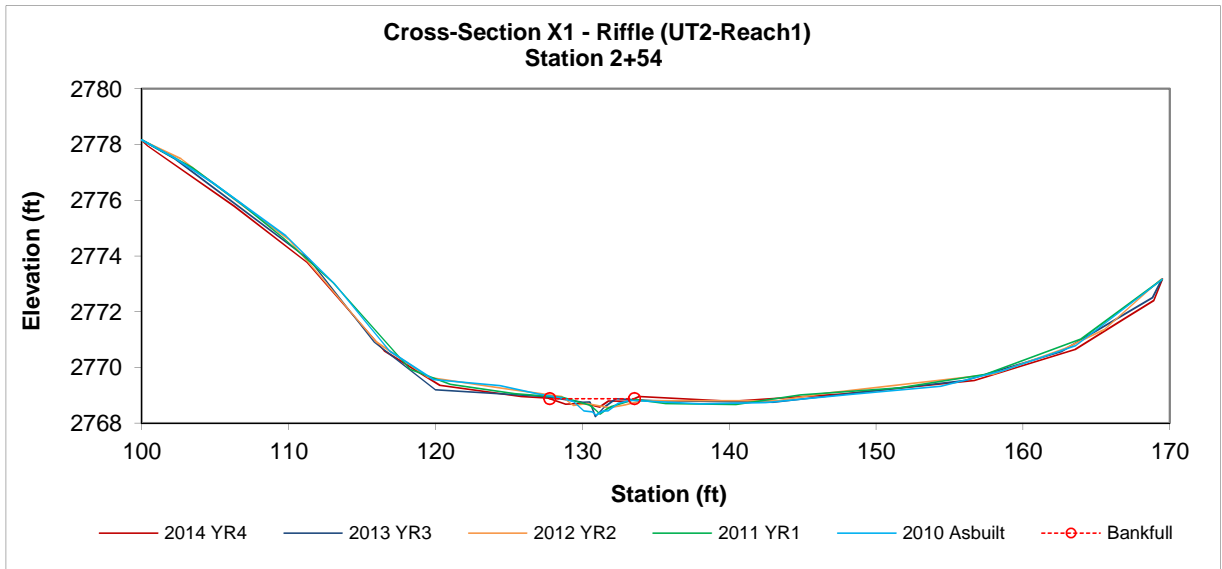
Feature	Stream Type	BKF Area	BKF Width	BKF Depth	Max BKF Depth	W/D	BH Ratio	ER	BKF Elev	TOB Elev
Riffle	Ba	0.8	5.78	0.15	0.3	39.79	1.1	4.7	2768.88	2768.9

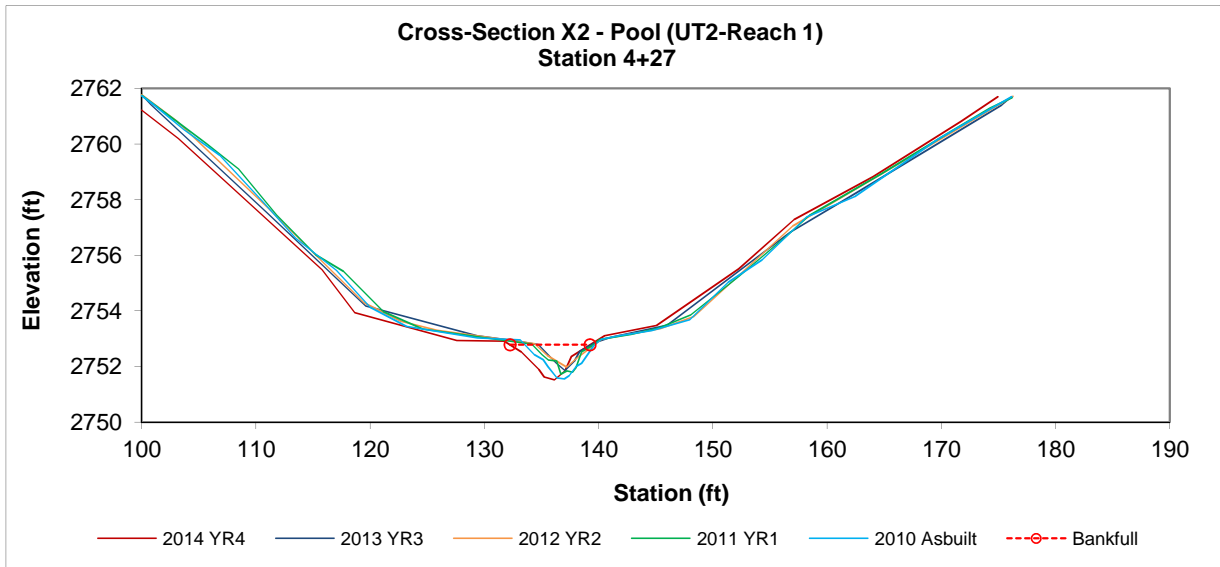
Feature	Stream Type	BKF Area	BKF Width	BKF Depth	Max BKF Depth	W/D	BH Ratio	ER	BKF Elev	TOB Elev
Pool		4.3	7.02	0.62	1.27	11.39	1.1	4.1	2752.78	2752.92

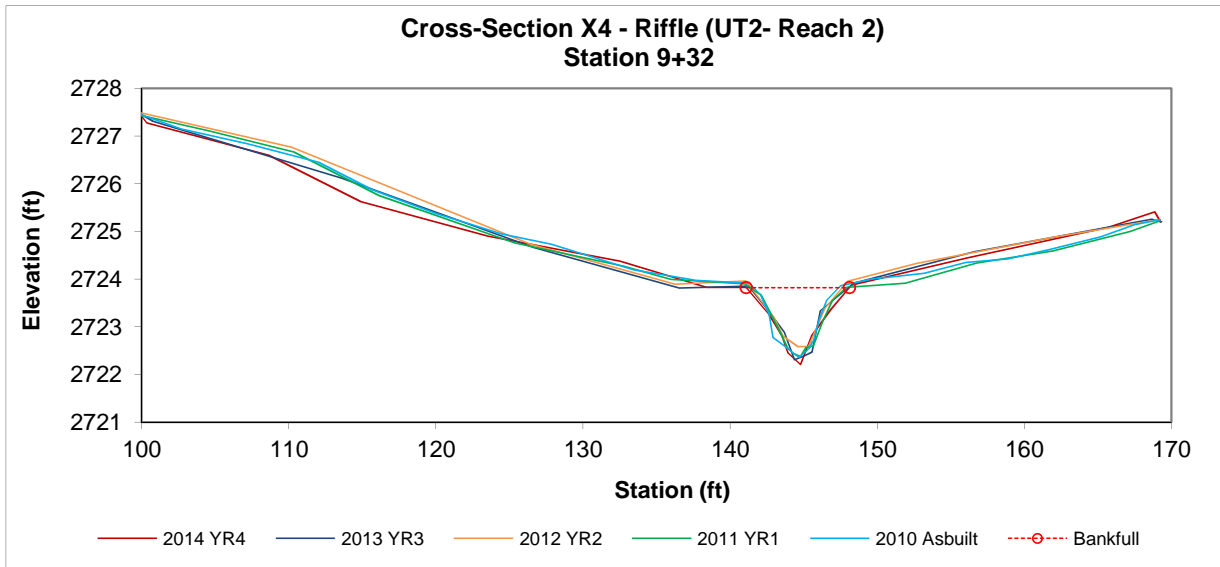
Feature	Stream Type	BKF Area	BKF Width	BKF Depth	Max BKF Depth	W/D	BH Ratio	ER	BKF Elev	TOB Elev
Riffle	Ba	5.1	7.01	0.73	1.61	9.59	1	7.4	2723.82	2723.82

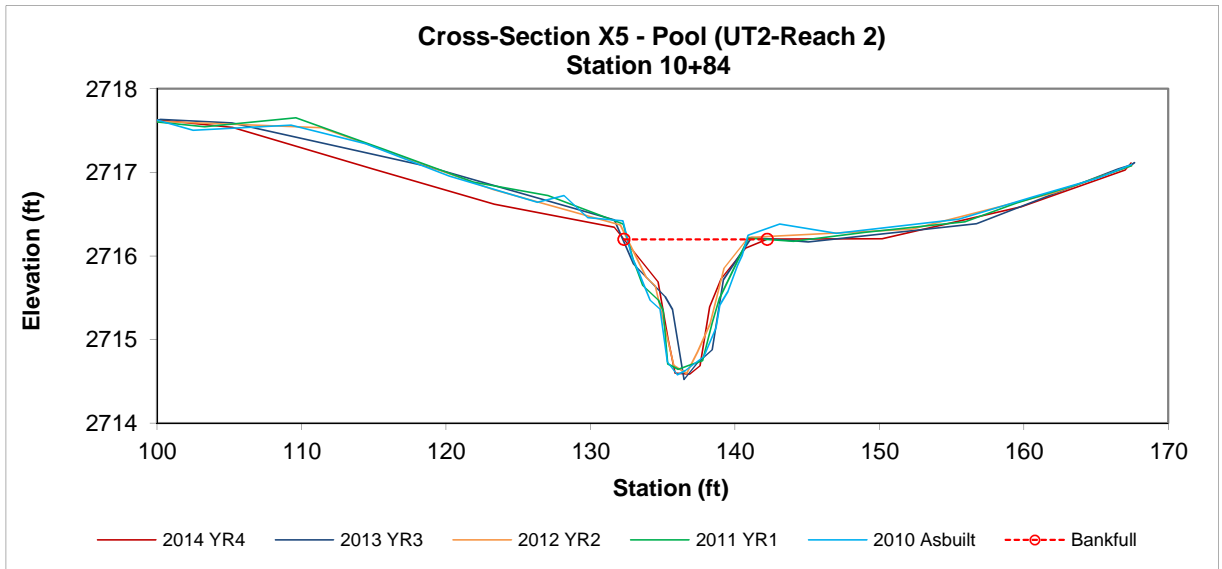
Feature	Stream Type	BKF Area	BKF Width	BKF Depth	Max BKF Depth	W/D	BH Ratio	ER	BKF Elev	TOB Elev
Pool		6.4	9.91	0.65	1.61	15.23	1	6.8	2716.2	2716.2

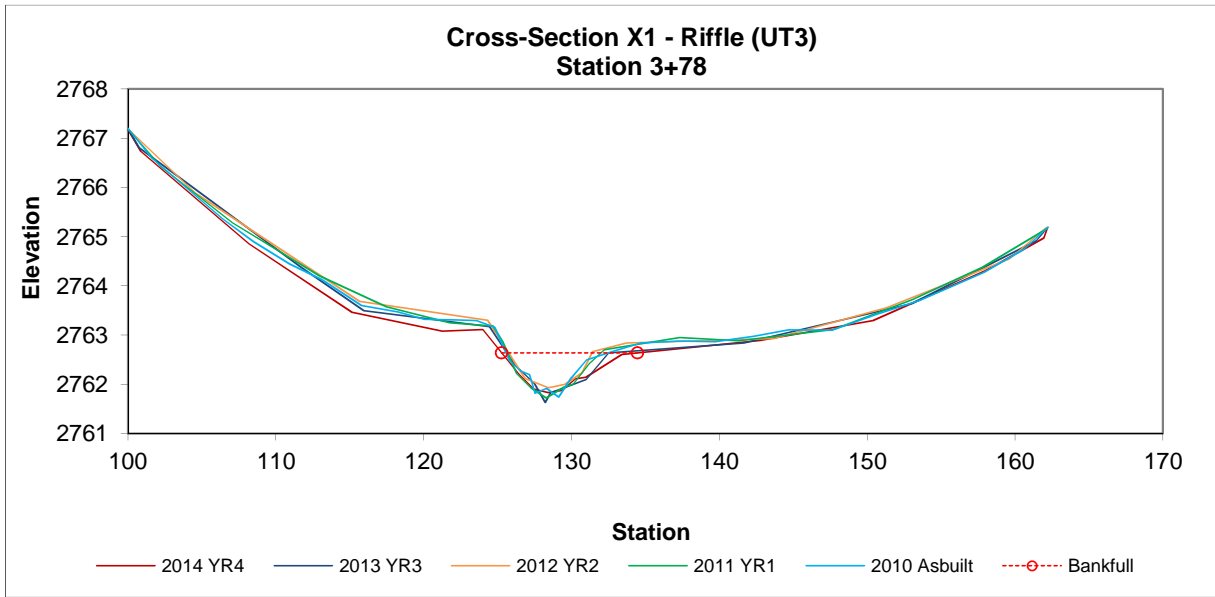
Feature	Stream Type	BKF Area	BKF Width	BKF Depth	Max BKF Depth	W/D	BH Ratio	ER	BKF Elev	TOB Elev
Riffle	Ba	3.9	9.19	0.43	0.81	21.39	1	3.9	2762.64	2762.61

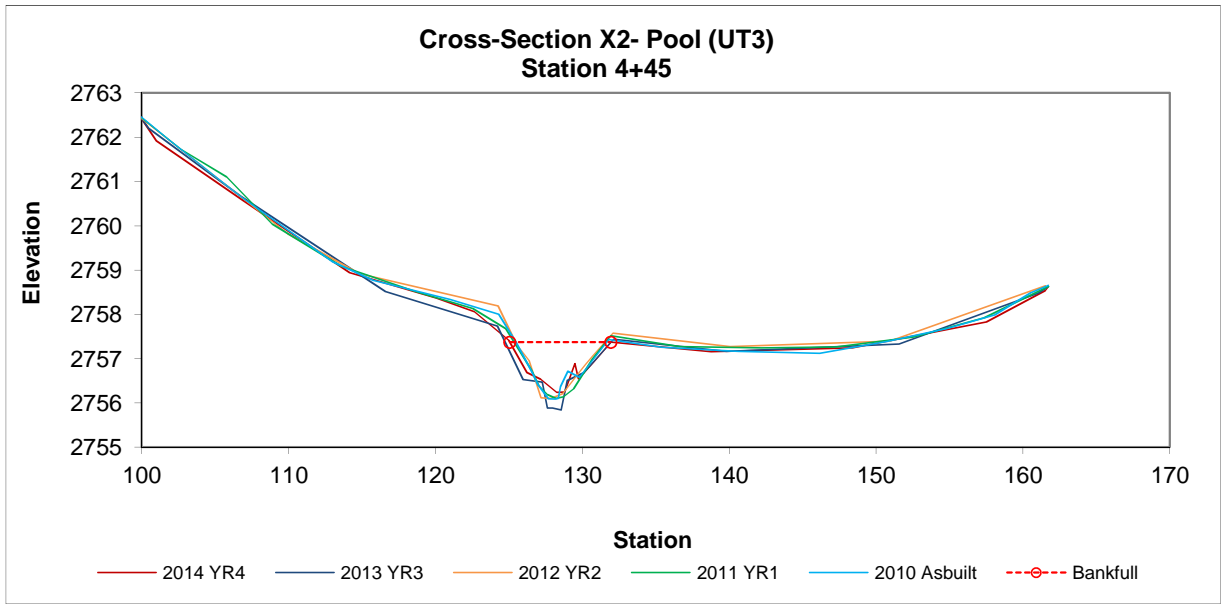
Feature	Stream Type	BKF Area	BKF Width	BKF Depth	Max BKF Depth	W/D	BH Ratio	ER	BKF Elev	TOB Elev
Pool		4.4	6.88	0.64	1.13	10.68	1	6.2	2757.37	2757.37

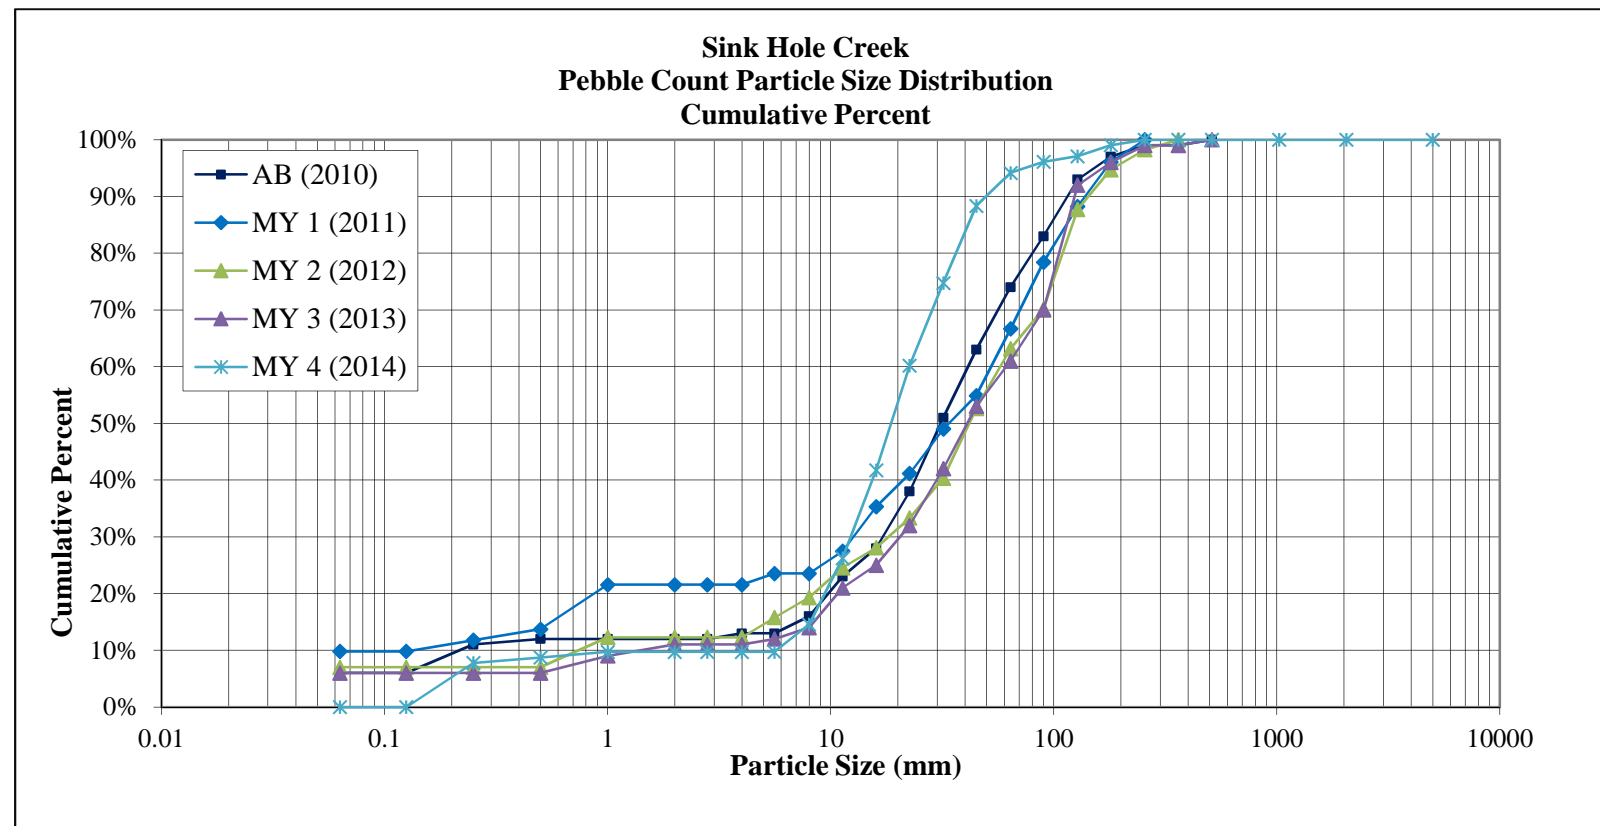
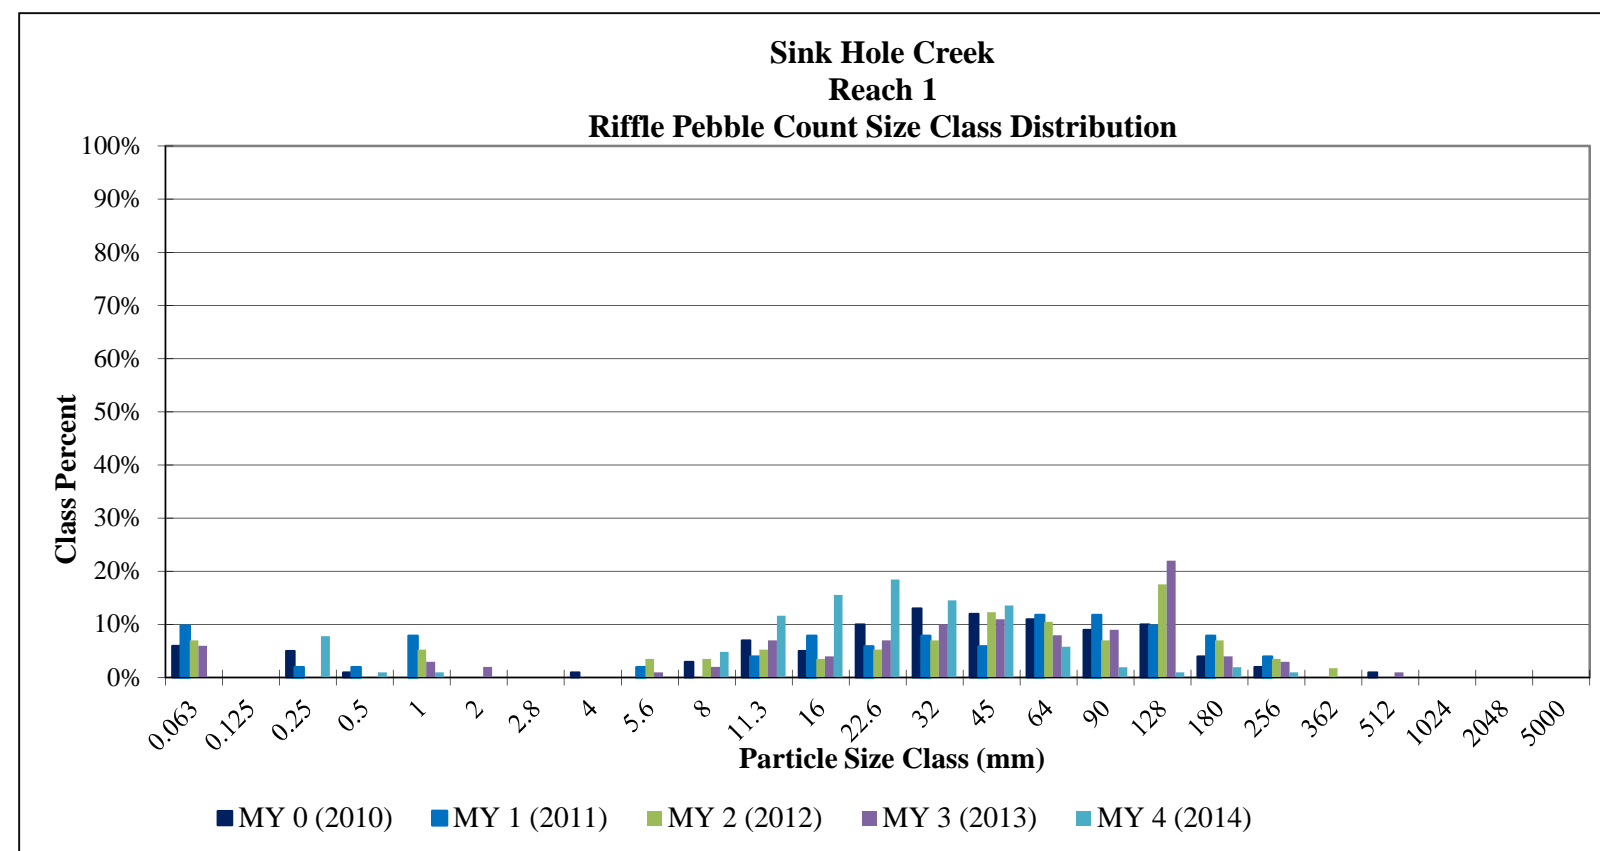
2014		
MATERIAL	PARTICLE SIZE (mm)		Total	Class %	% Cum
Silt/Clay	Silt / Clay	< .063		6%	6%
Sand	Very Fine	.063 - .125		0%	6%
	Fine	.125 - .25	8	0%	6%
	Medium	.25 - .50	1	0%	6%
	Coarse	.50 - 1.0	1	3%	9%
	Very Coarse	1.0 - 2.0		2%	11%
Gravel	Very Fine	2.0 - 2.8		0%	11%
	Very Fine	2.8 - 4.0		0%	11%
	Fine	4.0 - 5.6		1%	12%
	Fine	5.6 - 8.0	5	2%	14%
	Medium	8.0 - 11.0	12	7%	21%
	Medium	11.0 - 16.0	16	4%	25%
	Coarse	16 - 22.6	19	7%	32%
	Coarse	22.6 - 32	15	10%	42%
	Very Coarse	32 - 45	14	11%	53%
	Very Coarse	45 - 64	6	8%	61%
Cobble	Small	64 - 90	2	9%	70%
	Small	90 - 128	1	22%	92%
	Large	128 - 180	2	4%	96%
	Large	180 - 256	1	3%	99%
Boulder	Small	256 - 362		0%	99%
	Small	362 - 512		1%	100%
	Medium	512 - 1024		0%	100%
	Large-Very Large	1024 - 2048		0%	100%
Bedrock	Bedrock	> 2048		0%	100%
Total % of whole count			103	100%	100%

Summary Data	
Channel materials	
D <sub>50</sub> =	41.00
D <sub>84</sub> =	112.61
D <sub>95</sub> =	165.29

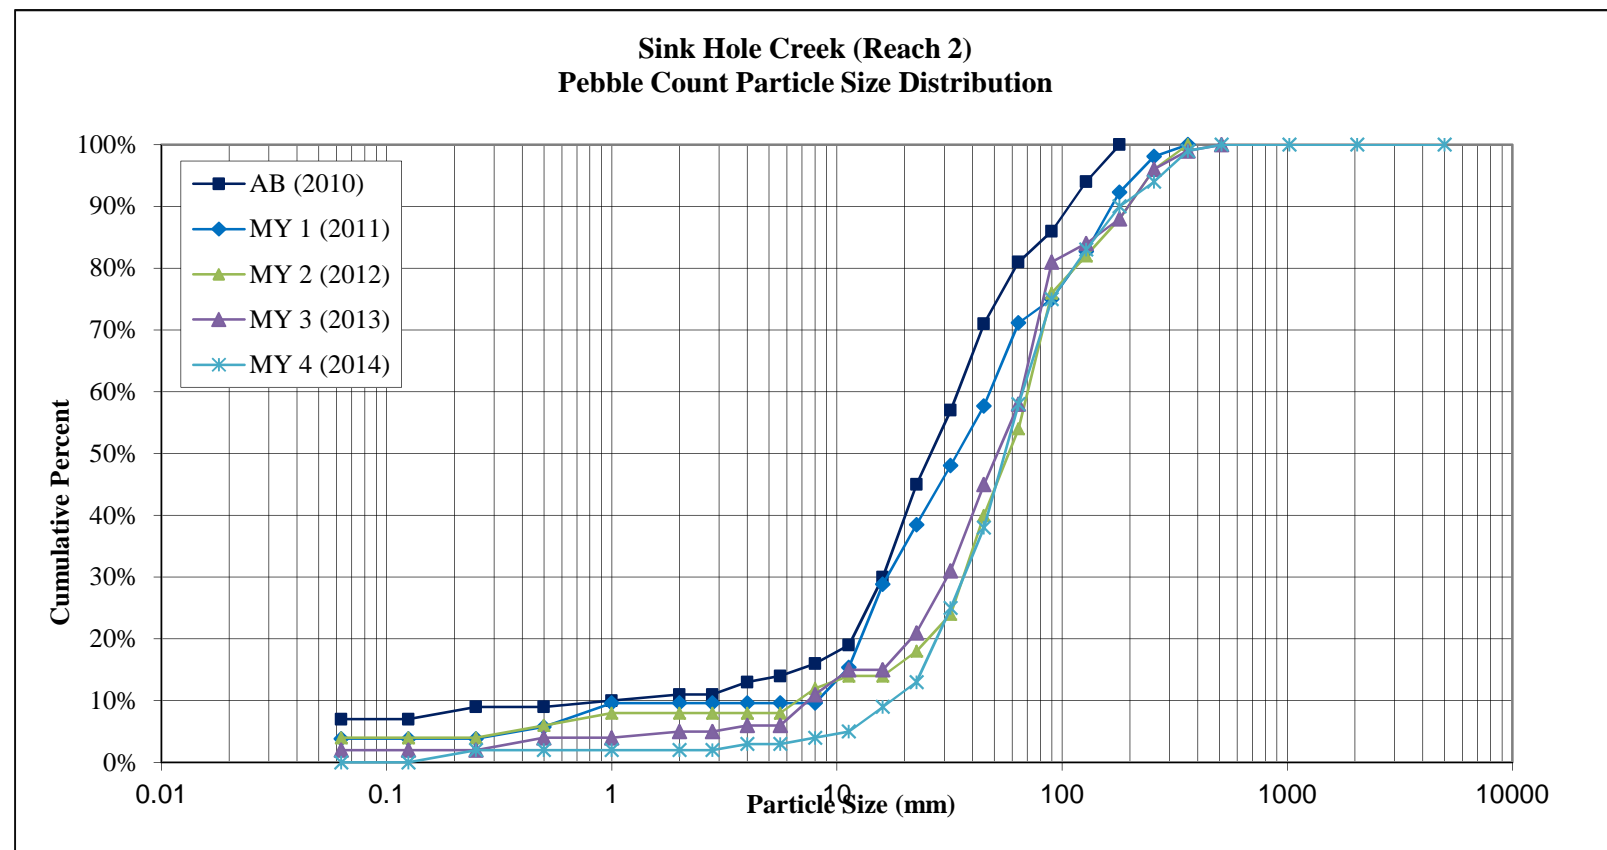
Cross-Section Pebble Count (Sink Hole Creek-Reach 2)

2014		
MATERIAL	PARTICLE SIZE (mm)	Total	Class %	% Cum	
Silt/Clay	Silt / Clay < .063		2%	0%	
Sand	Very Fine .063 - .125		0%	2%	
	Fine .125 - .25	2	0%	2%	
	Medium .25 - .50		2%	4%	
	Coarse .50 - 1.0		0%	4%	
	Very Coarse 1.0 - 2.0		1%	5%	
Gravel	Very Fine 2.0 - 2.8		0%	5%	
	Very Fine 2.8 - 4.0	1	1%	6%	
	Fine 4.0 - 5.6		0%	6%	
	Fine 5.6 - 8.0	1	5%	11%	
	Medium 8.0 - 11.0	1	4%	15%	
	Medium 11.0 - 16.0	4	0%	15%	
	Coarse 16 - 22.6	4	6%	21%	
	Coarse 22.6 - 32	12	10%	31%	
	Very Coarse 32 - 45	13	14%	45%	
	Very Coarse 45 - 64	20	13%	58%	
Cobble	Small 64 - 90	17	23%	81%	
	Small 90 - 128	8	3%	84%	
	Large 128 - 180	7	4%	88%	
	Large 180 - 256	4	8%	96%	
Boulder	Small 256 - 362	5	3%	99%	
	Small 362 - 512	1	1%	100%	
	Medium 512 - 1024		0%	100%	
	Large-Very Large 1024 - 2048		0%	100%	
Bedrock	Bedrock > 2048		0%	100%	
Total % of whole count		100	100%	100%

Summary Data	
<b>Channel materials</b>	
D <sub>50</sub> =	51.53
D <sub>84</sub> =	128.00
D <sub>95</sub> =	244.97
