SOUTH FORK HOPPERS CREEK STREAM AND WETLAND RESTORATION PROJECT

ANNUAL MONITORING REPORT FOR 2007 (YEAR 2)

Project Number: D04006-4

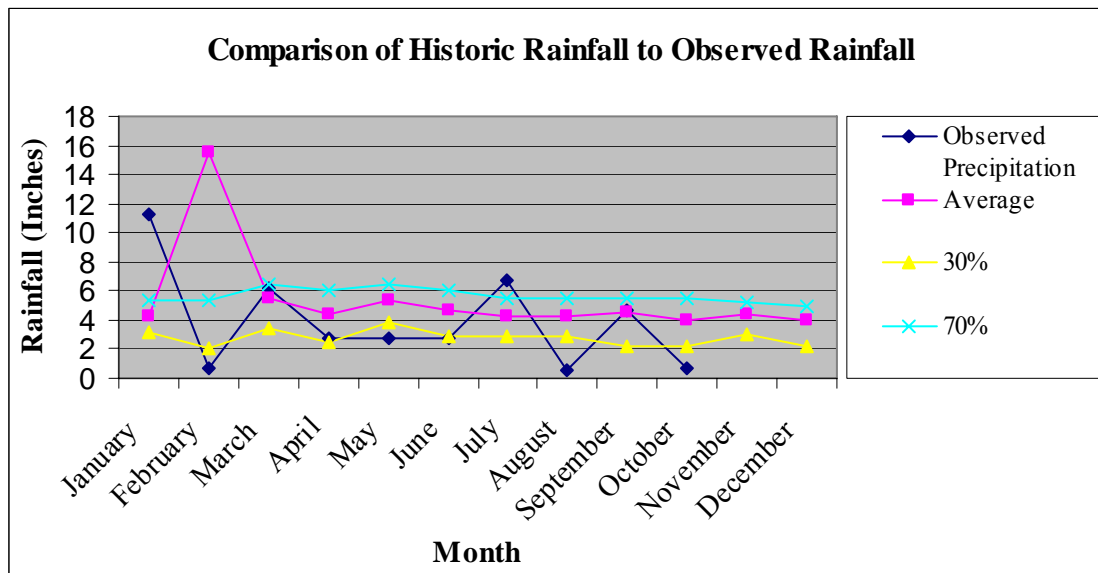
Figure 5. Historic Average vs. Observed Rainfall

^BMonthly on-site rainfall data unavailable, so total monthly rainfall data was calculated using the nearest USGS rain gauge data (USGS 03451500 FRENCH BROAD RIVER AT ASHEVILLE, NC) to the project site. (USGS, 2007)

Hydrologic monitoring results are shown in Table 11, 12 and Figure 5.

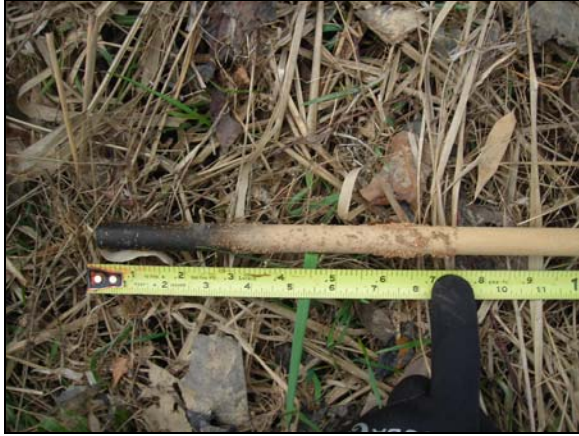
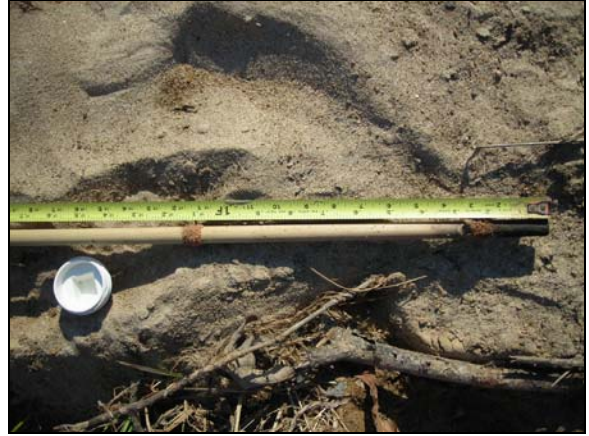
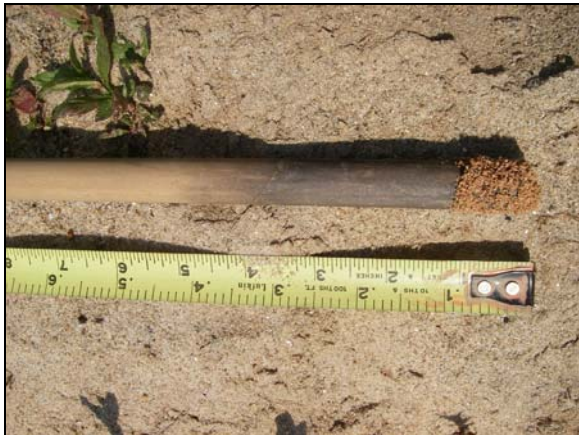
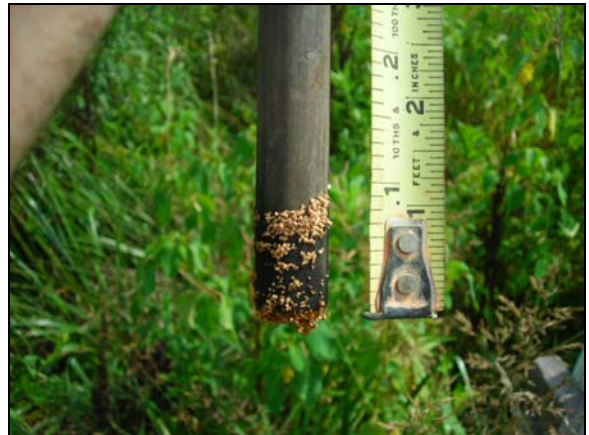
CREST GAUGE PHOTOS OF BANKFULL

Crest Gauge – 1/16/07

Crest Gauge – 3/13/07

Crest Gauge – 5/22/07

Crest Gauge – 7/17/07

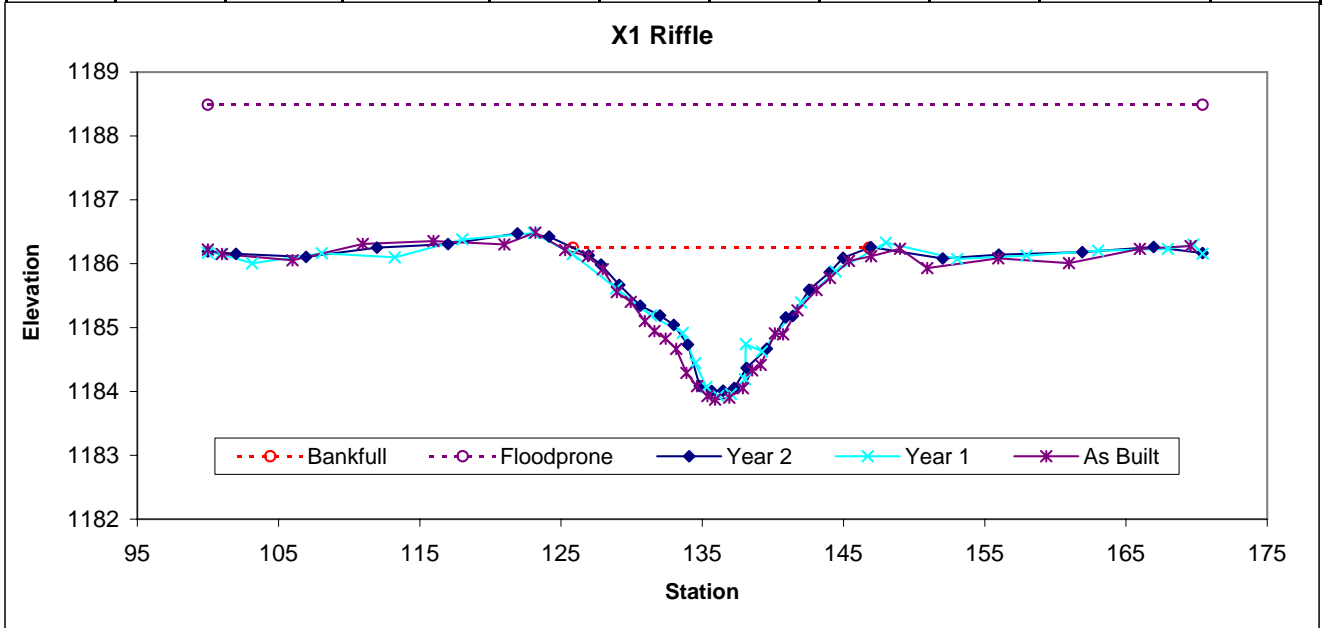
Permanent Cross Section X1
 (Year 2 Monitoring Data - collected October 2007)

Feature	Stream Type	BKF Area	BKF Width	BKF Depth	Max BKF Depth	W/D	BH Ratio	ER	BKF Elev	TOB Elev
Riffle	C	21.5	21	1.02	2.24	20.55	1	3.4	1186.25	1186.26

Year 2 cross-section monitoring data for stream stability were collected during October and November 2007 and compared to as-built conditions and Year 1 data (collected October 2006).

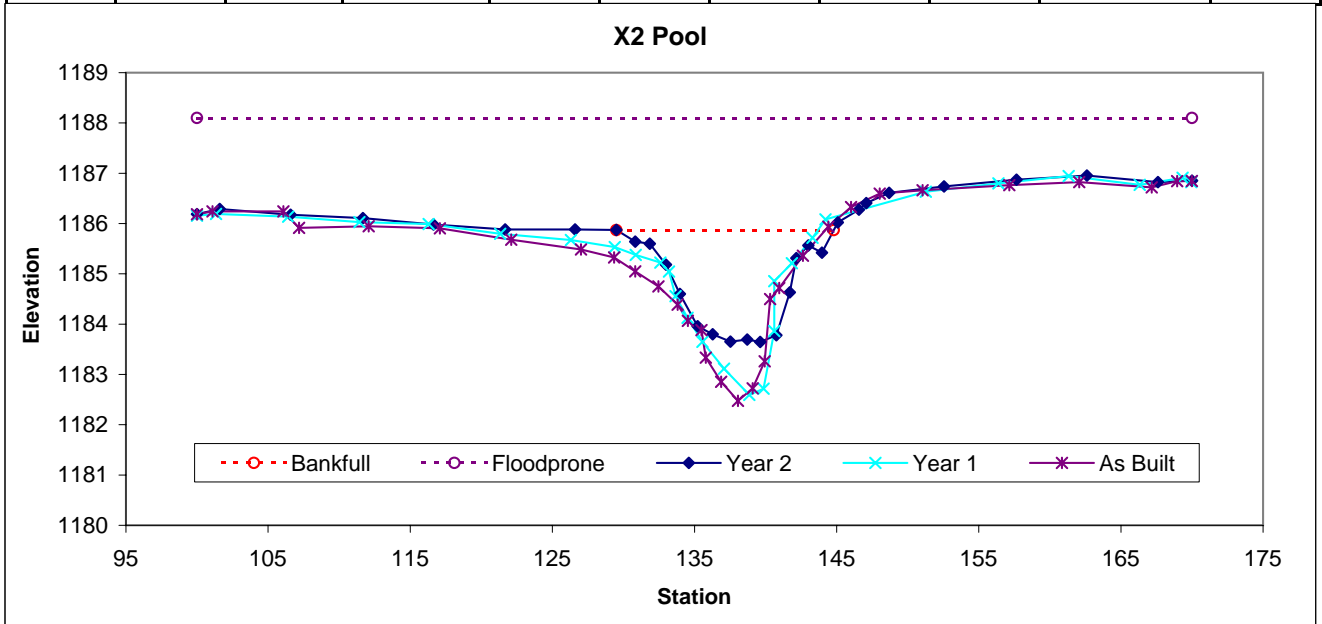
Permanent Cross Section X2
 (Year 2 Monitoring Data - collected October 2007)

Feature	Stream Type	BKF Area	BKF Width	BKF Depth	Max BKF Depth	W/D	BH Ratio	ER	BKF Elev	TOB Elev
Pool		18.7	15.3	1.22	2.23	12.52	1	4.6	1185.87	1185.87

A few cross-sections have aggraded, including sections 2, 6, 11, and 16. Cross-section 2, located near the downstream end of the Site, is likely aggrading in response to a beaver impoundment approximately 120 feet downstream of the project limits. The impoundment is slowing stream flow, which has resulted in the accumulation of fine sediment within the project area immediately upstream. Cross-sections 6 and 11 are located across pools found at the apex of a meander bend. Survey data from these sections indicate the aggradation on point bar features on the inside bank of the meander bend. Flow through a meander bend possesses higher conveyance velocity along its boundary with the outer bank of the bend, and lower flow velocity along its boundary with the bend's inner bank. As flow velocity reduces, its sediment transport capacity also reduces, causing flow to drop some of its transported sediment as it slows down. Point bar formation along the inside of a meander bend indicates flow velocity vectors occurring as designed, and is therefore expected. Cross-section 16 is located at the most upstream extent of the Site and is receiving a large sediment supply from its contributing watershed. All monitored cross-sections fell within the quantitative parameters defined for "C" type channels.

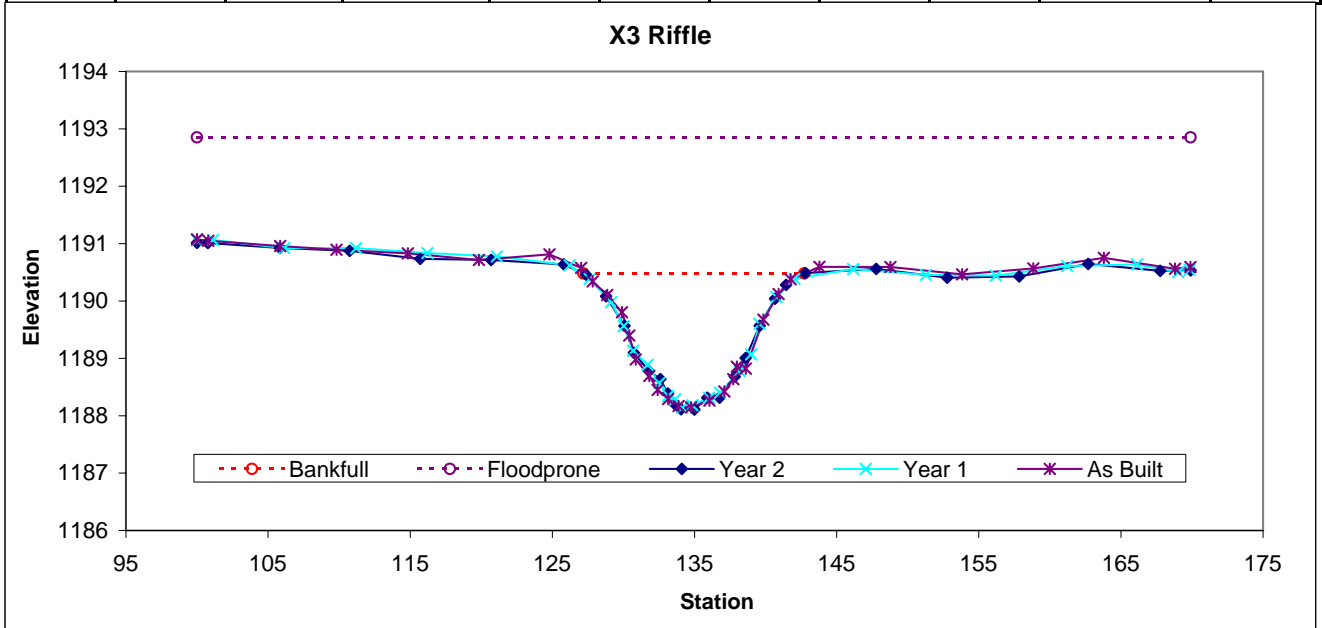
Permanent Cross Section X3
 (Year 2 Monitoring Data - collected October 2007)

Feature	Stream Type	BKF Area	BKF Width	BKF Depth	Max BKF Depth	W/D	BH Ratio	ER	BKF Elev	TOB Elev
Riffle	C	19.9	15.56	1.28	2.37	12.16	1	4.5	1190.48	1190.49

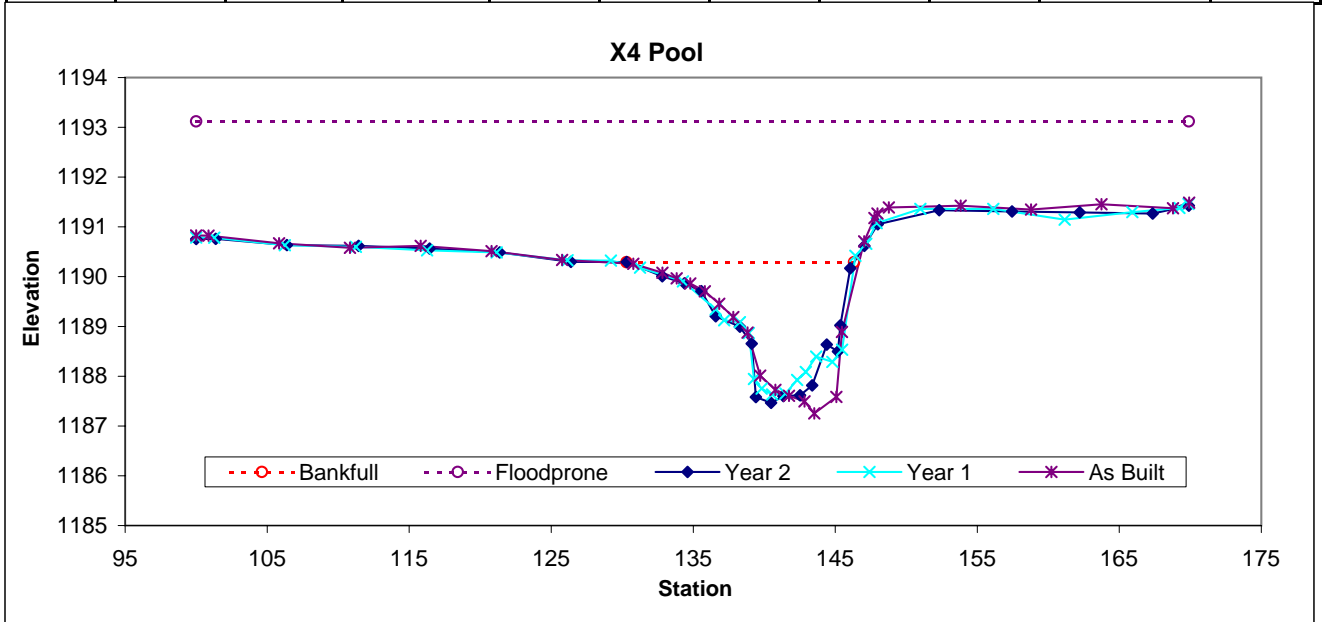
Permanent Cross Section X4
 (Year 2 Monitoring Data - collected October 2007)

Feature	Stream Type	BKF Area	BKF Width	BKF Depth	Max BKF Depth	W/D	BH Ratio	ER	BKF Elev	TOB Elev
Pool		21.2	16.02	1.32	2.83	12.1	1	4.4	1190.29	1190.29

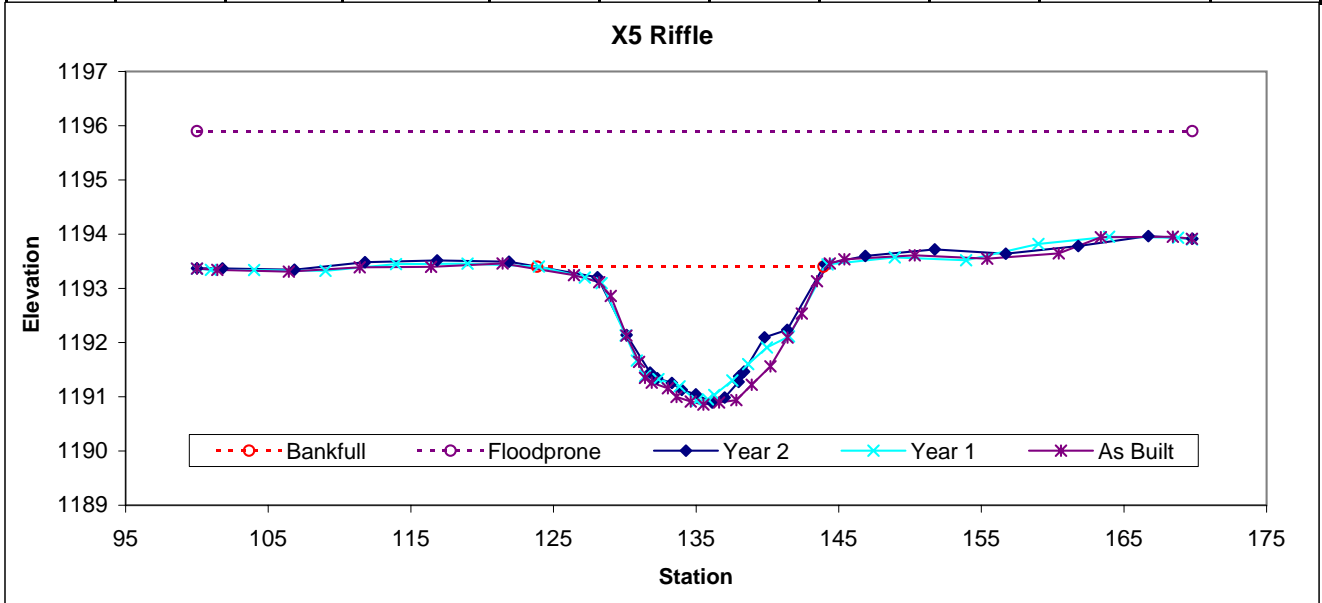
Permanent Cross Section X5
 (Year 2 Monitoring Data - collected October 2007)

Feature	Stream Type	BKF Area	BKF Width	BKF Depth	Max BKF Depth	W/D	BH Ratio	ER	BKF Elev	TOB Elev
Riffle	C	25.2	20.09	1.25	2.5	16.01	1	3.5	1193.4	1193.44

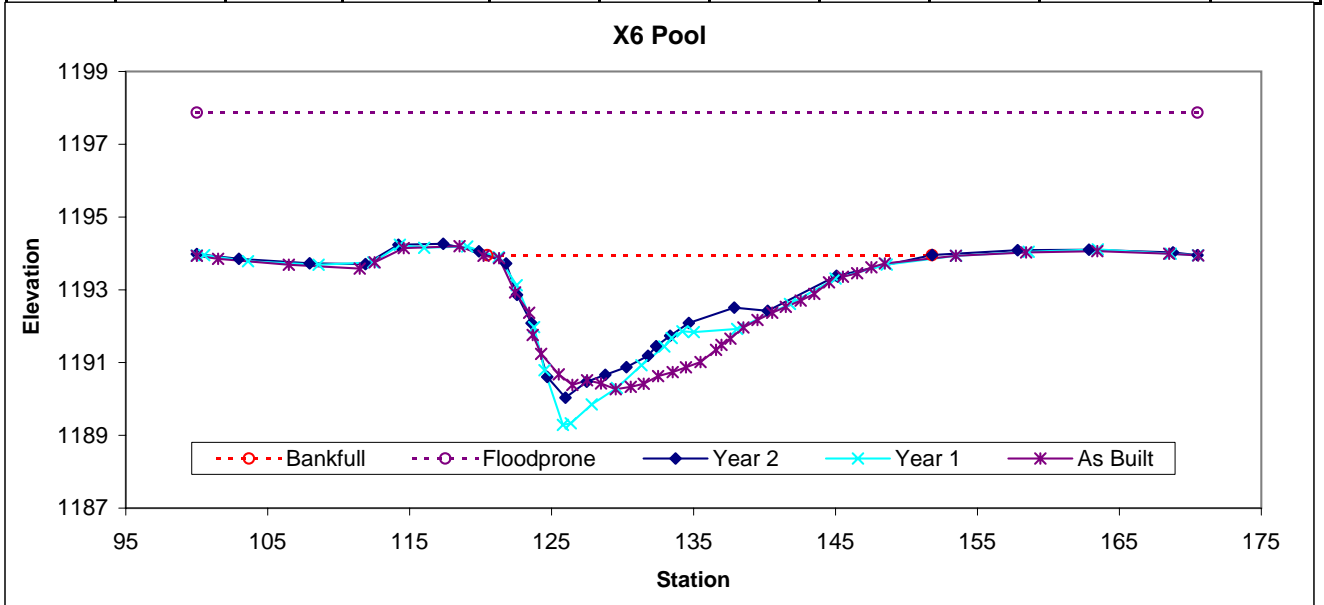
Permanent Cross Section X6
(Year 2 Monitoring Data - collected October 2007)

Feature	Stream Type	BKF Area	BKF Width	BKF Depth	Max BKF Depth	W/D	BH Ratio	ER	BKF Elev	TOB Elev
Pool		51.2	31.33	1.63	3.92	19.16	1	2.3	1193.95	1193.96

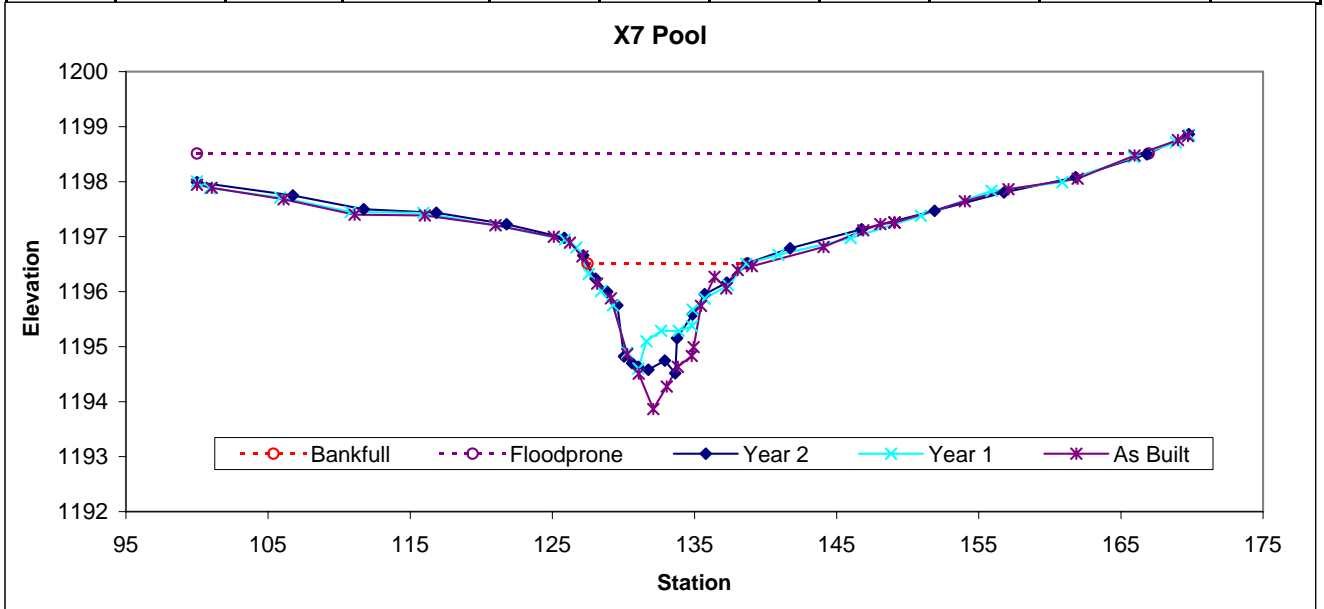
Permanent Cross Section X7
 (Year 2 Monitoring Data - collected October 2007)

Feature	Stream Type	BKF Area	BKF Width	BKF Depth	Max BKF Depth	W/D	BH Ratio	ER	BKF Elev	TOB Elev
Pool		11.2	11.26	0.99	2	11.34	1	5.9	1196.51	1196.51

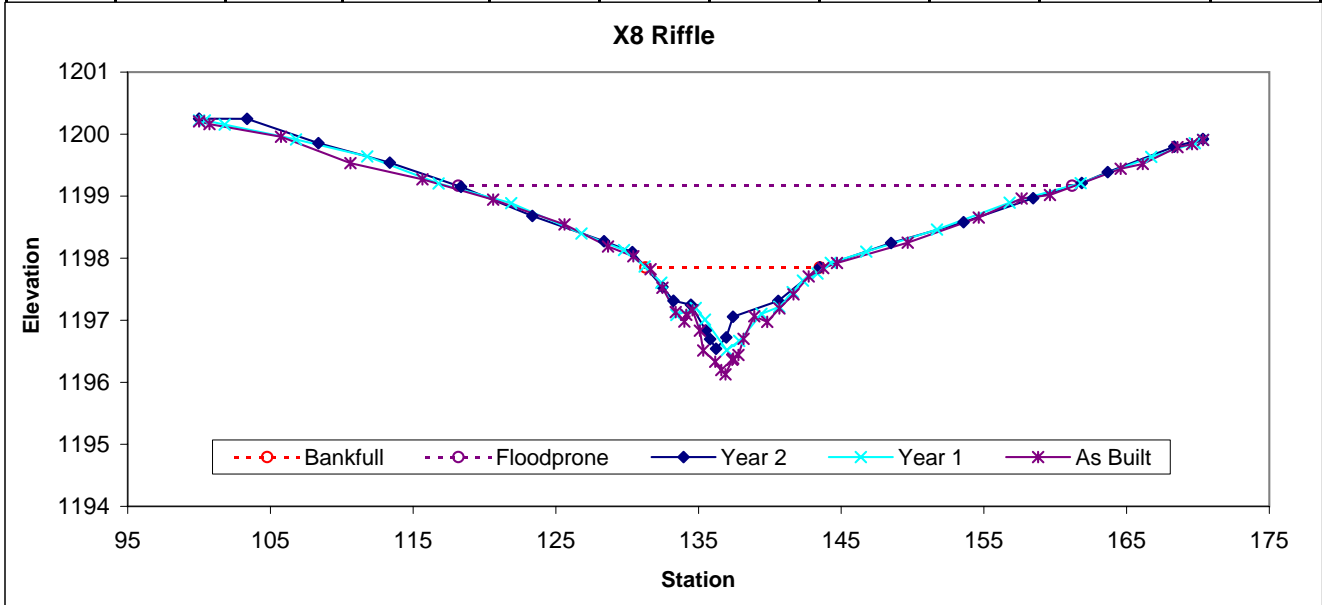
Permanent Cross Section X8
 (Year 2 Monitoring Data - collected October 2007)

Feature	Stream Type	BKF Area	BKF Width	BKF Depth	Max BKF Depth	W/D	BH Ratio	ER	BKF Elev	TOB Elev
Riffle	C	7.1	12.22	0.58	1.31	20.91	1	3.5	1197.85	1197.85

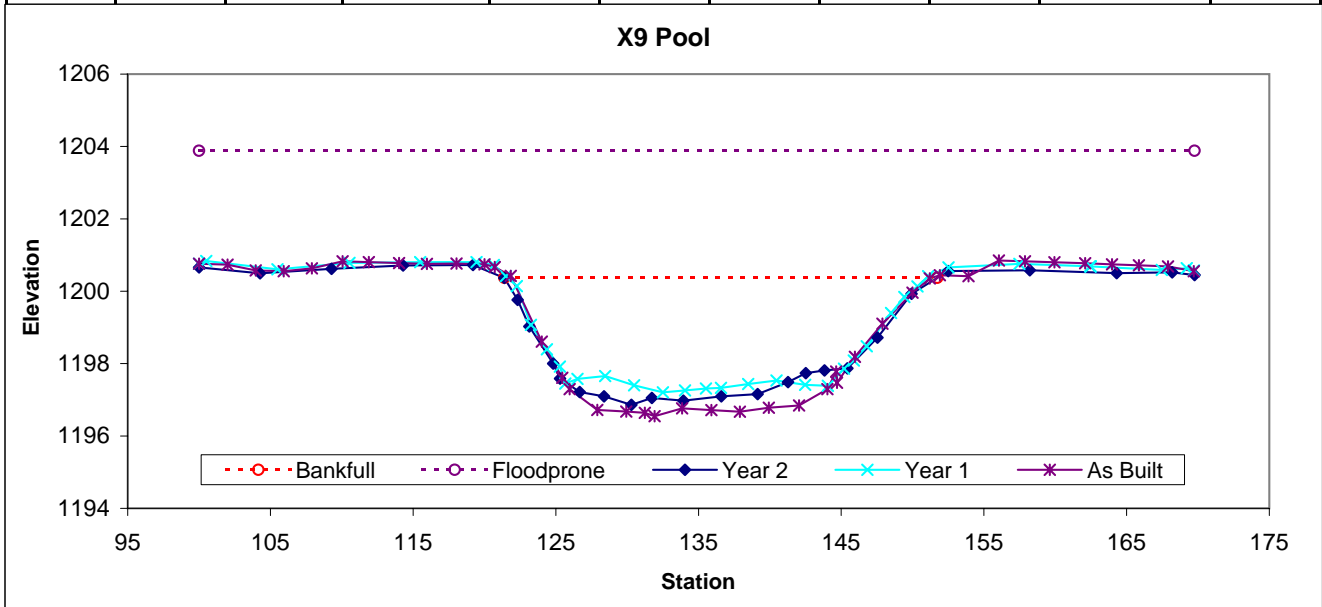
Permanent Cross Section X9
 (Year 2 Monitoring Data - collected October 2007)

Feature	Stream Type	BKF Area	BKF Width	BKF Depth	Max BKF Depth	W/D	BH Ratio	ER	BKF Elev	TOB Elev
Pool		75.6	30.33	2.49	3.51	12.18	1	2.3	1200.37	1200.37

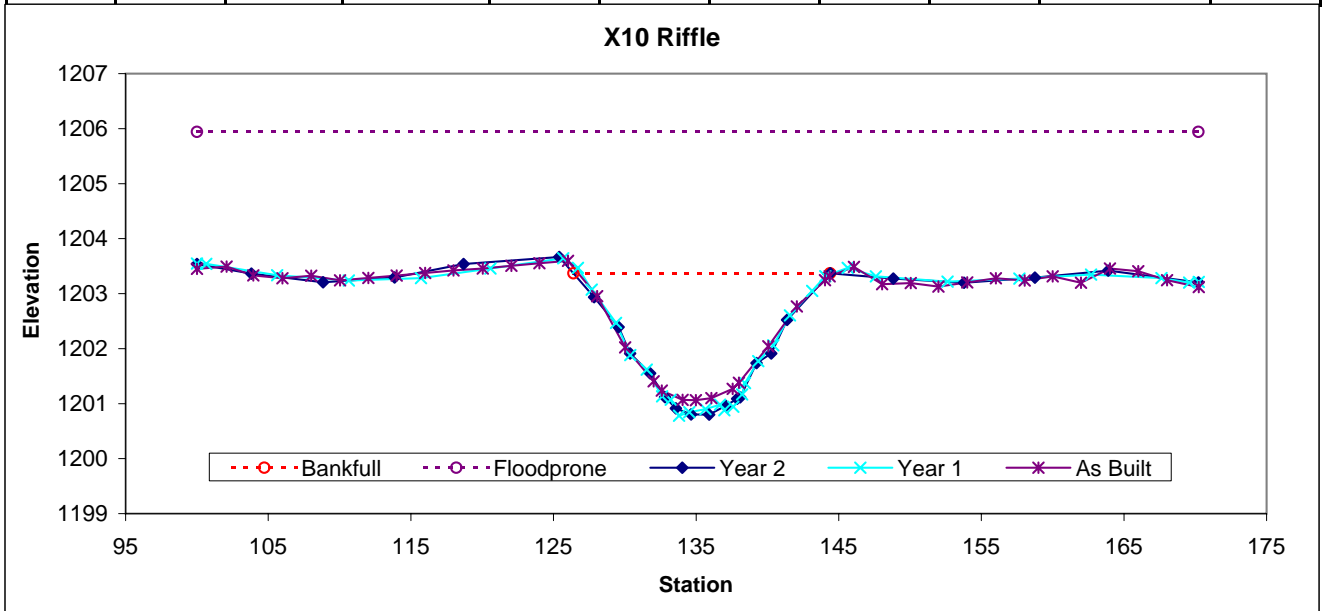
Feature	Stream Type	BKF Area	BKF Width	BKF Depth	Max BKF Depth	W/D	BH Ratio	ER	BKF Elev	TOB Elev
Riffle	C	26.3	18.01	1.46	2.57	12.34	1	3.9	1203.37	1203.37

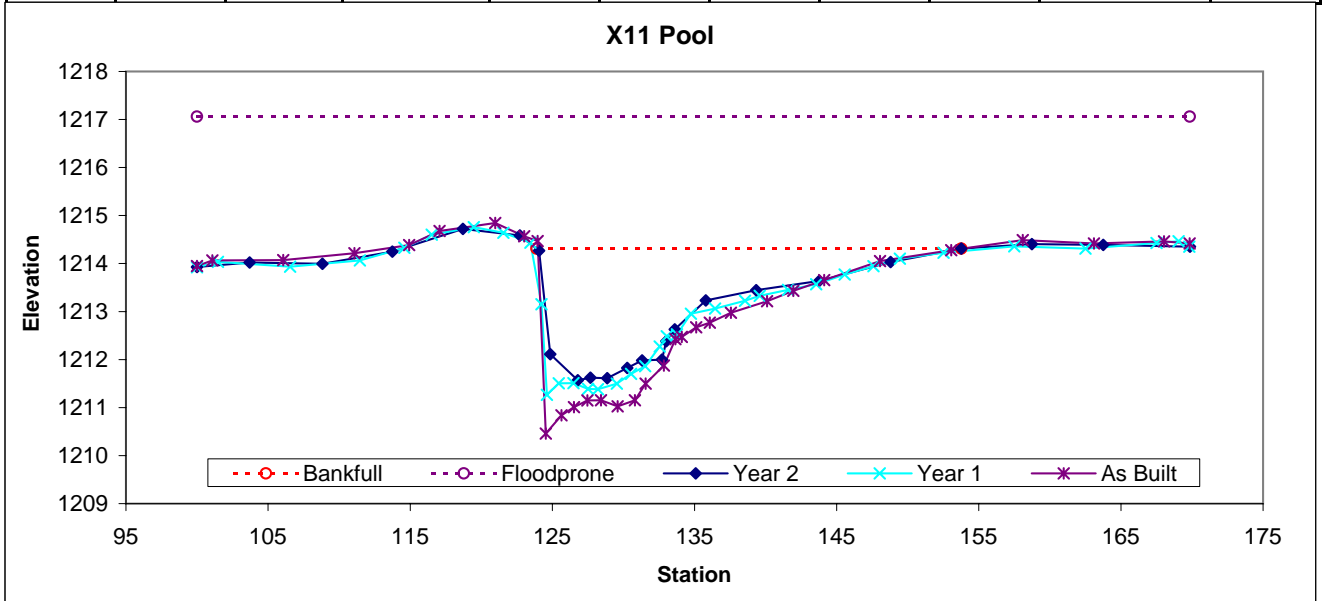
Permanent Cross Section X11
(Year 2 Monitoring Data - collected October 2007)

Feature	Stream Type	BKF Area	BKF Width	BKF Depth	Max BKF Depth	W/D	BH Ratio	ER	BKF Elev	TOB Elev
Pool		35.4	29.89	1.18	2.74	25.24	1	2.3	1214.31	1214.31

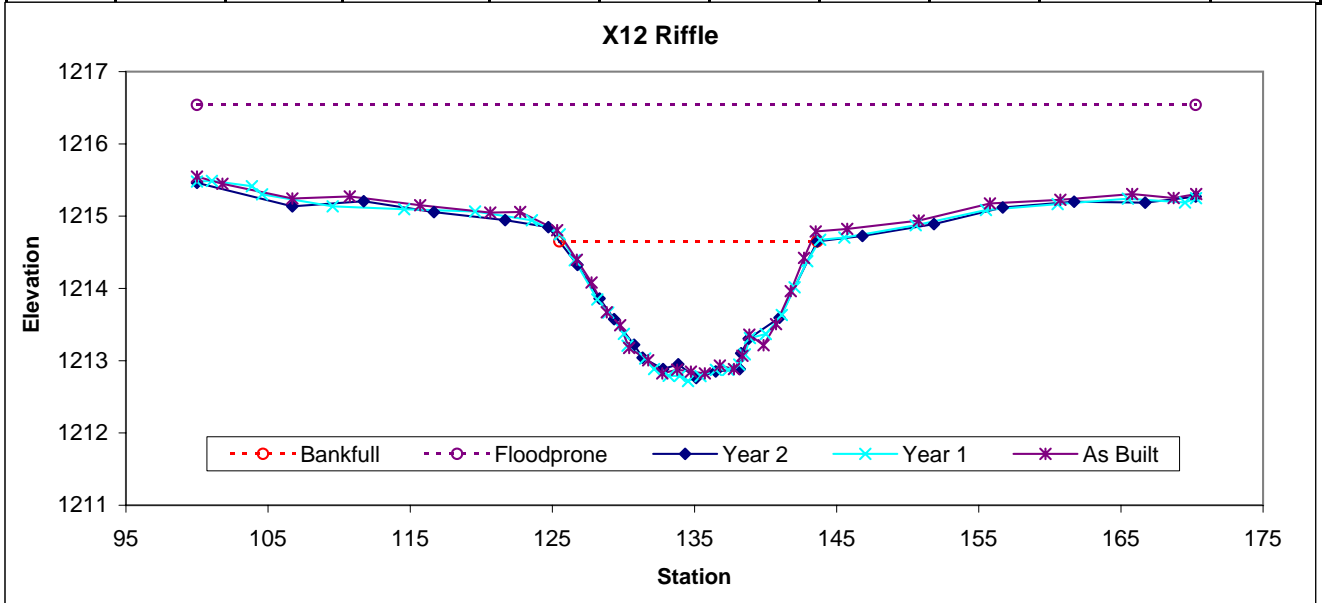
Permanent Cross Section X12
 (Year 2 Monitoring Data - collected October 2007)

Feature	Stream Type	BKF Area	BKF Width	BKF Depth	Max BKF Depth	W/D	BH Ratio	ER	BKF Elev	TOB Elev
Riffle	C	21.7	18.15	1.2	1.89	15.14	1	3.9	1214.65	1214.65

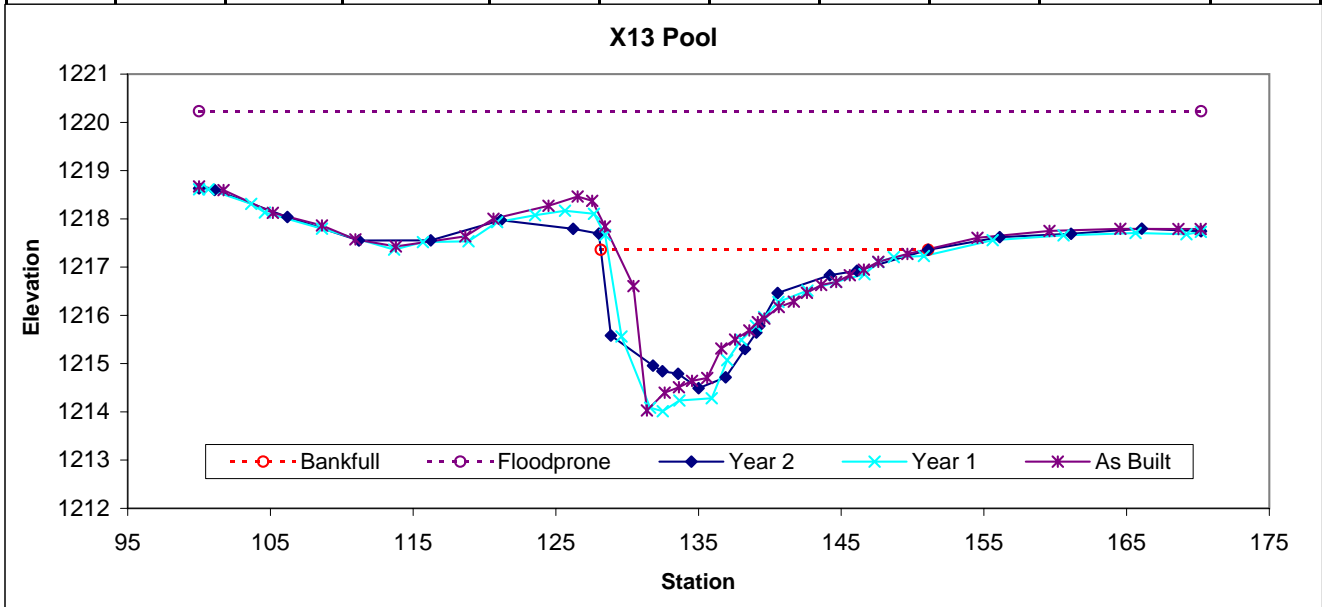
Permanent Cross Section X13
 (Year 2 Monitoring Data - collected October 2007)

Feature	Stream Type	BKF Area	BKF Width	BKF Depth	Max BKF Depth	W/D	BH Ratio	ER	BKF Elev	TOB Elev
Pool		31.6	22.93	1.38	2.87	16.67	1	3.1	1217.36	1217.36

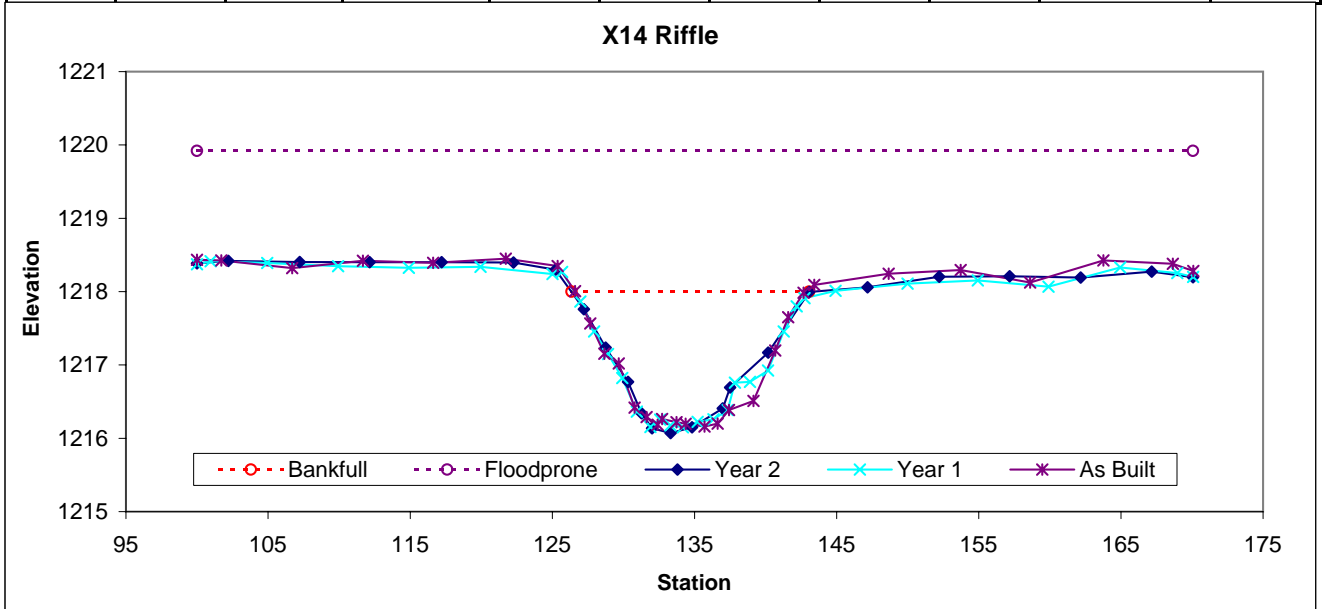
Permanent Cross Section X14
 (Year 2 Monitoring Data - collected October 2007)

Feature	Stream Type	BKF Area	BKF Width	BKF Depth	Max BKF Depth	W/D	BH Ratio	ER	BKF Elev	TOB Elev
Riffle	C	18.9	16.71	1.13	1.93	14.77	1	4.2	1218	1218

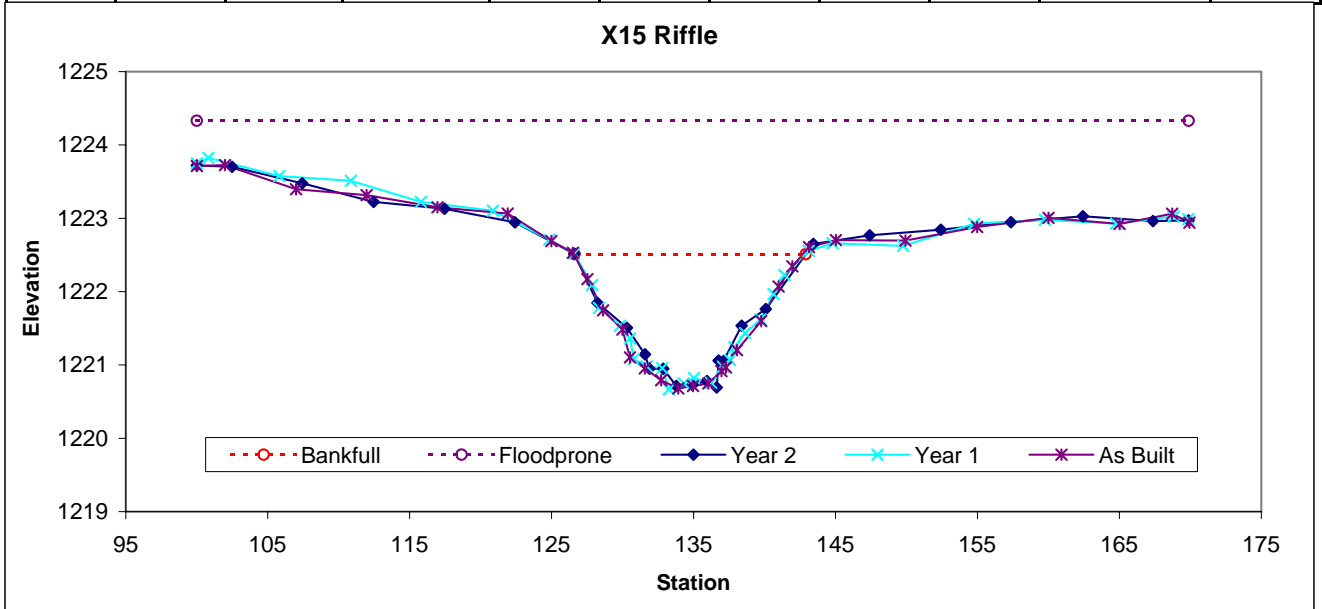
Permanent Cross Section X15
 (Year 2 Monitoring Data - collected October 2007)

Feature	Stream Type	BKF Area	BKF Width	BKF Depth	Max BKF Depth	W/D	BH Ratio	ER	BKF Elev	TOB Elev
Riffle	C	17.1	16.29	1.05	1.82	15.49	1	4.3	1222.51	1222.52

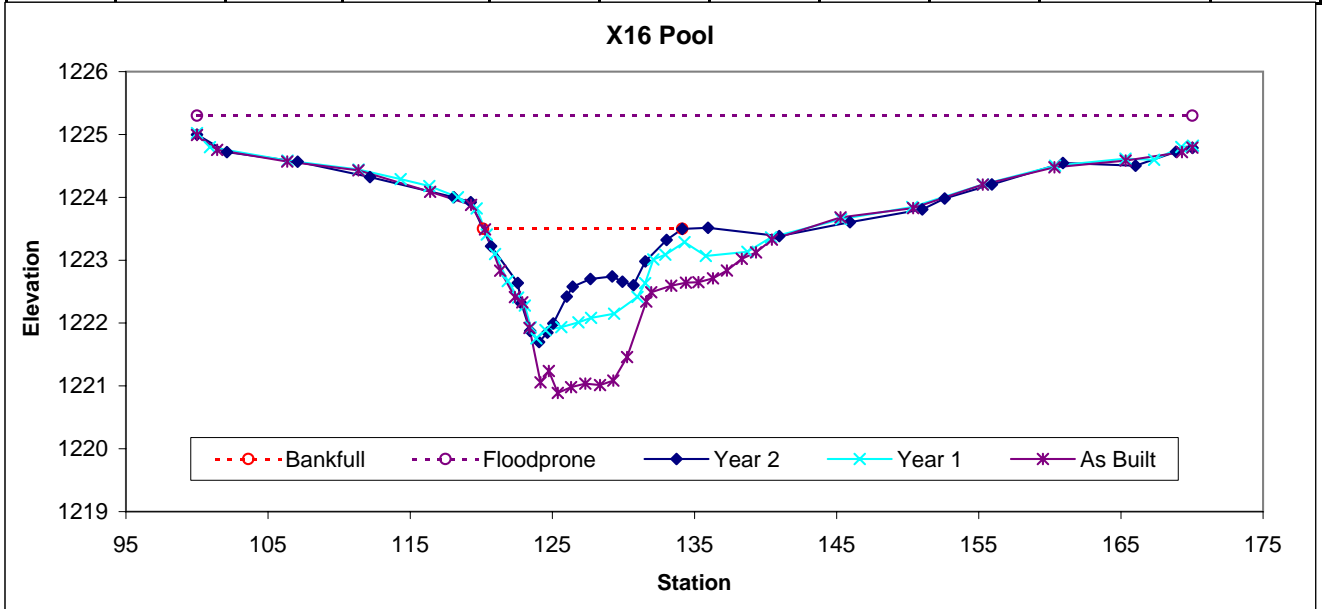
Permanent Cross Section X16
 (Year 2 Monitoring Data - collected October 2007)

Feature	Stream Type	BKF Area	BKF Width	BKF Depth	Max BKF Depth	W/D	BH Ratio	ER	BKF Elev	TOB Elev
Pool		11.3	14.01	0.81	1.8	17.29	1	5	1223.5	1223.5

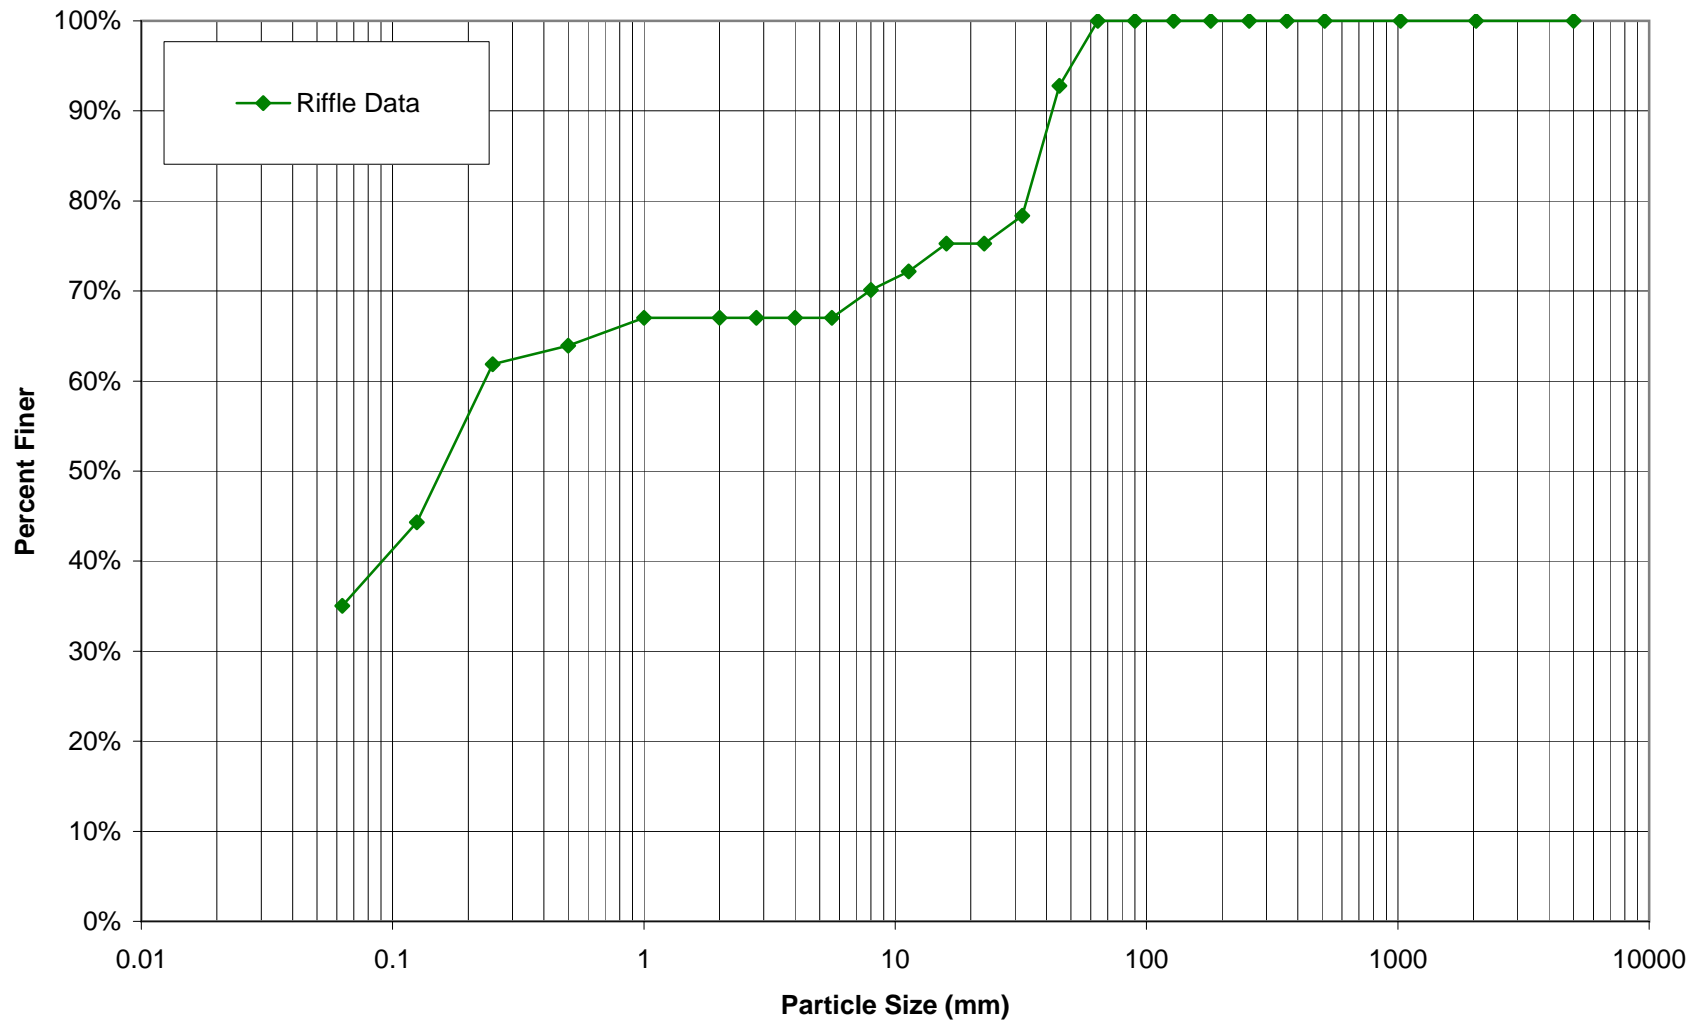
BUCK PROJECT NO. 108410
SITE OR PROJECT:	South Fork Hoppers Creek, Year 2 Monitoring
REACH/LOCATION:	X1-Riffle
DATE COLLECTED:	11/6/2007
FIELD COLLECTION BY:	RR/SU
DATA ENTRY BY:	KS

South Fork Hoppers Creek
X1-Riffle
Pebble Count Particle Size Distribution

Year 2 bed material samples were collected at each permanent cross-section during November 2007. Overall, bed material indicated coarser riffles and finer pools, however riffles showed a trend towards fining downstream of Pierce Road due to the backwater effects of the downstream beaver dam. Riffle cross-sections 1 and 3 had d50 of 0.15 mm and 0.7 mm, respectively, which corresponds to sand. The beaver dam causes the water to slow and fine particles to settle out of suspension, thus fining the riffle. Riffles begin to coarsen further upstream with a d50 of 7.5 mm at cross-section 5. Upstream of Pierce Road all riffle cross-sections have a d50 corresponding to very coarse gravel. Pools throughout the project site are dominated by sand. All pebble count data is provided in Appendix B.

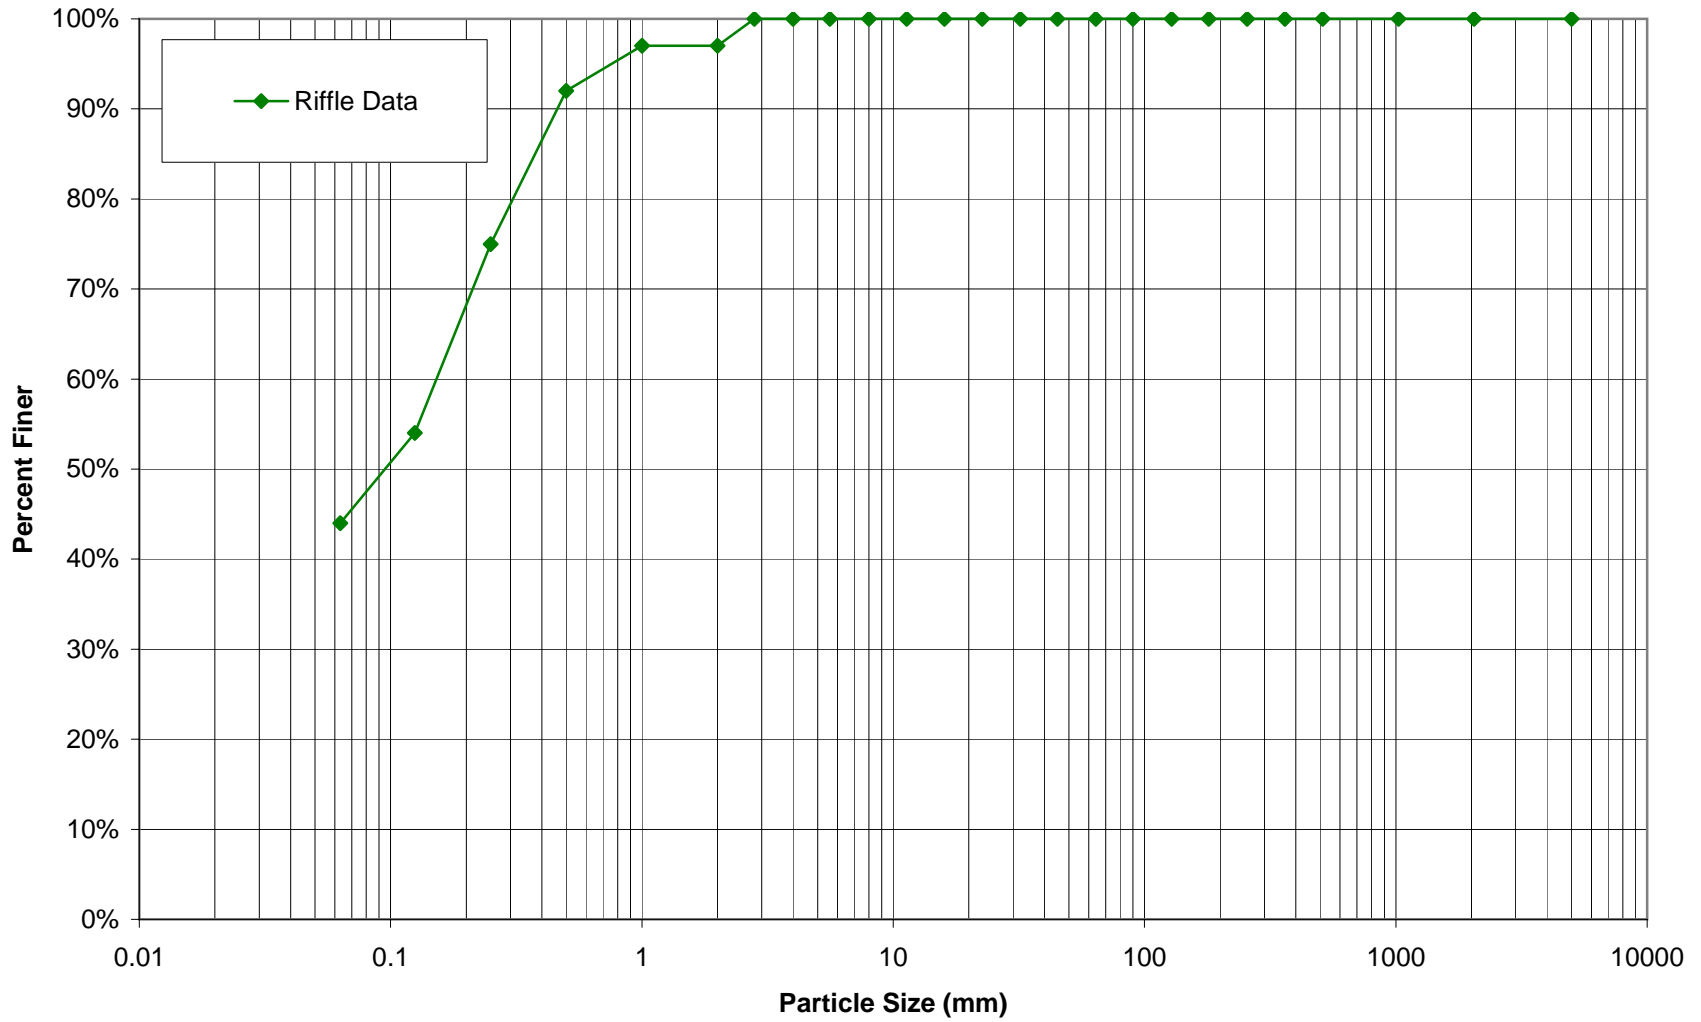
BUCK PROJECT NO. 108410
SITE OR PROJECT:	South Fork Hoppers Creek, Year 2 Monitoring
REACH/LOCATION:	X2-Pool
DATE COLLECTED:	11/6/2007
FIELD COLLECTION BY:	RR/SU
DATA ENTRY BY:	KS

South Fork Hoppers Creek
X2-Pool
Pebble Count Particle Size Distribution

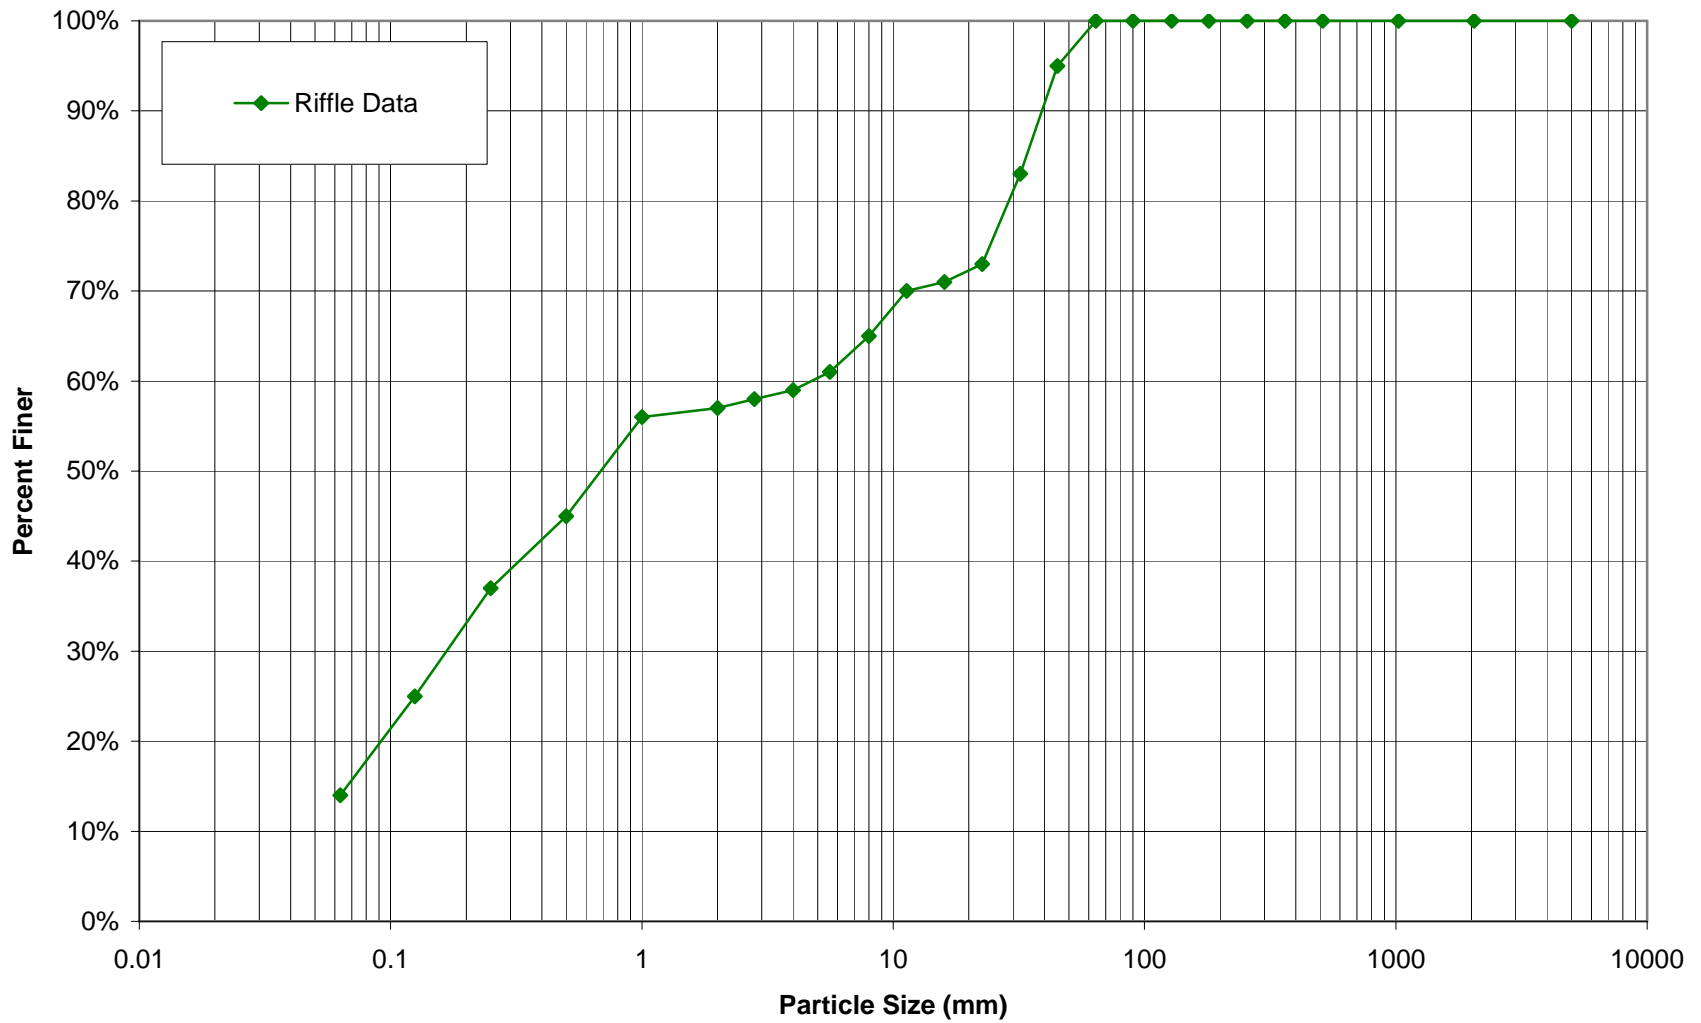
BUCK PROJECT NO. 108410
SITE OR PROJECT:	South Fork Hoppers Creek, Year 2 Monitoring
REACH/LOCATION:	X3-Riffle
DATE COLLECTED:	11/6/2007
FIELD COLLECTION BY:	RR/SU
DATA ENTRY BY:	KS

**South Fork Hoppers Creek
X3-Riffle
Pebble Count Particle Size Distribution**
