SOUTH FORK HOPPERS CREEK STREAM AND WETLAND RESTORATION PROJECT

ANNUAL MONITORING REPORT FOR 2007 (YEAR 2)

Project Number: D04006-4

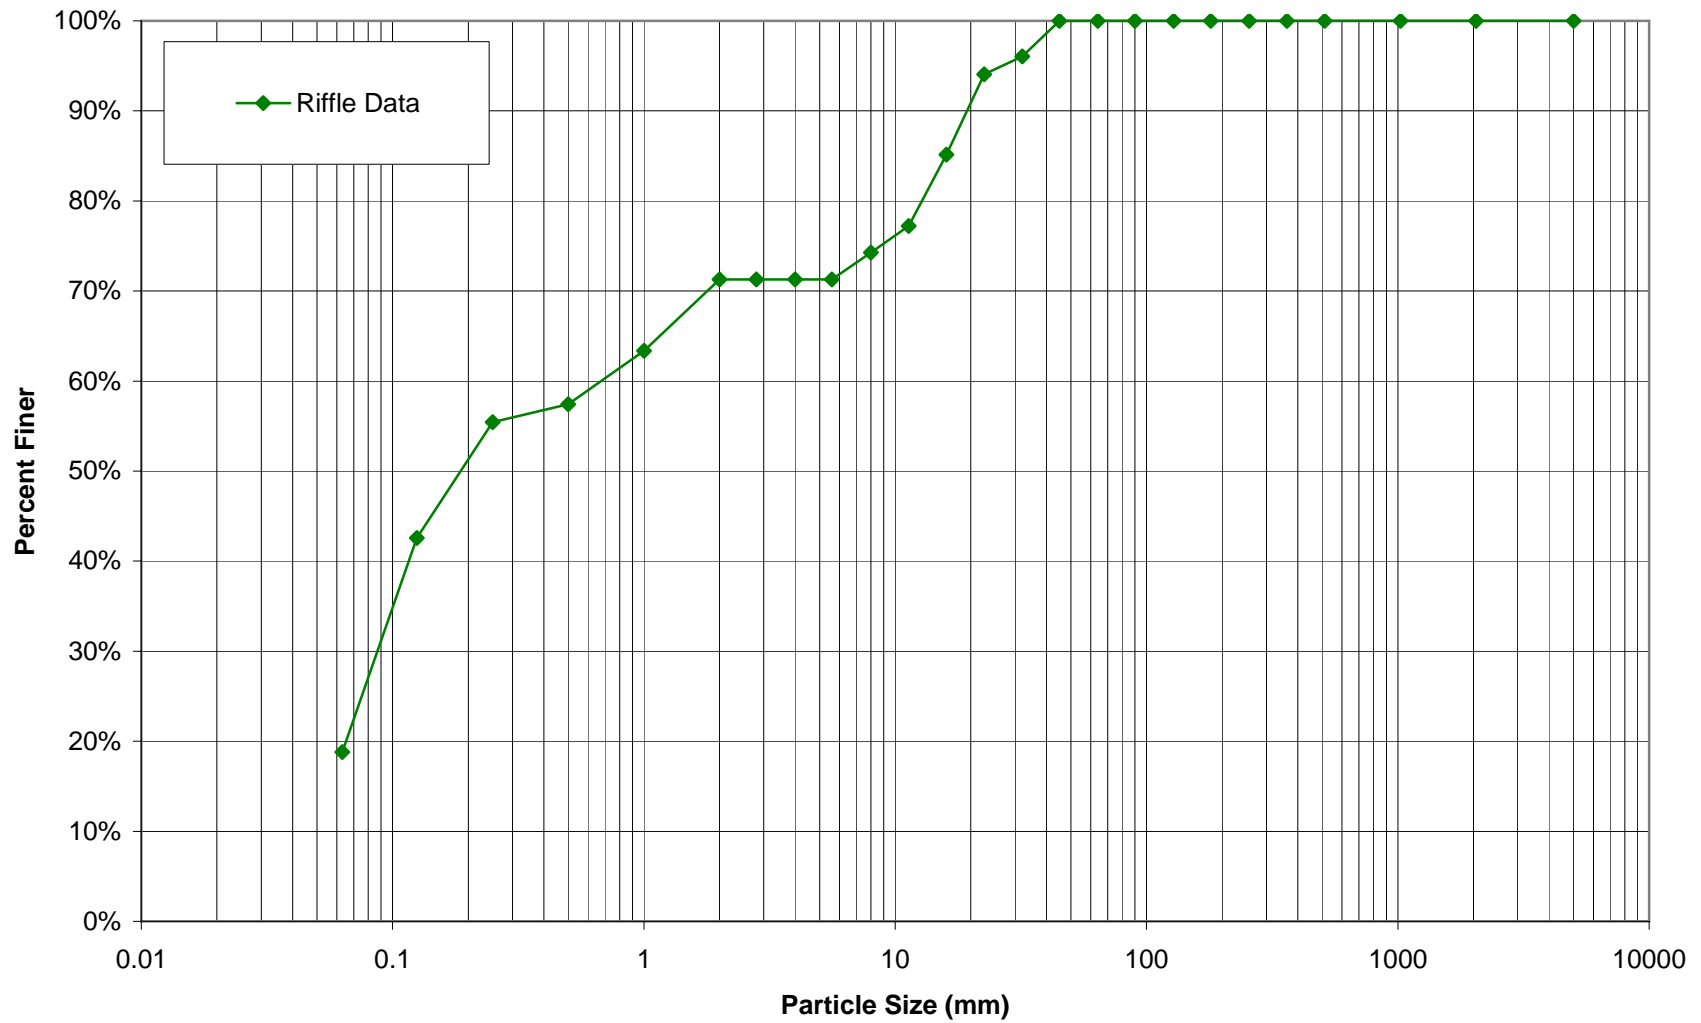
South Fork Hoppers Creek
X4-Pool
Pebble Count Particle Size Distribution

Year 2 bed material samples were collected at each permanent cross-section during November 2007. Overall, bed material indicated coarser riffles and finer pools, however riffles showed a trend towards fining downstream of Pierce Road due to the backwater effects of the downstream beaver dam. Riffle cross-sections 1 and 3 had d50 of 0.15 mm and 0.7 mm, respectively, which corresponds to sand. The beaver dam causes the water to slow and fine particles to settle out of suspension, thus fining the riffle. Riffles begin to coarsen further upstream with a d50 of 7.5 mm at cross-section 5. Upstream of Pierce Road all riffle cross-sections have a d50 corresponding to very coarse gravel. Pools throughout the project site are dominated by sand. All pebble count data is provided in Appendix B.

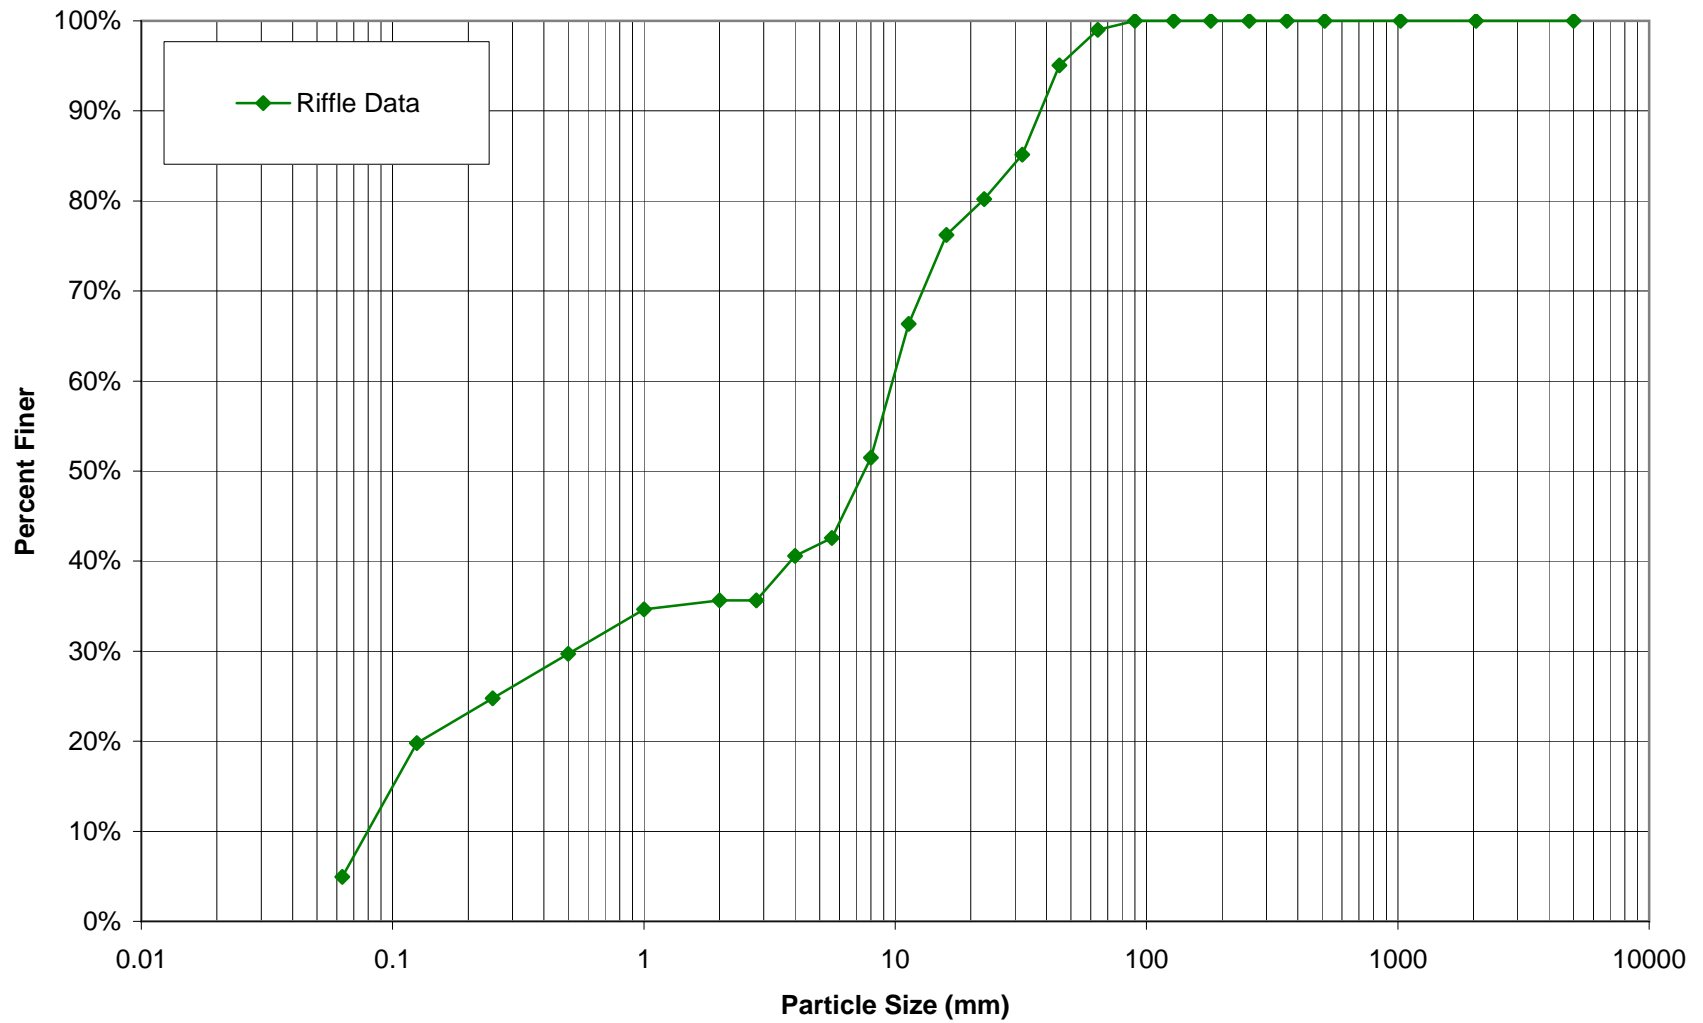
**South Fork Hoppers Creek
X5-Riffle
Pebble Count Particle Size Distribution**

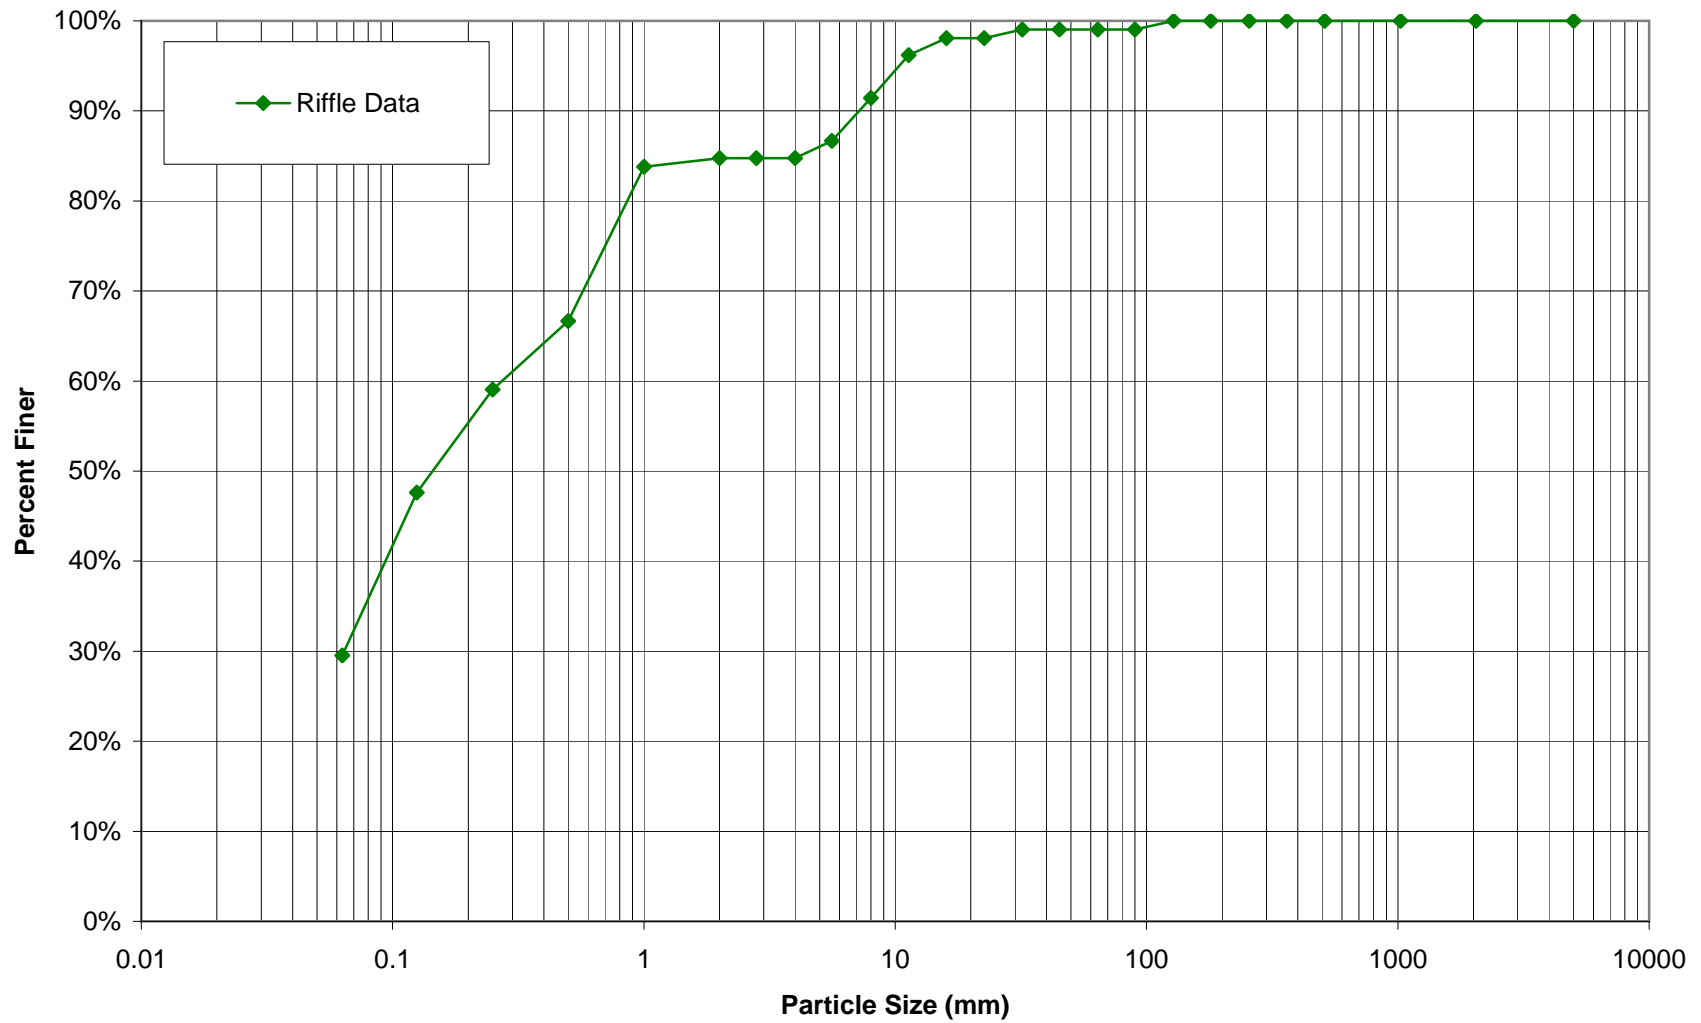
South Fork Hoppers Creek
X6-Pool
Pebble Count Particle Size Distribution

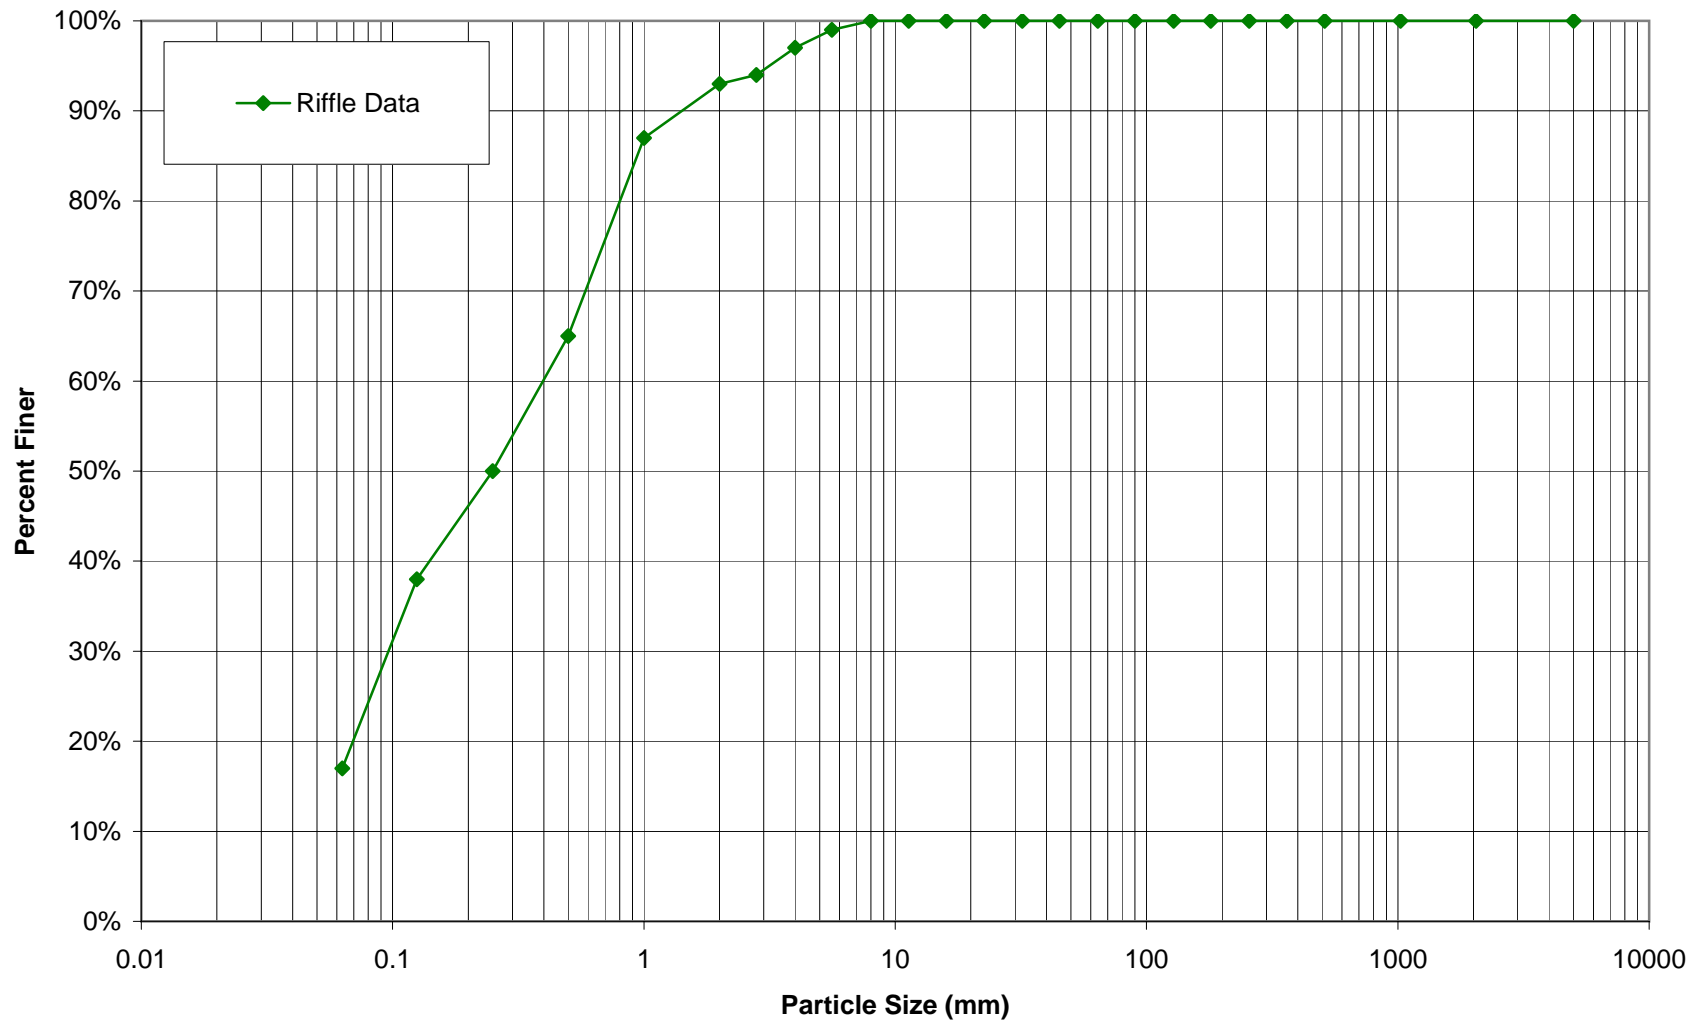
BUCK PROJECT NO. 108410
SITE OR PROJECT:	South Fork Hoppers Creek, Year 2 Monitoring
REACH/LOCATION:	X7-Pool
DATE COLLECTED:	11/6/2007
FIELD COLLECTION BY:	RR/SU
DATA ENTRY BY:	KS

South Fork Hoppers Creek
X7-Pool
Pebble Count Particle Size Distribution

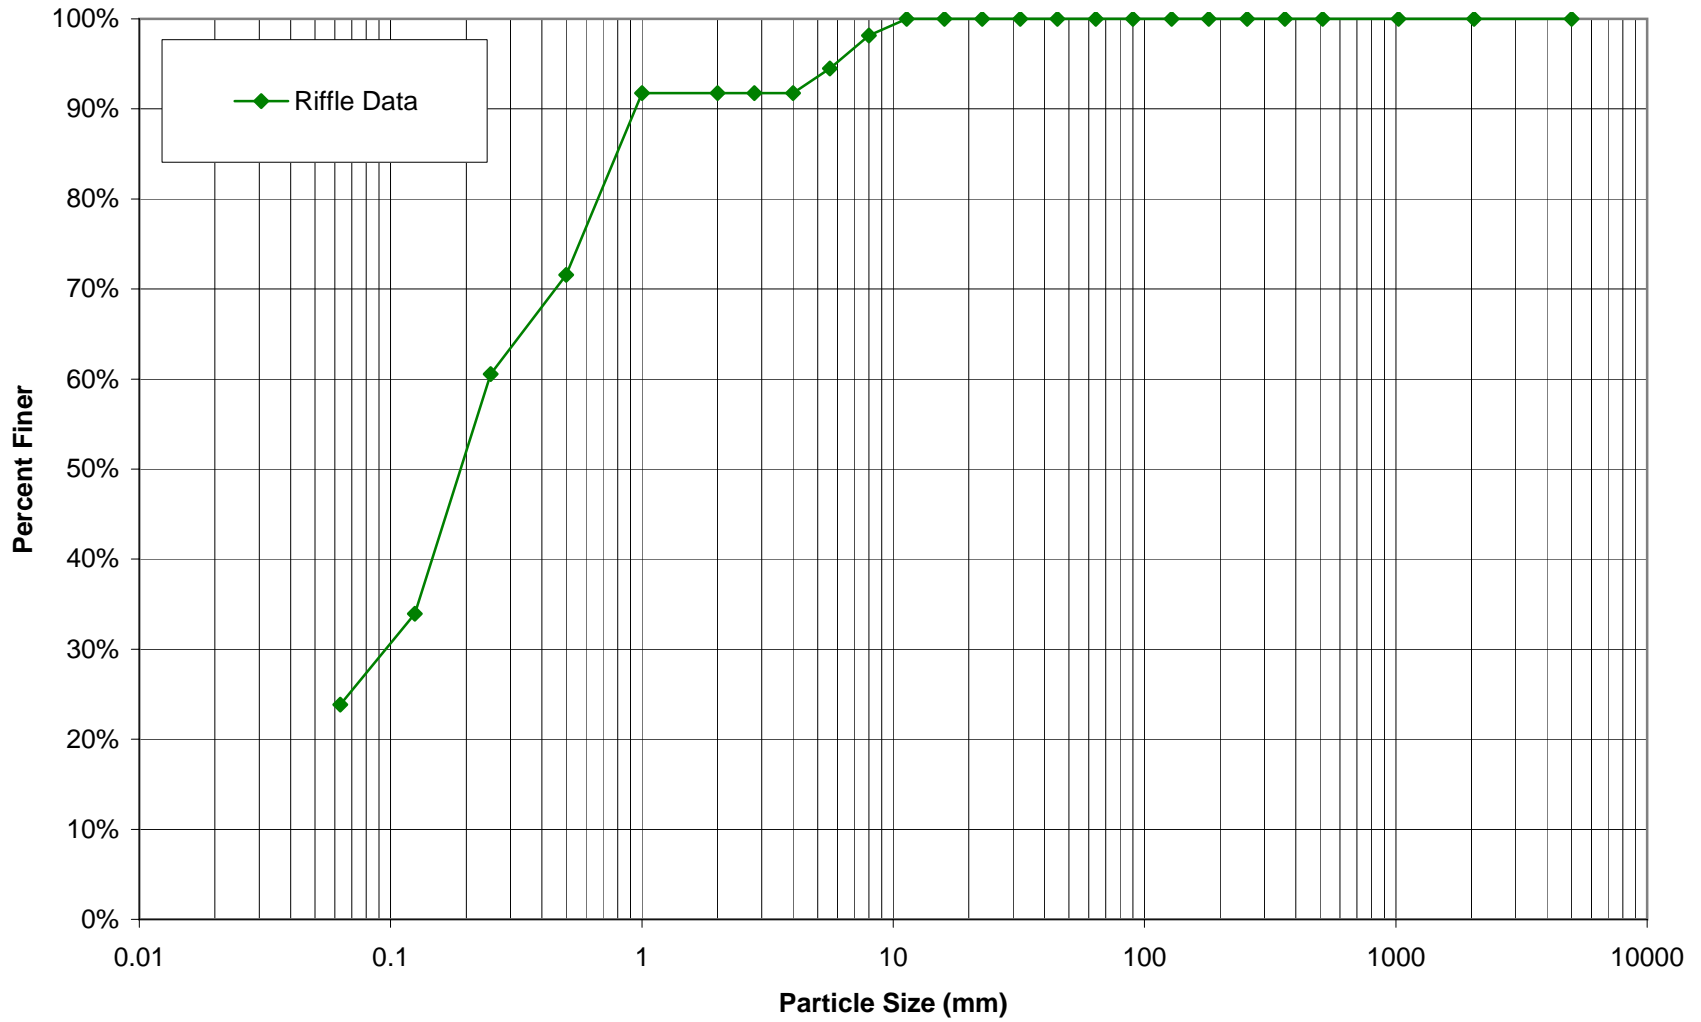
BUCK PROJECT NO.		108410
SITE OR PROJECT:	South Fork Hoppers Creek, Year 2 Monitoring	
REACH/LOCATION:	X8-Riffle	
DATE COLLECTED:	11/6/2007	
FIELD COLLECTION BY:	RR/SU	
DATA ENTRY BY:	KS

South Fork Hoppers Creek
X8-Riffle
Pebble Count Particle Size Distribution

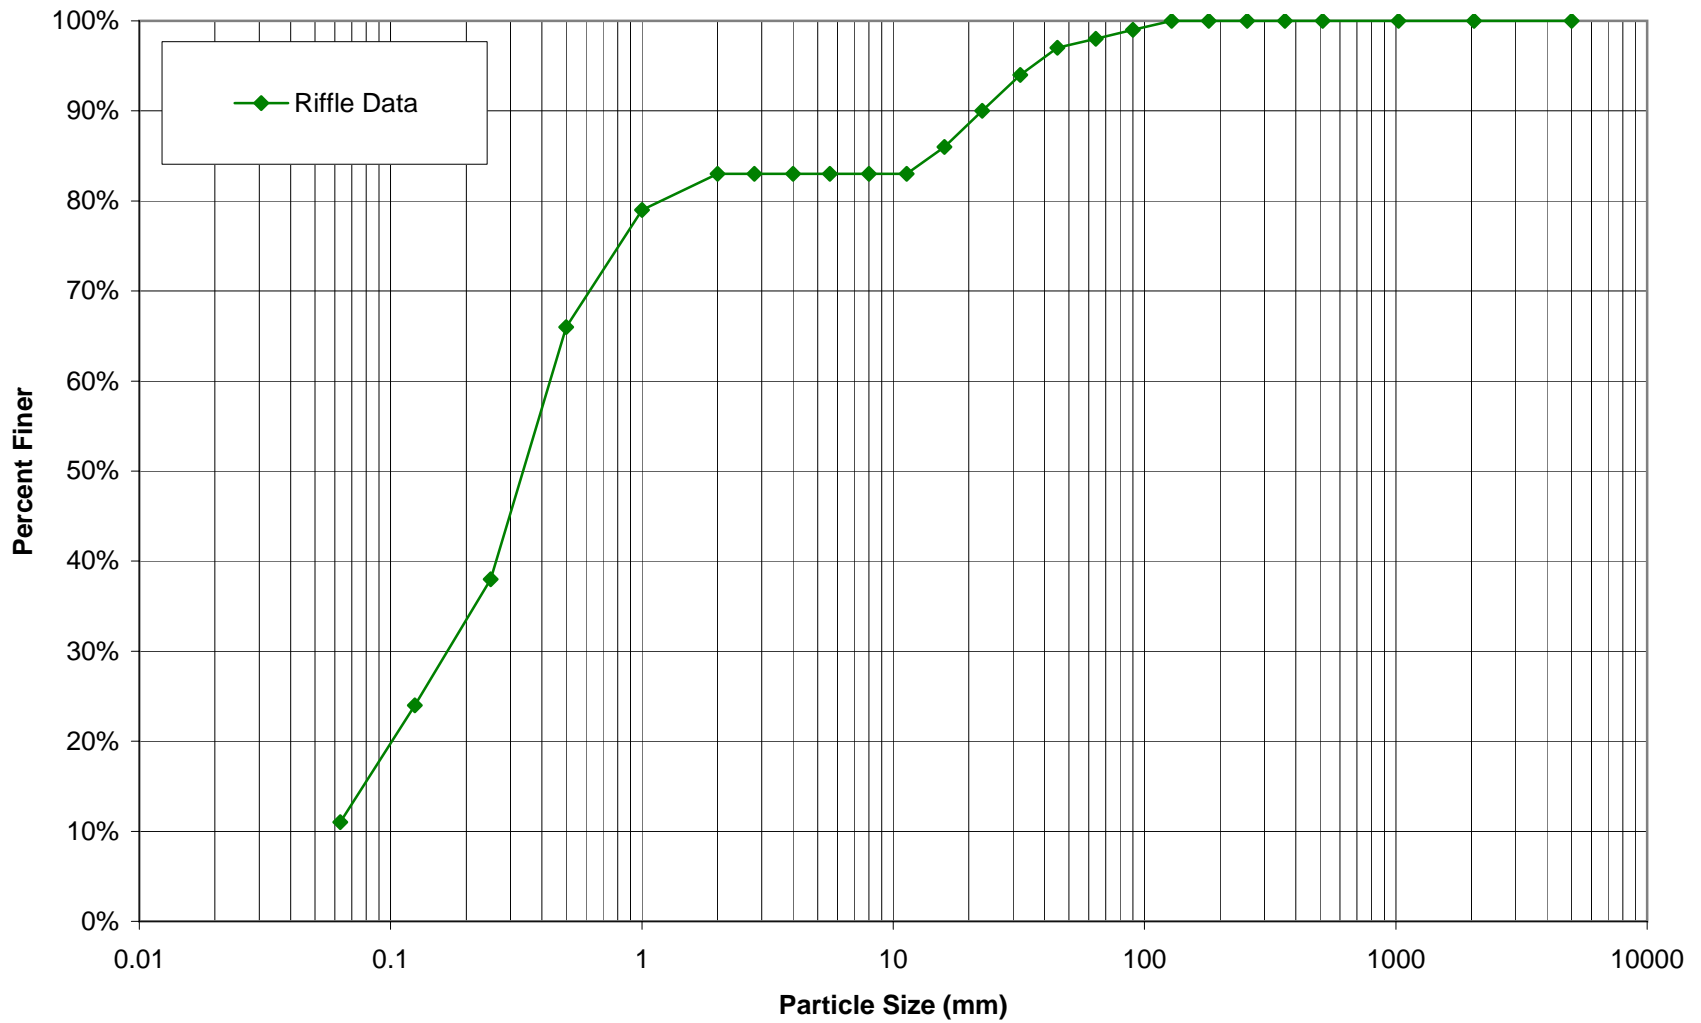
BUCK PROJECT NO. 108410
SITE OR PROJECT:	South Fork Hoppers Creek, Year 2 Monitoring
REACH/LOCATION:	X9-Pool
DATE COLLECTED:	11/5/2007
FIELD COLLECTION BY:	RR/IE
DATA ENTRY BY:	IE

South Fork Hoppers Creek
X9-Pool
Pebble Count Particle Size Distribution

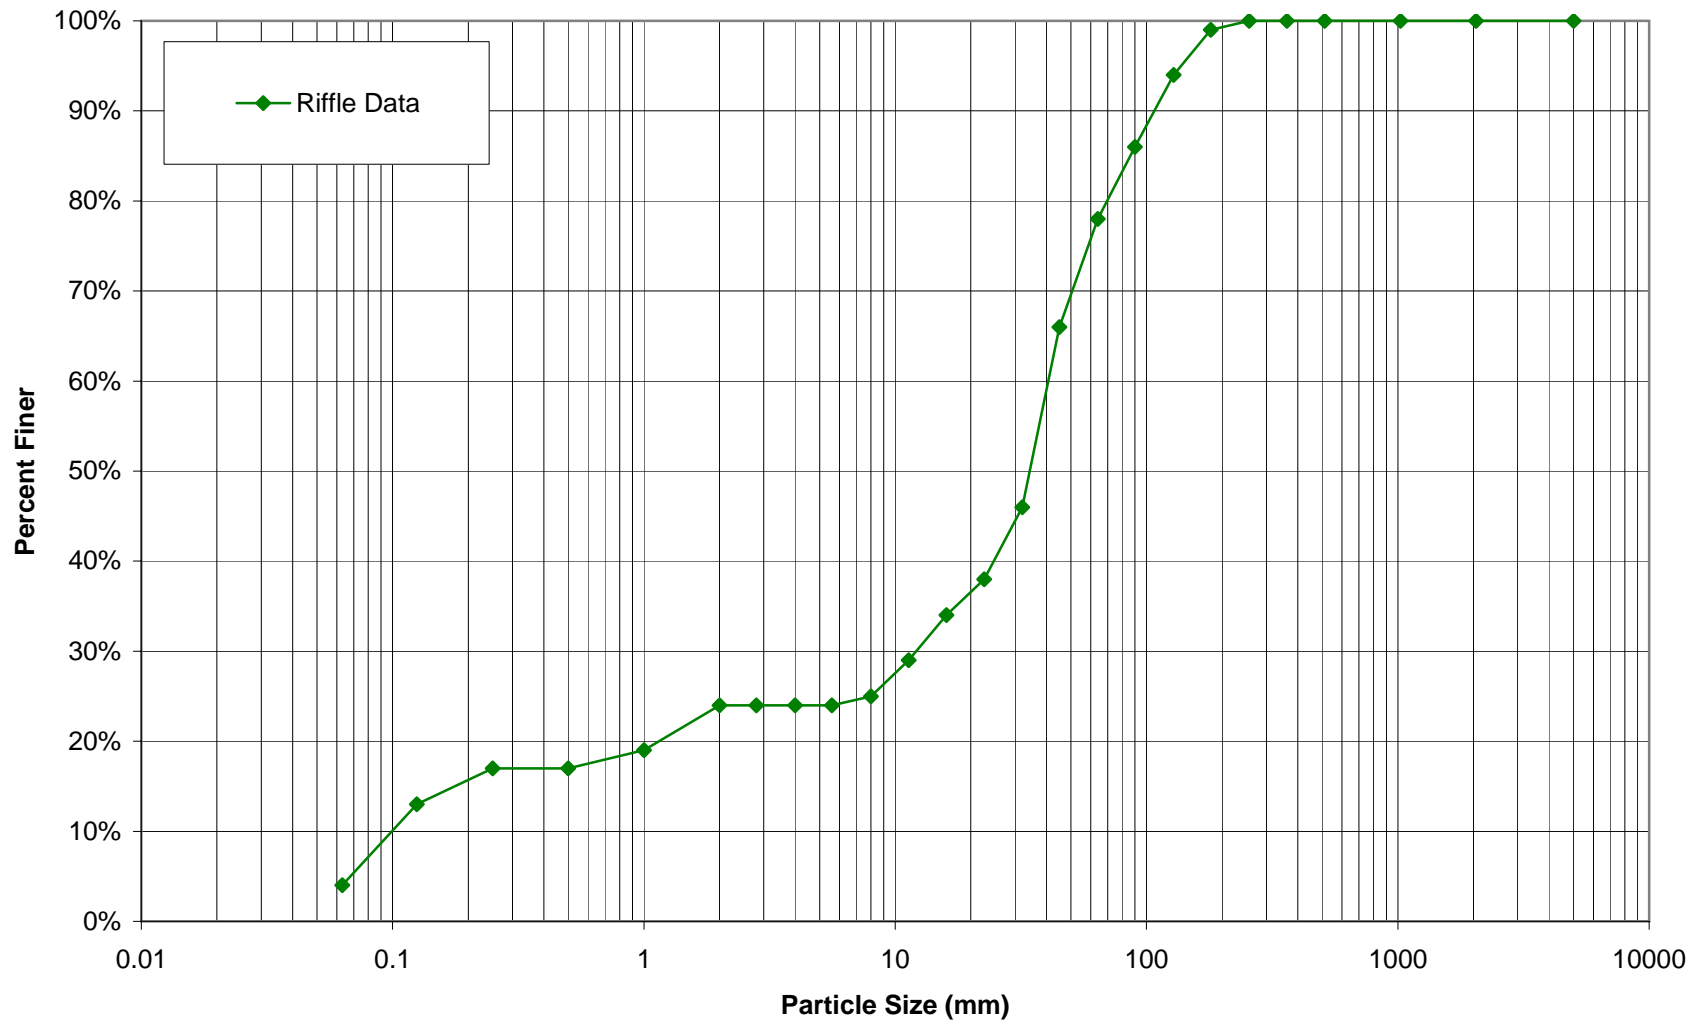
**Largest particles: 250.00
(riffle)**

**South Fork Hoppers Creek
X10-Riffle
Pebble Count Particle Size Distribution**

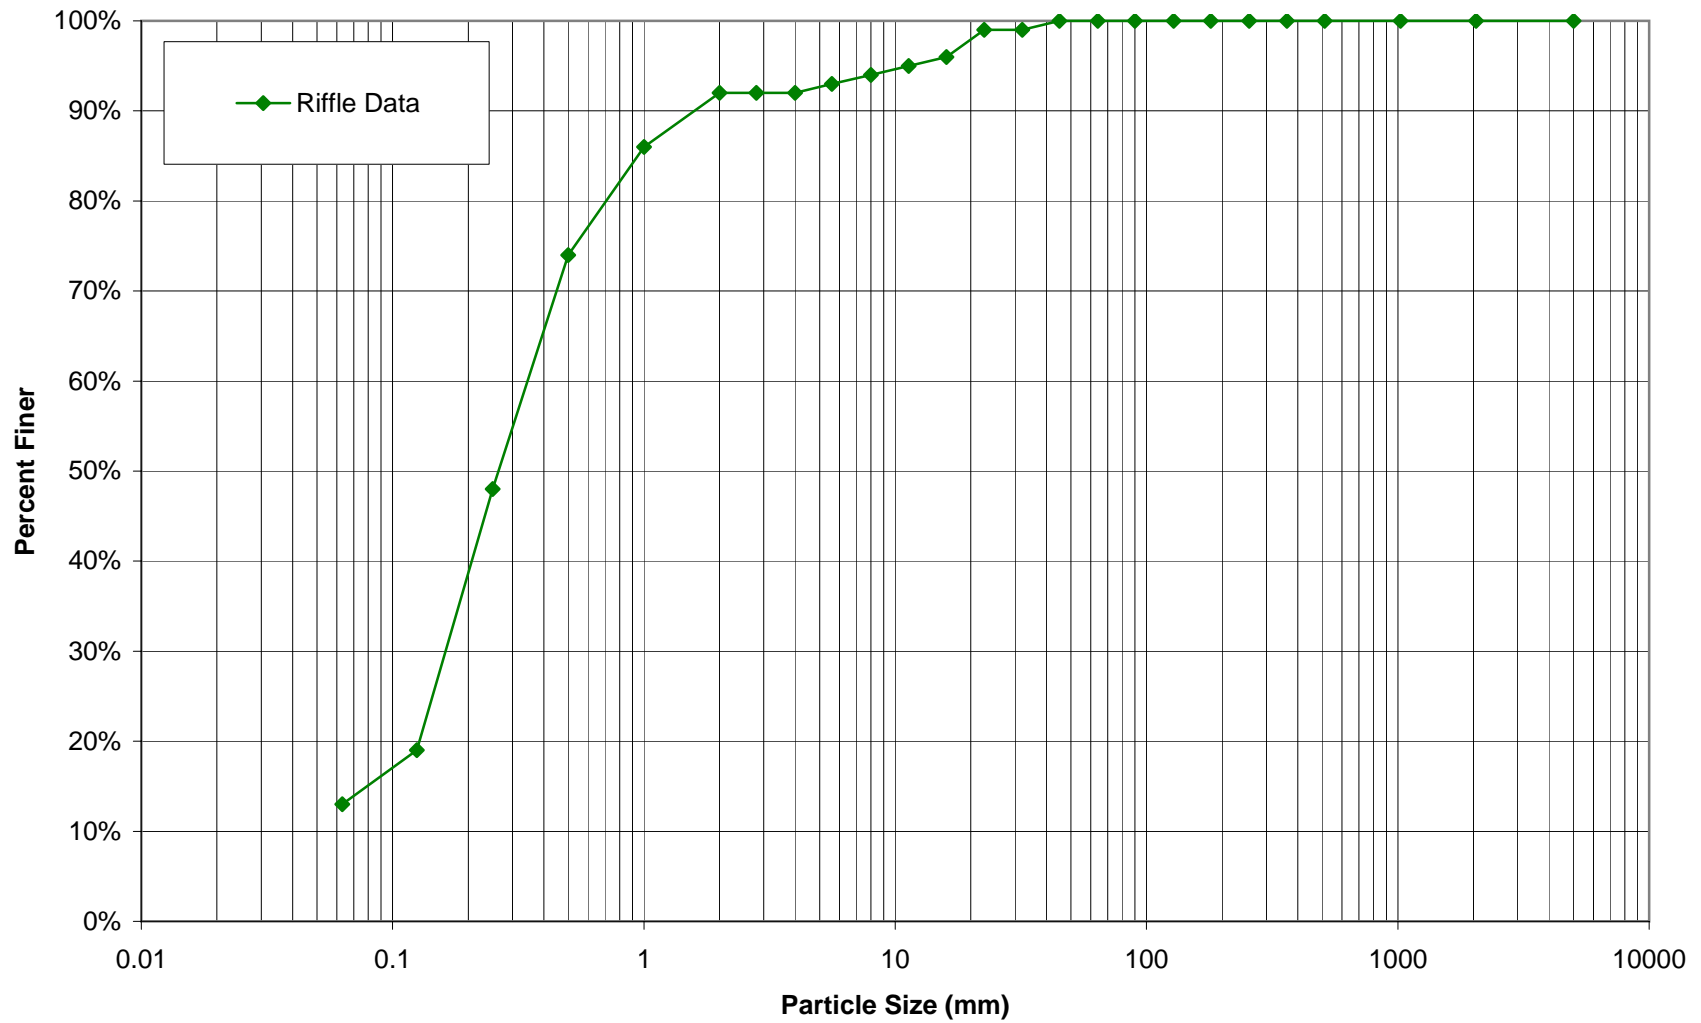
BUCK PROJECT NO.		108410
SITE OR PROJECT:	South Fork Hoppers Creek, Year 2 Monitoring	
REACH/LOCATION:	X11-Pool	
DATE COLLECTED:	11/5/2007	
FIELD COLLECTION BY:	RR/IE	
DATA ENTRY BY:	IE

South Fork Hoppers Creek
X11-Pool
Pebble Count Particle Size Distribution

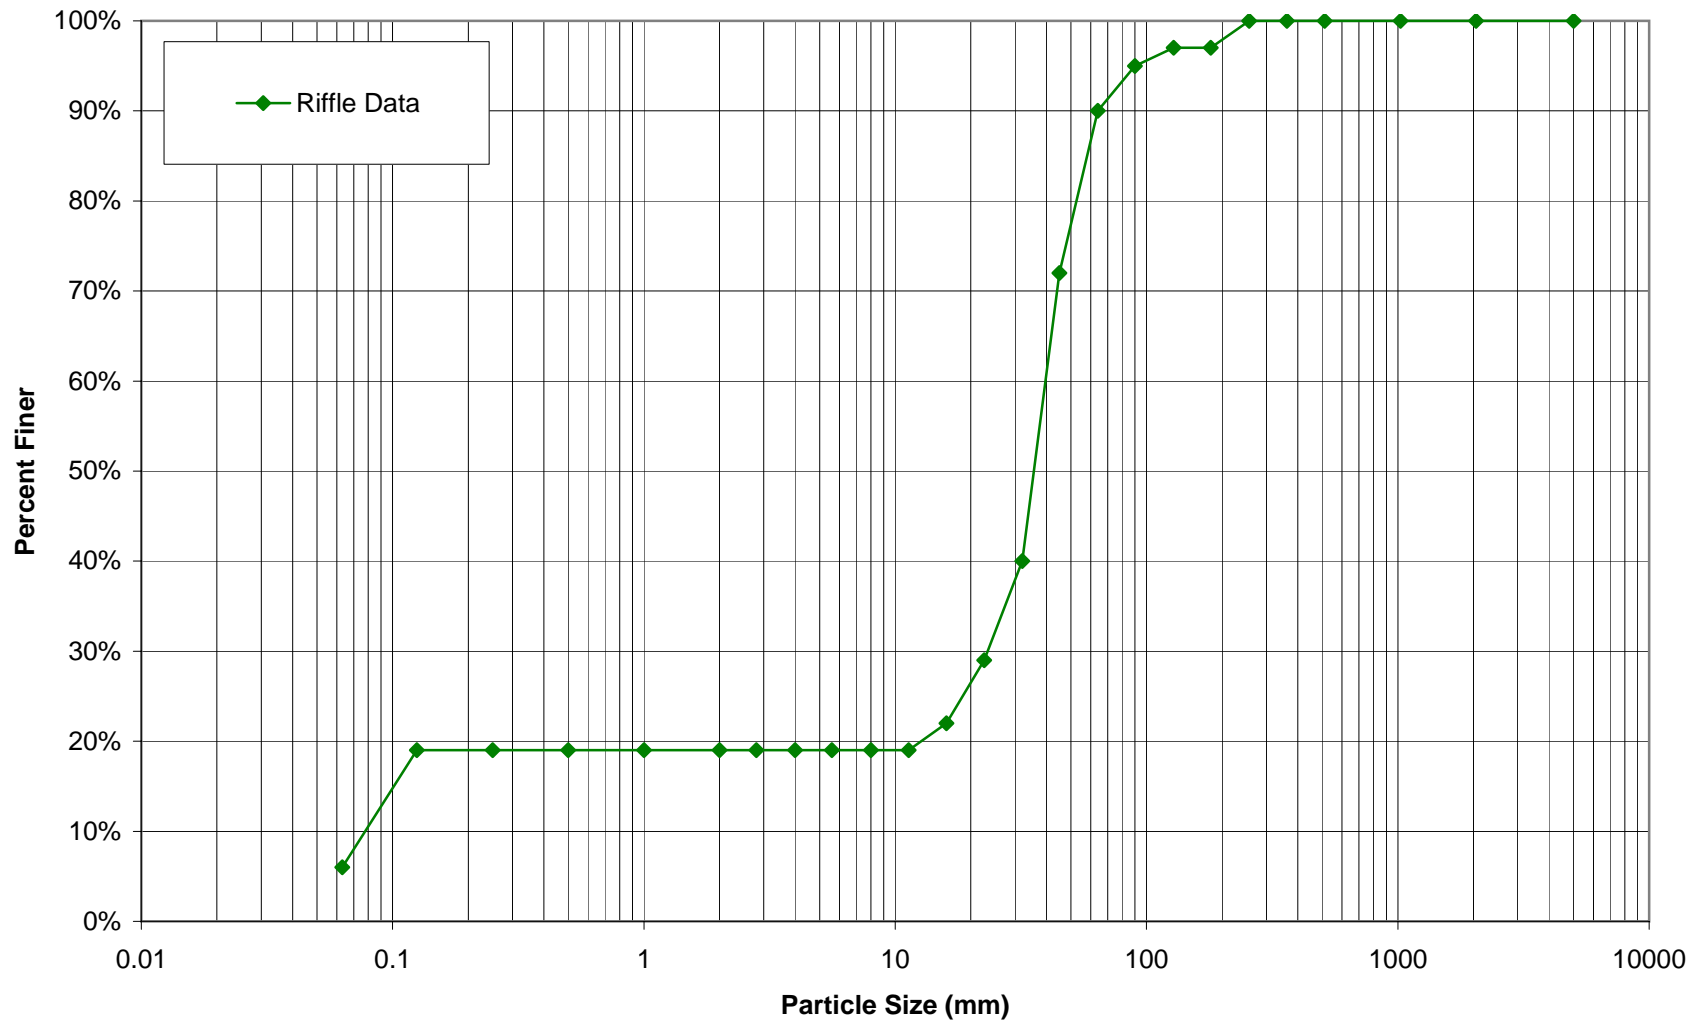
BUCK PROJECT NO. 108410
SITE OR PROJECT:	South Fork Hoppers Creek, Year 2 Monitoring
REACH/LOCATION:	X12-Riffle
DATE COLLECTED:	11/5/2007
FIELD COLLECTION BY:	RR/IE
DATA ENTRY BY:	IE

Largest particles: 240.00
(riffle)

South Fork Hoppers Creek
X12-Riffle
Pebble Count Particle Size Distribution

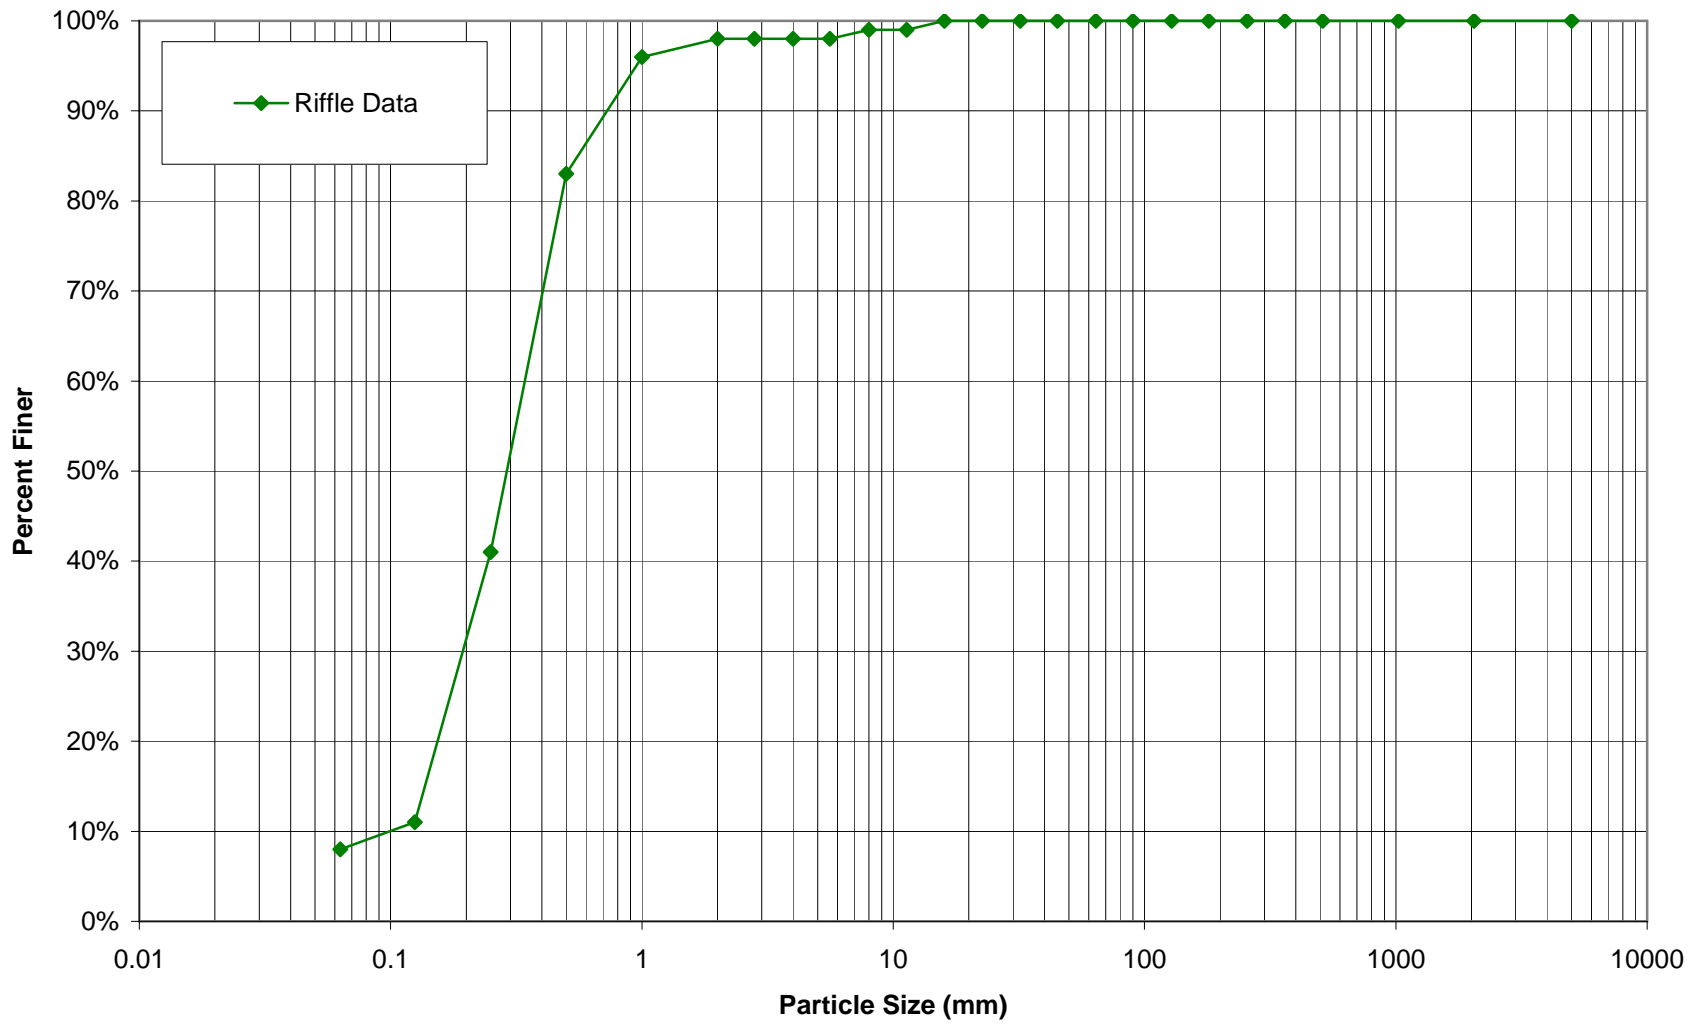
BUCK PROJECT NO.		108410
SITE OR PROJECT:	South Fork Hoppers Creek, Year 2 Monitoring	
REACH/LOCATION:	X13-Pool	
DATE COLLECTED:	11/5/2007	
FIELD COLLECTION BY:	RR/IE	
DATA ENTRY BY:	IE

South Fork Hoppers Creek
X13-Pool
Pebble Count Particle Size Distribution

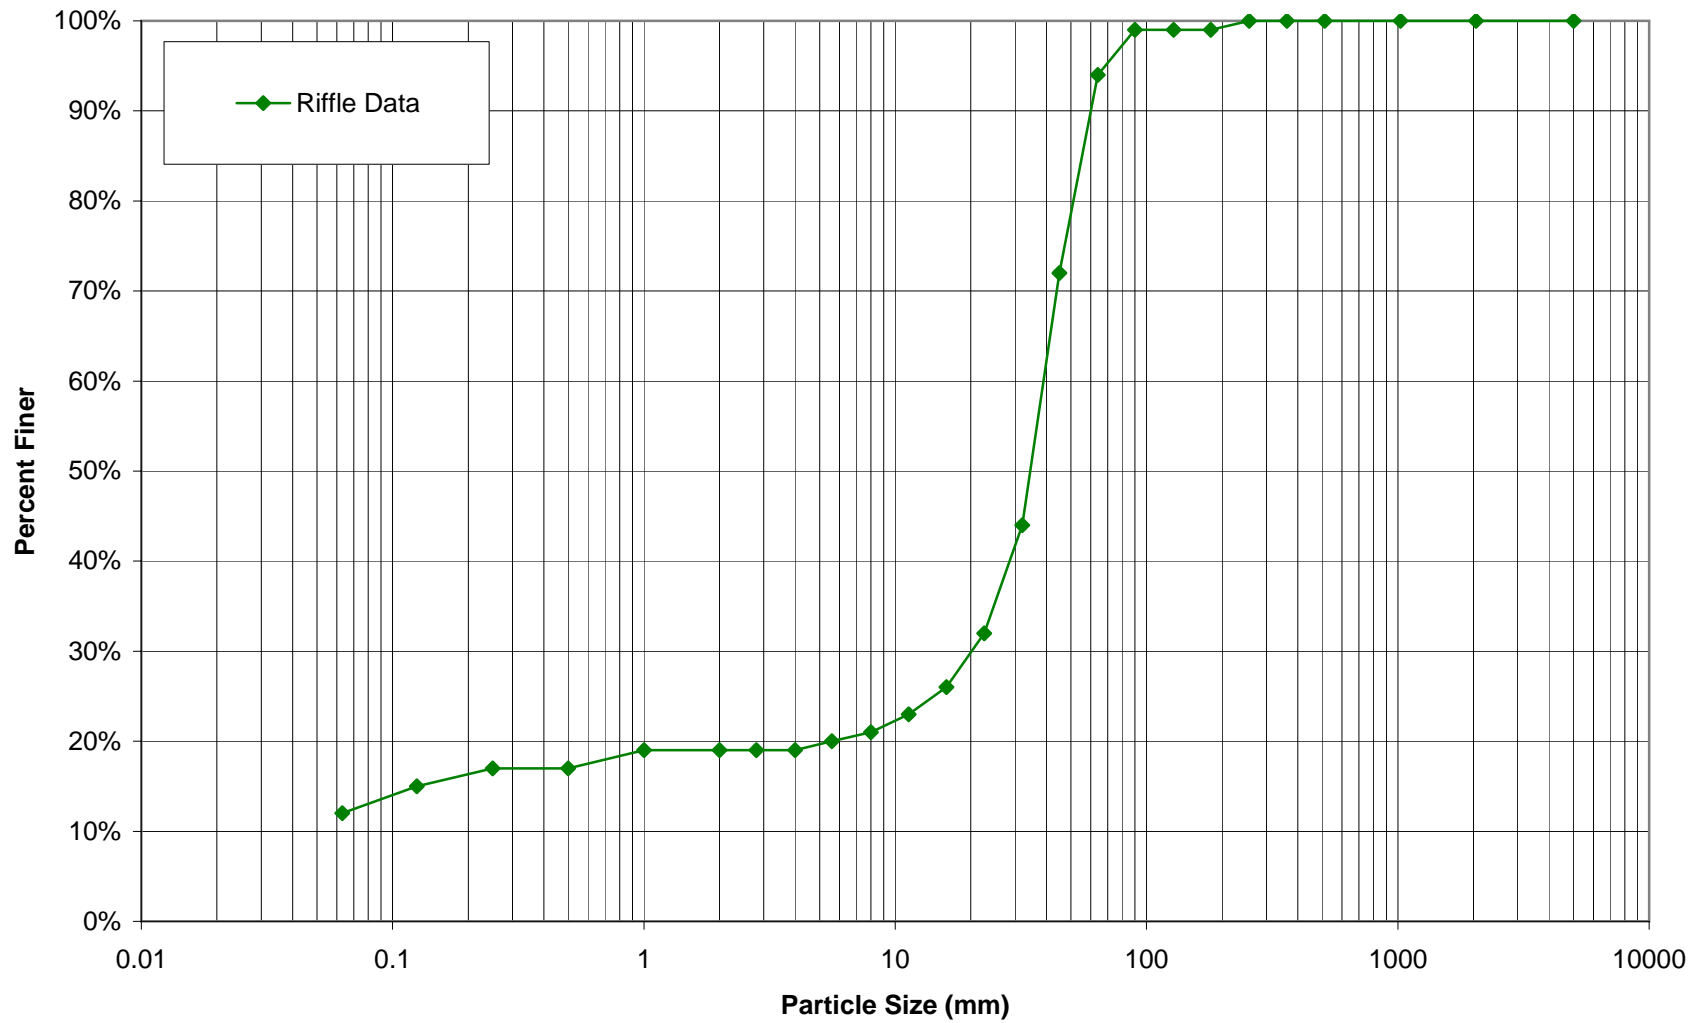
BUCK PROJECT NO. 108410
SITE OR PROJECT:	South Fork Hoppers Creek, Year 2 Monitoring
REACH/LOCATION:	X14-Riffle
DATE COLLECTED:	11/5/2007
FIELD COLLECTION BY:	RR/IE
DATA ENTRY BY:	IE

Largest particles: 200.00 (riffle)

South Fork Hoppers Creek
X14-Riffle
Pebble Count Particle Size Distribution

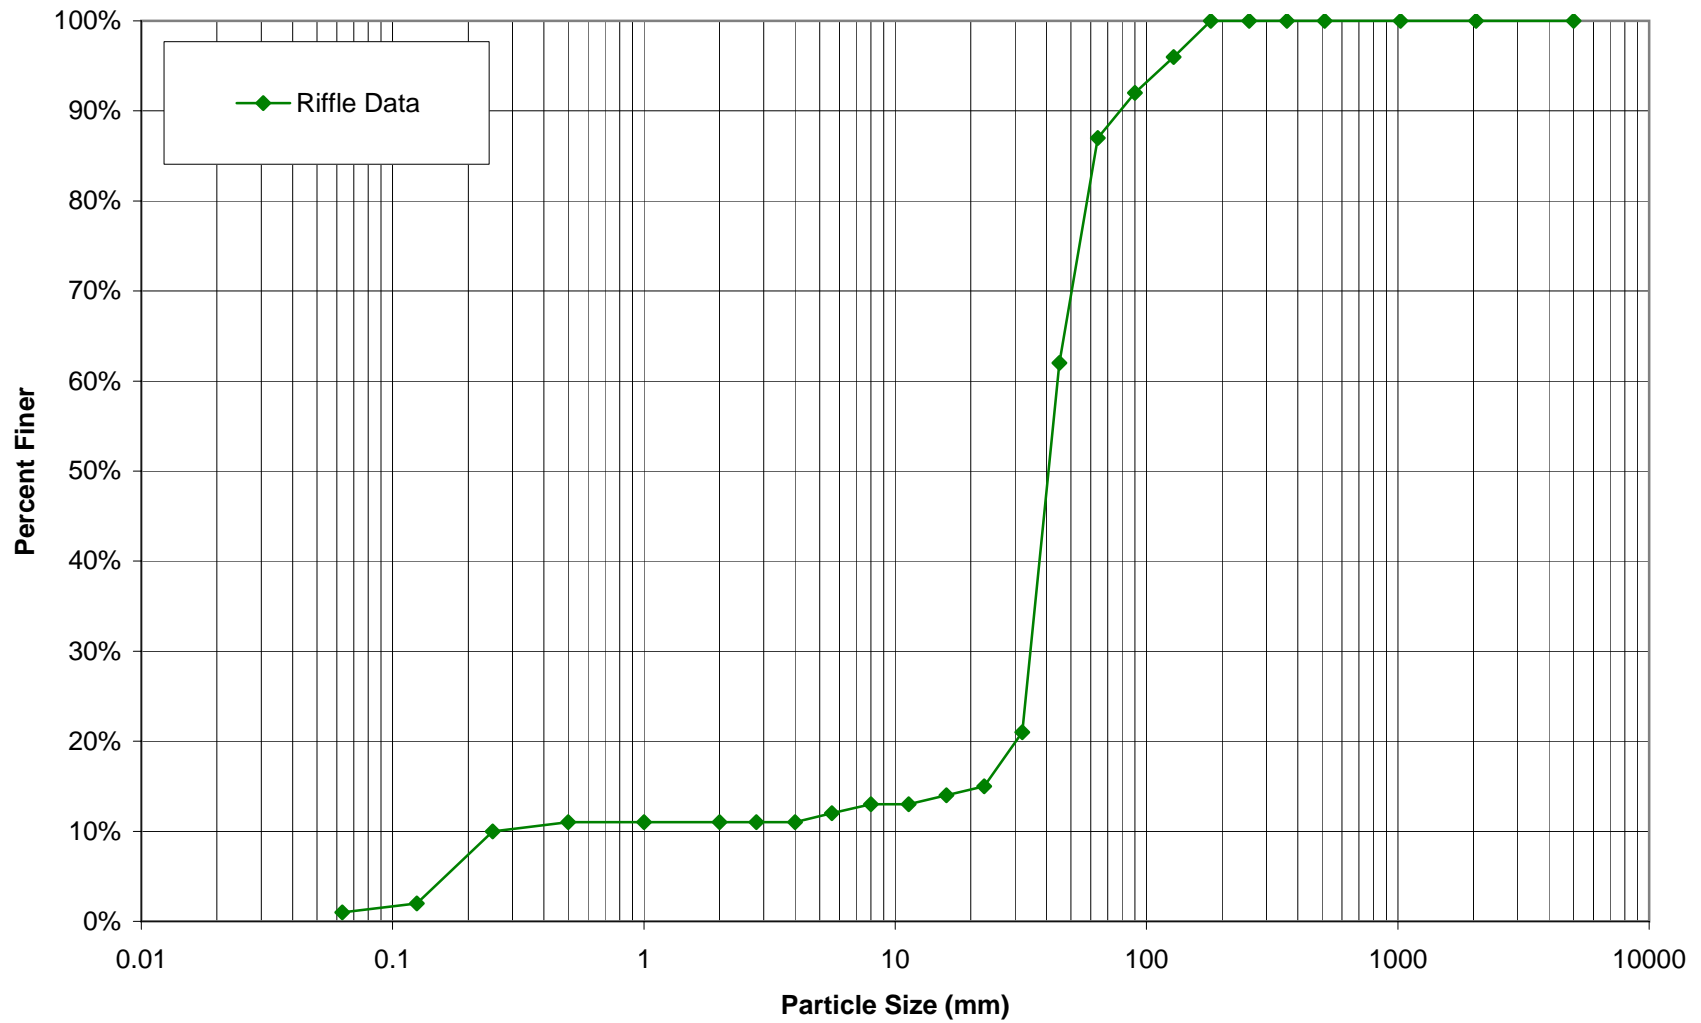
BUCK PROJECT NO. 108410
SITE OR PROJECT:	South Fork Hoppers Creek, Year 2 Monitoring
REACH/LOCATION:	X15-Riffle
DATE COLLECTED:	11/5/2007
FIELD COLLECTION BY:	RR/IE
DATA ENTRY BY:	IE

South Fork Hoppers Creek
X15-Riffle
Pebble Count Particle Size Distribution
