SOUTH FORK HOPPERS CREEK STREAM AND WETLAND RESTORATION PROJECT

ANNUAL MONITORING REPORT FOR 2007 (YEAR 2)

Project Number: D04006-4

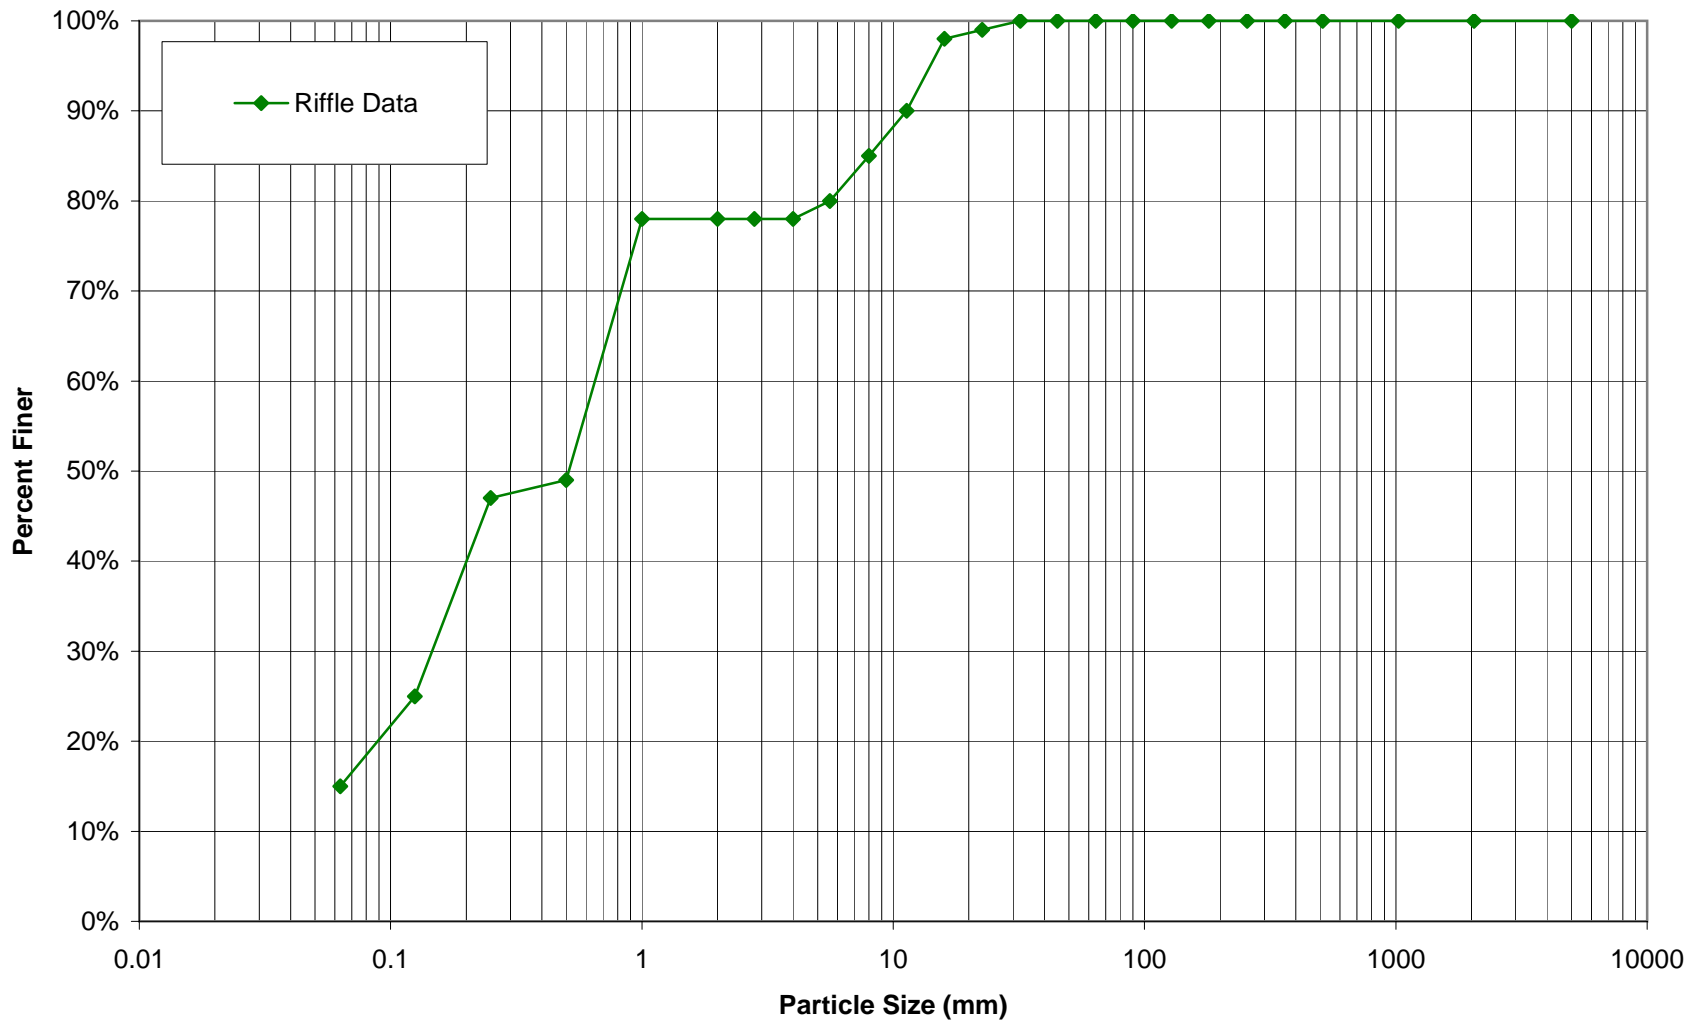
BUCK PROJECT NO.		108410
SITE OR PROJECT:	South Fork Hoppers Creek, Year 2 Monitoring	
REACH/LOCATION:	X16-Pool	
DATE COLLECTED:	11/5/2007	
FIELD COLLECTION BY:	RR/IE	
DATA ENTRY BY:	IE

South Fork Hoppers Creek
X16-Pool
Pebble Count Particle Size Distribution

Year 2 bed material samples were collected at each permanent cross-section during November 2007. Overall, bed material indicated coarser riffles and finer pools, however riffles showed a trend towards fining downstream of Pierce Road due to the backwater effects of the downstream beaver dam. Riffle cross-sections 1 and 3 had d50 of 0.15 mm and 0.7 mm, respectively, which corresponds to sand. The beaver dam causes the water to slow and fine particles to settle out of suspension, thus fining the riffle. Riffles begin to coarsen further upstream with a d50 of 7.5 mm at cross-section 5. Upstream of Pierce Road all riffle cross-sections have a d50 corresponding to very coarse gravel. Pools throughout the project site are dominated by sand. All pebble count data is provided in Appendix B.

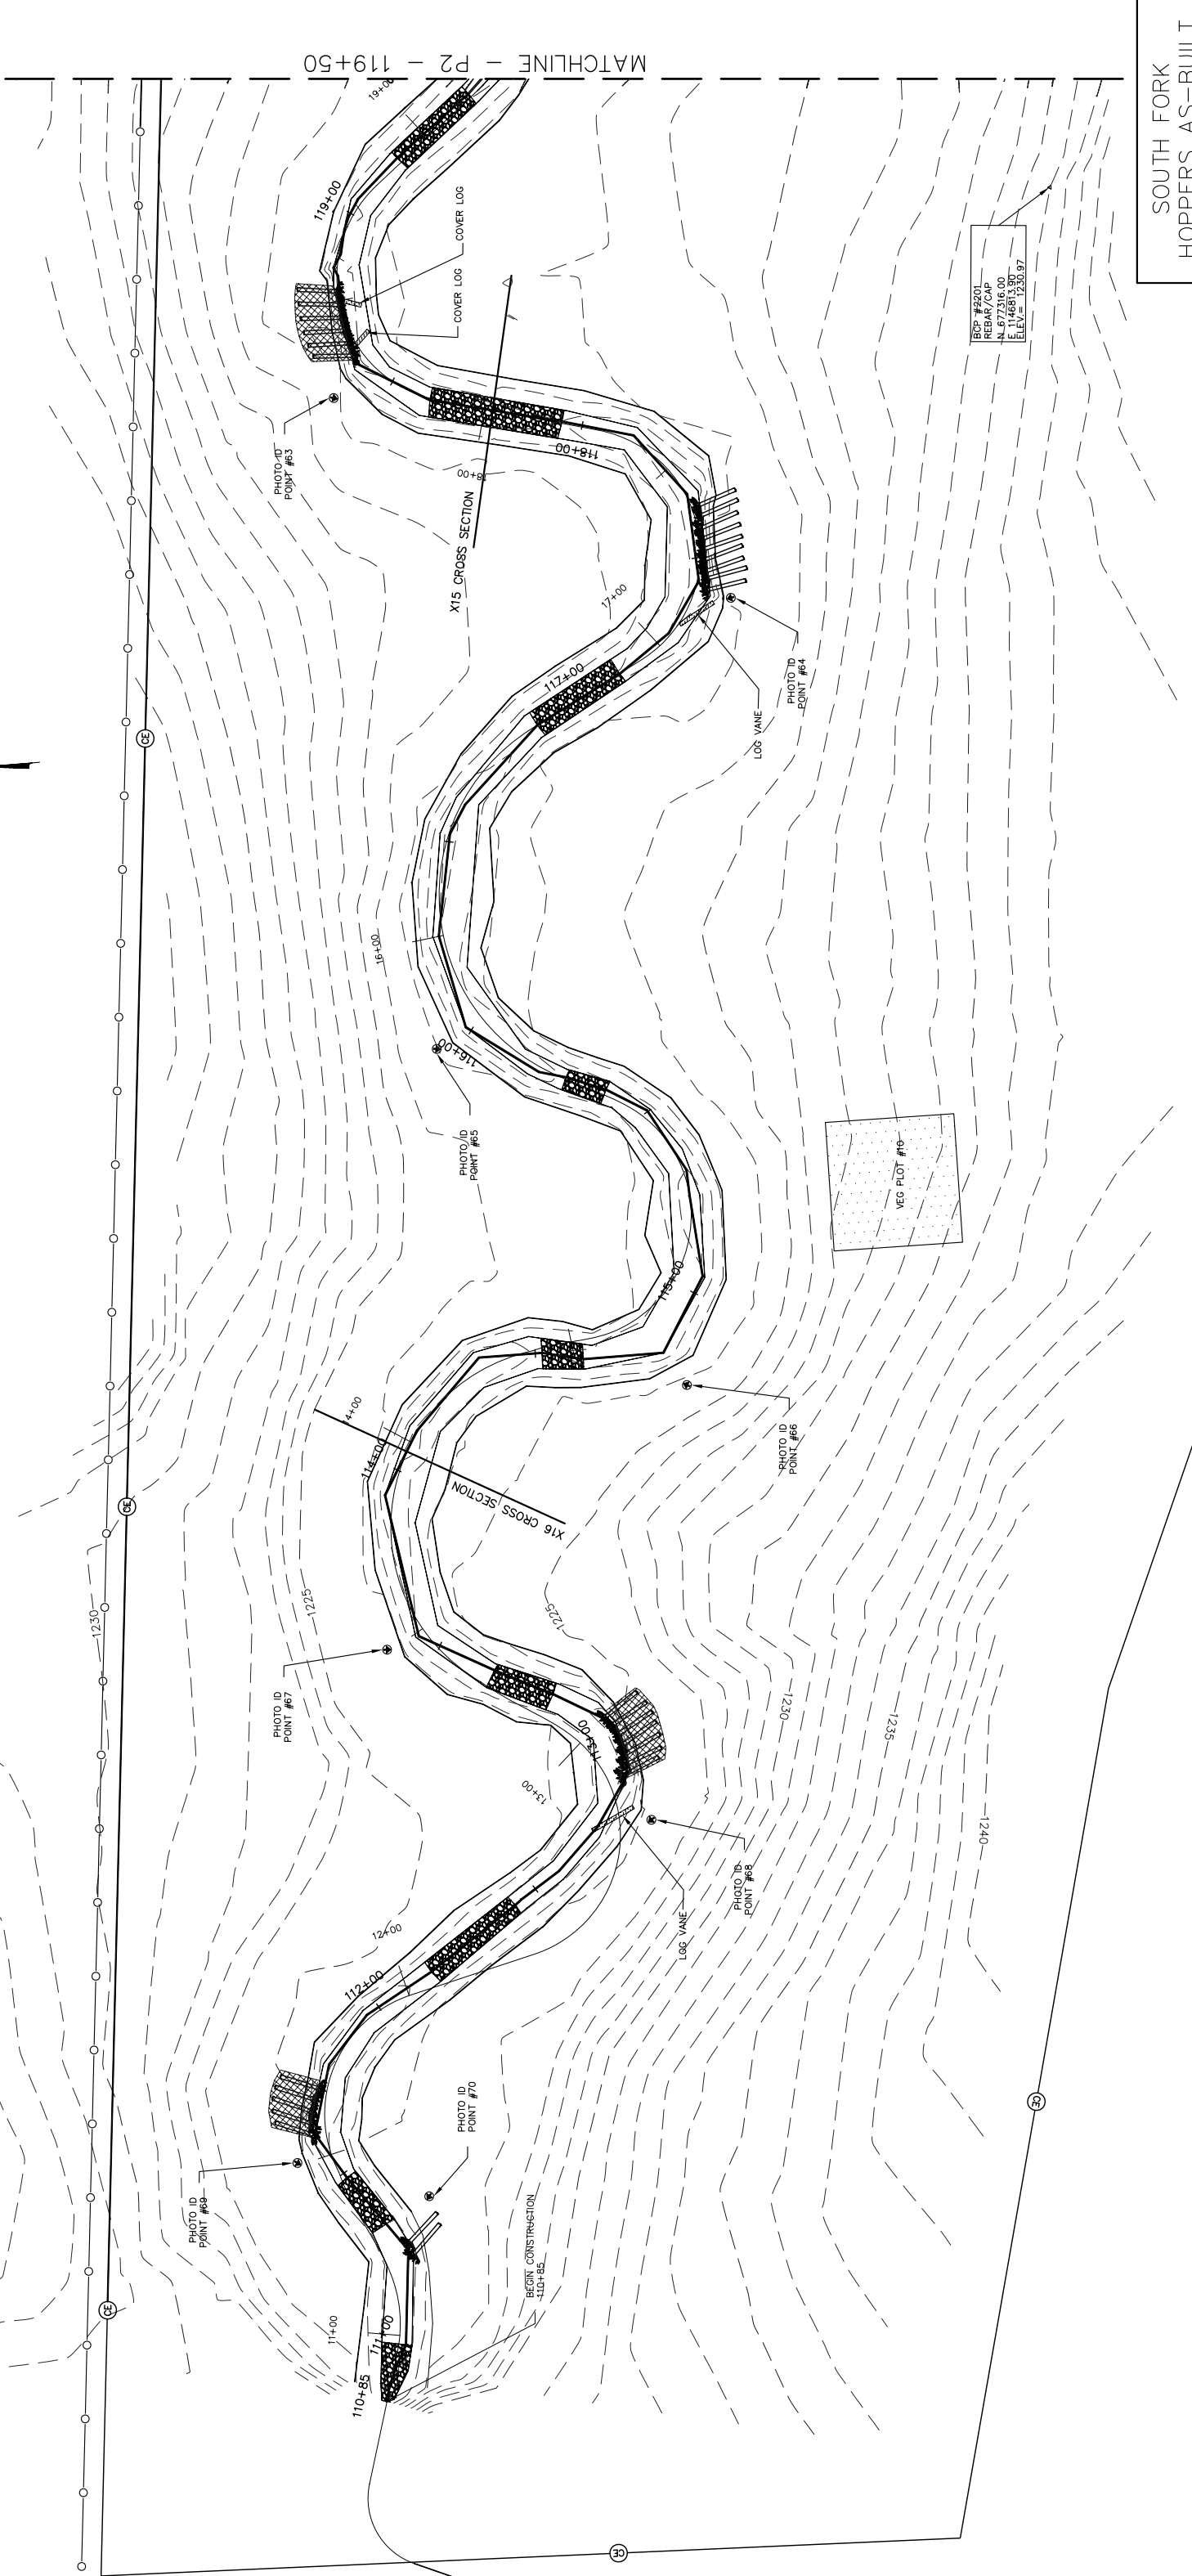
PROJECT REFERENCE NO. 0224C SHEET NO. P1
 PROJECT ENGINEER CLY
 APPROVED BY EGR
 DATE 06/30/2006

BCP #6201
 NEB# 7716.00
 N.E. 7716.00
 E. 1146813.90
 ELEV. = 1236.97

VEG PLOT #19

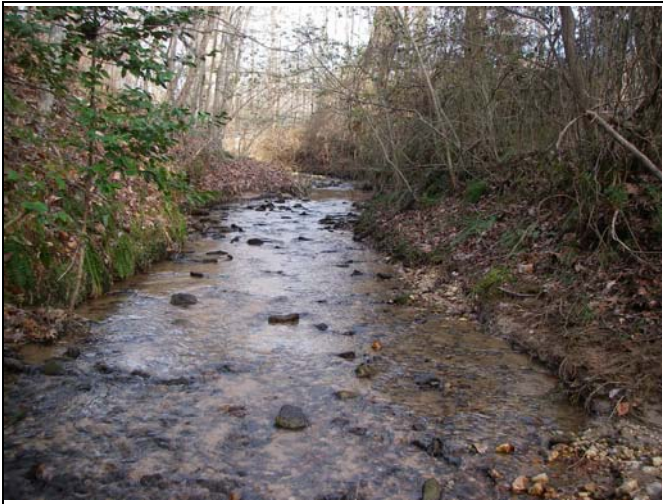
P-1

Site 1 – looking upstream

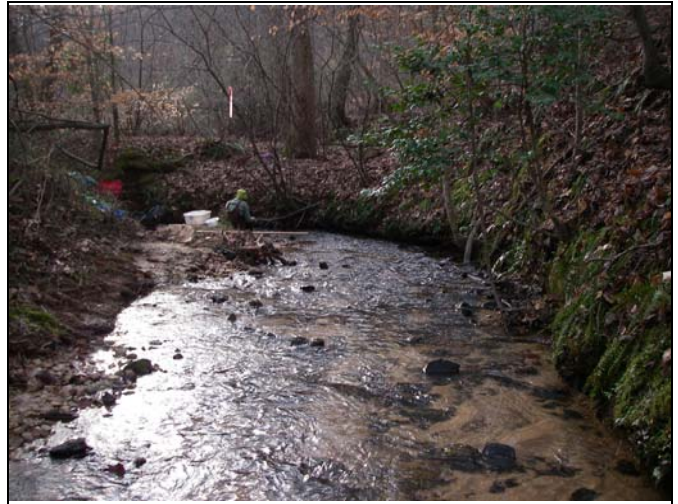
P-2

Site 1 – looking downstream

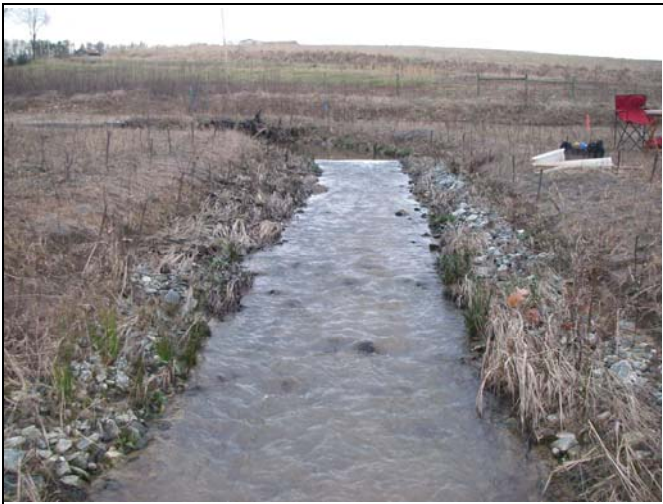
P-3

Site 2 – looking upstream

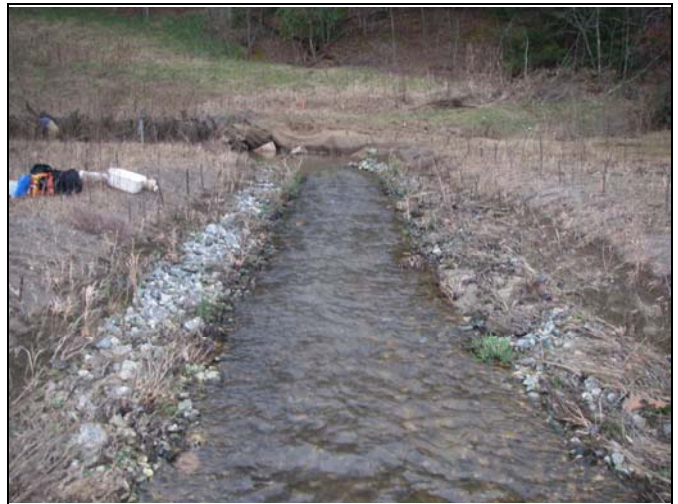
P-4

Site 2 – looking downstream

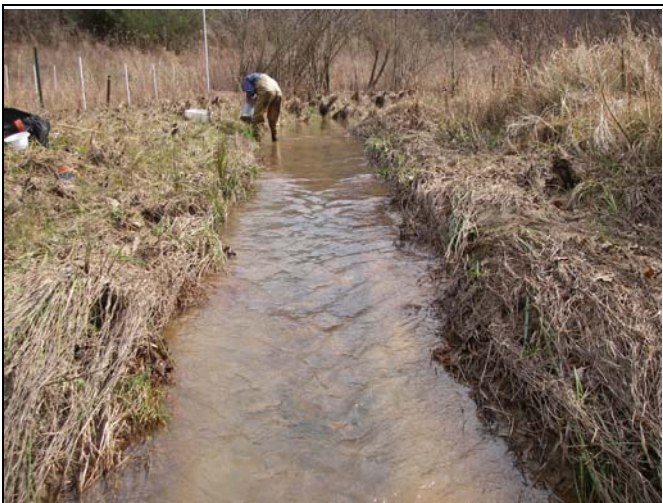
P-5

Site 3 – looking upstream

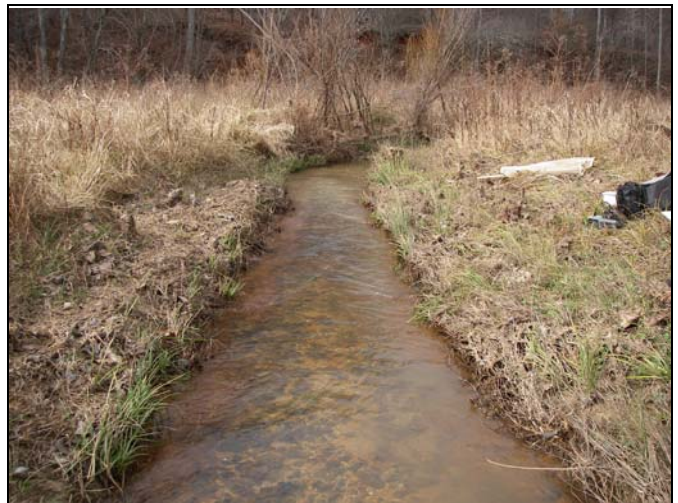
P-6

Site 3 – looking downstream

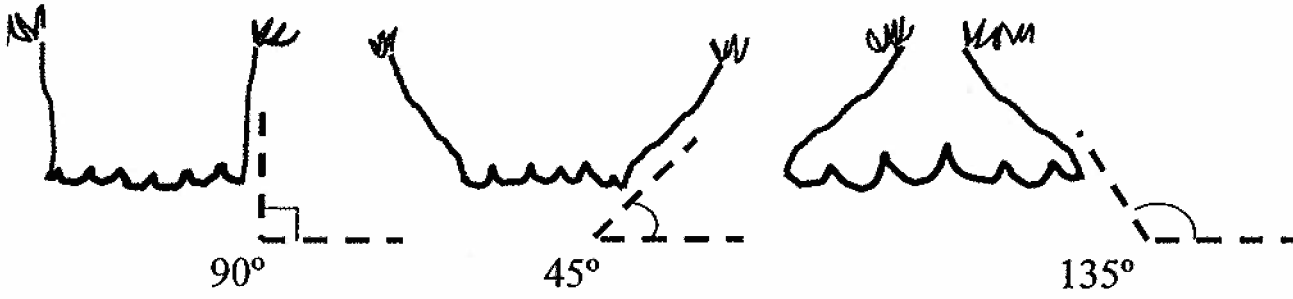
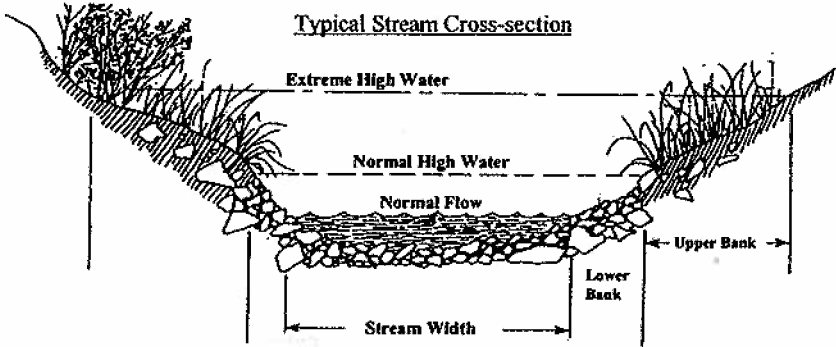
Diagram to determine bank angle:

This side is 45° bank angle.

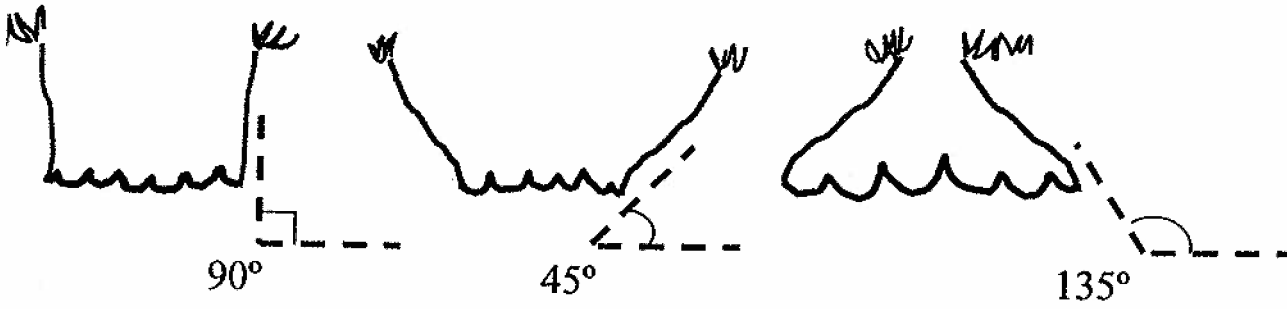
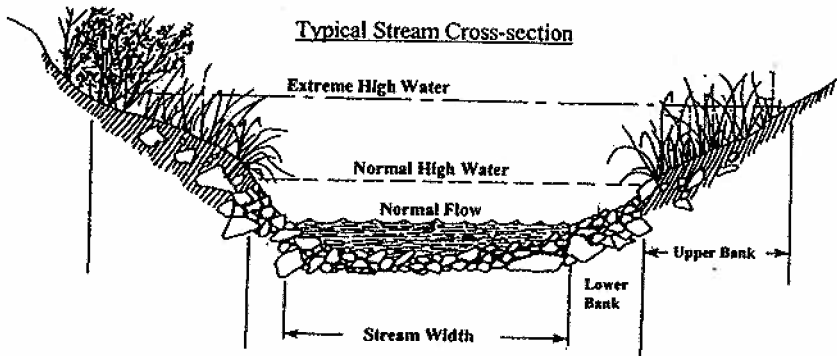
Diagram to determine bank angle:

This side is 45° bank angle.

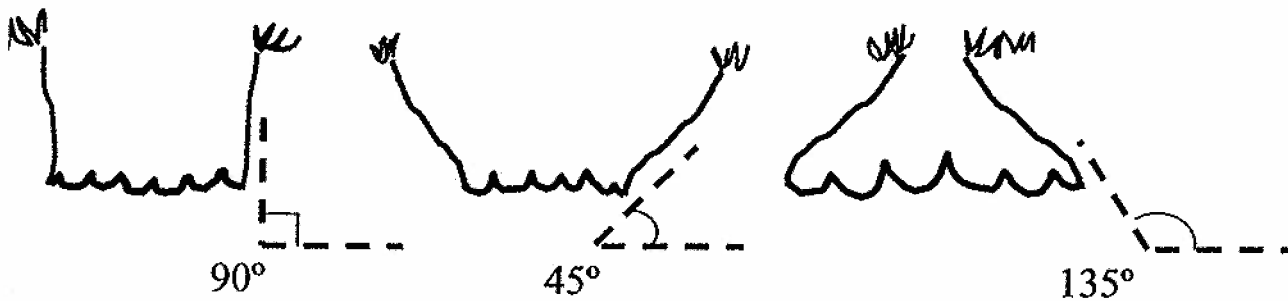
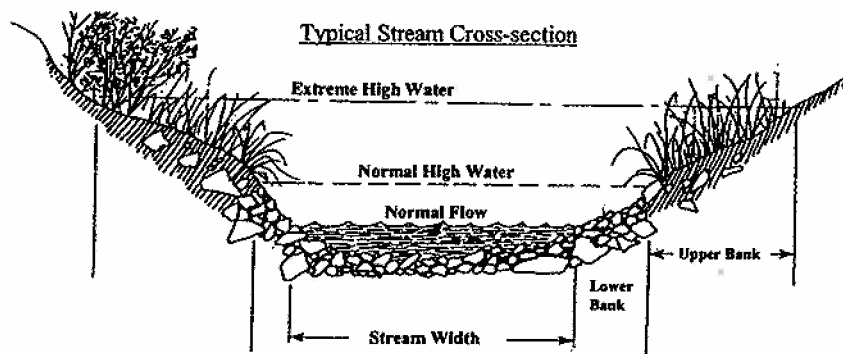
Diagram to determine bank angle:

This side is 45° bank angle.
