St. Clair Creek Restoration Project Year 6 Final Monitoring Report

Beaufort County, North Carolina

DMS Project ID No. 95015

Monitoring Year: 6 of 7

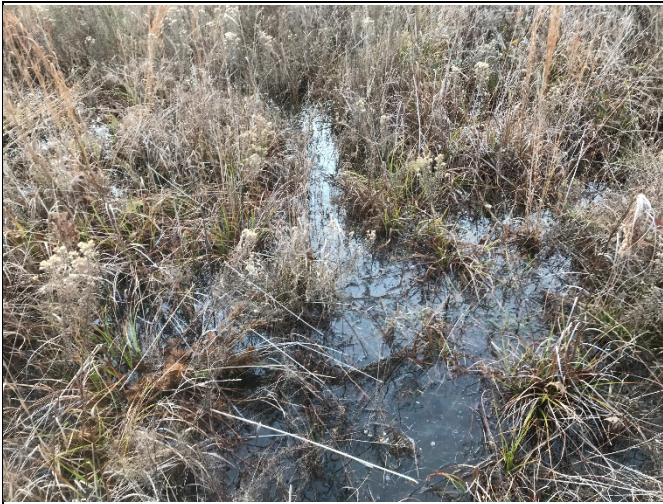
Flow Hydrology at Photo Point 12

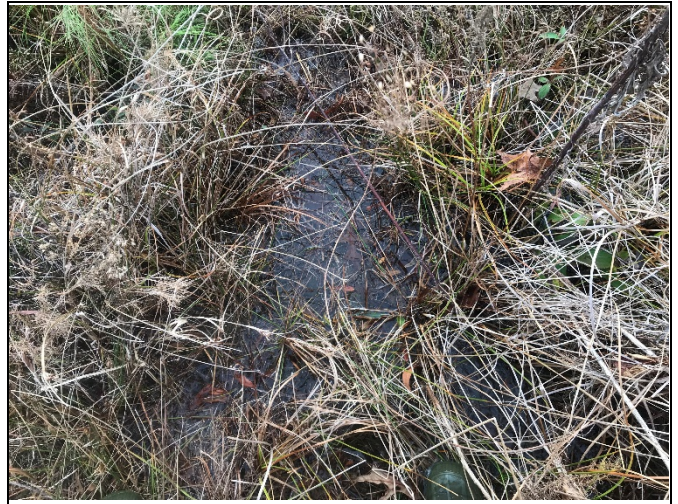
Flow Hydrology at Photo Point 13

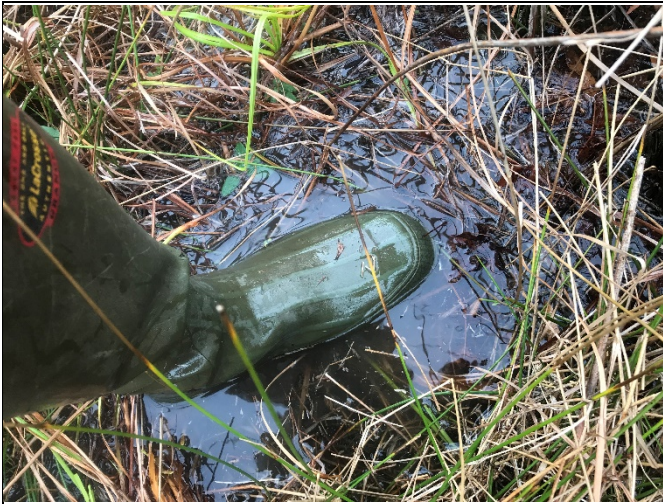
Flow Hydrology at Photo Point 14

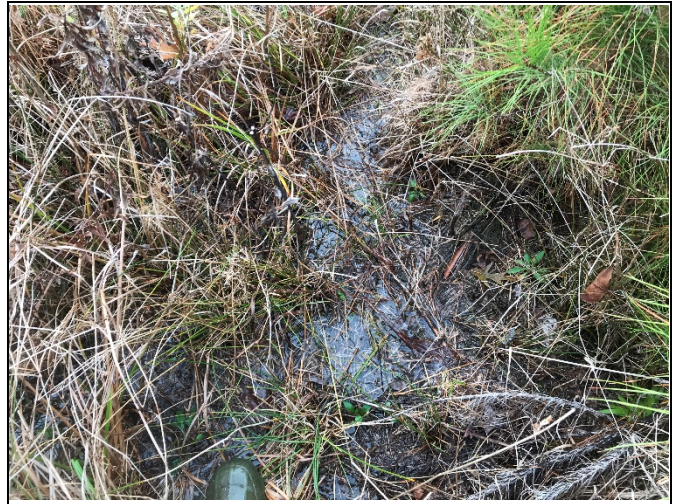
Flow Hydrology at Photo Point 15

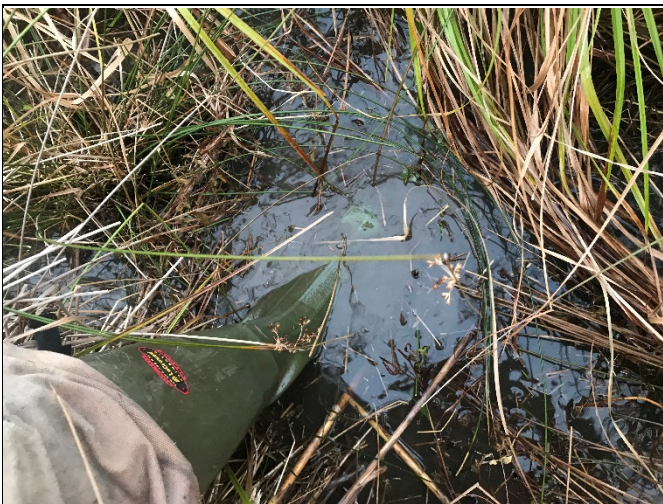
Flow Hydrology at Photo Point 20

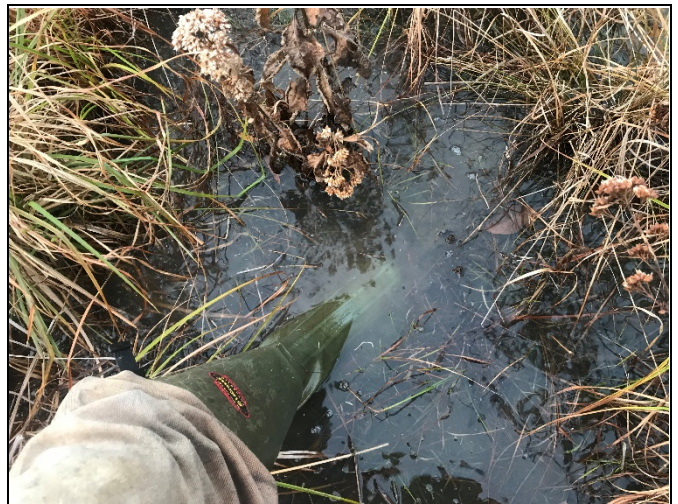
Flow Hydrology at Photo Point 21

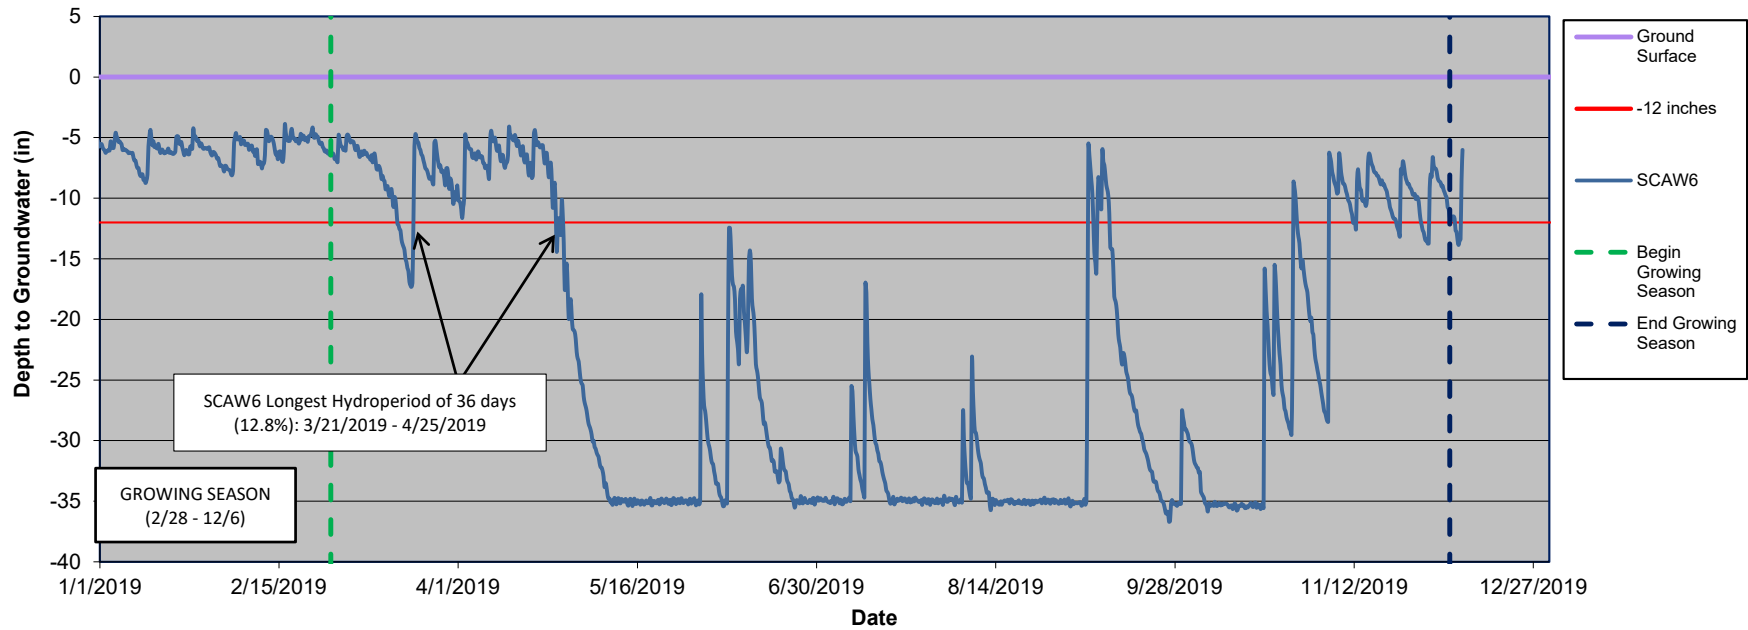
St. Clair Creek Wetland Restoration Well (UT2) (Supplemental Well - SCAW6)

St. Clair Creek Rain (2019)

*To gather additional well data in the wetland restoration area, In-Situ groundwater monitoring dataloggers SCAW5 - SCAW 8 were installed in April 2016, several weeks after the growing season had begun. Two additional In-Situ groundwater monitoring dataloggers SCAW9 and SCAW10 were installed in March 2017, just over two weeks past the start of the growing season in 2017.

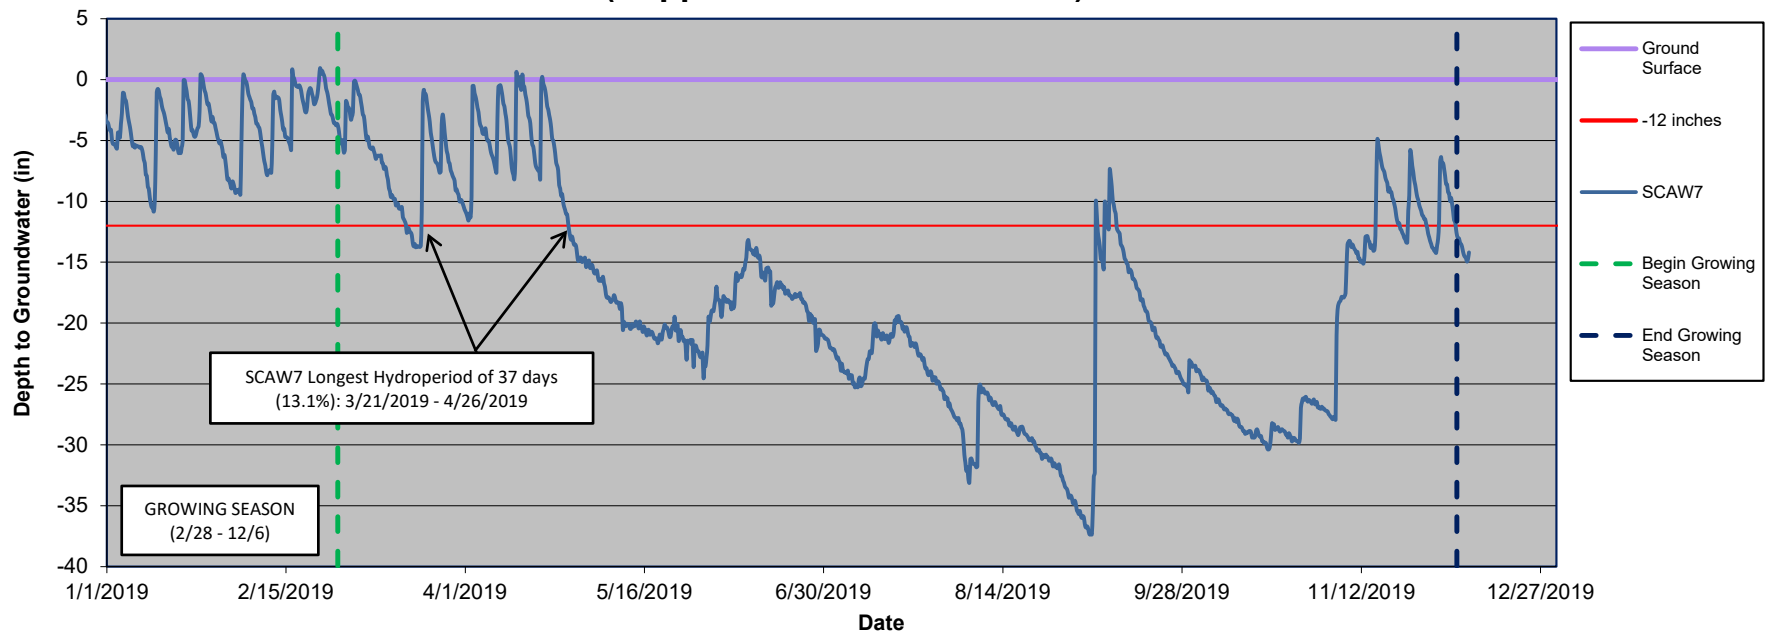
St. Clair Creek Wetland Restoration Well (UT3) (Supplemental Well - SCAW7)

St. Clair Creek Rain (2019)
