Monitoring Report MY01

**Stony Fork Restoration Site
Upper Neuse River Basin - 03020201
Monitoring Year 01
DMS Contract 6830**

**DMS Project Number 97085
DWR #: 2016-0372
USACE Action ID: 2016-00875
Johnston County, North Carolina**

**Monitoring Data Collected: 2019
Date Submitted: January 2020**

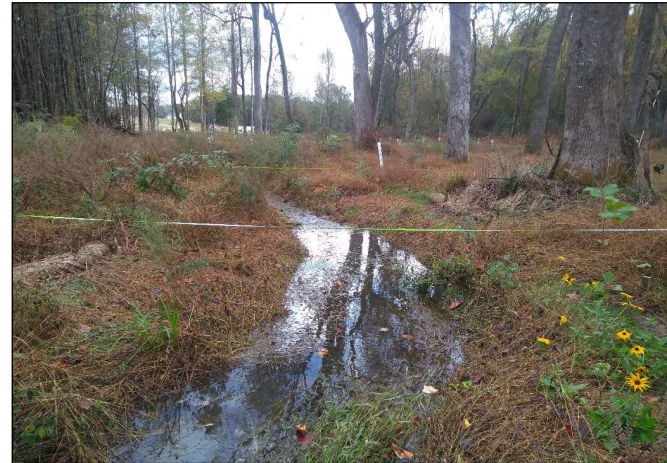
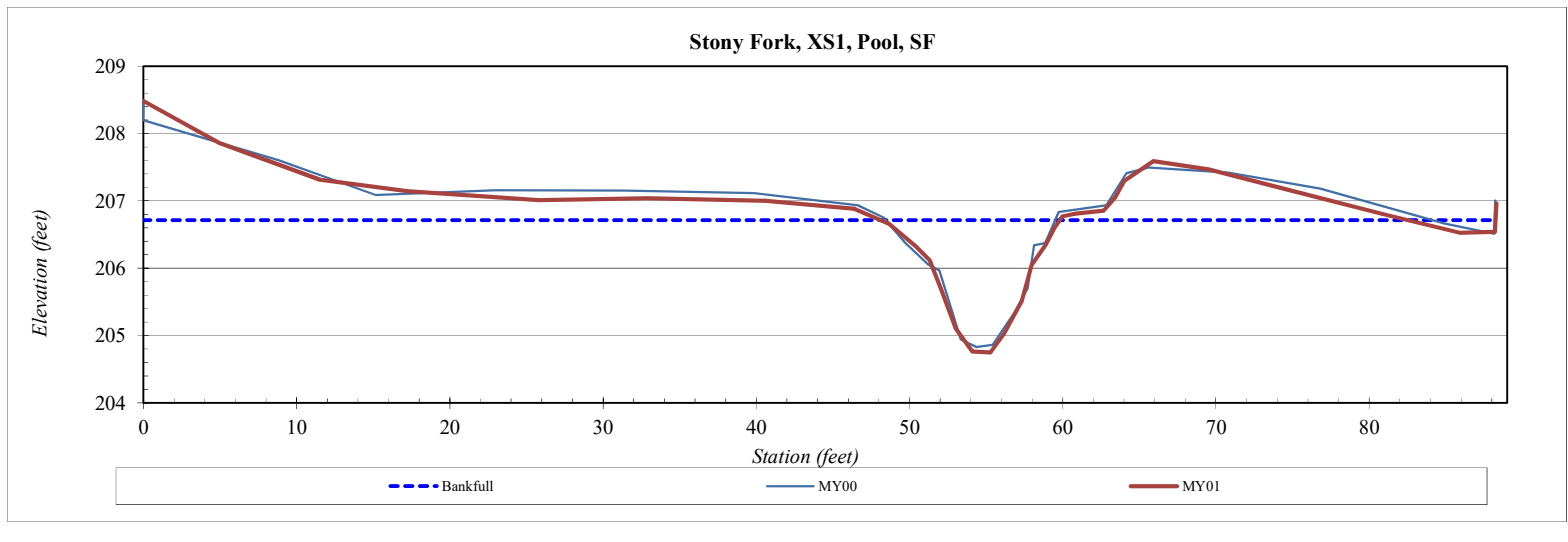
River Basin:	Neuse River
Site:	Stony Fork
XS ID	XS1
Drainage Area (sq mi):	0.28
Date:	11/8/2019
Field Crew:	T. Seelinger, A. Gutierrez

Station	Elevation
0.0	208.48
5.0	207.86
11.5	207.32
17.2	207.14
25.8	207.01
32.9	207.04
40.6	207.00
46.4	206.88
48.7	206.66
50.4	206.33
51.3	206.12
52.1	205.68
53.0	205.10
54.1	204.76
55.3	204.75
56.2	205.03
57.3	205.50
58.0	206.05
58.9	206.34
59.5	206.60
60.0	206.77
60.9	206.81
62.7	206.85
63.4	207.06
64.0	207.30
65.9	207.59
69.5	207.47
74.7	207.17
81.2	206.79
85.9	206.53
88.2	206.54
88.3	206.96

SUMMARY DATA	
Bankfull Elevation (ft) - Based on AB-Bankfull Area	206.71
Bankfull Cross-Sectional Area:	11.5
Total Cross-Sectional Area:	11.9
Bankfull Width:	11.7
Flood Prone Area Elevation:	---
Flood Prone Width:	---
Max Depth at Bankfull:	2.0
Mean Depth at Bankfull:	1.0
W / D Ratio:	---
Entrenchment Ratio:	---
Bank Height Ratio:	---
Thalweg Elevation:	204.7

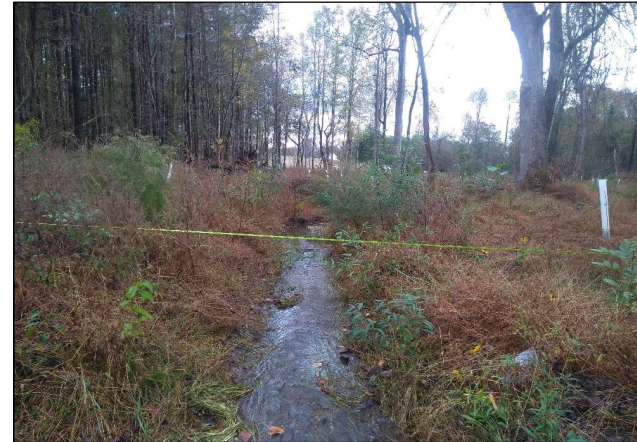
River Basin:	Neuse River
Site:	Stony Fork
XS ID	XS2
Drainage Area (sq mi):	0.28
Date:	11/8/2019
Field Crew:	T. Seelinger, A. Gutierrez

Station	Elevation
0.0	208.28
0.0	207.91
5.0	207.69
11.0	207.34
15.4	207.06
18.3	206.89
21.6	206.64
25.8	206.57
28.5	206.52
34.0	206.56
38.3	206.72
42.4	206.62
43.8	206.56
45.0	206.14
46.5	205.85
47.0	205.70
47.7	205.59
48.3	205.42
48.8	205.45
49.5	205.47
50.0	205.55
50.4	205.47
51.0	205.69
51.8	205.93
52.5	206.14
53.5	206.46
54.7	206.50
57.4	206.57
60.4	206.48
64.3	206.37
65.8	206.40
67.1	206.74
70.6	206.72
77.3	206.80
83.6	206.59
83.7	207.04

SUMMARY DATA	
Bankfull Elevation (ft) - Based on AB-Bankfull Area	206.57
Bankfull Cross-Sectional Area:	7.0
Total Cross-Sectional Area:	7.1
Bankfull Width:	11.0
Flood Prone Area Elevation:	207.7
Flood Prone Width:	79.3
Max Depth at Bankfull:	1.1
Mean Depth at Bankfull:	0.6
W / D Ratio:	17.3
Entrenchment Ratio:	7.2
Bank Height Ratio:	0.9
Thalweg Elevation:	205.4

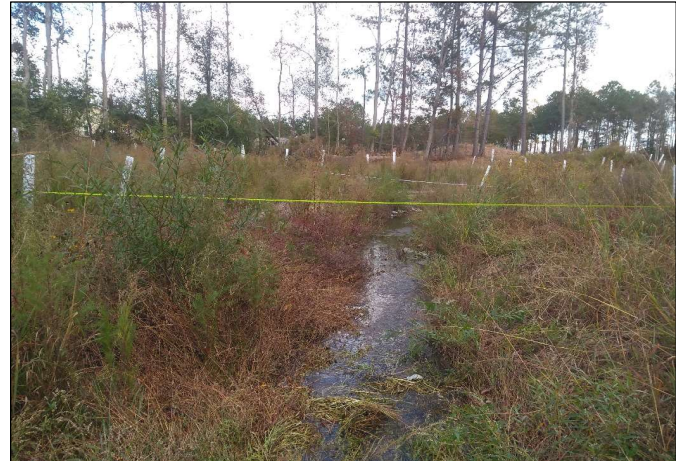
River Basin:	Neuse River
Site:	Stony Fork
XS ID	XS3
Drainage Area (sq mi):	0.46
Date:	11/8/2019
Field Crew:	T. Seelinger, A. Gutierrez

Station	Elevation
0.0	195.49
-0.1	195.30
8.9	194.99
13.0	194.68
14.5	194.49
19.6	193.42
24.6	193.02
31.1	192.56
35.3	192.55
38.1	192.55
39.4	192.06
40.8	191.41
41.5	191.30
42.0	191.27
42.3	190.90
43.5	190.93
44.7	190.76
45.3	190.81
46.2	190.81
47.1	191.15
48.1	191.66
49.4	192.13
49.9	192.31
50.4	192.49
51.7	192.60
55.6	192.63
59.9	192.79
63.2	193.11
68.1	193.83
69.8	194.31
70.9	194.16
70.6	194.52

SUMMARY DATA	
Bankfull Elevation (ft) - Based on AB-Bankfull Area	192.45
Bankfull Cross-Sectional Area:	12.5
Total Cross-Sectional Area:	13.2
Bankfull Width:	11.9
Flood Prone Area Elevation:	194.1
Flood Prone Width:	53.2
Max Depth at Bankfull:	1.7
Mean Depth at Bankfull:	1.0
W / D Ratio:	11.4
Entrenchment Ratio:	4.5
Bank Height Ratio:	1.0
Thalweg Elevation:	190.8

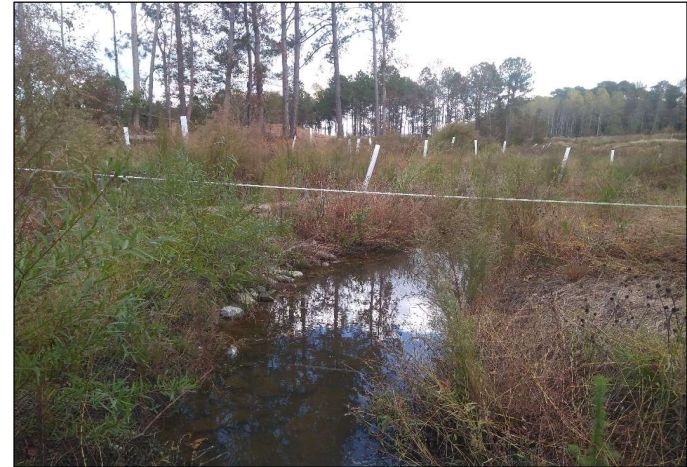
River Basin:	Neuse River
Site:	Stony Fork
XS ID	XS4
Drainage Area (sq mi):	0.46
Date:	11/8/2019
Field Crew:	T. Seelinger, A. Gutierrez

Station	Elevation
0.0	195.37
0.0	194.91
4.5	194.64
4.6	194.62
9.0	194.28
11.7	193.91
17.8	192.96
21.4	192.50
24.0	192.41
24.8	192.28
25.4	191.98
26.7	191.35
27.0	191.13
28.0	190.30
28.7	190.21
29.6	190.03
30.4	189.85
32.2	190.36
33.3	190.72
34.0	191.05
35.1	191.26
37.6	191.73
38.7	191.95
39.7	191.97
44.8	192.17
49.9	192.13
53.2	192.53
56.3	192.72
62.8	192.95
65.9	193.33
65.9	193.32

SUMMARY DATA	
Bankfull Elevation (ft) - Based on AB-Bankfull Area	191.92
Bankfull Cross-Sectional Area:	13.6
Total Cross-Sectional Area:	14.5
Bankfull Width:	13.0
Flood Prone Area Elevation:	---
Flood Prone Width:	---
Max Depth at Bankfull:	2.1
Mean Depth at Bankfull:	1.1
W / D Ratio:	---
Entrenchment Ratio:	---
Bank Height Ratio:	---
Thalweg Elevation:	189.9

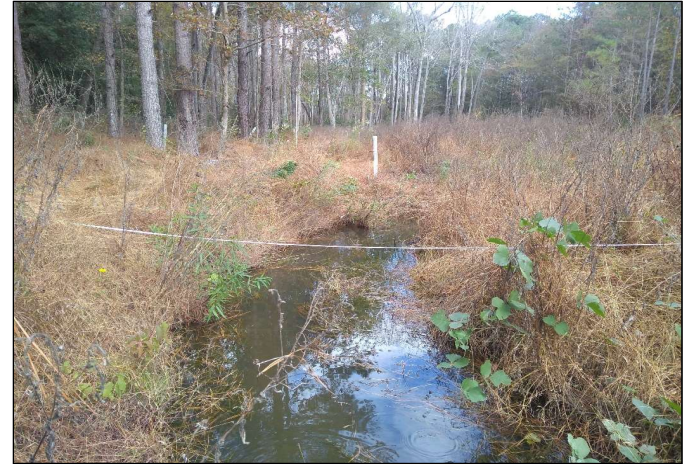
River Basin:	Neuse River
Site:	Stony Fork
XS ID	XS5
Drainage Area (sq mi):	0.46
Date:	11/8/2019
Field Crew:	T. Seelinger, A. Gutierrez

Station	Elevation
0.0	183.19
0.1	182.51
7.2	182.27
15.4	182.51
24.2	182.63
29.2	182.32
30.4	182.24
31.2	182.24
32.2	181.92
33.3	181.65
34.2	181.17
35.4	180.87
36.7	180.98
37.1	180.89
38.0	180.93
38.9	180.89
39.7	180.87
40.3	181.24
41.3	181.34
42.7	181.83
43.8	182.11
45.1	182.17
49.1	182.16
55.0	182.41
62.4	182.62
69.9	182.41
76.5	182.48
80.7	183.28

SUMMARY DATA	
Bankfull Elevation (ft) - Based on AB-Bankfull Area	182.17
Bankfull Cross-Sectional Area:	10.6
Total Cross-Sectional Area:	10.1
Bankfull Width:	13.6
Flood Prone Area Elevation:	183.5
Flood Prone Width:	80.7
Max Depth at Bankfull:	1.3
Mean Depth at Bankfull:	0.8
W / D Ratio:	17.4
Entrenchment Ratio:	5.9
Bank Height Ratio:	1.0
Thalweg Elevation:	180.9

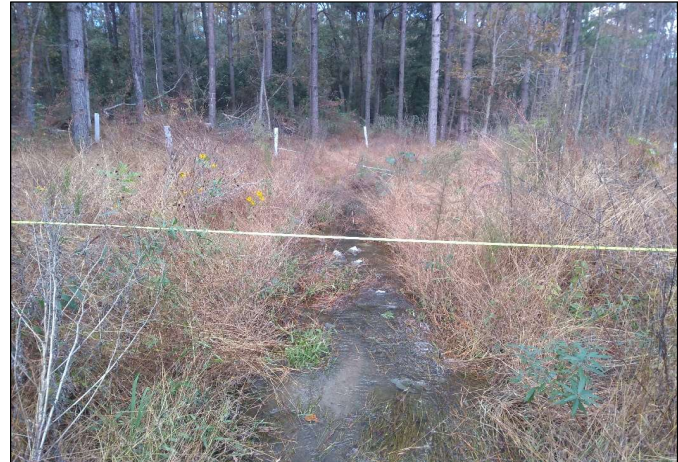
River Basin:	Neuse River
Site:	Stony Fork
XS ID	XS6
Drainage Area (sq mi):	0.46
Date:	11/8/2019
Field Crew:	T. Seelinger, A. Gutierrez

Station	Elevation
0.0	183.40
3.4	182.65
9.3	182.31
11.5	182.05
15.1	181.98
19.0	181.72
20.6	181.80
21.2	181.77
22.0	181.59
22.9	181.21
23.5	180.99
23.9	180.53
24.5	180.34
25.5	179.40
26.5	179.49
27.5	179.79
29.0	180.15
29.6	180.33
30.7	180.87
31.6	181.10
33.6	181.68
35.9	181.87
38.3	181.88
42.7	181.77
51.1	181.89
57.8	182.32
68.6	182.38
74.2	182.50
77.2	182.58
81.1	183.18

SUMMARY DATA	
Bankfull Elevation (ft) - Based on AB-Bankfull Area	181.75
Bankfull Cross-Sectional Area:	14.5
Total Cross-Sectional Area:	14.3
Bankfull Width:	13.1
Flood Prone Area Elevation:	---
Flood Prone Width:	---
Max Depth at Bankfull:	2.4
Mean Depth at Bankfull:	1.1
W / D Ratio:	---
Entrenchment Ratio:	---
Bank Height Ratio:	---
Thalweg Elevation:	179.4

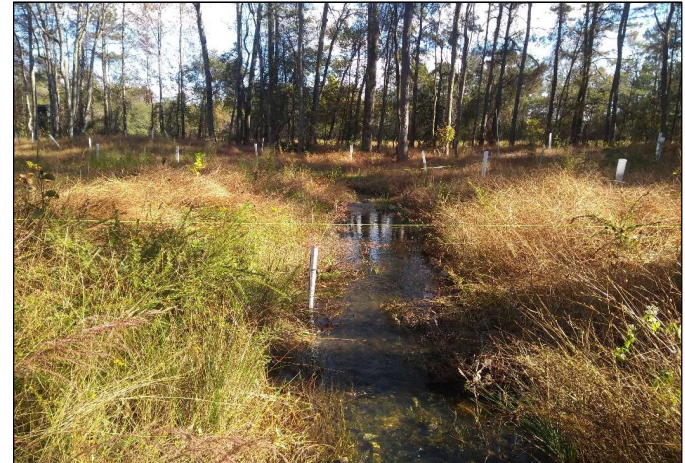
River Basin:	Neuse River
Site:	Stony Fork
XS ID	XS7
Drainage Area (sq mi):	0.83
Date:	11/8/2019
Field Crew:	T. Seelinger, A. Gutierrez

Station	Elevation
0.0	177.93
6.3	176.61
12.4	176.25
21.5	176.07
28.9	175.97
34.8	176.20
37.5	176.23
38.5	176.10
39.9	175.81
41.8	175.03
42.5	174.77
43.6	174.41
44.5	174.41
45.4	174.37
46.5	174.65
47.3	174.71
48.1	174.77
49.5	175.18
51.0	175.46
52.5	175.93
55.6	175.88
62.8	175.86
70.5	176.03
78.2	176.23
85.1	176.55
92.3	176.88
92.4	177.52

SUMMARY DATA	
Bankfull Elevation (ft) - Based on AB-Bankfull Area	175.99
Bankfull Cross-Sectional Area:	12.8
Total Cross-Sectional Area:	13.2
Bankfull Width:	13.4
Flood Prone Area Elevation:	177.6
Flood Prone Width:	90.8
Max Depth at Bankfull:	1.6
Mean Depth at Bankfull:	1.0
W / D Ratio:	14.0
Entrenchment Ratio:	6.8
Bank Height Ratio:	1.0
Thalweg Elevation:	174.4

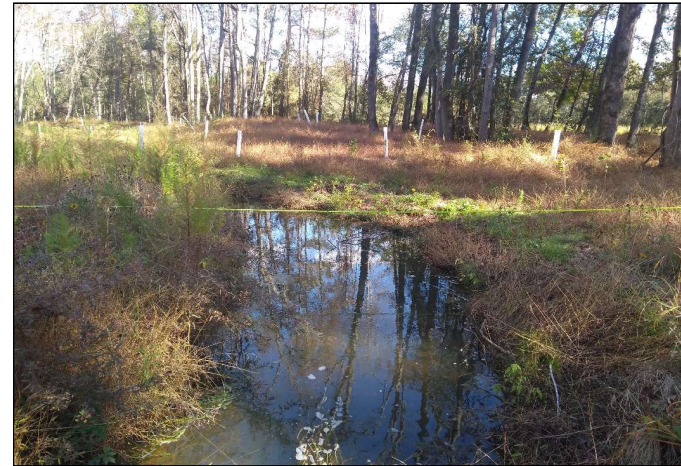
River Basin:	Neuse River
Site:	Stony Fork
XS ID	XS8
Drainage Area (sq mi):	0.83
Date:	11/8/2019
Field Crew:	T. Seelinger, A. Gutierrez

Station	Elevation
0.0	176.50
0.1	175.87
8.4	175.49
20.6	175.47
29.9	175.43
41.2	175.09
42.5	175.17
43.7	174.97
45.2	174.46
46.6	174.14
47.9	173.72
49.3	173.04
50.5	172.66
52.0	172.55
53.3	172.88
54.2	173.44
55.0	174.02
56.0	174.60
57.2	174.98
58.4	175.26
59.2	175.43
61.3	175.34
68.6	175.58
75.6	175.99
81.1	176.63
81.0	177.63

SUMMARY DATA	
Bankfull Elevation (ft) - Based on AB-Bankfull Area	175.21
Bankfull Cross-Sectional Area:	20.7
Total Cross-Sectional Area:	21.4
Bankfull Width:	14.5
Flood Prone Area Elevation:	---
Flood Prone Width:	---
Max Depth at Bankfull:	2.7
Mean Depth at Bankfull:	1.4
W / D Ratio:	---
Entrenchment Ratio:	---
Bank Height Ratio:	---
Thalweg Elevation:	172.5

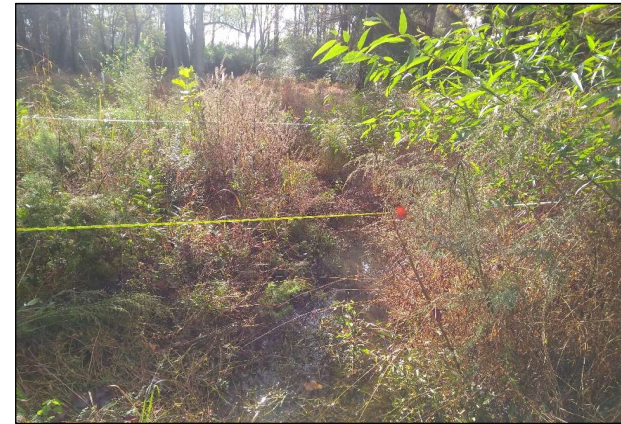
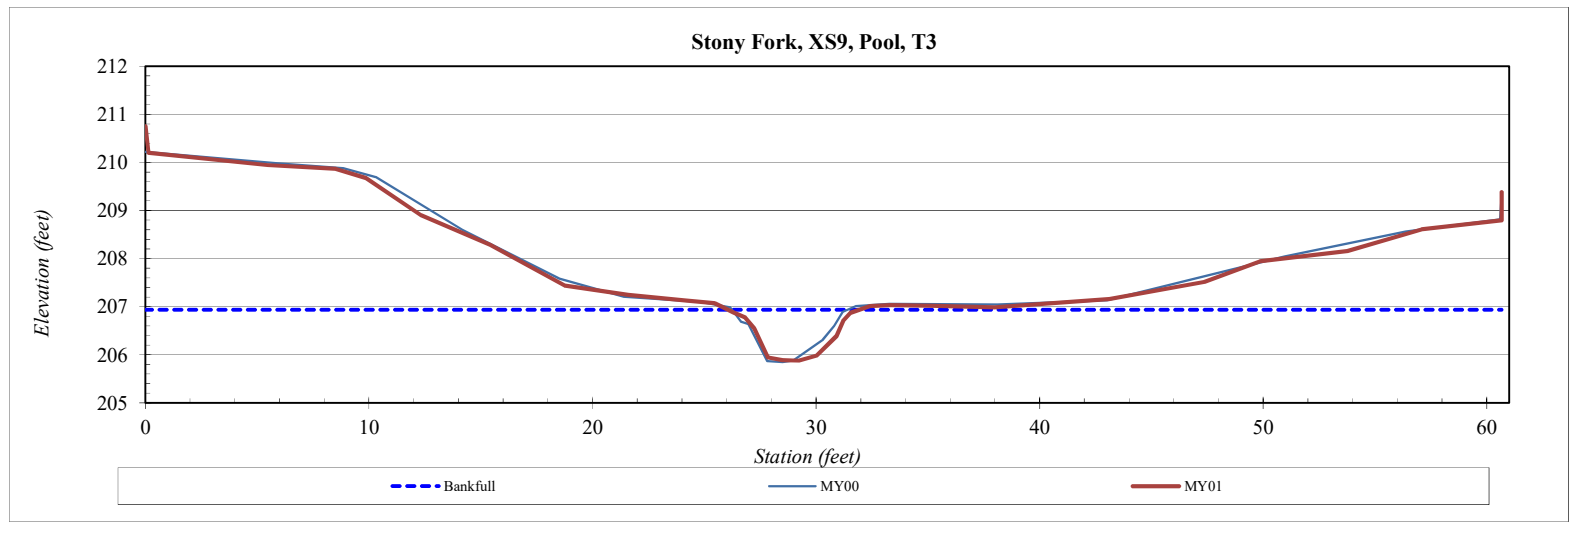
River Basin:	Neuse River
Site:	Stony Fork
XS ID	XS9
Drainage Area (sq mi):	0.04
Date:	11/8/2019
Field Crew:	T. Seelinger, A. Gutierrez

Station	Elevation
0.0	210.75
0.1	210.20
5.5	209.95
8.5	209.87
9.9	209.68
12.3	208.91
15.4	208.29
18.8	207.44
21.6	207.25
24.1	207.13
25.5	207.07
26.3	206.88
26.8	206.78
27.2	206.55
27.8	205.94
28.5	205.89
29.2	205.88
30.0	205.99
30.9	206.39
31.2	206.71
31.5	206.87
32.4	207.01
33.3	207.03
35.2	207.02
38.0	206.99
43.1	207.16
47.4	207.52
49.8	207.94
53.8	208.16
57.1	208.61
60.7	208.80
60.7	209.38

SUMMARY DATA	
Bankfull Elevation (ft) - Based on AB-Bankfull Area	206.94
Bankfull Cross-Sectional Area:	3.7
Total Cross-Sectional Area:	4.0
Bankfull Width:	5.9
Flood Prone Area Elevation:	---
Flood Prone Width:	---
Max Depth at Bankfull:	1.1
Mean Depth at Bankfull:	0.6
W / D Ratio:	---
Entrenchment Ratio:	---
Bank Height Ratio:	---
Thalweg Elevation:	205.9

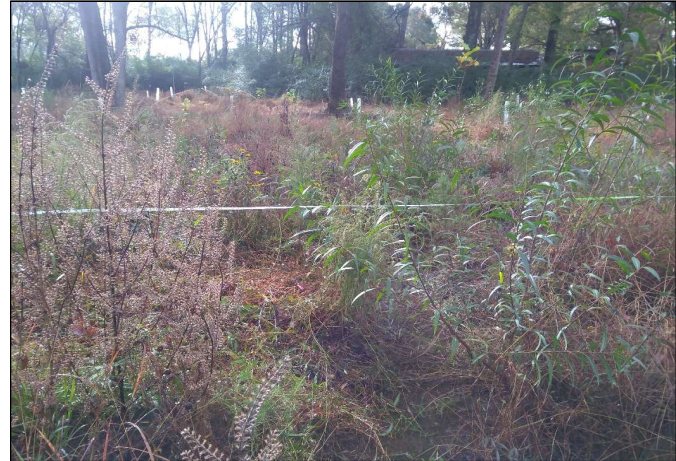
River Basin:	Neuse River
Site:	Stony Fork
XS ID	XS10
Drainage Area (sq mi):	0.04
Date:	11/8/2019
Field Crew:	T. Seelinger, A. Gutierrez

Station	Elevation
0.0	209.79
0.2	209.13
2.6	208.98
4.5	208.84
7.6	208.64
13.0	208.26
19.1	207.94
24.8	207.65
29.5	207.45
33.8	207.41
37.8	207.35
40.6	207.30
41.3	207.22
41.7	207.15
42.8	206.76
43.2	206.71
43.7	206.44
44.2	206.47
44.7	206.56
45.4	206.58
45.9	206.71
46.7	206.83
47.3	207.07
48.0	206.97
49.7	206.93
52.0	207.04
54.5	207.13
57.6	207.34
63.2	207.89
69.7	208.20
72.2	208.30
72.0	209.07

SUMMARY DATA	
Bankfull Elevation (ft) - Based on AB-Bankfull Area	207.10
Bankfull Cross-Sectional Area:	2.2
Total Cross-Sectional Area:	2.1
Bankfull Width:	5.5
Flood Prone Area Elevation:	207.8
Flood Prone Width:	39.4
Max Depth at Bankfull:	0.7
Mean Depth at Bankfull:	0.4
W / D Ratio:	13.7
Entrenchment Ratio:	7.2
Bank Height Ratio:	0.9
Thalweg Elevation:	206.4

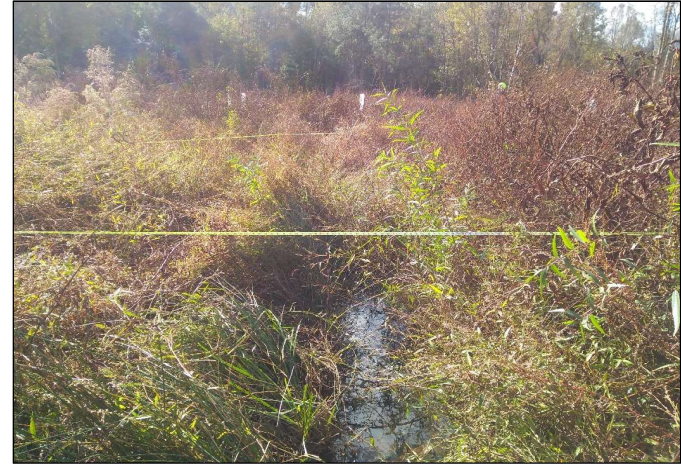
River Basin:	Neuse River
Site:	Stony Fork
XS ID	XS11
Drainage Area (sq mi):	0.02
Date:	11/8/2019
Field Crew:	T. Seelinger, A. Gutierrez

Station	Elevation
0.0	199.19
0.2	198.66
5.2	198.58
10.9	198.73
16.0	198.59
21.4	198.52
28.4	198.31
33.8	198.39
35.3	198.38
36.7	198.10
37.4	198.17
38.1	198.00
38.4	197.62
39.2	197.53
39.7	197.72
40.3	197.72
40.8	197.99
41.6	198.19
42.4	198.33
43.0	198.47
45.2	198.48
48.7	198.32
53.8	198.61
58.8	198.65
66.4	199.22
69.7	199.59
72.4	199.43
72.5	199.90

SUMMARY DATA	
Bankfull Elevation (ft) - Based on AB-Bankfull Area	198.27
Bankfull Cross-Sectional Area:	2.0
Total Cross-Sectional Area:	2.6
Bankfull Width:	5.8
Flood Prone Area Elevation:	199.0
Flood Prone Width:	63.7
Max Depth at Bankfull:	0.7
Mean Depth at Bankfull:	0.3
W / D Ratio:	17.1
Entrenchment Ratio:	10.9
Bank Height Ratio:	1.1
Thalweg Elevation:	197.5

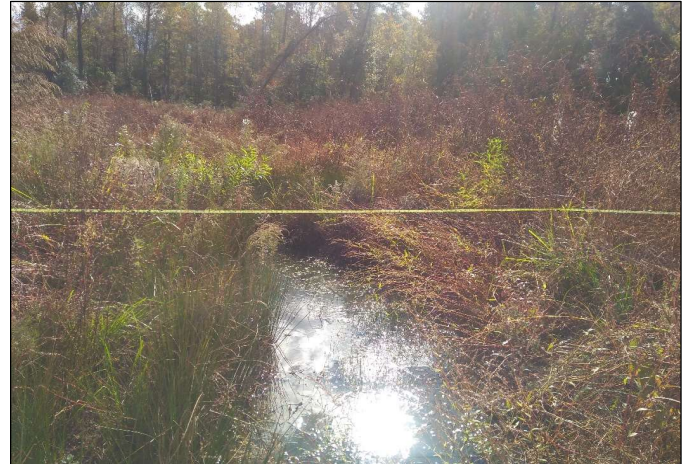
River Basin:	Neuse River
Site:	Stony Fork
XS ID	XS12
Drainage Area (sq mi):	0.02
Date:	11/8/2019
Field Crew:	T. Seelinger, A. Gutierrez

Station	Elevation
0.0	199.27
-0.1	198.87
4.8	198.77
11.8	198.69
19.1	198.51
26.3	198.47
32.9	198.50
37.2	198.46
39.2	198.37
40.7	198.35
41.3	198.39
42.0	198.19
42.9	197.96
43.3	197.94
44.0	197.60
44.8	197.40
45.3	197.22
46.2	197.10
47.0	197.25
47.5	197.63
47.9	197.78
48.4	198.13
49.3	198.46
50.7	198.45
52.4	198.58
55.0	198.82
57.1	199.29
61.0	199.52
65.4	199.67
71.3	199.71
75.2	200.03

SUMMARY DATA	
Bankfull Elevation (ft) - Based on AB-Bankfull Area	198.32
Bankfull Cross-Sectional Area:	4.8
Total Cross-Sectional Area:	5.5
Bankfull Width:	7.3
Flood Prone Area Elevation:	---
Flood Prone Width:	---
Max Depth at Bankfull:	1.2
Mean Depth at Bankfull:	0.7
W / D Ratio:	---
Entrenchment Ratio:	---
Bank Height Ratio:	---
Thalweg Elevation:	197.1

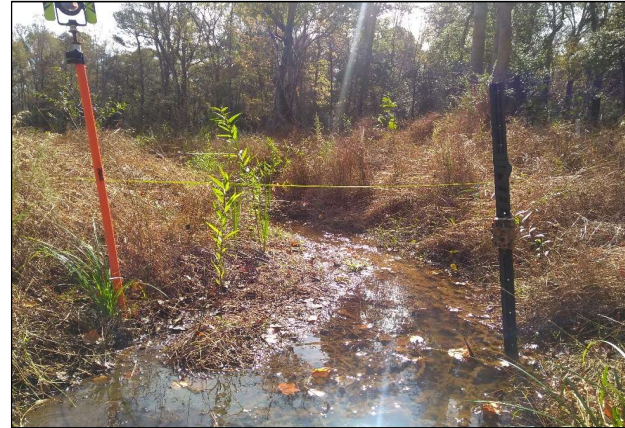
River Basin:	Neuse River
Site:	Stony Fork
XS ID	XS13
Drainage Area (sq mi):	0.14
Date:	11/11/2019
Field Crew:	T. Seelinger, A. Gutierrez

Station	Elevation
0.0	190.29
0.1	189.66
6.6	189.04
17.1	188.41
27.5	188.47
33.5	188.27
34.5	188.48
35.3	188.17
36.5	187.81
38.0	187.40
38.9	187.41
40.0	187.39
40.8	187.26
41.5	187.10
41.9	187.07
42.4	187.04
42.9	187.20
43.4	187.45
43.8	187.68
45.5	188.35
46.9	188.40
49.5	188.59
52.7	188.98
57.6	189.61
62.4	189.98
62.5	190.62

SUMMARY DATA	
Bankfull Elevation (ft) - Based on AB-Bankfull Area	188.43
Bankfull Cross-Sectional Area:	9.3
Total Cross-Sectional Area:	8.7
Bankfull Width:	12.7
Flood Prone Area Elevation:	---
Flood Prone Width:	---
Max Depth at Bankfull:	1.4
Mean Depth at Bankfull:	0.7
W / D Ratio:	---
Entrenchment Ratio:	---
Bank Height Ratio:	---
Thalweg Elevation:	187.0

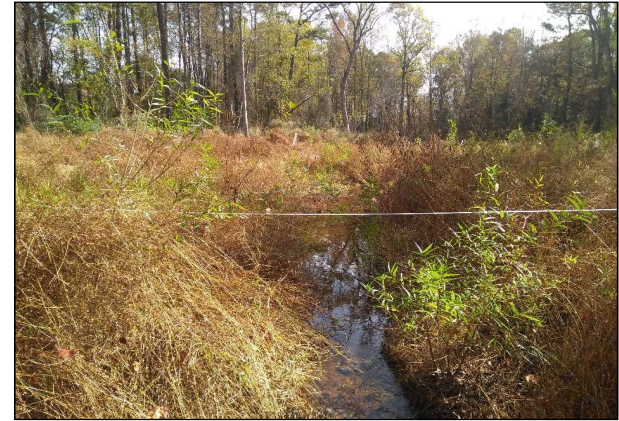
River Basin:	Neuse River
Site:	Stony Fork
XS ID	XS14
Drainage Area (sq mi):	0.14
Date:	11/11/2019
Field Crew:	T. Seelinger, A. Gutierrez

Station	Elevation
0.0	190.47
4.5	189.10
6.8	189.24
10.0	188.62
15.6	188.49
23.3	188.22
30.1	188.09
32.0	187.84
33.3	187.86
34.4	187.75
35.4	187.43
36.1	187.02
36.7	186.99
37.1	187.04
37.9	186.88
38.6	186.87
39.1	186.91
39.4	187.02
39.7	187.30
40.6	187.32
41.8	187.77
42.1	187.94
42.7	187.92
43.6	188.01
44.3	188.19
46.8	188.32
50.4	188.38
53.3	188.81
56.5	189.30
60.8	189.49
62.4	189.80
62.5	190.64

SUMMARY DATA	
Bankfull Elevation (ft) - Based on AB-Bankfull Area	187.94
Bankfull Cross-Sectional Area:	5.8
Total Cross-Sectional Area:	5.3
Bankfull Width:	11.8
Flood Prone Area Elevation:	189.0
Flood Prone Width:	46.8
Max Depth at Bankfull:	1.1
Mean Depth at Bankfull:	0.5
W / D Ratio:	24.0
Entrenchment Ratio:	4.0
Bank Height Ratio:	0.8
Thalweg Elevation:	186.9

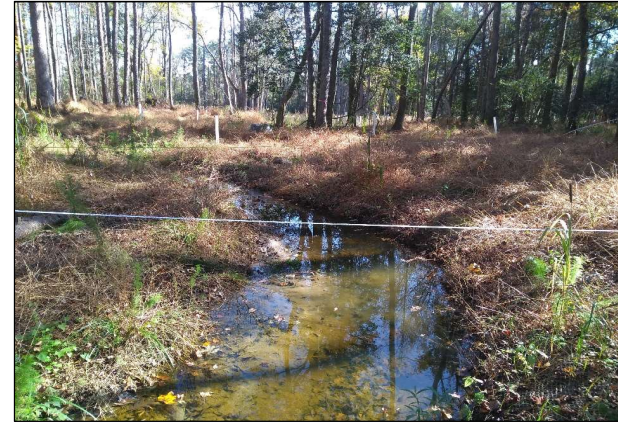
Station	Elevation
0.0	183.66
4.6	182.28
11.7	181.70
18.4	181.60
27.2	181.22
33.2	180.95
36.2	180.86
37.4	180.80
38.4	180.58
39.2	180.39
40.8	180.06
41.6	179.76
42.5	179.58
43.2	179.62
43.9	179.36
45.0	179.07
45.5	178.98
46.2	178.96
46.7	178.97
47.5	180.10
47.9	180.29
49.0	180.94
49.4	181.19
50.9	181.20
53.5	181.26
55.0	181.66
56.8	181.84
62.4	181.96
69.8	181.90
76.6	181.90
76.7	182.57

SUMMARY DATA	
Bankfull Elevation (ft) - Based on AB-Bankfull Area	180.82
Bankfull Cross-Sectional Area:	11.2
Total Cross-Sectional Area:	11.8
Bankfull Width:	11.7
Flood Prone Area Elevation:	---
Flood Prone Width:	---
Max Depth at Bankfull:	1.9
Mean Depth at Bankfull:	1.0
W / D Ratio:	---
Entrenchment Ratio:	---
Bank Height Ratio:	---
Thalweg Elevation:	179.0

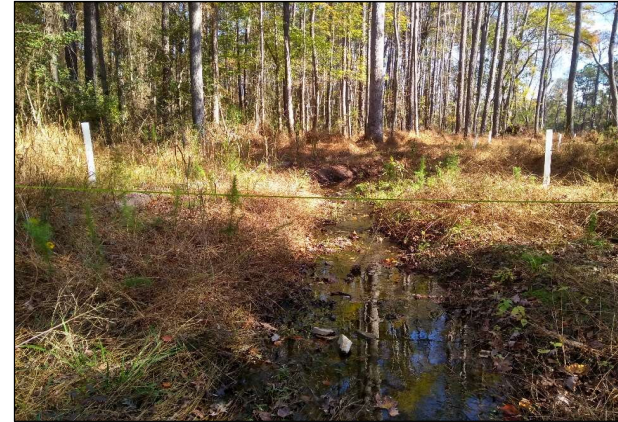
River Basin:	Neuse River
Site:	Stony Fork
XS ID	XS16
Drainage Area (sq mi):	0.22
Date:	11/11/2019
Field Crew:	T. Seelinger, A. Gutierrez

Station	Elevation
0.0	183.72
4.5	182.29
7.5	181.97
12.6	181.45
19.0	181.22
24.7	181.13
29.7	180.89
33.8	180.90
34.6	180.85
35.5	180.64
36.5	180.29
37.1	180.19
37.4	180.03
38.1	179.73
39.0	179.72
39.8	179.75
40.6	179.65
41.3	179.72
41.8	179.94
42.7	180.30
43.6	180.61
44.1	180.76
45.1	180.69
47.6	180.58
49.4	180.56
52.1	180.73
55.1	181.10
58.5	181.23
60.0	181.42
64.7	181.45
71.7	181.45
78.8	181.49
90.4	181.41

SUMMARY DATA	
Bankfull Elevation (ft) - Based on AB-Bankfull Area	180.74
Bankfull Cross-Sectional Area:	6.0
Total Cross-Sectional Area:	5.8
Bankfull Width:	9.9
Flood Prone Area Elevation:	181.8
Flood Prone Width:	81.6
Max Depth at Bankfull:	1.1
Mean Depth at Bankfull:	0.6
W / D Ratio:	16.3
Entrenchment Ratio:	8.3
Bank Height Ratio:	1.0
Thalweg Elevation:	179.7
