# **Monitoring Report MY02**

**Stony Fork Restoration Site  
Upper Neuse River Basin - 03020201  
Monitoring Year 02  
DMS Contract 6830**

**DMS Project Number 97085  
DWR #: 2016-0372  
USACE Action ID: 2016-00875  
Johnston County, North Carolina**

**Monitoring Data Collected: 2020  
Date Submitted: January 2021**

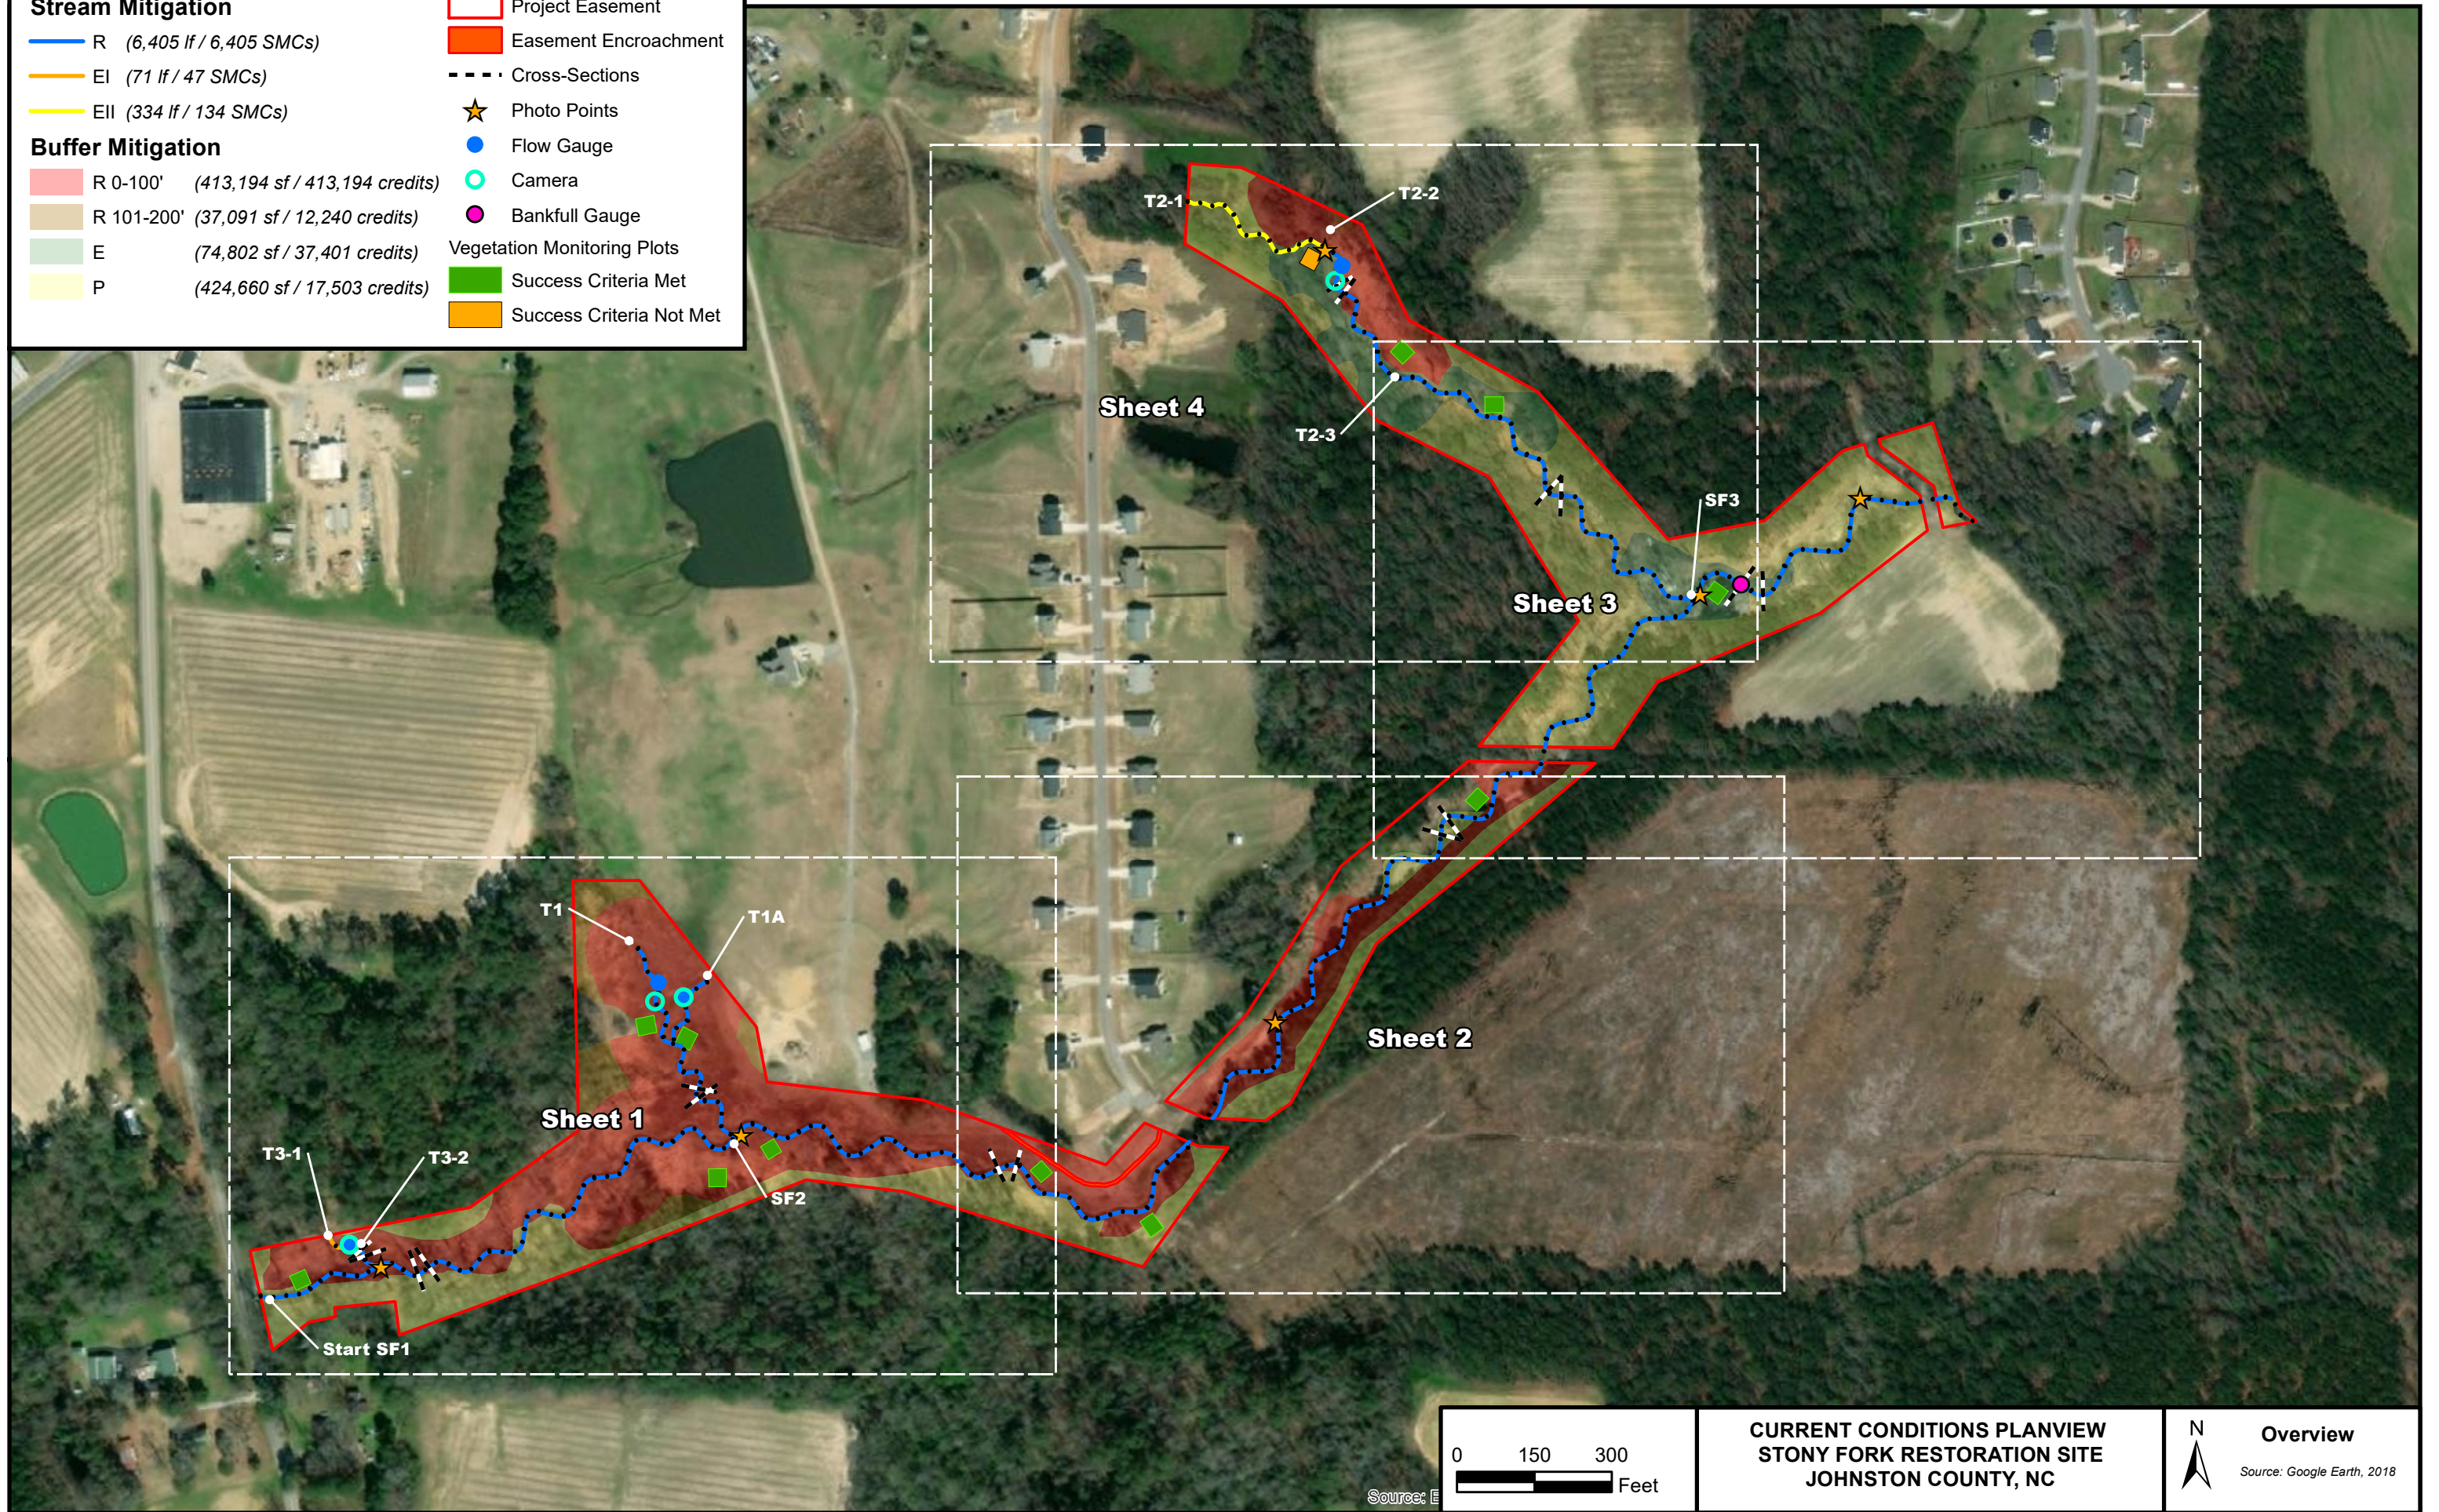
**CURRENT CONDITIONS PLANVIEW**  
**STONY FORK RESTORATION SITE**  
**JOHNSTON COUNTY, NC**

**Overview**  
 Source: Google Earth, 2018

During a site visit on June 5, 2020, ATV tracks entering the easement were noted. These tracks entered the easement from the end of Sherrill Farm Dr., turned northeast for approximately 500 feet before turning around and traveling along the northern edge of the easement until exiting the site along the relic farm road that runs parallel to Sherrill Farm Dr. At this time, the landowner was alerted of the issue and KCI monitored this area for continued trespass. As of December 8, 2020 no evidence of further trespass was noted but at a site visit on February 9, 2021, fresh ATV tracks were noted. These tracks ran from the end of Sherrill Farm Rd. to the relic farm road and did not turn northeast, as the original ones had. The landowner has been issued a formal notice of violation, which is included in Appendix F – Additional Information. Please see Appendix B – Visual Assessment Data for further information.

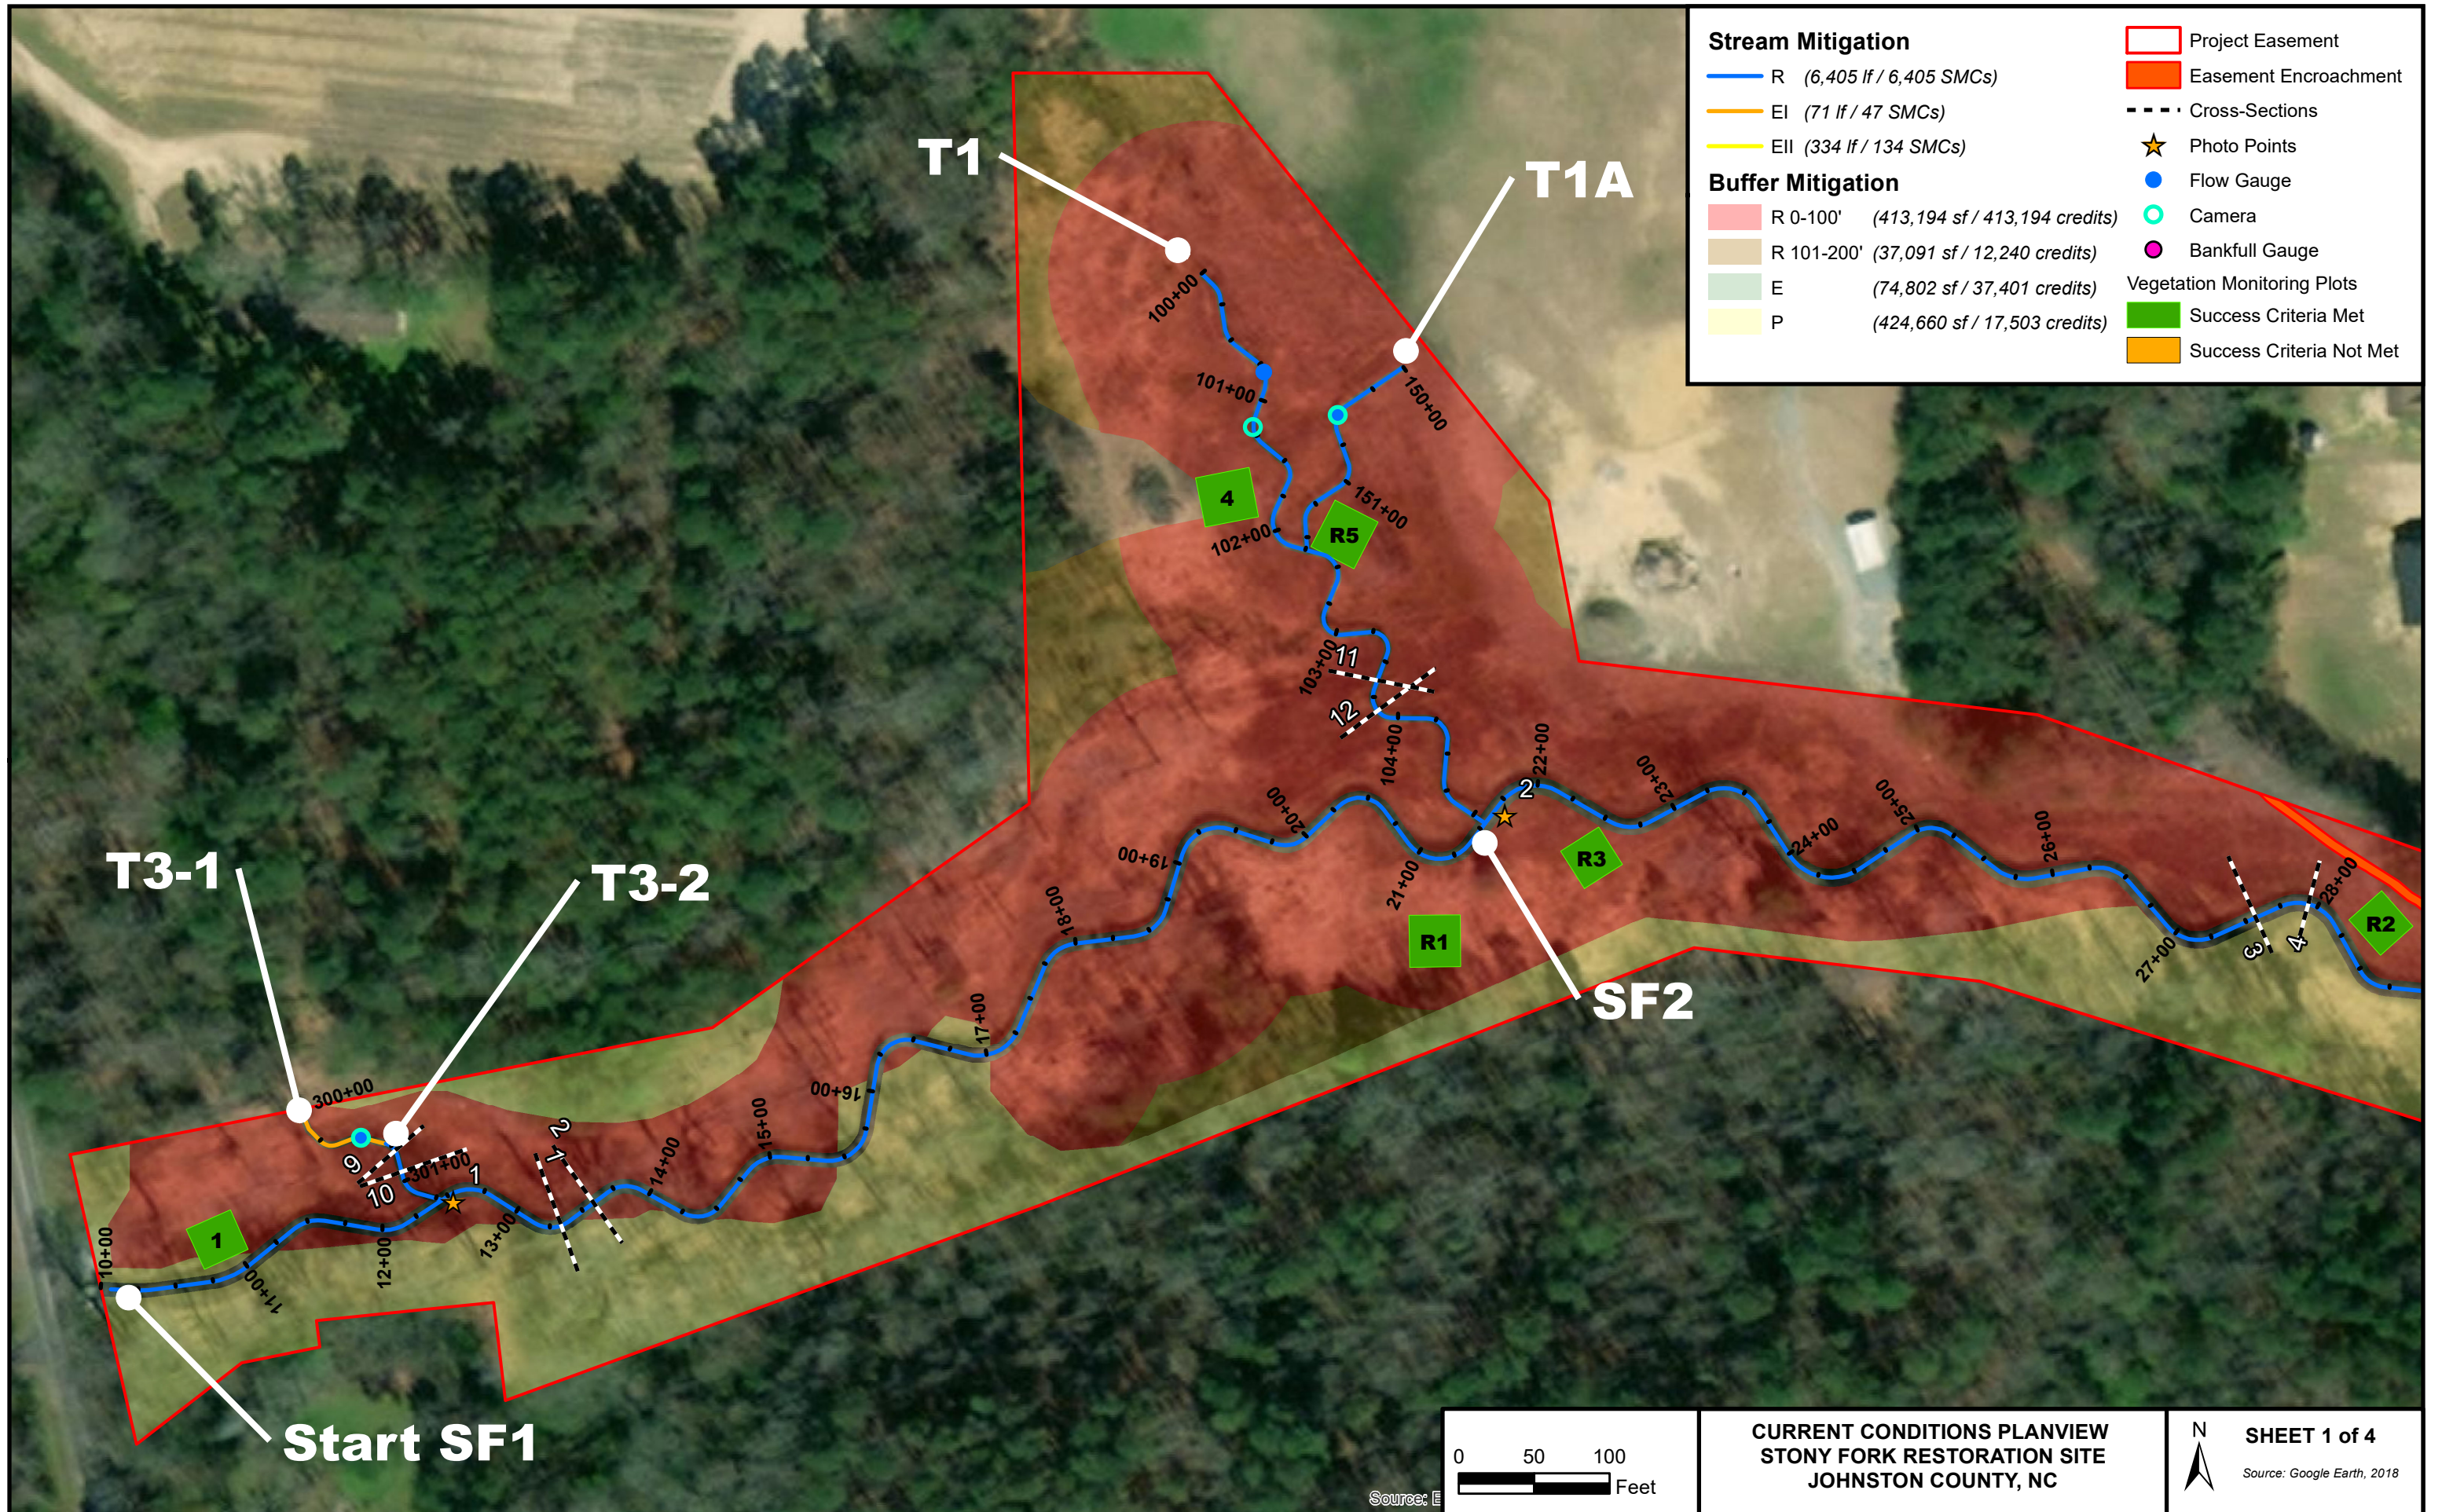
N  
 SHEET 1 of 4  
 Source: Google Earth, 2018

CURRENT CONDITIONS PLANVIEW  
 STONY FORK RESTORATION SITE  
 JOHNSTON COUNTY, NC

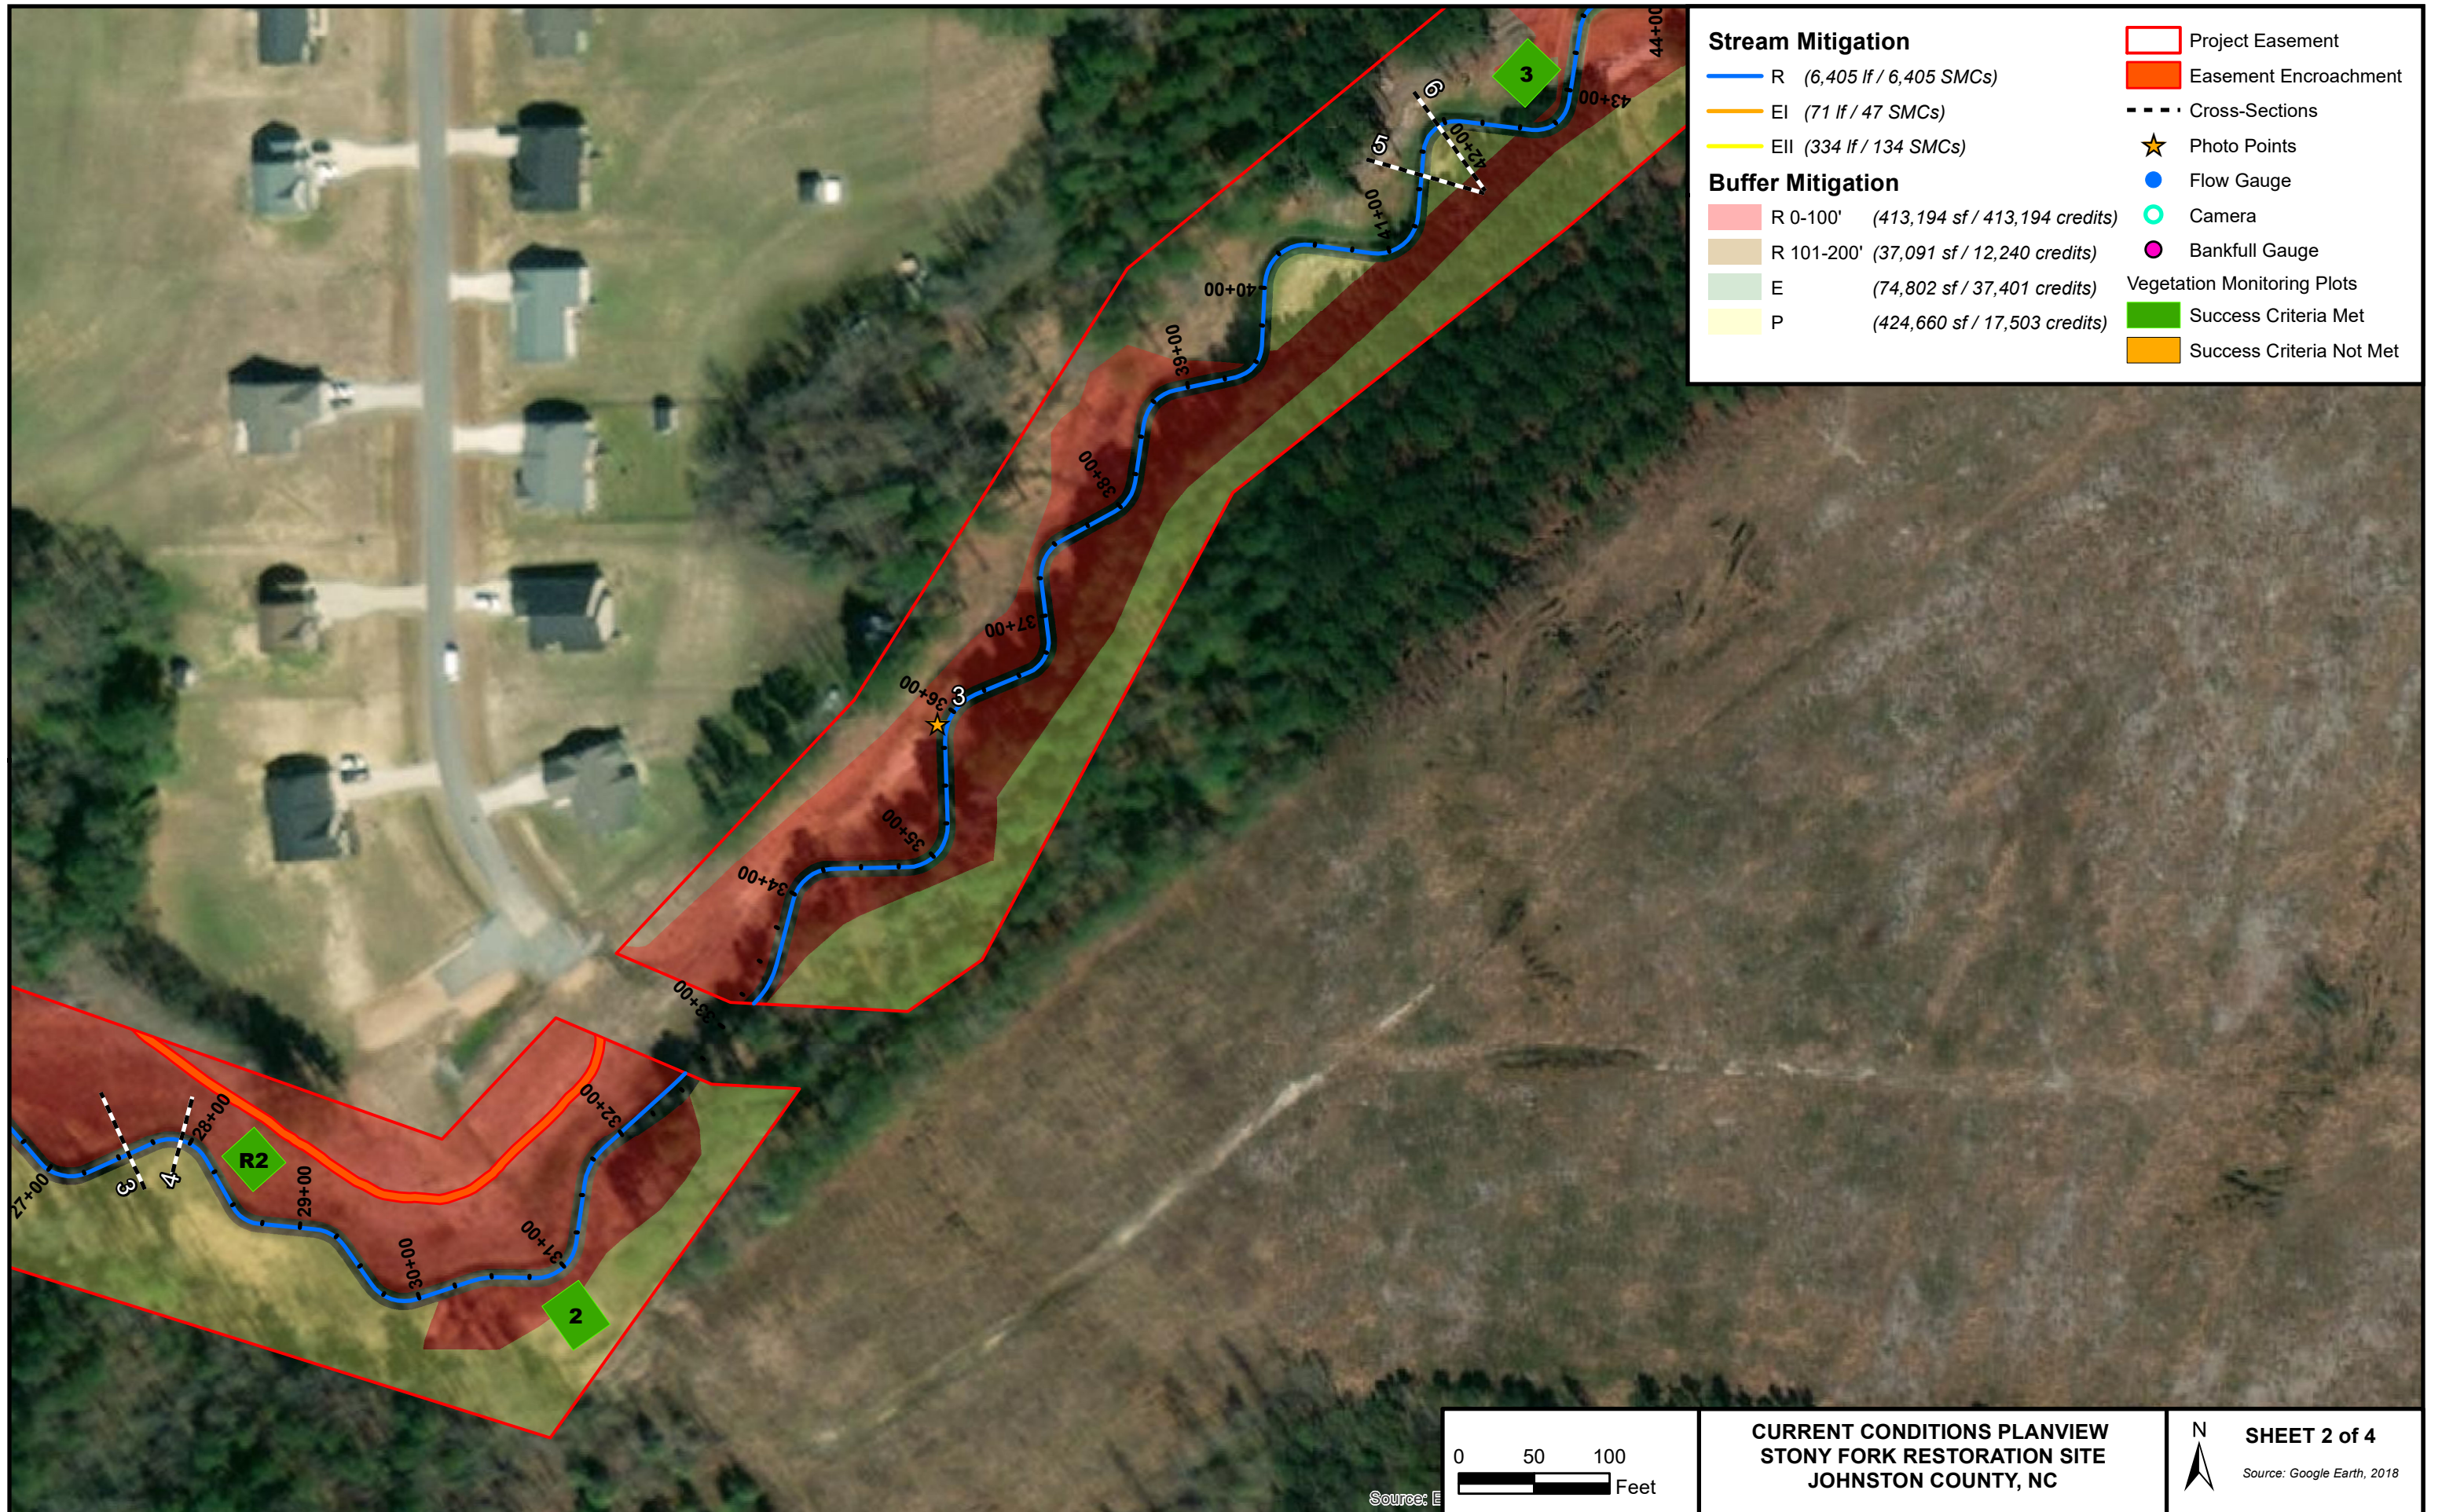
**SHEET 2 of 4**  
Source: Google Earth, 2018

**CURRENT CONDITIONS PLANVIEW**  
**STONY FORK RESTORATION SITE**  
**JOHNSTON COUNTY, NC**

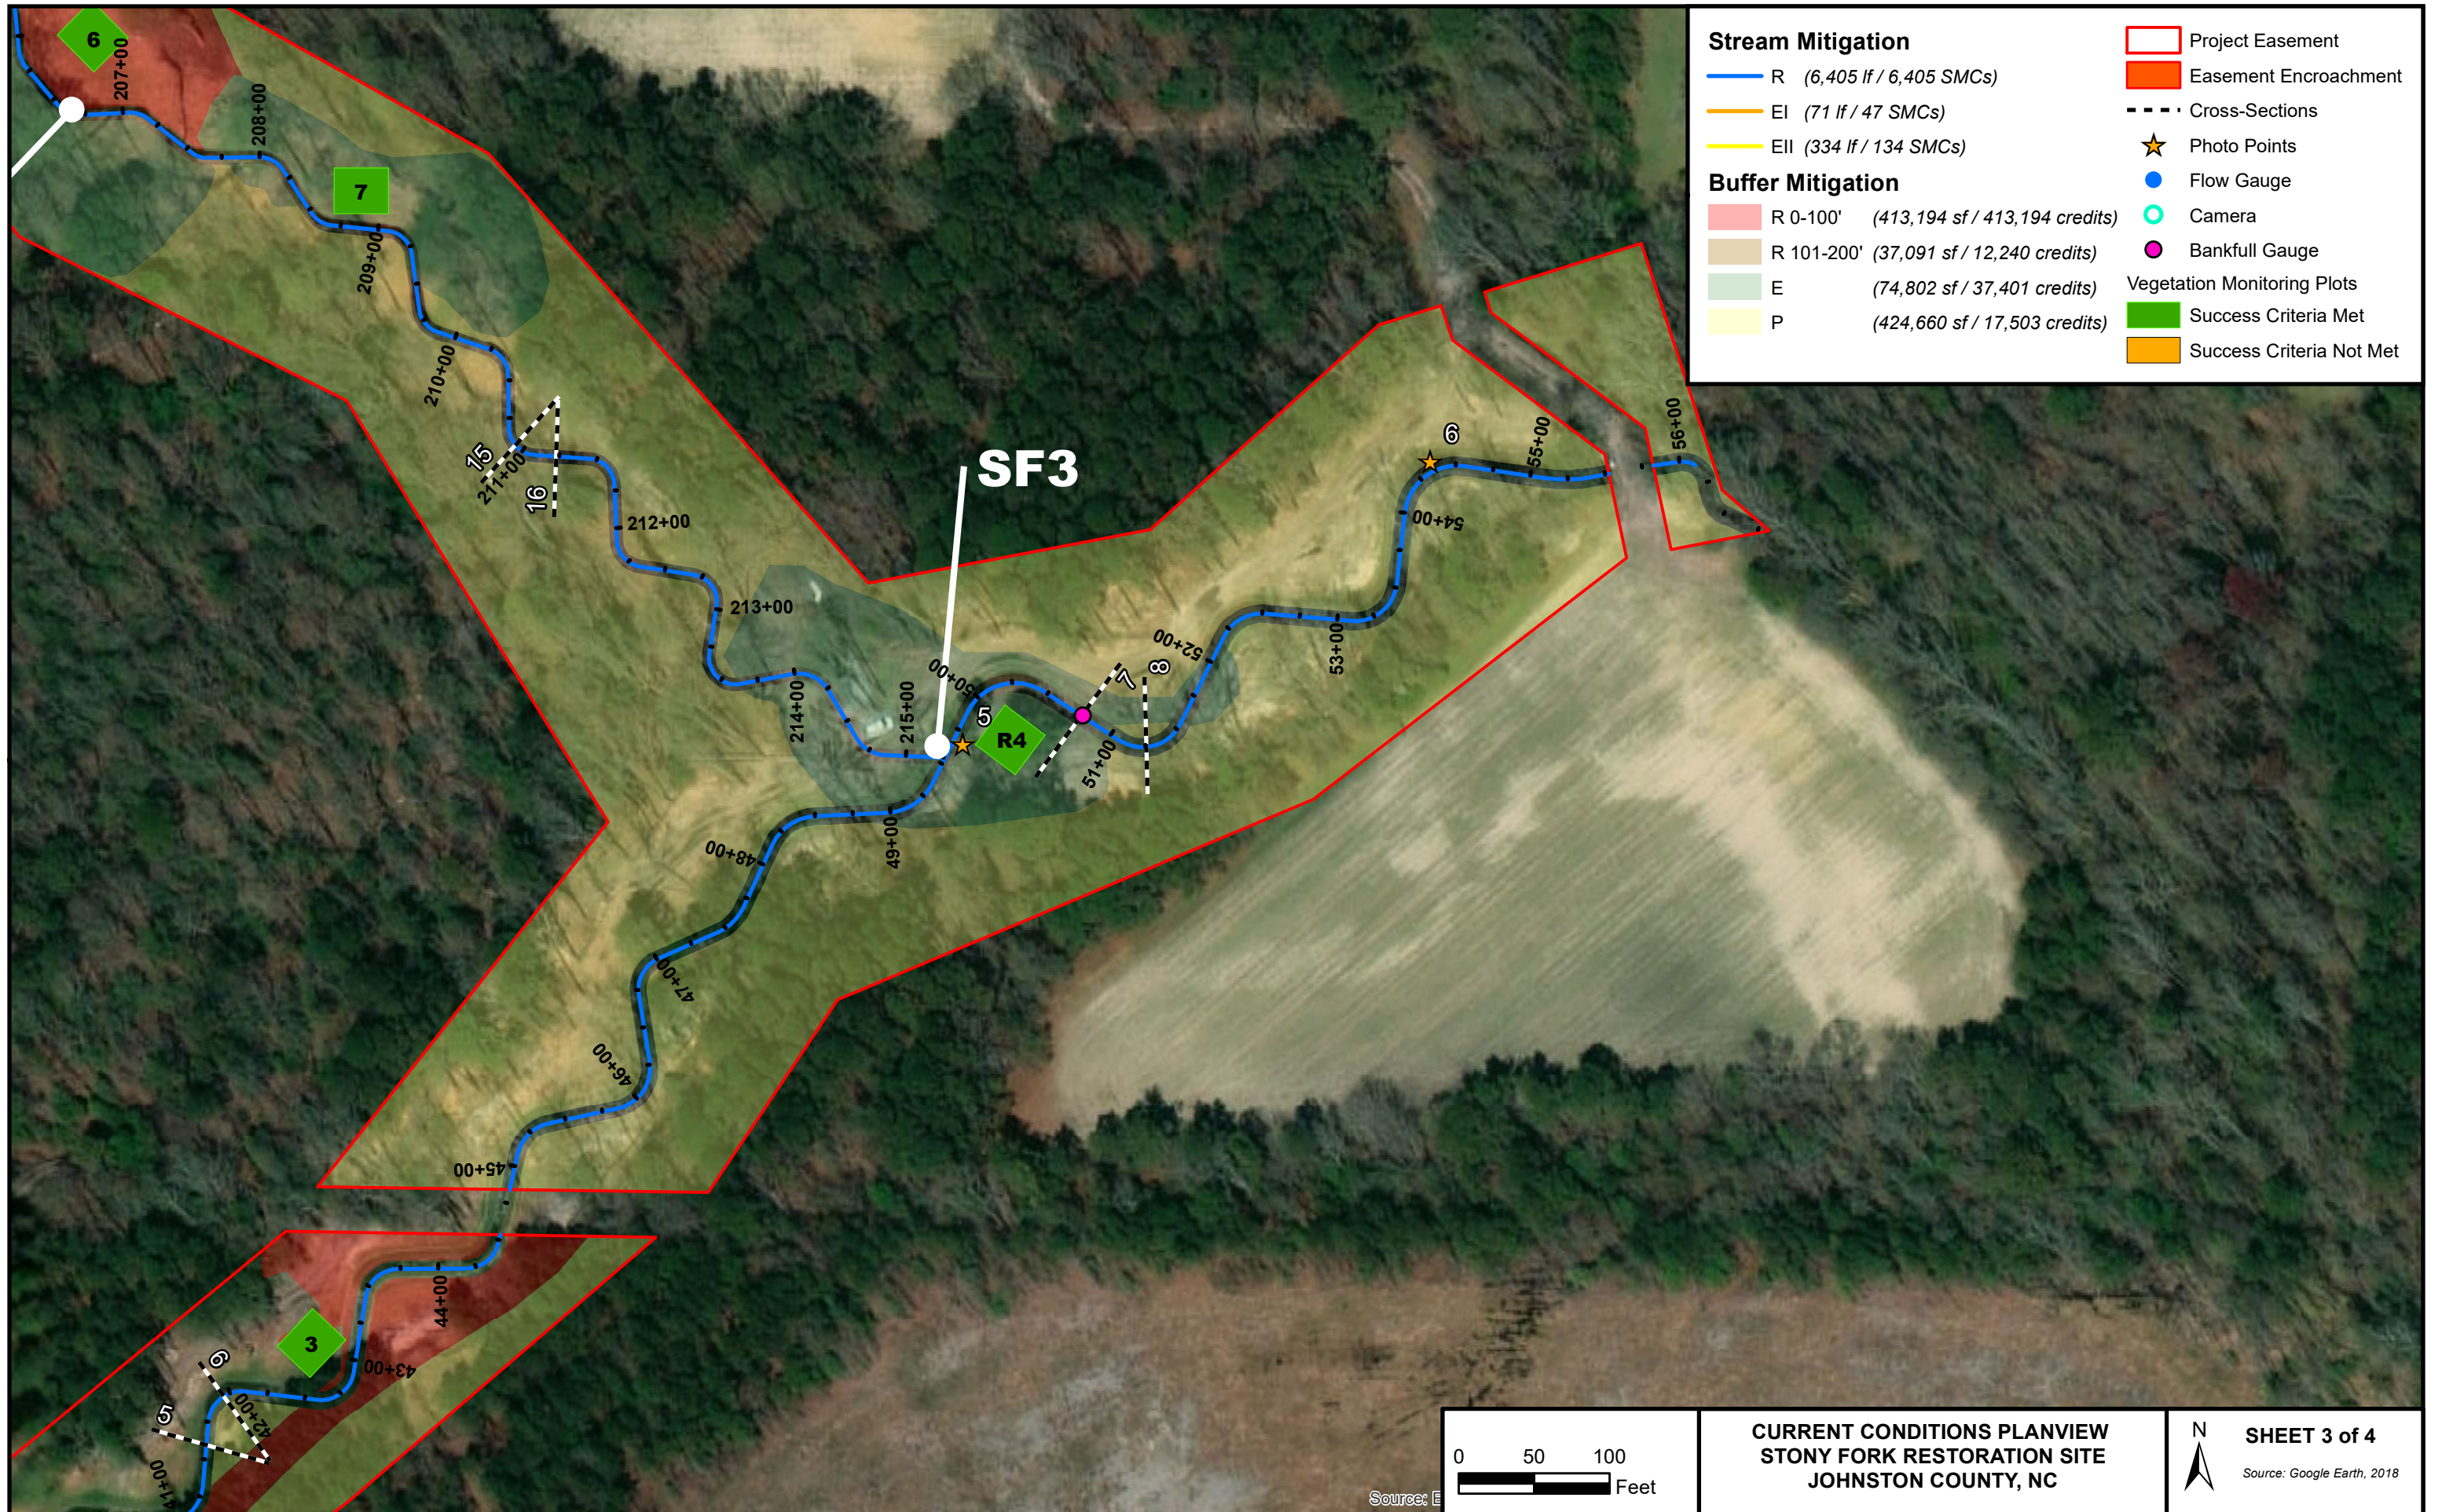
**SHEET 3 of 4**  
 Source: Google Earth, 2018

**CURRENT CONDITIONS PLANVIEW**  
**STONY FORK RESTORATION SITE**  
**JOHNSTON COUNTY, NC**

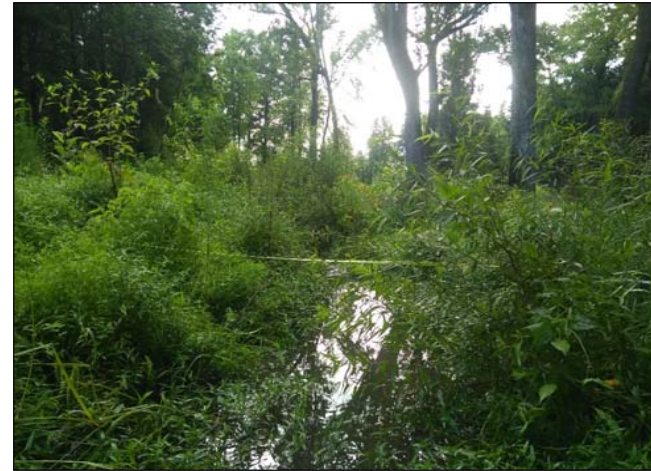
<b>River Basin:</b>	Neuse River
<b>Site:</b>	Stony Fork
<b>XS ID</b>	XS2
<b>Drainage Area (sq mi):</b>	0.28
<b>Date:</b>	6/18/2020
<b>Field Crew:</b>	T. Seelinger, A. Gutierrez

Station	Elevation
0.0	208.30
0.3	207.95
6.7	207.66
13.7	207.26
20.5	206.79
27.5	206.60
33.8	206.60
39.7	206.83
42.5	206.63
43.6	206.63
44.6	206.41
45.8	206.11
46.5	205.90
47.4	205.53
48.3	205.39
48.7	205.31
49.0	205.40
50.4	205.46
50.9	205.56
51.1	205.86
52.1	206.10
53.2	206.39
53.9	206.57
56.3	206.55
60.0	206.52
65.9	206.62
72.2	206.75
83.7	206.66
83.7	207.00

SUMMARY DATA	
<b>Bankfull Elevation (ft) - Based on AB-Bankfull Area</b>	206.60
<b>Bankfull Cross-Sectional Area:</b>	7.0
<b>Total Cross-Sectional Area:</b>	6.8
<b>Bankfull Width:</b>	10.2
<b>Flood Prone Area Elevation:</b>	207.9
<b>Flood Prone Width:</b>	82.0
<b>Max Depth at Bankfull:</b>	1.3
<b>Mean Depth at Bankfull:</b>	0.7
<b>W / D Ratio:</b>	14.8
<b>Entrenchment Ratio:</b>	8.0
<b>Bank Height Ratio:</b>	1.0
<b>Thalweg Elevation:</b>	205.3

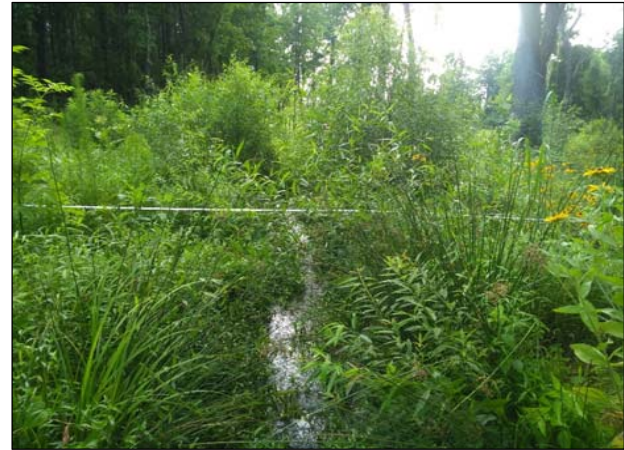
<b>River Basin:</b>	Neuse River
<b>Site:</b>	Stony Fork
<b>XS ID</b>	XS3
<b>Drainage Area (sq mi):</b>	0.46
<b>Date:</b>	6/18/2020
<b>Field Crew:</b>	T. Seelinger, A. Gutierrez

Station	Elevation
0.0	195.53
4.0	195.33
11.1	194.91
14.3	194.59
18.9	193.54
21.8	193.26
26.2	193.00
31.0	192.66
34.6	192.56
36.9	192.46
37.9	192.51
39.1	191.94
40.6	191.43
41.2	191.39
42.3	191.05
43.6	190.90
44.7	190.92
45.2	190.91
45.6	190.93
46.7	190.99
48.0	191.43
49.1	191.90
50.8	192.48
53.4	192.57
56.5	192.63
60.4	192.78
63.6	193.25
69.2	194.25
70.8	194.24
70.9	194.54

SUMMARY DATA	
<b>Bankfull Elevation (ft) - Based on AB-Bankfull Area</b>	192.41
<b>Bankfull Cross-Sectional Area:</b>	12.5
<b>Total Cross-Sectional Area:</b>	13.8
<b>Bankfull Width:</b>	12.5
<b>Flood Prone Area Elevation:</b>	193.9
<b>Flood Prone Width:</b>	50.1
<b>Max Depth at Bankfull:</b>	1.5
<b>Mean Depth at Bankfull:</b>	1.0
<b>W / D Ratio:</b>	12.6
<b>Entrenchment Ratio:</b>	4.0
<b>Bank Height Ratio:</b>	1.0
<b>Thalweg Elevation:</b>	190.9

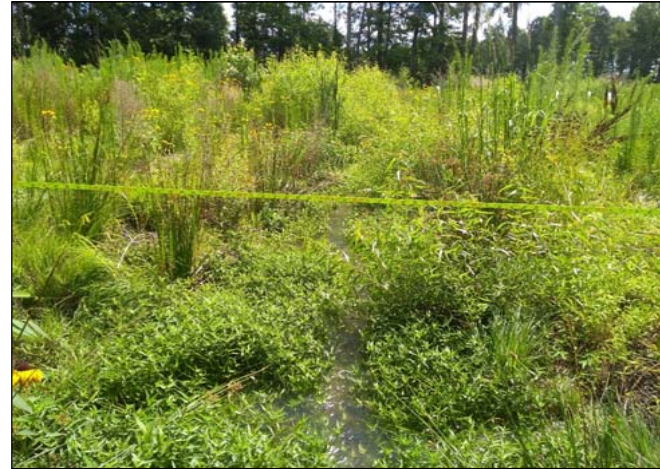
<b>River Basin:</b>	Neuse River
<b>Site:</b>	Stony Fork
<b>XS ID</b>	XS4
<b>Drainage Area (sq mi):</b>	0.46
<b>Date:</b>	6/18/2020
<b>Field Crew:</b>	T. Seelinger, A. Gutierrez

Station	Elevation
0.0	195.27
0.3	194.88
5.0	194.52
9.1	194.34
14.1	193.61
18.4	192.88
22.3	192.42
23.7	192.21
24.8	192.29
26.0	191.88
26.7	191.24
27.0	190.47
28.3	190.21
29.1	189.81
30.1	189.79
31.9	189.92
32.7	190.59
33.7	191.18
36.2	191.55
38.6	191.91
44.6	192.10
51.4	192.19
58.4	192.70
66.0	193.45
66.1	193.84

SUMMARY DATA	
<b>Bankfull Elevation (ft) - Based on AB-Bankfull Area</b>	191.88
<b>Bankfull Cross-Sectional Area:</b>	13.6
<b>Total Cross-Sectional Area:</b>	15.2
<b>Bankfull Width:</b>	12.4
<b>Flood Prone Area Elevation:</b>	---
<b>Flood Prone Width:</b>	---
<b>Max Depth at Bankfull:</b>	2.1
<b>Mean Depth at Bankfull:</b>	1.1
<b>W / D Ratio:</b>	---
<b>Entrenchment Ratio:</b>	---
<b>Bank Height Ratio:</b>	---
<b>Thalweg Elevation:</b>	189.8

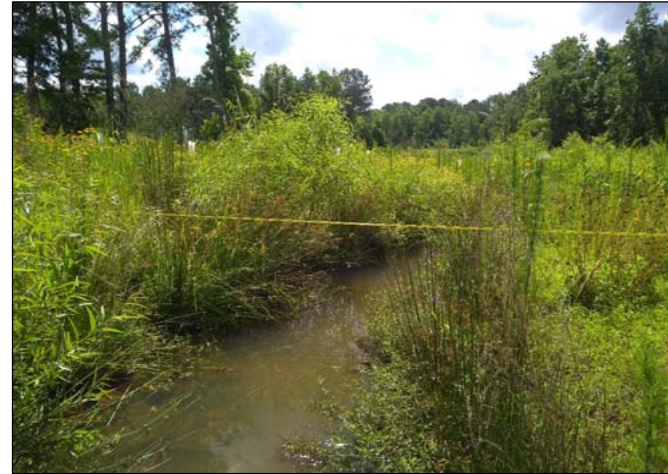
<b>River Basin:</b>	Neuse River
<b>Site:</b>	Stony Fork
<b>XS ID</b>	XS5
<b>Drainage Area (sq mi):</b>	0.46
<b>Date:</b>	6/18/2020
<b>Field Crew:</b>	T. Seelinger, A. Gutierrez

Station	Elevation
0.0	183.14
0.2	182.51
5.5	182.31
14.0	182.42
23.0	182.75
28.2	182.47
30.4	182.34
31.1	182.25
32.1	181.96
33.1	181.65
34.2	181.24
35.4	180.90
36.0	181.04
36.9	180.94
37.5	180.98
38.6	181.02
39.7	181.08
41.8	181.64
43.4	182.07
44.8	182.32
49.8	182.31
57.3	182.60
65.4	182.56
75.0	182.48
79.5	182.70
80.7	183.28

SUMMARY DATA	
<b>Bankfull Elevation (ft) - Based on AB-Bankfull Area</b>	182.23
<b>Bankfull Cross-Sectional Area:</b>	10.6
<b>Total Cross-Sectional Area:</b>	9.3
<b>Bankfull Width:</b>	13.2
<b>Flood Prone Area Elevation:</b>	183.6
<b>Flood Prone Width:</b>	80.7
<b>Max Depth at Bankfull:</b>	1.3
<b>Mean Depth at Bankfull:</b>	0.8
<b>W / D Ratio:</b>	16.4
<b>Entrenchment Ratio:</b>	6.1
<b>Bank Height Ratio:</b>	1.0
<b>Thalweg Elevation:</b>	180.9

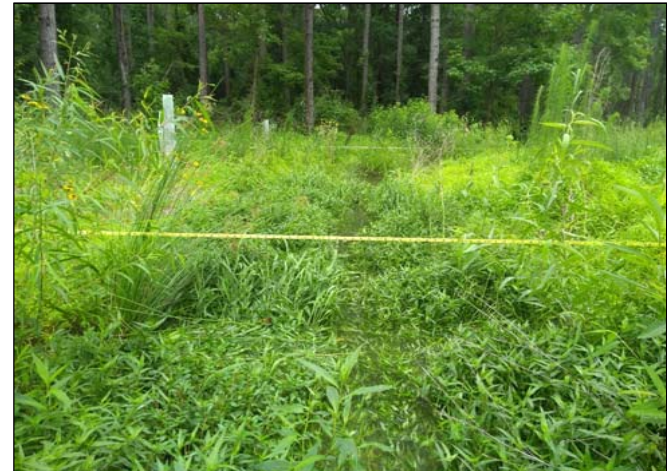
<b>River Basin:</b>	Neuse River
<b>Site:</b>	Stony Fork
<b>XS ID</b>	XS6
<b>Drainage Area (sq mi):</b>	0.46
<b>Date:</b>	6/18/2020
<b>Field Crew:</b>	T. Seelinger, A. Gutierrez

Station	Elevation
0.0	183.40
0.2	183.22
3.4	182.72
6.1	182.76
11.2	182.07
17.1	181.95
19.6	181.80
20.9	181.89
21.9	181.68
22.4	181.49
23.3	180.93
24.4	179.72
25.9	179.20
26.9	179.35
28.5	179.92
29.7	180.47
30.9	181.23
32.9	181.40
33.9	181.87
34.5	181.93
37.7	181.88
44.9	181.74
52.5	181.99
58.9	182.34
69.6	182.47
78.0	182.66
81.1	183.18

SUMMARY DATA	
<b>Bankfull Elevation (ft) - Based on AB-Bankfull Area</b>	181.68
<b>Bankfull Cross-Sectional Area:</b>	14.5
<b>Total Cross-Sectional Area:</b>	15.2
<b>Bankfull Width:</b>	11.5
<b>Flood Prone Area Elevation:</b>	---
<b>Flood Prone Width:</b>	---
<b>Max Depth at Bankfull:</b>	2.5
<b>Mean Depth at Bankfull:</b>	1.3
<b>W / D Ratio:</b>	---
<b>Entrenchment Ratio:</b>	---
<b>Bank Height Ratio:</b>	---
<b>Thalweg Elevation:</b>	179.2

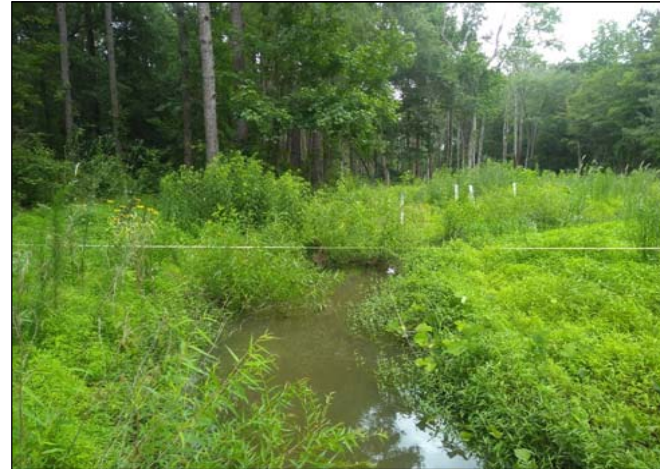
<b>River Basin:</b>	Neuse River
<b>Site:</b>	Stony Fork
<b>XS ID</b>	XS7
<b>Drainage Area (sq mi):</b>	0.83
<b>Date:</b>	6/29/2020
<b>Field Crew:</b>	T. Seelinger, A. Gutierrez

Station	Elevation
0.0	177.93
5.0	176.69
10.5	176.44
17.4	176.27
24.9	176.00
30.5	176.08
38.2	176.20
39.6	175.90
41.0	175.46
41.8	175.18
42.5	174.93
43.2	174.54
44.1	174.32
45.4	174.21
46.5	174.46
47.0	174.54
47.5	174.60
48.1	174.80
49.0	175.09
50.5	175.47
52.1	175.87
53.7	176.02
56.9	176.00
60.6	175.86
66.0	176.02
71.2	176.04
76.5	176.19
81.6	176.47
87.6	176.76
92.5	177.01
92.8	177.15

SUMMARY DATA	
<b>Bankfull Elevation (ft) - Based on AB-Bankfull Area</b>	175.99
<b>Bankfull Cross-Sectional Area:</b>	12.8
<b>Total Cross-Sectional Area:</b>	13.3
<b>Bankfull Width:</b>	14.2
<b>Flood Prone Area Elevation:</b>	177.8
<b>Flood Prone Width:</b>	92.2
<b>Max Depth at Bankfull:</b>	1.8
<b>Mean Depth at Bankfull:</b>	0.9
<b>W / D Ratio:</b>	15.7
<b>Entrenchment Ratio:</b>	6.5
<b>Bank Height Ratio:</b>	1.0
<b>Thalweg Elevation:</b>	174.2

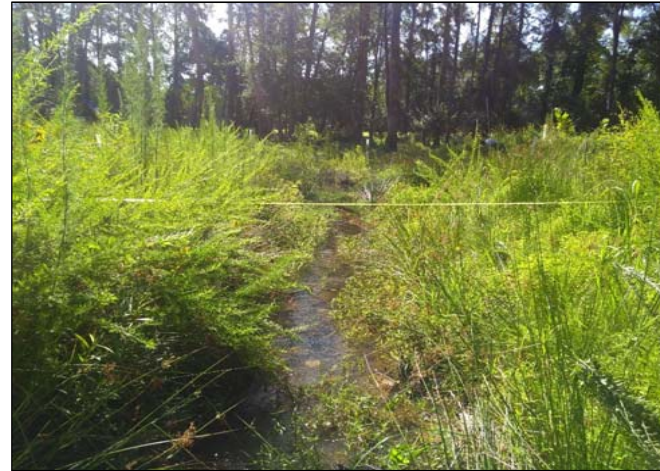
<b>River Basin:</b>	Neuse River
<b>Site:</b>	Stony Fork
<b>XS ID</b>	XS8
<b>Drainage Area (sq mi):</b>	0.83
<b>Date:</b>	6/29/2020
<b>Field Crew:</b>	T. Seelinger, A. Gutierrez

Station	Elevation
0.0	176.54
0.1	175.98
3.9	175.69
10.8	175.61
18.4	175.61
24.9	175.56
31.1	175.55
35.4	175.40
38.3	175.24
40.9	175.19
42.3	175.20
43.9	174.89
45.5	174.39
46.4	174.26
47.3	173.91
48.0	173.82
48.7	173.29
49.7	172.85
50.9	172.75
52.2	172.71
53.0	172.72
54.0	173.07
54.6	173.55
55.0	174.20
56.3	174.70
58.1	175.24
59.4	175.47
63.0	175.37
67.3	175.43
71.0	175.87
73.6	175.97
75.8	176.24
78.4	176.53
80.9	176.78
81.0	177.63

SUMMARY DATA	
<b>Bankfull Elevation (ft) - Based on AB-Bankfull Area</b>	175.21
<b>Bankfull Cross-Sectional Area:</b>	20.7
<b>Total Cross-Sectional Area:</b>	21.5
<b>Bankfull Width:</b>	15.7
<b>Flood Prone Area Elevation:</b>	---
<b>Flood Prone Width:</b>	---
<b>Max Depth at Bankfull:</b>	2.5
<b>Mean Depth at Bankfull:</b>	1.3
<b>W / D Ratio:</b>	---
<b>Entrenchment Ratio:</b>	---
<b>Bank Height Ratio:</b>	---
<b>Thalweg Elevation:</b>	172.7

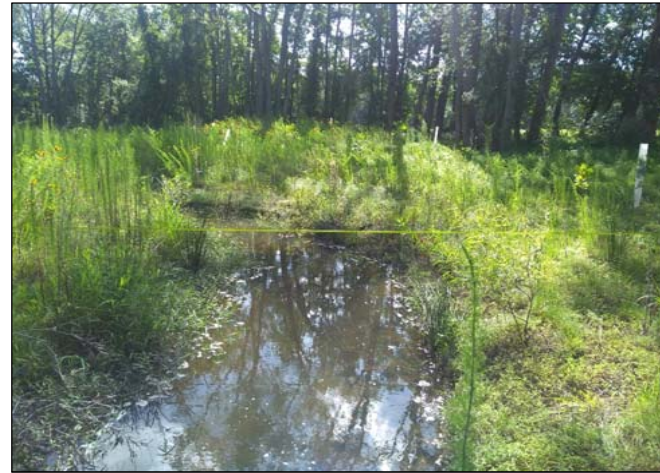
<b>River Basin:</b>	Neuse River
<b>Site:</b>	Stony Fork
<b>XS ID</b>	XS9
<b>Drainage Area (sq mi):</b>	0.04
<b>Date:</b>	6/18/2020
<b>Field Crew:</b>	T. Seelinger, A. Gutierrez

Station	Elevation
0.0	210.78
0.0	210.18
6.9	210.06
10.2	209.83
12.9	208.84
18.8	207.42
22.7	207.30
24.6	207.18
26.0	207.03
26.4	207.01
26.6	206.95
26.9	206.72
27.7	206.43
28.4	206.48
29.2	206.46
30.6	206.50
31.0	206.98
31.6	207.18
32.4	207.08
36.5	207.08
41.9	207.16
45.6	207.50
50.0	207.93
57.2	208.67
60.4	208.85
60.7	209.33

SUMMARY DATA	
<b>Bankfull Elevation (ft) - Based on AB-Bankfull Area</b>	207.26
<b>Bankfull Cross-Sectional Area:</b>	3.7
<b>Total Cross-Sectional Area:</b>	2.0
<b>Bankfull Width:</b>	8.2
<b>Flood Prone Area Elevation:</b>	---
<b>Flood Prone Width:</b>	---
<b>Max Depth at Bankfull:</b>	0.8
<b>Mean Depth at Bankfull:</b>	0.4
<b>W / D Ratio:</b>	---
<b>Entrenchment Ratio:</b>	---
<b>Bank Height Ratio:</b>	---
<b>Thalweg Elevation:</b>	206.4

The second-year cross-section survey was completed between June 18 and 28, 2020 and found that the dimensions of the stream are as designed, with some small variation as is typical for stream restoration projects. Cross-section 9, located on T3, showed about six inches of aggradation. This reach received a large amount of sediment input during 2020 from portions of the stream located upstream of the project reaches. This section of the project will be monitored to ensure that this sediment washes through the system in the coming monitoring years. The monitored cross-section data have been calculated by adjusting the bankfull elevation to maintain the baseline bankfull area for each cross-section.

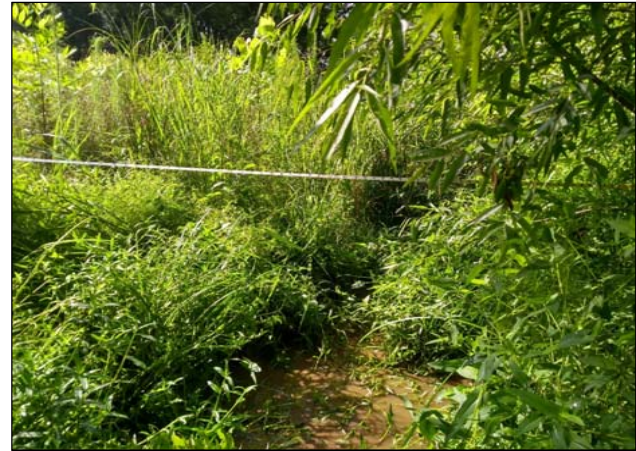
<b>River Basin:</b>	Neuse River
<b>Site:</b>	Stony Fork
<b>XS ID</b>	XS10
<b>Drainage Area (sq mi):</b>	0.04
<b>Date:</b>	6/18/2020
<b>Field Crew:</b>	T. Seelinger, A. Gutierrez

Station	Elevation
0.0	209.78
0.0	209.22
6.0	208.71
12.4	208.29
17.3	207.99
21.3	207.81
26.0	207.65
32.3	207.49
38.6	207.42
40.9	207.26
41.5	207.26
42.4	207.11
42.7	206.93
43.4	206.56
44.2	206.53
44.6	206.49
45.3	206.68
46.1	206.82
46.8	206.98
47.4	207.01
50.2	206.99
54.0	207.12
57.9	207.50
63.5	208.03
69.2	208.15
71.9	208.36
71.9	209.09

SUMMARY DATA	
<b>Bankfull Elevation (ft) - Based on AB-Bankfull Area</b>	207.17
<b>Bankfull Cross-Sectional Area:</b>	2.2
<b>Total Cross-Sectional Area:</b>	1.8
<b>Bankfull Width:</b>	5.4
<b>Flood Prone Area Elevation:</b>	207.9
<b>Flood Prone Width:</b>	41.5
<b>Max Depth at Bankfull:</b>	0.7
<b>Mean Depth at Bankfull:</b>	0.4
<b>W / D Ratio:</b>	13.4
<b>Entrenchment Ratio:</b>	7.7
<b>Bank Height Ratio:</b>	0.8
<b>Thalweg Elevation:</b>	206.5

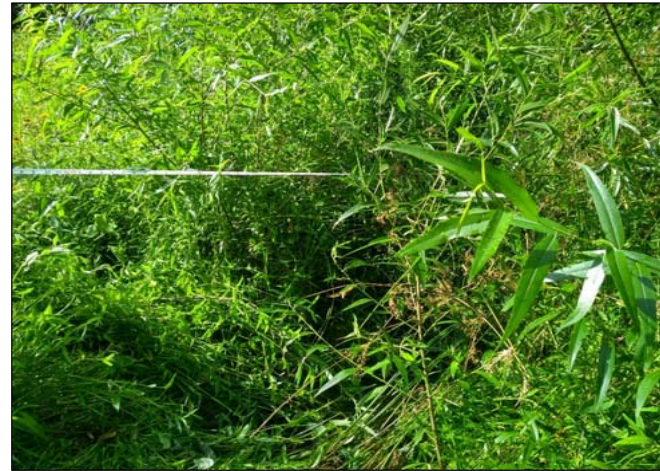
<b>River Basin:</b>	Neuse River
<b>Site:</b>	Stony Fork
<b>XS ID</b>	XS11
<b>Drainage Area (sq mi):</b>	0.02
<b>Date:</b>	6/18/2020
<b>Field Crew:</b>	T. Seelinger, A. Gutierrez

Station	Elevation
0.0	199.11
0.2	198.68
7.7	198.70
14.9	198.72
22.8	198.52
30.6	198.43
34.8	198.40
36.7	198.21
37.6	198.16
38.2	197.94
38.6	197.63
39.9	197.64
40.6	197.72
41.2	198.01
42.1	198.44
43.9	198.44
47.1	198.45
52.2	198.46
59.1	198.59
65.8	199.12
69.6	199.35
72.5	199.43
72.6	199.79

SUMMARY DATA	
<b>Bankfull Elevation (ft) - Based on AB-Bankfull Area</b>	198.27
<b>Bankfull Cross-Sectional Area:</b>	2.0
<b>Total Cross-Sectional Area:</b>	2.6
<b>Bankfull Width:</b>	5.7
<b>Flood Prone Area Elevation:</b>	198.9
<b>Flood Prone Width:</b>	63.2
<b>Max Depth at Bankfull:</b>	0.6
<b>Mean Depth at Bankfull:</b>	0.4
<b>W / D Ratio:</b>	16.0
<b>Entrenchment Ratio:</b>	11.2
<b>Bank Height Ratio:</b>	1.2
<b>Thalweg Elevation:</b>	197.6

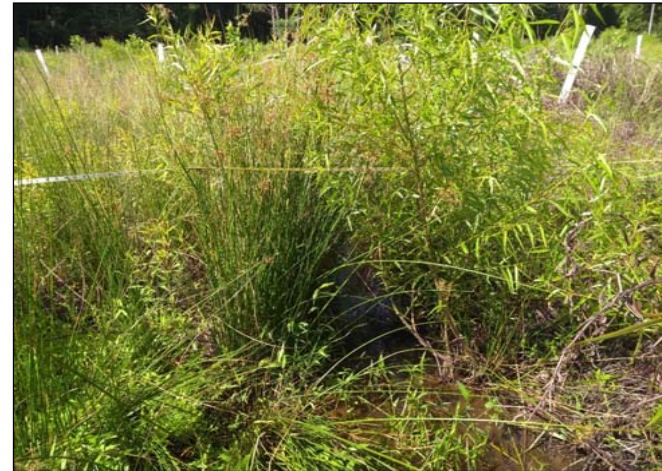
<b>River Basin:</b>	Neuse River
<b>Site:</b>	Stony Fork
<b>XS ID</b>	XS12
<b>Drainage Area (sq mi):</b>	0.02
<b>Date:</b>	6/18/2020
<b>Field Crew:</b>	T. Seelinger, A. Gutierrez

Station	Elevation
0.0	199.27
0.2	198.88
7.8	198.72
15.3	198.73
24.0	198.35
33.0	198.57
37.3	198.38
41.3	198.35
42.8	197.93
43.6	197.82
44.3	197.48
45.1	197.26
46.1	197.21
46.9	197.23
47.8	197.89
48.9	198.40
50.6	198.50
52.7	198.47
55.4	198.82
58.3	199.50
63.2	199.77
67.8	199.68
71.4	199.77
75.3	200.03

SUMMARY DATA	
<b>Bankfull Elevation (ft) - Based on AB-Bankfull Area</b>	198.34
<b>Bankfull Cross-Sectional Area:</b>	4.8
<b>Total Cross-Sectional Area:</b>	5.3
<b>Bankfull Width:</b>	7.4
<b>Flood Prone Area Elevation:</b>	---
<b>Flood Prone Width:</b>	---
<b>Max Depth at Bankfull:</b>	1.1
<b>Mean Depth at Bankfull:</b>	0.7
<b>W / D Ratio:</b>	---
<b>Entrenchment Ratio:</b>	---
<b>Bank Height Ratio:</b>	---
<b>Thalweg Elevation:</b>	197.2

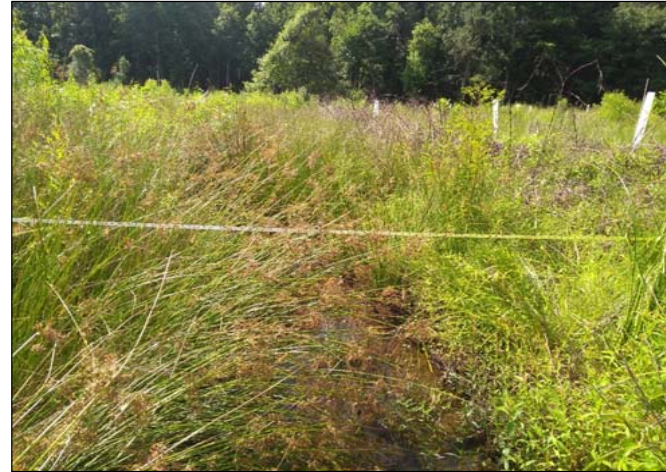
<b>River Basin:</b>	Neuse River
<b>Site:</b>	Stony Fork
<b>XS ID</b>	XS13
<b>Drainage Area (sq mi):</b>	0.14
<b>Date:</b>	6/29/2020
<b>Field Crew:</b>	T. Seelinger, A. Gutierrez

Station	Elevation
0.0	190.20
2.6	189.52
5.0	189.12
8.1	188.79
19.2	188.42
26.7	188.18
31.1	188.53
33.4	188.48
34.3	188.50
35.4	188.21
37.1	187.73
38.7	187.15
39.2	186.75
39.7	186.57
40.7	186.48
41.7	186.60
42.5	186.84
43.1	187.23
44.3	187.69
45.0	188.37
45.7	188.41
47.5	188.59
54.0	189.18
59.4	189.70
62.5	189.90
62.6	190.51

SUMMARY DATA	
<b>Bankfull Elevation (ft) - Based on AB-Bankfull Area</b>	188.20
<b>Bankfull Cross-Sectional Area:</b>	9.3
<b>Total Cross-Sectional Area:</b>	11.0
<b>Bankfull Width:</b>	9.5
<b>Flood Prone Area Elevation:</b>	---
<b>Flood Prone Width:</b>	---
<b>Max Depth at Bankfull:</b>	1.7
<b>Mean Depth at Bankfull:</b>	1.0
<b>W / D Ratio:</b>	---
<b>Entrenchment Ratio:</b>	---
<b>Bank Height Ratio:</b>	---
<b>Thalweg Elevation:</b>	186.5
