# **Monitoring Report MY02**

**Stony Fork Restoration Site  
Upper Neuse River Basin - 03020201  
Monitoring Year 02  
DMS Contract 6830**

**DMS Project Number 97085  
DWR #: 2016-0372  
USACE Action ID: 2016-00875  
Johnston County, North Carolina**

**Monitoring Data Collected: 2020  
Date Submitted: January 2021**

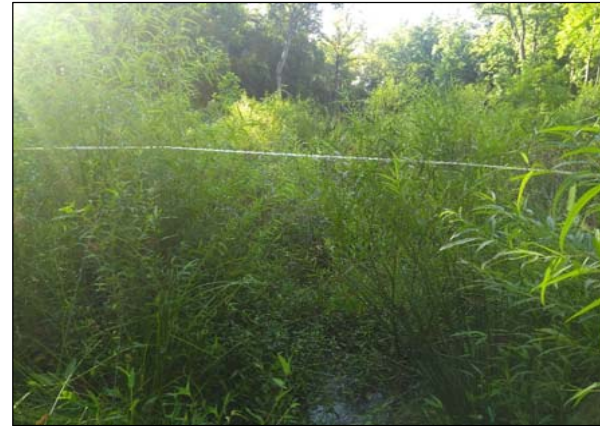
<b>River Basin:</b>	Neuse River
<b>Site:</b>	Stony Fork
<b>XS ID</b>	XS14
<b>Drainage Area (sq mi):</b>	0.14
<b>Date:</b>	6/29/2020
<b>Field Crew:</b>	T. Seelinger, A. Gutierrez

SUMMARY DATA	
<b>Bankfull Elevation (ft) - Based on AB-Bankfull Area</b>	188.05
<b>Bankfull Cross-Sectional Area:</b>	5.8
<b>Total Cross-Sectional Area:</b>	4.4
<b>Bankfull Width:</b>	11.1
<b>Flood Prone Area Elevation:</b>	189.1
<b>Flood Prone Width:</b>	47.2
<b>Max Depth at Bankfull:</b>	1.1
<b>Mean Depth at Bankfull:</b>	0.5
<b>W / D Ratio:</b>	21.4
<b>Entrenchment Ratio:</b>	4.2
<b>Bank Height Ratio:</b>	0.9
<b>Thalweg Elevation:</b>	187.0

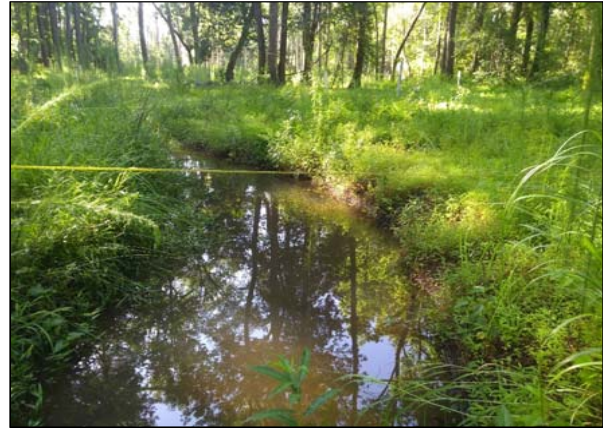
<b>River Basin:</b>	Neuse River
<b>Site:</b>	Stony Fork
<b>XS ID</b>	XS15
<b>Drainage Area (sq mi):</b>	0.22
<b>Date:</b>	6/29/2020
<b>Field Crew:</b>	T. Seelinger, A. Gutierrez

SUMMARY DATA	
<b>Bankfull Elevation (ft) - Based on AB-Bankfull Area</b>	180.73
<b>Bankfull Cross-Sectional Area:</b>	11.2
<b>Total Cross-Sectional Area:</b>	12.8
<b>Bankfull Width:</b>	10.9
<b>Flood Prone Area Elevation:</b>	---
<b>Flood Prone Width:</b>	---
<b>Max Depth at Bankfull:</b>	1.8
<b>Mean Depth at Bankfull:</b>	1.0
<b>W / D Ratio:</b>	---
<b>Entrenchment Ratio:</b>	---
<b>Bank Height Ratio:</b>	---
<b>Thalweg Elevation:</b>	178.9

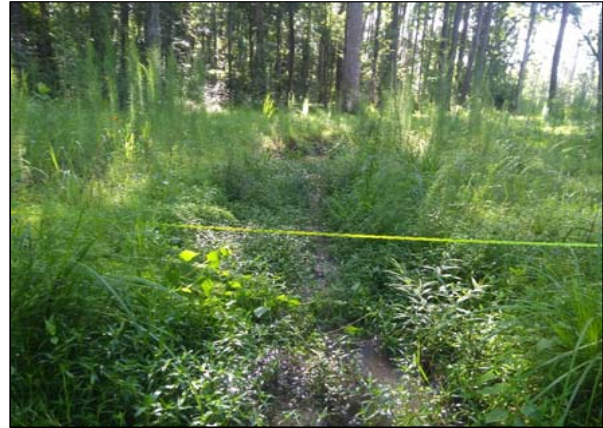
<b>River Basin:</b>	Neuse River
<b>Site:</b>	Stony Fork
<b>XS ID</b>	XS16
<b>Drainage Area (sq mi):</b>	0.22
<b>Date:</b>	6/29/2020
<b>Field Crew:</b>	T. Seelinger, A. Gutierrez

SUMMARY DATA	
<b>Bankfull Elevation (ft) - Based on AB-Bankfull Area</b>	180.81
<b>Bankfull Cross-Sectional Area:</b>	6.0
<b>Total Cross-Sectional Area:</b>	5.2
<b>Bankfull Width:</b>	10.0
<b>Flood Prone Area Elevation:</b>	181.8
<b>Flood Prone Width:</b>	75.5
<b>Max Depth at Bankfull:</b>	1.0
<b>Mean Depth at Bankfull:</b>	0.6
<b>W / D Ratio:</b>	16.6
<b>Entrenchment Ratio:</b>	7.6
<b>Bank Height Ratio:</b>	0.9
<b>Thalweg Elevation:</b>	179.8

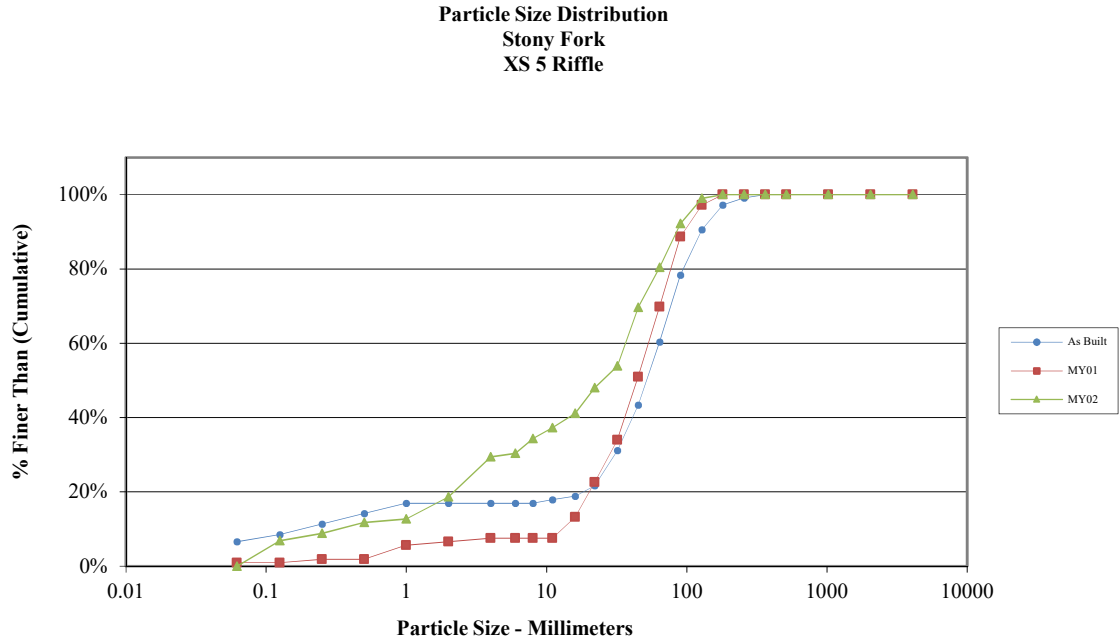
Cross-Section 5 Riffle - MY02			
Particle	Millimeter		Count
Silt/Clay	< 0.062	S/C	
Very Fine	.062 - .125	S	7
Fine	.125 - .25	A	2
Medium	.25 - .50	N	3
Coarse	.50 - 1	D	1
Very Coarse	1 - 2	S	6
Very Fine	2 - 4		11
Fine	4 - 5.7	G	1
Fine	5.7 - 8	R	4
Medium	8 - 11.3	A	3
Medium	11.3 - 16	V	4
Coarse	16 - 22.6	E	7
Coarse	22.6 - 32	L	6
Very Coarse	32 - 45	S	16
Very Coarse	45 - 64		11
Small	64 - 90	C	12
Small	90 - 128	O	7
Large	128 - 180	B	1
Large	180 - 256	L	
Small	256 - 362	B	
Small	362 - 512	L	
Medium	512 - 1024	D	
Lrg- Very Lrg	1024 - 2048	R	
Bedrock	>2048	BDRK	
		<b>Total</b>	102
Note:

Size (mm)	
D16	1.5
D35	8.6
D50	25
D65	41
D84	71
D95	100

Size Distribution	
mean	10.3
dispersion	9.8
skewness	-0.30

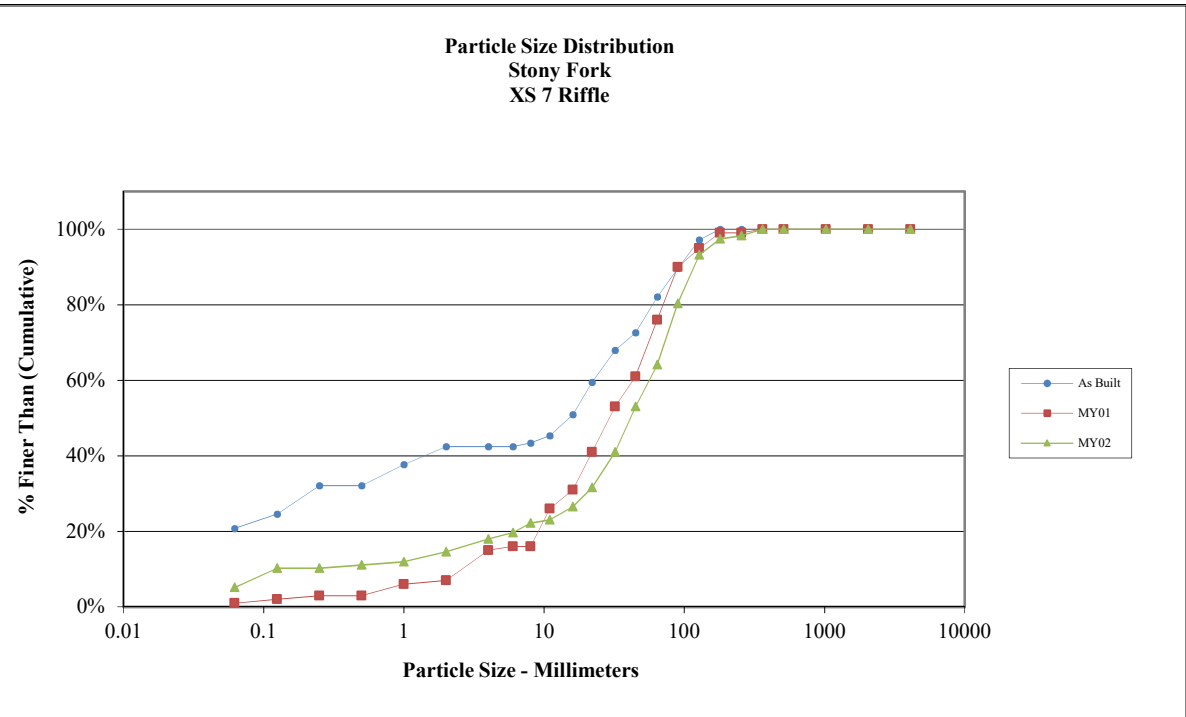
Cross-Section 7 Riffle -MY02			
Particle	Millimeter		Count
Silt/Clay	< 0.062	S/C	6
Very Fine	.062 - .125	S	6
Fine	.125 - .25	A	
Medium	.25 - .50	N	1
Coarse	.50 - 1	D	1
Very Coarse	1 - 2	S	3
Very Fine	2 - 4		4
Fine	4 - 5.7	G	2
Fine	5.7 - 8	R	3
Medium	8 - 11.3	A	1
Medium	11.3 - 16	V	4
Coarse	16 - 22.6	E	6
Coarse	22.6 - 32	L	11
Very Coarse	32 - 45	S	14
Very Coarse	45 - 64		13
Small	64 - 90	C	19
Small	90 - 128	O	15
Large	128 - 180	B	5
Large	180 - 256	L	1
Small	256 - 362	B	2
Small	362 - 512	L	
Medium	512 - 1024	D	
Lrg- Very Lrg	1024 - 2048	R	
Bedrock	>2048	BDRK	
		<b>Total</b>	117

Size (mm)	
D16	2.7
D35	25
D50	41
D65	65
D84	100
D95	150

Size Distribution	
mean	16.4
dispersion	8.8
skewness	-0.32

Type	
silt/clay	5%
sand	9%
gravel	50%
cobble	33%
boulder	2%
bedrock	0%
hardpan	0%
wood/det	0%
artificial	0%

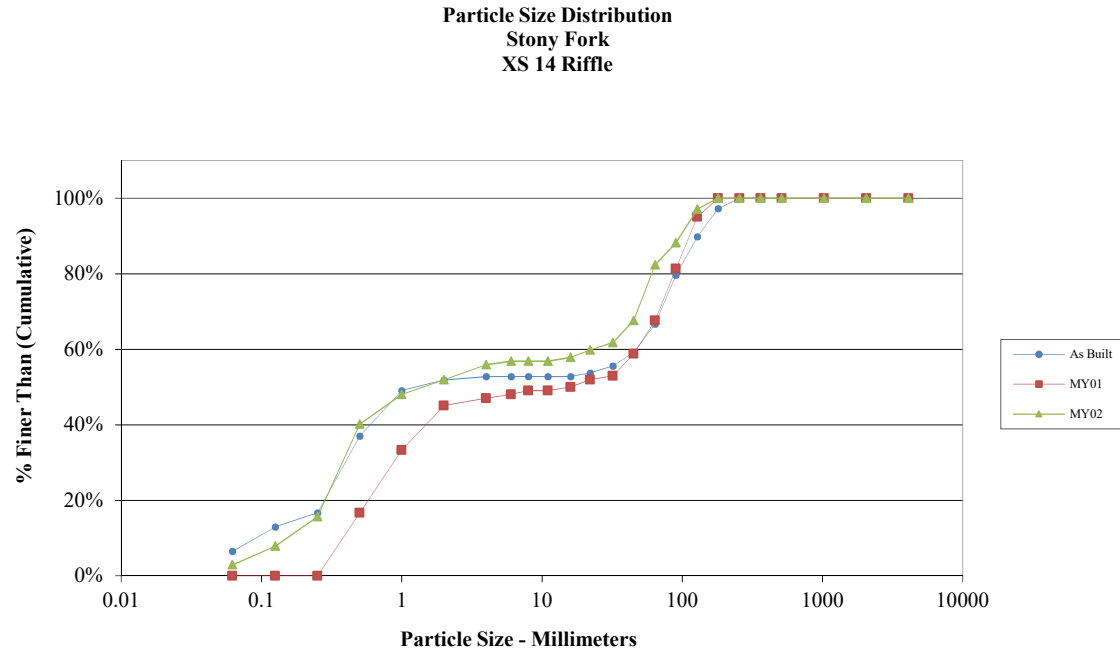
Cross-Section 14 Riffle - MY02			
Particle	Millimeter		Count
Silt/Clay	< 0.062	S/C	3
Very Fine	.062 - .125	S	5
Fine	.125 - .25	A	8
Medium	.25 - .50	N	25
Coarse	.50 - 1	D	8
Very Coarse	1 - 2	S	4
Very Fine	2 - 4		4
Fine	4 - 5.7	G	1
Fine	5.7 - 8	R	
Medium	8 - 11.3	A	
Medium	11.3 - 16	V	1
Coarse	16 - 22.6	E	2
Coarse	22.6 - 32	L	2
Very Coarse	32 - 45	S	6
Very Coarse	45 - 64		15
Small	64 - 90	C	6
Small	90 - 128	O	9
Large	128 - 180	B	3
Large	180 - 256	L	
Small	256 - 362	B	
Small	362 - 512	L	
Medium	512 - 1024	D	
Lrg- Very Lrg	1024 - 2048	R	
Bedrock	>2048	BDRK	
		<b>Total</b>	102

Size (mm)	
D16	0.25
D35	0.43
D50	1.4
D65	39
D84	70
D95	120

Size Distribution	
mean	4.2
dispersion	27.8
skewness	0.30
