Stricker Branch Stream Restoration Project

Contract #: D06054-G
County: Cabarrus
Cataloging Unit: Yadkin 03040105
Monitoring Firm POC: Mid-Atlantic Mitigation, LLC
Rich Mogensen (704) 782-4133
Kimley-Horn Associates, Inc.
Will Wilhelm (704) 333-5131
Prepared For: EEP Project Manager, Guy Pearce

Mitigation Report

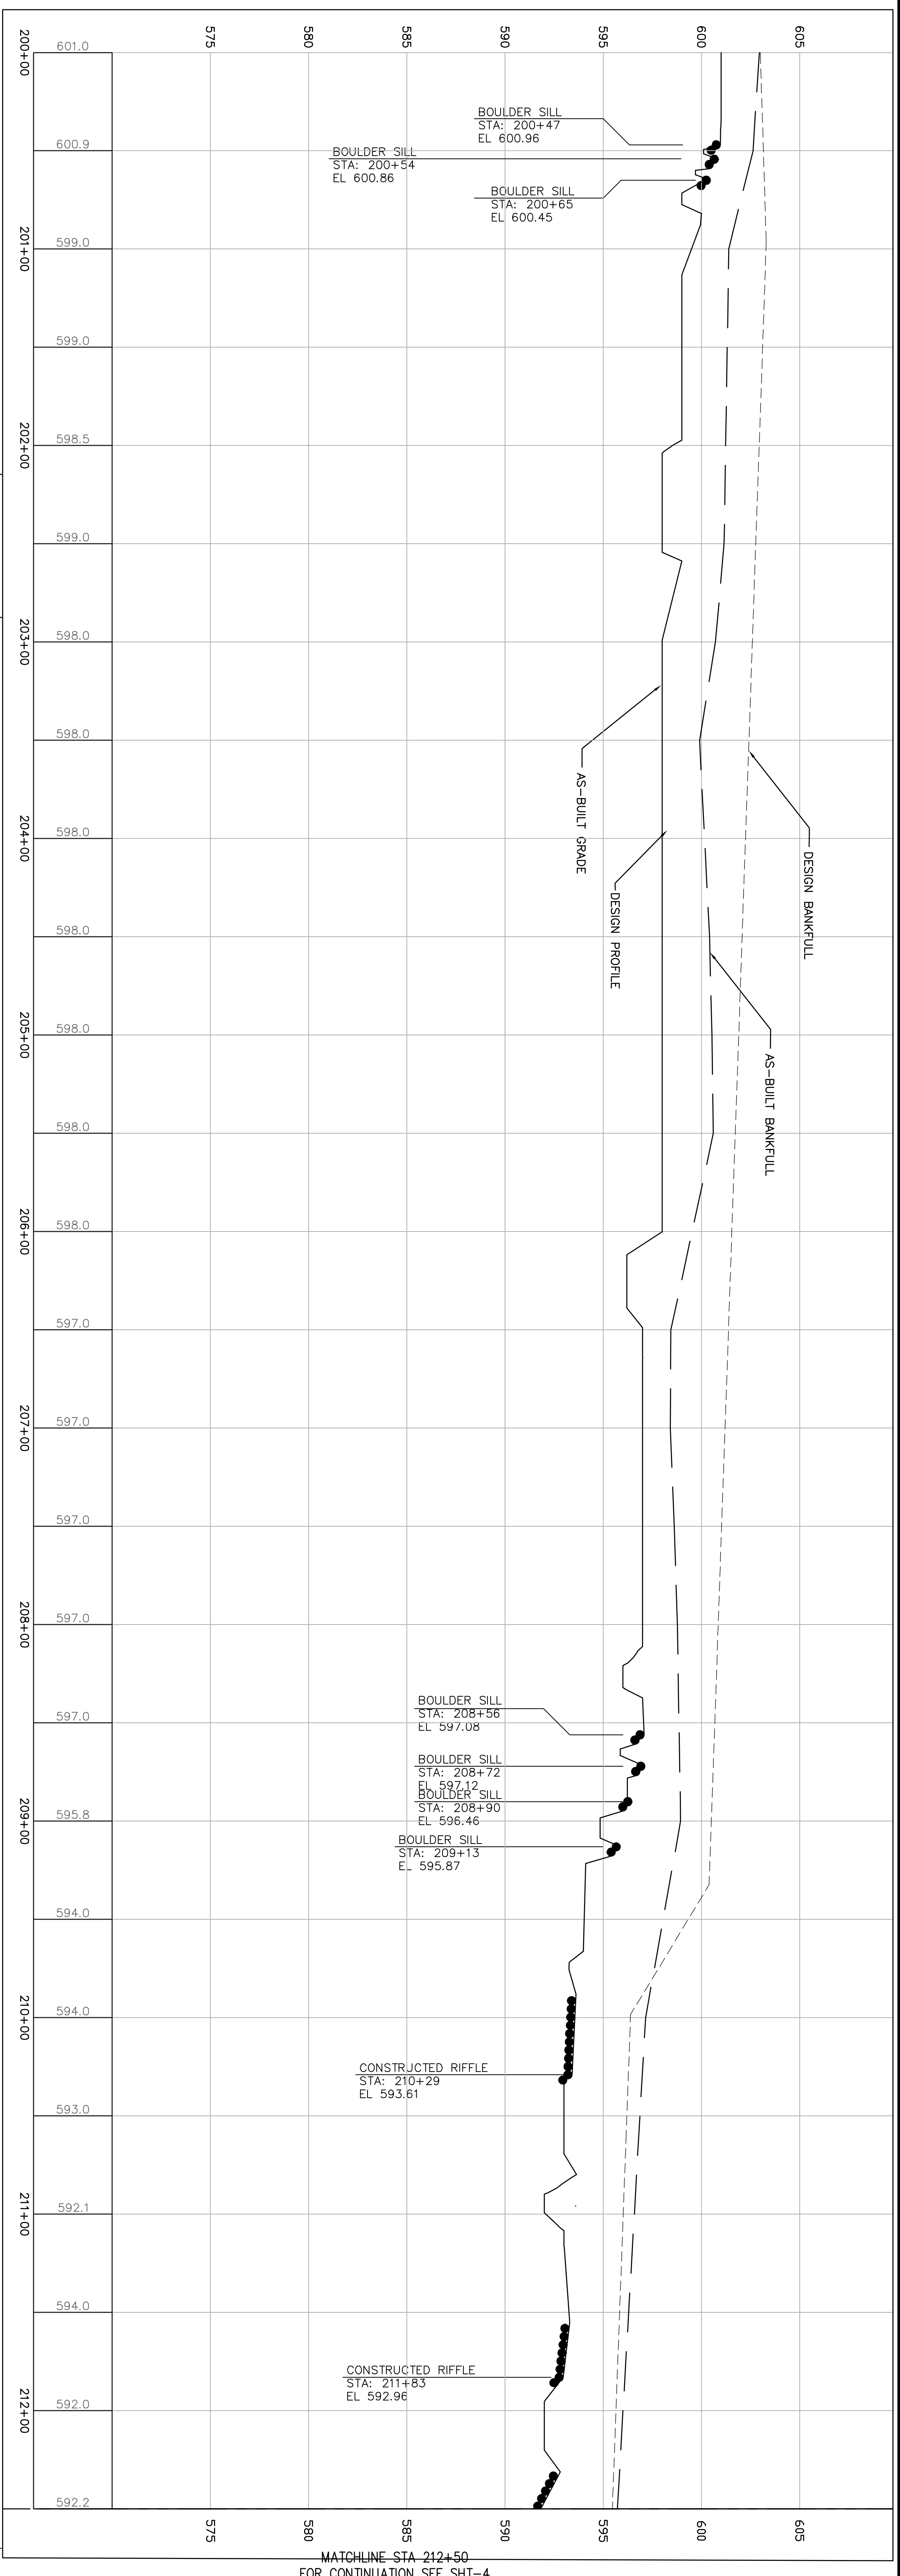
DESIGN LENGTH 3120 L.F.
AS-BUILT LENGTH 2490 L.F.
AS-BUILT SMUGS 2380 L.F.
AS-BUILT SMUGS-AS-BUILT LENGTH MINUS LENGTH OUTSIDE OF EASEMENT

- DESIGN CENTERLINE
- - - CONSERVATION EASEMENT
- AS-BUILT THALWEG
- - - AS-BUILT BANKFULL
- BOULDER SILL
- CONSTRUCTED RIFFLE
- GROSS VANE
- LOG VANE
- ROOTWAD
- PHOTO POINTS

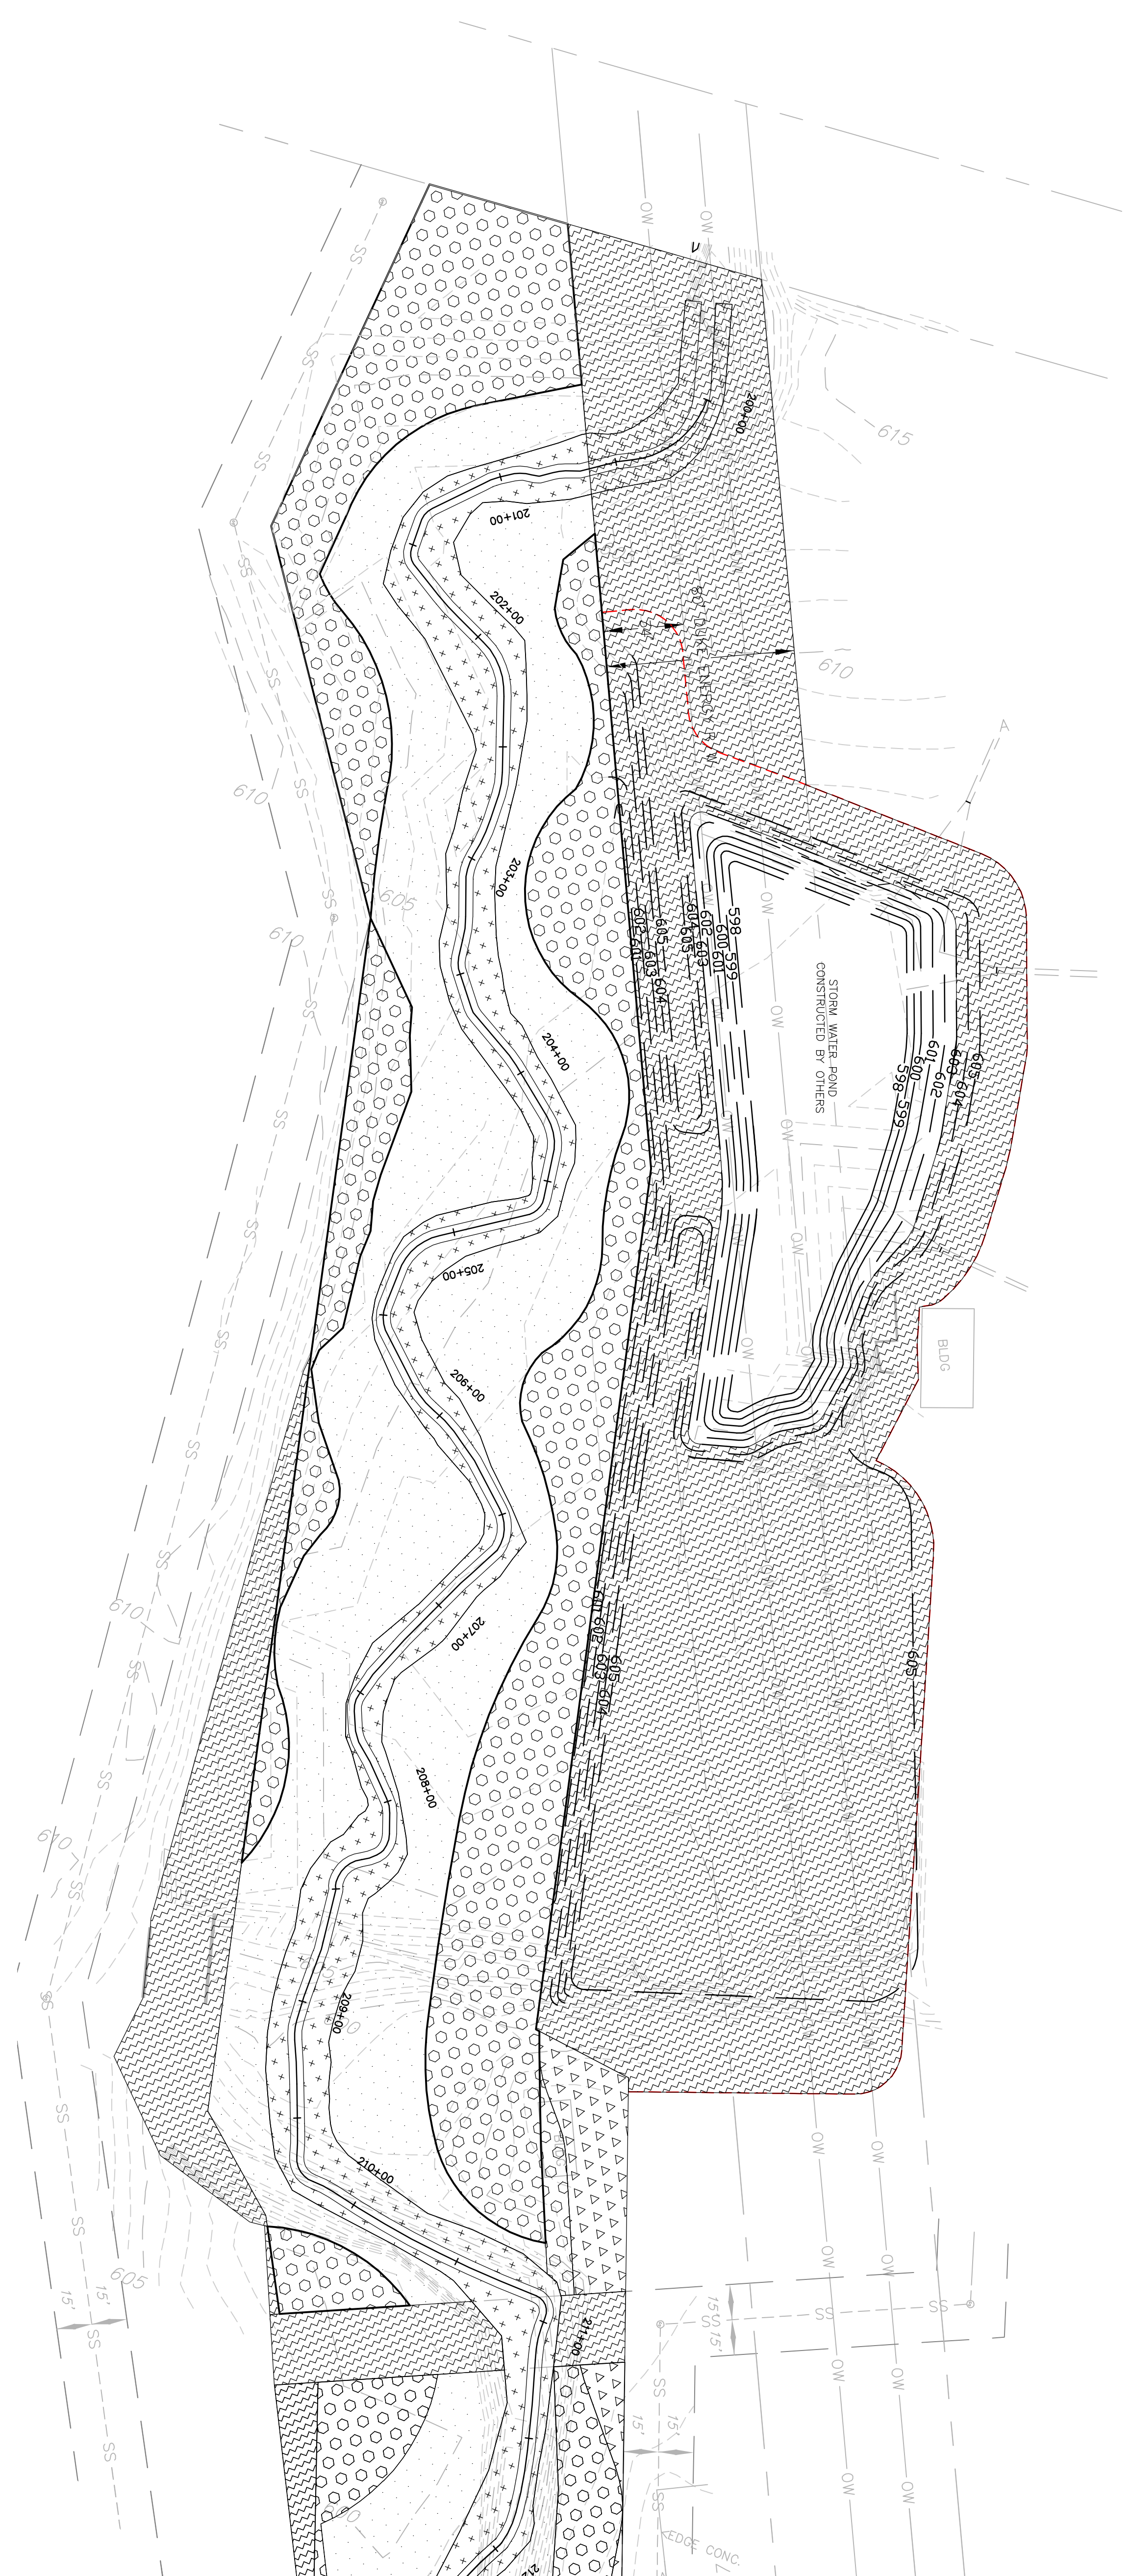
TITLE: **PLANTING PLAN**

[Brick pattern]	ZONE 1 - STREAM BANK
[Diagonal line pattern]	ZONE 2 - RIPARIAN/BANKFULL BENCH
[Cross-hatch pattern]	ZONE 3 - TRANSITIONAL
[Dotted pattern]	ZONE 4 - UPLAND
[Dashed line]	ZONE 5 - OUTSIDE OF EASEMENT

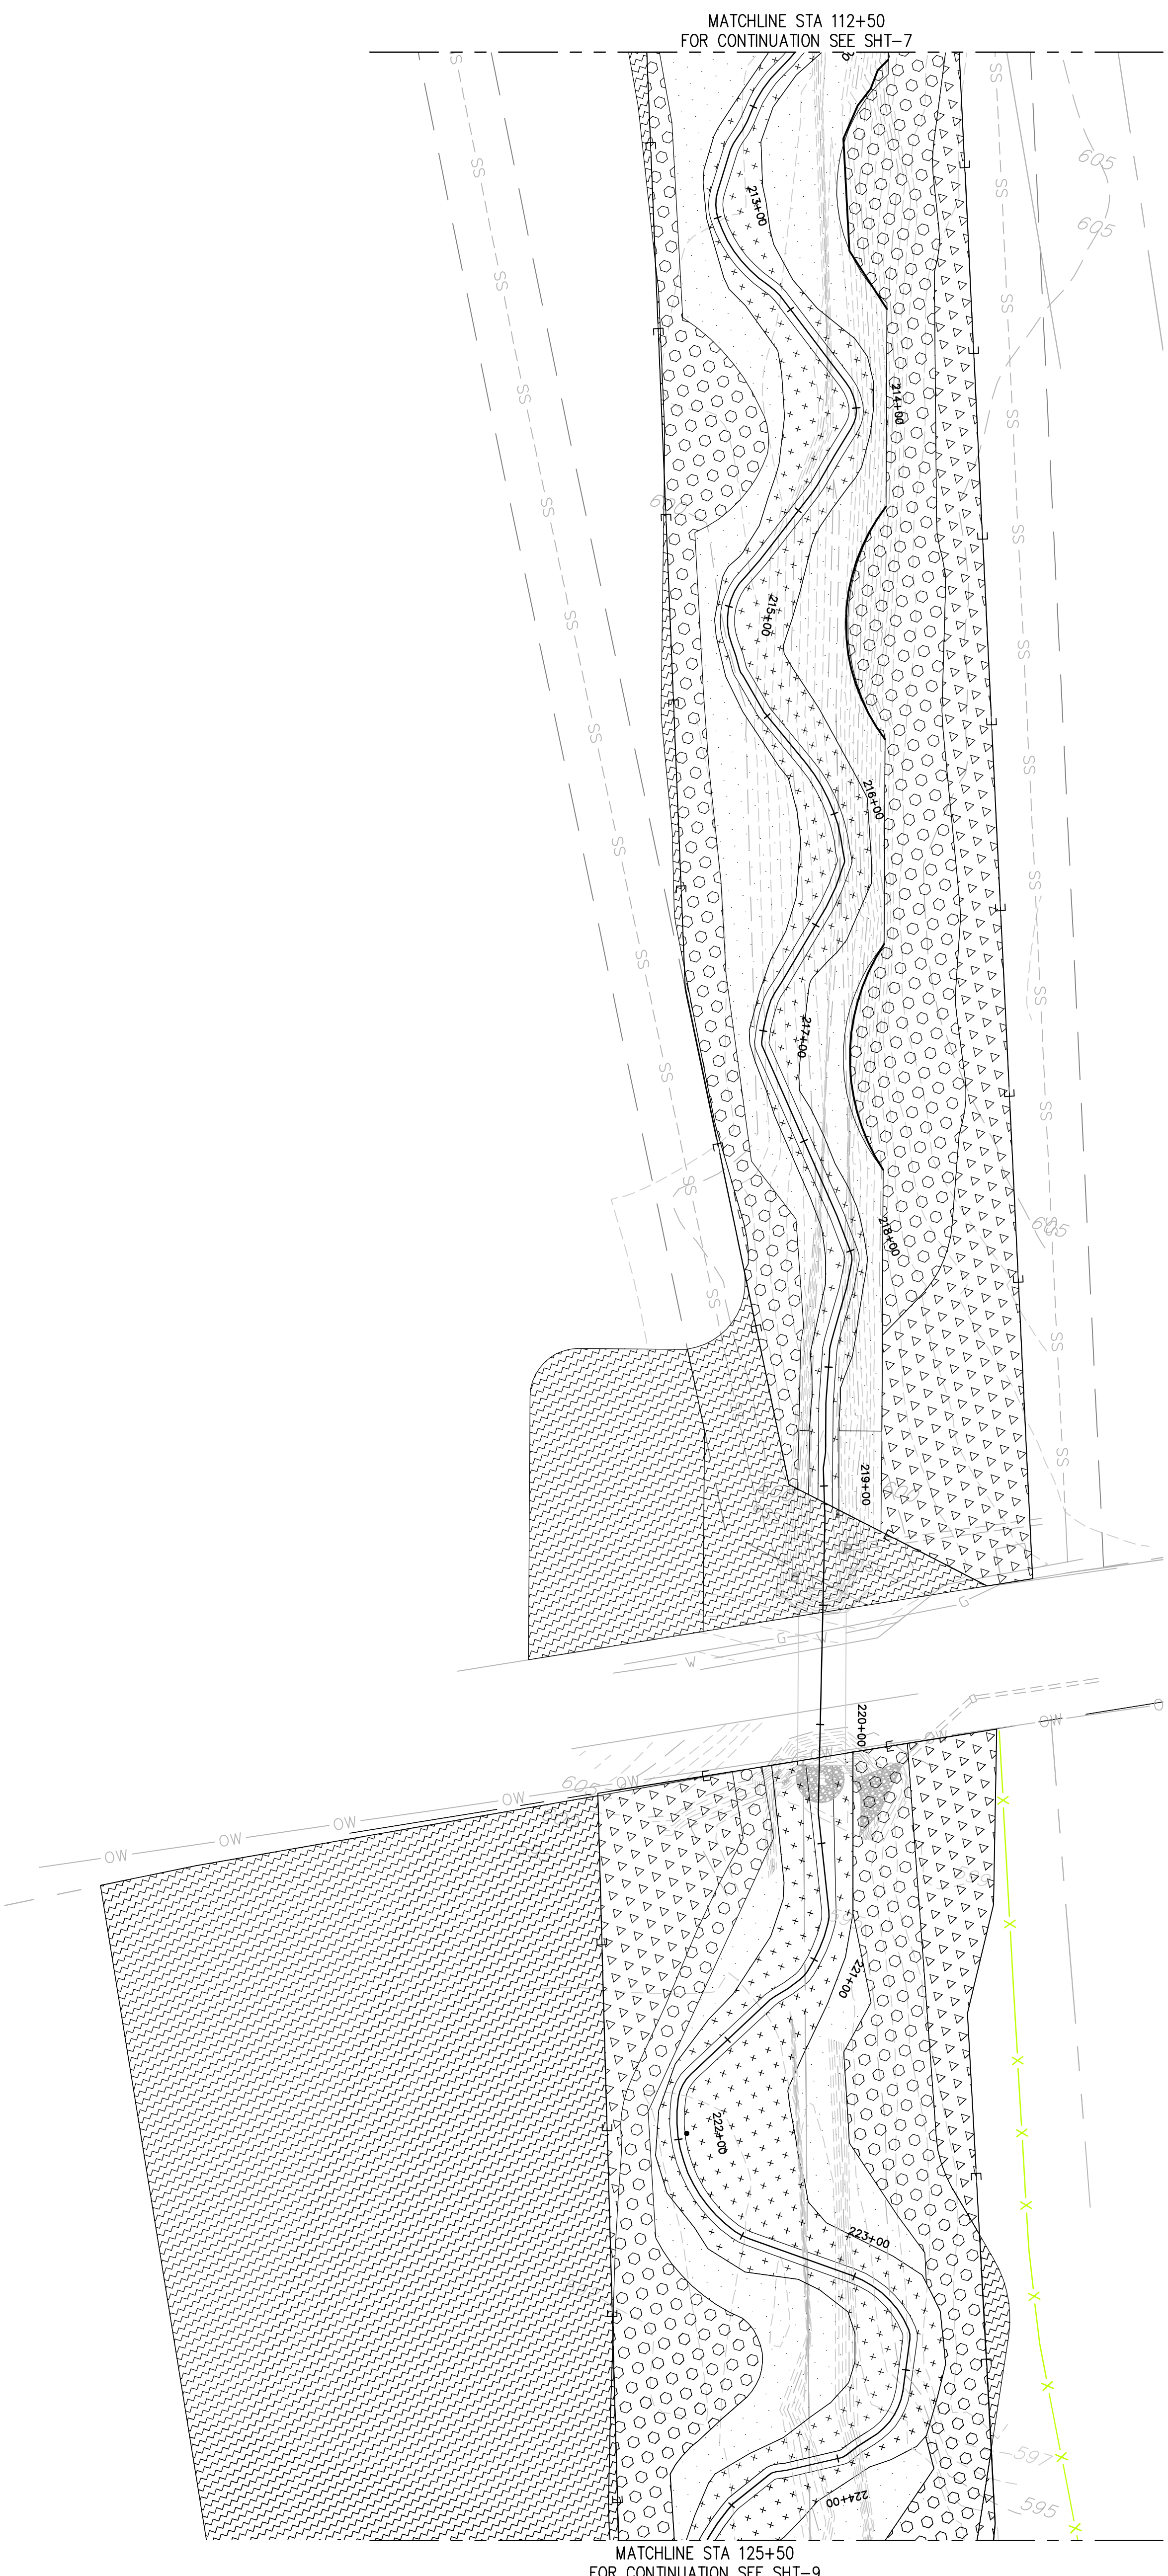
TITLE: **PLANTING PLAN**

LEGEND	
	ZONE 1 - STREAM BANK
	ZONE 2 - RIPARIAN/BANKFULL BENCH
	ZONE 3 - TRANSITIONAL
	ZONE 4 - UPLAND
	ZONE 5 - OUTSIDE OF EASEMENT

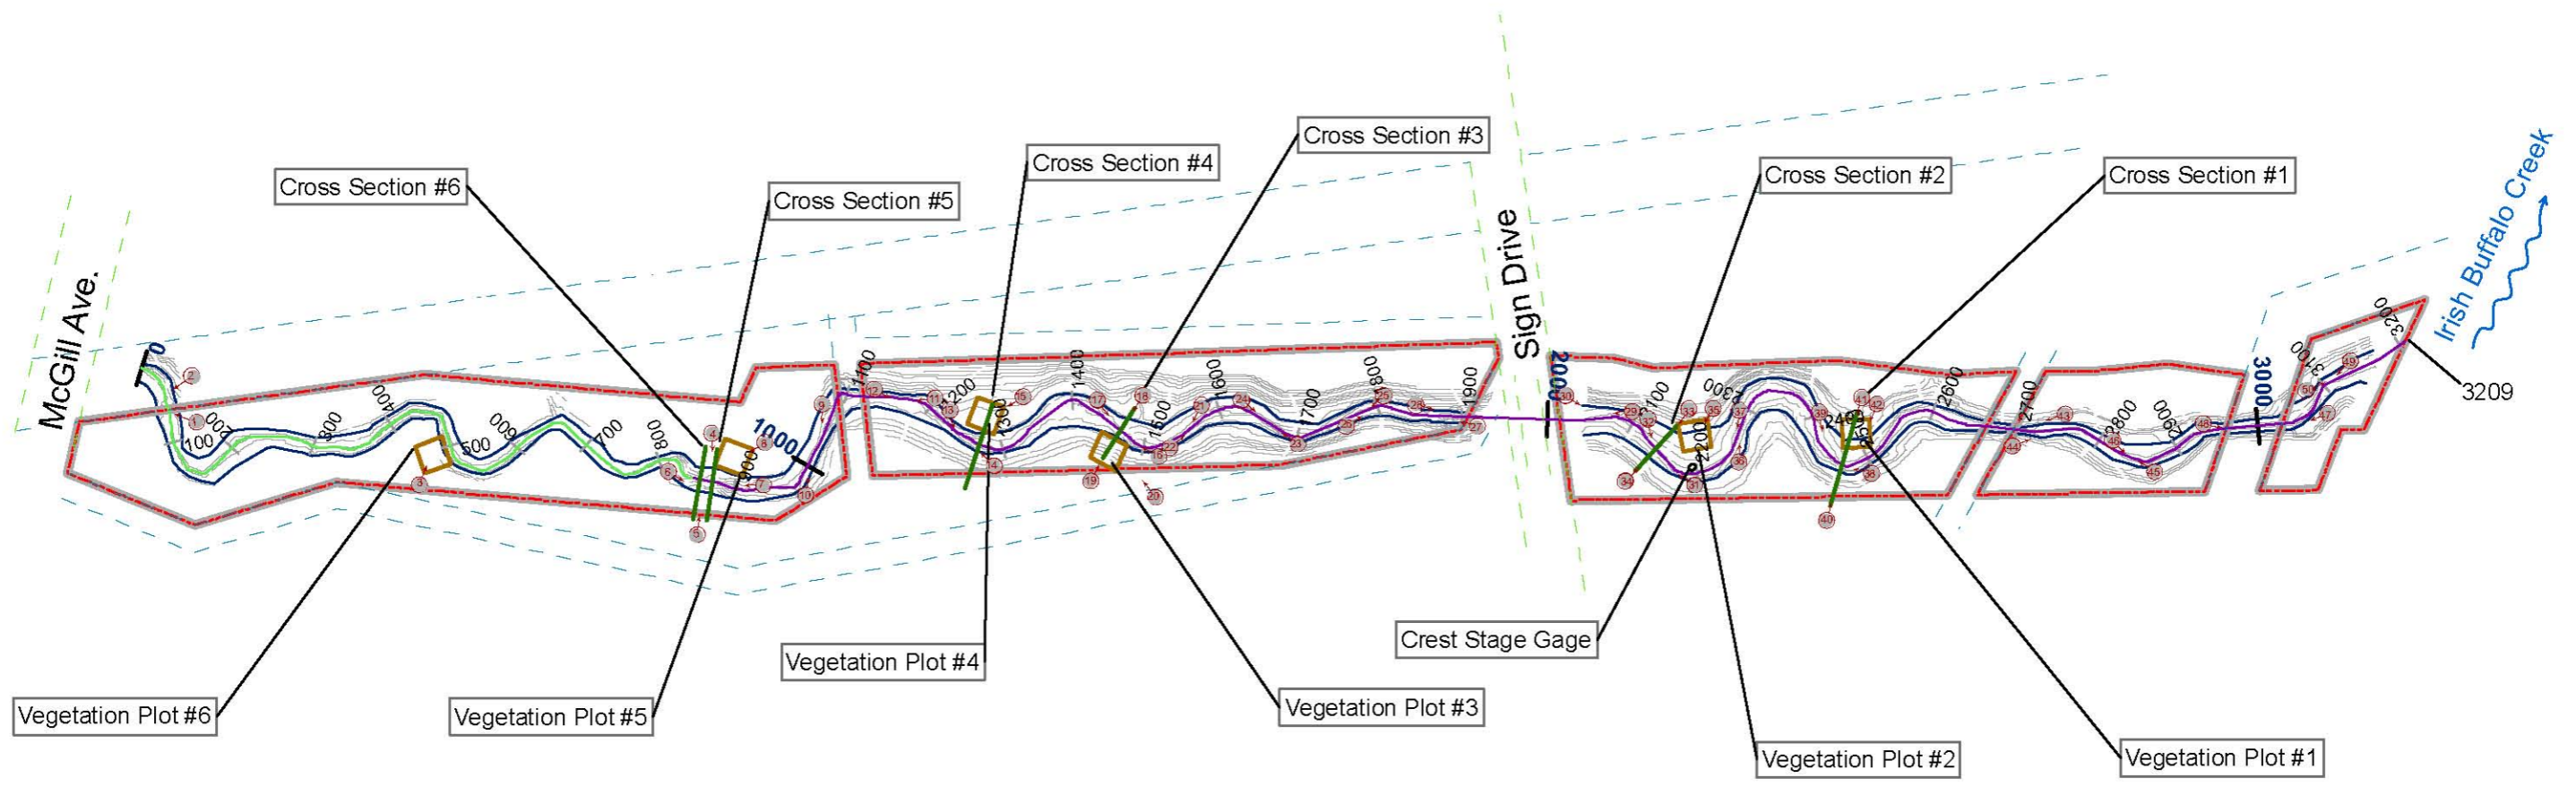
Title Stricker Branch Monitoring Map			
Prepared For: Mid-Atlantic Mitigation, LLC.	Project	Stricker Branch Stream Restoration Cabarrus County, North Carolina	
	Date	3/11/08	KHA Project Number 018285002
			Figure 1

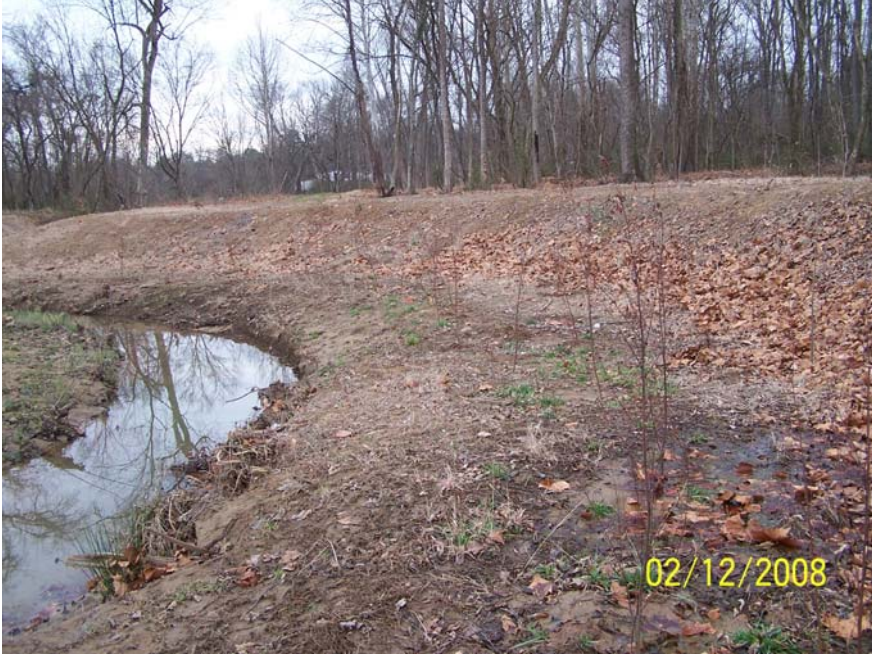
Photo Point 31 – Root Wads at Station 222+00 facing downstream, from right bank

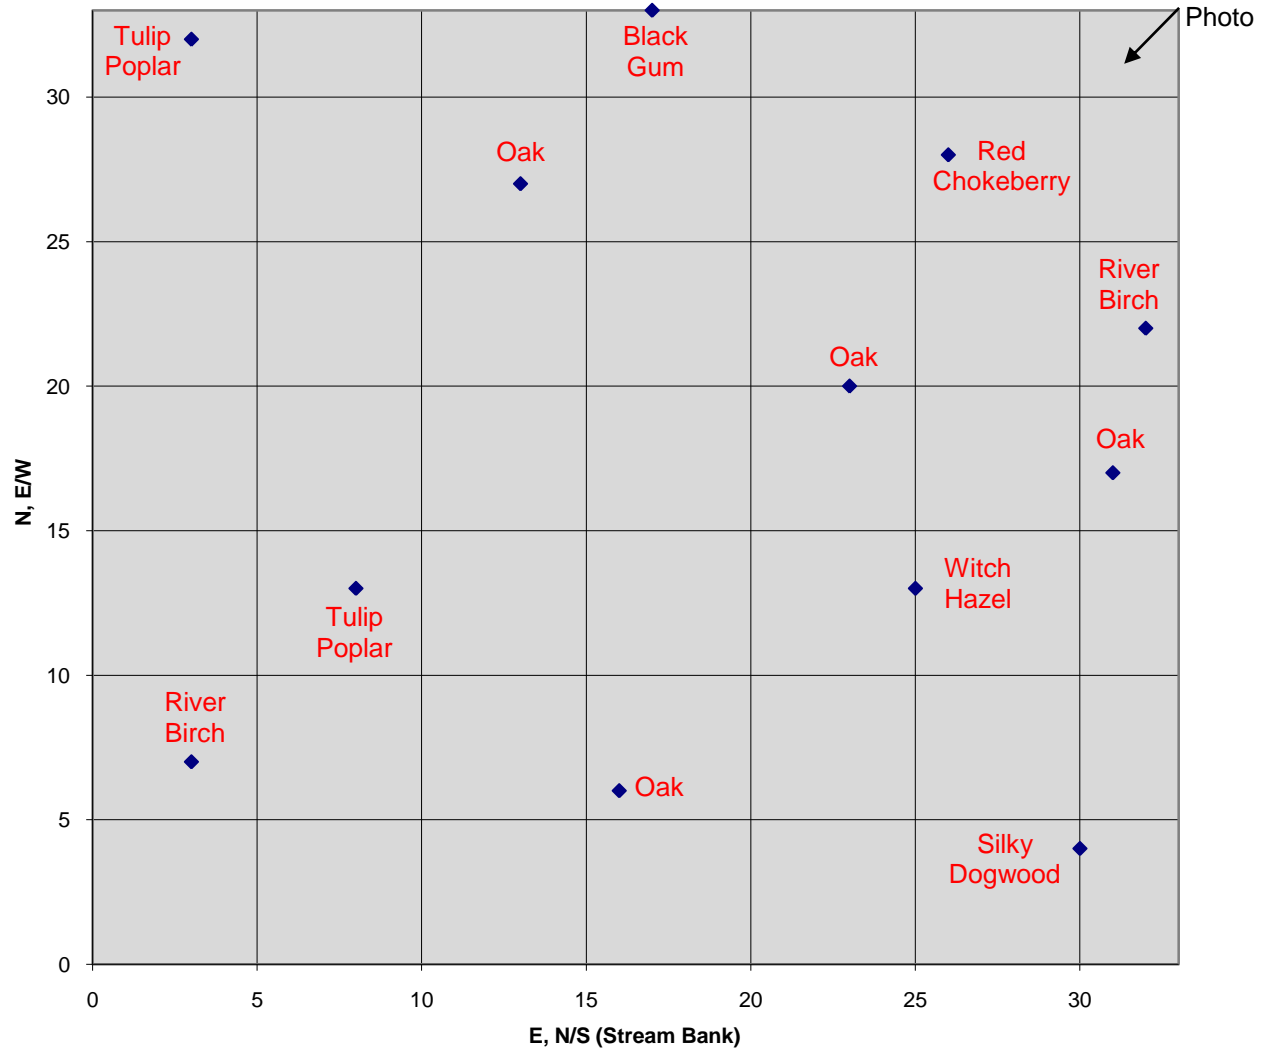
VP 1

X	Y	Species	Comments
	3	7 River Birch	
	3	32 Tulip Poplar	
	8	13 Tulip Poplar	
	13	27 Oak Sp.	
	16	6 Oak Sp.	
	17	33 Black Gum	
	23	20 Oak Sp.	
	25	13 Witch Hazel	
	26	28 Red Choke Berry	
	30	4 Silky Dogwood	
	31	17 Oak Sp.	
	32	22 River Birch	
		<hr/>	
		12 stems	
<hr/>	12 =		
1089		<div style="border: 1px solid black; padding: 2px; display: inline-block;">480</div>	43560

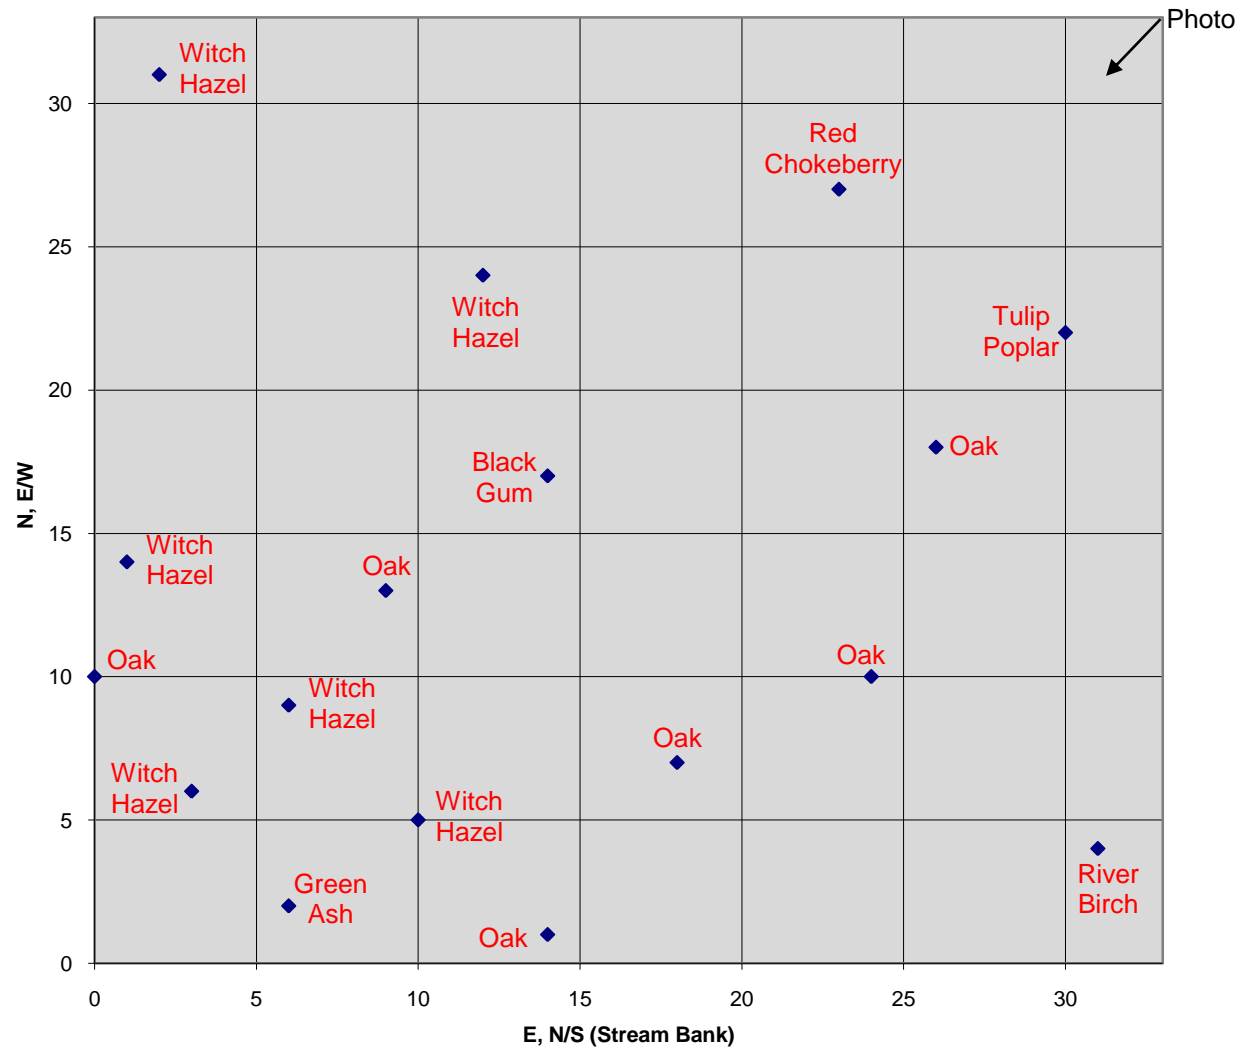
VP 2

X	Y	Species	Comments
	0	10 Oak Sp.	
	1	14 Witch Hazel	
	2	31 Witch Hazel	
	3	6 Witch Hazel	
	6	9 Witch Hazel	
	6	2 Green Ash	
	9	13 Oak Sp.	
	10	5 Witch Hazel	
	12	24 Witch Hazel	
	14	17 Black Gum	
	14	1 Oak Sp.	
	18	7 Oak Sp.	
	23	27 Red Chokeberry	
	24	10 Oak Sp.	
	26	18 Oak Sp.	
	30	22 Tulip Poplar	
	31	4 River Birch	
		<hr/> 17 stems	
	17 =	680	
<hr/>	1089		43560
