Tarlton Stream and Wetland Restoration Project

Contract #: D05013-1
County: Cumberland
Cataloging Unit: Cape Fear 03030004
Monitoring Firm POC: Mid-Atlantic Mitigation, LLC
Rich Mogensen (704) 782-4133
Kimley-Horn Associates, Inc.
Will Wilhelm (704) 333-5131
Prepared For: EEP Project Manager, Guy Pearce

Mitigation Report

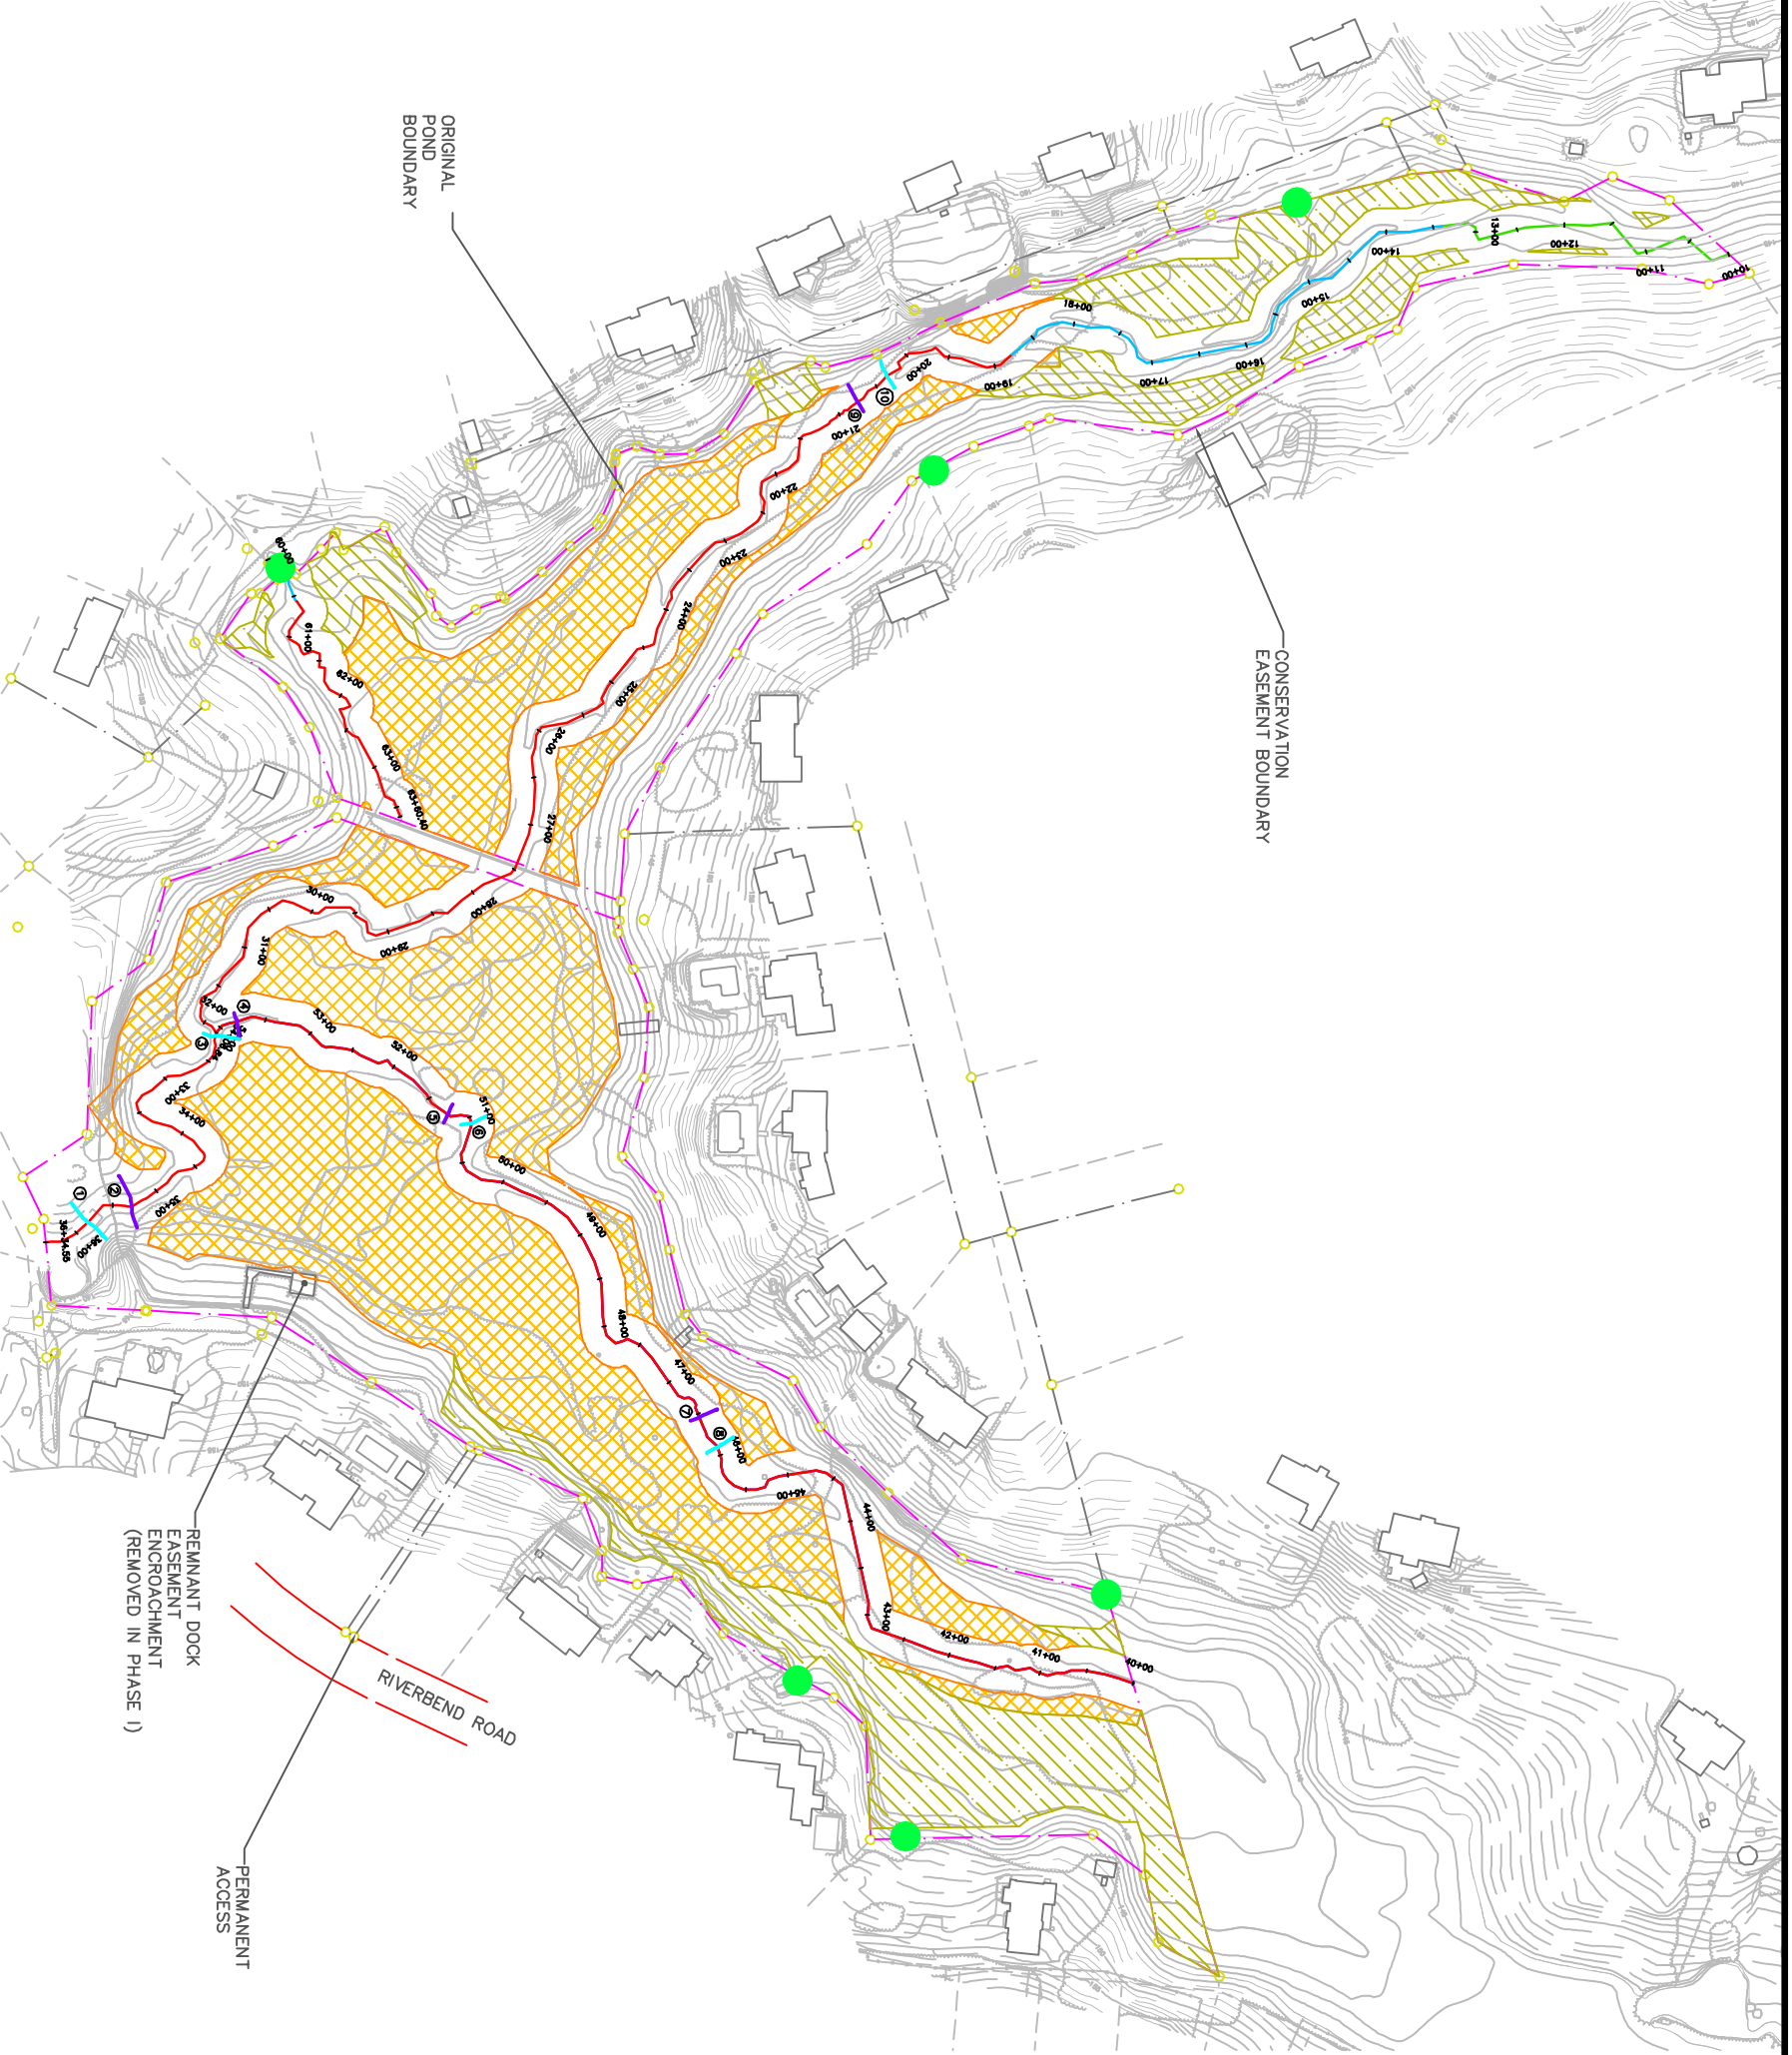
MITIGATION SUMMARY					
MITIGATION TYPE	RESTORATION LENGTH (FEET)	ENHANCEMENT LENGTH (FEET)	PRESERVATION LENGTH (FEET)	TOTAL MILES	% RESTORATION
STREAM	3,221	826	295		
	AS-BUILT LENGTH (FEET)	3,465	596	341	
	MITIGATION UNITS	3,465	397	68	3,930
	PRE-EXISTING LENGTH (FEET)	6.8	2.4	-	
	AS-BUILT AREA (ACRES)	6.6	2.7	-	
RIVERINE WETLAND	MITIGATION UNITS	6.6	1.4	-	8.0
					83%

SITE LEGEND	
	MAJOR CONTOUR
	MINOR CONTOUR
	PROPERTY BOUNDARY
	WETLAND ENHANCEMENT
	WETLAND RESTORATION
	STREAM RESTORATION
	STREAM ENHANCEMENT
	STREAM PRESERVATION
	STABLE PIPE OUTFALL
	PERMANENT CROSS SECTIONS
	RIFLE
	POOL

The total area of restored riverine wetland is 6.6 acres, and the total area of enhanced riverine wetland is 2.7 acres. The Tarlton Site yields 3,930 stream mitigation units and 8 riverine wetland mitigation units. The goals and objectives of the Tarlton Stream and Wetland Restoration Project are to restore a naturally stable stream and riparian wetland community; to restore a bottomland hardwood wetland community; and to provide stormwater management from residential run-off. In addition, water quality will be improved, flood storage will be increased, wildlife and aquatic habitat will be restored and the threat of flooding of downstream areas will be eliminated. A Project Map is provided in Attachment B.
