AS-BUILT MITIGATION PLAN
THREE MILE CREEK RESTORATION SITE
AVERY COUNTY, NORTH CAROLINA
(Contract #16-D06125-A)

FULL DELIVERY PROJECT
TO PROVIDE STREAM AND WETLAND MITIGATION
IN THE FRENCH BROAD RIVER BASIN
CATALOGING UNIT 06010108

April 2009

**THREE MILE CREEK RESTORATION SITE
AS-BUILT MITIGATION PLAN
AVERY COUNTY**

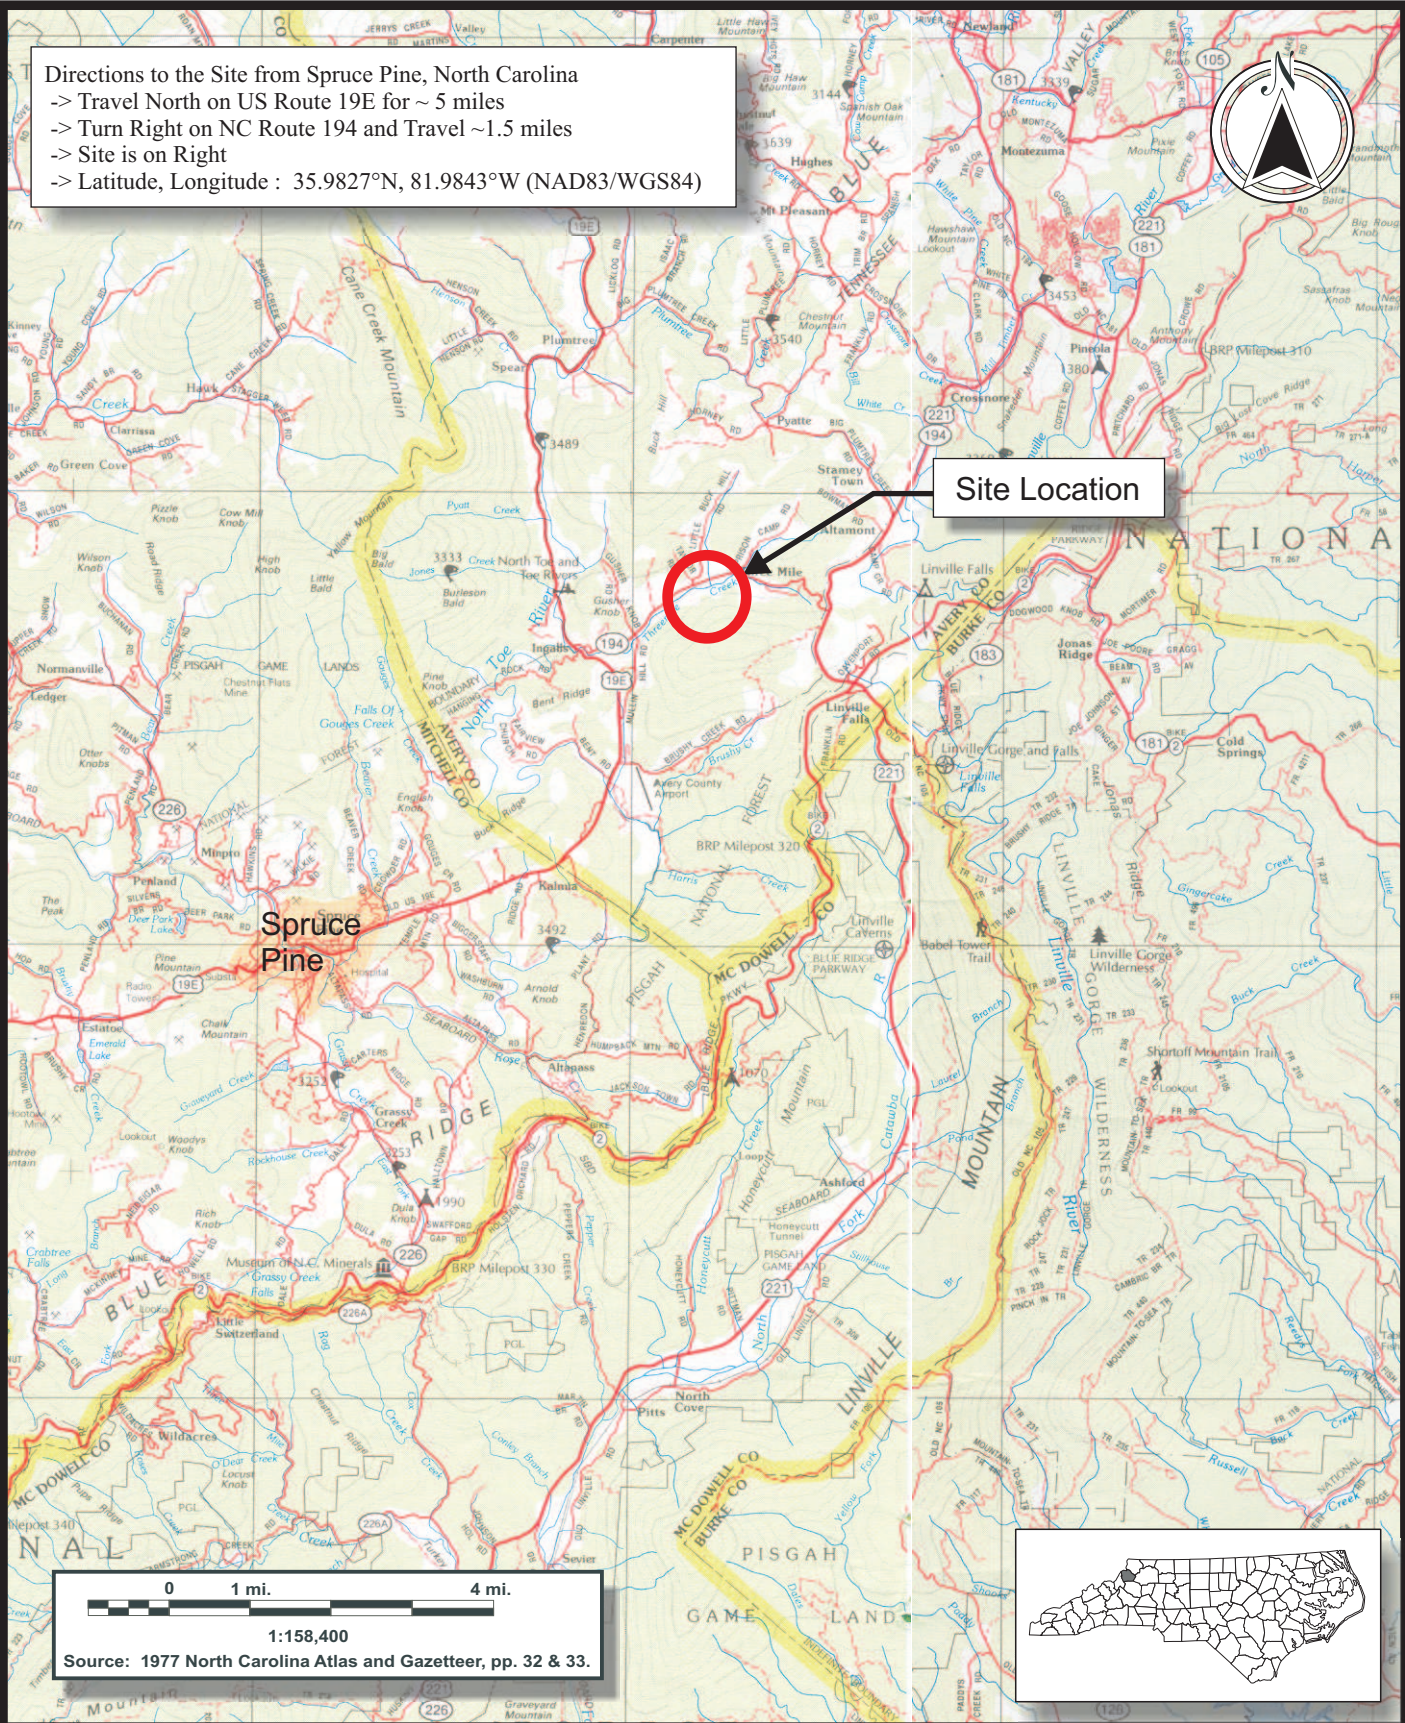
FIGURE
1

SITE LOCATION
THREE MILE CREEK RESTORATION SITE
 Avery County, North Carolina

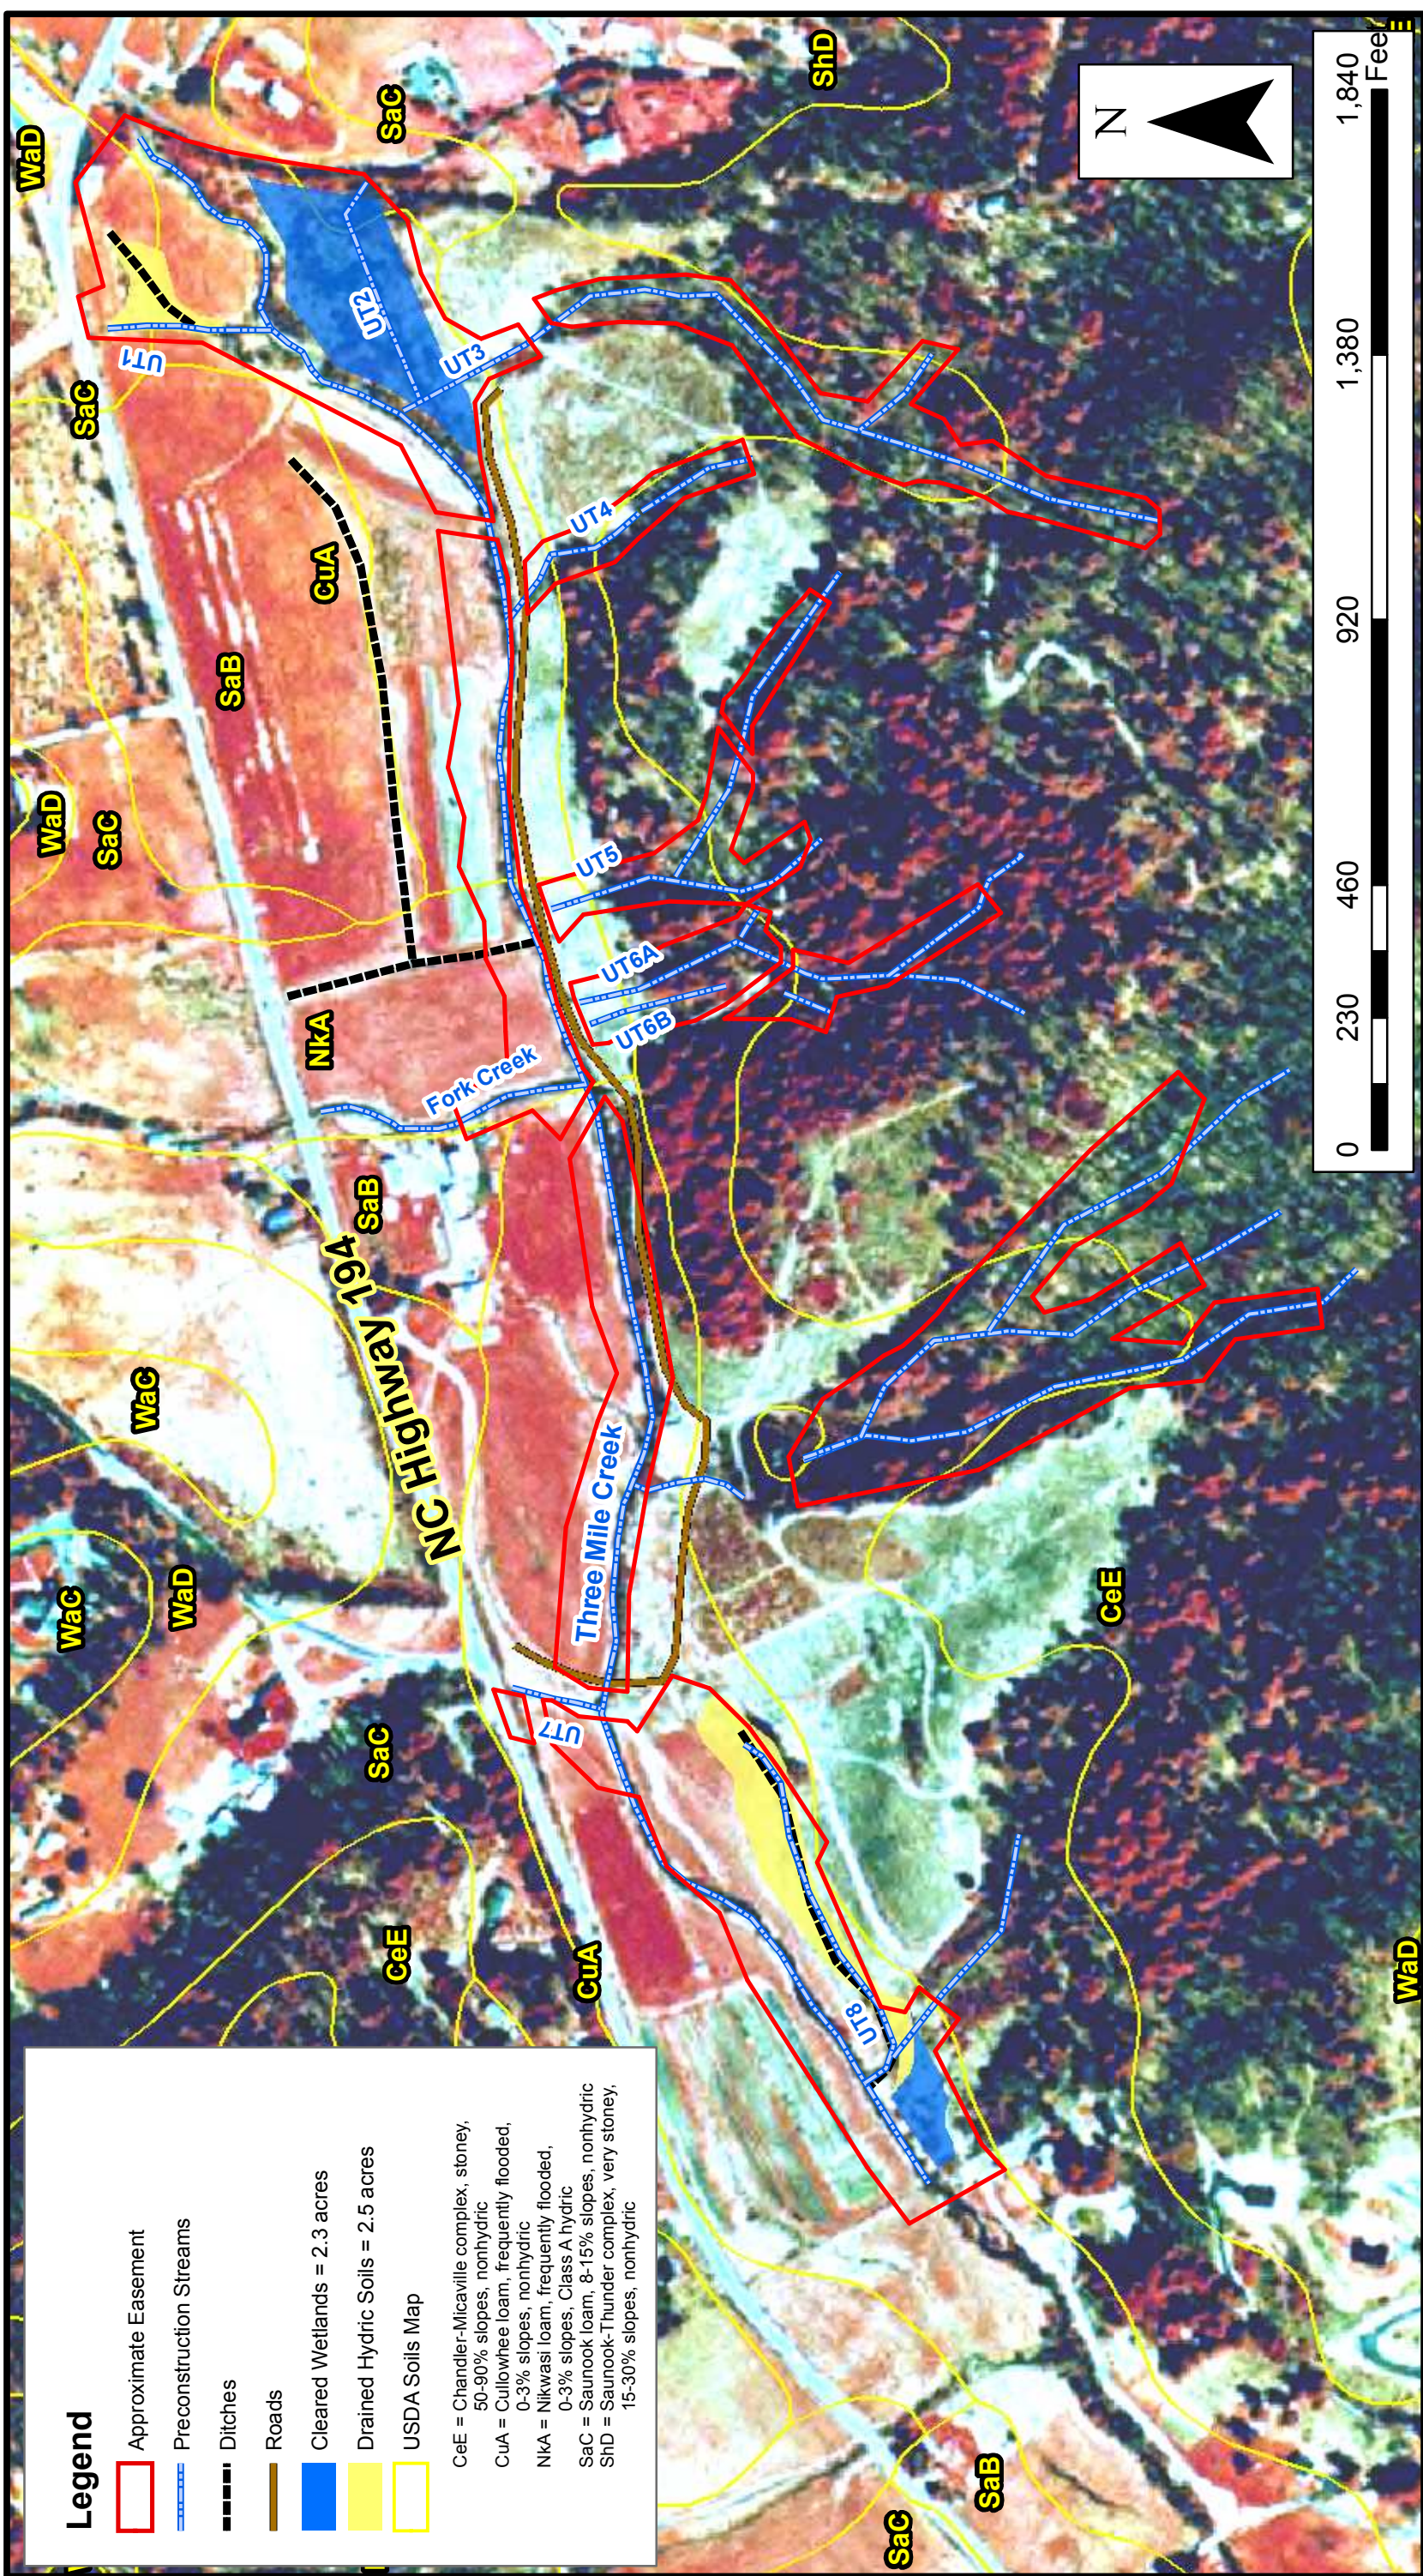
PRECONSTRUCTION CONDITIONS
THREE MILE CREEK RESTORATION SITE
 Avery County, North Carolina

Prior to construction, the project was characterized by agricultural land utilized for Christmas tree and ornamental landscape nursery plant production, timber harvest, and livestock grazing (Figure 2, Appendix A). Agricultural practices including the maintenance and removal of riparian vegetation and relocation, dredging, and straightening of onsite streams resulted in degraded water quality, unstable channel characteristics (stream entrenchment, erosion, and bank collapse), and reduced storage capacity and floodwater attenuation. In addition, hydric soils were disturbed due to regular plowing and vegetation maintenance, hoof shear from livestock, and the removal of groundwater hydrology inputs from the rerouting and straightening of Site tributaries.

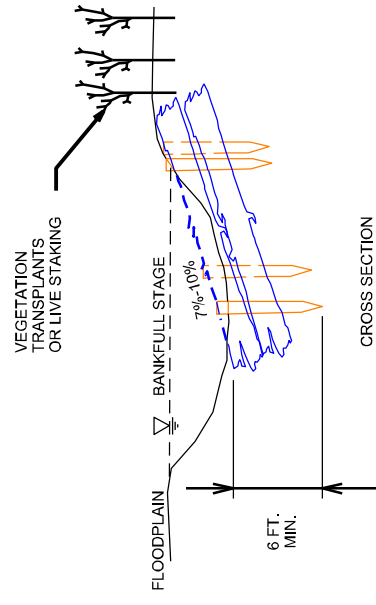
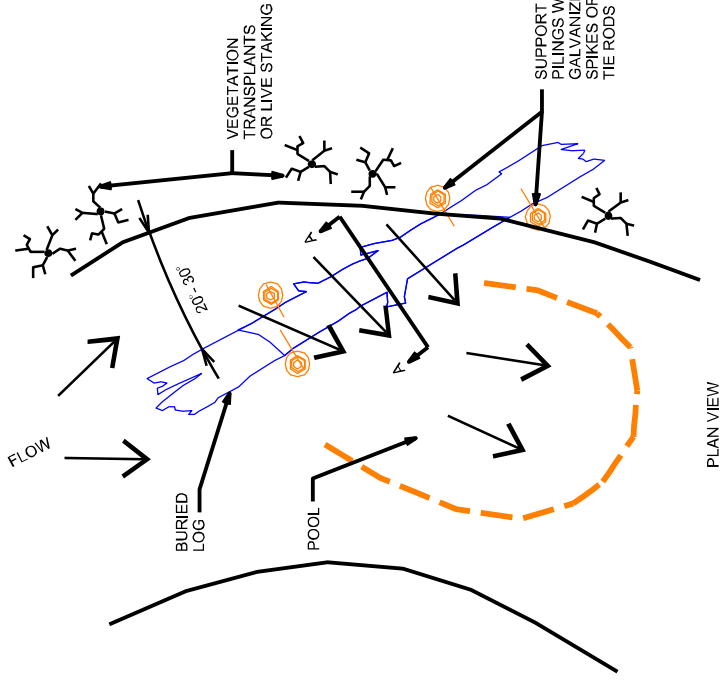
TYPICAL LOG VANE

- NOTES:
1. EXPOSED VANE OCCUPIES 1/3 OF THE BANKFULL WIDTH OF THE CHANNEL.
 2. SUPPORT PILINGS SHALL BE PENCIL SHARPENED, UNTREATED, PEELED, A MINIMUM OF 4 INCHES IN TOP DIAMETER, AND 8 FEET LONG.
 3. LOGS SHALL CONSIST OF NATIVE HARDWOOD SPECIES, RELATIVELY STRAIGHT WITH A MINIMUM DIAMETER OF 15 INCHES AND APPROXIMATELY 35 FEET IN LENGTH.
 4. USE FILTER FABRIC TO SEAL GAPS BETWEEN LOGS.

- CLOSE-UP OF SUPPORT PILING
- SUPPORT PILING SHOULD BE CUT SLIGHTLY BELOW THE TOP LOG
 - AFTER PLACING LOGS, DRIVE REBAR THROUGH LOGS AND BEND ENDS.
 - REBAR MAY BE REPLACED WITH LAG BOLT WITH APPROVAL OF THE ENGINEER.

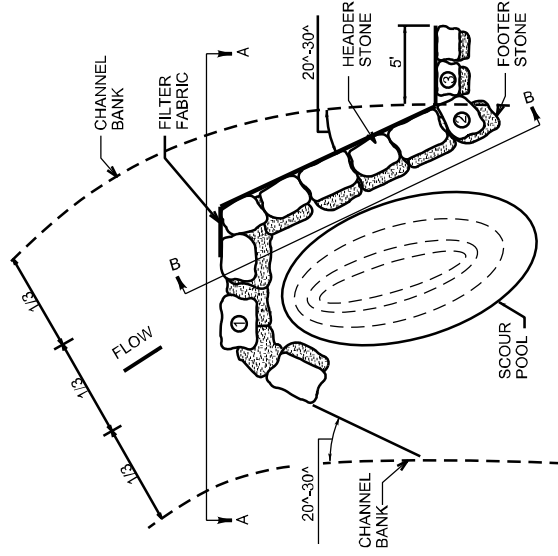
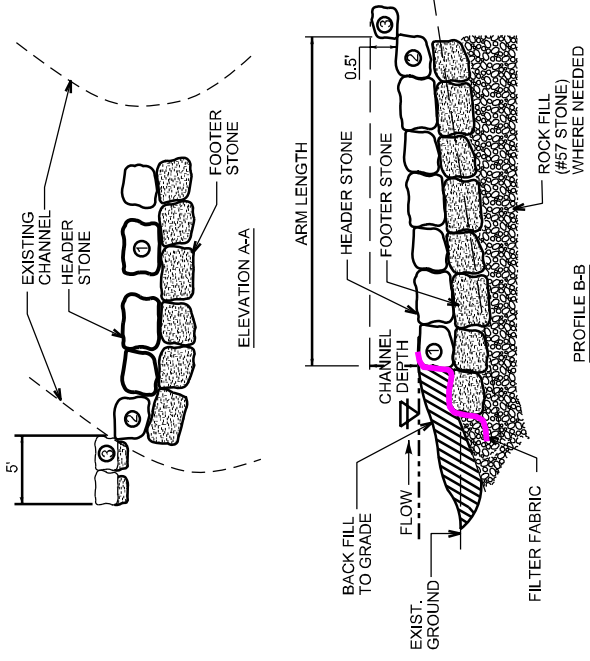
TYPICAL J-HOOK VANE

NOTE: HEADER AND FOOTER STONES ARE LARGE, ANGULAR BOULDERS MEASURING A MINIMUM OF 32" ALONG THE SHORTEST DIMENSION.

PLAN VIEW

REACH	ARM LENGTH (FT.)	CHANNEL DEPTH (FT.)
MAIN CHANNEL	20.0	2.1 - 2.5
FORK CREEK	15.0	1.8
TRIBUTARIES	8.0	0.4 - 0.8

PROFILE B-B

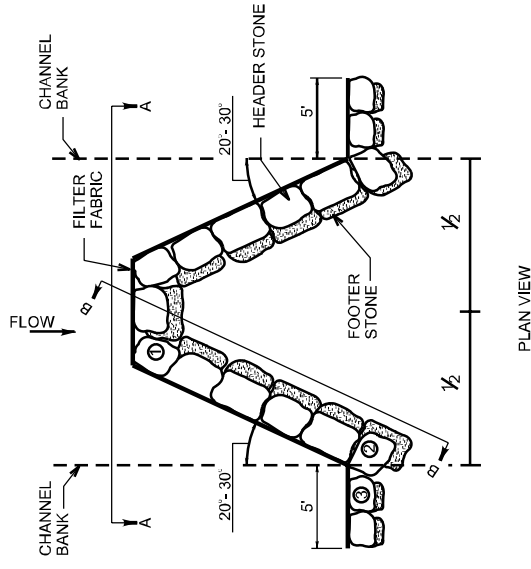
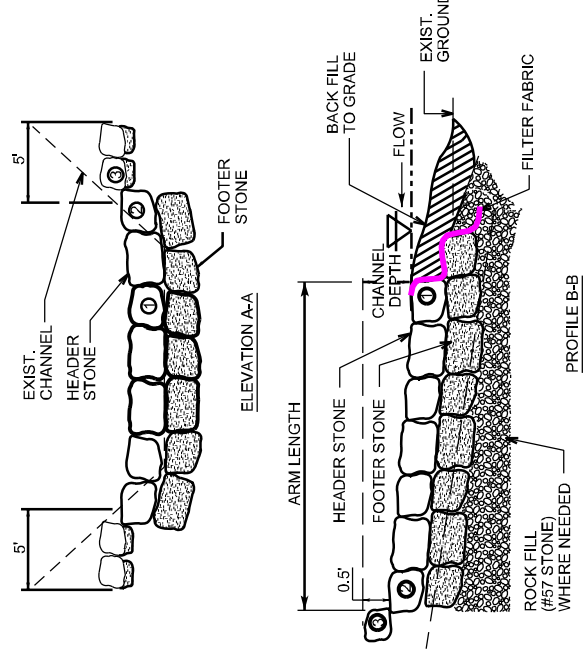
TYPICAL CROSS-VANE

NOTE: HEADER AND FOOTER STONES ARE LARGE, ANGULAR BOULDERS MEASURING A MINIMUM OF 32" ALONG THE SHORTEST DIMENSION.

PLAN VIEW

PROFILE B-B

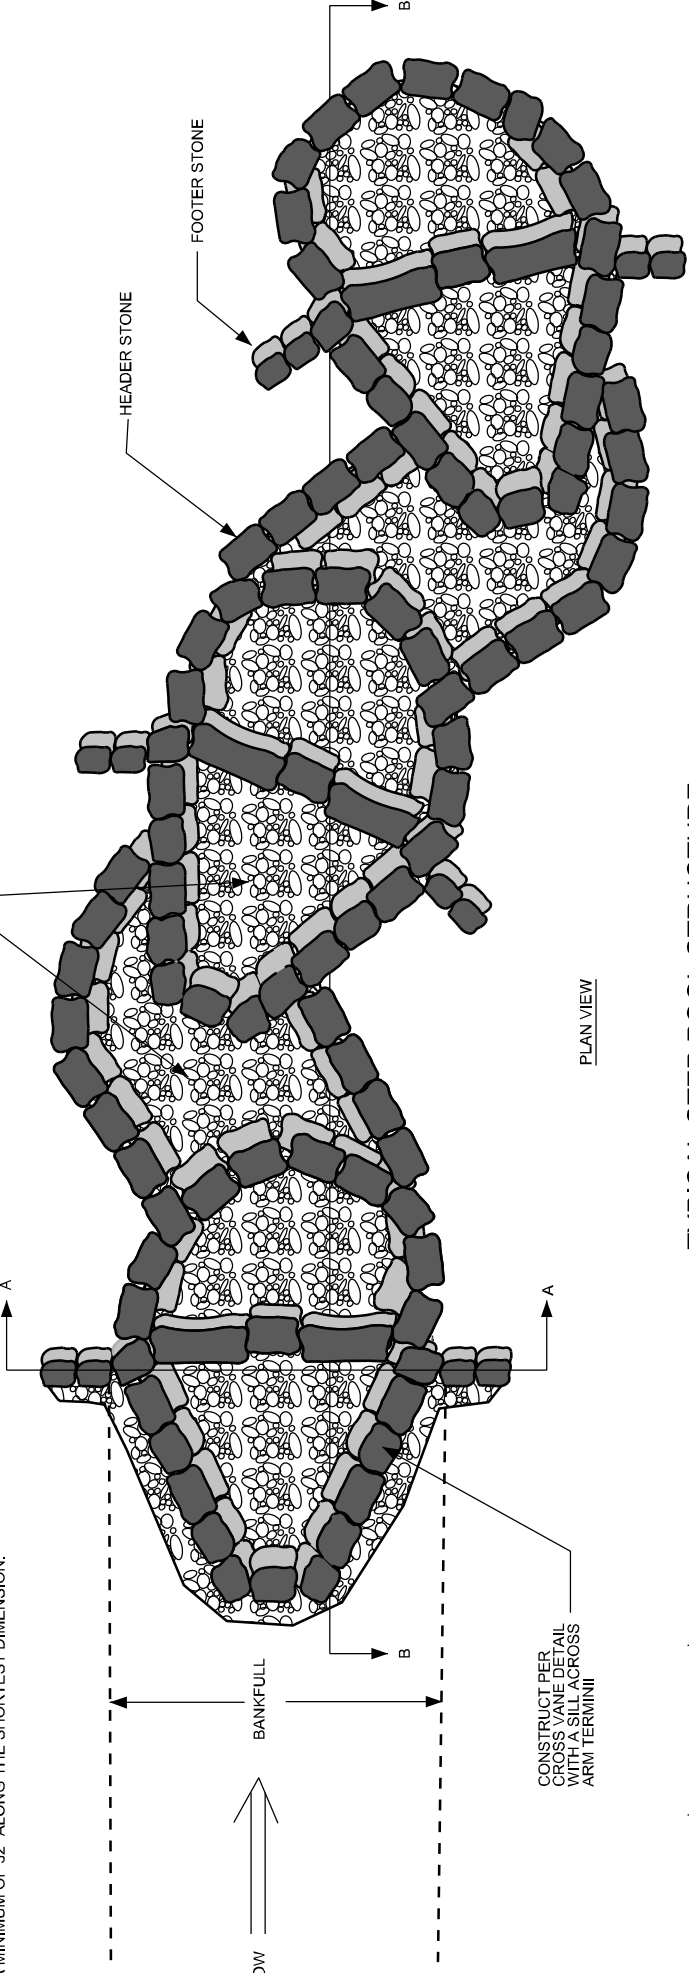
TYPICAL STEP POOL STRUCTURE

FILL SCOULL HOLE TO MINIMUM DEPTH
 6 INCHES CLASS 1 STONE
 ON TOP OF FILTER FABRIC

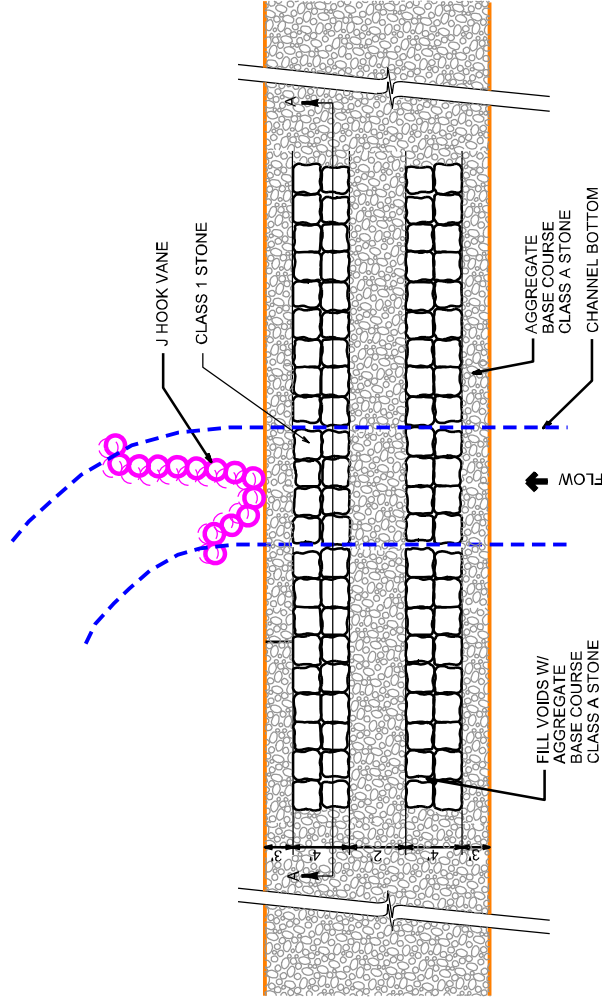
PERMANENT CHANNEL FORD DETAIL

- NOTES:
- KEEP FORD CROSS FALL WITHIN 1-2% OF STREAM GRADIENT.
 - FILL VOIDS BETWEEN CLASS 1 STONE WITH AGGREGATE BASE COURSE CLASS A TO CREATE DRIVEABLE SURFACE.

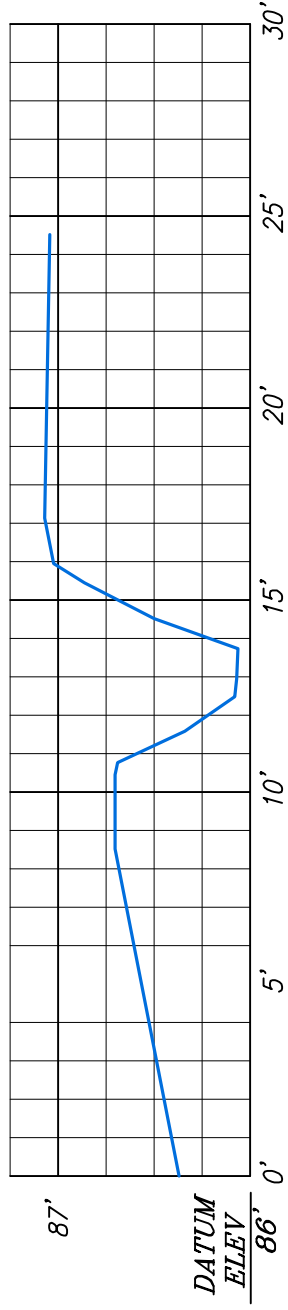
CROSS-SECTION 1R
(EAST BANK TO WEST BANK)
SCALE: 1" = 5' HORZ./1" = 1' VERT.

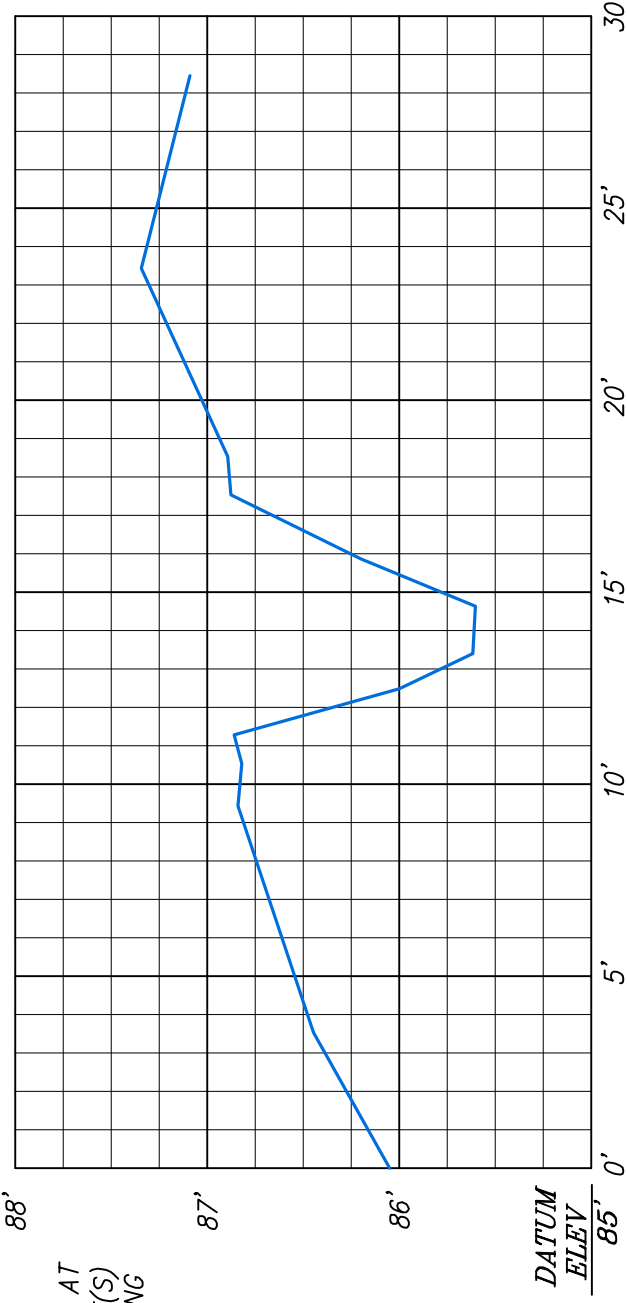
CROSS-SECTION 2P
(EAST BANK TO WEST BANK)
SCALE: 1" = 5' HORZ./1" = 1' VERT.

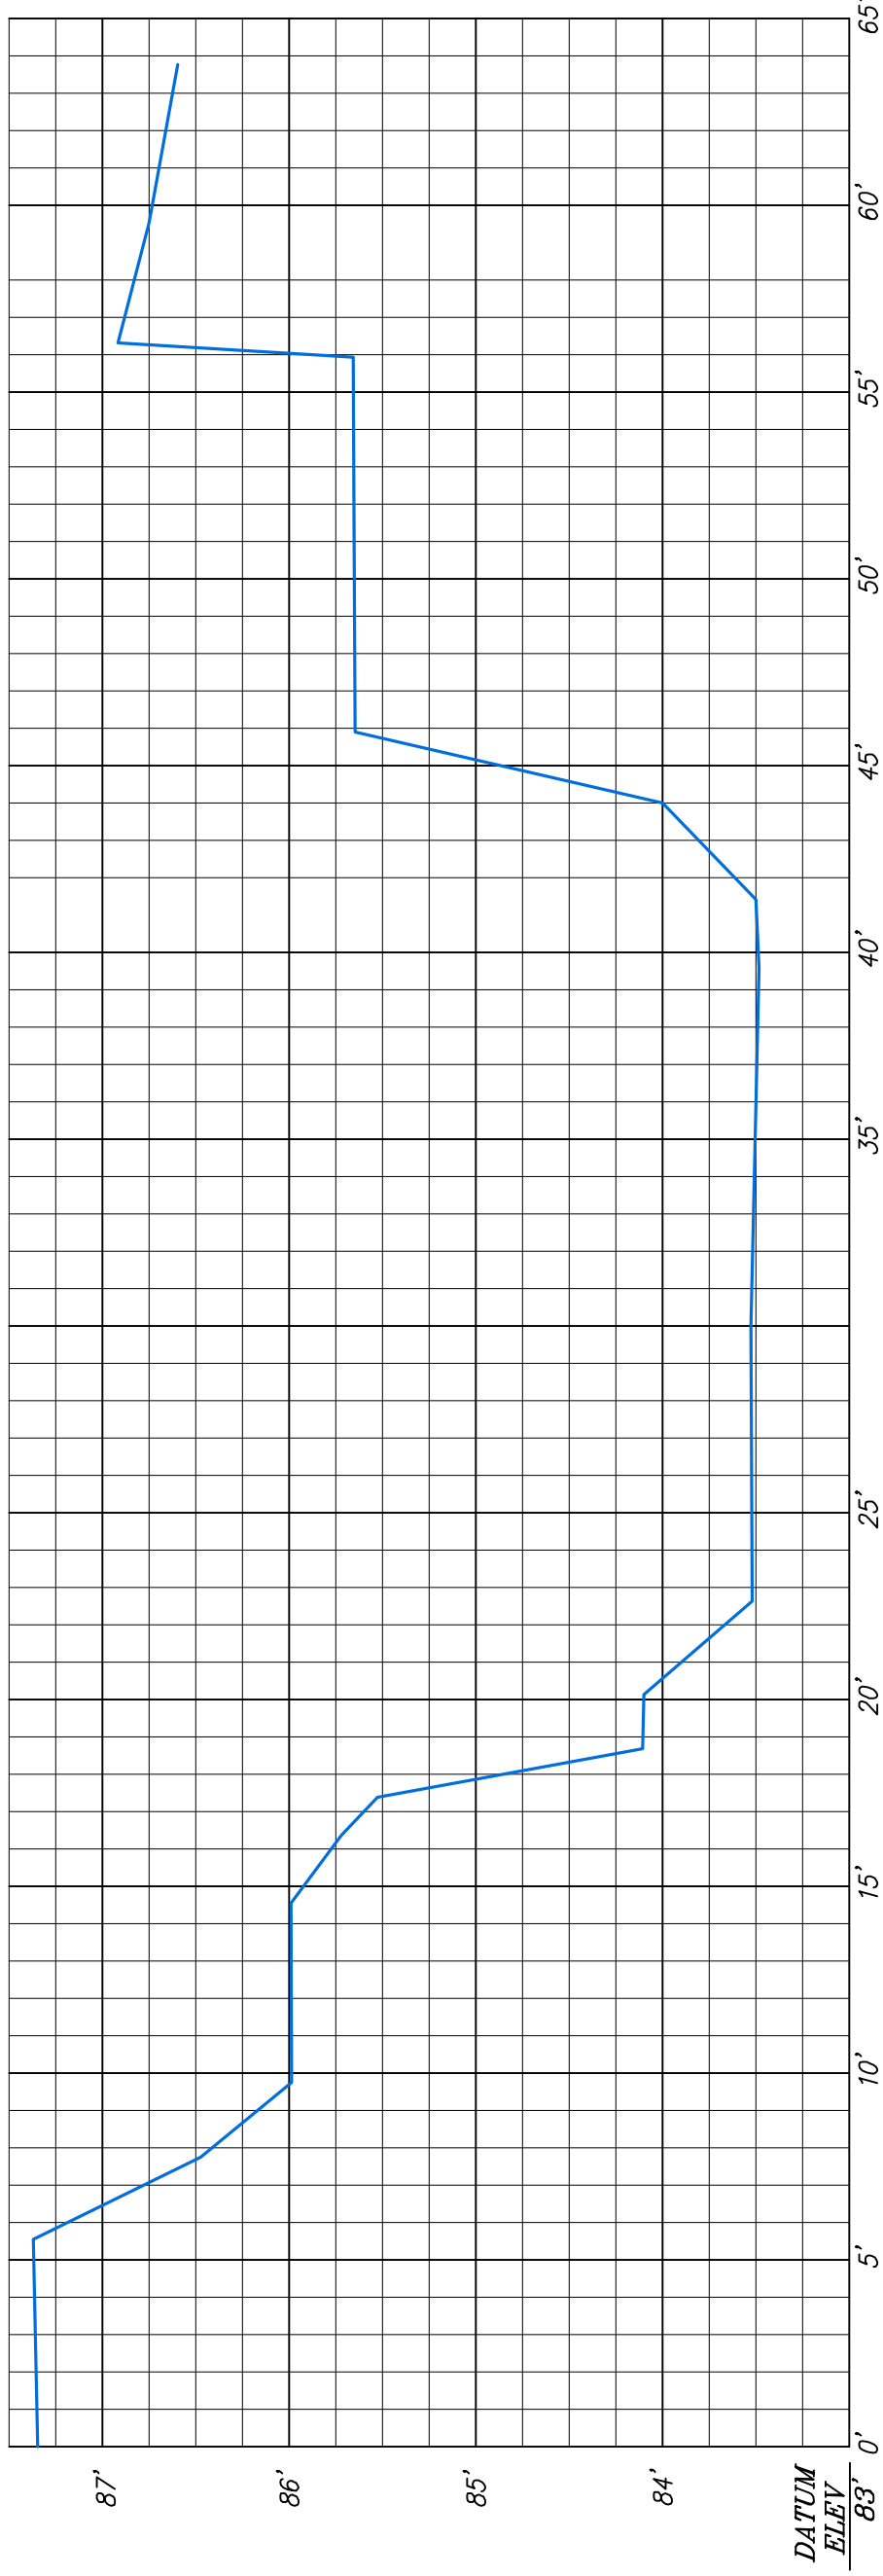
CROSS-SECTION 3R
(EAST BANK TO WEST BANK)
SCALE: 1" = 5' HORZ./1" = 1' VERT.

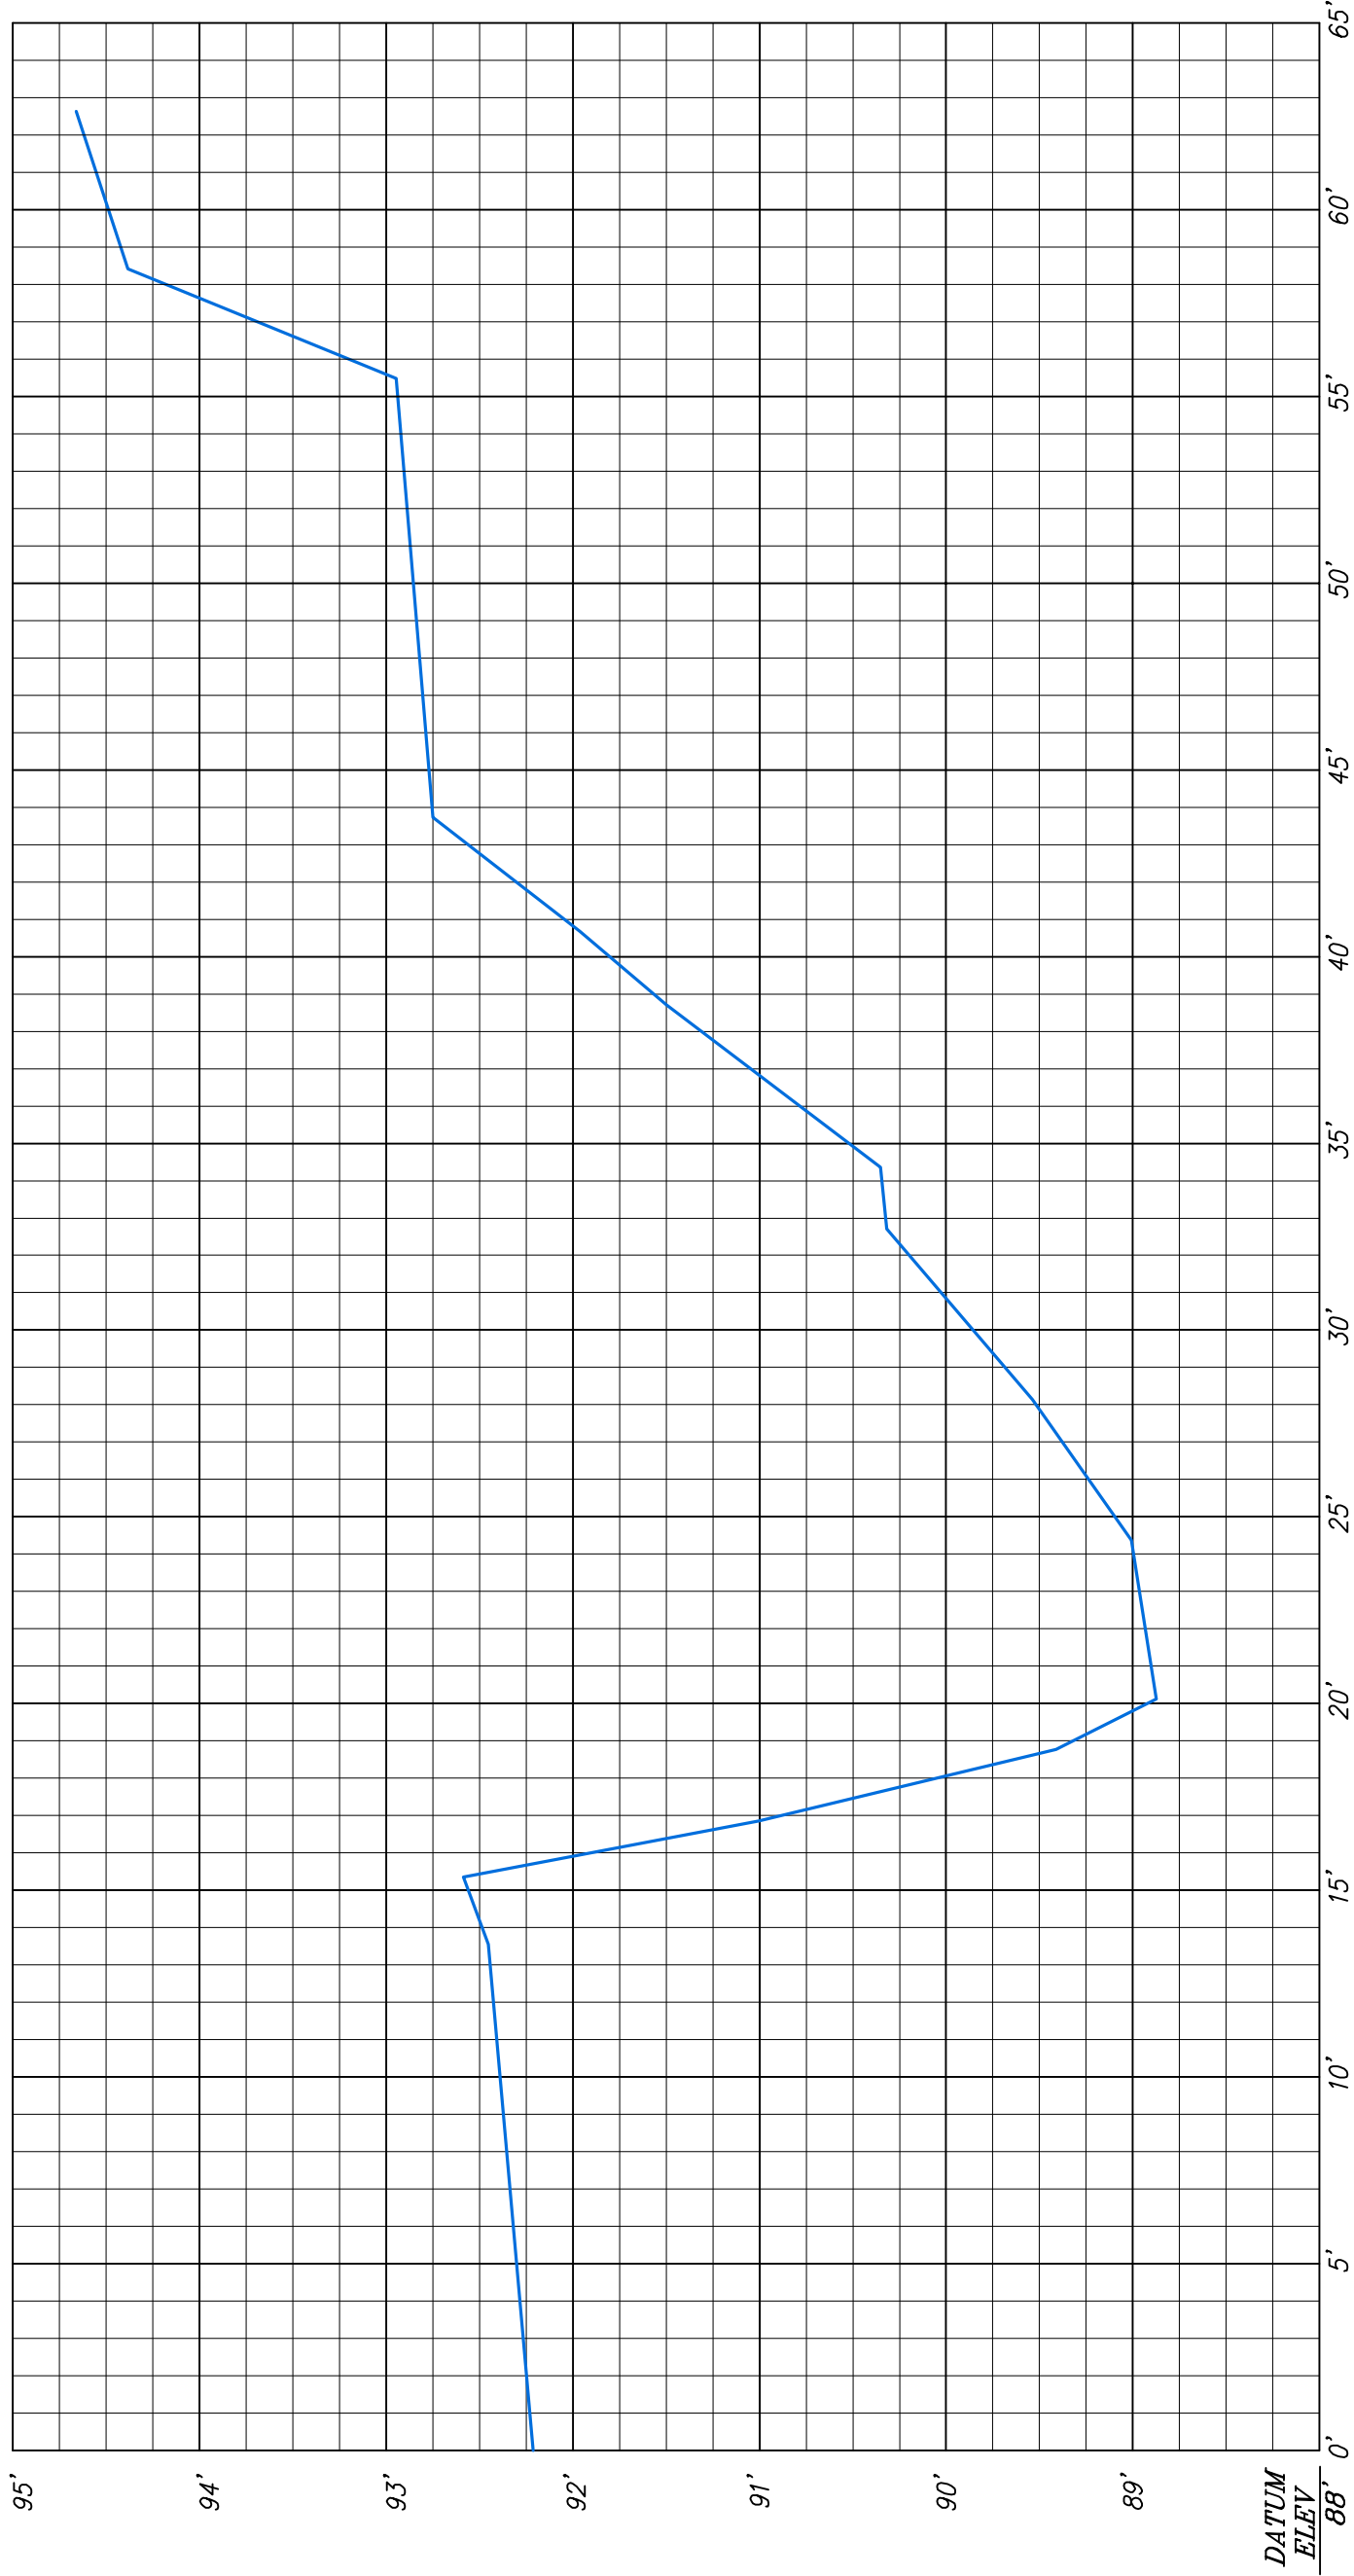
CROSS-SECTION 4P
 (EAST BANK TO WEST BANK)
 SCALE: 1"=5' HORZ./1"=1' VERT.

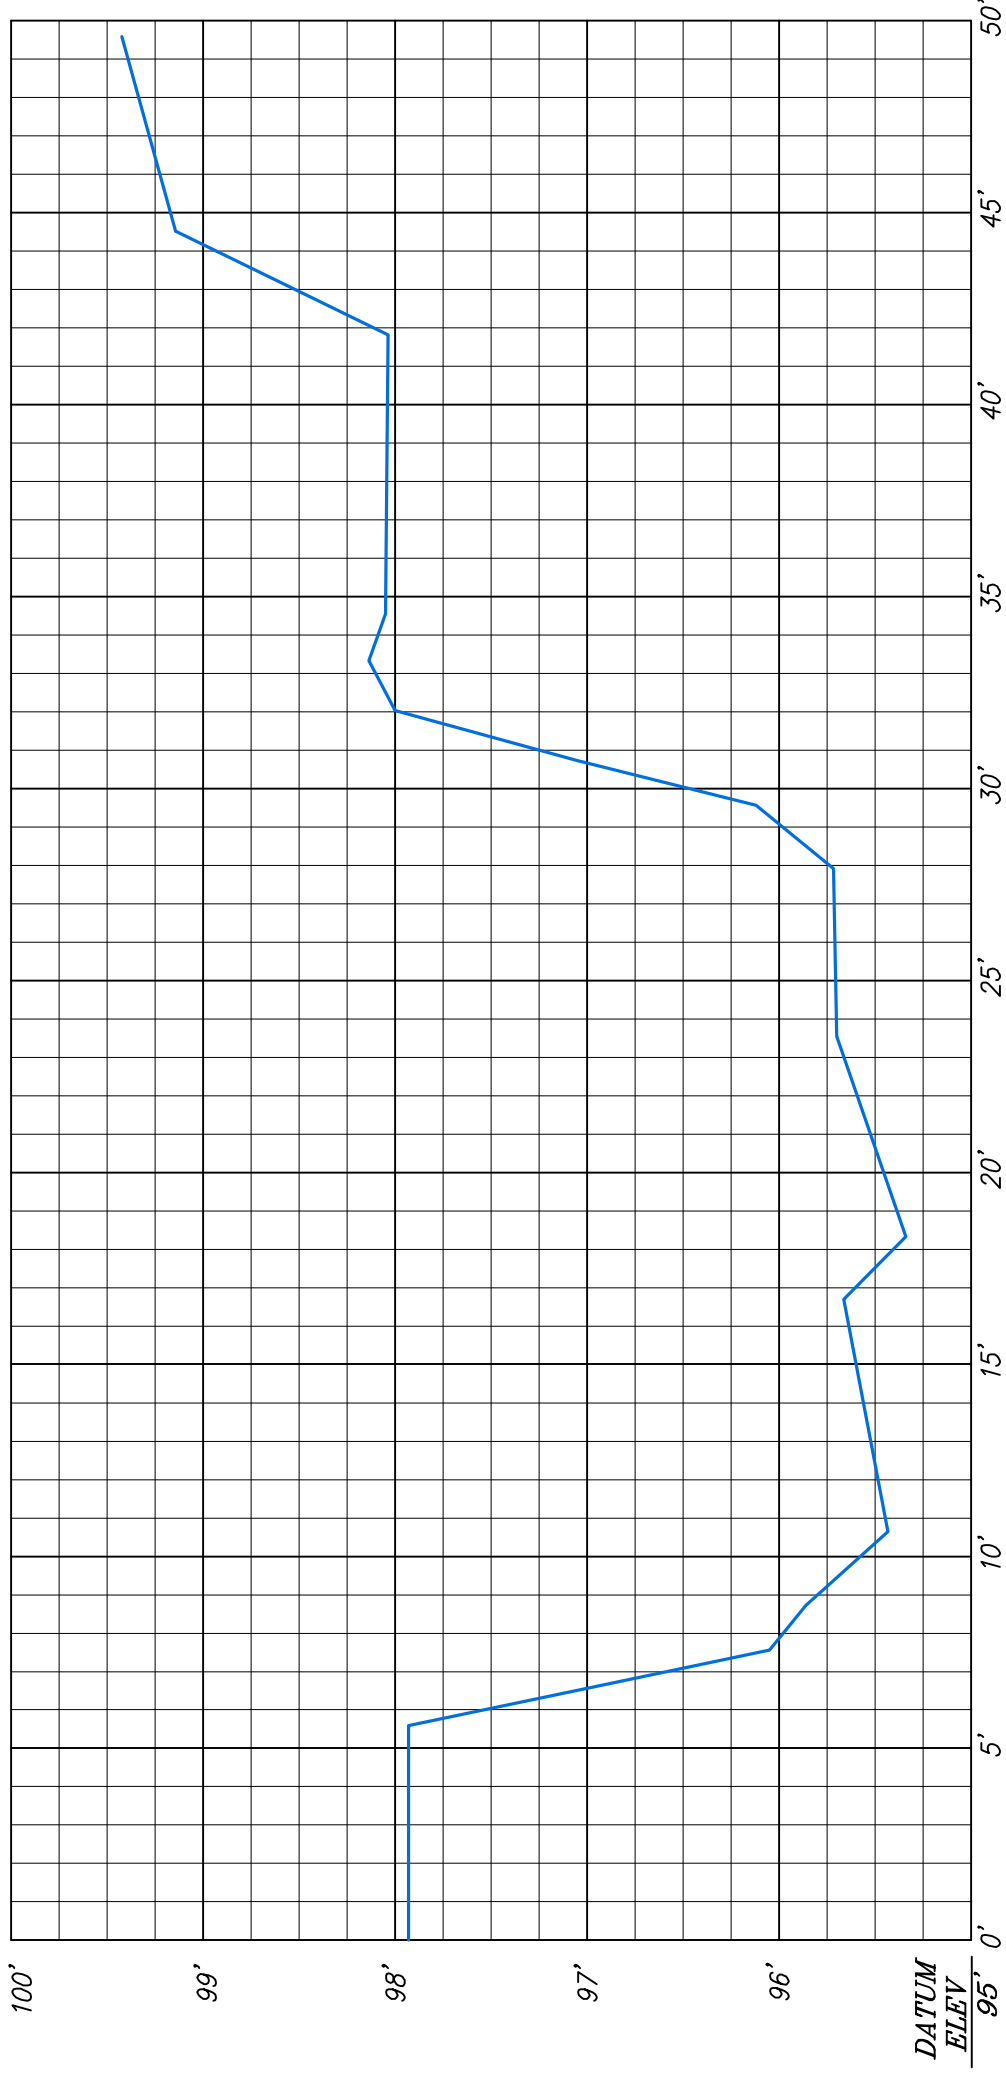
CROSS-SECTION 5R
(EAST BANK TO WEST BANK)
SCALE: 1"=5' HORIZ./1"=1' VERT.

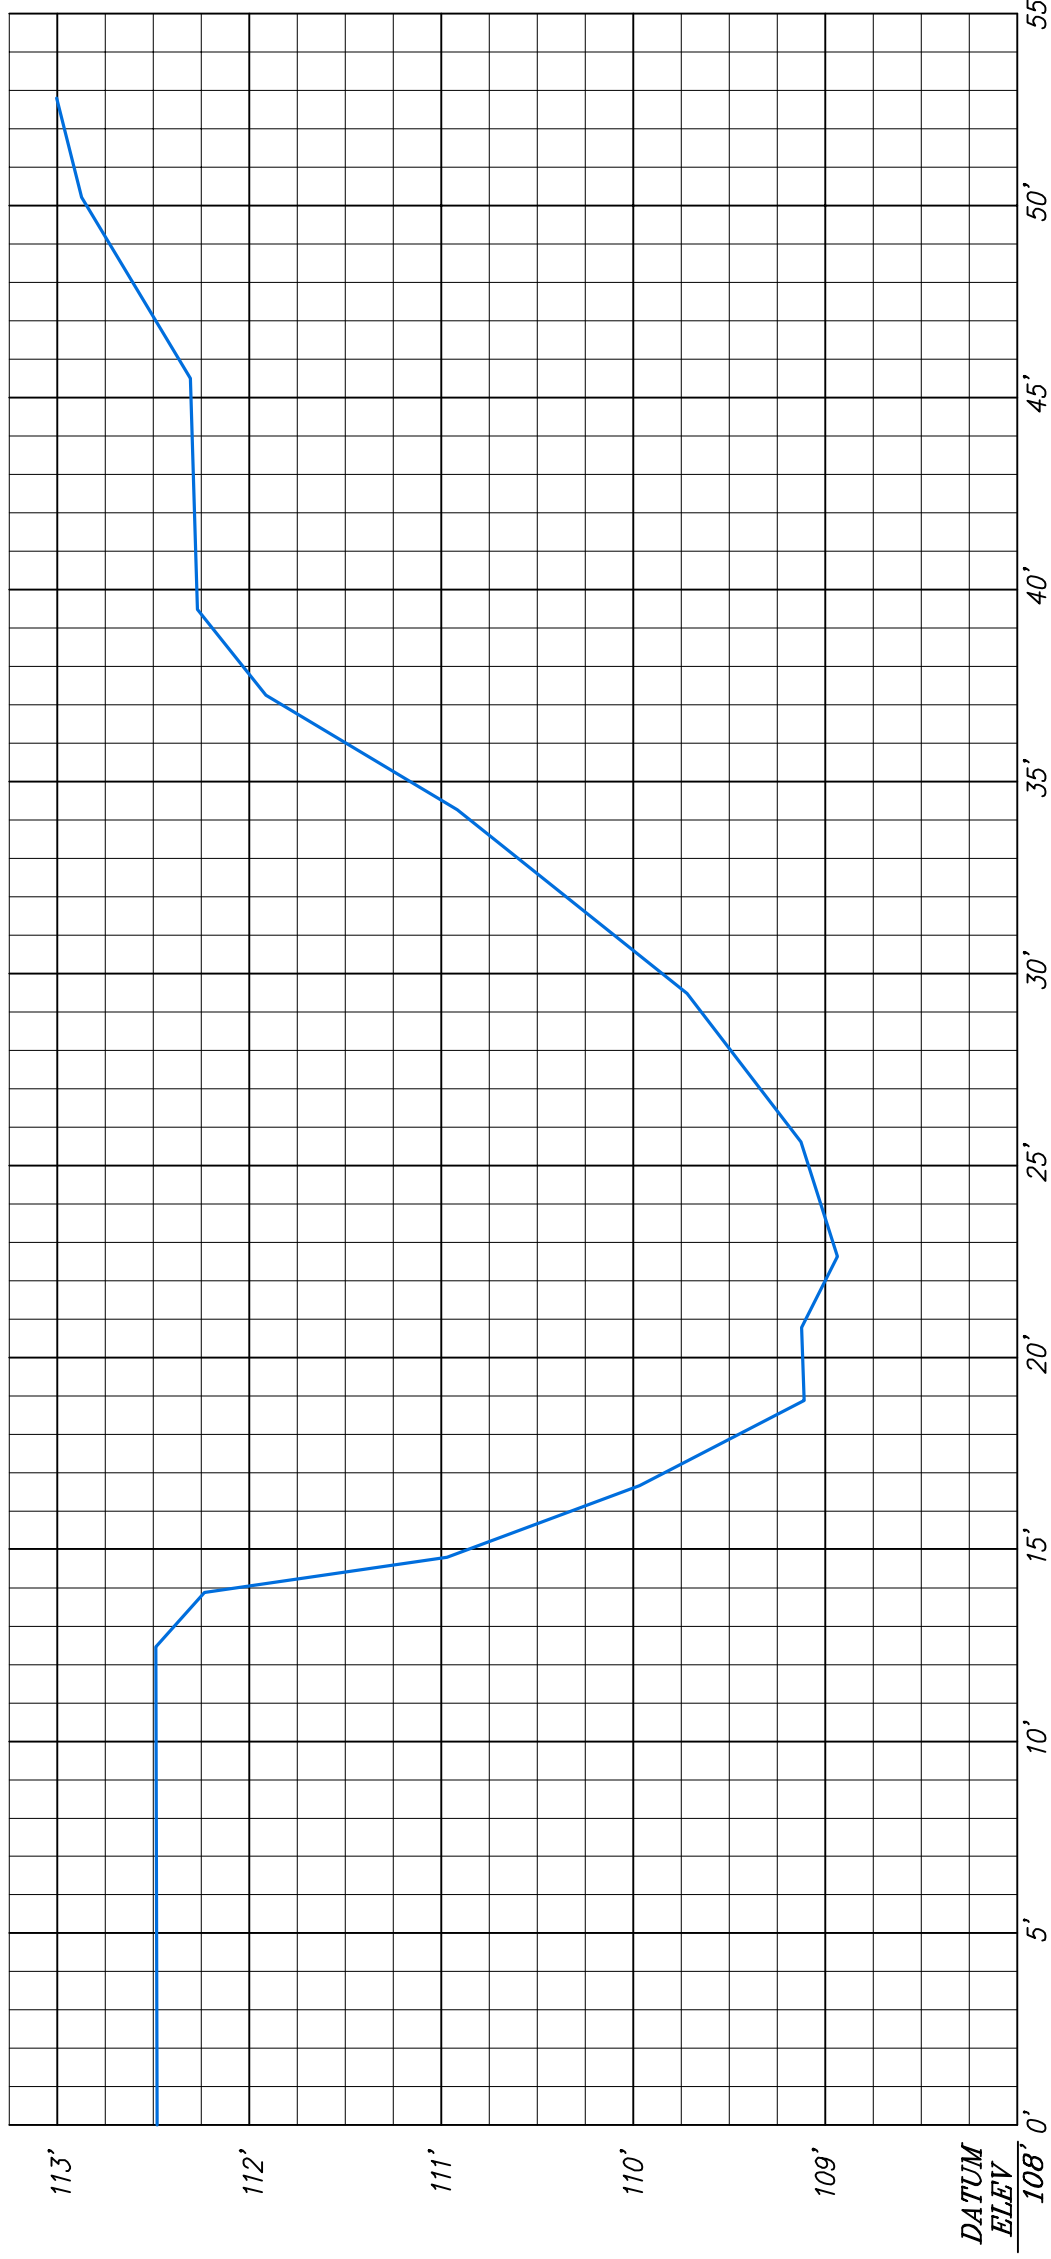
CROSS-SECTION 8P
 (EAST BANK TO WEST BANK)
 SCALE: 1"=5' HORIZ./1"=1' VERT.
