AS-BUILT MITIGATION PLAN
THREE MILE CREEK RESTORATION SITE
AVERY COUNTY, NORTH CAROLINA
(Contract #16-D06125-A)

FULL DELIVERY PROJECT
TO PROVIDE STREAM AND WETLAND MITIGATION
IN THE FRENCH BROAD RIVER BASIN
CATALOGING UNIT 06010108

April 2009

**THREE MILE CREEK RESTORATION SITE
AS-BUILT MITIGATION PLAN
AVERY COUNTY**

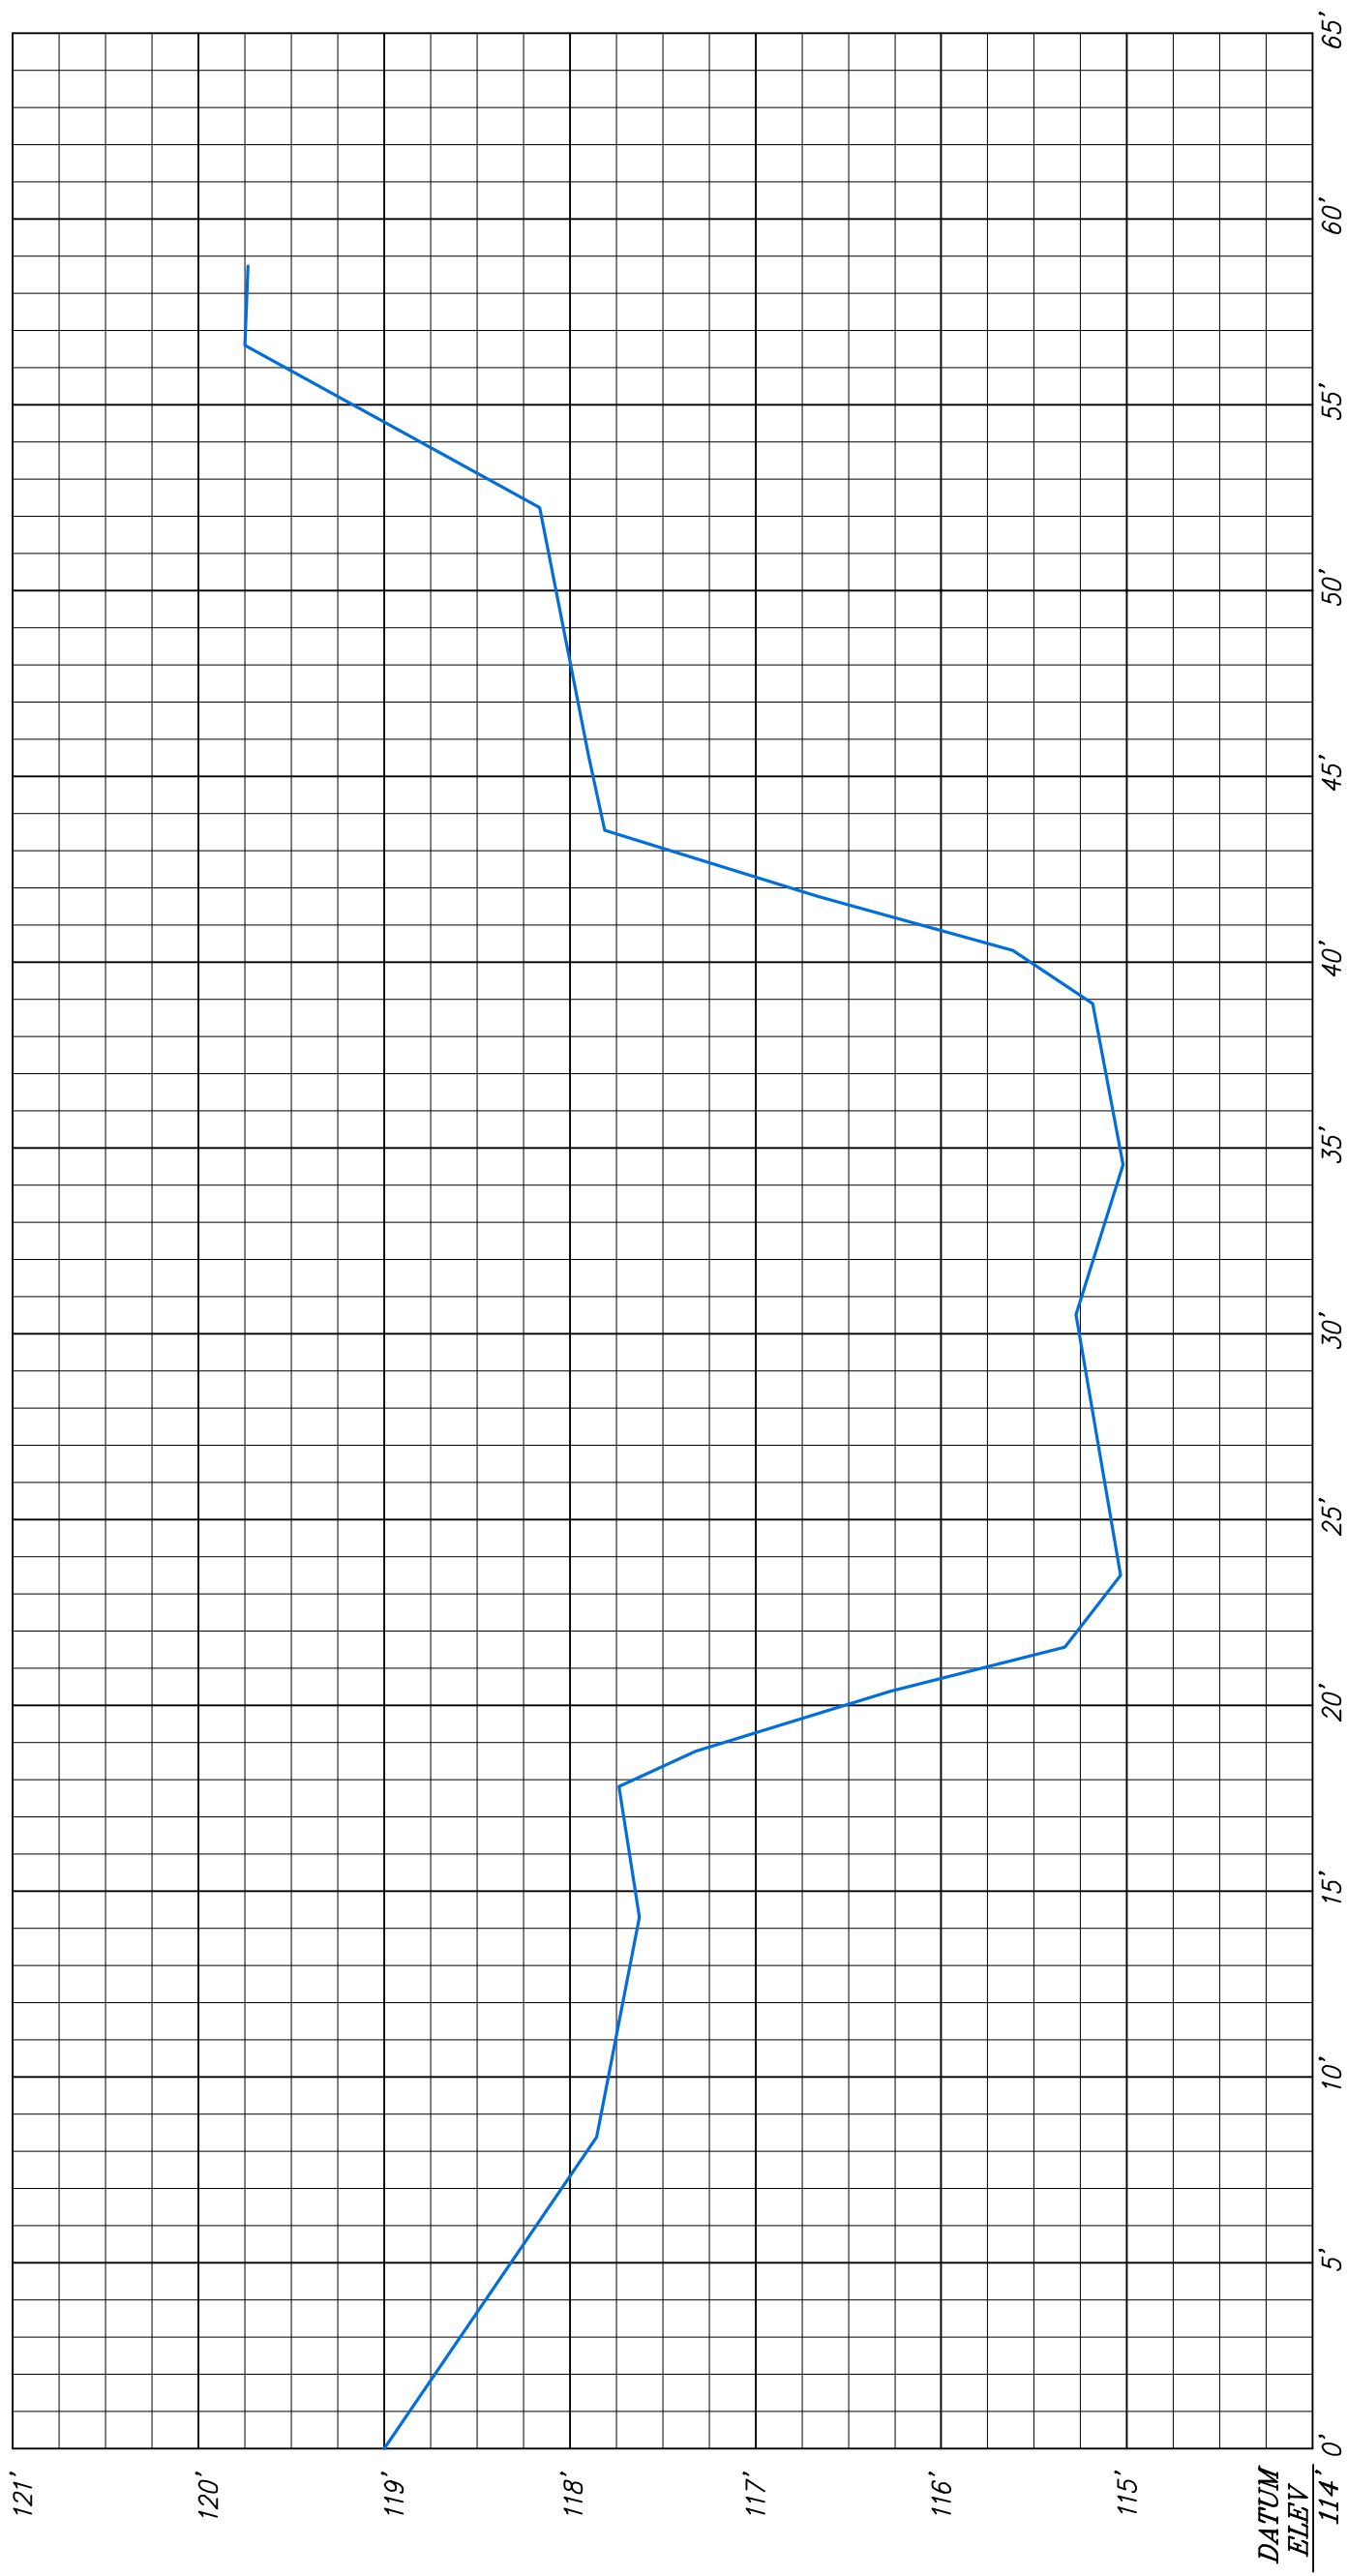
CROSS-SECTION 9R
 (EAST BANK TO WEST BANK)
 SCALE: 1"=5' HORZ./1"=1' VERT.

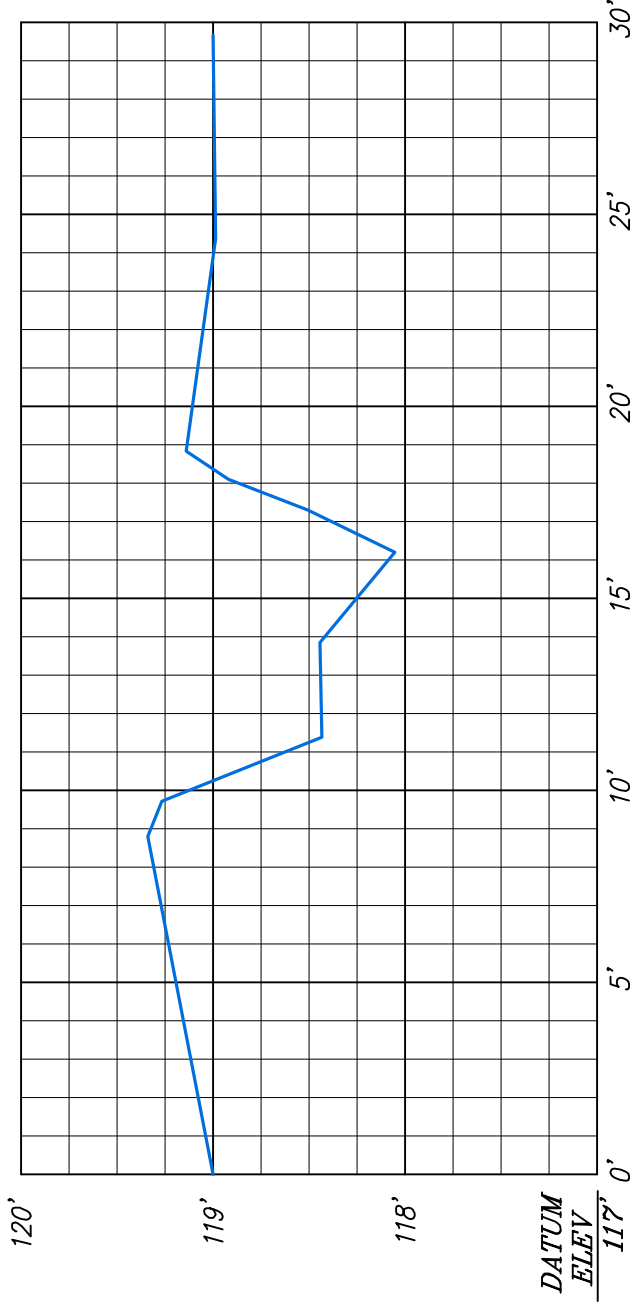
CROSS-SECTION 10R
(EAST BANK TO WEST BANK)
SCALE: 1"=5' HORZ./1"=1' VERT.

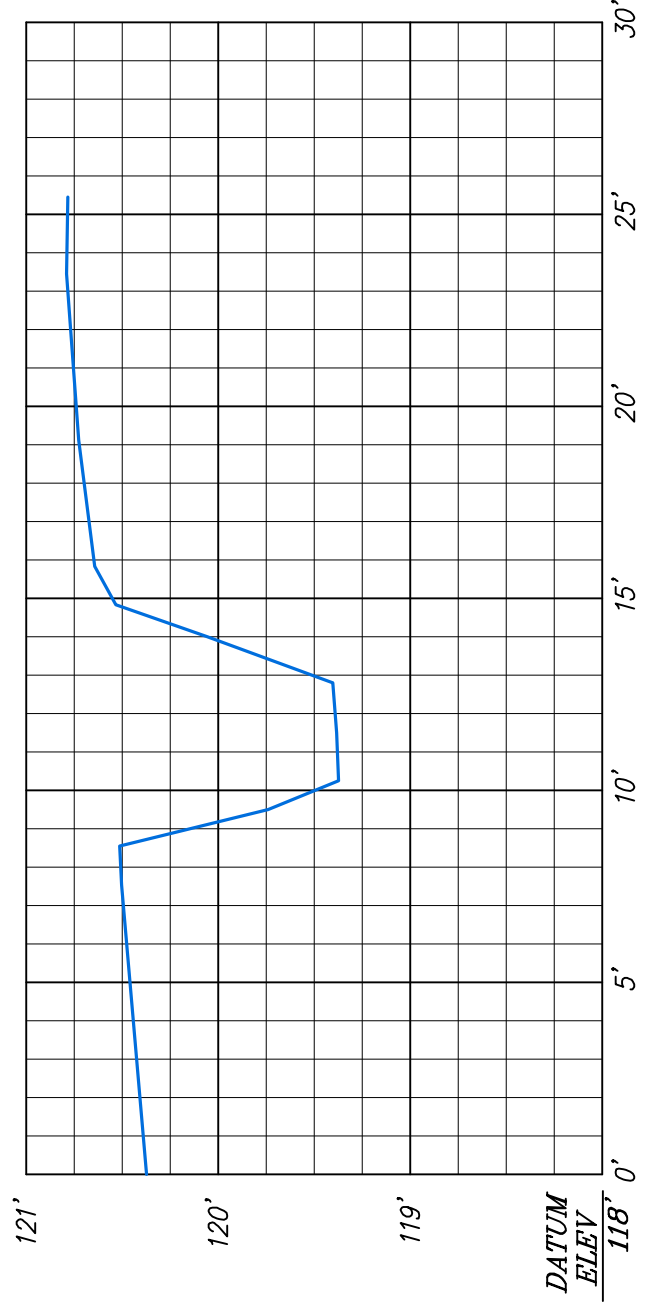
CROSS-SECTION 11P
(EAST BANK TO WEST BANK)
SCALE: 1"=5' HORZ./1"=1' VERT.

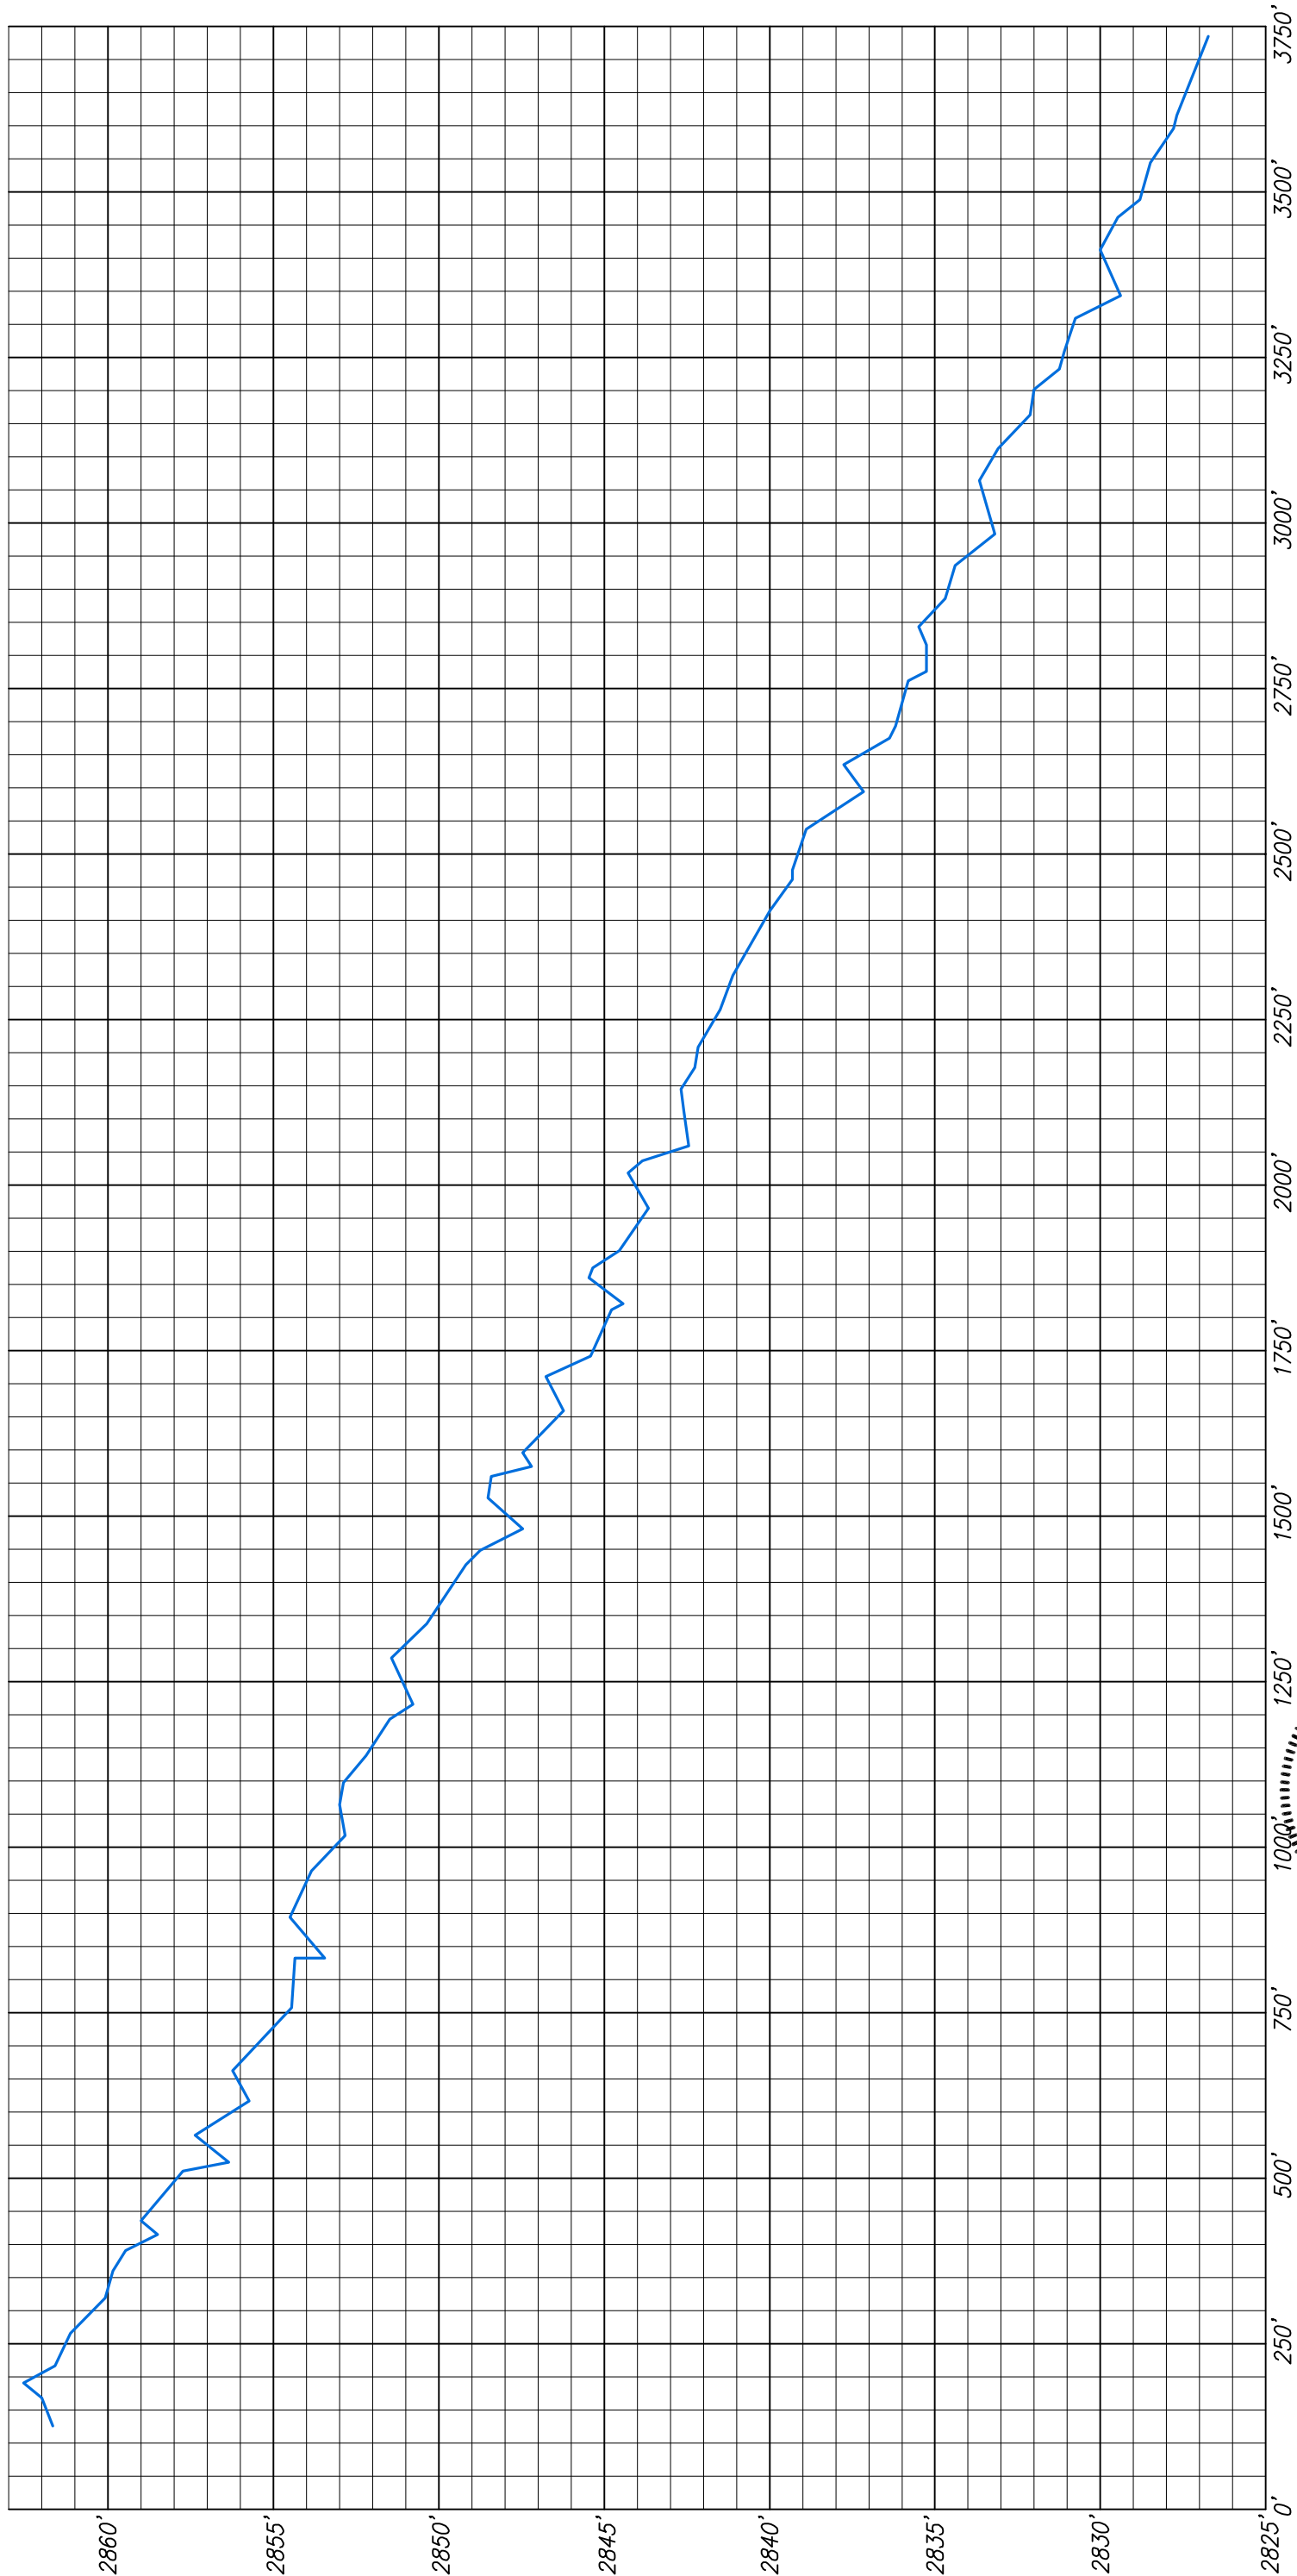
NOTE:
 ALL ELEVATIONS SHOWN ARE REFERENCED TO NAVD 1988. BENCHMARK USED: NCGS MARKER "MORRISON" WITH AN ELEVATION OF 2,679.26' NAVD 88. (THIS SHEET ONLY).

MAIN CHANNEL CENTERLINE PROFILE
 SCALE: 1"=250' HORZ./1"=5' VERT.

Baseline/as-built measurements, performed in November 2008, emulated the proposed channel morphology; data are included in Tables 6 and 7A to 7C, and cross-section and longitudinal profile plots can be found in Appendix C.

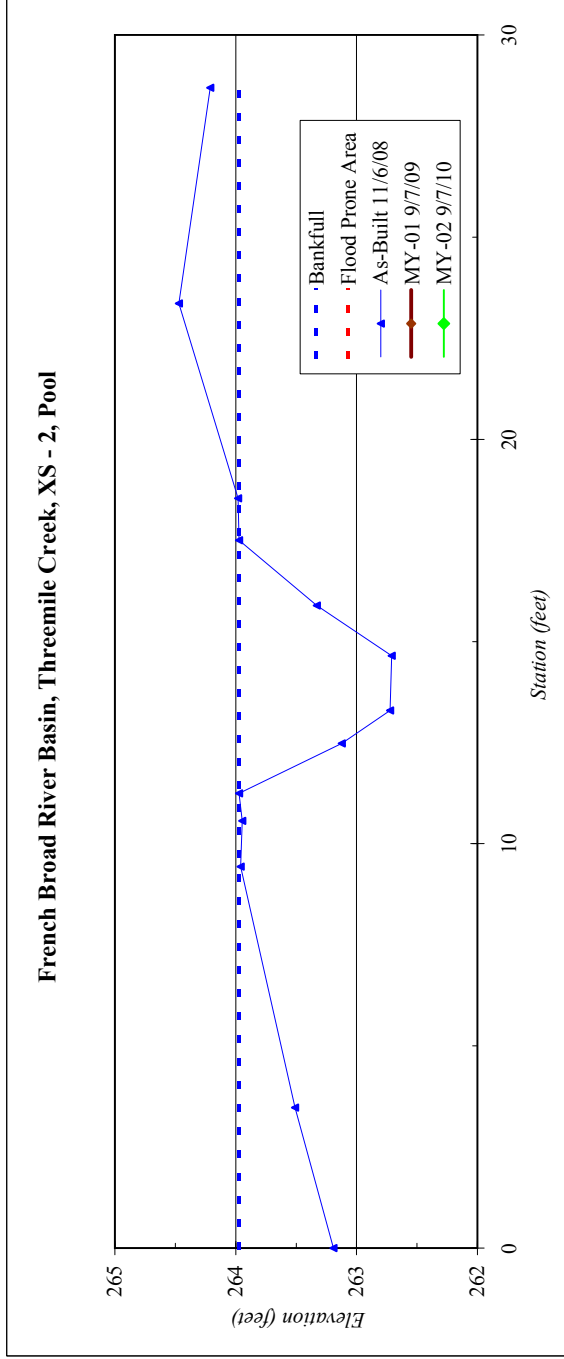
River Basin:	French Broad
Watershed:	Threemile Creek
XS ID	XS - 2, Pool
Drainage Area (sq mi):	0.05
Date:	11/6/2008
Field Crew:	Lewis, St. Clair

SUMMARY DATA		
Bankfull Elevation:		264.0
Bankfull Cross-Sectional Area:		4.8
Bankfull Width:		6.3
Flood Prone Area Elevation:		-
Flood Prone Width:		-
Max Depth at Bankfull:		1.3
Mean Depth at Bankfull:		0.8
W / D Ratio:		-
Entrenchment Ratio:		-
Bank Height Ratio:		-

Stream Type	E
--------------------	---

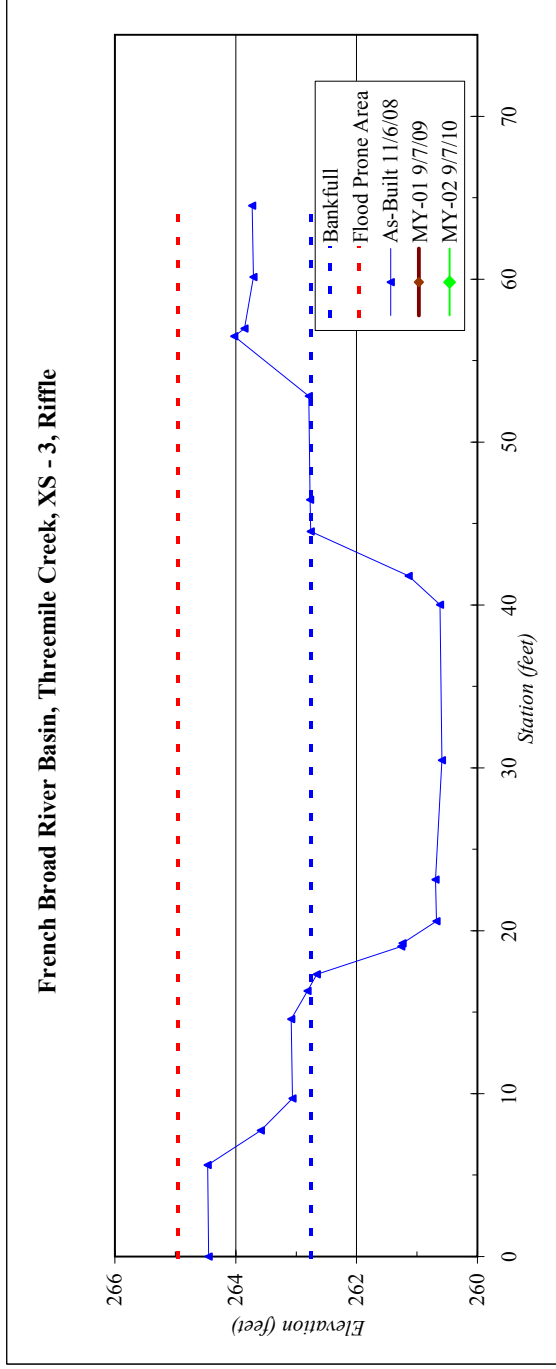
River Basin:	French Broad
Watershed:	Threemile Creek
XS ID	XS - 3, Riffle
Drainage Area (sq mi):	4.7
Date:	11/6/2008
Field Crew:	Lewis, St.Clair

Station	Elevation
0.00	264.45
5.62	264.46
7.74	263.59
9.71	263.06
14.57	263.08
16.31	262.81
17.33	262.66
19.03	261.26
19.23	261.24
20.58	260.68
23.13	260.69
30.48	260.59
40.01	260.62
41.78	261.14
44.5	262.8
46.5	262.8
52.8	262.8
56.5	264.0
57.0	263.9
60.1	263.7
64.5	263.7

SUMMARY DATA	
Bankfull Elevation:	262.8
Bankfull Cross-Sectional Area:	51.1
Bankfull Width:	27.8
Flood Prone Area Elevation:	265.0
Flood Prone Width:	>65
Max Depth at Bankfull:	2.2
Mean Depth at Bankfull:	1.8
W / D Ratio:	15.2
Entrenchment Ratio:	>5
Bank Height Ratio:	1.0

Stream Type E/C

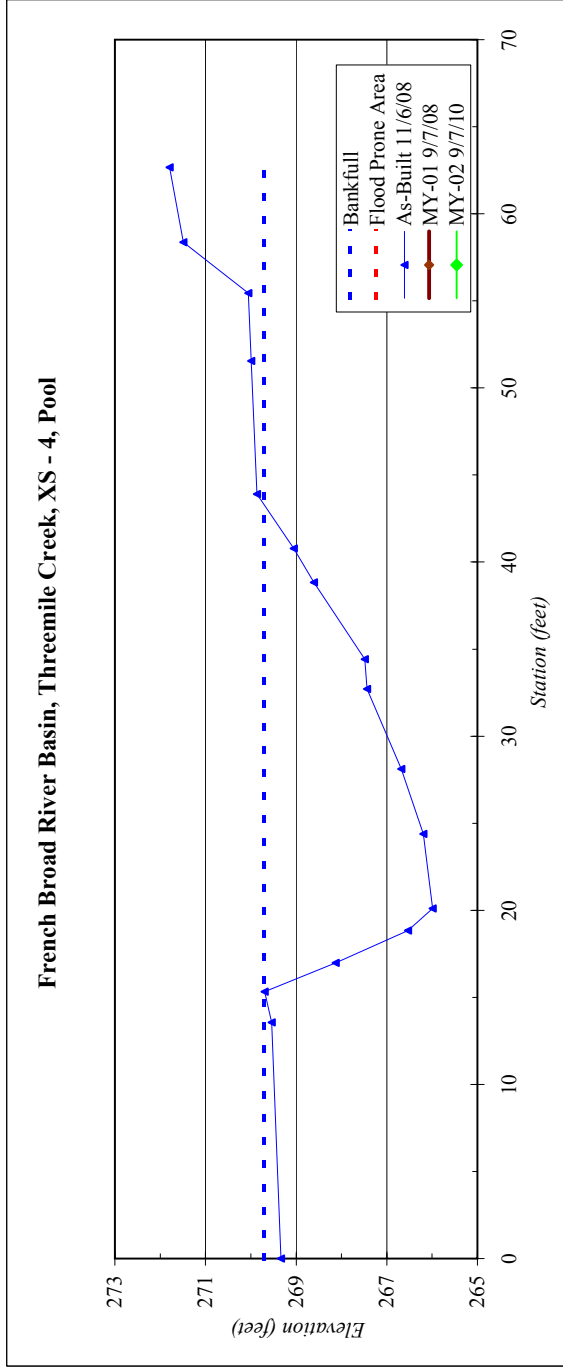
River Basin:	French Broad
Watershed:	Threemile Creek
XS ID	XS - 4, Pool
Drainage Area (sq mi):	4.7
Date:	11/6/2008
Field Crew:	Lewis, St.Clair

Station	Elevation
0.0	269.3
13.6	269.5
15.3	269.7
17.0	268.1
18.8	266.5
20.1	266.0
24.4	266.2
28.1	266.7
32.7	267.4
34.4	267.5
38.8	268.6
40.8	269.1
43.9	269.9
51.6	270.0
55.5	270.06
58.4	271.49
62.7	271.79

SUMMARY DATA	
Bankfull Elevation:	269.7
Bankfull Cross-Sectional Area:	63.4
Bankfull Width:	27.9
Flood Prone Area Elevation:	-
Flood Prone Width:	-
Max Depth at Bankfull:	2.3
Mean Depth at Bankfull:	3.7
W / D Ratio:	-
Entrenchment Ratio:	-
Bank Height Ratio:	-

Stream Type **E**

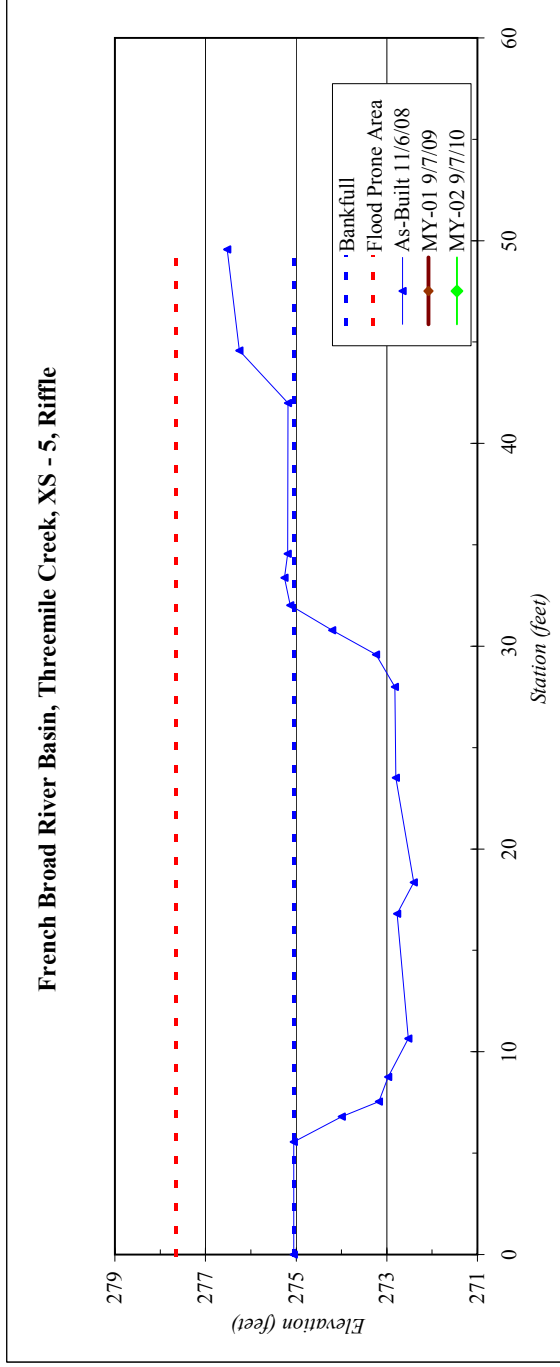
River Basin:	French Broad
Watershed:	Threemile Creek
XS ID	XS - 5, Riffle
Drainage Area (sq mi):	4.7
Date:	11/6/2008
Field Crew:	Lewis, St.Clair

Station	Elevation
0.0	275.1
5.6	275.1
6.8	274.0
7.5	273.2
8.8	273.0
10.7	272.5
16.8	272.8
18.4	272.4
23.5	272.8
28.0	272.8
29.6	273.2
30.8	274.2
32.0	275.1
33.4	275.3
34.6	275.2
42.0	275.2
44.6	276.3
49.6	276.5

SUMMARY DATA	
Bankfull Elevation:	275.1
Bankfull Cross-Sectional Area:	55.0
Bankfull Width:	21.6
Flood Prone Area Elevation:	277.7
Flood Prone Width:	>65
Max Depth at Bankfull:	2.6
Mean Depth at Bankfull:	2.1
W / D Ratio:	12.6
Entrenchment Ratio:	>5
Bank Height Ratio:	1.0

Stream Type: E/C

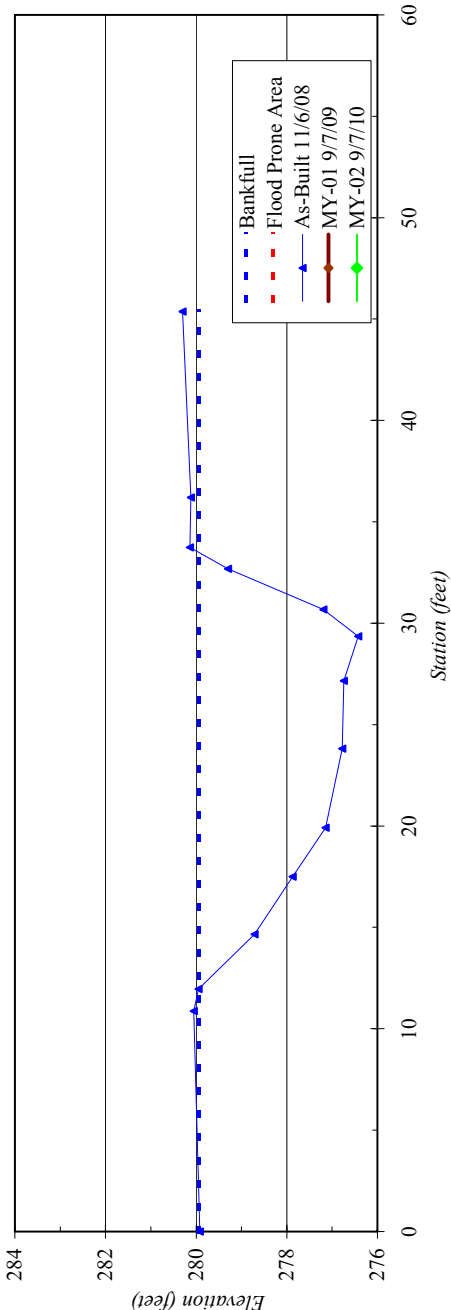
French Broad River Basin, Threemile Creek, XS - 6, Pool

River Basin:	French Broad
Watershed:	Threemile Creek
XS ID	XS - 6, Pool
Drainage Area (sq mi):	4.7
Date:	11/6/2008
Field Crew:	Lewis, St.Clair

Station	Elevation
0.0	279.9
10.9	280.1
12.0	279.9
14.7	278.7
17.5	277.9
19.9	277.1
23.8	276.8
27.2	276.7
29.4	276.4
30.7	277.2
32.7	279.3
33.7	280.1
36.2	280.1
45.4	280.3

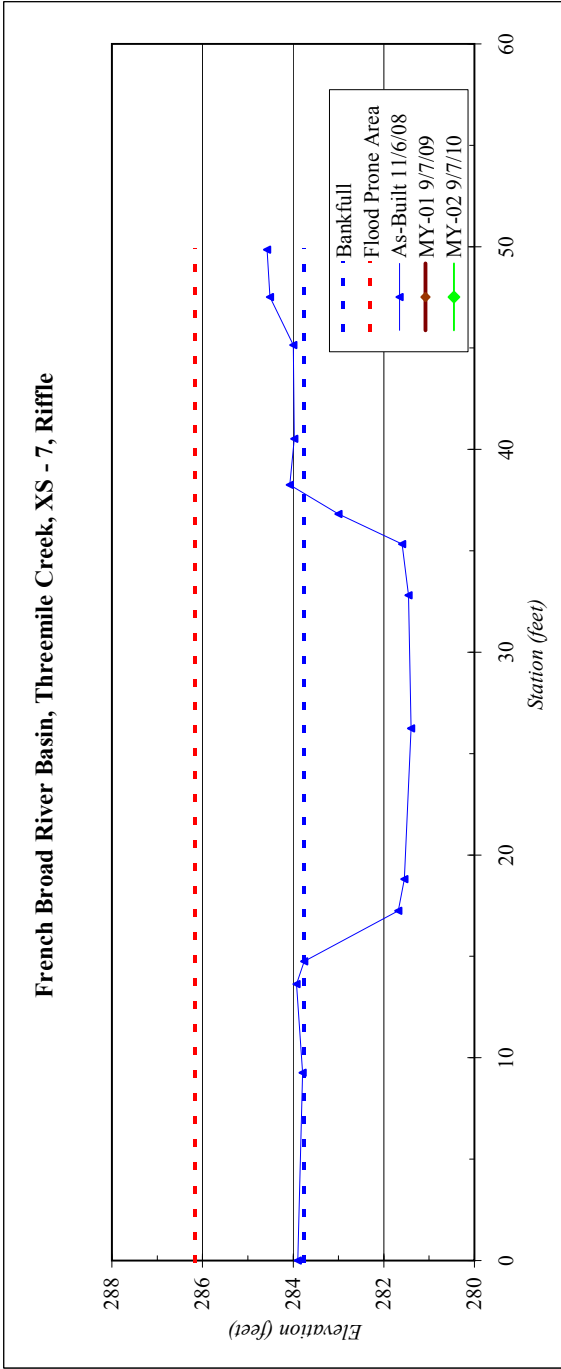
River Basin:	French Broad
Watershed:	Threemile Creek
XS ID	XS - 7, Riffle
Drainage Area (sq mi):	4.7
Date:	11/6/2008
Field Crew:	Lewis, St.Clair

Station	Elevation
0.0	283.9
9.3	283.8
13.6	283.9
14.8	283.8
17.2	281.7
18.8	281.5
26.2	281.4
32.8	281.5
35.3	281.6
36.8	283.0
38.2	284.1
40.5	284.0
45.2	284.0
47.5	284.5
49.9	284.6

SUMMARY DATA	
Bankfull Elevation:	283.8
Bankfull Cross-Sectional Area:	46.5
Bankfull Width:	23.1
Flood Prone Area Elevation:	286.2
Flood Prone Width:	>65
Max Depth at Bankfull:	2.4
Mean Depth at Bankfull:	2.0
W / D Ratio:	11.5
Entrenchment Ratio:	>5
Bank Height Ratio:	1.0

Stream Type: E/C

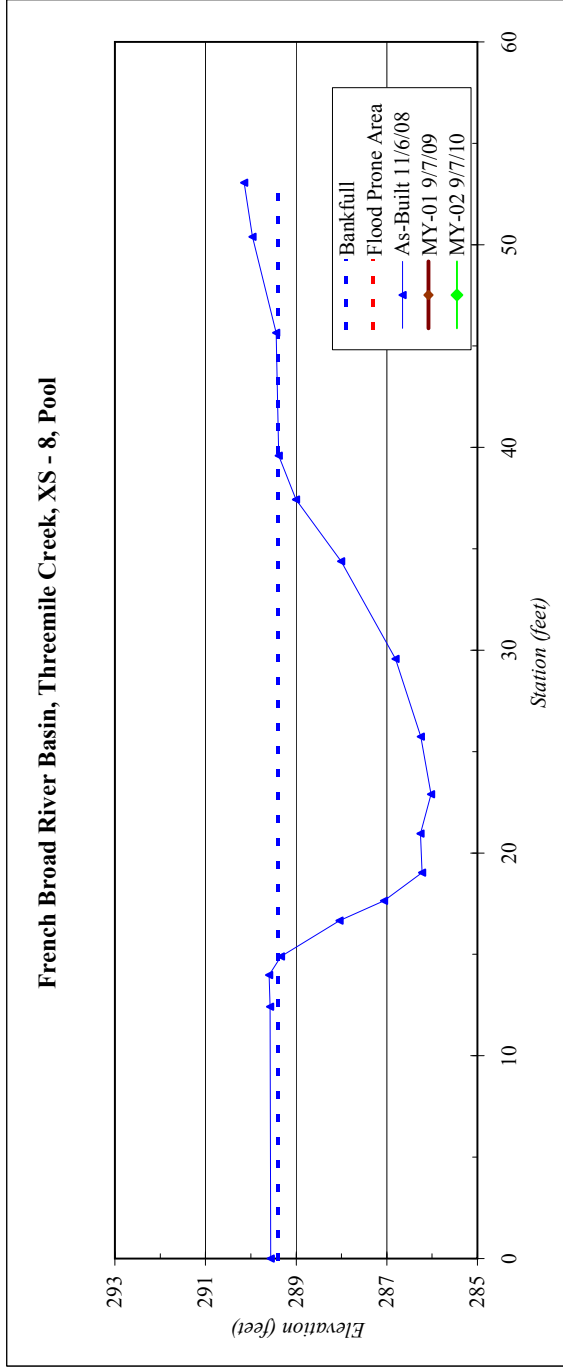
River Basin:	French Broad
Watershed:	Threemile Creek
XS ID	XS - 8, Pool
Drainage Area (sq mi):	4.7
Date:	11/6/2008
Field Crew:	Lewis, St.Clair

Station	Elevation
0.0	289.6
12.4	289.6
14.0	289.6
14.9	289.3
16.7	288.0
17.6	287.1
19.0	286.2
21.0	286.3
22.9	286.0
25.7	286.3
29.6	286.8
34.4	288.0
37.4	289.0
39.6	289.4
45.7	289.4
50.4	290.0
53.1	290.1

SUMMARY DATA	
Bankfull Elevation:	289.4
Bankfull Cross-Sectional Area:	52.1
Bankfull Width:	25.7
Flood Prone Area Elevation:	-
Flood Prone Width:	-
Max Depth at Bankfull:	3.4
Mean Depth at Bankfull:	2.0
W / D Ratio:	-
Entrenchment Ratio:	-
Bank Height Ratio:	-

Stream Type: E/C

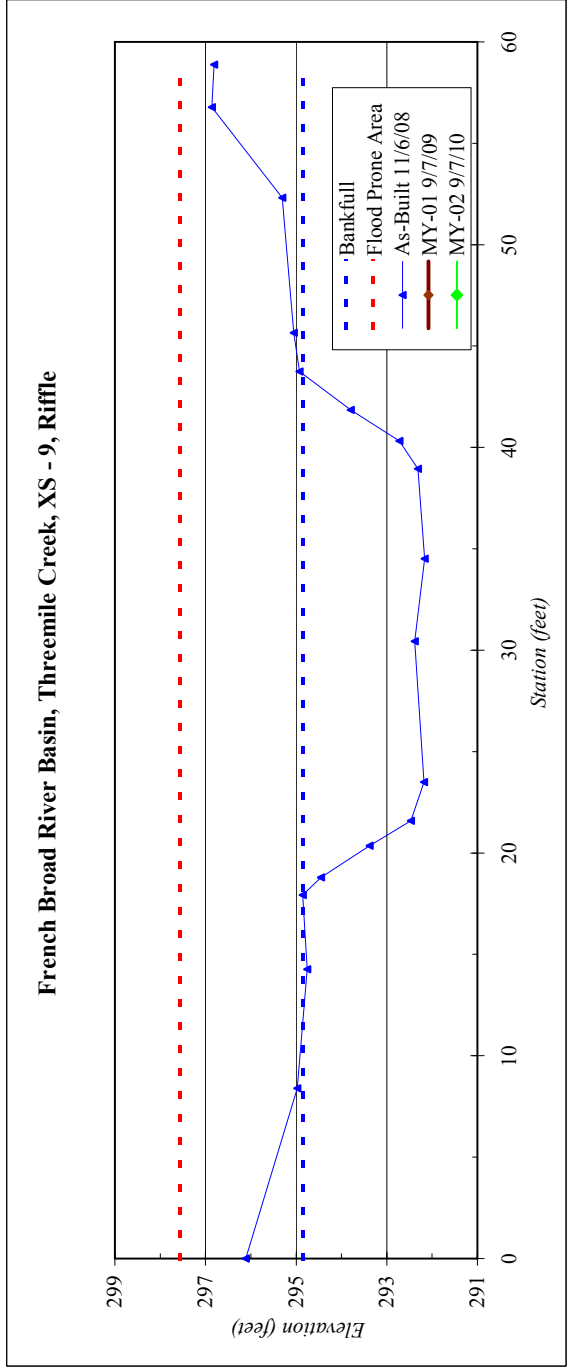
River Basin:	French Broad
Watershed:	Threemile Creek
XS ID	XS - 9, Riffle
Drainage Area (sq mi):	4.7
Date:	11/6/2008
Field Crew:	Lewis, St.Clair

Station	Elevation
0.0	296.1
8.4	295.0
14.3	294.8
17.9	294.9
18.8	294.5
20.4	293.4
21.6	292.5
23.5	292.2
30.4	292.4
34.5	292.2
38.9	292.3
40.3	292.7
41.9	293.8
43.7	294.9
45.7	295.0
52.3	295.3
56.8	296.9
58.9	296.8

SUMMARY DATA		
Bankfull Elevation:		294.9
Bankfull Cross-Sectional Area:		55.3
Bankfull Width:		25.7
Flood Prone Area Elevation:		297.6
Flood Prone Width:		>65
Max Depth at Bankfull:		2.7
Mean Depth at Bankfull:		2.2
W/D Ratio:		11.9
Entrenchment Ratio:		>5
Bank Height Ratio:		1.0

Stream Type: E/C

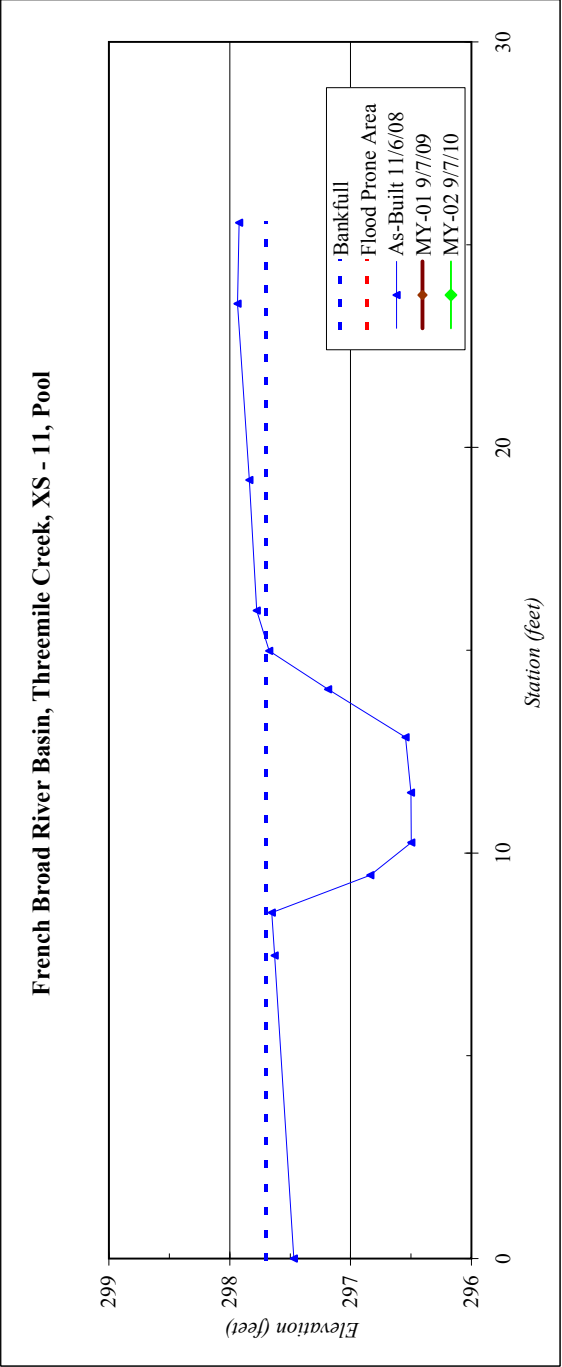
River Basin:	French Broad
Watershed:	Threemile Creek
XS ID	XS - 11, Pool
Drainage Area (sq mi):	0.05
Date:	11/6/2008
Field Crew:	Lewis, St.Clair

Station	Elevation
0.0	297.5
7.5	297.6
8.5	297.7
9.5	296.8
10.3	296.5
11.5	296.5
12.9	296.5
14.0	297.2
15.0	297.7
16.0	297.8
19.2	297.8
23.5	297.9
25.5	297.9

SUMMARY DATA		
Bankfull Elevation:		297.7
Bankfull Cross-Sectional Area:		5.3
Bankfull Width:		6.4
Flood Prone Area Elevation:		-
Flood Prone Width:		-
Max Depth at Bankfull:		1.2
Mean Depth at Bankfull:		0.8
W / D Ratio:		-
Entrenchment Ratio:		-
Bank Height Ratio:		-

Stream Type: E/C

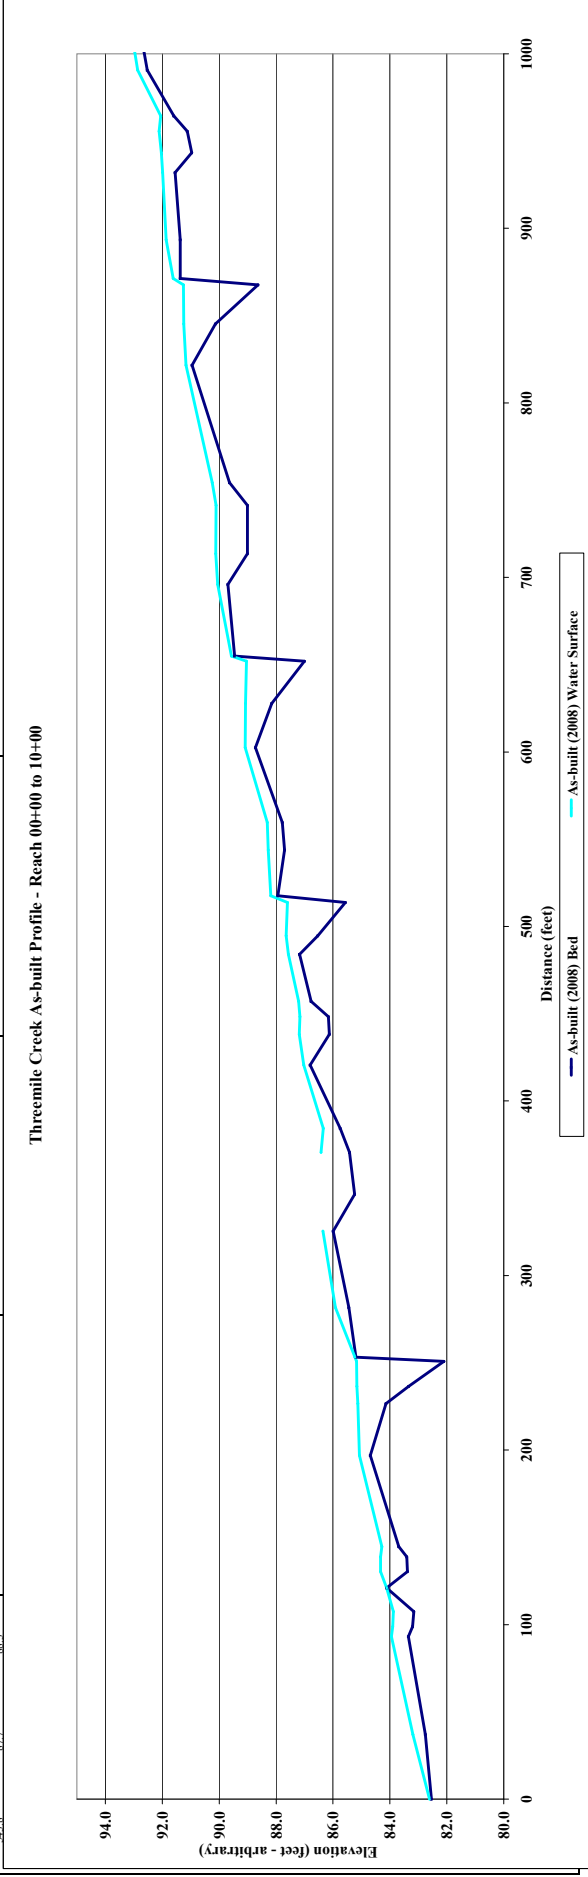
Project Name		Threemile Creek - As-built (2008) Profile											
Reach		all											
Feature		Profile											
Date	10/21/08												
Crew	Lewis, St. Clair												
Station	2008			2009			2010			2011			
	As-built Survey	Water Elevation	Bed Elevation	Year 1 Monitoring / Survey	Water Elevation	Bed Elevation	Year 2 Monitoring / Survey	Water Elevation	Bed Elevation	Year 3 Monitoring / Survey	Water Elevation	Bed Elevation	
0+0	82.3	82.6

As-built	2008	2009	2010
Avg. Water Surface Slope	0.0098		
Riffle Length	51.0		
Avg. Riffle Slope	0.0154		
Pool Length	46.0		
Pool to Pool Spacing	110.0

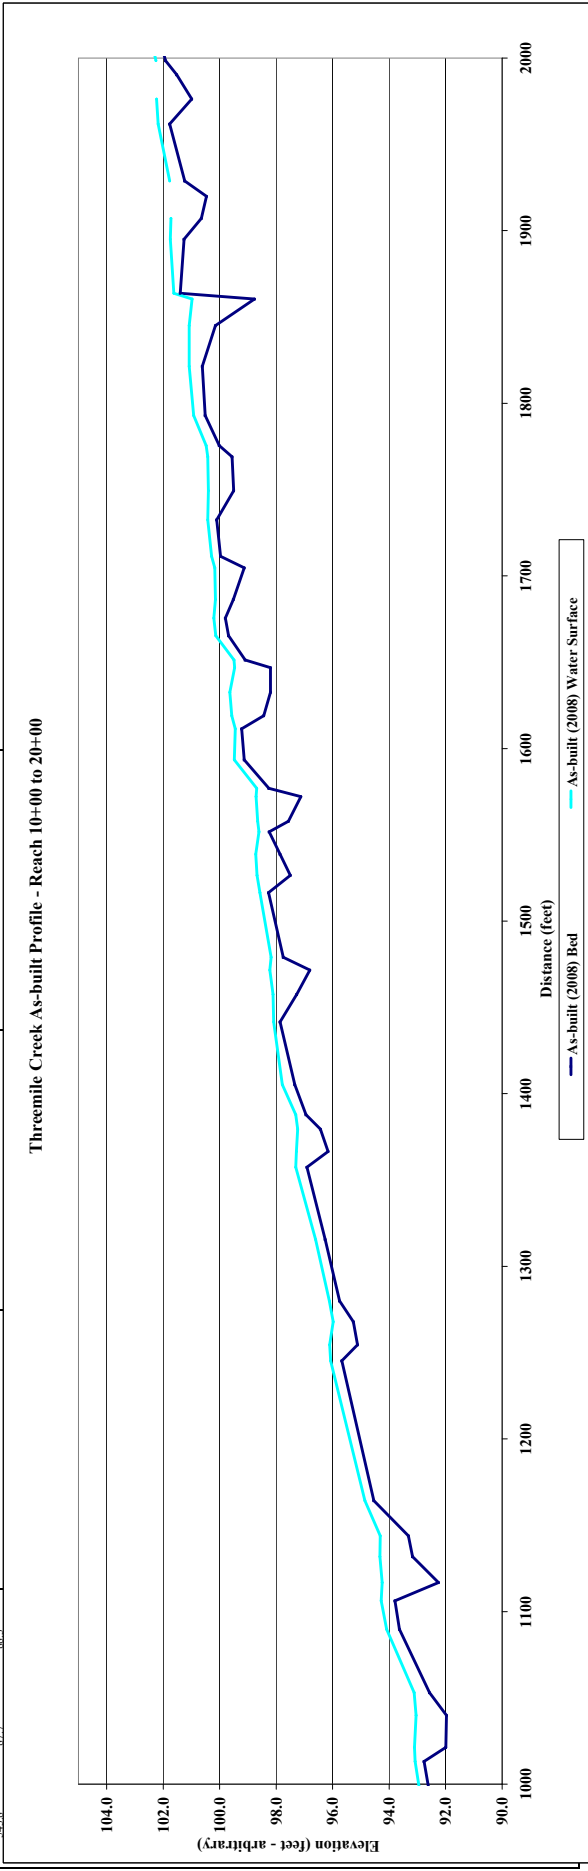
Project Name: Threemile Creek - As-built (2008) Profile									
Reach: all									
Profile									
Feature: 102108									
Date: Lewis, S, Clar									
Crew:									
Station	2008		2009		2010		2011		
	As-built Survey	Water Elevation	Year 1 Monitoring / Survey	Water Elevation	Year 2 Monitoring / Survey	Water Elevation	Year 3 Monitoring / Survey	Water Elevation	
	Bed Elevation		Bed Elevation		Bed Elevation		Bed Elevation		
0+0	82.5

As-built	2008	2009	2010
Avg. Water Surface Slope	0.0098			
Riffle Length	51.0			
Avg. Riffle Slope	0.0154			
Pool Length	46.0			
Avg. Pool Slope	110.0

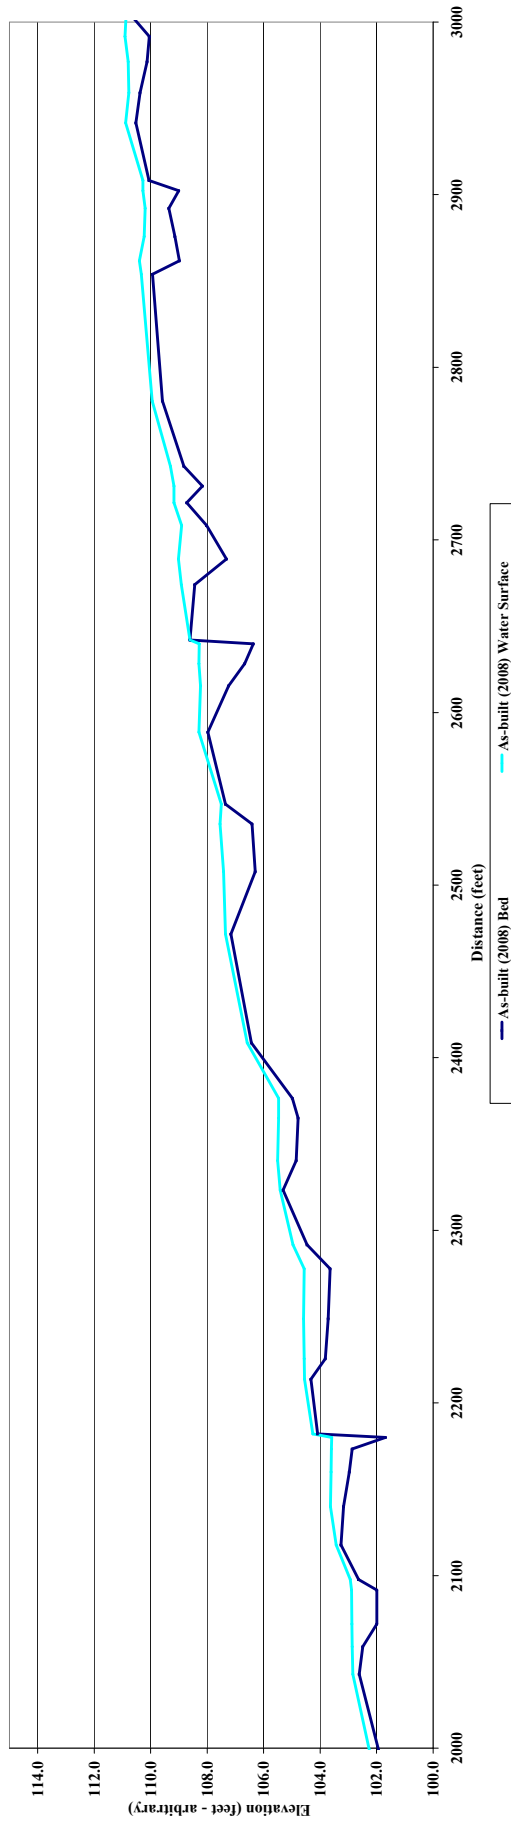
Threemile Creek As-built Profile - Reach 20+00 to 30+00

Project Name: Threemile Creek - As-built (2008) Profile									
Reach: all									
Profile									
Feature: 102108									
Date: Lewis, S, Clar									
Crew:									
Station	2008		2009		2010		2011		
	As-built Survey	Water Elevation	Year 1 Monitoring / Survey	Water Elevation	Year 2 Monitoring / Survey	Water Elevation	Year 3 Monitoring / Survey	Water Elevation	
0+0	82.5	82.6

As-built	2008	2009	2010
Avg. Water Surface Slope	0.0098			
Riffle Length	51.0			
Avg. Riffle Slope	0.0154			
Pool Length	46.0			
Avg. Pool Slope	110.0

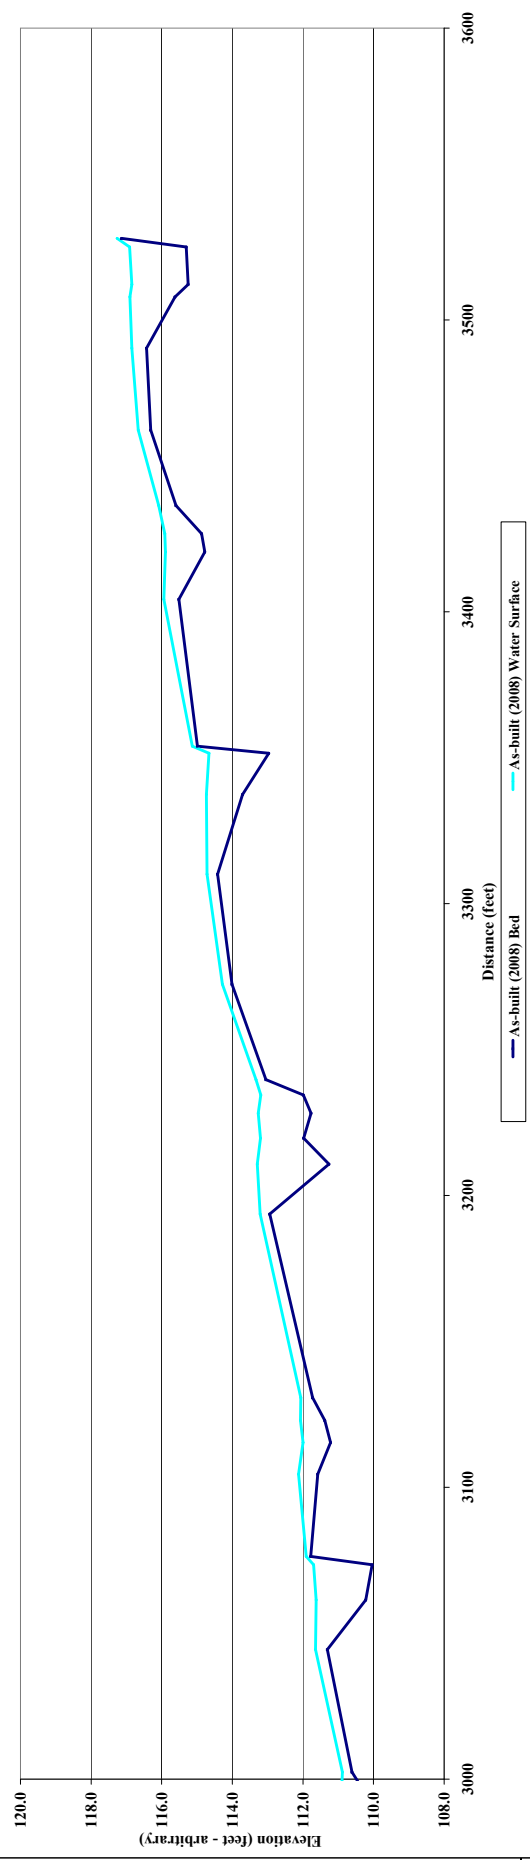
Threemile Creek As-built Profile - Reach 30+00 to 36+00

Project Name: Threemile Creek - As-built (2008) Profile												
Reach: all												
Profile												
Feature: 10/21/08												
Date: Lewis, S, Clar												
Crew:												
Station	2008			2009			2010			2011		
	As-built Survey	Water Elevation		Year 1 Monitoring /Survey	Water Elevation		Year 2 Monitoring /Survey	Water Elevation		Year 3 Monitoring /Survey	Water Elevation	
	Bed Elevation		Station	Bed Elevation	Water Elevation	Station	Bed Elevation	Water Elevation	Station	Bed Elevation	Water Elevation	Station
0+0	82.3	82.6

As-built	2008	2009	2010
Avg. Water Surface Slope	0.0098			
Riffle Length	51.0			
Avg. Riffle Slope	0.0154			
Pool Length	46.0			
Avg. Pool Slope	110.0
