**YEAR 1 (2009)**  
**ANNUAL MONITORING REPORT**  
**THREE MILE CREEK RESTORATION SITE**  
**AVERY COUNTY, NORTH CAROLINA**  
**(Contract #16-D06125-A)**

**FULL DELIVERY PROJECT**  
**TO PROVIDE STREAM AND WETLAND MITIGATION**  
**IN THE FRENCH BROAD RIVER BASIN**  
**CATALOGING UNIT 06010108**

**November 2009**

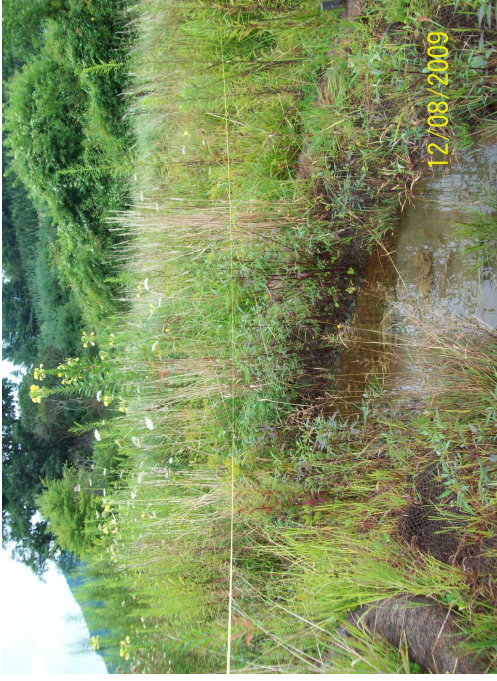
<b>River Basin:</b>	French Broad
<b>Watershed:</b>	Threemile Creek
<b>XS ID</b>	XS - 2, Pool
<b>Drainage Area (sq mi):</b>	0.05
<b>Date:</b>	8/18/2009
<b>Field Crew:</b>	Lewis, Dean, Perkinson

Station	Elevation
0.00	263.09
1.73	263.39
2.67	263.39
4.08	263.42
5.62	263.70
7.73	263.75
9.79	264.04
11.08	264.06
13.69	262.84
15.21	262.87
15.51	263.10
16.29	263.27
17.63	263.62
18.20	263.99
19.33	264.22
21.5	264.3
23.1	264.3
23.8	264.4
25.7	264.3
28.2	264.1
29.3	264.3

SUMMARY DATA	
<b>Bankfull Elevation:</b>	264.1
<b>Bankfull Cross-Sectional Area:</b>	5.4
<b>Bankfull Width:</b>	7.5
<b>Flood Prone Area Elevation:</b>	-
<b>Flood Prone Width:</b>	-
<b>Max Depth at Bankfull:</b>	1.2
<b>Mean Depth at Bankfull:</b>	0.7
<b>W / D Ratio:</b>	-
<b>Entrenchment Ratio:</b>	-
<b>Bank Height Ratio:</b>	-

Stream Type: E

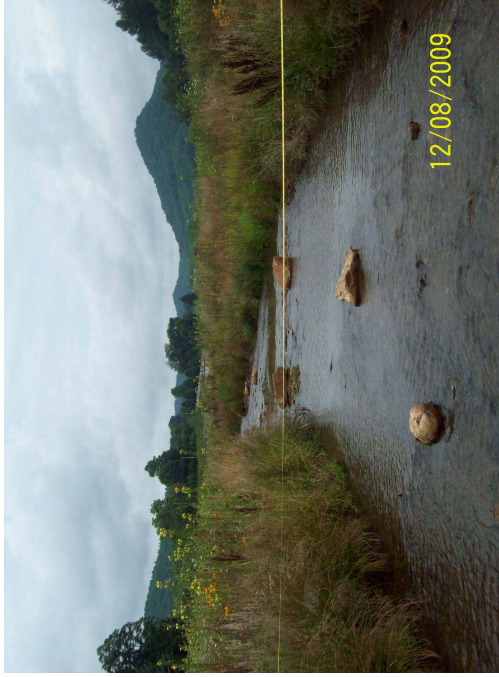
<b>River Basin:</b>	French Broad
<b>Watershed:</b>	Threemile Creek
<b>XS ID</b>	XS - 3, Riffle
<b>Drainage Area (sq mi):</b>	4.7
<b>Date:</b>	8/18/2009
<b>Field Crew:</b>	Lewis, Dean, Perkinson

Station	Elevation
0.00	264.30
2.90	264.11
4.60	264.30
6.18	264.16
9.29	262.95
10.94	262.72
12.30	262.84
14.28	262.71
15.39	262.79
17.32	262.33
19.38	261.10
20.87	260.71
21.30	260.55
25.54	260.49
28.5	260.4
32.3	260.4
34.7	260.4
37.6	260.5
39.3	260.5
41.3	261.1
44.0	262.5
45.2	262.7
46.8	262.7
48.0	262.8
50.4	262.8
52.9	262.9
55.7	263.90
59.6	263.62
63.8	263.77

SUMMARY DATA	
<b>Bankfull Elevation:</b>	262.7
<b>Bankfull Cross-Sectional Area:</b>	51.9
<b>Bankfull Width:</b>	30.3
<b>Flood Prone Area Elevation:</b>	265.0
<b>Flood Prone Width:</b>	>65
<b>Max Depth at Bankfull:</b>	2.3
<b>Mean Depth at Bankfull:</b>	1.7
<b>W/D Ratio:</b>	17.7
<b>Entrenchment Ratio:</b>	>5
<b>Bank Height Ratio:</b>	1.0

Stream Type: E/C

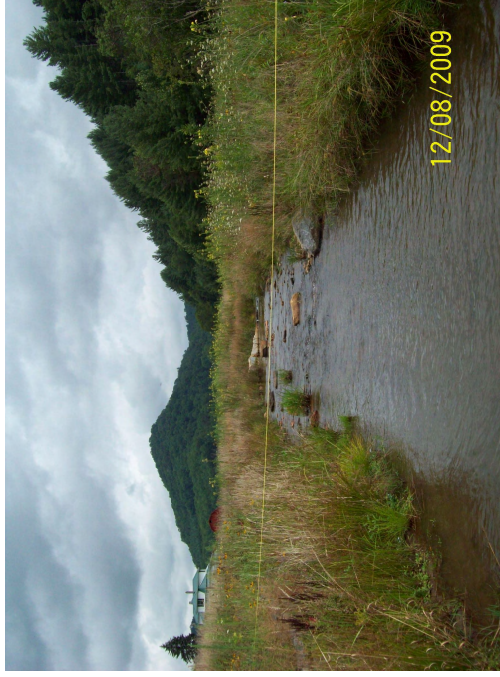
<b>River Basin:</b>	French Broad
<b>Watershed:</b>	Threemile Creek
<b>XS ID</b>	XS - 4, Pool
<b>Drainage Area (sq mi):</b>	4.7
<b>Date:</b>	8/18/2009
<b>Field Crew:</b>	Lewis, Dean, Perkinson

Station	Elevation
0.0	269.4
6.0	269.4
12.4	269.5
15.0	269.6
15.9	269.1
17.3	267.6
18.4	267.3
18.9	266.5
19.8	266.0
21.9	266.0
25.8	266.1
28.6	266.5
30.7	266.8
31.3	267.3
32.7	267.51
34.5	267.60
36.6	267.98
38.5	268.54
40.0	268.86
42.0	269.37
43.8	269.90
47.7	270.03
51.9	269.89
55.2	269.90
59.2	271.61
62.6	271.80

SUMMARY DATA	
<b>Bankfull Elevation:</b>	269.6
<b>Bankfull Cross-Sectional Area:</b>	62.8
<b>Bankfull Width:</b>	27.8
<b>Flood Prone Area Elevation:</b>	-
<b>Flood Prone Width:</b>	-
<b>Max Depth at Bankfull:</b>	3.6
<b>Mean Depth at Bankfull:</b>	2.3
<b>W / D Ratio:</b>	-
<b>Entrenchment Ratio:</b>	-
<b>Bank Height Ratio:</b>	-

Stream Type: E

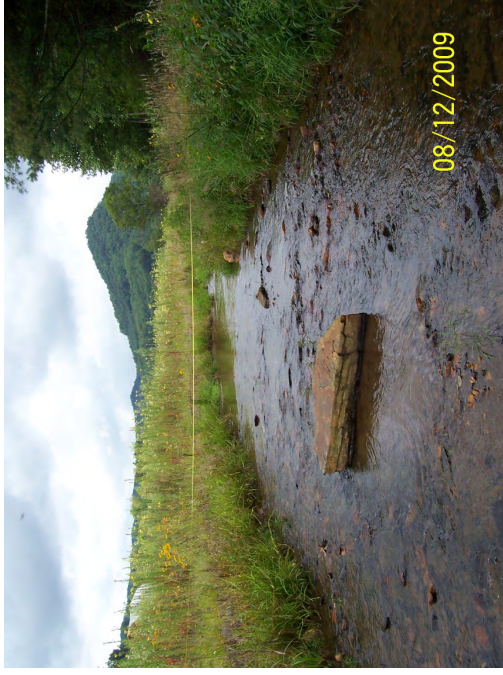
<b>River Basin:</b>	French Broad
<b>Watershed:</b>	Threemile Creek
<b>XS ID</b>	XS - 5, Riffle
<b>Drainage Area (sq mi):</b>	4.7
<b>Date:</b>	8/18/2009
<b>Field Crew:</b>	Lewis, Dean, Perkinson

Station	Elevation
0.0	275.0
4.0	275.1
5.8	274.9
7.4	273.4
8.1	273.0
9.6	272.6
14.0	272.3
19.0	272.4
22.3	272.4
25.4	272.5
27.8	272.6
29.1	273.2
29.9	273.4
30.7	274.0
32.2	274.9
32.8	275.1
34.8	275.1
41.8	275.0
43.1	275.3
44.4	276.1
46.3	276.3
49.7	276.4

SUMMARY DATA	
<b>Bankfull Elevation:</b>	275.1
<b>Bankfull Cross-Sectional Area:</b>	60.6
<b>Bankfull Width:</b>	28.6
<b>Flood Prone Area Elevation:</b>	277.9
<b>Flood Prone Width:</b>	>65
<b>Max Depth at Bankfull:</b>	2.8
<b>Mean Depth at Bankfull:</b>	2.1
<b>W / D Ratio:</b>	13.5
<b>Entrenchment Ratio:</b>	>5
<b>Bank Height Ratio:</b>	1.0

Stream Type	E/C
-------------	-----

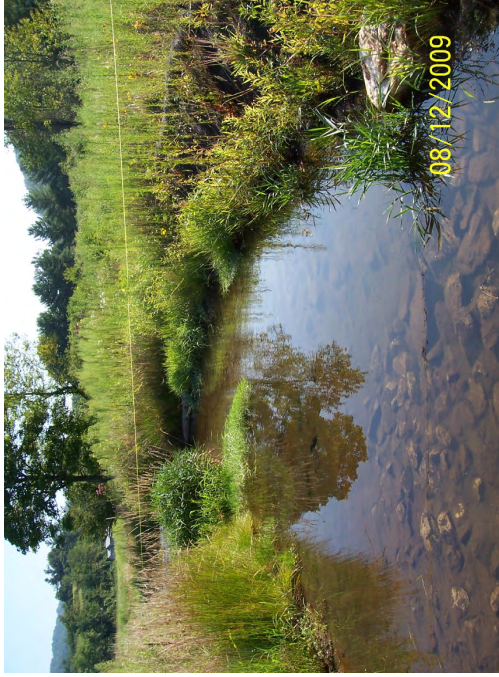
<b>River Basin:</b>	French Broad
<b>Watershed:</b>	Threemile Creek
<b>XS ID</b>	XS - 8_Pool
<b>Drainage Area (sq mi):</b>	4.7
<b>Date:</b>	8/18/2009
<b>Field Crew:</b>	Lewis, Dean, Perkinson

Station	Elevation
0.0	289.70
8.4	289.58
14.0	289.50
14.7	289.39
15.6	288.82
16.7	287.90
17.8	287.27
18.4	286.75
18.8	286.33
19.3	286.22
23.0	285.92
24.6	286.04
26.0	286.32
27.2	286.60
29.2	286.69
30.4	287.24
31.6	287.45
33.2	287.81
35.4	288.30
37.3	288.84
39.1	289.19
42.1	289.40
46.2	289.50
49.8	289.89
53.5	290.11

SUMMARY DATA	
<b>Bankfull Elevation:</b>	289.4
<b>Bankfull Cross-Sectional Area:</b>	52.4
<b>Bankfull Width:</b>	27.2
<b>Flood Prone Area Elevation:</b>	-
<b>Flood Prone Width:</b>	-
<b>Max Depth at Bankfull:</b>	3.5
<b>Mean Depth at Bankfull:</b>	1.9
<b>W / D Ratio:</b>	-
<b>Entrenchment Ratio:</b>	-
<b>Bank Height Ratio:</b>	-

<b>Stream Type</b>	E/C
--------------------	-----

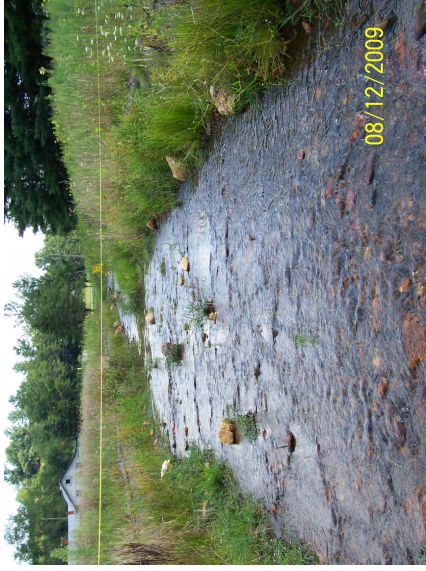
<b>River Basin:</b>	French Broad
<b>Watershed:</b>	Threemile Creek
<b>XS ID</b>	XS - 9, Riffle
<b>Drainage Area (sq mi):</b>	4.7
<b>Date:</b>	8/18/2009
<b>Field Crew:</b>	Lewis, Dean, Perkinson

Station	Elevation
0.0	296.1
7.8	295.0
10.6	294.7
15.3	294.5
17.6	294.8
18.5	294.6
19.6	294.1
21.1	292.8
22.2	292.4
23.5	292.2
25.5	292.1
30.1	292.3
31.8	292.3
33.4	292.2
35.9	292.2
38.9	292.3
40.4	292.7
41.1	293.3
42.1	294.1
43.2	294.6
43.8	294.9
44.9	294.9
47.9	294.9
52.4	295.2
54.5	295.8
56.9	296.8
59.0	296.9

SUMMARY DATA	
<b>Bankfull Elevation:</b>	294.8
<b>Bankfull Cross-Sectional Area:</b>	53.7
<b>Bankfull Width:</b>	26.0
<b>Flood Prone Area Elevation:</b>	297.4
<b>Flood Prone Width:</b>	>65
<b>Max Depth at Bankfull:</b>	2.6
<b>Mean Depth at Bankfull:</b>	2.1
<b>W / D Ratio:</b>	12.6
<b>Entrenchment Ratio:</b>	>5
<b>Bank Height Ratio:</b>	1.0

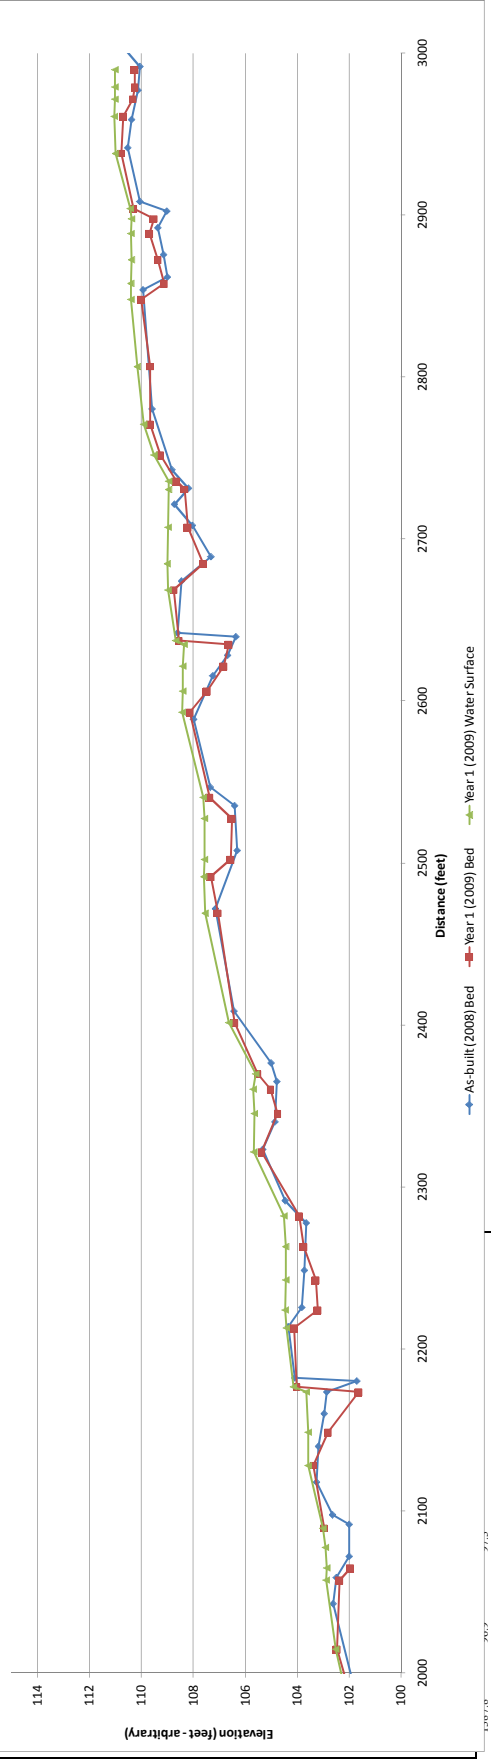
Threemile Creek As-built Profile - Reach 20+00 to 30+00

Avg. Water Surface Slope	2009	2010	2011
Avg. Riffle Length	51.0	52.9	
Avg. Pool Length	0.0154	0.0143	
Avg. Pool Slope	46.0	38.0	
	110.0	0.0008

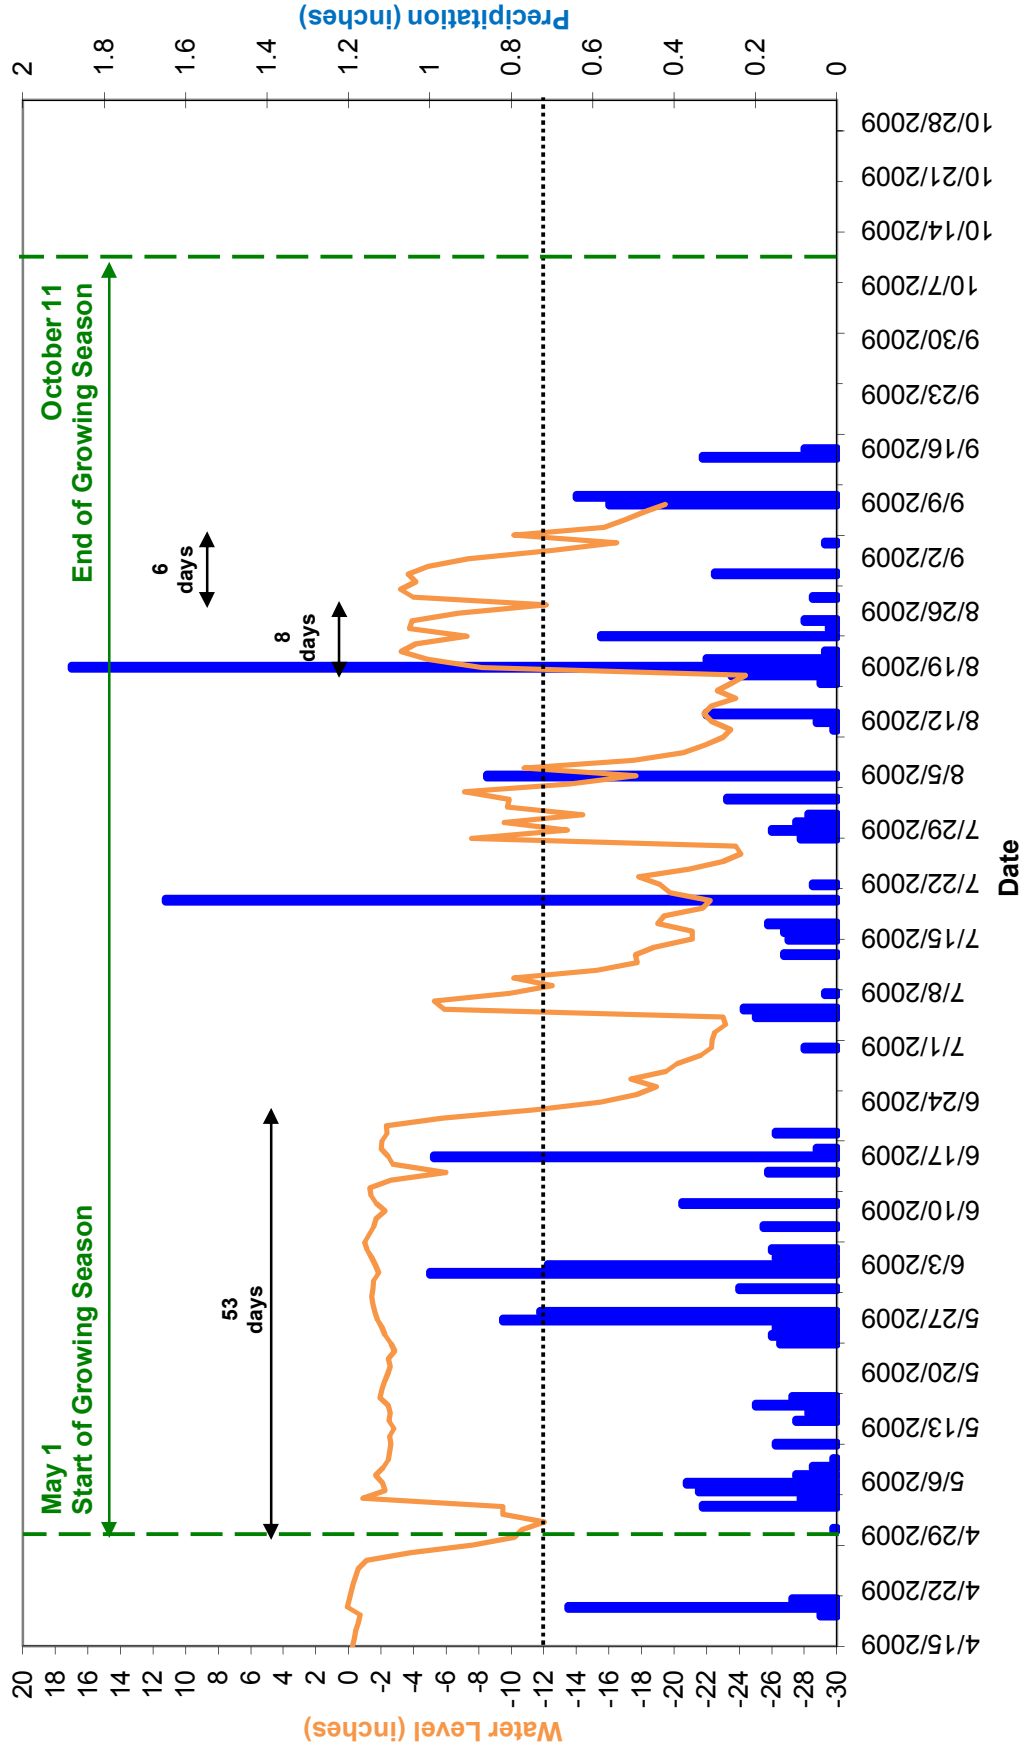
### Threemile- Groundwater Gauge Reference Year 1 (2009 Data)
