**YEAR 2 (2010)**  
**ANNUAL MONITORING REPORT**  
**THREE MILE CREEK RESTORATION SITE**  
**AVERY COUNTY, NORTH CAROLINA**  
**(Contract #16-D06125-A)**

**FULL DELIVERY PROJECT**  
**TO PROVIDE STREAM AND WETLAND MITIGATION**  
**IN THE FRENCH BROAD RIVER BASIN**  
**CATALOGING UNIT 06010108**

**September 2010**

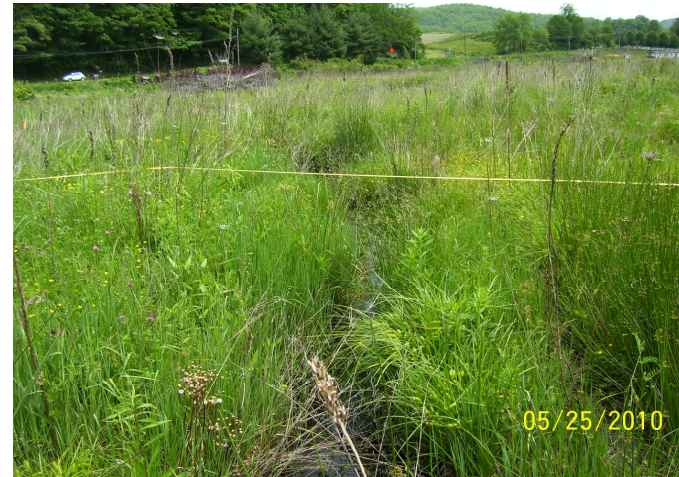
Station	Elevation
0.00	263.62
5.63	263.66
7.88	263.74
9.72	263.73
10.67	263.75
11.09	263.62
11.41	263.55
12.03	263.17
12.52	263.17
12.63	263.12
12.91	263.08
13.24	263.14
13.66	263.27
14.06	263.27
14.62	263.54
15.30	263.85
15.83	264.04
16.45	264.33
17.55	264.22
19.81	264.18
21.75	264.09
24.95	264.07

SUMMARY DATA	
<b>Bankfull Elevation:</b>	263.8
<b>Bankfull Cross-Sectional Area:</b>	1.7
<b>Bankfull Width:</b>	4.4
<b>Flood Prone Area Elevation:</b>	264.5
<b>Flood Prone Width:</b>	>80
<b>Max Depth at Bankfull:</b>	0.7
<b>Mean Depth at Bankfull:</b>	0.4
<b>W / D Ratio:</b>	11.4
<b>Entrenchment Ratio:</b>	>5
<b>Bank Height Ratio:</b>	1.0

<b>Stream Type</b>	E
--------------------	---

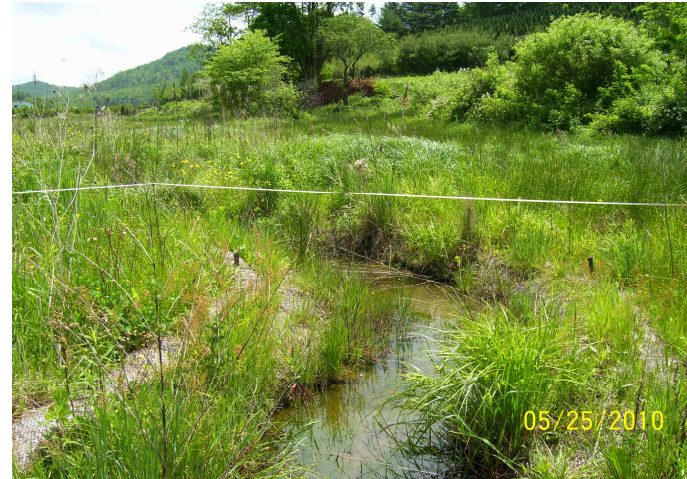
<b>River Basin:</b>	French Broad
<b>Watershed:</b>	Threemile Creek
<b>XS ID</b>	XS - 2, Pool
<b>Drainage Area (sq mi):</b>	0.05
<b>Date:</b>	5/25/2010
<b>Field Crew:</b>	Dean, Perkinson

Station	Elevation
0.00	263.15
1.33	263.29
2.87	263.39
4.27	263.64
6.79	263.81
8.63	263.92
10.17	264.04
10.81	264.11
11.34	263.90
11.71	263.56
12.05	263.41
12.79	262.91
13.49	262.77
14.30	262.75
14.76	262.87
15.20	263.08
15.75	263.28
16.47	263.37
17.06	263.55
17.64	263.83
18.84	264.24
19.87	264.23
23.87	264.50
26.33	264.20
28.94	264.18

SUMMARY DATA	
<b>Bankfull Elevation:</b>	264.1
<b>Bankfull Cross-Sectional Area:</b>	5.9
<b>Bankfull Width:</b>	7.6
<b>Flood Prone Area Elevation:</b>	-
<b>Flood Prone Width:</b>	-
<b>Max Depth at Bankfull:</b>	1.3
<b>Mean Depth at Bankfull:</b>	0.8
<b>W / D Ratio:</b>	-
<b>Entrenchment Ratio:</b>	-
<b>Bank Height Ratio:</b>	-

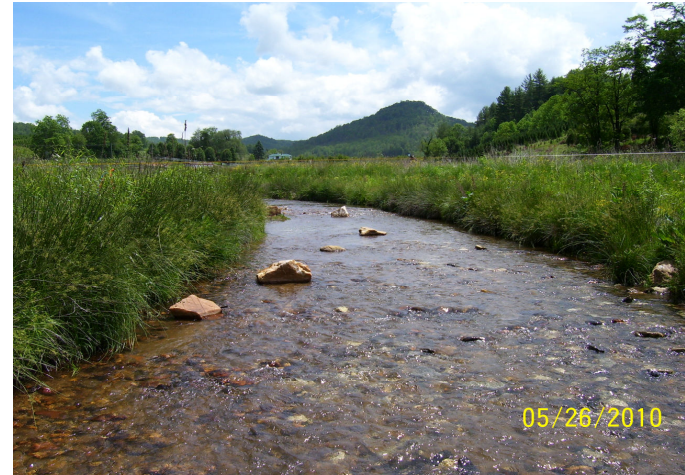
<b>River Basin:</b>	French Broad
<b>Watershed:</b>	Threemile Creek
<b>XS ID</b>	XS - 3, Riffle
<b>Drainage Area (sq mi):</b>	4.7
<b>Date:</b>	5/25/2010
<b>Field Crew:</b>	Dean, Perkinson

Station	Elevation
0.00	264.27
5.56	264.21
6.23	264.19
7.27	263.58
7.82	263.31
8.66	263.03
9.48	262.87
10.80	262.74
12.40	262.85
14.35	262.83
15.64	262.84
16.26	262.72
16.92	262.43
17.82	261.95
18.65	261.55
19.21	261.21
19.97	261.09
20.92	260.69
22.28	260.41
26.86	260.41
29.26	260.41
31.70	260.41
34.25	260.37
35.98	260.46
37.87	260.48
38.97	260.53
39.78	260.69
41.40	261.25
42.19	261.41
42.79	261.66
43.55	262.13
44.94	262.58
46.42	262.61
48.84	262.81
51.52	262.76
53.95	262.95

SUMMARY DATA	
<b>Bankfull Elevation:</b>	262.6
<b>Bankfull Cross-Sectional Area:</b>	49.9
<b>Bankfull Width:</b>	28.5
<b>Flood Prone Area Elevation:</b>	264.8
<b>Flood Prone Width:</b>	>65
<b>Max Depth at Bankfull:</b>	2.2
<b>Mean Depth at Bankfull:</b>	1.8
<b>W / D Ratio:</b>	16.3
<b>Entrenchment Ratio:</b>	>5
<b>Bank Height Ratio:</b>	1.0

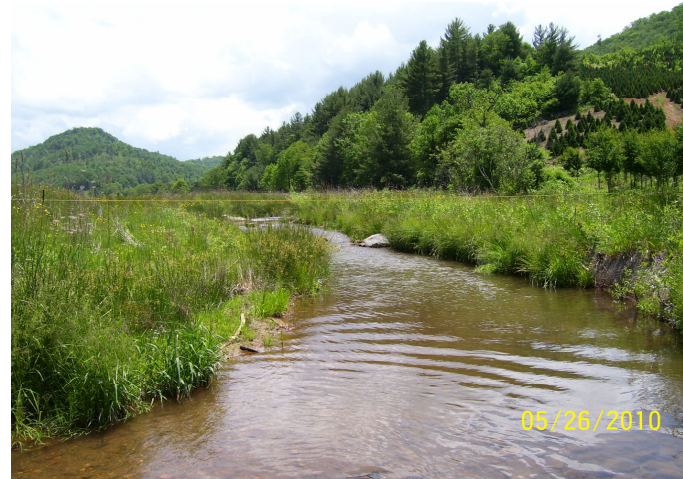
<b>River Basin:</b>	French Broad
<b>Watershed:</b>	Threemile Creek
<b>XS ID</b>	XS - 4, Pool
<b>Drainage Area (sq mi):</b>	4.7
<b>Date:</b>	5/25/2010
<b>Field Crew:</b>	Dean, Perkinson

Station	Elevation
5.7	269.3
8.9	269.4
12.6	269.4
14.2	269.5
15.2	269.4
15.7	268.7
17.2	267.7
18.0	267.7
18.6	267.5
19.2	267.2
19.4	266.5
19.7	266.1
19.9	266.1
20.4	266.0
21.0	266.0
22.2	266.0
23.5	266.0
26.0	266.1
27.6	266.2
29.2	266.4
30.4	266.6
31.1	266.8
31.5	267.0
32.0	267.2
32.4	267.5
32.9	267.6
33.7	267.7
35.4	267.7
36.1	267.8
37.1	268.0
37.7	268.1
38.7	268.4
39.4	268.6
40.7	268.8
42.0	269.0
43.3	269.4

SUMMARY DATA	
<b>Bankfull Elevation:</b>	269.4
<b>Bankfull Cross-Sectional Area:</b>	58.9
<b>Bankfull Width:</b>	27.9
<b>Flood Prone Area Elevation:</b>	-
<b>Flood Prone Width:</b>	-
<b>Max Depth at Bankfull:</b>	3.4
<b>Mean Depth at Bankfull:</b>	2.1
<b>W / D Ratio:</b>	-
<b>Entrenchment Ratio:</b>	-
<b>Bank Height Ratio:</b>	-

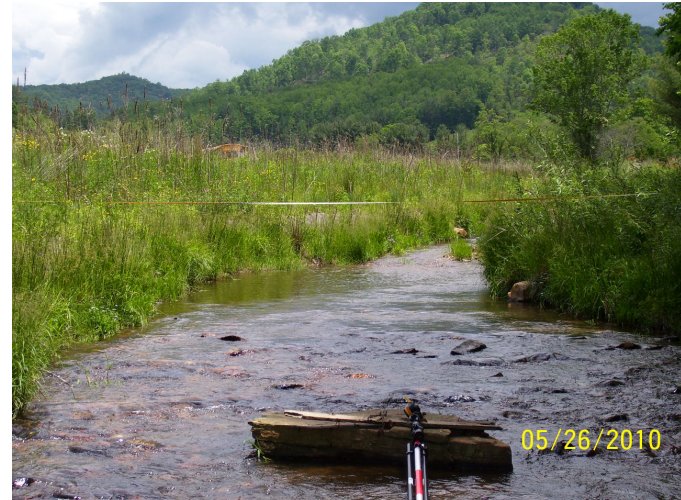
<b>River Basin:</b>	French Broad
<b>Watershed:</b>	Threemile Creek
<b>XS ID</b>	XS - 5, Riffle
<b>Drainage Area (sq mi):</b>	4.7
<b>Date:</b>	5/25/2010
<b>Field Crew:</b>	Dean, Perkinson

Station	Elevation
0.0	275.0
3.3	275.0
4.1	275.0
5.2	274.8
5.4	274.8
6.0	274.6
6.6	274.2
7.1	273.5
7.8	273.3
8.0	273.1
8.6	273.1
9.3	272.9
9.6	272.7
10.3	272.5
12.9	272.4
14.9	272.2
17.4	272.3
21.1	272.4
24.2	272.6
26.5	272.4
27.8	272.5
28.3	272.8
29.2	273.1
29.7	273.2
30.4	273.4
31.3	273.8
32.5	274.7
33.2	275.0
34.2	275.1
36.3	275.0
39.4	274.9
41.9	275.0
43.1	275.3
44.3	275.6
46.2	276.2
50.5	276.4

SUMMARY DATA	
<b>Bankfull Elevation:</b>	275.0
<b>Bankfull Cross-Sectional Area:</b>	61.3
<b>Bankfull Width:</b>	29.6
<b>Flood Prone Area Elevation:</b>	277.8
<b>Flood Prone Width:</b>	>65
<b>Max Depth at Bankfull:</b>	2.8
<b>Mean Depth at Bankfull:</b>	2.1
<b>W / D Ratio:</b>	14.3
<b>Entrenchment Ratio:</b>	>5
<b>Bank Height Ratio:</b>	1.0

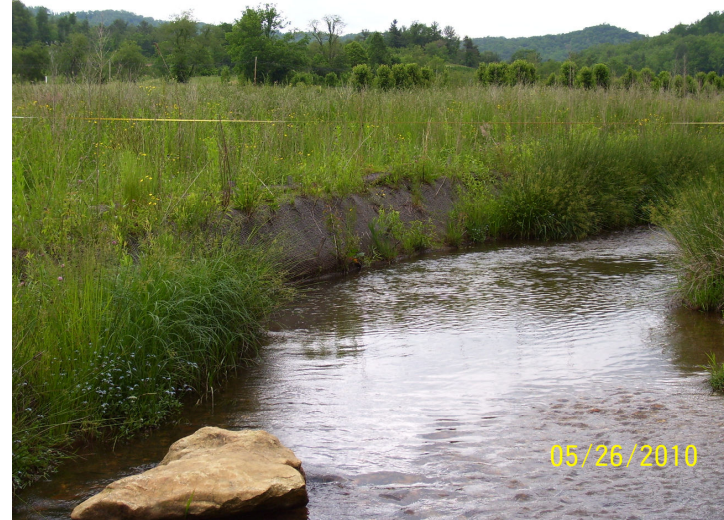
<b>River Basin:</b>	French Broad
<b>Watershed:</b>	Threemile Creek
<b>XS ID</b>	XS - 6, Pool
<b>Drainage Area (sq mi):</b>	4.7
<b>Date:</b>	5/25/2010
<b>Field Crew:</b>	Dean, Perkinson

Station	Elevation
0.0	279.9
4.7	279.9
9.0	280.0
10.7	279.9
11.9	279.9
12.4	279.6
13.2	279.2
13.9	279.0
15.0	278.7
15.9	278.4
16.7	278.3
17.6	278.2
18.4	278.1
18.8	278.1
19.7	277.6
20.6	277.2
21.7	276.9
22.8	276.9
23.6	276.7
24.3	276.6
25.4	276.5
26.6	276.4
27.6	276.1
28.5	275.8
29.1	275.7
29.8	275.6
30.2	275.6
30.9	275.7
31.5	276.2
32.9	278.9
33.4	279.9
34.1	280.1
35.7	280.0
37.1	279.9
38.4	279.9
41.1	280.1

SUMMARY DATA	
<b>Bankfull Elevation:</b>	279.9
<b>Bankfull Cross-Sectional Area:</b>	54.6
<b>Bankfull Width:</b>	21.5
<b>Flood Prone Area Elevation:</b>	-
<b>Flood Prone Width:</b>	-
<b>Max Depth at Bankfull:</b>	4.3
<b>Mean Depth at Bankfull:</b>	2.5
<b>W / D Ratio:</b>	-
<b>Entrenchment Ratio:</b>	-
<b>Bank Height Ratio:</b>	-

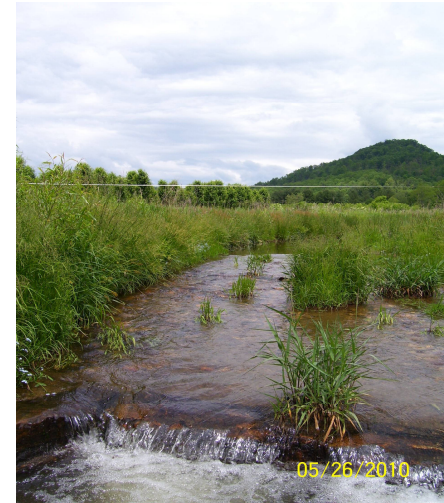
<b>River Basin:</b>	French Broad
<b>Watershed:</b>	Threemile Creek
<b>XS ID</b>	XS - 7, Riffle
<b>Drainage Area (sq mi):</b>	4.7
<b>Date:</b>	5/25/2010
<b>Field Crew:</b>	Dean, Perkinson

Station	Elevation
0.0	283.9
7.0	283.6
11.4	283.7
13.4	283.8
14.6	283.8
15.1	283.6
16.0	282.9
16.8	282.2
17.6	281.9
18.2	281.8
19.0	281.5
20.1	281.6
21.4	281.4
24.1	281.2
25.0	281.4
26.7	281.3
28.6	281.2
29.7	281.1
31.0	281.3
32.1	281.3
33.4	281.2
34.0	281.3
34.9	281.5
35.7	281.8
36.5	282.2
37.4	283.2
38.2	283.8
38.6	284.0
40.1	284.1
41.1	283.9
43.6	283.9
47.5	284.5
50.1	284.5

SUMMARY DATA	
<b>Bankfull Elevation:</b>	283.8
<b>Bankfull Cross-Sectional Area:</b>	48.7
<b>Bankfull Width:</b>	23.6
<b>Flood Prone Area Elevation:</b>	286.4
<b>Flood Prone Width:</b>	>65
<b>Max Depth at Bankfull:</b>	2.6
<b>Mean Depth at Bankfull:</b>	2.1
<b>W / D Ratio:</b>	11.4
<b>Entrenchment Ratio:</b>	>5
<b>Bank Height Ratio:</b>	1.0

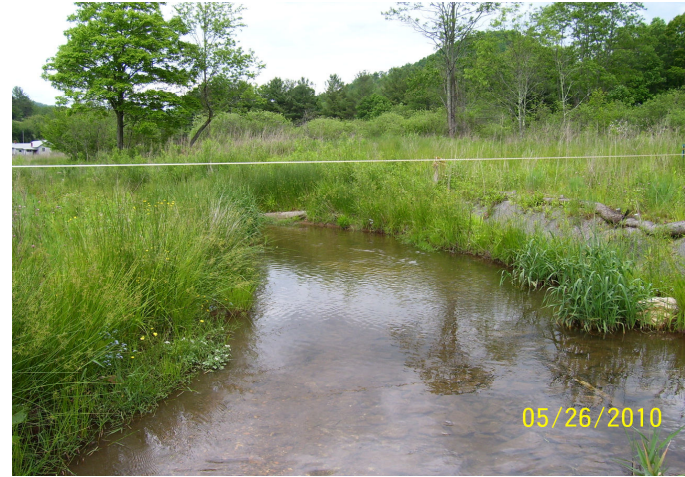
<b>River Basin:</b>	French Broad
<b>Watershed:</b>	Threemile Creek
<b>XS ID</b>	XS - 8, Pool
<b>Drainage Area (sq mi):</b>	4.7
<b>Date:</b>	5/25/2010
<b>Field Crew:</b>	Dean, Perkinson

Station	Elevation
0.0	289.70
5.3	289.73
9.6	289.52
11.8	289.39
13.3	289.02
14.6	289.20
18.9	285.62
19.7	285.74
20.0	285.78
21.0	285.78
21.8	285.98
22.3	286.05
22.9	285.85
23.8	285.95
24.8	286.34
25.3	286.32
25.7	286.53
26.6	286.68
27.2	286.56
27.9	286.50
28.8	286.33
29.2	286.62
29.7	286.83
30.2	287.35
31.6	287.58
33.0	287.64
34.5	287.99
35.9	288.32
37.0	288.63
38.5	289.07
40.0	289.33
42.4	289.37
46.0	289.44
49.4	289.68
52.2	290.03
53.5	290.08

SUMMARY DATA	
<b>Bankfull Elevation:</b>	289.2
<b>Bankfull Cross-Sectional Area:</b>	51.2
<b>Bankfull Width:</b>	26.7
<b>Flood Prone Area Elevation:</b>	-
<b>Flood Prone Width:</b>	-
<b>Max Depth at Bankfull:</b>	3.6
<b>Mean Depth at Bankfull:</b>	1.9
<b>W / D Ratio:</b>	-
<b>Entrenchment Ratio:</b>	-
<b>Bank Height Ratio:</b>	-

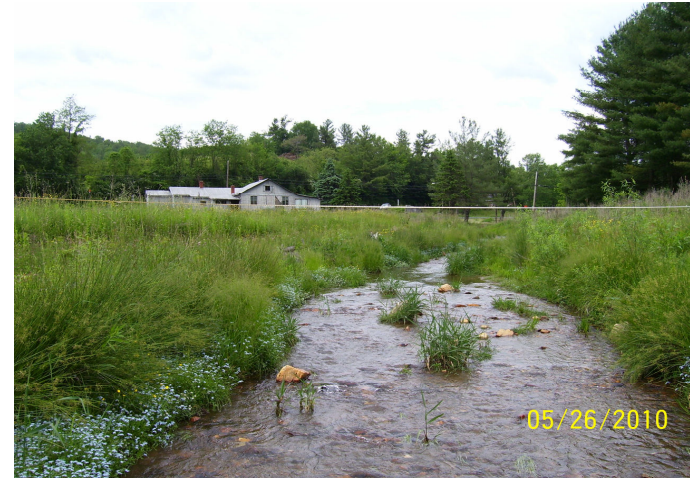
<b>River Basin:</b>	French Broad
<b>Watershed:</b>	Threemile Creek
<b>XS ID</b>	XS - 9, Riffle
<b>Drainage Area (sq mi):</b>	4.7
<b>Date:</b>	5/25/2010
<b>Field Crew:</b>	Dean, Perkinson

Station	Elevation
0.0	296.0
6.4	295.3
9.5	294.7
11.6	294.7
14.4	294.5
16.0	294.5
16.7	294.6
17.8	294.6
18.7	294.4
19.7	294.0
20.0	293.6
20.6	293.2
21.7	292.7
22.6	292.5
23.3	292.4
24.0	292.2
24.9	292.2
26.3	292.2
27.6	292.2
28.8	292.2
29.7	292.3
30.5	292.3
31.5	292.3
33.0	292.0
34.4	292.0
35.4	292.0
36.4	292.2
37.4	292.5
38.8	292.9
40.1	292.6
41.4	293.1
42.4	293.9
43.4	294.5
44.0	294.8
44.9	294.9
47.8	295.0

SUMMARY DATA	
<b>Bankfull Elevation:</b>	294.6
<b>Bankfull Cross-Sectional Area:</b>	50.4
<b>Bankfull Width:</b>	25.8
<b>Flood Prone Area Elevation:</b>	297.2
<b>Flood Prone Width:</b>	>65
<b>Max Depth at Bankfull:</b>	2.6
<b>Mean Depth at Bankfull:</b>	2.0
<b>W / D Ratio:</b>	13.2
<b>Entrenchment Ratio:</b>	>5
<b>Bank Height Ratio:</b>	1.0

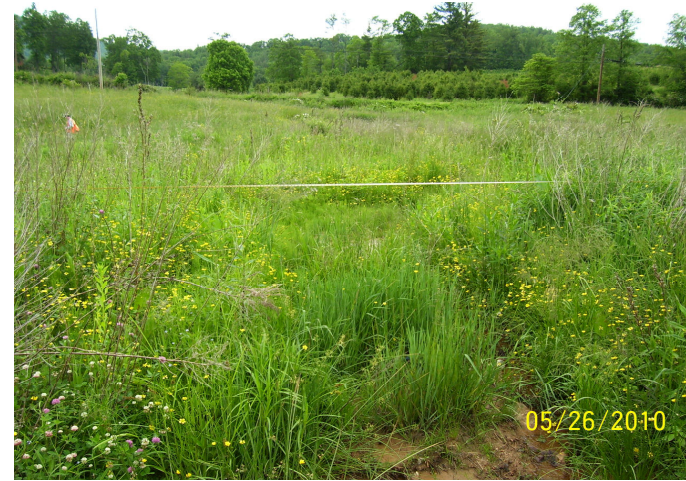
<b>River Basin:</b>	French Broad
<b>Watershed:</b>	Threemile Creek
<b>XS ID</b>	XS - 10, Riffle
<b>Drainage Area (sq mi):</b>	0.05
<b>Date:</b>	5/25/2010
<b>Field Crew:</b>	Dean, Perkinson

Station	Elevation
0.0	296.21
3.4	296.31
5.1	296.23
6.3	296.26
8.0	296.28
8.8	296.38
10.0	296.00
10.8	295.76
11.6	295.58
12.4	295.54
13.0	295.59
13.7	295.65
14.3	295.77
14.8	295.81
15.5	295.77
16.6	295.7
17.7	295.9
18.8	296.1
20.0	296.0
22.0	296.1
23.6	296.0
26.4	296.1
29.8	296.0

SUMMARY DATA	
<b>Bankfull Elevation:</b>	296.1
<b>Bankfull Cross-Sectional Area:</b>	3.1
<b>Bankfull Width:</b>	9.1
<b>Flood Prone Area Elevation:</b>	296.7
<b>Flood Prone Width:</b>	>35
<b>Max Depth at Bankfull:</b>	0.6
<b>Mean Depth at Bankfull:</b>	0.3
<b>W / D Ratio:</b>	26.7
<b>Entrenchment Ratio:</b>	>5
<b>Bank Height Ratio:</b>	1.0

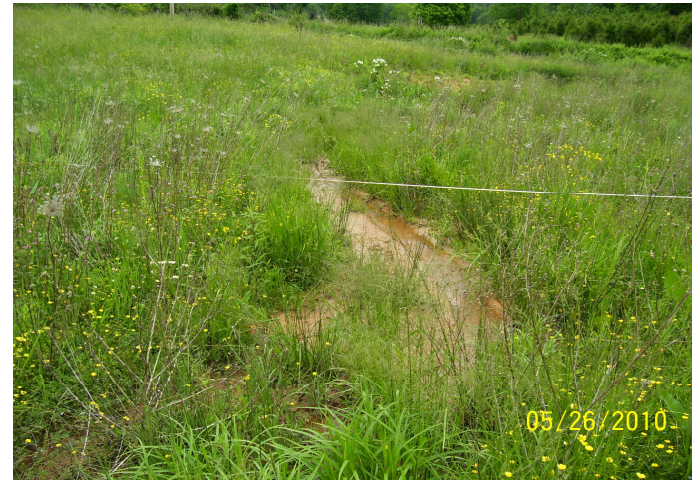
<b>River Basin:</b>	French Broad
<b>Watershed:</b>	Threemile Creek
<b>XS ID</b>	XS - 11, Pool
<b>Drainage Area (sq mi):</b>	0.05
<b>Date:</b>	5/25/2010
<b>Field Crew:</b>	Dean, Perkinson

Station	Elevation
0.0	297.5
1.0	297.5
2.6	297.5
3.9	297.6
5.6	297.5
7.0	297.6
8.4	297.7
9.0	297.6
9.7	297.6
10.1	297.6
10.6	297.6
11.1	297.6
11.5	297.7
12.1	297.8
12.5	297.6
13.1	297.6
13.7	297.7
14.3	297.6
15.3	297.7
16.7	297.8
18.2	297.8
19.7	297.8
21.2	297.9
22.9	298.1
25.6	297.8

SUMMARY DATA	
<b>Bankfull Elevation:</b>	297.7
<b>Bankfull Cross-Sectional Area:</b>	0.5
<b>Bankfull Width:</b>	6.6
<b>Flood Prone Area Elevation:</b>	-
<b>Flood Prone Width:</b>	-
<b>Max Depth at Bankfull:</b>	0.2
<b>Mean Depth at Bankfull:</b>	0.1
<b>W / D Ratio:</b>	-
<b>Entrenchment Ratio:</b>	-
<b>Bank Height Ratio:</b>	-

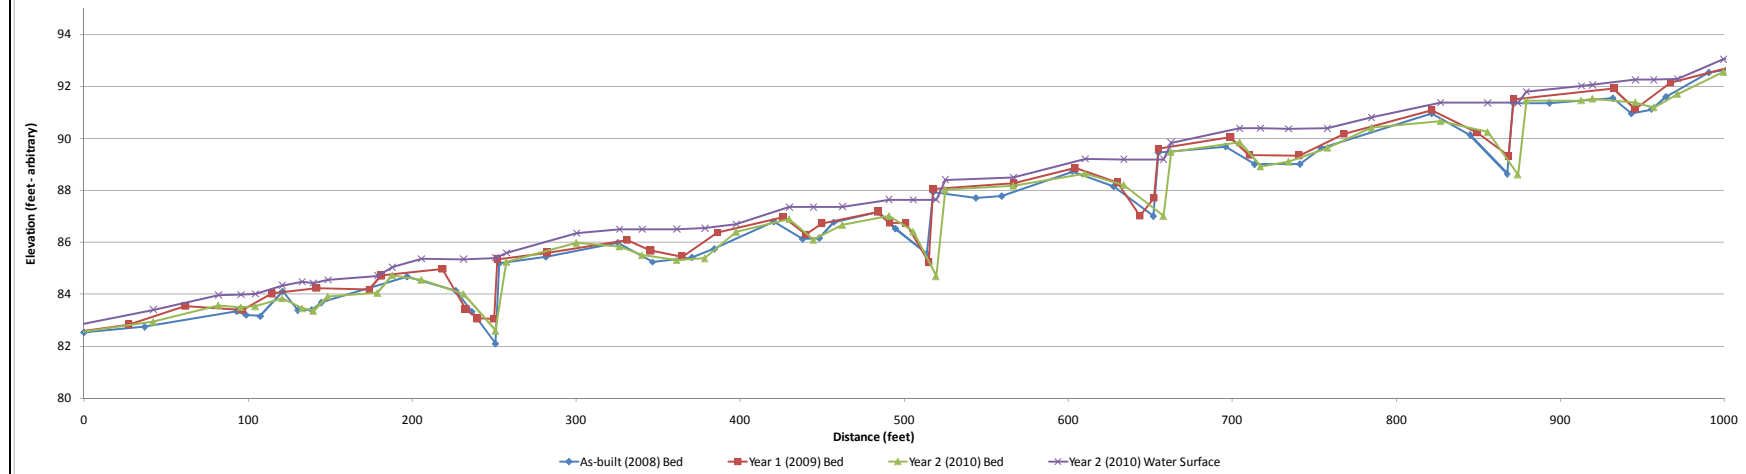
Threemile Creek Year 2 (2010) Profile - Reach 00+00 to 10+00

Project Name: Threemile Creek - Year 1 (2009) Profile											
Reach: 00+00 - 10+00											
Feature: Profile											
Date: 5/20/10											
Crew: Lewis, Jerginson											
2008 As-built Survey			2009 Year 1 Monitoring /Survey			2010 Year 2 Monitoring /Survey			2011 Year 3 Monitoring /Survey		
Station	Bed Elevation	Water Elevation	Station	Bed Elevation	Water Elevation	Station	Bed Elevation	Water Elevation	Station	Bed Elevation	Water Elevation

As-built	2009	2010	2011
Avg. Water Surface Slope	0.0098	0.0097	0.0098	
Riffle Length	51	53	51	
Avg. Riffle Slope	0.0154	0.0143	0.0148	
Pool Length	46	38	44	
Pool to Pool Spacing	-----	0.0008	0.0

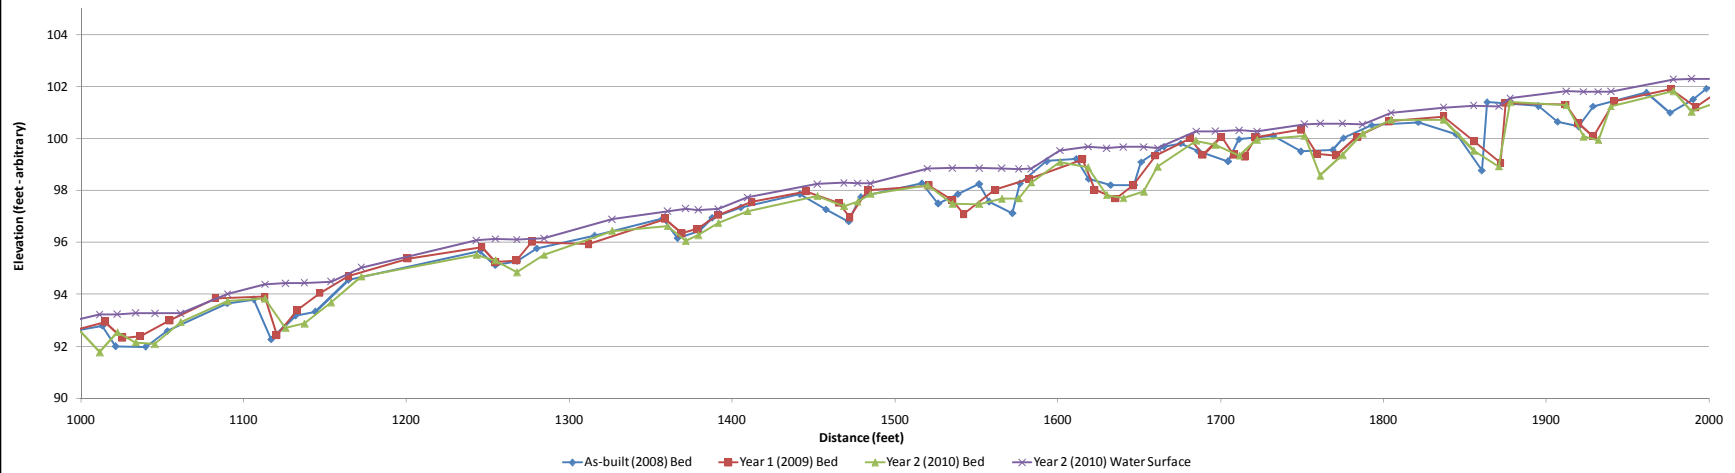
Threemile Creek Year 2 (2010) Profile - Reach 10+00 to 20+00

As-built	2009	2010	2011
Avg. Water Surface Slope	0.0098	0.0097	0.0098	
Riffle Length	51.0	52.9	51	
Avg. Riffle Slope	0.0154	0.0143	0.0148	
Pool Length	46.0	38.0	44	
Avg. Pool Slope	110.0	0.0008	0.0

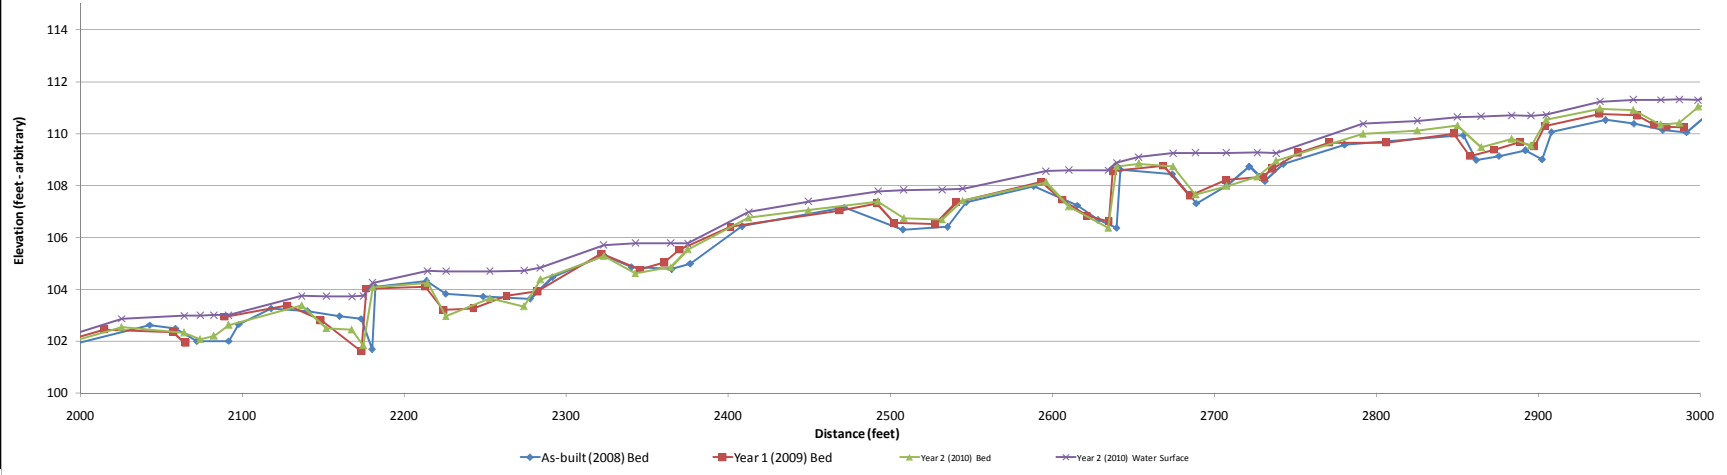
Threemile Creek Year 2 (2010) Profile - Reach 20+00 to 30+00

As-built	2009	2010	2011
Avg. Water Surface Slope	0.0098	0.0097	0.0098	
Riffle Length	51.0	52.9	51	
Avg. Riffle Slope	0.0154	0.0143	0.0148	
Pool Length	46.0	38.0	44	
Avg. Pool Slope	110.0	0.0008	0.0

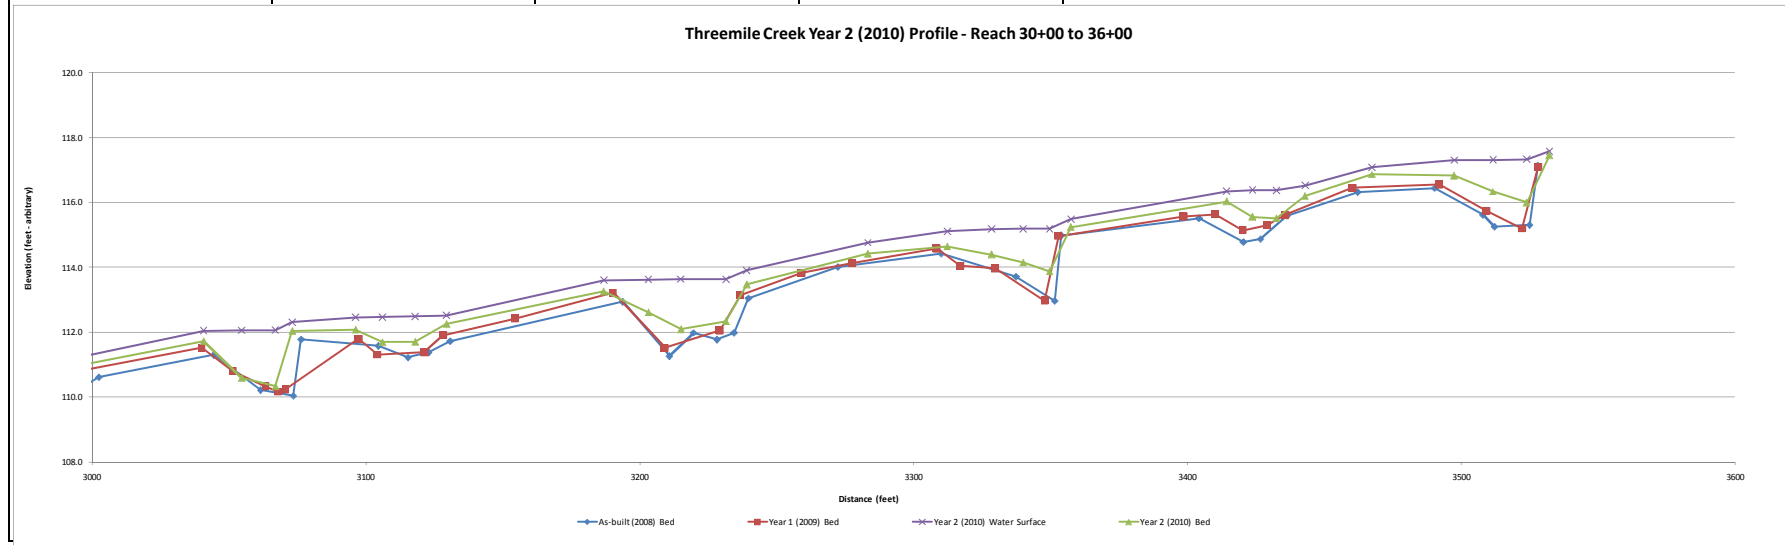
Project Name Threemile Creek - Year 1 (2009) Profile											
Reach 30+00 - 36+00											
Feature Profile											
Date 5/20/10											
Crew Lewis, Jerginson											
2008 As-built Survey			2009 Year 1 Monitoring /Survey			2010 Year 2 Monitoring /Survey			2011 Year 3 Monitoring /Survey		
Station	Bed Elevation	Water Elevation	Station	Bed Elevation	Water Elevation	Station	Bed Elevation	Water Elevation	Station	Bed Elevation	Water Elevation

As-built	2009	2010	2011
Avg. Water Surface Slope	0.0098	0.0097		
Rifle Length	51.0	52.9	51	
Avg. Rifle Slope	0.0154	0.0143	0.0148	
Pool Length	46.0	38.0	44	
Avg. Pool Slope	110.0	0.0008	0.0
