# **STREAM MITIGATION PLAN**

## **Tick Creek Condoret Property Chatham County, North Carolina**

**State Project No. 8.U492107  
TIP No. U-2524WM**

**September 2002**

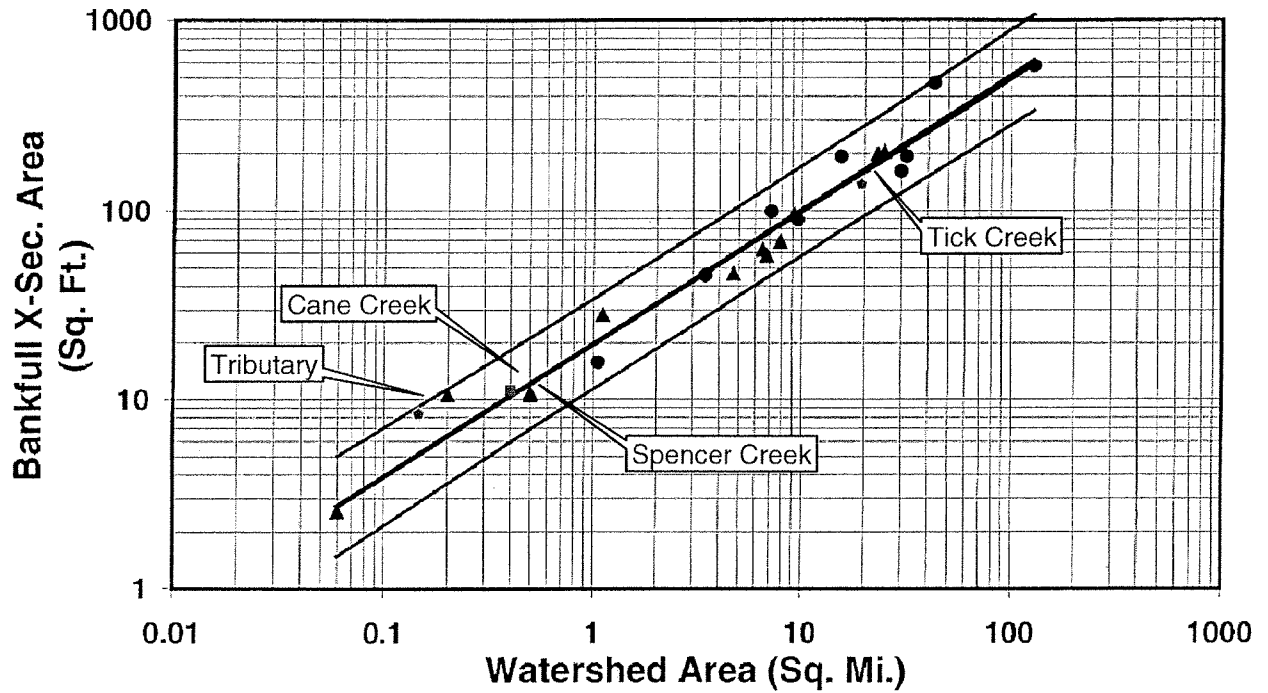
$A_{bkf} = 18.21 A_w^{0.75}; (R^2 = 0.98)$   
 $A_w = \text{watershed drainage area (mi}^2)$   
 $A_{bkf} = \text{bankfull cross sectional area (ft}^2)$

- ▲ Reference Reaches
- Gage Stations
- Project Reference Reaches
- Project Site
- Upper 95%
- Predicted
- Lower 95%

In ungaged areas, Dave Rosgen recommends verifying bankfull with the development of regional curves. The regional curves normally plot bankfull discharge ( $Q_{bkt}$ ), cross-sectional area, width, and depth as a function of drainage area. The cross-sectional areas of Tick Creek, the Unnamed Tributary, and the reference reach sites used for this report are plotted on the Rural Piedmont Regional Curve of North Carolina developed by the North Carolina State University (NCSU) Water Quality Group, 2000 (Figure 3).

Data obtained from field surveys described in Section 2.2.2 were used to compute the morphological characteristics shown on the graph. The cross-sectional areas for Tick Creek and the Unnamed Tributary plot along the trend line for the Rural Regional Curve. The bankfull cross-sectional area for the Unnamed Tributaries design channel was determined from evaluating the North Carolina regional curve relationships and comparing them to the reference reach sites surveyed near the restoration site.

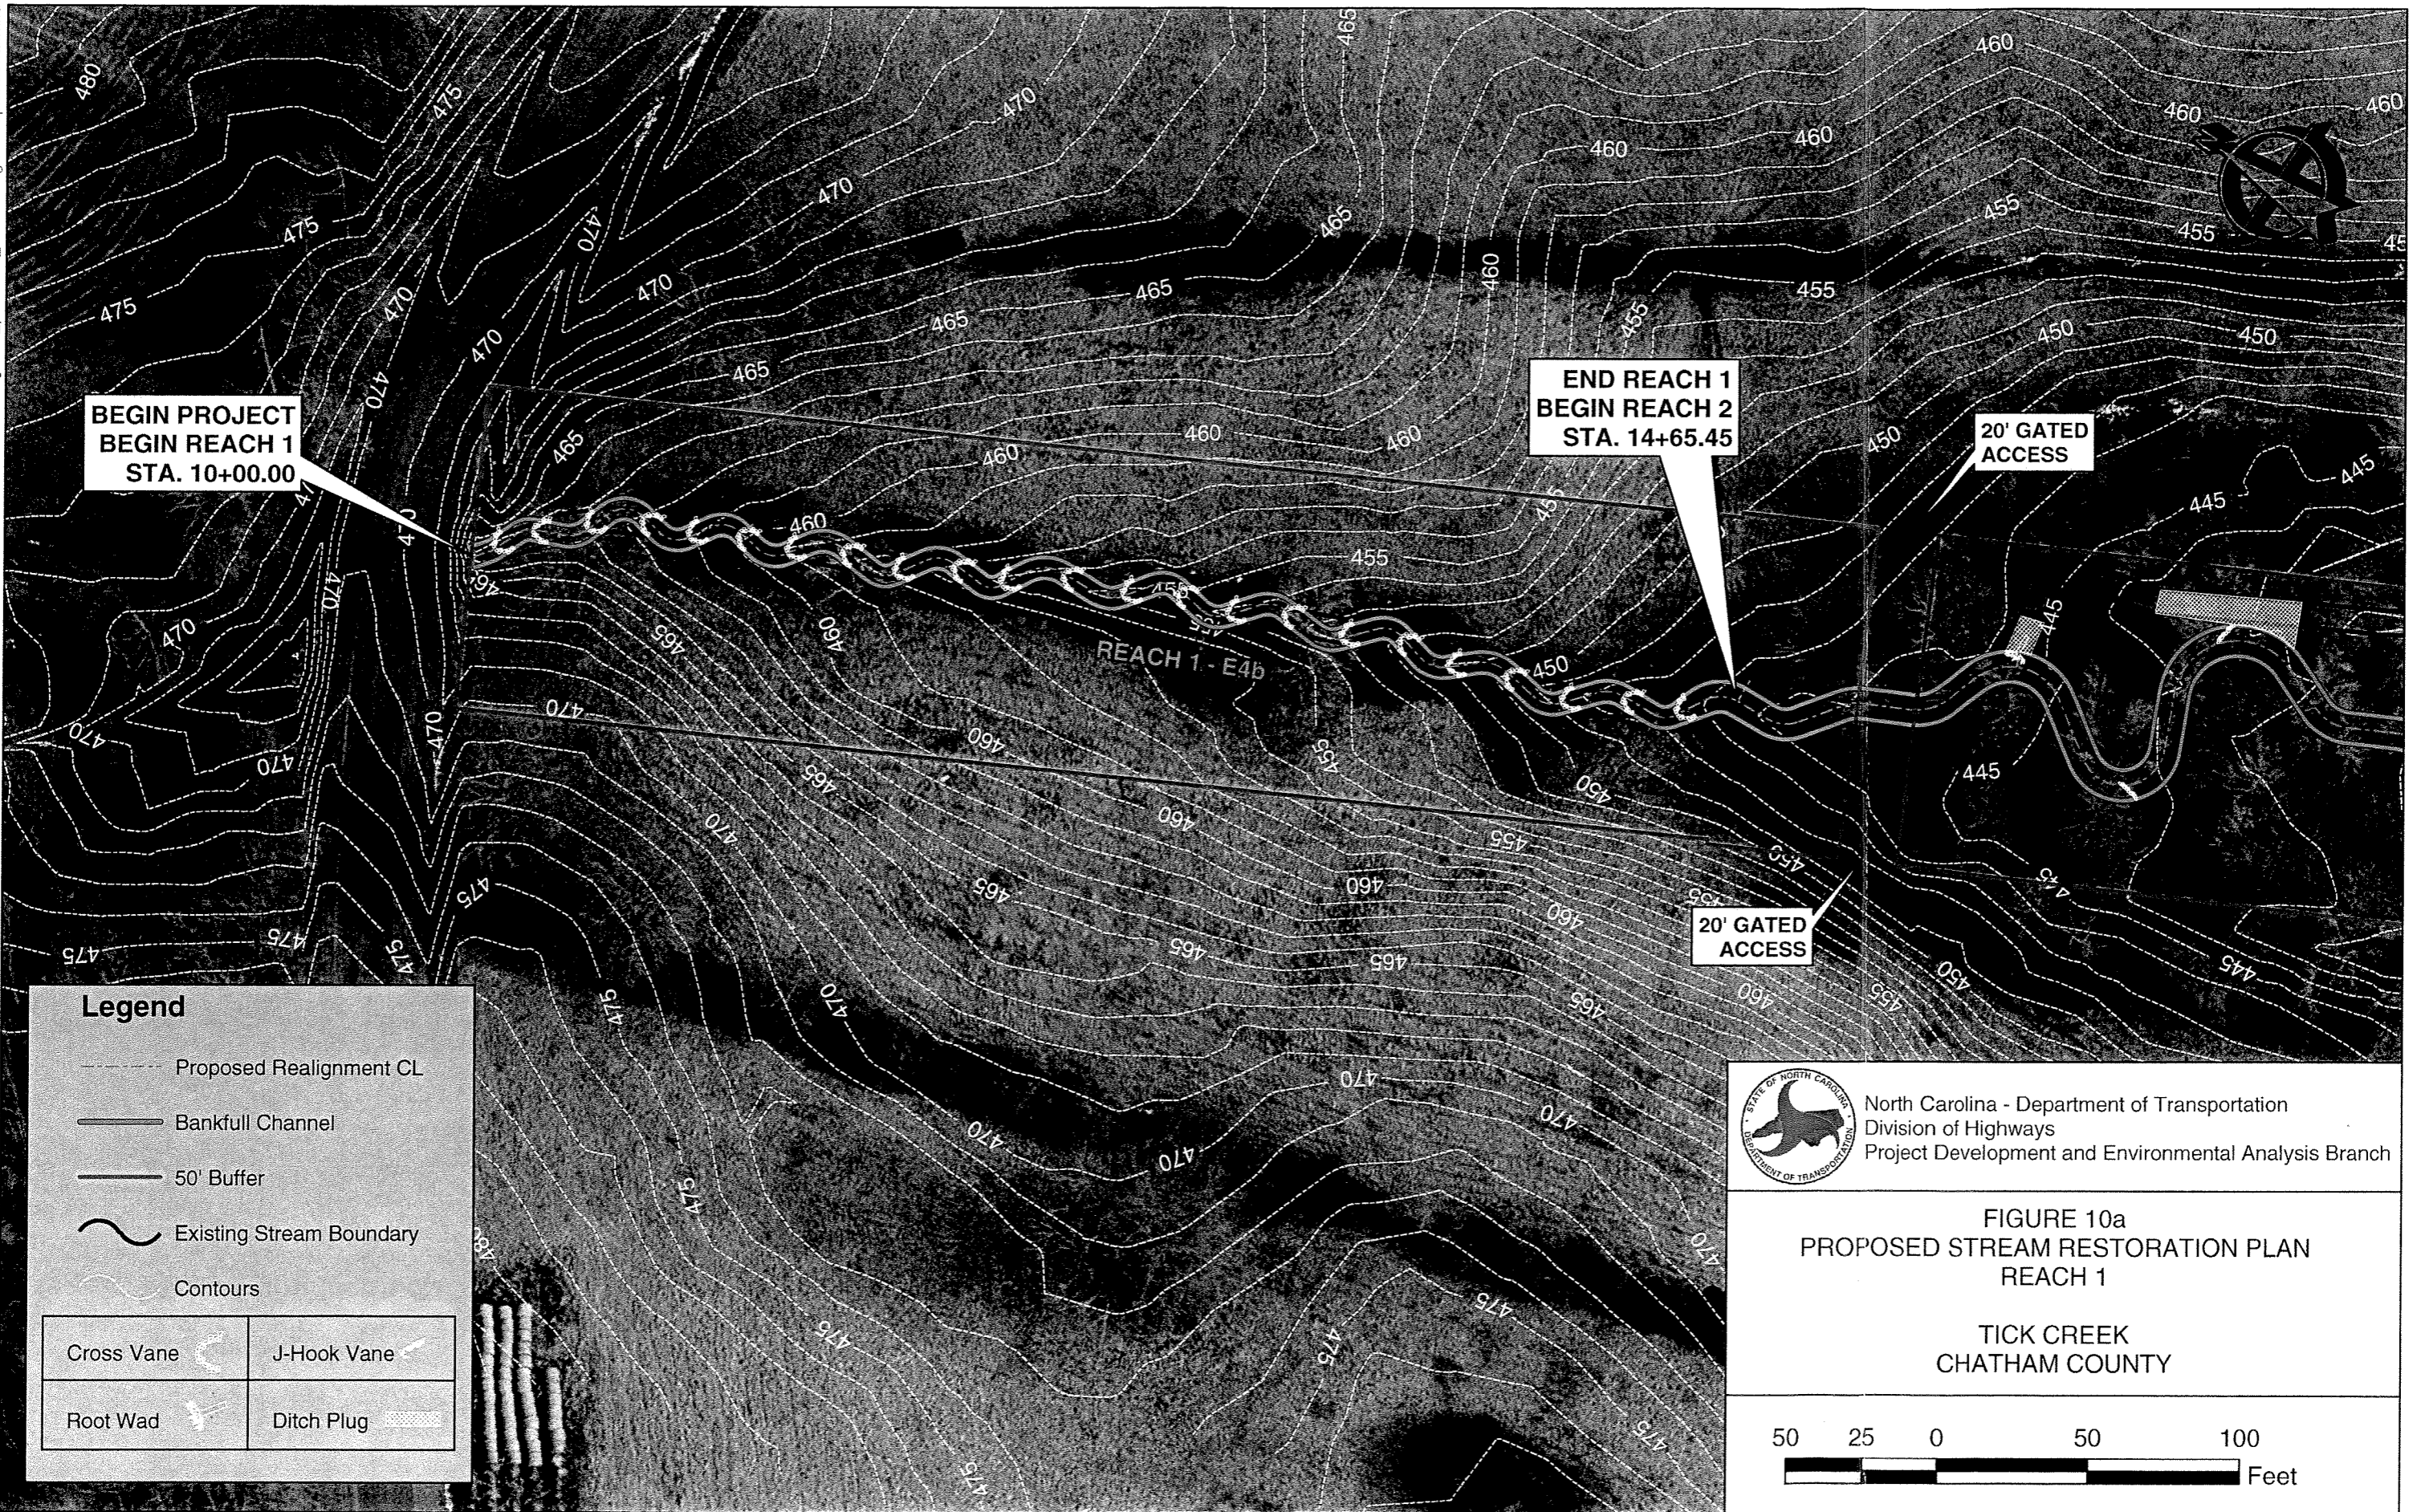
**BEGIN PROJECT  
BEGIN REACH 1  
STA. 10+00.00**

**END REACH 1  
BEGIN REACH 2  
STA. 14+65.45**

The existing Unnamed Tributary has some existing riffle/pool sequences, but they are sporadic. The design channel will incorporate riffles and pools to provide bedform found in C and E stream types with gravel bottoms (Figure 11). Pools will be located in the outside of meander bends with riffles in the inflection points between meanders. The degree of bedform alterations will relate to the type of valley the existing channels flow through. The proposed riffles will have a thalweg depth that ranges between 1.2 to 1.5 feet. Cross vanes will be utilized as grade control structures throughout the proposed channels. The cross vanes will be constructed out of natural materials such as boulders and stone. Modifications to the bedform will provide stability and habitat to the channel.

Several structure types will be installed in the stream channels. These structures include cross vanes, j-hook vanes, and root wads, which will all be constructed from natural materials. The need for additional structure types will be assessed during the final design stage.

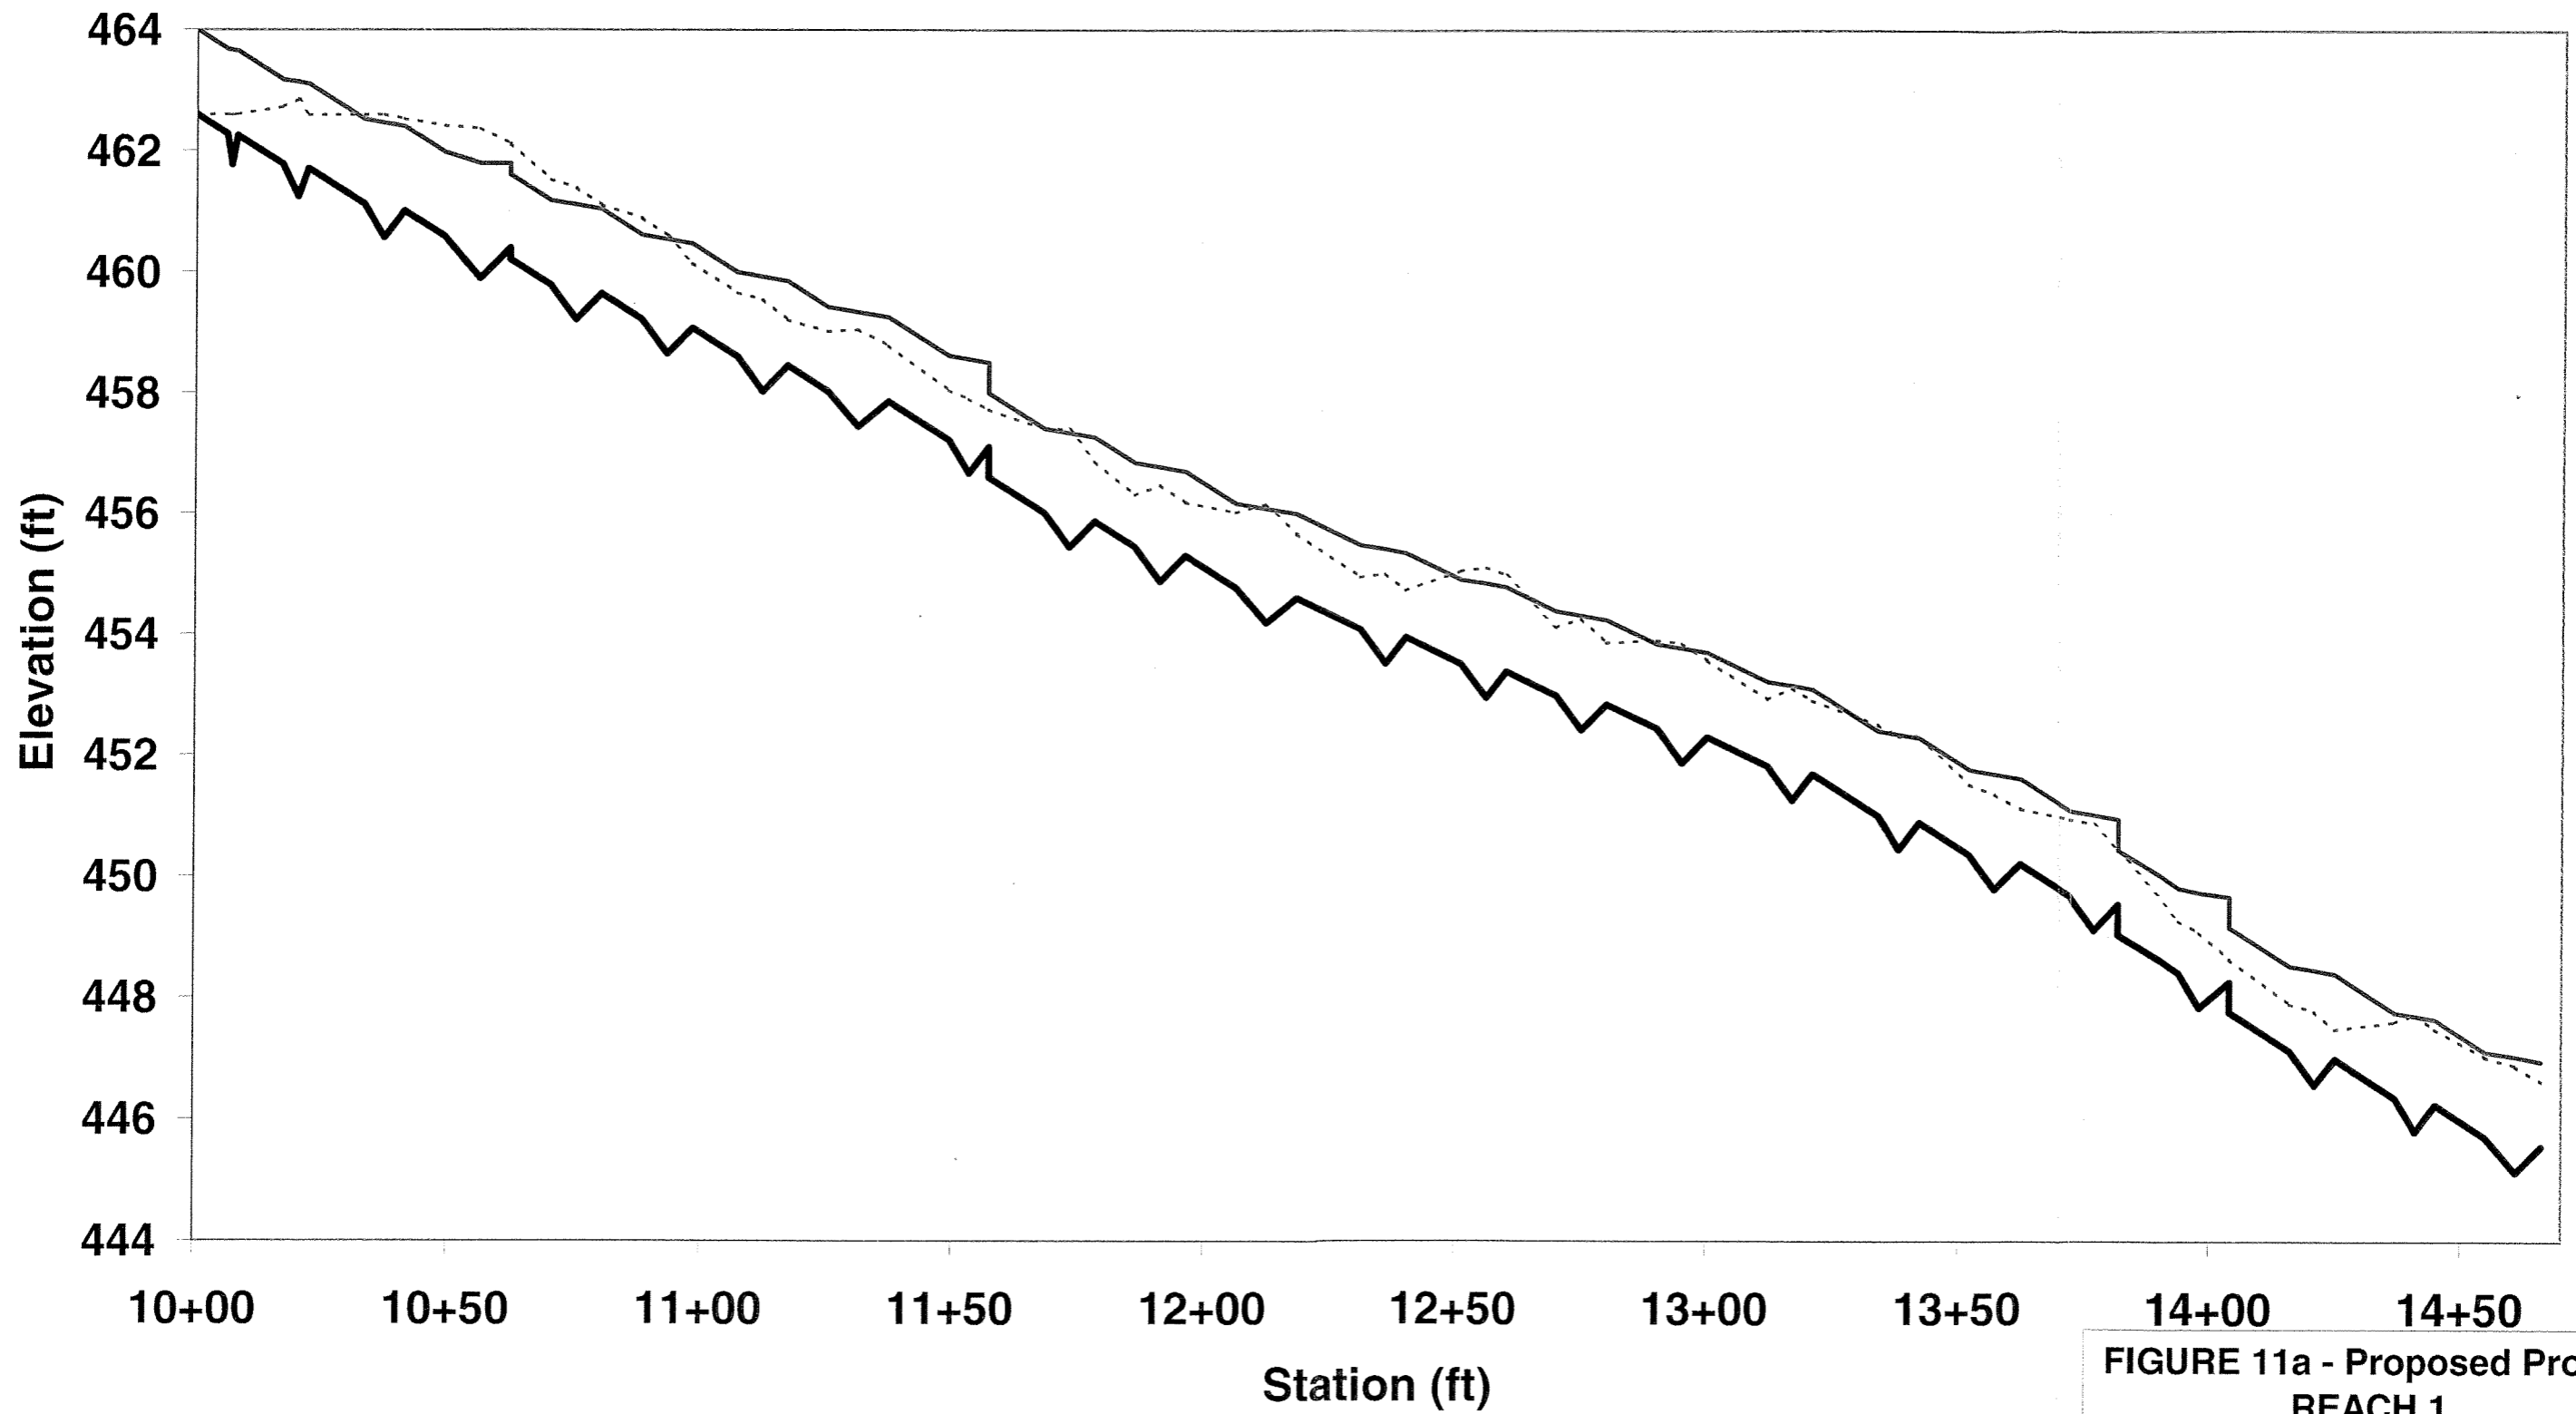
**FIGURE 11a - Proposed Profile  
REACH 1  
Tick Creek Restoration Plan  
Chatham County, North Carolina**

..... Existing Grade      — Proposed Bankfull      — Proposed Thalweg

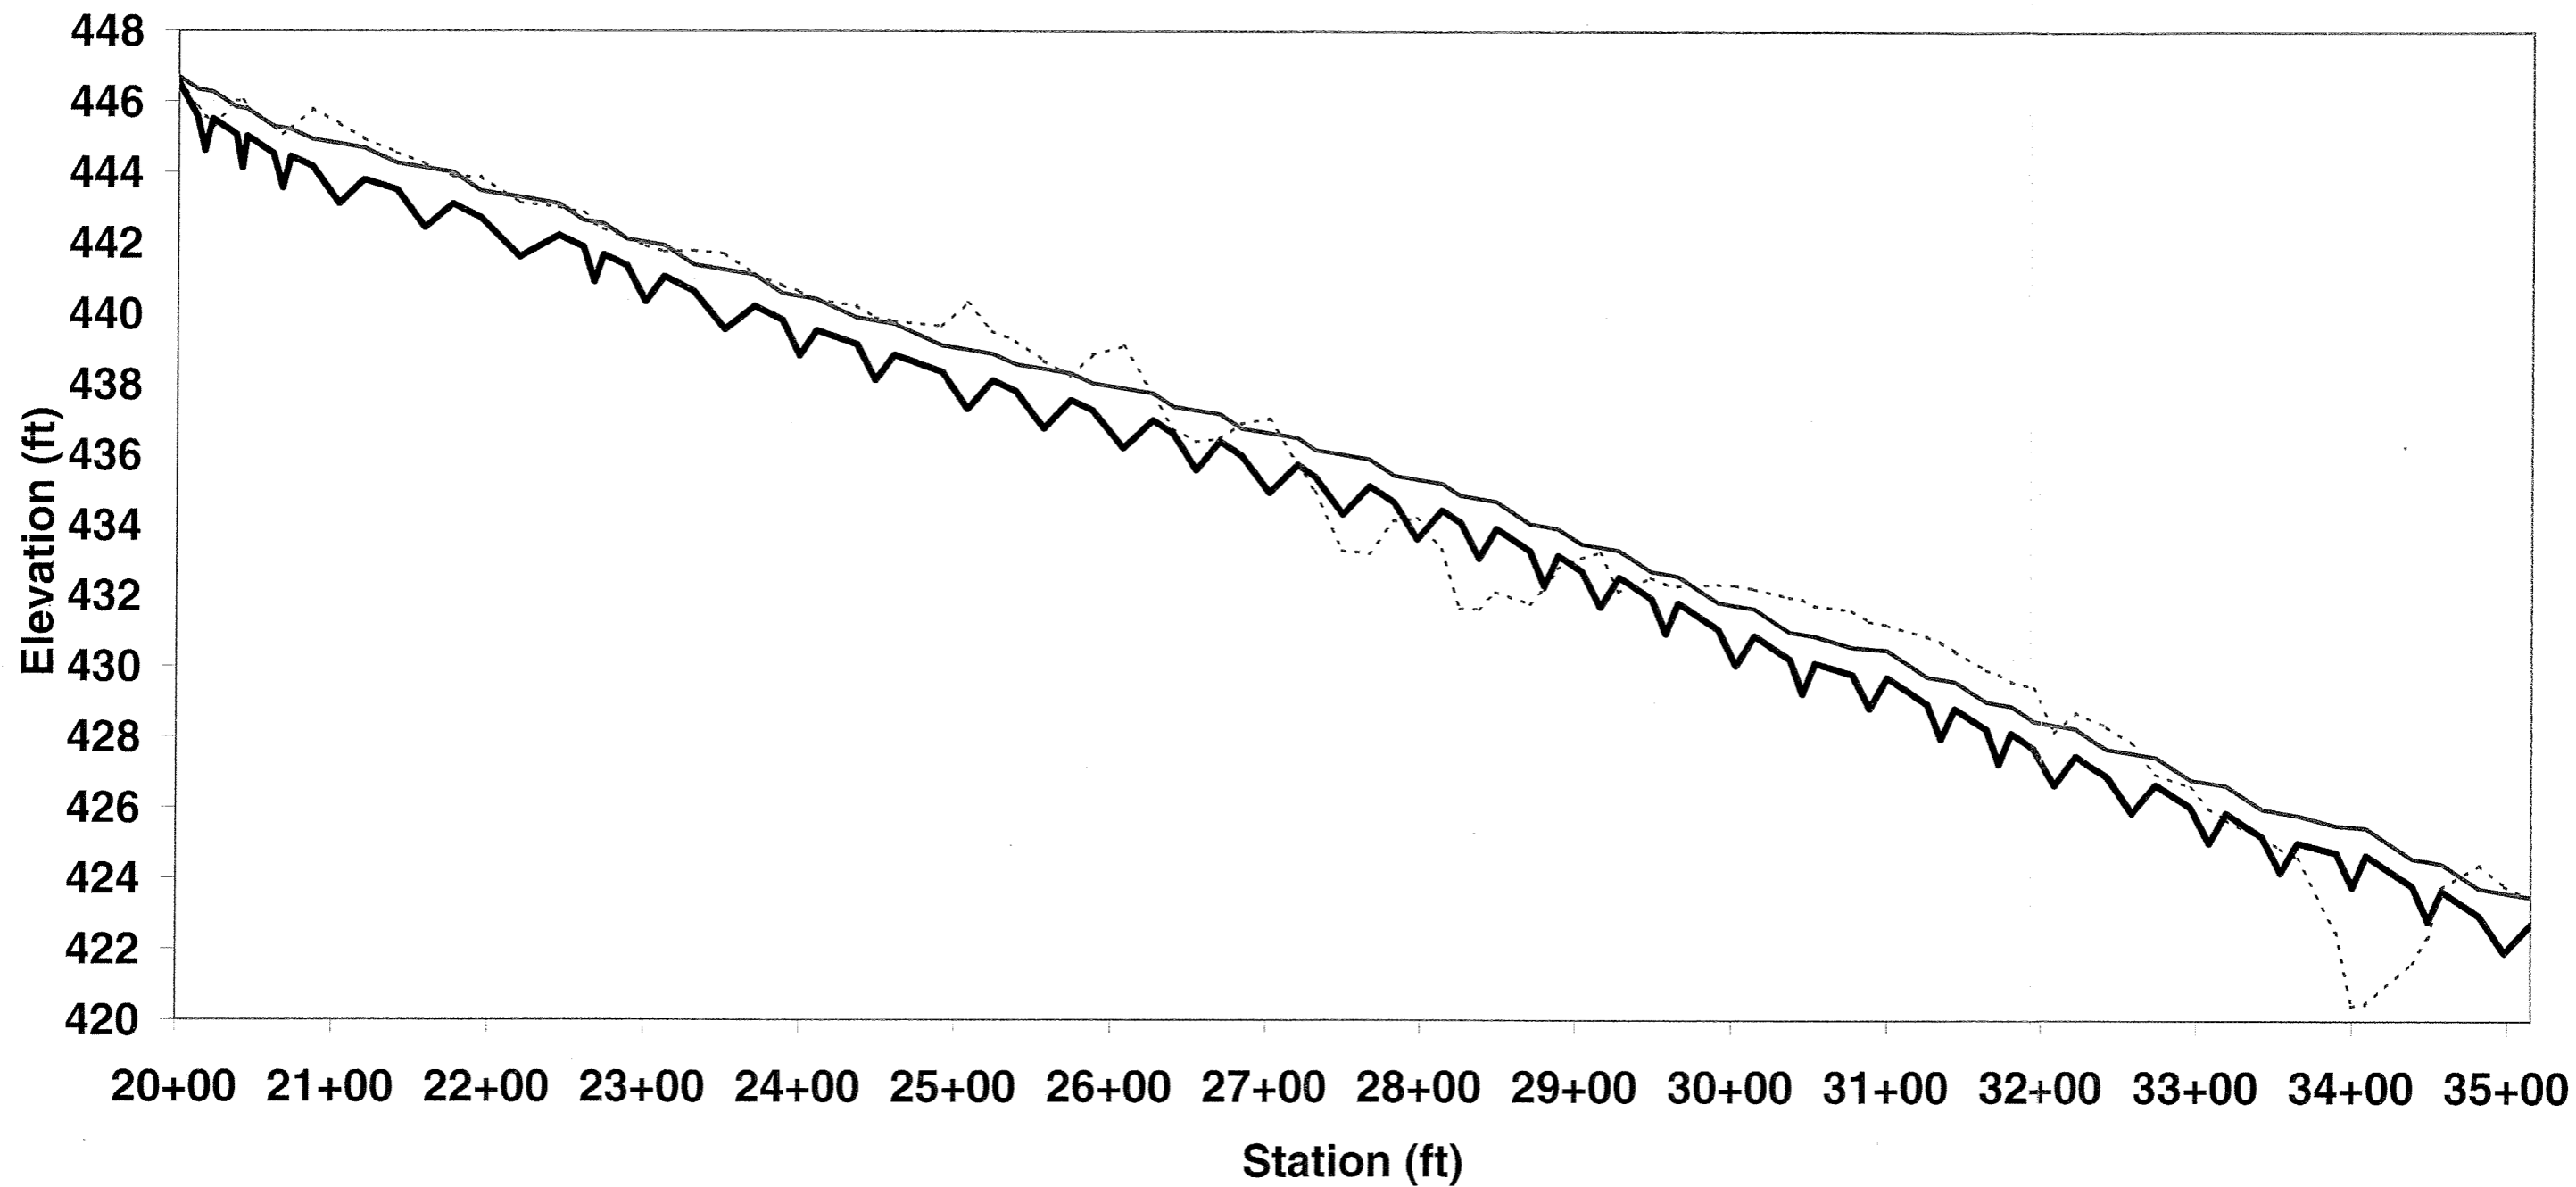
**FIGURE 11b - Proposed Profile  
REACH 2  
Tick Creek Restoration Plan  
Chatham County, North Carolina**

..... Existing Grade      — Proposed Bankfull      — Proposed Thalweg

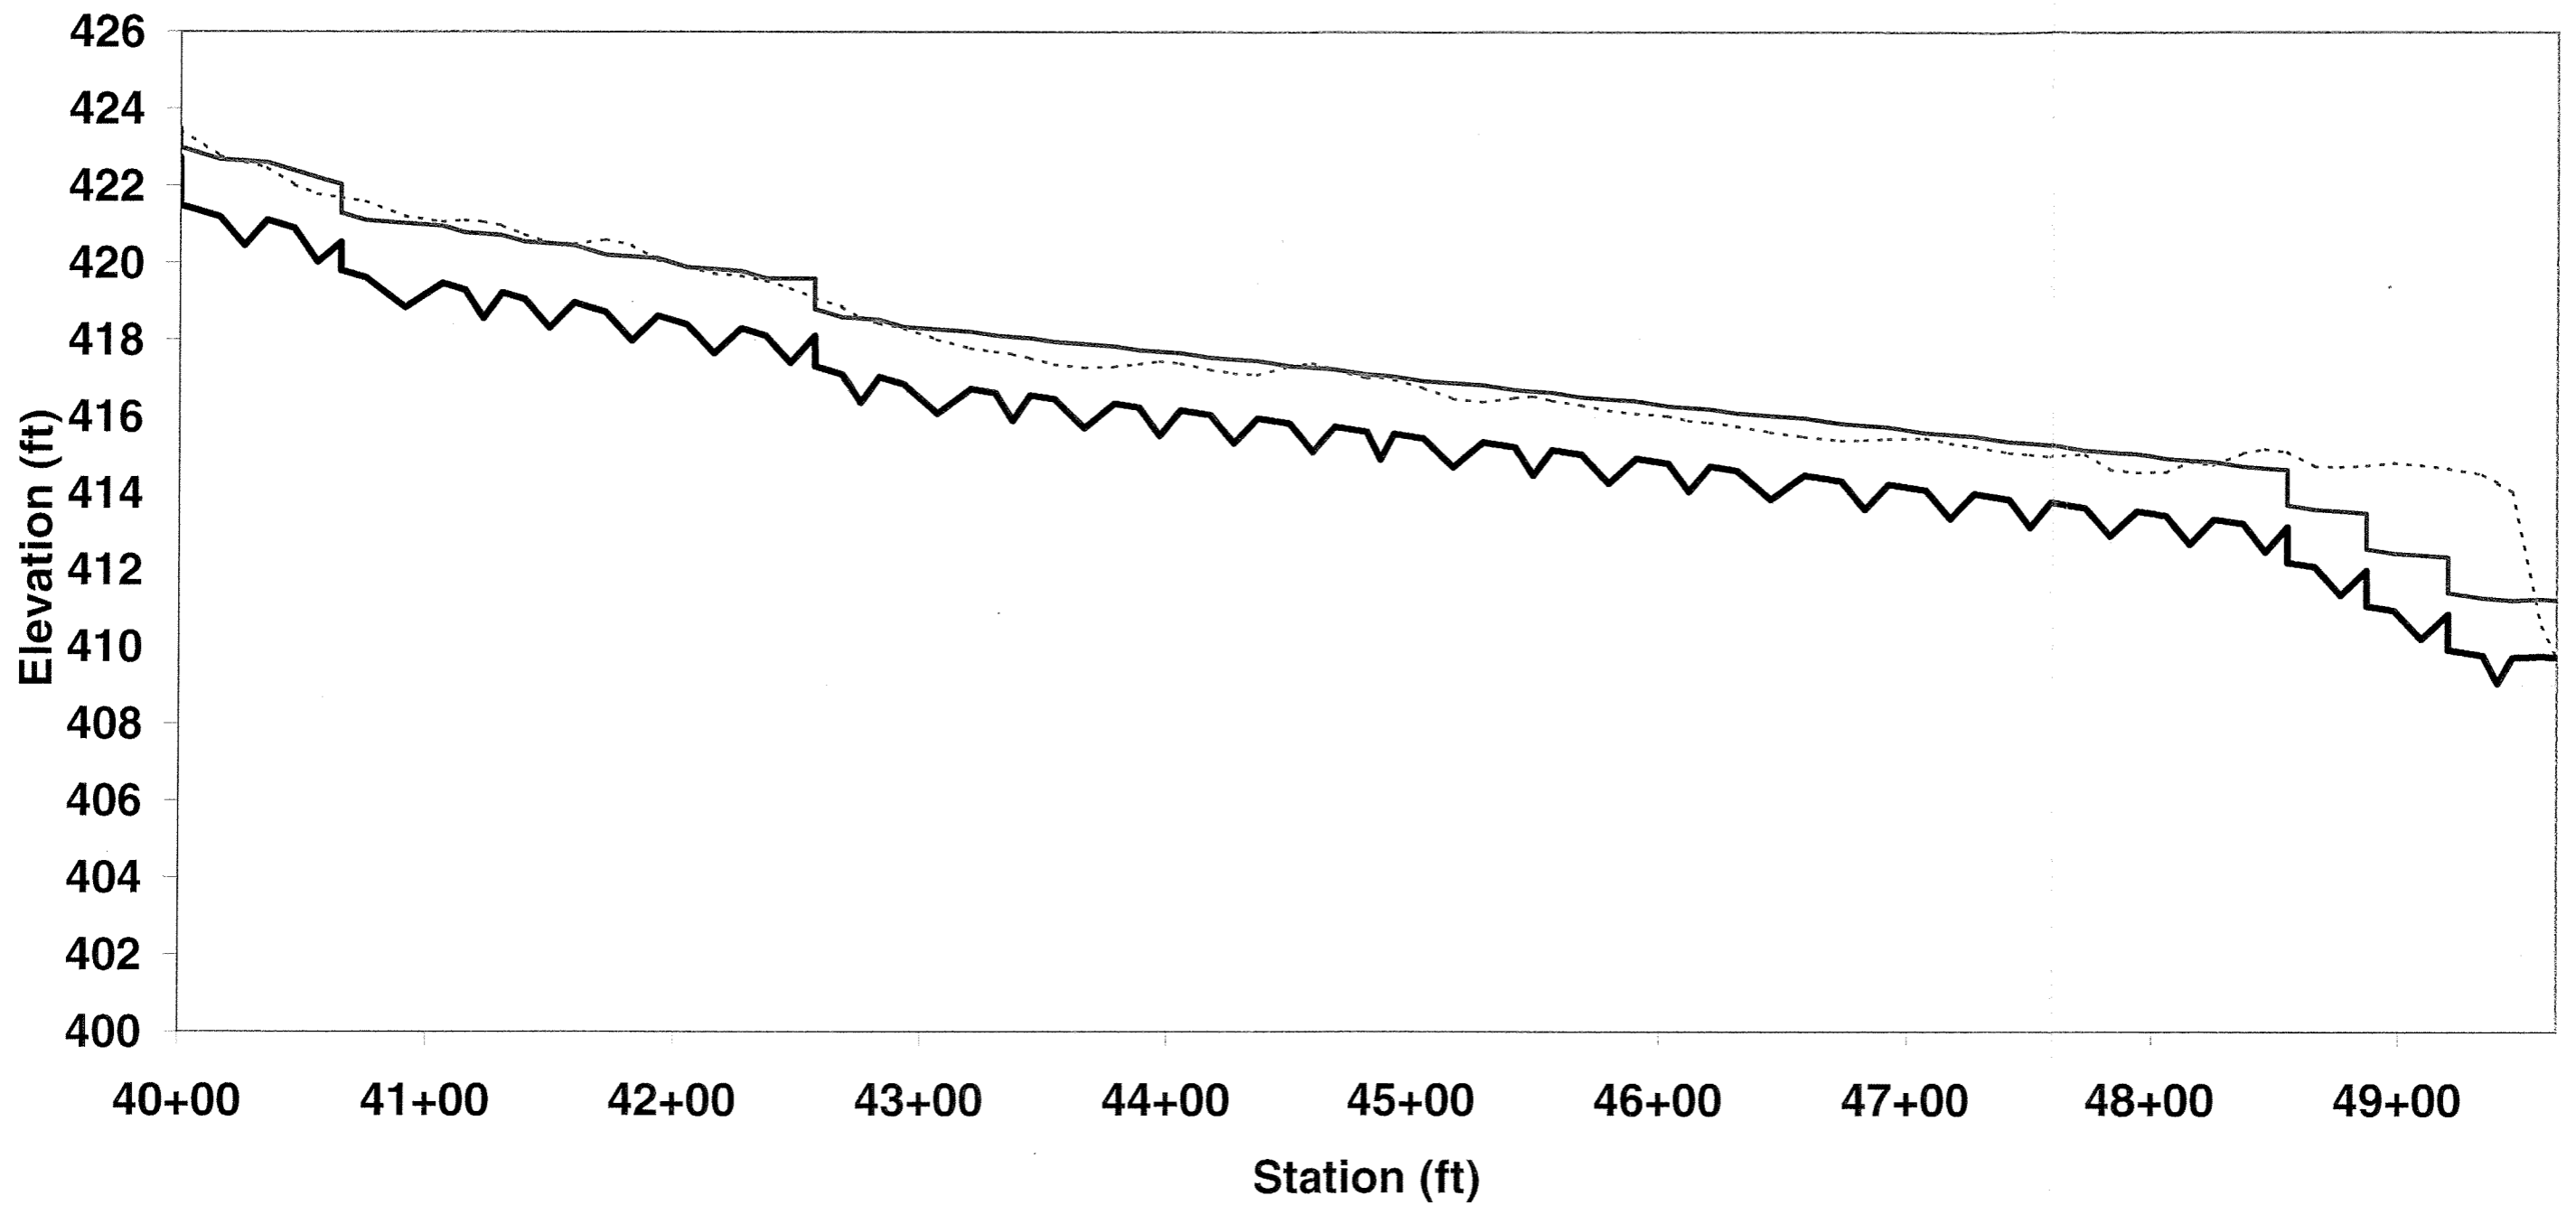
**FIGURE 11c - Proposed Profile  
REACH 3  
Tick Creek Restoration Plan  
Chatham County, North Carolina**

..... Existing Grade    — Proposed Bankfull    — Proposed Thalweg

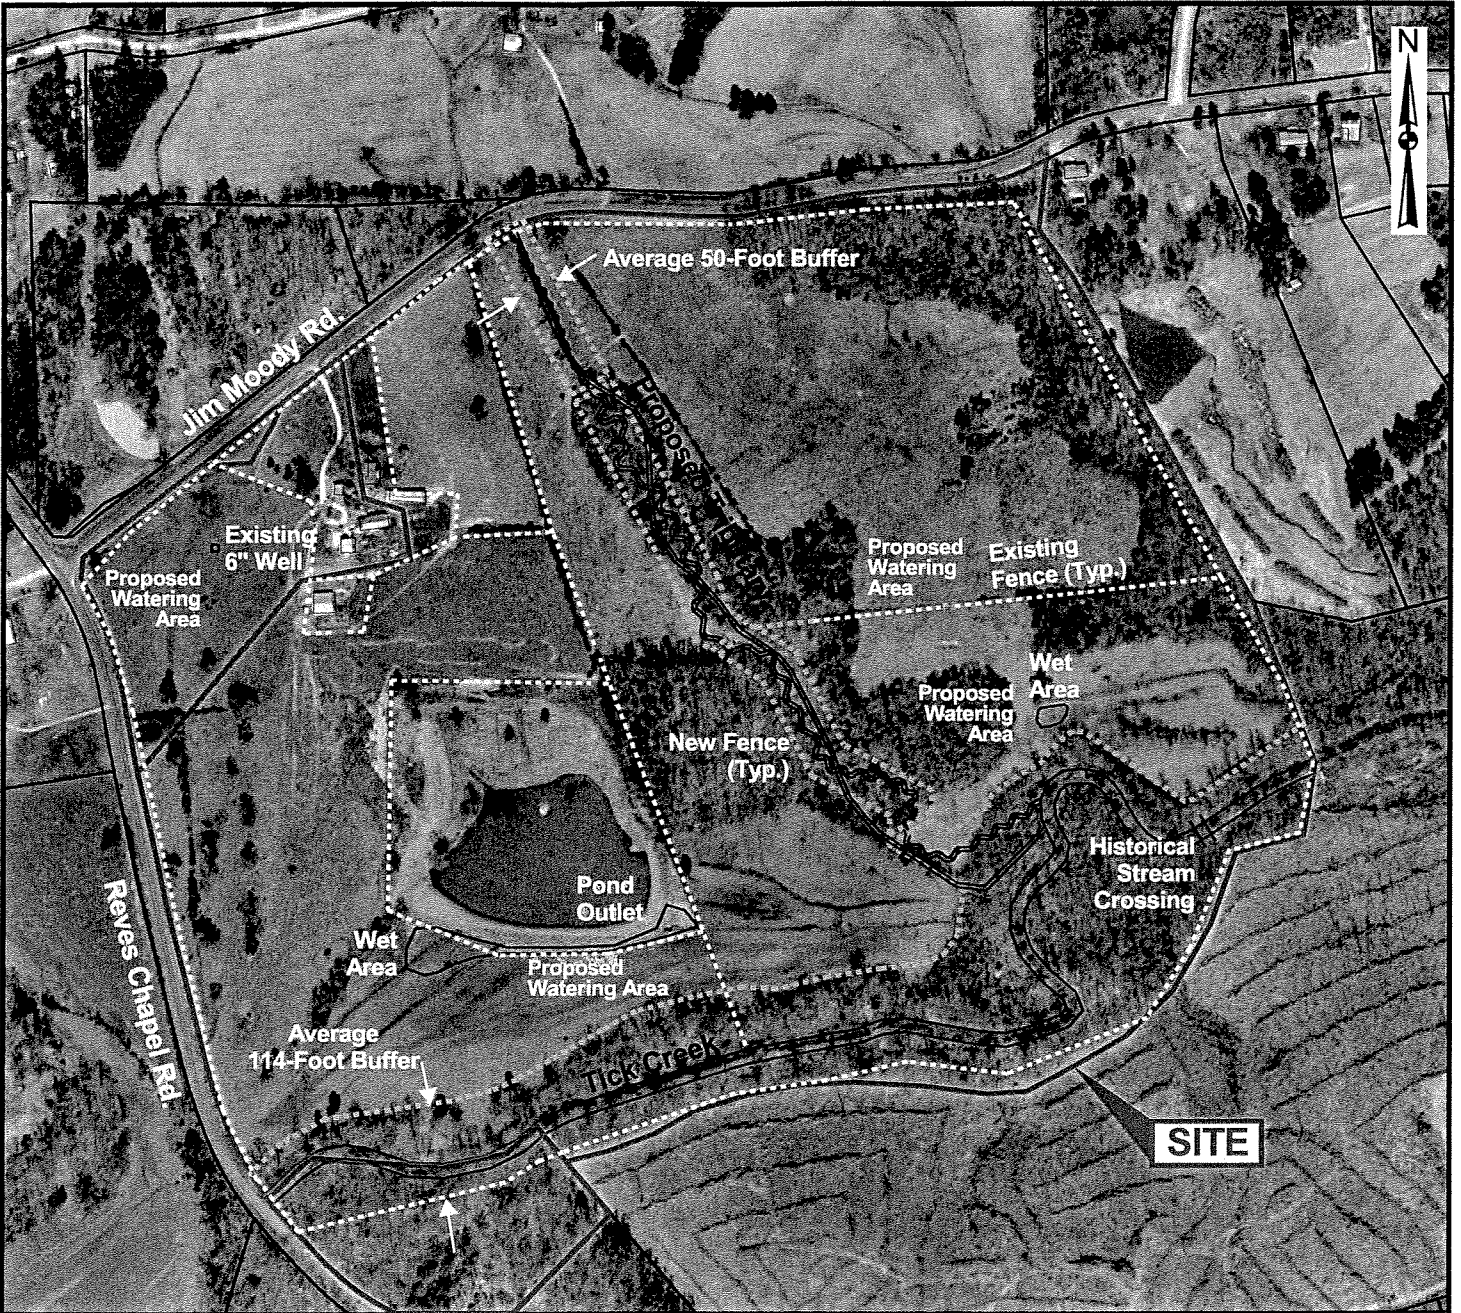
**FIGURE 12**  
**PROPOSED FENCING AND WATERING STRUCTURES**

The entire Unnamed Tributary will be classified as stream restoration qualifying for 1:1 mitigation credit. The proposed stream will be about 2,946 feet in length, which is 349 feet longer than the existing stream. Final stream length will be determined during the design phase. As part of the stream restoration, a 50-foot vegetated buffer will be planted surrounding the stream channel (Figure 12). The total buffer acreage for the Unnamed Tributary will be approximately 6.0 acres.

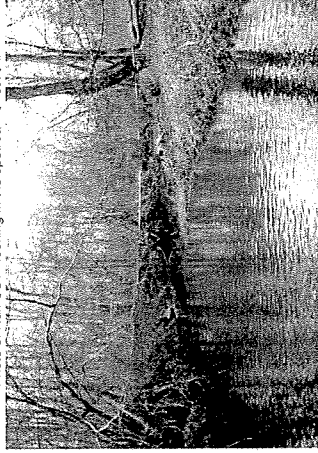
Photo of Run CS#1 looking in the upstream direction.

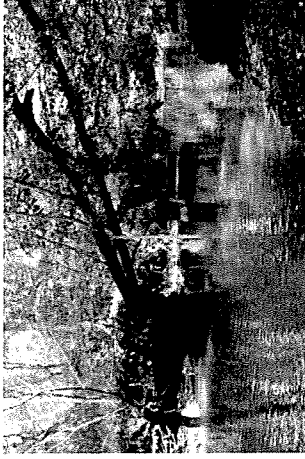
Pool CS#1

Photo of Rifle CS#1 looking in the downstream direction.

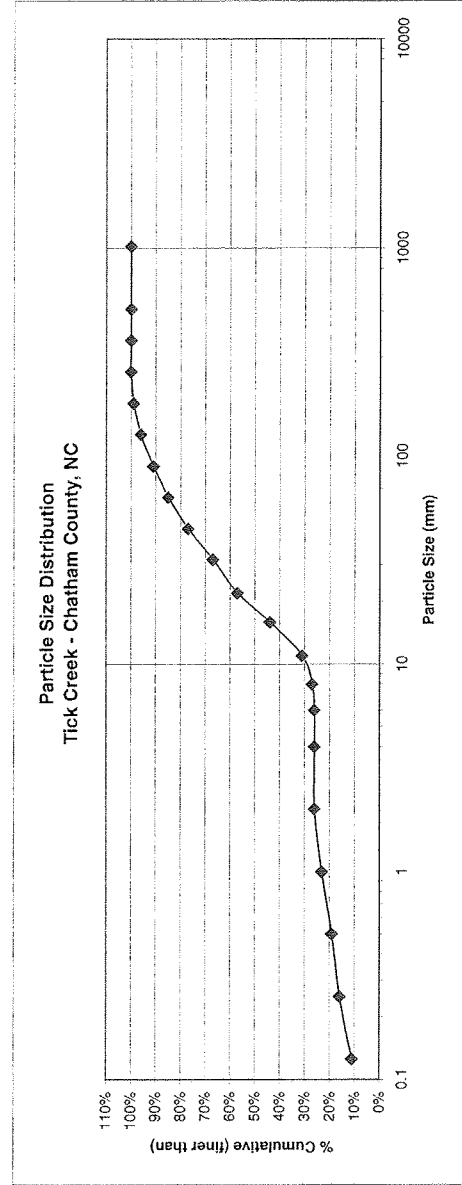
Riffle Sample  
Tick Creek- Main Stream

Sieve Size (mm)	0.062	0.075	0.106	0.25	0.3	0.6	0.85	1.18	2	4.75	9.5	12.7	19	25	LP1	LP2
micro		75	106	250	300	600	850								240	225
Tare Weight(lbs)	0.81	0.74	0.76	0.81	0.82	0.87	0.95	1.91	1.3	2.27	2.42	2.46	2.56	2.57	weight	34.48

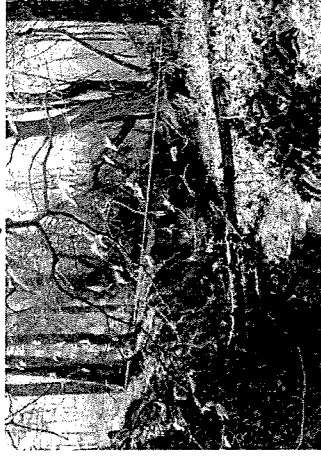
Photo of Riffle CS#6 looking in the downstream direction.

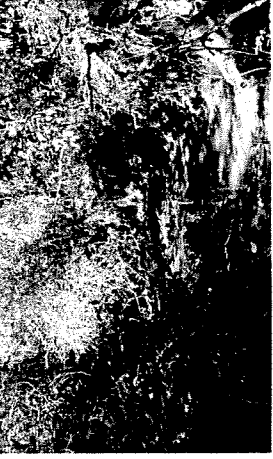
Pool CS#2

Photo of Riffle CS#1 looking in the downstream direction.

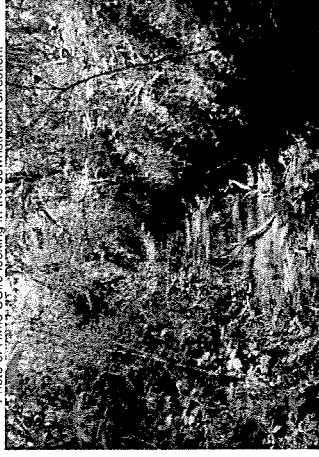
Field Crew:	Ben Goetz, Dan Clinton, Jan Almon, Phillip Todd
River Basin:	Cape Fear
Watershed:	Tick Creek
Stream Reach:	Condoret, Tributary
Drainage Area:	0.13 sq mi ( ac)
Date:	9/25/2001
Station:	N/A
Feature:	Riffle CS#9, backwards

Bank Erosion Hazard Index (BEHI)			
Criteria	Value	Index	Bank Erosion Potential
Bank Ht/Bk Ht	2.3	8.2	very high
Bank Depth/Bank Ht	0.6	6.8	high
Root Density (%)	29	7.9	high
Bank Angle (Degrees)	60	3.9	low
Surface Protection (%)	40	5.2	moderate
Bank Materials	SH/Clay	0	
TOTALS		32	high

Photo of Riffle CS#9 looking in the downstream direction.

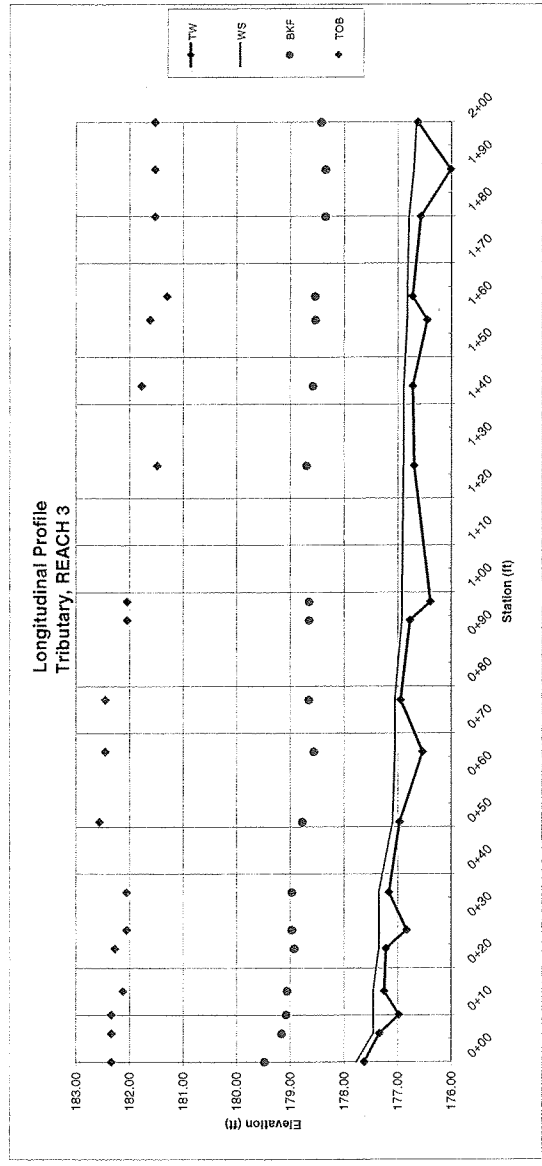
**LONGITUDINAL PROFILE**  
 River Basin: Cape Fear  
 Watershed: Tick Creek  
 Stream Reach: Middle Tributary  
 DA (sq mi): 0.13 sq mi  
 Date: 2/28/2002

Average Slope: 0.59

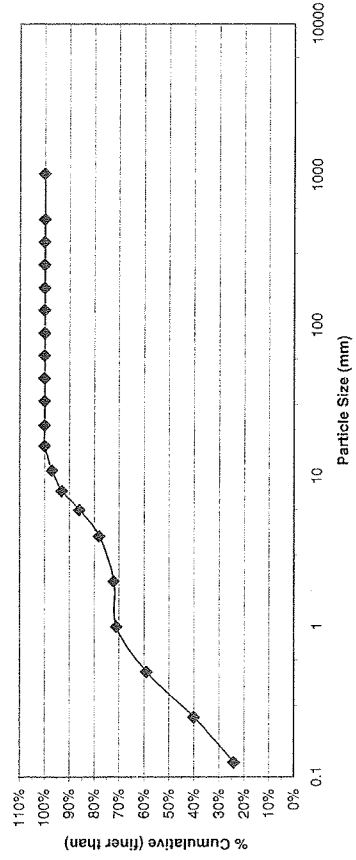
**Particle Size Distribution  
Tick Creek - Chatham County, NC**

PEBBLE COUNT										
Site: Condoret Property		2/28/2002								
Party: Ben Goetz, Jan Patterson		Tributary (Lower Reach: Lower Woods)								
Inches	Particle Silt/Clay	Millimeter	S/C	Riffle	Pool	Total No.	Item %	% Cumulative		
	Very Fine	< 0.062	S	3	5	8	8%	8%		
	Fine	.062 - .125	A	5	11	16	16%	24%		
	Medium	.125 - .25	N	3	13	16	16%	40%		
	Coarse	.25 - .50	D	6	13	19	19%	59%		
.04 - .08	Very Coarse	.50 - 1.0	S	5	7	12	12%	71%		
.08 - .16	Very Fine	1.0 - 2.0	S	1	0	1	1%	72%		
.16 - .22	Fine	2.0 - 4.0	G	3	3	6	6%	78%		
.22 - .31	Fine	4.0 - 5.7	R	5	3	8	8%	86%		
.31 - .44	Medium	5.7 - 8.0	A	5	2	7	7%	93%		
.44 - .63	Medium	8.0 - 11.3	V	3	1	4	4%	97%		
.63 - .89	Coarse	11.3 - 16.0	E	1	2	3	3%	100%		
.89 - 1.26	Coarse	16.0 - 22.6	L	0	0	0	0%	100%

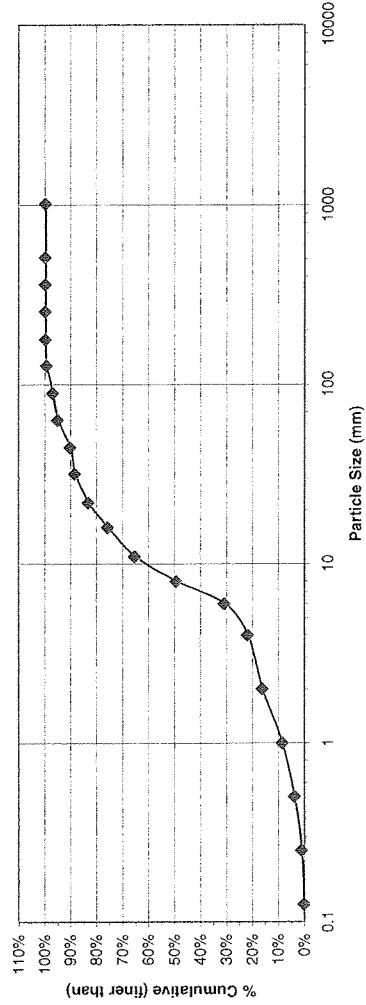
**Particle Size Distribution  
Tick Creek - Chatham County, NC**

PEBBLE COUNT									
Site: Condoret Property		3/4/2002		Tributary					
Party: Ben Goetz, Jan Patterson									
Inches	Particle	Millimeter	S/C	Upper	Middle	Lower	Total No.	Item %	% Cumulative
	Silt/Clay	< 0.062		0	0	0	0	0%	0%
	Very Fine	.062 - .125	S	0	0	0	0	0%	0%
	Fine	.125 - .25	A	0	0	2	2	1%	1%
	Medium	.25 - .50	N	0	1	5	6	3%	4%
	Coarse	.50 - 1.0	D	1	3	6	10	5%	8%
.04 - .08	Very Coarse	1.0 - 2.0	S	5	6	5	16	8%	16%
.08 - .16	Very Fine	2.0 - 4.0		6	3	3	12	6%	22%
.16 - .22	Fine	4.0 - 5.7	G	11	4	4	19	9%	31%
.22 - .31	Fine	5.7 - 8.0	R	14	11	14	39	18%	49%
.31 - .44	Medium	8.0 - 11.3	A	7	16	11	34	16%	65%
.44 - .63	Medium	11.3 - 16.0	V	5	12	5	22	10%	75%
.63 - .89	Coarse	16.0 - 22.6	E	1	12	3	16	8%	83%
.89 - 1.26	Coarse	22.6 - 32.0	L	0	9	2	11	5%	88%

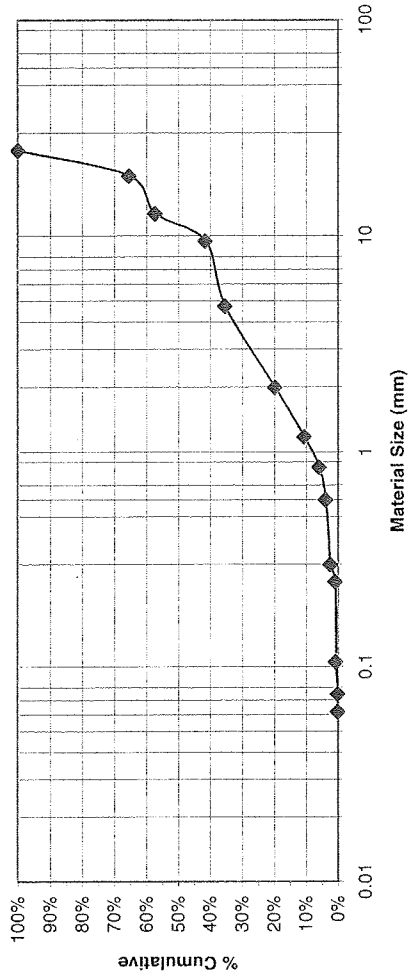
Bar Material Particle Size Distribution  
Trib Reach 1 - Chatham County, NC

Riffle Sample  
Tick Creek- Trib Reach 1

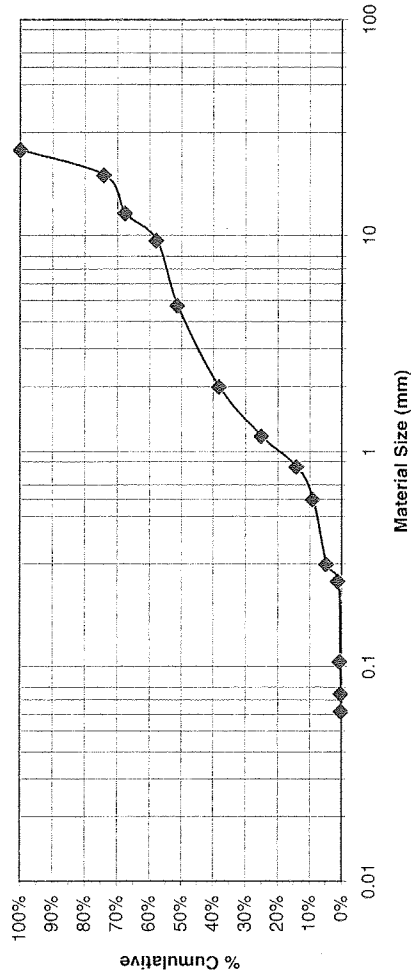
Bar Material Particle Size Distribution  
Tick Creek - Chatham County, NC

Riffle Sample  
Tick Creek- Main Stream

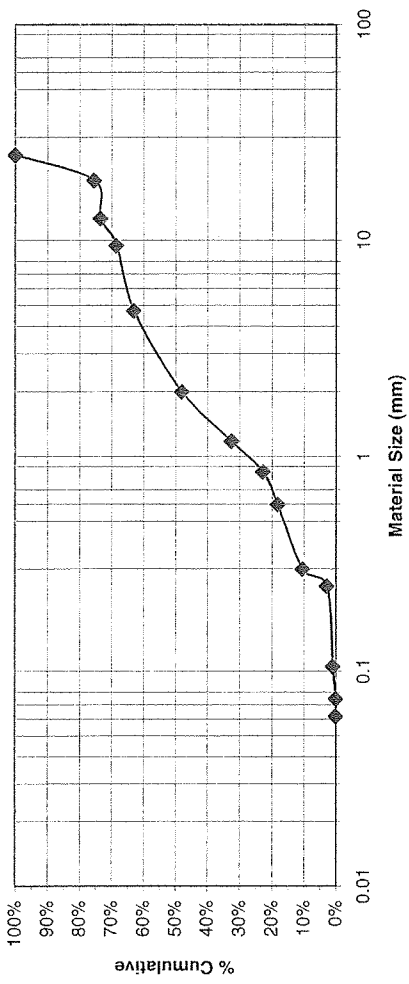
Bar Material Particle Size Distribution  
Tick Creek - Chatham County, NC

Riffle Sample  
Tick Creek- Main Stream

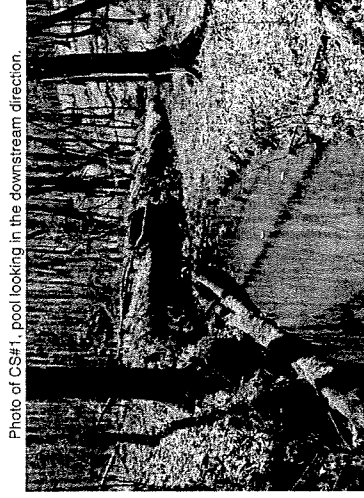
Photo of CS#1, pool looking in the downstream direction.

Field Crew: Ben Goetz, Jan Patterson, Jane Almon  
 River Basin: Cape Fear  
 Watershed: Trib of the South Fork of Cane Creek  
 Reach: Trib of the South Fork of Cane Creek  
 DA: 0.41 sq mi (257 ac)  
 Date: 4/2/2002  
 Station: 2+79  
 Feature: CS #1, Pool

SUMMARY DATA (BANKFULL)	
A(BKF)	15.3
W(BKF)	10.1
Max d	1.8
Mean d	1.5

Bank Erosion Hazard Index (BEHI)			
Criteria	Value	Index	Bank Erosion Potential
Bank Ht/BK Ht	1	1	very low
Root Depth/Bank Ht	1	1	very low
Root Density (%)	60	2.4	low
Bank Angle (Degrees)	80	5.9	moderate
Surface Protection (%)	60	2.4	low
Bank Materials	silt, clay		
<b>TOTAL</b>		<b>12.7</b>	<b>low</b>

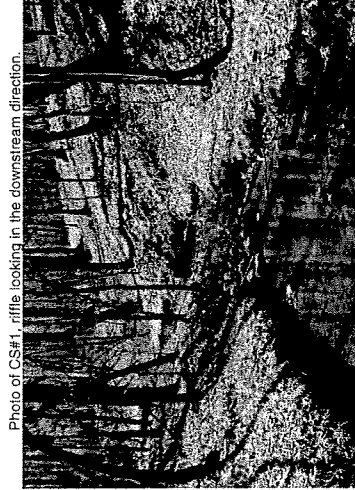
Photo of CS#1, riffle looking in the downstream direction.

SUMMARY DATA (BANKFULL)	
A(BKF)	11.6
W(BKF)	13.0
Max d	1.4
Mean d	0.9
W/D	14.5
Entrenchment	2.0
Stream Type	C4
Area from Rural Regional Curve	12

Bank Erosion Hazard Index (BEHI)		
Criteria	Value	Index
Bank H/Bk Ht	1	1
Root Depth/Bank Ht	40	4.8
Bank Angle (Degrees)	10	1.4
Surface Protection (%)	80	5.9
Bank Materials	clay	0
		14.1
		low
