# **STREAM MITIGATION PLAN**

## **Tick Creek Condoret Property Chatham County, North Carolina**

**State Project No. 8.U492107  
TIP No. U-2524WM**

**September 2002**

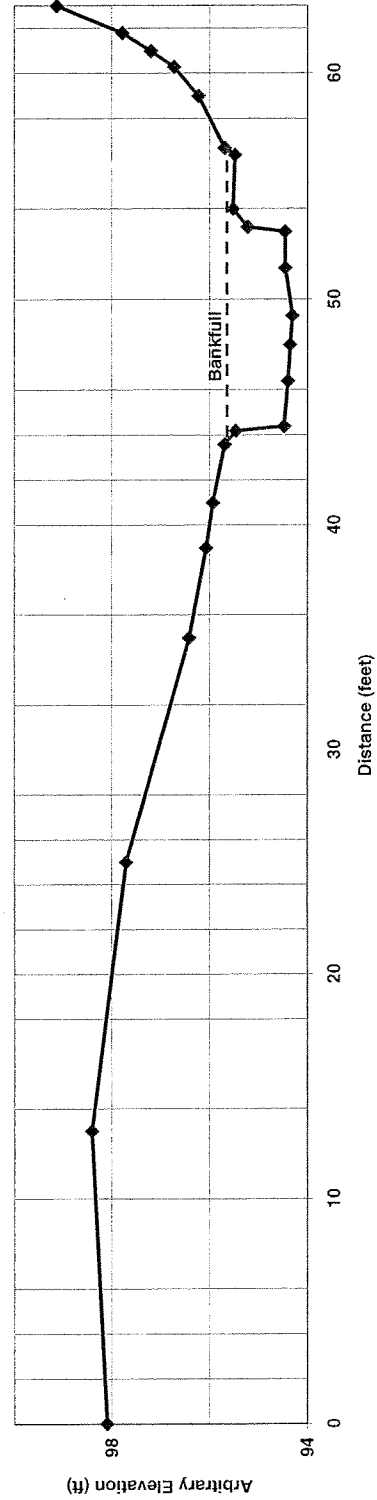
Cross Section #3, Riffle

Field Crew: Ben Goetz, Jan Patterson, Jane Almon  
 River Basin: Cape Fear  
 Watershed: Trib of the South Fork of Cane Creek  
 Reach: Trib of the South Fork of Cane Creek  
 DA: 0.41 sq mi (257 ac)  
 Date: 4/2/2002  
 Station: 4+52  
 Feature: CS #3, Riffle

Bank Erosion Hazard Index (BEHI)				
Criteria	Value	Index	Bank Erosion Potential	
Bank Ht/Bk Ht	1	1	very low	
Bank Depth/Bank Ht	1	1	very low	
Root Density (%)	70	3.2	moderate	
Bank Angle (Degrees)	10	1.4	very low	
Surface Protection (%)	80	5.9	very low	
Bank Materials	clay	0		
			12.5	LOW

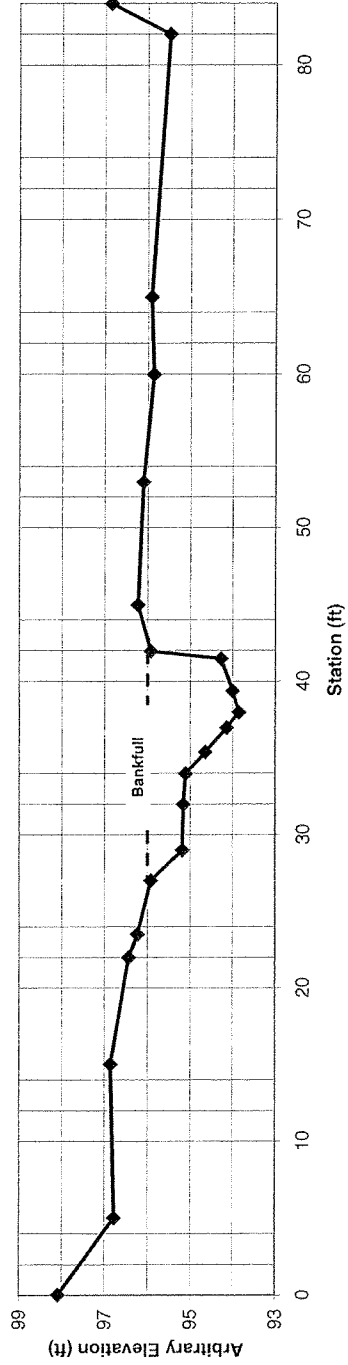
Cross Section #4, Pool

Field Crew: Ben Goetz, Jan Patterson, Jane Almon  
 River Basin: Cape Fear  
 Watershed: Trib of the South Fork of Cane Creek  
 Reach: Trib of the South Fork of Cane Creek  
 DA: 0.41 sq mi (257 ac)  
 Date: 4/2/2002  
 Station: 5+35  
 Feature: CS #4, Pool

SUMMARY DATA (BANKFULL)	
A(BKF)	17.4
W(BKF)	15.0
Max d	2.1
Mean d	1.2

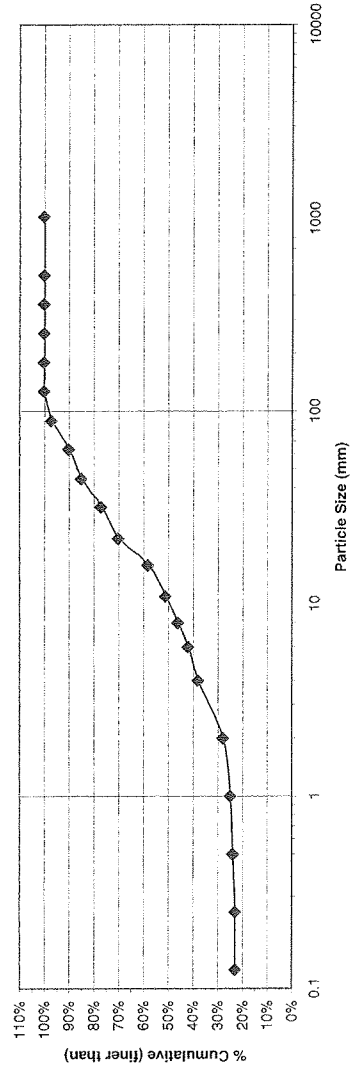
Particle Size Distribution  
Tick Creek - Chatham County, NC

PEBBLE COUNT												
Site: Little Beaver Creek					3/25/2002							
Party: Ben Goetz, Jan Patterson					Little Beaver Creek							
Inches	Particle Silt/Clay	Millimeter < 0.062	Particle Count						Total No.	Item %	% Cumulative	
			Riffle 1	Riffle 2	Pool 1	Riffle 1	Pool 2	Pool 2				
	Very Fine	.062 - .125	S							0	0%	23%
	Fine	.125 - .25	A							0	0%	23%
	Medium	.25 - .50	N							1	1%	24%
	Coarse	.50 - 1.0	D							1	1%	25%
.04 - .08	Very Coarse	1.0 - 2.0	S	1						3	3%	28%
.08 - .16	Very Fine	2.0 - 4.0		4						10	10%	38%
.16 - .22	Fine	4.0 - 5.7	G	1						4	4%	42%
.22 - .31	Fine	5.7 - 8.0	R	2	1					4	4%	46%
.31 - .44	Medium	8.0 - 11.3	A	2						5	5%	51%
.44 - .63	Medium	11.3 - 16.0	V	1						7	7%	58%
.63 - .89	Coarse	16.0 - 22.6	E	1						12	12%	70%
.89 - 1.26	Coarse	22.6 - 32.0	L	1						7	7%	77%

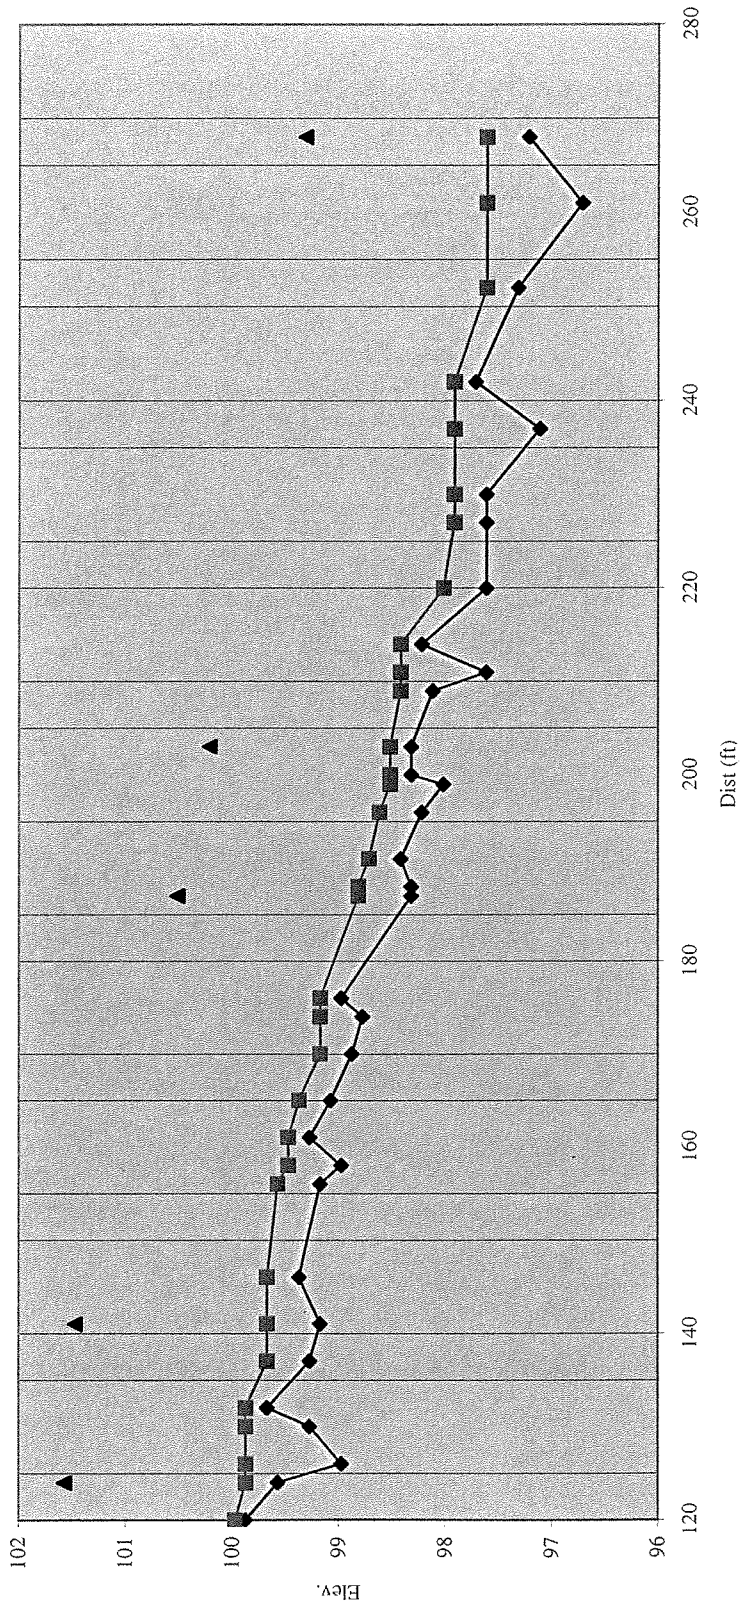
Stream Name: Spencer Creek in Uwaharrie

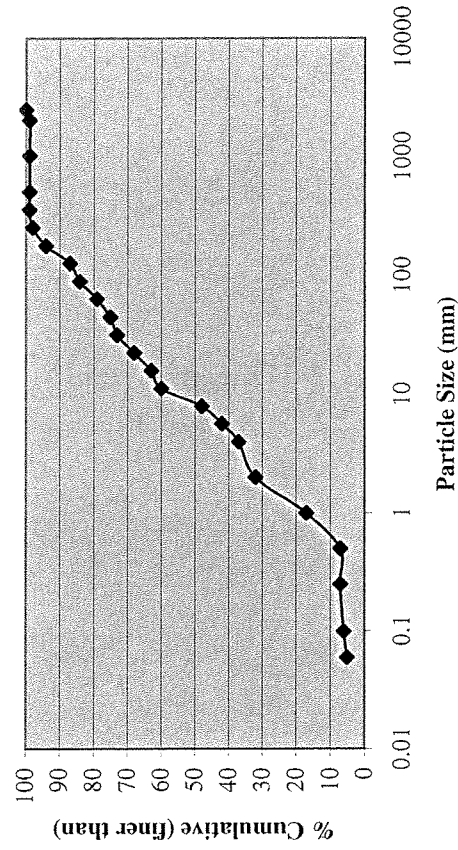
Pebble Count @ Spencer Creek in Uwharrie

Site: Spencer Creek in Uwharrie

D84: 77 mm
