FINAL
Baseline Monitoring Document and As-Built Baseline Report
Town Creek Restoration Project – Option B

Stanly County, North Carolina

DMS Project ID No. 95026; NCDEQ Contract No. 003990

Baseline Monitoring Document and As-Built Baseline Report Town Creek Restoration Project – Option B

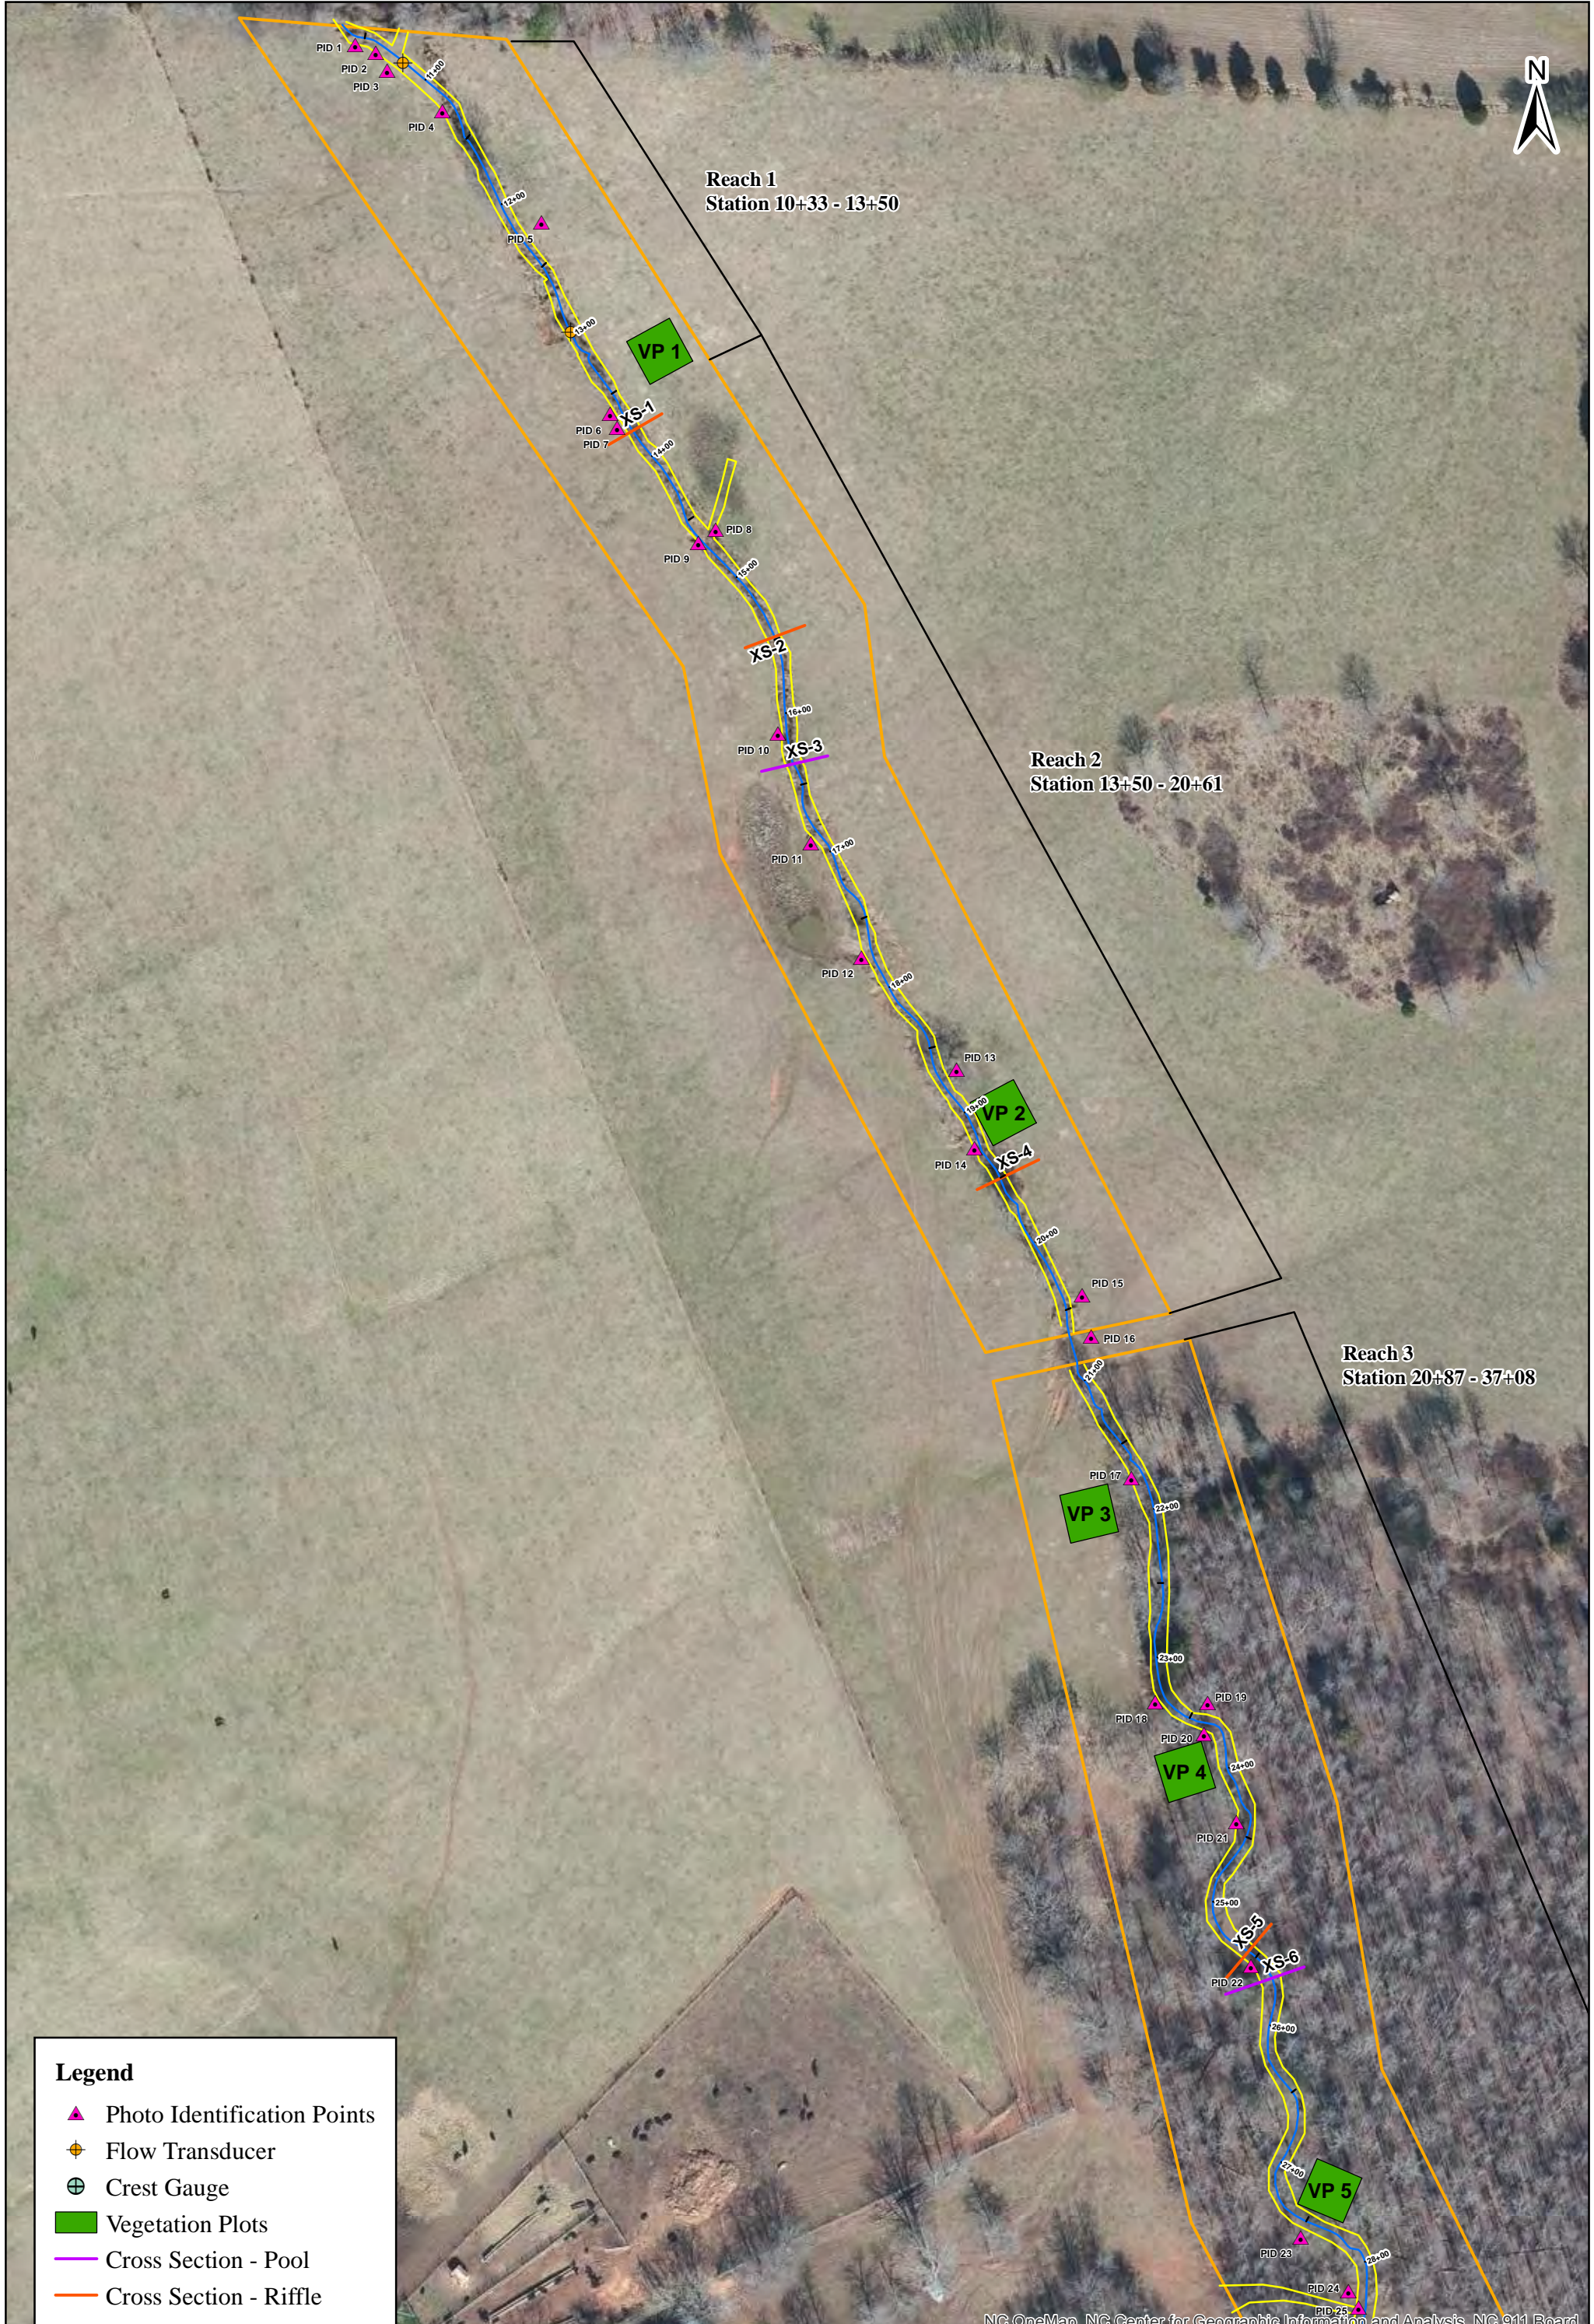
Figure 4a. Current Condition Plan View

- ▲ Photo Identification Points
- ⊕ Flow Transducer
- ⊕ Crest Gauge
- Vegetation Plots
- Cross Section - Pool
- Cross Section - Riffle

Town Creek Restoration Project - Option B
Stanly County, NC

Figure	1	Vicinity Map
Figure	2	Mitigation Summary Map
Figure	3	Reference Site Locations Map
Figure	4-4b	Current Conditions Plan View Maps

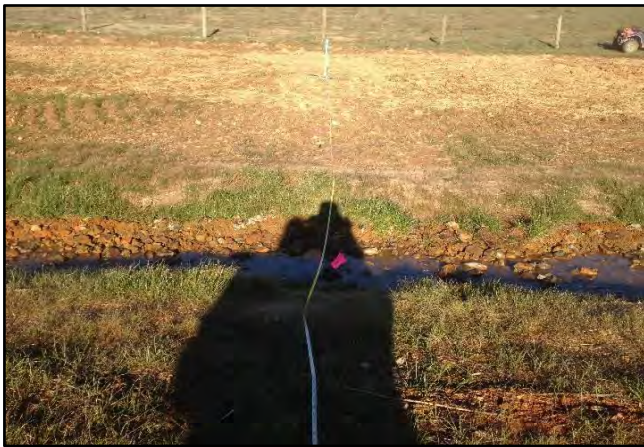
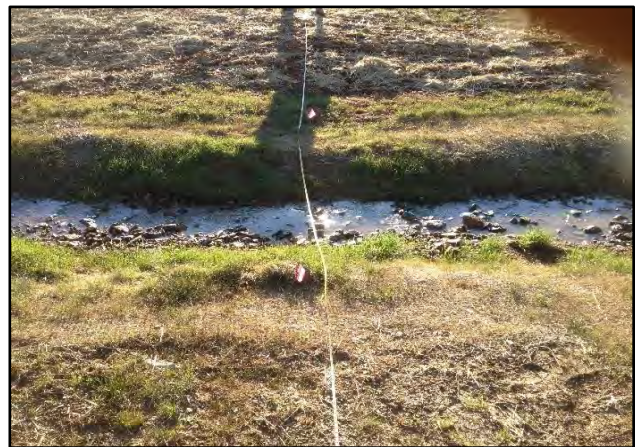
Permanent Cross-section
X1 - Reach 2
(As-built Data - Collected April 2016)

Feature	Stream Type	BKF Area	BKF Width	BKF Depth	Max BKF Depth	W/D	BH Ratio	ER	BKF Elev	TOB Elev	WFGPA
Riffle	C	5.79	8.75	0.66	1.09	13.23	1.01	3.09	586.35	586.36	27.05

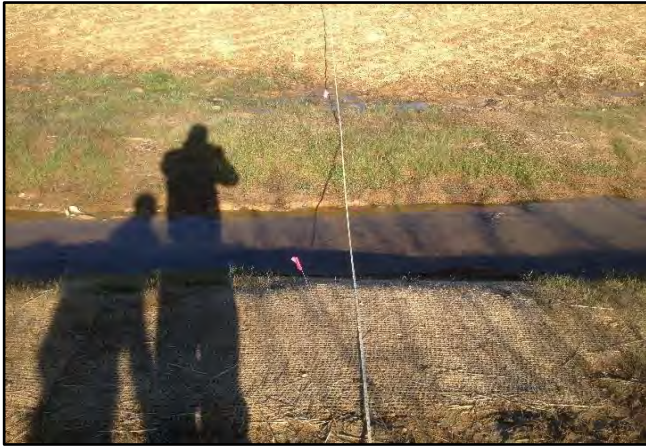
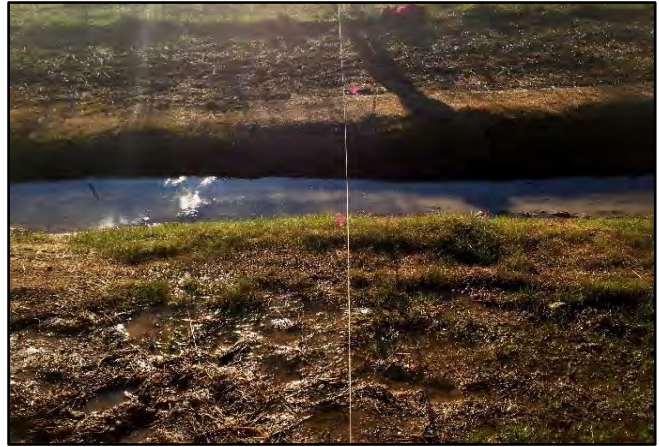
**Permanent Cross-section
X2 - Reach 2
(As-built Data - Collected April 2016)**

Feature	Stream Type	BKF Area	BKF Width	BKF Depth	Max BKF Depth	W/D	BH Ratio	ER	BKF Elev	TOB Elev	WFGPA
Riffle	E	8.28	9.17	0.90	1.37	10.17	1.01	3.70	583.31	583.32	33.92

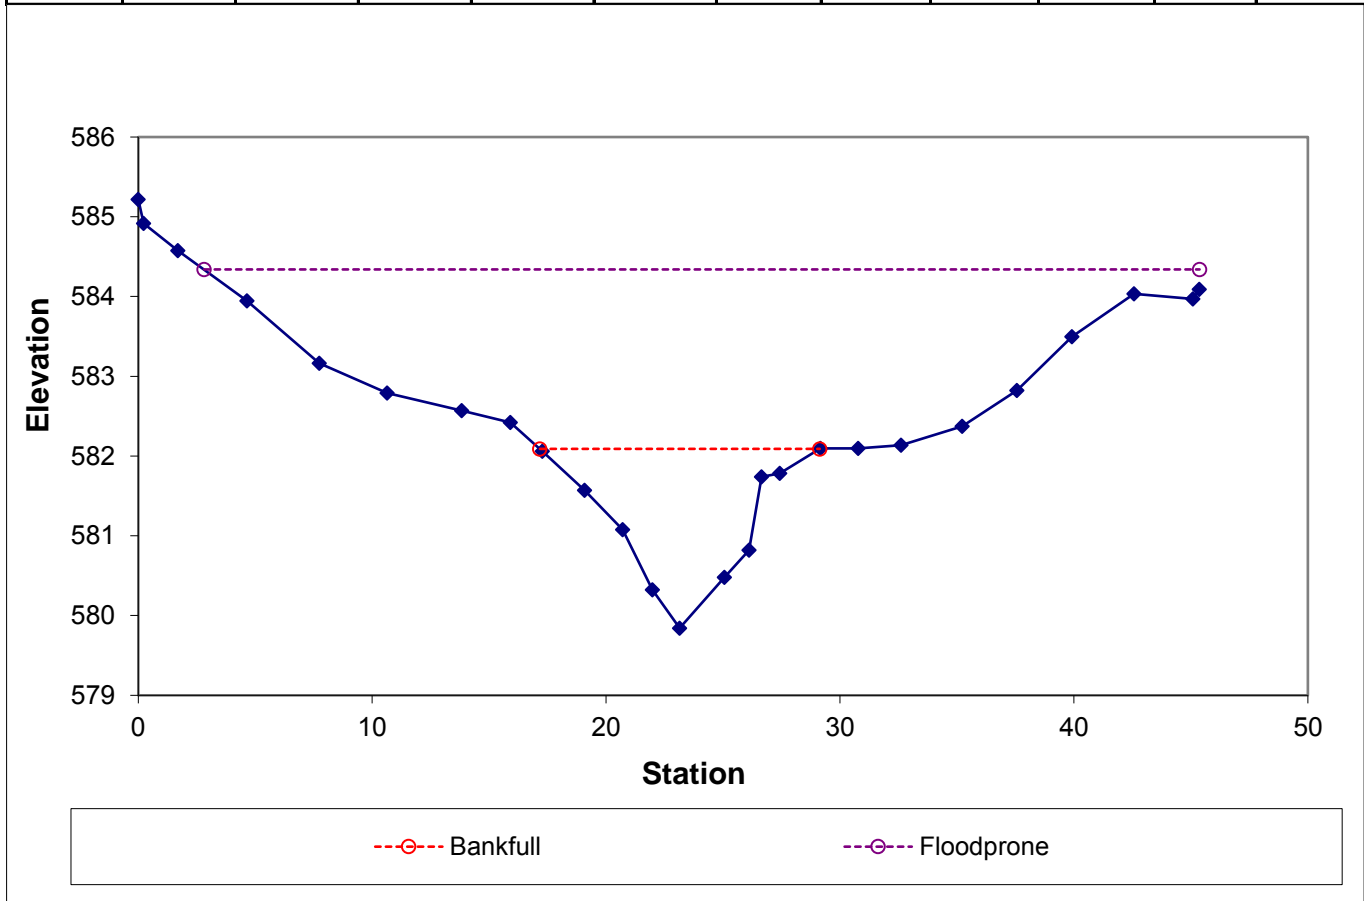
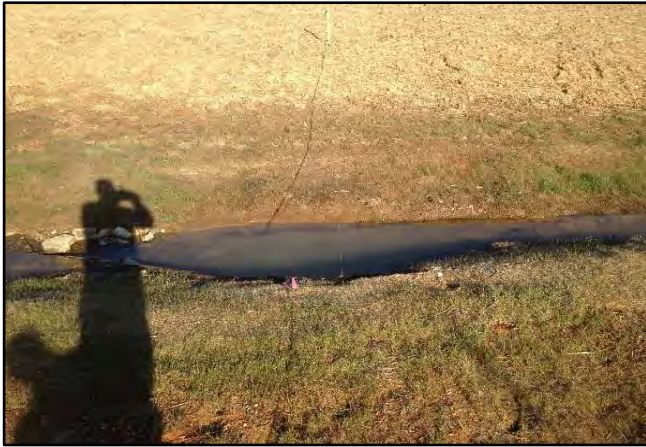
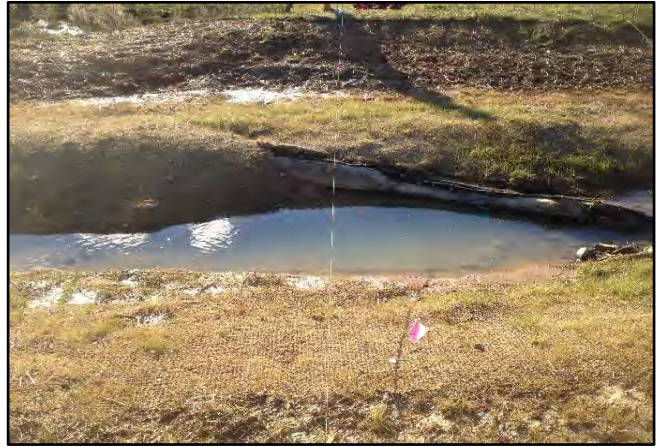
Permanent Cross-section
X3 - Reach 2
(As-built Data - Collected April 2016)

Feature	Stream Type	BKF Area	BKF Width	BKF Depth	Max BKF Depth	W/D	BH Ratio	ER	BKF Elev	TOB Elev	WFGPA
Pool		12.01	11.96	1.00	2.25	11.92	1.00	3.56	582.09	582.10	42.56

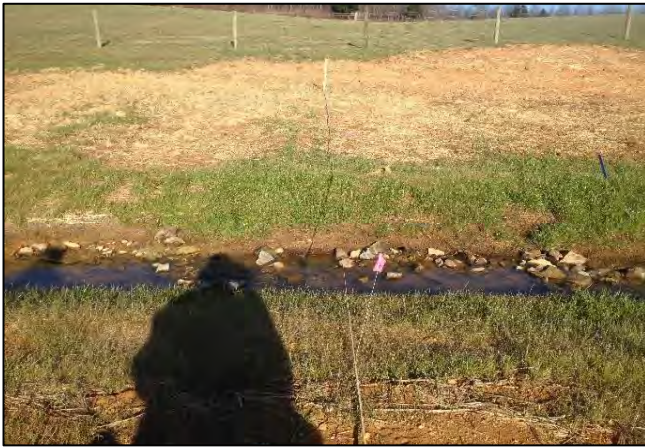
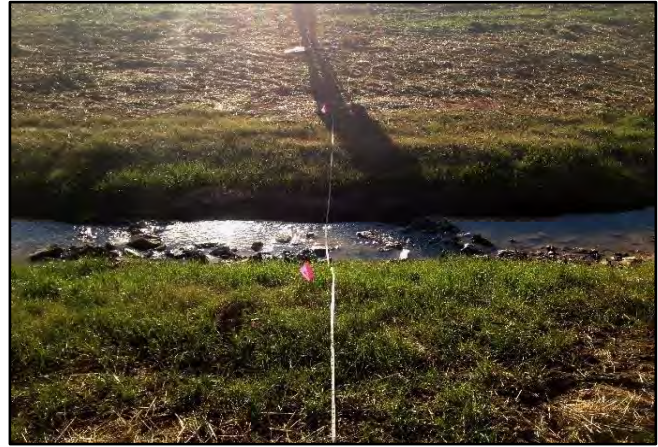
Permanent Cross-section
X4 - Reach 2
(As-built Data - Collected April 2016)

Feature	Stream Type	BKF Area	BKF Width	BKF Depth	Max BKF Depth	W/D	BH Ratio	ER	BKF Elev	TOB Elev	WFPA
Riffle	C	8.38	10.00	0.84	1.45	11.92	1.00	4.13	576.81	576.81	41.34

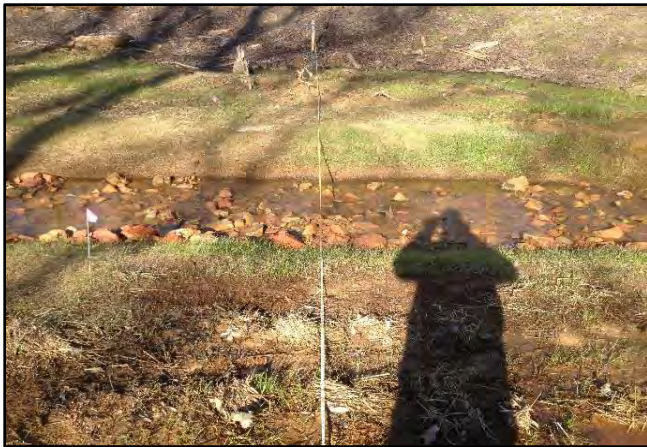
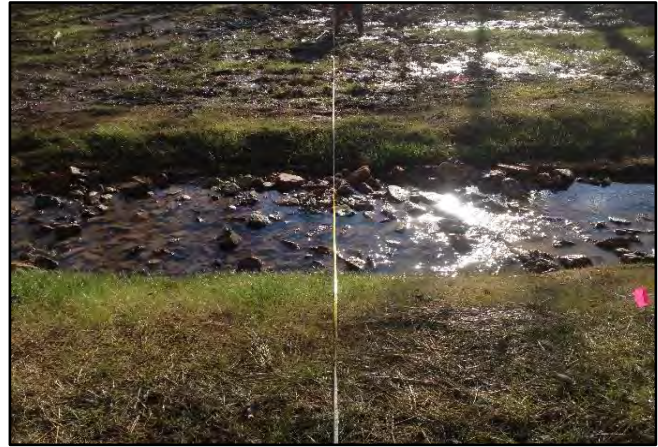
**Permanent Cross-section
X5 - Reach 3
(As-built Data - Collected April 2016)**

Feature	Stream Type	BKF Area	BKF Width	BKF Depth	Max BKF Depth	W/D	BH Ratio	ER	BKF Elev	TOB Elev	WFGPA
Riffle	C	8.68	10.65	0.82	1.44	13.05	1.00	4.52	568.85	568.86	48.09

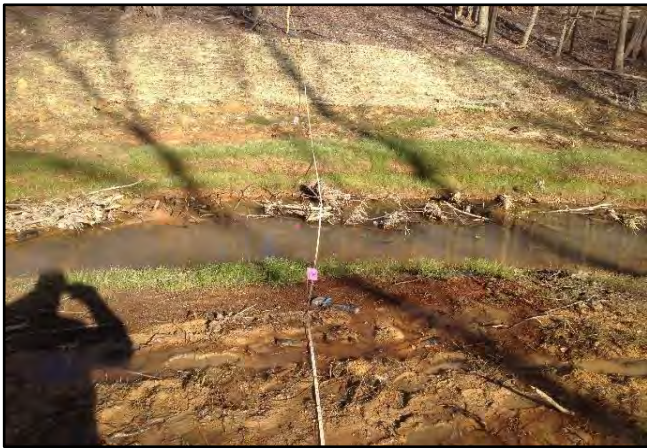
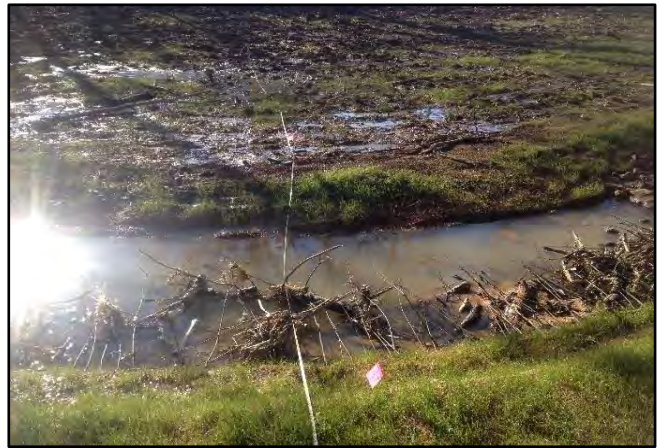
**Permanent Cross-section
X6 - Reach 3
(As-built Data - Collected April 2016)**

Feature	Stream Type	BKF Area	BKF Width	BKF Depth	Max BKF Depth	W/D	BH Ratio	ER	BKF Elev	TOB Elev	WFGPA
Pool		14.54	13.63	1.07	2.09	12.77	1.00	3.69	568.63	568.63	50.26

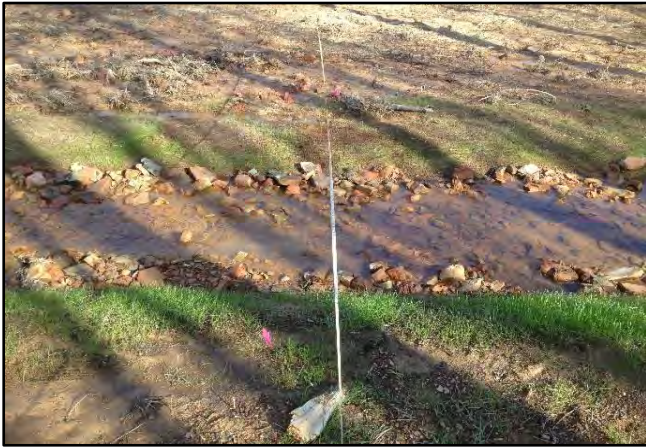
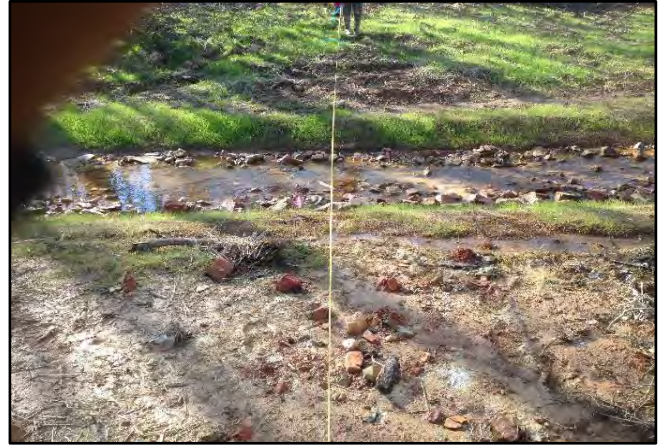
**Permanent Cross-section
X7 - Reach 3
(As-built Data - Collected April 2016)**

Feature	Stream Type	BKF Area	BKF Width	BKF Depth	Max BKF Depth	W/D	BH Ratio	ER	BKF Elev	TOB Elev	WFGPA
Riffle	C	6.51	9.84	0.66	1.03	14.87	1.00	3.89	563.96	563.96	38.30

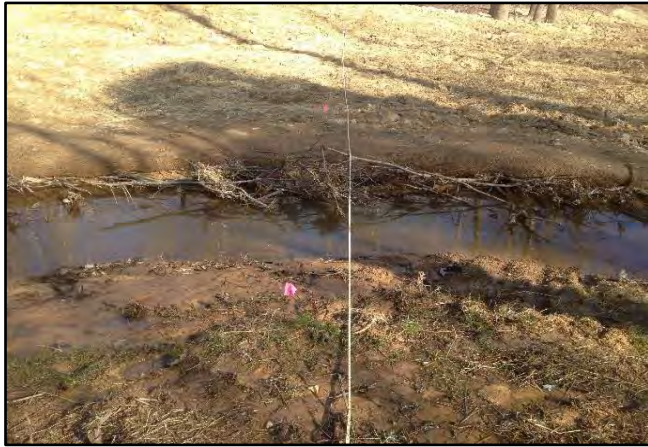
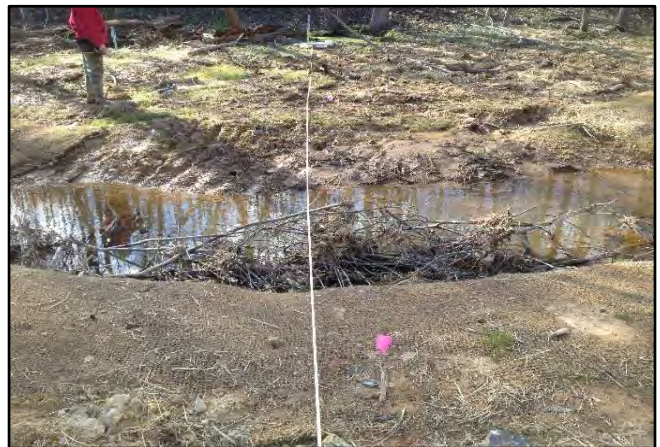
Permanent Cross-section
X8 - Reach 3
(As-built Data - Collected April 2016)

Feature	Stream Type	BKF Area	BKF Width	BKF Depth	Max BKF Depth	W/D	BH Ratio	ER	BKF Elev	TOB Elev	WFPA
Pool		14.42	11.92	1.21	2.24	9.85	1.00	4.23	555.44	555.45	50.45

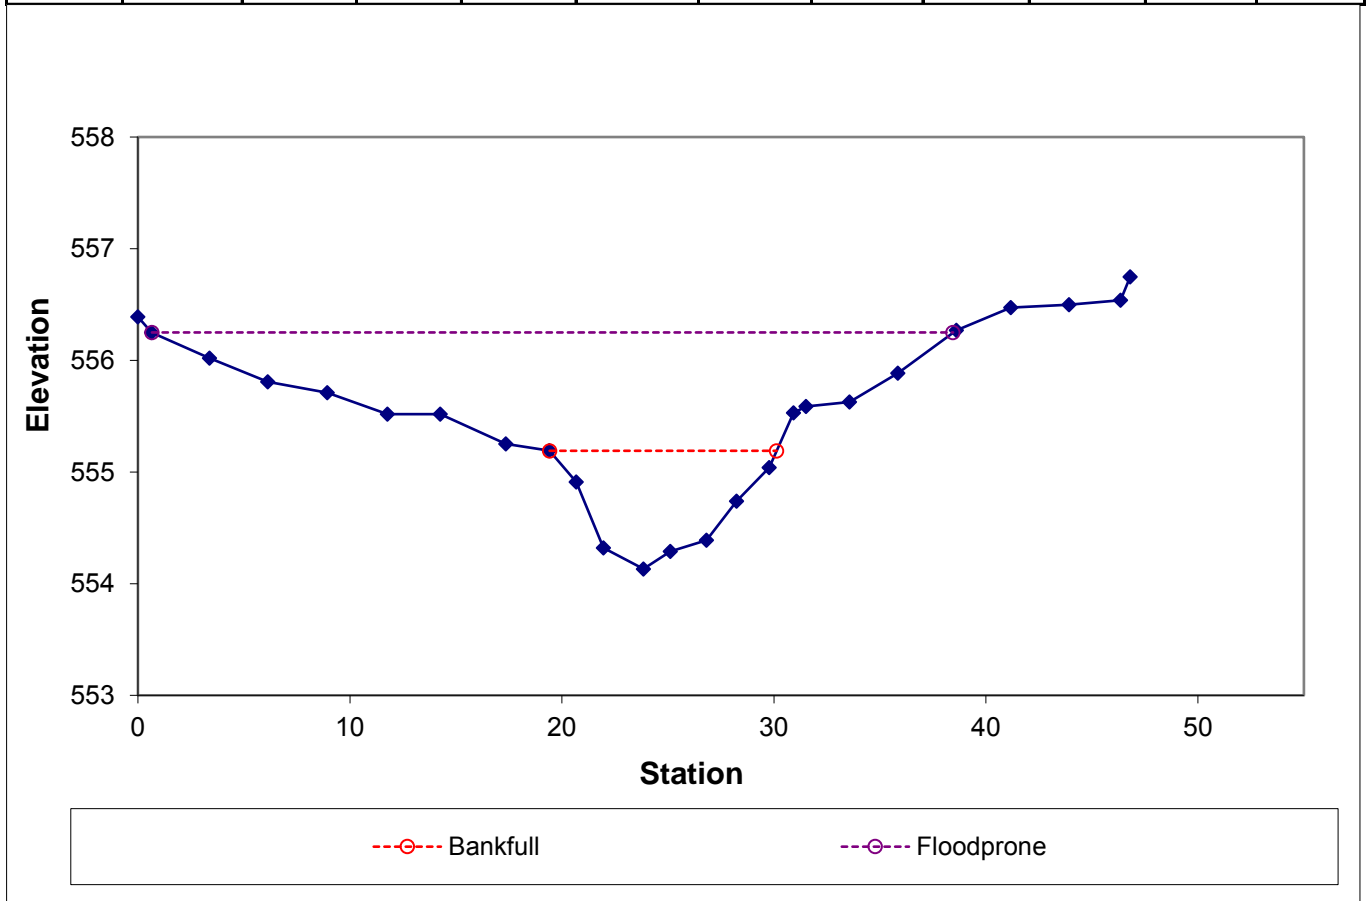
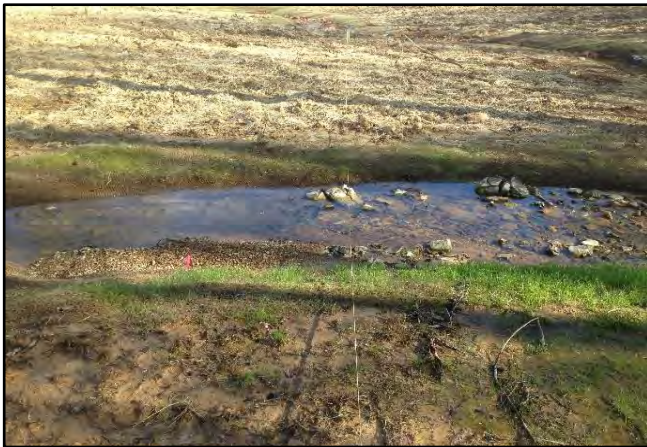
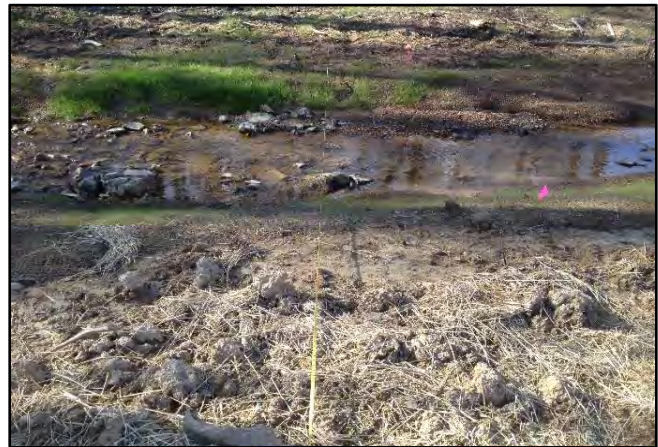
Permanent Cross-section
X9 - Reach 3
(As-built Data - Collected April 2016)

Feature	Stream Type	BKF Area	BKF Width	BKF Depth	Max BKF Depth	W/D	BH Ratio	ER	BKF Elev	TOB Elev	WFPA
Riffle	C	6.79	10.71	0.63	1.06	16.87	1.00	3.53	555.19	555.19	37.79

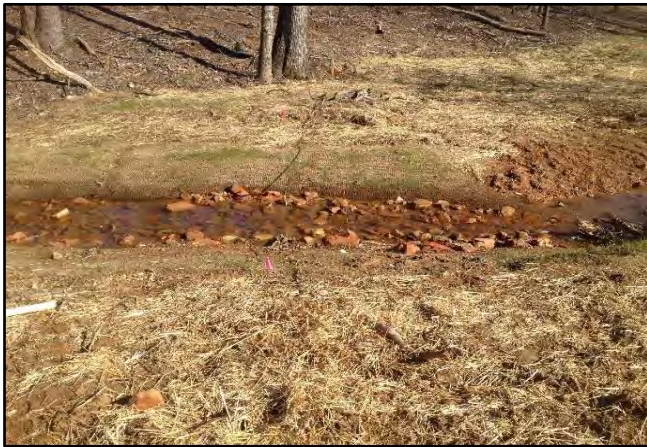
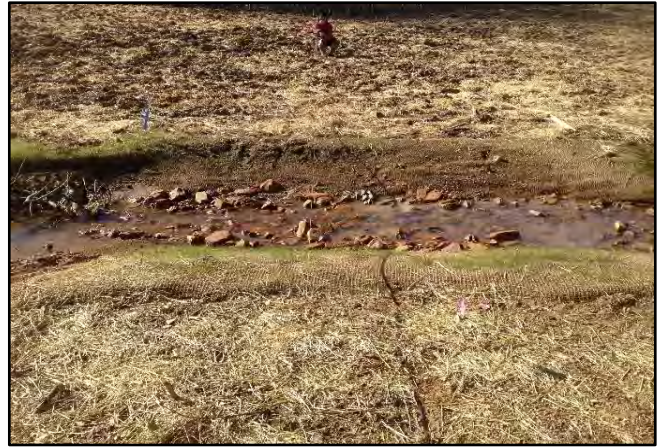
Permanent Cross-section
X10 - Reach 5
(As-built Data - Collected April 2016)

Feature	Stream Type	BKF Area	BKF Width	BKF Depth	Max BKF Depth	W/D	BH Ratio	ER	BKF Elev	TOB Elev	WFPA
Riffle	C	8.00	10.36	0.77	1.18	13.43	1.01	5.70	550.83	550.84	59.38

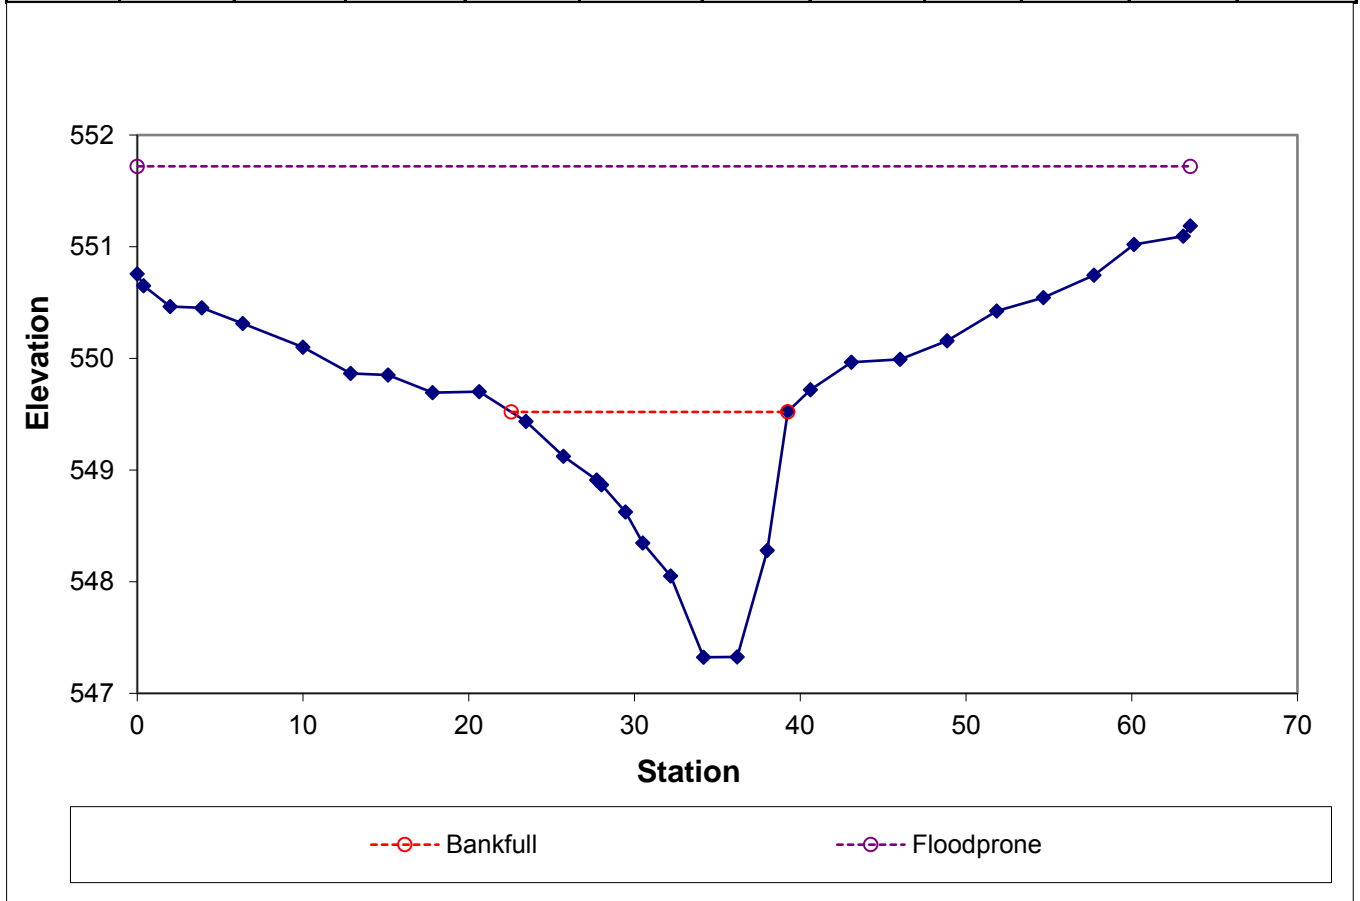
Feature	Stream Type	BKF Area	BKF Width	BKF Depth	Max BKF Depth	W/D	BH Ratio	ER	BKF Elev	TOB Elev	WFPA
Pool		18.19	16.70	1.09	2.20	15.34	1.00	3.81	549.52	549.52	63.54

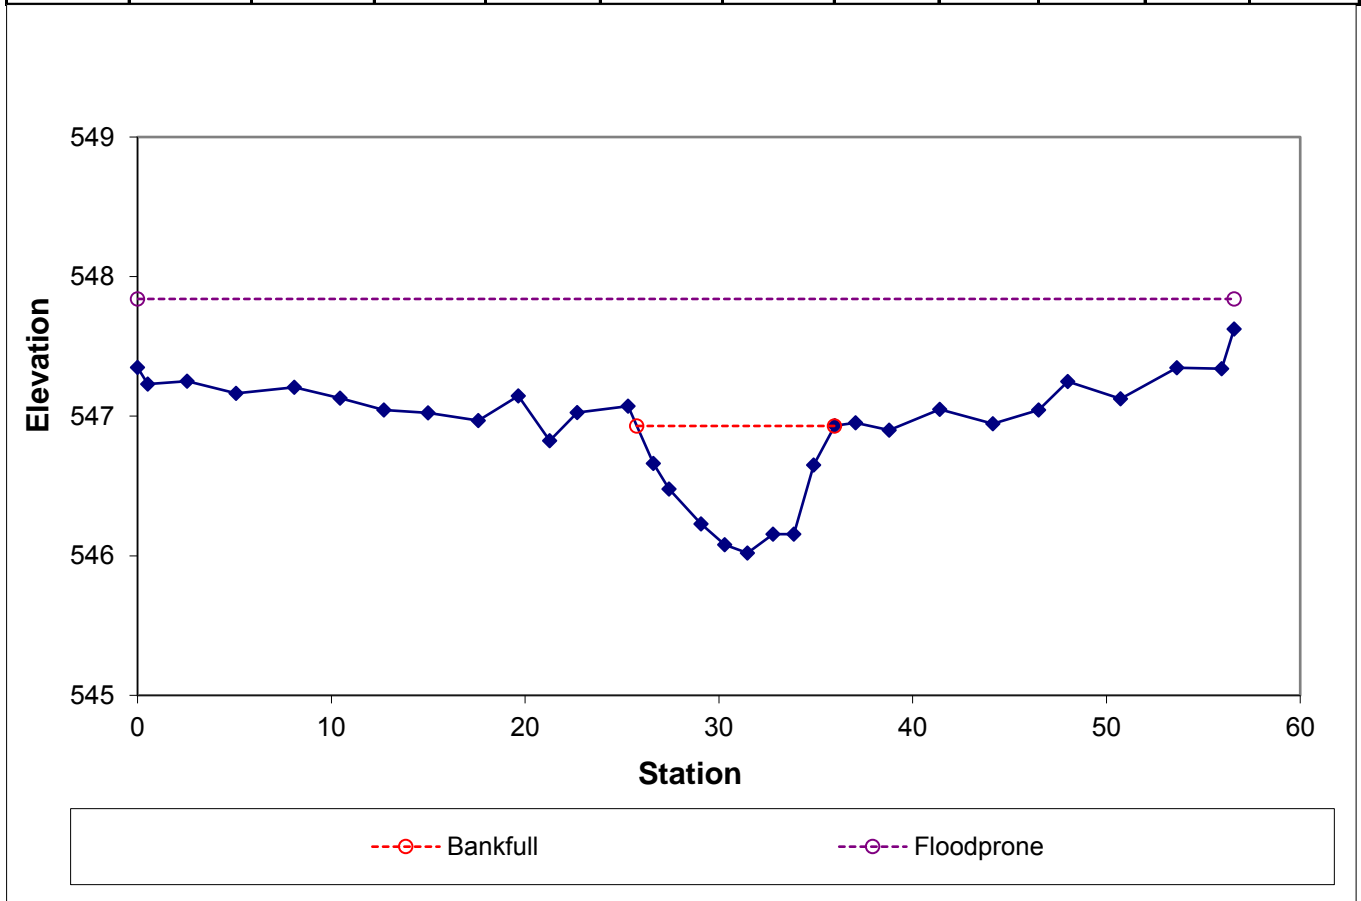
Permanent Cross-section
X13 - Reach 5
(As-built Data - Collected April 2016)

Feature	Stream Type	BKF Area	BKF Width	BKF Depth	Max BKF Depth	W/D	BH Ratio	ER	BKF Elev	TOB Elev	WFGPA
Riffle	C	5.97	10.19	0.59	0.91	17.40	1.00	5.55	546.93	546.93	56.59

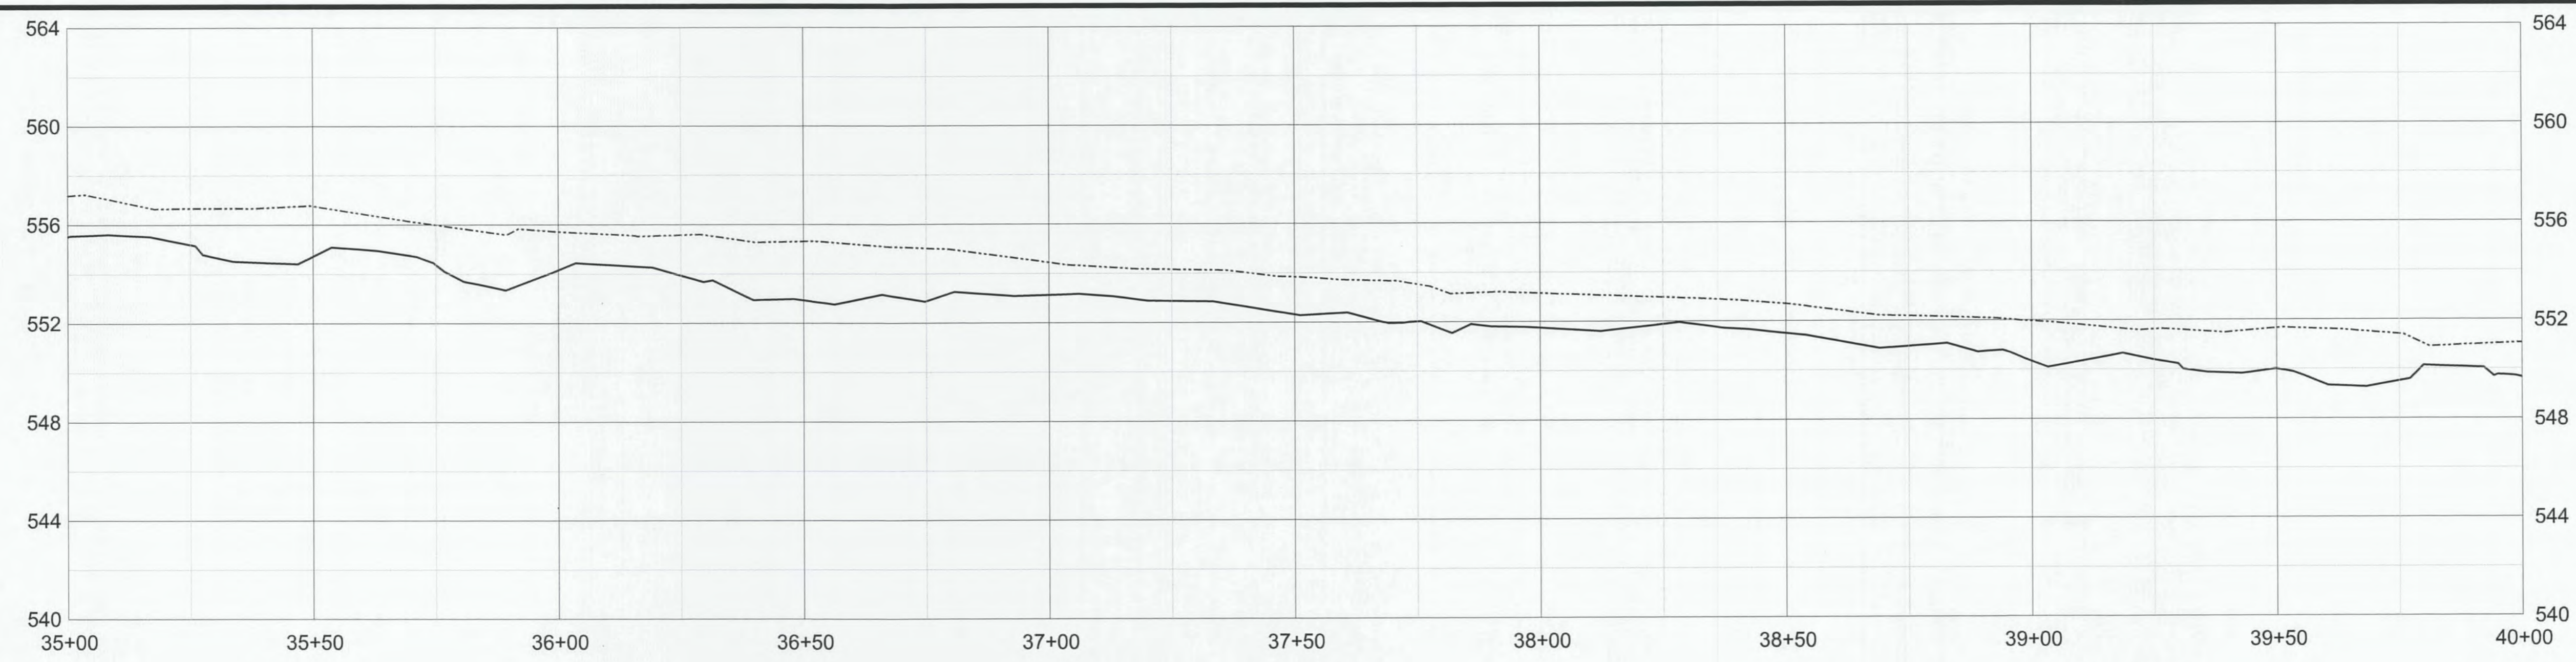
AS-BUILT SURVEY PLAN & PROFILE

- AS-BUILT THALWEG
- AS-BUILT LOW BANK

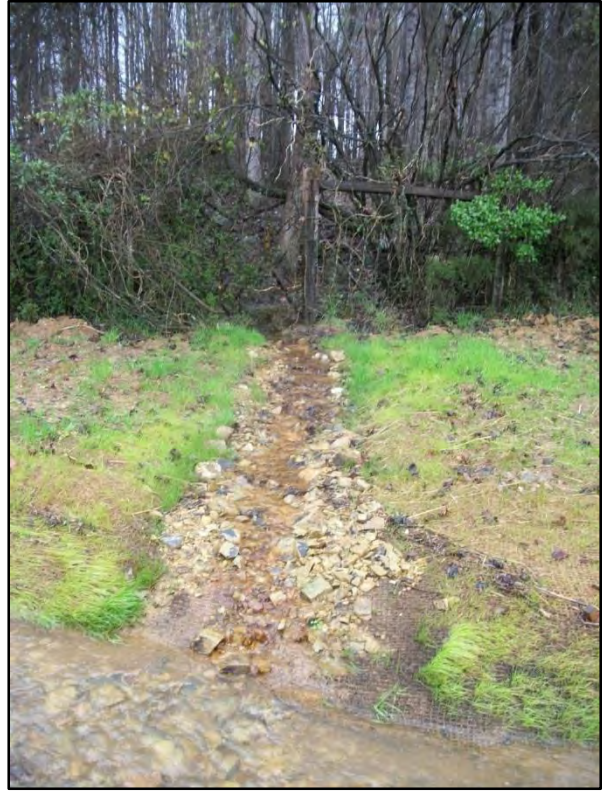
PID 3: Station 10+70 – Left Floodplain Rock Lined Channel (12/31/15)

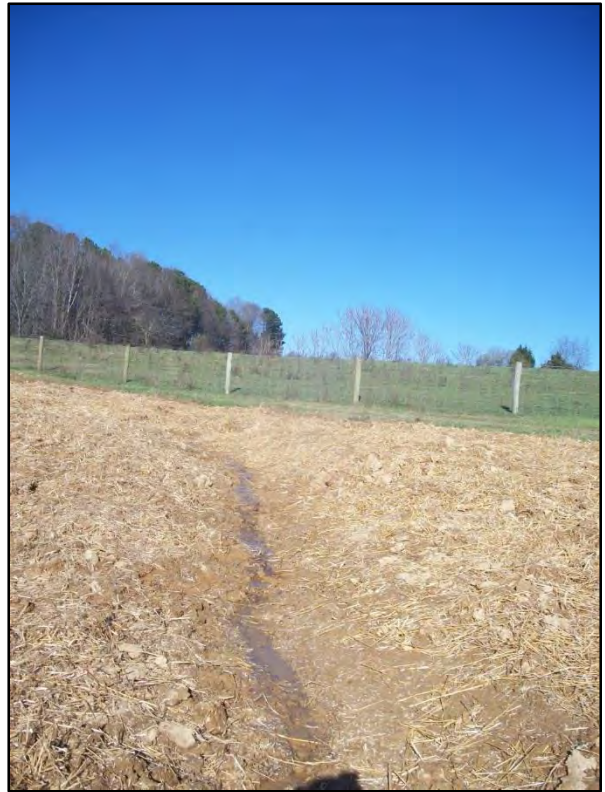
**PID 8: Station 14+65 – Left Floodplain
Matted Drainage Swale (1/14/16)**

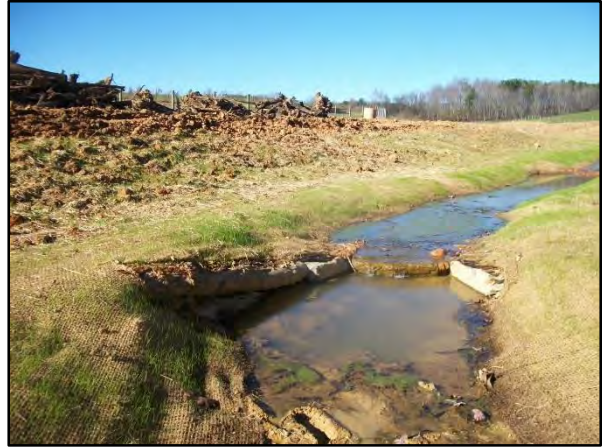
PID 17: Station 21+75 – Upstream (12/15/15)

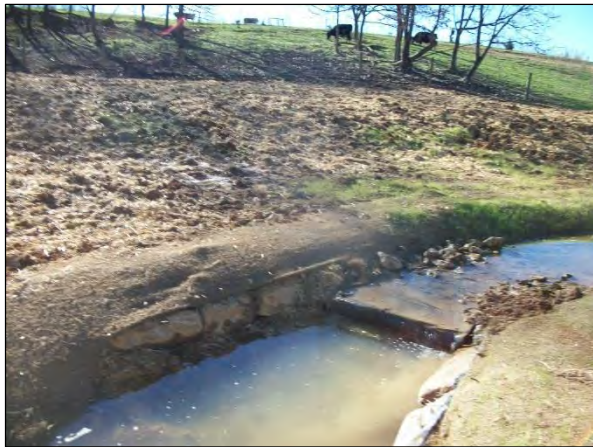
PID 18: Station 23+30 – Upstream (12/15/16)

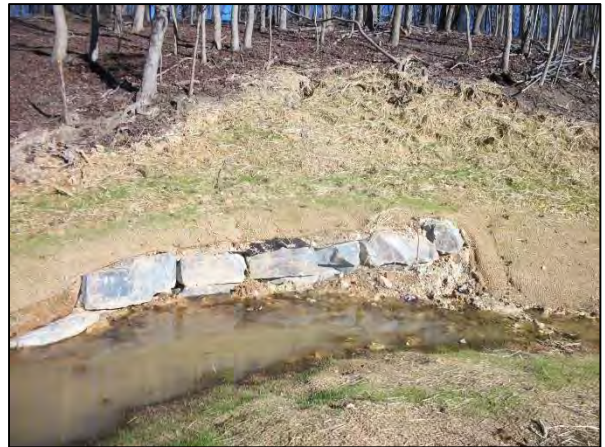
PID 19: Station 23+60 – Upstream (1/13/16)

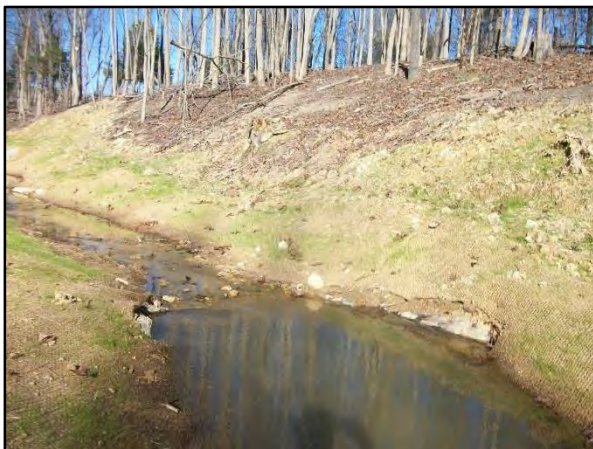
PID 20: Station 23+60 – Left Bank (12/15/15)

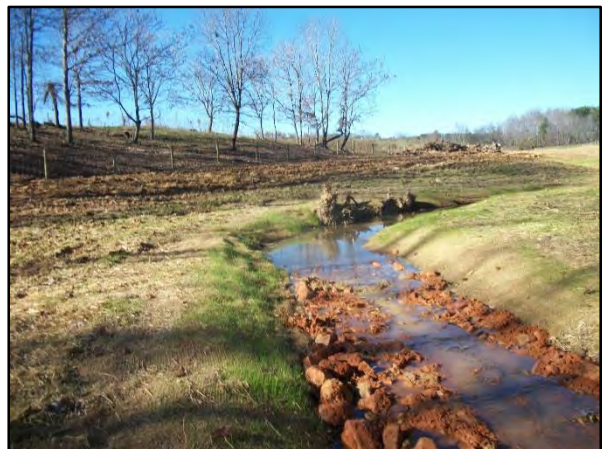
PID 21: Station 24+50 – Upstream (12-15-15)

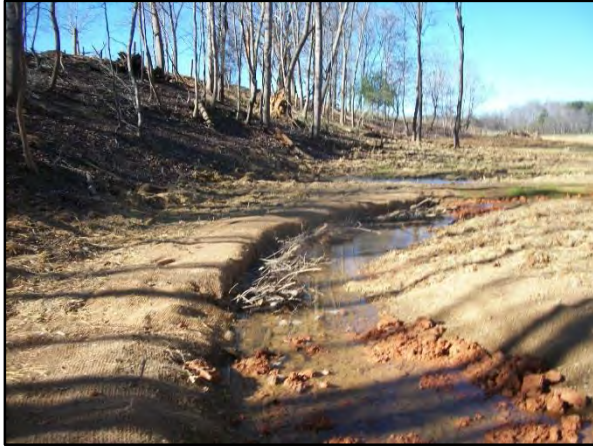
PID 22: Station 25+50 – Upstream (12/15/15)

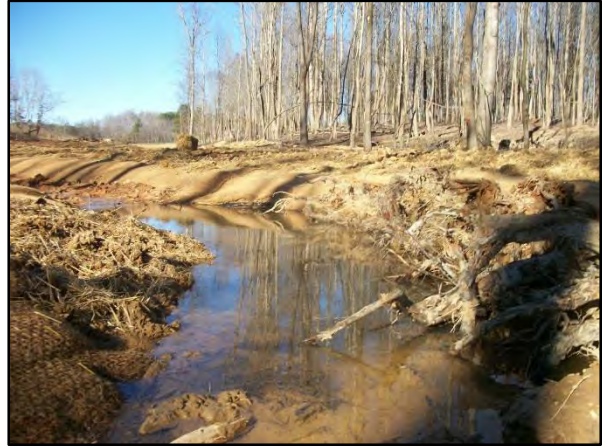
PID 23: Station 27+50 – Upstream (12/15/15)

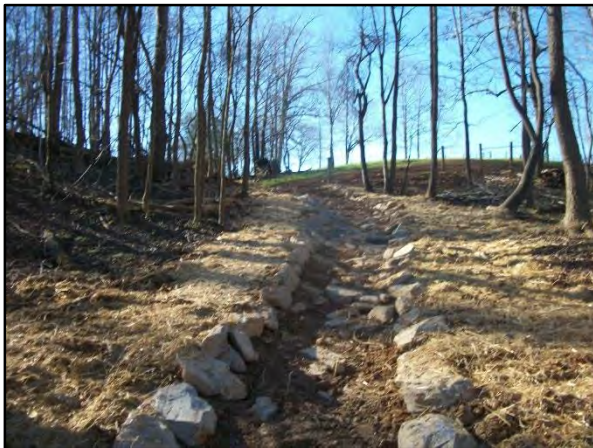
PID 24: Station 28+10 – Upstream (12/15/15)

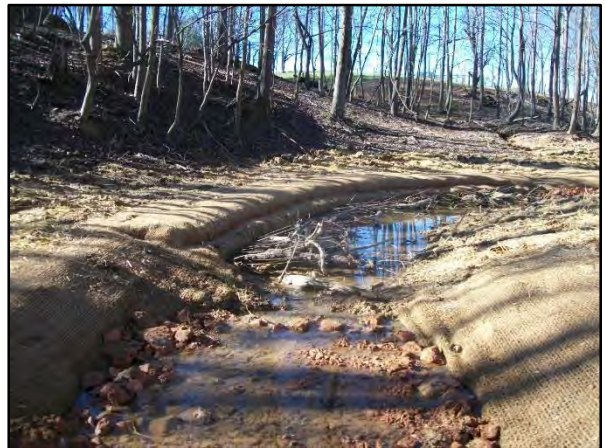
**PID 25: Station 28+35 – Right Floodplain
Rock Lined Channel (1/13/16)**

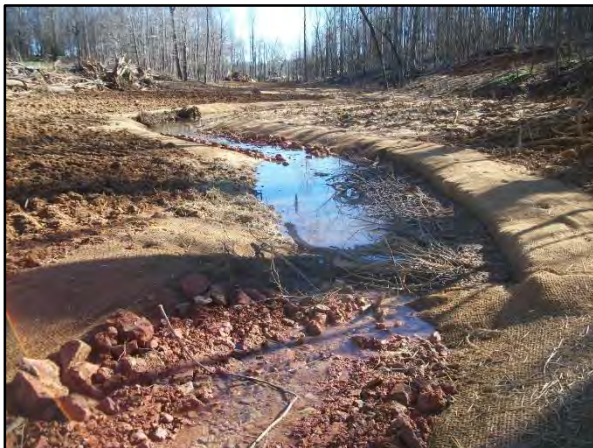
PID 26: Station 28+90 – Upstream (12/15/15)

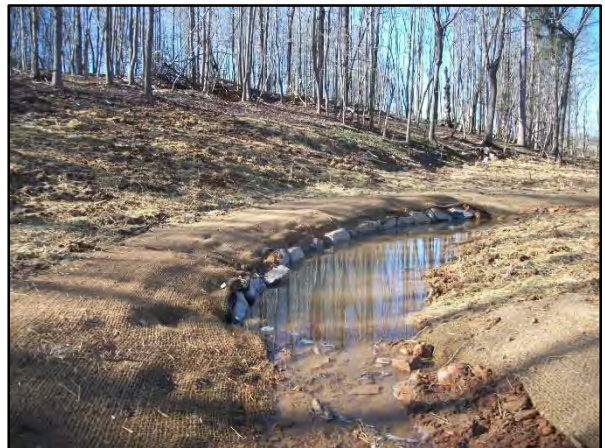
**PID 27: Station 29+80 – Downstream
(12/15/15)**

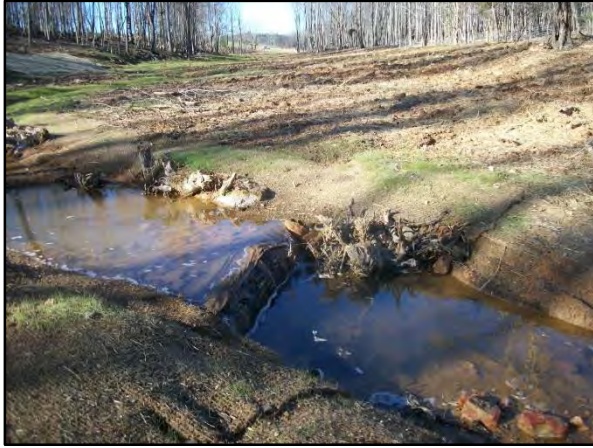
PID 28: Station 31+40 – Upstream (12/15/15)

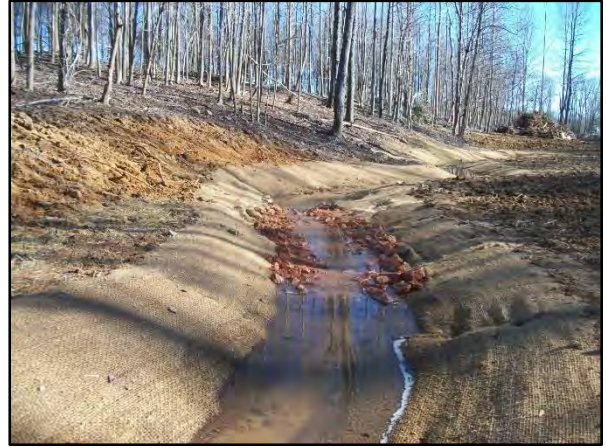
PID 29: Station 33+10 – Upstream (1/13/16)

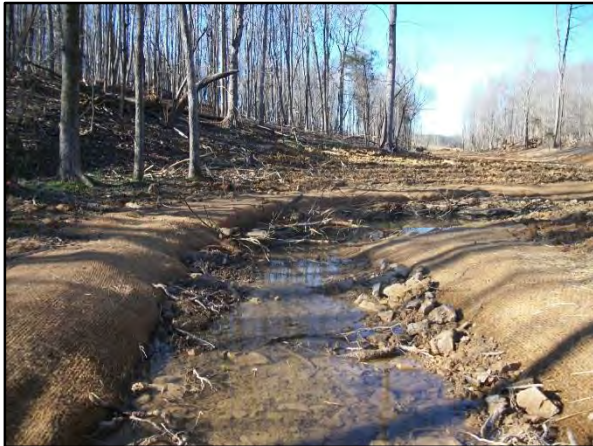
PID 30: Station 33+45 – Downstream (12/15/15)

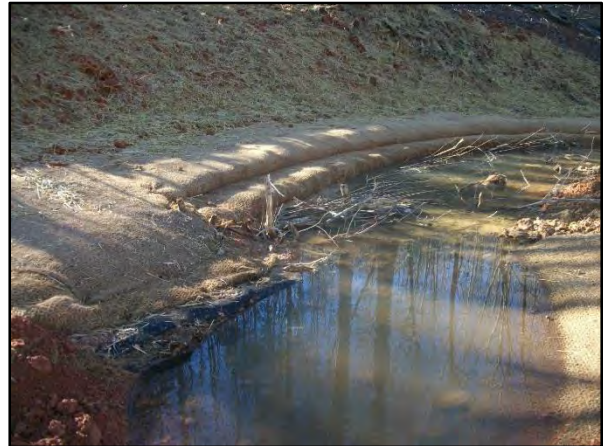
PID 31: Station 35+50 – Upstream (12/15/15)

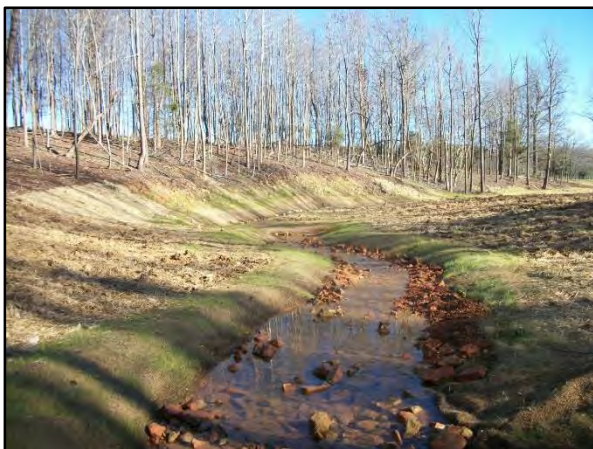
PID 32: Station 36+90 – Upstream (12/15/15)

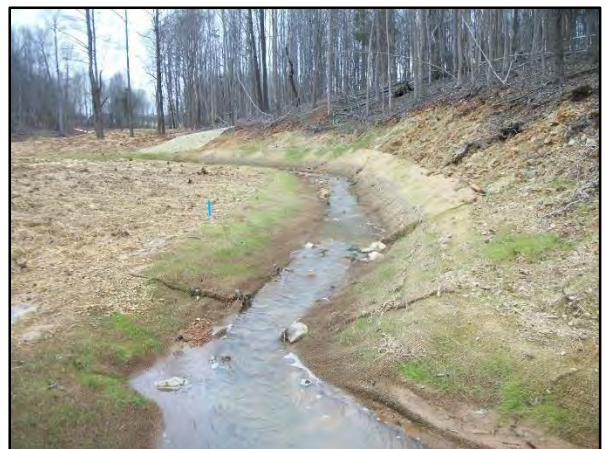
PID 33: Station 37+15 – Downstream (1/13/16)

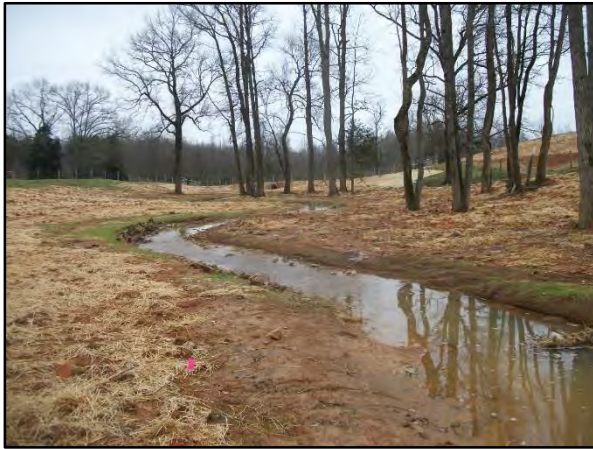
PID 34: Station 39+05 – Upstream (2/4/16)
