FINAL
Baseline Monitoring Document and As-Built Baseline Report
Town Creek Restoration Project – Option B

Stanly County, North Carolina

DMS Project ID No. 95026; NCDEQ Contract No. 003990

Baseline Monitoring Document and As-Built Baseline Report Town Creek Restoration Project – Option B

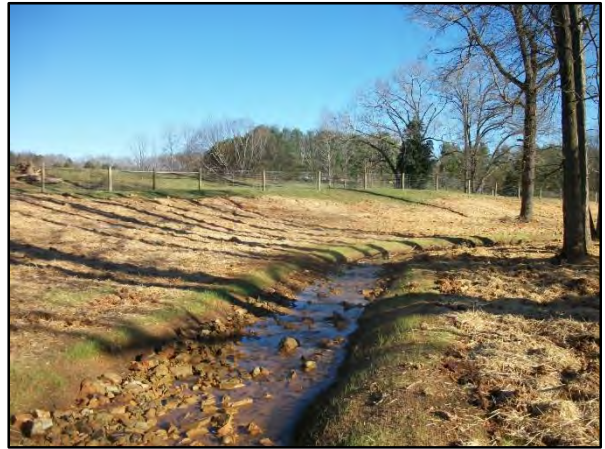
PID 35: Station 42+00 – Downstream (2/4/16)

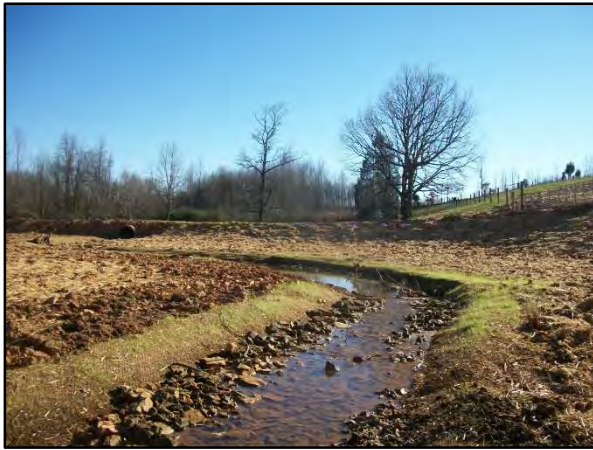
PID 36: Station 43+25 – Downstream (1/13/16)

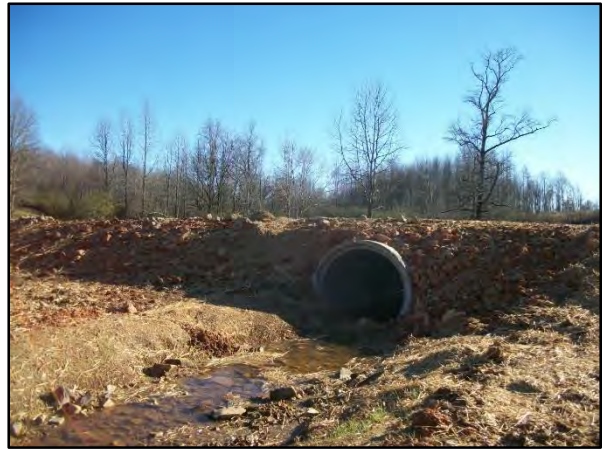
PID 37: Station 44+25 – Downstream (1/13/16)

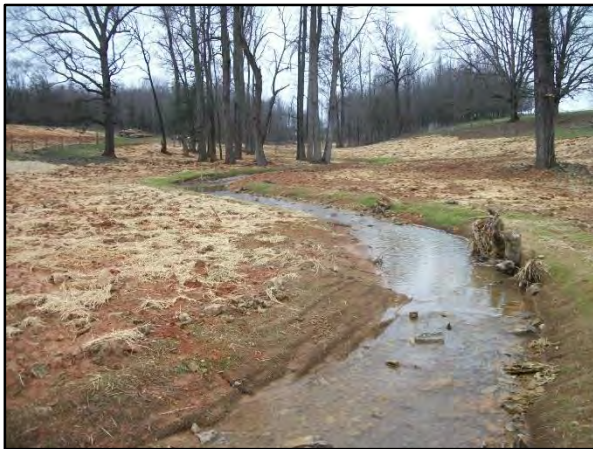
PID 38: Station 45+30 Downstream (1/13/16)

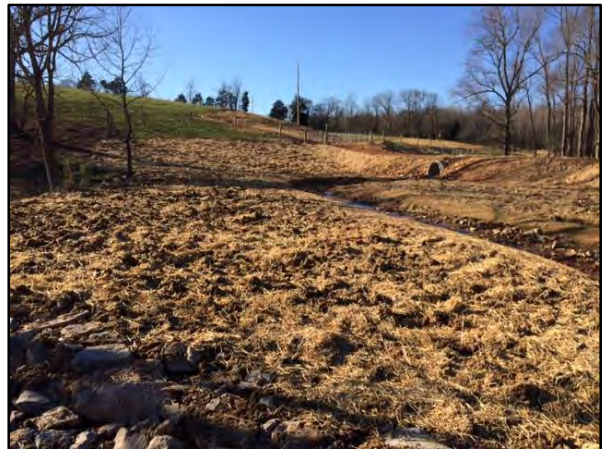
PID 39: Station 45+50 – Upstream (2/4/16)

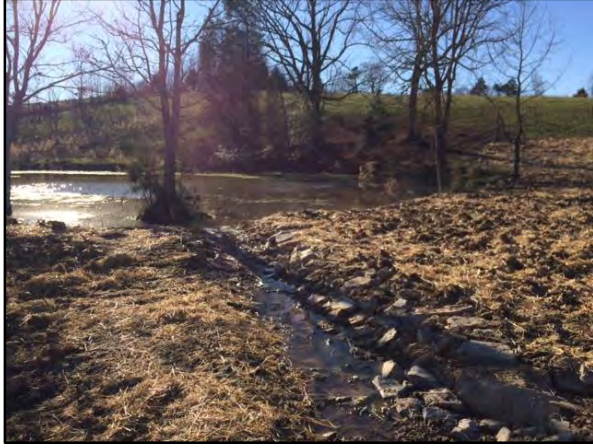
PID 40: Station 46+90 – Upstream (1/13/16)

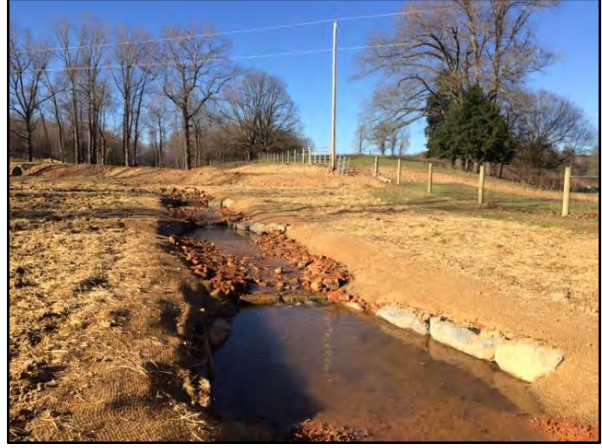
**PID 41: Station 47+00 – Right Floodplain
Rock Lined Channel from Wetland (1/13/16)**

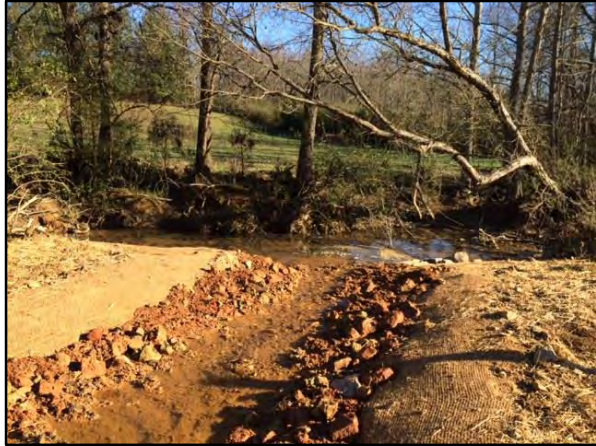
PID 42: Station 47+75 – Upstream (1/13/16)
