**AS-BUILT BASELINE MONITORING REPORT
Tributaries of Wicker Branch Stream Restoration
Union County, North Carolina
DMS Project Number: 95022
Contract No: 003982
USACE Action Id No: SAW 2013-01680**

**Yadkin River
03040105**

Data Collection Period May – June 2015

January 2016

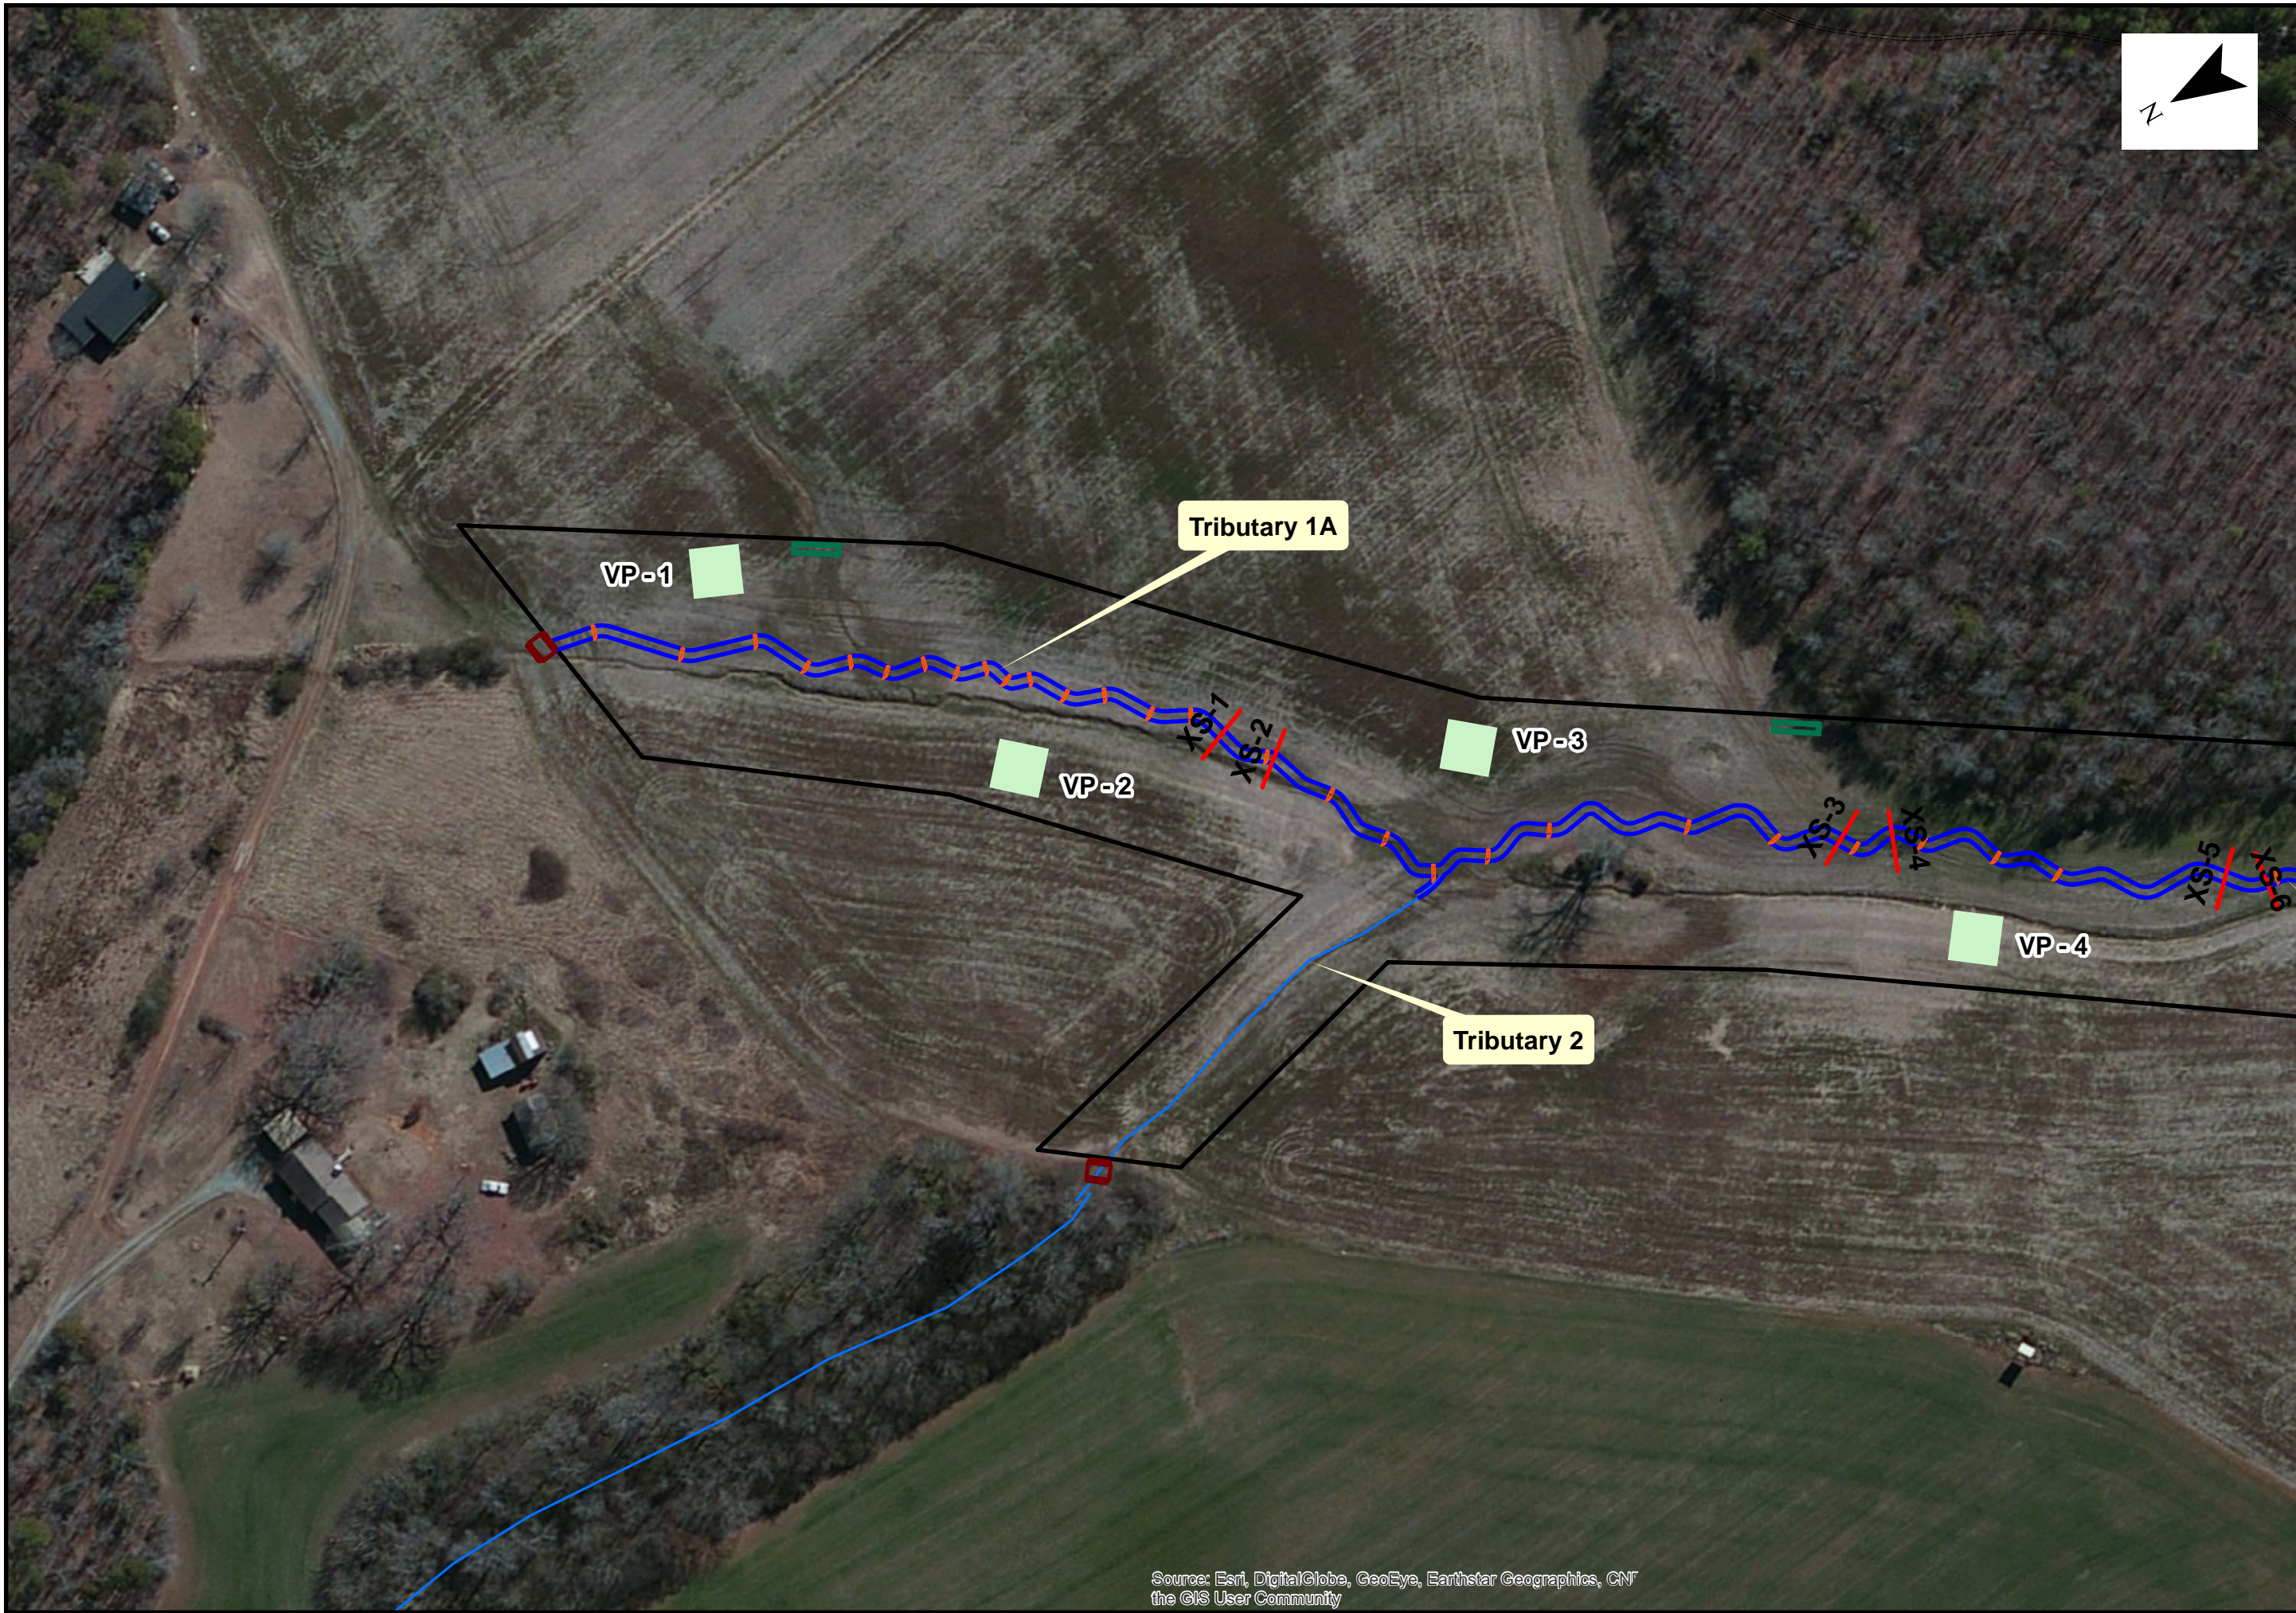
FIGURE 2a

Existing Condition Plan View
 Tributaries of Wicker Branch Stream Restoration
 Union County, NC
 DMS Project No. 95022

The project site consists of four stream channels that currently flow through active agricultural land and prior to restoration efforts were devoid of riparian vegetation (**Appendix B, Figure 2**). Tributary 1 enters the tract as a first order stream and is joined by first order Tributary 2 becoming a second order stream. Tributary 3 and 4 are both first order tributaries in their entirety within the project site. Tributary 1 originates from an outfall and spillway from an upstream pond, while Tributary 2 originates from roadway runoff. Tributary 3 originates from seepage arising from the dam of the upstream pond, and lastly Tributary 4 starts from the outfall and spillway from another upstream pond, located to the northeast of the project site.

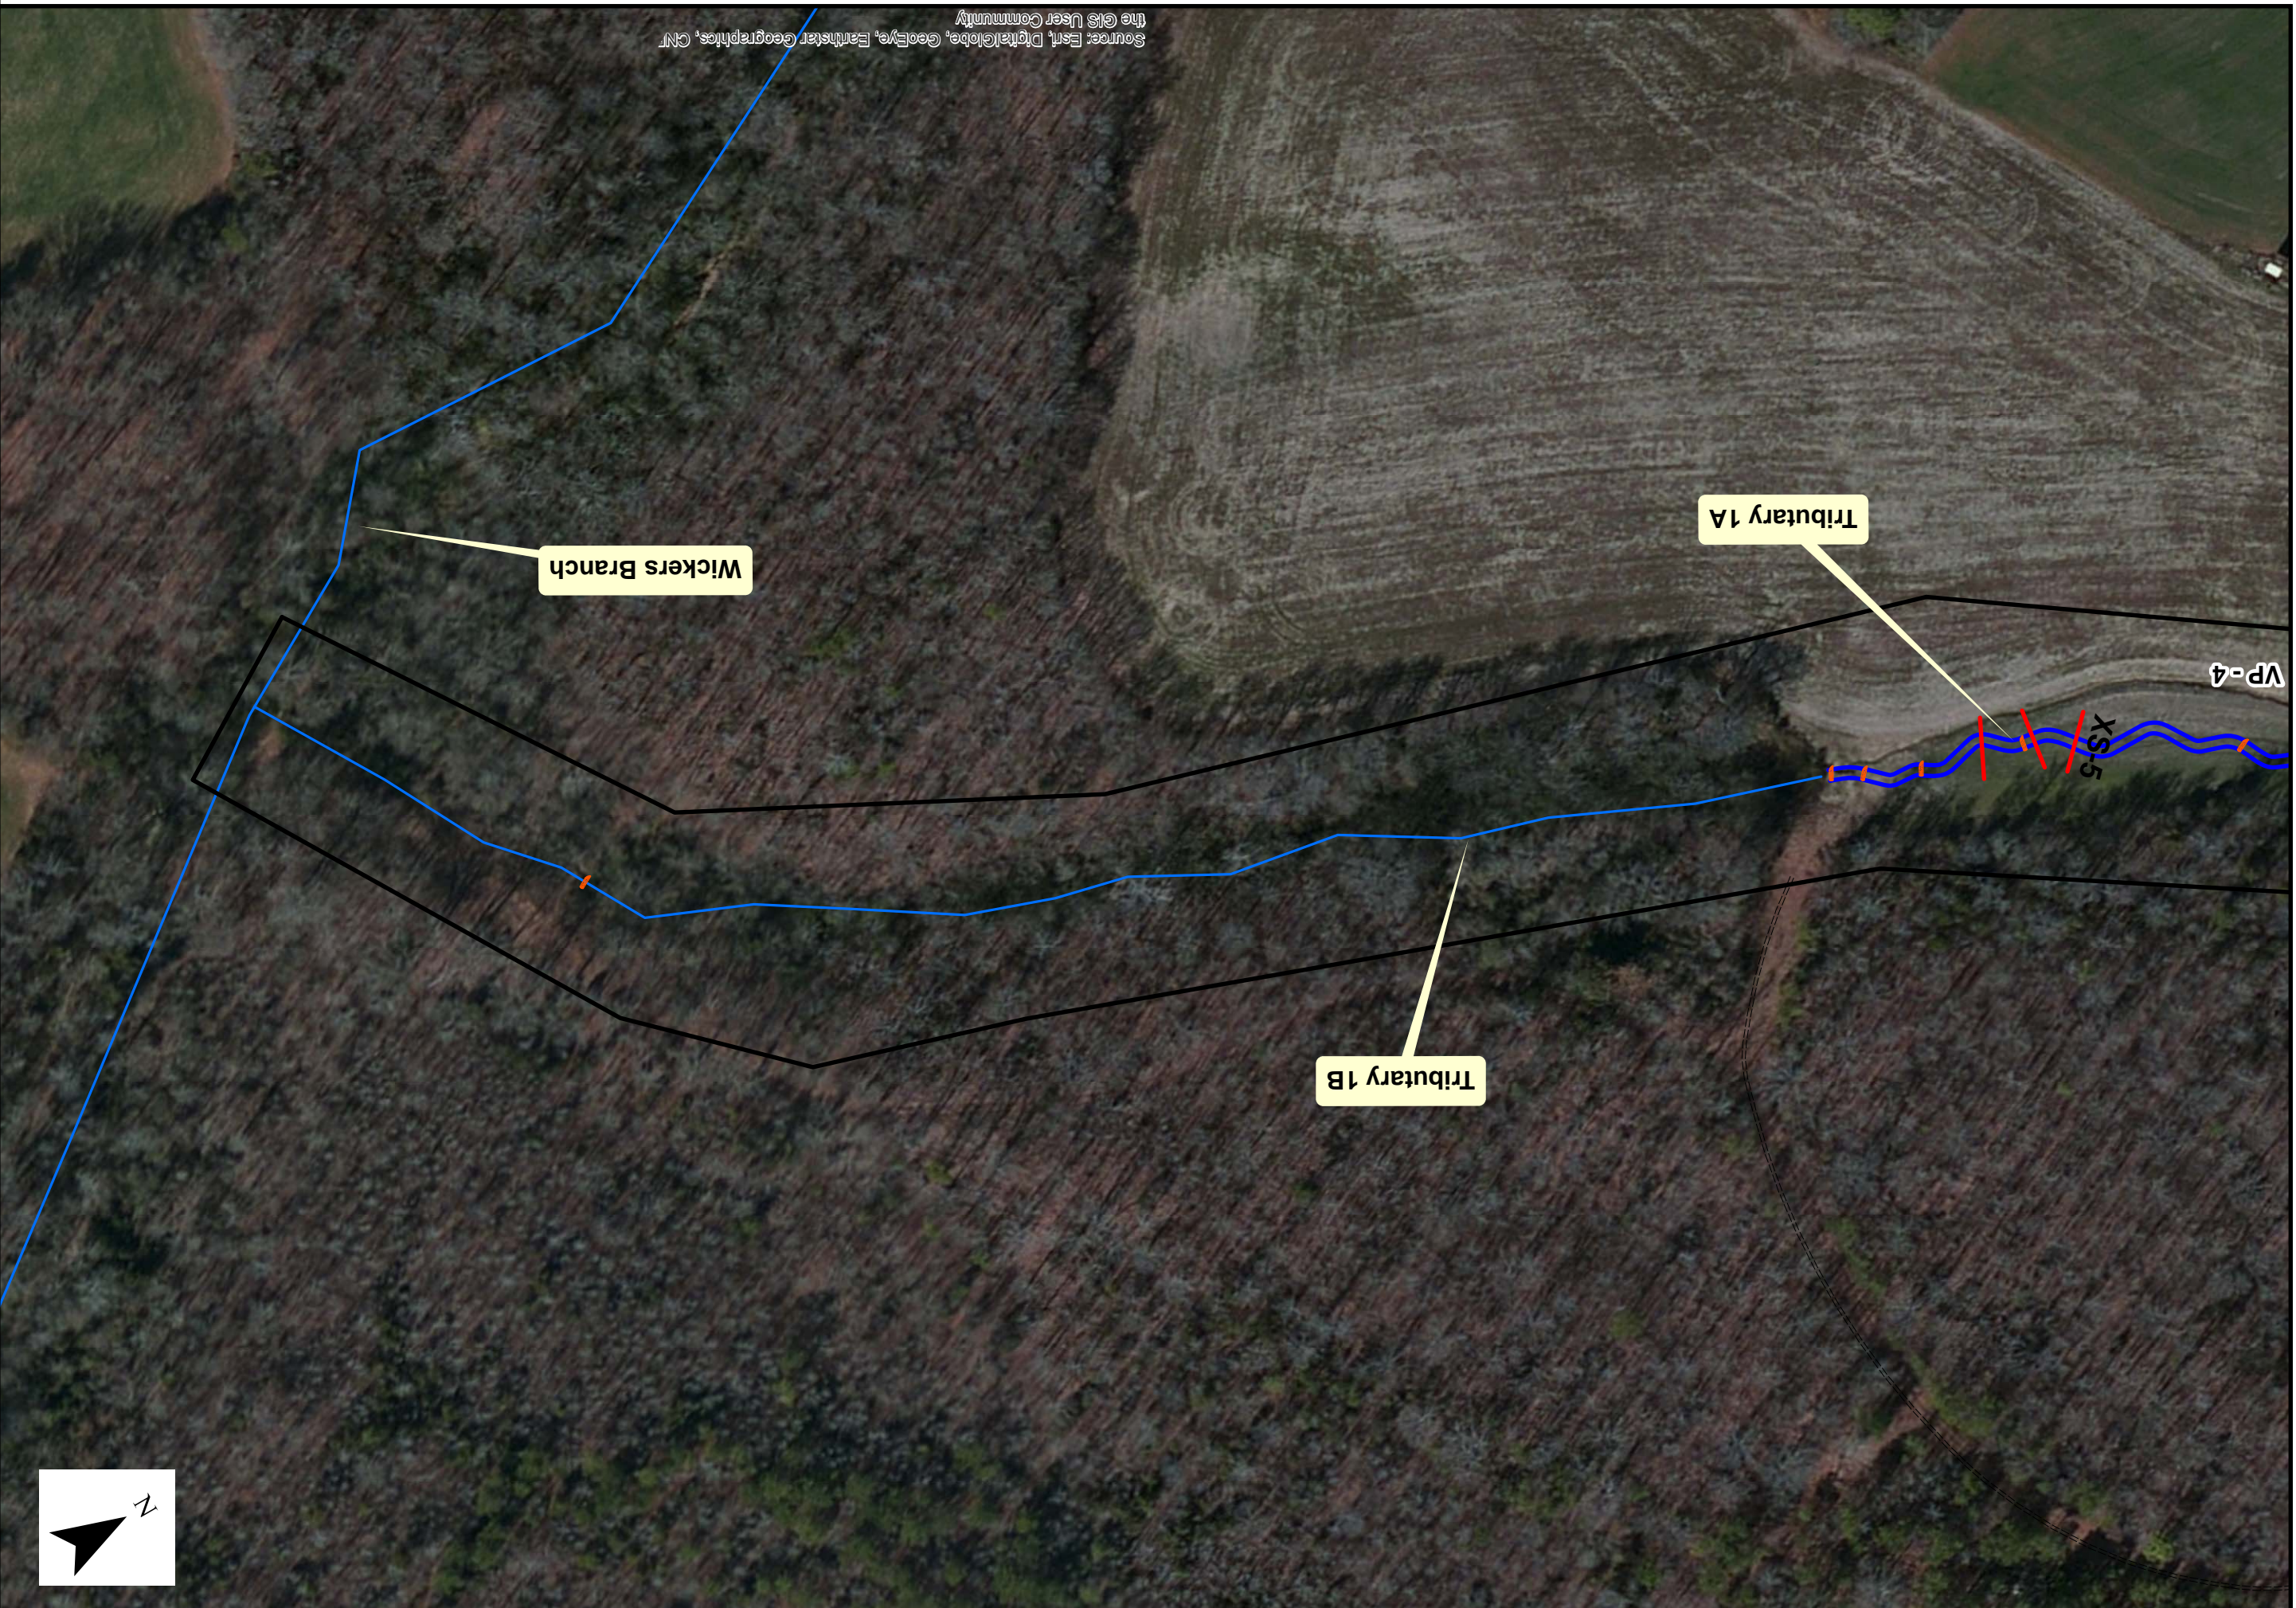
FIGURE
2b

Existing Condition Plan View
Tributaries of Wicker Branch Stream Restoration
Union County, NC
DMS Project No. 95022

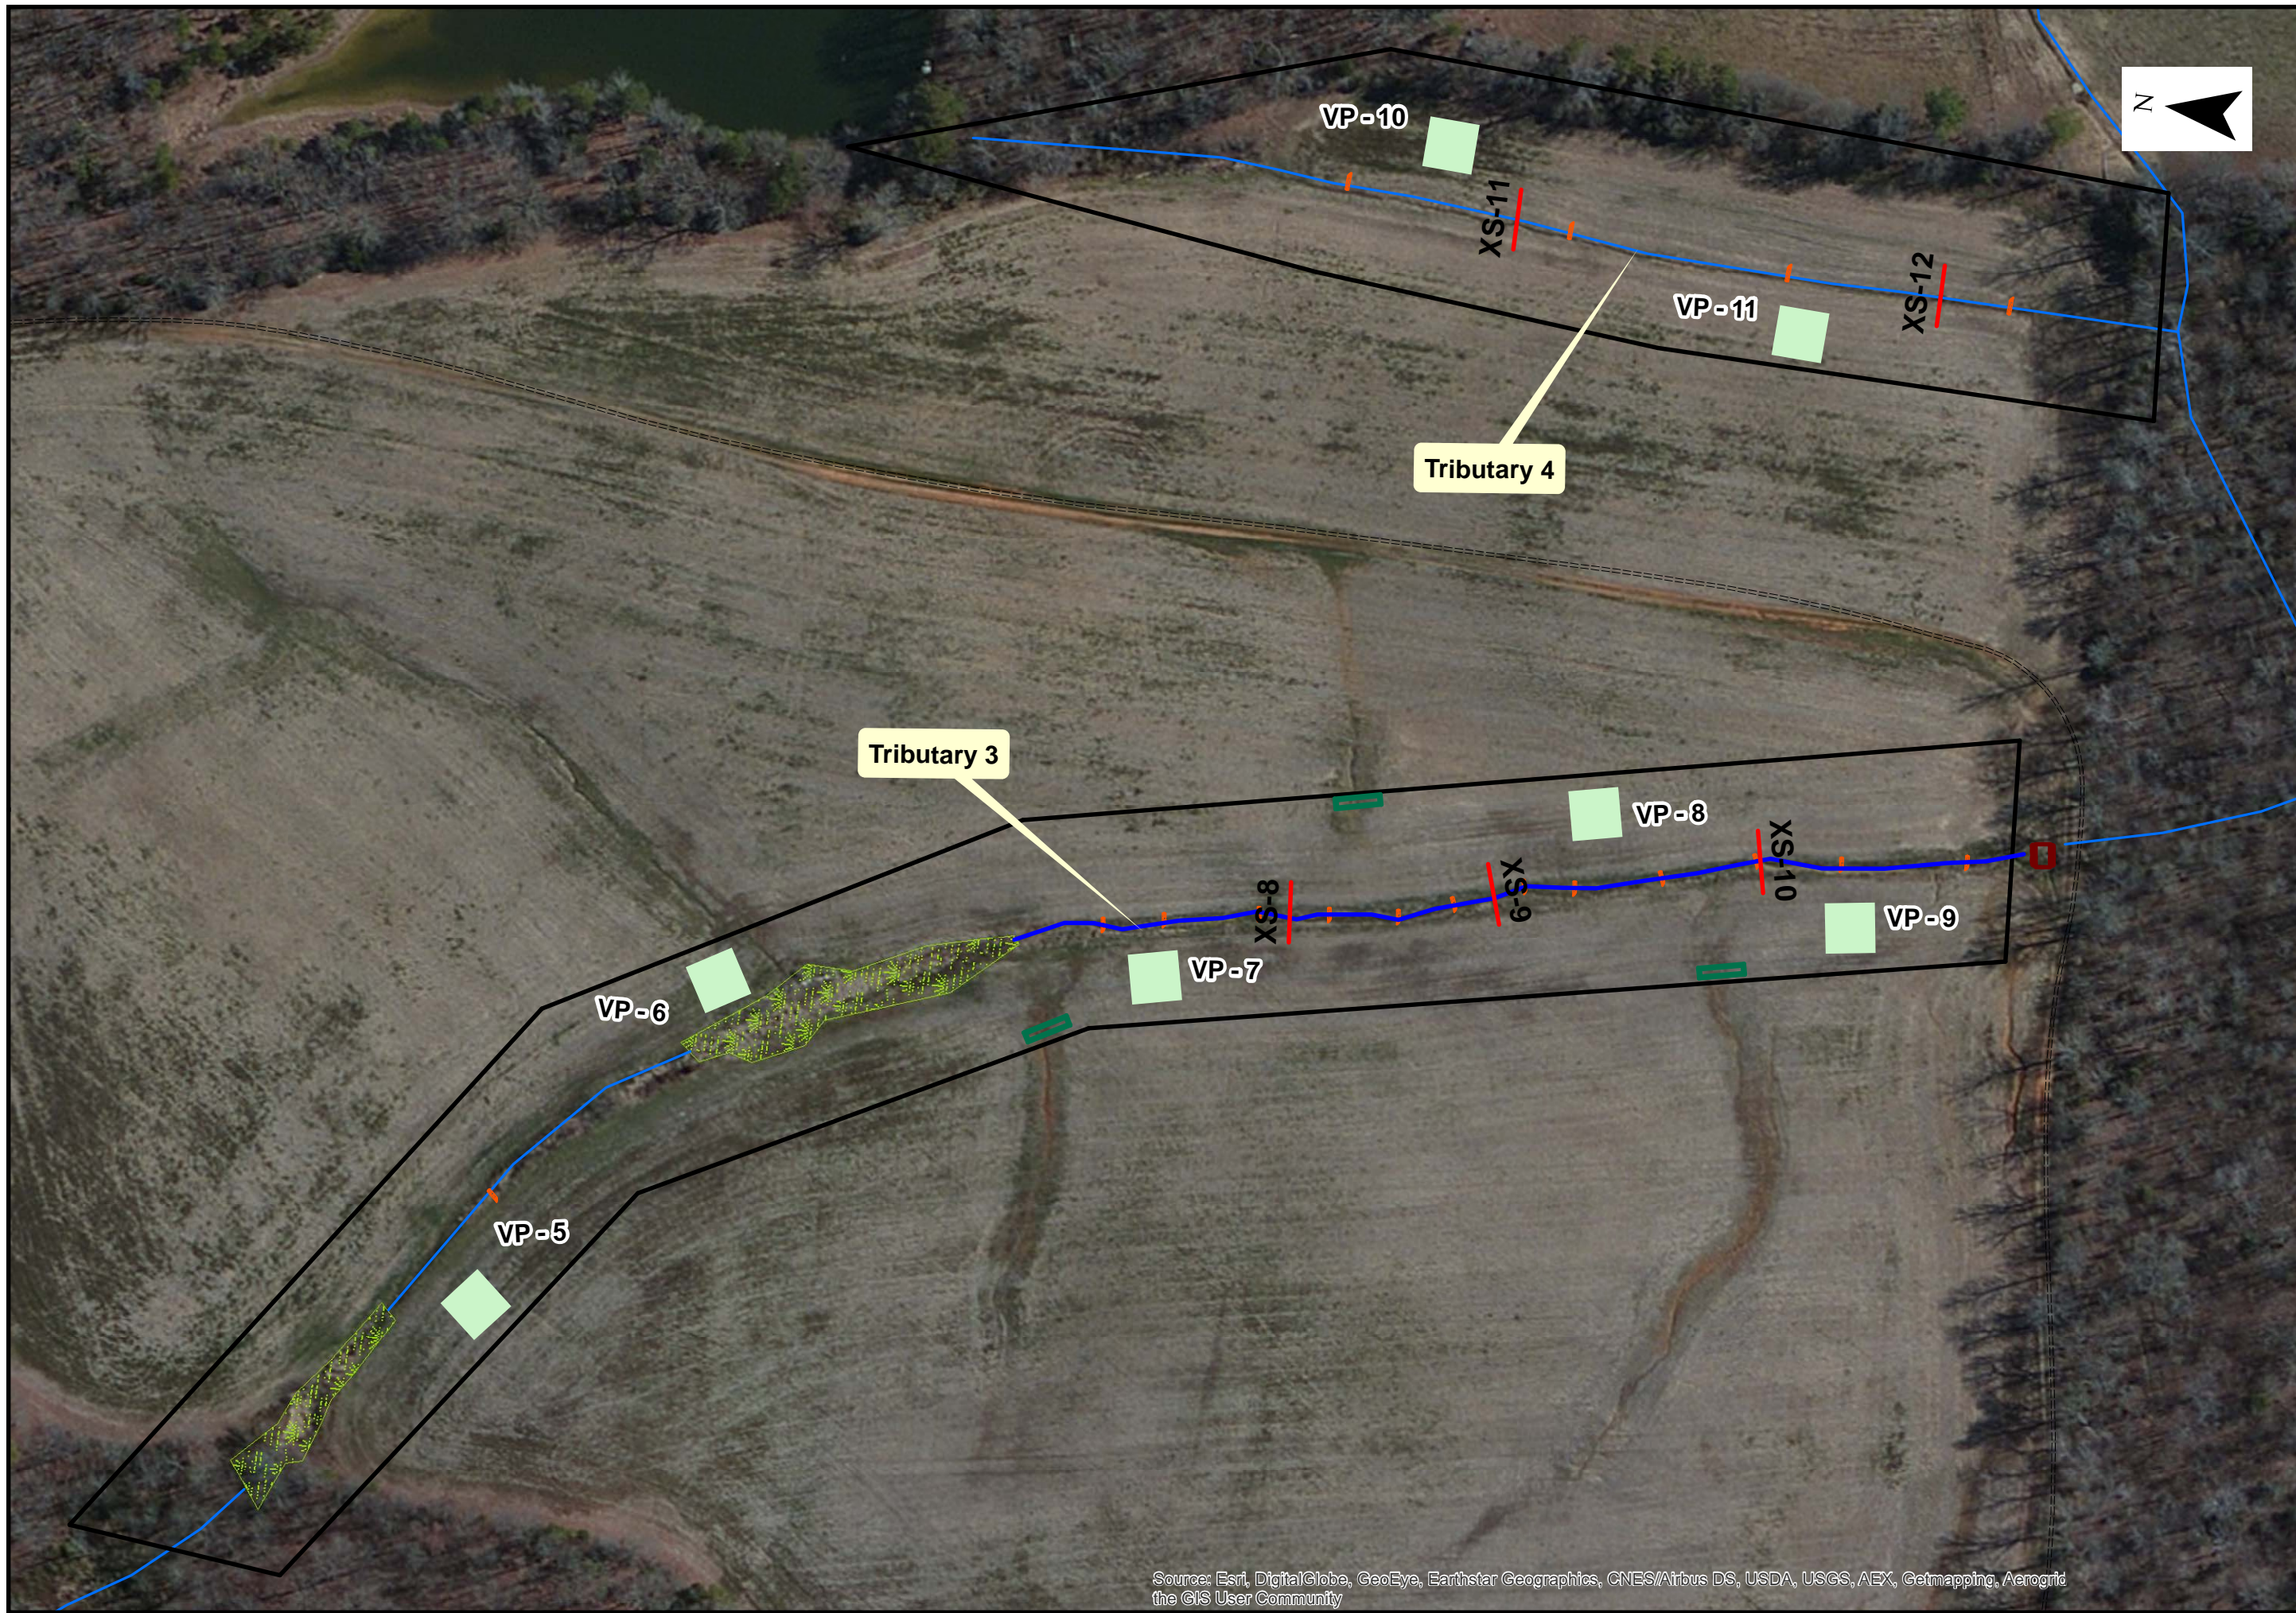
Existing Condition Plan View
Tributaries of Wicker Branch Stream Restoration
Union County, NC
DMS Project No. 95022

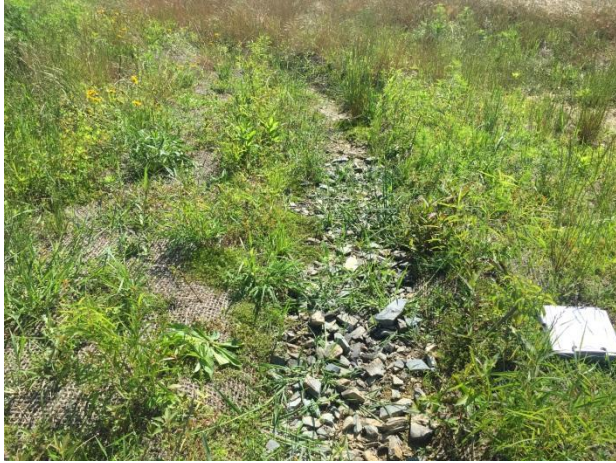
Cross Section 1 (looking upstream) – 6/5/15

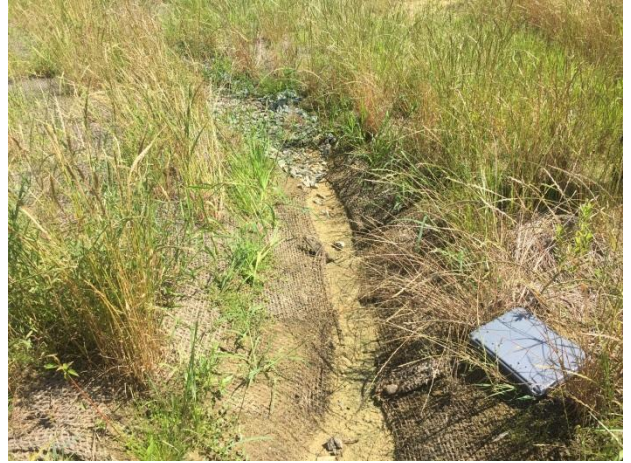
Cross Section 4 (looking upstream) – 6/5/15

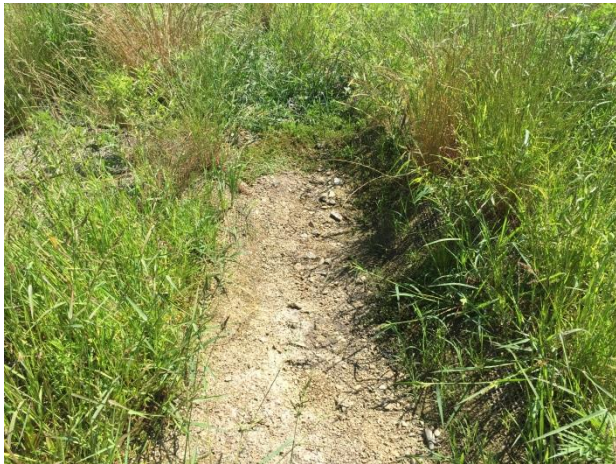
Cross Section 2 (looking upstream) – 6/5/15

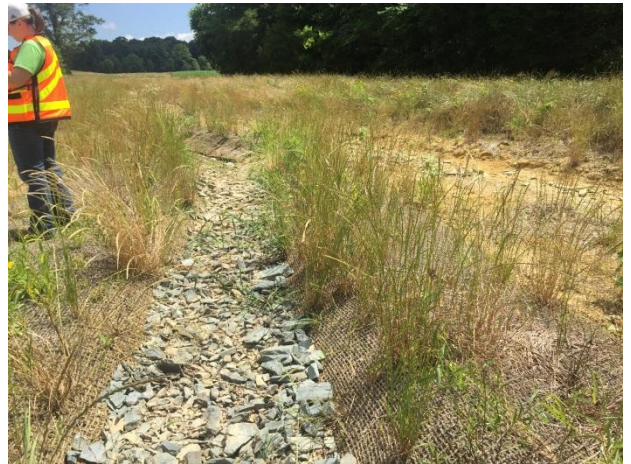
Cross Section 5 (looking upstream) – 6/5/15

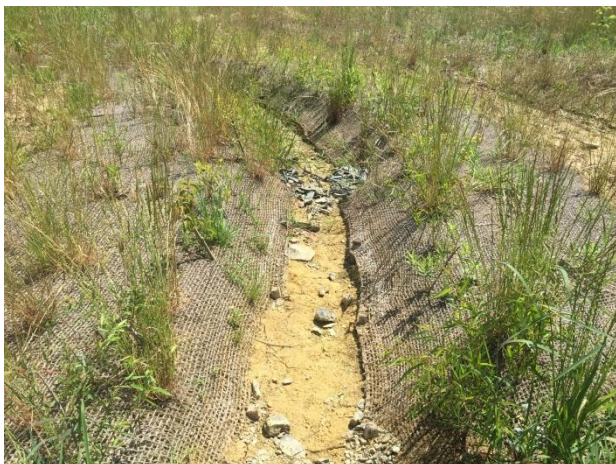
Cross Section 3 (looking upstream) – 6/5/15

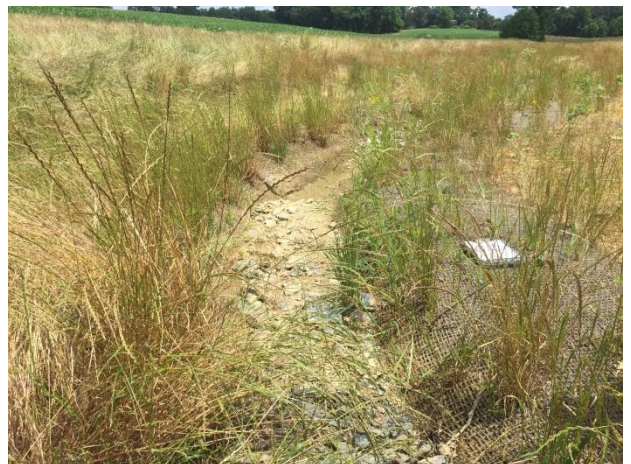
Cross Section 6 (looking upstream) – 6/5/15

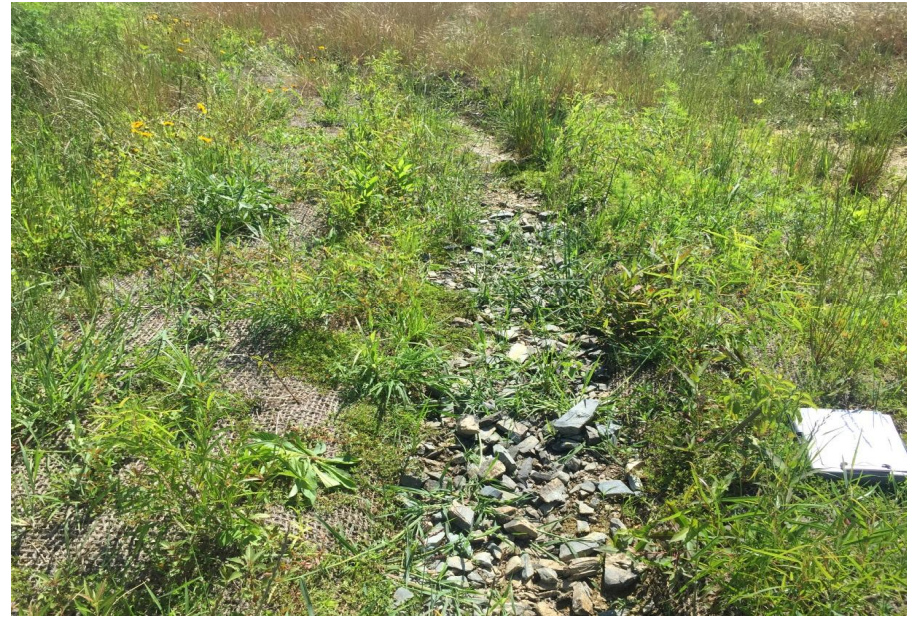
Photo: Cross-section 1 looking upstream

Station	Elevation	
0.00	578.89	LTPIN
0.04	578.17	LBPIN
4.47	577.43	GR
11.48	577.55	GR
15.84	577.70	GR
18.26	577.67	BKF
19.11	577.14	TOE
19.96	577.25	TW
21.30	577.14	TOE
22.49	577.82	TOB
24.51	577.76	GR
29.19	577.67	GR
34.40	577.61	GR
39.94	578.05	RBPIN
39.96	578.60	RTPIN

Summary Data	
Bankfull Elevation	577.67
Bankfull Width (ft)	3.97
Floodprone Width (ft)	50
Bankfull Mean Depth (ft)	0.38
Bankfull Max Depth (ft)	0.53
Bankfull Cross Sectional Area (ft ²)	1.51
Bankfull Width/Depth Ratio	10.45
Bankfull Entrenchment Ratio	10.06

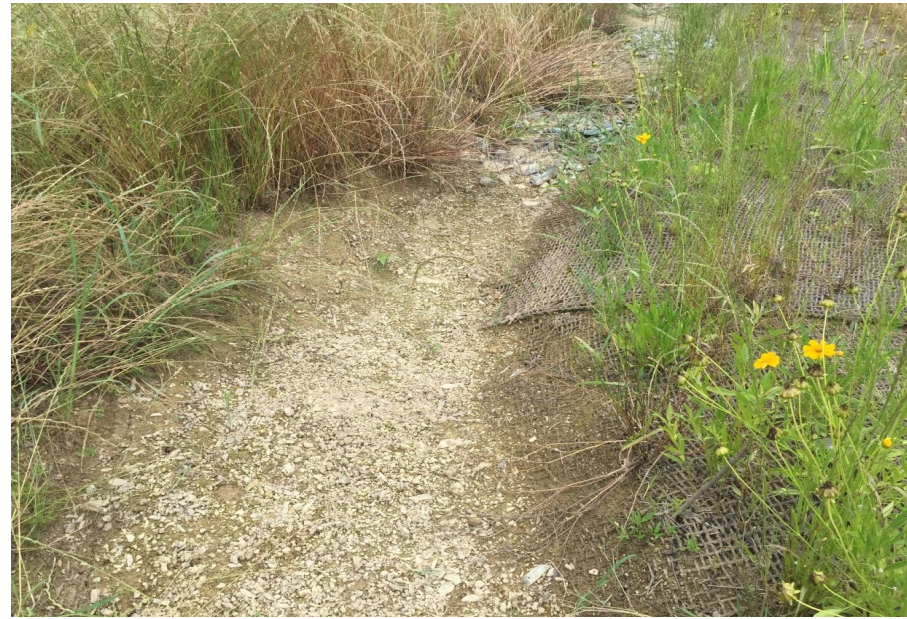
Photo: Cross-section 7 looking upstream

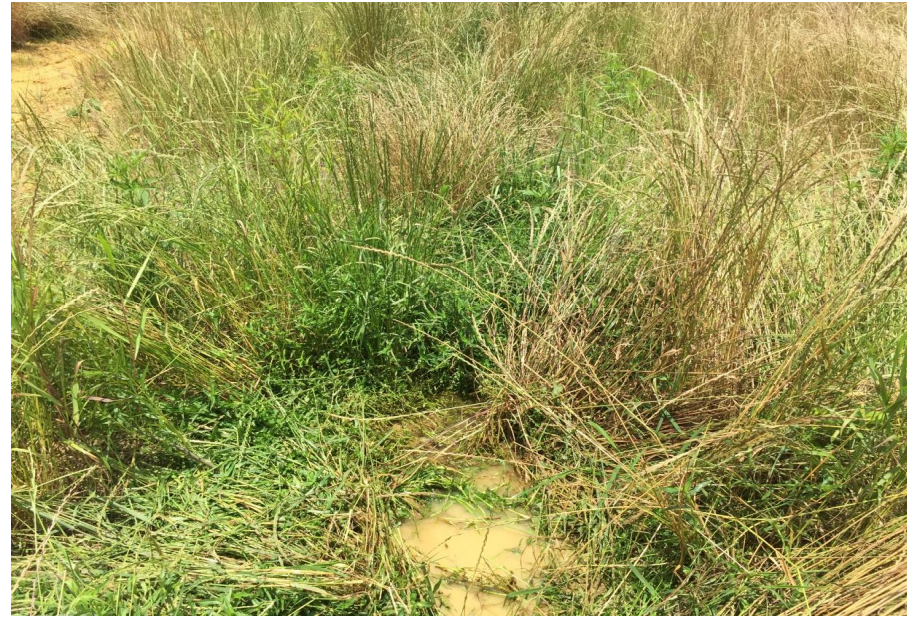
Photo: Cross-section 8 looking downstream

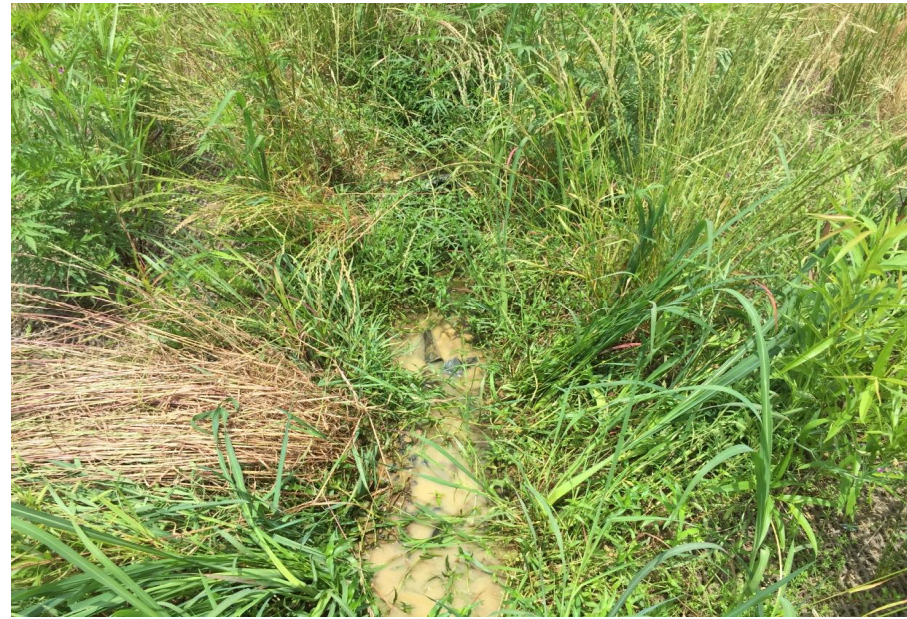
Photo: Cross-section 9 looking upstream

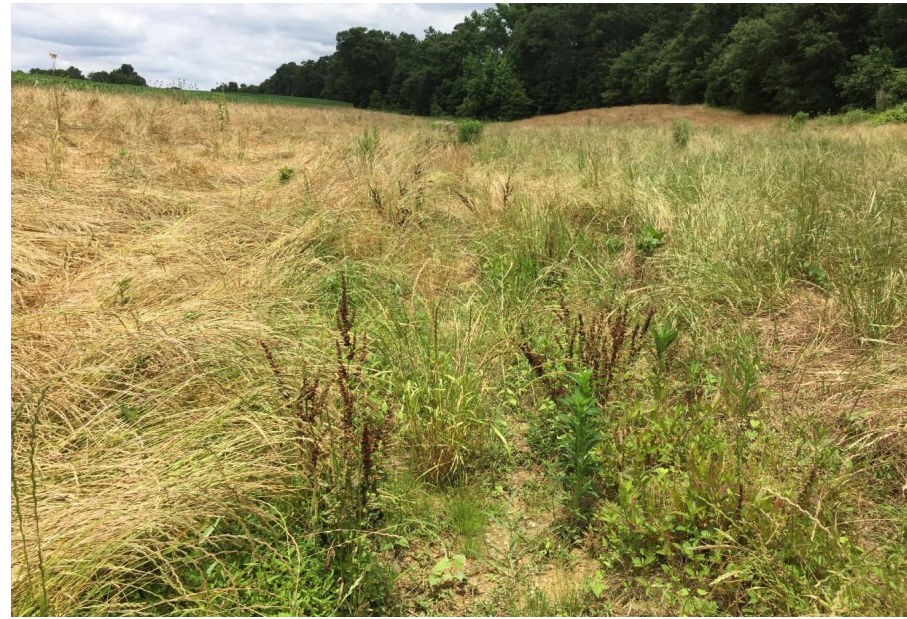
Photo: Cross-section 12 looking upstream

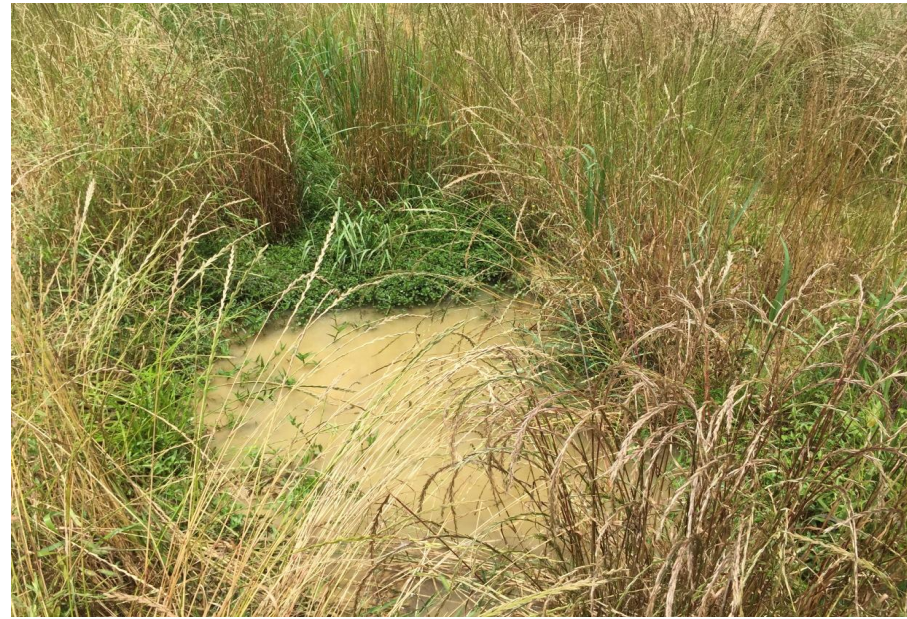
Photo: Cross-section 10 looking upstream

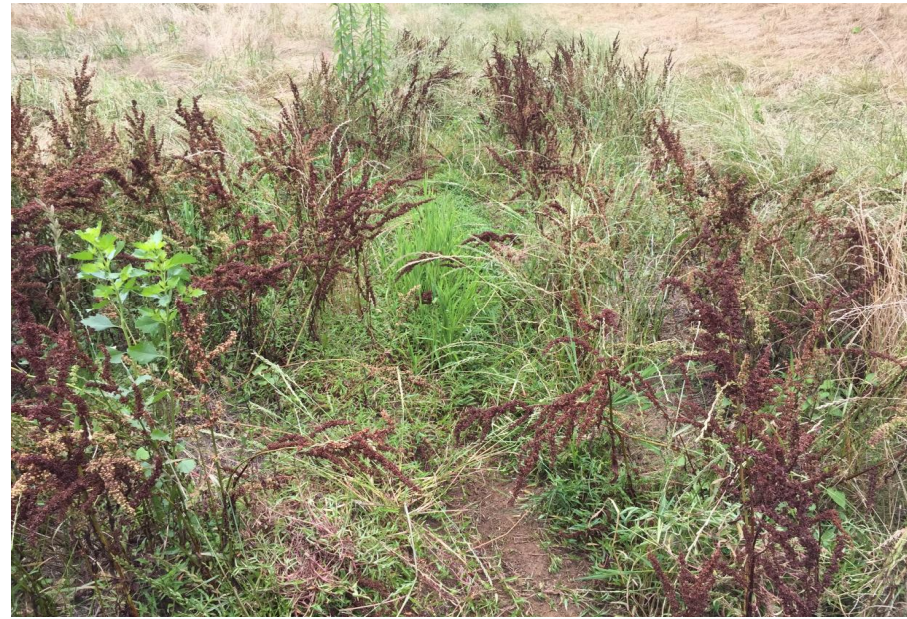
Photo: Cross-section 11 looking upstream
