# ANNUAL REPORT FOR 2004

**Tulula Bog Stream Site**  
**Graham County**  
**Project No. 6.939004T**  
**TIP No. A-9WM**

Prepared By:  
Office of Natural Environment & Roadside Environmental Unit  
North Carolina Department of Transportation  
October 2004

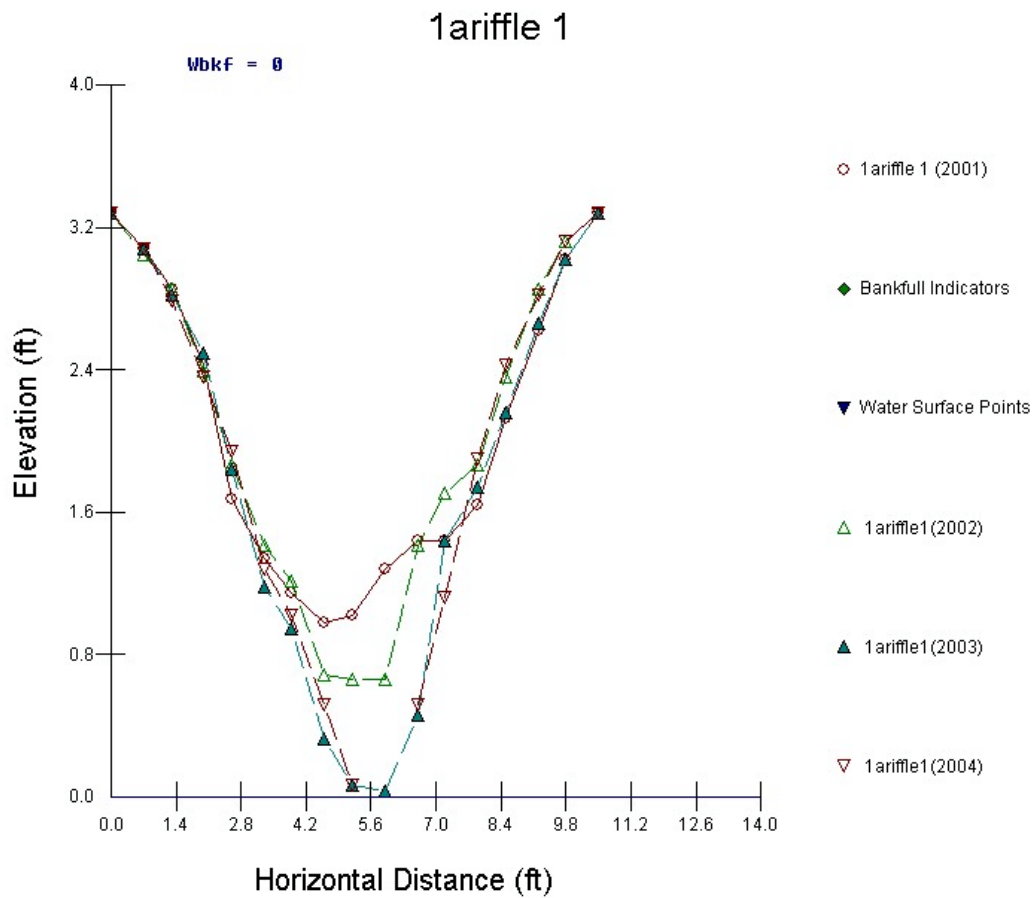
**Cross-Section #1 (1aRiffle1) Abbreviated Morphological Summary**

2001	2002	2003	2004	2005
Bankfull Cross Sectional Area (ft <sup>2</sup> )	13.82	13.84	16.37	15.91	
Maximum Bankfull Depth (ft)	2.3	2.62	3.25	3.28	
Bankfull Mean Depth (ft)	1.32	1.32	1.56	1.52	
Bankfull Width (ft)	10.5	10.5	10.5	10.5

The cross sections established during the monitoring survey are currently being monitored to determine the actual extent of aggradation or degradation. All of the cross section locations appeared stable with little or no active bank erosion. Some degradation was noted during initial water release but cross sections remain stable from 2003 to 2004. Longitudinal profile data has also been collected for each reach. Survey data collected during each monitoring periods may vary depending on actual location of rod placement and alignment; however, this information should remain similar in overall appearance. Longitudinal surveys, cross section comparisons, and pebble count comparisons are presented in Appendix A.

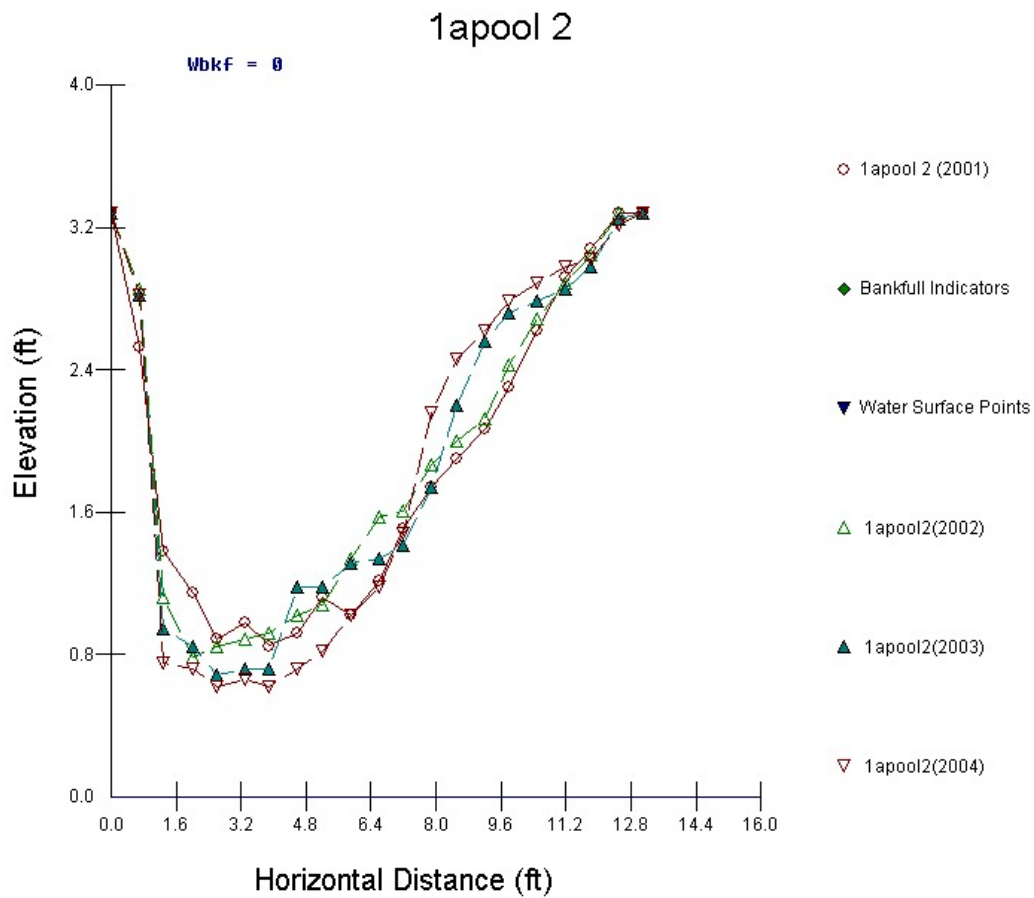
**Cross-Section #4 (1aPool2) Abbreviated Morphological Summary**

2001	2002	2003	2004	2005
<b>Bankfull Cross Sectional Area (ft<sup>2</sup>)</b>	18.9	18.29	18.36	18.84	
<b>Maximum Bankfull Depth (ft)</b>	2.43	2.49	2.59	2.66	
<b>Bankfull Mean Depth (ft)</b>	1.51	1.46	1.4	1.44	
<b>Bankfull Width (ft)</b>	12.5	12.5	13.1	13.1

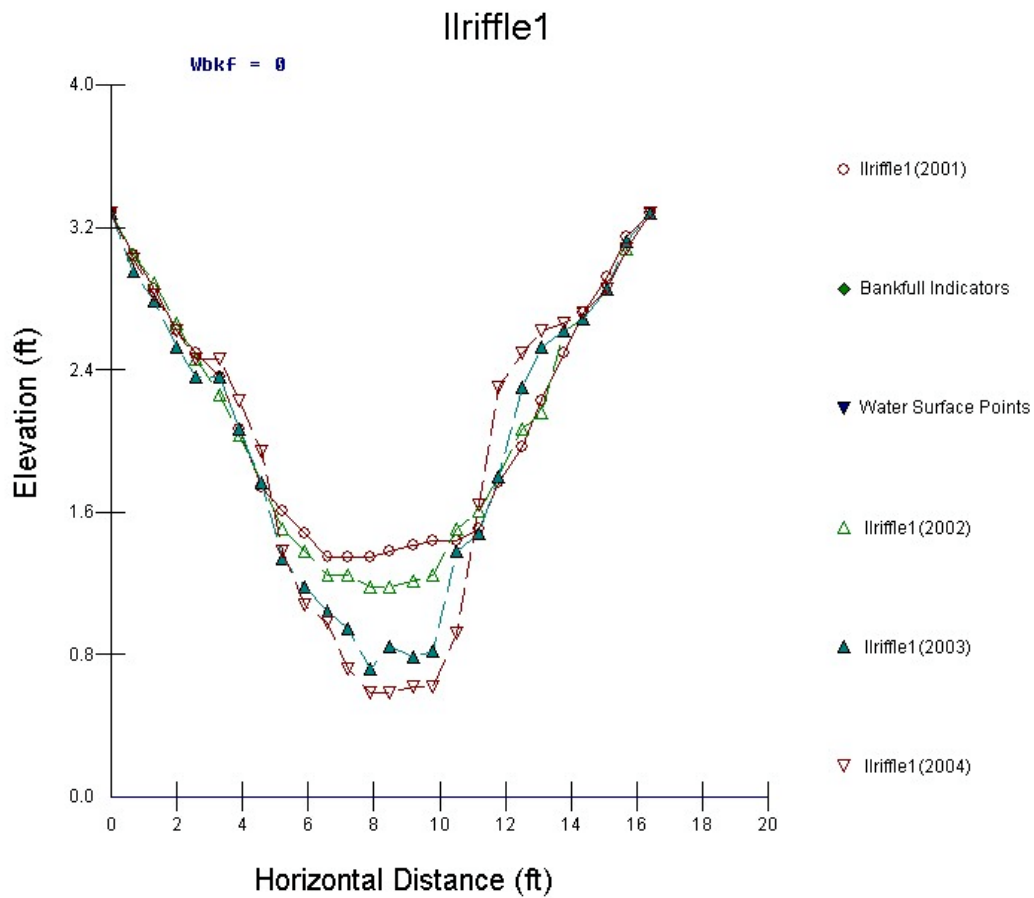
**Cross-Section #1 (2Riffle1) Abbreviated Morphological Summary**

2001	2002	2003	2004	2005
Bankfull Cross Sectional Area (ft <sup>2</sup> )	19.66	20.33	21.92	21.88	
Maximum Bankfull Depth (ft)	1.93	2.1	2.56	2.69	
Bankfull Mean Depth (ft)	1.2	1.24	1.34	1.33	
Bankfull Width (ft)	16.4	16.4	16.4	16.4

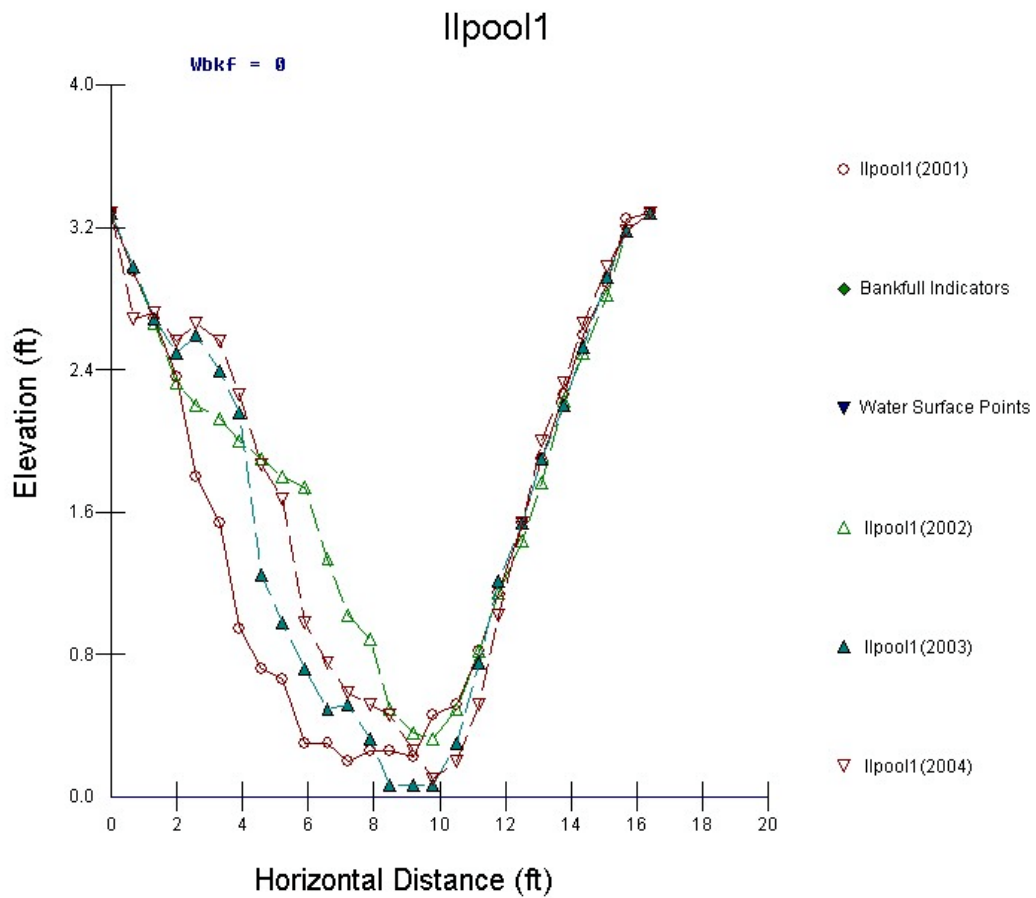
**Cross-Section # 3(2Pool1) Abbreviated Morphological Summary**

2001	2002	2003	2004	2005
<b>Bankfull Cross Sectional Area (ft<sup>2</sup>)</b>	30.26	25.02	27.83	26.03	
<b>Maximum Bankfull Depth (ft)</b>	3.08	2.95	3.21	3.18	
<b>Bankfull Mean Depth (ft)</b>	1.85	1.53	1.7	1.59	
<b>Bankfull Width (ft)</b>	16.4	16.4	16.4	16.4

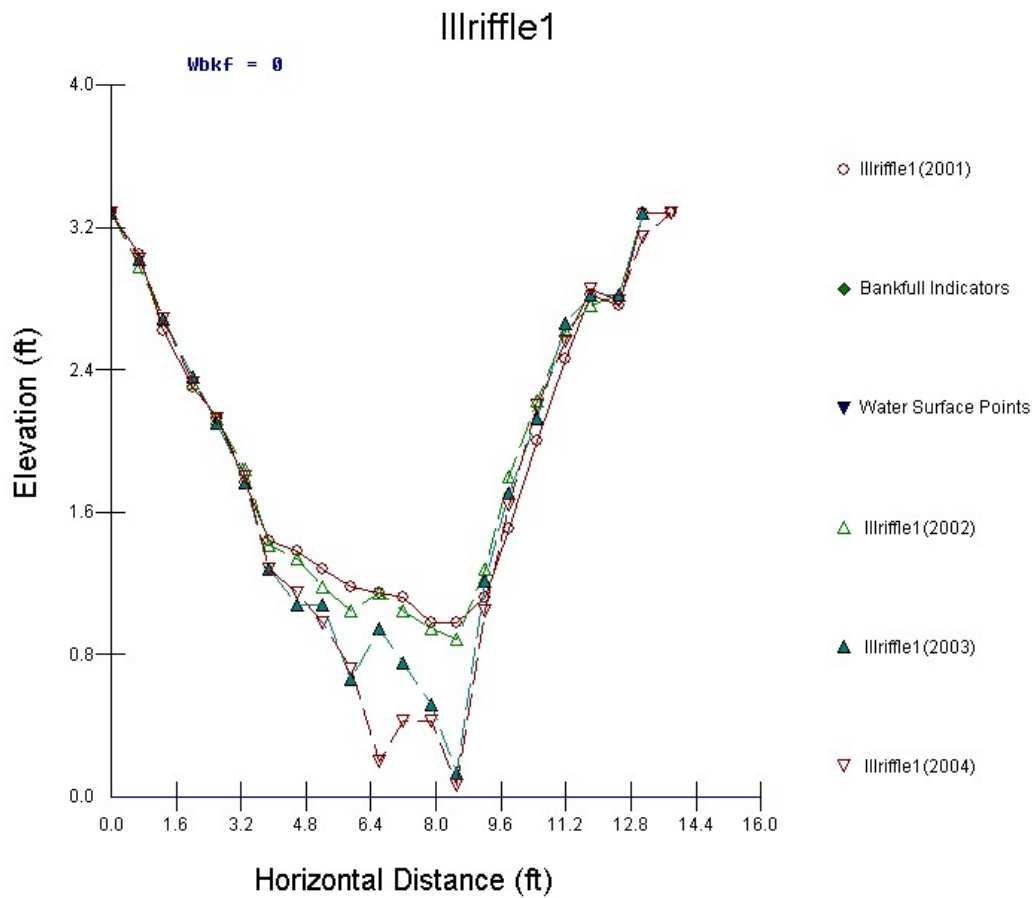
**Cross-Section #1 (3Riffle1) Abbreviated Morphological Summary**

2001	2002	2003	2004	2005
<b>Bankfull Cross Sectional Area (ft<sup>2</sup>)</b>	18.54	18.25	20.07	21.07	
<b>Maximum Bankfull Depth (ft)</b>	2.3	2.39	3.15	3.21	
<b>Bankfull Mean Depth (ft)</b>	1.42	1.39	1.53	1.53	
<b>Bankfull Width (ft)</b>	13.1	13.1	13.1	13.8

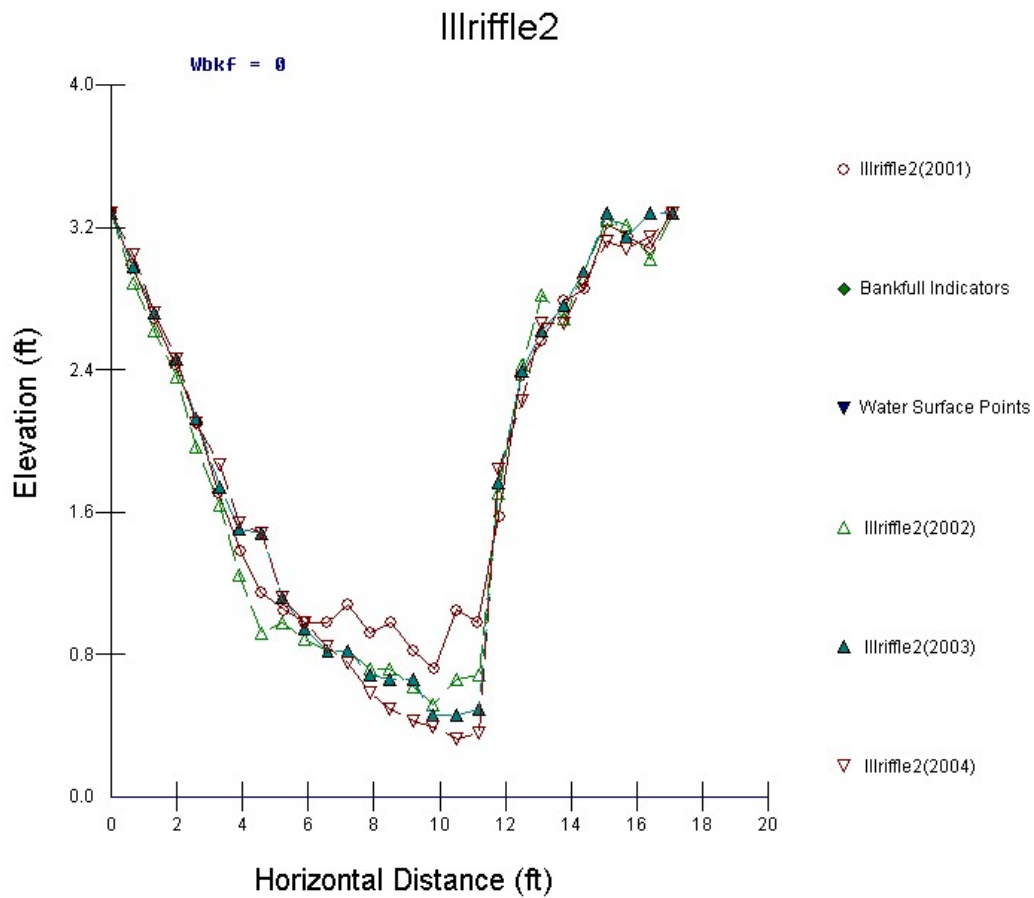
**Cross-Section #2 (3Riffle2) Abbreviated Morphological Summary**

2001	2002	2003	2004	2005
Bankfull Cross Sectional Area (ft <sup>2</sup> )	23.89	25.5	24.73	25.53	
Maximum Bankfull Depth (ft)	2.56	2.76	2.82	2.95	
Bankfull Mean Depth (ft)	1.4	1.49	1.51	1.49	
Bankfull Width (ft)	17.06	17.1	16.4	17.1

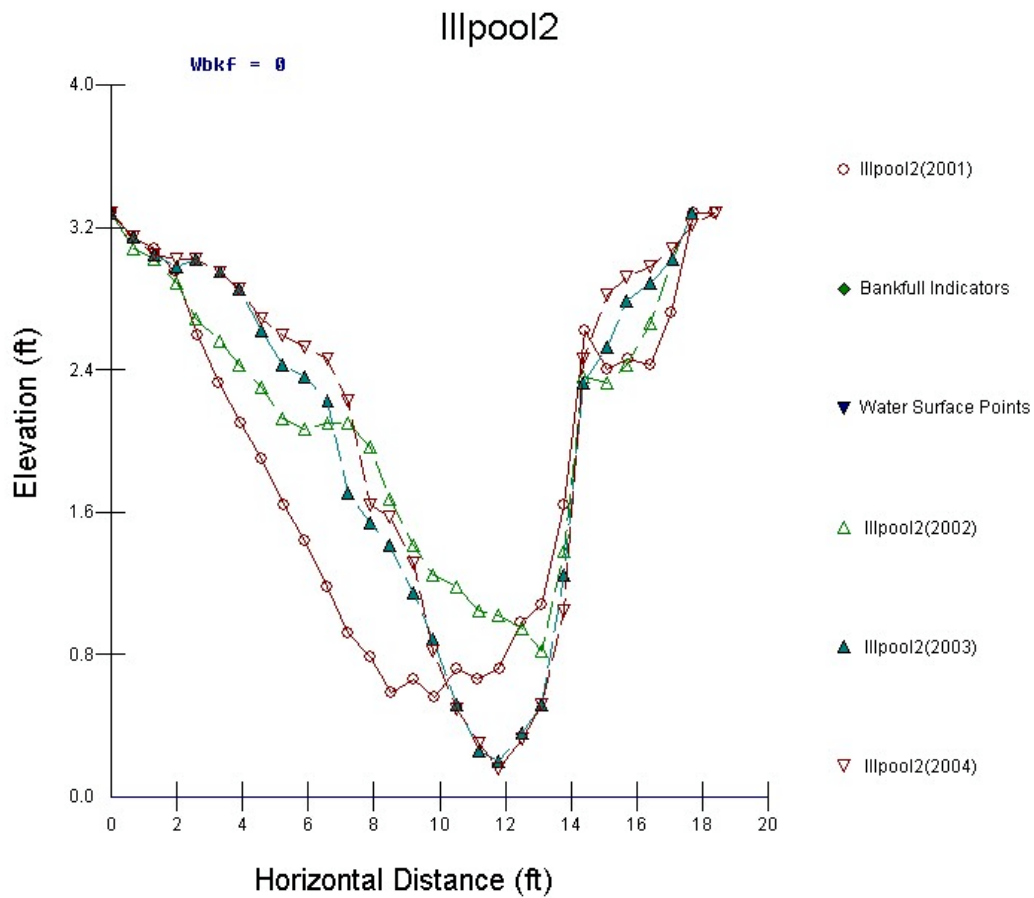
**Cross-Section #4 (3Pool2) Abbreviated Morphological Summary**

2001	2002	2003	2004	2005
Bankfull Cross Sectional Area (ft <sup>2</sup> )	26.88	21.26	22.48	21.23	
Maximum Bankfull Depth (ft)	2.72	2.46	3.08	3.12	
Bankfull Mean Depth (ft)	1.52	1.2	1.27	1.15	
Bankfull Width (ft)	17.72	17.7	17.7	18.4

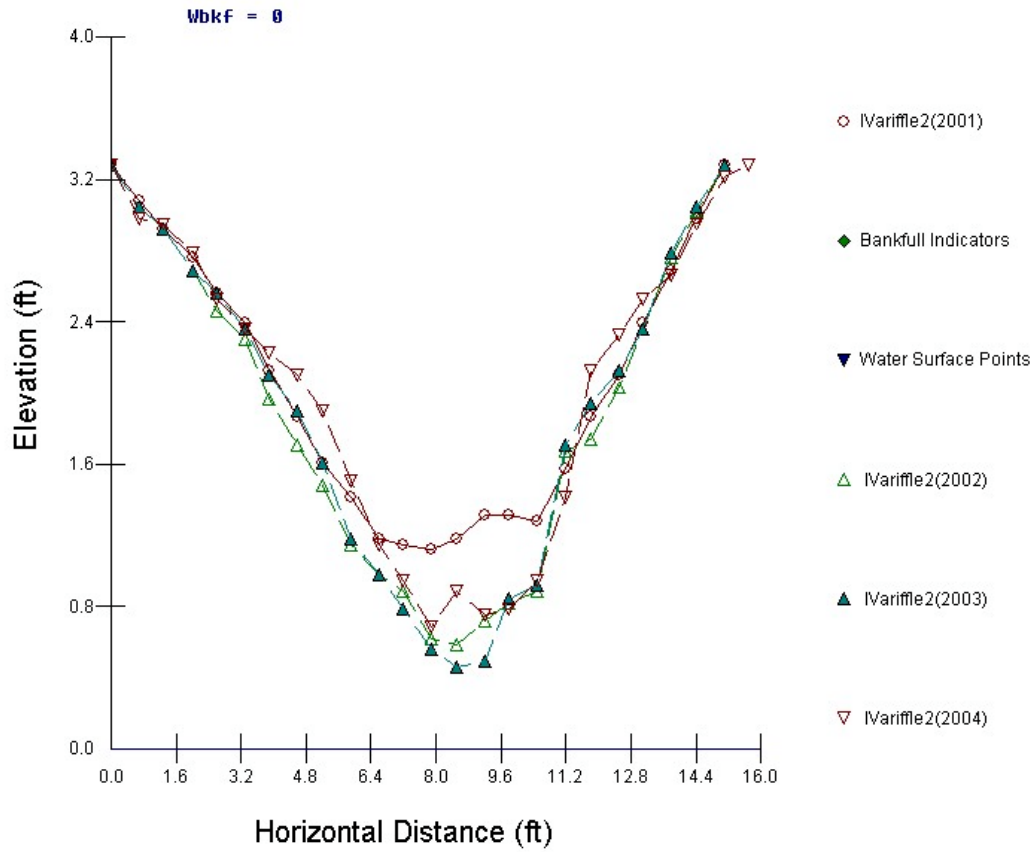
## IVariffle2

**Cross-Section #2 (4aRiffle2) Abbreviated Morphological Summary**

2001	2002	2003	2004	2005
<b>Bankfull Cross Sectional Area (ft<sup>2</sup>)</b>	19.24	21.9	21.52	20.16	
<b>Maximum Bankfull Depth (ft)</b>	2.16	2.69	2.82	2.59	
<b>Bankfull Mean Depth (ft)</b>	1.27	1.45	1.42	1.28	
<b>Bankfull Width (ft)</b>	15.1	15.1	15.1	15.7

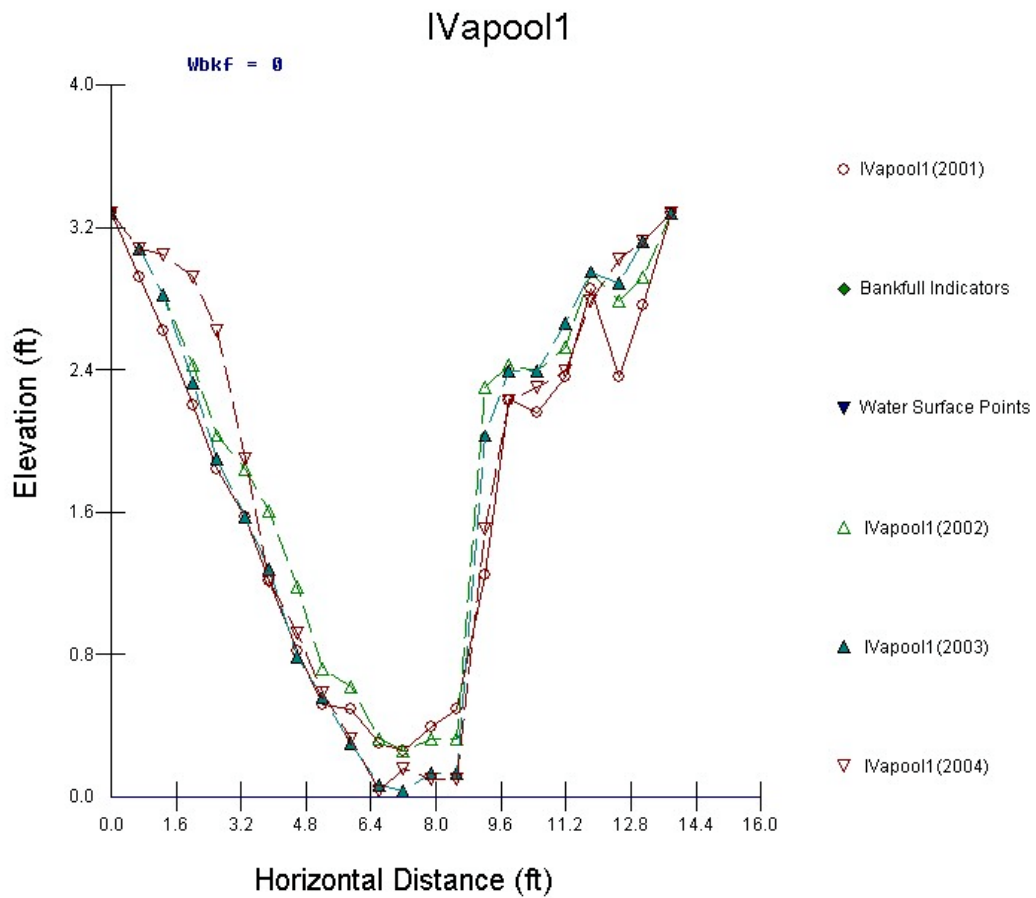
**Cross-Section #3 (4aPool1) Abbreviated Morphological Summary**

2001	2002	2003	2004	2005
<b>Bankfull Cross Sectional Area (ft<sup>2</sup>)</b>	22.3	19.49	21.11	20.5	
<b>Maximum Bankfull Depth (ft)</b>	3.02	3.02	3.25	3.25	
<b>Bankfull Mean Depth (ft)</b>	1.62	1.41	1.53	1.49	
<b>Bankfull Width (ft)</b>	13.8	13.8	13.8	13.8

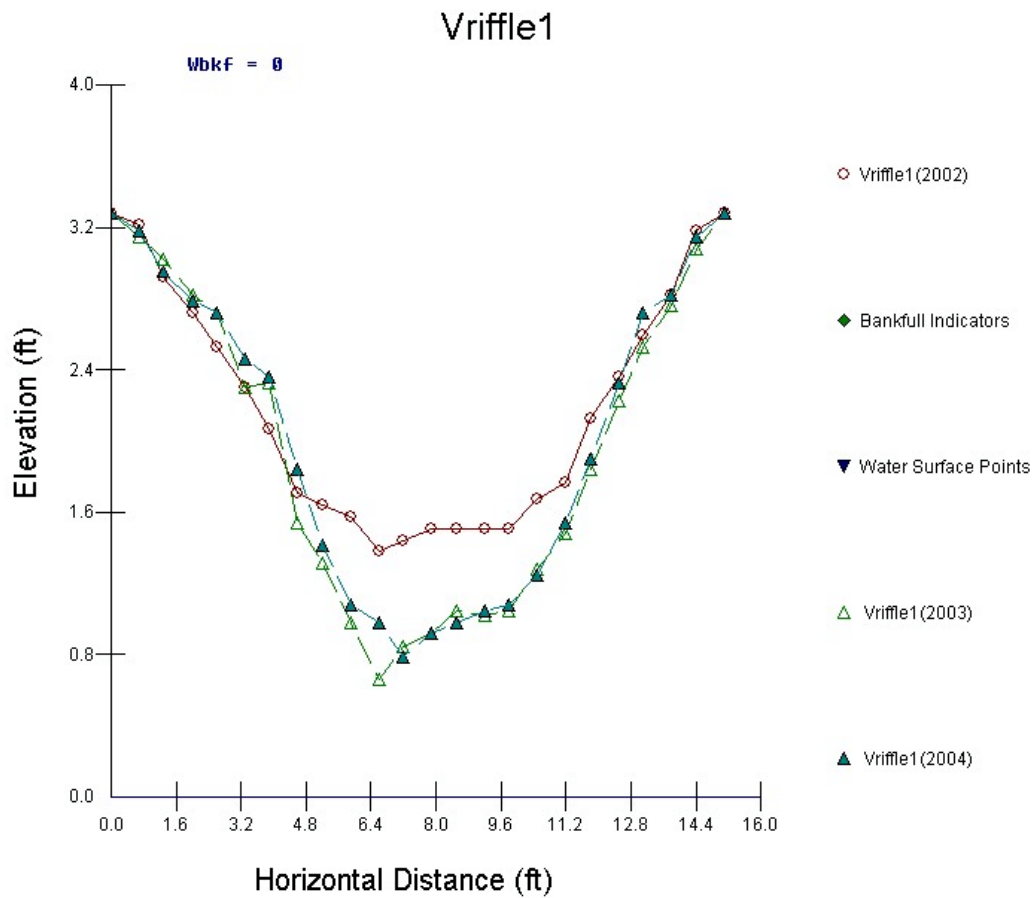
**Cross-Section #1 (5Riffle1) Abbreviated Morphological Summary**

2002	2003	2004	2005	2006
<b>Bankfull Cross Sectional Area (ft<sup>2</sup>)</b>	17.14	20.52	19.62		
<b>Maximum Bankfull Depth (ft)</b>	1.9	2.62	2.49		
<b>Bankfull Mean Depth (ft)</b>	1.13	1.36	1.3		
<b>Bankfull Width (ft)</b>	15.1	15.1	15.1

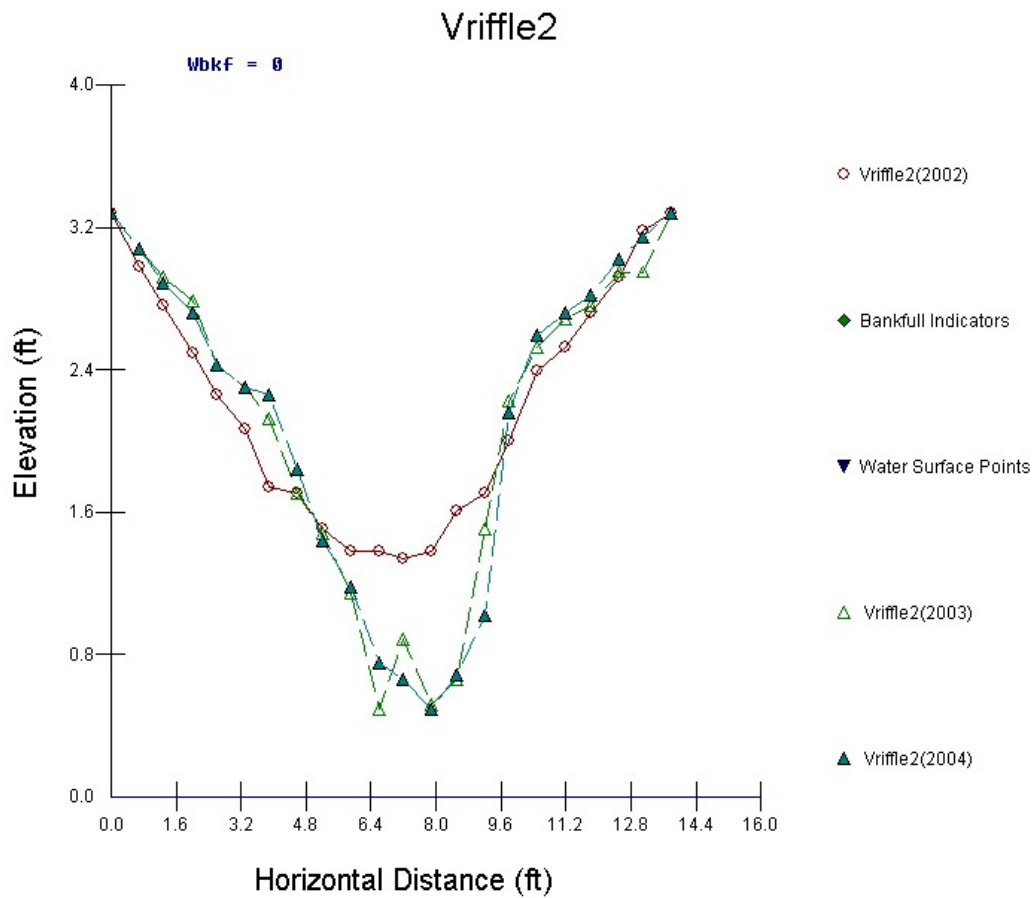
**Cross-Section #2 (5Riffle2) Abbreviated Morphological Summary**

2002	2003	2004	2005	2006
<b>Bankfull Cross Sectional Area (ft<sup>2</sup>)</b>	15.44	16.67	16.64		
<b>Maximum Bankfull Depth (ft)</b>	1.94	2.79	2.79		
<b>Bankfull Mean Depth (ft)</b>	1.12	1.21	1.21		
<b>Bankfull Width (ft)</b>	13.8	13.8	13.8

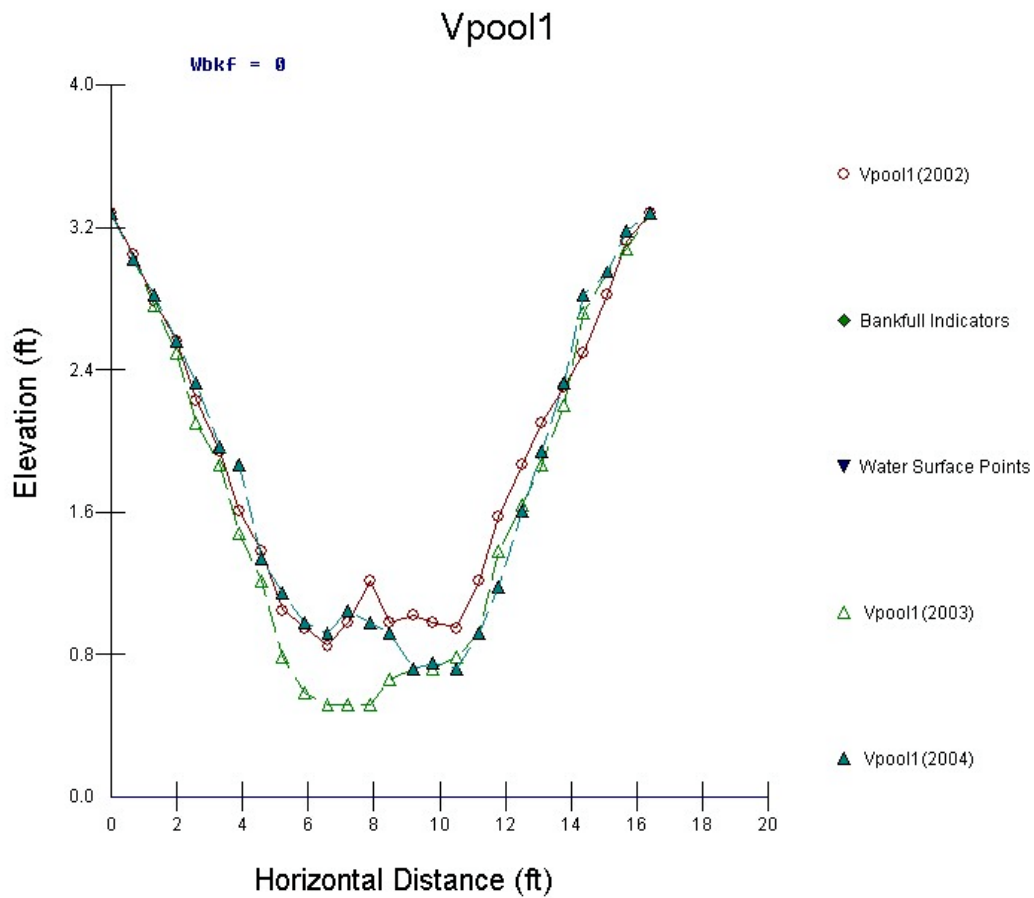
**Cross-Section #3 (5Pool1) Abbreviated Morphological Summary**

2002	2003	2004	2005	2006
<b>Bankfull Cross Sectional Area (ft<sup>2</sup>)</b>	<b>24.09</b>	<b>25.43</b>	<b>24.74</b>		
<b>Maximum Bankfull Depth (ft)</b>	<b>2.43</b>	<b>2.66</b>	<b>2.56</b>		
<b>Bankfull Mean Depth (ft)</b>	<b>1.47</b>	<b>1.61</b>	<b>1.51</b>		
<b>Bankfull Width (ft)</b>	<b>16.4</b>	<b>15.78</b>	<b>16.4</b>

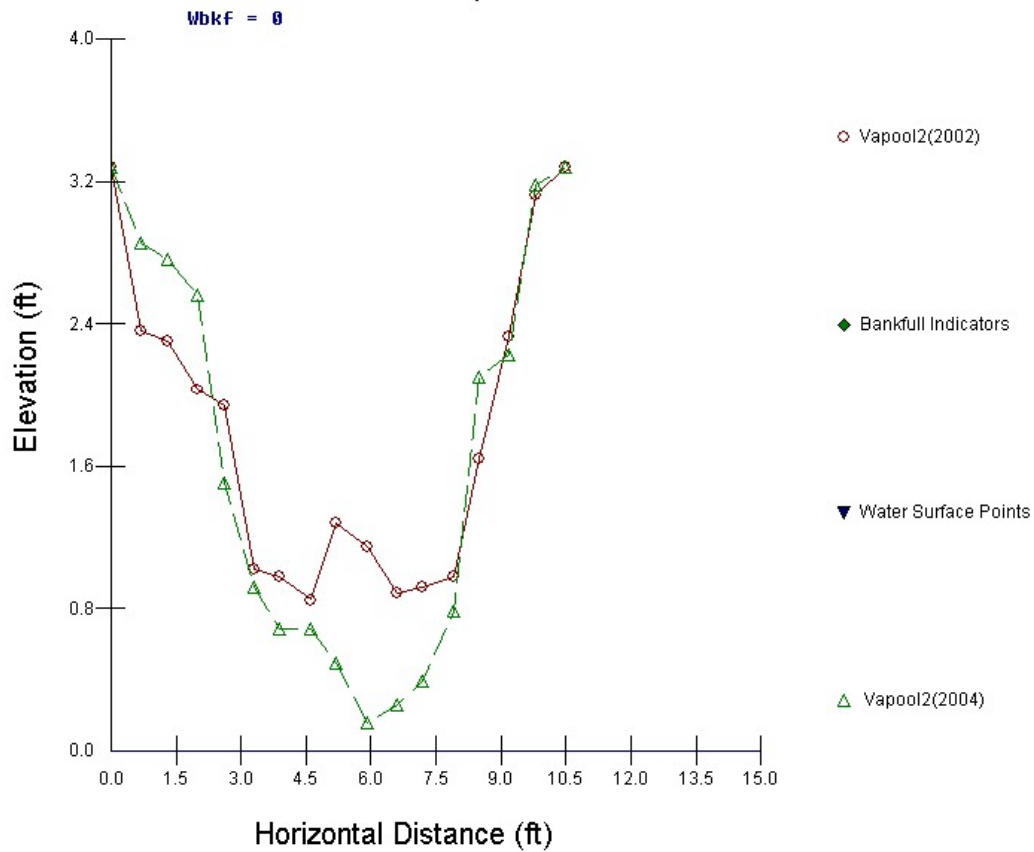
## Vapool 2

Cross-Section #4 (5aPool2) Abbreviated Morphological Summary

2002	2003	2004	2005	2006
Bankfull Cross Sectional Area (ft <sup>2</sup> )	16.62	N/a	18.11		
Maximum Bankfull Depth (ft)	2.43	N/a	3.12		
Bankfull Mean Depth (ft)	1.58	N/a	1.72		
Bankfull Width (ft)	10.5	N/a	10.5

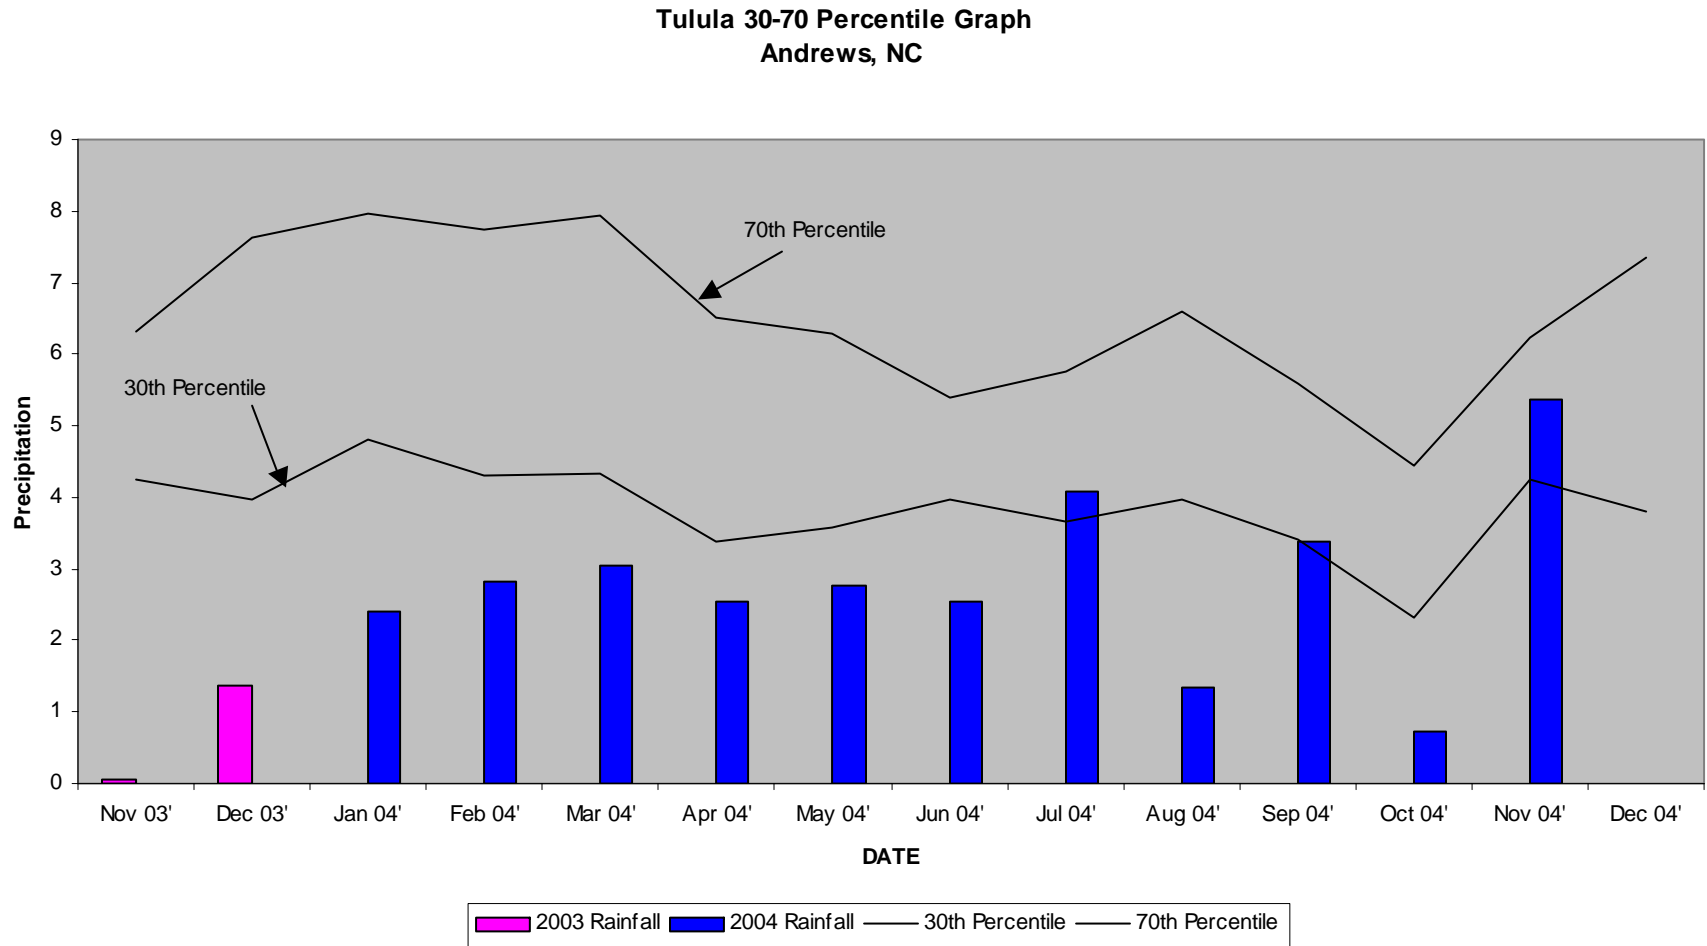
Figure 4. Tulula Bog 30-70 Graph

Figure 4 is a comparison of monthly rainfall for the period of November 2003 through November 2004 to historical precipitation (collected between 1973 and 2004) for Andrews, North Carolina. This comparison gives an indication of how 2004 relates to historical data in terms of climate conditions. The NC State Climate Office provided all local rainfall information.
