UNDERWOOD MITIGATION SITE

Chatham County, NC

NCEEP Project Number 94641

Baseline Monitoring Document and As-Built Baseline Report

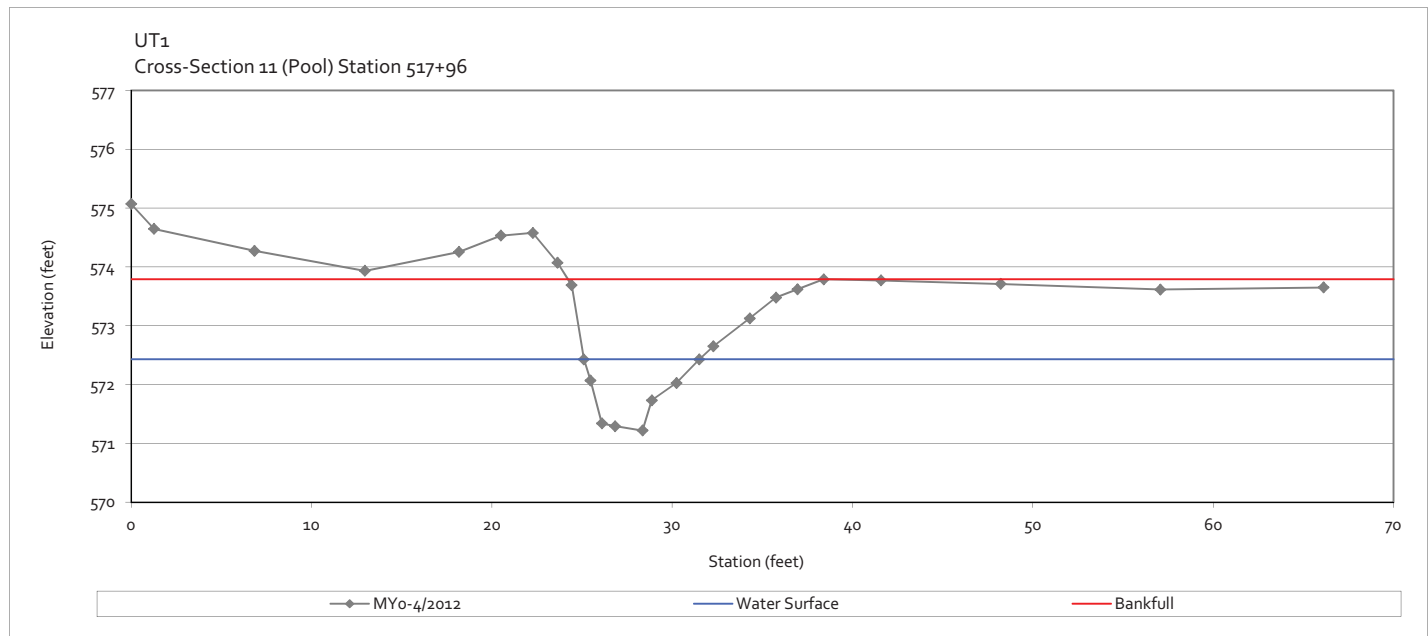
Appendix 2. Morphological Summary Data and Plots
Cross-Section Plots
Underwood Mitigation Site (NCEP Project No. 94641)
UT1, Cross-Section 11 (Pool)
Monitoring Year 0

River Basin	Cape Fear
Watershed HUC	303002050050
XS ID	11
Drainage Area	230 acres
Date	1/22/2013
Field Crew	DT, AT

Summary Data	
Bankfull Elevation (ft)	573.8
Bankfull Cross-Sectional Area (ft ²)	17.7
Bankfull Width (ft)	14.2
Flood Prone Area Elevation (ft)	N/A
Flood Prone Width (ft)	N/A
Max Depth at Bankfull (ft)	2.6
Mean Depth at Bankfull (ft)	1.3
W/D Ratio	11.3
Entrenchment Ratio	N/A
Bank Height Ratio	1.0
Stream Type	N/A

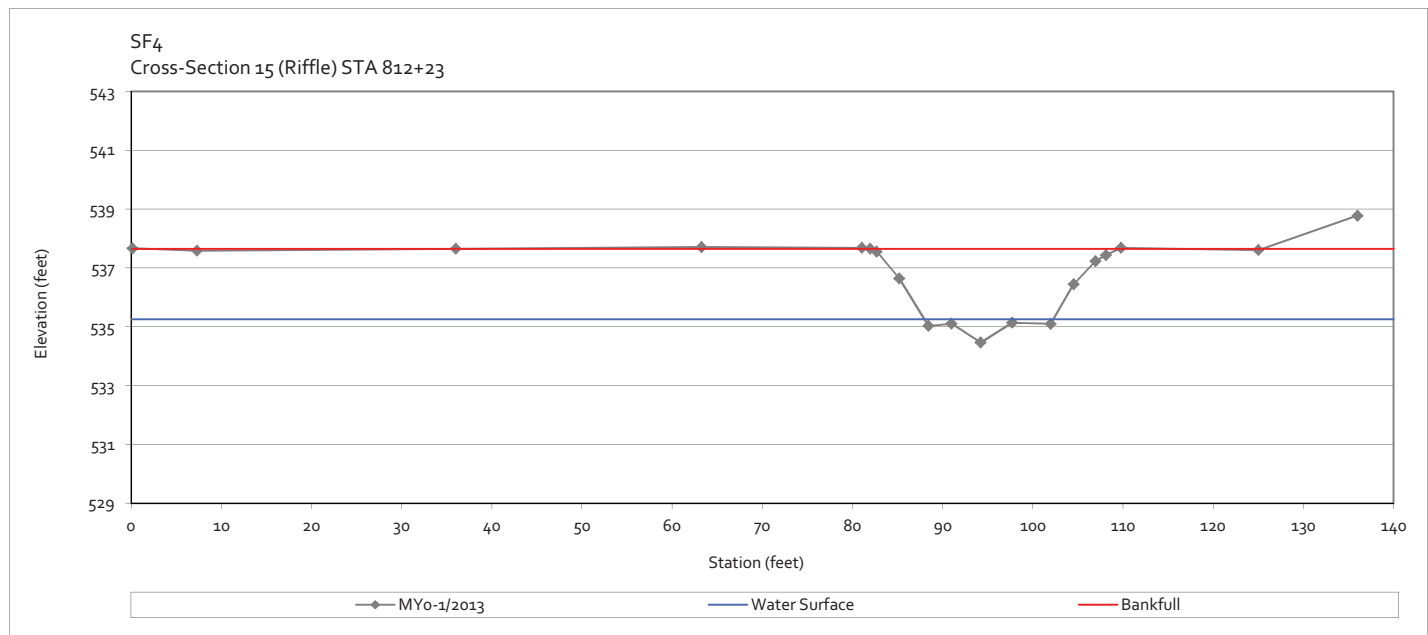
Appendix 2. Morphological Summary Data and Plots
Cross-Section Plots
Underwood Mitigation Site (NCEP Project No. 94641)
SF4, Cross-Section 15 (Riffle)
Monitoring Year 0

River Basin	Cape Fear
Watershed HUC	303002050050
XS ID	15
Drainage Area	3,362 acres
Date	1/22/2013
Field Crew	DT, AT

Summary Data	
Bankfull Elevation (ft)	537.7
Bankfull Cross-Sectional Area (ft ²)	51.2
Bankfull Width (ft)	27.6
Flood Prone Area Elevation (ft)	540.8
Flood Prone Width (ft)	200+
Max Depth at Bankfull (ft)	3.2
Mean Depth at Bankfull (ft)	1.9
W/D Ratio	14.9
Entrenchment Ratio	2.2+
Bank Height Ratio	1.0
Stream Type	C

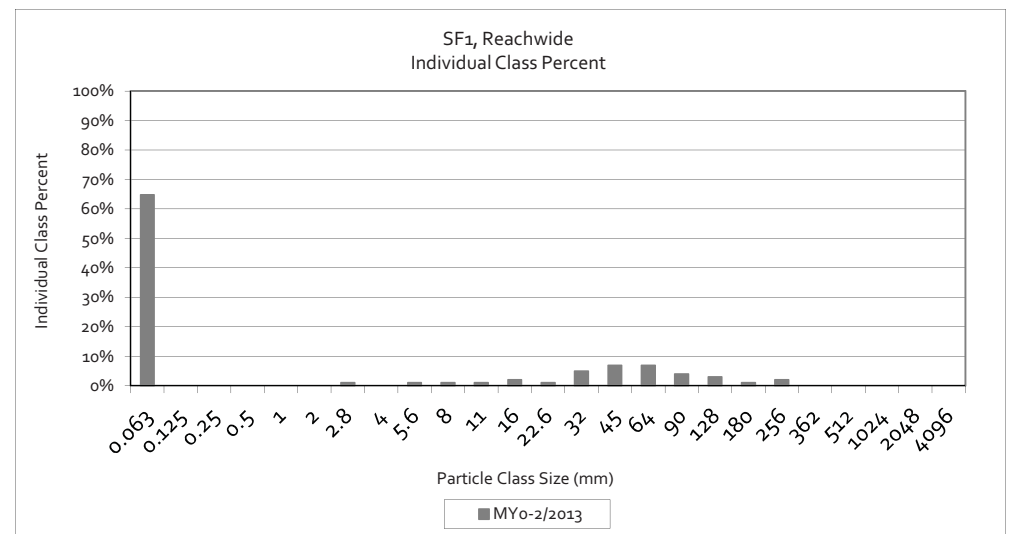
Appendix 2. Morphological Summary Data and Plots
Reachwide and Cross-Section Pebble Count Plots
Underwood Mitigation Site (NCEEP Project No. 94641)
SF1, Reachwide
Monitoring Year 0

Reachwide Channel materials (mm)	
D ₁₆ =	silt/clay
D ₃₅ =	silt/clay
D ₅₀ =	silt/clay
D ₈₄ =	46.6
D ₉₅ =	100.0
D ₁₀₀ =	256.0

The as-built condition for each of these reaches indicates a significant increase in substrate particle size (Table 5a – 5c). The substrate data for each constructed reach were compared to the design shear stress parameters from the mitigation plan to assess the potential for bed degradation. The shear stress and calculated for the constructed channels are generally within the allowable range, which indicate that the channel is not at risk to trend toward channel degradation.

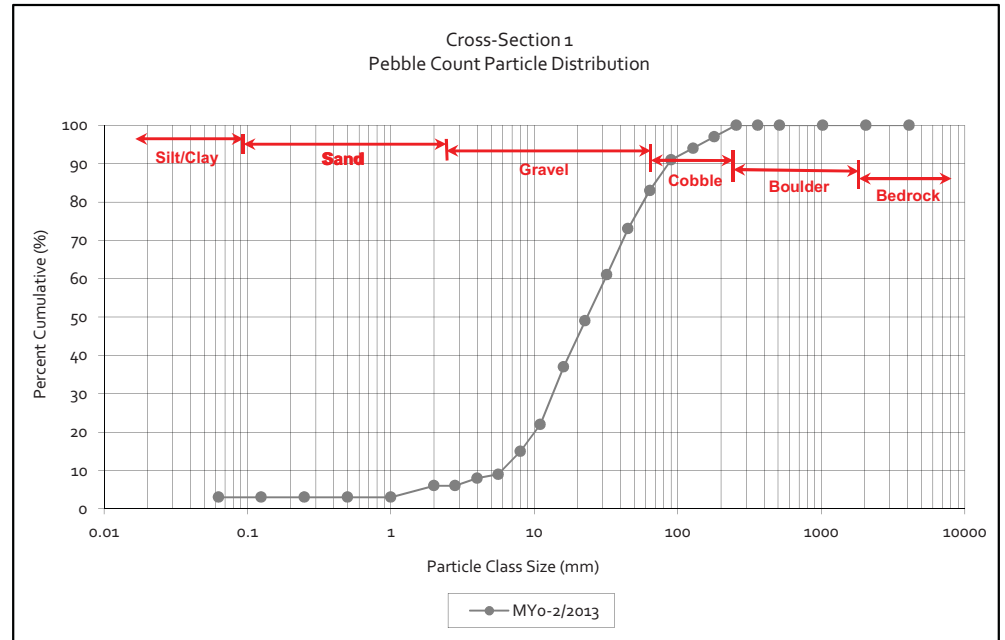
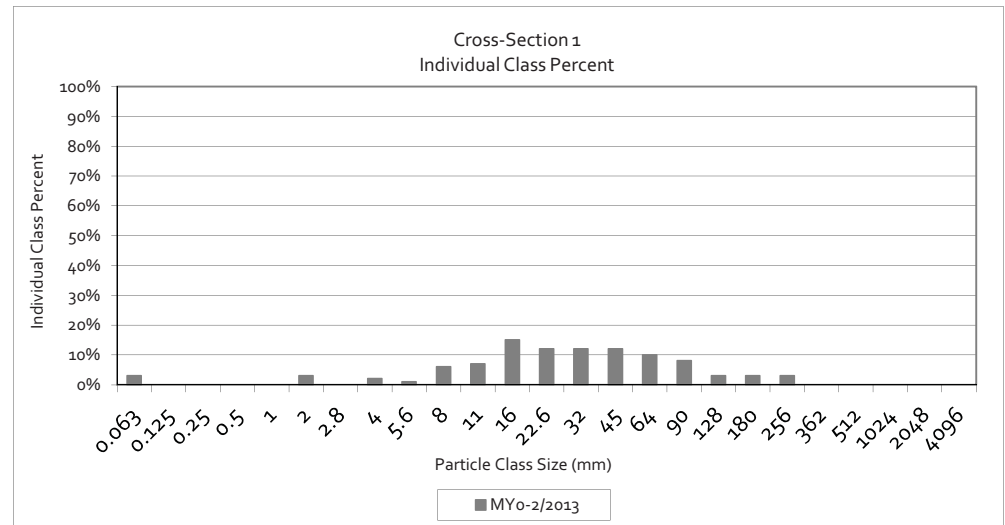
Appendix 2. Morphological Summary Data and Plots
Reachwide and Cross-Section Substrate Plots
Underwood Mitigation Site (NCEP Project No. 94641)
SF1, Cross-Section 1
Monitoring Year 0

Cross-Section 1 Channel materials (mm)	
D ₁₆ =	8.4
D ₃₅ =	15.2
D ₅₀ =	23.3
D ₈₄ =	66.8
D ₉₅ =	143.4
D ₁₀₀ =	256.0

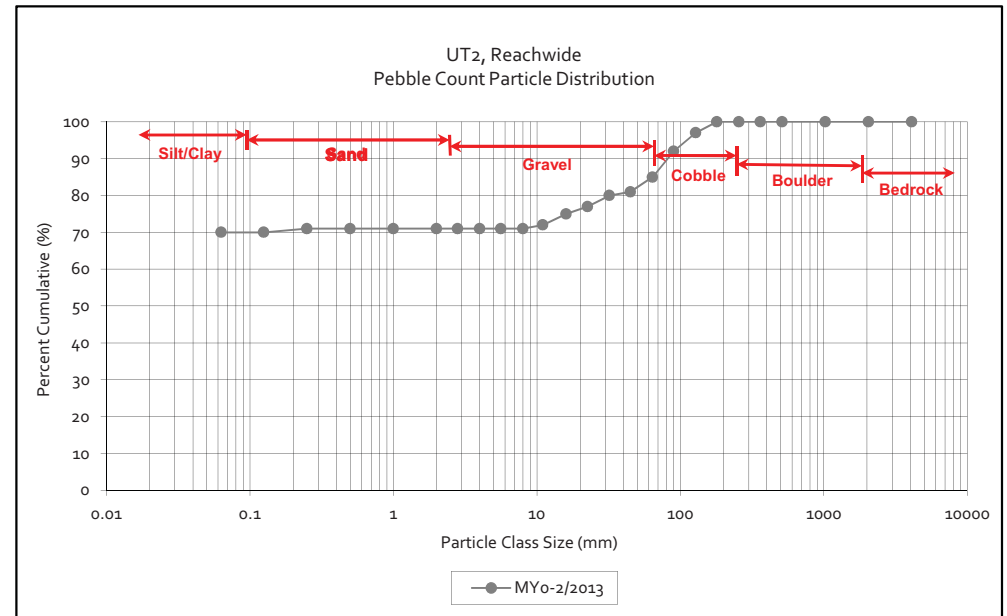
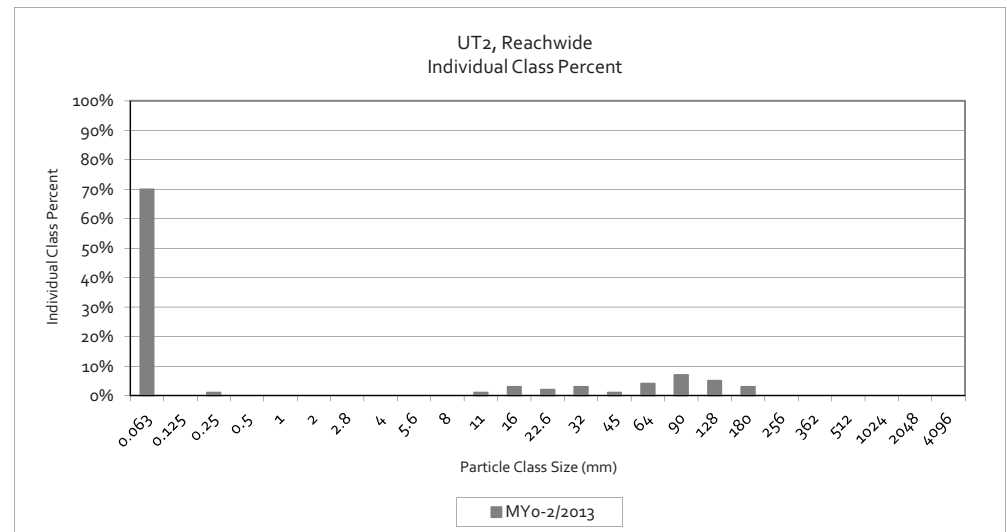
Appendix 2. Morphological Summary Data and Plots
Reachwide and Cross-Section Pebble Count Plots
Underwood Mitigation Site (NCEEP Project No. 94641)
UT2, Reachwide
Monitoring Year 0

Reachwide Channel materials (mm)	
D ₁₆ =	silt/clay
D ₃₅ =	silt/clay
D ₅₀ =	silt/clay
D ₈₄ =	58.6
D ₉₅ =	111.2
D ₁₀₀ =	180.0

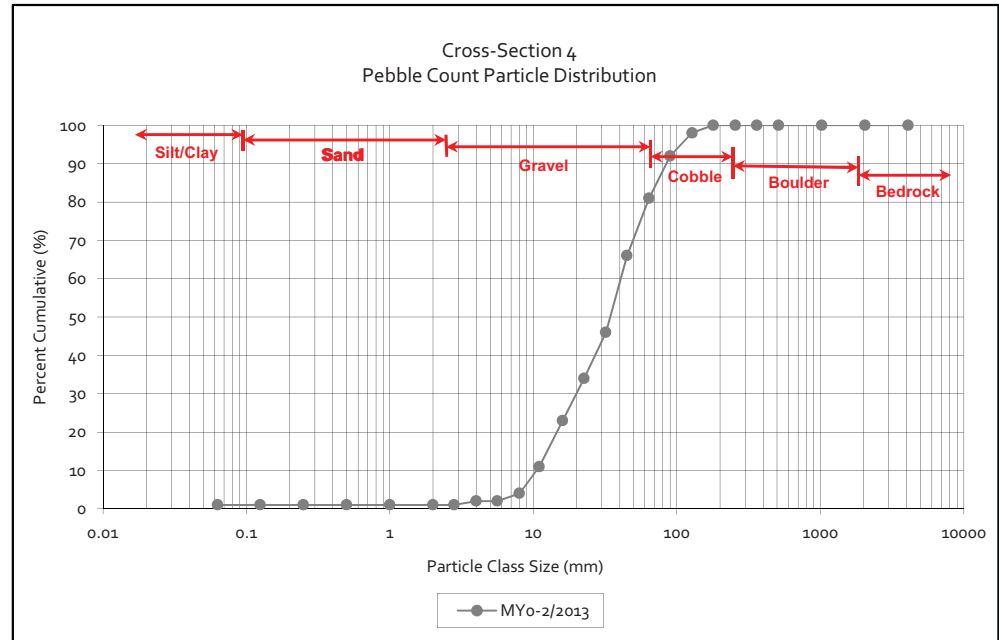
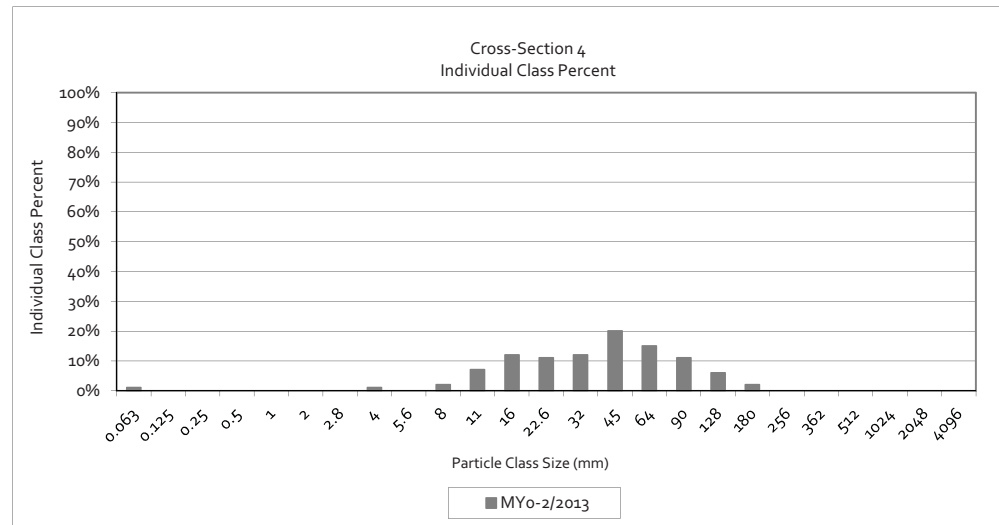
Appendix 2. Morphological Summary Data and Plots
Reachwide and Cross-Section Substrate Plots
Underwood Mitigation Site (NCEP Project No. 94641)
UT2, Cross-Section 4
Monitoring Year 0

Cross-Section 4 Channel materials (mm)	
D ₁₆ =	12.9
D ₃₅ =	23.3
D ₅₀ =	34.3
D ₈₄ =	70.2
D ₉₅ =	107.3
D ₁₀₀ =	180.0

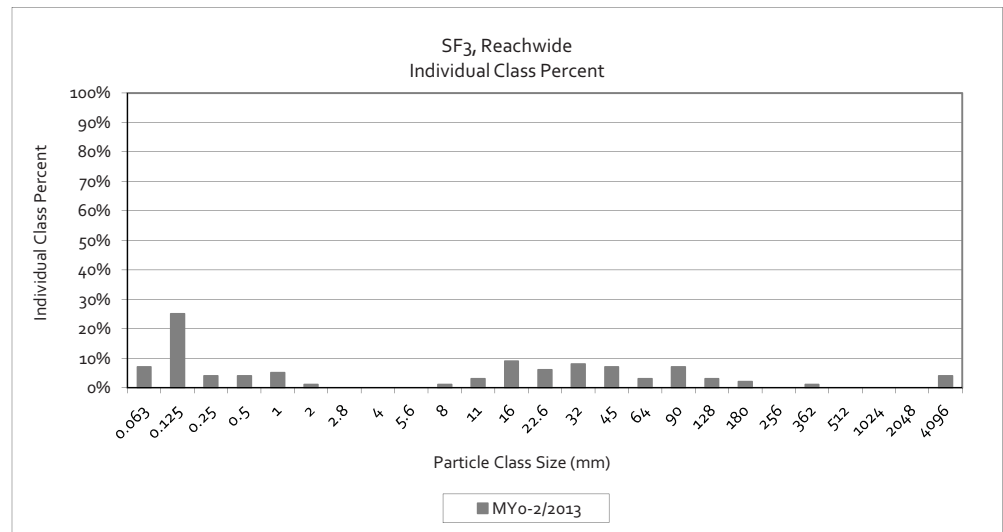
Appendix 2. Morphological Summary Data and Plots
 Reachwide and Cross-Section Pebble Count Plots
 Underwood Mitigation Site (NCEP Project No. 94641)
 SF3, Reachwide
 Monitoring Year 0

Reachwide Channel materials (mm)	
D ₁₆ =	0.08
D ₃₅ =	0.21
D ₅₀ =	11.0
D ₈₄ =	67.2
D ₉₅ =	256.0
D ₁₀₀ =	>2048

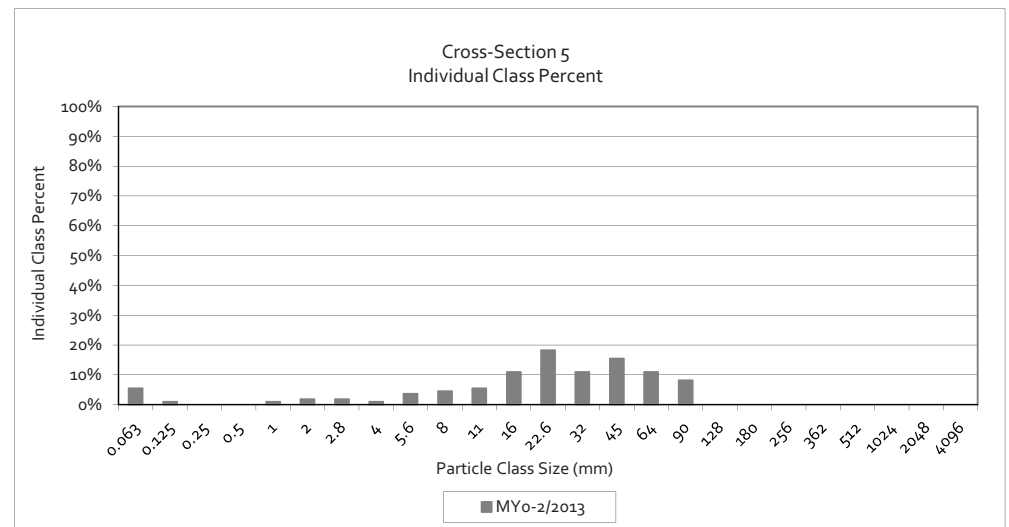
Appendix 2. Morphological Summary Data and Plots
 Reachwide and Cross-Section Substrate Plots
 Underwood Mitigation Site (NCEEP Project No. 94641)
 SF3, Cross-Section 5
 Monitoring Year 0

Cross-Section 5 Channel materials (mm)	
D ₁₆ =	5.8
D ₃₅ =	15.3
D ₅₀ =	20.7
D ₈₄ =	49.7
D ₉₅ =	73.1
D ₁₀₀ =	90.0

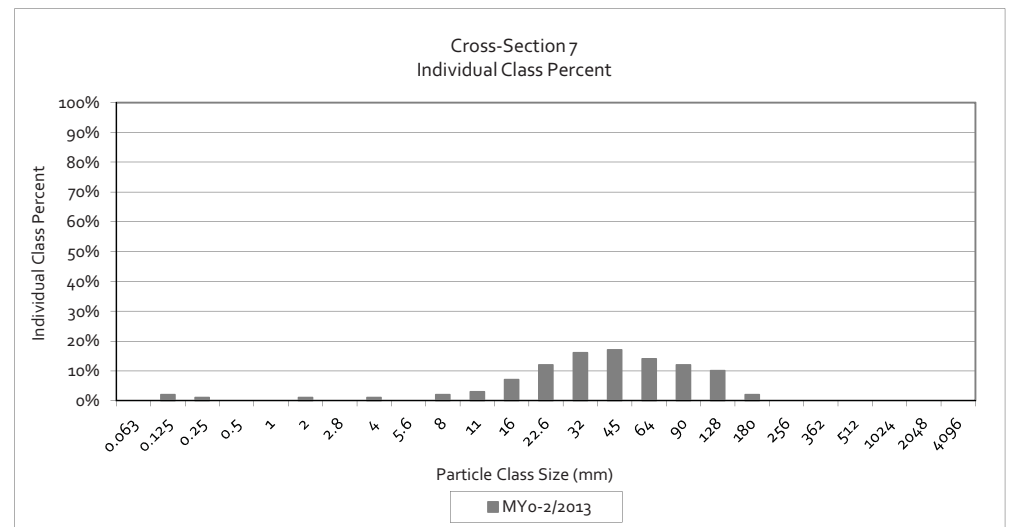
Cross-Section 7 Channel materials (mm)	
D ₁₆ =	15.2
D ₃₅ =	25.7
D ₅₀ =	35.4
D ₈₄ =	80.3
D ₉₅ =	115.2
D ₁₀₀ =	180.0

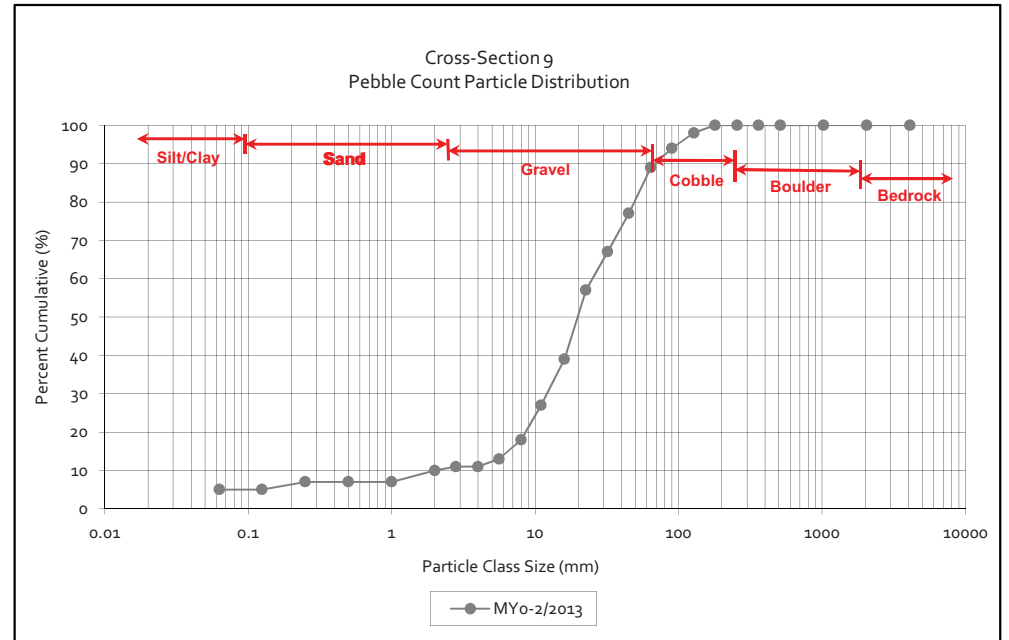
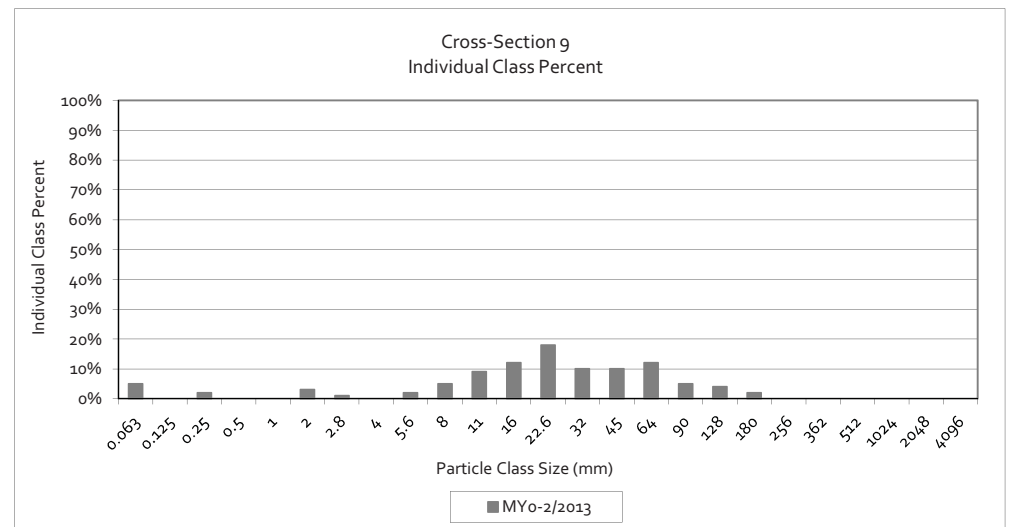
Appendix 2. Morphological Summary Data and Plots
 Reachwide and Cross-Section Substrate Plots
 Underwood Mitigation Site (NCEEP Project No. 94641)
 SF3, Cross-Section 9
 Monitoring Year 0

Cross-Section 9 Channel materials (mm)	
D ₁₆ =	6.9
D ₃₅ =	14.1
D ₅₀ =	19.8
D ₈₄ =	55.3
D ₉₅ =	98.3
D ₁₀₀ =	180.0

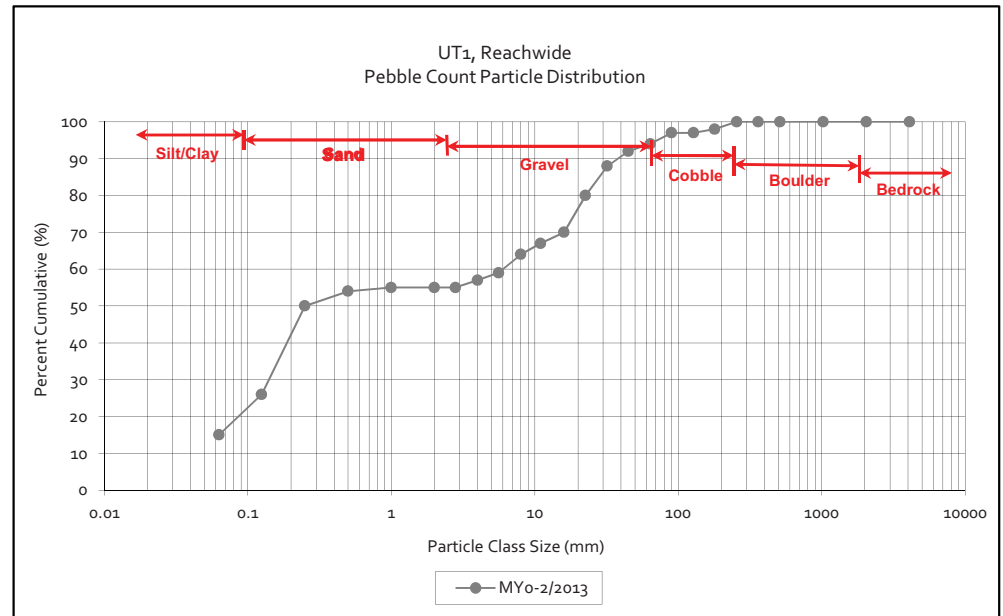
Appendix 2. Morphological Summary Data and Plots
 Reachwide and Cross-Section Pebble Count Plots
 Underwood Mitigation Site (NCEP Project No. 94641)
 UT1, Reachwide
 Monitoring Year 0

Reachwide Channel materials (mm)	
D ₁₆ =	0.07
D ₃₅ =	0.16
D ₅₀ =	0.3
D ₈₄ =	26.9
D ₉₅ =	71.7
D ₁₀₀ =	256.0

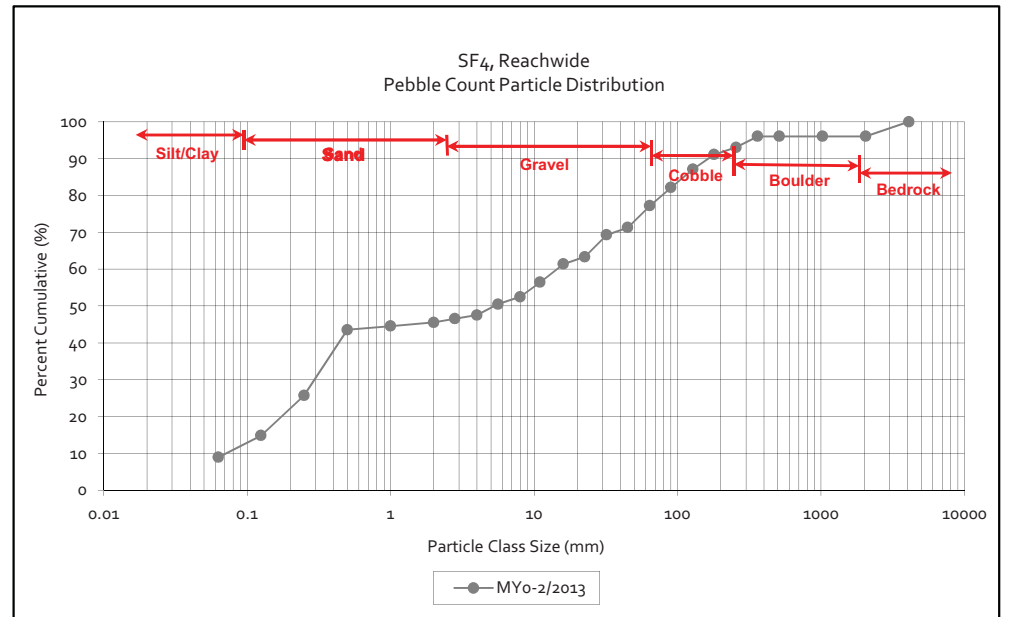
Appendix 2. Morphological Summary Data and Plots
Reachwide and Cross-Section Pebble Count Plots
Underwood Mitigation Site (NCEP Project No. 94641)
SF4, Reachwide
Monitoring Year 0

Reachwide Channel materials (mm)	
D ₁₆ =	0.13
D ₃₅ =	0.36
D ₅₀ =	5.3
D ₈₄ =	102.5
D ₉₅ =	320.7
D ₁₀₀ =	>2048

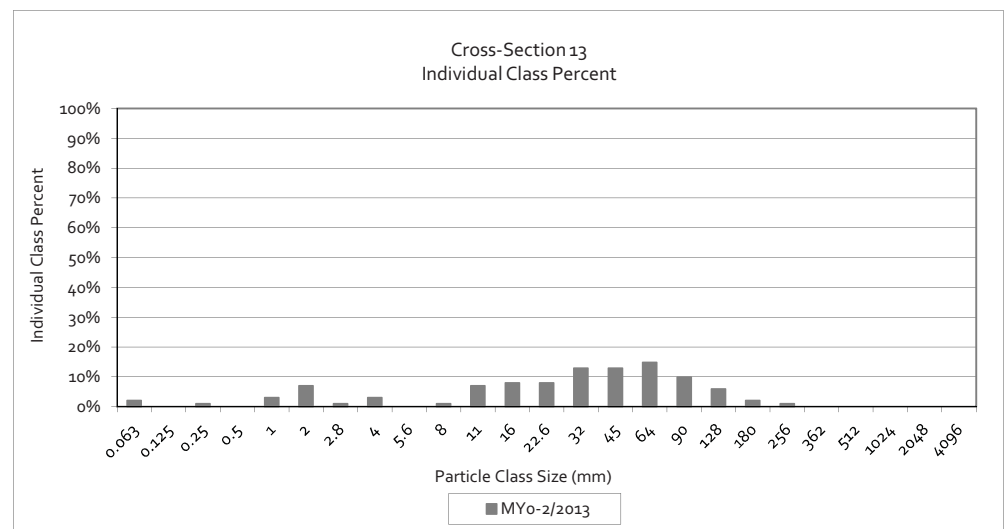
Appendix 2. Morphological Summary Data and Plots
Reachwide and Cross-Section Substrate Plots
Underwood Mitigation Site (NCEP Project No. 94641)
SF4, Cross-Section 13
Monitoring Year 0

Cross-Section 13 Channel materials (mm)	
D ₁₅ =	3.6
D ₃₅ =	17.7
D ₅₀ =	29.1
D ₈₄ =	70.5
D ₉₅ =	113.5
D ₁₀₀ =	256.0

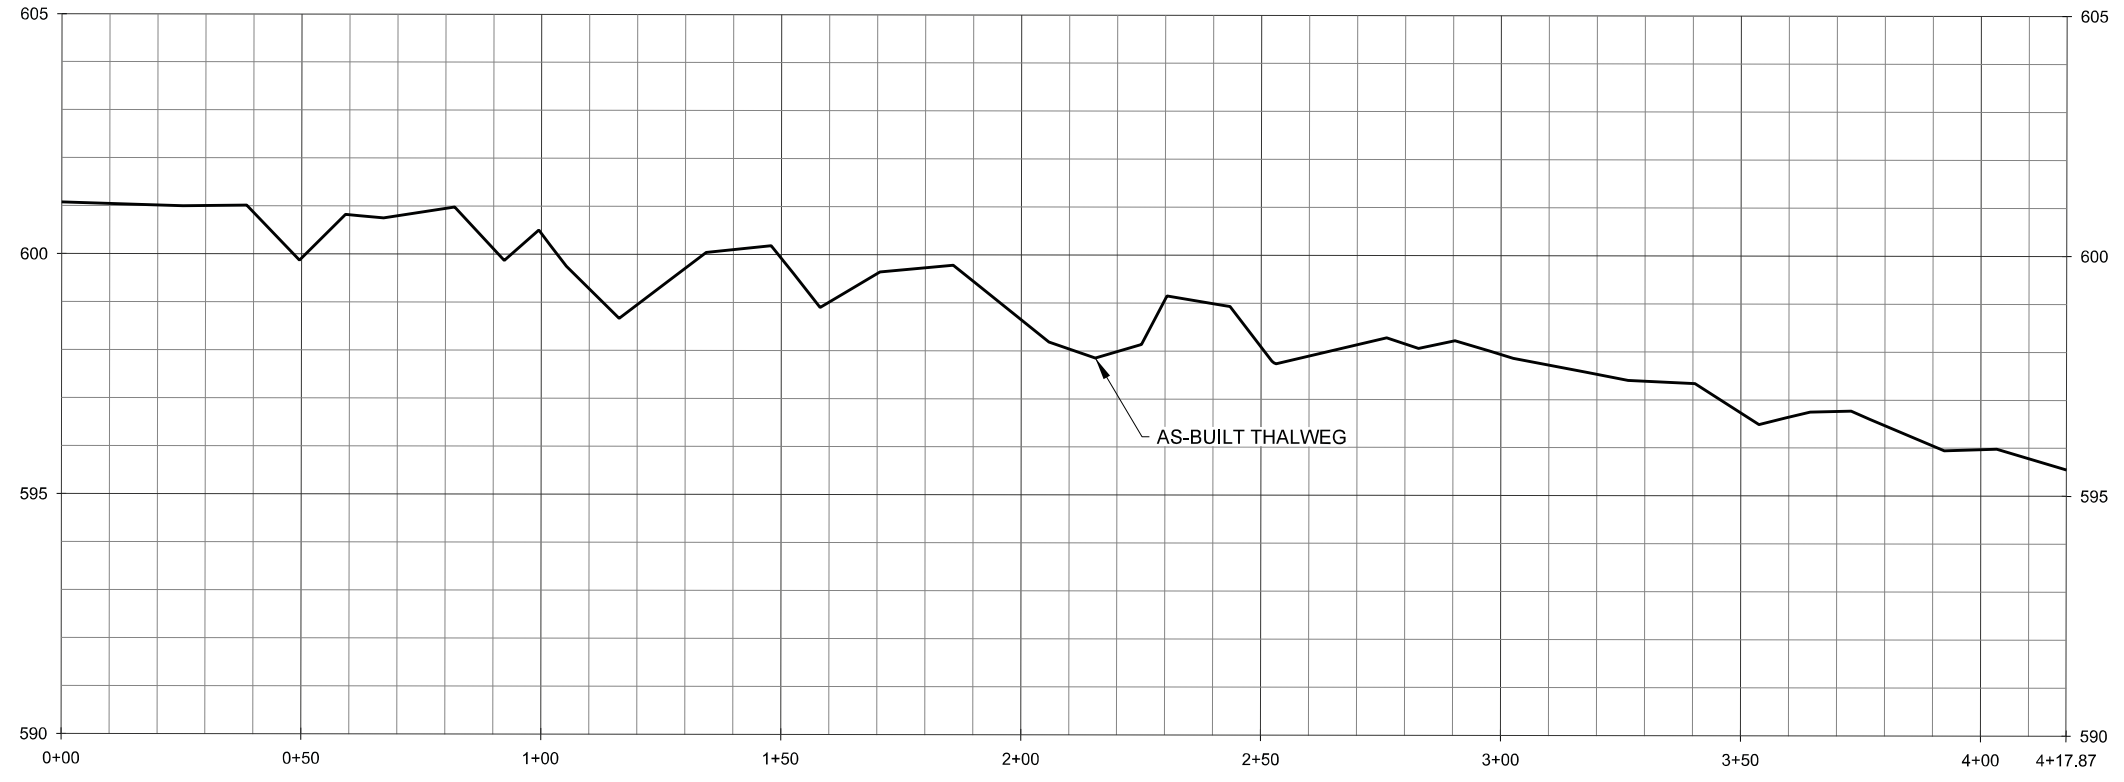
STREAM BASELINE PLANS

Underwood Mitigation Site
Chatham County, NC
Stream Baseline Plans
SF 1 Plan and Profile
