# **Baseline Monitoring Document and As-Built Baseline Report Upper Silver Creek Stream and Wetland Restoration Project**

**Burke County, North Carolina**

DMS Project ID No. 94645

**Michael Baker**

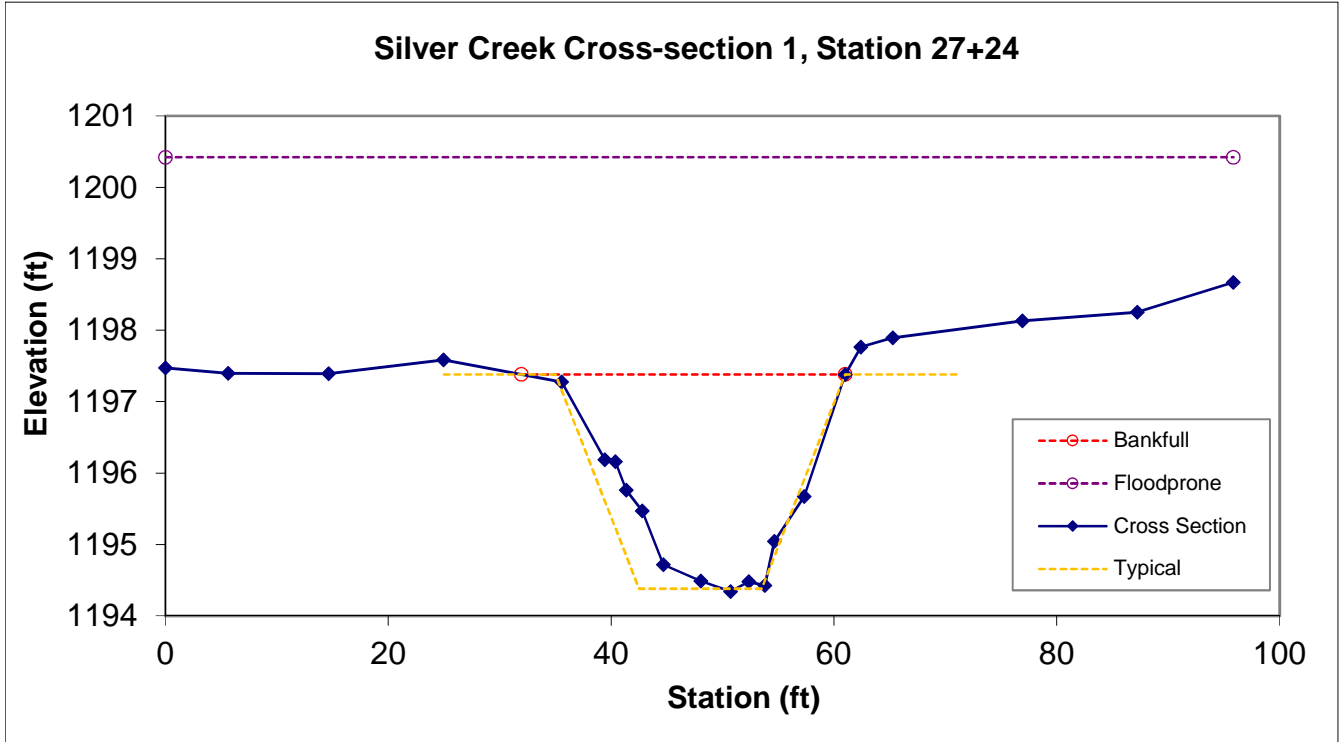
Permanent Cross-section 1  
 (As-Built Data - collected March, 2015)

Feature	Stream Type	BKF Area	BKF Width	BKF Depth	Max BKF Depth	W/D	BH Ratio	ER	BKF Elev	TOB Elev
Riffle	C	49.2	29.06	1.69	3.04	17.16	1.1	3.3	1197.38	1197.58

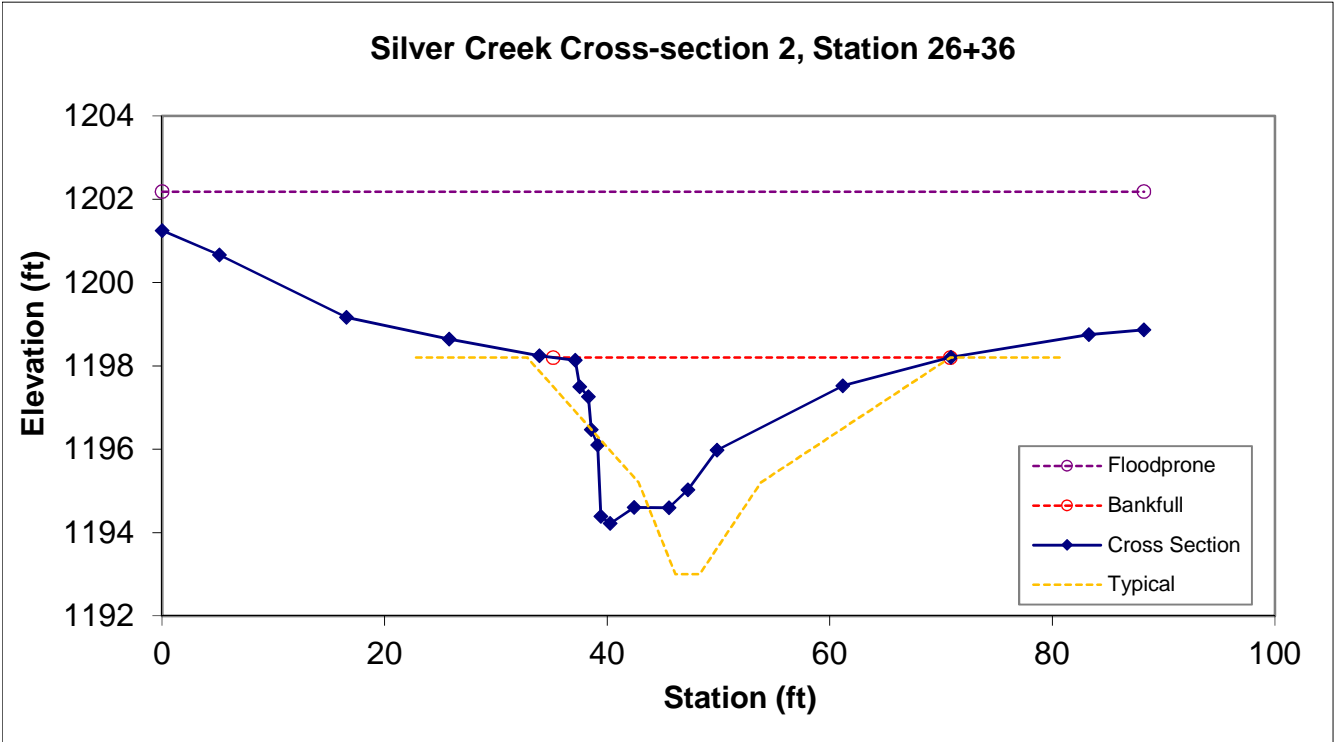
Permanent Cross-section 2  
(As-Built Data - collected March, 2015)

Feature	Stream Type	BKF Area	BKF Width	BKF Depth	Max BKF Depth	W/D	BH Ratio	ER	BKF Elev	TOB Elev
Pool	C	58.3	35.67	1.63	3.98	21.82	1	2.5	1198.2	1198.21

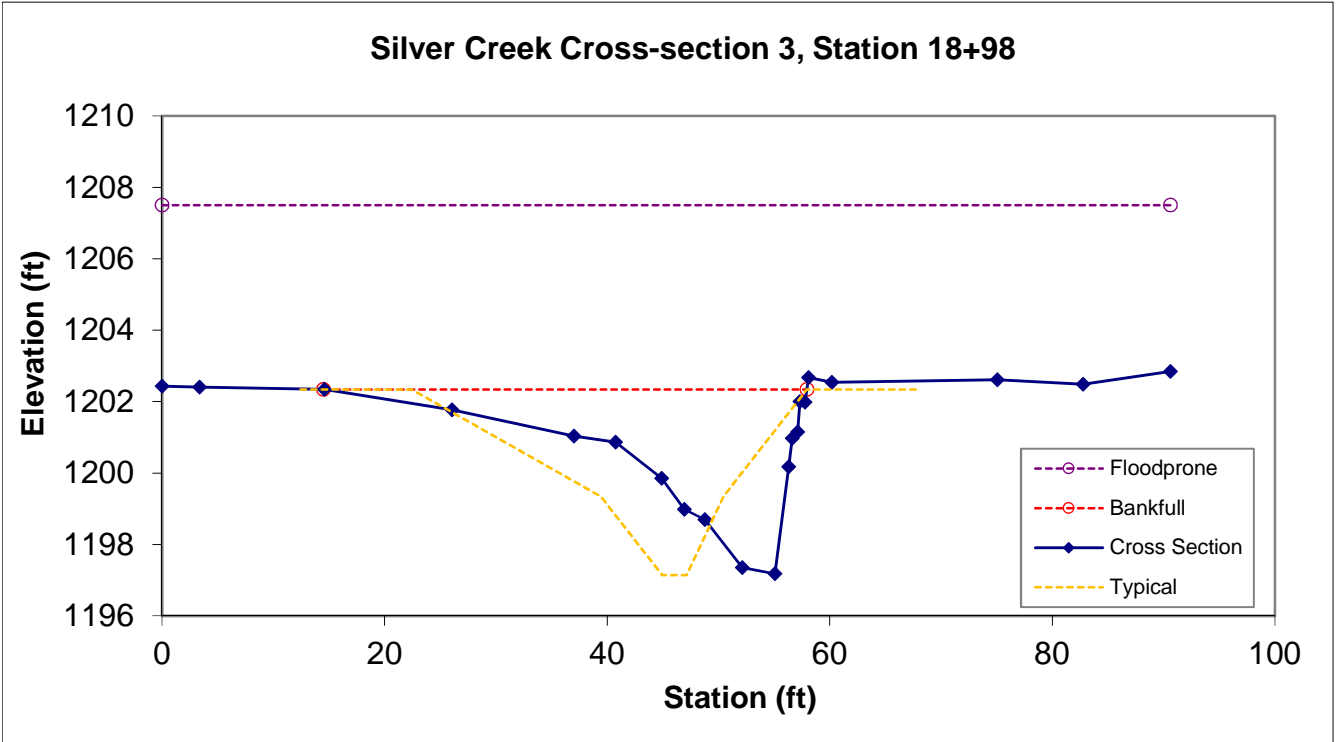
Permanent Cross-section 3  
(As-Built Data - collected March, 2015)

Feature	Stream Type	BKF Area	BKF Width	BKF Depth	Max BKF Depth	W/D	BH Ratio	ER	BKF Elev	TOB Elev
Pool	C	74.9	43.45	1.72	5.16	25.2	0.7	2.1	1202.34	1201.03

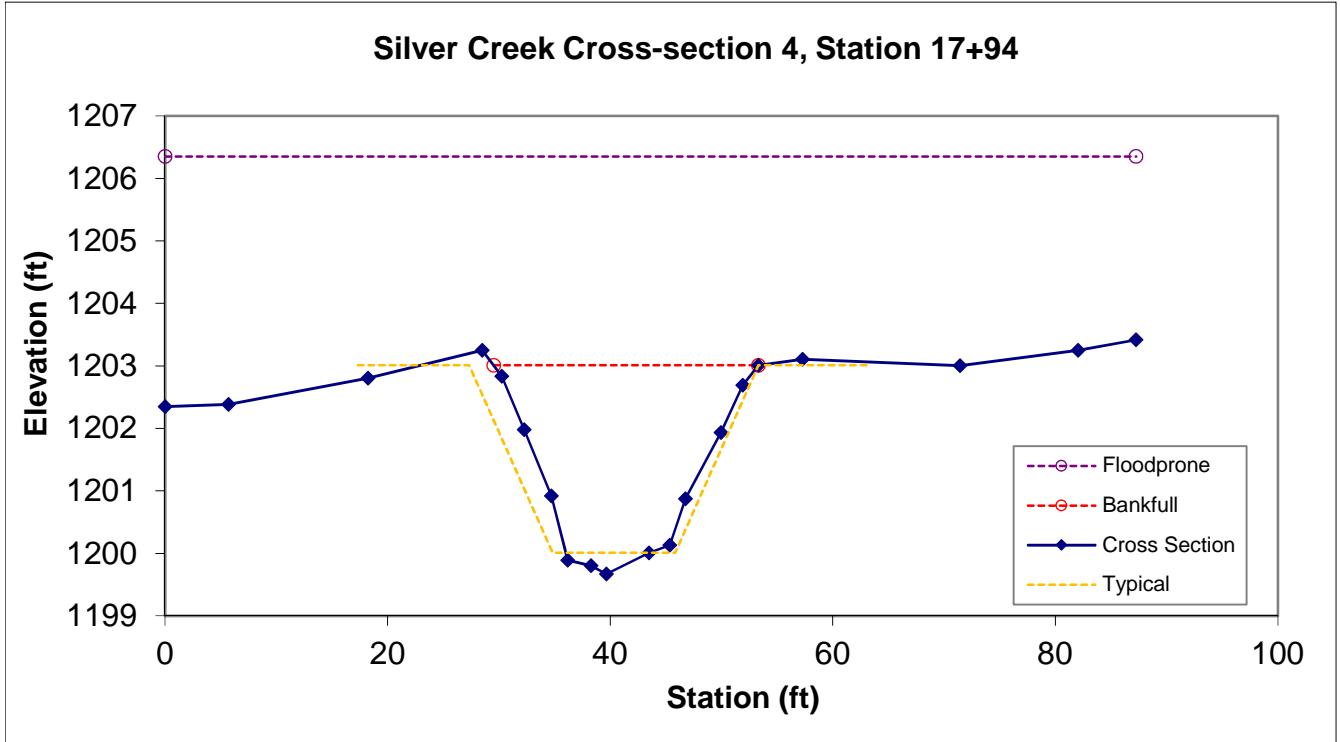
Permanent Cross-section 4  
 (As-Built Data - collected March, 2015)

Feature	Stream Type	BKF Area	BKF Width	BKF Depth	Max BKF Depth	W/D	BH Ratio	ER	BKF Elev	TOB Elev
Riffle	E	48	23.81	2.01	3.34	11.82	1	3.7	1203.01	1203.01

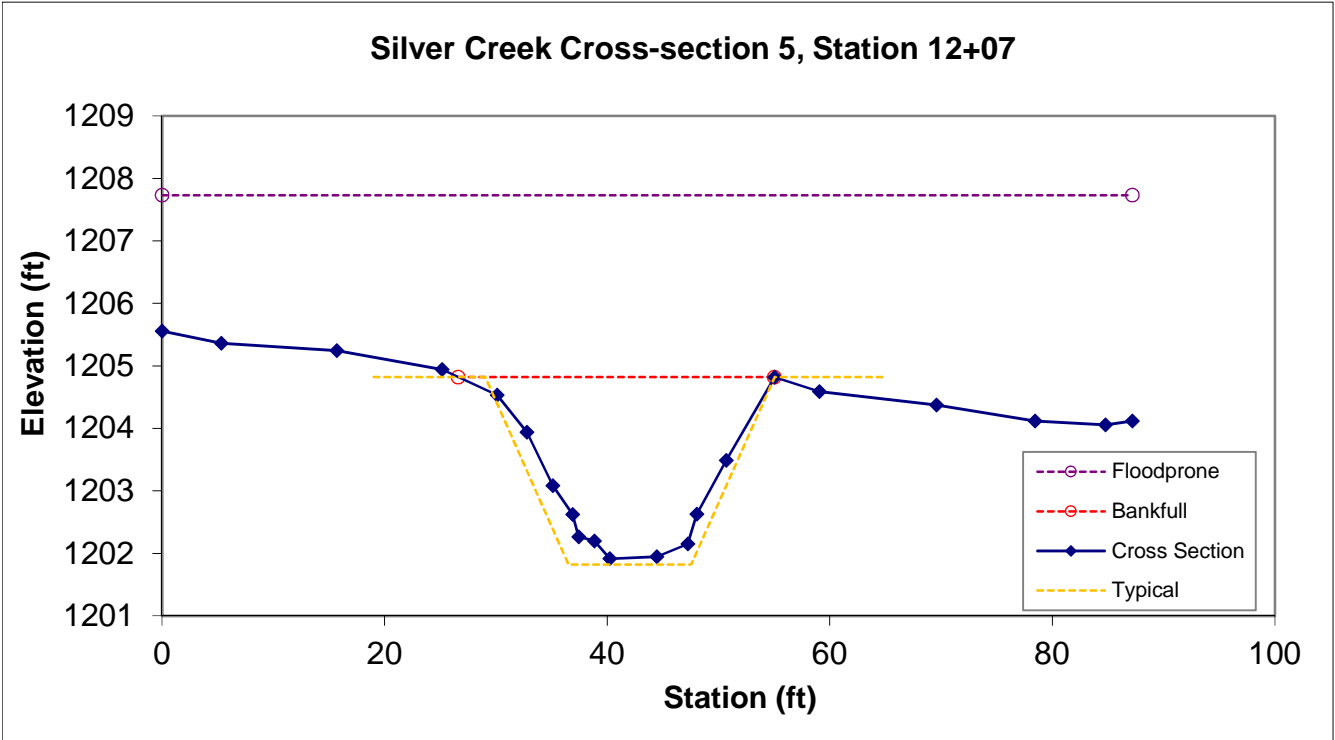
Permanent Cross-section 5  
(As-Built Data - collected March, 2015)

Feature	Stream Type	BKF Area	BKF Width	BKF Depth	Max BKF Depth	W/D	BH Ratio	ER	BKF Elev	TOB Elev
Riffle	C	46.9	28.43	1.65	2.91	17.25	1	3.1	1204.82	1204.82

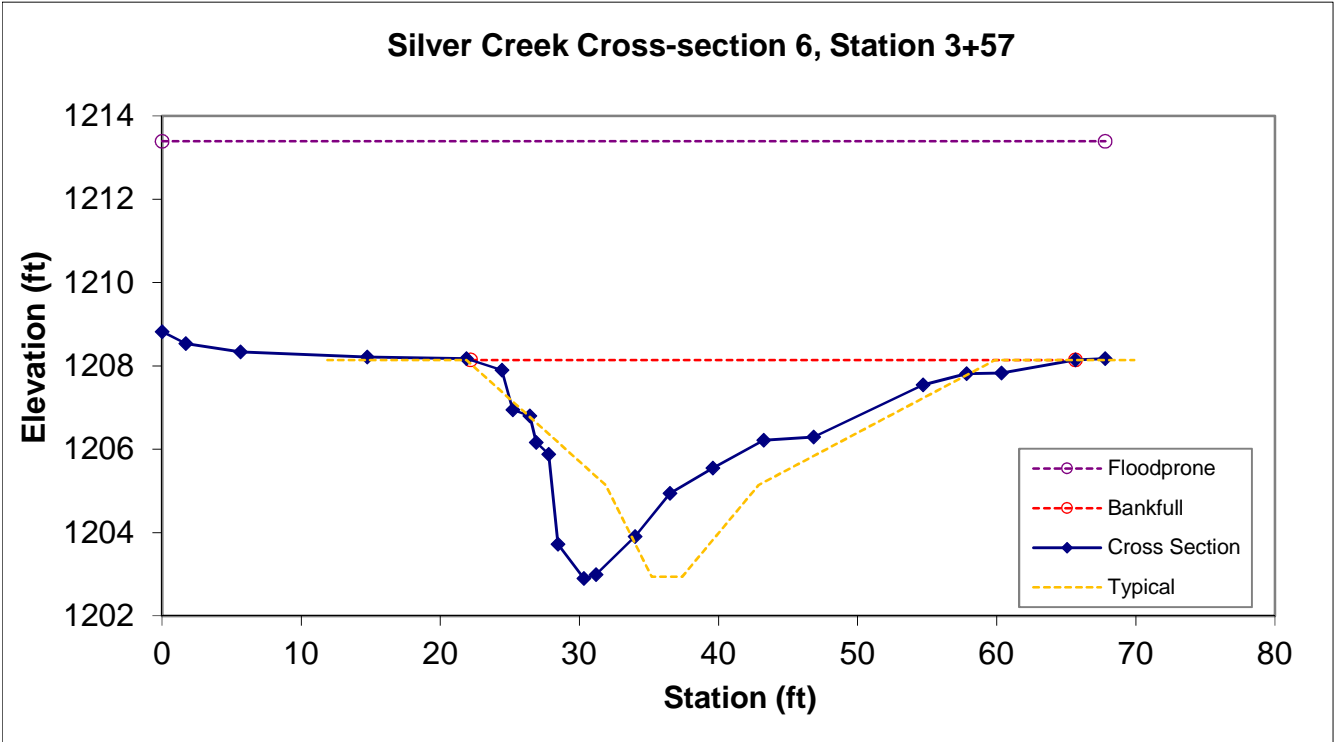
Permanent Cross-section 6  
(As-Built Data - collected March, 2015)

Feature	Stream Type	BKF Area	BKF Width	BKF Depth	Max BKF Depth	W/D	BH Ratio	ER	BKF Elev	TOB Elev
Pool	C	80.1	43.48	1.84	5.25	23.59	1	1.6	1208.14	1208.14

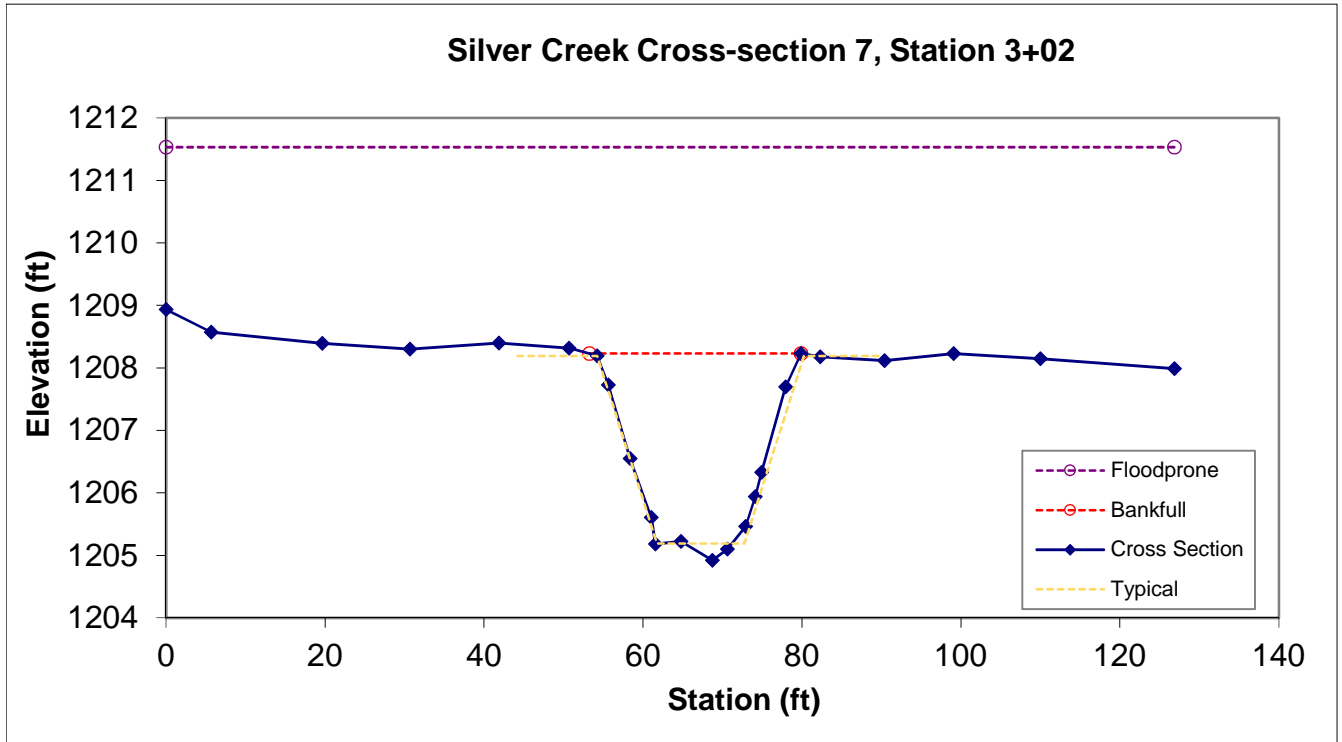
Permanent Cross-section 7  
 (As-Built Data - collected March, 2015)

Feature	Stream Type	BKF Area	BKF Width	BKF Depth	Max BKF Depth	W/D	BH Ratio	ER	BKF Elev	TOB Elev
Riffle	E	54.5	26.61	2.05	3.3	12.98	1	4.8	1208.23	1208.19

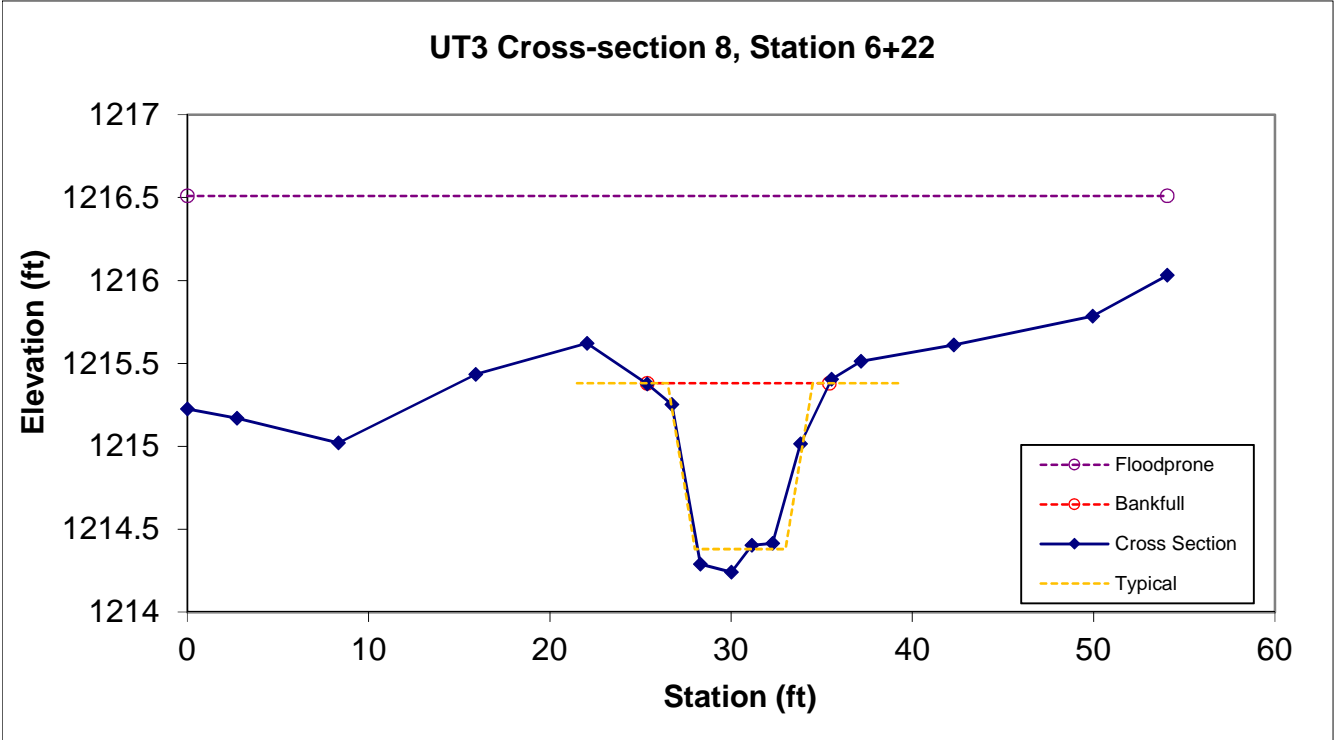
Permanent Cross-section 8  
(As-Built Data - collected March, 2015)

Feature	Stream Type	BKF Area	BKF Width	BKF Depth	Max BKF Depth	W/D	BH Ratio	ER	BKF Elev	TOB Elev
Riffle	C	6.5	10.05	0.65	1.13	15.46	1	5.4	1215.38	1215.41

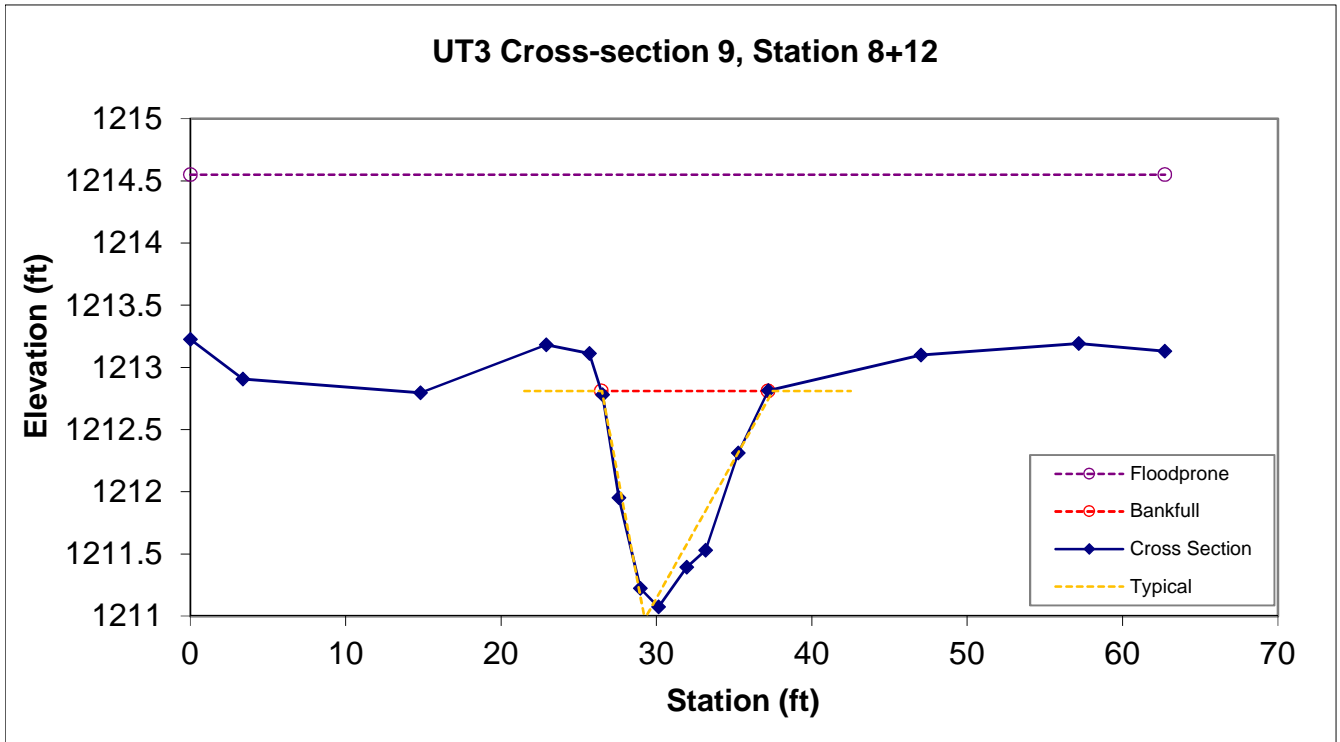
Permanent Cross-section 9  
 (As-Built Data - collected March, 2015)

Feature	Stream Type	BKF Area	BKF Width	BKF Depth	Max BKF Depth	W/D	BH Ratio	ER	BKF Elev	TOB Elev
Pool	E	10.9	10.73	1.02	1.74	10.53	1	5.8	1212.81	1212.81

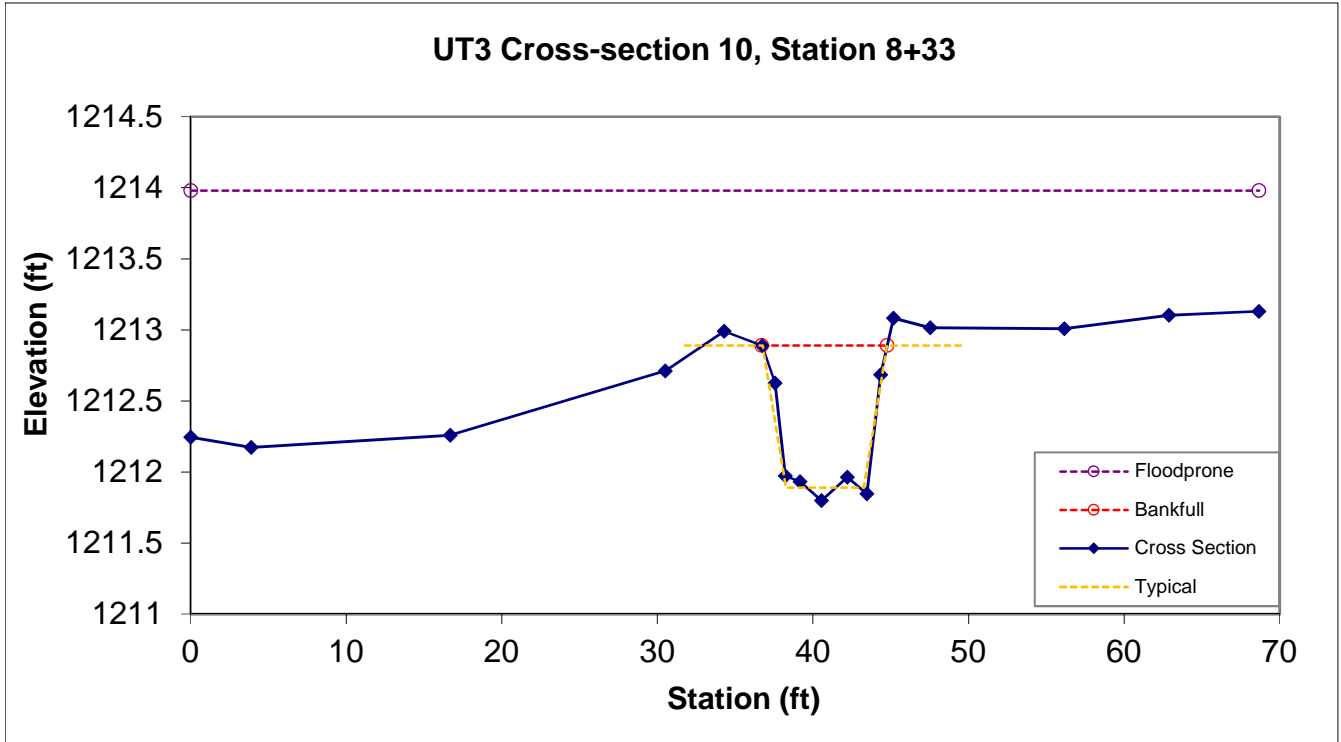
Permanent Cross-section 10  
 (As-Built Data - collected March, 2015)

Feature	Stream Type	BKF Area	BKF Width	BKF Depth	Max BKF Depth	W/D	BH Ratio	ER	BKF Elev	TOB Elev
Riffle	E	6.3	8.07	0.78	1.09	10.34	1.1	8.5	1212.89	1212.99

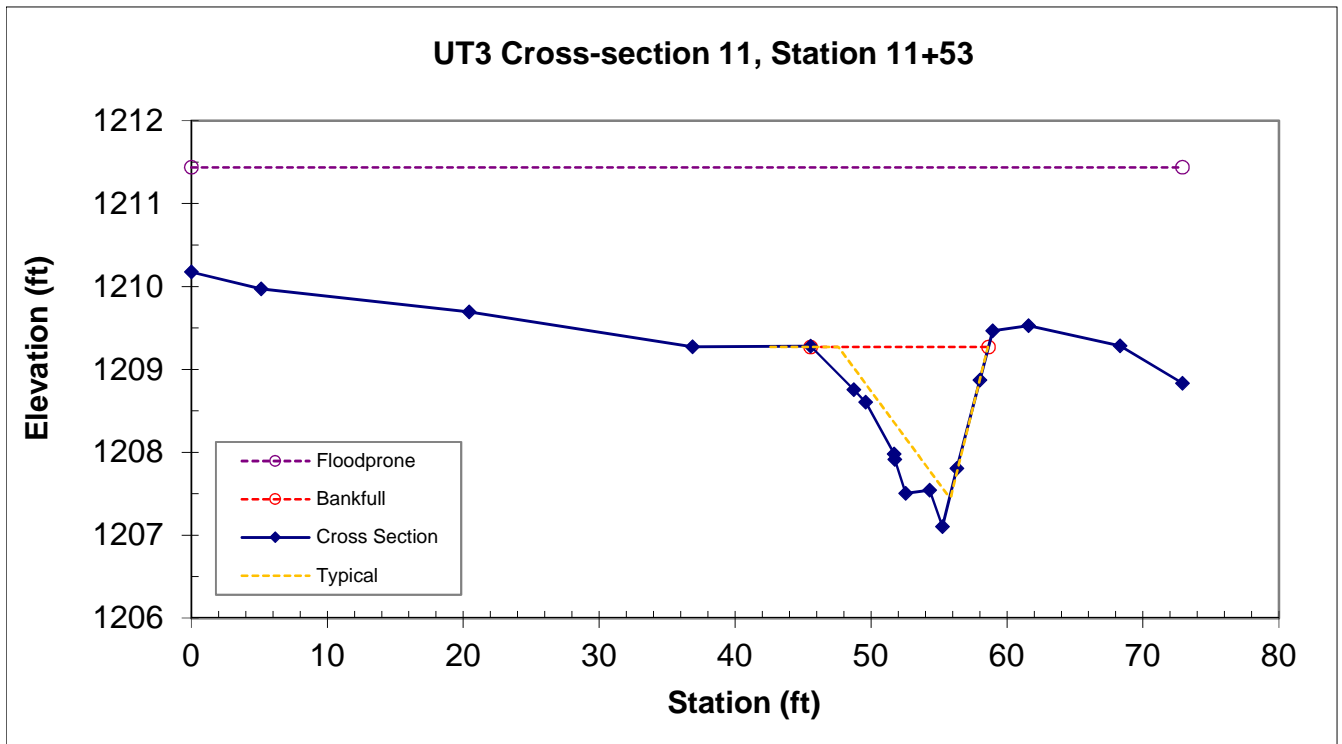
Permanent Cross-section 11  
 (As-Built Data - collected March, 2015)

Feature	Stream Type	BKF Area	BKF Width	BKF Depth	Max BKF Depth	W/D	BH Ratio	ER	BKF Elev	TOB Elev
Pool	C	13.22	13.03	1.01	2.17	12.8	1	>5.6	1209.27	1211.436

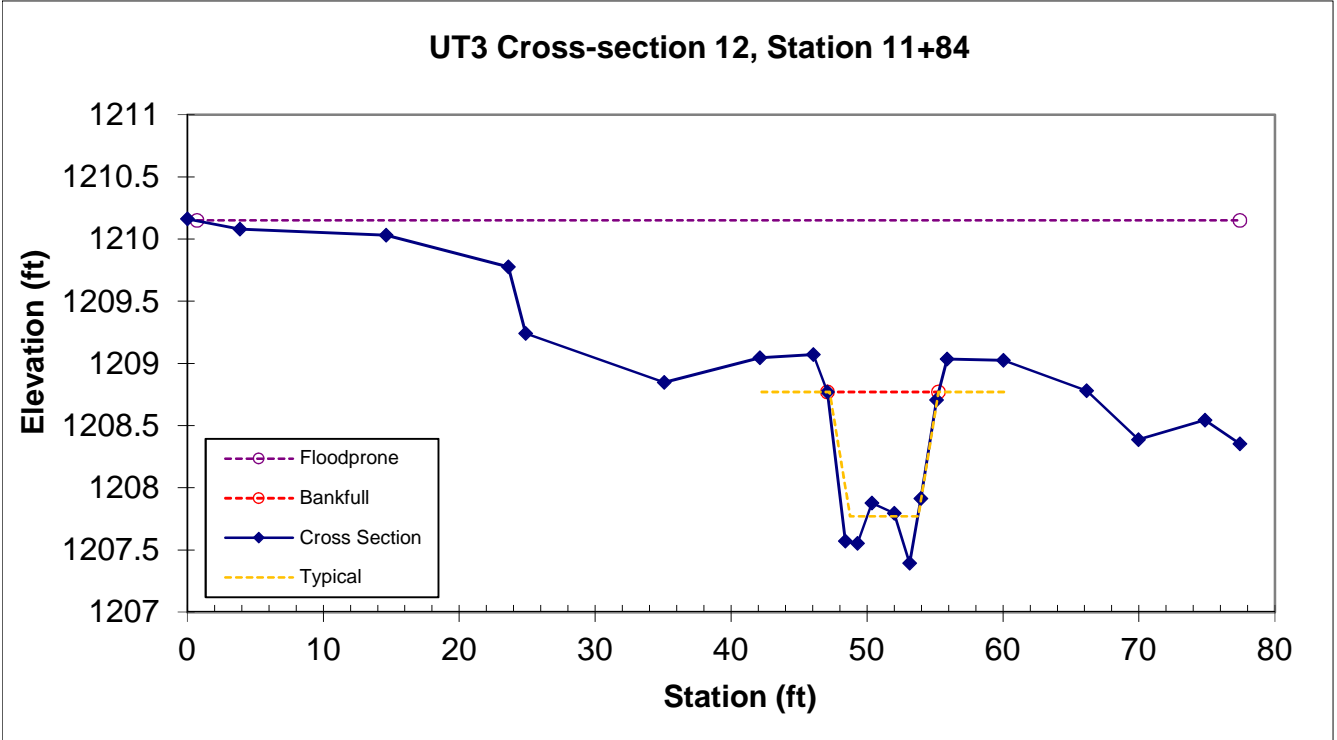
Permanent Cross-section 12  
(As-Built Data - collected March, 2015)

Feature	Stream Type	BKF Area	BKF Width	BKF Depth	Max BKF Depth	W/D	BH Ratio	ER	BKF Elev	TOB Elev
Riffle	E	7.3	8.17	0.9	1.38	9.12	1.2	9.4	1208.77	1209.04

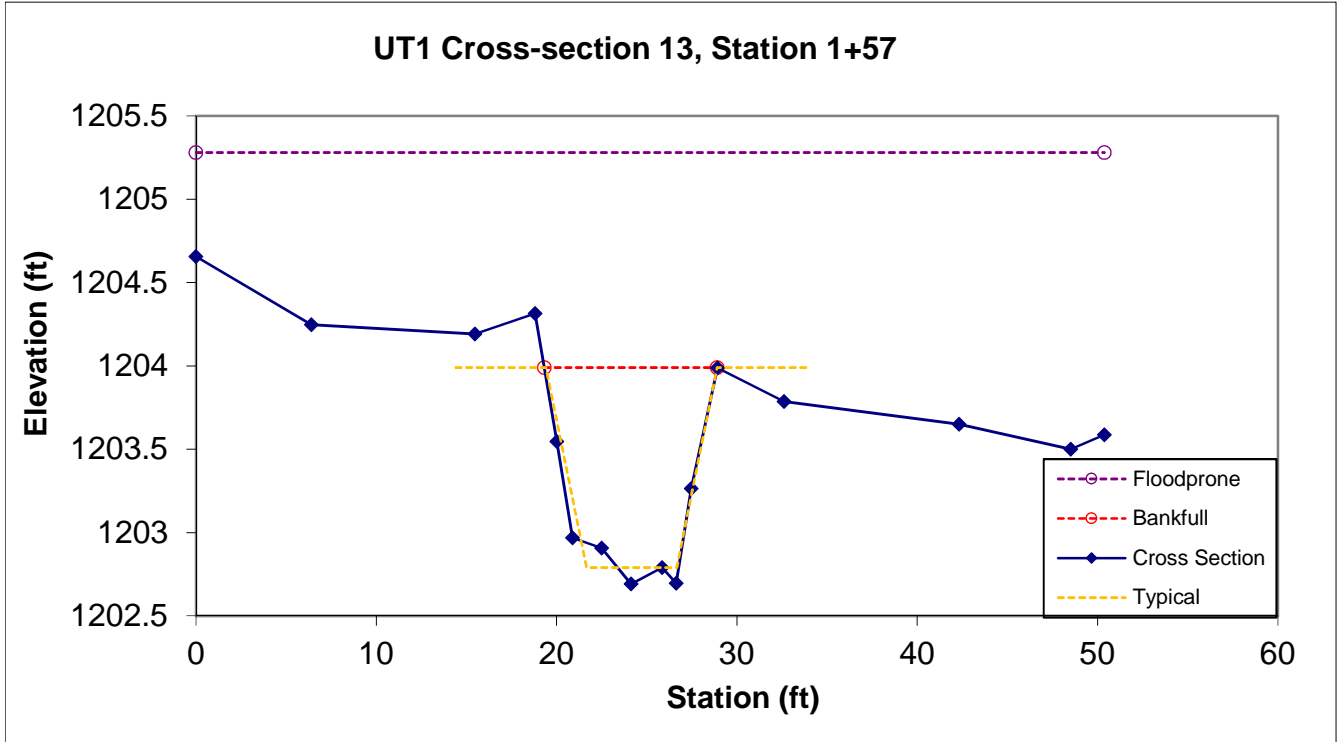
Permanent Cross-section 13  
 (As-Built Data - collected March, 2015)

Feature	Stream Type	BKF Area	BKF Width	BKF Depth	Max BKF Depth	W/D	BH Ratio	ER	BKF Elev	TOB Elev
Riffle	E	8.9	9.59	0.93	1.3	10.33	1	5.3	1203.99	1203.99

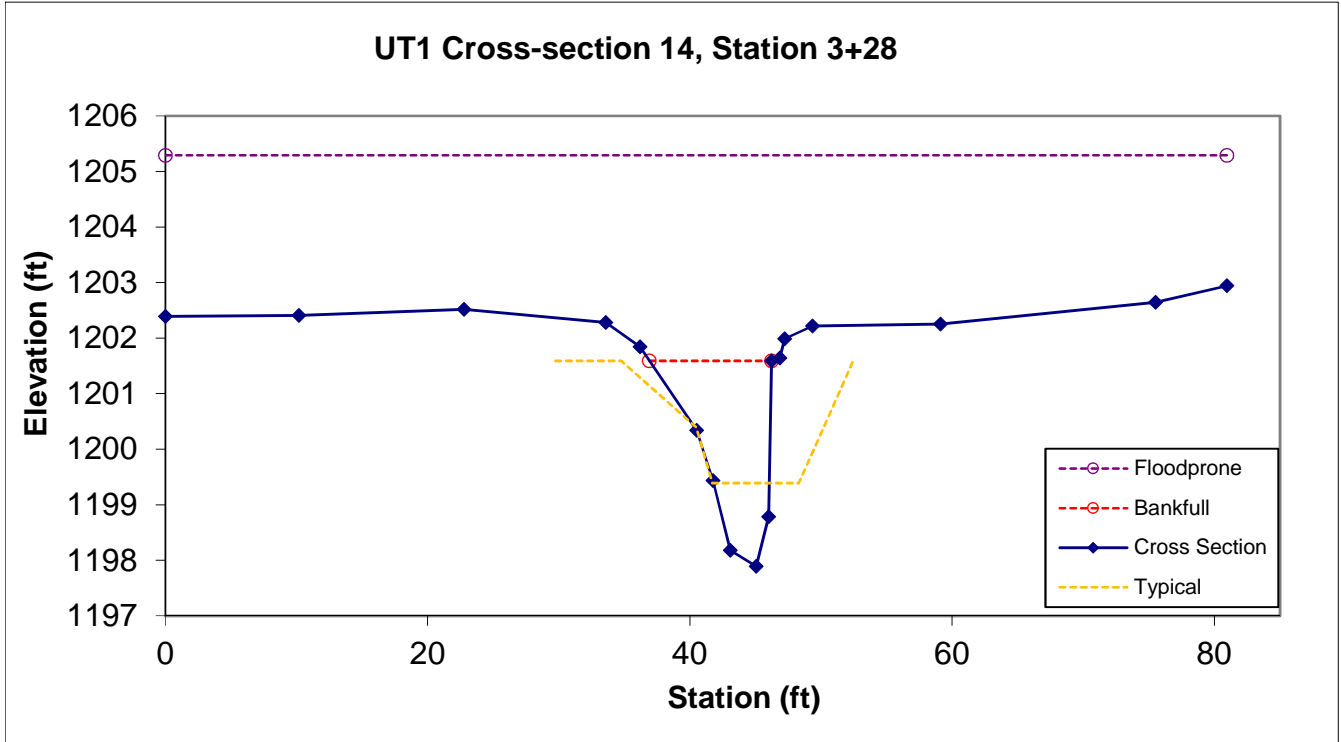
Permanent Cross-section 14  
 (As-Built Data - collected March, 2015)

Feature	Stream Type	BKF Area	BKF Width	BKF Depth	Max BKF Depth	W/D	BH Ratio	ER	BKF Elev	TOB Elev
Pool	E	18.5	9.32	1.98	3.7	4.71	1.1	8.7	1201.59	1201.99

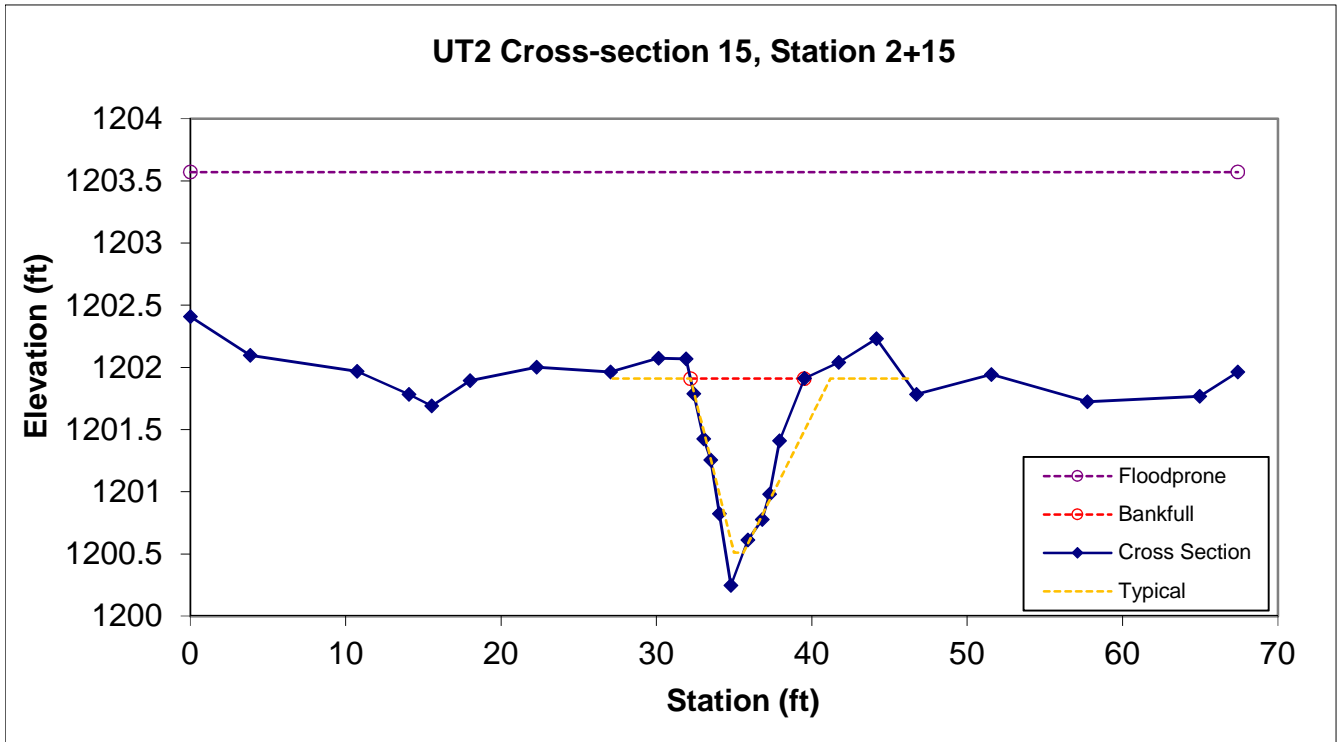
Permanent Cross-section 15  
 (As-Built Data - collected June, 2015)

Feature	Stream Type	BKF Area	BKF Width	BKF Depth	Max BKF Depth	W/D	BH Ratio	ER	BKF Elev	TOB Elev
Pool	E	6.1	7.33	0.83	1.66	8.88	1.1	9.2	1201.91	1202.04

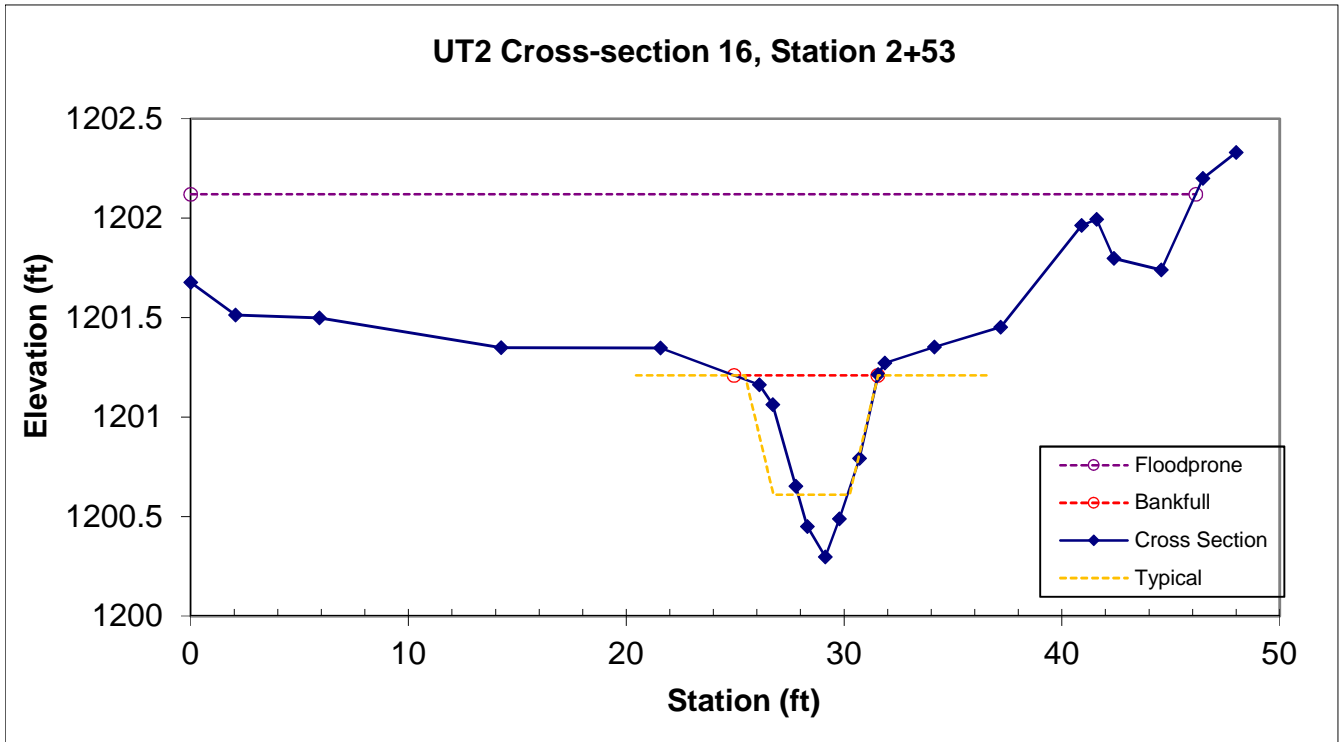
Permanent Cross-section 16  
 (As-Built Data - collected June, 2015)

Feature	Stream Type	BKF Area	BKF Width	BKF Depth	Max BKF Depth	W/D	BH Ratio	ER	BKF Elev	TOB Elev
Riffle	C	2.7	6.6	0.41	0.91	15.99	1.2	7	1201.21	1201.35

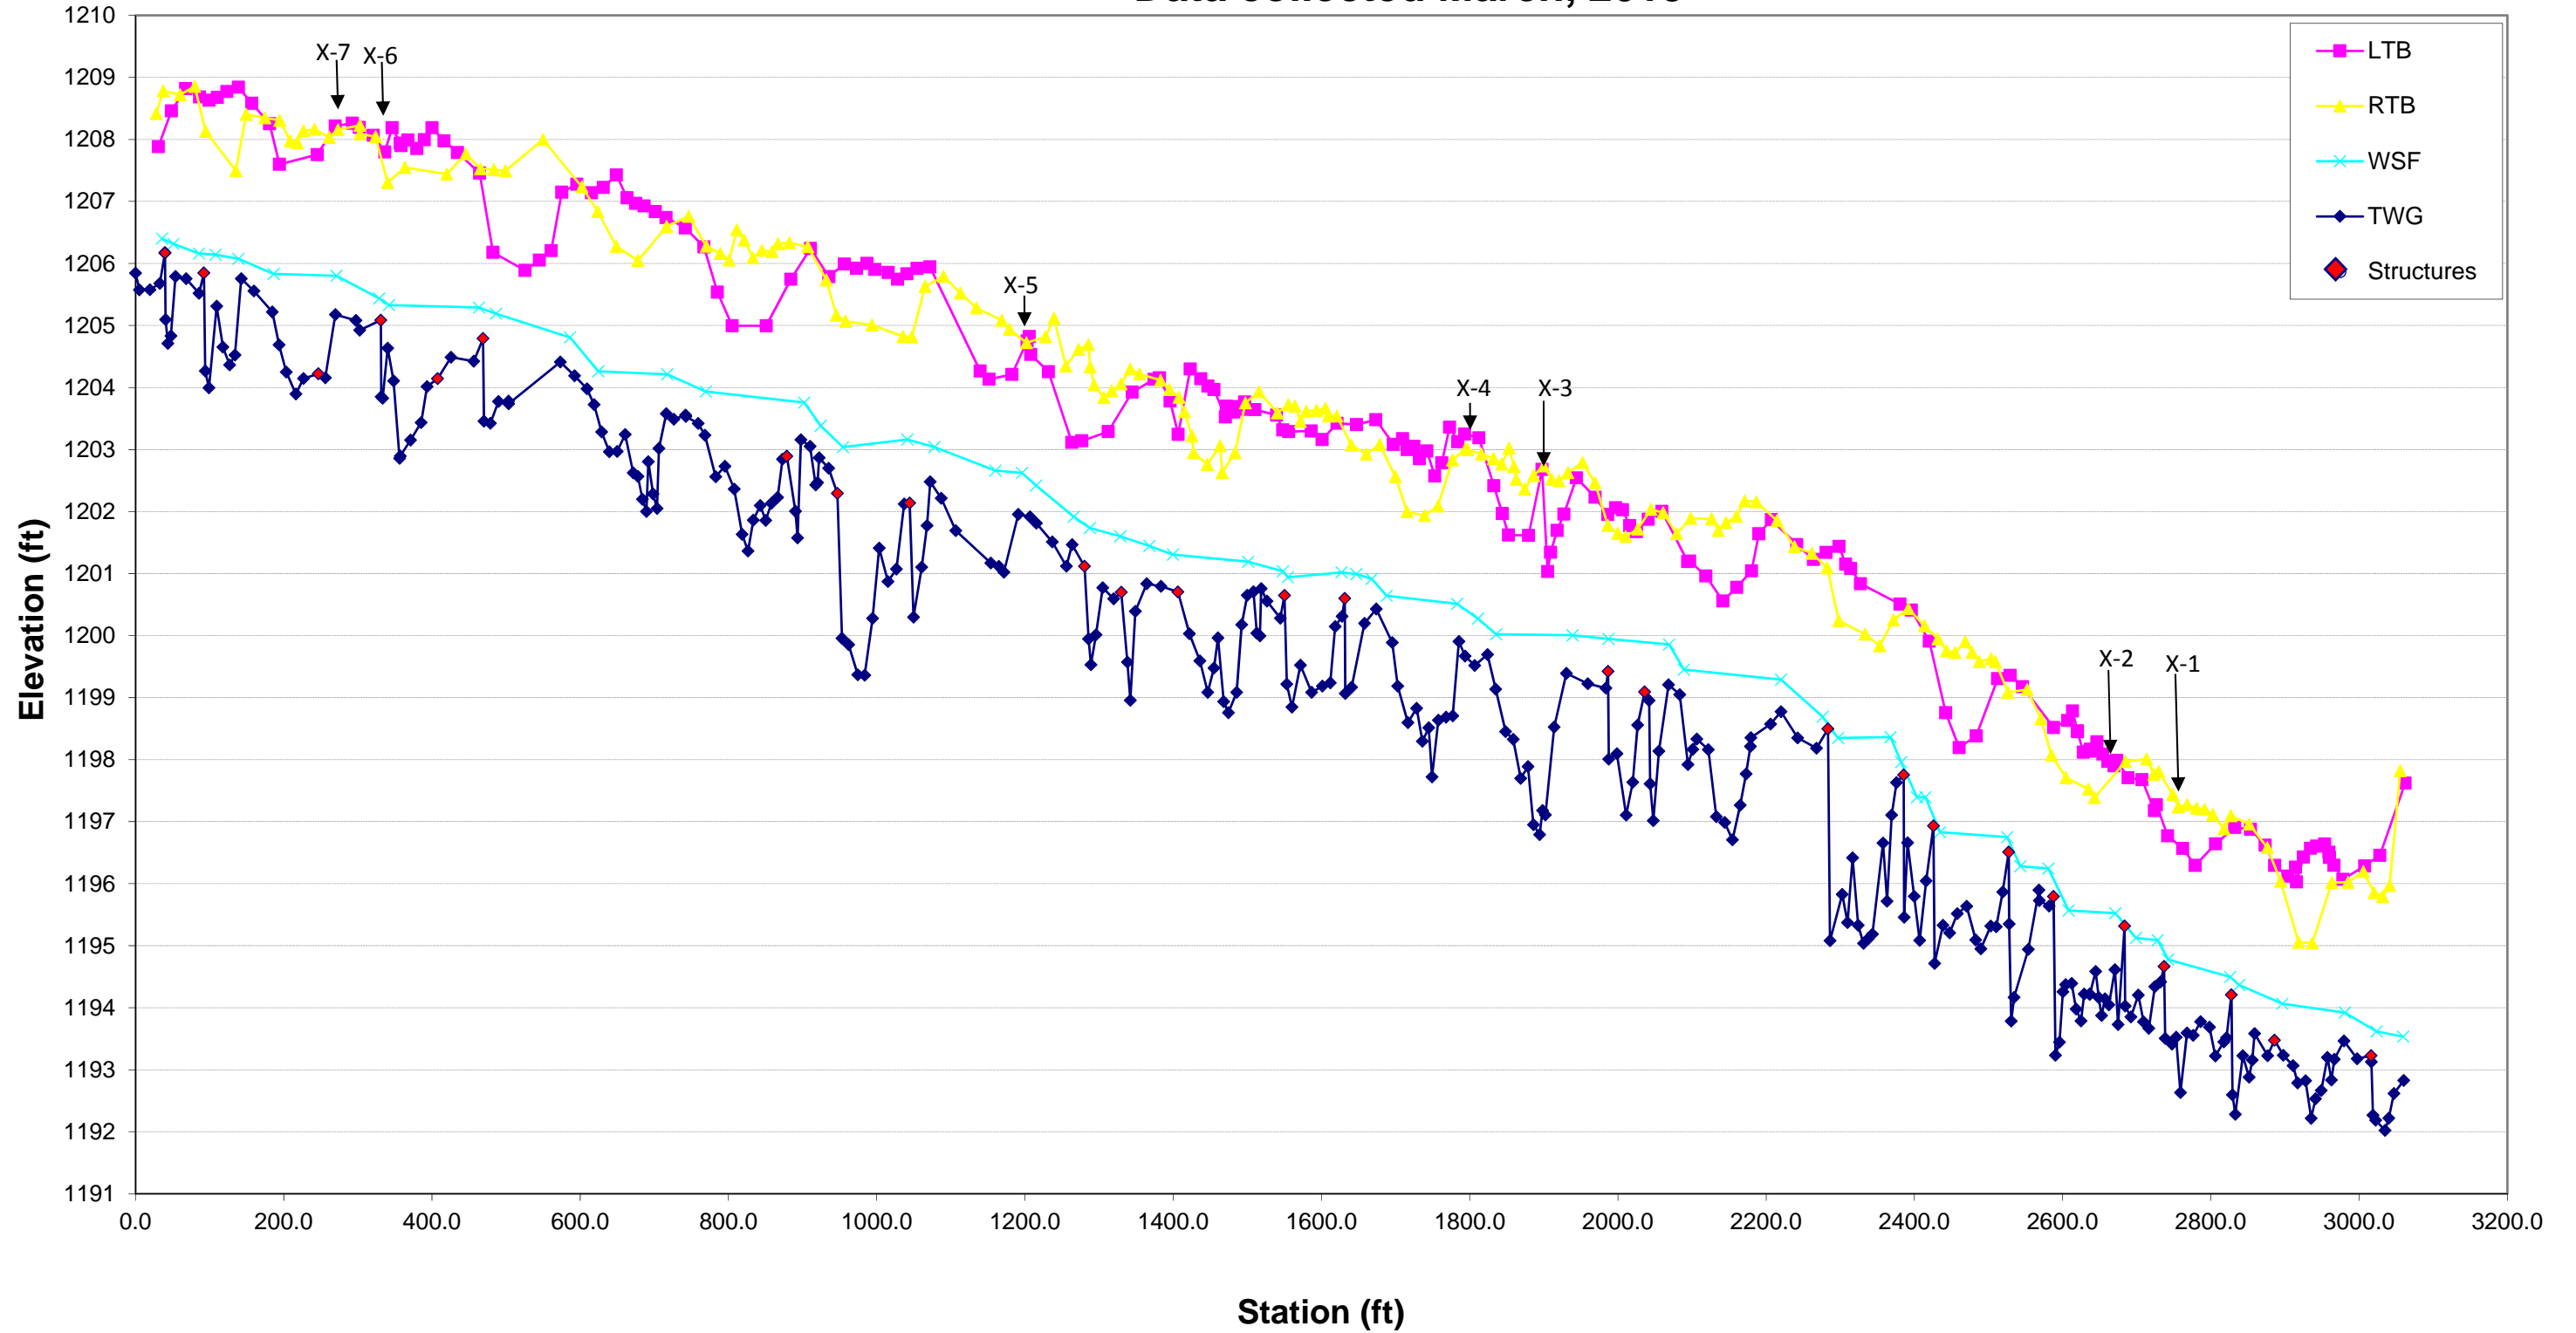
# As-built Profile of Silver Creek, Station 0+00 to 32+00

## Data collected March, 2015
