# **Baseline Monitoring Document and As-Built Baseline Report Upper Silver Creek Stream and Wetland Restoration Project**

**Burke County, North Carolina**

DMS Project ID No. 94645

**Michael Baker**

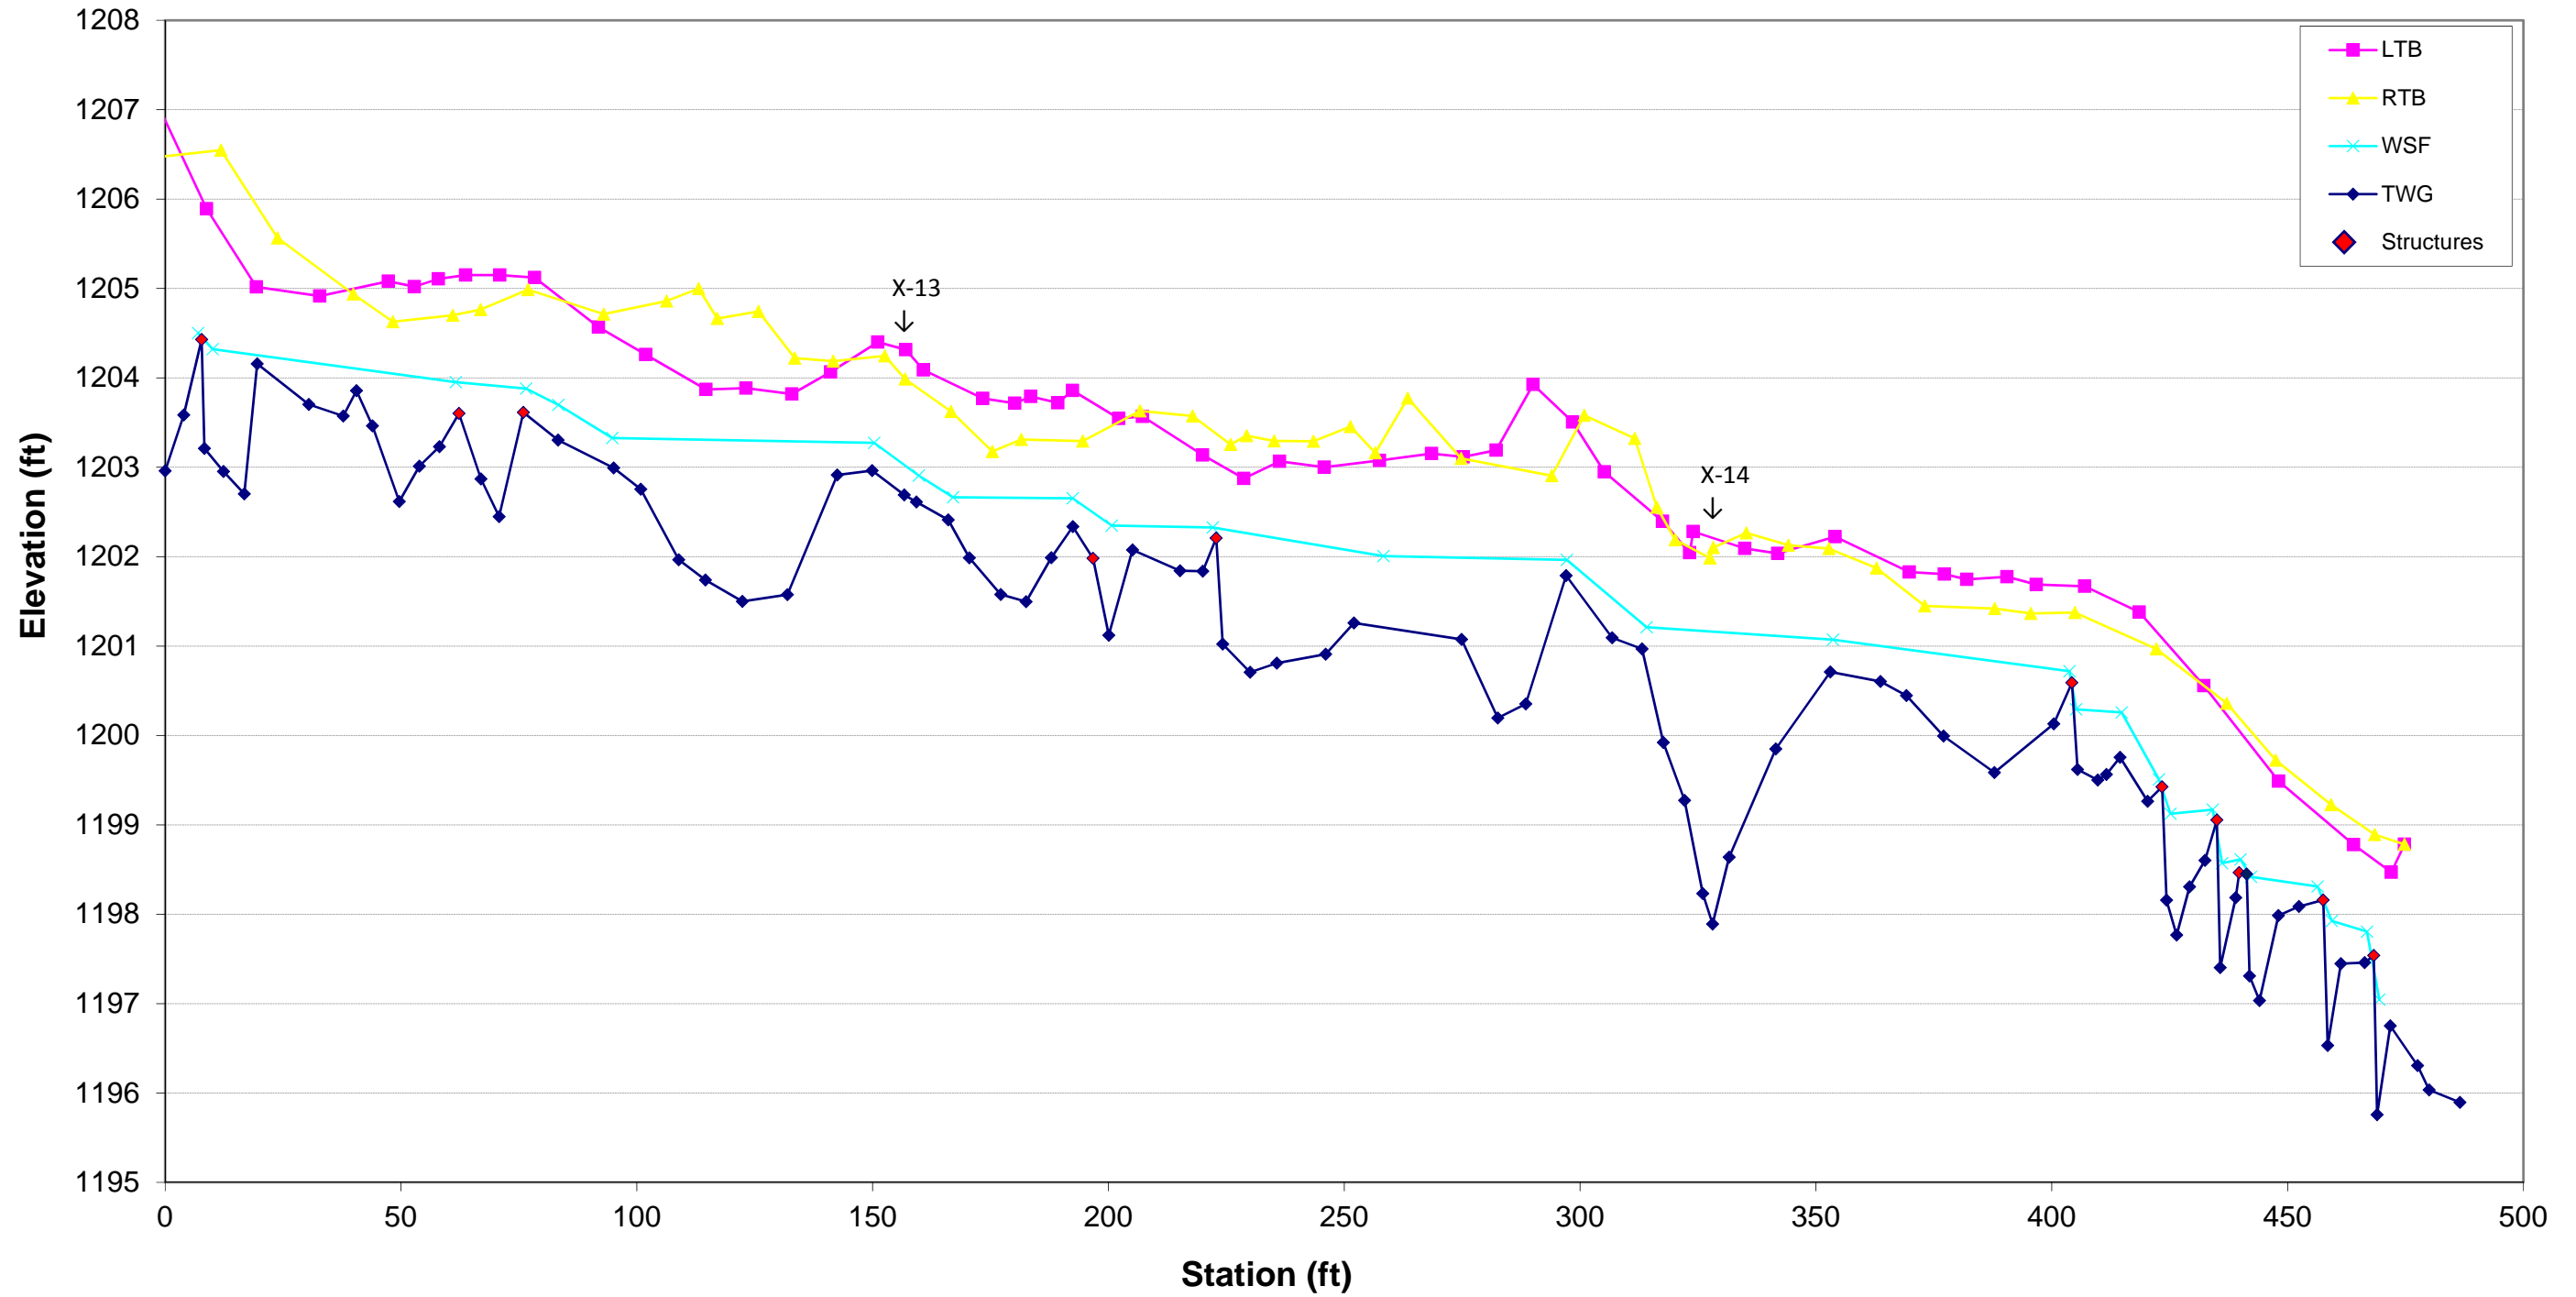
**As-built Profile of UT1, Station 0+00 to 5+00**  
**Data collected March, 2015**

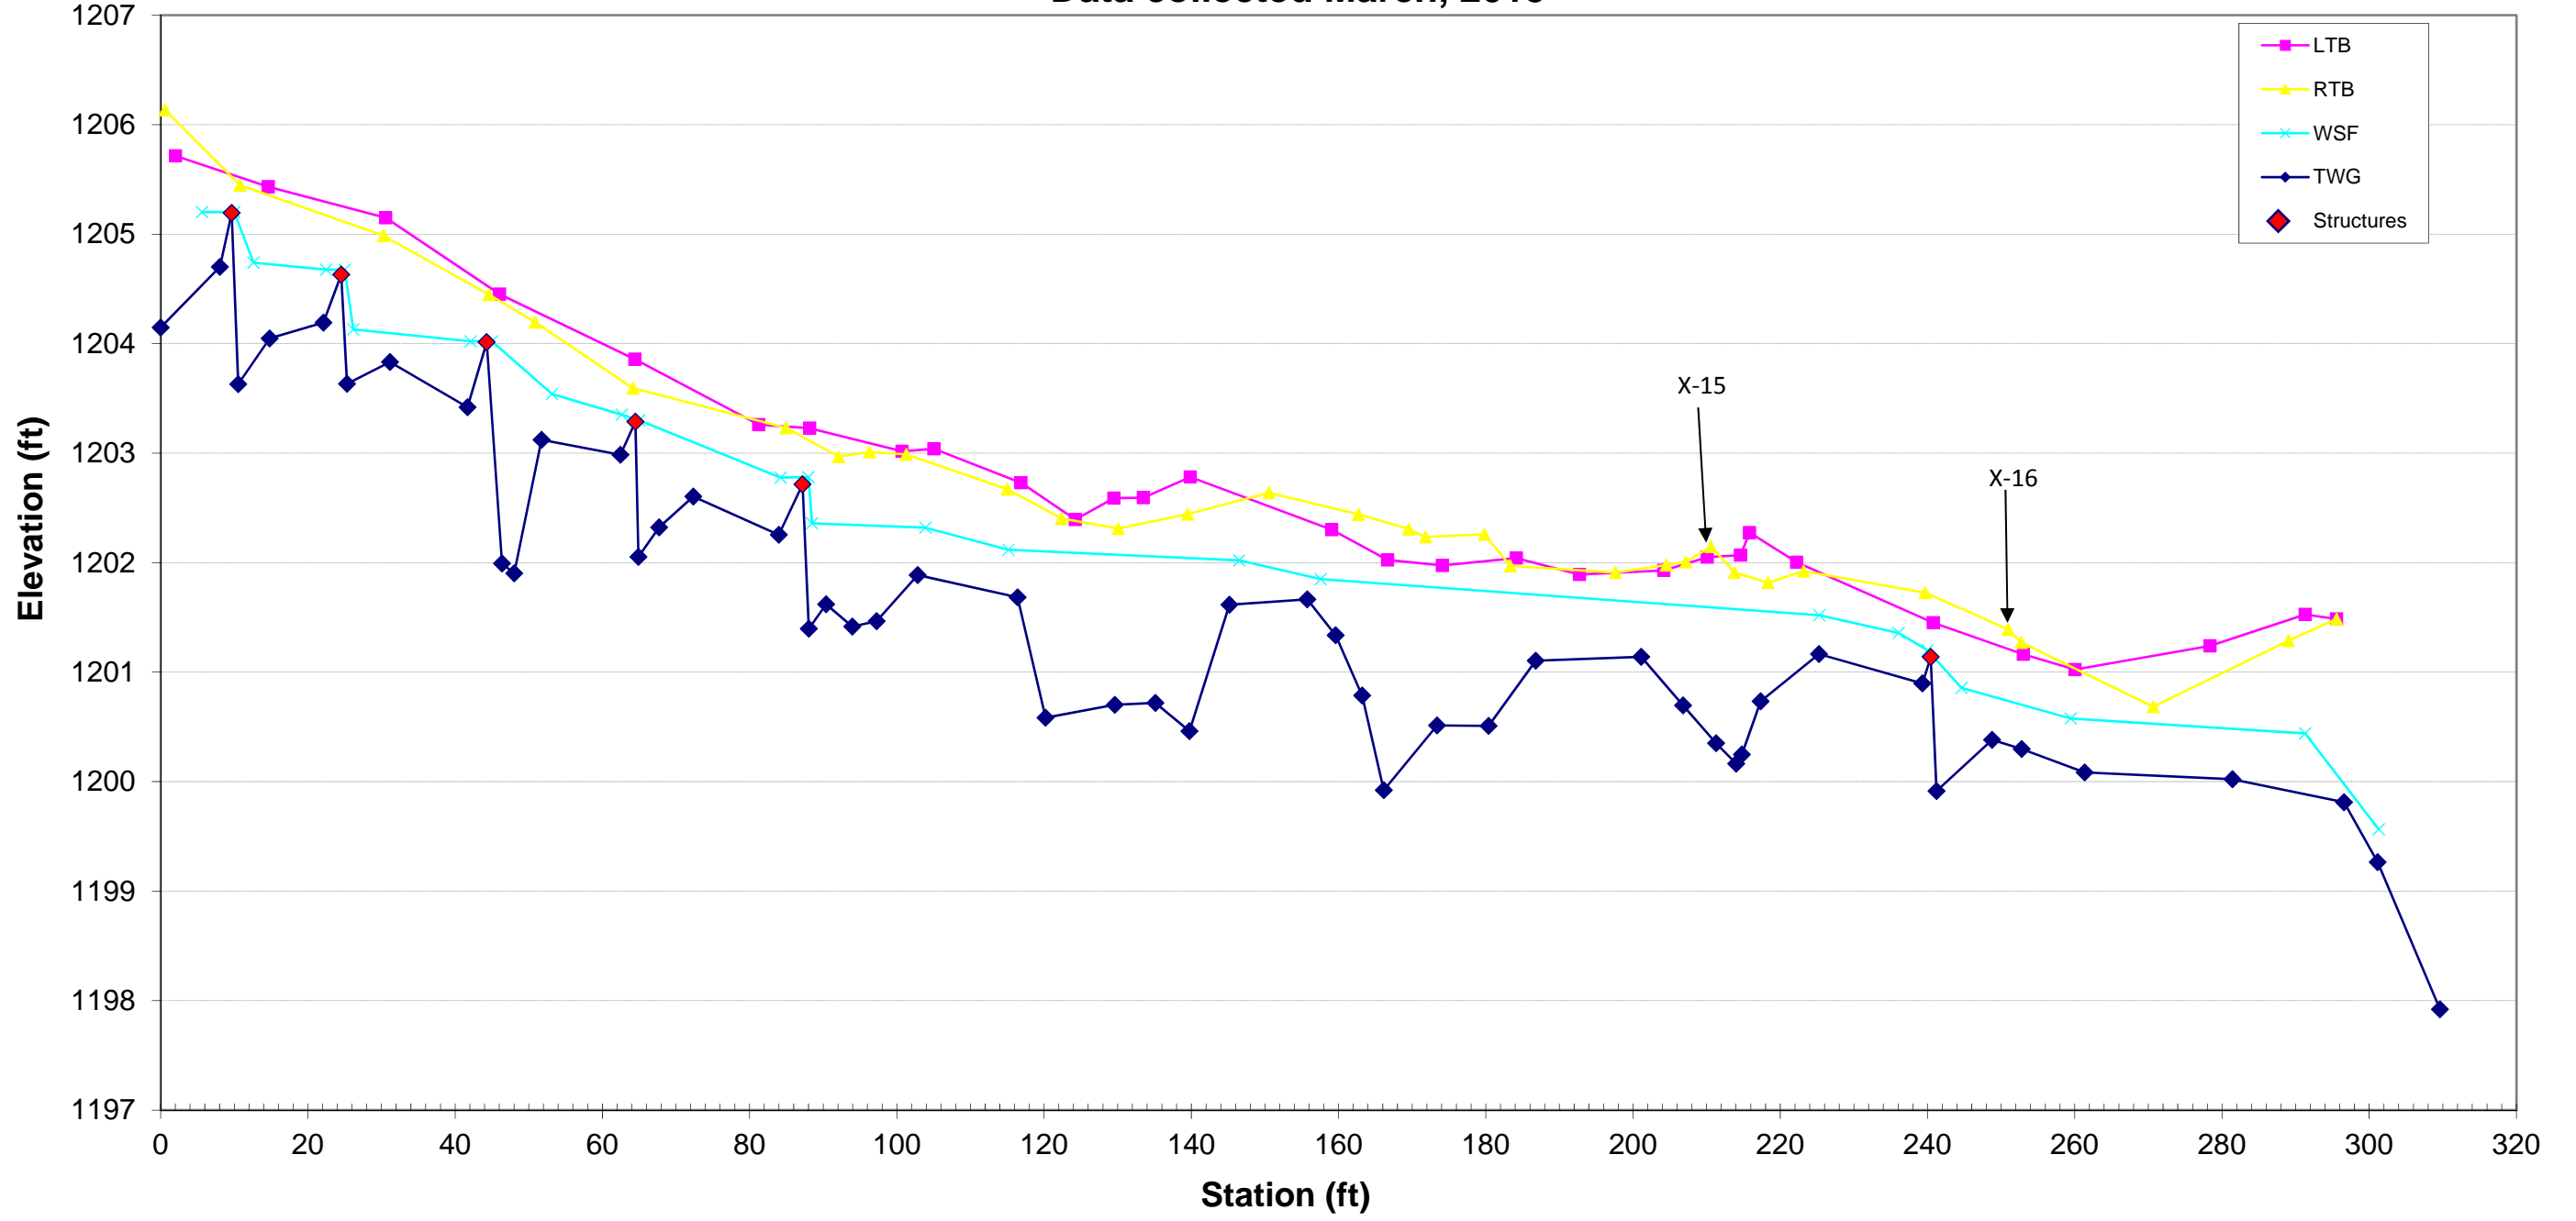
As-built Profile of UT2, Station 0+00 to 3+20  
Data collected March, 2015

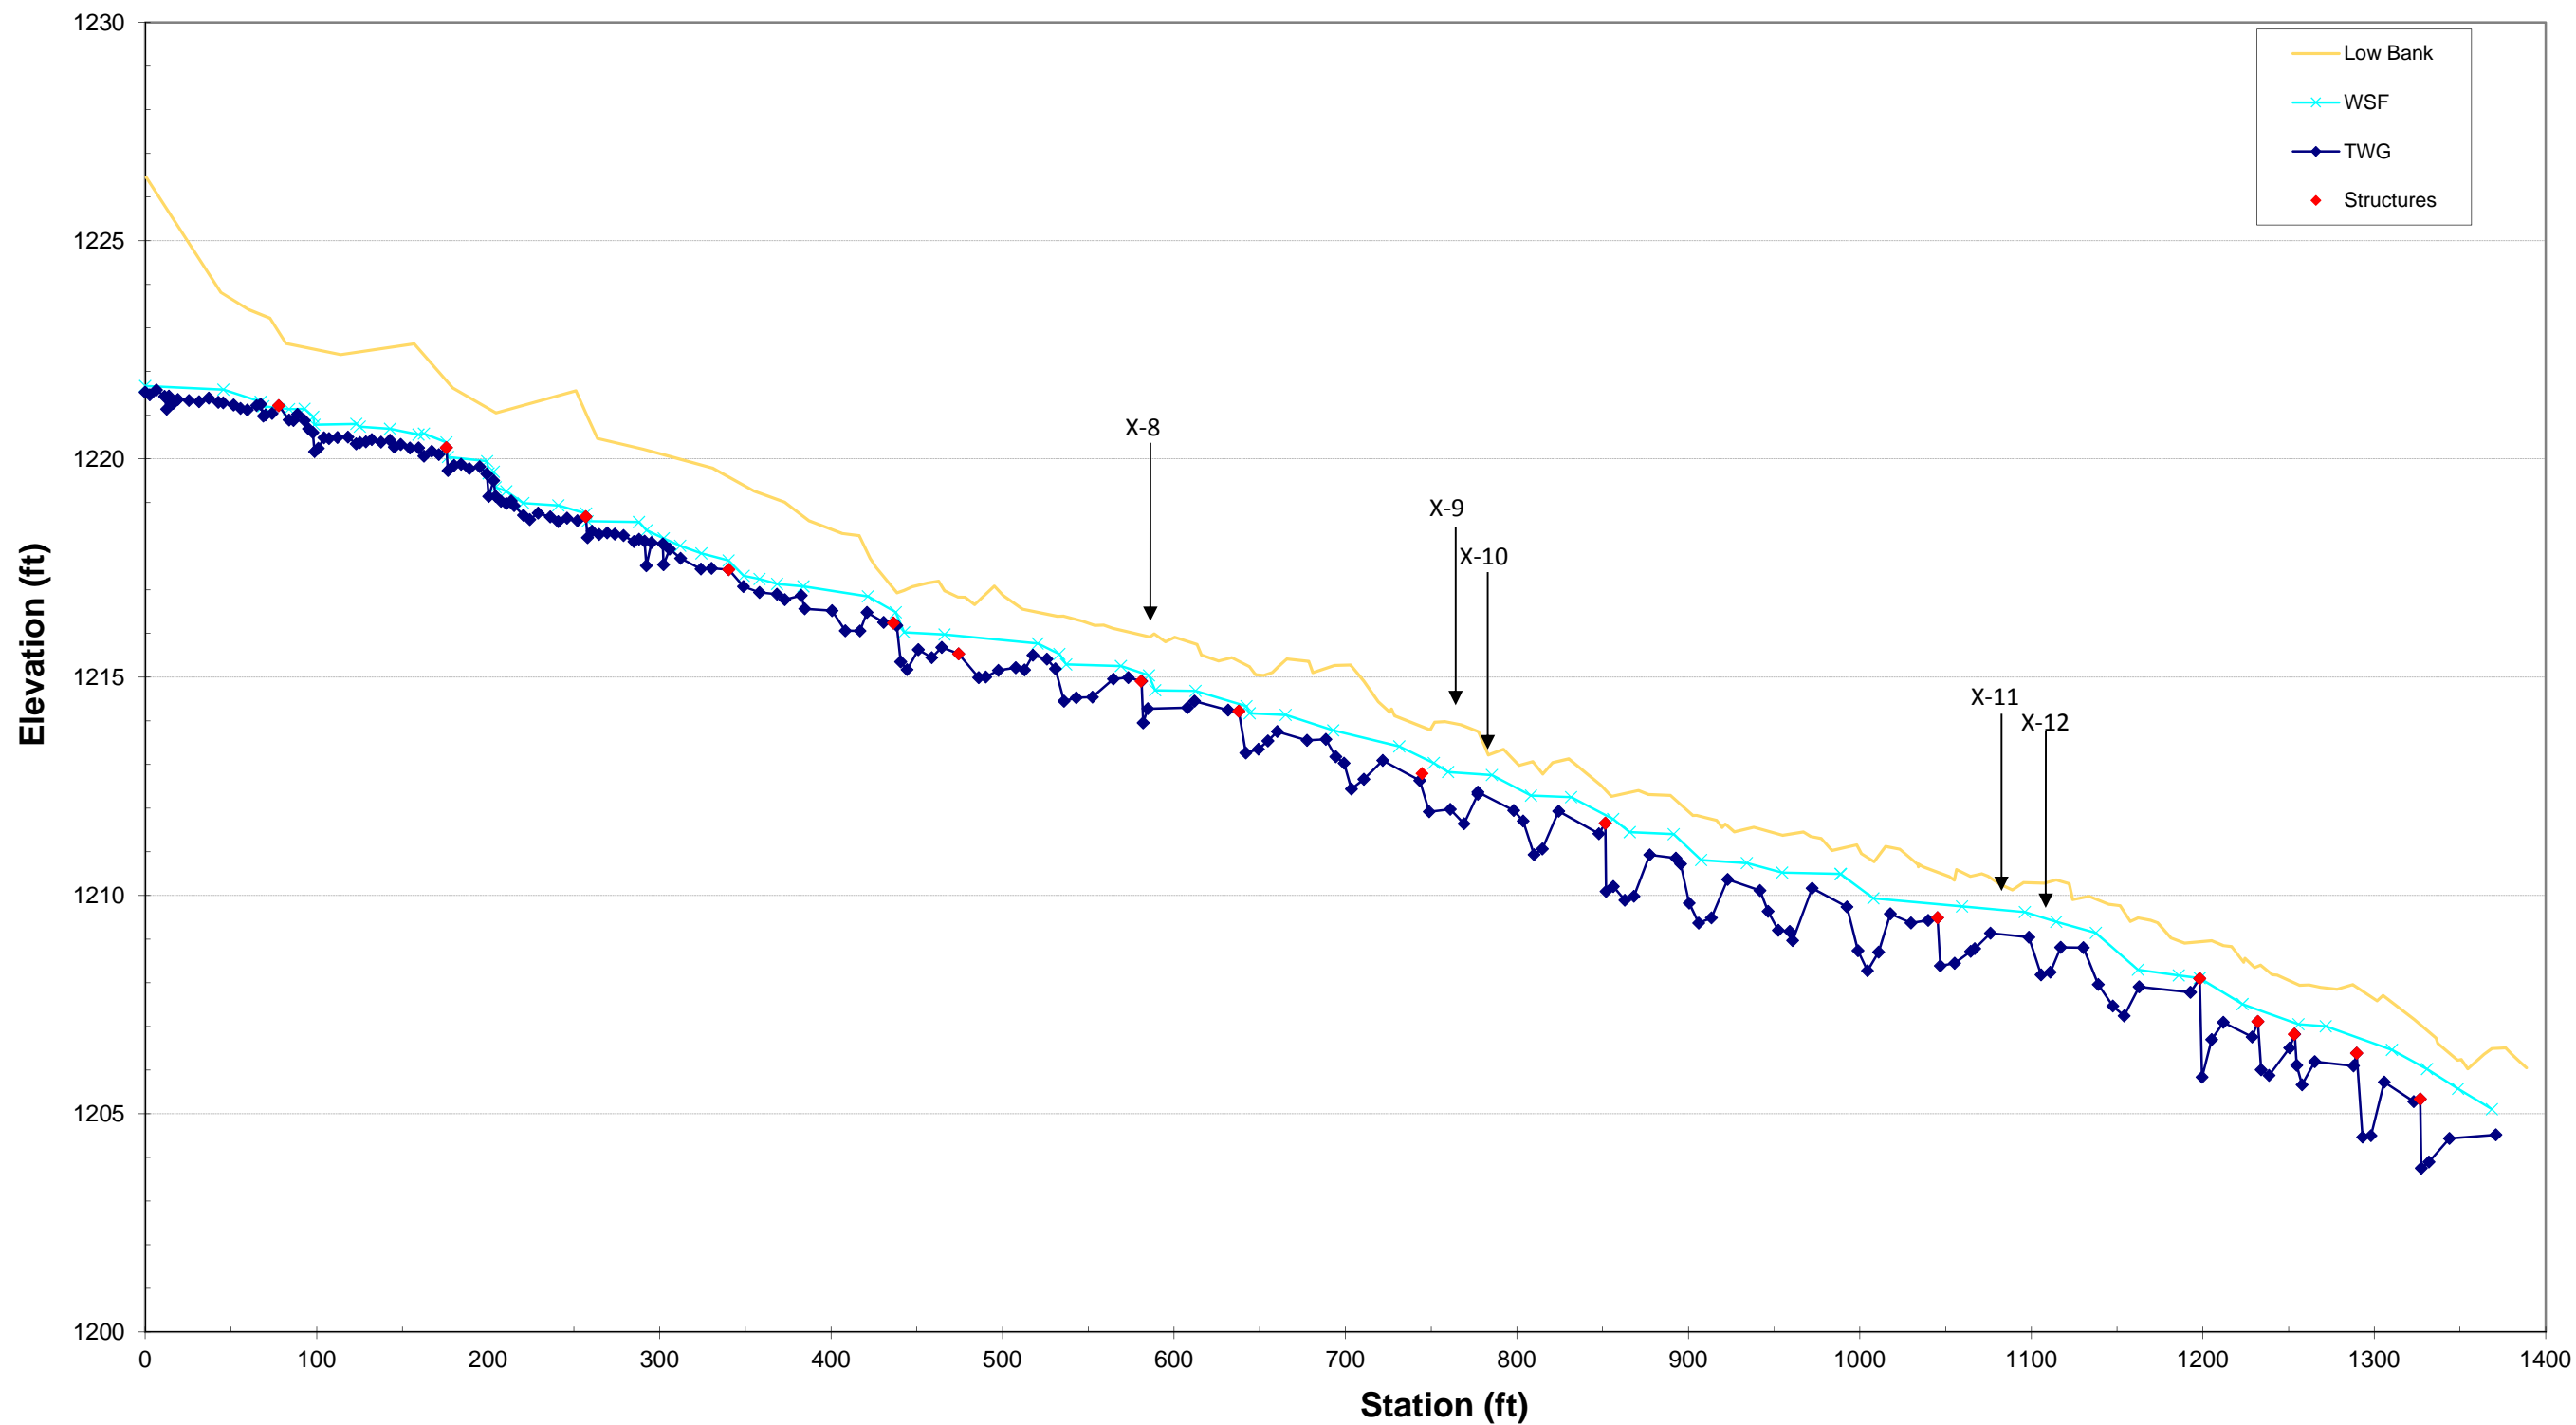
As-built Profile of UT3, Station 0+00 to 14+00  
Data collected March, 2015

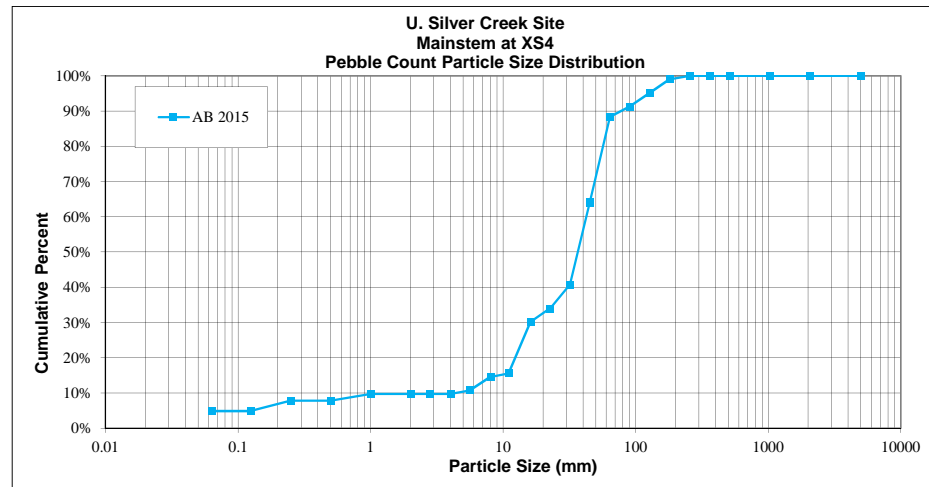
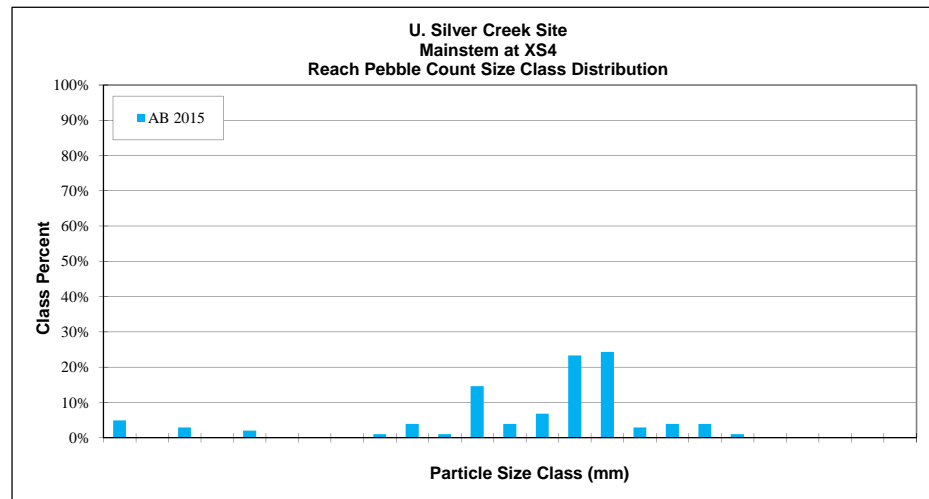
Cross-Section Pebble Count; As-built Survey  
 U. Silver Creek Mitigation Project, DMS# 94645

SITE OR PROJECT:	U. Silver Cr
REACH/LOCATION:	Riffle at XS4
FEATURE:	Riffle

Summary Data			
Channel materials			
D16 =	11.1	D84 =	60.1
D35 =	23.8	D95 =	126.3
D50 =	36.6	D100 =	180 - 256

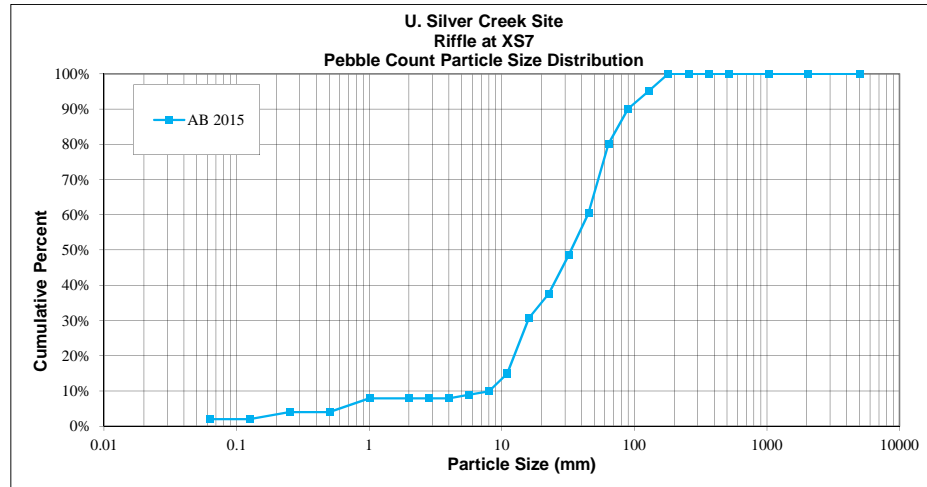
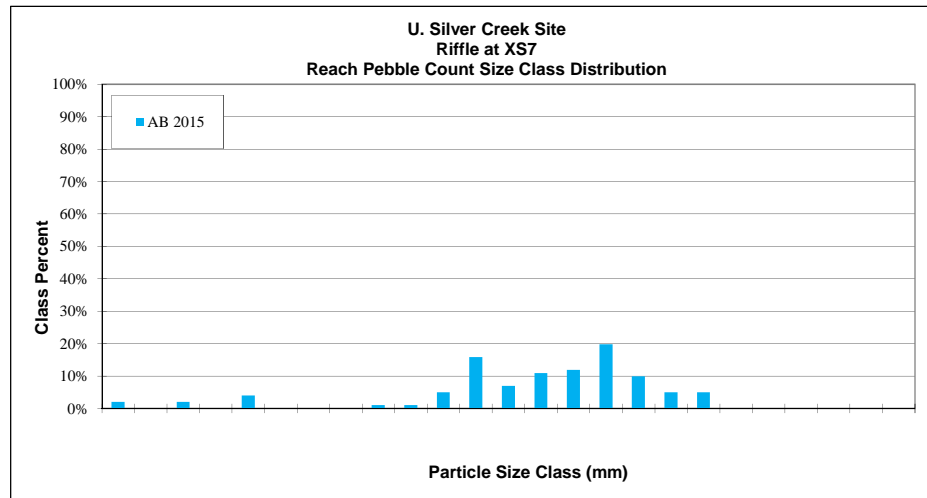
Cross-Section Pebble Count; As-built Survey  
 U. Silver Creek Mitigation Project, DMS# 94645

SITE OR PROJECT:	U. Silver Cr
REACH/LOCATION:	Riffle at XS7
FEATURE:	Riffle

Summary Data			
Channel materials			
D16 =	11.3	D84 =	73.0
D35 =	19.8	D95 =	127.5
D50 =	33.4	D100 =	128 - 180

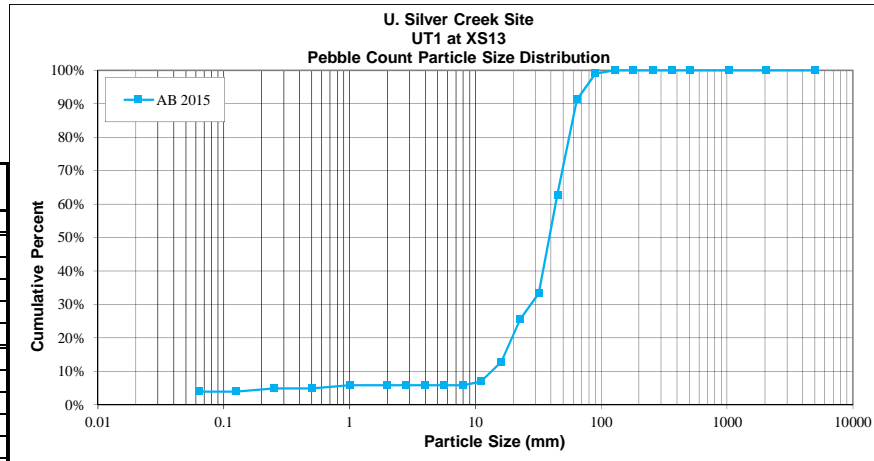
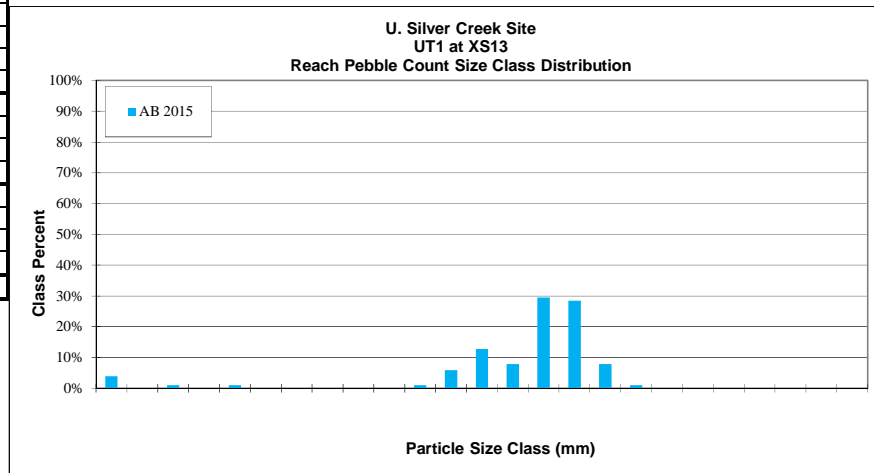
Cross-Section Pebble Count; As-built Survey  
 U. Silver Creek Mitigation Project, DMS# 94645

SITE OR PROJECT:	U. Silver Cr
REACH/LOCATION:	UT1 XS13
FEATURE:	Riffle

Summary Data			
Channel materials			
D16 =	17.5	D84 =	58.6
D35 =	32.6	D95 =	75.6
D50 =	38.8	D100 =	90 - 128

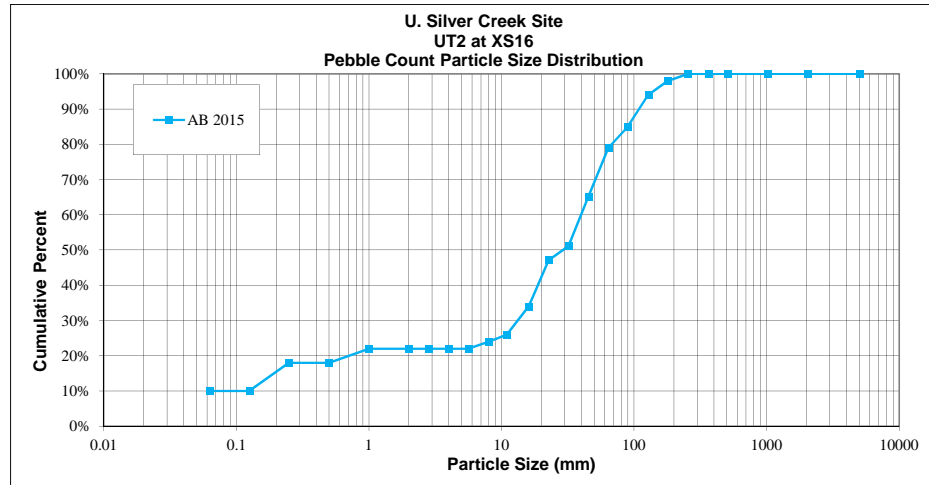
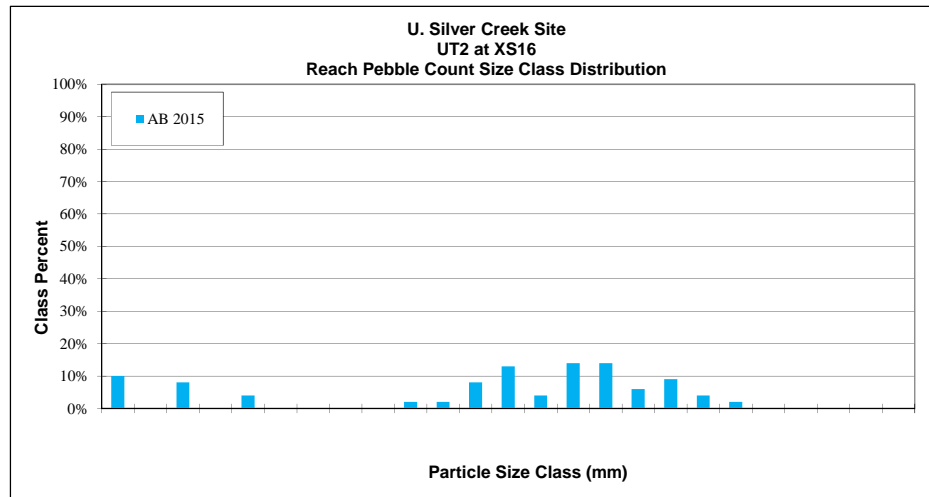
Cross-Section Pebble Count; As-built Survey  
 U. Silver Creek Mitigation Project, DMS# 94645

SITE OR PROJECT:	U. Silver Cr
REACH/LOCATION:	UT2 XS16
FEATURE:	Riffle

Summary Data			
Channel materials			
D16 =	0.2	D84 =	85.0
D35 =	16.4	D95 =	139.4
D50 =	29.3	D100 =	180 - 256

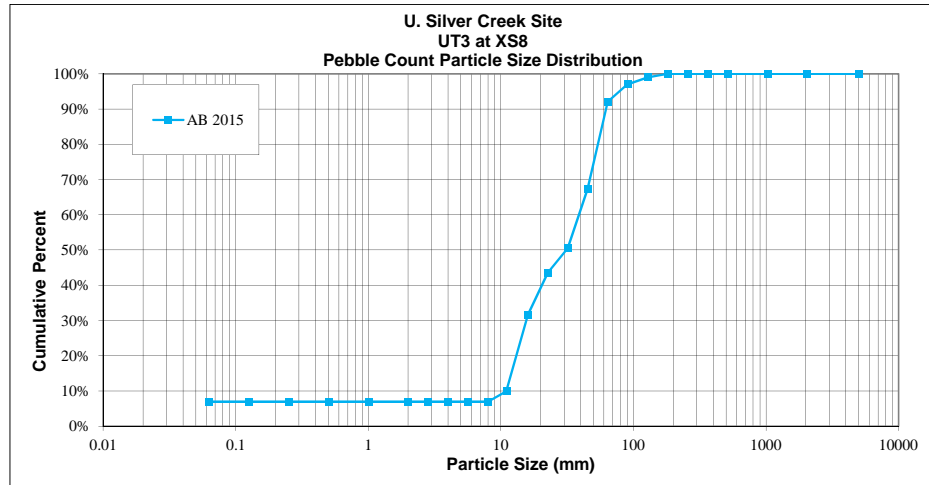
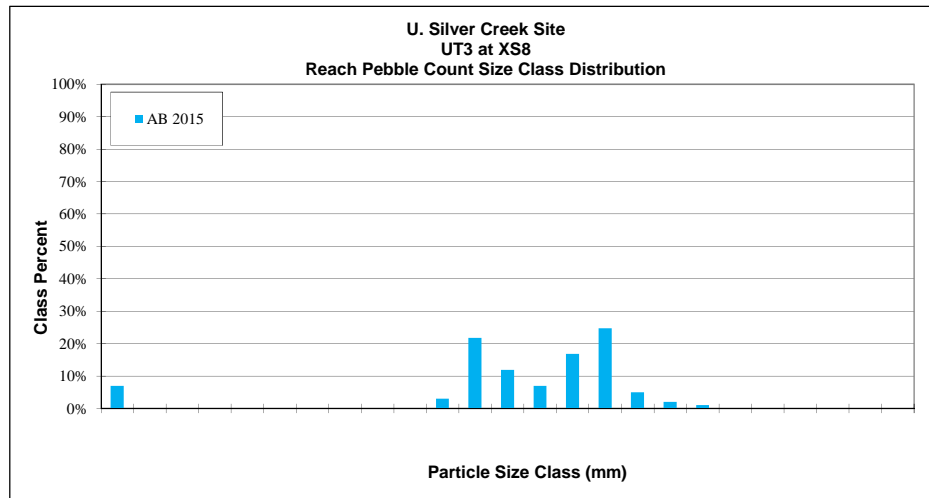
Cross-Section Pebble Count; As-built Survey  
 U. Silver Creek Mitigation Project, DMS# 94645

SITE OR PROJECT:	U. Silver Cr
REACH/LOCATION:	UT3 XS8
FEATURE:	Riffle

Summary Data			
Channel materials			
D16 =	12.2	D84 =	57.0
D35 =	17.6	D95 =	78.3
D50 =	31.2	D100 =	128 - 180

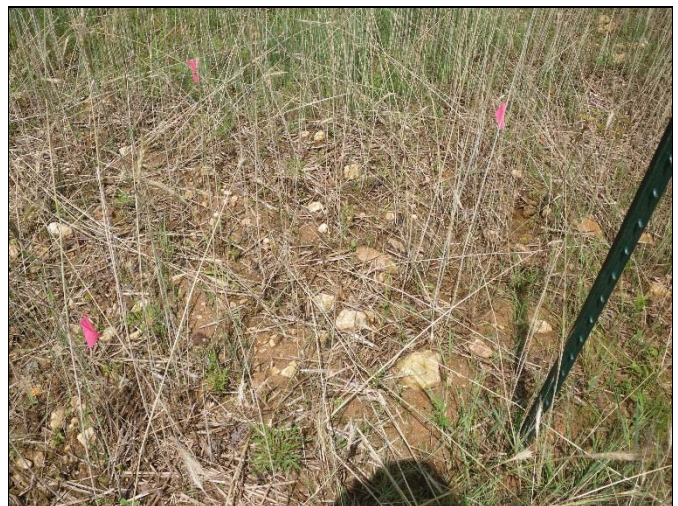
Photo 12. Vegetation Plot 6 – Herbaceous photo.

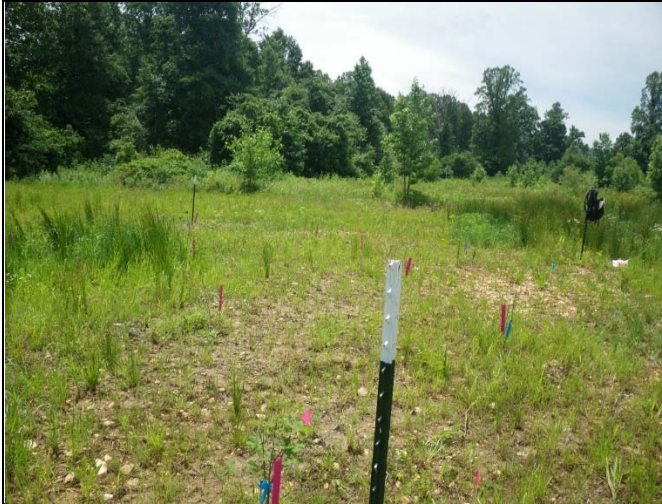
Photo 13. Vegetation Plot 7 – Tree photo.

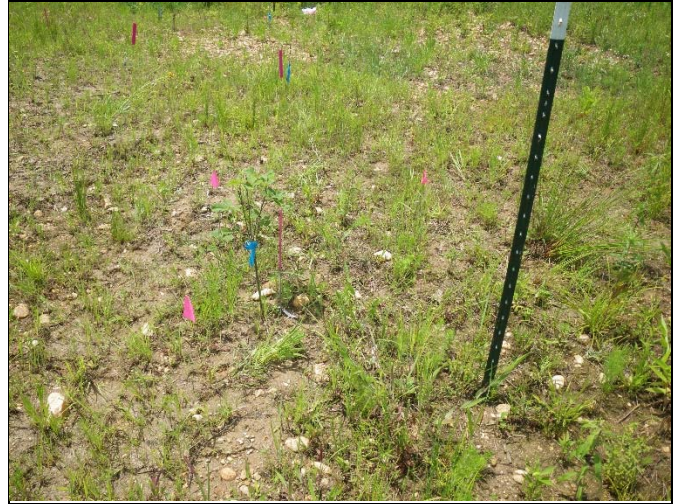
Photo 14. Vegetation Plot 7 – Herbaceous photo.

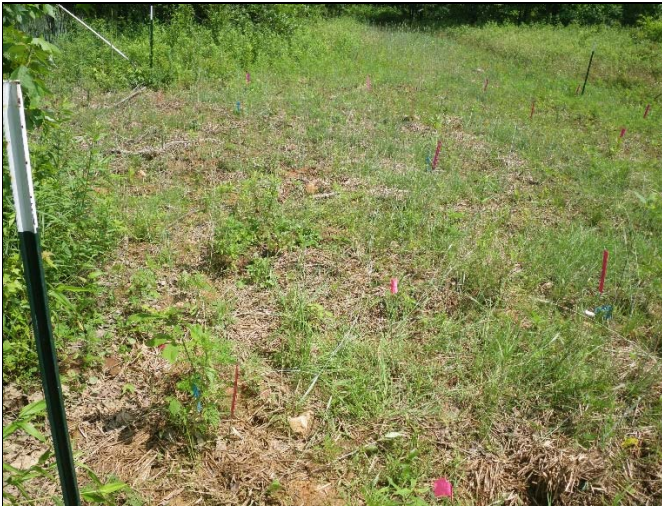
Photo 15. Vegetation Plot 8 – Tree photo.

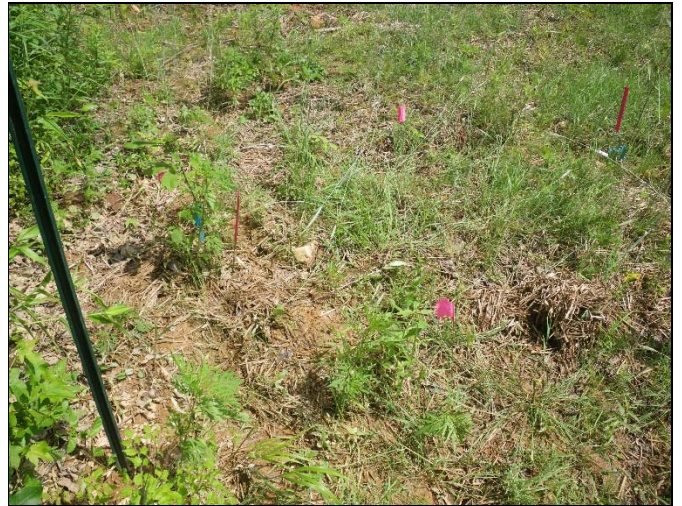
Photo 16. Vegetation Plot 8 – Herbaceous photo.

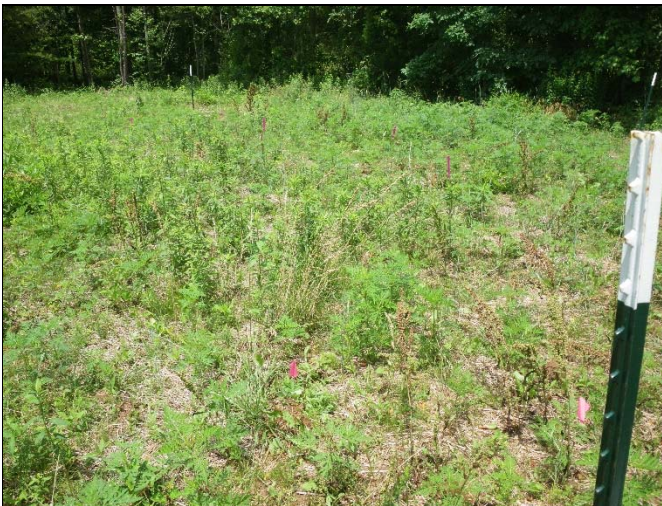
Photo 17. Vegetation Plot 9 – Tree photo.

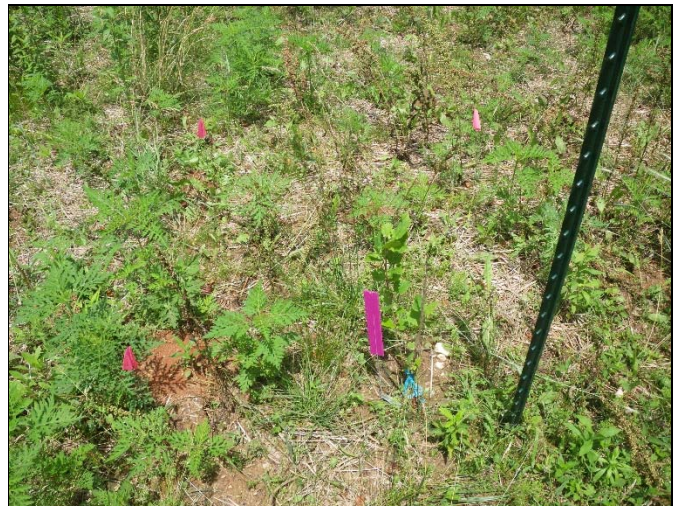
Photo 18. Vegetation Plot 9 – Herbaceous photo.

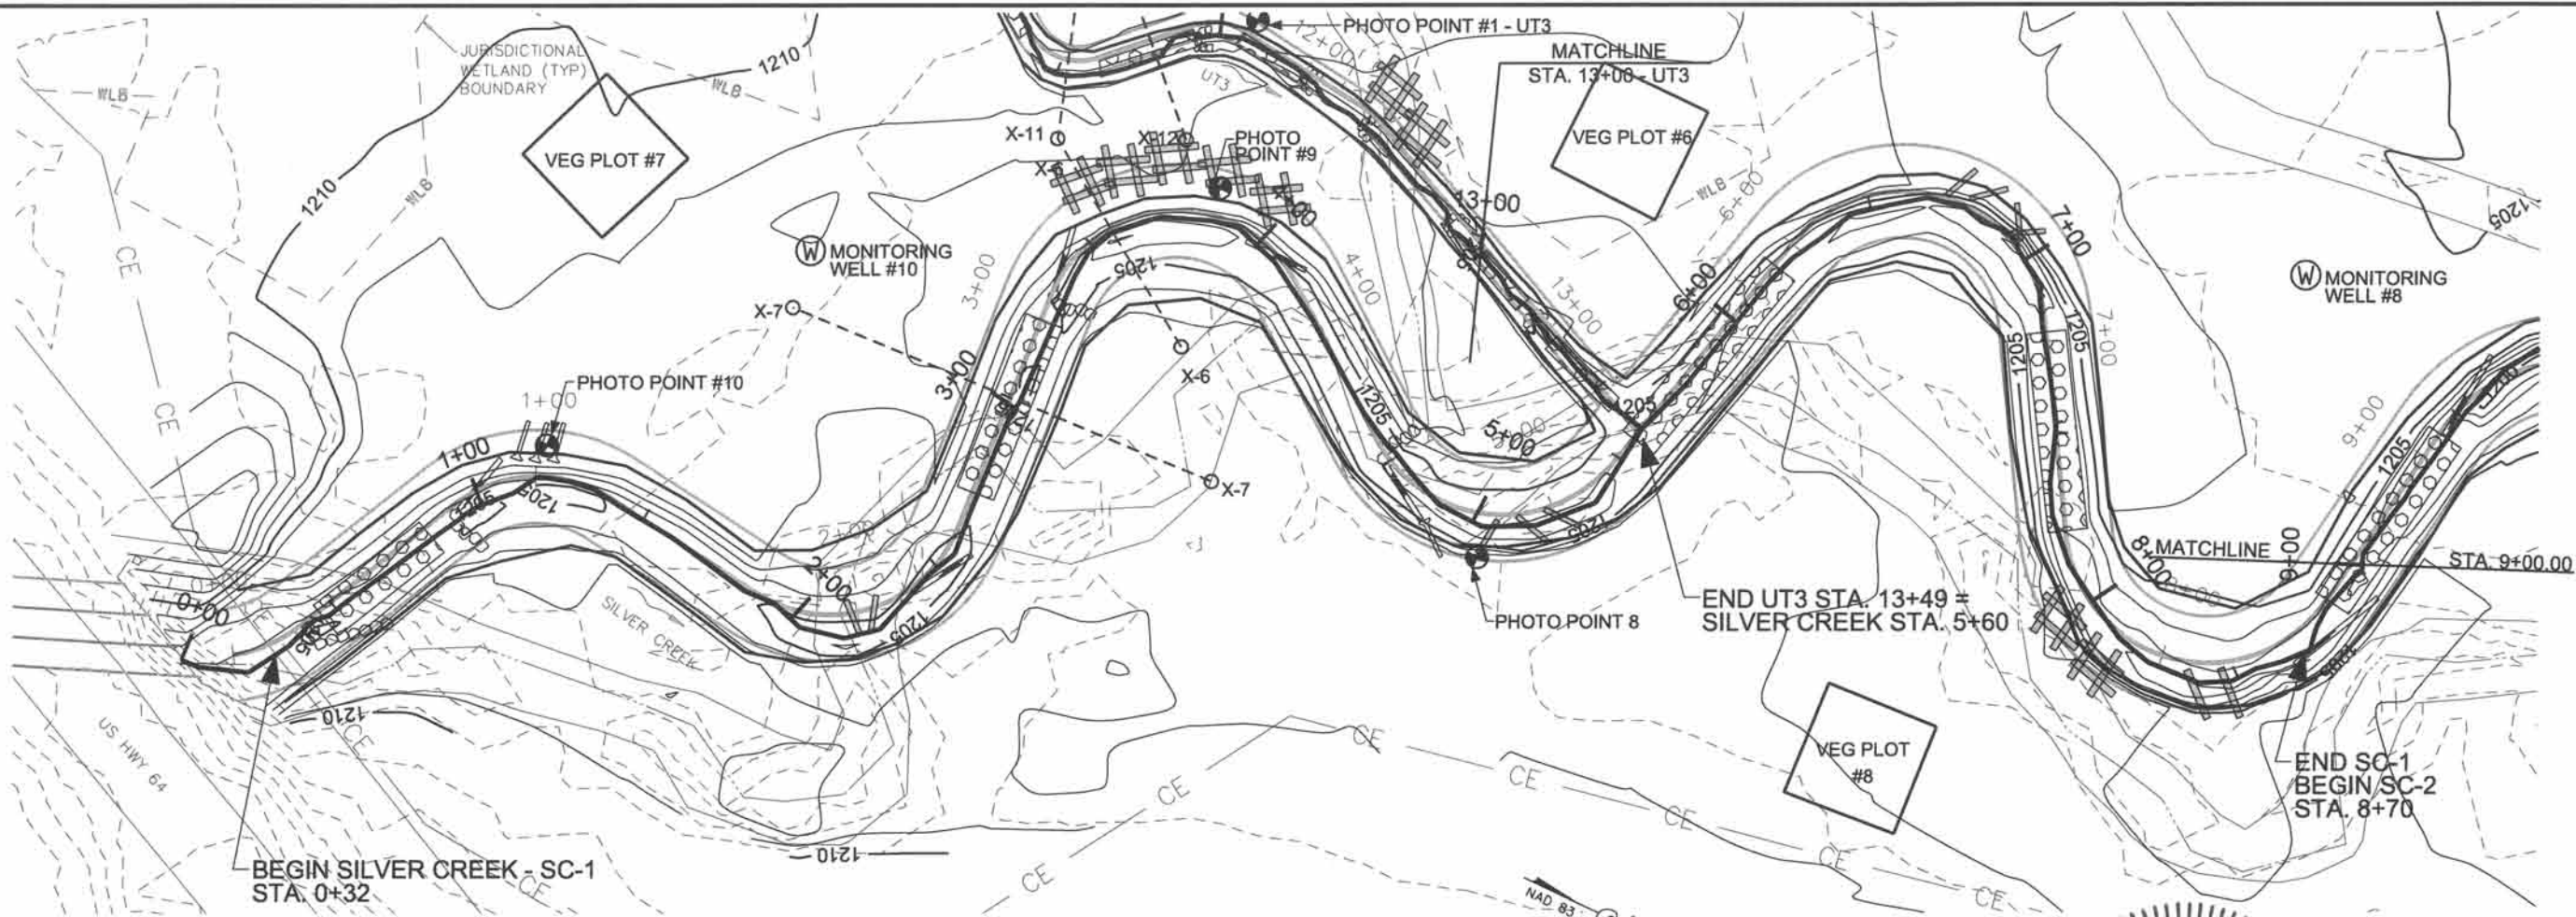
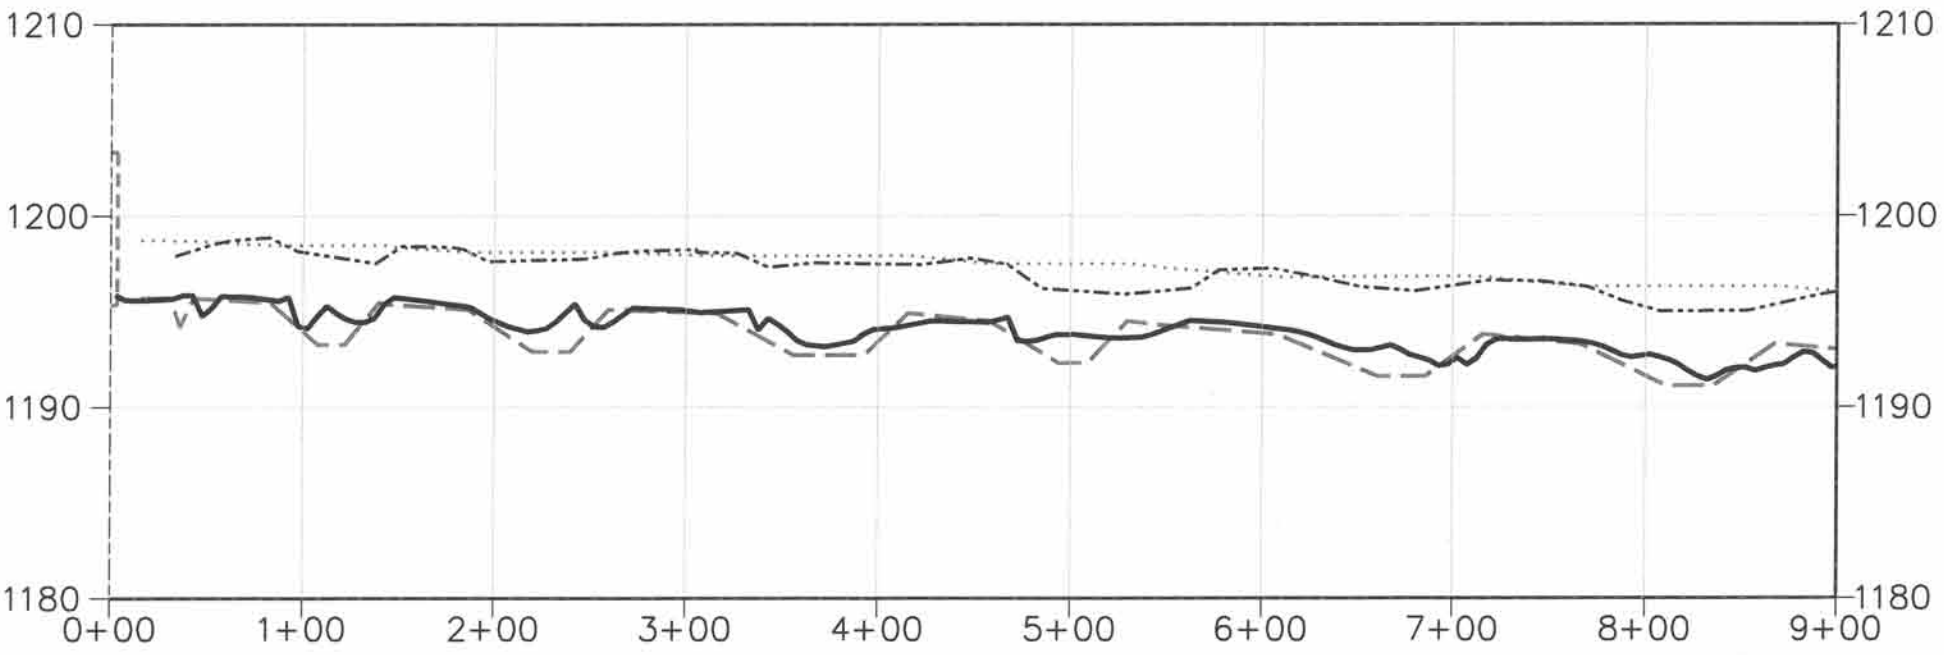
LEGEND OF PROFILES

- - - - - PROPOSED THALWEG  
 . . . . . PROPOSED LOW BANK  
 \_\_\_\_\_ AS-BUILT THALWEG  
 - . - . - . AS-BUILT LOW BANK

PROFILE SCALE  
 HORIZONTAL: 1"=100'  
 VERTICAL: 1"=10'
