# **Baseline Monitoring Document and As-Built Baseline Report Upper Silver Creek Stream and Wetland Restoration Project**

**Burke County, North Carolina**

DMS Project ID No. 94645

**Michael Baker**

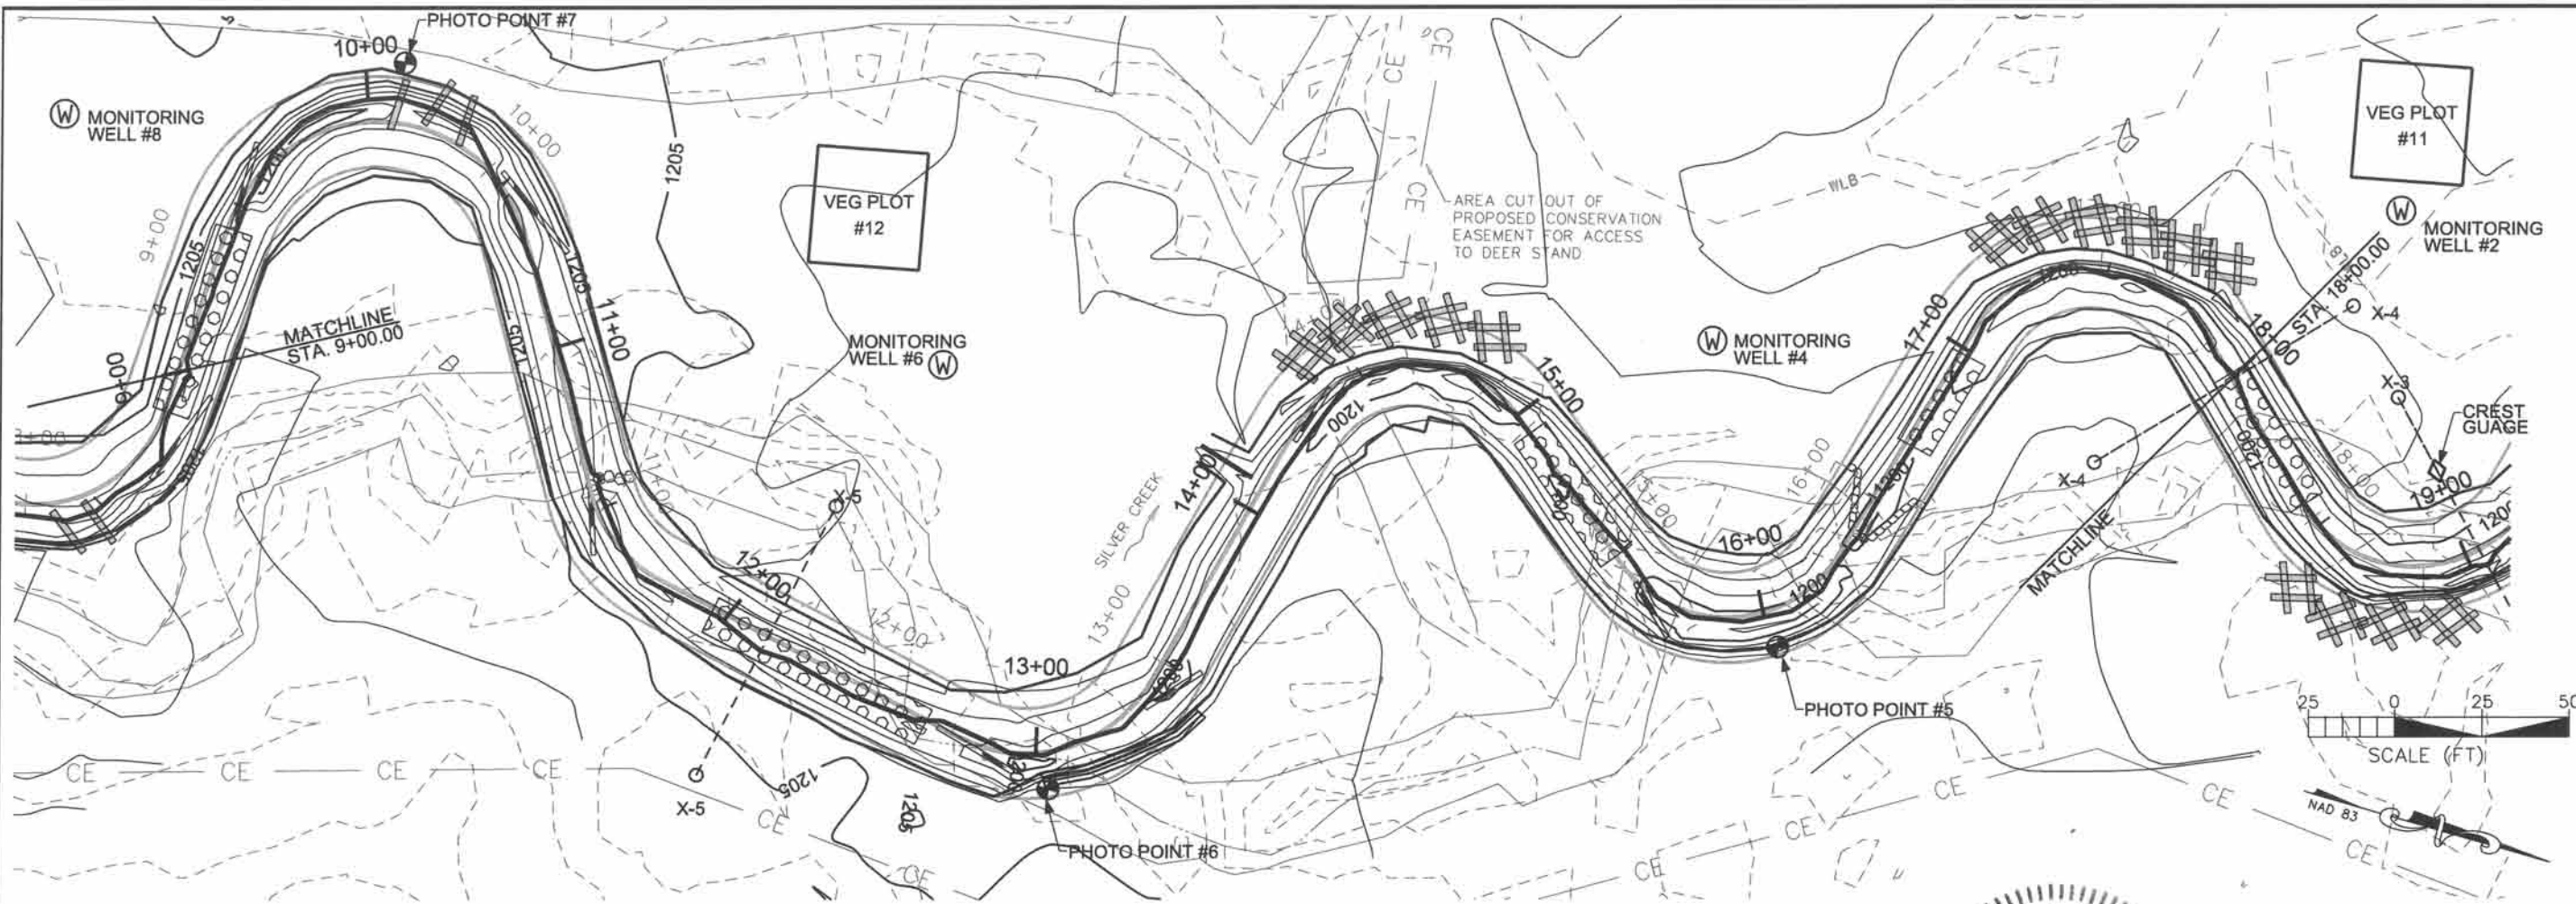
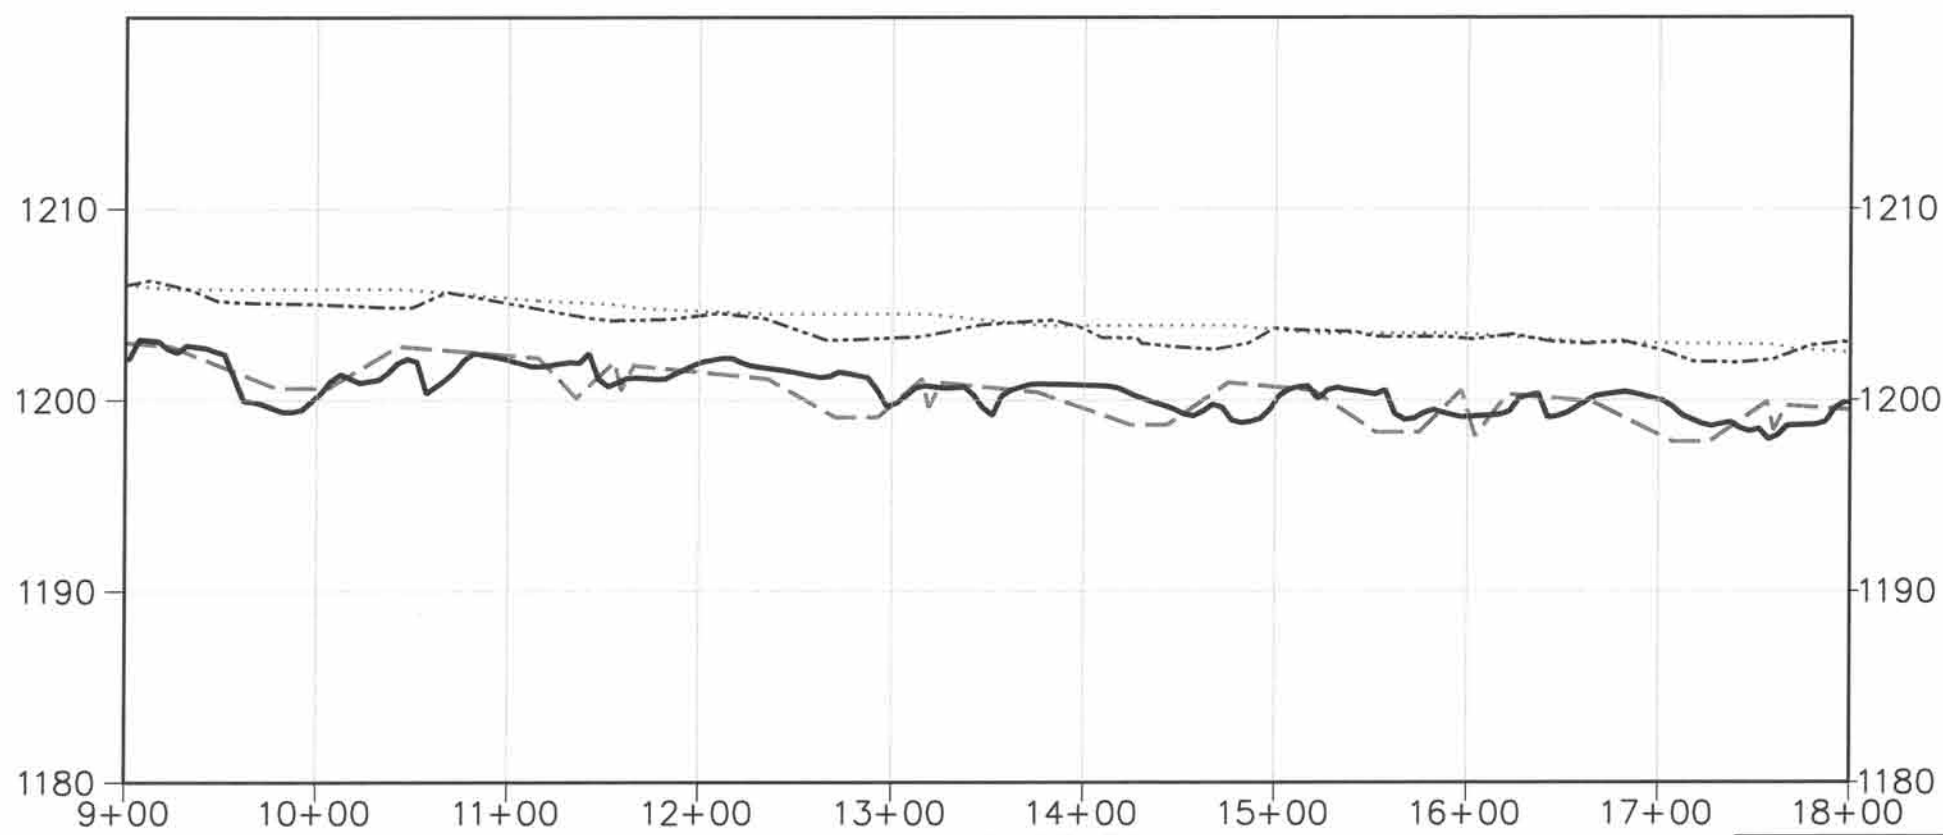
LEGEND OF PROFILES

- - - - - PROPOSED THALWEG      - - - - - AS-BUILT THALWEG  
 ..... PROPOSED LOW BANK      - · - · - AS-BUILT LOW BANK

PROFILE SCALE  
 HORIZONTAL: 1"=100'  
 VERTICAL: 1"=10'

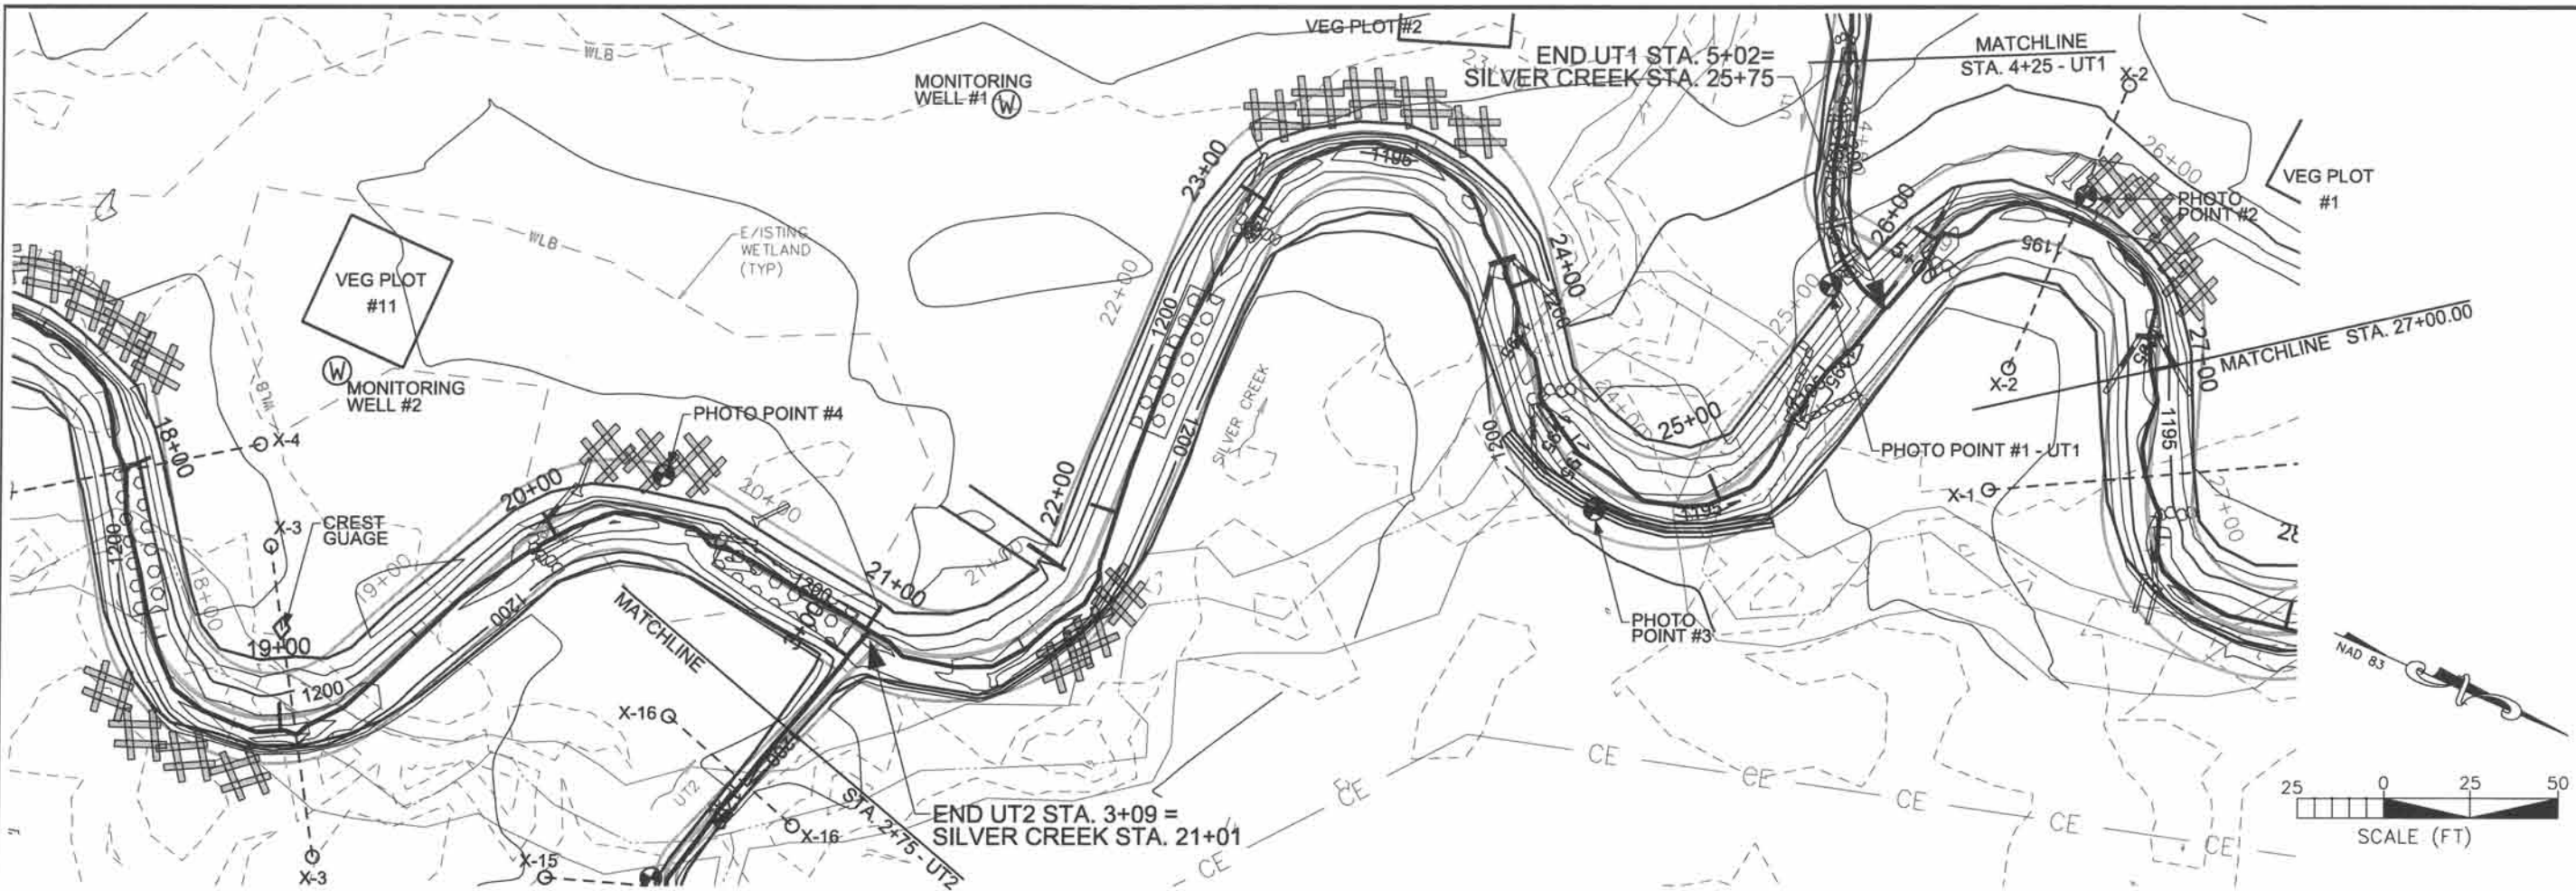
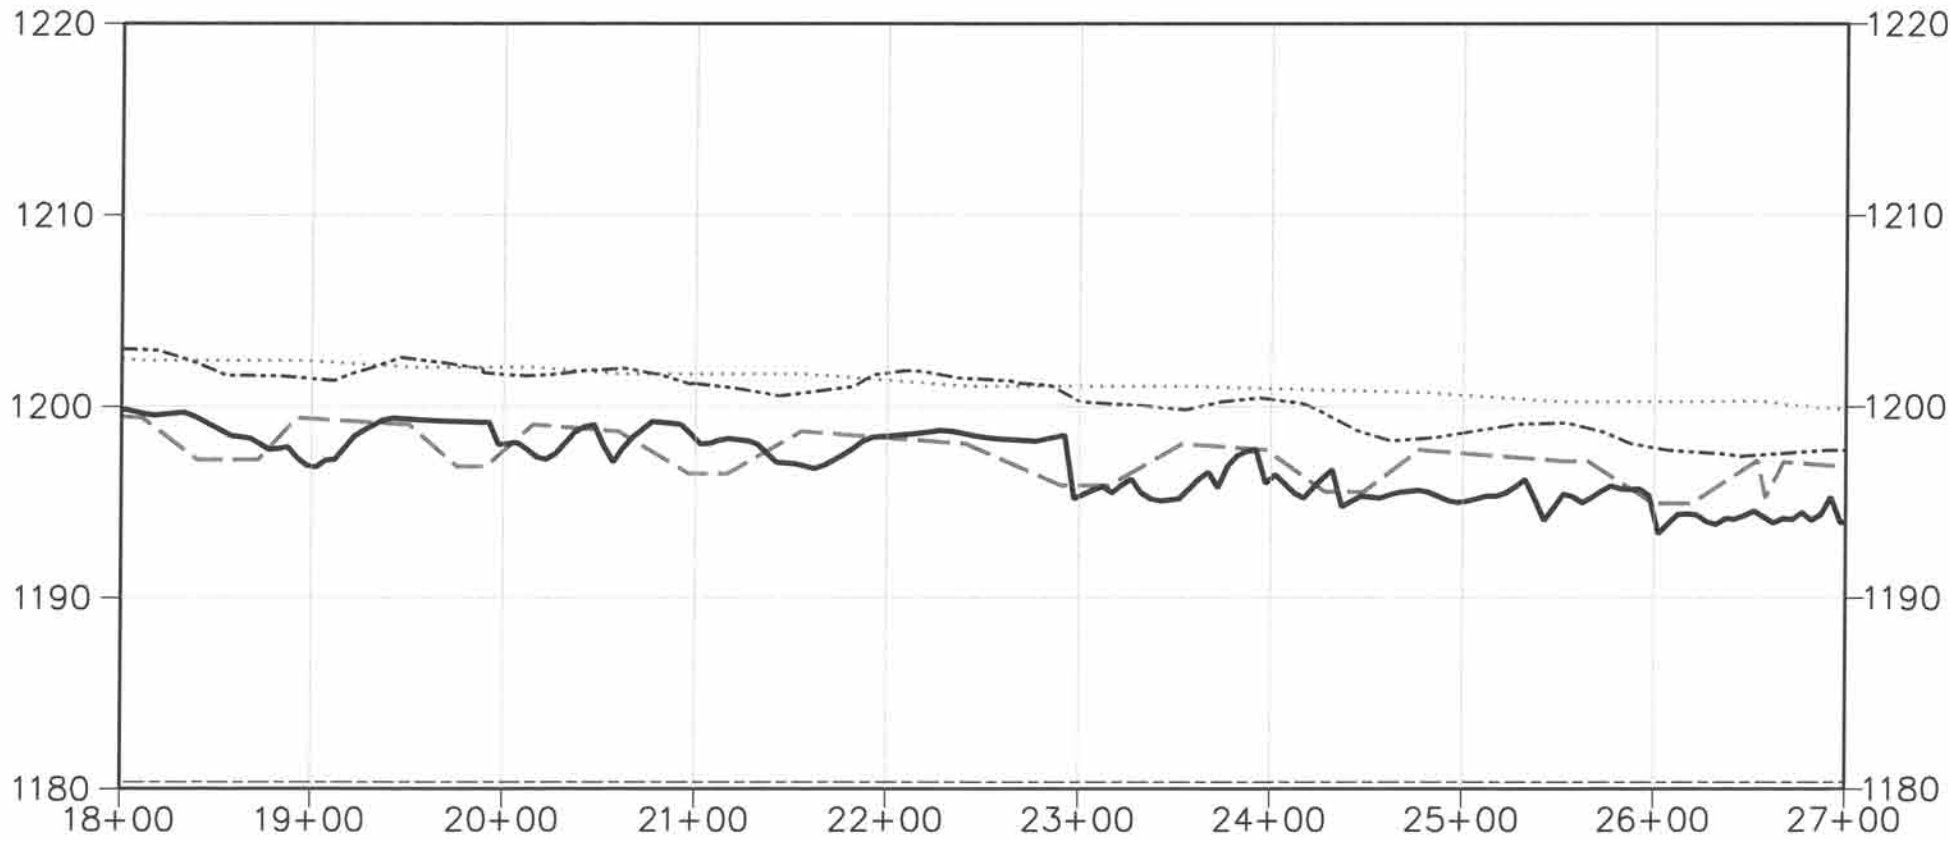
LEGEND OF PROFILES

- - - - - PROPOSED THALWEG      - - - - - AS-BUILT THALWEG  
 ..... PROPOSED LOW BANK      - · - · - AS-BUILT LOW BANK

PROFILE SCALE  
 HORIZONTAL: 1"=100'  
 VERTICAL: 1"=10'

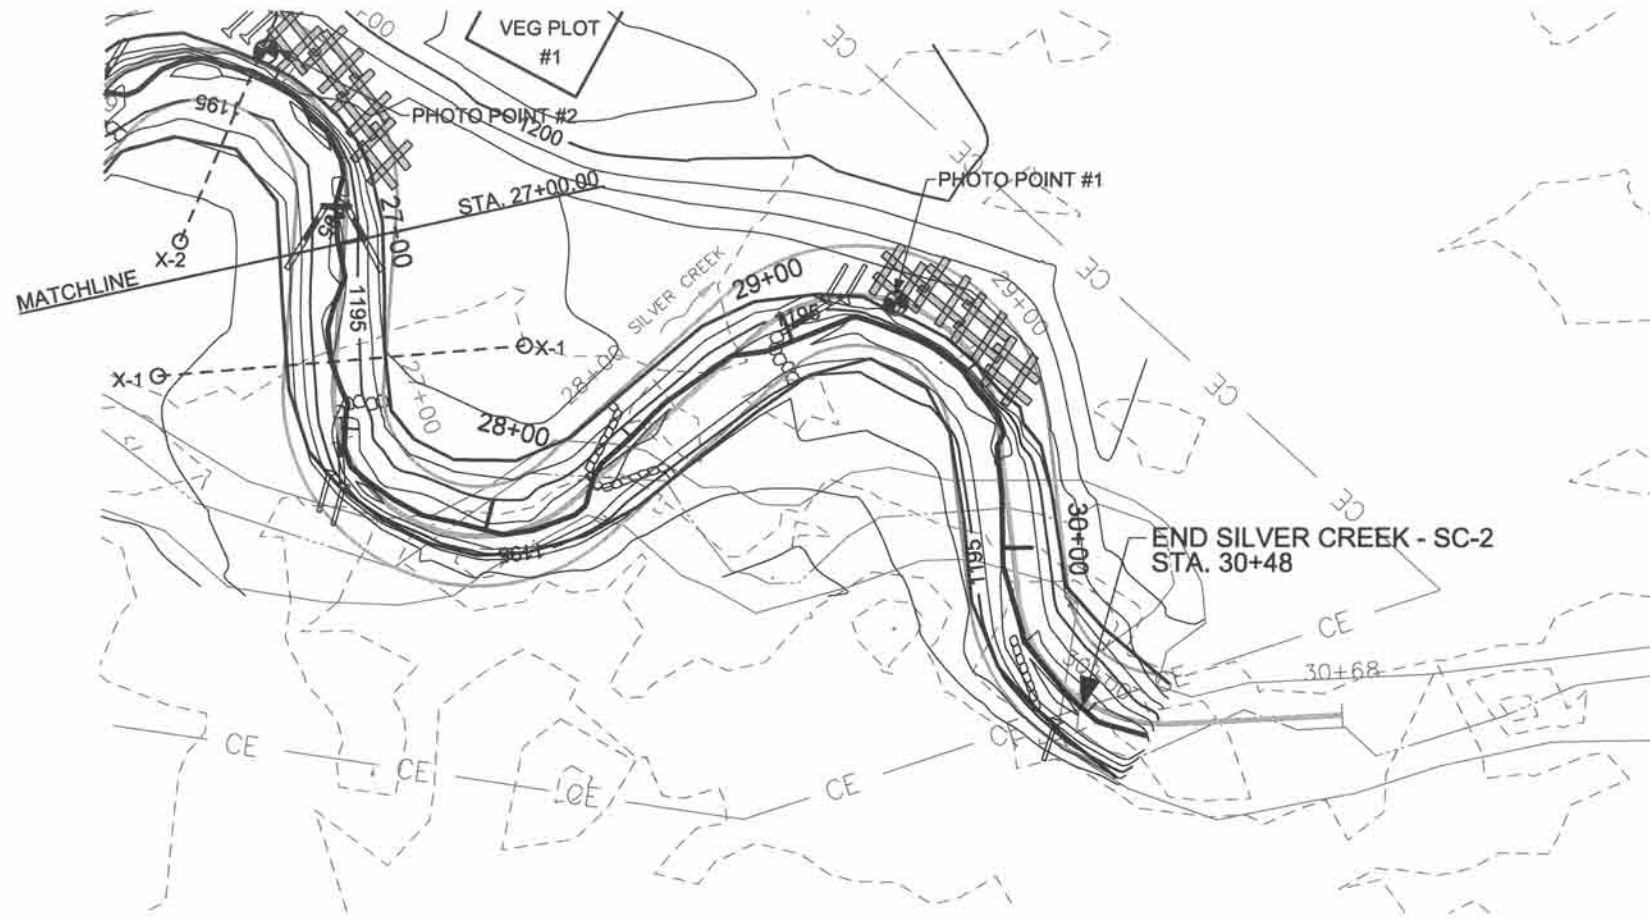
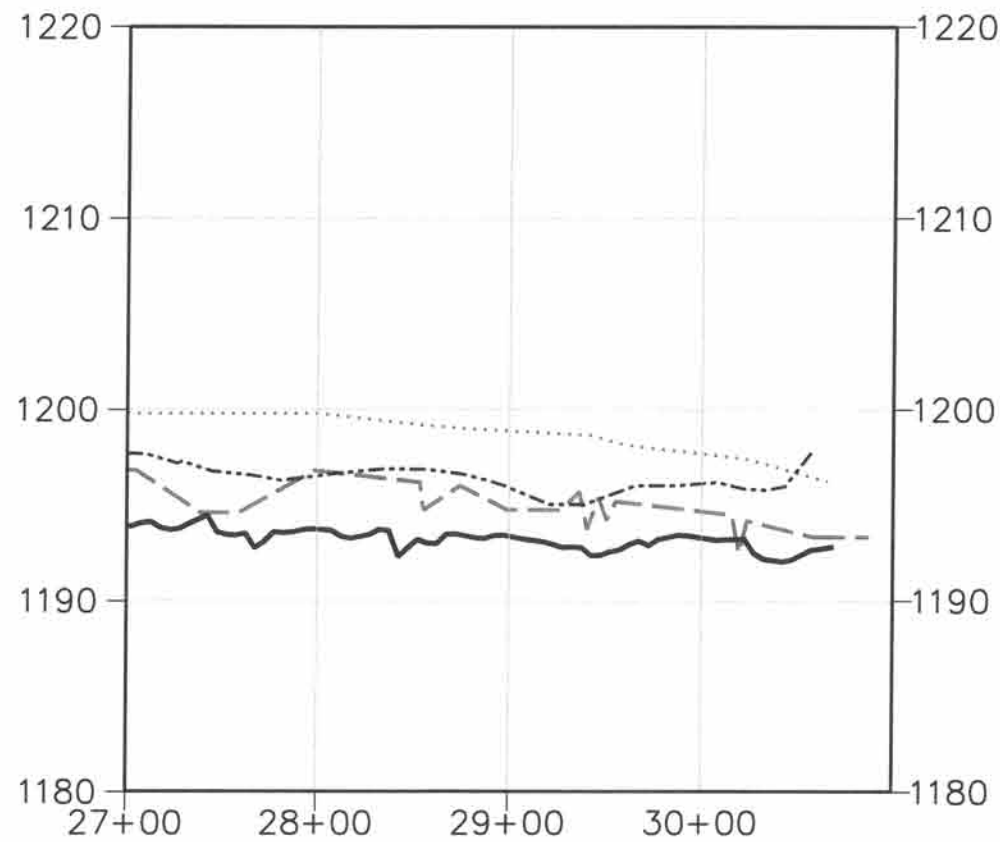
PROFILE SCALE  
 HORIZONTAL: 1"=100'  
 VERTICAL: 1"=10'

- LEGEND OF PROFILES
- PROPOSED THALWEG
  - ..... PROPOSED LOW BANK
  - AS-BUILT THALWEG
  - · - · - AS-BUILT LOW BANK

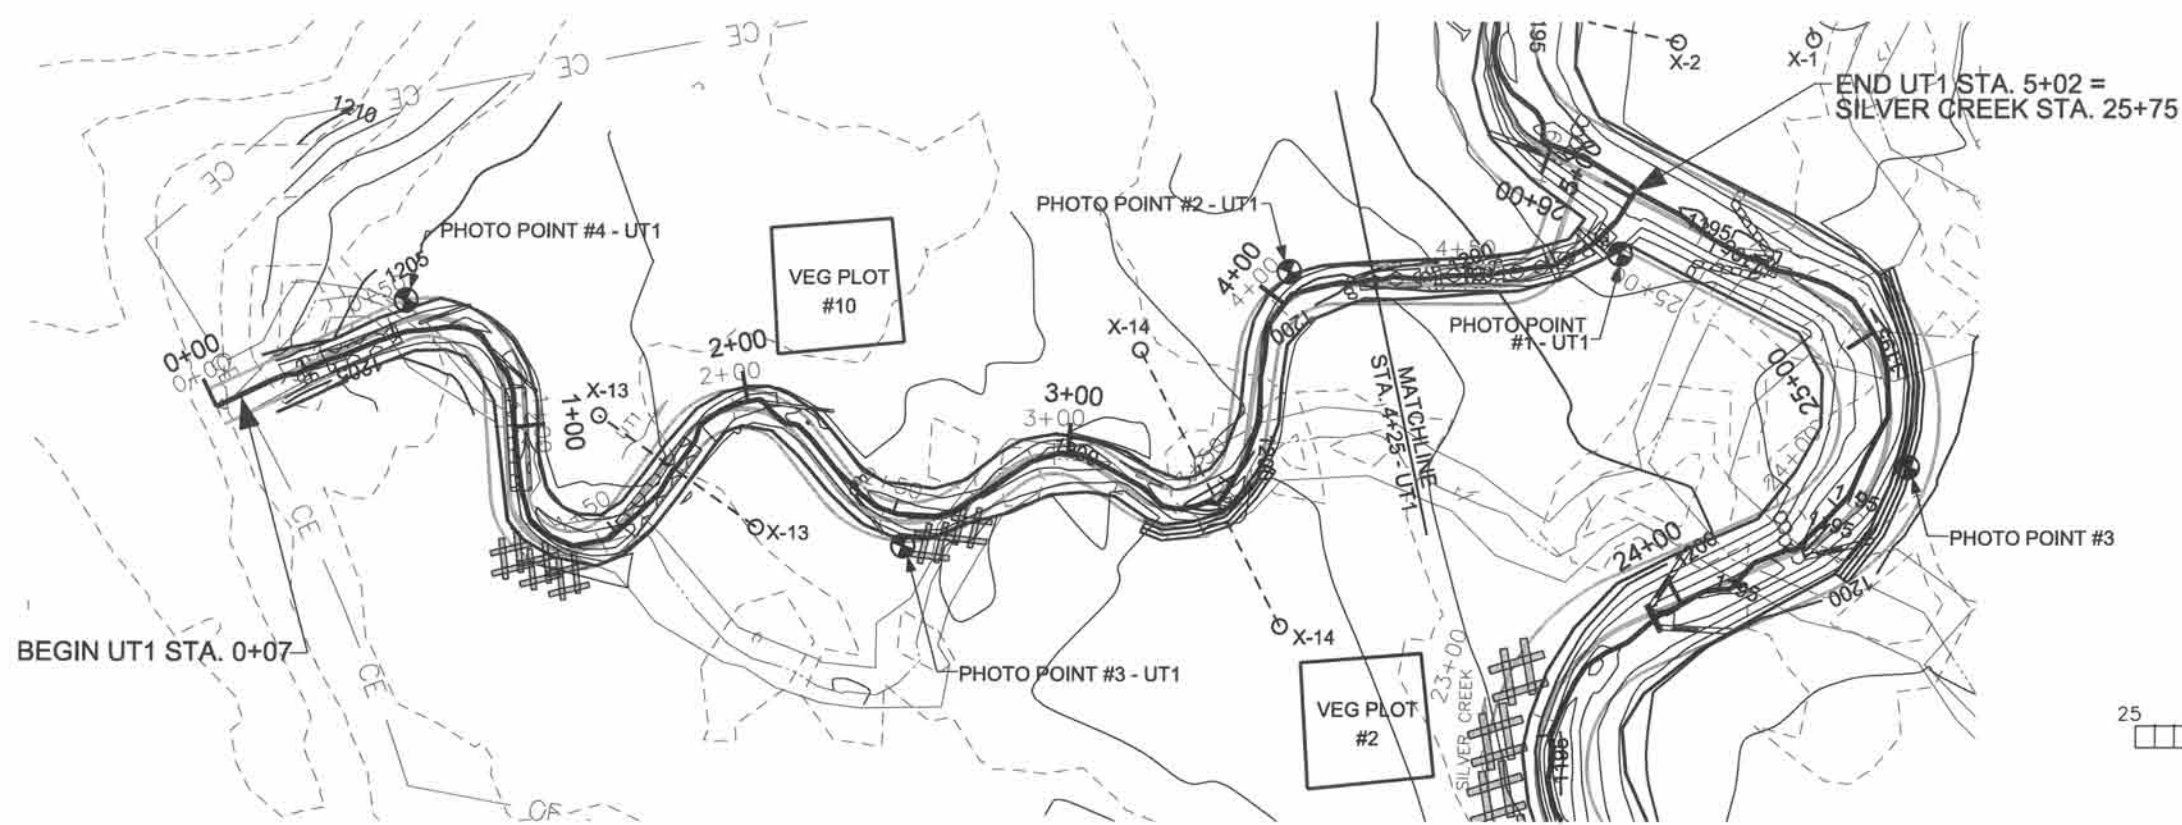
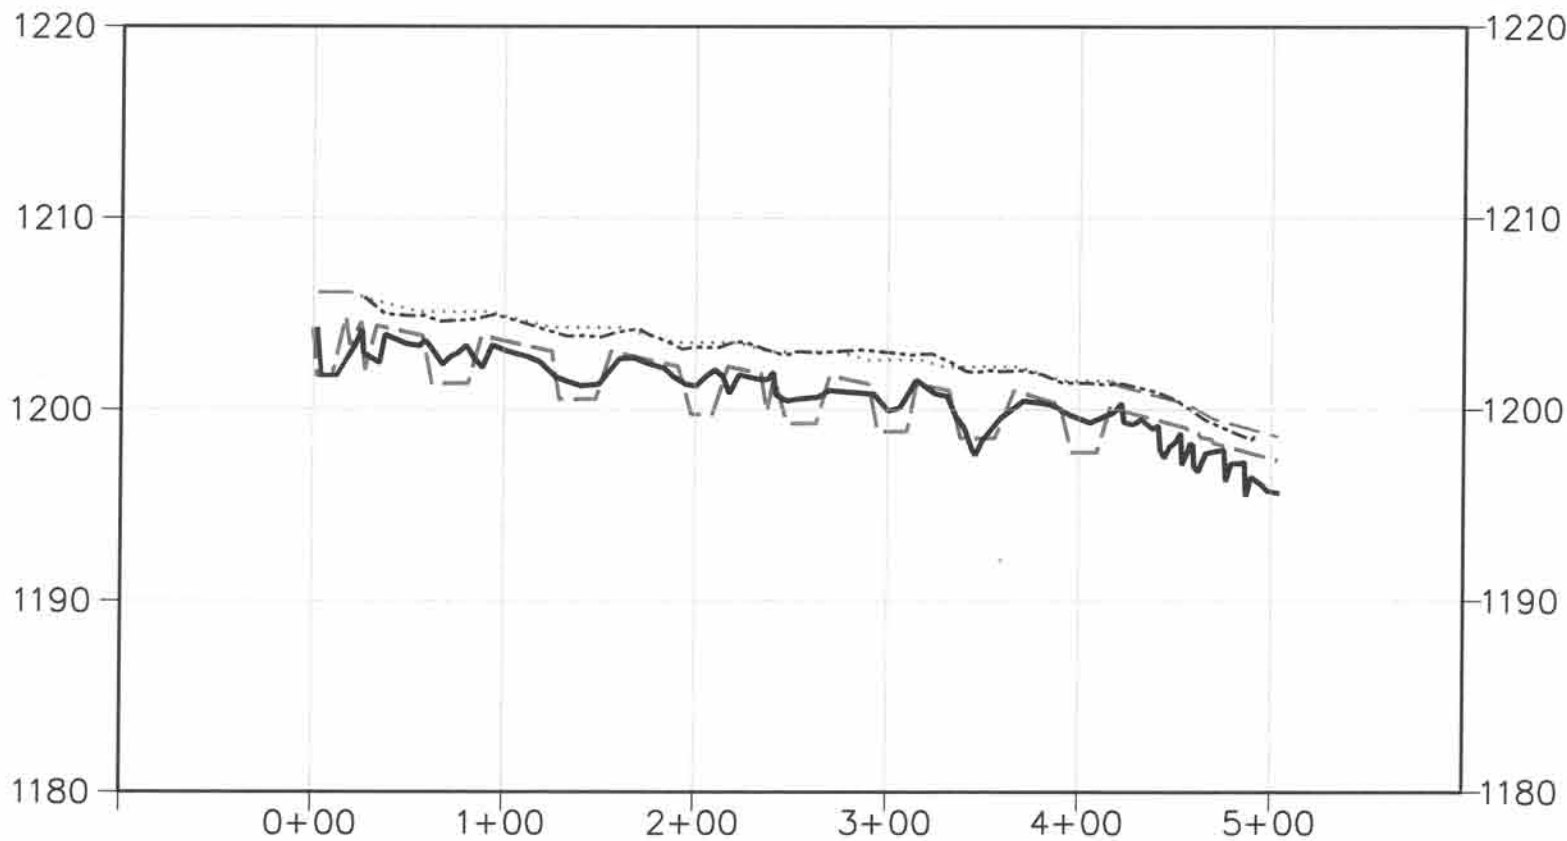
LEGEND OF PROFILES

- PROPOSED THALWEG
- PROPOSED LOW BANK
- \_\_\_\_\_ AS-BUILT THALWEG
- AS-BUILT LOW BANK

PROFILE SCALE  
HORIZONTAL: 1"=100'  
VERTICAL: 1"=10'

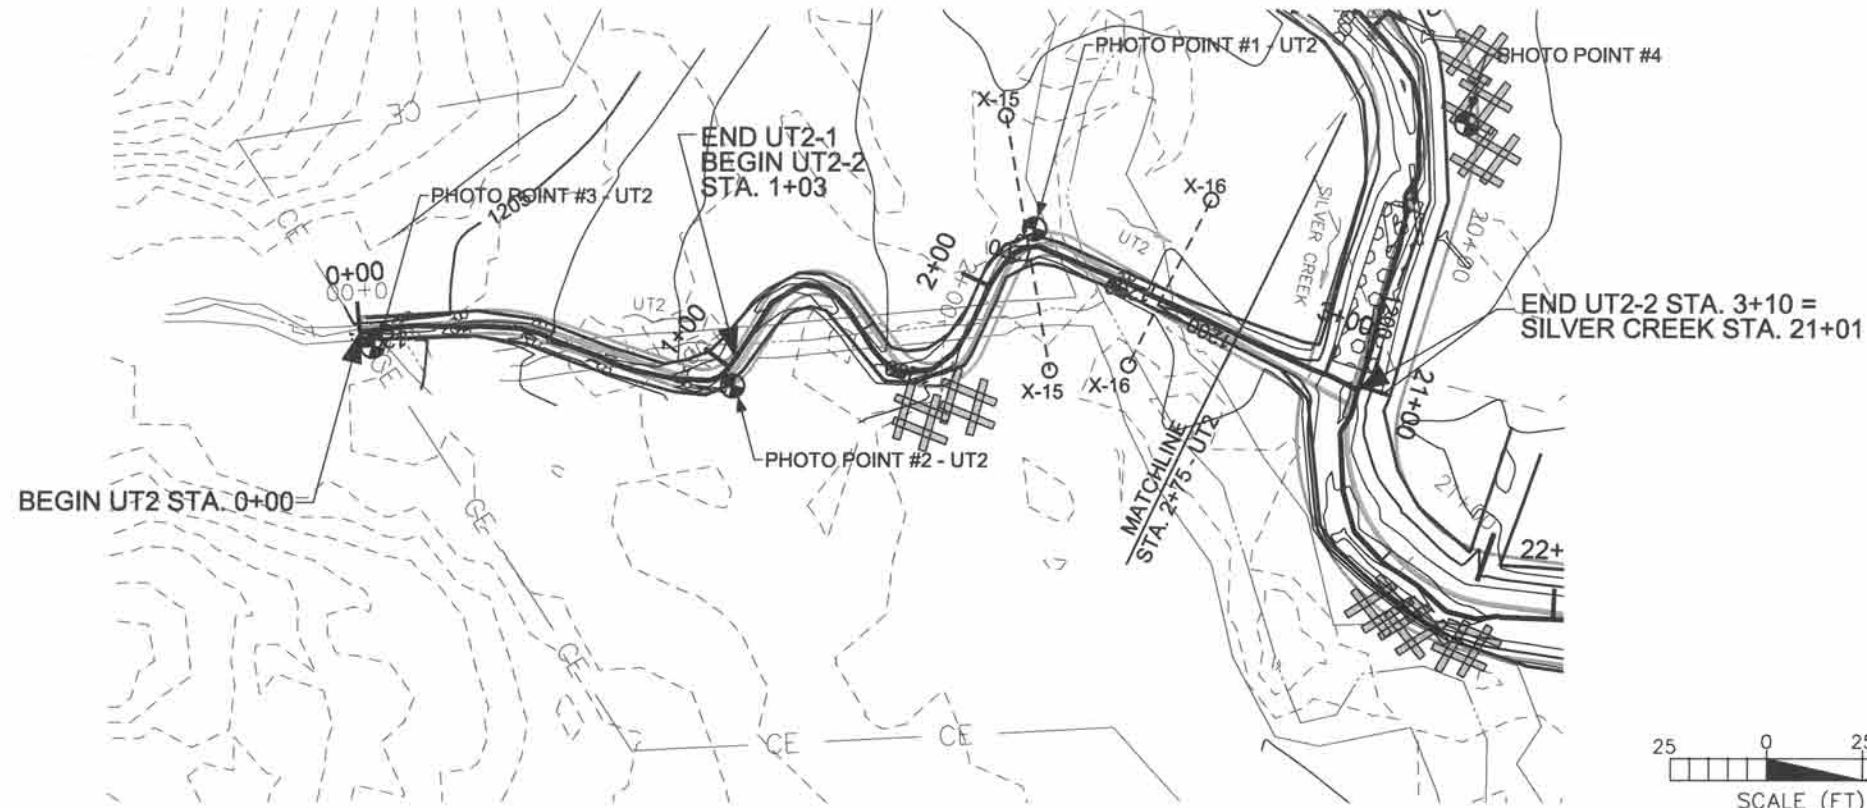
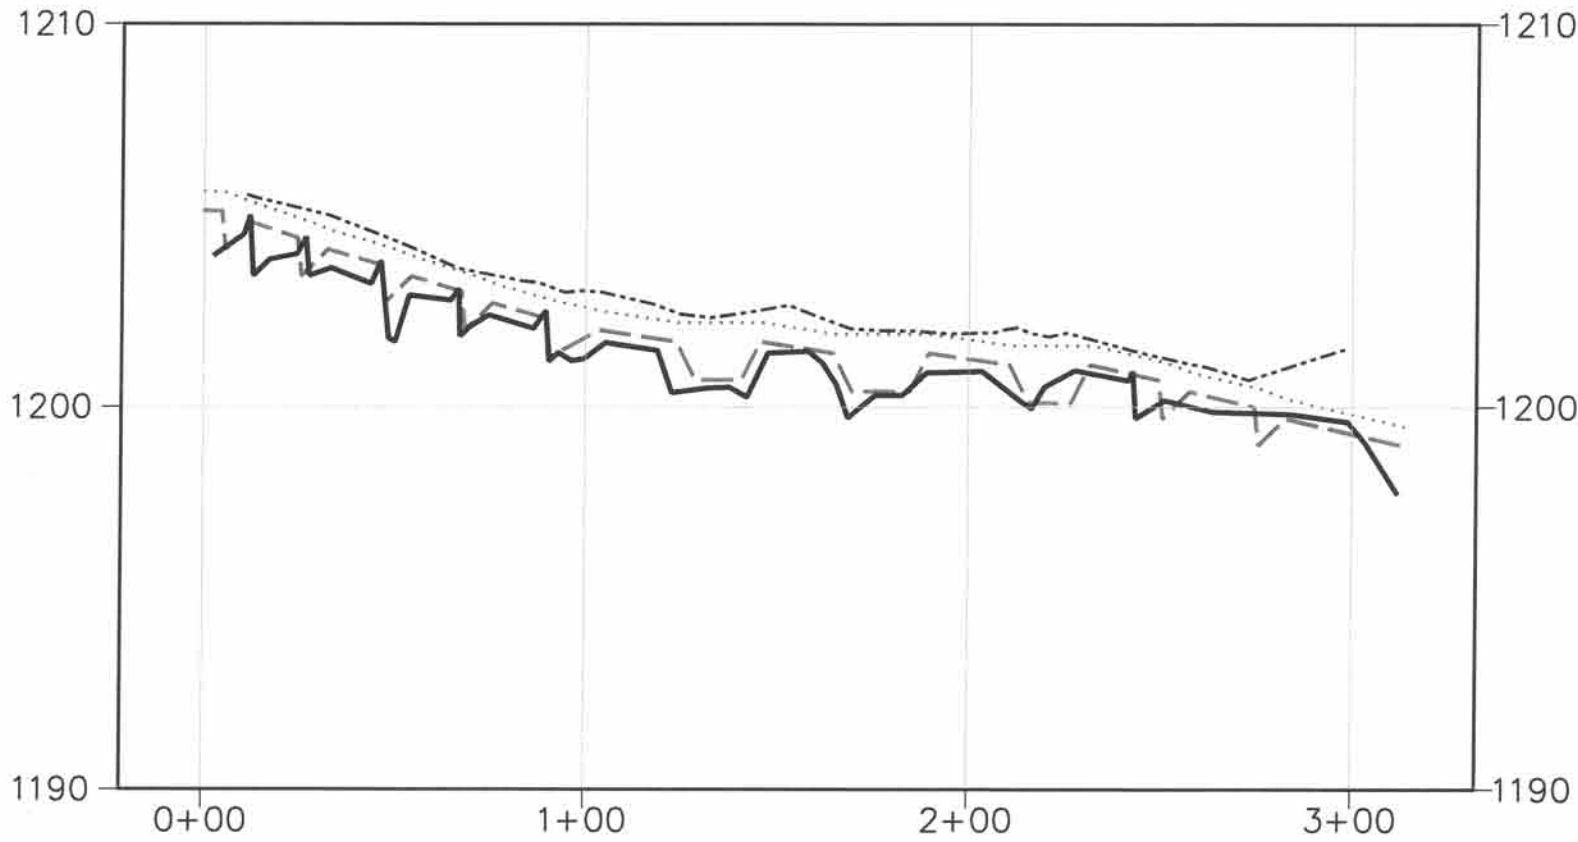
LEGEND OF PROFILES

- PROPOSED THALWEG
- PROPOSED LOW BANK
- AS-BUILT THALWEG
- AS-BUILT LOW BANK

PROFILE SCALE  
 HORIZONTAL: 1"=100'  
 VERTICAL: 1"=10'

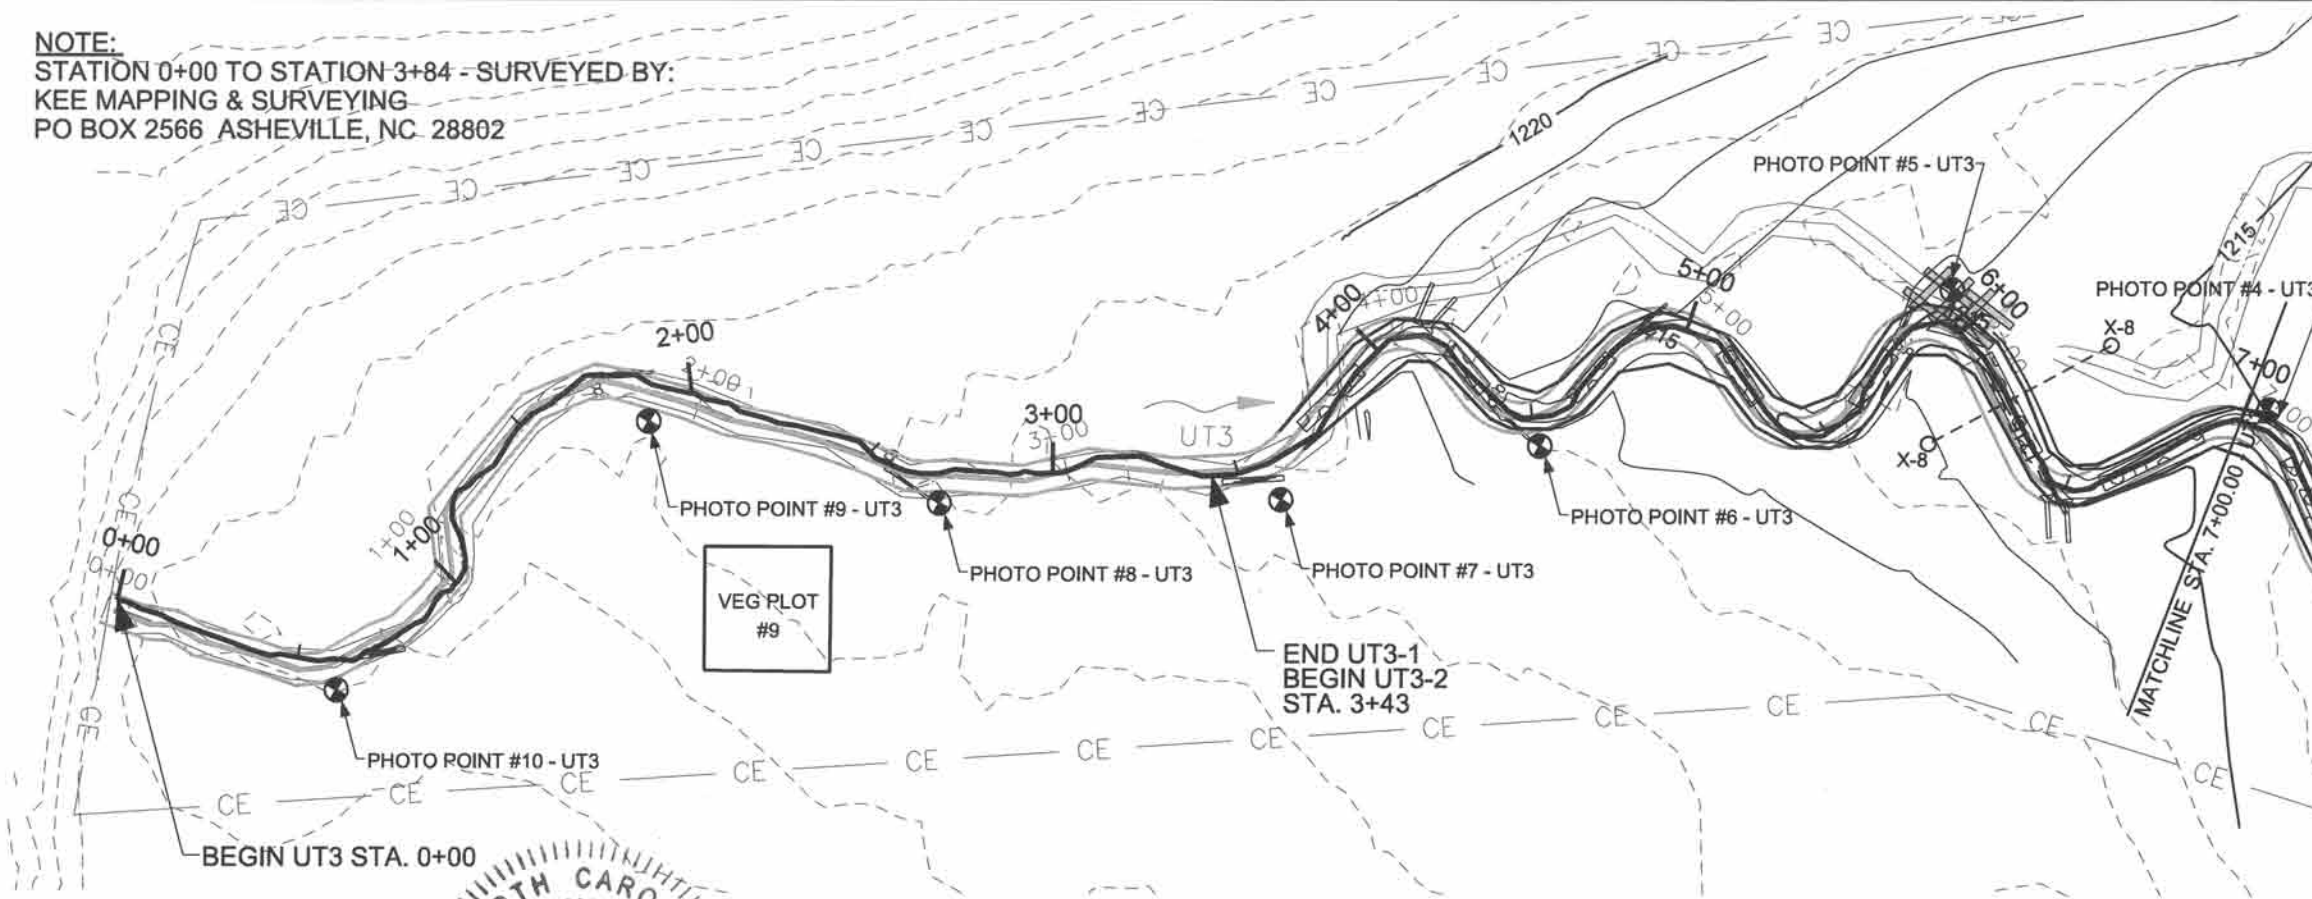
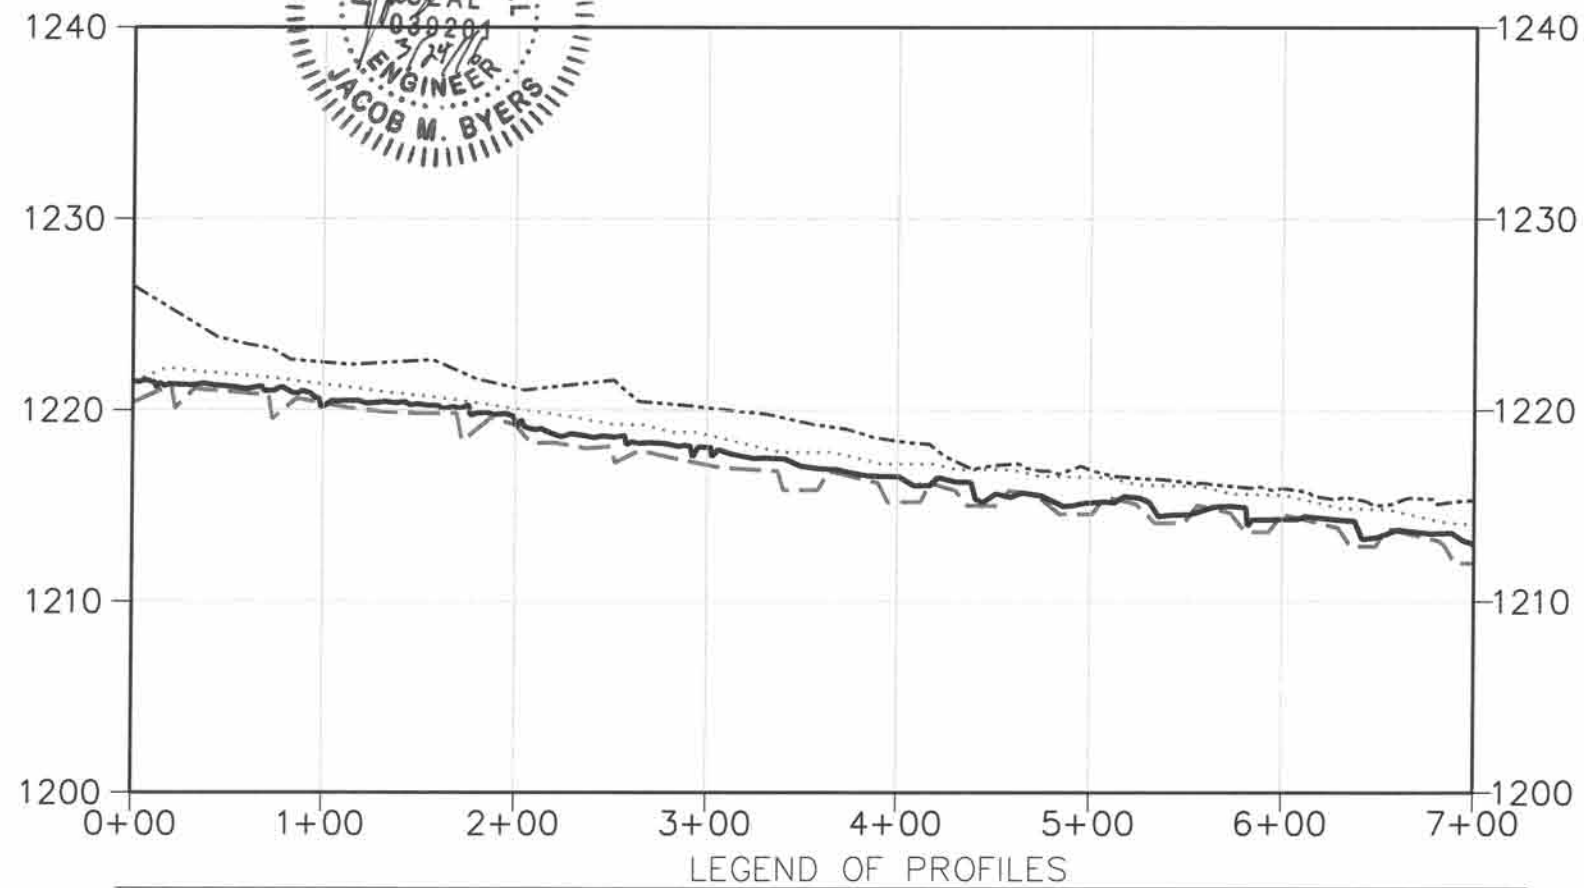
NOTE:  
STATION 0+00 TO STATION 3+84 - SURVEYED BY:  
KEE MAPPING & SURVEYING  
PO BOX 2566 ASHEVILLE, NC 28802

LEGEND OF PROFILES  
--- PROPOSED THALWEG      — AS-BUILT THALWEG  
..... PROPOSED LOW BANK      - - - AS-BUILT LOW BANK

PROFILE SCALE  
HORIZONTAL: 1"=100'  
VERTICAL: 1"=10'
