# **Baseline Monitoring Document and As-Built Baseline Report Upper Silver Creek Stream and Wetland Restoration Project**

**Burke County, North Carolina**

DMS Project ID No. 94645

**Michael Baker**

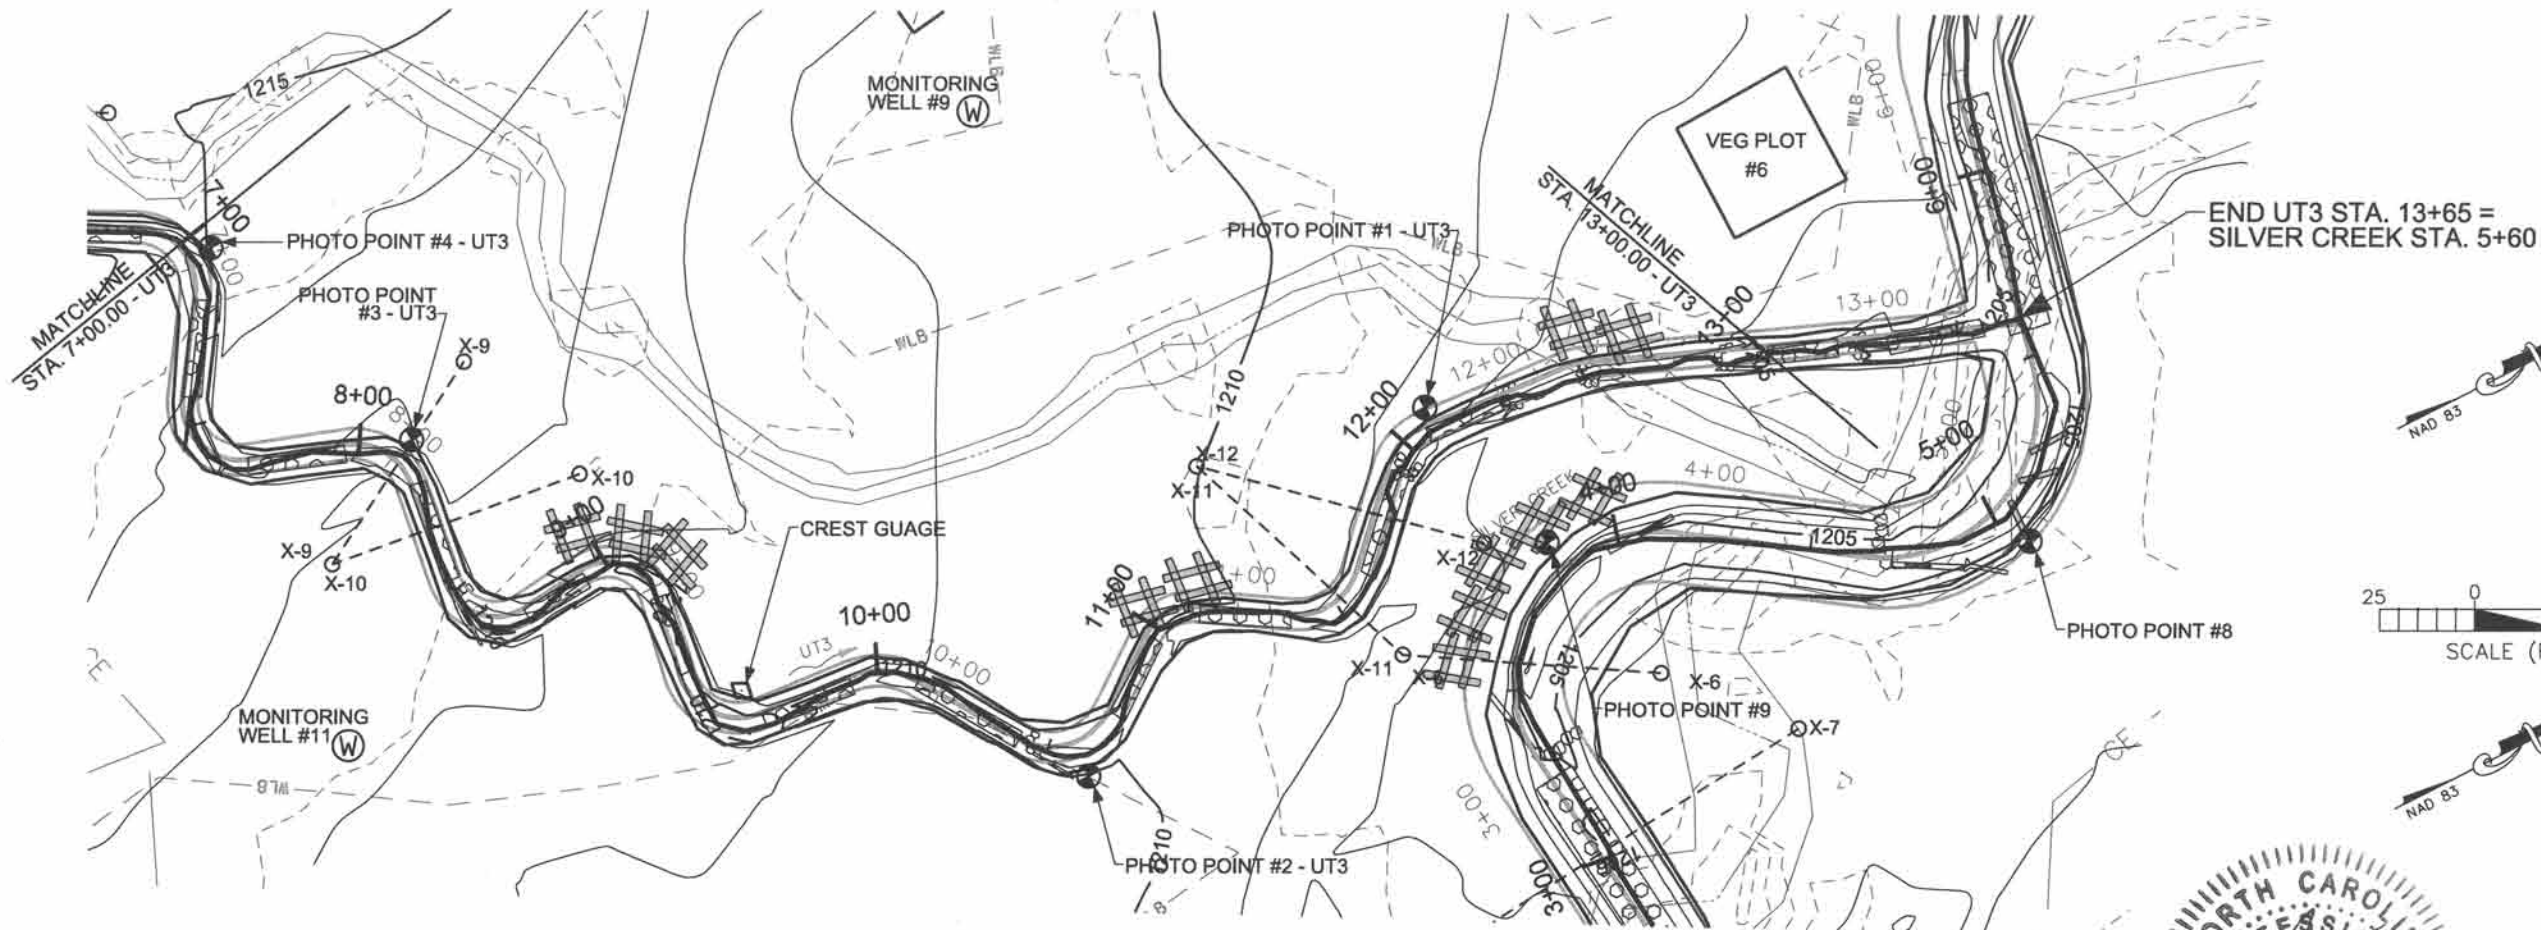
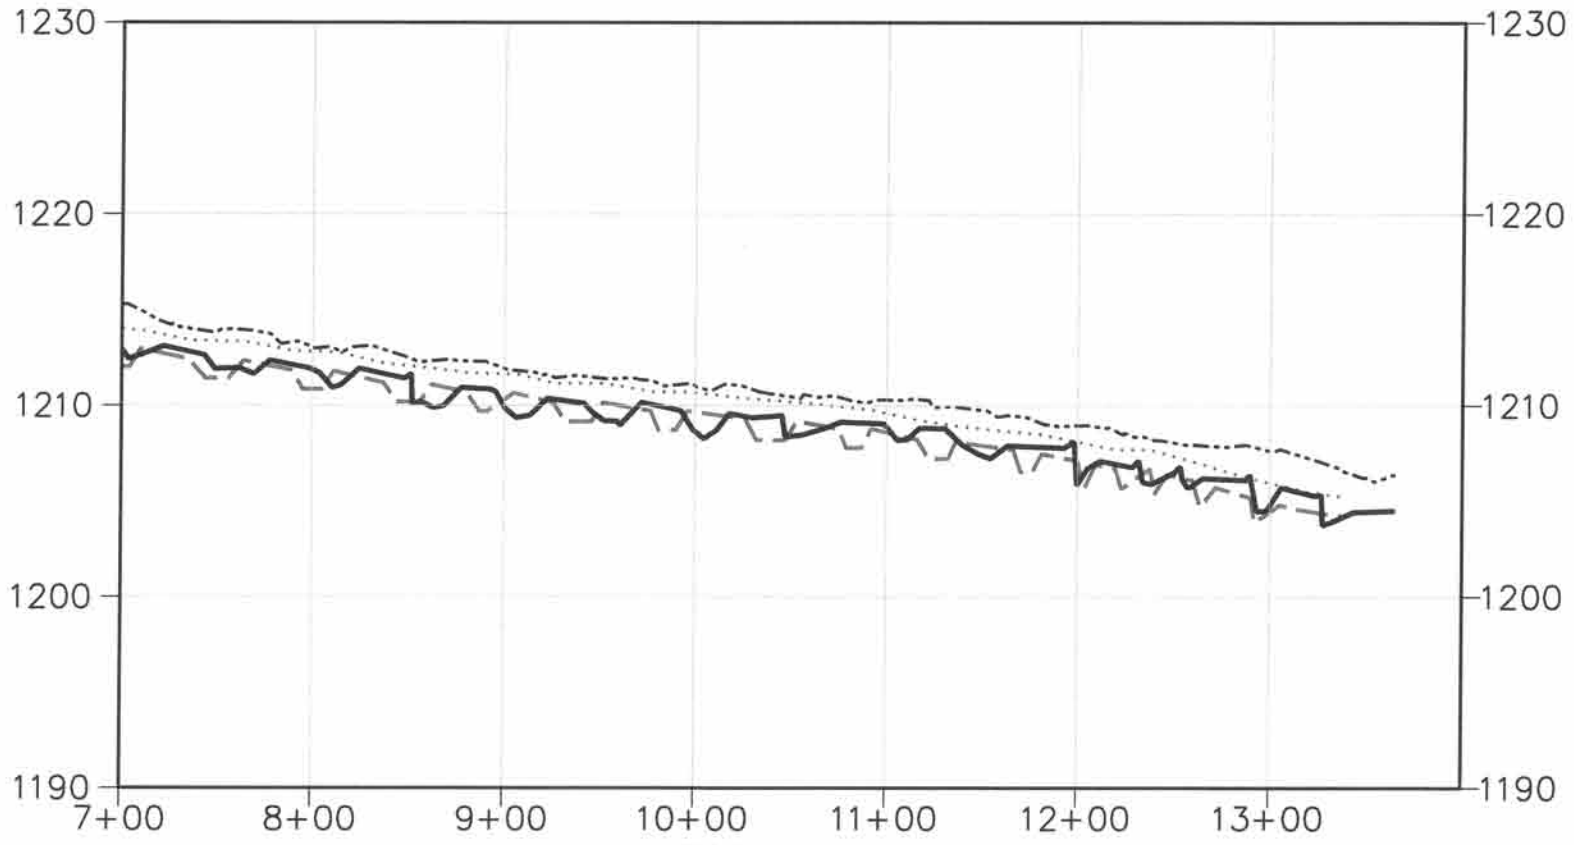
- - - - - PROPOSED THALWEG      \_\_\_\_\_ AS-BUILT THALWEG  
 ..... PROPOSED LOW BANK      - - - - - AS-BUILT LOW BANK

PROFILE SCALE  
 HORIZONTAL: 1"=100'  
 VERTICAL: 1"=10'

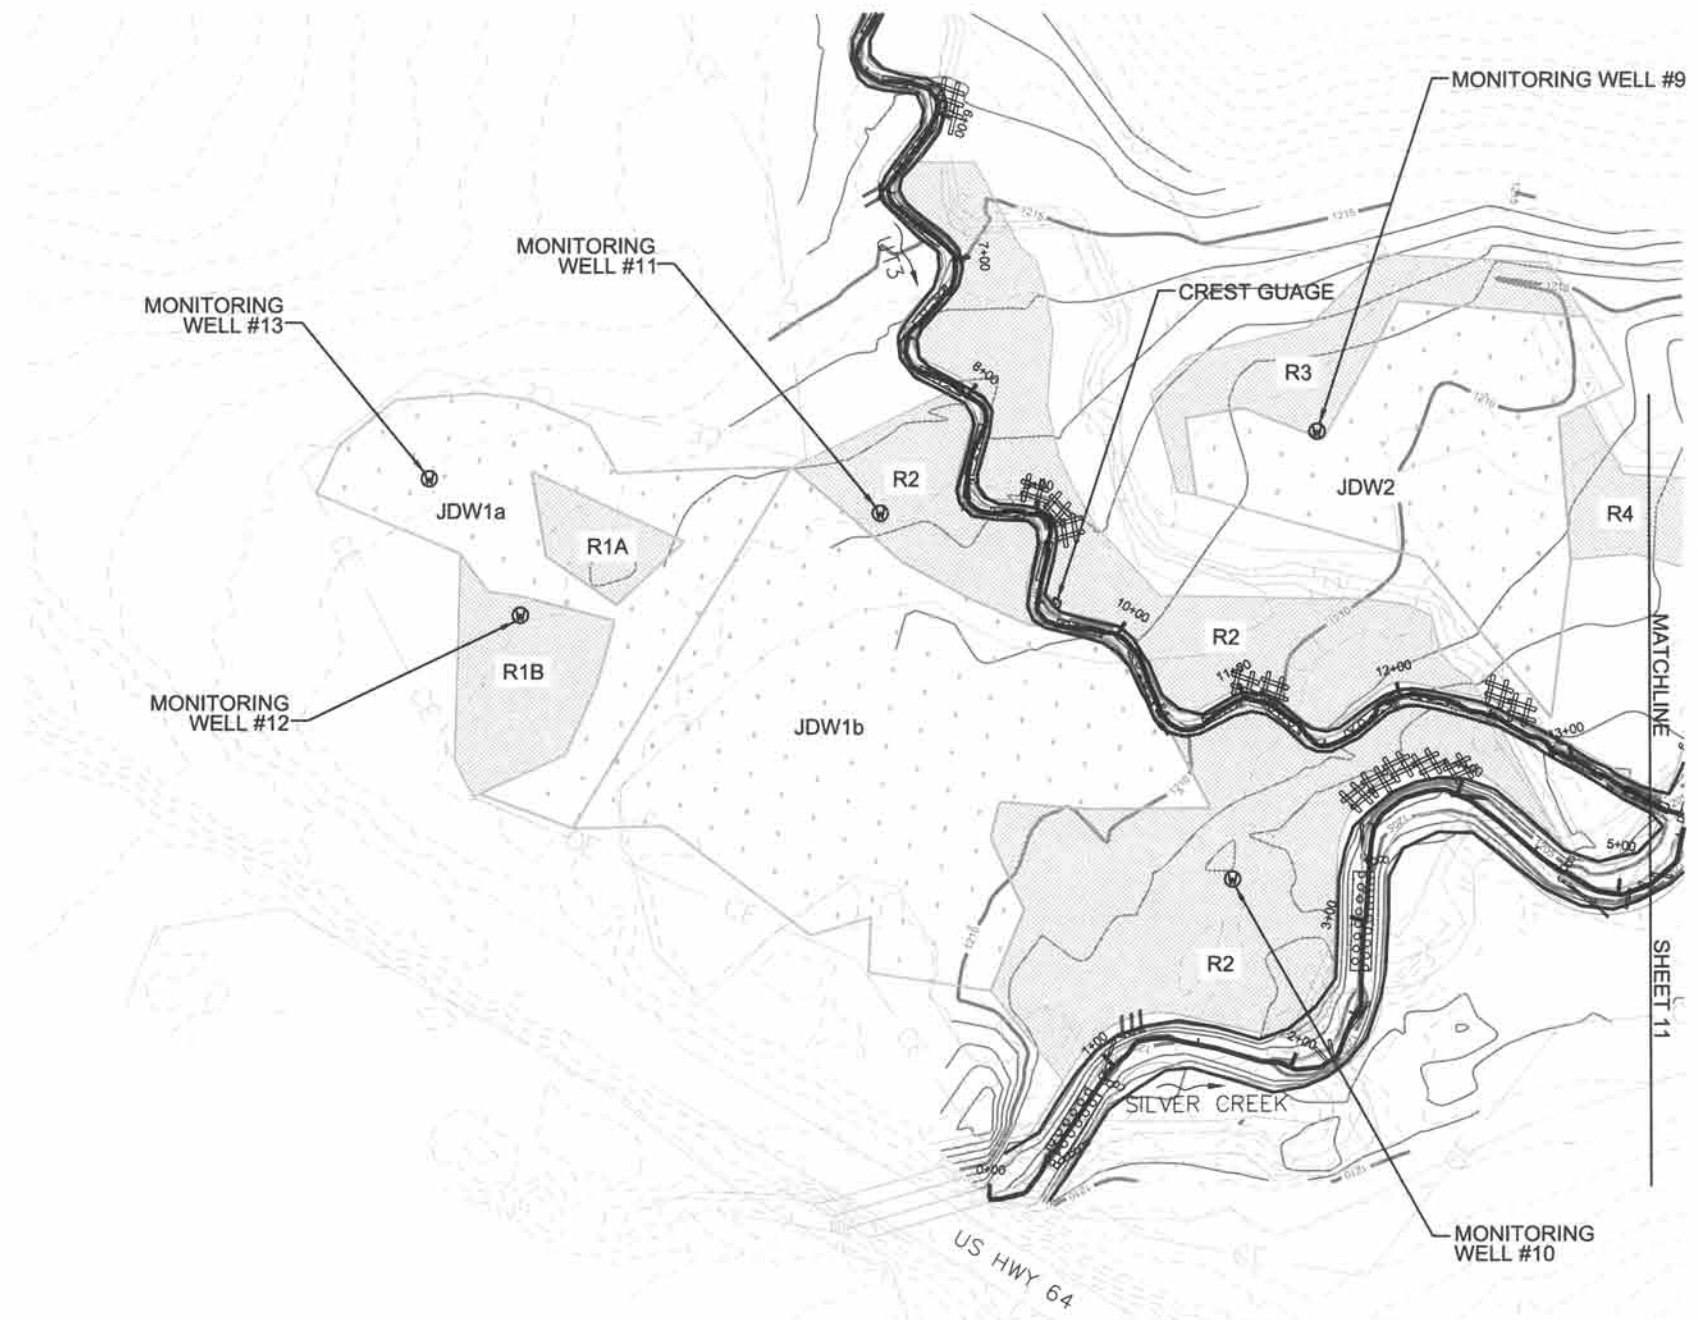
Wetland Crediting

Wetland Name	Credit Type	Acreage	Ratio	WMU
JDW1a	Enhancement	0.42	2:1	0.21
JDW1b	Enhancement	1.01	2:1	0.51
JDW2	Enhancement	0.51	2:1	0.25
R1a	Restoration	0.06	1:1	0.06
R1b	Restoration	0.15	1:1	0.15
R2	Restoration	1.22	1:1	1.22
R3	Restoration	0.18	1:1	0.18
R4	See Sht 11	-	-	-
Sheet Subtotal				2.58

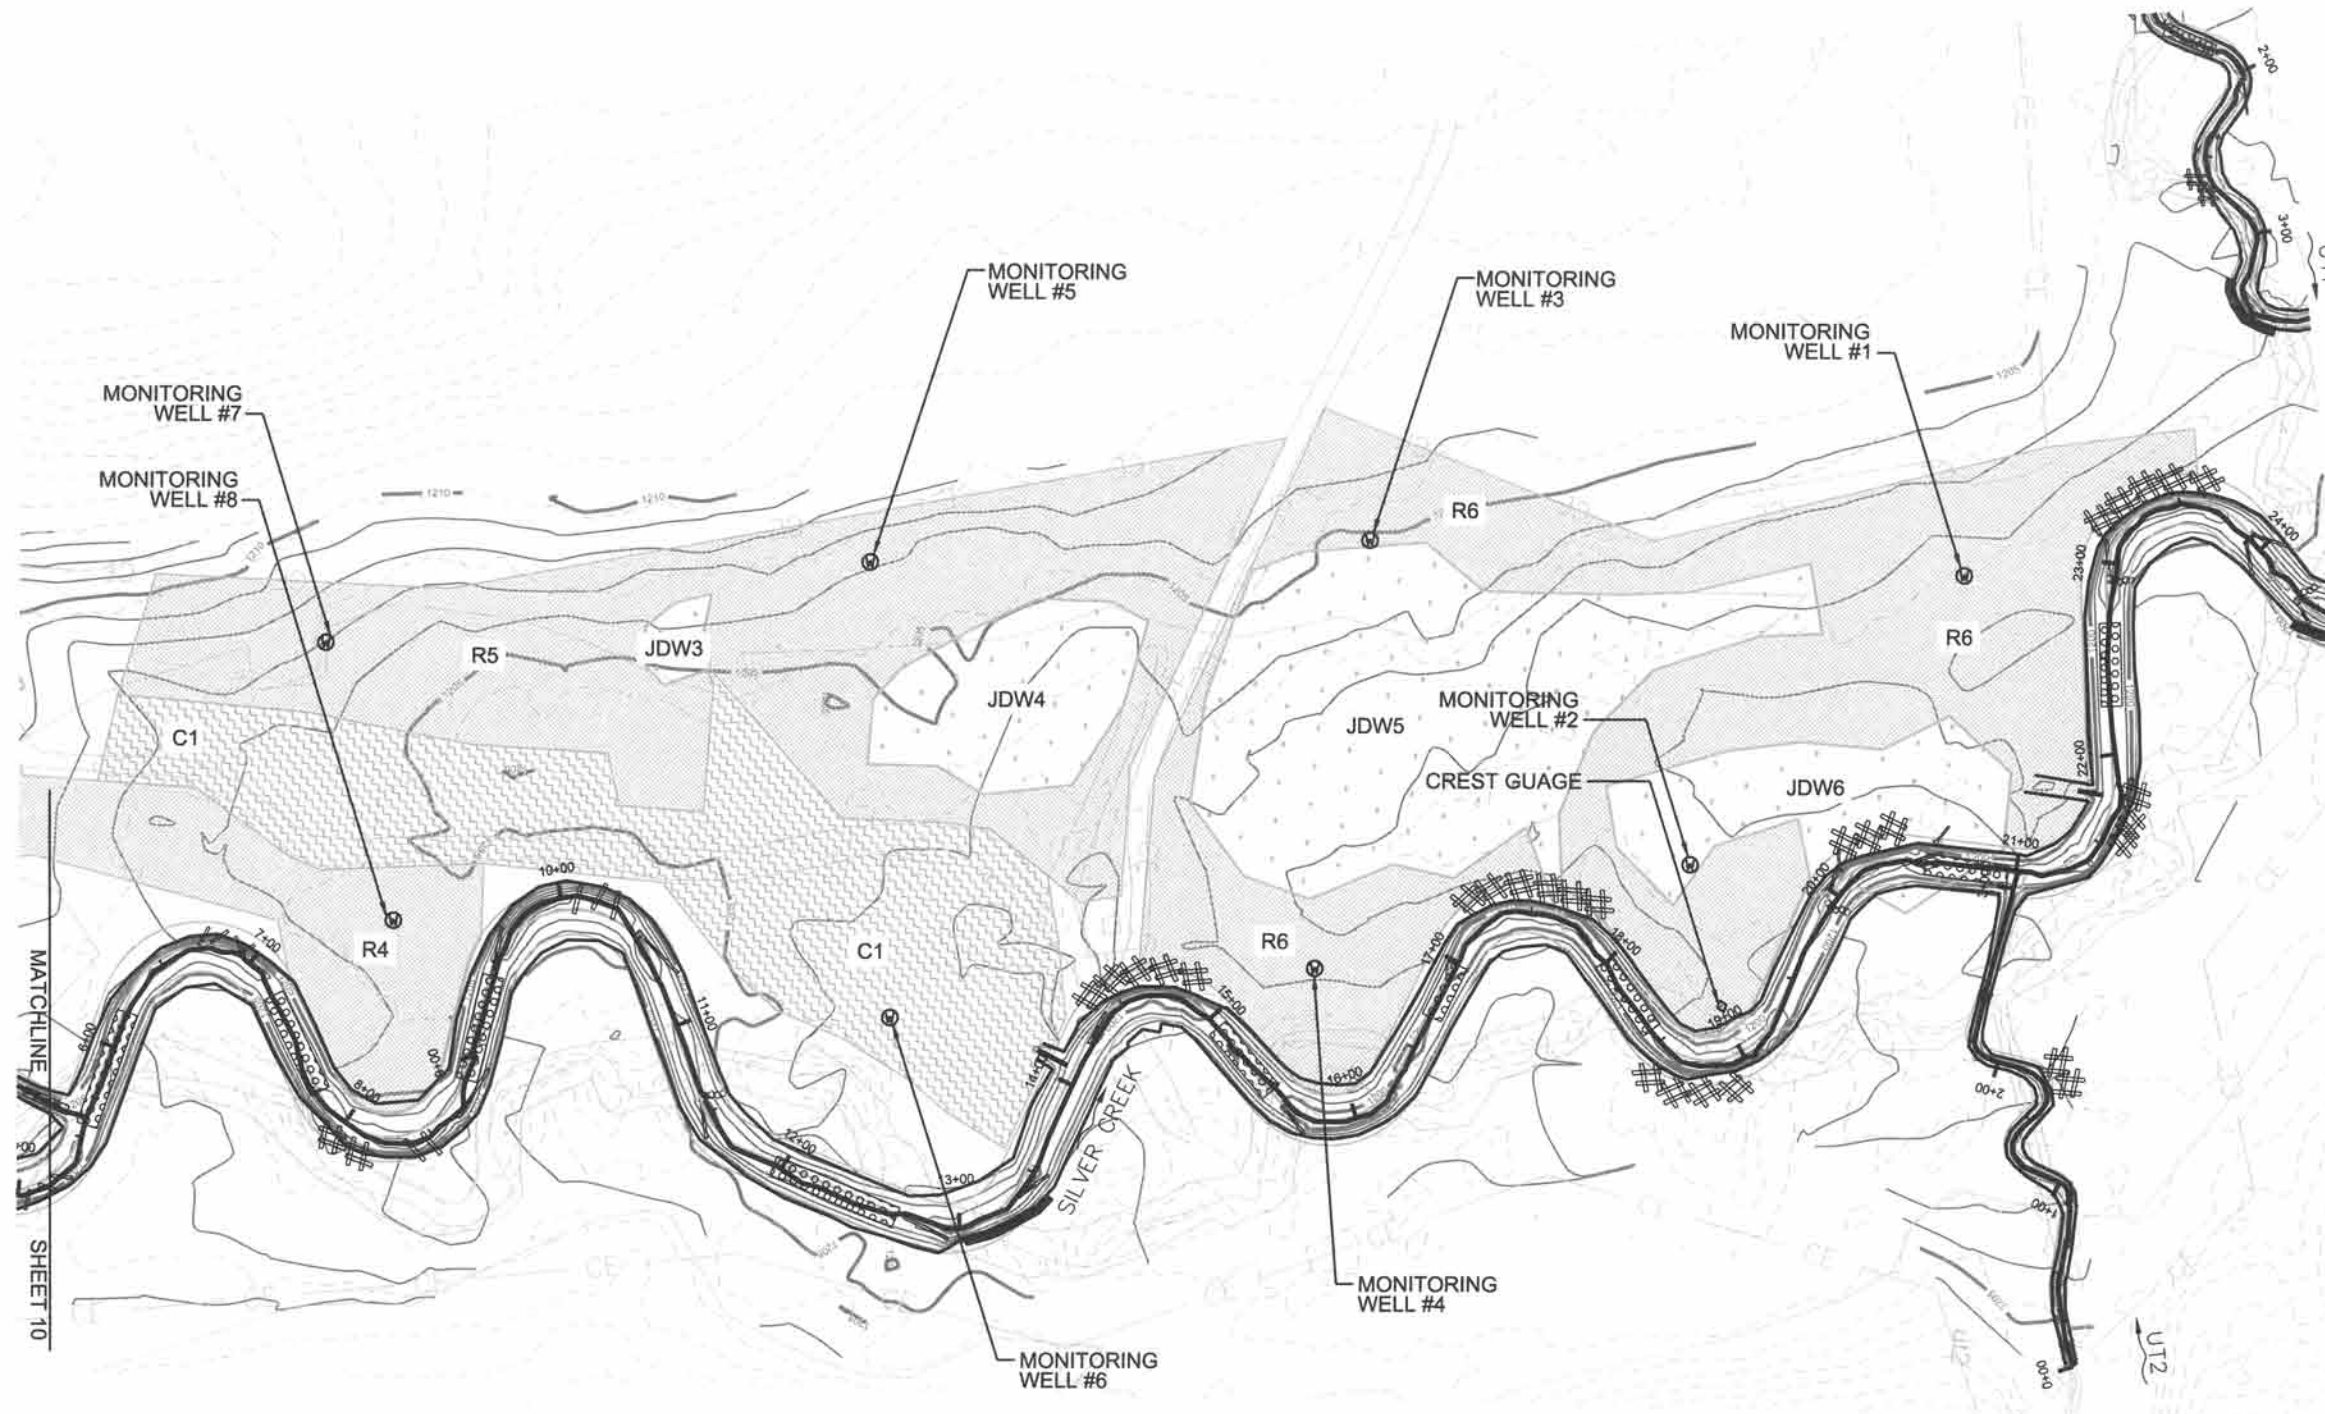
Project No. 120598  
Date:  
DESIGNED:  
DRAWN:  
CHECKED:  
Sheet: 10 of 11

Wetland Crediting				
Wetland Name	Credit Type	Acreage	Ratio	WMU
JDW3	Enhancement	0.03	2:1	0.02
JDW4	Enhancement	0.24	2:1	0.12
JDW5	Enhancement	0.81	2:1	0.40
JDW6	Enhancement	0.25	2:1	0.13
R4	Restoration	0.44	1:1	0.44
R5	Restoration	1.29	1:1	1.29
R6	Restoration	1.54	1:1	1.54
C1	Creation	0.99	3:1	0.33
Sheet Subtotal				4.27
Project Total				6.85

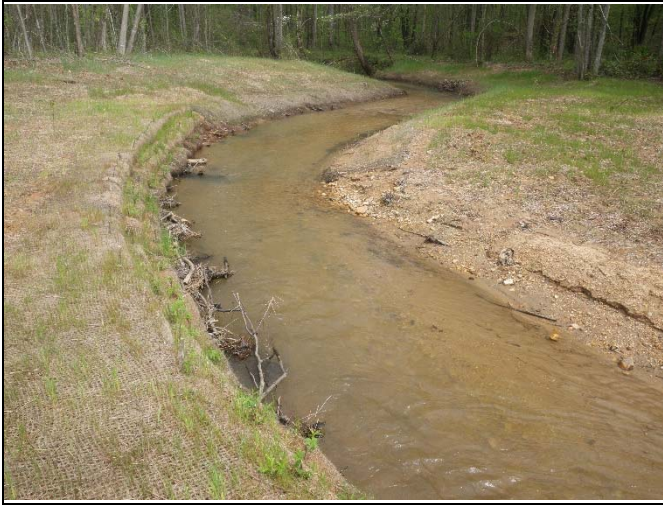
Photo 1. Mainstem Photo Point 1 – Station 29+26 (April 17, 2015) downstream view from left bank.

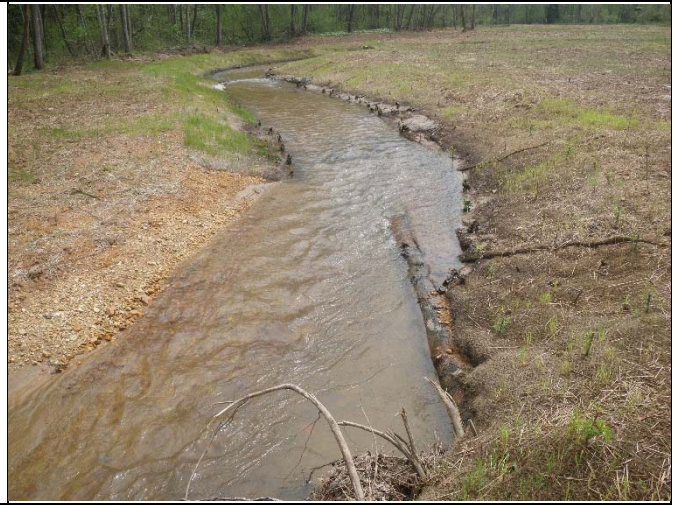
Photo 2. Mainstem Photo Point 1 – Station 29+26 (April 17, 2015) upstream view from left bank.

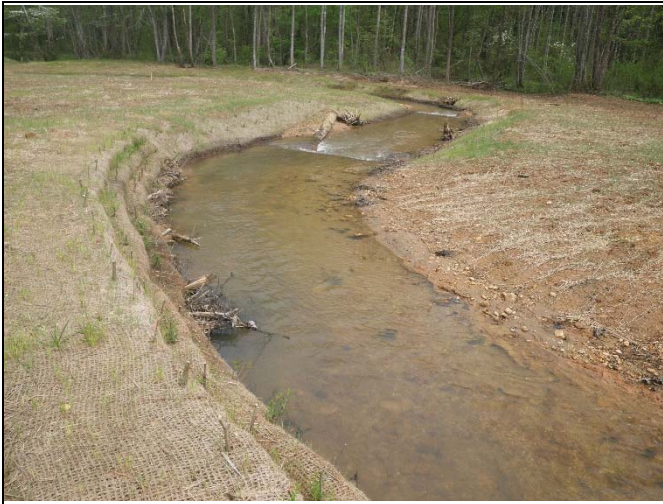
Photo 3. Mainstem Photo Point 2 – Station 26+44 (April 17, 2015) downstream view from left bank.

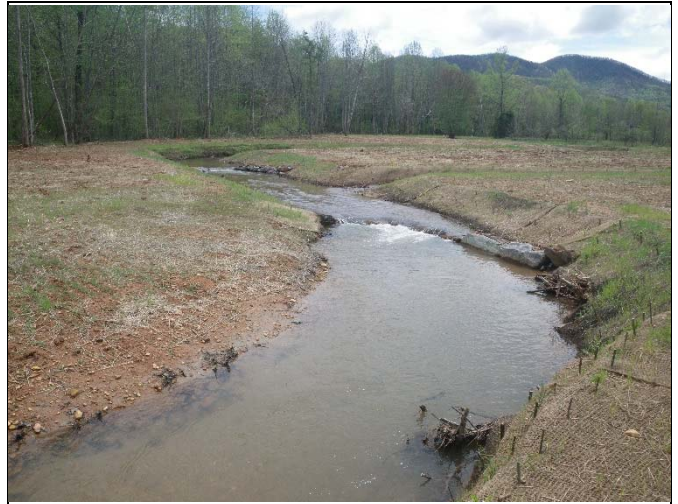
Photo 4. Mainstem Photo Point 2 – Station 26+44 (April 17, 2015) upstream from left bank.

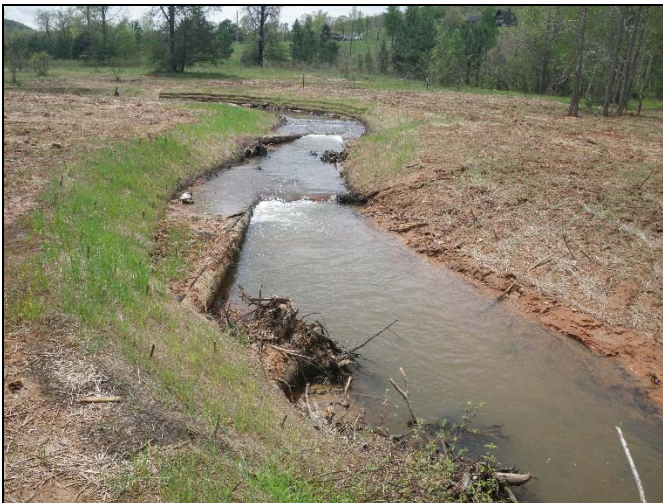
Photo 5. Mainstem Photo Point 3 – Station 24+70 (April 17, 2015) upstream from right bank.

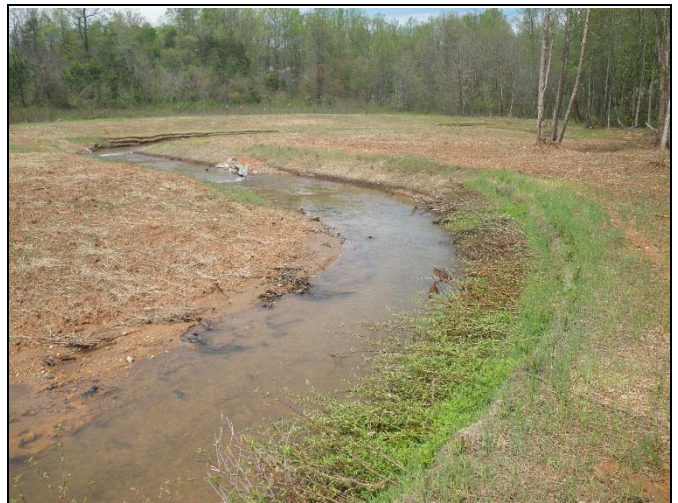
Photo 6. Mainstem Photo Point 3 – Station 24+70 (April 17, 2015) downstream from right bank.

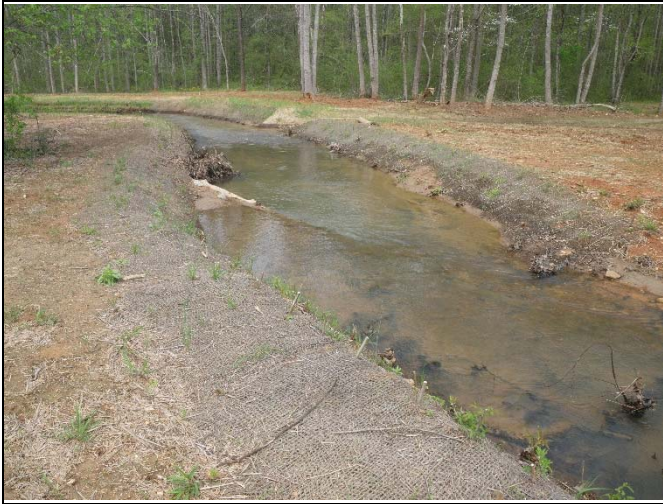
Photo 7. Mainstem Photo Point 4 (PP4) – Station 20+30 (April 17, 2015) downstream from left bank.

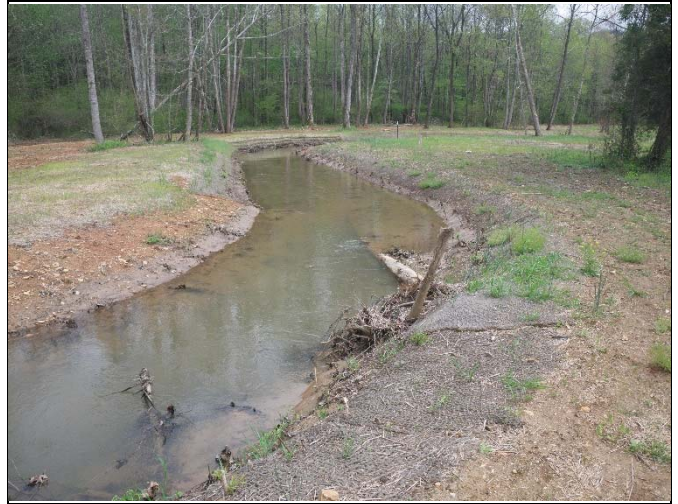
Photo 8. Mainstem Photo Point 4 (PP4) – Station 20+30 (April 17, 2015) upstream from left bank.

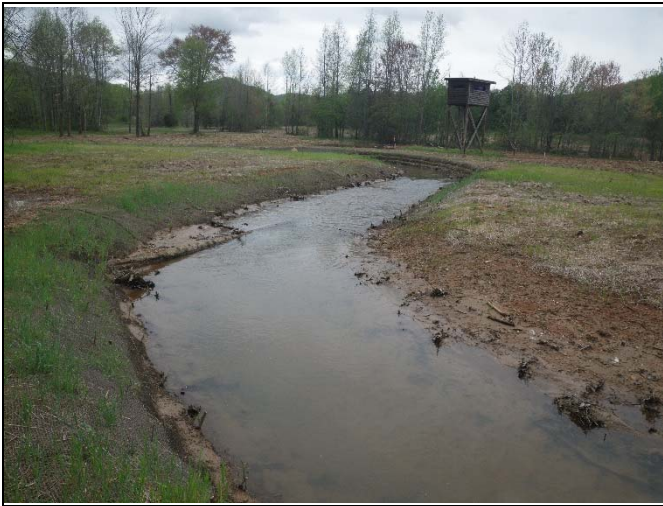
Photo 9. Mainstem Photo Point 5 – Station 16+03 (April 17, 2015) upstream from right bank.

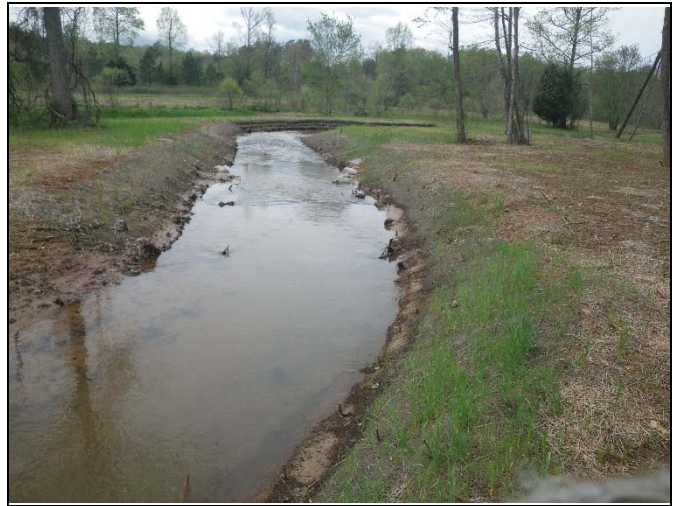
Photo 10. Mainstem Photo Point 5 – Station 16+03 (April 17, 2015) downstream from right bank.

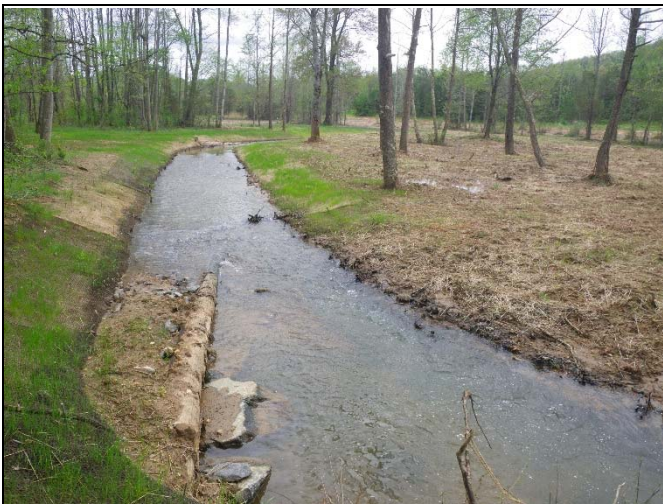
Photo 11. Mainstem Photo Point 6 – Station 13+03 (April 17, 2015) upstream from right bank.

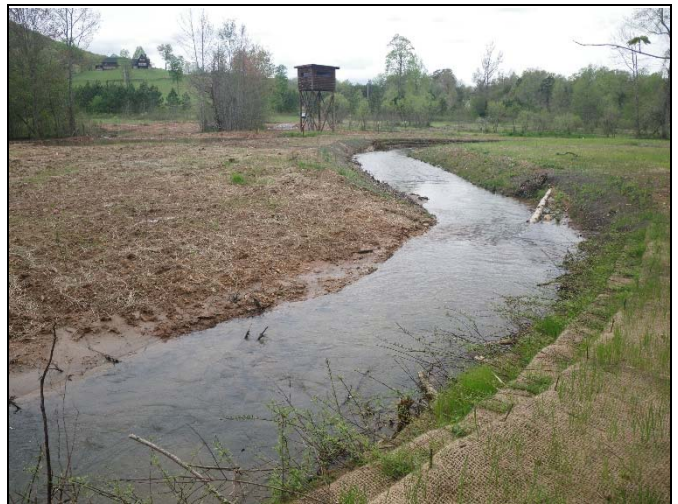
Photo 12. Mainstem Photo Point 5 – Station 13+03 (April 17, 2015) downstream from right bank.

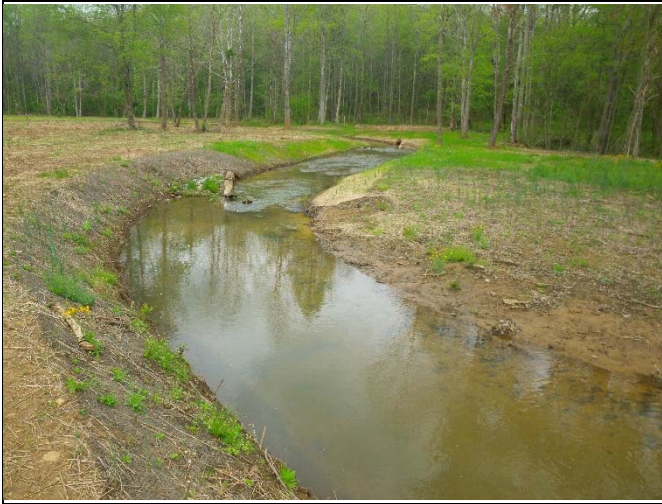
Photo 13. Mainstem Photo Point 7 – Station 10+11  
(April 17, 2015) downstream from left bank.

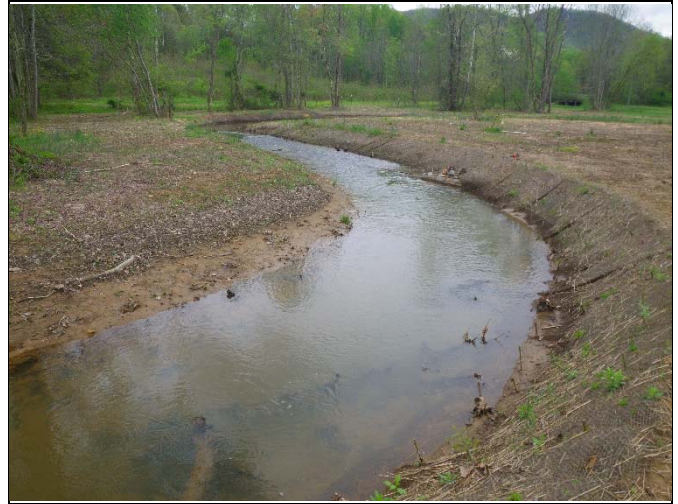
Photo 14. Mainstem Photo Point 7 – Station 10+11  
(April 17, 2015) upstream from left bank.

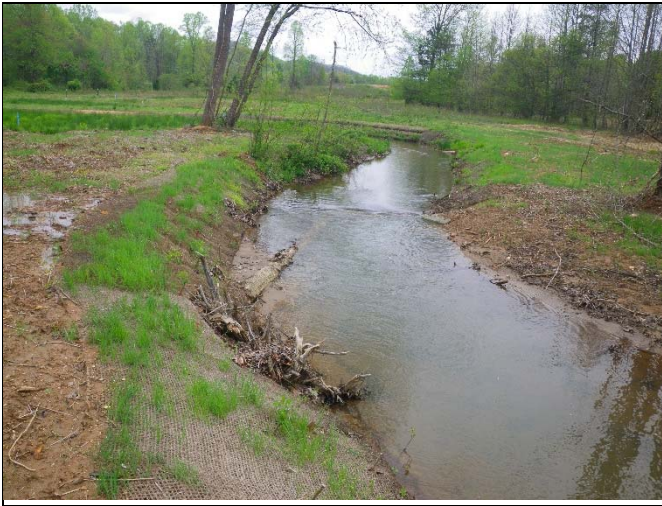
Photo 15. Mainstem Photo Point 8 – Station 5+06  
(April 17, 2015) upstream from right bank.

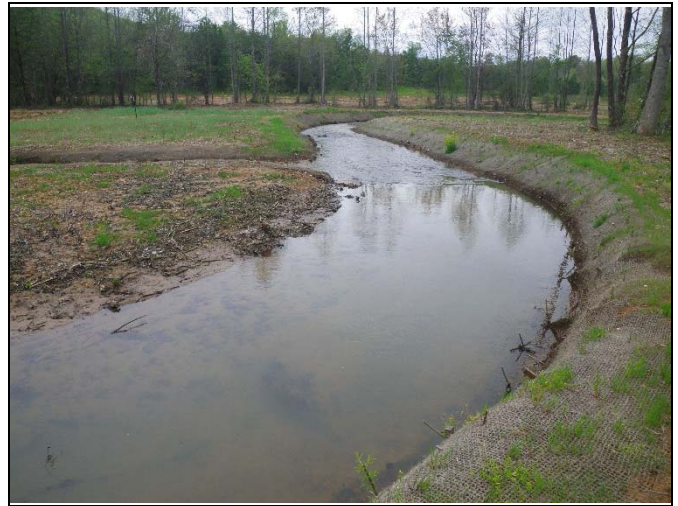
Photo 16. Mainstem Photo Point 8 – Station 5+06  
(April 17, 2015) downstream from right bank.

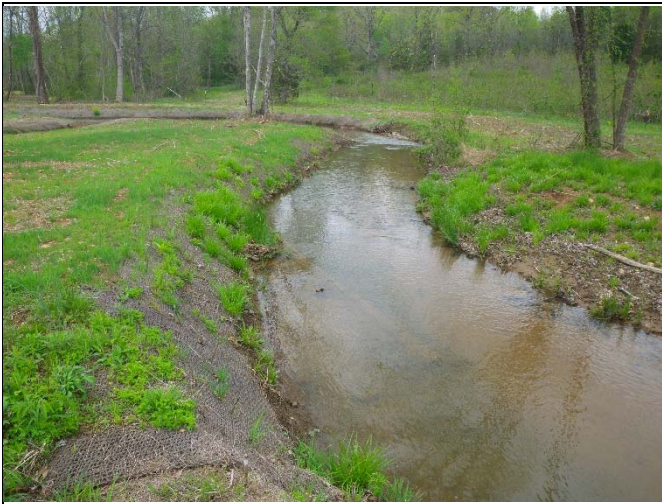
Photo 17. Mainstem Photo Point 9 – Station 3+87  
(April 17, 2015) downstream from left bank.

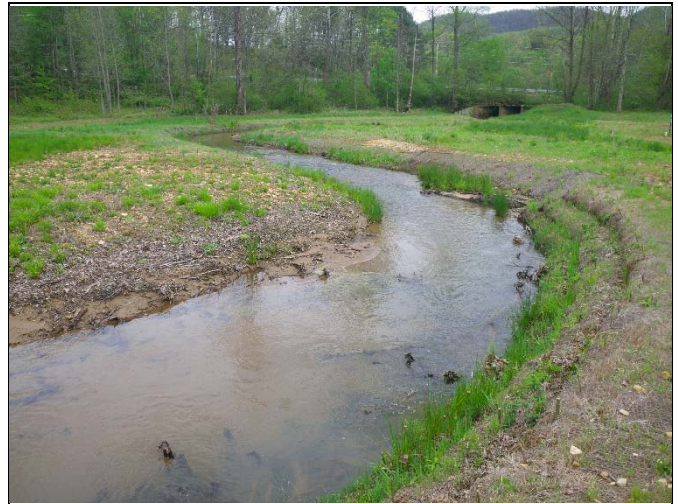
Photo 18. Mainstem Photo Point 9 – Station 3+87  
(April 17, 2015) upstream from left bank.

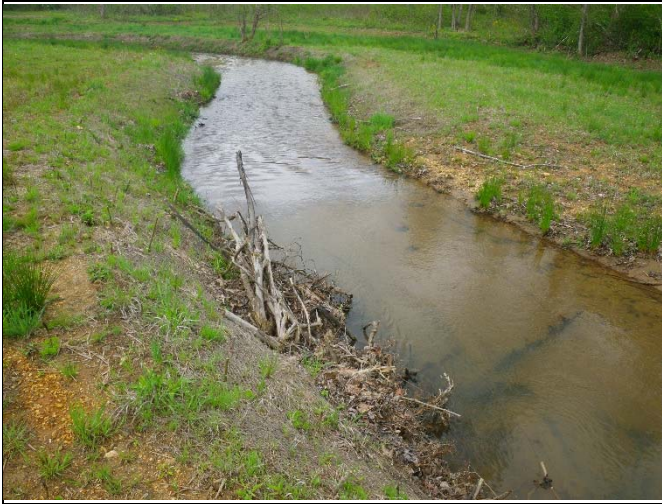
Photo 19. Mainstem Photo Point 10 – Stat. 1+22 (April 17, 2015) downstream from left bank.

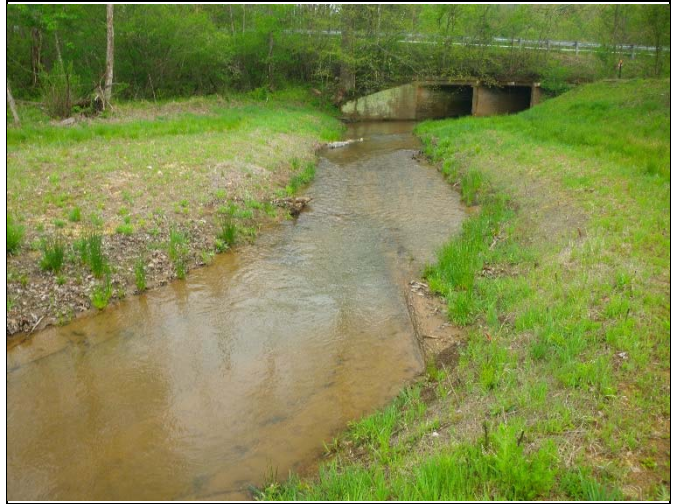
Photo 20. Mainstem Photo Point 10 – Stat. 1+22 (April 17, 2015) upstream from left bank.

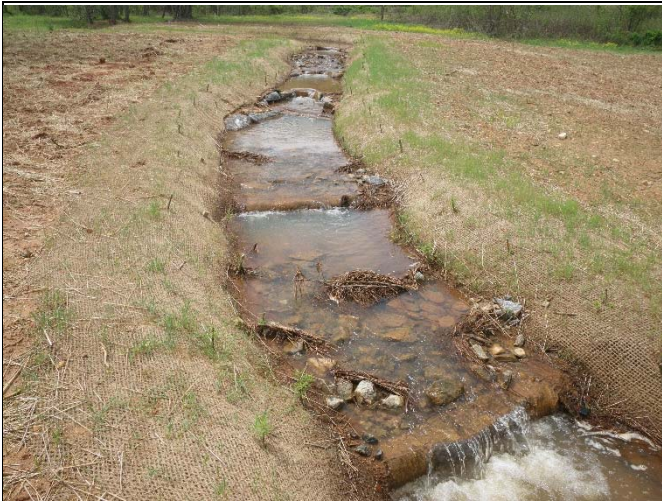
Photo 21. UT1 Photo Point 1 – Station 4+82 (April 17, 2015) upstream from left bank.

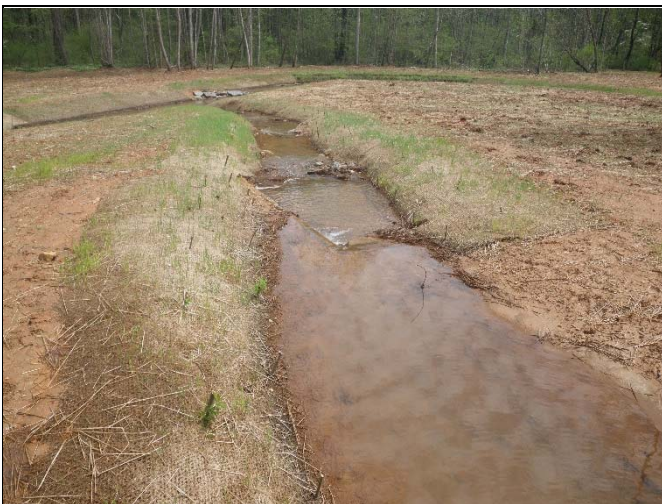
Photo 22. UT1 Photo Point 2 – Station 4+07 (April 17, 2015) downstream from left bank.

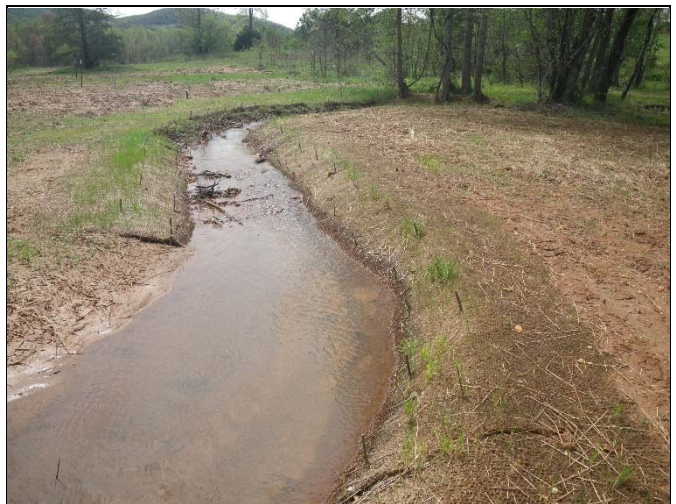
Photo 23. UT1 Photo Point 2 – Station 4+07 (April 17, 2015) upstream from left bank.

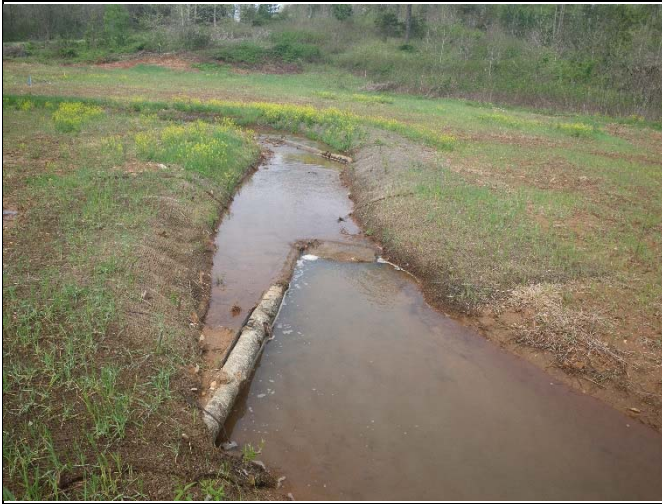
Photo 24. UT1 Photo Point 3 – Station 2+55  
(April 17, 2015) upstream from right bank.

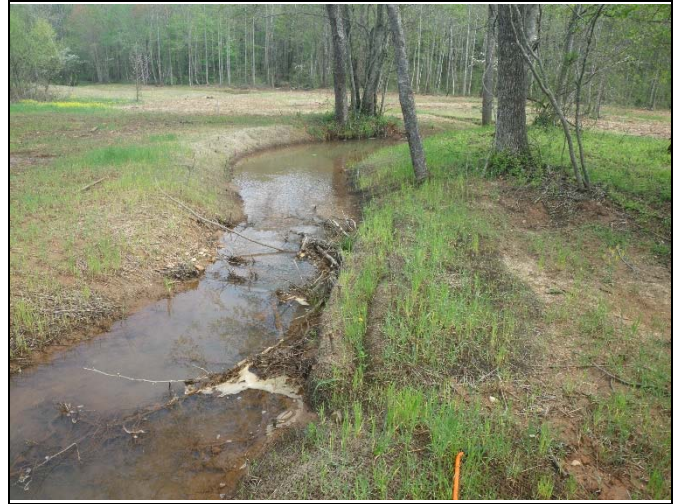
Photo 25. UT1 Photo Point 3 – Station 2+55  
(April 17, 2015) downstream from right bank.

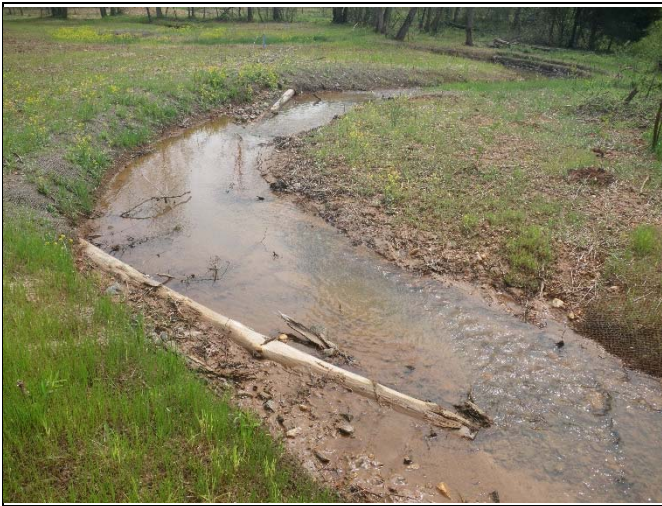
Photo 26. UT1 Photo Point 4 – Station 0+55  
(April 17, 2015) downstream from left bank.

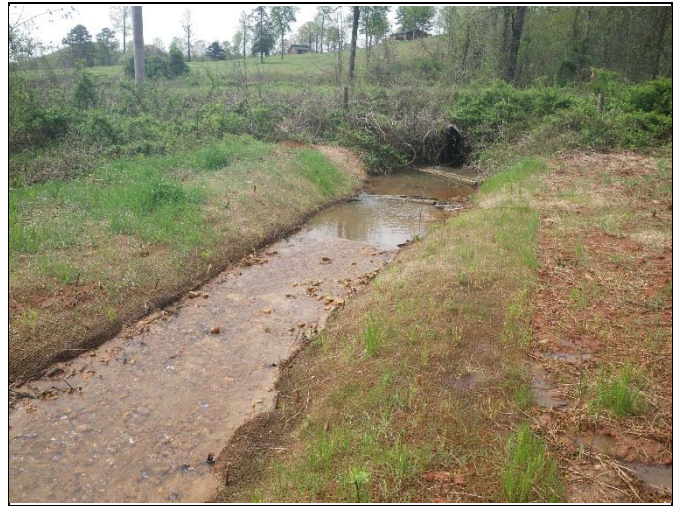
Photo 27. UT1 Photo Point 4 – Station 0+55  
(April 17, 2015) upstream from left bank.

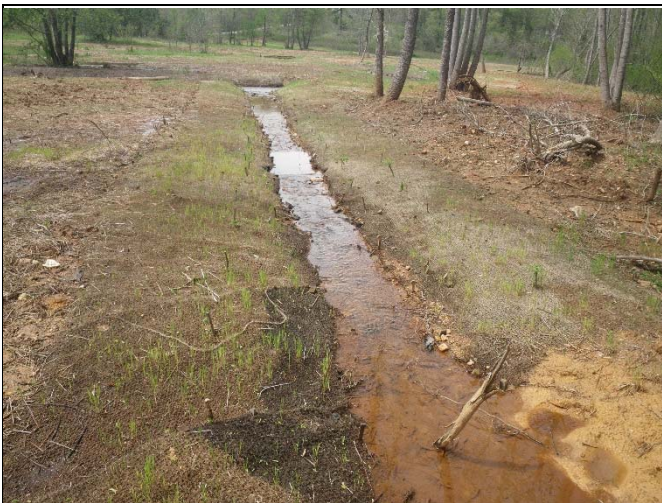
Photo 28. UT2 Photo Point 1 – Station 2+15  
(April 17, 2015) downstream from left bank.

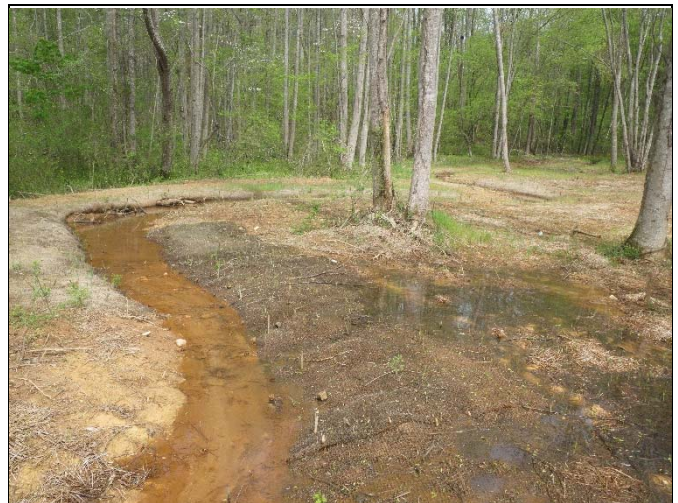
Photo 29. UT2 Photo Point 1 – Station 2+15  
(April 17, 2015) upstream from left bank.

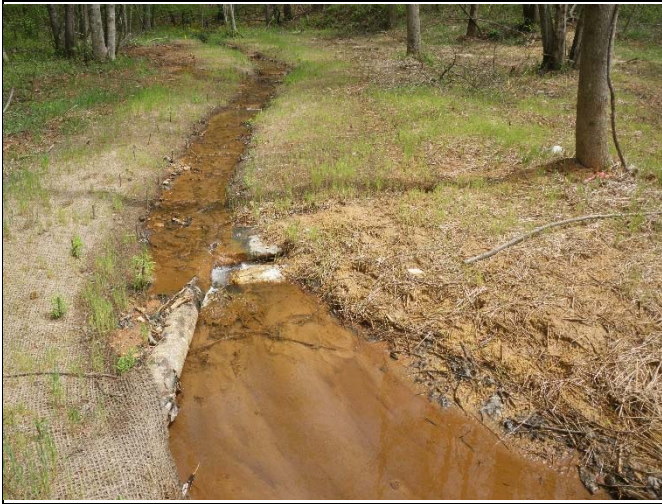
Photo 30. UT2 Photo Point 2 – Station 0+96  
(April 17, 2015) upstream from left bank.

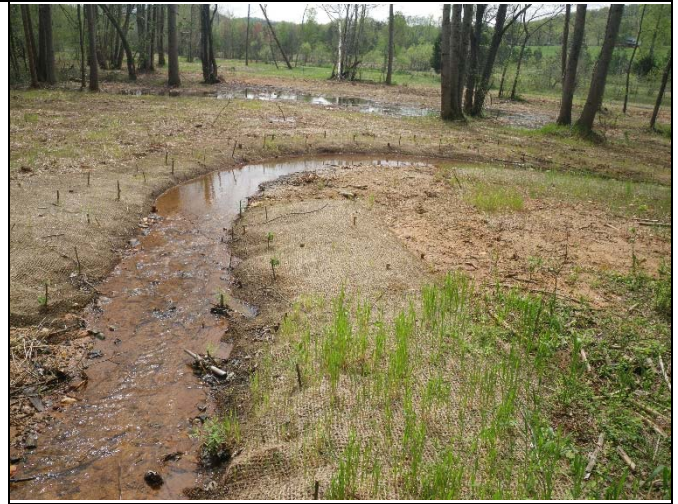
Photo 31. UT2 Photo Point 2 – Station 0+96  
(April 17, 2015) downstream from left bank.

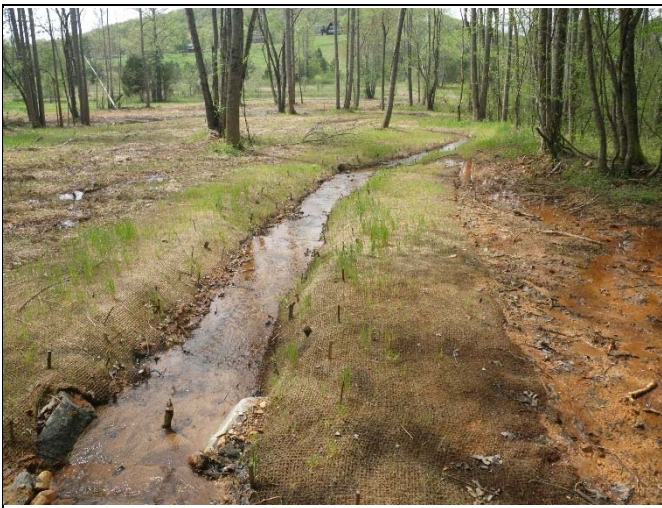
Photo 32. UT2 Photo Point 3 – Station 0+02  
(April 17, 2015) downstream from left bank.

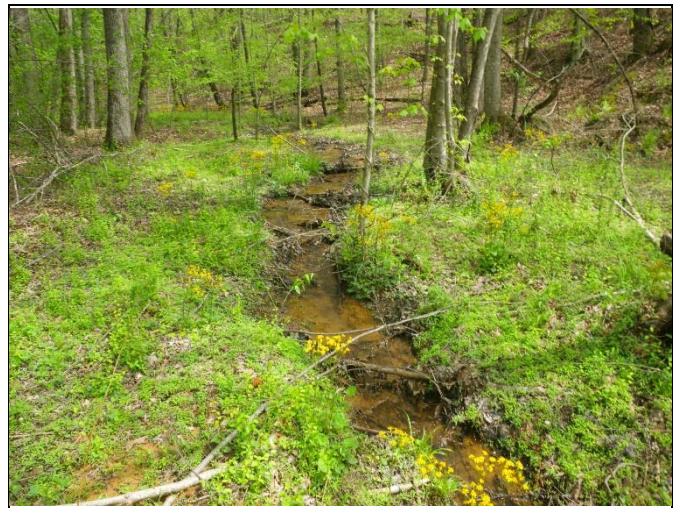
Photo 33. UT2 Photo Point 3 – Station 0+02  
(April 17, 2015) upstream from left bank.

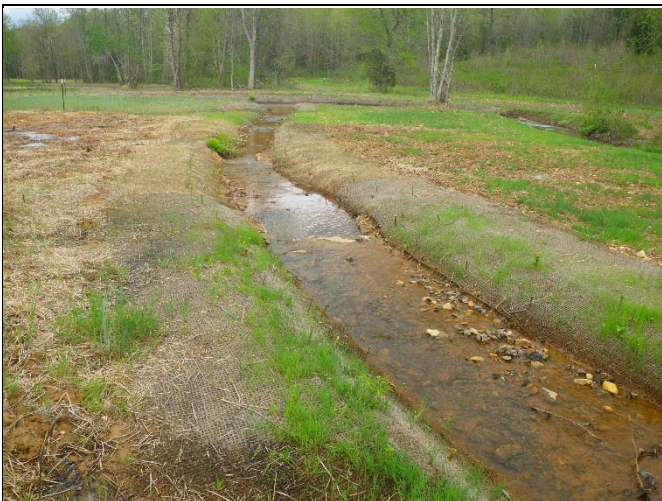
Photo 34. UT3 Photo Point 1 – Station 11+91  
(April 17, 2015) downstream from left bank.

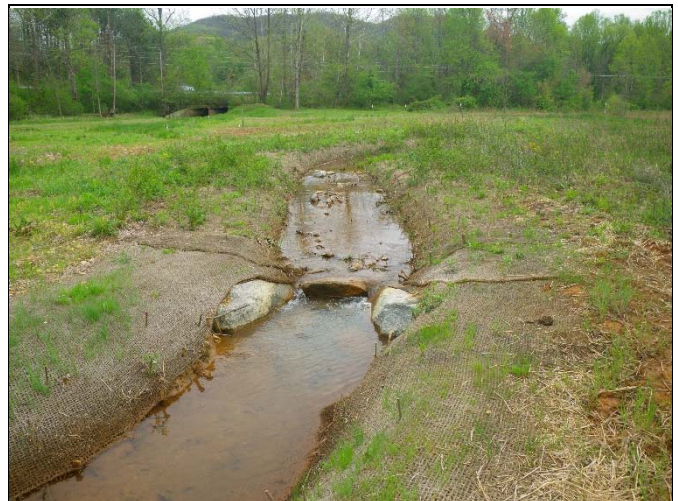
Photo 35. UT3 Photo Point 1 – Station 11+91  
(April 17, 2015) upstream from left bank.

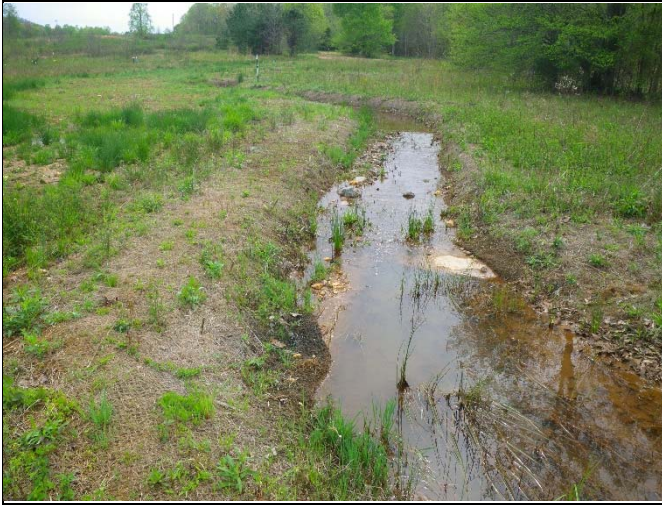
Photo 36. UT3 Photo Point 2 – Station 10+47  
(April 17, 2015) upstream from right bank.

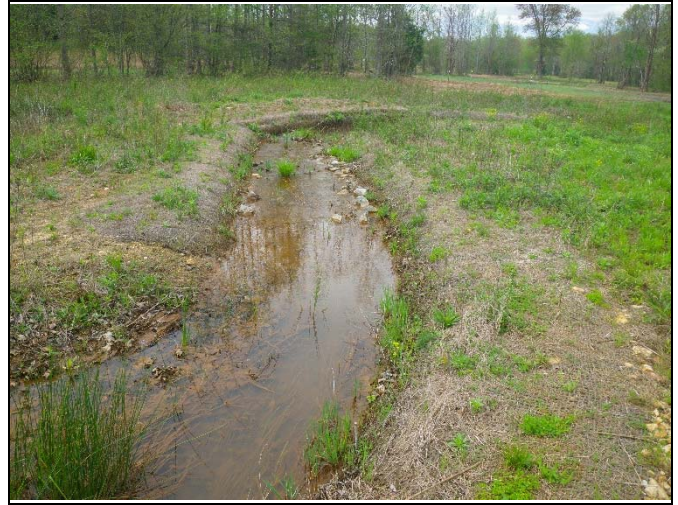
Photo 37. UT3 Photo Point 2 – Station 10+47  
(April 17, 2015) downstream from right bank.

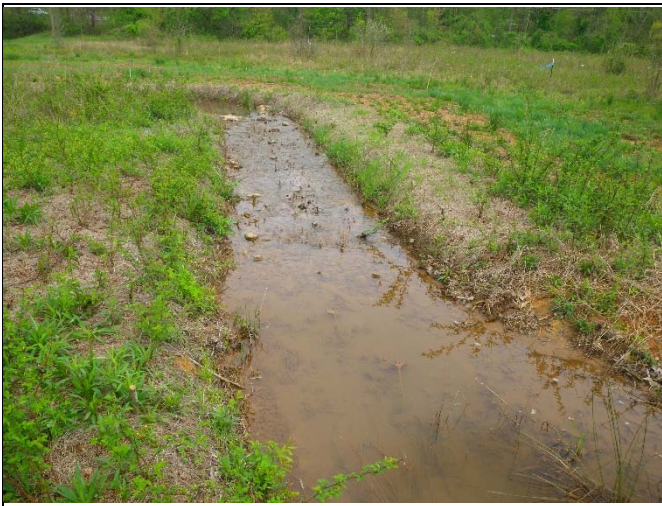
Photo 38. UT3 Photo Point 3 – Station 8+02  
(April 17, 2015) downstream from left bank.
