# **Baseline Monitoring Document and As-Built Baseline Report Upper Silver Creek Stream and Wetland Restoration Project**

**Burke County, North Carolina**

DMS Project ID No. 94645

**Michael Baker**

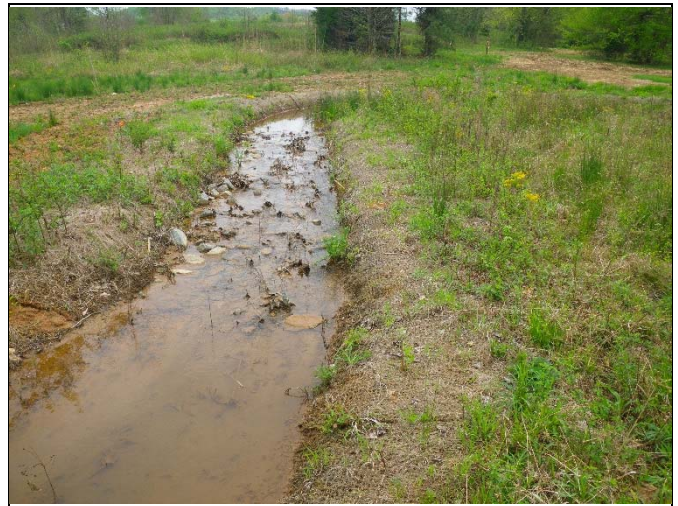
Photo 39. UT3 Photo Point 3 – Station 8+02  
(April 17, 2015) upstream from left bank.

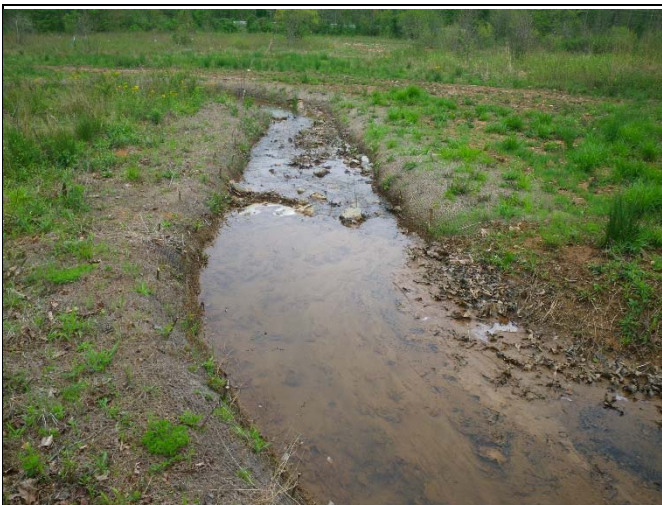
Photo 40. UT3 Photo Point 4 – Station 6+95  
(April 17, 2015) downstream from left bank.

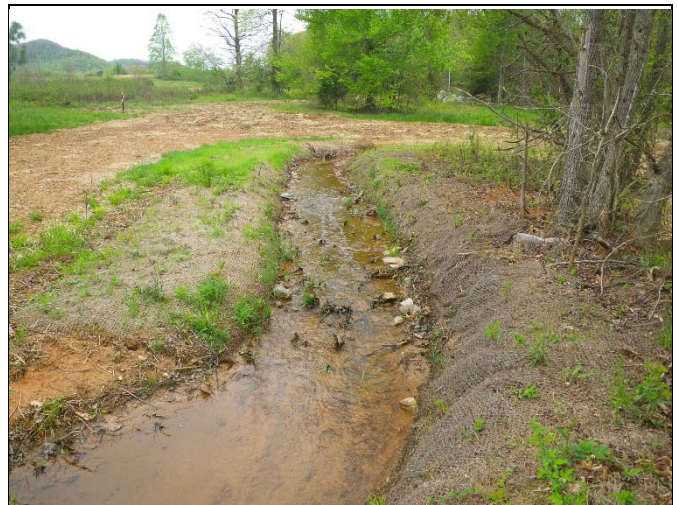
Photo 41. UT3 Photo Point 4 – Station 6+95  
(April 17, 2015) upstream from left bank.

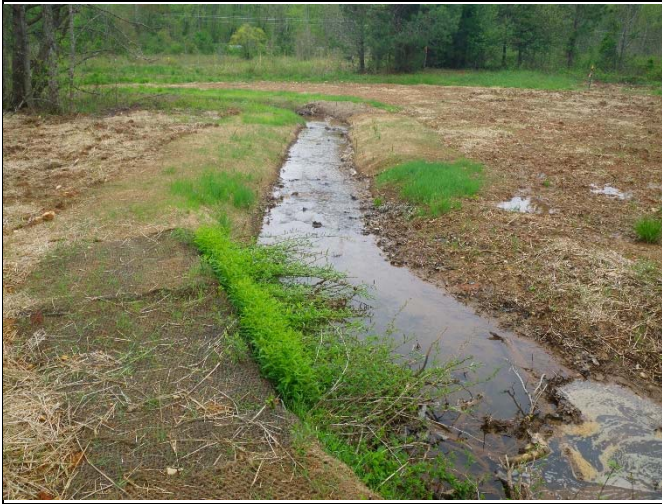
Photo 42. UT3 Photo Point 5 – Station 5+87  
(April 17, 2015) downstream from left bank.

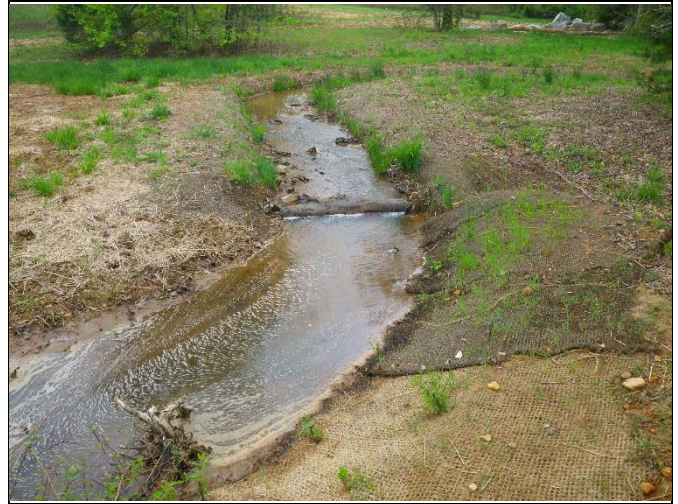
Photo 43. UT3 Photo Point 5 – Station 5+87  
(April 17, 2015) upstream from left bank.

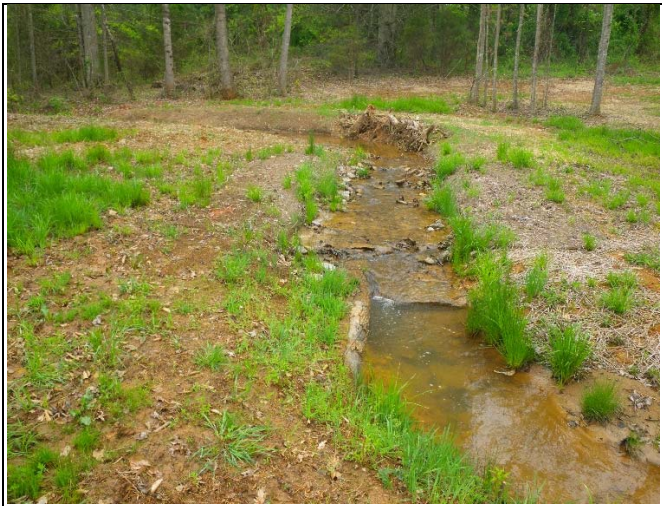
Photo 44. UT3 Photo Point 6 – Station 4+55  
(April 17, 2015) upstream from right bank.

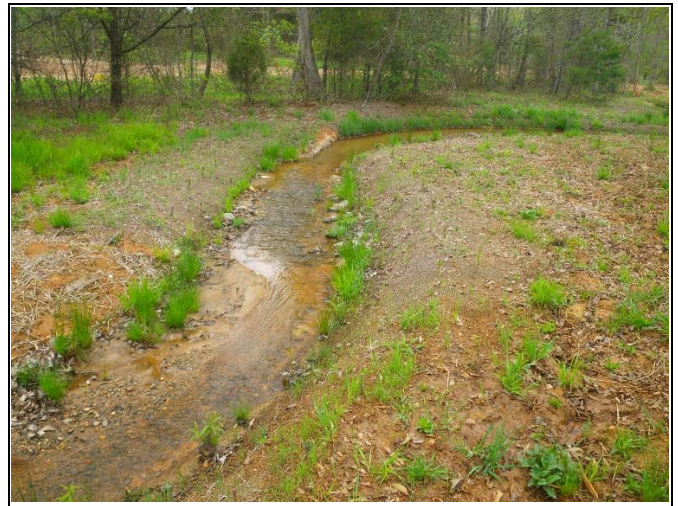
Photo 45. UT3 Photo Point 6 – Station 4+55  
(April 17, 2015) downstream from right bank.

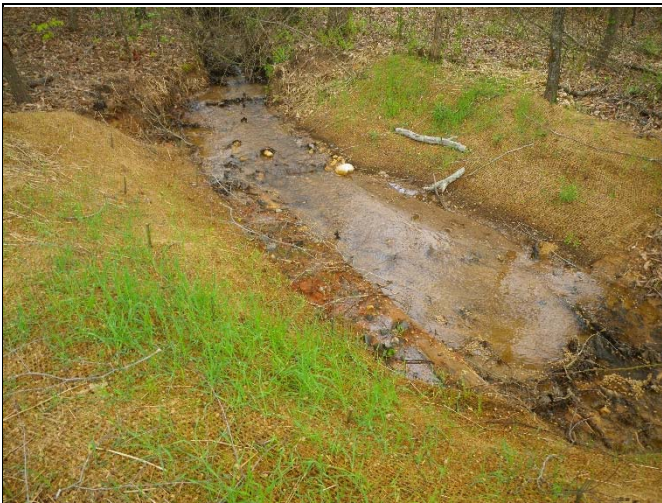
Photo 46. UT3 Photo Point 7 – Station 3+47  
(April 17, 2015) upstream to structure.

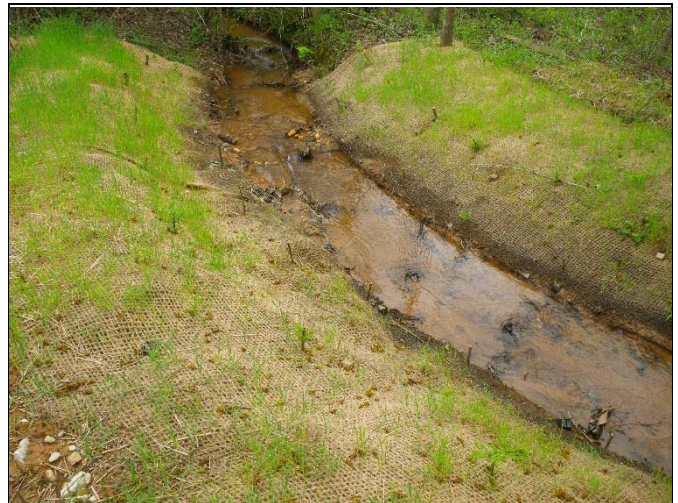
Photo 47. UT3 Photo Point 8 – Station 2+67  
(April 17, 2015) upstream to structure.

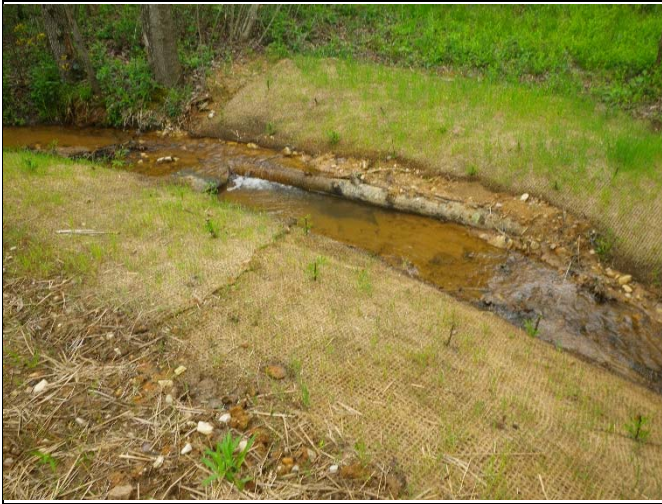
Photo 48. UT3 Photo Point 9 – Station 1+89  
(April 17, 2015) upstream to structure.

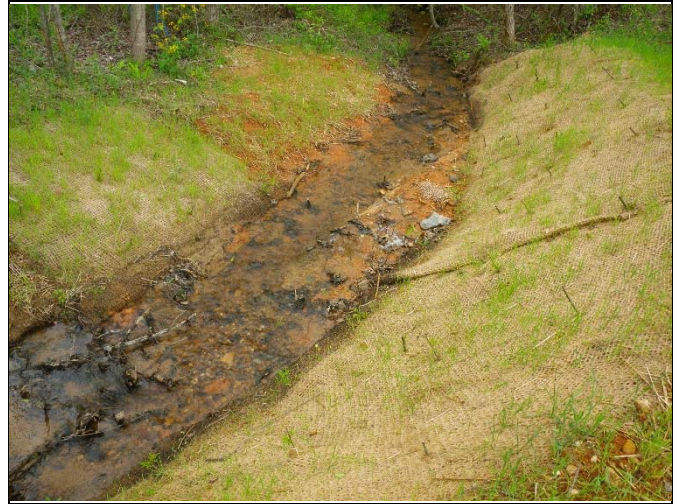
Photo 49. UT3 Photo Point 10 – Station 0+61  
(April 17, 2015) downstream to structure.

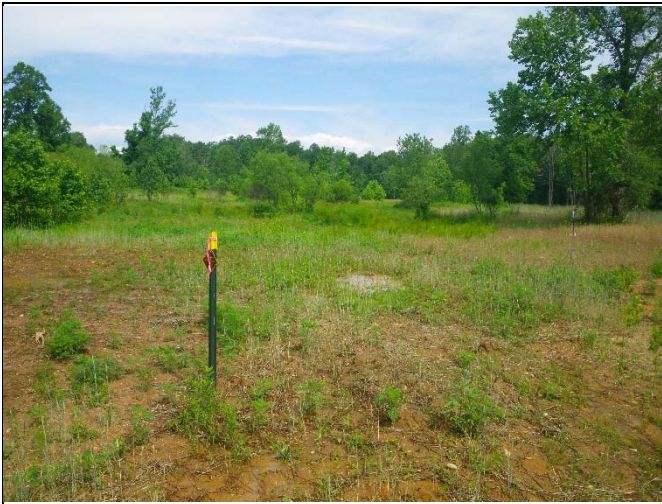
Photo 62. As-built Wetland Photo Point – downstream of  
deer-stand.

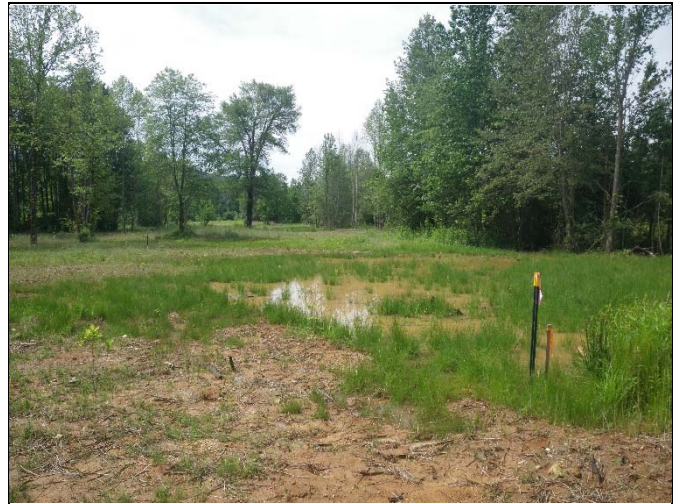
Photo 63. As-built Wetland Photo Point – upstream of deer-  
stand.

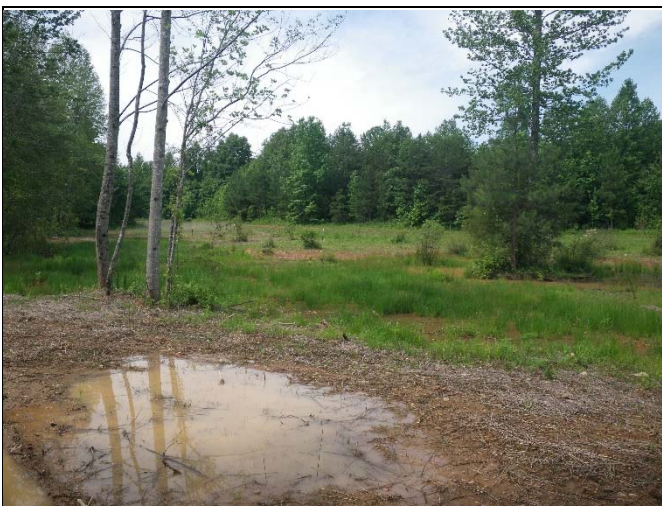
Photo 64. As-built Wetland Photo Point – left bank cross-  
section 7 pin to veg plot 5.

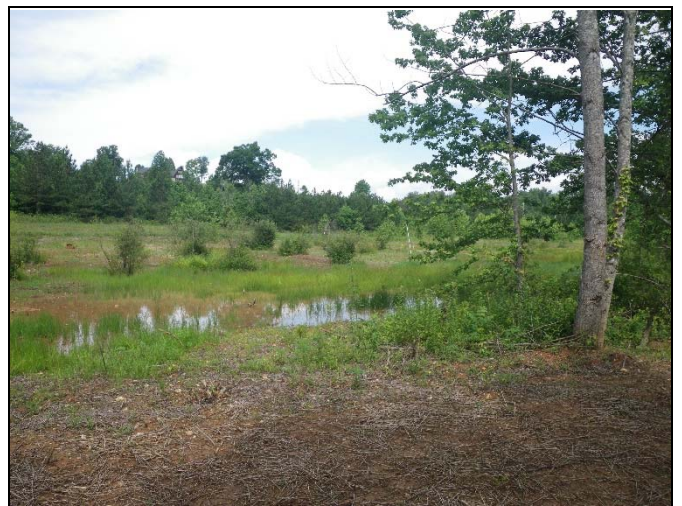
Photo 65. As-built Wetland Photo Point – left bank cross-  
section 7 pin to veg plot 4.

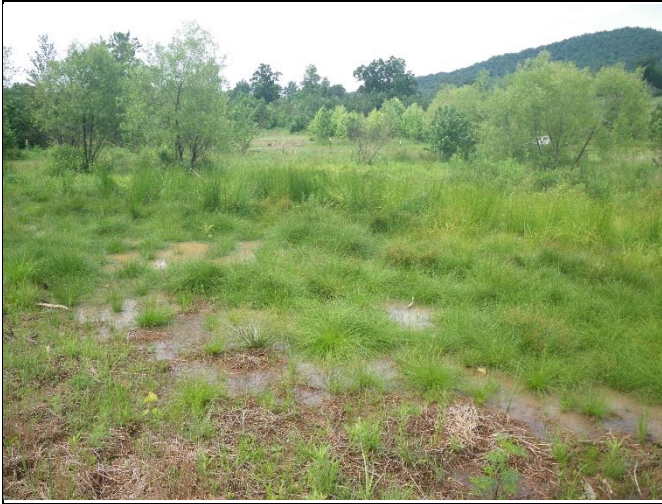
Photo 66. As-built Wetland Photo Point – left bank cross-section 6 pin to veg plot 3.

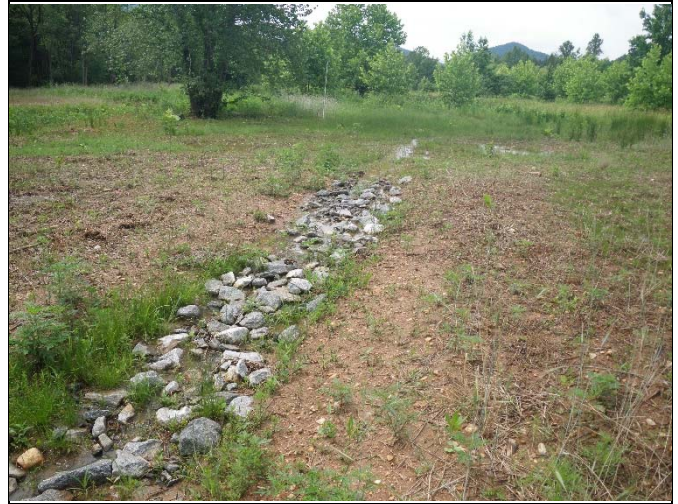
Photo 67. As-built Wetland Photo Point – up valley from left bank at station 22+00.
