Upper Silver Creek Restoration Project Year 2 Monitoring Report

Burke County, North Carolina

NCDMS Project ID Number – 94645

Monitoring Year: 2 of 5

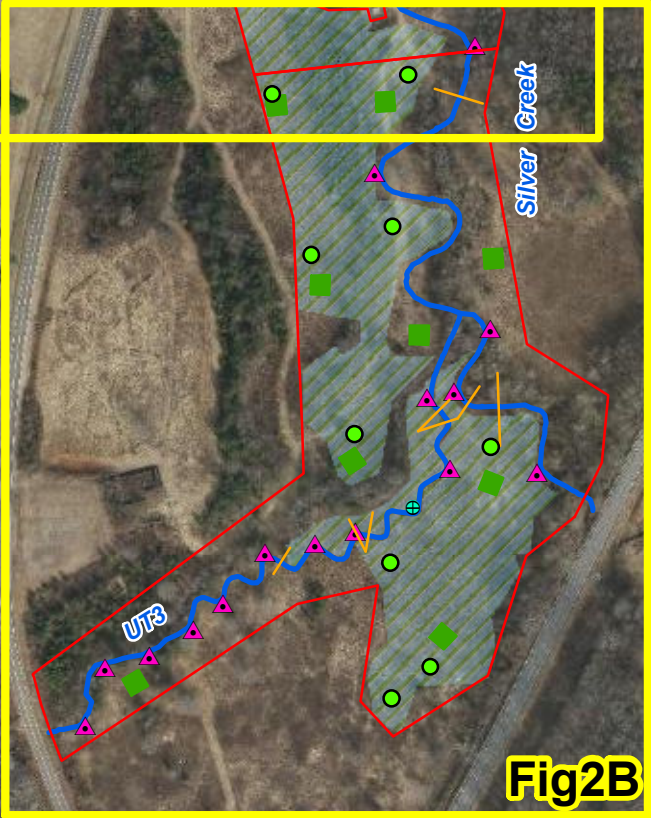
Figure 2
Current Conditions Plan View - MY&
Overview Map
Upper Silver Creek Site

Figure 2A. CCPV North half of Project

Figure 2B. CCPV South half of Project

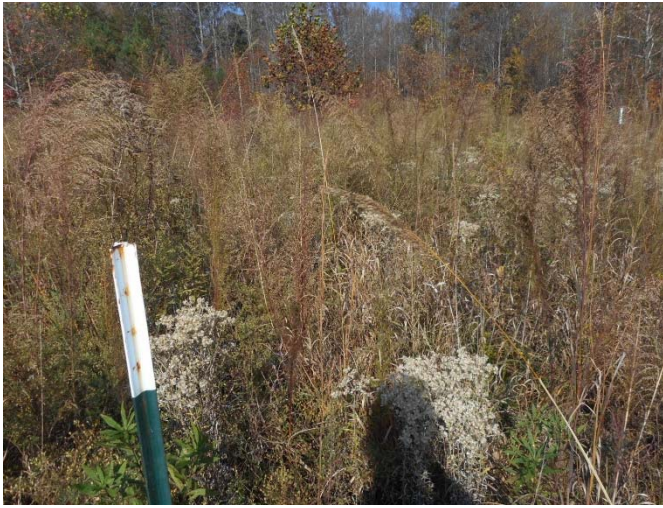
Photo 1. Vegetation Plot 1 – Tree photo (November 1, 2016).

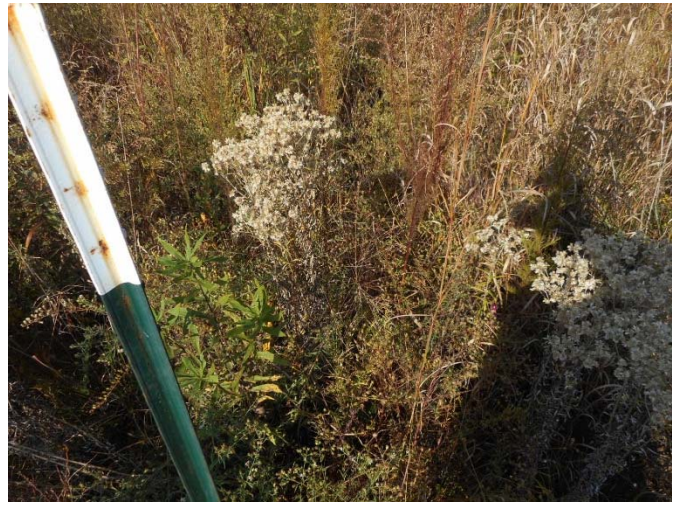
Photo 2. Vegetation Plot 1 – Herbaceous photo (November 1, 2016).

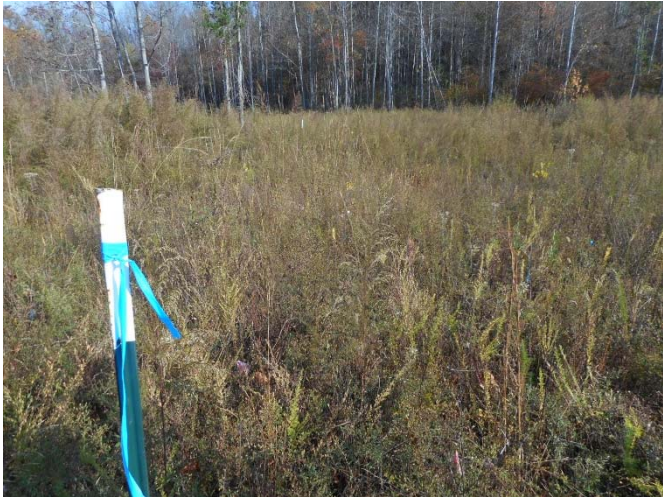
Photo 3. Vegetation Plot 2 – Tree photo (November 1, 2016).

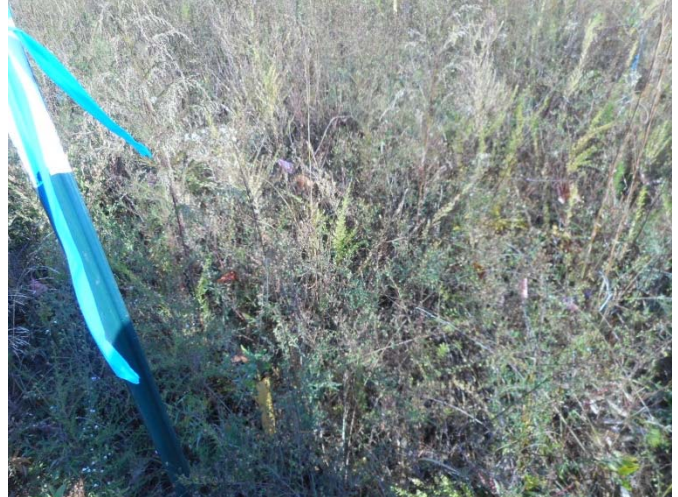
Photo 4. Vegetation Plot 2 – Herbaceous photo (November 1, 2016).

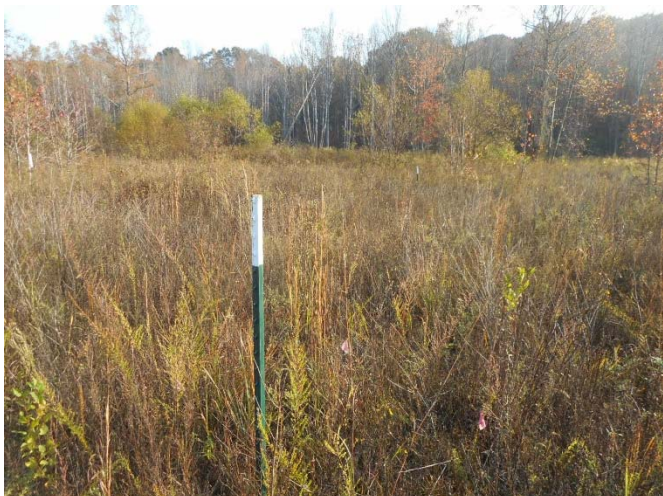
Photo 5. Vegetation Plot 3 – Tree photo (November 1, 2016).

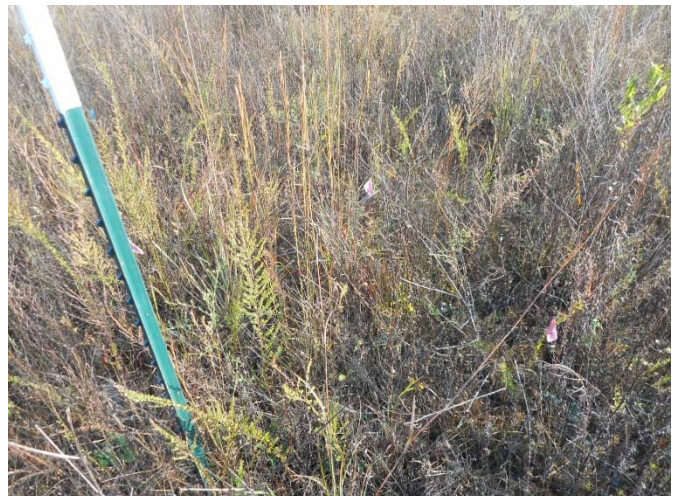
Photo 6. Vegetation Plot 3 – Herbaceous photo (November 1, 2016).

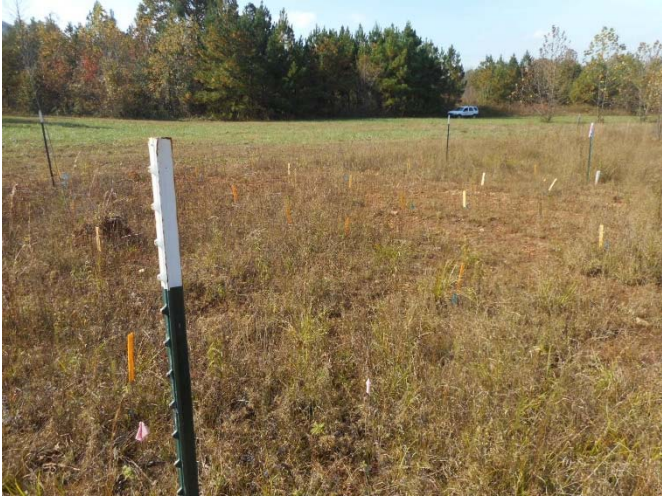
Photo 7. Vegetation Plot 4 – Tree photo (November 1, 2016).

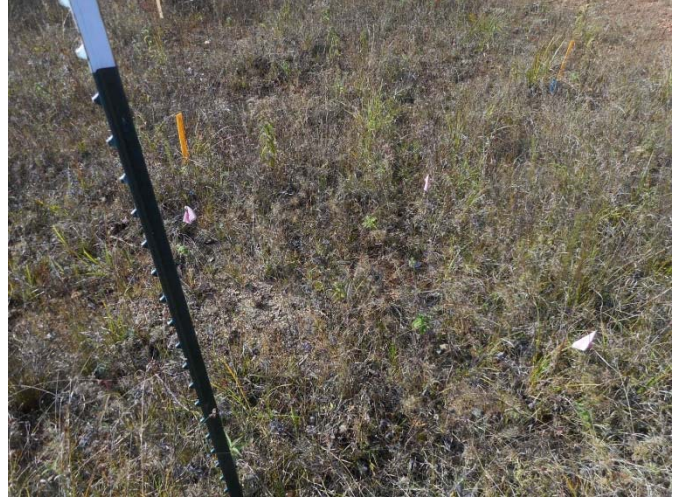
Photo 8. Vegetation Plot 4 – Herbaceous photo (November 1, 2016).

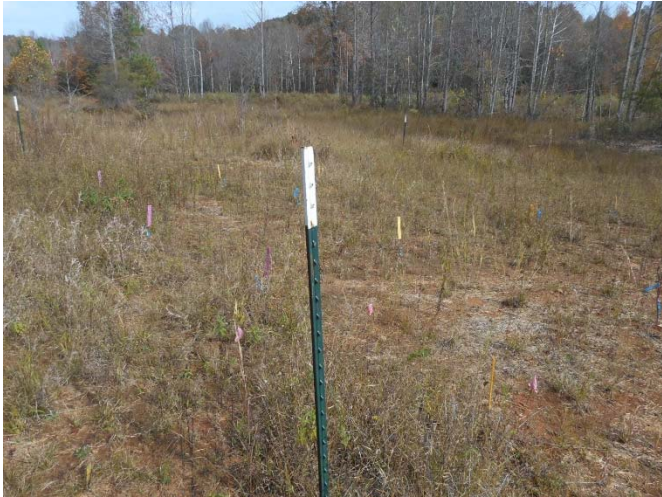
Photo 9. Vegetation Plot 5 – Tree photo (November 1, 2016).

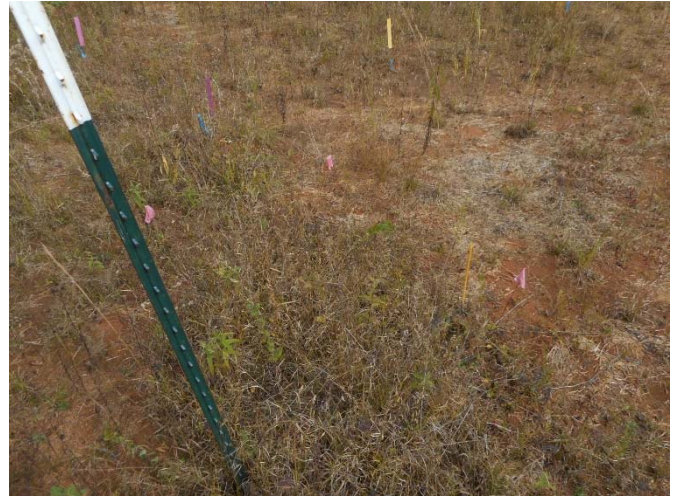
Photo Point 10, Vegetation Plot 5 – Herbaceous photo (November 1, 2016).

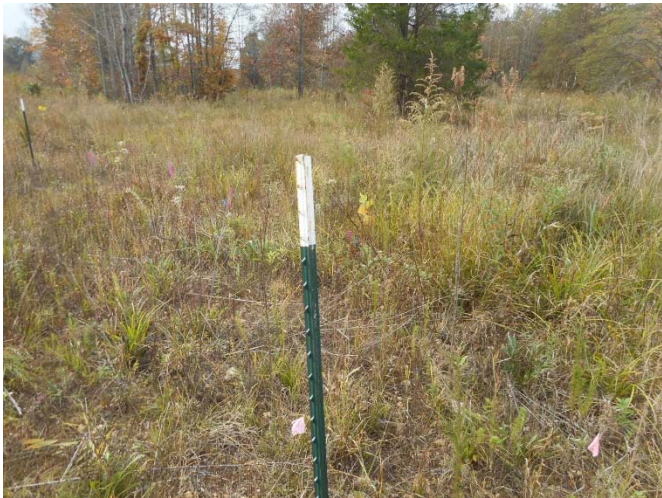
Photo 11. Vegetation Plot 6 – Tree photo (November 1, 2016).

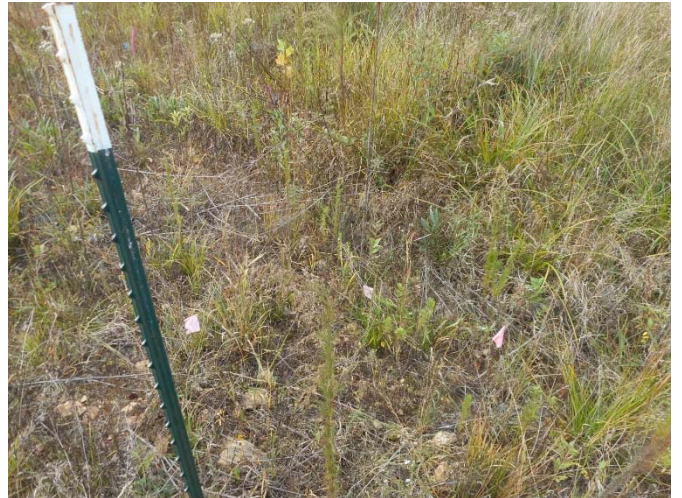
Photo 12. Vegetation Plot 6 – Herbaceous photo (November 1, 2016).

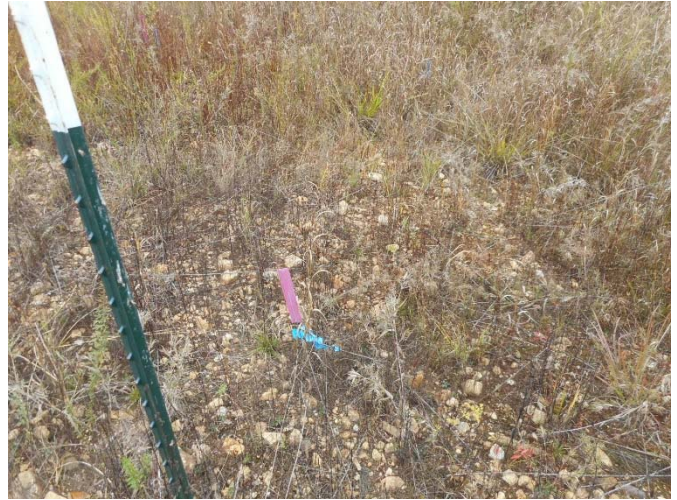
Photo 14. Vegetation Plot 7 – Herbaceous photo (November 1, 2016).

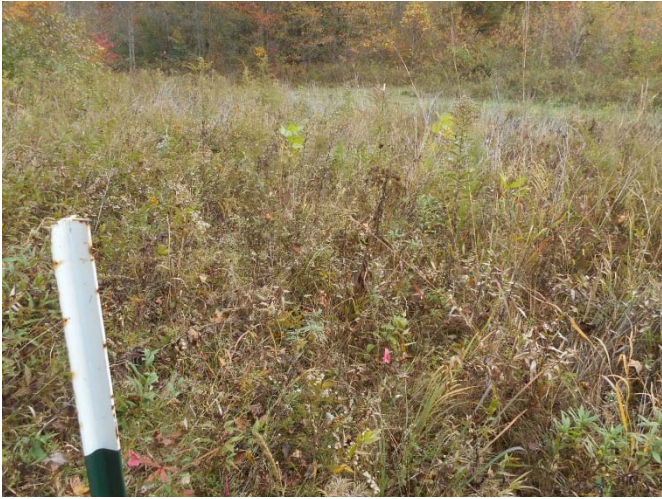
Photo 15. Vegetation Plot 8 – Tree photo (November 1, 2016).

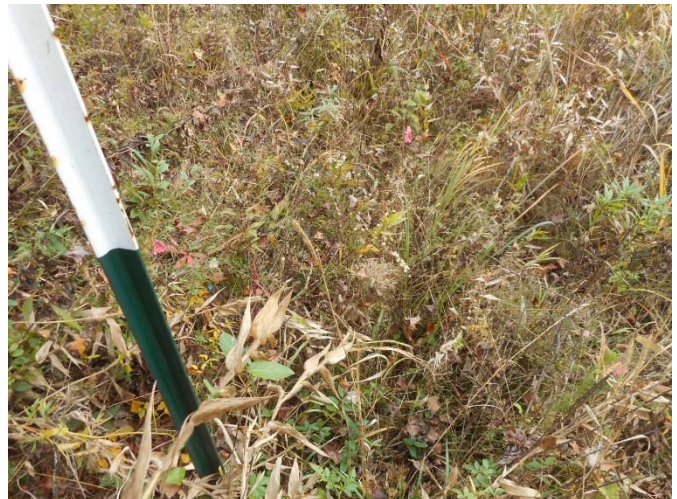
Photo 16. Vegetation Plot 8 – Herbaceous photo (November 1, 2016).

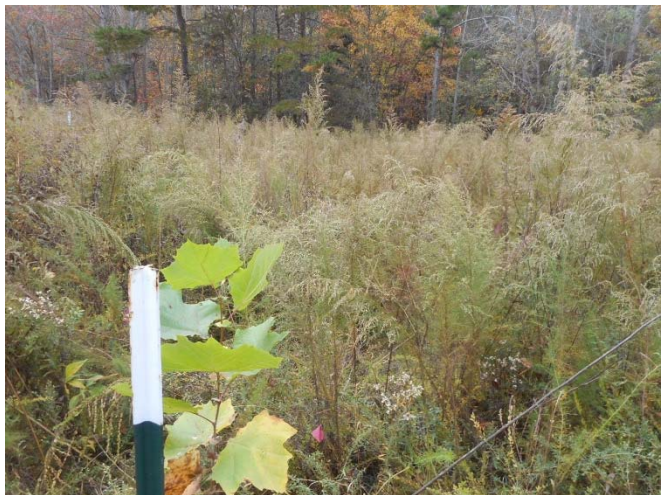
Photo 17. Vegetation Plot 9 – Tree photo (November 1, 2016).

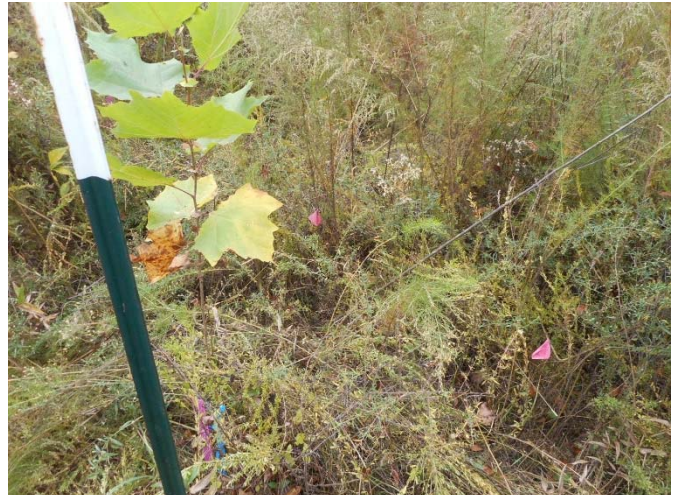
Photo 18. Vegetation Plot 9 – Herbaceous photo (November 1, 2016).

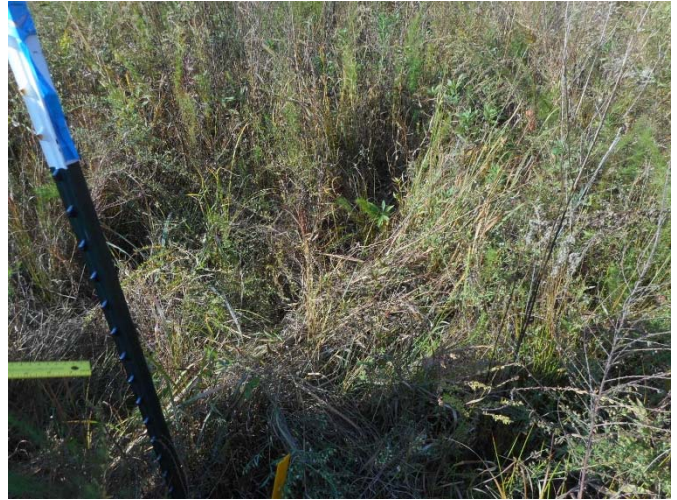
Photo 20. Vegetation Plot 10 – Herbaceous photo (November 1, 2016).

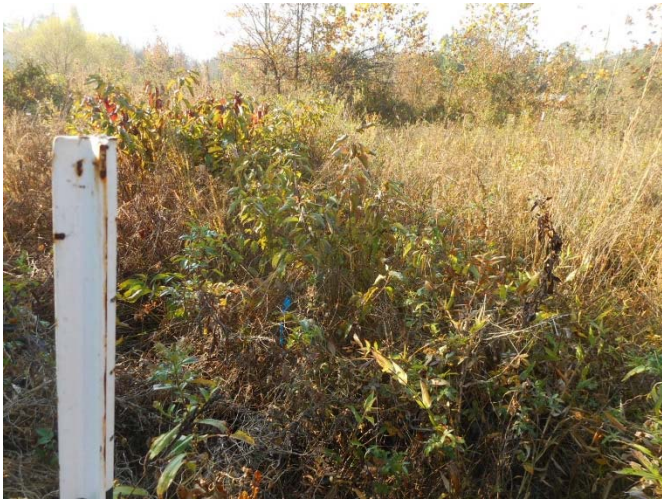
Photo 21. Vegetation Plot 11 – Tree photo (November 1, 2016).

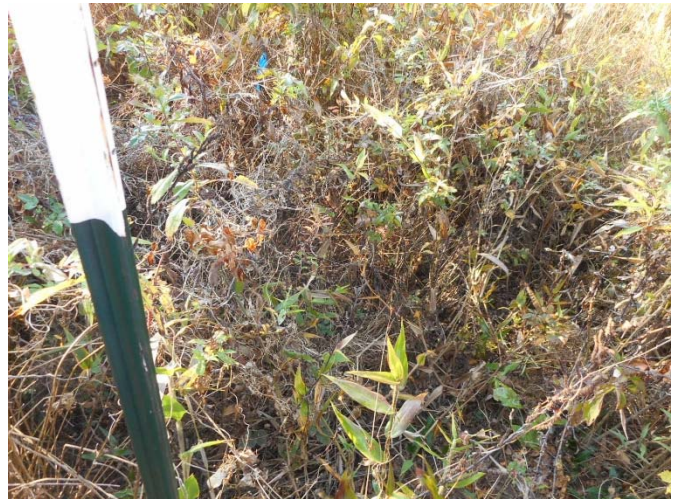
Photo 22. Vegetation Plot 11 – Herbaceous photo (November 1, 2016).

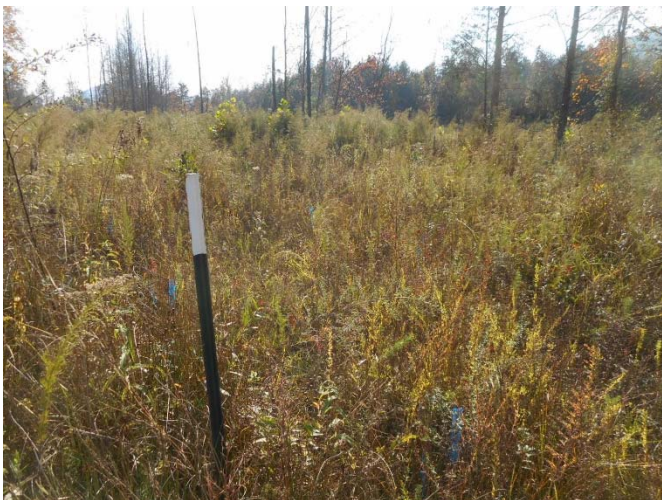
Photo 23. Vegetation Plot 12 – Tree photo (November 1, 2016).

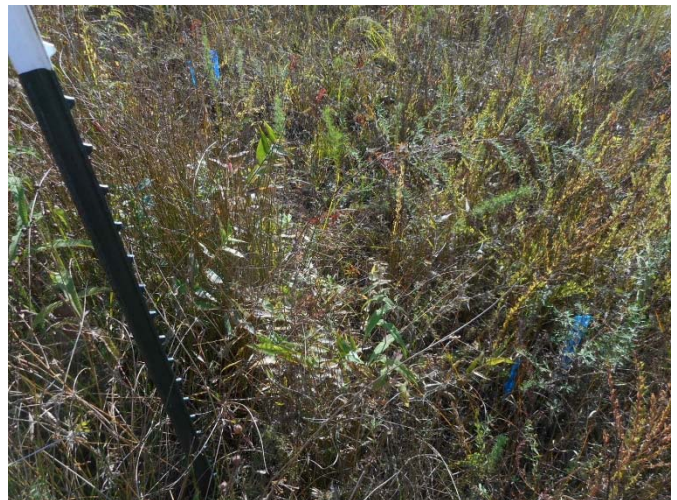
Photo 24. Vegetation Plot 12 – Herbaceous photo (November 1, 2016).

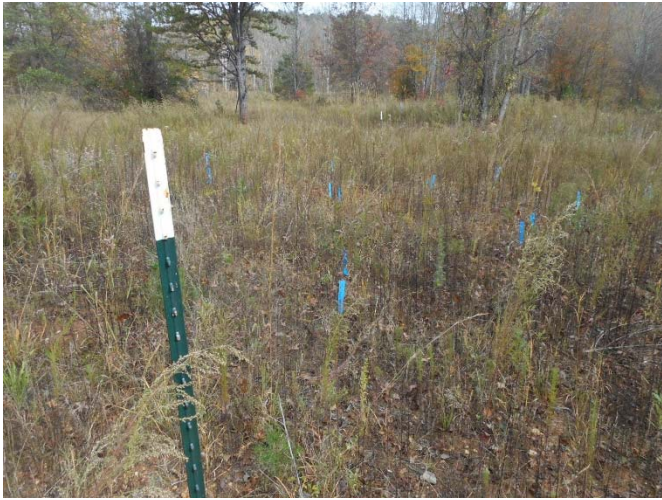
Photo 25. Vegetation Plot 13 – Tree photo (November 1, 2016).

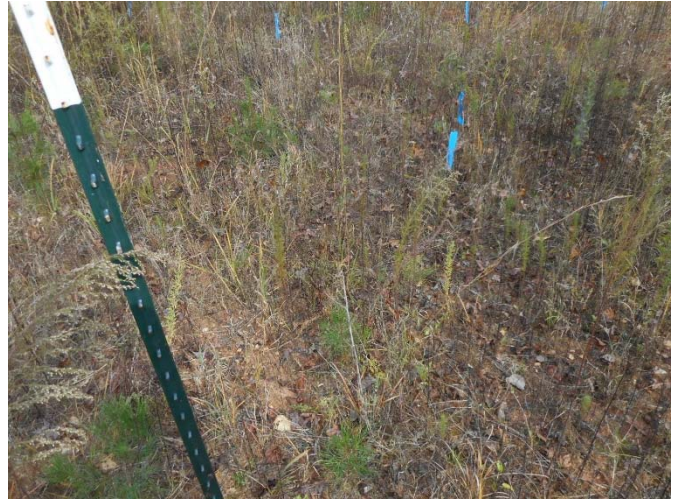
Photo 26. Vegetation Plot 13 – Herbaceous photo (November 1, 2016).

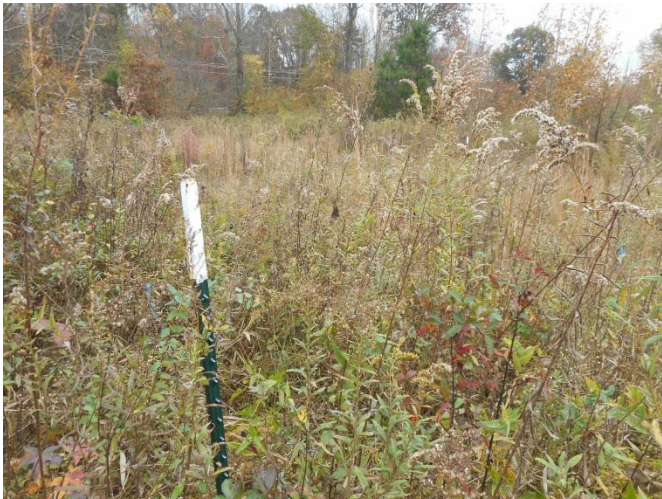
Photo 27. Vegetation Plot 14 – Tree photo (November 1, 2016).

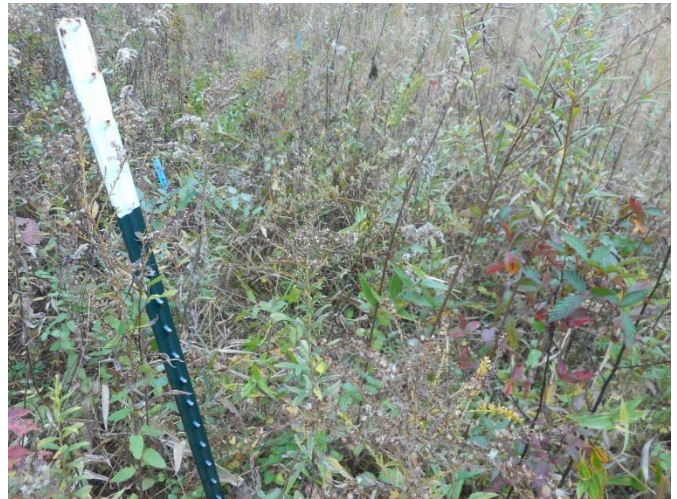
Photo 28. Vegetation Plot 14 – Herbaceous photo (November 1, 2016).

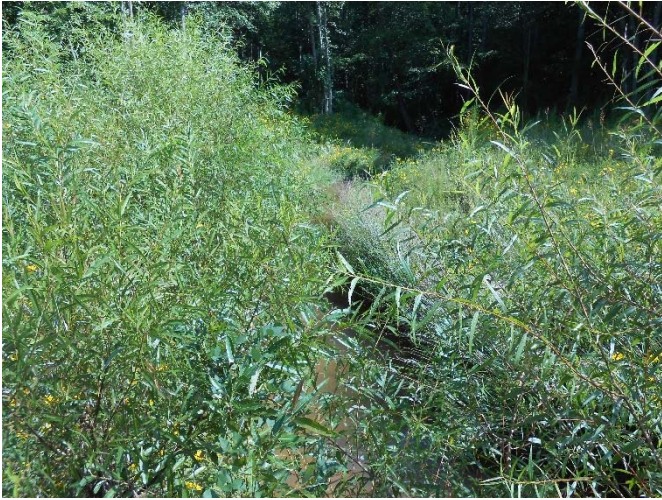
Photo 1. Mainstem Photo Point 1 – Station 29+26 (August 30, 2016) downstream view from left bank.

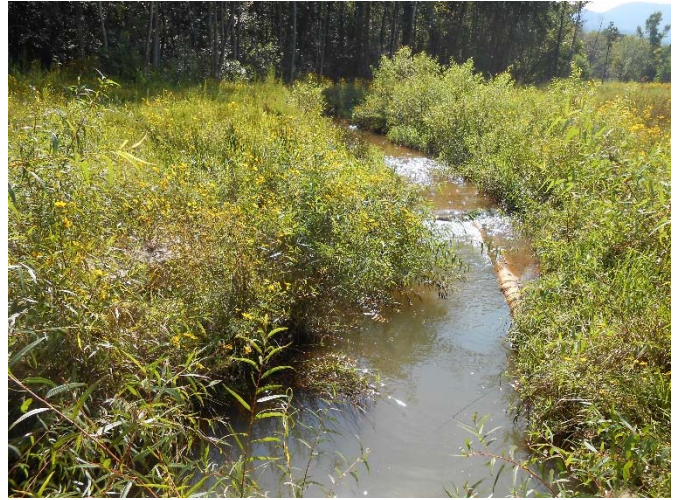
Photo 2. Mainstem Photo Point 1 – Station 29+26 (August 30, 2016) upstream view from left bank.

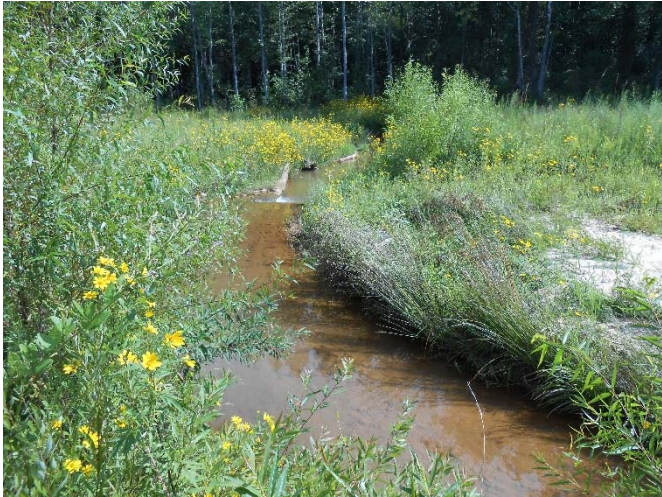
Photo 3. Mainstem Photo Point 2 – Station 26+44 (August 30, 2016) downstream view from left bank.

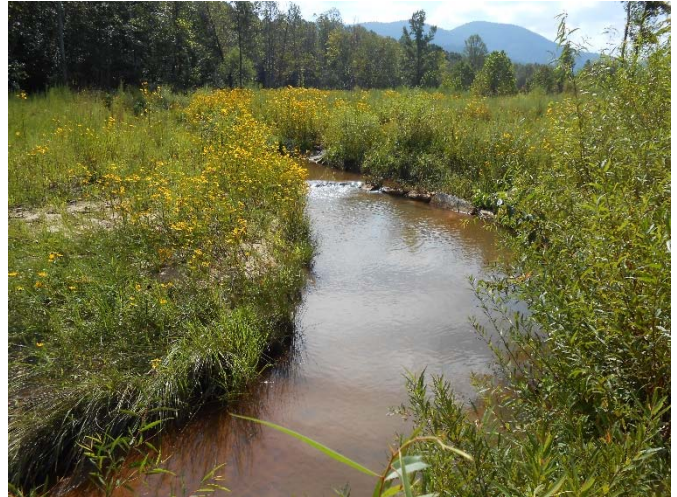
Photo 4. Mainstem Photo Point 2 – Station 26+44 (August 30, 2016) upstream from left bank.

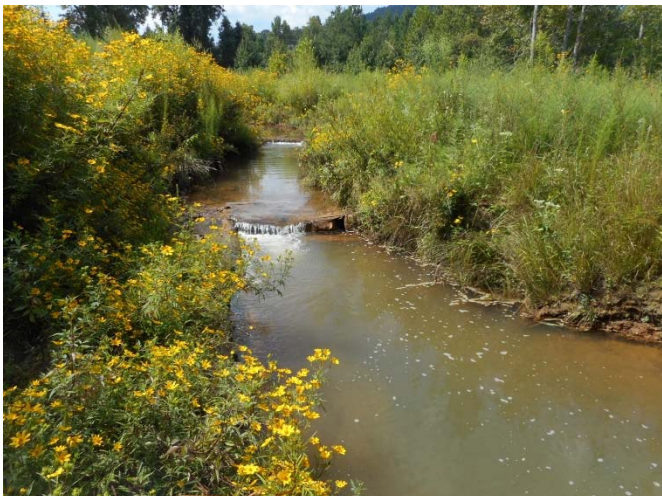
Photo 5. Mainstem Photo Point 3 – Station 24+70 (August 30, 2016) upstream from right bank.

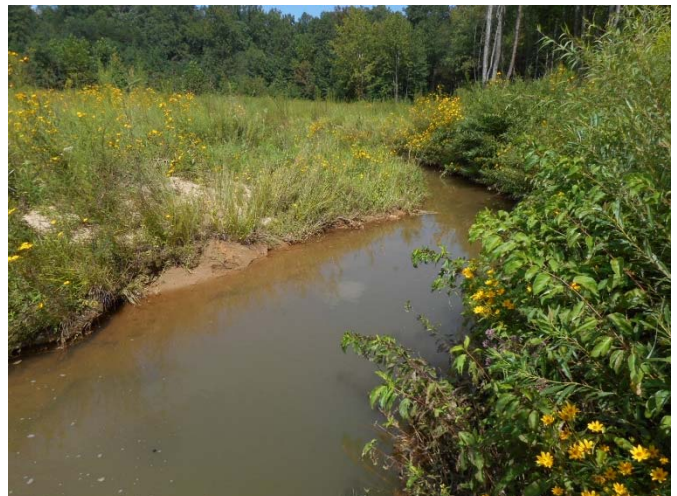
Photo 6. Mainstem Photo Point 3 – Station 24+70 (August 30, 2016) downstream from right bank.

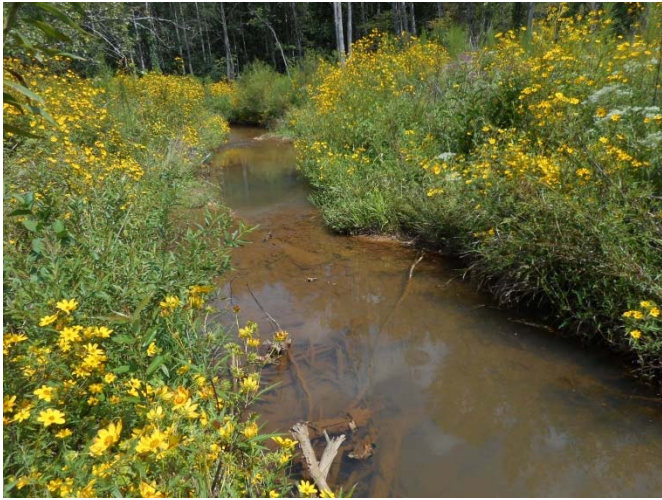
Photo 7. Mainstem Photo Point 4 (PP4) – Station 20+30 (August 30, 2016) downstream from left bank.

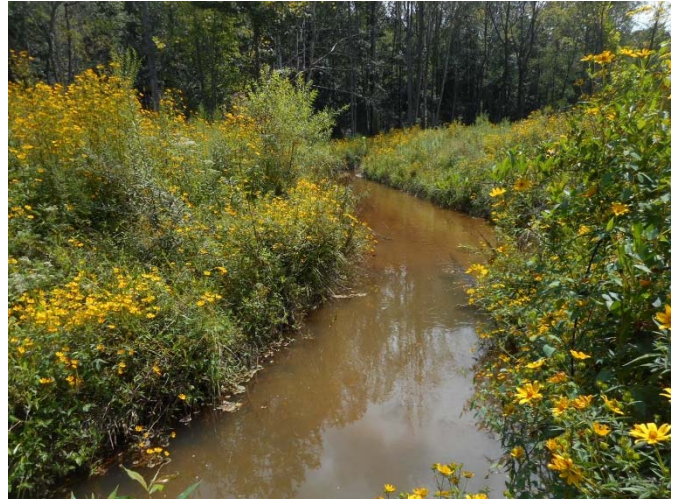
Photo 8. Mainstem Photo Point 4 (PP4) – Station 20+30 (August 30, 2016) upstream from left bank.

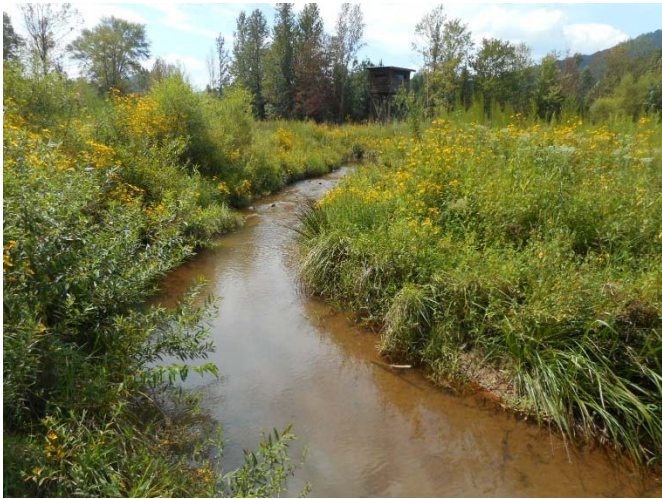
Photo 9. Mainstem Photo Point 5 – Station 16+03 (August 30, 2016) upstream from right bank.

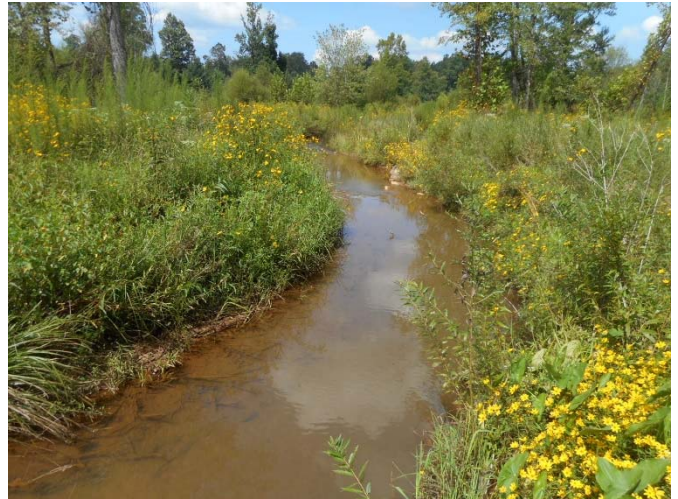
Photo 10, Mainstem Photo Point 5 – Station 16+03 (August 30, 2016) downstream from right bank.

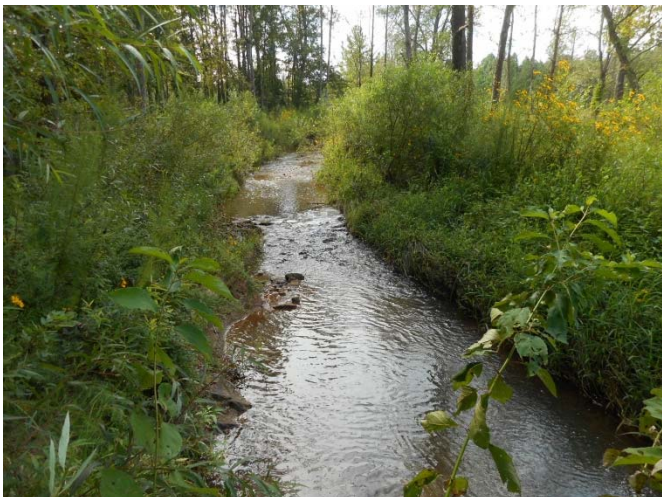
Photo 11. Mainstem Photo Point 6 – Station 13+03 (August 30, 2016) upstream from right bank.

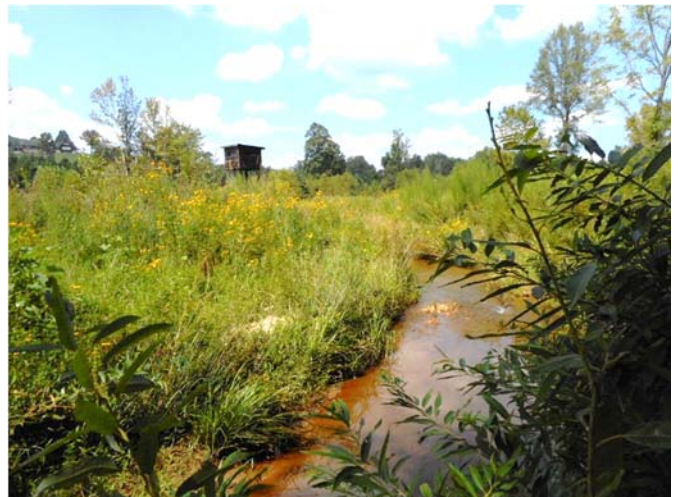
Photo 12. Mainstem Photo Point 5 – Station 13+03 (August 30, 2016) downstream from right bank.

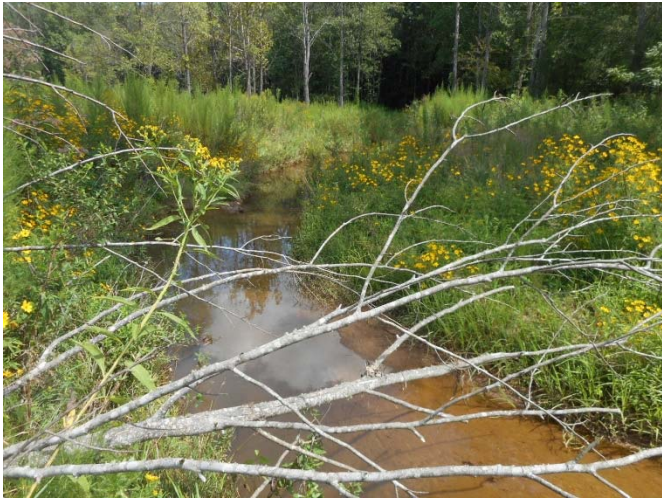
Photo 13. Mainstem Photo Point 7 – Station 10+11
(August 30, 2016) downstream from left bank.

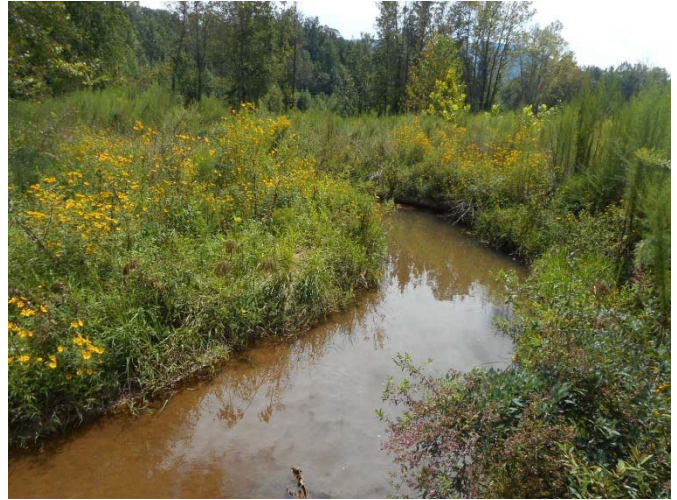
Photo 14. Mainstem Photo Point 7 – Station 10+11
(August 30, 2016) upstream from left bank.

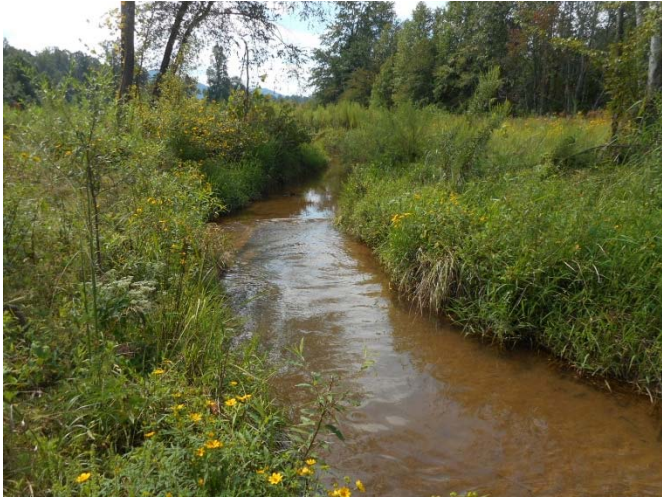
Photo 15. Mainstem Photo Point 8 – Station 5+06
(August 30, 2016) upstream from right bank.

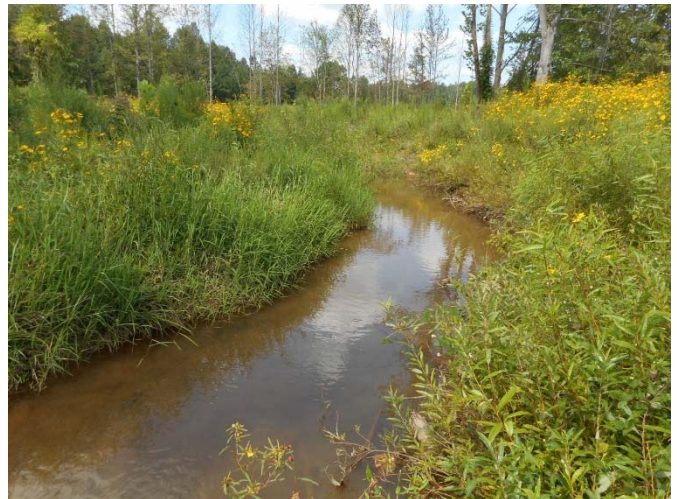
Photo 16. Mainstem Photo Point 8 – Station 5+06
(August 30, 2016) downstream from right bank.

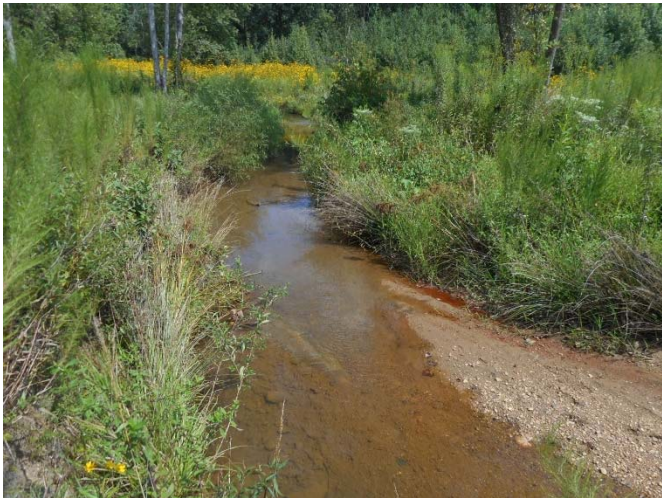
Photo 17. Mainstem Photo Point 9 – Station 3+87
(August 30, 2016) downstream from left bank.

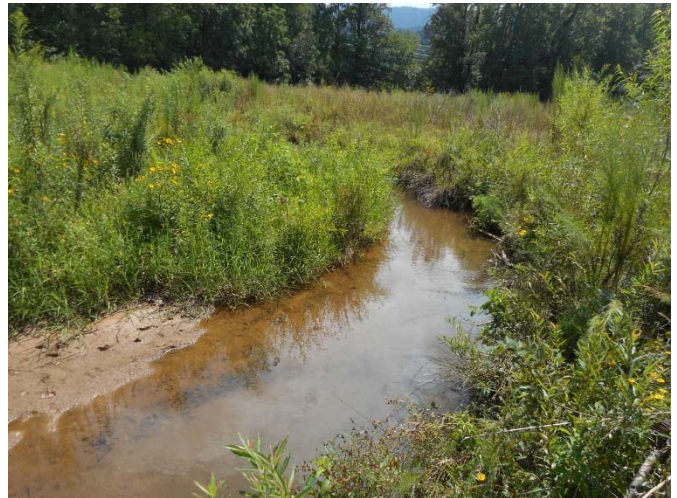
Photo 18. Mainstem Photo Point 9 – Station 3+87
(August 30, 2016) upstream from left bank.

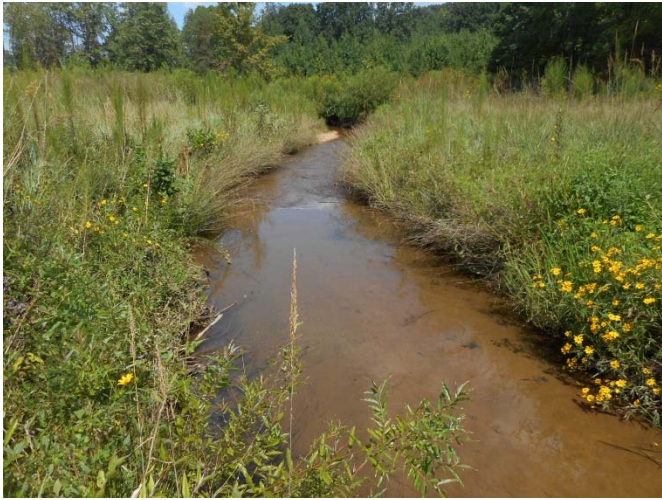
Photo 19. Mainstem Photo Point 10 – Stat. 1+22 (August 30, 2016) downstream from left bank.

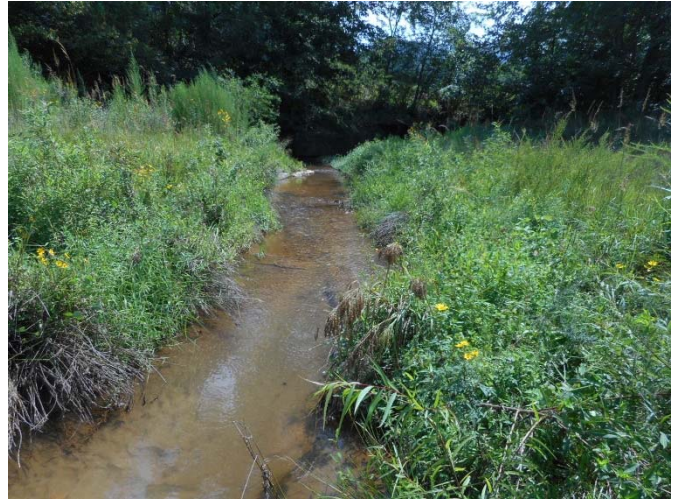
Photo 20. Mainstem Photo Point 10 – Stat. 1+22 (August 30, 2016) upstream from left bank.

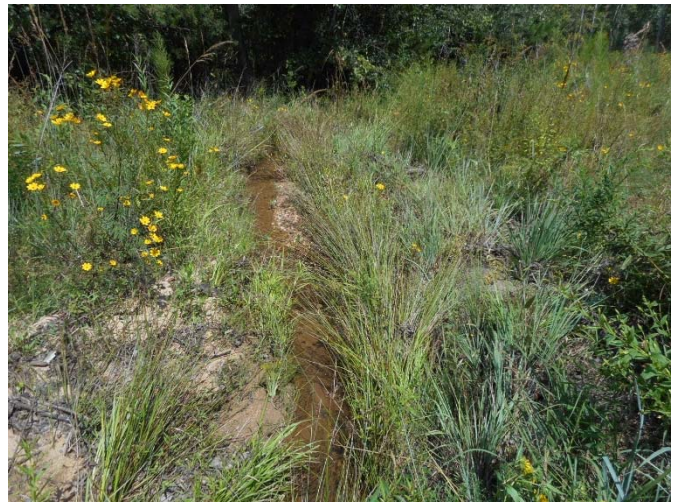
Photo 45. UT3 Photo Point 6 – Station 4+55 (August 30, 2016) downstream from right bank.

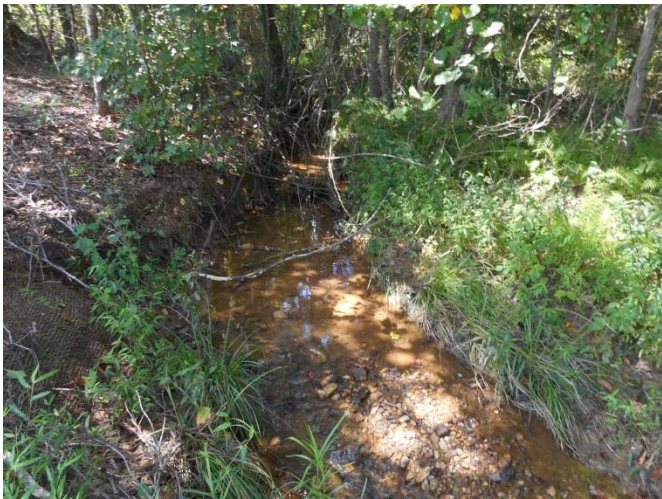
Photo 46. UT3 Photo Point 7 – Station 3+60 (August 30, 2016) upstream to structure.

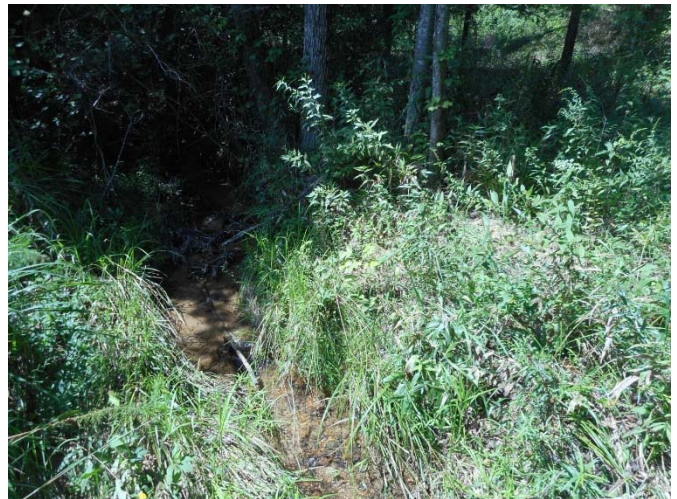
Photo 47. UT3 Photo Point 8 – Station 2+70 (August 30, 2016) upstream to structure.

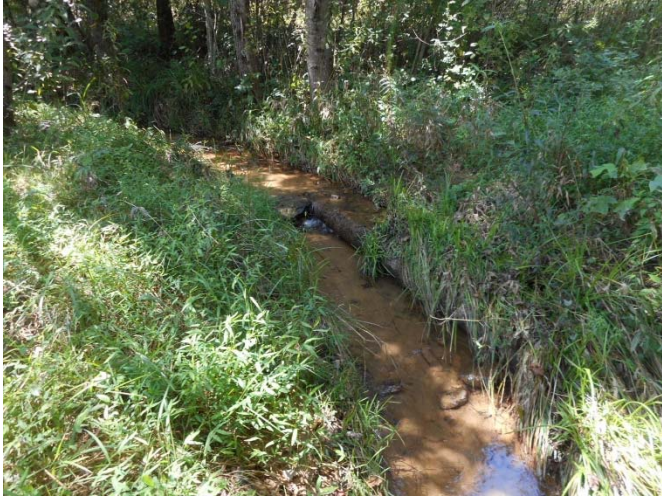
Photo 48. UT3 Photo Point 9 – Station 1+90
(August 30, 2016) upstream to structure.

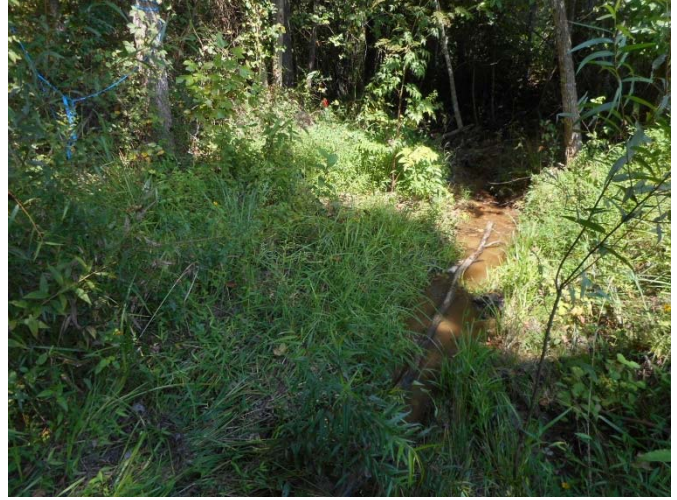
Photo 49. UT3 Photo Point 10 – Station 0+60
(August 30, 2016) downstream to structure.

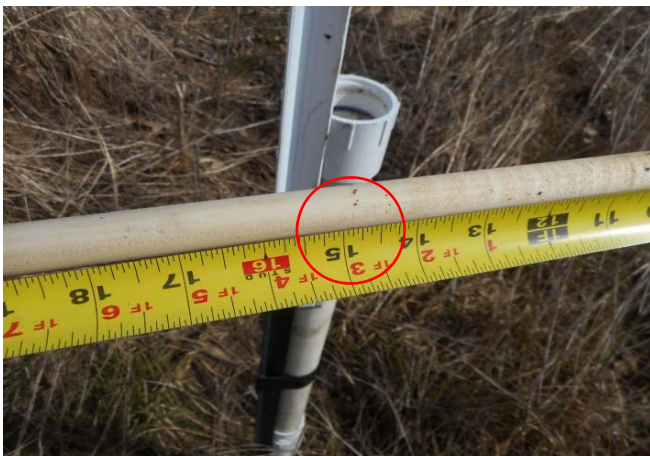
Photo 1. Silver Creek crest gauge staff showing cork deposition in red circle at 15.0 above the bottom of the staff, which is at the bankfull elevation.

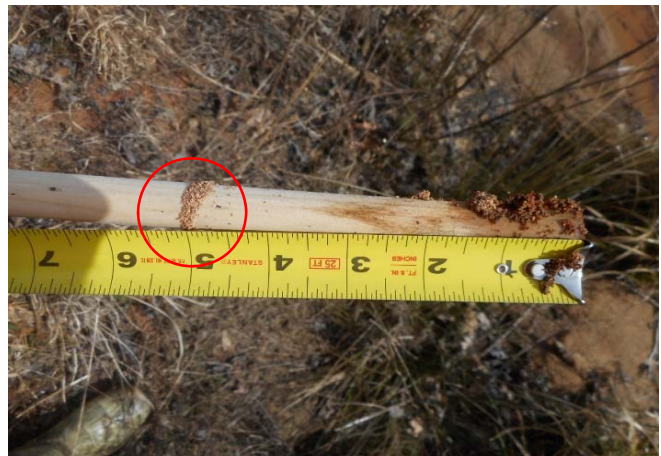
Photo 2. UT3 crest gauge staff showing cork deposition in red circle at 5.0 ft above the bottom of the staff, which is at the bankfull elevation.

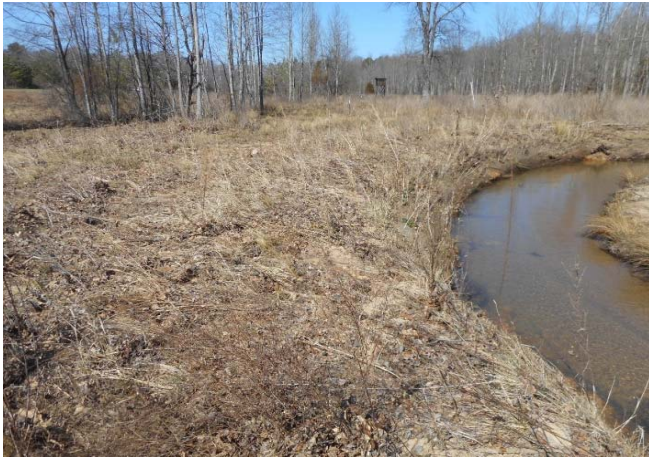
Photo 3. Silver Creek stream bank showing accumulated debris of wrack line and bent over vegetation well above bankfull. Verifies crest gauge measurement.

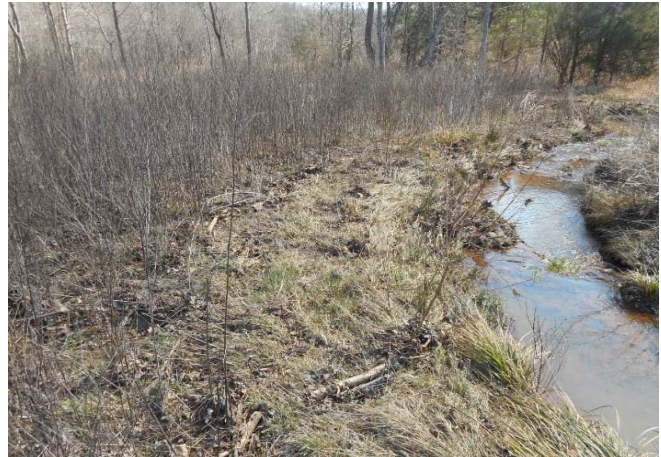
Photo 4. Stream bank along UT3 showing accumulated debris along wrack line in vegetation well above bankfull. Verifies crest gauge measurements.

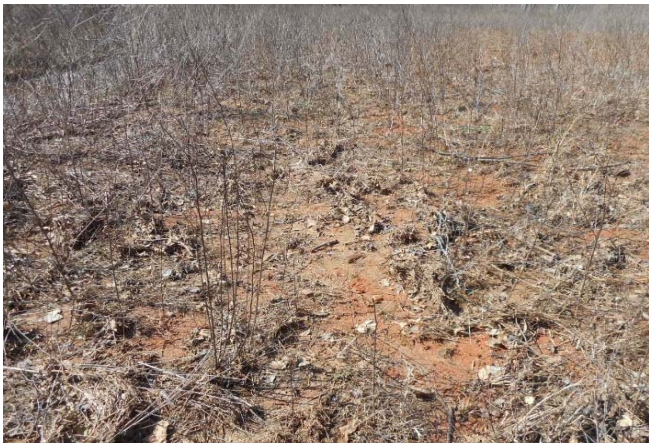
Photo 5. Floodplain along Silver Creek showing accumulated debris of wrack line indicating high flows that were out of bank and filling the valley.

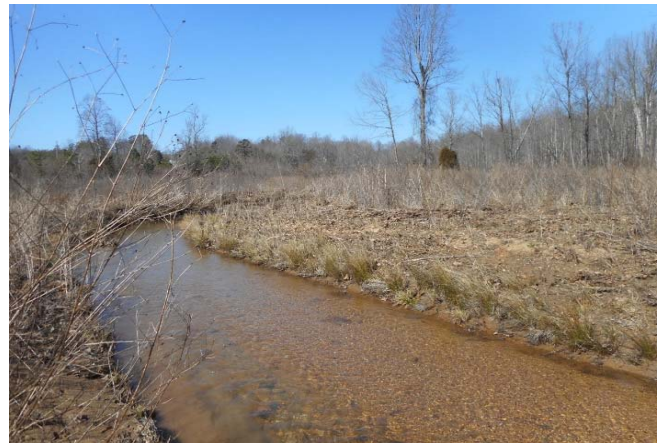
Photo 6. Stream bank along Silver Creek showing accumulated debris at the top of bank where flood waters were leaving the channel.

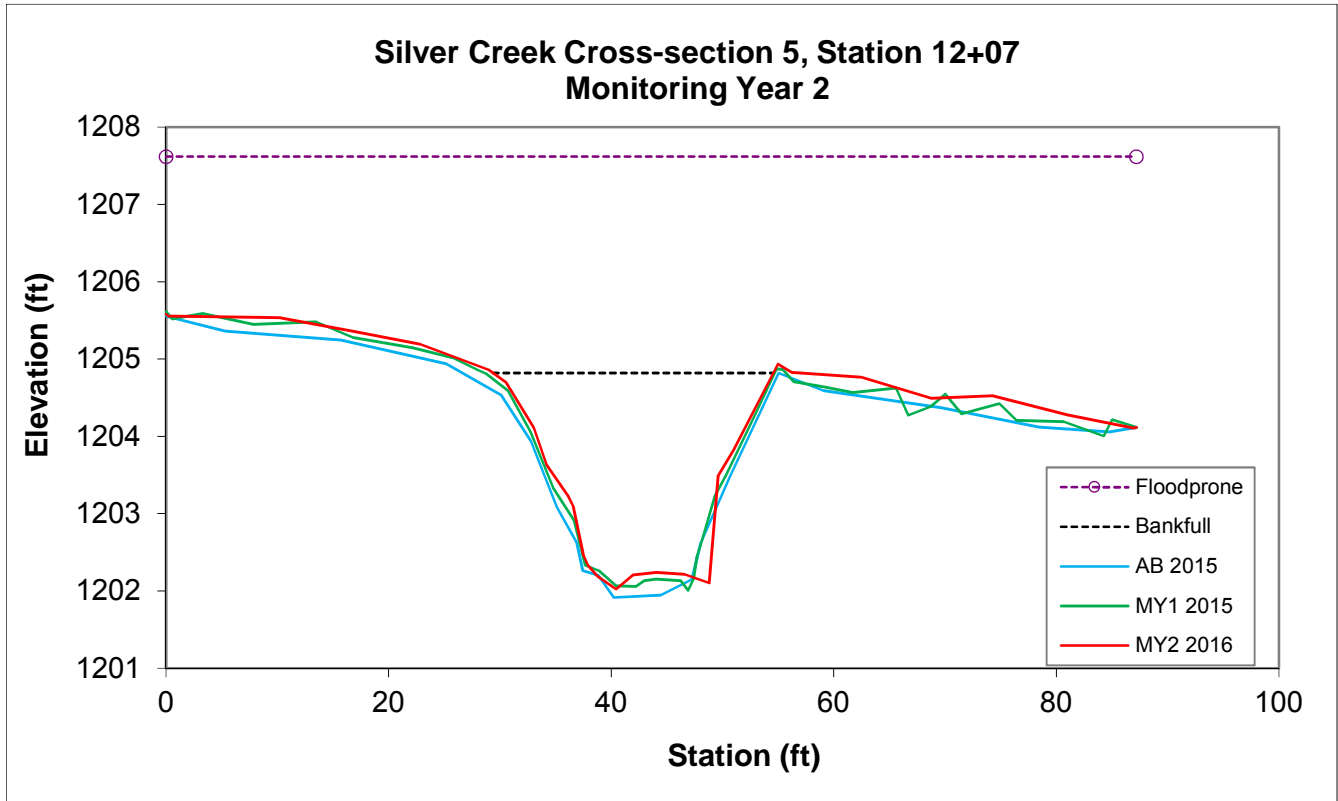
Permanent Cross-section 5
(MY2 Data - collected November, 2016)

Based on fixed baseline BKF

Feature	Stream Type	BKF Area	BKF Width	BKF Depth	Max BKF Depth	W/D	BH Ratio	ER	BKF Elev	TOB Elev
Riffle	C	42.3	25.21	1.68	2.8	15.04	1	3.5	1204.82	1204.7

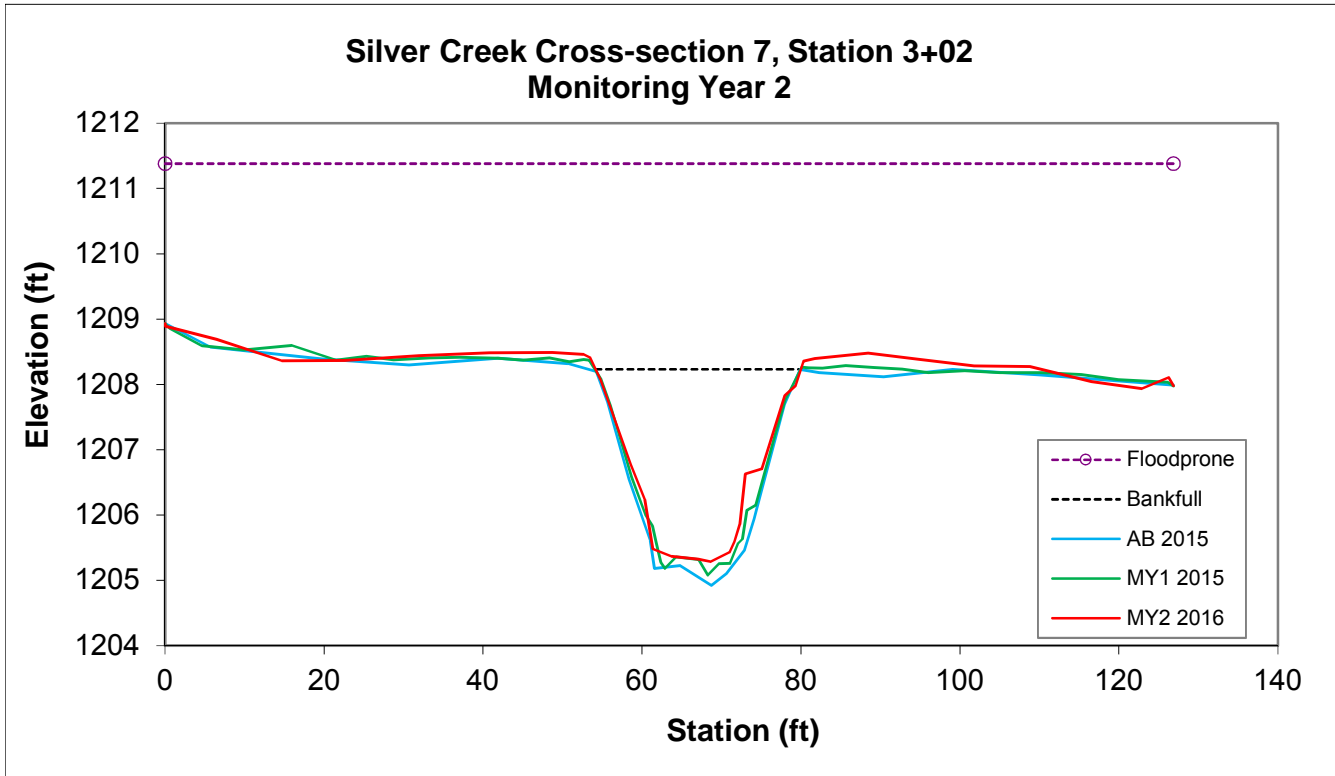
Permanent Cross-section 7
 (MY2 Data - collected November, 2016)

Based on fixed baseline BKF

Feature	Stream Type	BKF Area	BKF Width	BKF Depth	Max BKF Depth	W/D	BH Ratio	ER	BKF Elev	TOB Elev
Riffle	C	47.6	25.82	1.84	2.95	14.02	1	4.9	1208.23	1208.36
