Upper Silver Creek Restoration Project Year 2 Monitoring Report

Burke County, North Carolina

NCDMS Project ID Number – 94645

Monitoring Year: 2 of 5

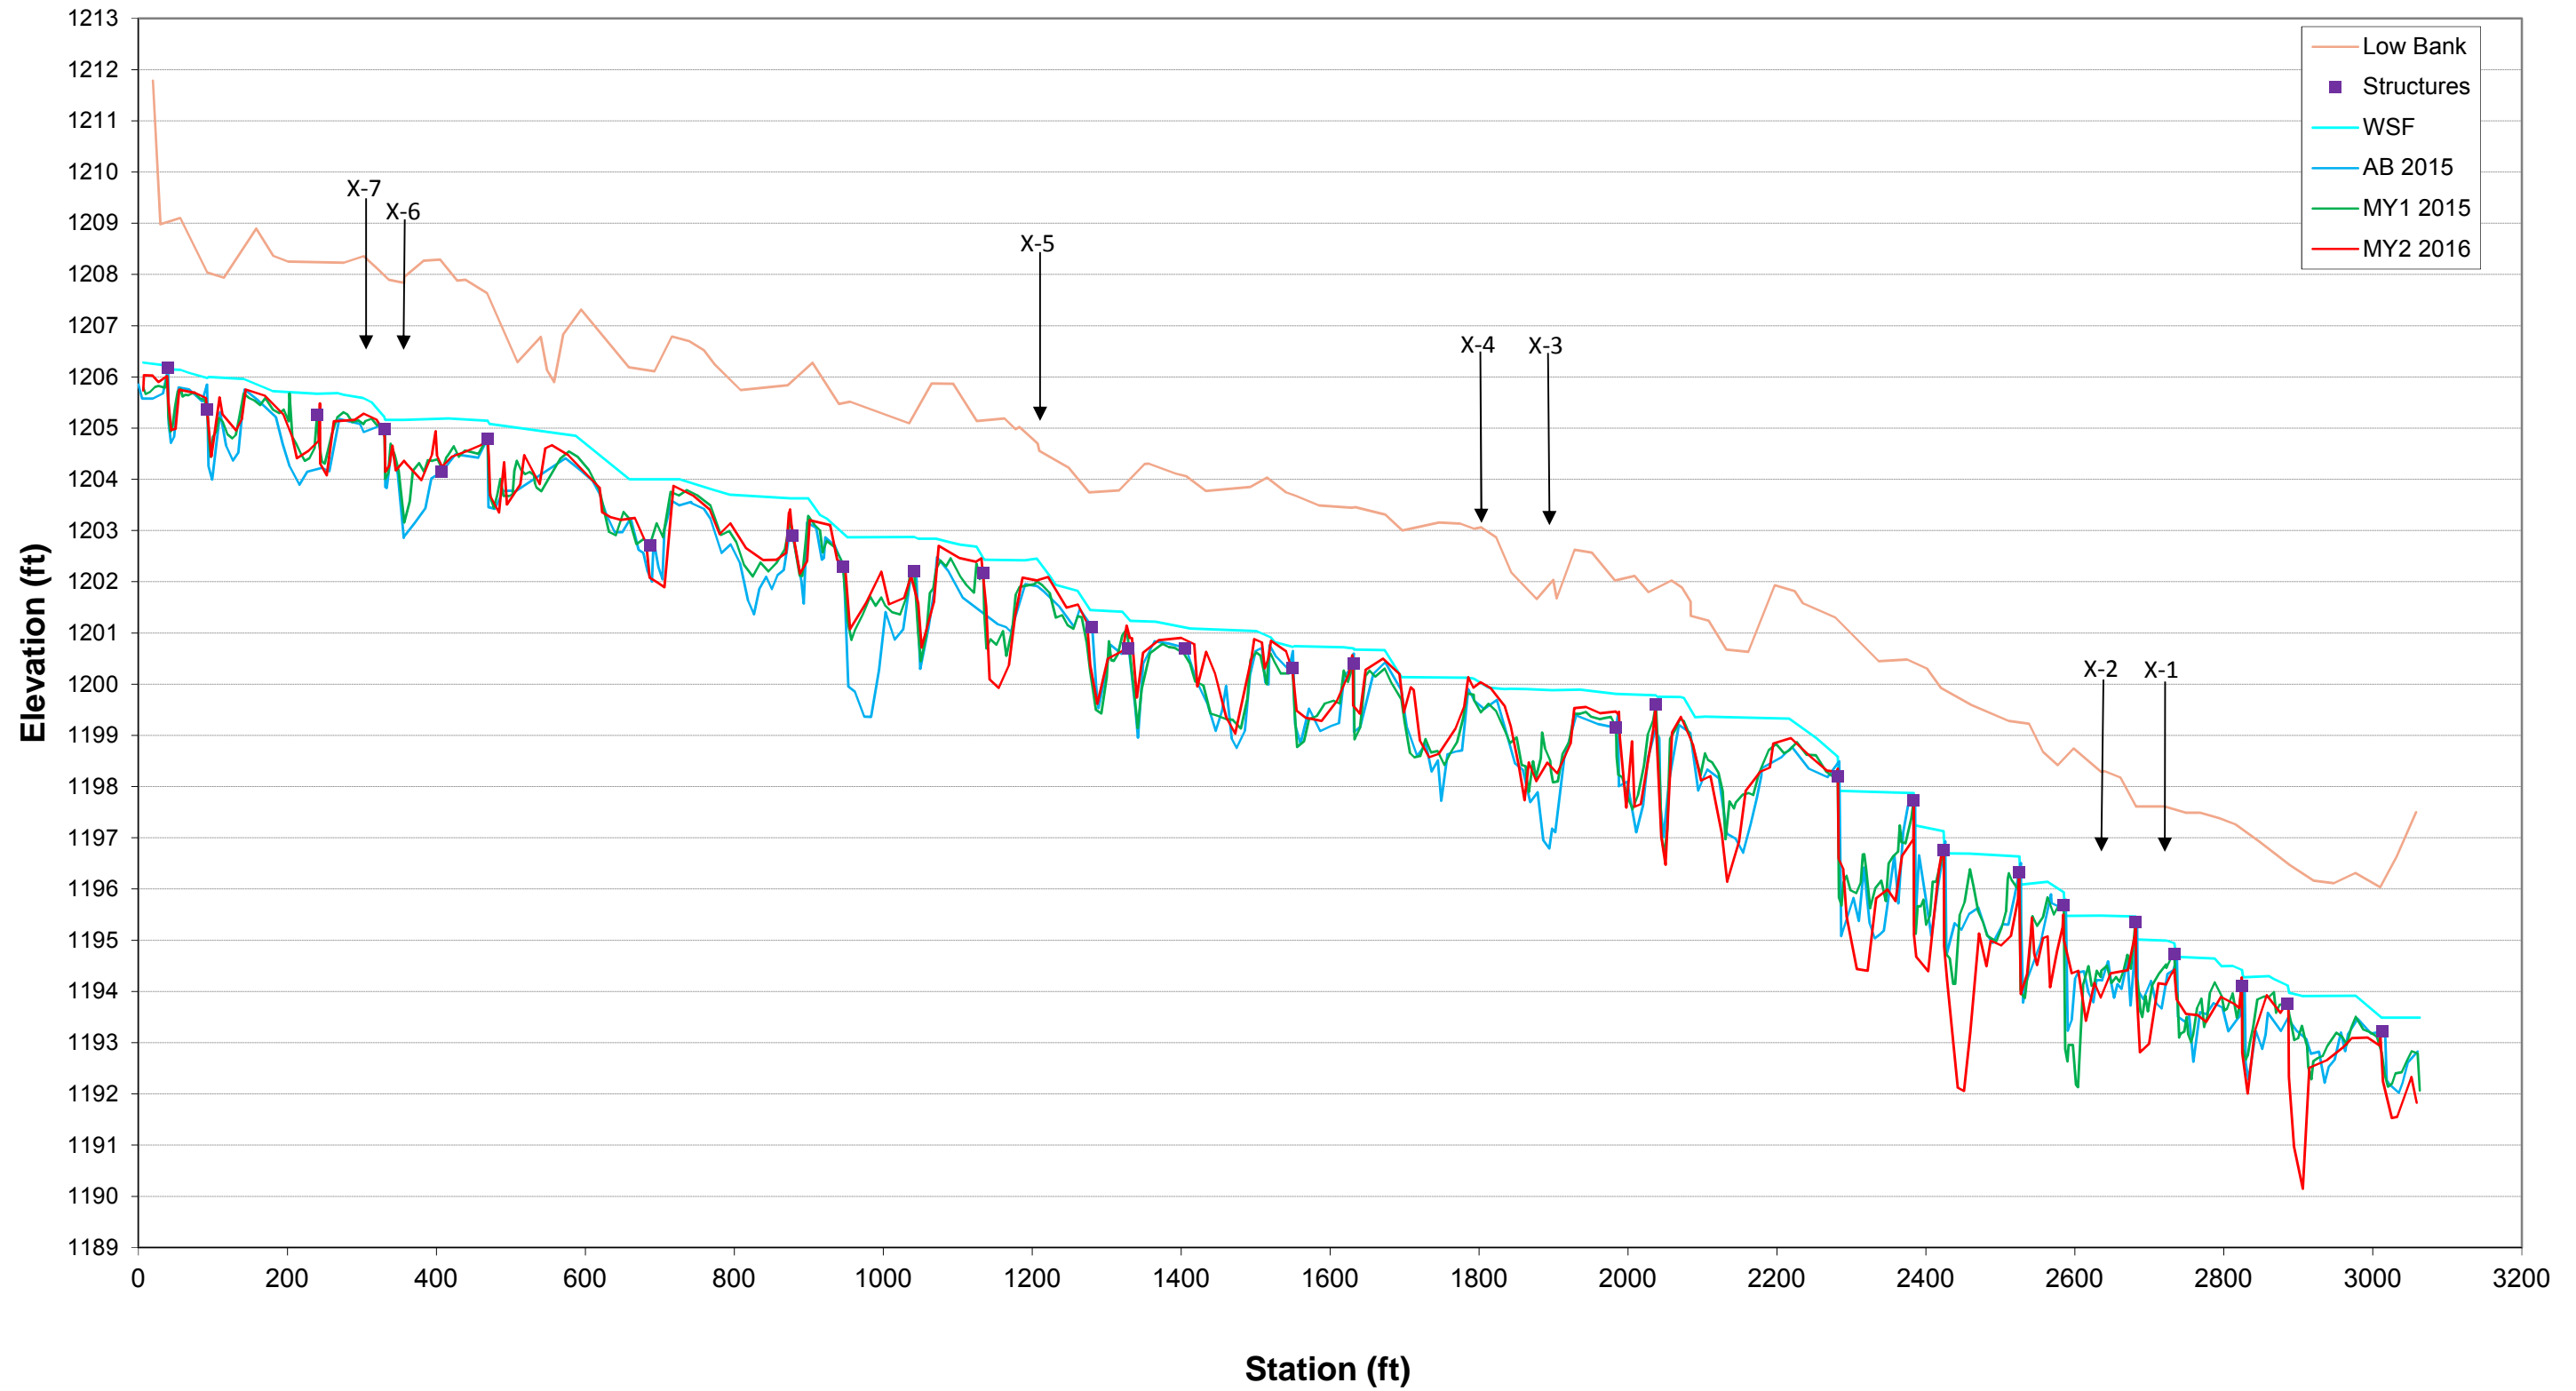
Monitoring Year 2 Profile of U. Silver Creek, Station 0+00 to 32+00 Data collected November, 2016

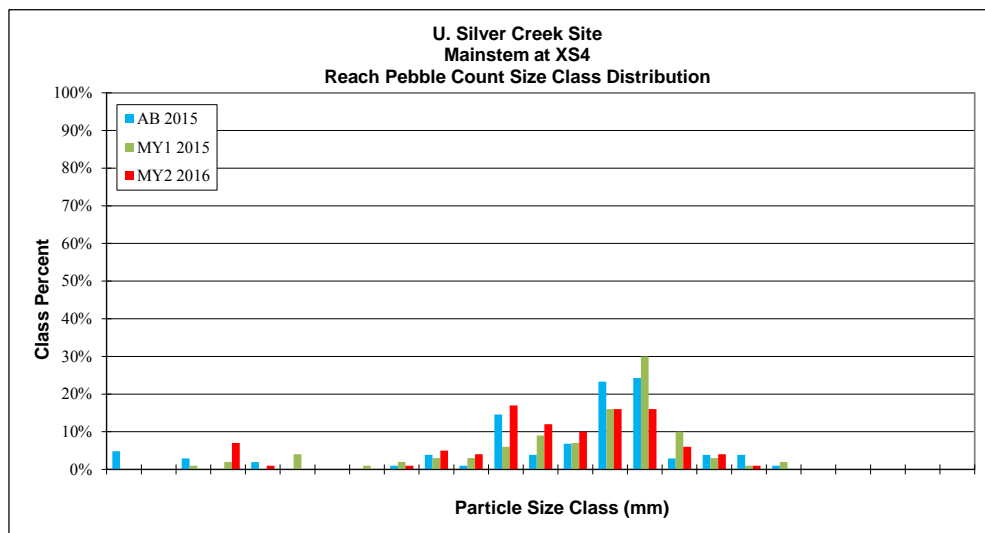
Largest particle= 130

Summary Data			
Channel materials			
D16 =	9.4	D84 =	57.3
D35 =	16.0	D95 =	90.0
D50 =	25.1	D100 =	128 - 180

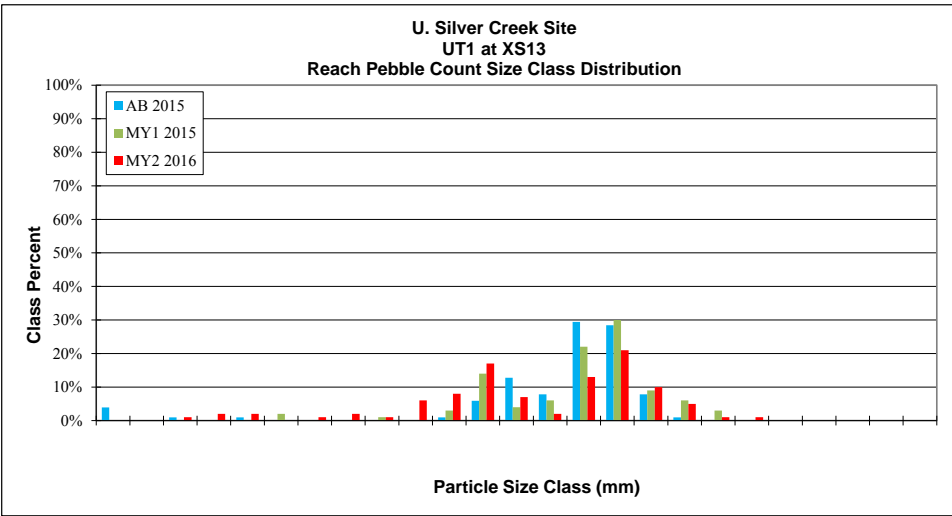
SITE OR PROJECT:		U. Silver Cr				
REACH/LOCATION:		UT1 XS13				
FEATURE:		Riffle				
DATE:		2-Nov-16				
		MY2 2016			Distribution	
MATERIAL	PARTICLE	SIZE (mm)	Total	Class %	% Cum	Plot Size (mm)
Silt/Clay	Silt / Clay	< .063			0%	0.063
	Very Fine	.063 - .125			0%	0.125
Sand	Fine	.125 - .25	1	1%	1%	0.25
	Medium	.25 - .50	2	2%	3%	0.50
	Coarse	.50 - 1.0	2	2%	5%	1.0
	Very Coarse	1.0 - 2.0			5%	2.0
Gravel	Very Fine	2.0 - 2.8	1	1%	6%	2.8
	Very Fine	2.8 - 4.0	2	2%	8%	4.0
	Fine	4.0 - 5.6	1	1%	9%	5.6
	Fine	5.6 - 8.0	6	6%	15%	8.0
	Medium	8.0 - 11.0	8	8%	23%	11.0
	Medium	11.0 - 16.0	17	17%	40%	16.0
	Coarse	16 - 22.6	7	7%	47%	22.6
	Coarse	22.6 - 32	2	2%	49%	32
	Very Coarse	32 - 45	13	13%	62%	45
	Very Coarse	45 - 64	21	21%	83%	64
Cobble	Small	64 - 90	10	10%	93%	90
	Small	90 - 128	5	5%	98%	128
	Large	128 - 180	1	1%	99%	180
	Large	180 - 256	1	1%	100%	256
Boulder	Small	256 - 362			100%	362
	Small	362 - 512			100%	512
	Medium	512 - 1024			100%	1024

Largest particle= 210

Summary Data	
Channel materials	
D16 =	8.3
D35 =	14.3
D50 =	32.9
D84 =	66.2
D95 =	103.6
D100 =	180 - 256

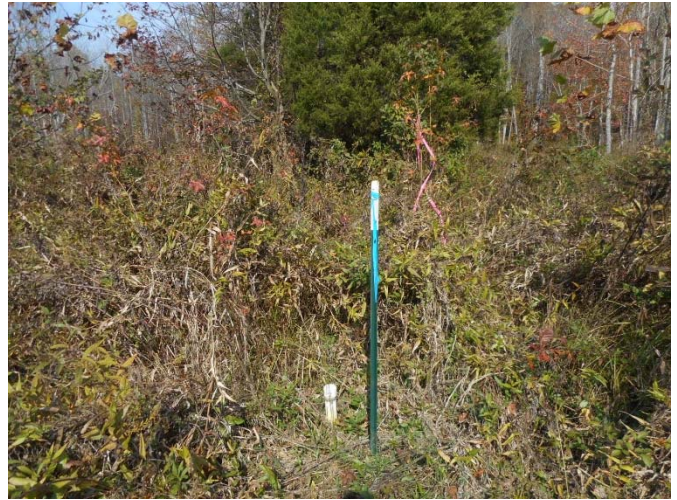
Photo 2. Wetland Photo Point – W2, replicates photo 51 in Baseline Report (November 1, 2016).

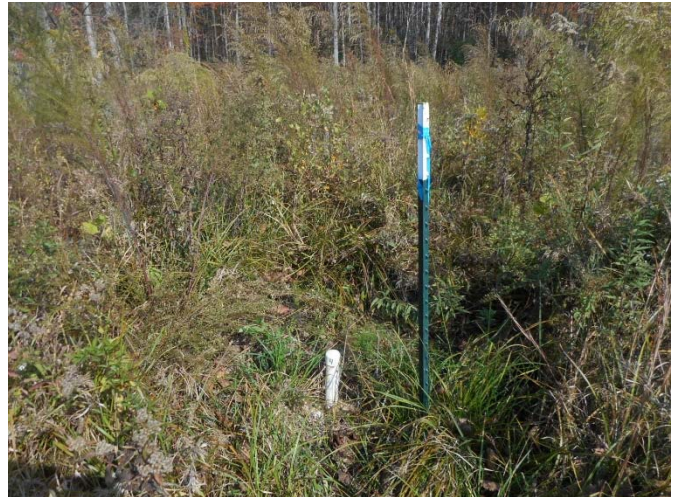
Photo 4. Wetland Photo Point – W4, replicates photo 53 in Baseline Report (November 1, 2016).

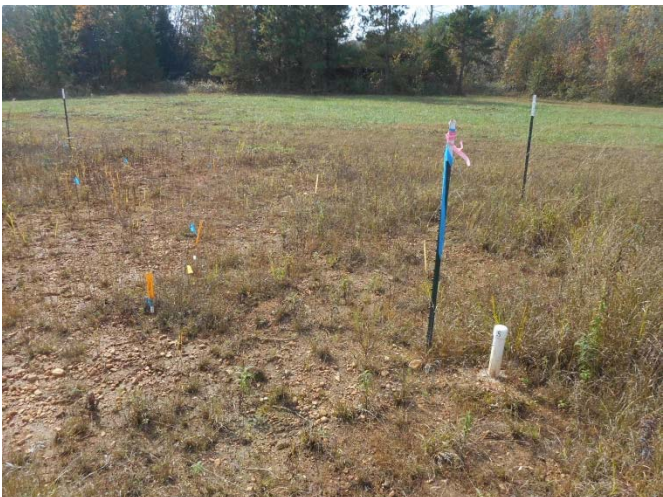
Photo 5. Wetland Photo Point – W5, replicates photo 54 in Baseline Report (November 1, 2016).

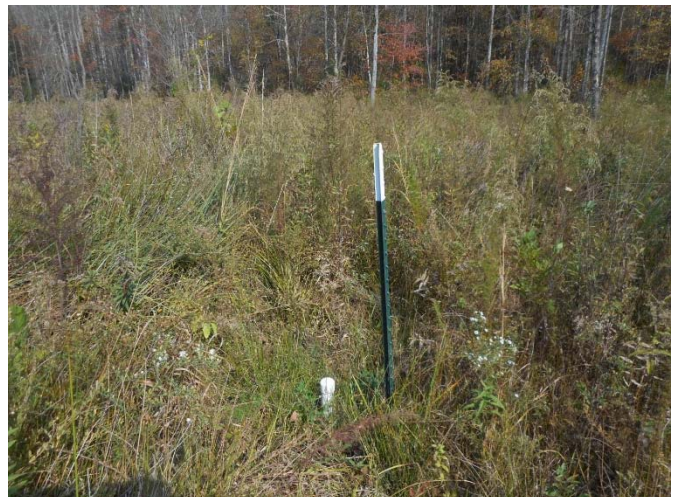
Photo 6. Wetland Photo Point – W6, replicates photo 55 in Baseline Report (November 1, 2016).

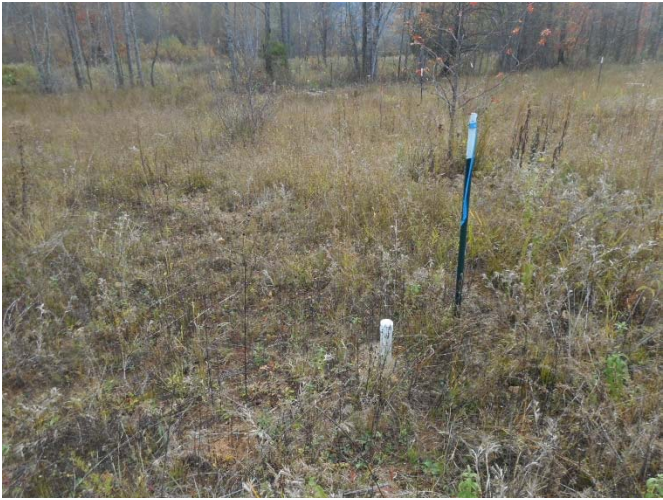
Photo 7. Wetland Photo Point – W7, replicates photo 56 in Baseline Report (November 1, 2016).

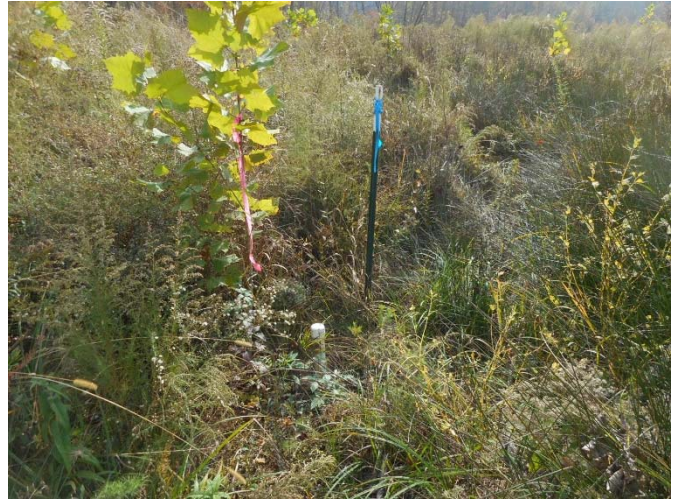
Photo 8. Wetland Photo Point – W8, replicates photo 57 in Baseline Report (November 1, 2016).

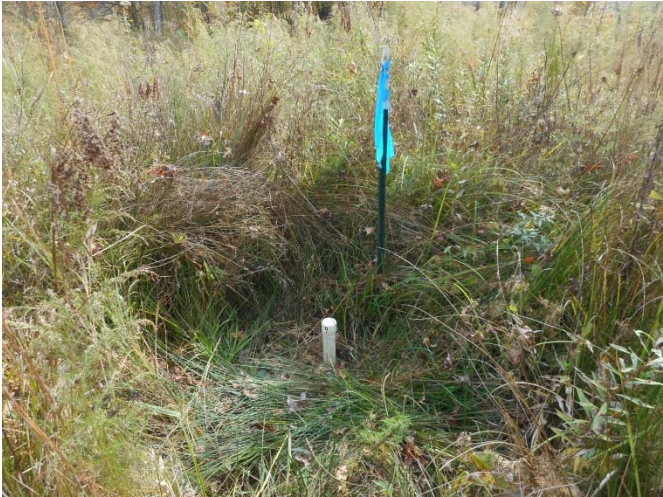
Photo 9. Wetland Photo Point – W9, replicates photo 58 in Baseline Report (November 1, 2016).

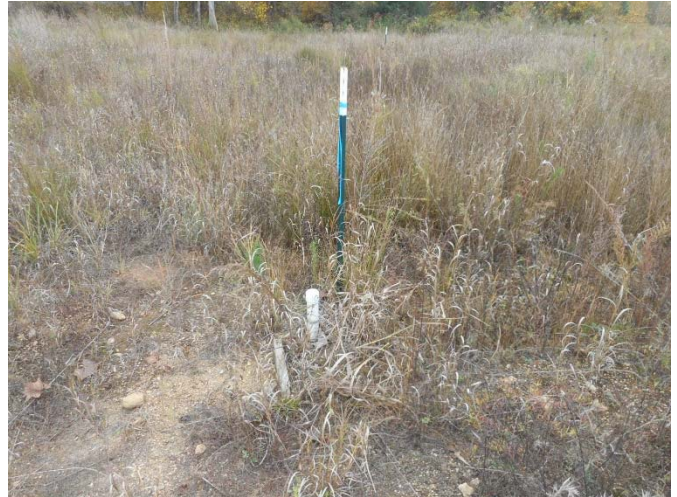
Photo 10. Wetland Photo Point – W10, replicates photo 59 in Baseline Report (November 1, 2016).

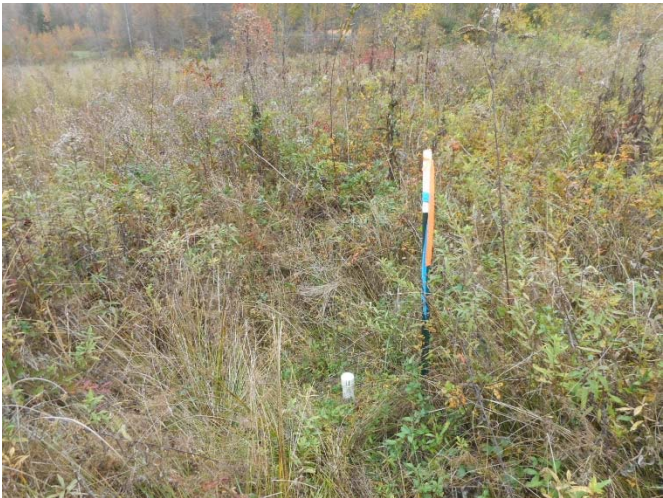
Photo 11. Wetland Photo Point – W11, replicates photo 60 in Baseline Report (November 1, 2016).

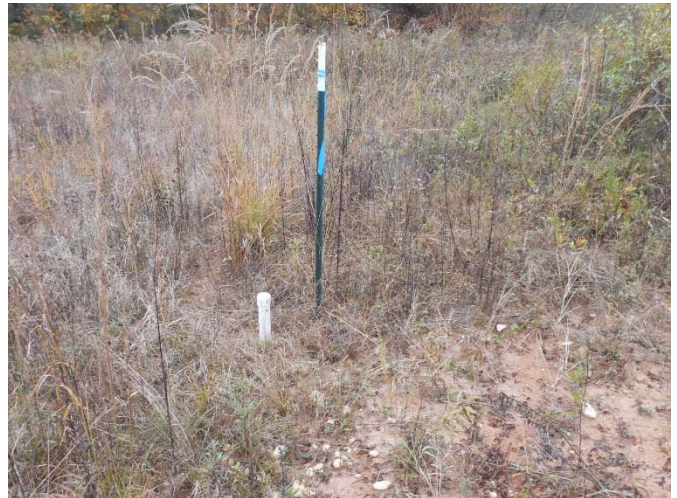
Photo 12. Wetland Photo Point – W12, replicates photo 61 in Baseline Report (November 1, 2016).

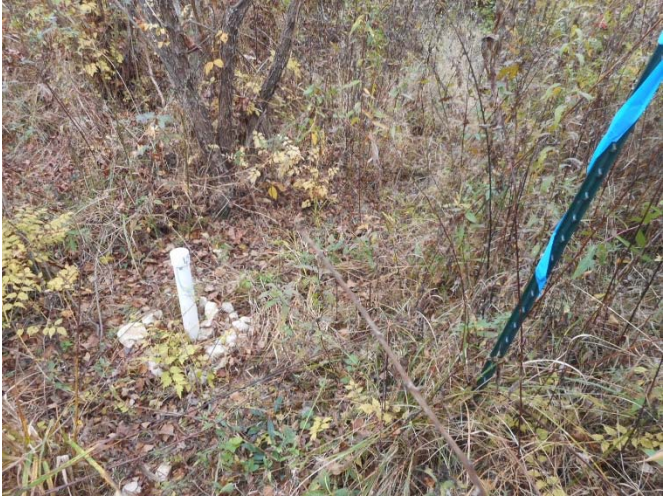
Photo 13. Wetland Photo Point – W13 added between time of baseline and MY1 survey, (April 1, 2015)
