Upper Silver Creek Restoration Project Year 4 Monitoring Report

**Burke County, North Carolina
NCDMS Project ID Number – 94645**

Report Prepared and Submitted by Michael Baker Engineering, Inc.
797 Haywood Road, Suite 201
Asheville, NC 28806

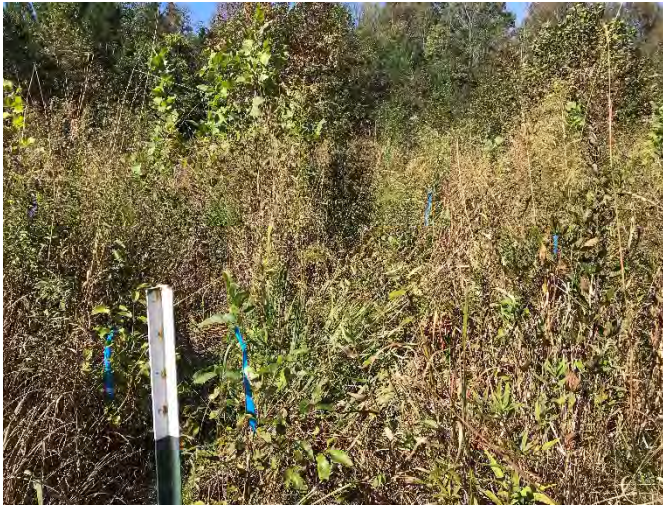
Photo 1. Vegetation Plot 1 – Tree photo
(October 18, 2018).

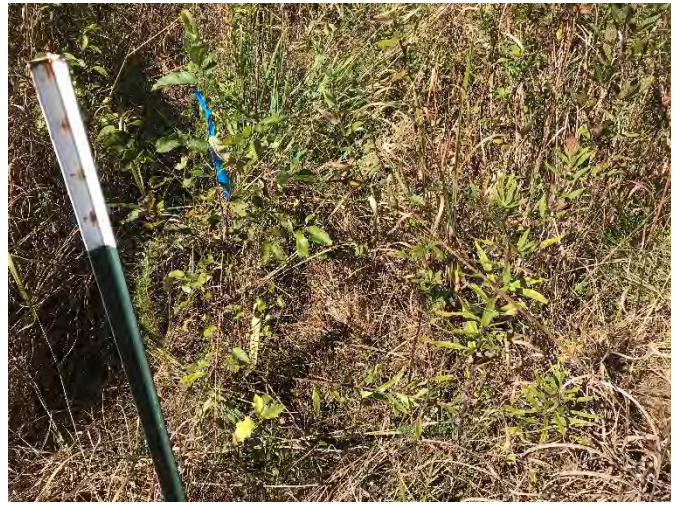
Photo 2. Vegetation Plot 1 – Herbaceous photo
(October 18, 2018).

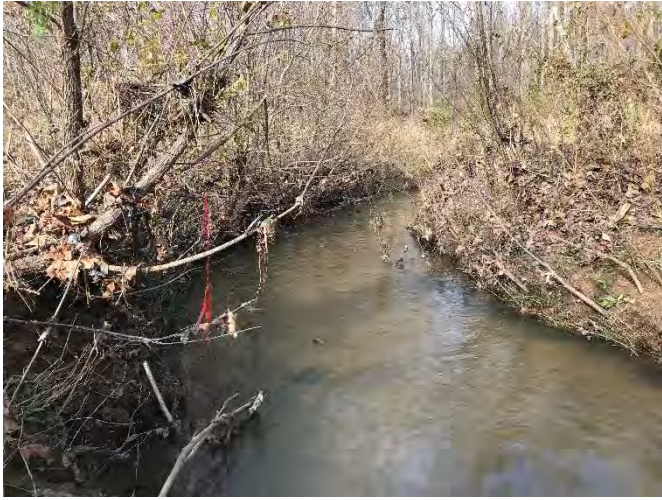
Photo 1. Mainstem Photo Point 1 – Station 29+26 (November 18, 2018) downstream view from left bank.

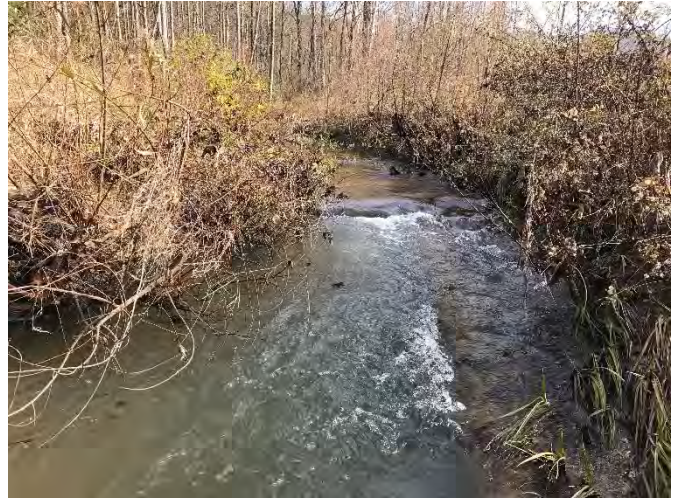
Photo 2. Mainstem Photo Point 1 – Station 29+26 (November 18, 2018) upstream view from left bank.

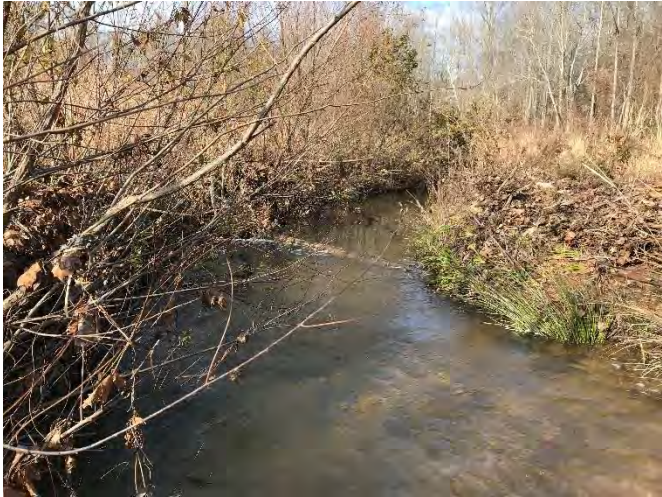
Photo 3. Mainstem Photo Point 2 – Station 26+44 (November 18, 2018) downstream view from left bank.

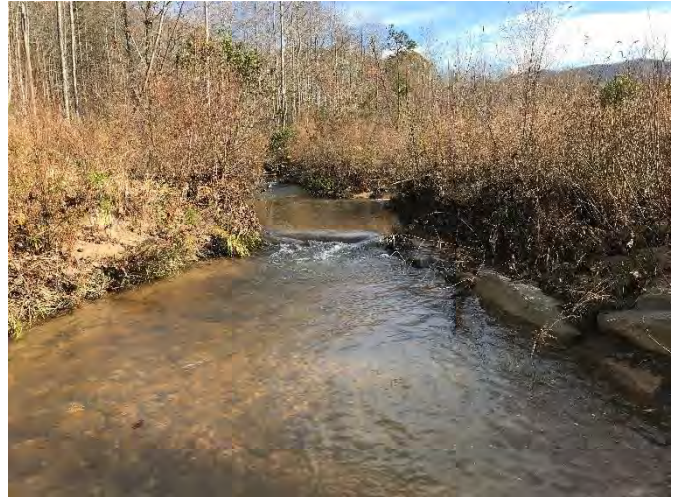
Photo 4. Mainstem Photo Point 2 – Station 26+44 (November 18, 2018) upstream from left bank.

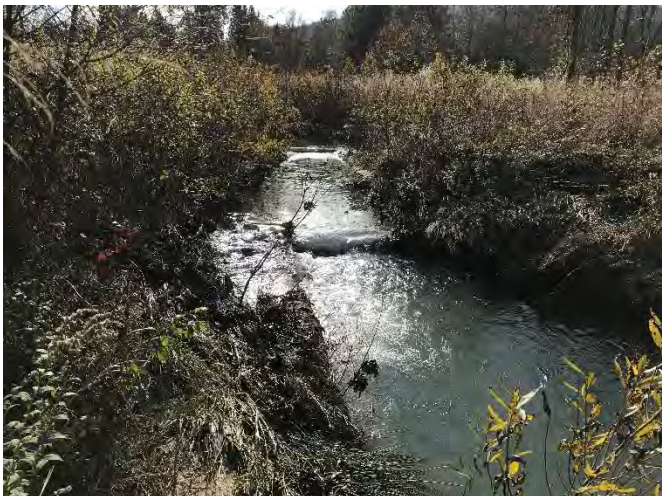
Photo 5. Mainstem Photo Point 3 – Station 24+70 (November 18, 2018) upstream from right bank.

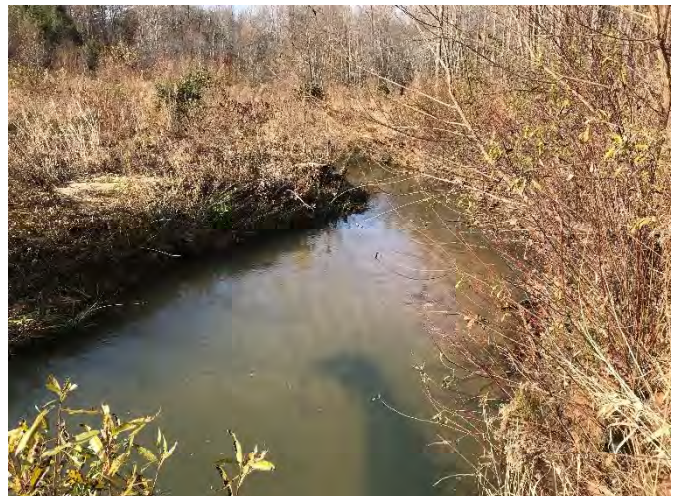
Photo 6. Mainstem Photo Point 3 – Station 24+70 (November 18, 2018) downstream from right bank.

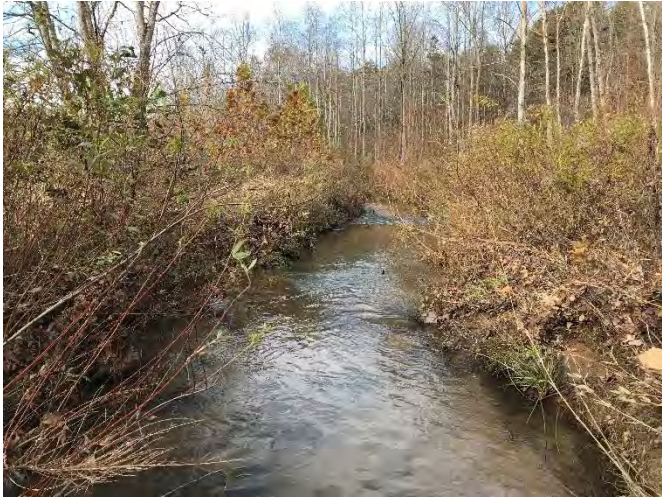
Photo 7. Mainstem Photo Point 4 (PP4) – Station 20+30 (November 18, 2018) downstream from left bank.

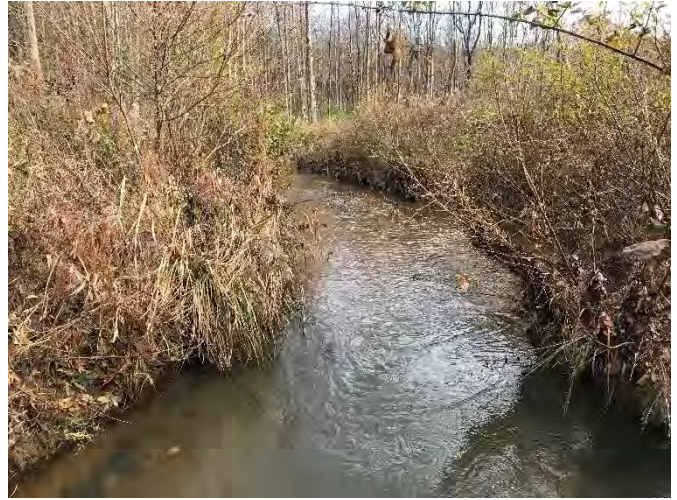
Photo 8. Mainstem Photo Point 4 (PP4) – Station 20+30 (November 18, 2018) upstream from left bank.

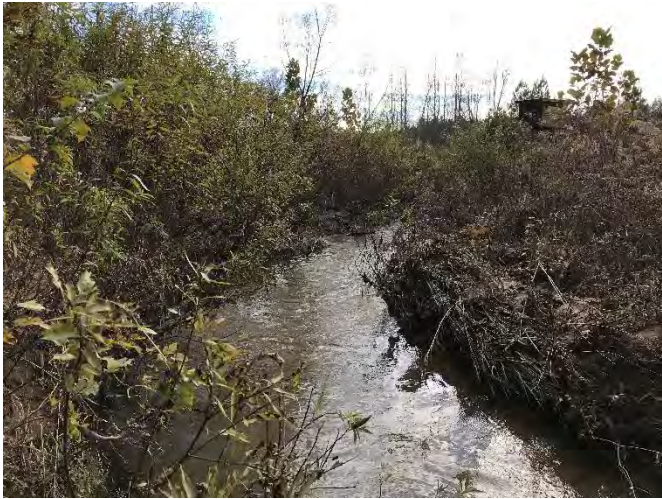
Photo 9. Mainstem Photo Point 5 – Station 16+03 (November 18, 2018) upstream from right bank.

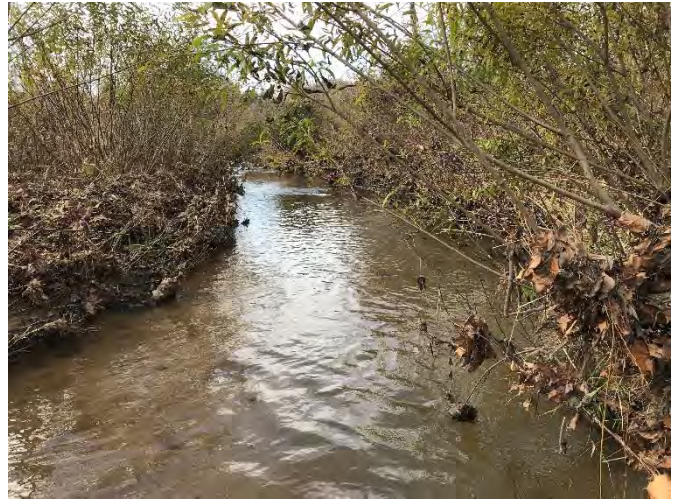
Photo 10, Mainstem Photo Point 5 – Station 16+03 (November 18, 2018) downstream from right bank.

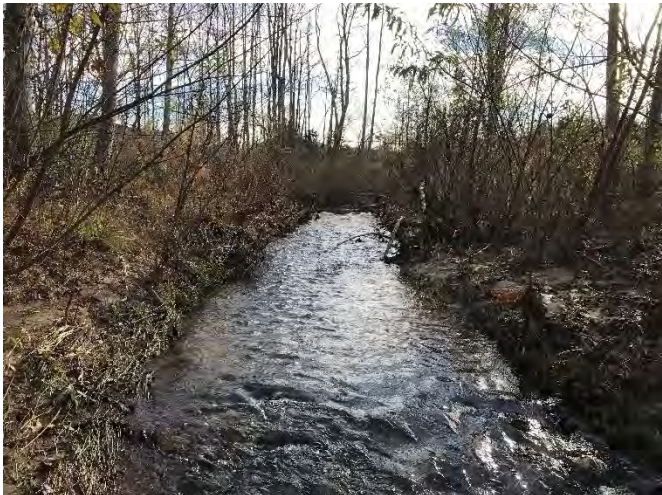
Photo 11. Mainstem Photo Point 6 – Station 13+03 (November 18, 2018) upstream from right bank.

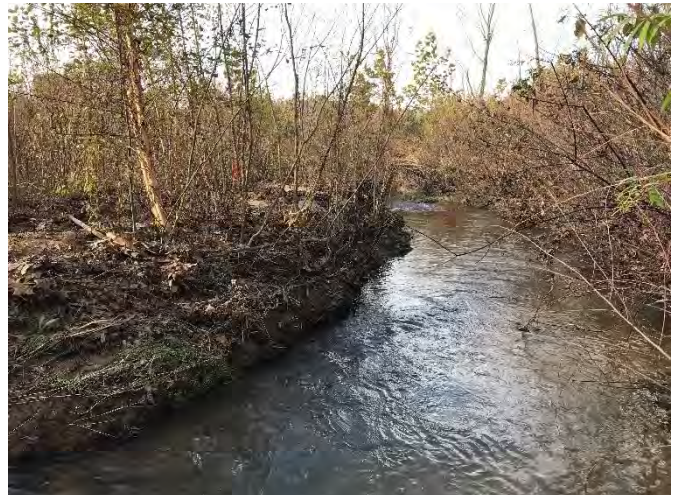
Photo 12. Mainstem Photo Point 6 – Station 13+03 (November 18, 2018) downstream from right bank.

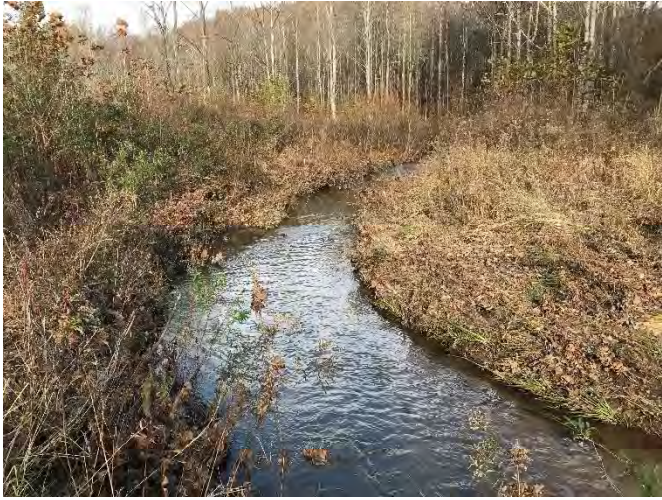
Photo 13. Mainstem Photo Point 7 – Station 10+11 (November 18, 2018) downstream from left bank.

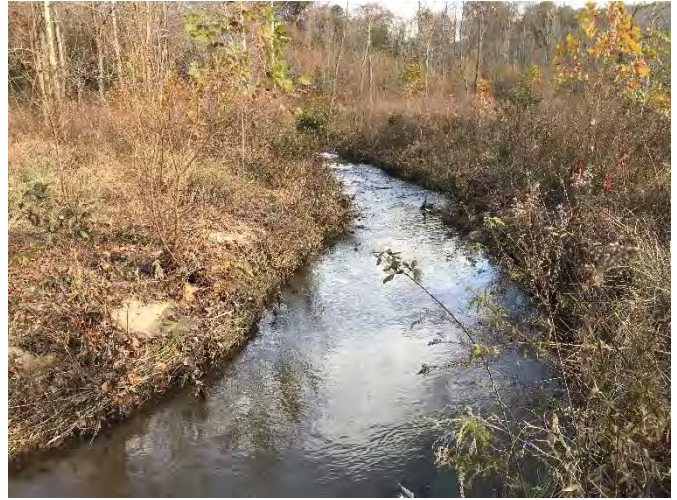
Photo 14. Mainstem Photo Point 7 – Station 10+11 (November 18, 2018) upstream from left bank.

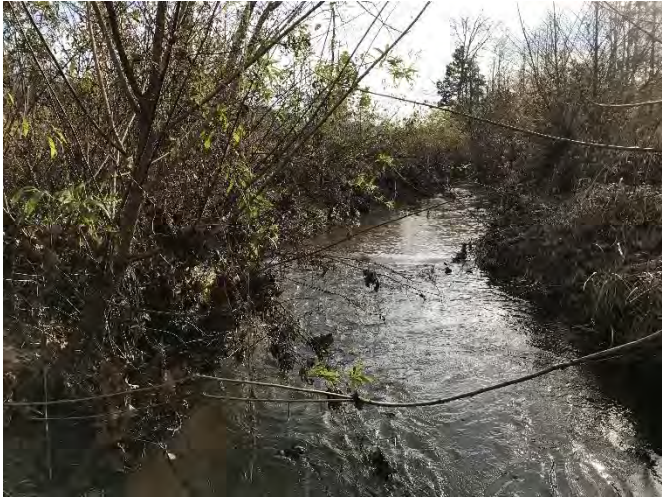
Photo 15. Mainstem Photo Point 8 – Station 5+06 (November 18, 2018) upstream from right bank.

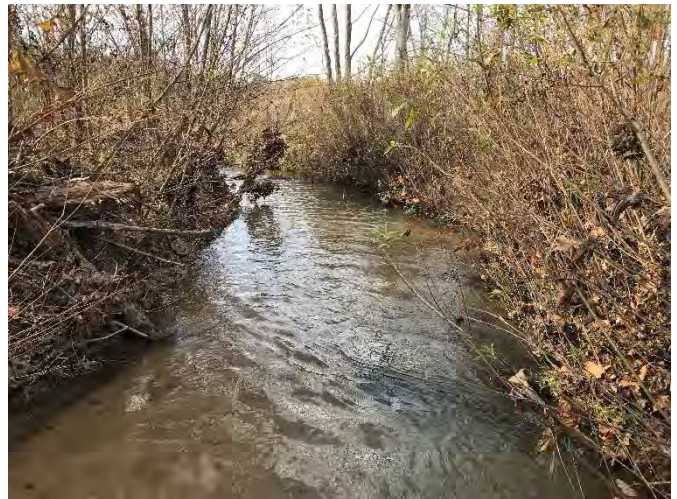
Photo 16. Mainstem Photo Point 8 – Station 5+06 (November 18, 2018) downstream from right bank.

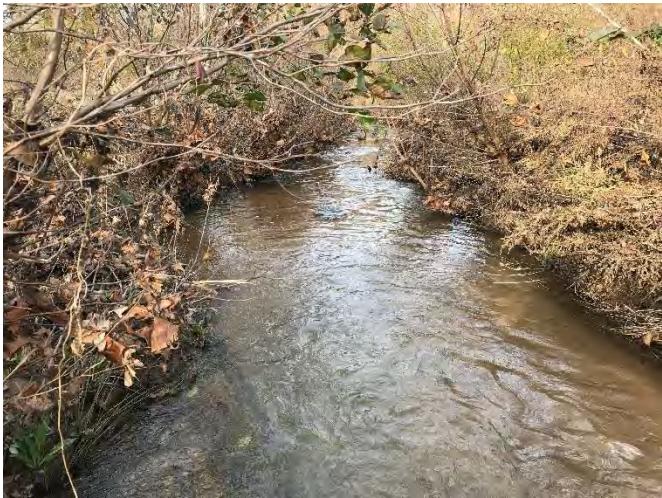
Photo 17. Mainstem Photo Point 9 – Station 3+87 (November 18, 2018) downstream from left bank.

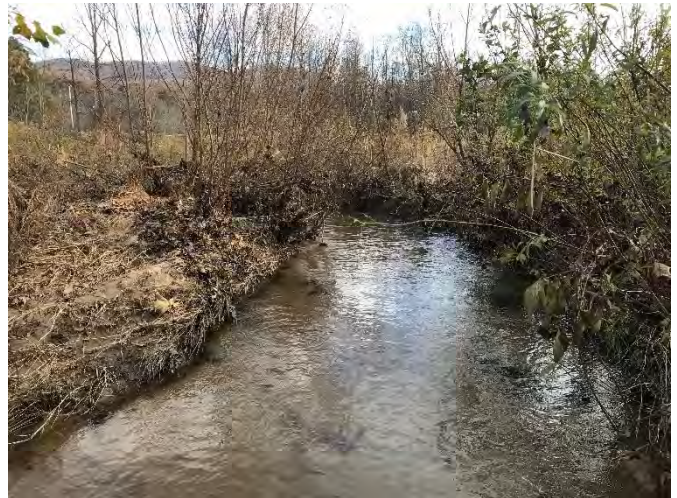
Photo 18. Mainstem Photo Point 9 – Station 3+87 (November 18, 2018) upstream from left bank.

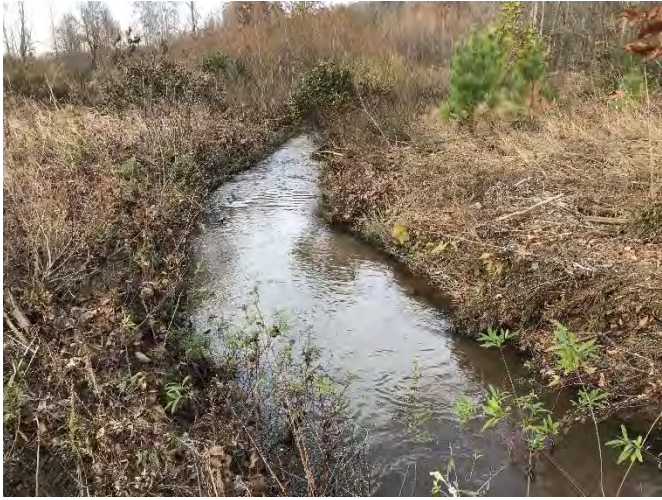
Photo 19. Mainstem Photo Point 10 – Stat. 1+22 (November 18, 2018) downstream from left bank.

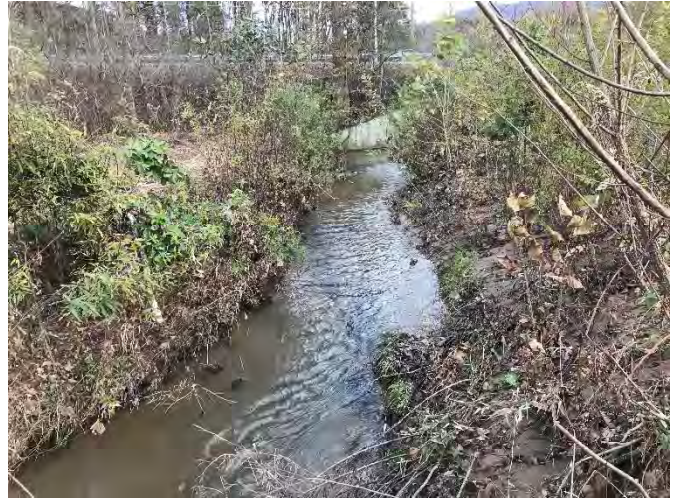
Photo 20. Mainstem Photo Point 10 – Stat. 1+22 (November 18, 2018) upstream from left bank.

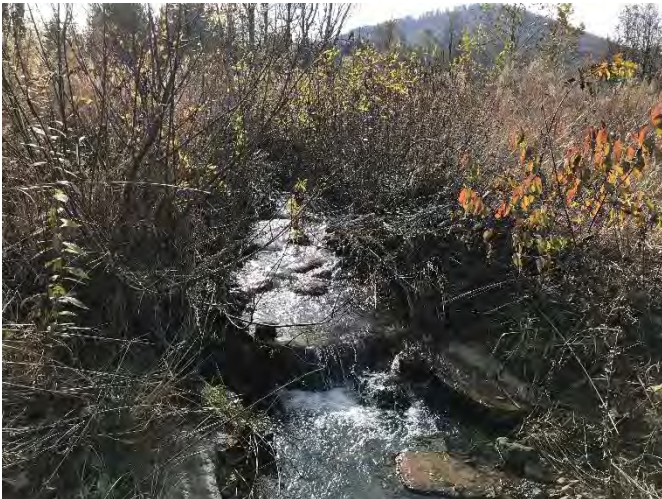
Photo 21. UT1 Photo Point 1 – Station 4+82 (November 18, 2018) upstream from left bank.

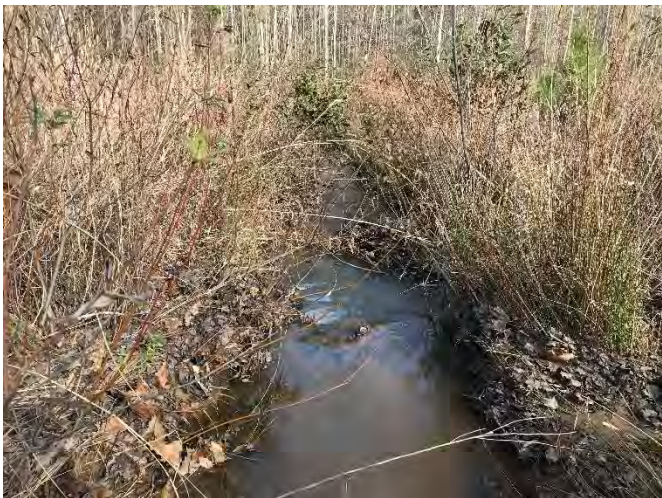
Photo 22. UT1 Photo Point 2 – Station 4+07 (November 18, 2018) downstream from left bank.

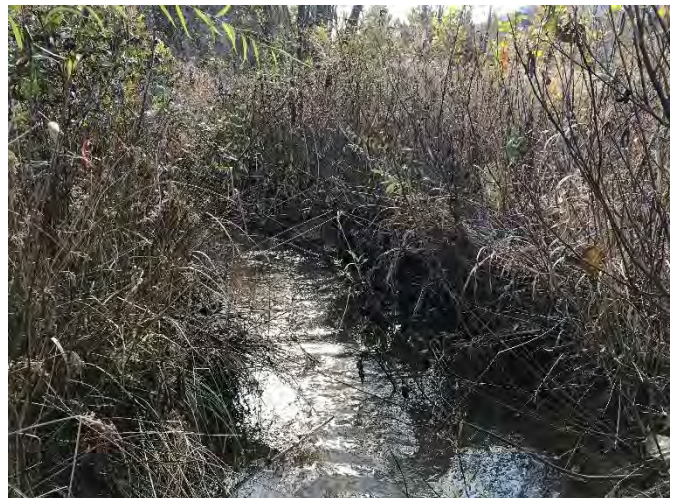
Photo 23. UT1 Photo Point 2 – Station 4+07 (November 18, 2018) upstream from left bank.

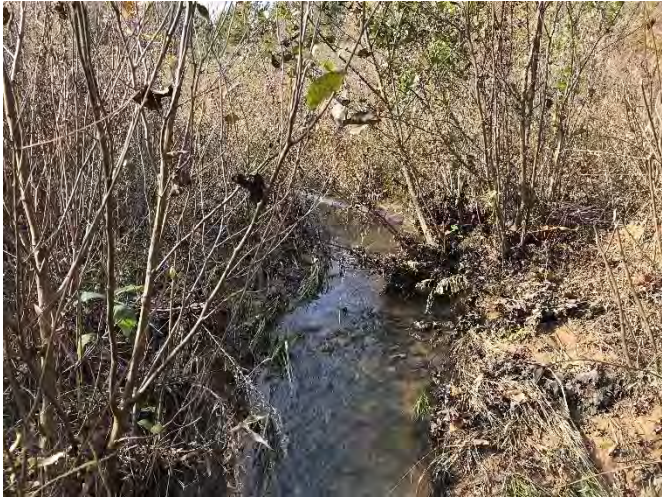
Photo 24. UT1 Photo Point 3 – Station 2+55
(November 18, 2018) upstream from right bank.

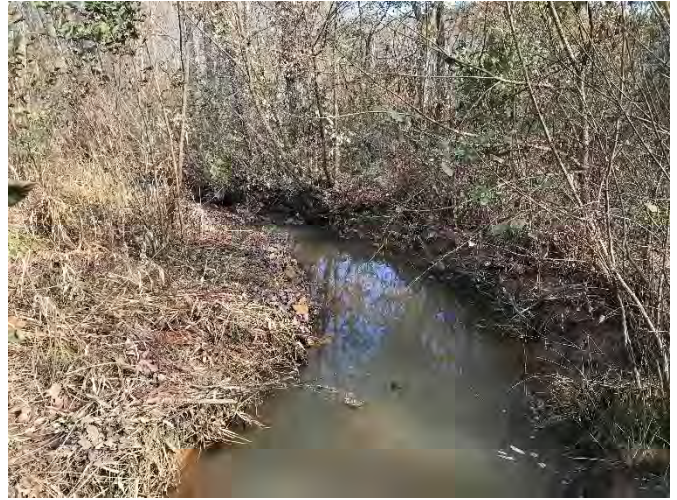
Photo 25. UT1 Photo Point 3 – Station 2+55
(November 18, 2018) downstream from right bank.

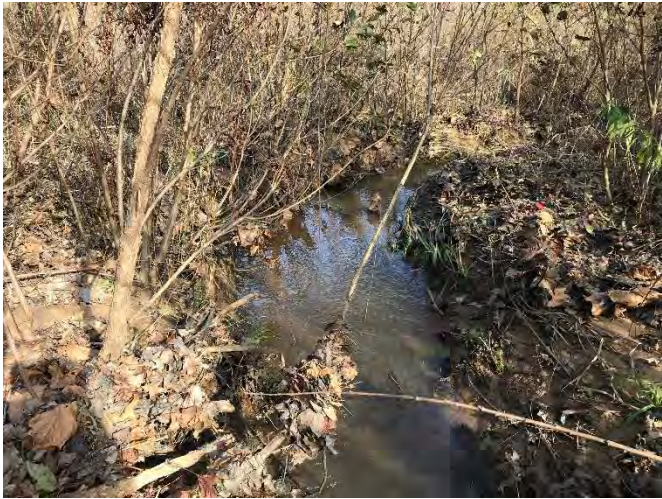
Photo 26. UT1 Photo Point 4 – Station 0+55
(November 18, 2018) downstream from left bank.

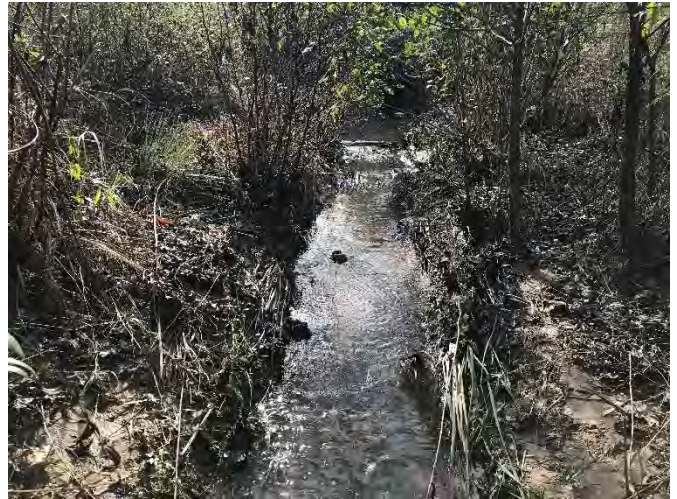
Photo 27. UT1 Photo Point 4 – Station 0+55
(November 18, 2018) upstream from left bank.

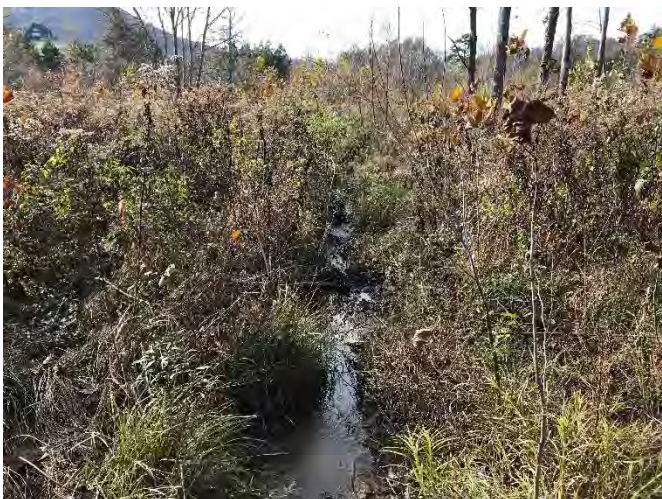
Photo 28. UT2 Photo Point 1 – Station 2+15
(November 18, 2018) downstream from left bank.

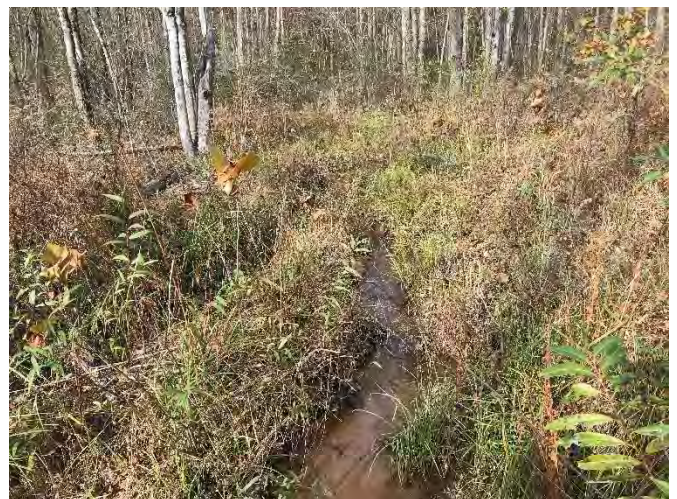
Photo 29. UT2 Photo Point 1 – Station 2+15
(November 18, 2018) upstream from left bank.

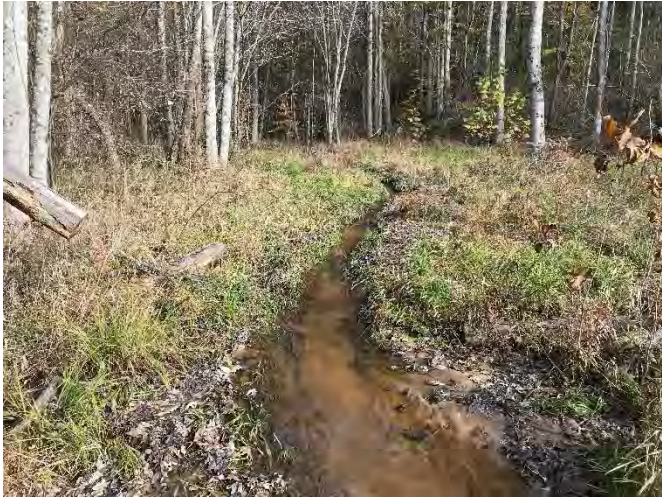
Photo 30. UT2 Photo Point 2 – Station 0+96 (November 18, 2018) upstream from right bank.

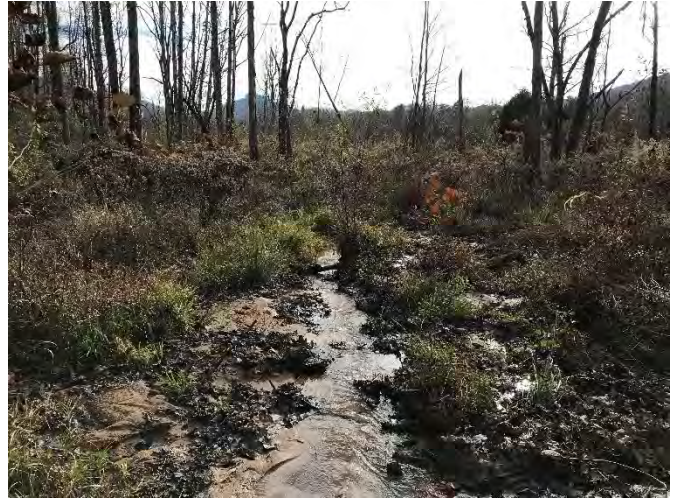
Photo 31. UT2 Photo Point 2 – Station 0+96 (November 18, 2018) downstream from right bank.

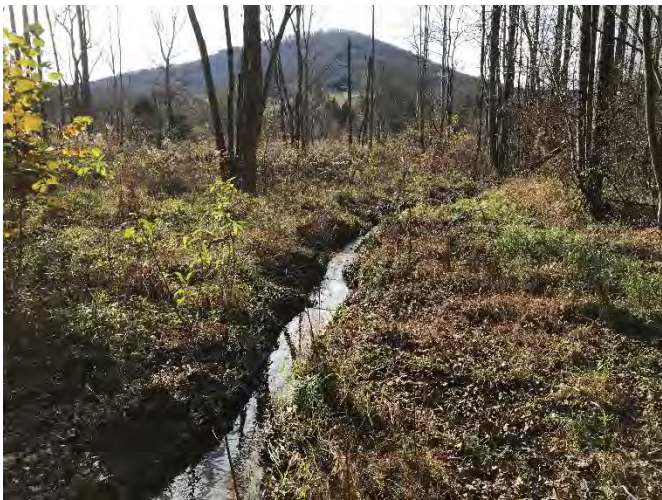
Photo 32. UT2 Photo Point 3 – Station 0+02 (November 18, 2018) downstream from right bank.

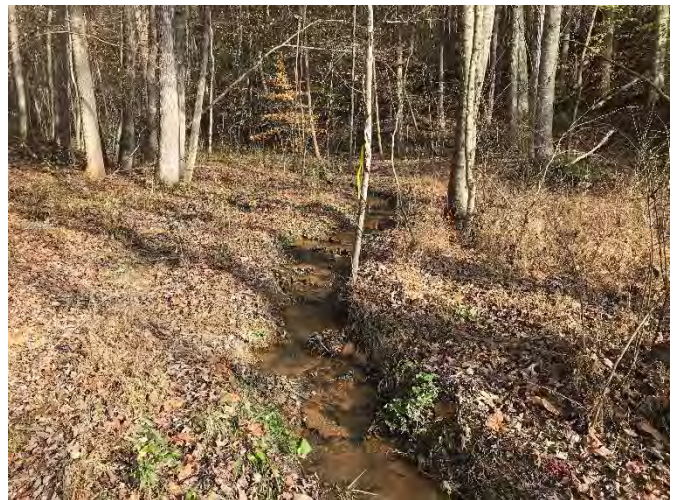
Photo 33. UT2 Photo Point 3 – Station 0+02 (November 18, 2018) upstream from right bank.

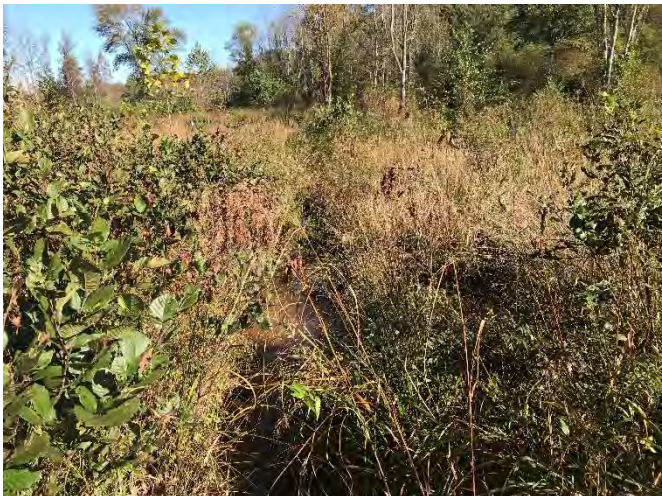
Photo 34. UT3 Photo Point 1 – Station 12+10 (October 18, 2018) downstream from left bank.

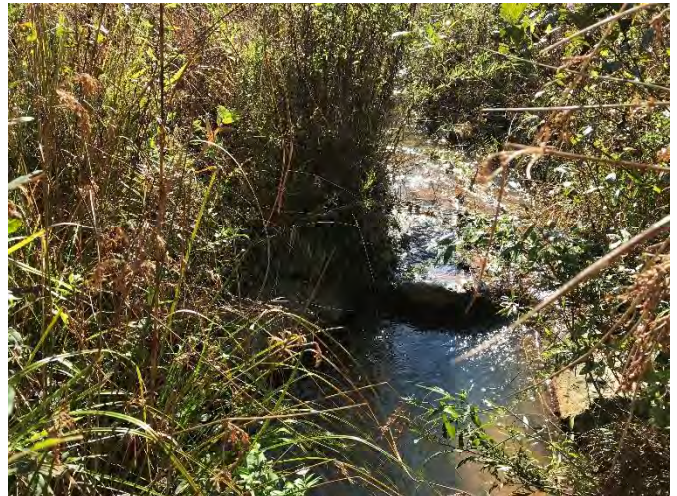
Photo 35. UT3 Photo Point 1 – Station 12+10 (October 18, 2018) upstream from left bank.

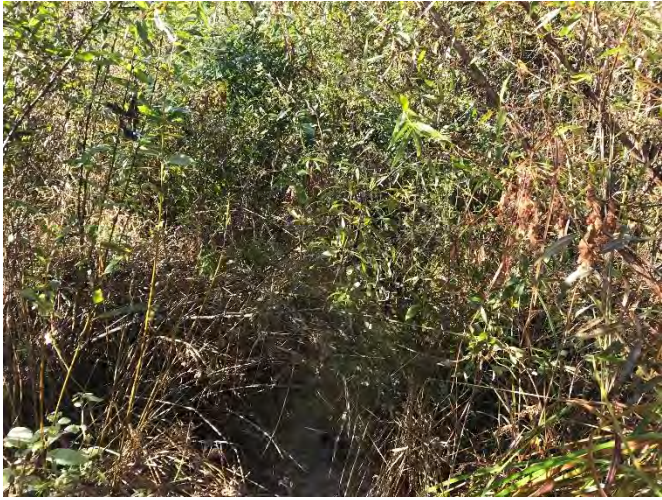
Photo 36. UT3 Photo Point 2 – Station 10+66
(October 18, 2018) upstream from right bank.

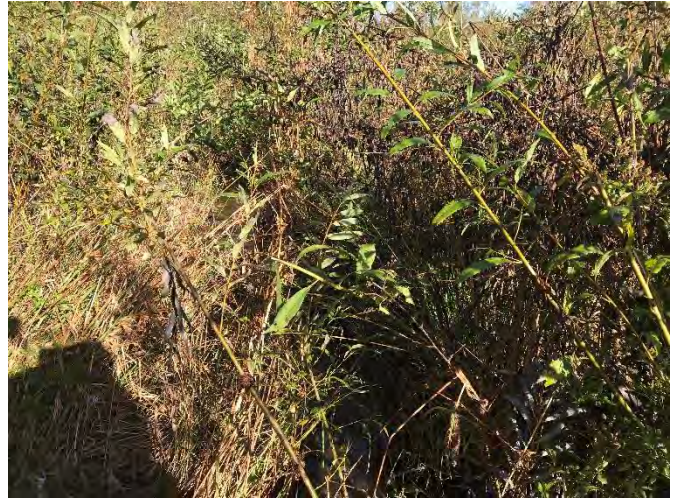
Photo 37. UT3 Photo Point 2 – Station 10+66
(October 18, 2018) downstream from right bank.

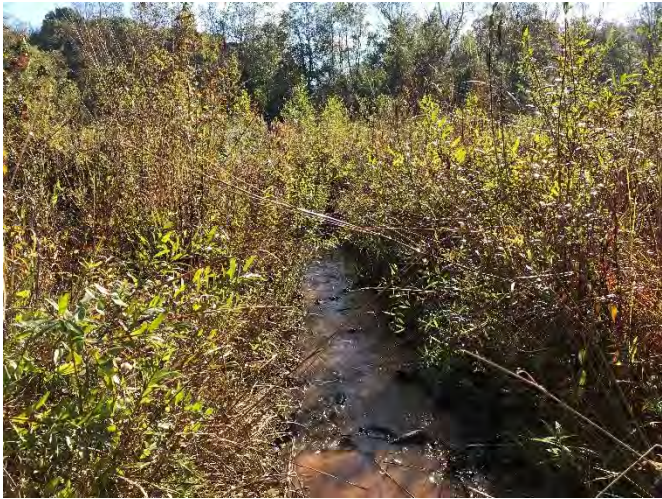
Photo 38. UT3 Photo Point 3 – Station 8+10
(October 18, 2018) downstream from left bank.

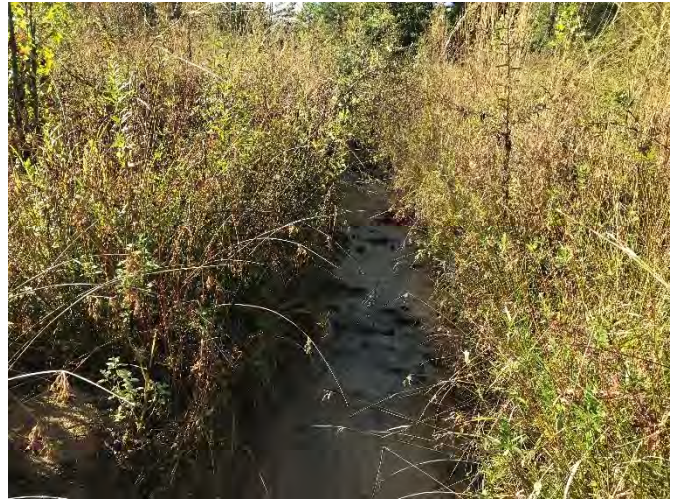
Photo 39. UT3 Photo Point 3 – Station 8+10
(October 18, 2018) upstream from left bank.

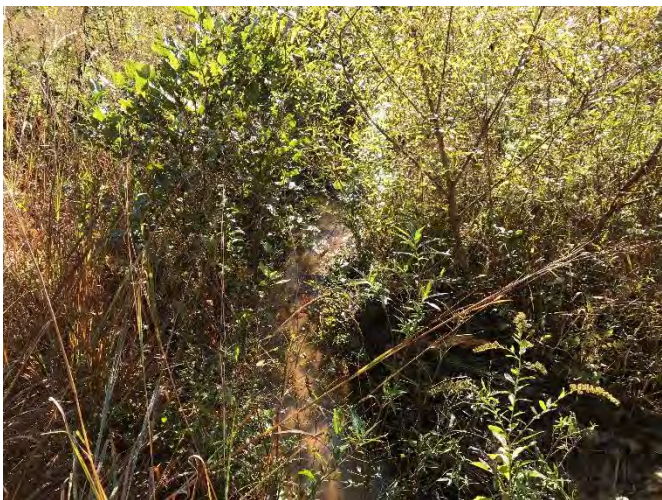
Photo 40. UT3 Photo Point 4 – Station 7+05
(October 18, 2018) downstream from left bank.

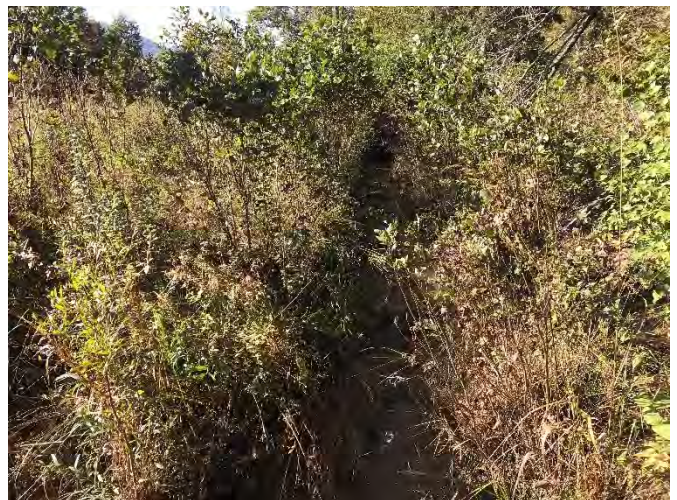
Photo 41. UT3 Photo Point 4 – Station 7+05
(October 18, 2018) upstream from left bank.

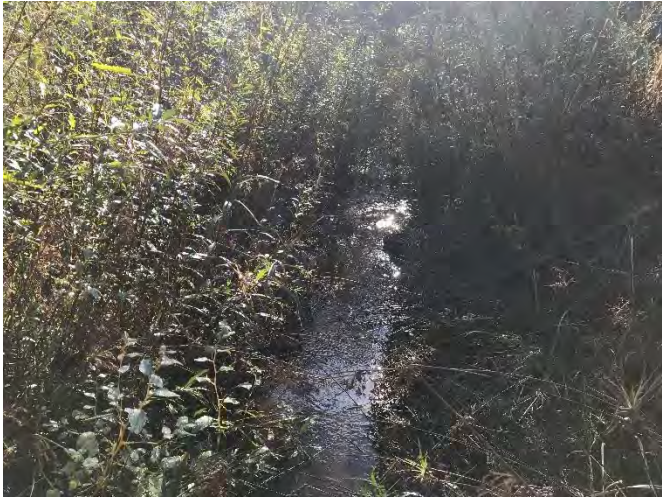
Photo 42. UT3 Photo Point 5 – Station 5+95 (October 18, 2018) downstream from left bank.

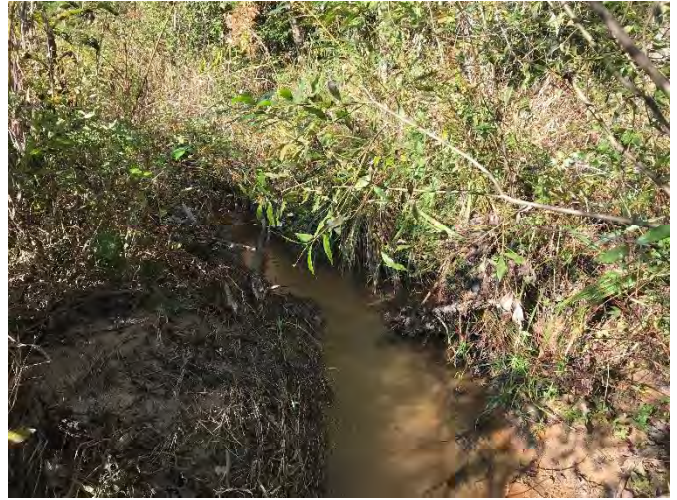
Photo 43. UT3 Photo Point 5 – Station 5+95 (October 18, 2018) upstream from left bank.

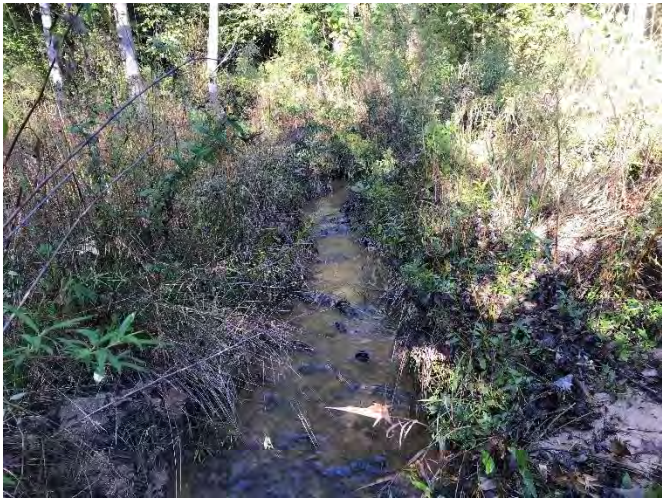
Photo 44. UT3 Photo Point 6 – Station 4+55 (October 18, 2018) upstream from right bank.

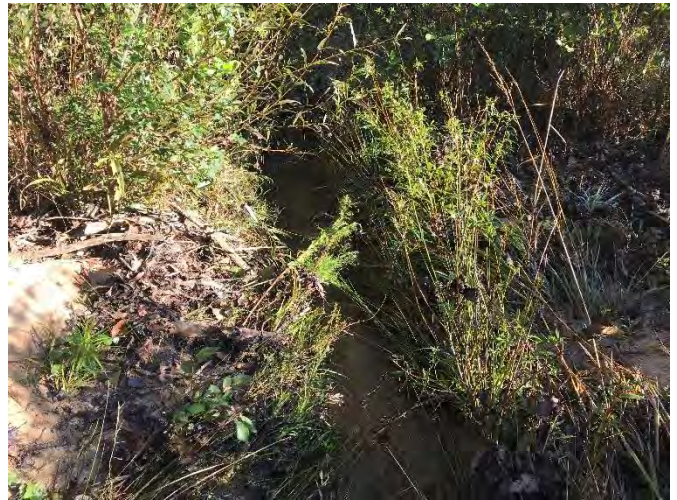
Photo 45. UT3 Photo Point 6 – Station 4+55 (October 18, 2018) downstream from right bank.

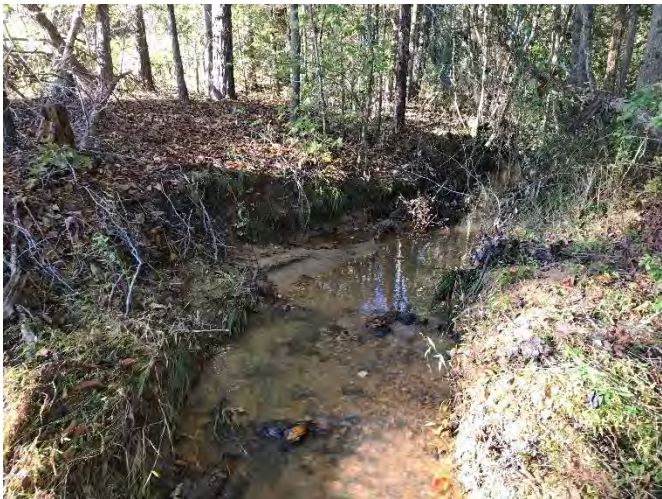
Photo 46. UT3 Photo Point 7 – Station 3+60 (October 18, 2018) upstream to structure.

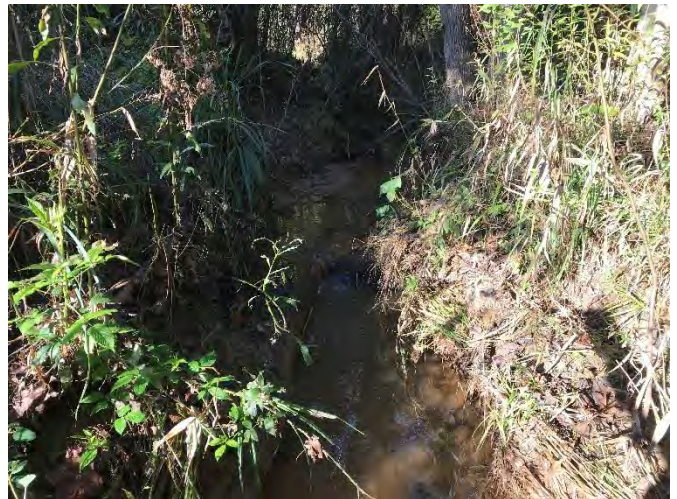
Photo 47. UT3 Photo Point 8 – Station 2+70 (October 18, 2018) upstream to structure.

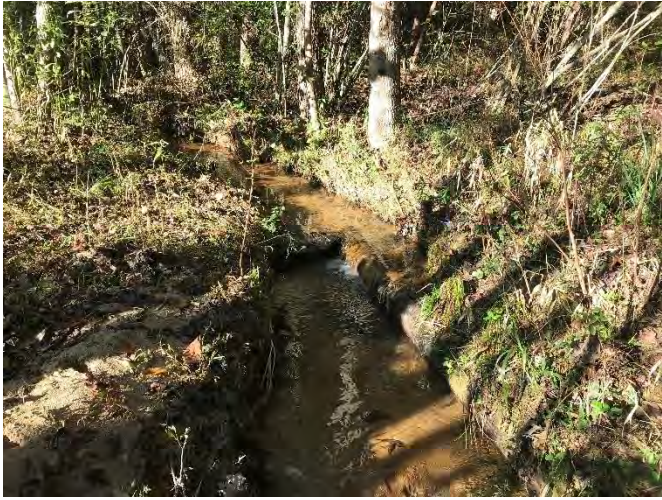
Photo 48. UT3 Photo Point 9 – Station 1+90
(October 18, 2018) upstream to structure.

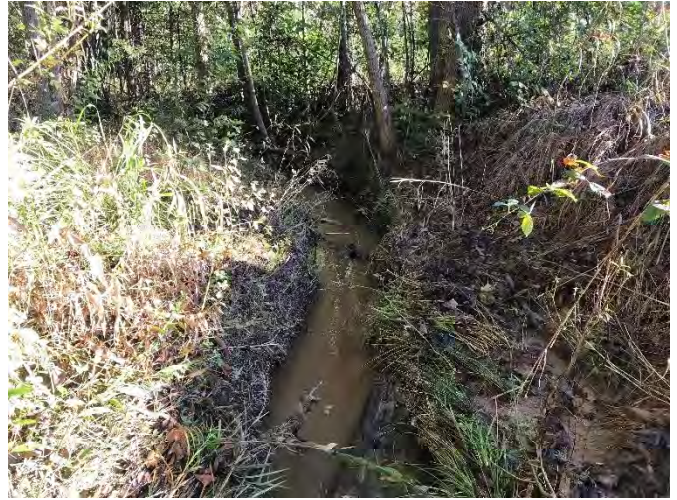
Photo 49. UT3 Photo Point 10 – Station 0+60
(October 18, 2018) downstream to structure.

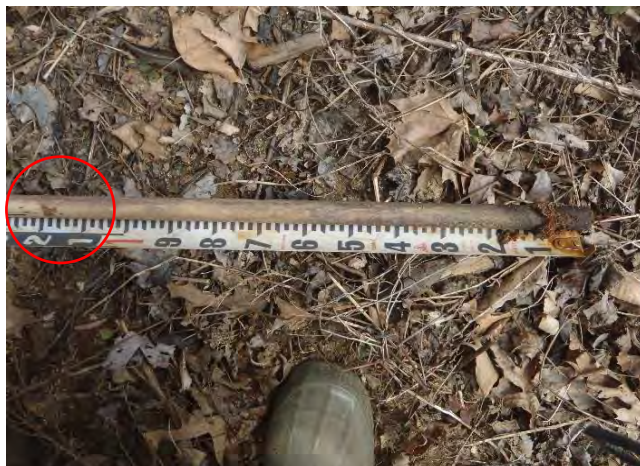
Photo 1. Silver Creek mainstem crest gauge staff showing cork deposition in red circle at 1.19' above the bottom of the staff, which is at the bankfull elevation (4/2/2018)

¹ Height indicates the highest position of cork shavings on the dowel and the height above bankfull, as 0" on the dowel is set at bankfull

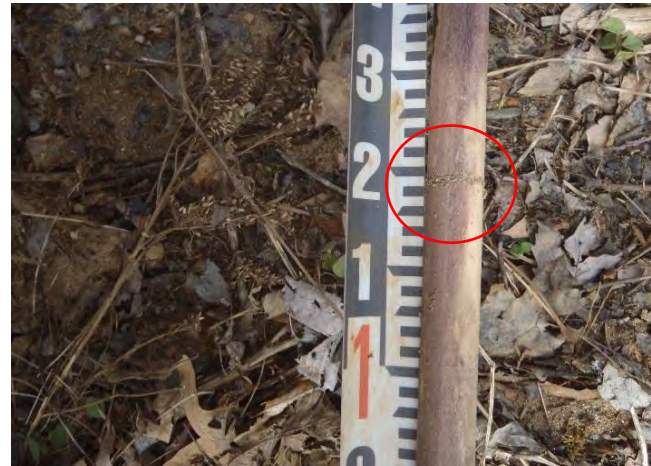
Photo 2. Silver Creek mainstem crest gauge staff showing cork deposition in red circle at 1.19' above the bottom of the staff, which is at the bankfull elevation (4/2/2018)

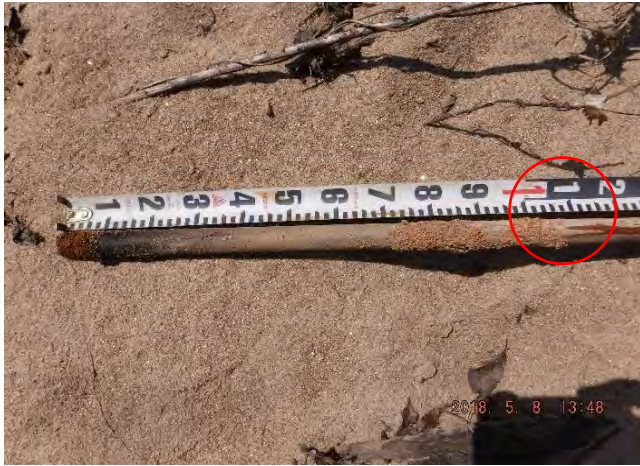
Photo 3. Silver Creek mainstem crest gauge staff showing cork deposition in red circle at 1.08' above the bottom of the staff, which is at the bankfull elevation (5/8/2018)

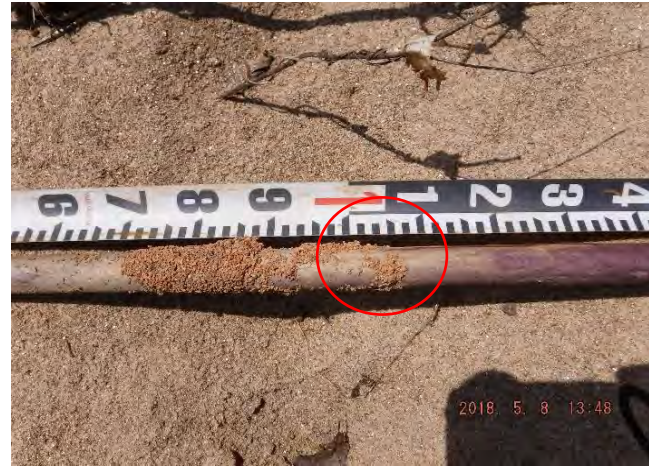
Photo 4. Silver Creek mainstem crest gauge staff showing cork deposition in red circle at 1.08' above the bottom of the staff, which is at the bankfull elevation (5/8/2018)

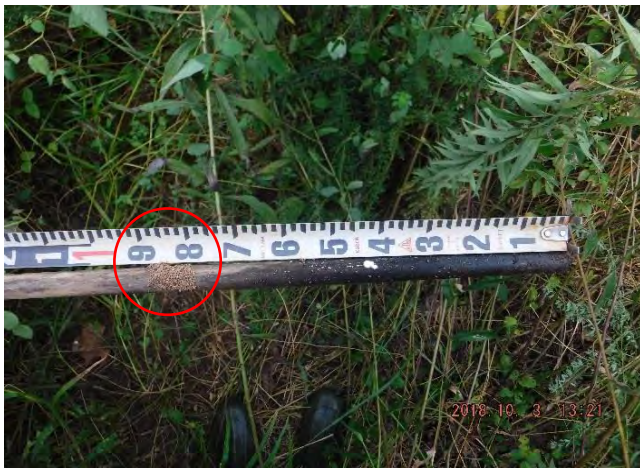
Photo 5. Silver Creek mainstem crest gauge staff showing cork deposition in red circle at 0.88' above the bottom of the staff, which is at the bankfull elevation (10/3/2018)

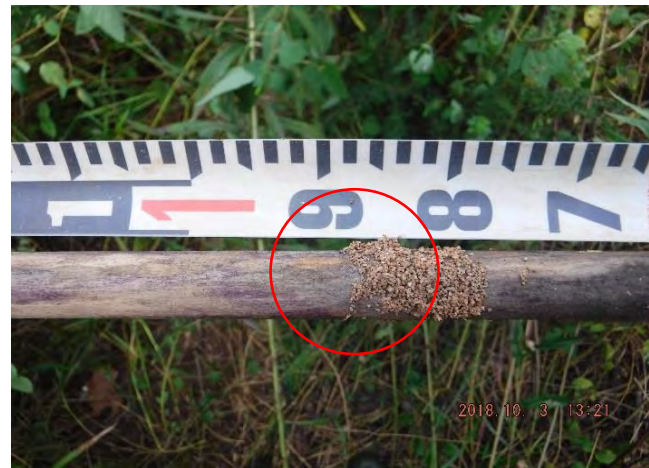
Photo 6. Silver Creek mainstem crest gauge staff showing cork deposition in red circle at 0.88' above the bottom of the staff, which is at the bankfull elevation (10/3/2018)

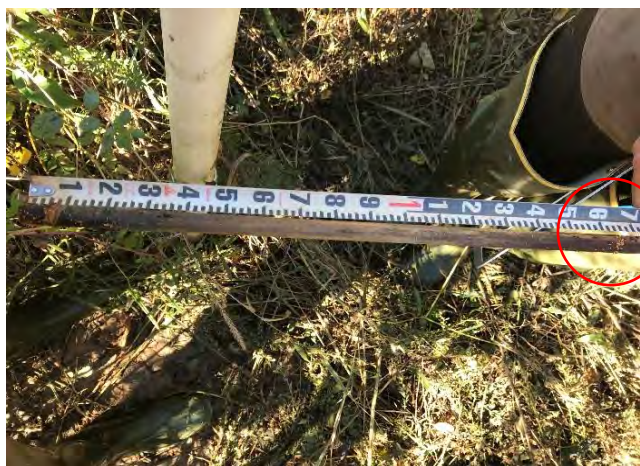
Photo 7. Silver Creek mainstem crest gauge staff showing cork deposition in red circle at 1.64' above the bottom of the staff, which is at the bankfull elevation (10/18/2018)

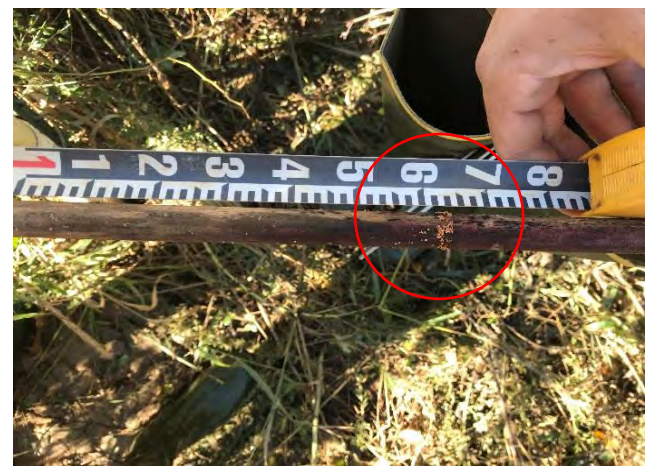
Photo 8. Silver Creek mainstem crest gauge staff showing cork deposition in red circle at 1.64' above the bottom of the staff, which is at the bankfull elevation (10/18/2018)

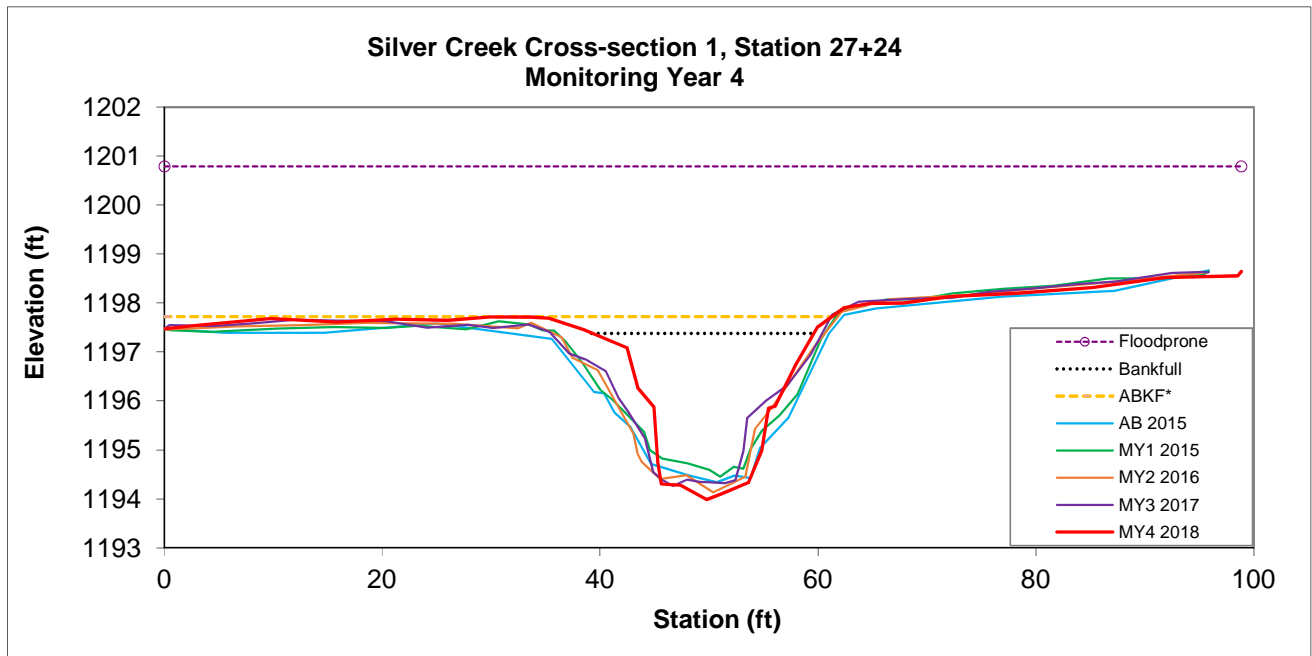
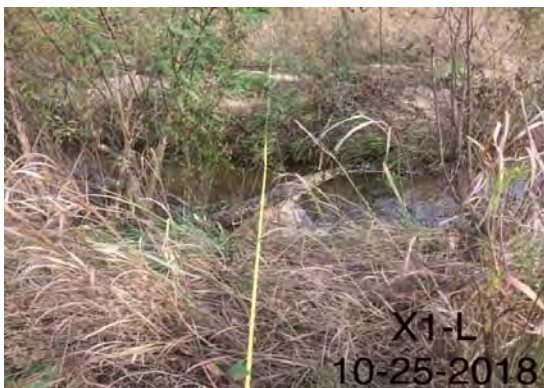
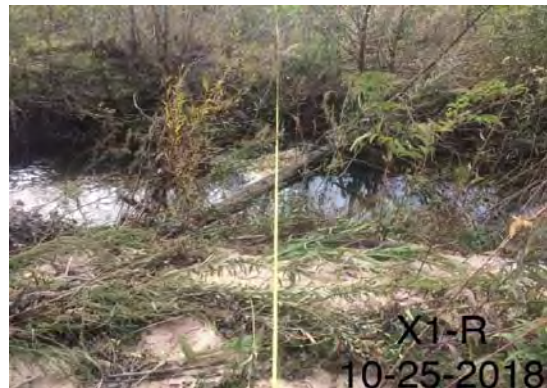
Figure 6. Cross-sections with Annual Overlays

Based on fixed baseline BKF

Feature	Stream Type	BKF Area	BKF Width	BKF Depth	Max BKF Depth	W/D	BH Ratio	ER	BKF Elev	TOB Elev	Low TOB Depth
Riffle	C	38.27	20.28	1.89	3.39	10.73	1.00	4.87	1197.38	1197.73	3.74

Looking at the Left Bank

Looking at the Right Bank

Note: *ABKF stands for as-built bankfull which represents the bankfull line held at the as-built cross sectional area.
