Upper Silver Creek Restoration Project Year 4 Monitoring Report

**Burke County, North Carolina
NCDMS Project ID Number – 94645**

Report Prepared and Submitted by Michael Baker Engineering, Inc.
797 Haywood Road, Suite 201
Asheville, NC 28806

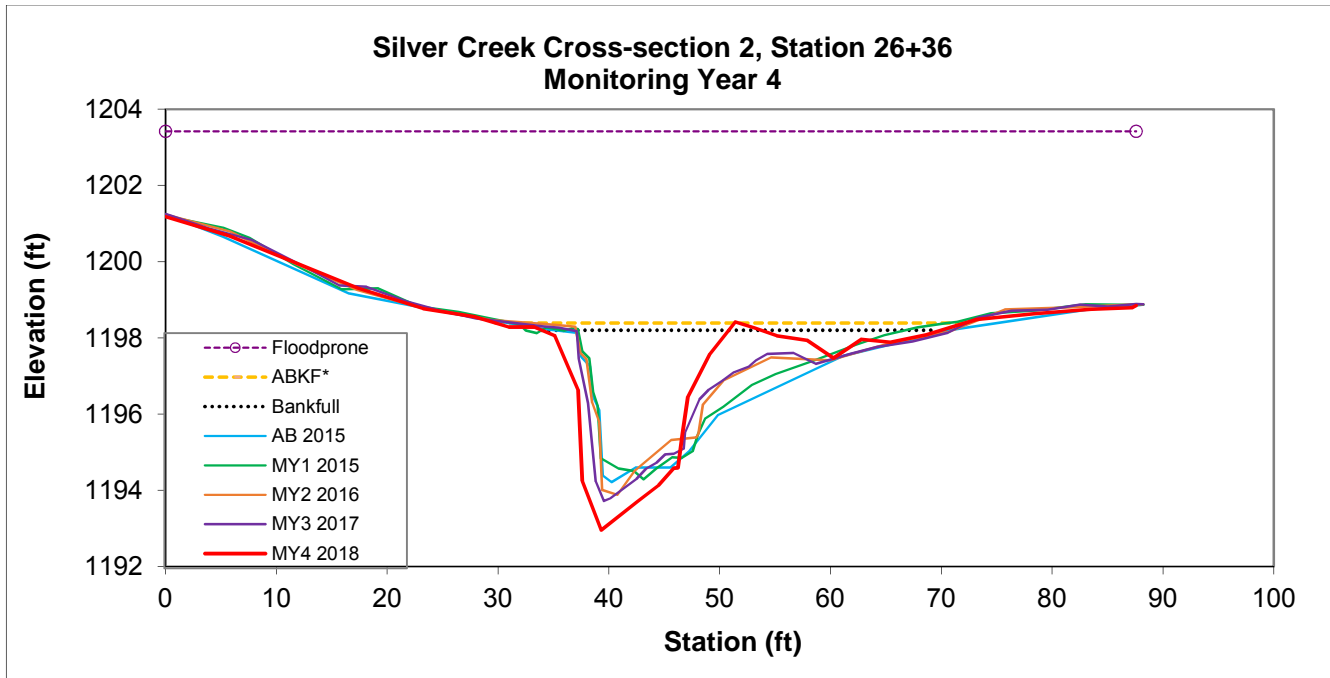
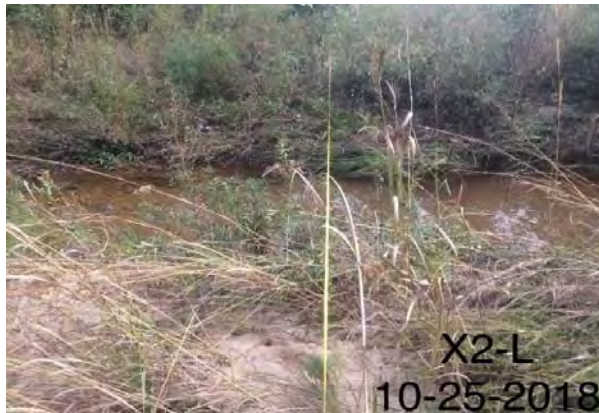
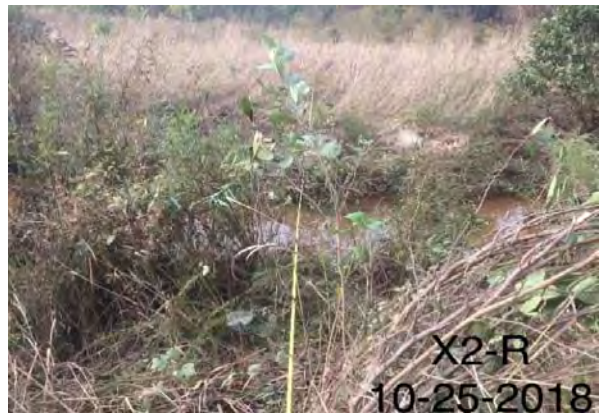
Based on fixed baseline BKF

Feature	Stream Type	BKF Area	BKF Width	BKF Depth	Max BKF Depth	W/D	BH Ratio	ER	BKF Elev	TOB Elev	Low TOB Depth
Pool	-	51.28	33.02	1.55	5.24	21.30	0.98	2.67	1198.20	1198.28	5.32

Looking at the Left Bank

Looking at the Right Bank

Note: *ABKF stands for as-built bankfull which represents the bankfull line held at the as-built cross sectional area.

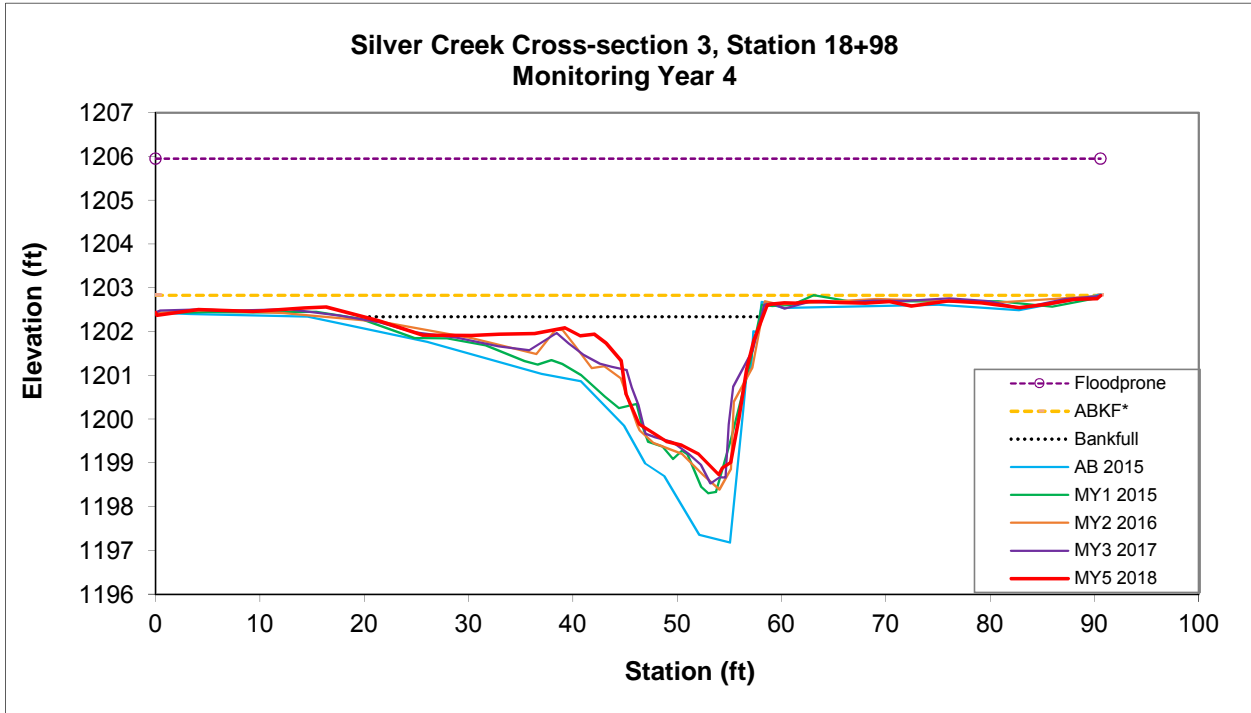
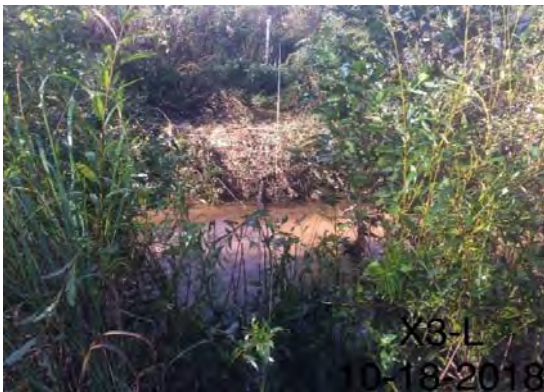
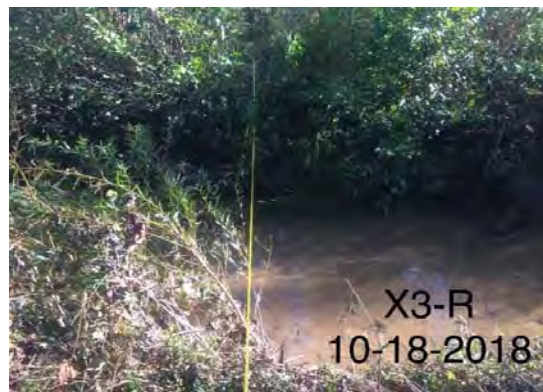
Based on fixed baseline BKF

Feature	Stream Type	BKF Area	BKF Width	BKF Depth	Max BKF Depth	W/D	BH Ratio	ER	BKF Elev	TOB Elev	Low TOB Depth
Pool	-	43.51	38.31	1.14	3.61	33.61	0.93	2.36	1202.34	1202.56	3.83

Looking at the Left Bank

Looking at the Right Bank

Note: *ABKF stands for as-built bankfull which represents the bankfull line held at the as-built cross sectional area.

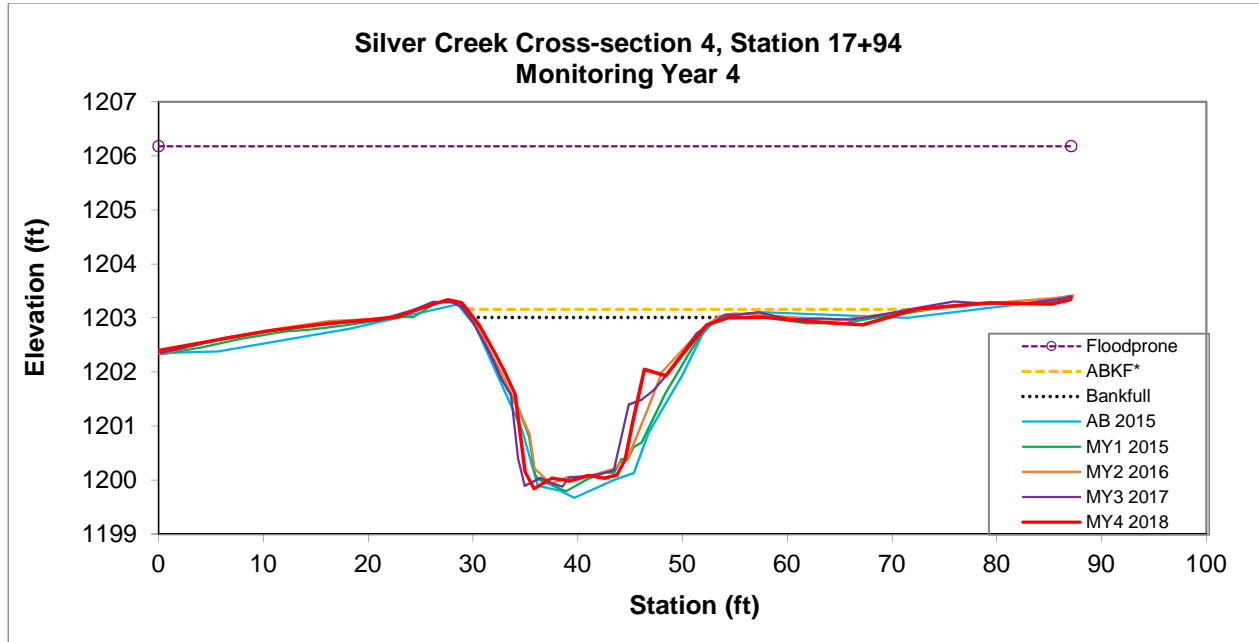
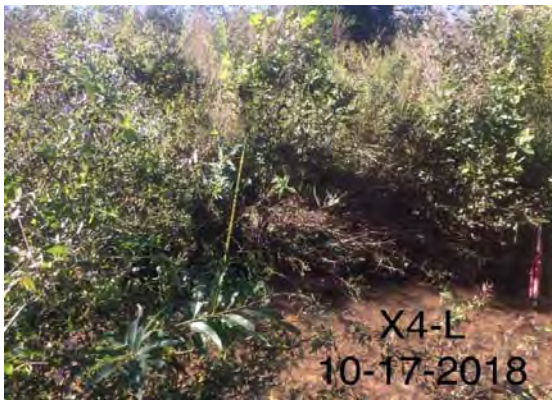
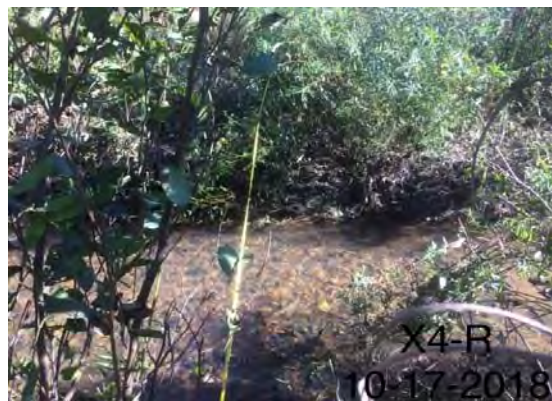
Based on fixed baseline BKF

Feature	Stream Type	BKF Area	BKF Width	BKF Depth	Max BKF Depth	W/D	BH Ratio	ER	BKF Elev	TOB Elev	Low TOB Depth
Riffle	C	41.81	37.72	1.11	3.17	33.98	0.95	2.31	1203.01	1203.0	3.16

Looking at the Left Bank

Looking at the Right Bank

Note: *ABKF stands for as-built bankfull which represents the bankfull line held at the as-built cross sectional area.

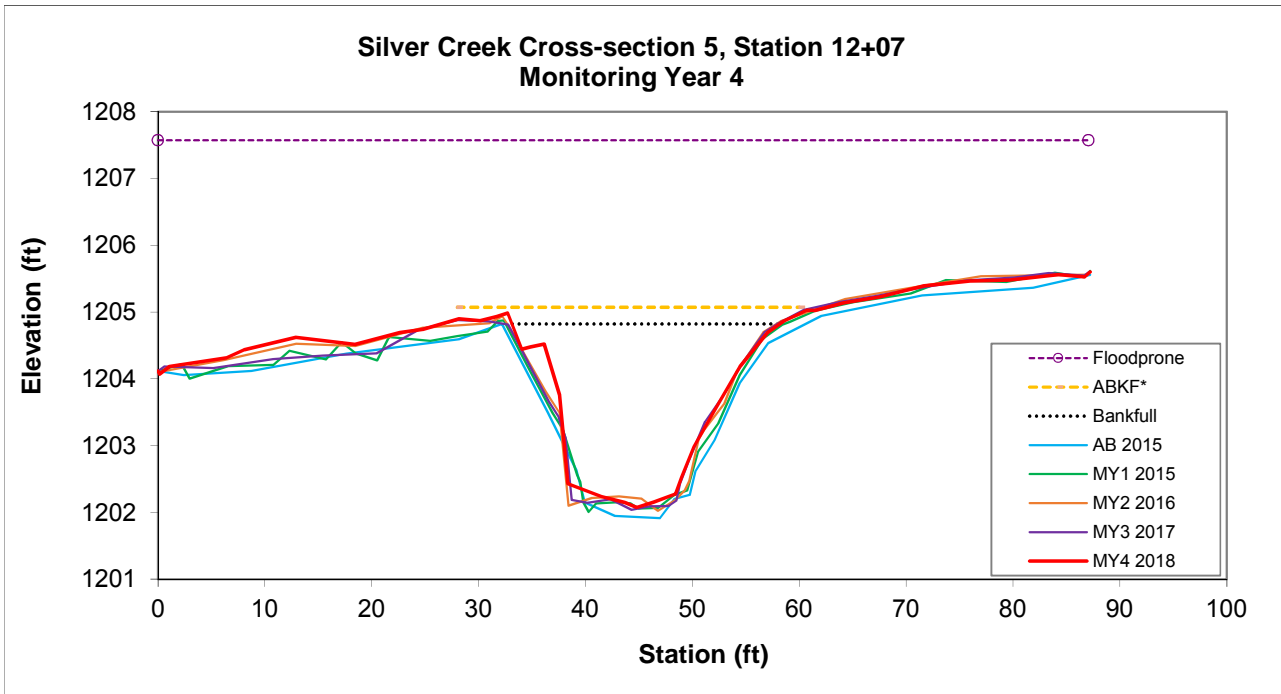
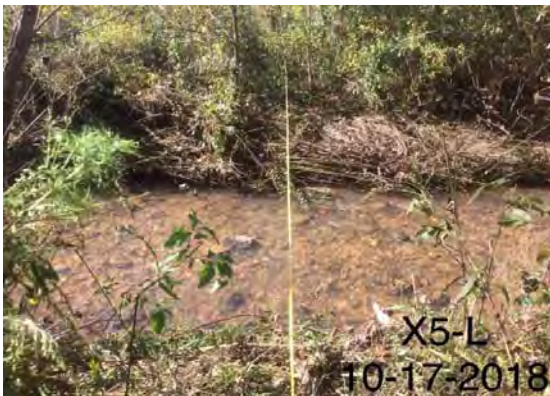
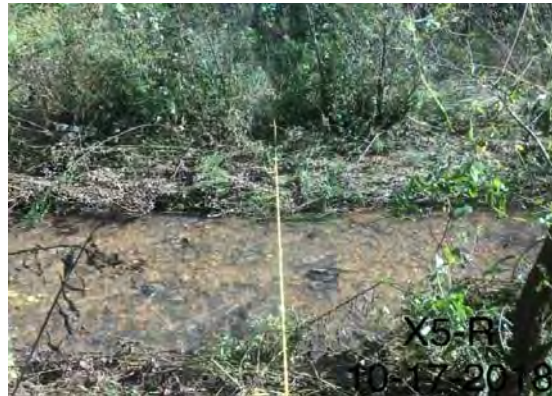
Based on fixed baseline BKF

Feature	Stream Type	BKF Area	BKF Width	BKF Depth	Max BKF Depth	W/D	BH Ratio	ER	BKF Elev	TOB Elev	Low TOB Depth
Riffle	C	39.5	25.0	1.58	2.75	15.8	0.97	3.77	1204.82	1204.99	2.92

Looking at the Left Bank

Looking at the Right Bank

Note: *ABKF stands for as-built bankfull which represents the bankfull line held at the as-built cross sectional area.

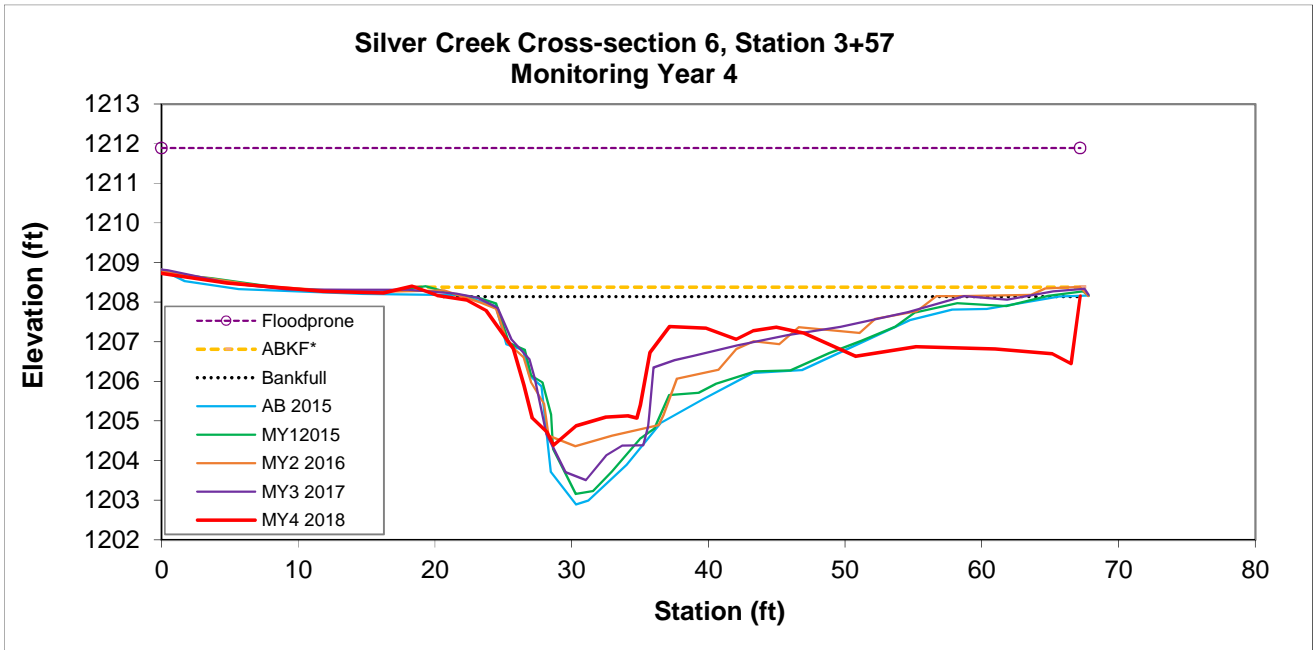
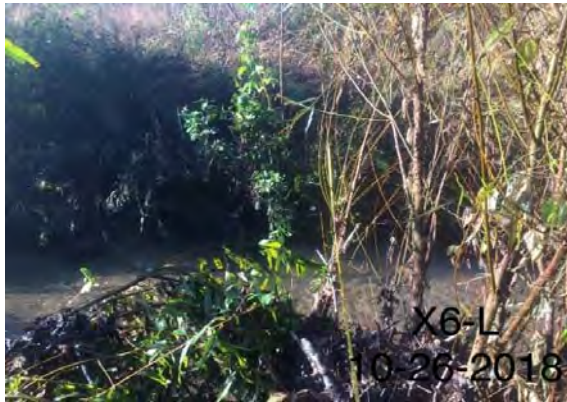
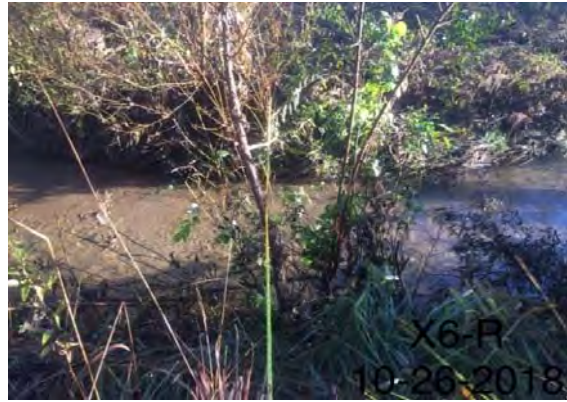
Based on fixed baseline BKF

Feature	Stream Type	BKF Area	BKF Width	BKF Depth	Max BKF Depth	W/D	BH Ratio	ER	BKF Elev	TOB Elev	Low TOB Depth
Pool	-	68.54	44.93	1.53	3.75	29.37	0.94	1.51	1208.14	1208.16	3.77

Looking at the Left Bank

Looking at the Right Bank

Note: *ABKF stands for as-built bankfull which represents the bankfull line held at the as-built cross sectional area.

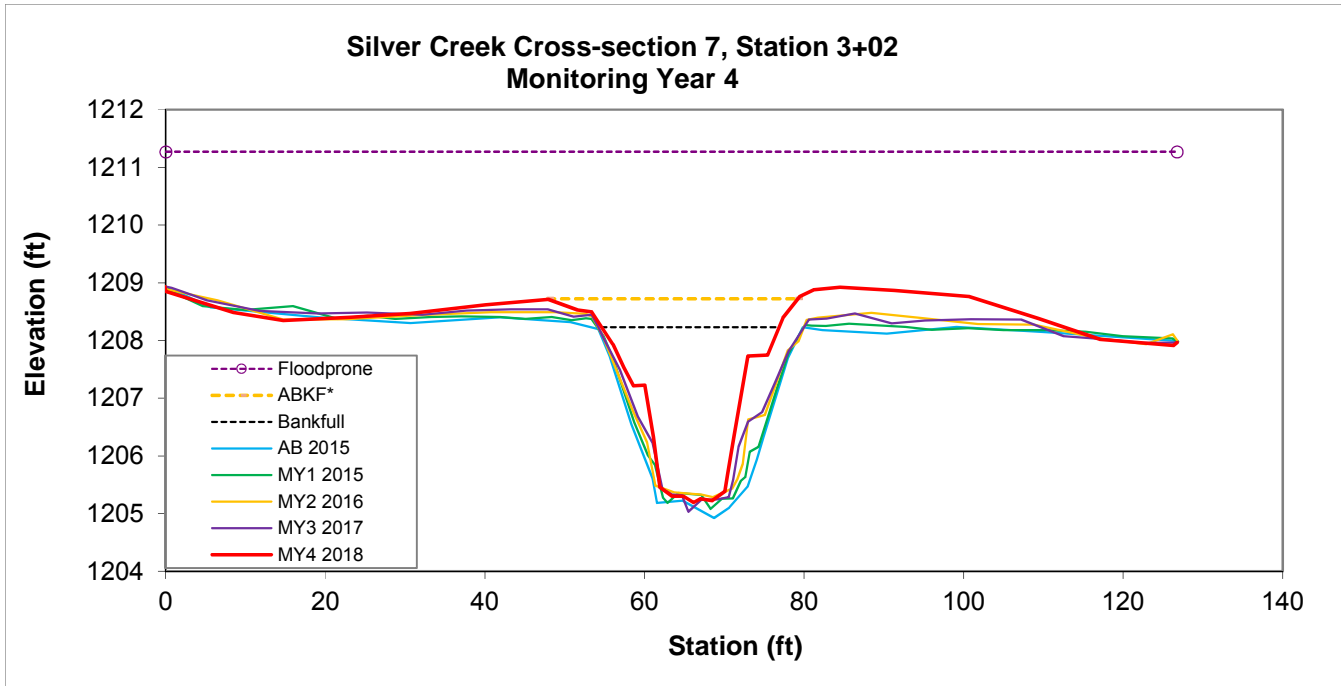
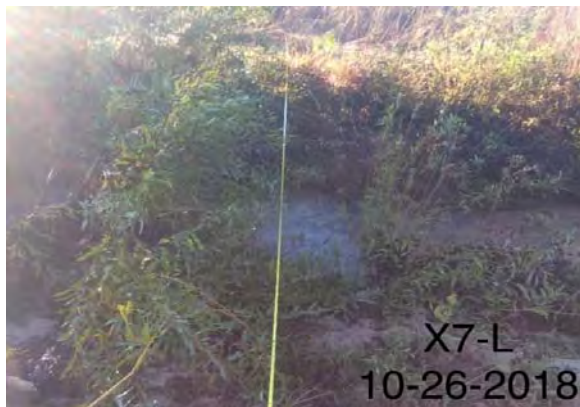
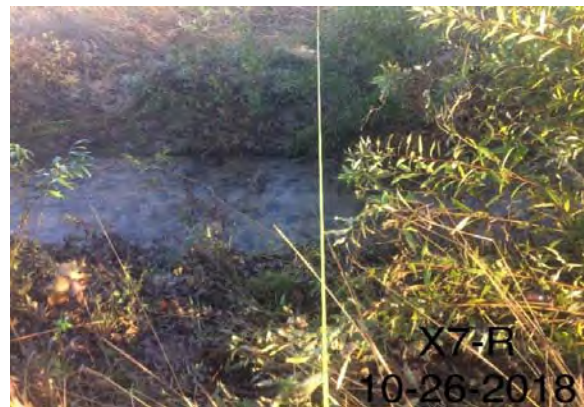
Based on fixed baseline BKF

Feature	Stream Type	BKF Area	BKF Width	BKF Depth	Max BKF Depth	W/D	BH Ratio	ER	BKF Elev	TOB Elev	Low TOB Depth
Riffle	C	37.16	22.23	1.67	3.04	13.31	1.00	5.71	1208.23	1208.71	3.52

Looking at the Left Bank

Looking at the Right Bank

Note: *ABKF stands for as-built bankfull which represents the bankfull line held at the as-built cross sectional area.

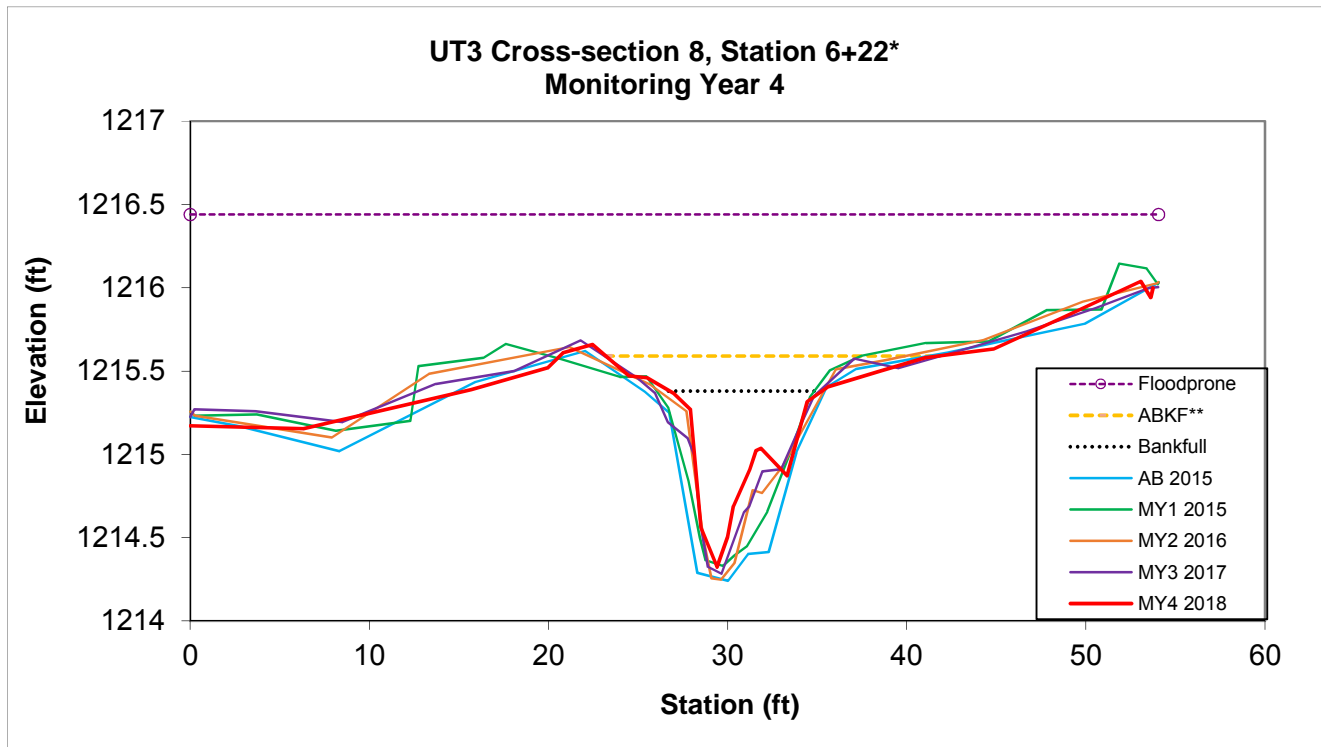
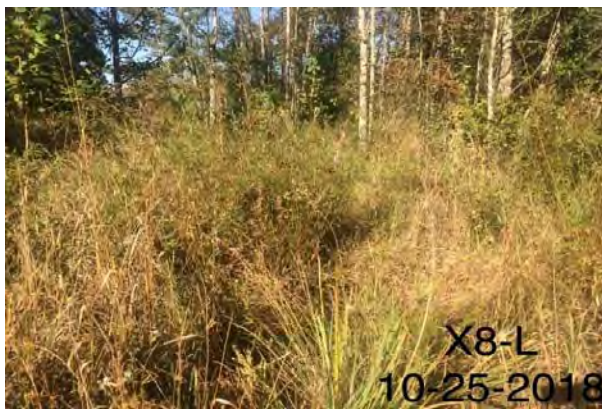
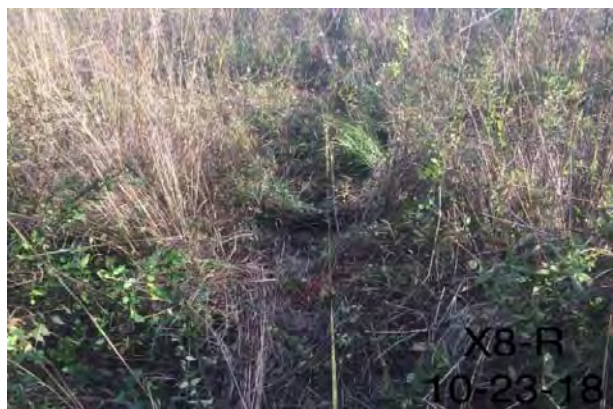
Based on fixed baseline BKF

Feature	Stream Type	BKF Area	BKF Width	BKF Depth	Max BKF Depth	W/D	BH Ratio	ER	BKF Elev	TOB Elev	Low TOB Depth
Riffle	C	3.74	8.50	0.44	1.06	19.32	0.86	6.32	1215.38	1215.41	1.09

Looking at the Left Bank

Looking at the Right Bank

* Note: Stationing for Cross-section 8 has been changed to 6+22; this was the surveyed location last year and this year and is changed from what is shown in the As-built survey and the MY1 report.

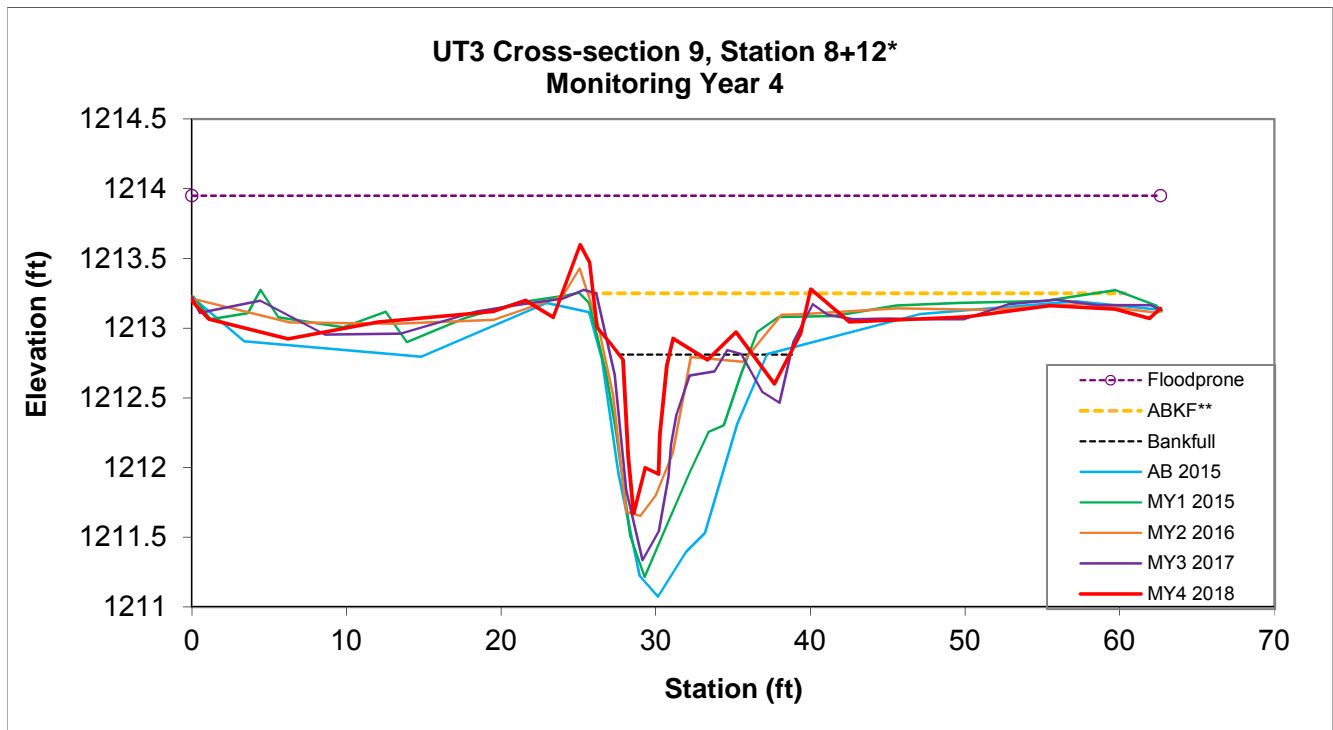
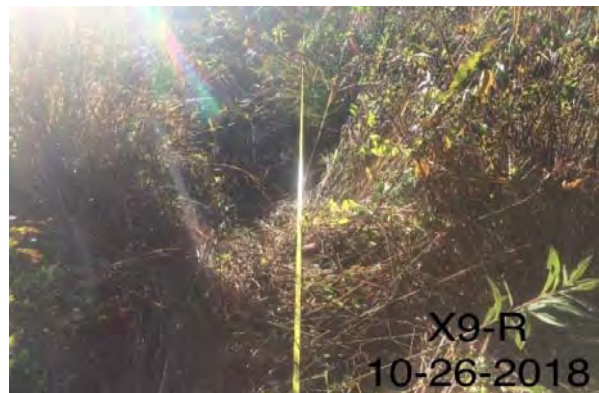
Based on fixed baseline BKF

Feature	Stream Type	BKF Area	BKF Width	BKF Depth	Max BKF Depth	W/D	BH Ratio	ER	BKF Elev	TOB Elev	Low TOB Depth
Pool	-	2.40	6.54	0.37	1.14	17.68	1.02	9.59	1212.81	1213.28	1.61

Looking at the Left Bank

Looking at the Right Bank

Note: *Stationing for Cross-section 9 is being changed to 8+12 which is the surveyed location for the last two years and changes from what was indicated in the As-built survey and the MY1 report.

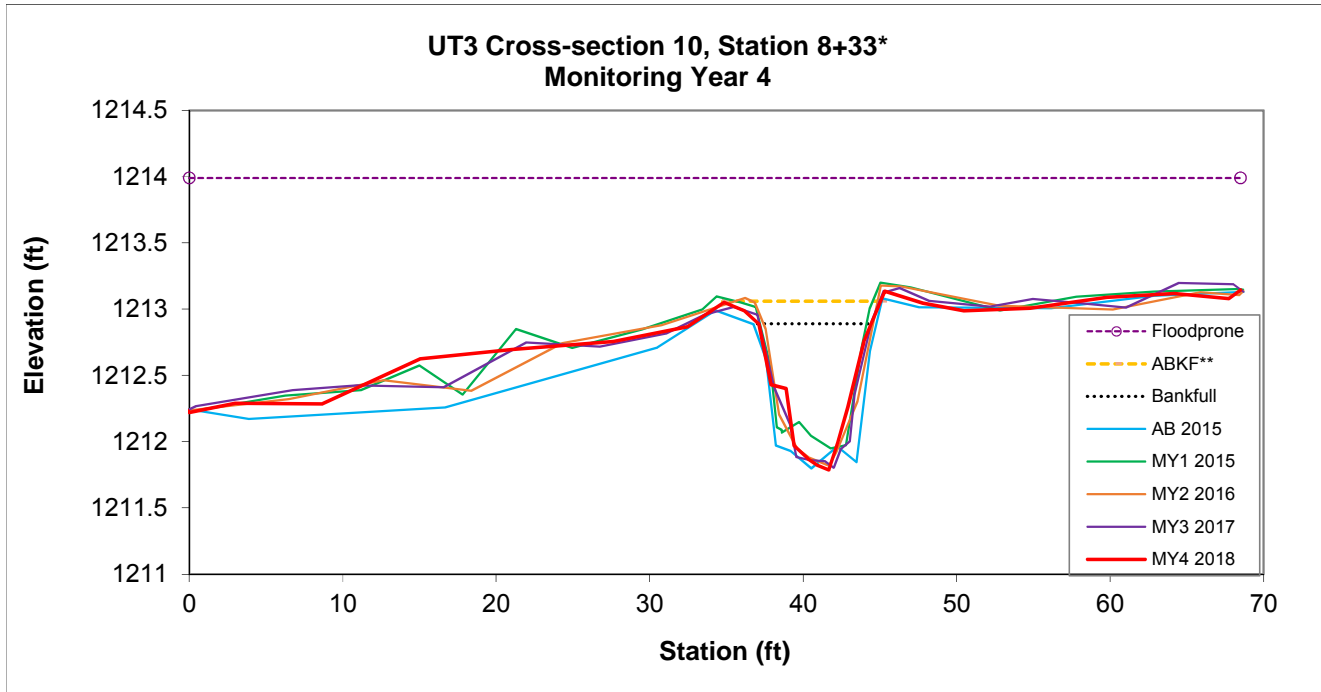
Based on fixed baseline BKF

Feature	Stream Type	BKF Area	BKF Width	BKF Depth	Max BKF Depth	W/D	BH Ratio	ER	BKF Elev	TOB Elev	Low TOB Depth
Riffle	E	4.85	7.34	0.66	1.1	11.12	0.99	9.35	1212.89	1213.05	1.262

Note: *Stationing for Cross-section 10 is being changed to 8+33 which is the surveyed location for the last two years and changes from what was indicated in the As-built survey and the MY1 report.

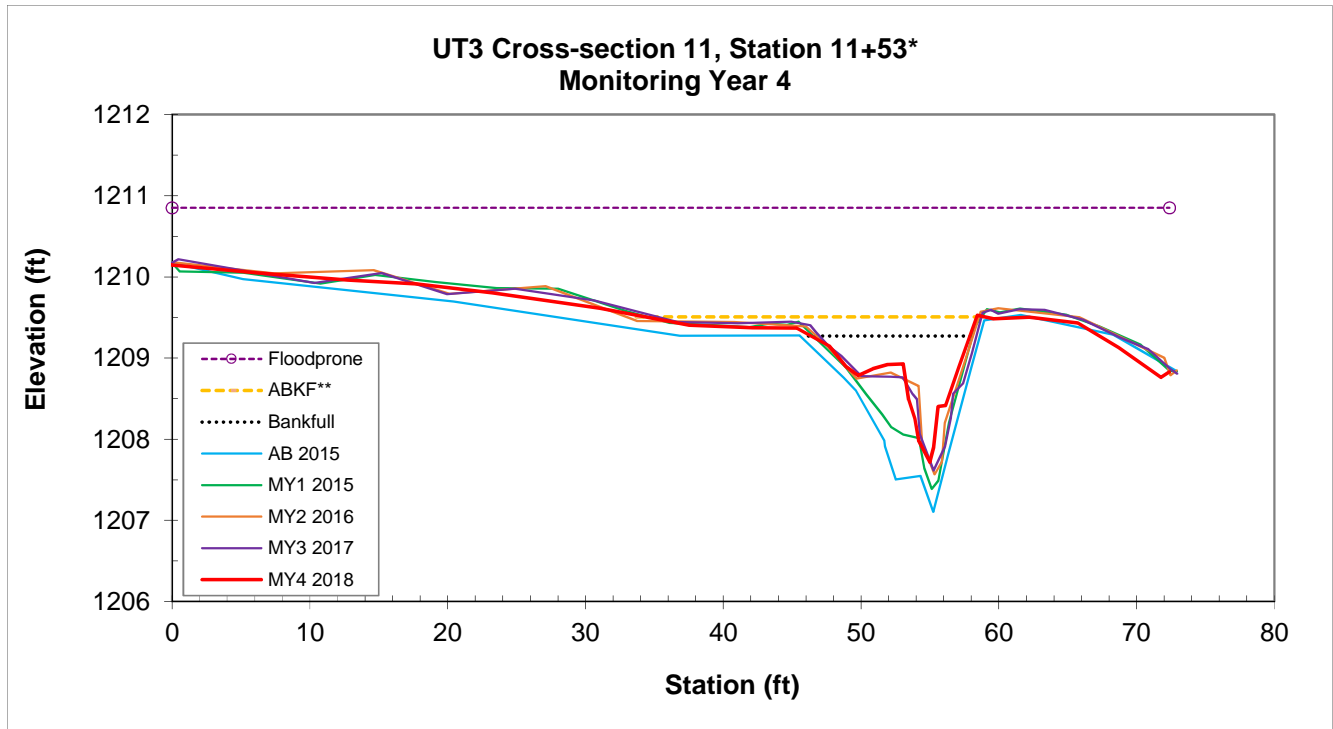
Based on fixed baseline BKF

Feature	Stream Type	BKF Area	BKF Width	BKF Depth	Max BKF Depth	W/D	BH Ratio	ER	BKF Elev	TOB Elev	Low TOB Depth
Pool	-	6.12	11.51	0.53	1.56	21.72	0.92	6.34	1209.27	1209.37	1.65

Note: *Stationing for Cross-section 11 is being changed to 11+53 which is the surveyed location for the last two years and changes from what was indicated in the As-built survey and the MY1 report.

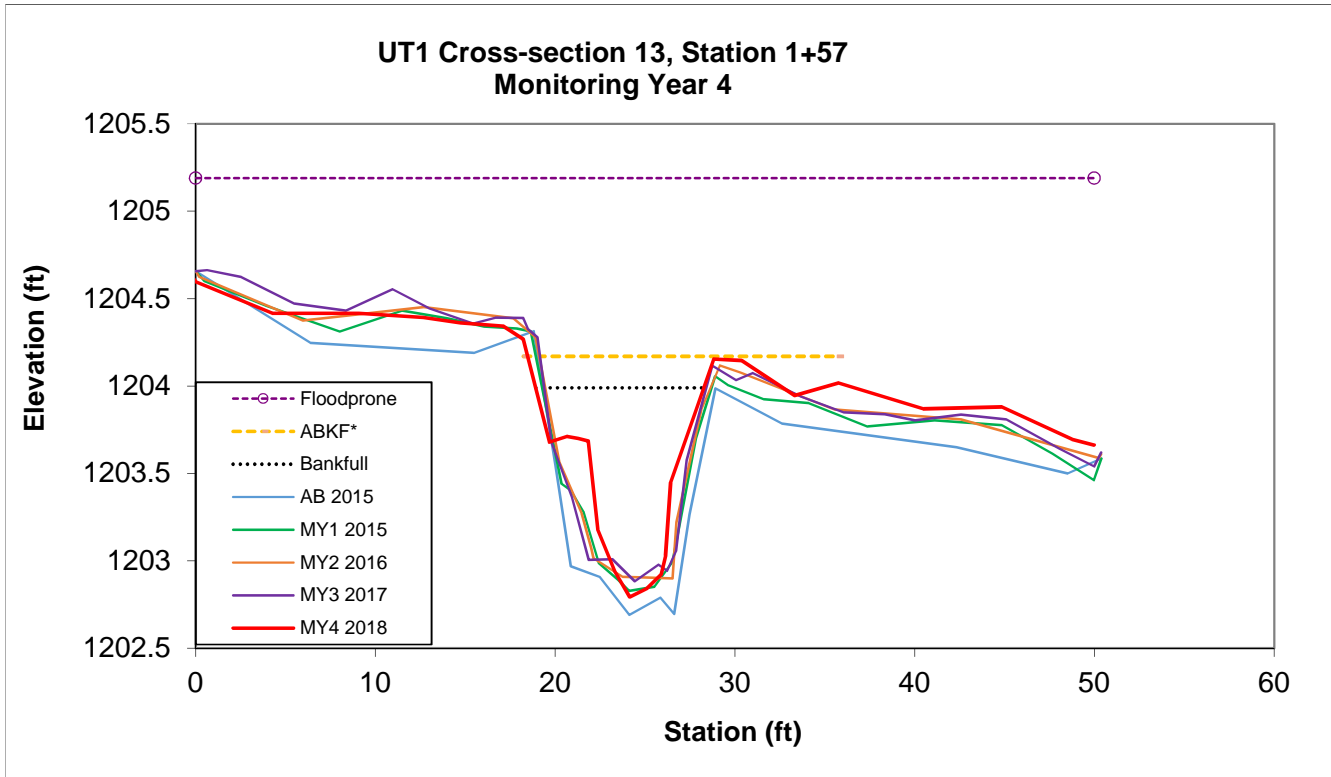
Based on fixed baseline bankfull

Feature	Stream Type	BKF Area	BKF Width	BKF Depth	Max BKF Depth	W/D	BH Ratio	ER	BKF Elev	TOB Elev	Low TOB Depth
Riffle	C	5.87	11.49	0.51	1.2	22.53	0.99	4.38	1203.99	1204.16	1.37

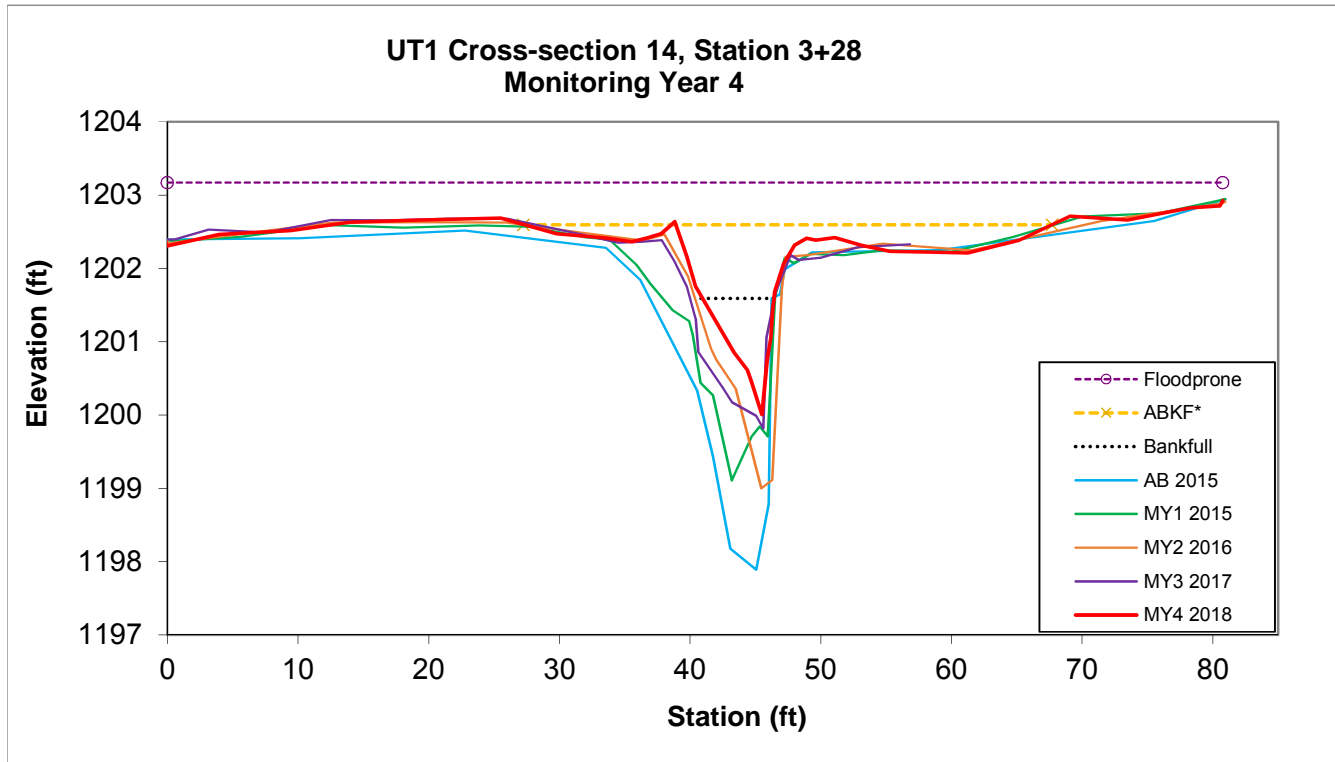
Based on fixed baseline bankfull

Feature	Stream Type	BKF Area	BKF Width	BKF Depth	Max BKF Depth	W/D	BH Ratio	ER	BKF Elev	TOB Elev	Low TOB Depth
Pool	-	3.91	5.46	0.72	1.58	7.58	0.92	14.83	1201.59	1202.41	2.40

Note: *ABKF stands for as-built bankfull which represents the bankfull line held at the as-built cross sectional area.

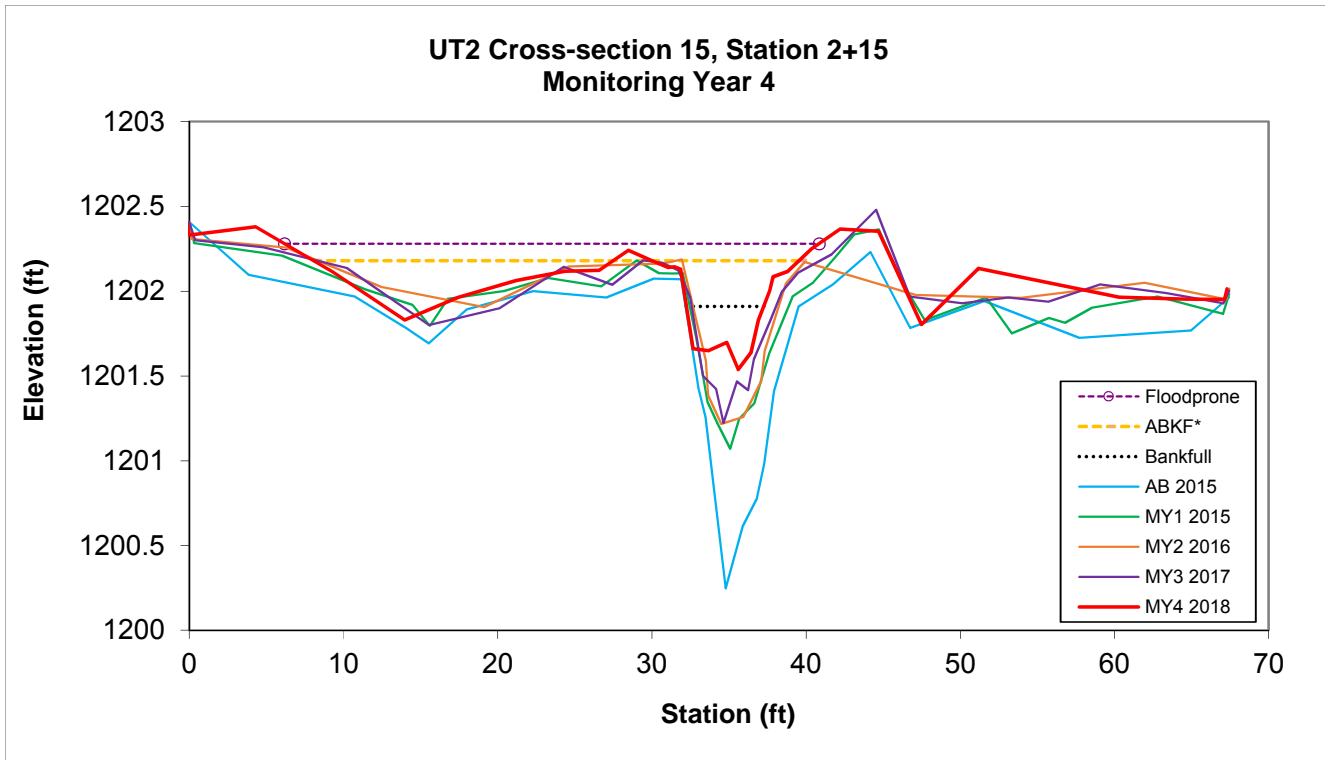
Based on fixed baseline BKF

Feature	Stream Type	BKF Area	BKF Width	BKF Depth	Max BKF Depth	W/D	BH Ratio	ER	BKF Elev	TOB Elev	Low TOB Depth
Pool	-	1.17	5.01	0.23	0.37	21.78	0.92	11.39	1201.91	1202.14	0.60

Note: *ABKF stands for as-built bankfull which represents the bankfull line held at the as-built cross sectional area.

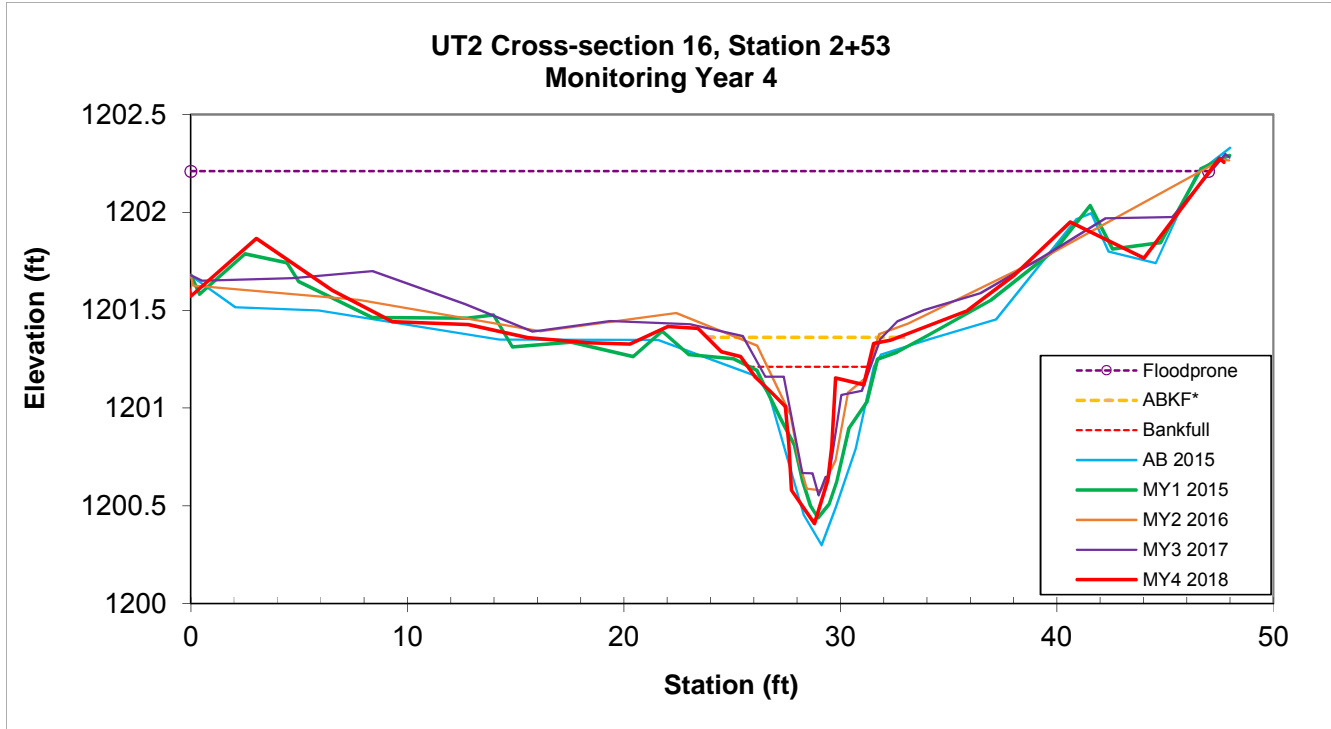
Based on fixed baseline BKF

Feature	Stream Type	BKF Area	BKF Width	BKF Depth	Max BKF Depth	W/D	BH Ratio	ER	BKF Elev	TOB Elev	Low TOB Depth
Riffle	C	1.72	5.55	0.31	0.80	17.90	0.97	8.29	1201.21	1201.33	0.92

Note: *ABKF stands for as-built bankfull which represents the bankfull line held at the as-built cross sectional area.

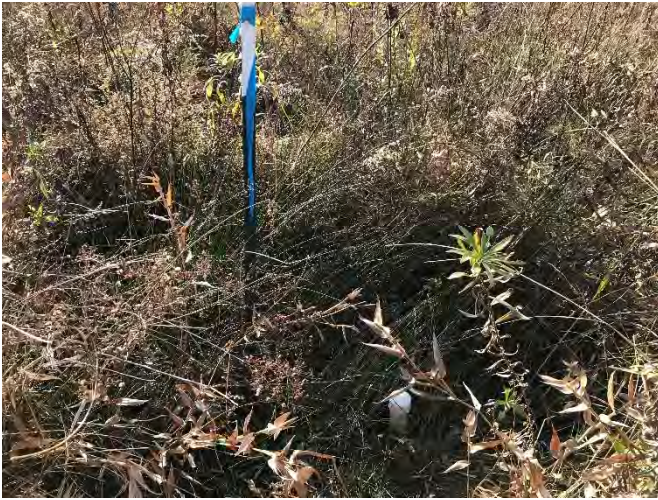
Photo 1. Wetland Photo Point – W1, replicates photo 50 in Baseline Report (November 18, 2018).

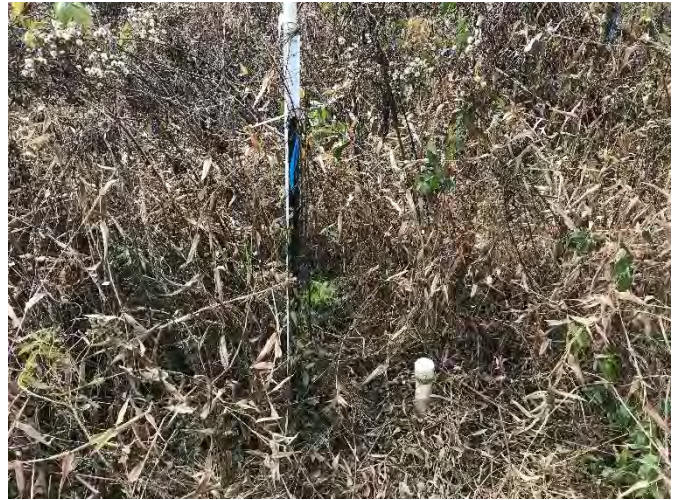
Photo 2. Wetland Photo Point – W2, replicates photo 51 in Baseline Report (November 18, 2018).

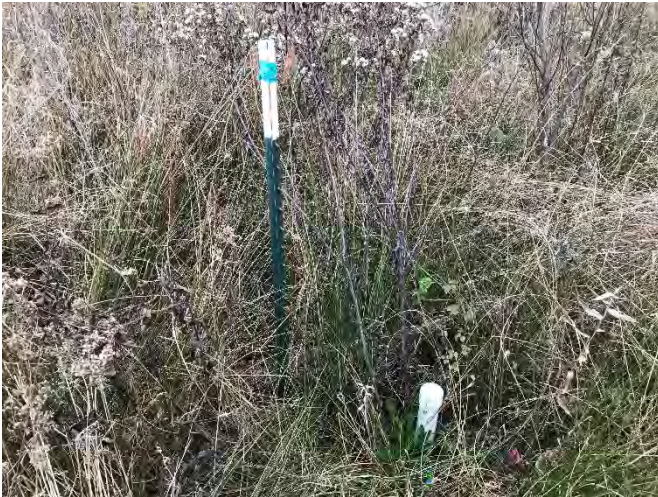
Photo 3. Wetland Photo Point – W3 replicates photo 52 in Baseline Report (November 18, 2018).

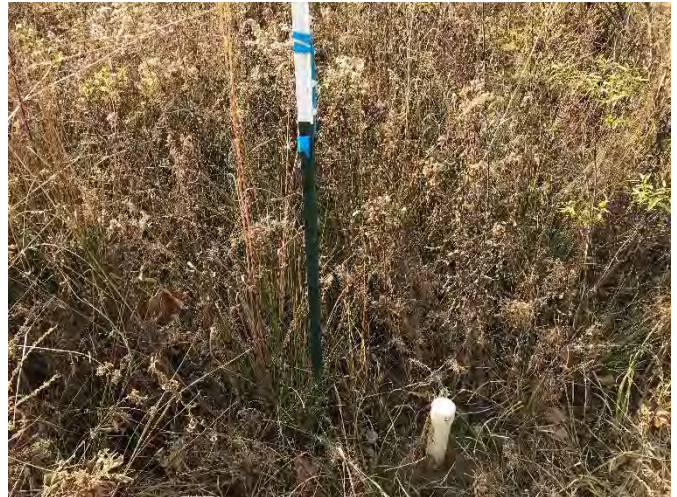
Photo 4. Wetland Photo Point – W4, replicates photo 53 in Baseline Report (November 18, 2018).

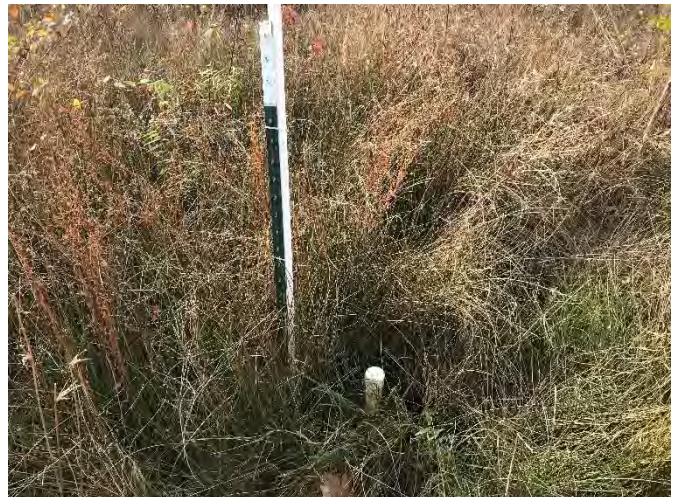
Photo 6. Wetland Photo Point – W6, replicates photo 55 in Baseline Report (November 18, 2018).

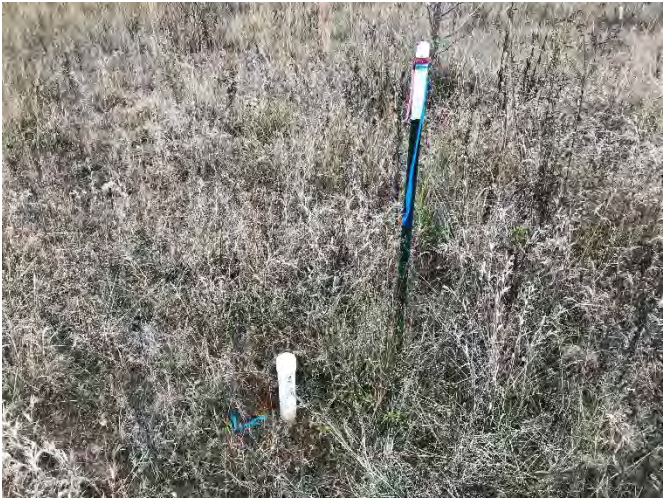
Photo 7. Wetland Photo Point – W7, replicates photo 56 in Baseline Report (November 18, 2018).

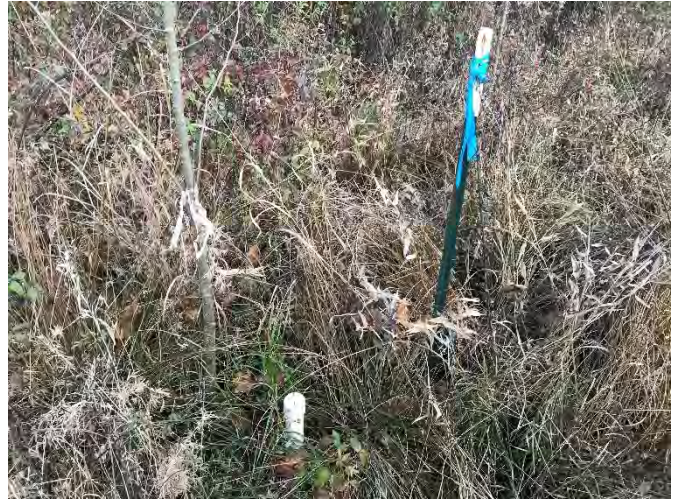
Photo 8. Wetland Photo Point – W8, replicates photo 57 in Baseline Report (November 18, 2018).

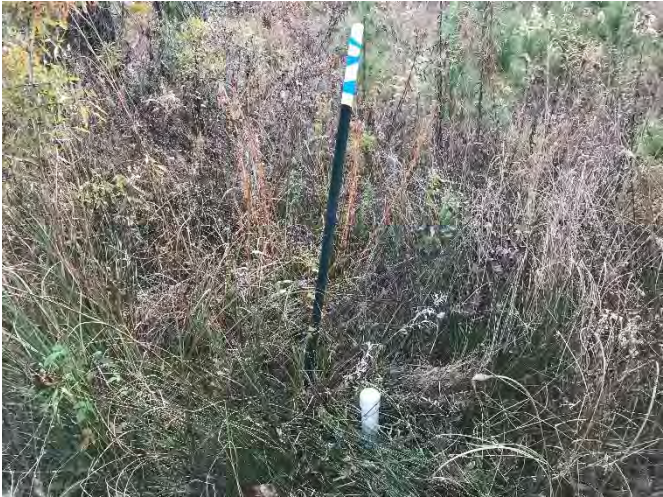
Photo 9. Wetland Photo Point – W9, replicates photo 58 in Baseline Report (November 18, 2018).

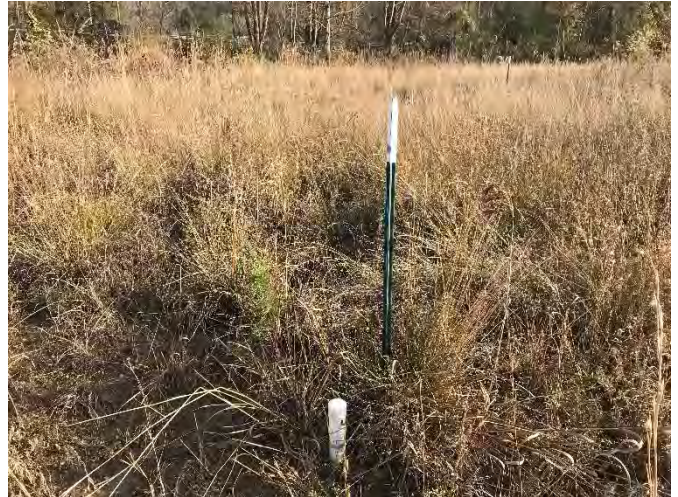
Photo 10. Wetland Photo Point – W10, replicates photo 59 in Baseline Report (November 18, 2018).

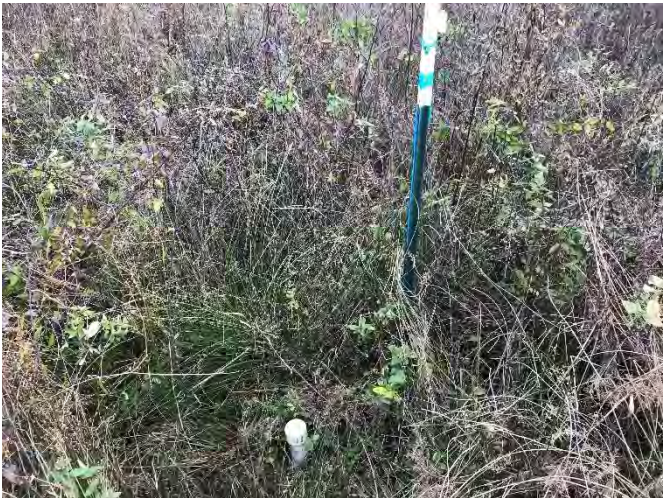
Photo 11. Wetland Photo Point – W11, replicates photo 60 in Baseline Report (November 18, 2018).

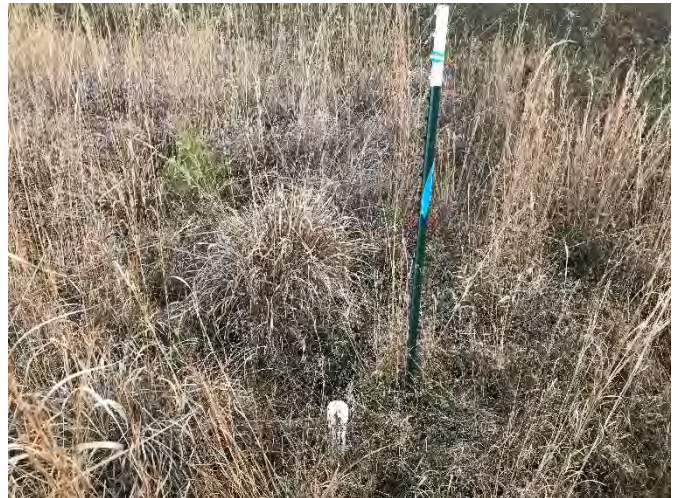
Photo 12. Wetland Photo Point – W12, replicates photo 61 in Baseline Report (November 18, 2018).

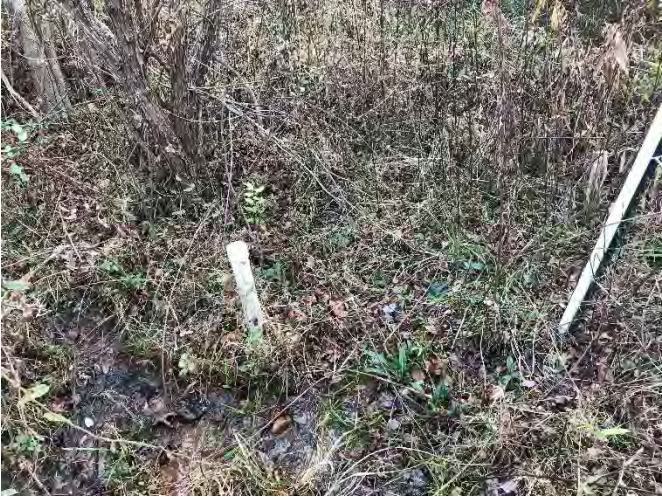
Photo 13. Wetland Photo Point – W13 added between time of baseline and MY1 survey, (November 18, 2018)
