# **UT to Rush Fork Stream Mitigation Project Year 1 (2022) Monitoring Report FINAL**

DMS Project ID No. 100068, DEQ Contract No. 7535

Haywood County, North Carolina, French Broad River Basin: 06010106

MY1 Data Collection Period: October – November 2022

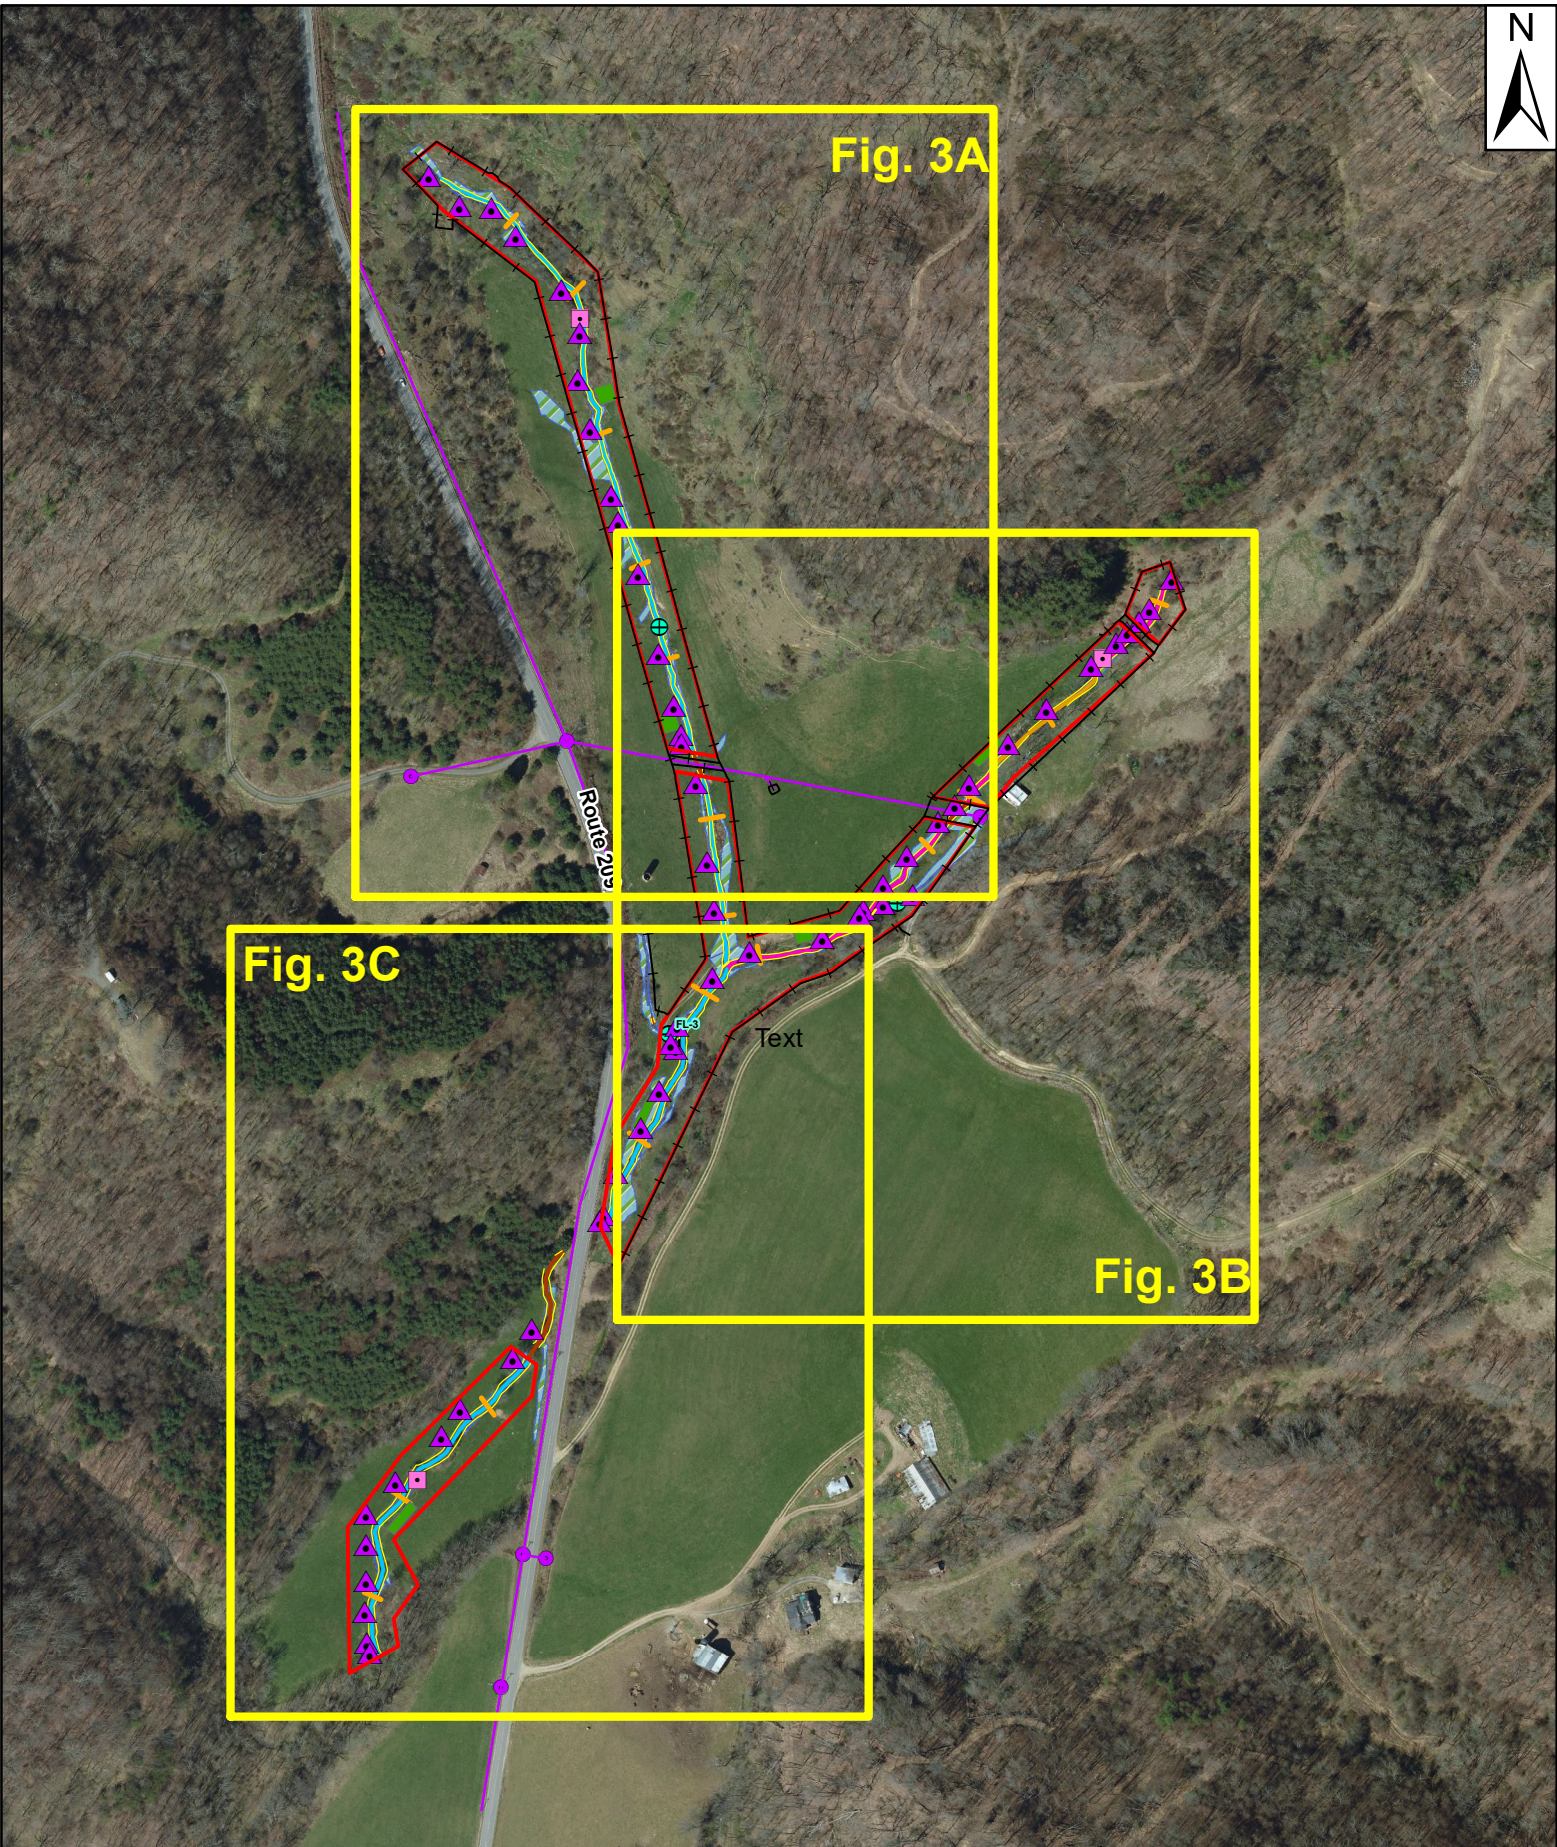
Figure 3. Current Condition  
Plan View (CCPV) Overview MY1  
UT to Rush Fork Project  
Haywood County

The specific locations of monitoring features, such as vegetation plots, permanent cross-sections, reference photograph stations, and crest gauges, are shown on the CCPV map found in Appendix B.

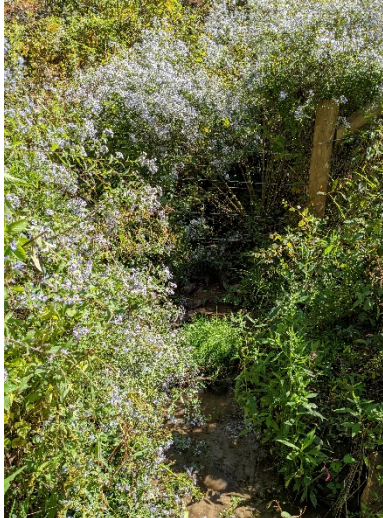
PP-1: UT1, R 1, Station 11+00.  
Upstream. October 4, 2022.

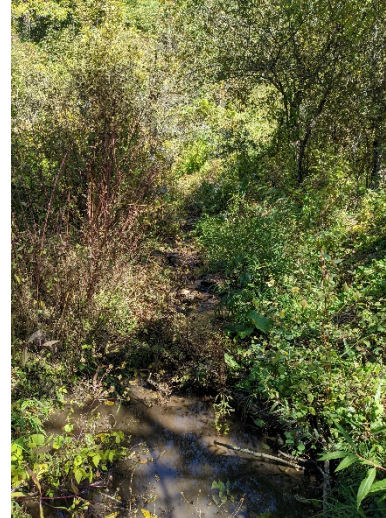
PP-2: UT1, R 1, Station 11+80.  
Upstream. October 4, 2022.

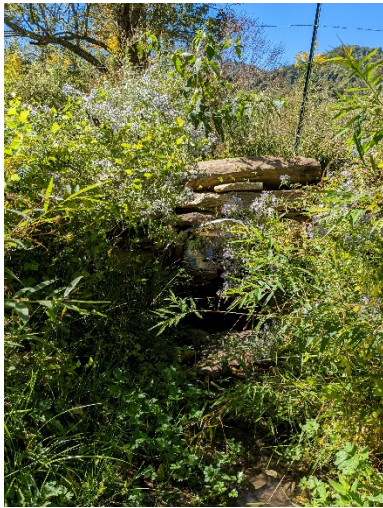
PP-3: UT1, R 1, Station 12+10  
Culvert. Downstream. October 4,  
2022.

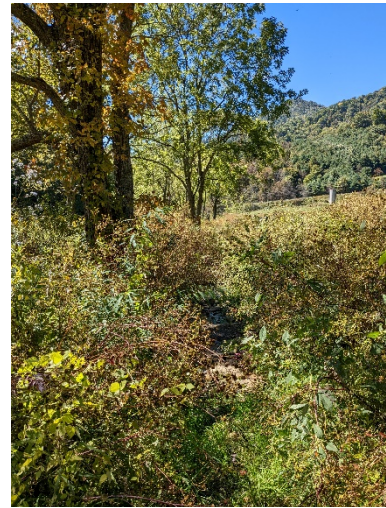
PP-4: UT1, R 1, Station 12+33  
Downstream. October 4, 2022.

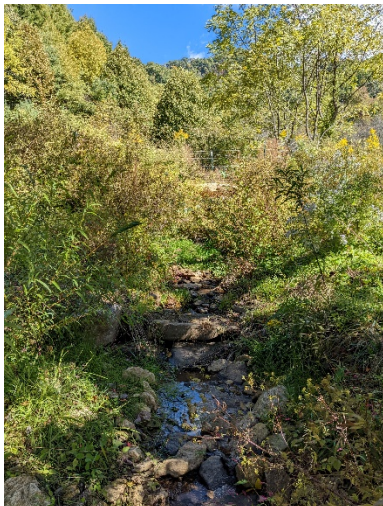
PP-6: UT1, R 2, Station 13+25.  
Upstream. October 4, 2022.

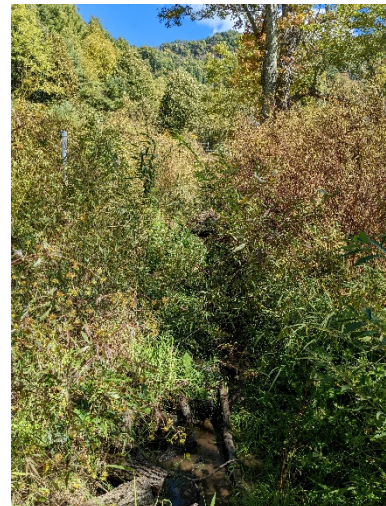
PP-7: UT1, R 2, Station 14+60.  
Upstream. October 4, 2022.

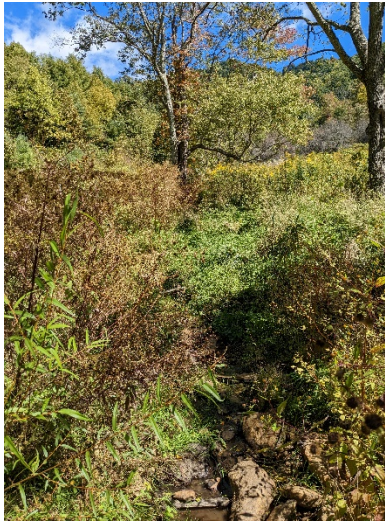
**PP-7: UT1, R 2, Station 14+60.  
Upstream. October 4, 2022.**

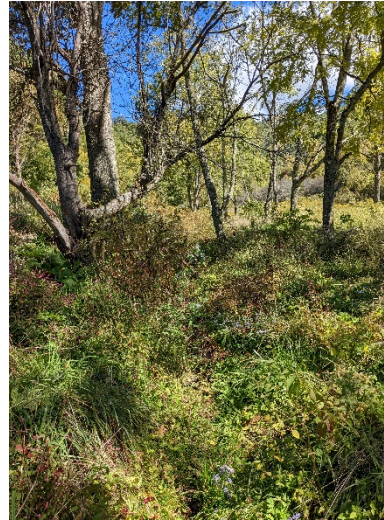
**PP-8: UT1, R 2, Station 15+50.  
Upstream. October 4, 2022.**

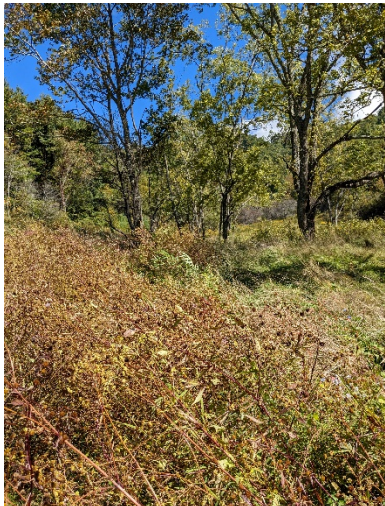
**PP-9: UT1, R 3, Station 16+50.  
Upstream. October 4, 2022.**

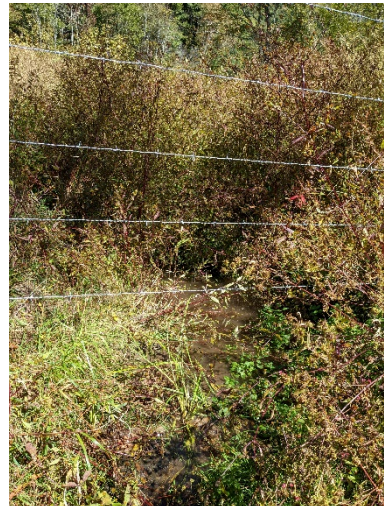
**PP-10: UT1, R 3, 16+80.  
Upstream. October 4, 2022.**

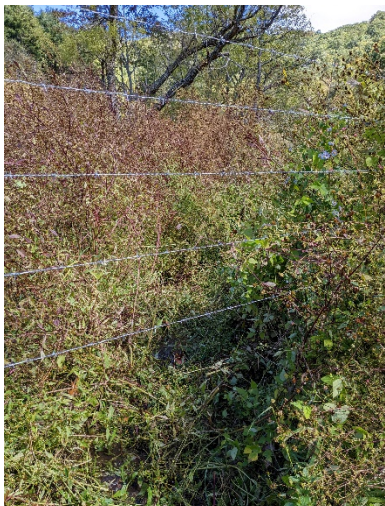
**P-11: UT1, R 3, Station 17+35.  
Upstream. October 4, 2022.**

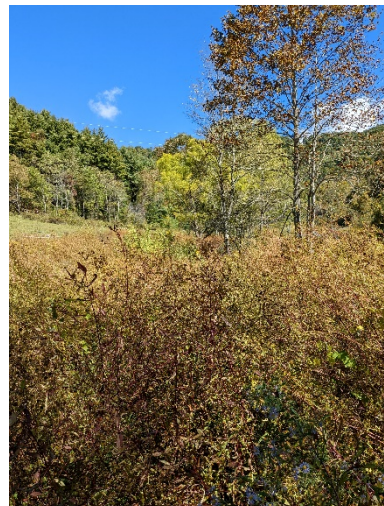
**PP-12: UT1, R 3, Station 18+25.  
Upstream. October 4, 2022.**

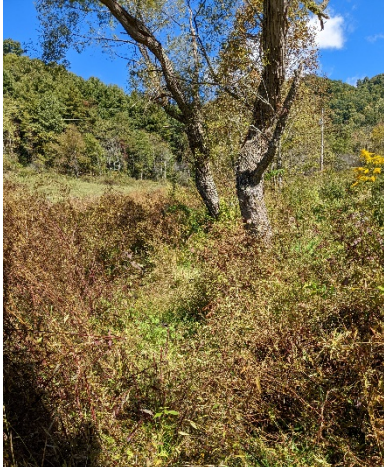
PP-13: UT1, R 3, Station 18+90.  
Upstream. October 4, 2022.

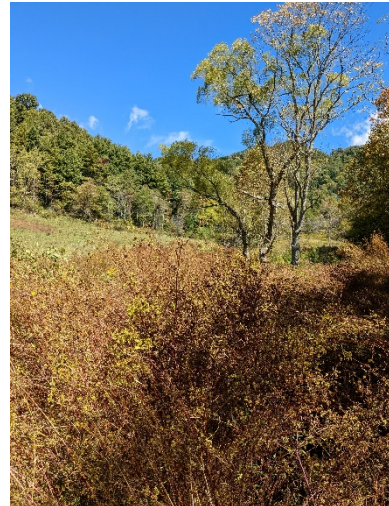
PP-14: UT1 R 3, Station 19+55.  
Upstream. October 4, 2022.

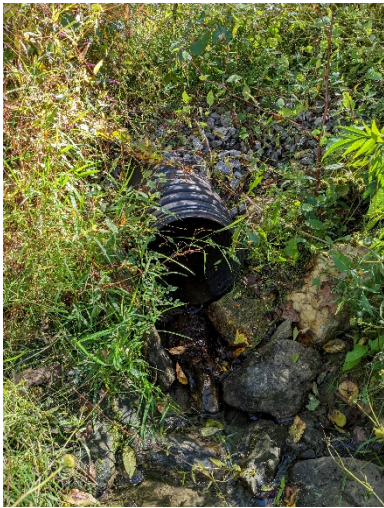
PP-15: UT2, Station 10+15.  
Upstream. October 4, 2022.

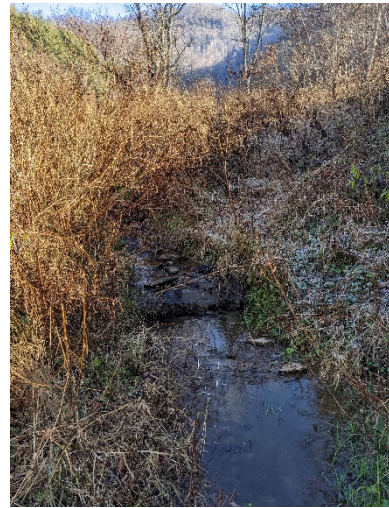
PP-16: UT2, Station 10+85.  
Upstream. November 29, 2022

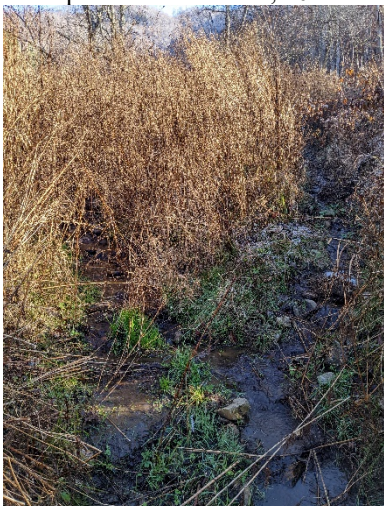
PP-17: UT1, R3, Station 19+70.  
Upstream. November 29, 2022

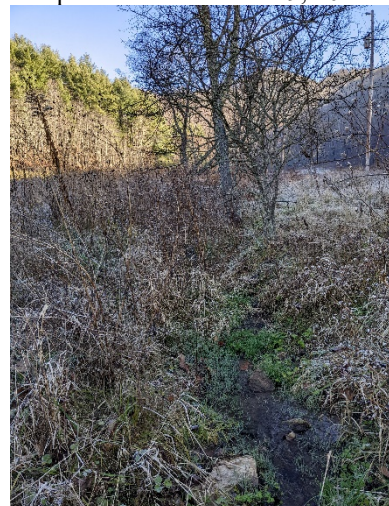
PP-18: UT1, R 3, Station 20+60.  
Upstream. November 29, 2022

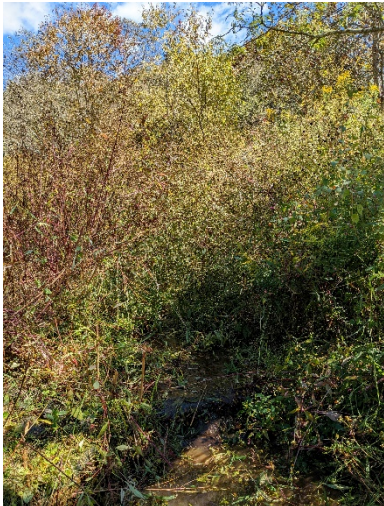
PP-19: UT1, R 3, Station 22+00.  
Upstream. October 4, 2022

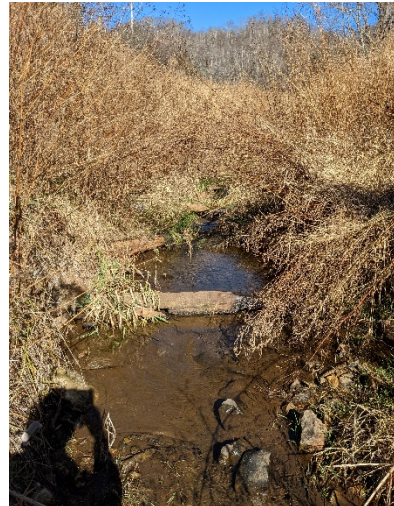
PP-20: UT1, R 4, Station 22+75.  
Upstream.

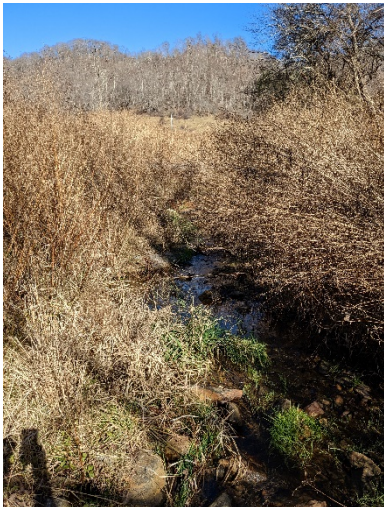
PP-21: UT1, R 4, Station 23+90.  
Upstream.

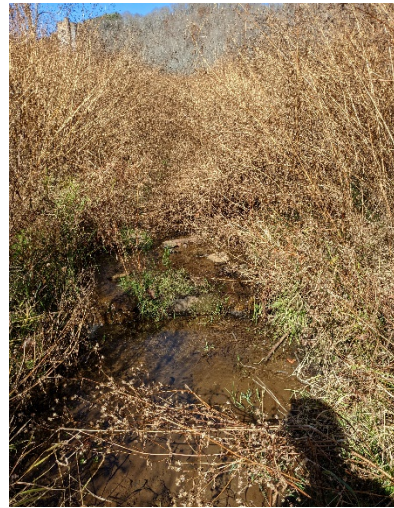
PP-22: UT1, R 4, Station 24+20.  
Upstream. November 9, 2022

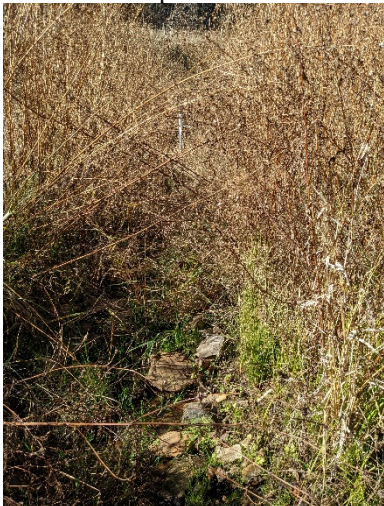
PP-23: UT4, Station 10+50.  
Upstream. November 9, 2022

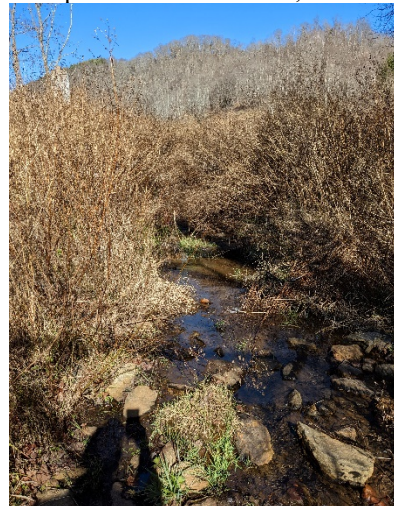
PP-24: UT1, R 4, Station 25+25.  
Upstream. November 29, 2022

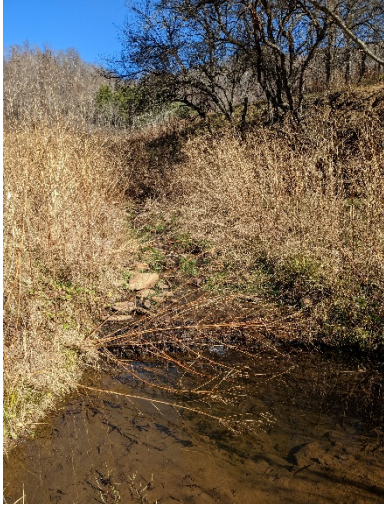
PP-25: UT1, R 4, Station 26+00.  
Upstream. November 29, 2022

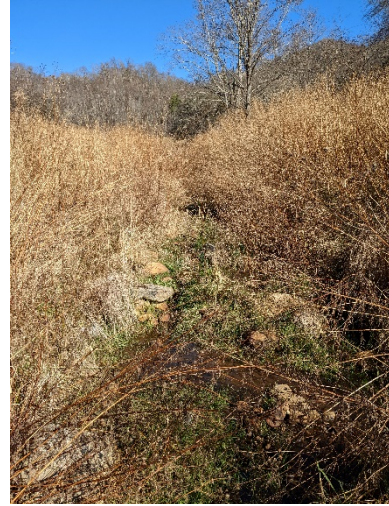
PP-26: UT1, R 4, Station 27+00.  
Upstream. November 29, 2022

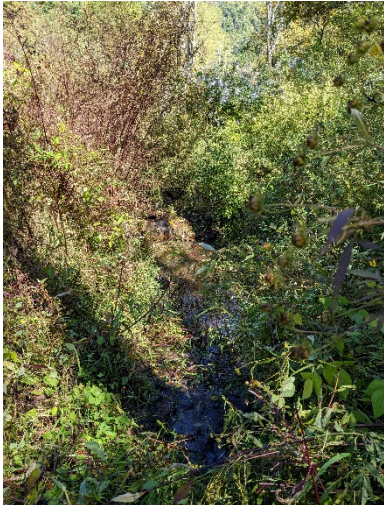
PP-27: UT1, R 4, Station 27+75.  
Upstream. October 4, 2022

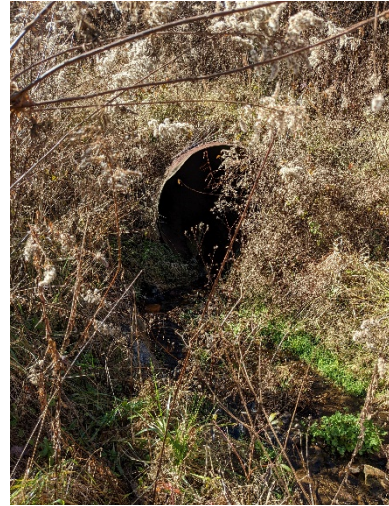
PP-28: UT1, R 4, Station 27+90.  
Downstream. November 29, 2022

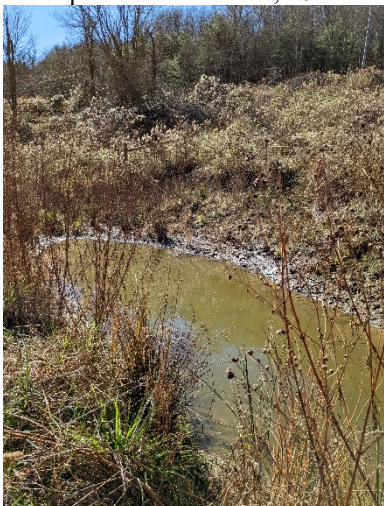
PP-29: BMP at Top of UT3.  
November 9, 2022.

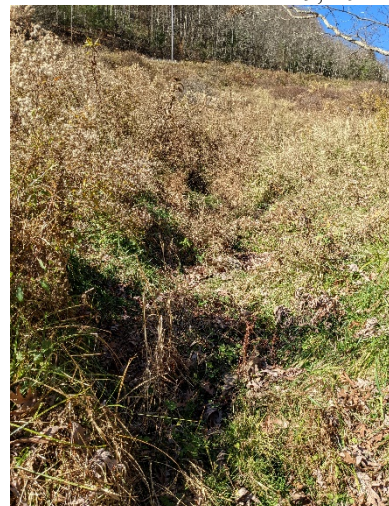
PP-30: UT3, Station 10+00.  
Upstream. November 9, 2022

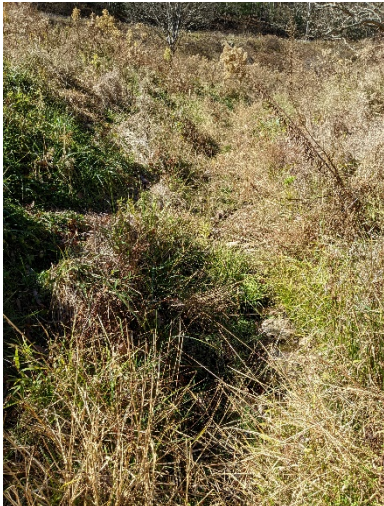
PP-31: UT3, Station 11+10.  
Upstream. November 9, 2022

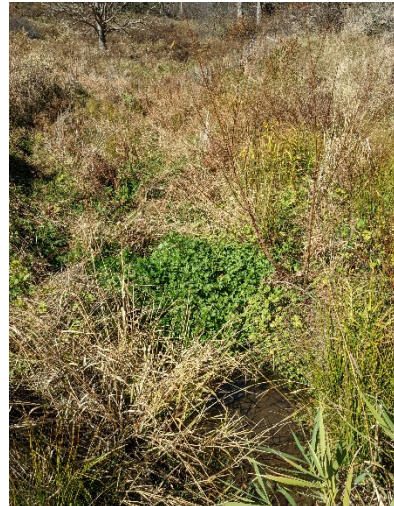
PP-32: UT3, Station 11+75.  
Upstream. November 9, 2022

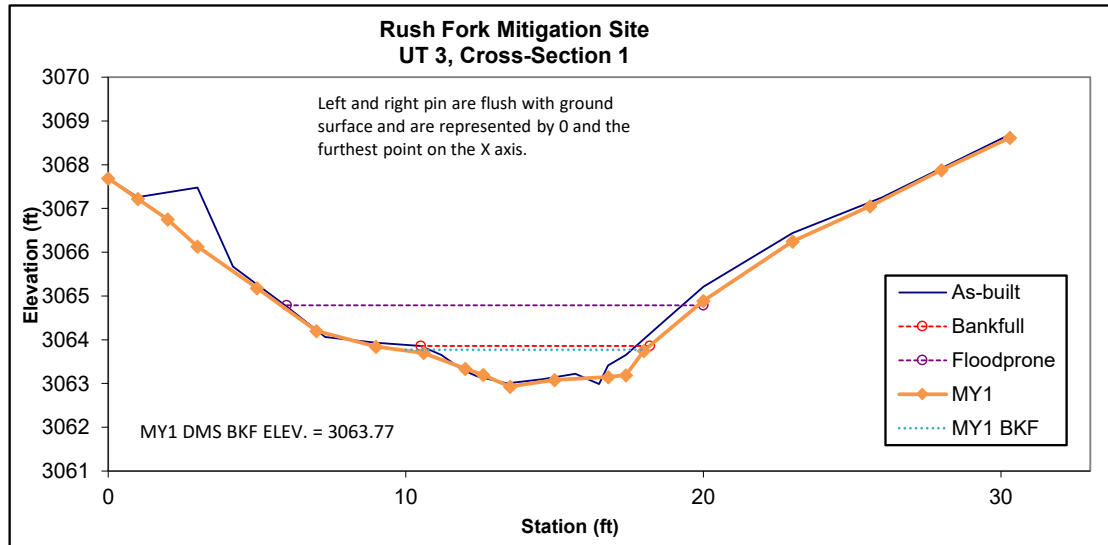
**Permanent Cross-Section 1**

Feature	Stream Type	BKF Area	BKF Width	BKF Depth	Max BKF Depth	W/D	BH Ratio	ER	BKF Elev	LTOB Elev
Riffle	B	4.96	9.19	0.5	0.9	17.0	1.1	1.6	3063.86	3063.86

Note: Per DMS/IRT request, bank height ratio for MY1 has been calculated using the bankfull elevation as determined from the as-built bankfull area. All other values were calculated using the as-built bankfull elevation.

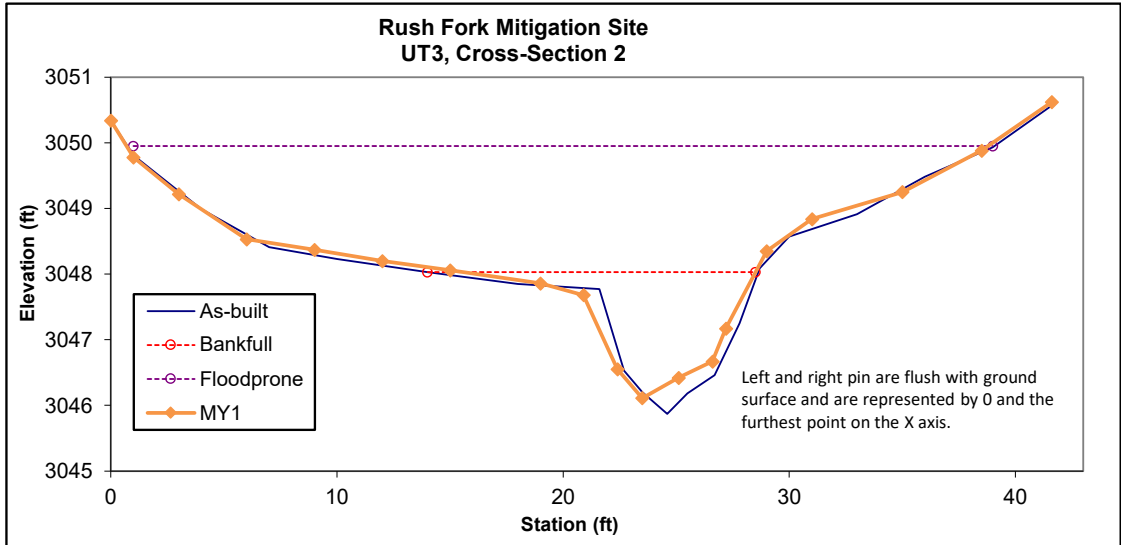
**Permanent Cross-Section 2**

Feature	Stream Type	BKF Area	BKF Width	BKF Depth	Max BKF Depth	W/D	BH Ratio	ER	BKF Elev	LTOB Elev
Pool	C	10.36	13.51	0.77	1.92	17.55	--	--	3048.03	3048.03

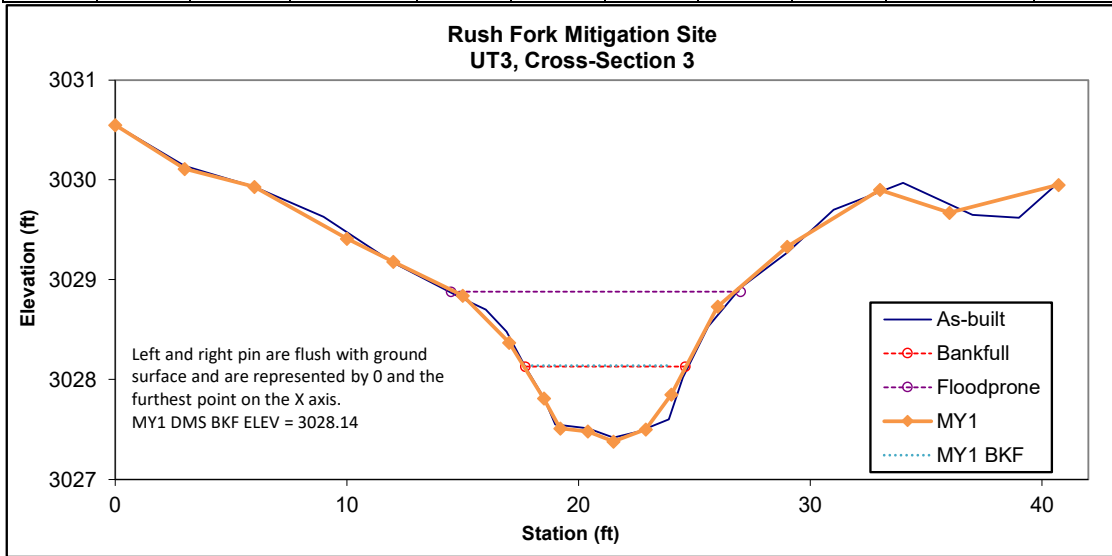
Feature	Stream Type	BKF Area	BKF Width	BKF Depth	Max BKF Depth	W/D	BH Ratio	ER	BKF Elev	LTOB Elev
Riffle	B	3.66	7.64	0.48	0.75	15.92	1.0	1.8	3028.13	3028.13

Note: Per DMS/IRT request, bank height ratio for MY1 has been calculated using the bankfull elevation as determined from the as-built bankfull area. All other values were calculated using the as-built bankfull elevation.

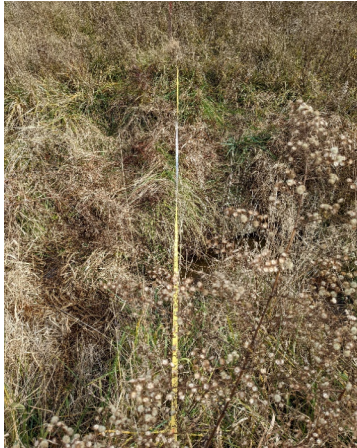
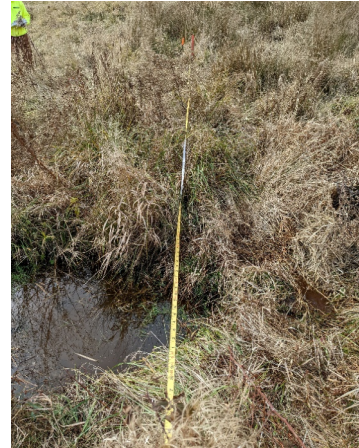
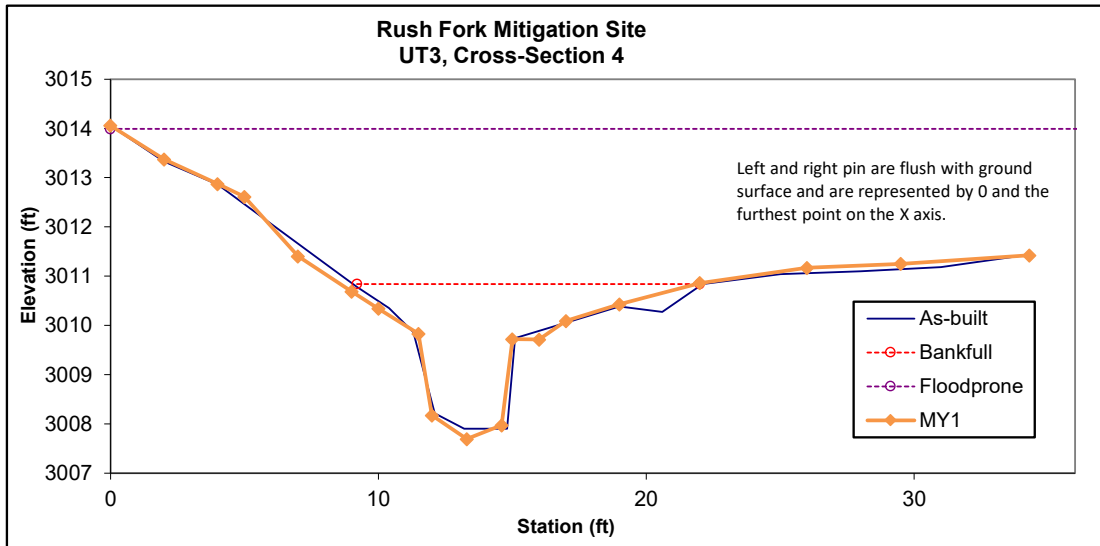
**Permanent Cross-Section 4**

Year 1 Survey Collected: November 2022

Looking at the Left Bank

Looking at the Right Bank

Feature	Stream Type	BKF Area	BKF Width	BKF Depth	Max BKF Depth	W/D	BH Ratio	ER	BKF Elev	LTOB Elev
Pool	E	14.74	13.42	1.1	3.15	12.2	--	--	3010.84	3010.84

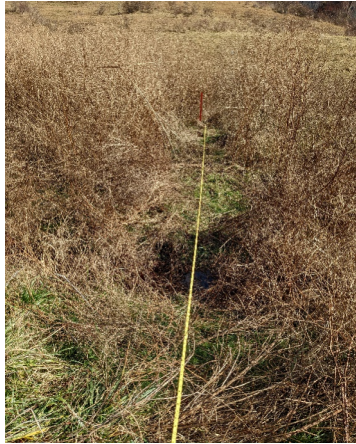
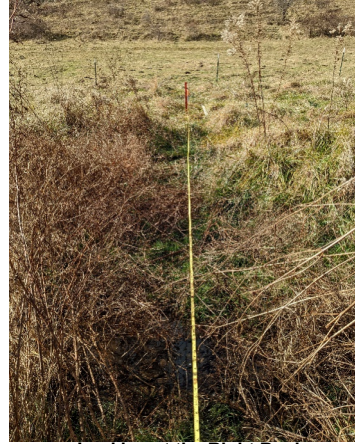
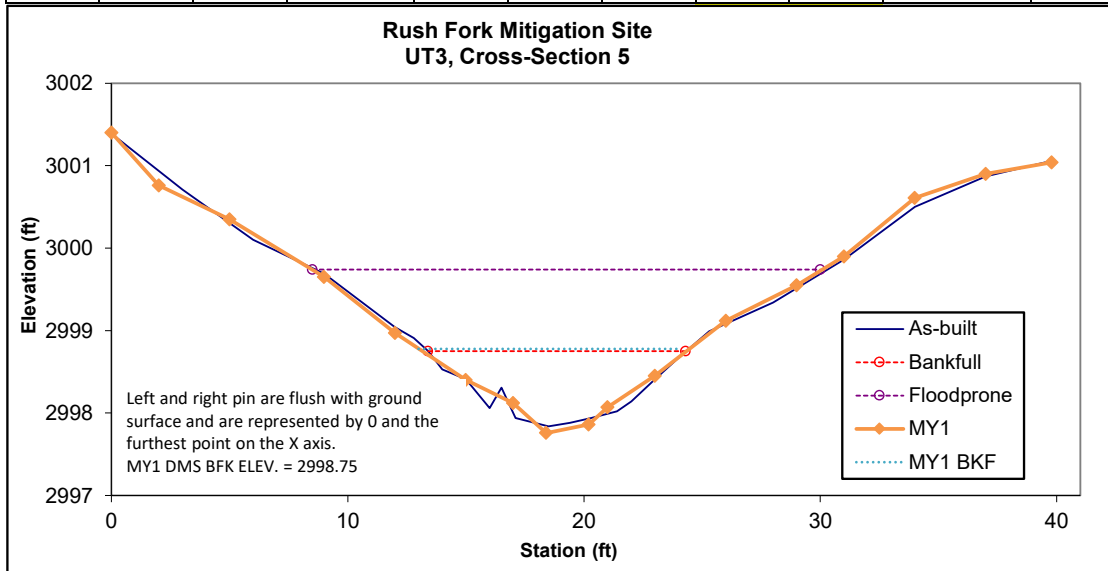
**Permanent Cross-Section 5**

Year 1 Survey Collected: November 2022

Looking at the Left Bank

Looking at the Right Bank

Feature	Stream Type	BKF Area	BKF Width	BKF Depth	Max BKF Depth	W/D	BH Ratio	ER	BKF Elev	LTOB Elev
Riffle	B	6.14	12.34	0.50	0.99	24.68	1.00	1.90	2998.75	2998.75

Note: Per DMS/IRT request, bank height ratio for MY1 has been calculated using the bankfull elevation as determined from the as-built bankfull area. All other values were calculated using the as-built bankfull elevation.

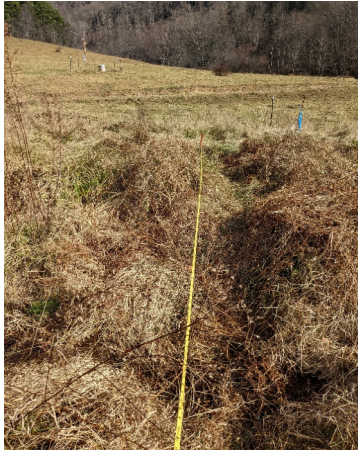
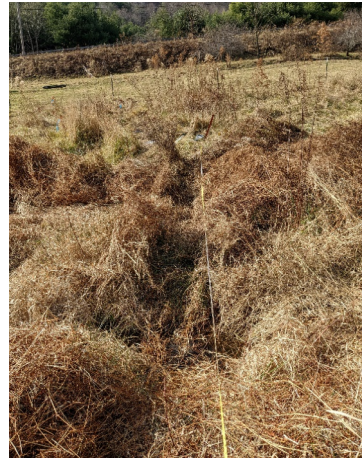
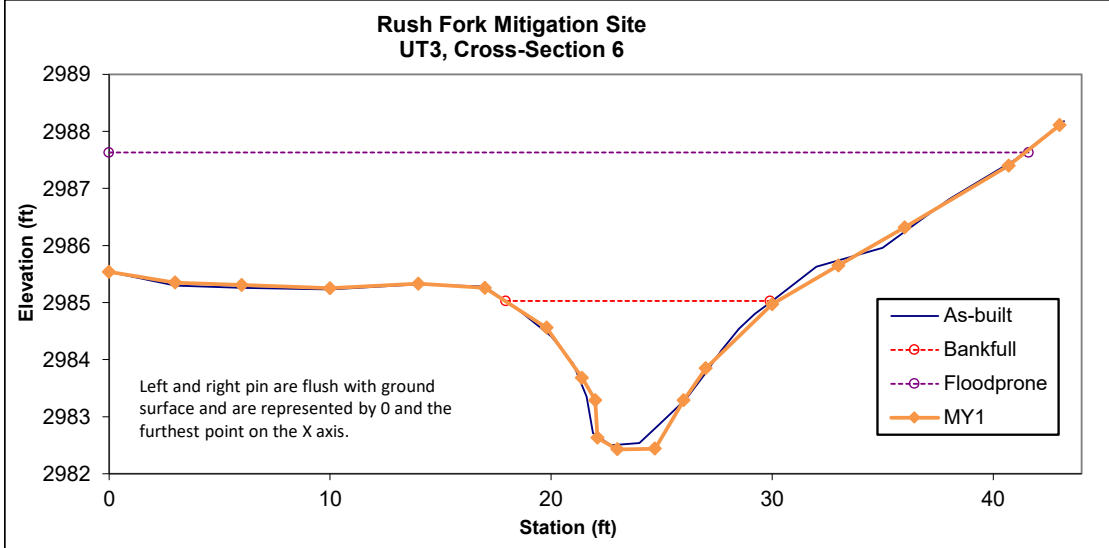
**Permanent Cross-Section 6**

Year 1 Survey Collected: November 2022

Looking at the Left Bank

Looking at the Right Bank

Feature	Stream Type	BKF Area	BKF Width	BKF Depth	Max BKF Depth	W/D	BH Ratio	ER	BKF Elev	LTOB Elev
Pool	E	15.74	12.08	1.30	2.60	9.29	--	--	2985.03	2985.03

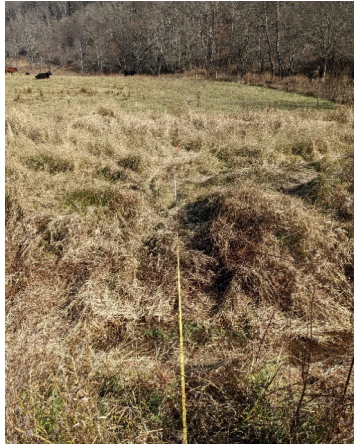
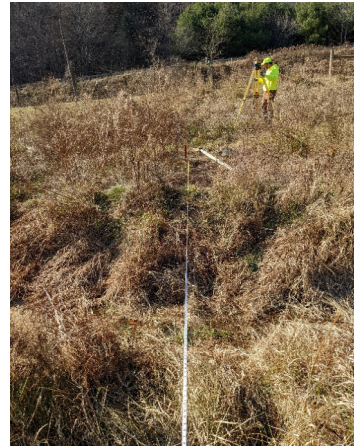
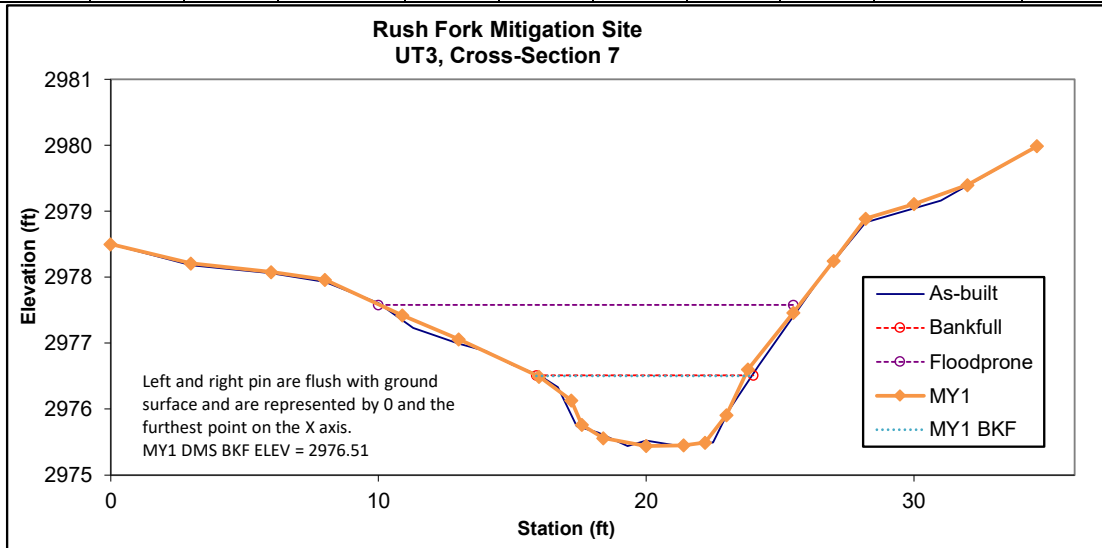
**Permanent Cross-Section 7**

Year 1 Survey Collected: November 2022

Looking at the Left Bank

Looking at the Right Bank

Feature	Stream Type	BKF Area	BKF Width	BKF Depth	Max BKF Depth	W/D	BH Ratio	ER	BKF Elev	LTOB Elev
Riffle	B	5.93	7.7	0.77	1.07	10	1	2.1	2976.51	2976.51

Note: Per DMS/IRT request, bank height ratio for MY1 has been calculated using the bankfull elevation as determined from the as-built bankfull area. All other values were calculated using the as-built bankfull elevation.

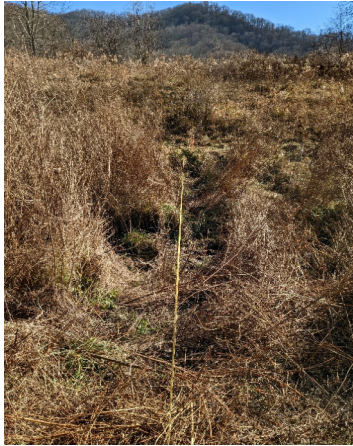
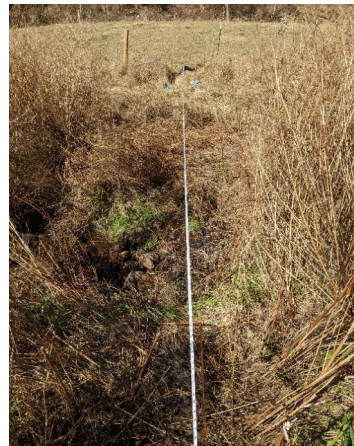
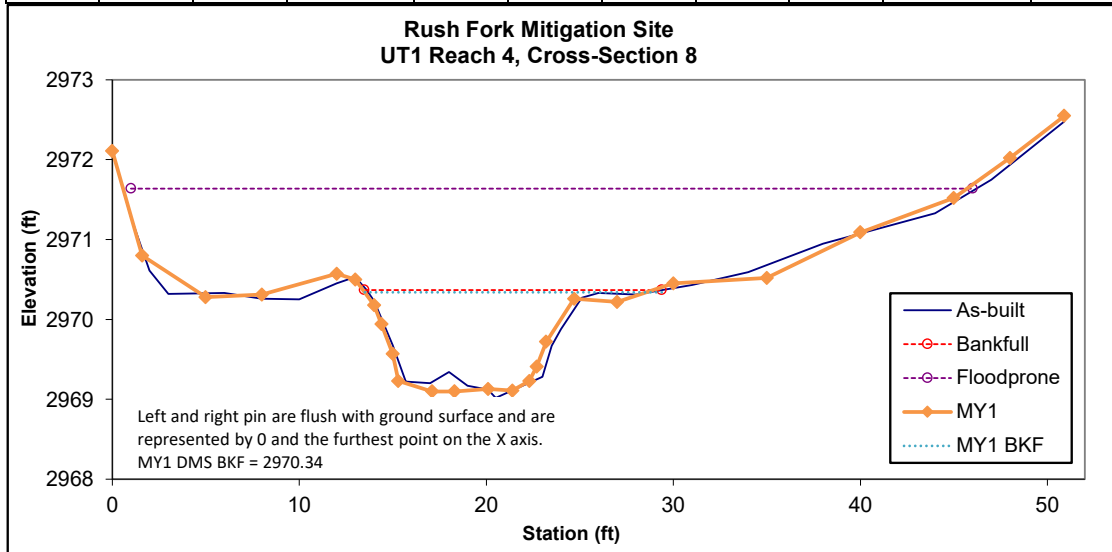
**Permanent Cross-Section 8**

Year 1 Survey Collected: November 2022

Looking at the Left Bank

Looking at the Right Bank

Feature	Stream Type	BKF Area	BKF Width	BKF Depth	Max BKF Depth	W/D	BH Ratio	ER	BKF Elev	LTOB Elev
Riffle	C	11.34	15.55	0.73	1.27	21.30	1.0	2.4	2970.37	2970.37

Note: Per DMS/IRT request, bank height ratio for MY1 has been calculated using the bankfull elevation as determined from the as-built bankfull area. All other values were calculated using the as-built bankfull elevation.

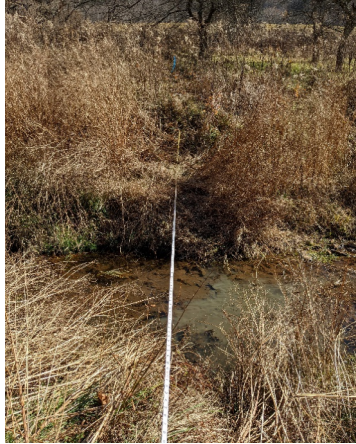
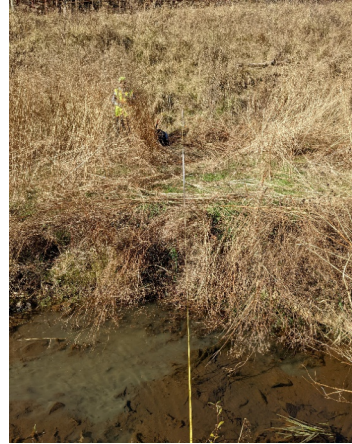
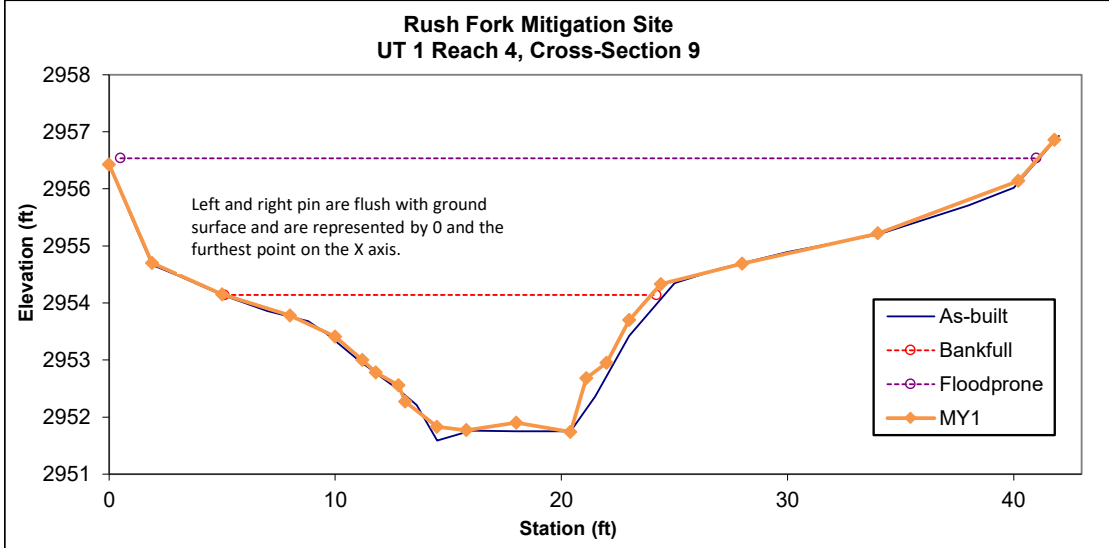
**Permanent Cross-Section 9**

Year 1 Survey Collected: November 2022

Looking at the Left Bank

Looking at the Right Bank

Feature	Stream Type	BKF Area	BKF Width	BKF Depth	Max BKF Depth	W/D	BH Ratio	ER	BKF Elev	LTOB Elev
Pool	B	25.75	19.32	1.33	2.40	14.53	--	--	2954.14	2954.14

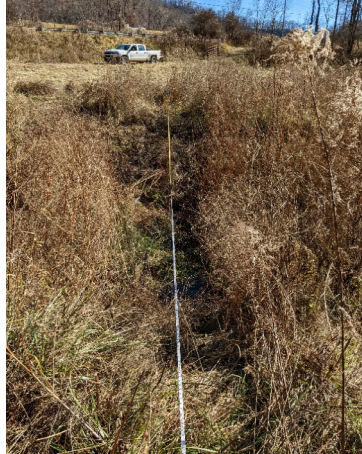
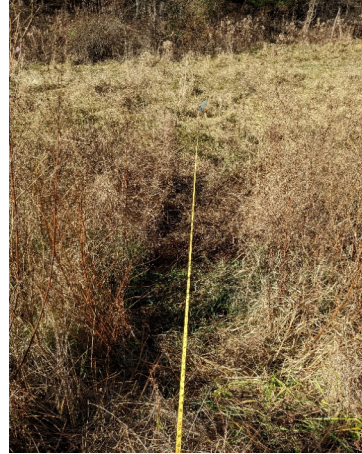
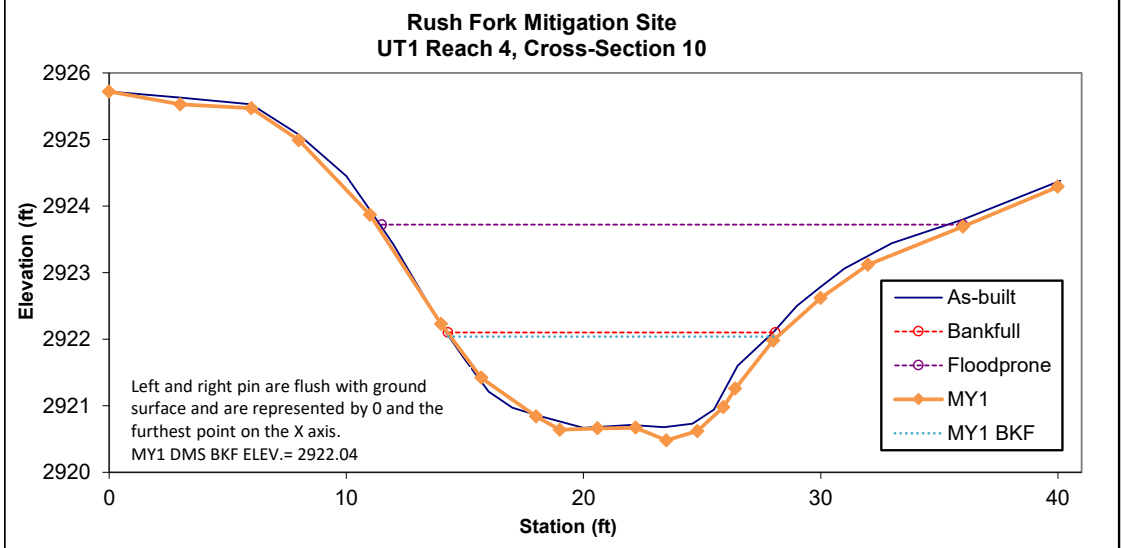
**Permanent Cross-Section 10**

Year 1 Survey Collected: November 2022

Looking at the Left Bank

Looking at the Right Bank

Feature	Stream Type	BKF Area	BKF Width	BKF Depth	Max BKF Depth	W/D	BH Ratio	ER	BKF Elev	LTOB Elev
Riffle	B	15.28	13.73	1.11	1.62	12.37	1.0	1.7	2922.10	2922.10

Note: Per DMS/IRT request, bank height ratio for MY1 has been calculated using the bankfull elevation as determined from the as-built bankfull area. All other values were calculated using the as-built bankfull elevation.

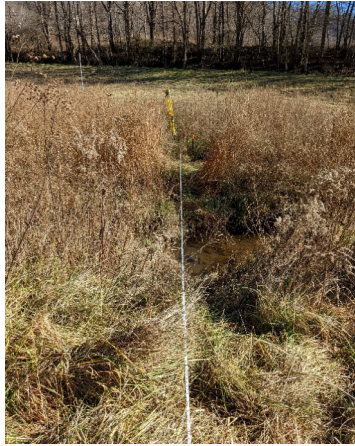
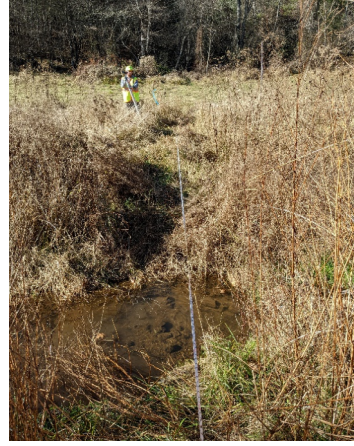
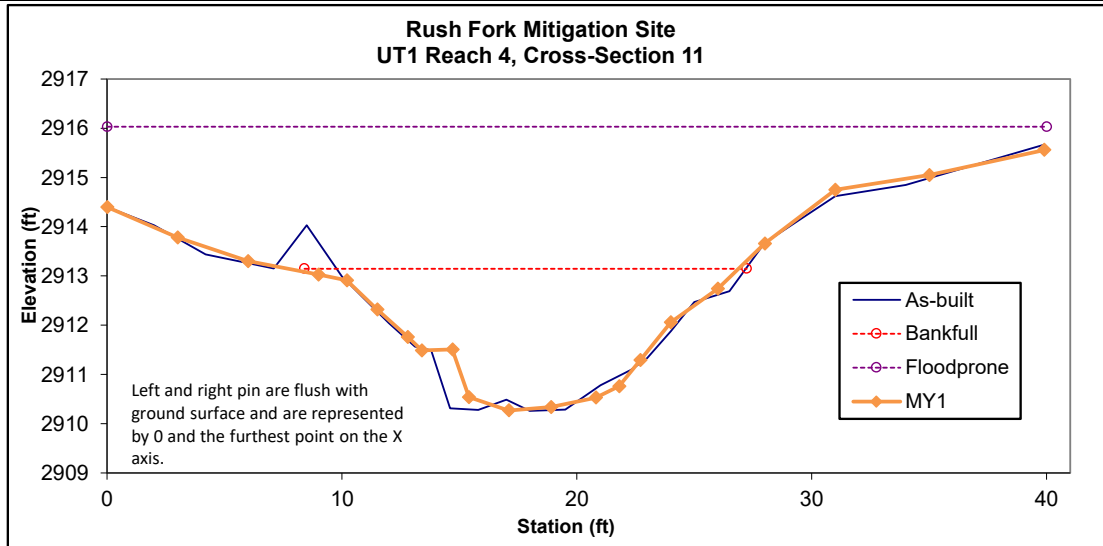
**Permanent Cross-Section 11**

Year 1 Survey Collected: November 2022

Looking at the Left Bank

Looking at the Right Bank

Feature	Stream Type	BKF Area	BKF Width	BKF Depth	Max BKF Depth	W/D	BH Ratio	ER	BKF Elev	LTOB Elev
Pool	E	30.05	20.89	1.44	2.88	14.51	--	--	2913.15	2913.15

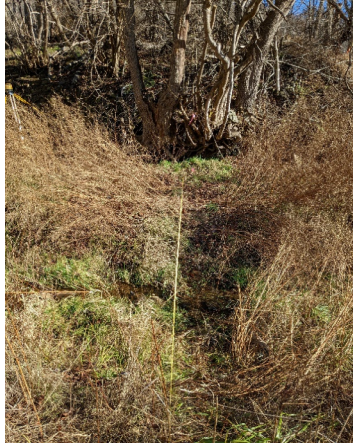
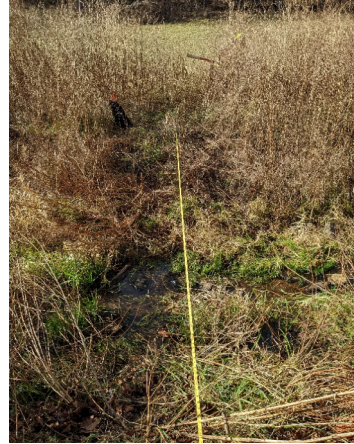
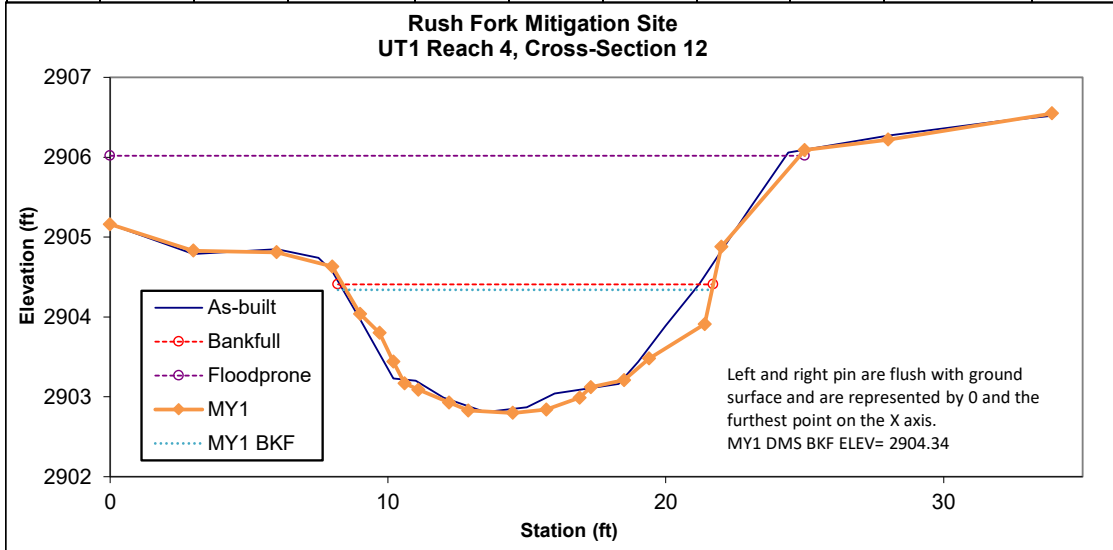
**Permanent Cross-Section 12**

Year 1 Survey Collected: November 2022

Looking at the Left Bank

Looking at the Right Bank

Feature	Stream Type	BKF Area	BKF Width	BKF Depth	Max BKF Depth	W/D	BH Ratio	ER	BKF Elev	LTOB Elev
Riffle	B	15.37	13.71	1.12	1.61	12.24	1.0	1.8	2904.41	2904.41

Note: Per DMS/IRT request, bank height ratio for MY1 has been calculated using the bankfull elevation as determined from the as-built bankfull area. All other values were calculated using the as-built bankfull elevation.

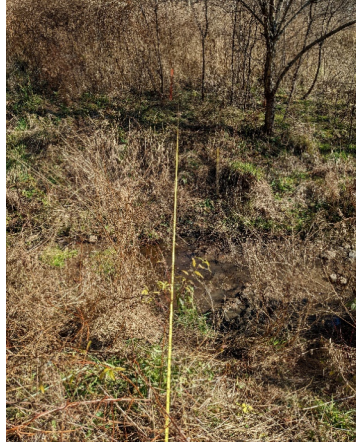
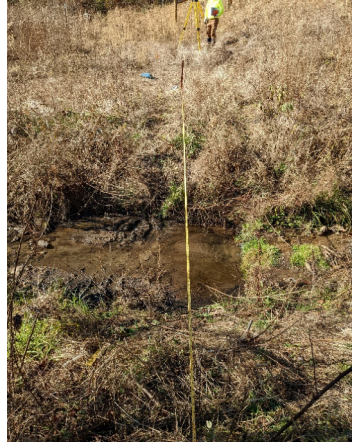
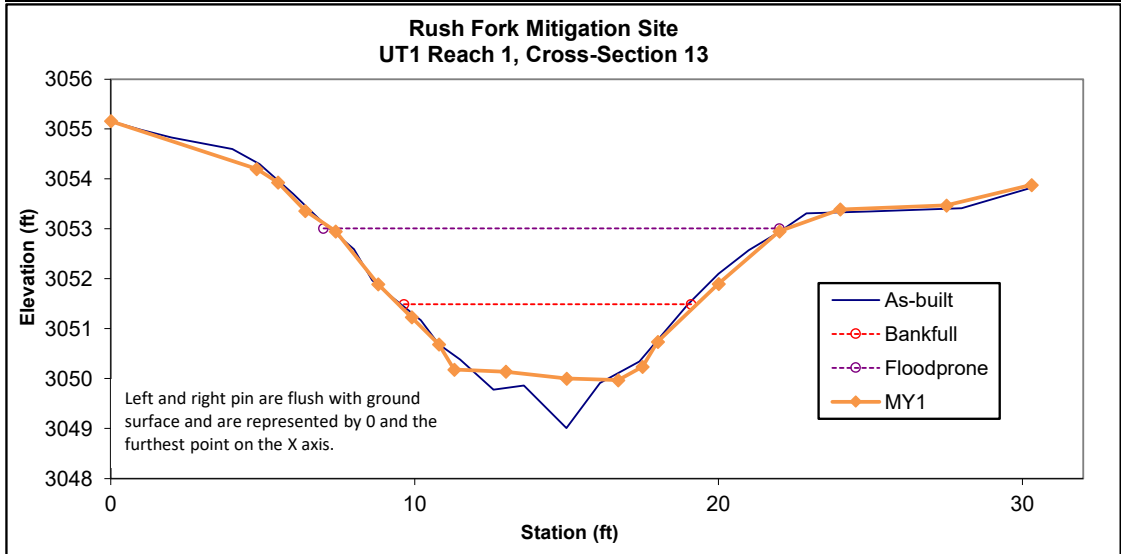
**Permanent Cross-Section 13**

Year 1 Survey Collected: November 2022

Looking at the Left Bank

Looking at the Right Bank

Feature	Stream Type	BKF Area	BKF Width	BKF Depth	Max BKF Depth	W/D	BH Ratio	ER	BKF Elev	LTOB Elev
Pool	E	10.64	9.39	1.13	1.52	8.31	--	--	3051.49	3051.49
