# **UT to Rush Fork Stream Mitigation Project Year 1 (2022) Monitoring Report FINAL**

DMS Project ID No. 100068, DEQ Contract No. 7535

Haywood County, North Carolina, French Broad River Basin: 06010106

MY1 Data Collection Period: October – November 2022

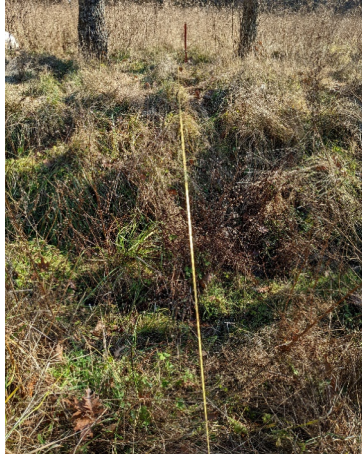
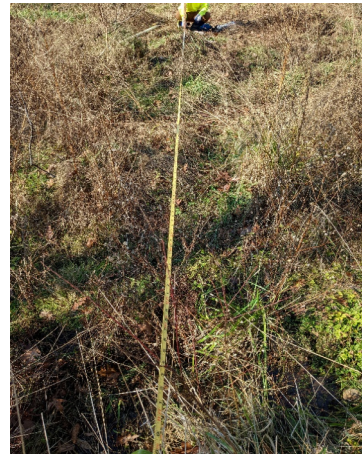
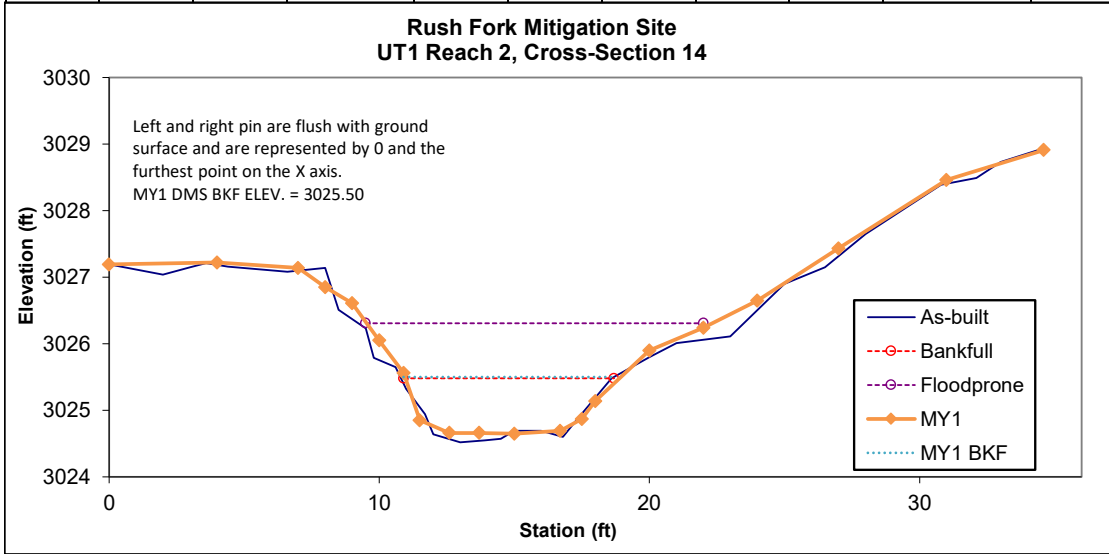
**Permanent Cross-Section 14**

Year 1 Survey Collected: November 2022

Looking at the Left Bank

Looking at the Right Bank

Feature	Stream Type	BKF Area	BKF Width	BKF Depth	Max BKF Depth	W/D	BH Ratio	ER	BKF Elev	LTOB Elev
Riffle	B	5.29	7.99	0.66	0.83	12.11	1	1.6	3025.48	3025.48

Note: Per DMS/IRT request, bank height ratio for MY1 has been calculated using the bankfull elevation as determined from the as-built bankfull area. All other values were calculated using the as-built bankfull elevation.

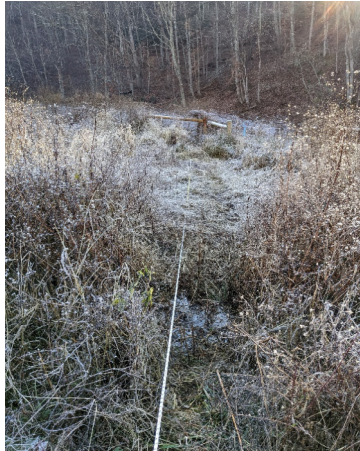
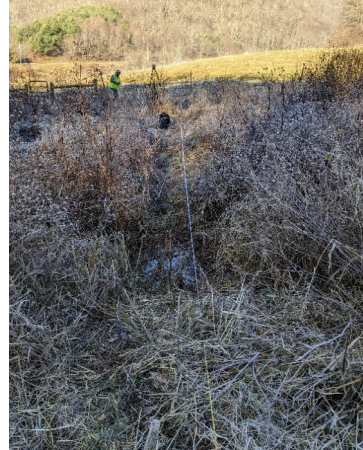
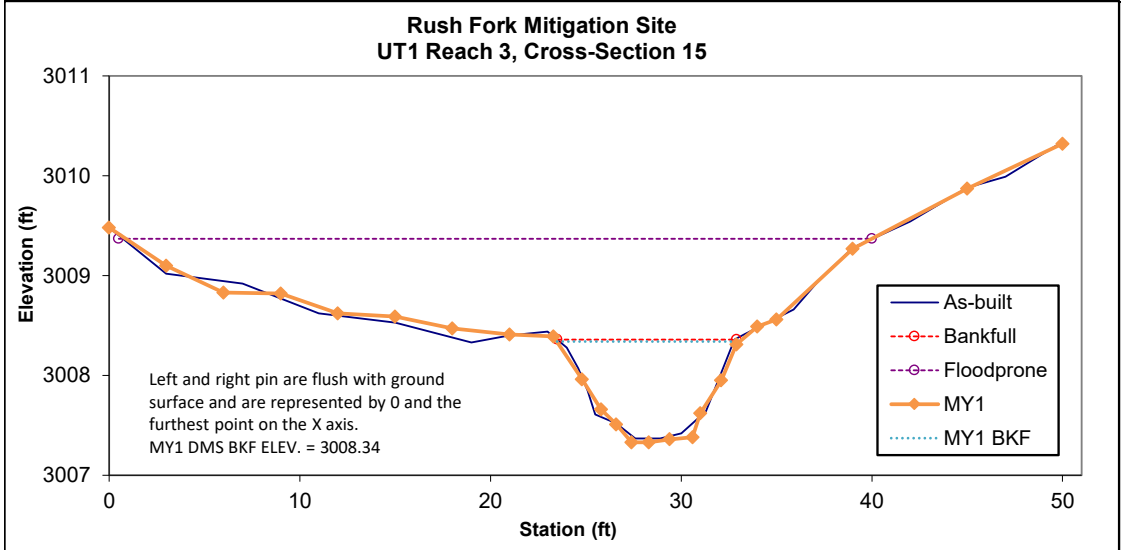
**Permanent Cross-Section 15**

Year 1 Survey Collected: November 2022

Looking at the Left Bank

Looking at the Right Bank

Feature	Stream Type	BKF Area	BKF Width	BKF Depth	Max BKF Depth	W/D	BH Ratio	ER	BKF Elev	LTOB Elev
Riffle	C	6.48	9.46	0.69	1.02	13.71	1	4	3008.35	3008.35

Note: Per DMS/IRT request, bank height ratio for MY1 has been calculated using the bankfull elevation as determined from the as-built bankfull area. All other values were calculated using the as-built bankfull elevation.

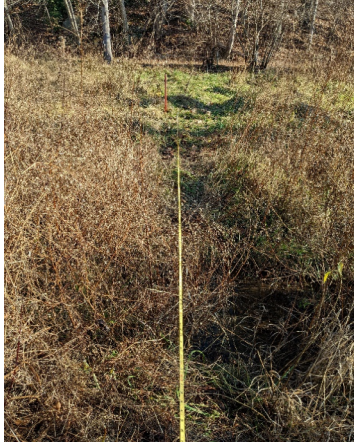
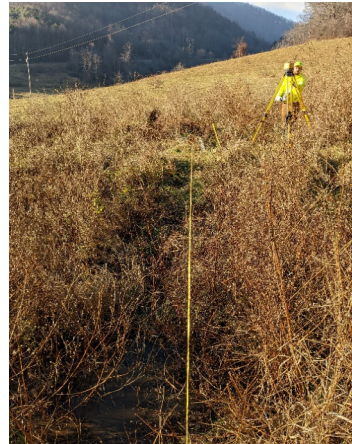
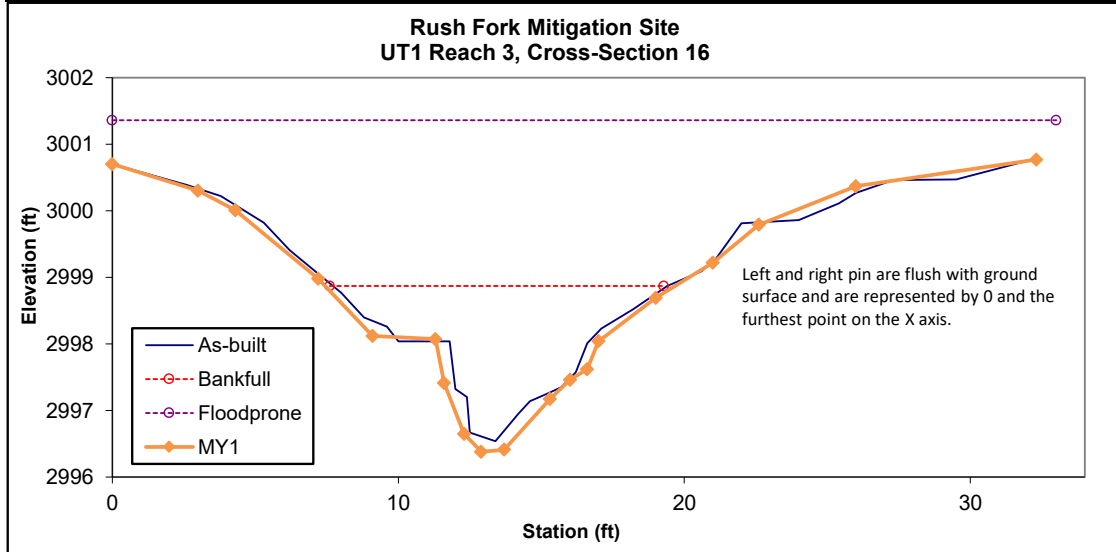
**Permanent Cross-Section 16**  
 Year 1 Survey Collected: November 2022

Looking at the Left Bank

Looking at the Right Bank

Feature	Stream Type	BKF Area	BKF Width	BKF Depth	Max BKF Depth	W/D	BH Ratio	ER	BKF Elev	LTOB Elev
Pool	E	14.14	12.48	1.13	2.49	11.04	--	--	2998.87	2998.87

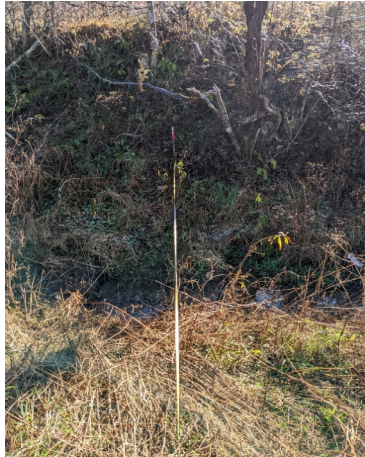
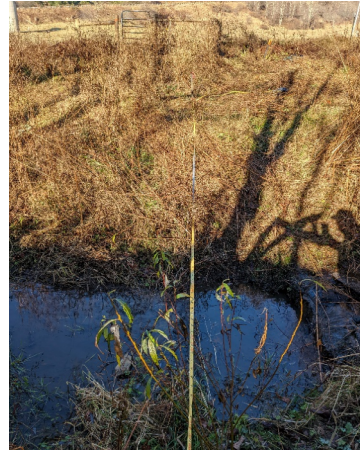
**Permanent Cross-Section 17**

Year 1 Survey Collected: November 2022

Looking at the Left Bank

Looking at the Right Bank

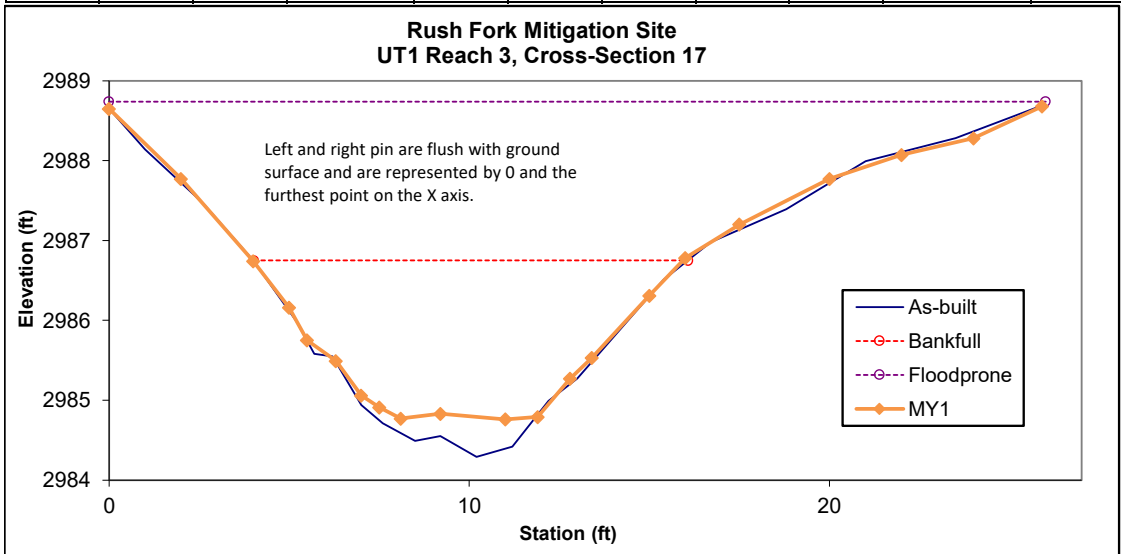
Feature	Stream Type	BKF Area	BKF Width	BKF Depth	Max BKF Depth	W/D	BH Ratio	ER	BKF Elev	LTOB Elev
Pool	B	15.99	11.94	1.34	1.99	8.91	--	--	2986.75	2986.75

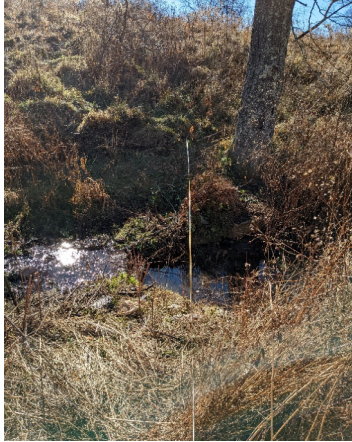
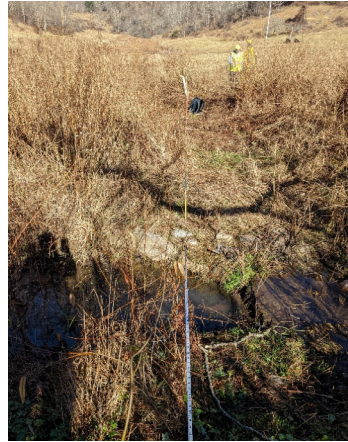
**Permanent Cross-Section 18**

Year 1 Survey Collected: November 2022

Looking at the Left Bank

Looking at the Right Bank

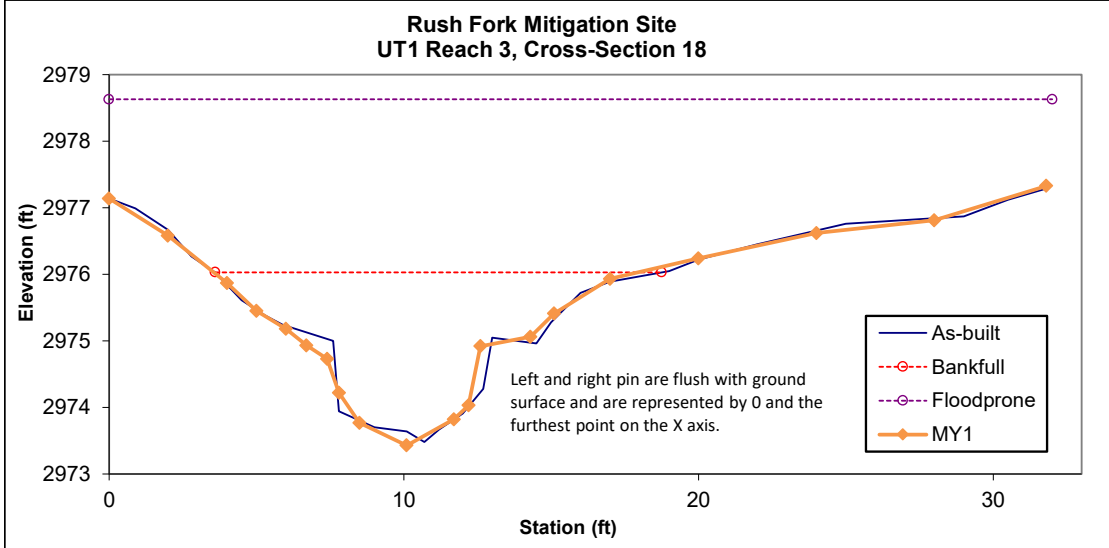
Feature	Stream Type	BKF Area	BKF Width	BKF Depth	Max BKF Depth	W/D	BH Ratio	ER	BKF Elev	LTOB Elev
Pool	B	17.1	13.5	1.3	2.6	10.6	--	--	2976.03	2976.03

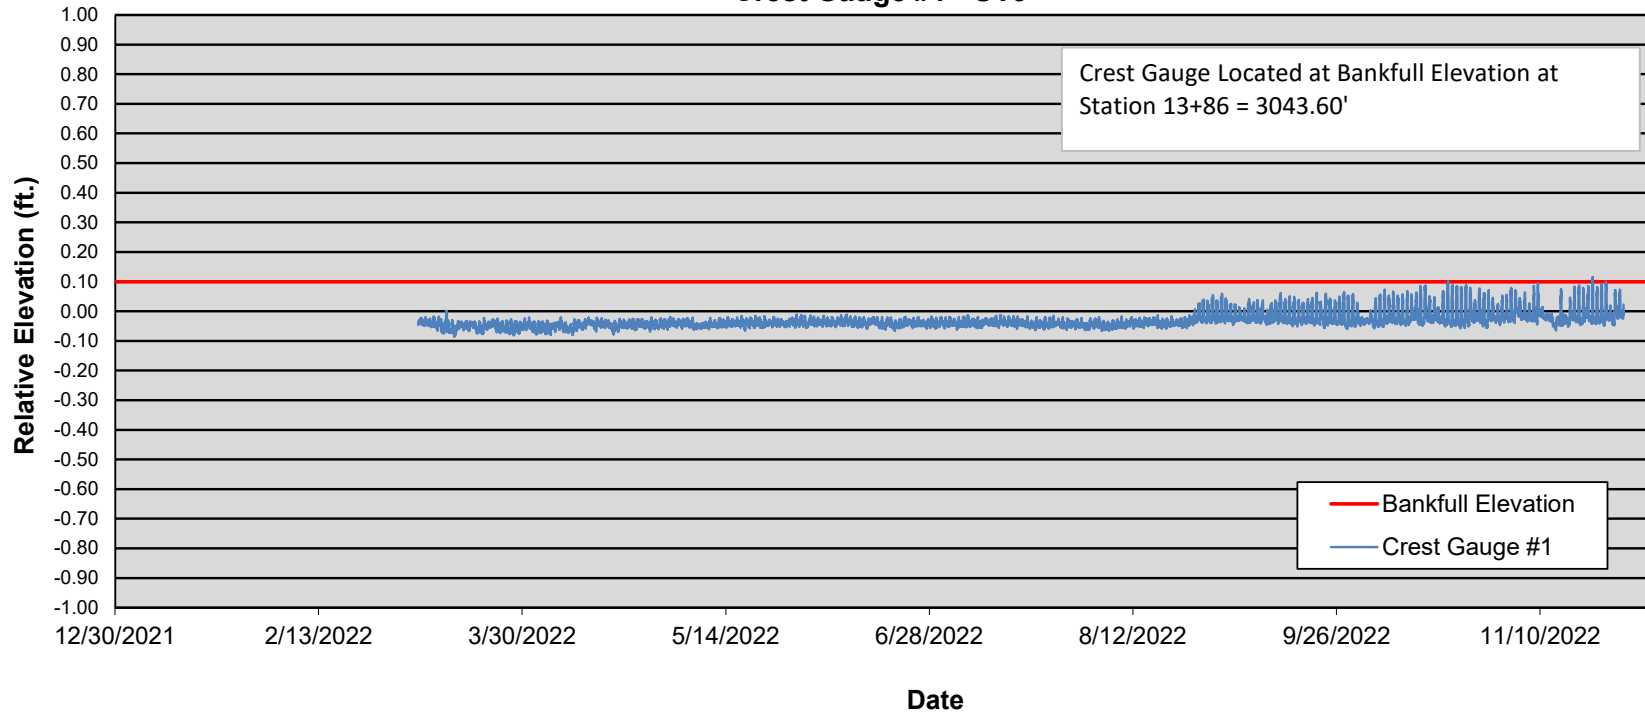
### Rush Fork Crest Gauge #1 - UT3

Note: Crest gauge readings were corroborated with associated spikes in the automated Continuous Stage Recorder (see graph in Appendix E) and/or with photographs (Appendix B).

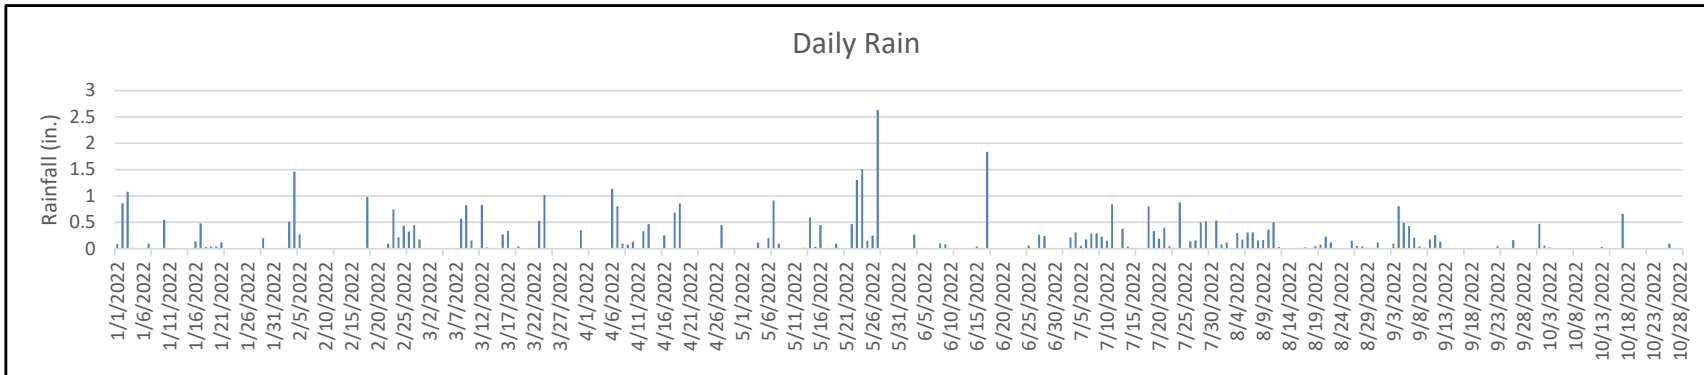
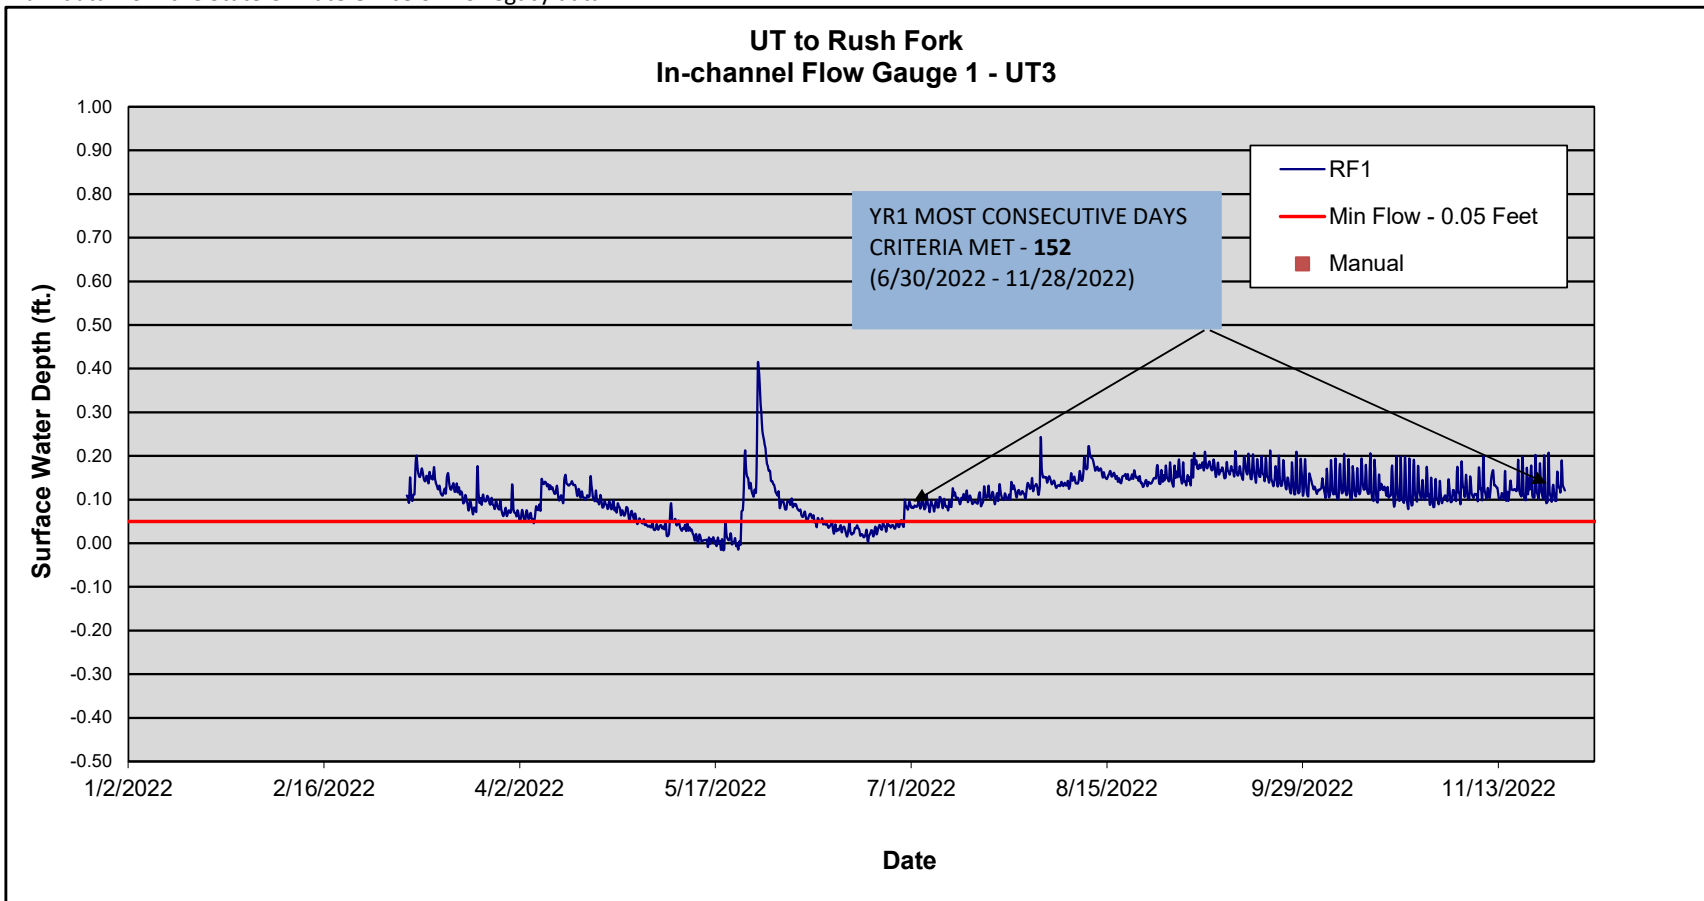
Figure 5 Flow Gauge Graphs

Rain data from the State Climate Office of NC Legacy data.

\*Surface water flow is estimated to have occurred when the pressure transducer reading is equal to or above 0.05 feet in depth.

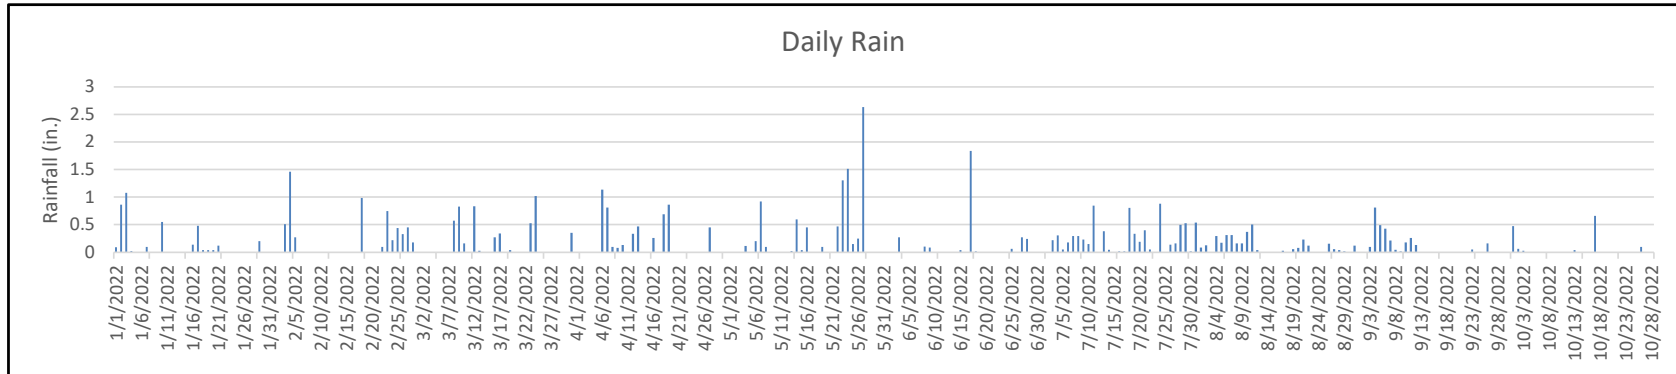
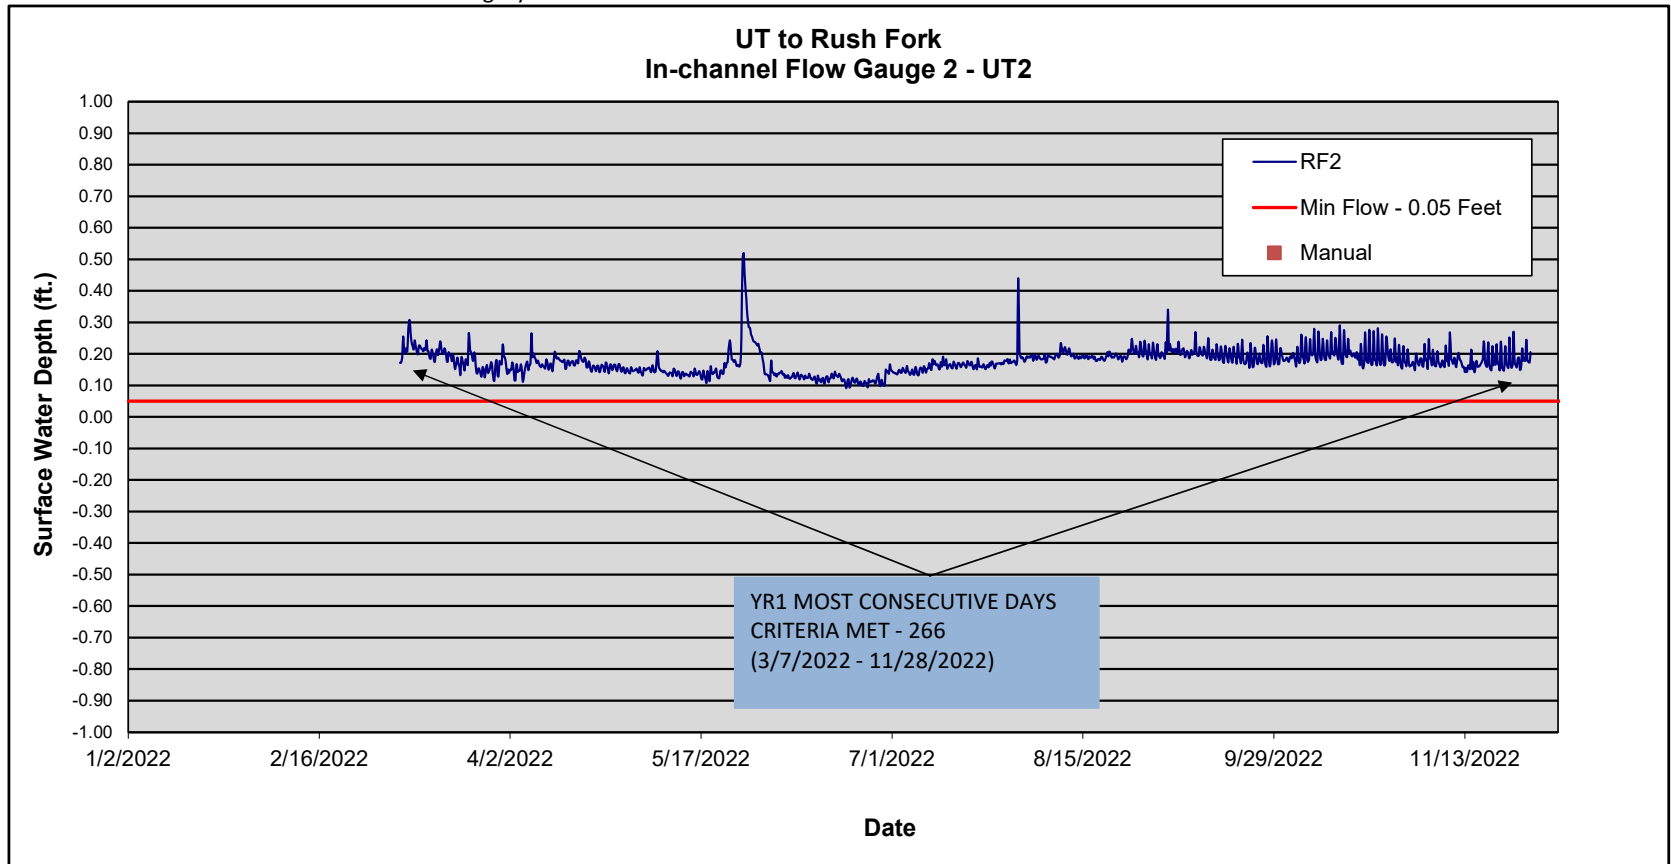
Figure 5 Flow Gauge Graphs

Rain data from the State Climate Office of NC Legacy data.

\*Surface water flow is estimated to have occurred when the pressure transducer reading is equal to or above 0.05 feet in depth.

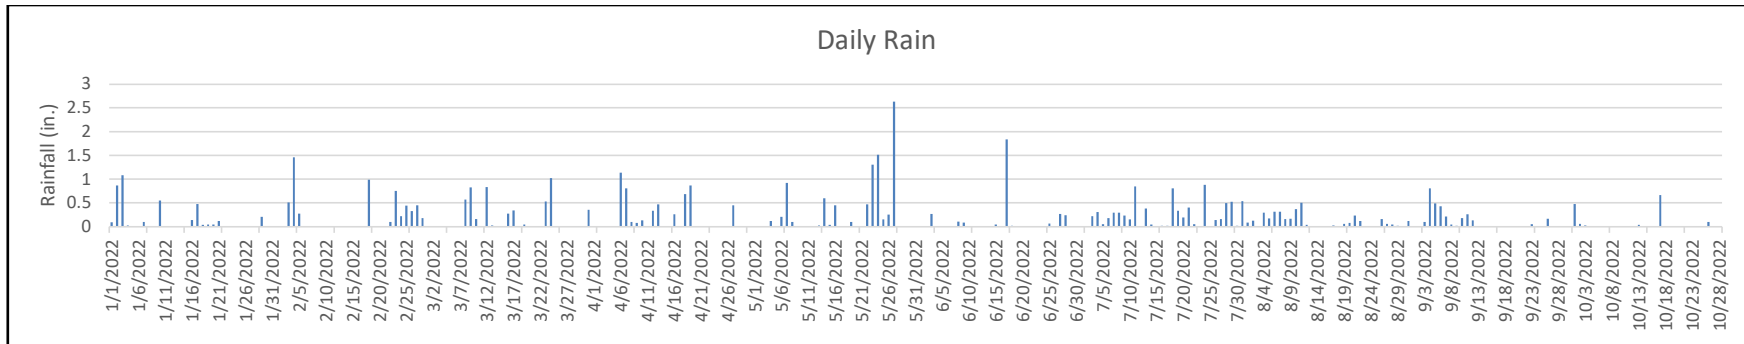
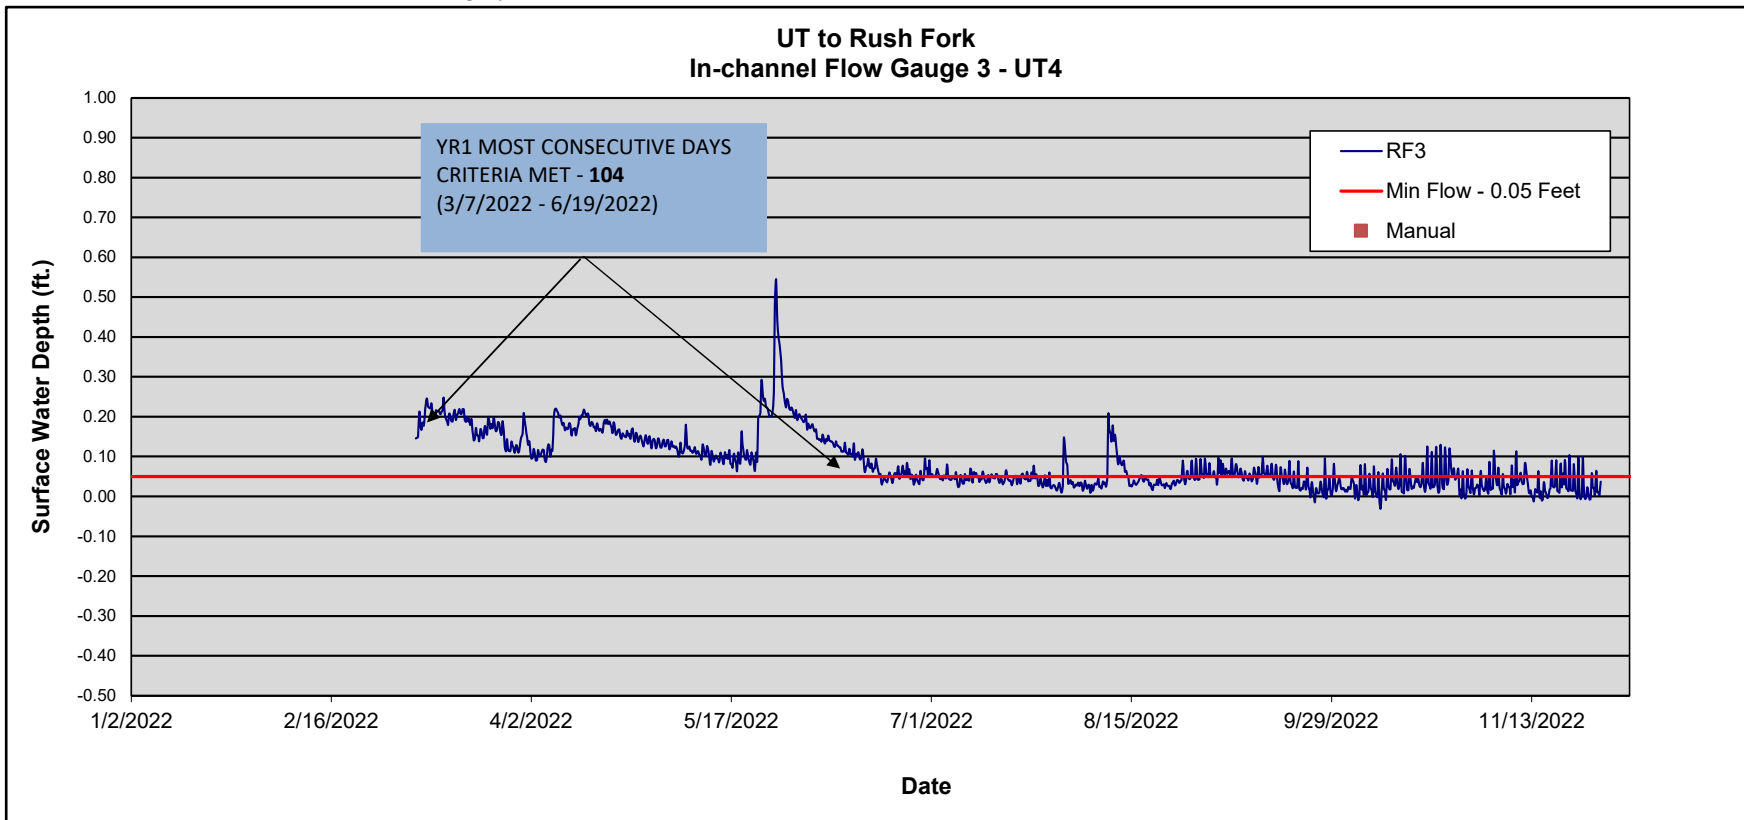
Figure 5 Flow Gauge Graphs

Rain data from the State Climate Office of NC Legacy data.

\*Surface water flow is estimated to have occurred when the pressure transducer reading is equal to or above 0.05 feet in depth.
